Heath Dairy Road Stream Restoration Site Randolph County, North Carolina

DMS Project #170

MY – 02 Fall Monitoring Report

Mogensen Mitigation, Inc.

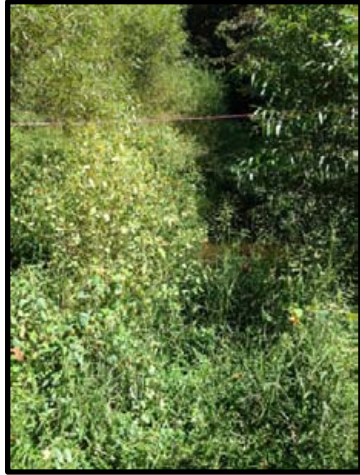
Cross Section 1 (upstream) MY2

Photographs illustrate the site's vegetation and morphological stability on an annual basis. Cross-section photos should demonstrate no excessive erosion or degradation of the banks. Longitudinal photos should indicate the absence of persistent bars within the channel or vertical incision. Grade control structures should remain stable. Deposition of sediment on the bank side of vane arms is preferable. Maintenance of scour pools on the channel side of vane arms is expected. Reference photos will also be taken for each of the vegetation plots.

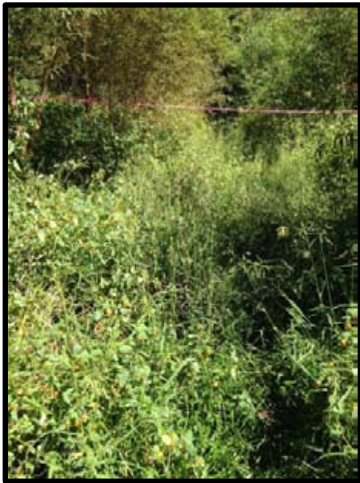
Cross Section 2 (upstream) MY2

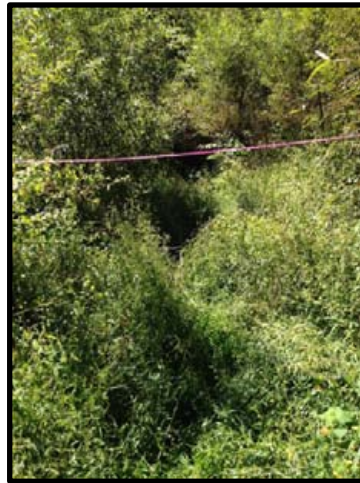
Cross Section 2 (downstream) MY2

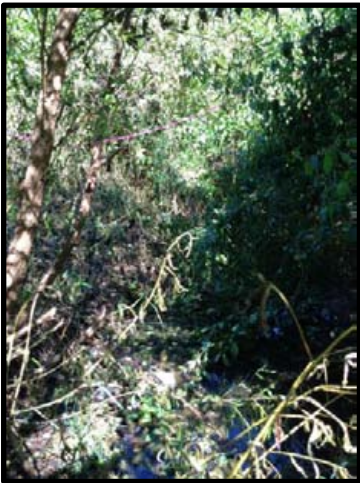
Cross Section 3 (upstream) MY2

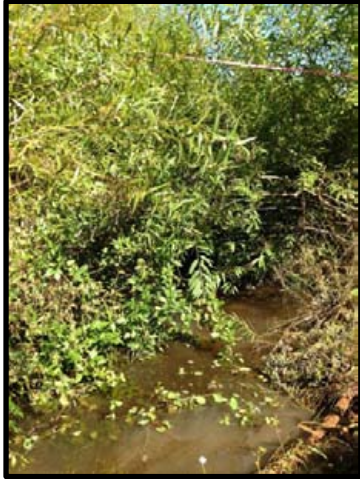
Cross Section 4 (upstream) MY2

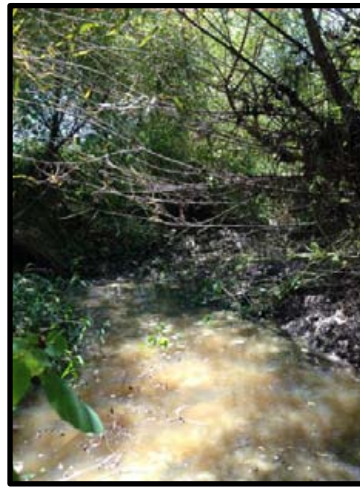
Cross Section 5 (downstream) MY2

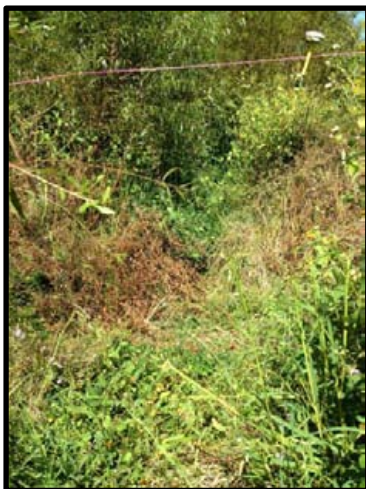
Cross Section 6 (upstream) MY2

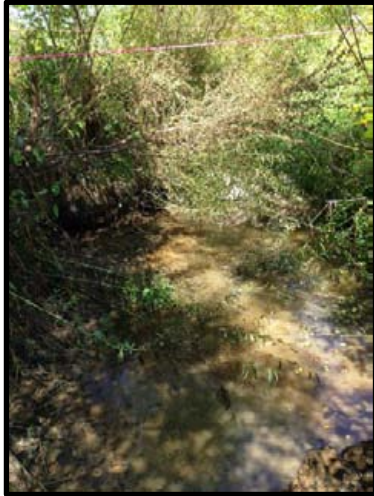
Cross Section 7 (upstream) MY2

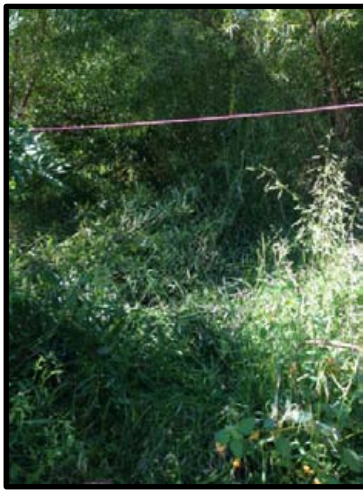
Cross Section 8 (upstream) MY2

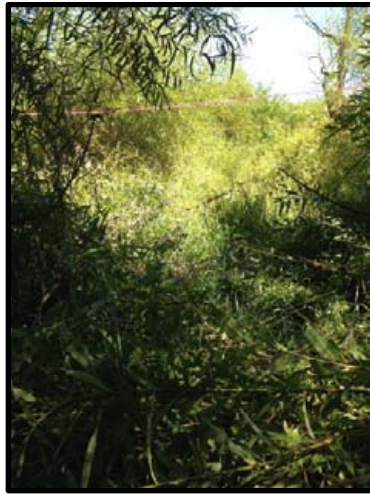
Cross Section 8 (downstream) MY2

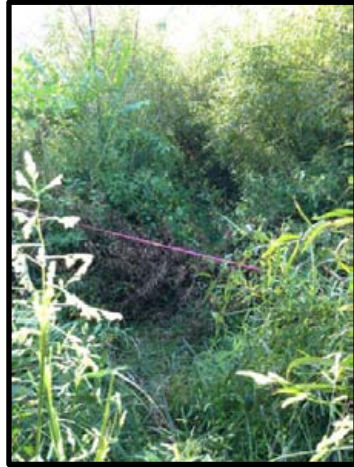
Cross Section 10 (upstream) MY2

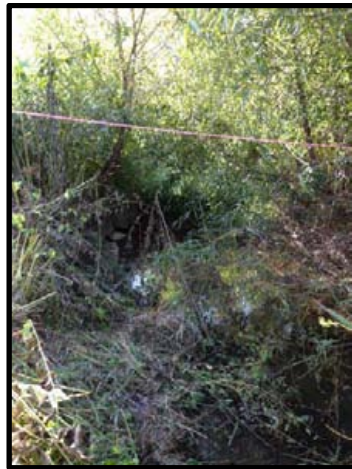
Cross Section 11 (upstream) MY2

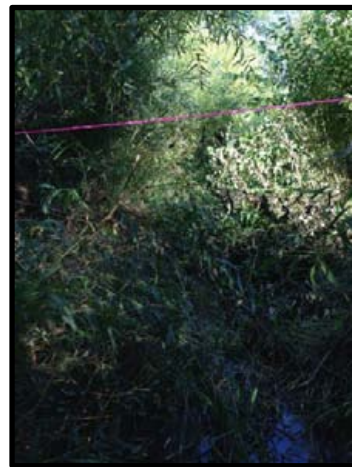
Cross Section 11 (downstream) MY2

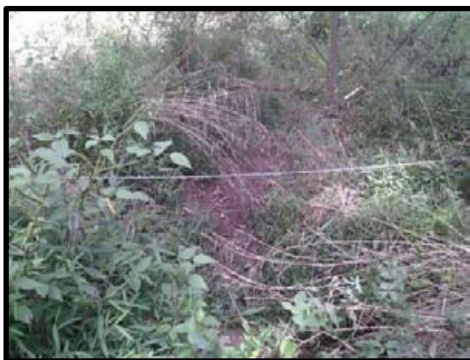
Cross Section 12 (upstream) MY2

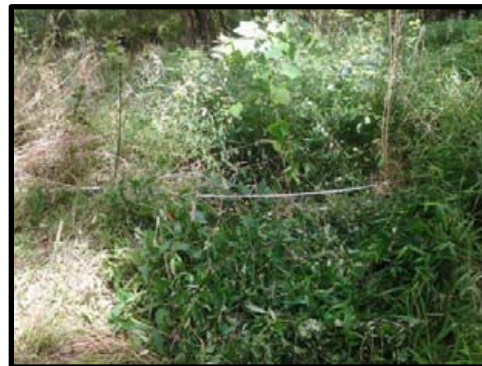
Cross Section 12 (downstream) MY2

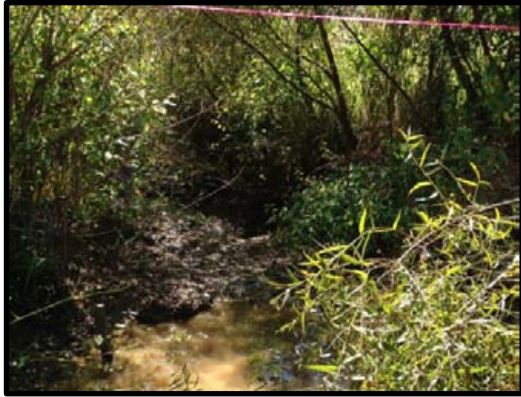
Cross Section 13 (upstream) MY2

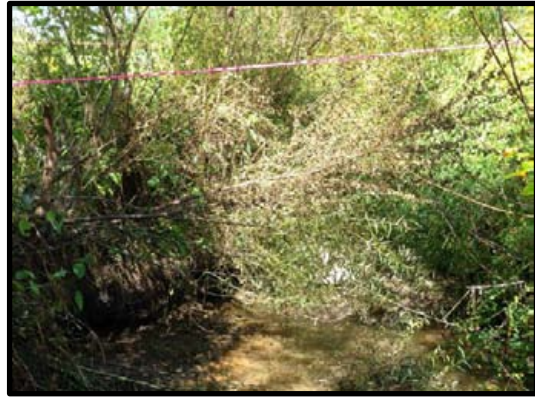
Cross Section 13 (downstream) MY2

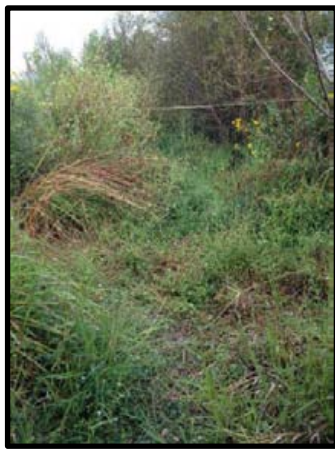
Cross Section 14 (upstream) MY2

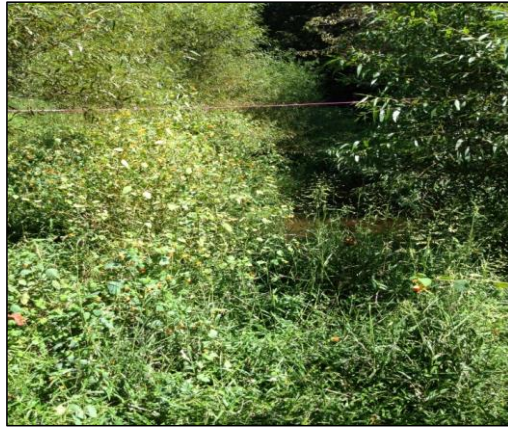
XS-1: Upstream

Figure 3.1 Cross Section Data

Project Name	Heath Dairy
DMS Project Number	170
Cross-Section ID	XS-1, Pool
Survey Date	9/2015
SUMMARY DATA	
Bankfull Elevation (ft)	613.16
Bankfull Cross-Sectional Area (ft ²)	13.80
Bankfull Width (ft)	19.57
Flood Prone Area Elevation (ft)	614.20
Flood Prone Width (ft)	32.00
Bankfull Mean Depth (ft)	0.96
Bankfull Max Depth (ft)	1.05
W/D Ratio	20.38
Entrenchment Ratio	1.64
Bank Height Ratio	1.00

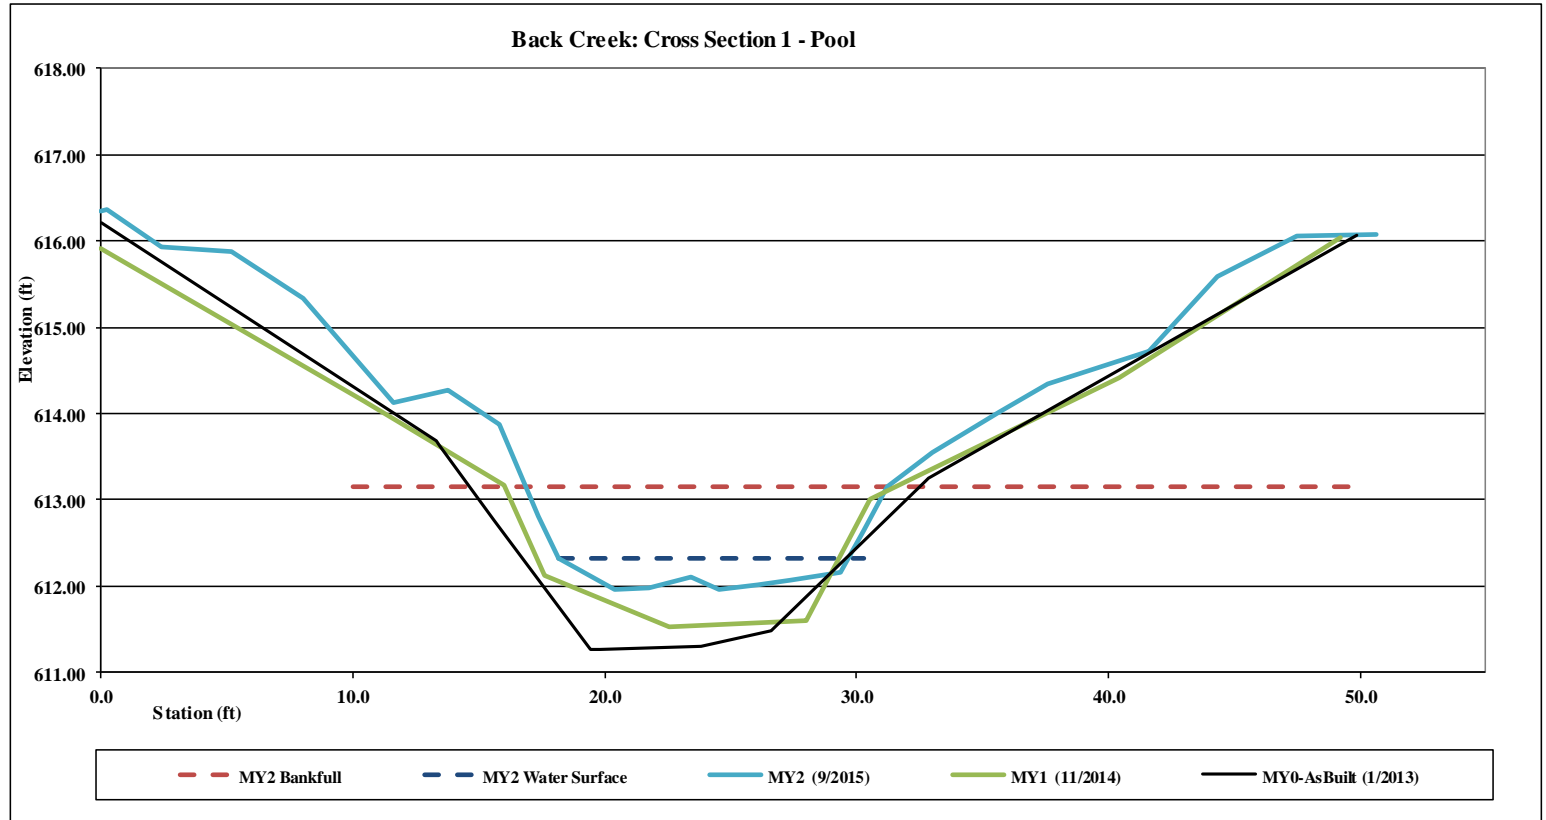
Station	Elevation	Notes
0.00	616.34	LPIN
0.23	616.37	
2.39	615.94	
5.16	615.88	
8.03	615.34	
11.64	614.13	TLB
13.77	614.26	
15.81	613.88	
17.38	612.80	
18.19	612.32	LEW
20.41	611.96	
21.78	611.98	
23.41	612.11	THW
24.54	611.97	
26.12	612.02	
27.38	612.07	
29.37	612.16	
30.28	612.65	REW
31.21	613.16	TRB
33.04	613.55	
35.69	614.01	
37.60	614.34	
41.62	614.72	
44.31	615.59	
47.46	616.05	
50.67	616.07	RPIN

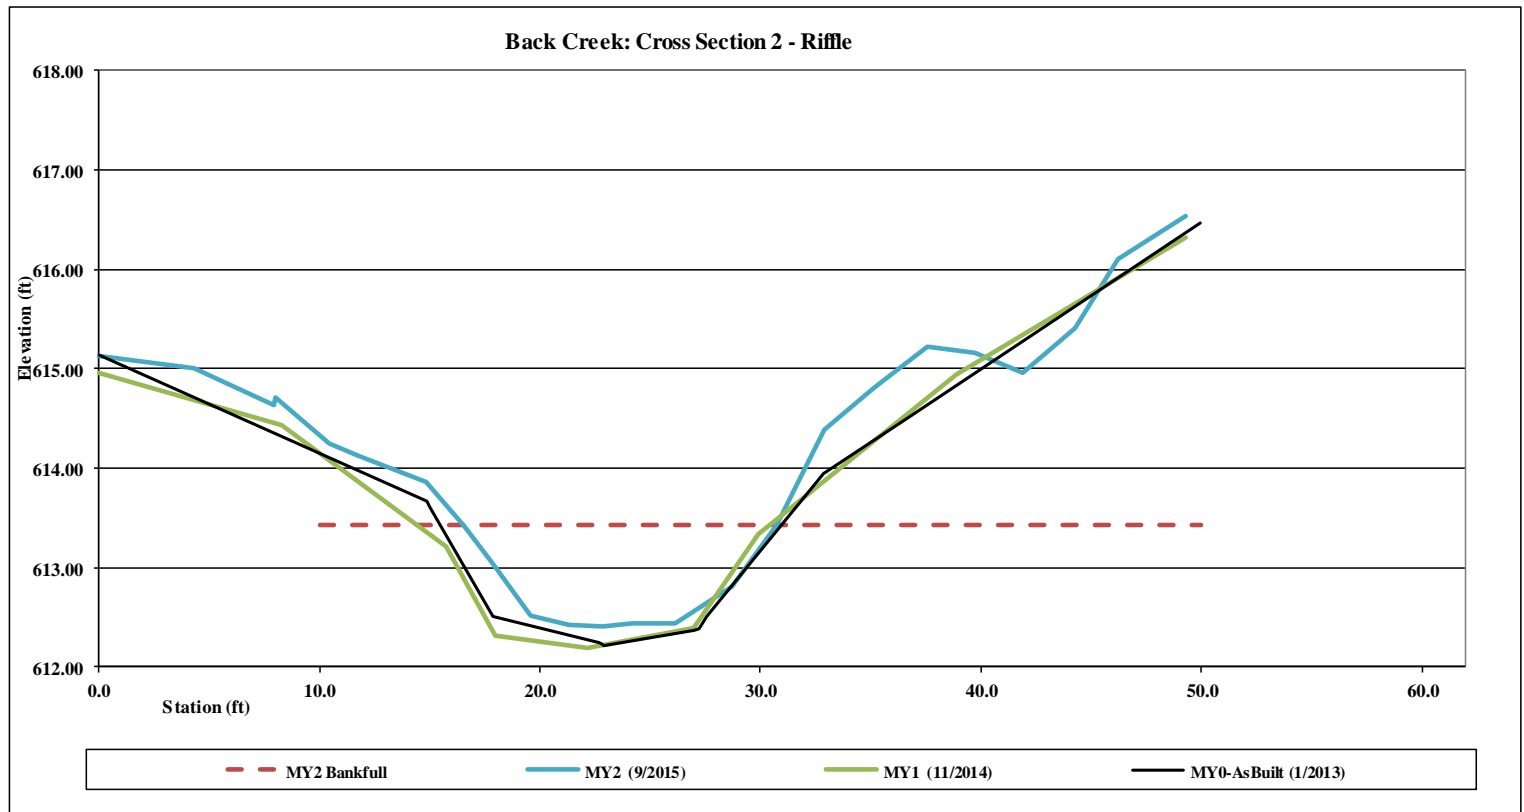
Figure 3.2 Cross Section Data

Project Name	Heath Dairy
DMS Project Number	170
Cross-Section ID	XS-2, Riffle
Survey Date	9/2015
SUMMARY DATA	
Bankfull Elevation (ft)	613.43
Bankfull Cross-Sectional Area (ft²)	10.70
Bankfull Width (ft)	15.87
Flood Prone Area Elevation (ft)	614.46
Flood Prone Width (ft)	25.30
Bankfull Mean Depth (ft)	0.75
Bankfull Max Depth (ft)	1.03
W/D Ratio	21.16
Entrenchment Ratio	1.59
Bank Height Ratio	1.00

Station	Elevation	Notes
0.00	615.13	LPIN
4.33	615.00	
7.95	614.63	
8.00	614.71	
10.45	614.25	
11.76	614.12	
14.84	613.86	TLB
16.57	613.41	
17.91	613.03	
19.56	612.51	
21.29	612.42	
22.85	612.40	THW
24.17	612.44	
26.14	612.43	
28.72	612.81	
30.71	613.43	TRB
32.90	614.38	
35.12	614.80	
37.59	615.22	
39.74	615.16	
41.90	614.97	
44.29	615.41	
46.24	616.10	
49.28	616.54	RPIN

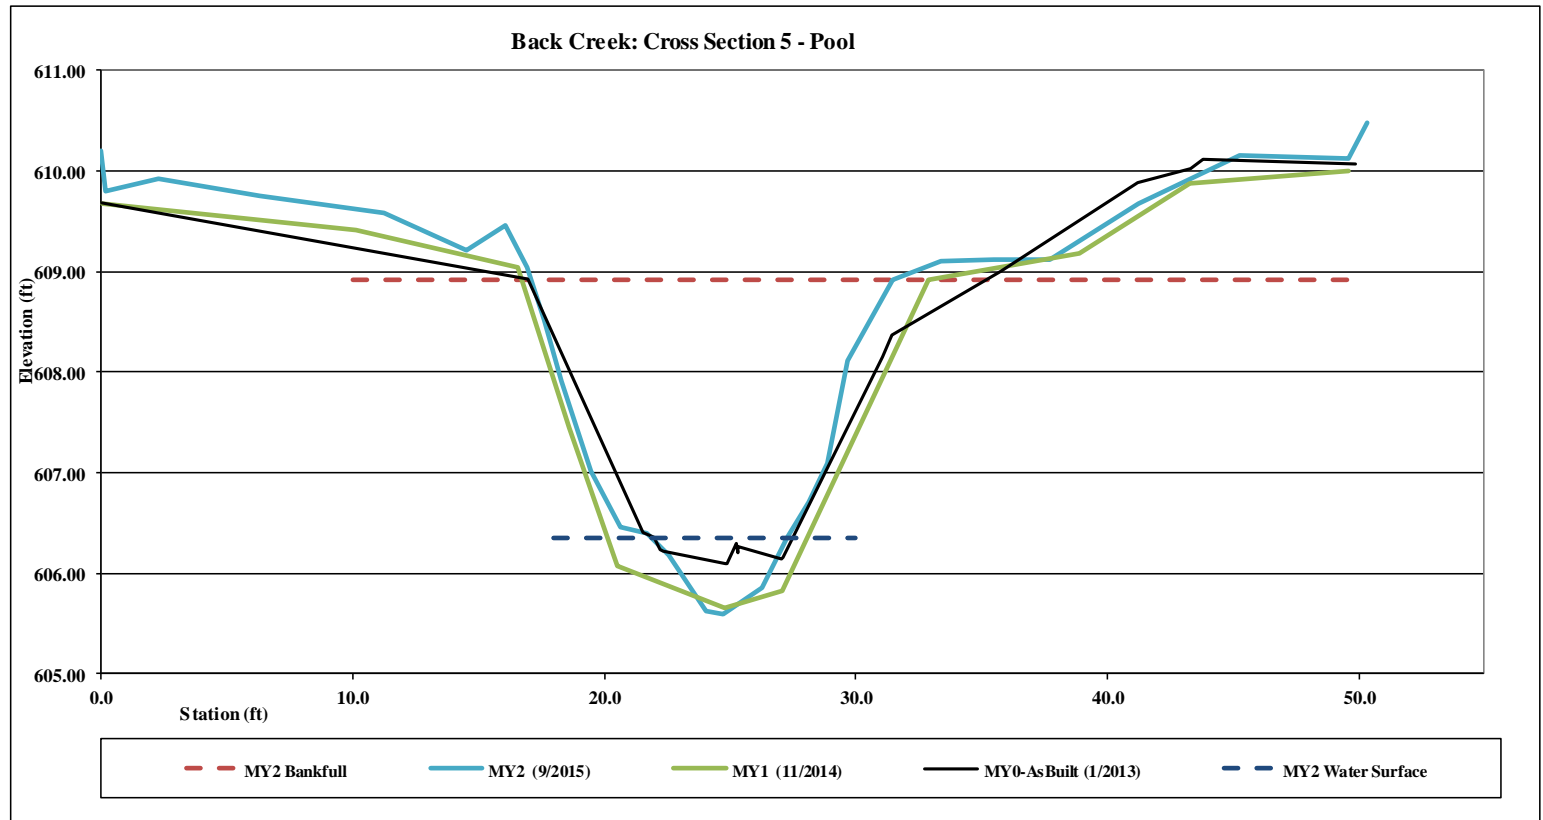
Figure 3.5 Cross Section Data

Project Name	Heath Dairy
DMS Project Number	170
Cross-Section ID	XS-5, Pool
Survey Date	9/2015
SUMMARY DATA	
Bankfull Elevation (ft)	608.92
Bankfull Cross-Sectional Area (ft²)	29.60
Bankfull Width (ft)	17.33
Flood Prone Area Elevation (ft)	612.23
Flood Prone Width (ft)	50.00
Bankfull Mean Depth (ft)	2.06
Bankfull Max Depth (ft)	3.30
W/D Ratio	8.41
Entrenchment Ratio	2.89
Bank Height Ratio	1.00

Station	Elevation	Notes
0.00	610.20	LPIN
0.19	609.79	
2.27	609.92	
6.28	609.76	
11.28	609.58	
14.52	609.22	
16.07	609.45	TLB
16.94	609.04	
17.60	608.52	
18.27	607.91	
19.47	607.02	
20.64	606.45	
21.73	606.39	LEW
22.58	606.18	
24.04	605.62	THW
24.73	605.58	
26.28	605.86	
27.25	606.35	REW
28.12	606.71	
28.88	607.10	
29.69	608.11	
31.50	608.92	
33.41	609.10	TRB
35.46	609.12	
37.71	609.12	
41.24	609.68	
45.24	610.16	
49.61	610.13	
50.34	610.48	RPIN

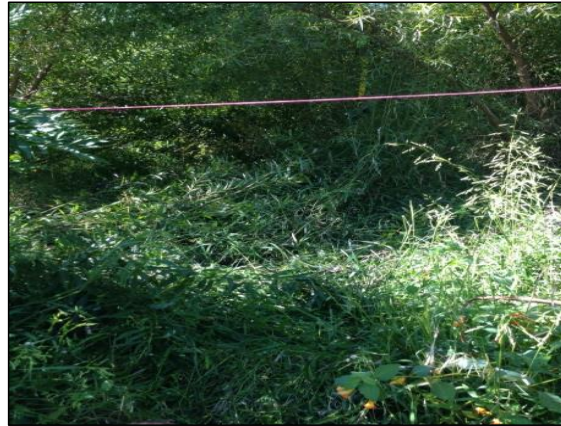
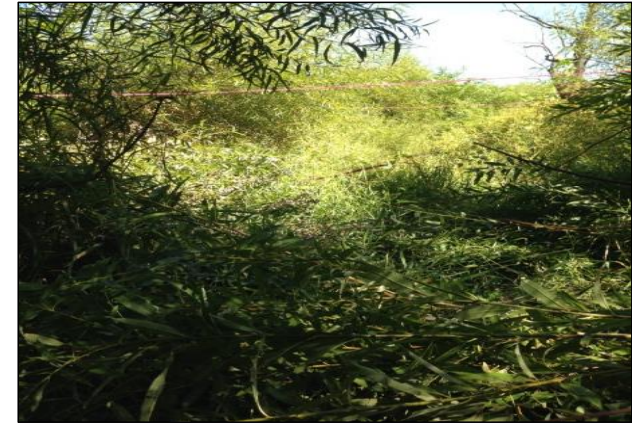
Figure 3.8 Cross Section Data

Project Name	Heath Dairy
DMS Project Number	170
Cross-Section ID	XS-8 - Riffle
Survey Date	9/2015
SUMMARY DATA	
Bankfull Elevation (ft)	602.42
Bankfull Cross-Sectional Area (ft²)	28.10
Bankfull Width (ft)	23.26
Flood Prone Area Elevation (ft)	604.32
Flood Prone Width (ft)	100.00
Bankfull Mean Depth (ft)	1.10
Bankfull Max Depth (ft)	1.90
W/D Ratio	21.15
Entrenchment Ratio	4.30
Bank Height Ratio	1.00

XS-8: Upstream

XS-8: Downstream

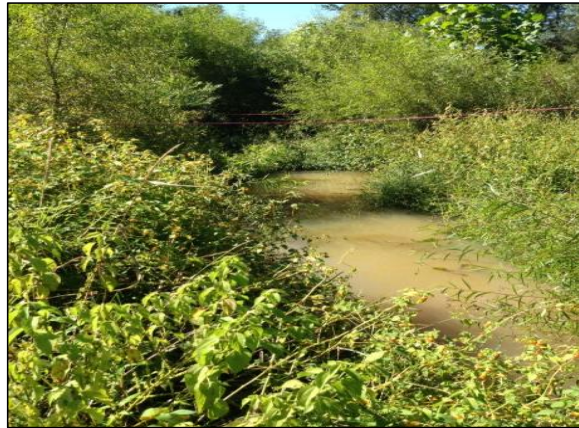
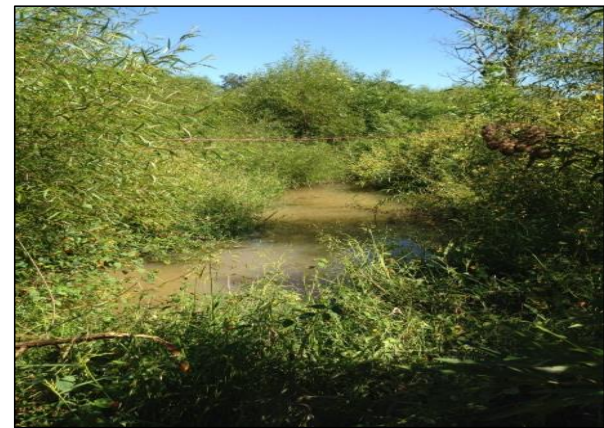
Figure 3.9 Cross Section Data

Project Name	Heath Dairy
DMS Project Number	170
Cross-Section ID	XS-9, Pool
Survey Date	9/2015
SUMMARY DATA	
Bankfull Elevation (ft)	602.77
Bankfull Cross-Sectional Area (ft ²)	52.00
Bankfull Width (ft)	21.64
Flood Prone Area Elevation (ft)	606.52
Flood Prone Width (ft)	100.00
Bankfull Mean Depth (ft)	1.33
Bankfull Max Depth (ft)	3.75
W/D Ratio	16.27
Entrenchment Ratio	4.62
Bank Height Ratio	1.00

XS-9: Upstream

XS-9: Downstream

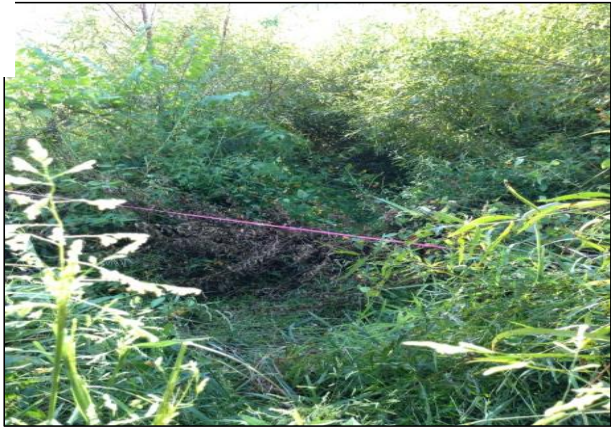
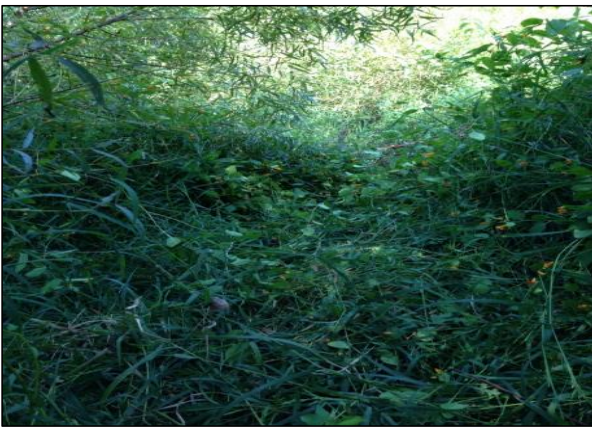
Figure 3.10 Cross Section Data

Project Name	Heath Dairy
DMS Project Number	170
Cross-Section ID	XS-10, Riffle
Survey Date	9/2015
SUMMARY DATA	
Bankfull Elevation (ft)	599.9
Bankfull Cross-Sectional Area (ft²)	21.90
Bankfull Width (ft)	24.41
Flood Prone Area Elevation (ft)	601.71
Flood Prone Width (ft)	100.00
Bankfull Mean Depth (ft)	0.92
Bankfull Max Depth (ft)	1.81
W/D Ratio	26.54
Entrenchment Ratio	4.10
Bank Height Ratio	1.00

XS-10: Upstream

XS-10: Downstream

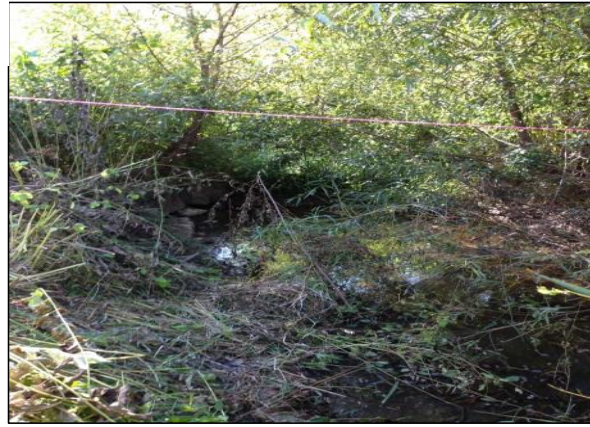
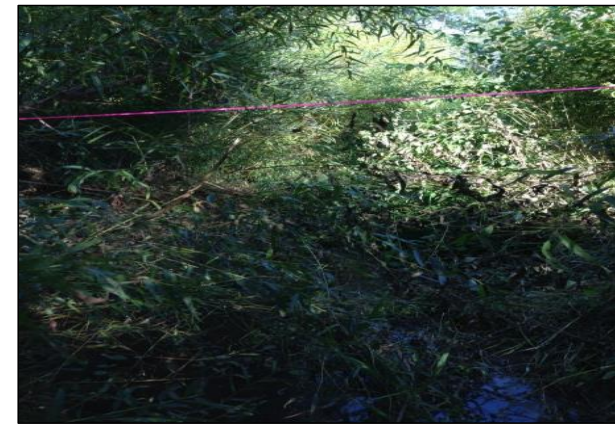
Figure 3.11 Cross Section Data

Project Name	Heath Dairy
DMS Project Number	170
Cross-Section ID	XS-11, Pool
Survey Date	9/2015
SUMMARY DATA	
Bankfull Elevation (ft)	599.55
Bankfull Cross-Sectional Area (ft²)	28.80
Bankfull Width (ft)	19.04
Flood Prone Area Elevation (ft)	602.40
Flood Prone Width (ft)	100.00
Bankfull Mean Depth (ft)	1.64
Bankfull Max Depth (ft)	2.85
W/D Ratio	11.61
Entrenchment Ratio	5.25
Bank Height Ratio	1.00

XS-11: Upstream

XS-11: Downstream

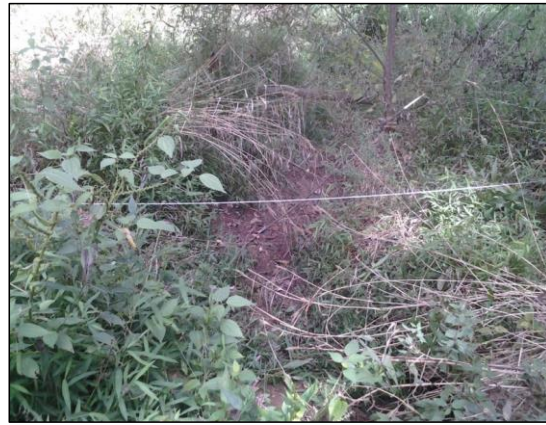
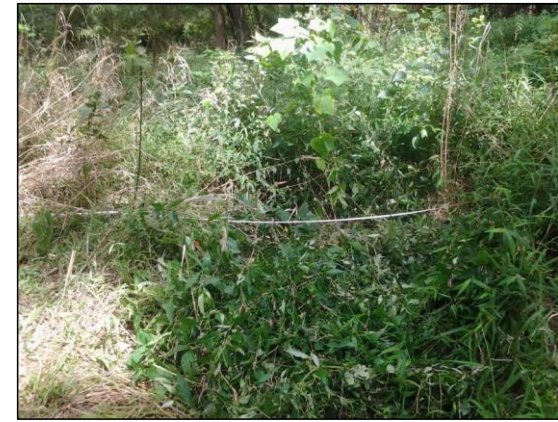
Figure 3.12 Cross Section Data

Project Name	Heath Dairy
DMS Project Number	170
Cross-Section ID	XS-12, Riffle
Survey Date	9/2015
SUMMARY DATA	
Bankfull Elevation (ft)	595.97
Bankfull Cross-Sectional Area (ft²)	20.40
Bankfull Width (ft)	17.50
Flood Prone Area Elevation (ft)	597.50
Flood Prone Width (ft)	100.00
Bankfull Mean Depth (ft)	1.14
Bankfull Max Depth (ft)	1.53
W/D Ratio	15.35
Entrenchment Ratio	5.71
Bank Height Ratio	1.00

XS-12: Upstream

XS-12: Downstream

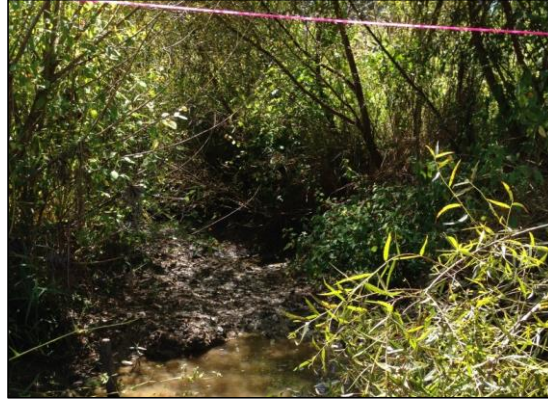
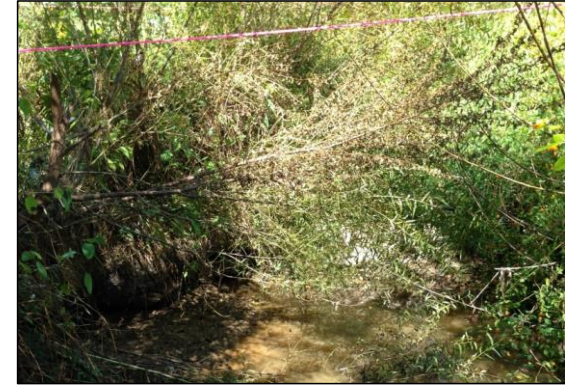
Figure 3.13 Cross Section Data

Project Name	Heath Dairy
DMS Project Number	170
Cross-Section ID	XS-13, Pool
Survey Date	9/2015
SUMMARY DATA	
Bankfull Elevation (ft)	595.31
Bankfull Cross-Sectional Area (ft²)	21.10
Bankfull Width (ft)	11.00
Flood Prone Area Elevation (ft)	597.62
Flood Prone Width (ft)	100.00
Bankfull Mean Depth (ft)	1.74
Bankfull Max Depth (ft)	2.31
W/D Ratio	6.32
Entrenchment Ratio	9.09
Bank Height Ratio	1.00

XS-13: Upstream

XS-13: Downstream

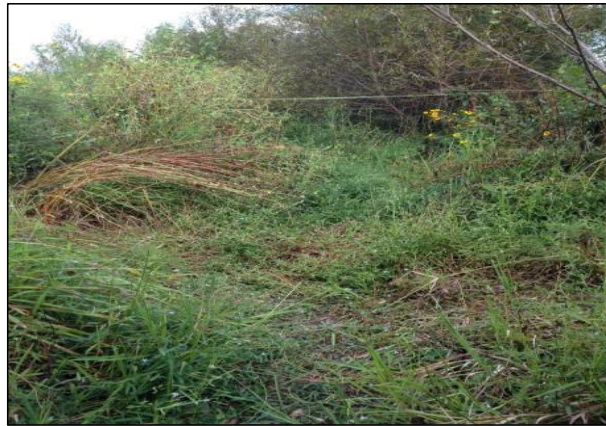
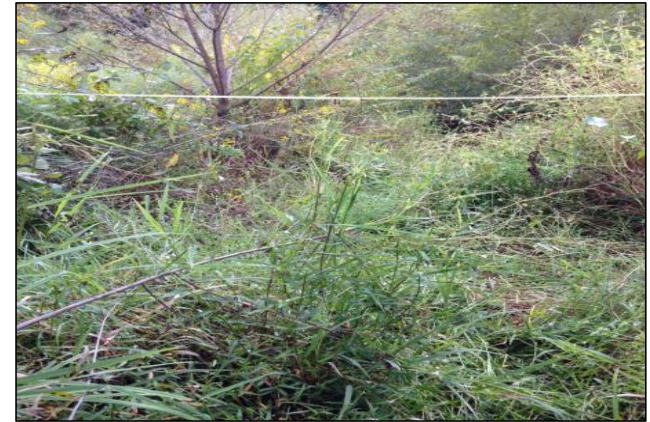
Figure 3.14 Cross Section Data

Project Name	Heath Dairy
DMS Project Number	170
Cross-Section ID	XS-14, Riffle
Survey Date	9/2015
SUMMARY DATA	
Bankfull Elevation (ft)	594.65
Bankfull Cross-Sectional Area (ft²)	22.30
Bankfull Width (ft)	18.42
Flood Prone Area Elevation (ft)	596.71
Flood Prone Width (ft)	70.00
Bankfull Mean Depth (ft)	1.01
Bankfull Max Depth (ft)	2.06
W/D Ratio	18.24
Entrenchment Ratio	3.80
Bank Height Ratio	1.00

XS-14: Upstream

XS-14: Downstream

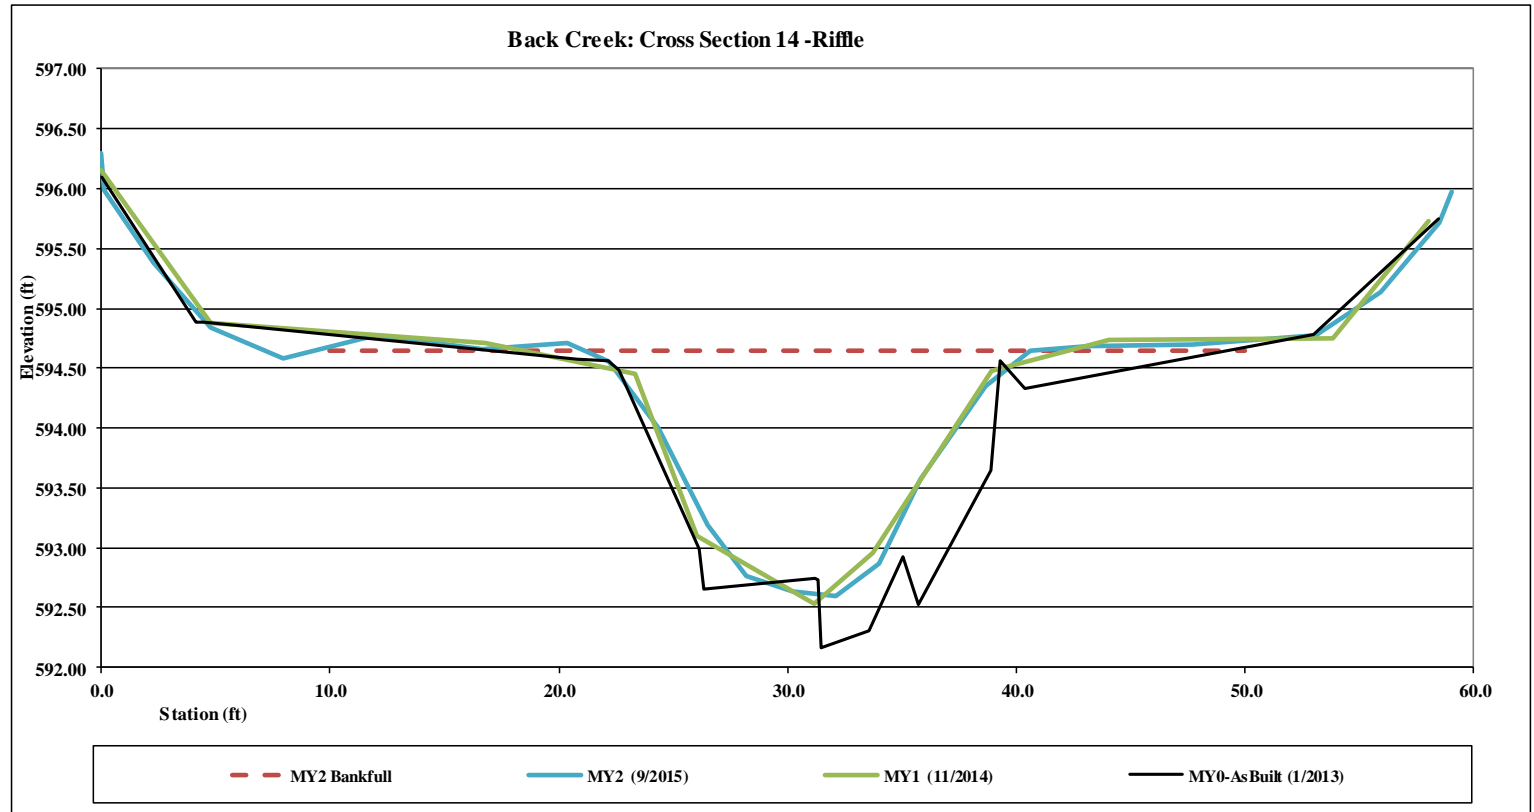
Station	Elevation	Notes
0.00	596.30	LPIN
0.13	595.99	
2.29	595.38	
4.78	594.83	
7.93	594.59	
12.02	594.78	
16.65	594.66	
20.35	594.71	
22.18	594.56	TLB
24.38	594.00	
26.53	593.19	
28.22	592.77	
30.21	592.63	
32.10	592.59	THW
34.00	592.87	
35.82	593.58	
38.63	594.35	
40.60	594.65	TRB
43.19	594.69	
47.71	594.69	
53.08	594.77	
55.93	595.14	
58.51	595.71	
59.04	595.97	RPIN

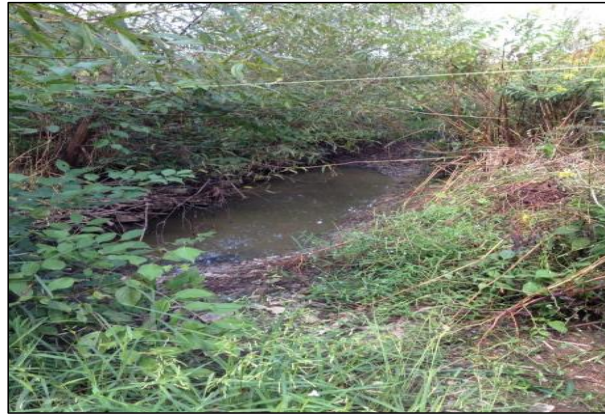
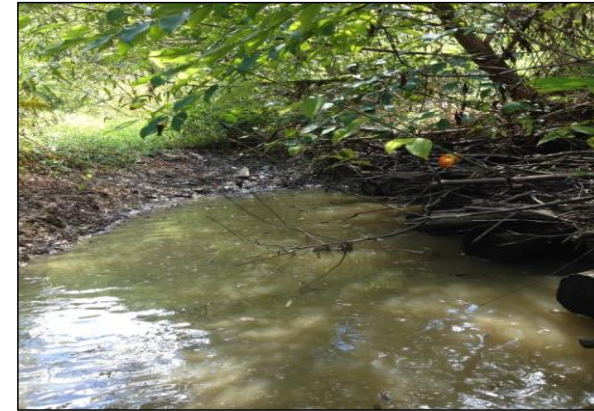
Figure 3.15 Cross Section Data

Project Name	Heath Dairy
DMS Project Number	170
Cross-Section ID	XS-15, Pool
Survey Date	9/2015
SUMMARY DATA	
Bankfull Elevation (ft)	593.84
Bankfull Cross-Sectional Area (ft²)	30.00
Bankfull Width (ft)	18.64
Flood Prone Area Elevation (ft)	596.96
Flood Prone Width (ft)	100.00
Bankfull Mean Depth (ft)	1.84
Bankfull Max Depth (ft)	3.12
W/D Ratio	10.13
Entrenchment Ratio	5.37
Bank Height Ratio	1.00

XS-15: Upstream

XS-15: Downstream

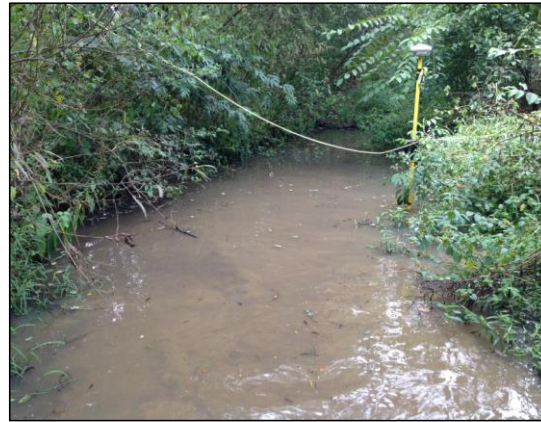
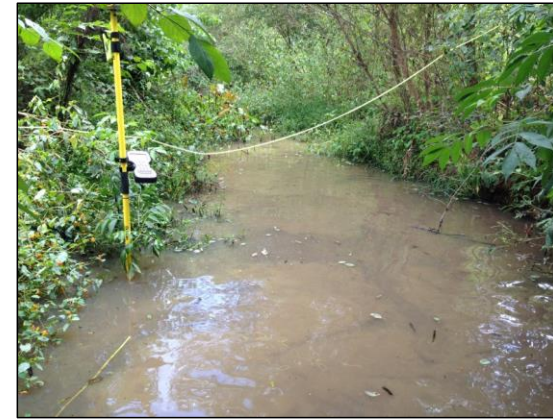
Figure 3.16 Cross Section Data

Project Name	Heath Dairy
DMS Project Number	170
Cross-Section ID	XS-16, Pool
Survey Date	9/2015
SUMMARY DATA	
Bankfull Elevation (ft)	588.16
Bankfull Cross-Sectional Area (ft ²)	45.00
Bankfull Width (ft)	21.29
Flood Prone Area Elevation (ft)	591.36
Flood Prone Width (ft)	60.00
Bankfull Mean Depth (ft)	2.45
Bankfull Max Depth (ft)	3.20
W/D Ratio	8.69
Entrenchment Ratio	2.82
Bank Height Ratio	1.00

XS-16: Upstream

XS-16: Downstream

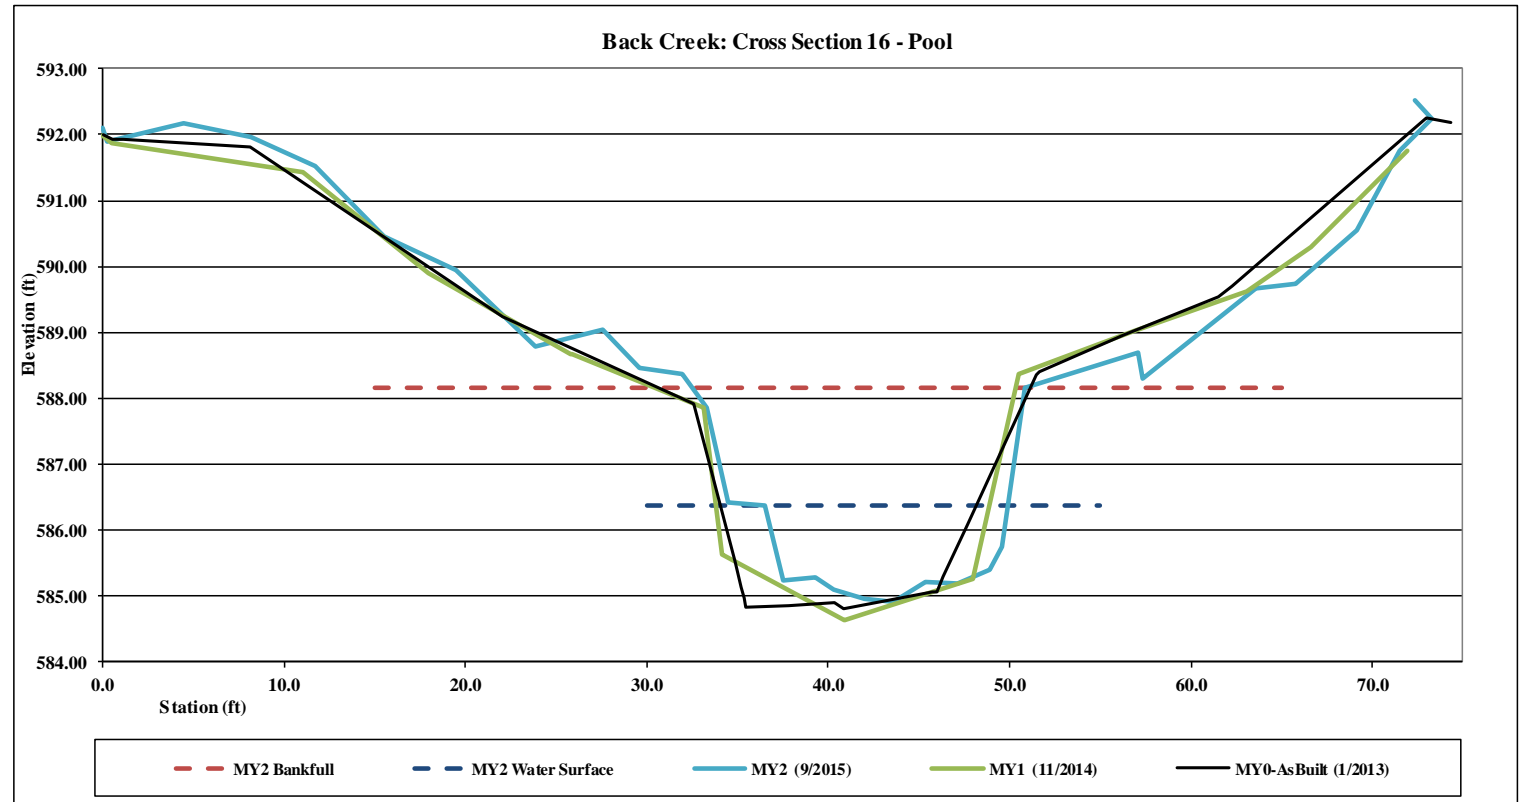
Station	Elevation	Notes
0.00	592.11	LPIN
0.27	591.91	
4.50	592.18	
8.19	591.97	
11.69	591.53	
15.52	590.46	
19.47	589.94	
23.86	588.78	
27.55	589.05	
29.57	588.46	TLB
31.99	588.37	
33.31	587.85	
34.50	586.41	
36.53	586.37	LEW
37.54	585.23	
39.28	585.28	
40.26	585.11	
42.02	584.96	THW
43.57	584.91	
45.35	585.20	
47.09	585.18	
48.87	585.41	
49.56	585.74	REW
50.86	588.16	TRB
57.05	588.70	
57.35	588.30	
63.56	589.67	
65.78	589.74	
69.12	590.55	
71.50	591.76	
73.30	592.24	
72.38	592.53	RPIN

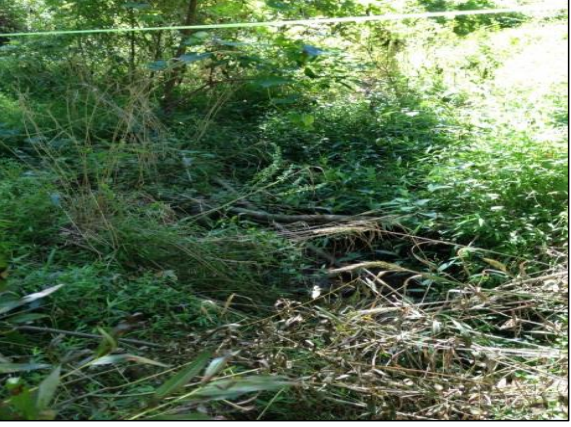
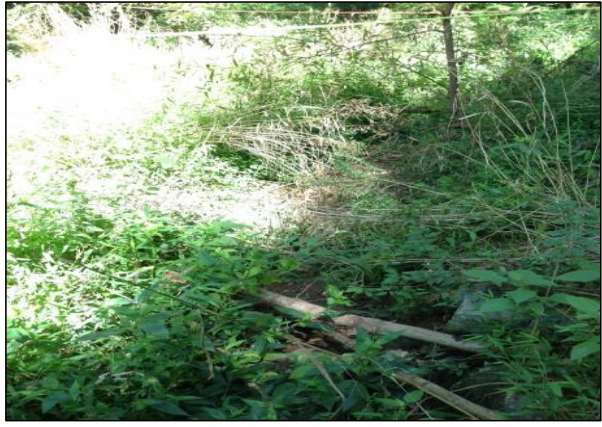
Figure 3.17 Cross Section Data

Project Name	Heath Dairy
DMS Project Number	170
Cross-Section ID	XS-17, Pool
Survey Date	9/2015
SUMMARY DATA	
Bankfull Elevation (ft)	626.54
Bankfull Cross-Sectional Area (ft²)	5.46
Bankfull Width (ft)	4.90
Flood Prone Area Elevation (ft)	627.92
Flood Prone Width (ft)	20.00
Bankfull Mean Depth (ft)	1.11
Bankfull Max Depth (ft)	1.38
W/D Ratio	4.41
Entrenchment Ratio	4.08
Bank Height Ratio	1.00

XS-17: Upstream

XS-17: Downstream

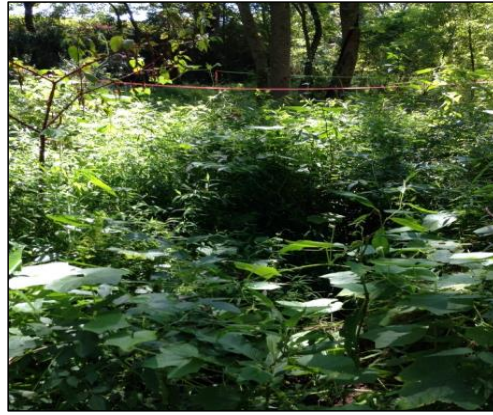
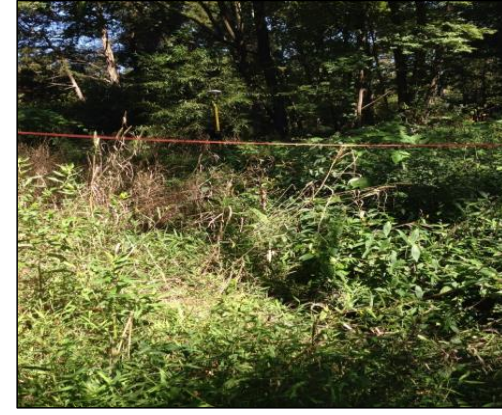
Figure 3.18 Cross Section Data

Project Name	Heath Dairy
DMS Project Number	170
Cross-Section ID	XS-18, Riffle
Survey Date	9/2015
SUMMARY DATA	
Bankfull Elevation (ft)	626.62
Bankfull Cross-Sectional Area (ft²)	5.42
Bankfull Width (ft)	6.30
Flood Prone Area Elevation (ft)	627.71
Flood Prone Width (ft)	30.00
Bankfull Mean Depth (ft)	0.54
Bankfull Max Depth (ft)	1.09
W/D Ratio	11.67
Entrenchment Ratio	4.76
Bank Height Ratio	1.00

XS-18: Upstream

XS-18: Downstream

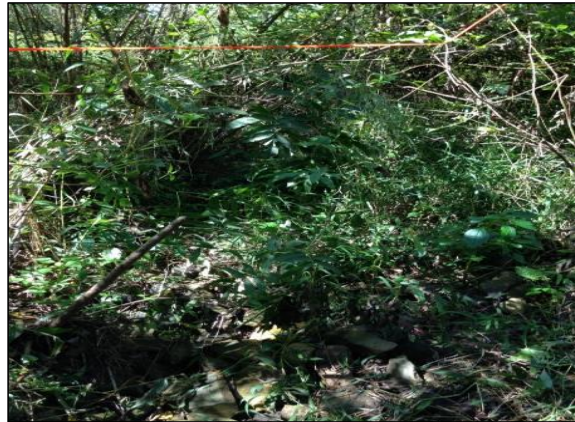
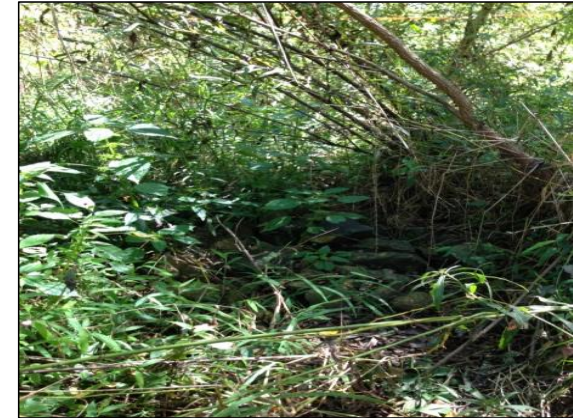
Figure 3.19 Cross Section Data

Project Name	Heath Dairy
DMS Project Number	170
Cross-Section ID	XS-19, Riffle
Survey Date	9/2015
SUMMARY DATA	
Bankfull Elevation (ft)	616.16
Bankfull Cross-Sectional Area (ft²)	4.15
Bankfull Width (ft)	8.72
Flood Prone Area Elevation (ft)	616.76
Flood Prone Width (ft)	30.00
Bankfull Mean Depth (ft)	0.27
Bankfull Max Depth (ft)	0.60
W/D Ratio	32.29
Entrenchment Ratio	3.44
Bank Height Ratio	1.00

XS-19: Upstream

XS-19: Downstream

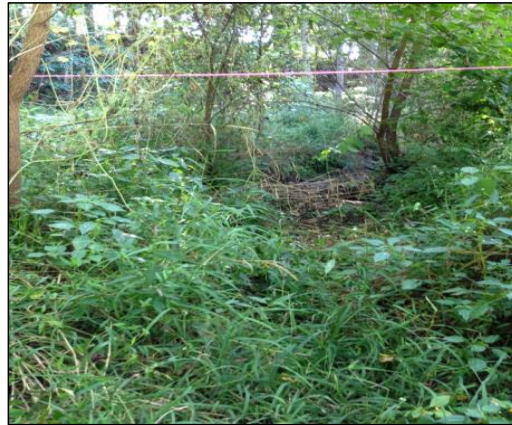
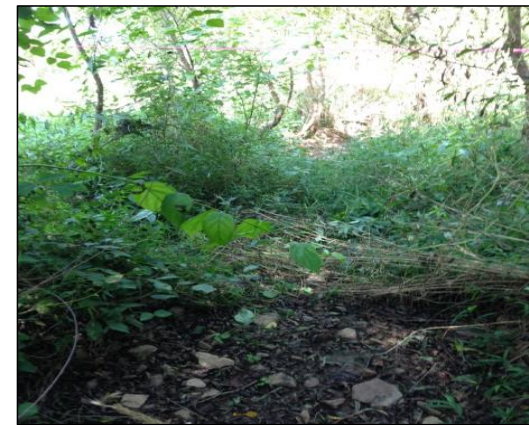
Figure 3.20 Cross Section Data

Project Name	Heath Dairy
DMS Project Number	170
Cross-Section ID	XS-20, Riffle
Survey Date	9/2015
SUMMARY DATA	
Bankfull Elevation (ft)	608.78
Bankfull Cross-Sectional Area (ft²)	4.37
Bankfull Width (ft)	12.01
Flood Prone Area Elevation (ft)	609.44
Flood Prone Width (ft)	30.00
Bankfull Mean Depth (ft)	0.44
Bankfull Max Depth (ft)	0.66
W/D Ratio	27.29
Entrenchment Ratio	2.50
Bank Height Ratio	1.00

XS-20: Upstream

XS-20: Downstream

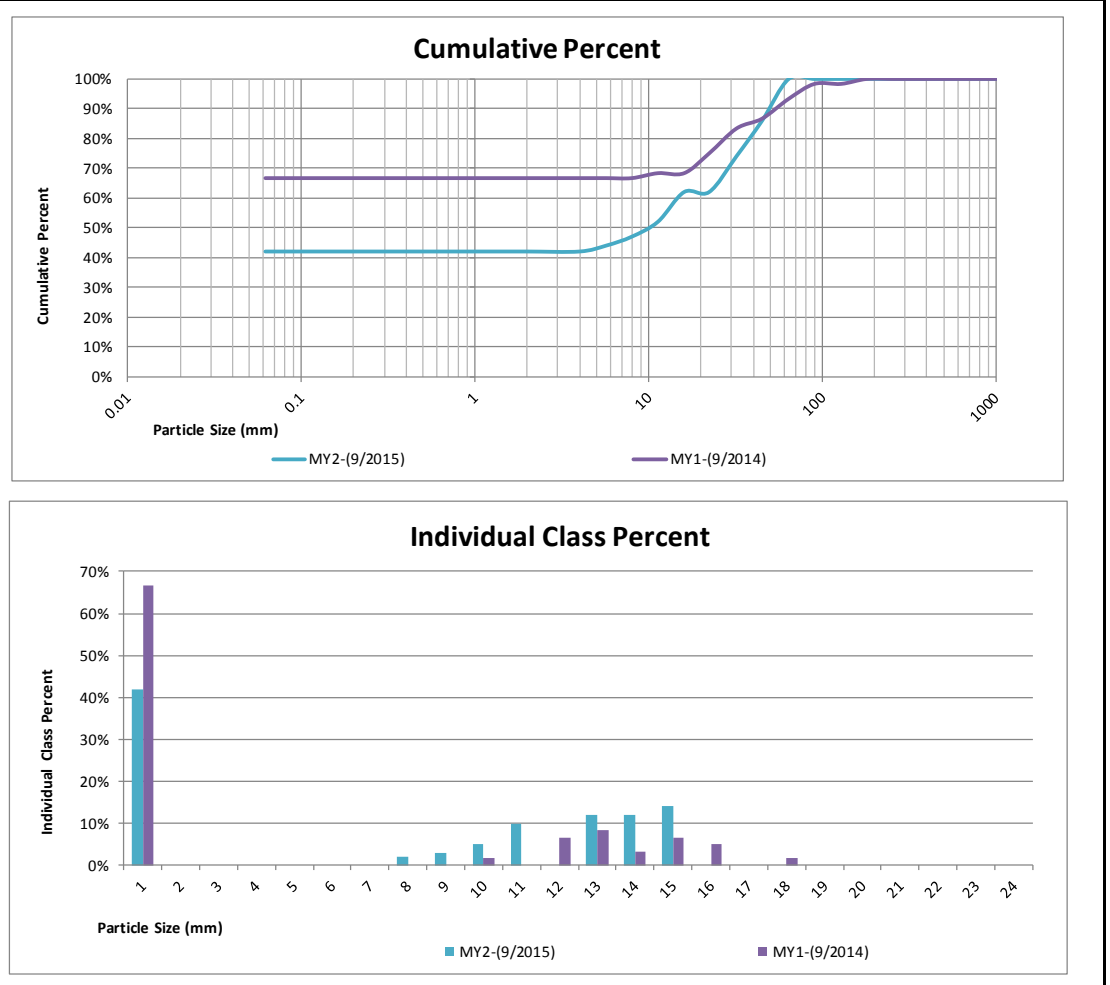
Figure 5.9. Pebble Counts

Project Name: Heath Dairy					
Reach: Back Creek					
Feature: Rifle (XS 10)					
		MY2-(9/2015)			
Description	Material	Size (mm)	Total #	Item %	Cum %
Silt/Clay	silt/clay	0.062	42	42%	42%
Sand	very fine sand	0.125	0	0%	42%
	fine sand	0.250	0	0%	42%
	medium sand	0.50	0	0%	42%
	coarse sand	1.00	0	0%	42%
	ery coarse san	2.0	0	0%	42%
Gravel	very fine grave	4.0	0	0%	42%
	fine gravel	5.7	2	2%	44%
	fine gravel	8.0	3	3%	47%
	medium gravel	11.3	5	5%	52%
	medium gravel	16.0	10	10%	62%
	course gravel	22.3	0	0%	62%
	course gravel	32.0	12	12%	74%
	ery coarse grav	45	12	12%	86%
	ery coarse grav	64	14	14%	100%
Cobble	small cobble	90	0	0%	100%
	medium cobble	128	0	0%	100%
	large cobble	180	0	0%	100%
	ery large cobbl	256	0	0%	100%
	Boulder	small boulder	362	0	0%
small boulder		512	0	0%	100%
medium boulder		1024	0	0%	100%
large boulder		2048	0	0%	100%
Bedrock	bedrock	40096	0	0%	100%
TOTAL % of whole count		-	100	100%	100%
Summary Data

D50	9.0				
D84	42.0				
D95	60.0
