# MONITORING YEAR 3 ANNUAL REPORT

## HENRY FORK MITIGATION SITE

Catawba County, NC  
DEQ Contract No. 005782  
DMS Project No. 96306

Data Collection Period: April 2018 - November 2018  
Submission Date: December 4, 2018

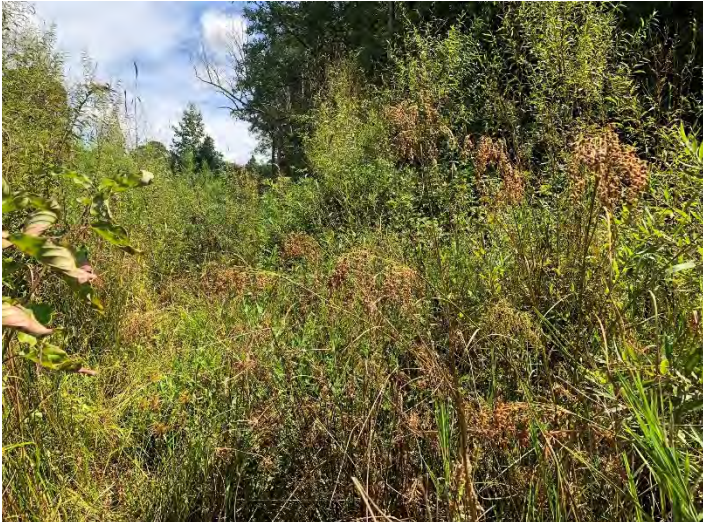
**Photo Point 1** – view upstream UT1B (9/4/2018)

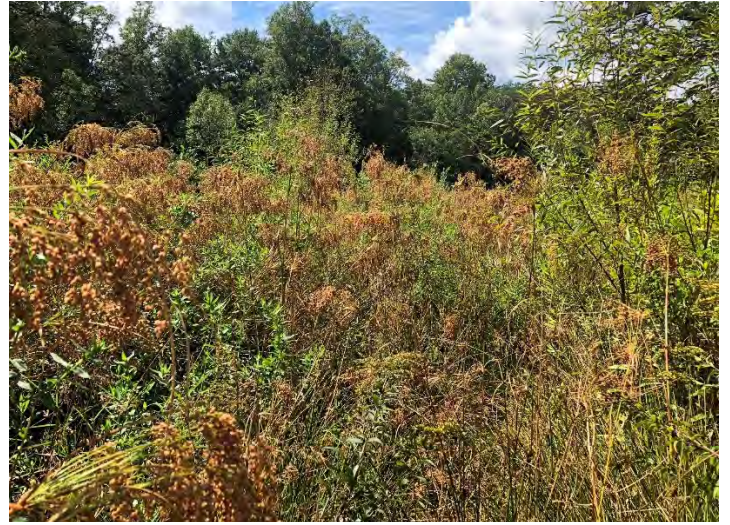
**Photo Point 1** – view downstream UT1B (9/4/2018)

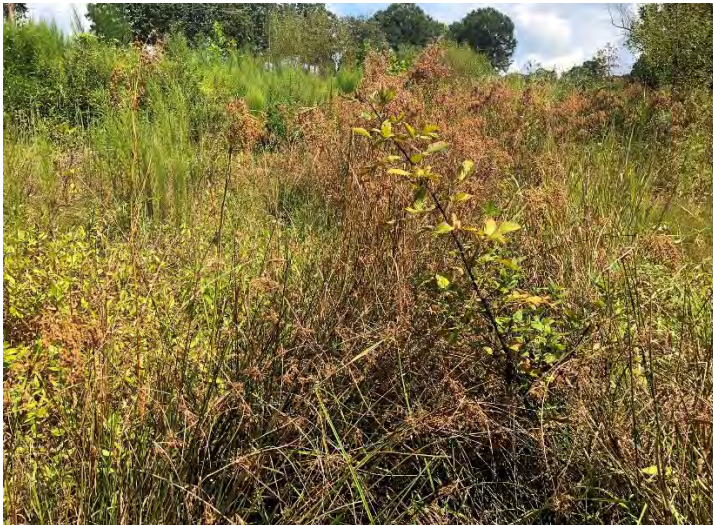
**Photo Point 2** – view upstream UT1B (9/4/2018)

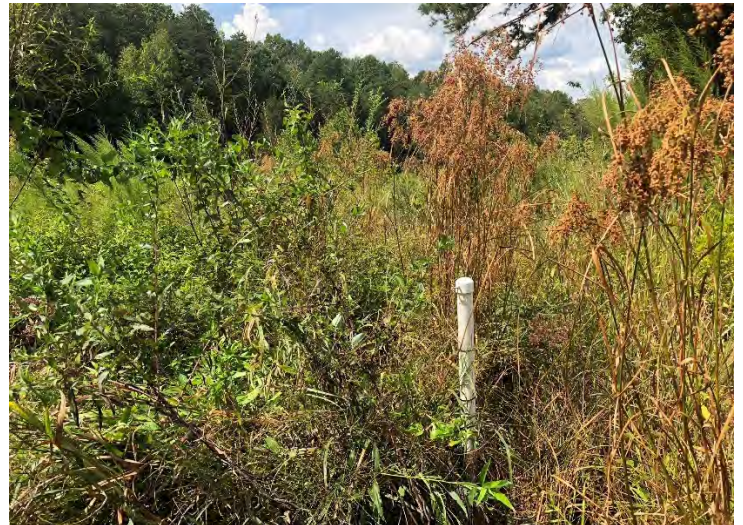
**Photo Point 2** – view downstream UT1B (9/4/2018)

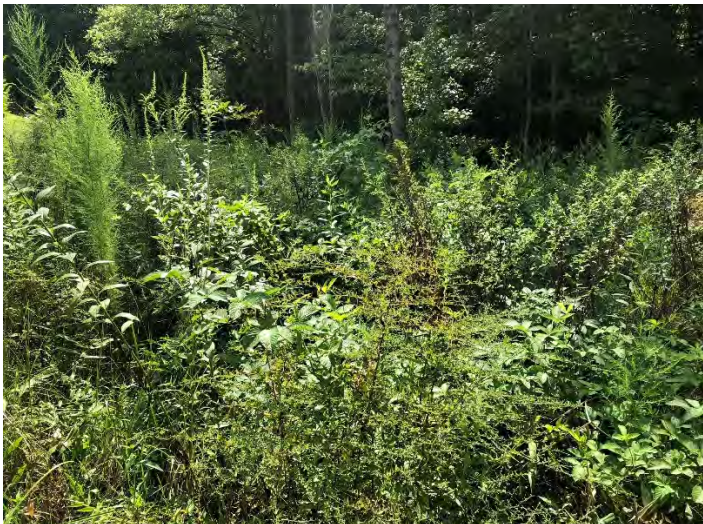
**Photo Point 3** – view upstream UT1 R1 Upper (9/4/2018)

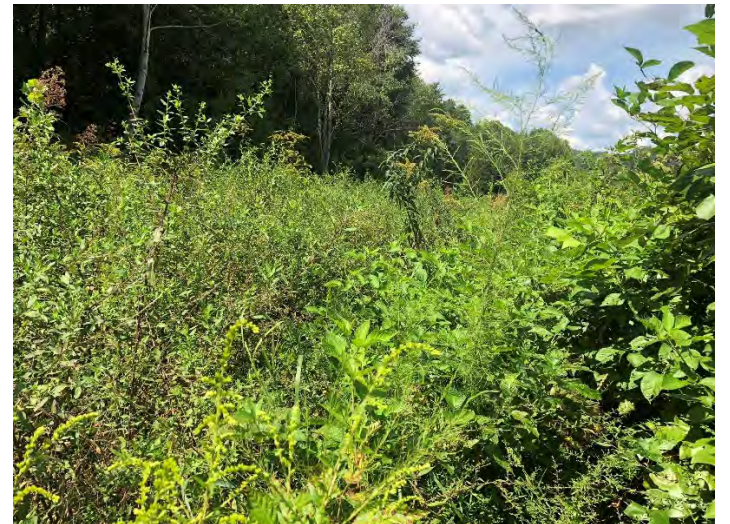
**Photo Point 3** – view downstream UT1 R1 Upper (9/4/2018)

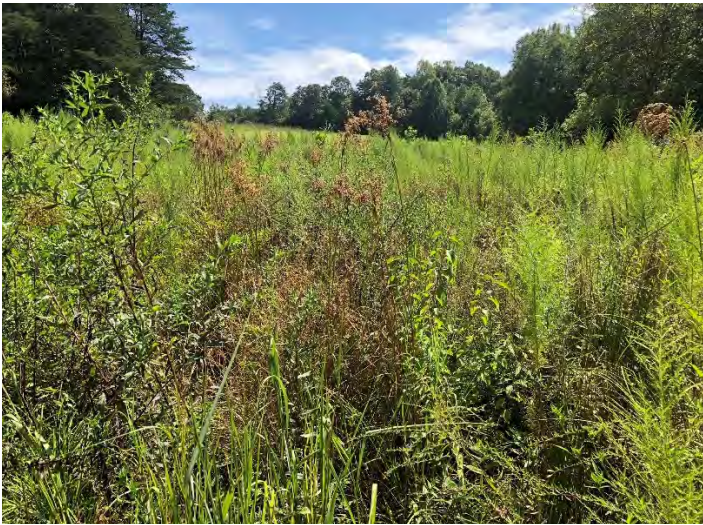
**Photo Point 4** – view upstream UT1 R1 Upper (9/4/2018)

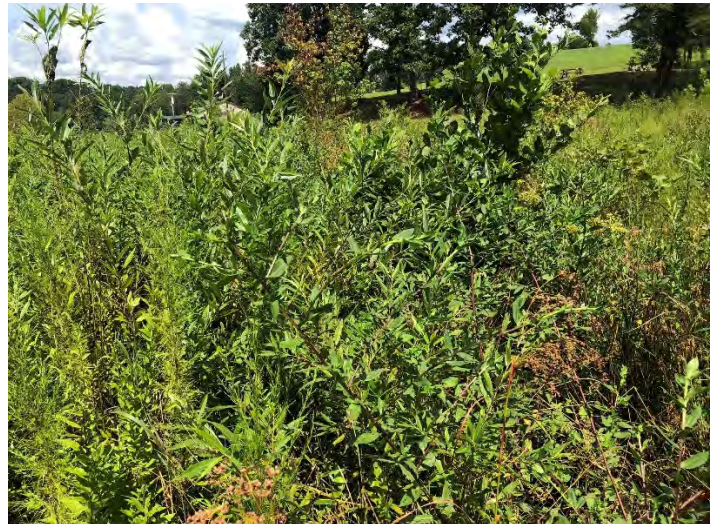
**Photo Point 4** – view downstream UT1 R1 Upper (9/4/2018)

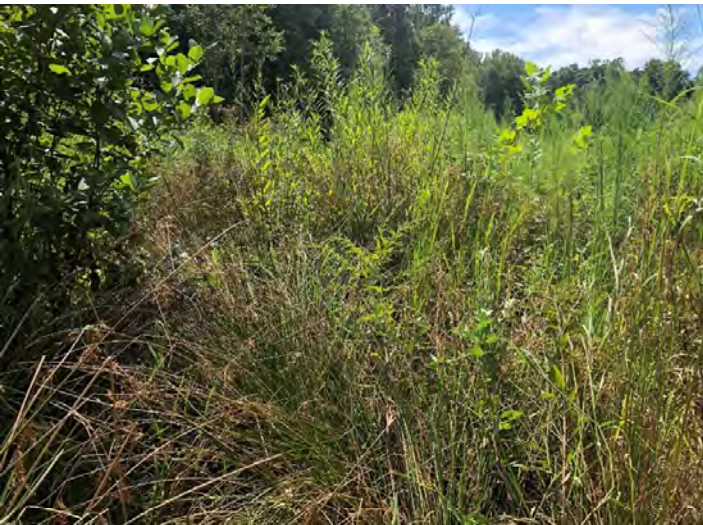
**Photo Point 5** – view upstream UT1 R1 Lower (9/4/2018)

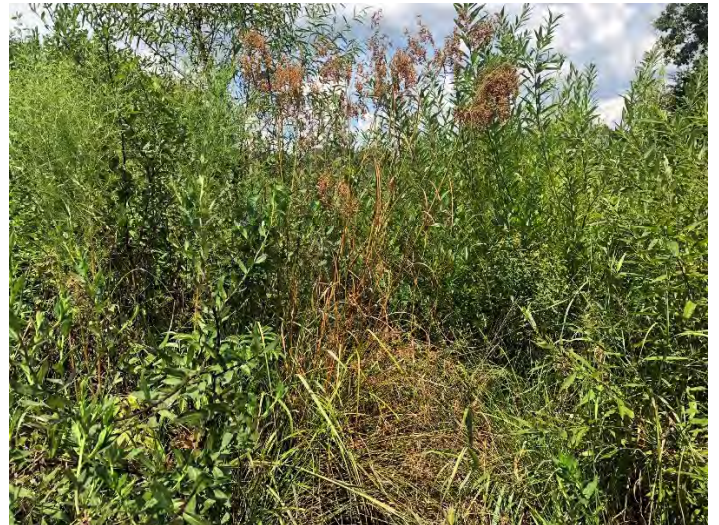
**Photo Point 5** – view downstream UT1 R1 Lower (9/4/2018)

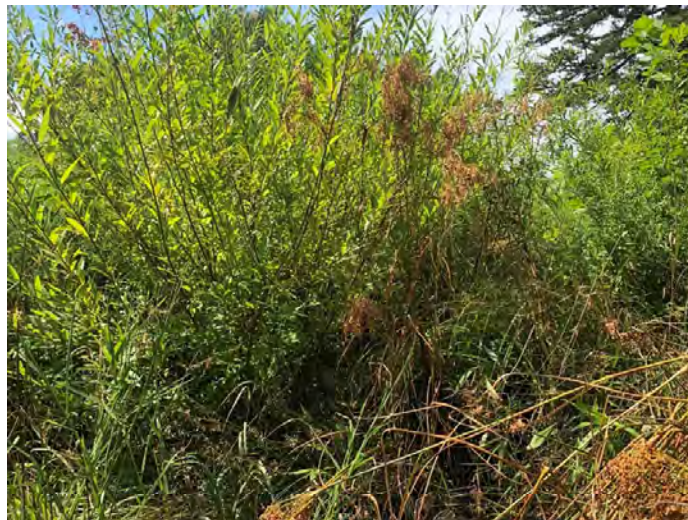
**Photo Point 5** – view upstream of UT1B (9/4/2018)

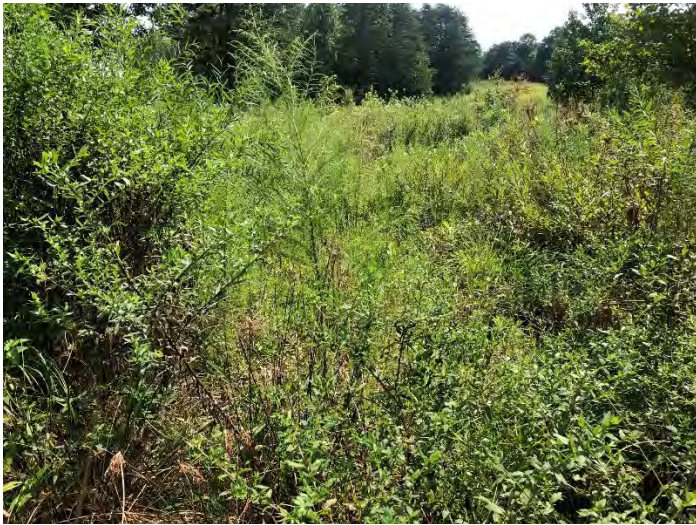
**Photo Point 6** – view upstream UT1 R1 Lower (9/4/2018)

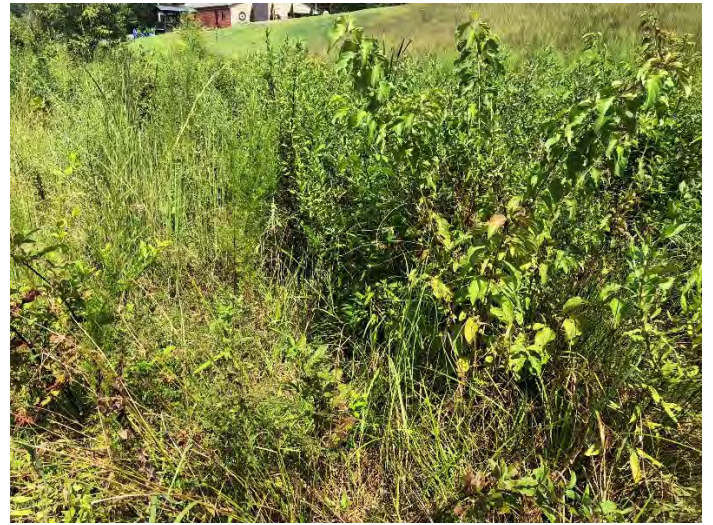
**Photo Point 6** – view downstream UT1 R1 Lower (9/4/2018)

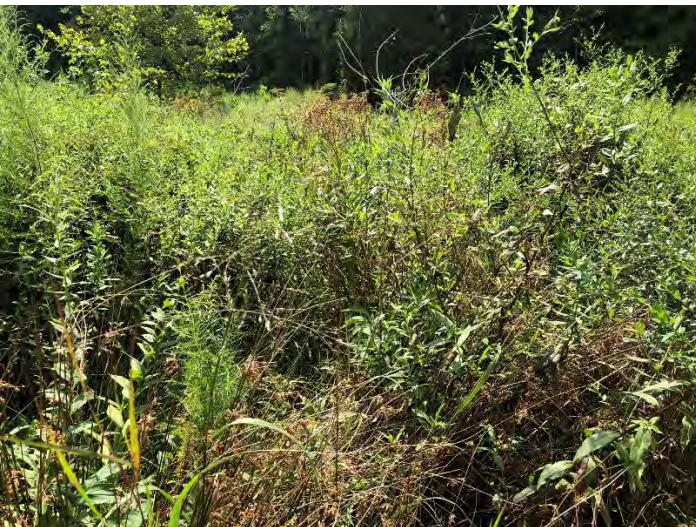
**Photo Point 7** – view upstream UT1 R1 Lower (9/4/2018)

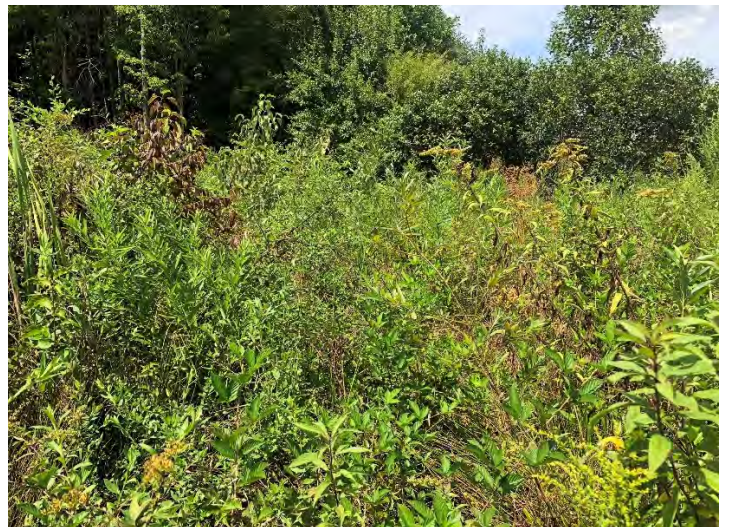
**Photo Point 7** – view downstream UT1 R1 Lower (9/4/2018)

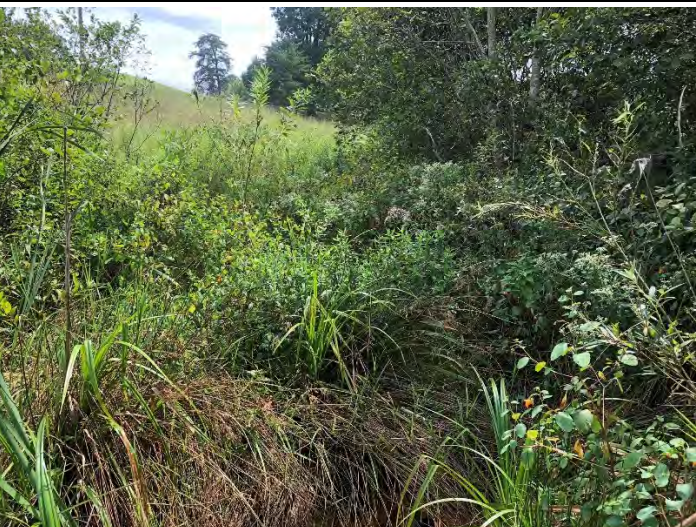
**Photo Point 8** – view upstream UT1 R1 Lower (9/4/2018)

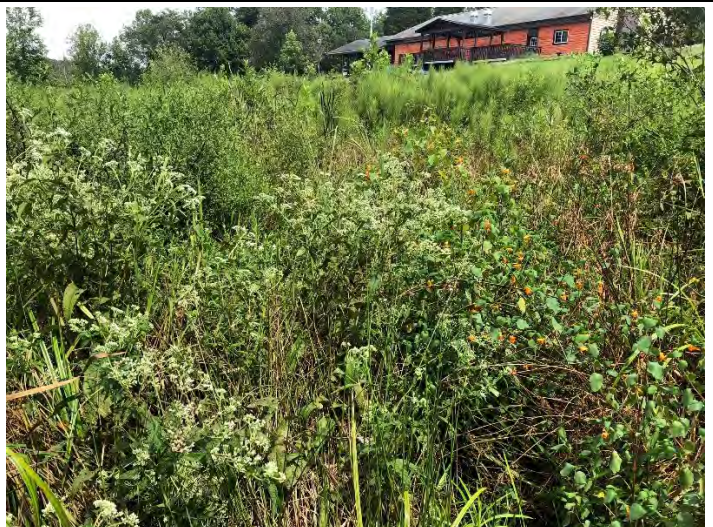
**Photo Point 8** – view downstream UT1 R1 Lower (9/4/2018)

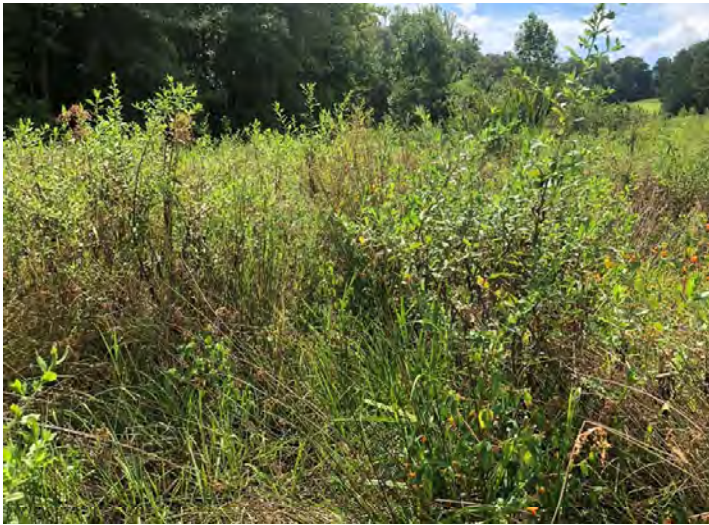
**Photo Point 9** – view upstream UT1 R1 Lower (9/4/2018)

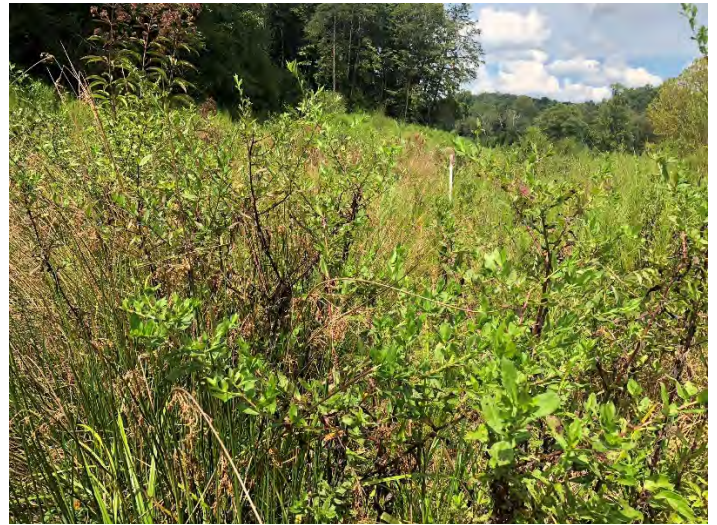
**Photo Point 9** – view downstream UT1 R1 Lower (9/4/2018)

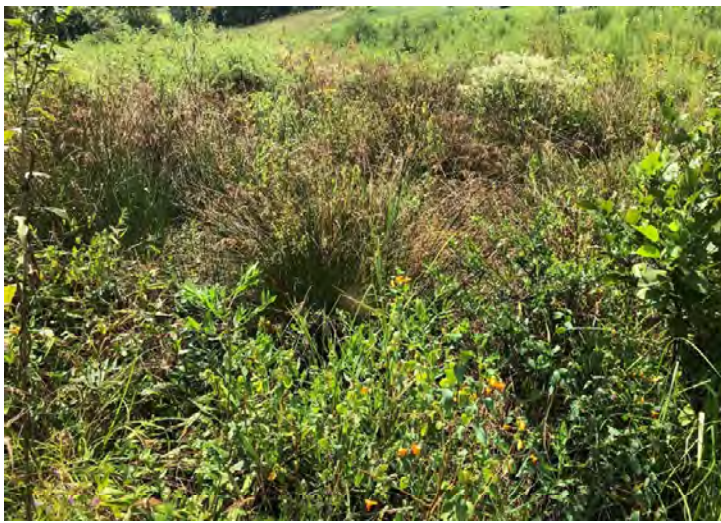
**Photo Point 10** – view upstream UT1 R1 Lower (9/4/2018)

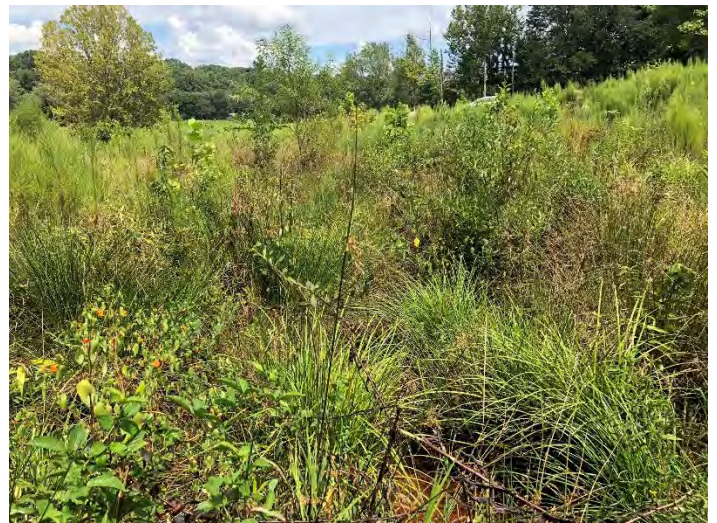
**Photo Point 10** –view downstream UT1 R1 Lower (9/4/2018)

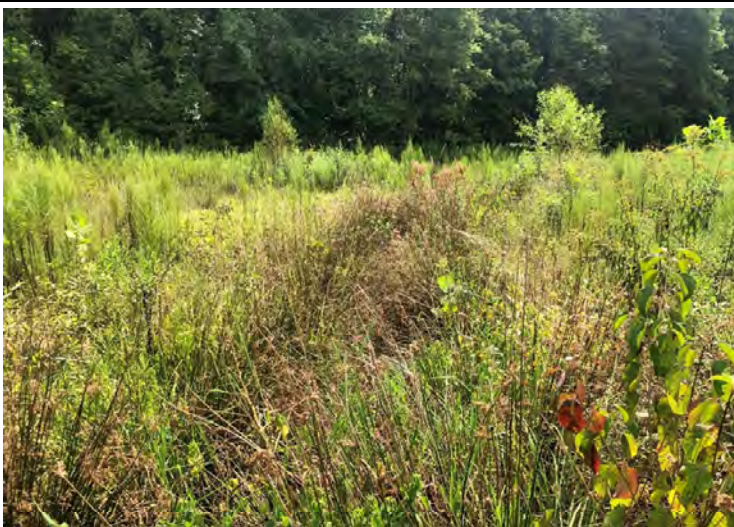
**Photo Point 11** – view upstream UT1 R1 Lower (9/4/2018)

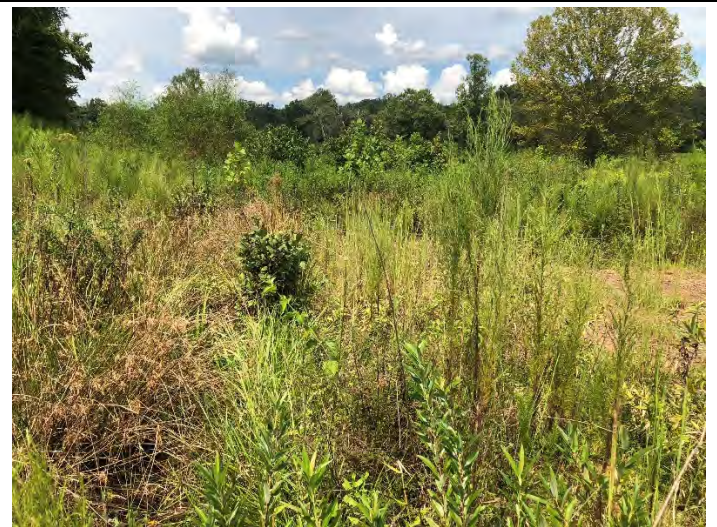
**Photo Point 11** –view downstream UT1 R1 Lower (9/4/2018)

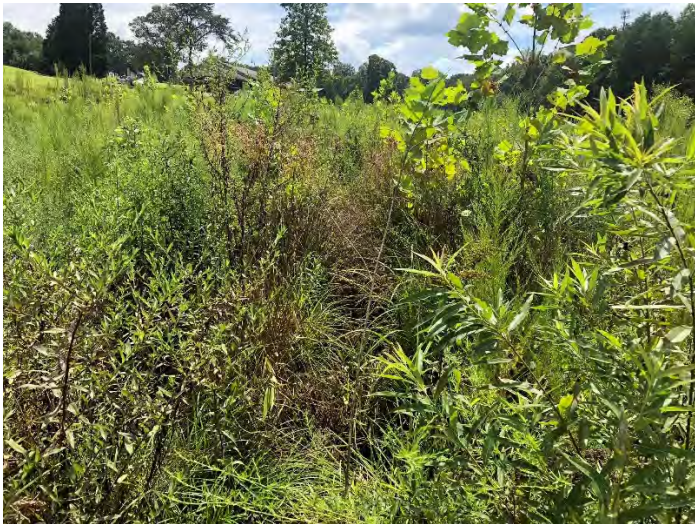
**Photo Point 12** – view upstream UT1 R1 Lower (9/4/2018)

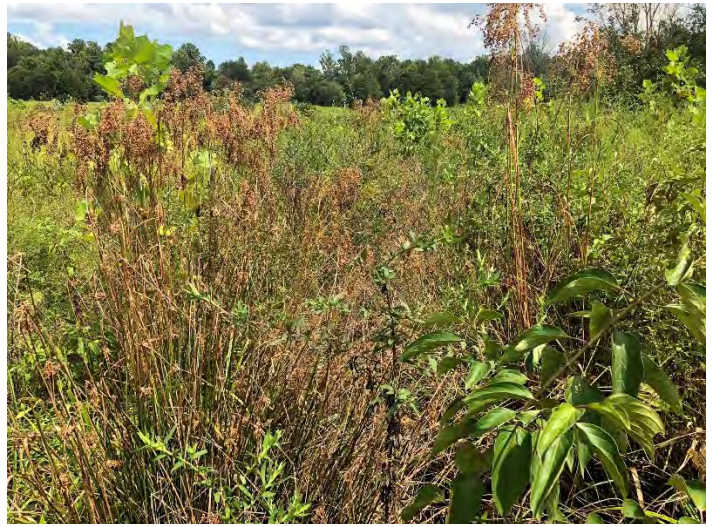
**Photo Point 12** –view downstream UT1 R1 Lower (9/4/2018)

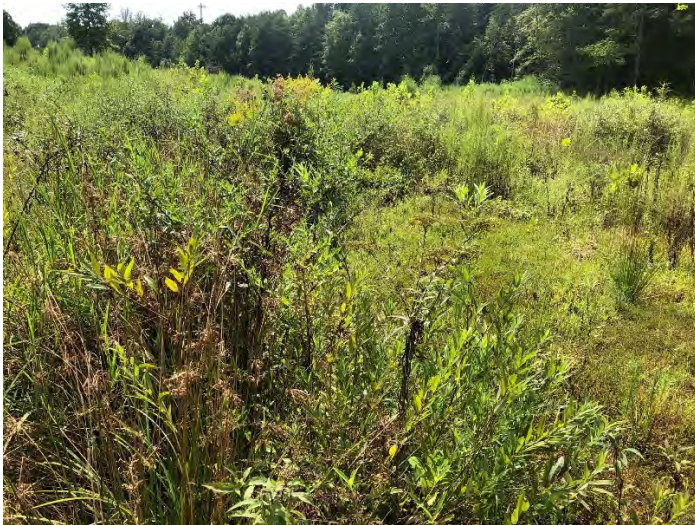
**Photo Point 13** – view upstream UT1 R1 Lower (9/4/2018)

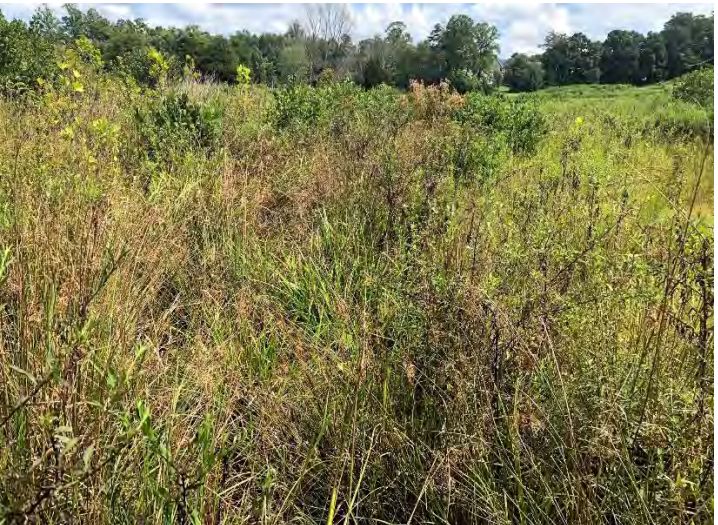
**Photo Point 13** –view downstream UT1 R1 Lower (9/4/2018)

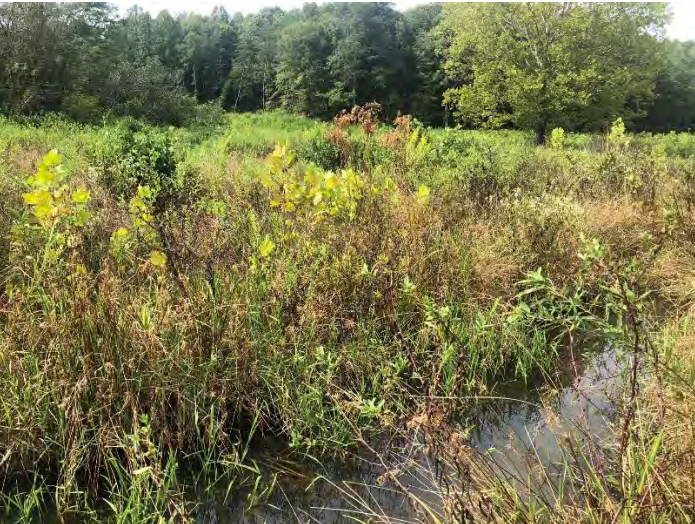
**Photo Point 14** – view upstream UT1 R2 (9/4/2018)

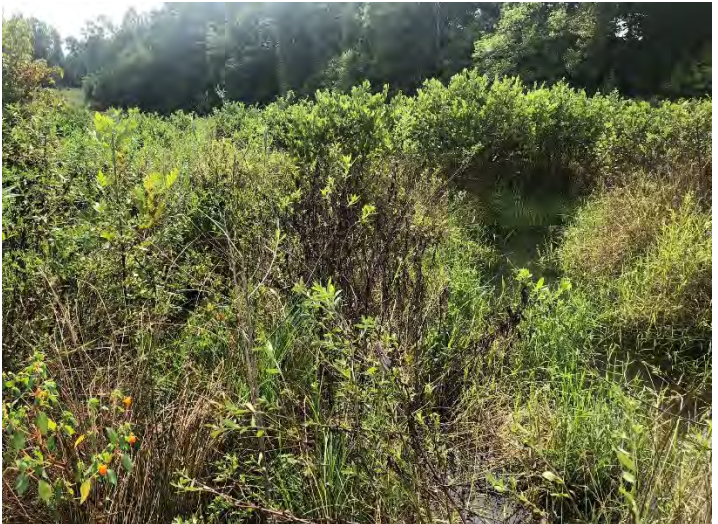
**Photo Point 14** – view downstream UT1 R2 (9/4/2018)

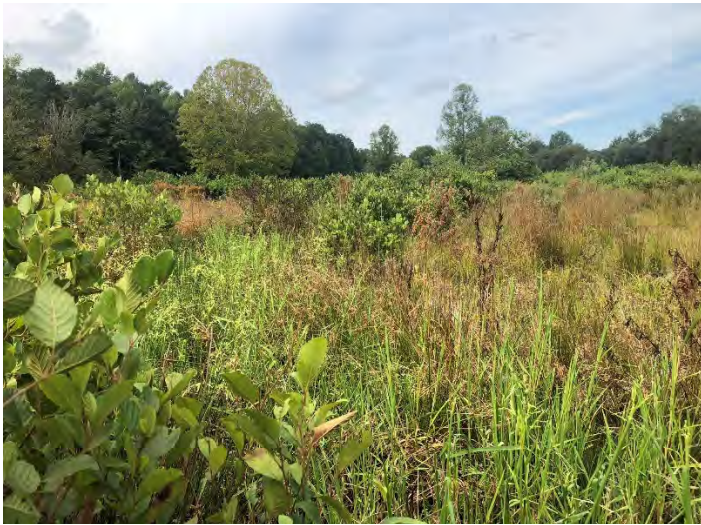
**Photo Point 15** – view upstream UT1 R2 (9/4/2018)

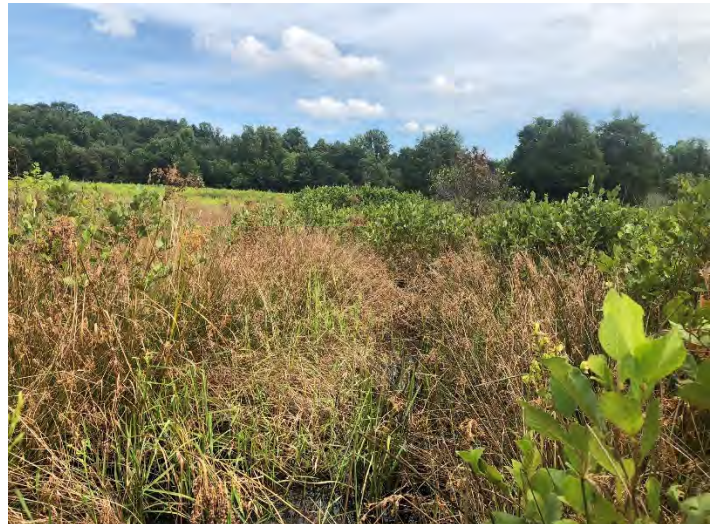
**Photo Point 15** – view downstream UT1 R2 (9/4/2018)

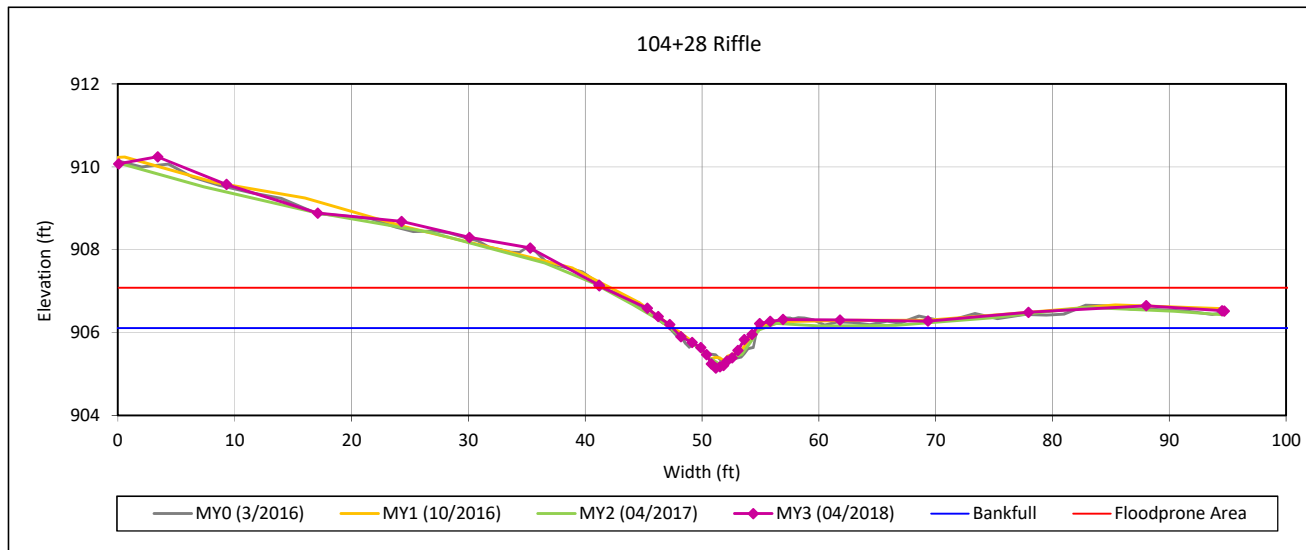
#### Cross-Section 1-UT1 R1

#### Bankfull Dimensions

3.5	x-section area (ft.sq.)
7.2	width (ft)
0.5	mean depth (ft)
1.0	max depth (ft)
7.5	wetted perimeter (ft)
0.5	hydraulic radius (ft)
14.7	width-depth ratio
52.2	W flood prone area (ft)
7.3	entrenchment ratio
1.1	low bank height ratio

Survey Date: 04/2018  
Field Crew: Wildlands Engineering

In general, riffle cross sections show little to no change in the bankfull area, maximum depth ratio, or width-to-depth ratio. Surveyed riffle cross sections fell within the parameters defined for channels of the appropriate Rosgen (Rosgen, 1994 & 1996) stream type. Pebble counts in UT1 Reach 1 and UT1B indicate maintenance of coarser materials in the riffle features and finer particles in the pool features. Refer to Appendix 2 for the visual stability assessment table, Current Conditions Plan View (CCPV) map, and reference photographs. Refer to Appendix 4 for the morphological data and plots.

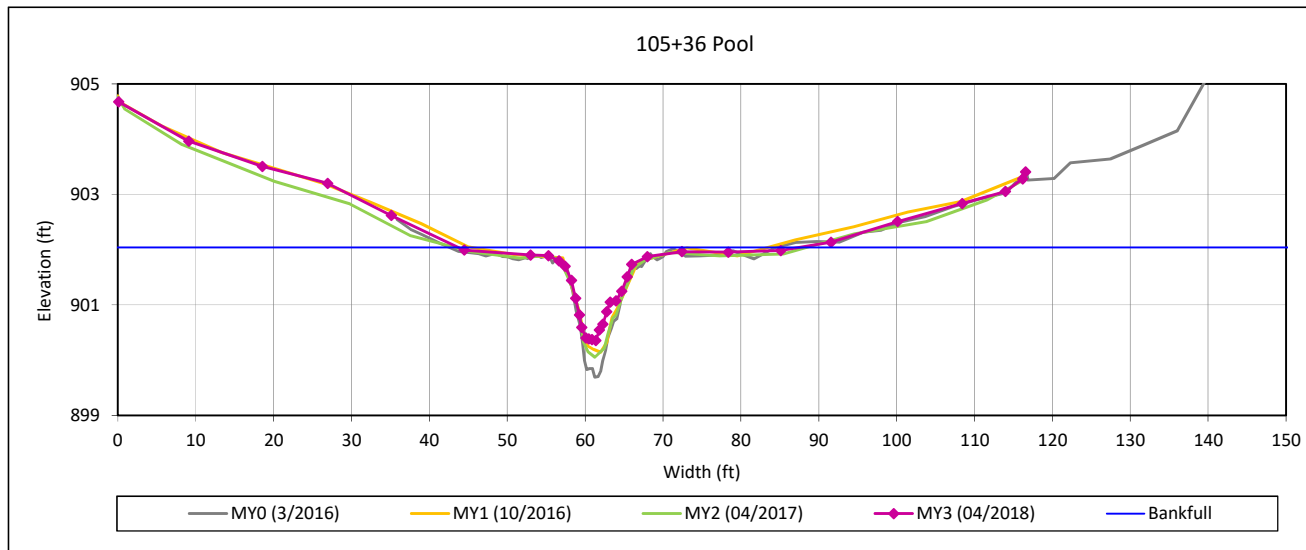
#### Cross-Section 2-UT1 R1

#### Bankfull Dimensions

10.7	x-section area (ft.sq.)
17.2	width (ft)
0.6	mean depth (ft)
1.7	max depth (ft)
17.7	wetted perimeter (ft)
0.6	hydraulic radius (ft)

Survey Date: 04/2018  
Field Crew: Wildlands Engineering

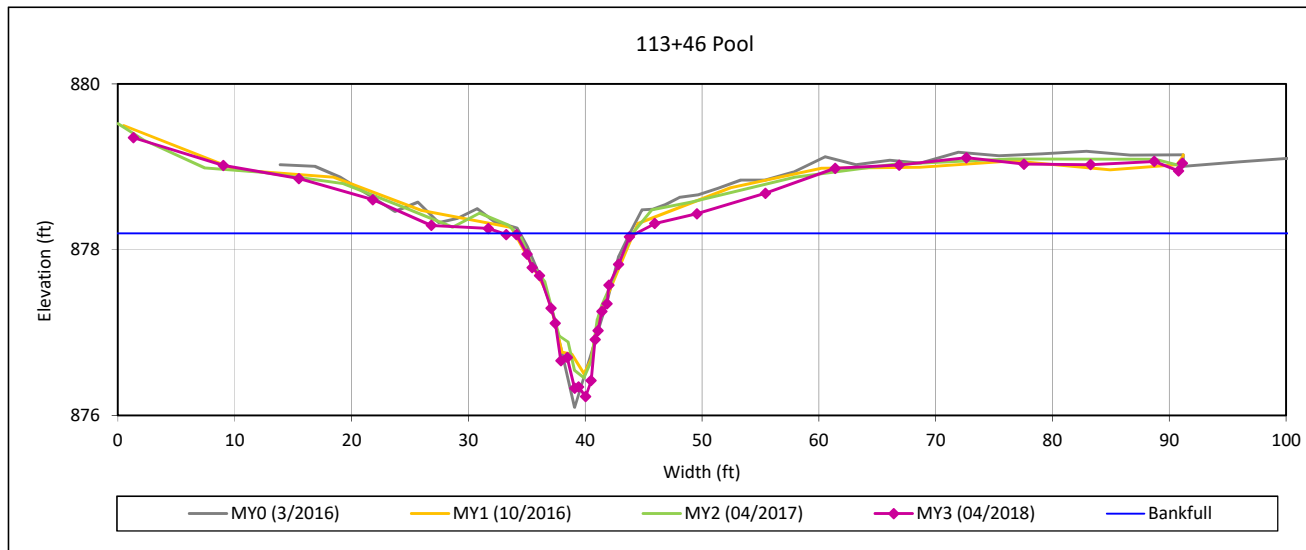
#### Cross-Section 3-UT1 R1

#### Bankfull Dimensions

9.1	x-section area (ft.sq.)
11.4	width (ft)
0.8	mean depth (ft)
2.0	max depth (ft)
12.5	wetted perimeter (ft)
0.7	hydraulic radius (ft)

Survey Date: 04/2018  
Field Crew: Wildlands Engineering

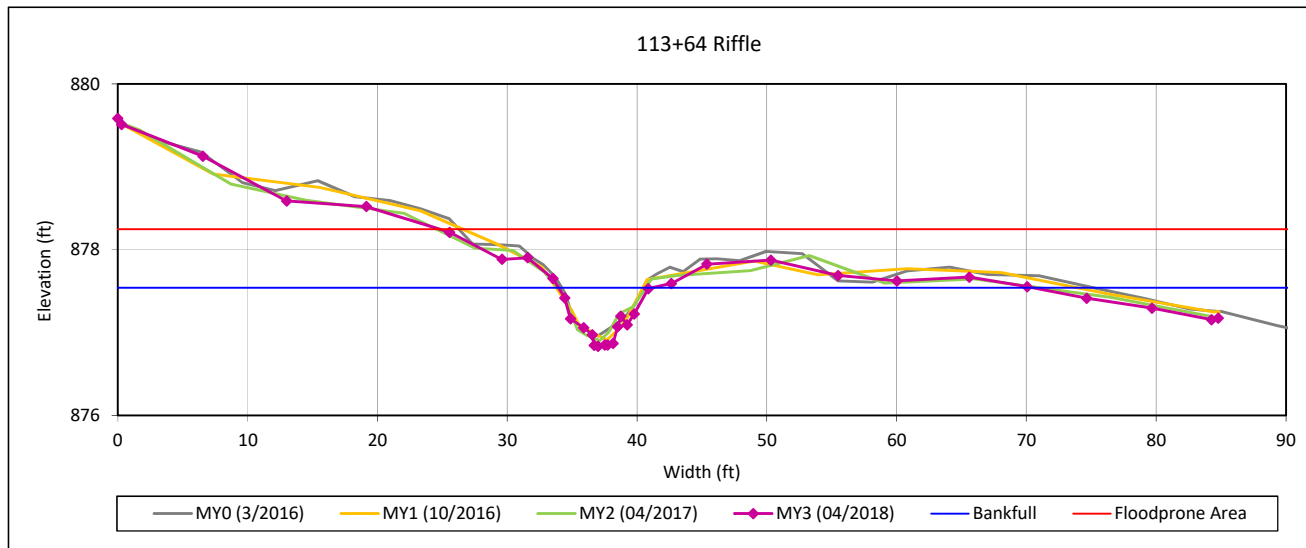
#### Cross-Section 4-UT1 R1

#### Bankfull Dimensions

2.9	x-section area (ft.sq.)
7.2	width (ft)
0.4	mean depth (ft)
0.7	max depth (ft)
7.5	wetted perimeter (ft)
0.4	hydraulic radius (ft)
17.9	width-depth ratio
63.7	W flood prone area (ft)
8.9	entrenchment ratio
1.1	low bank height ratio

Survey Date: 04/2018  
Field Crew: Wildlands Engineering

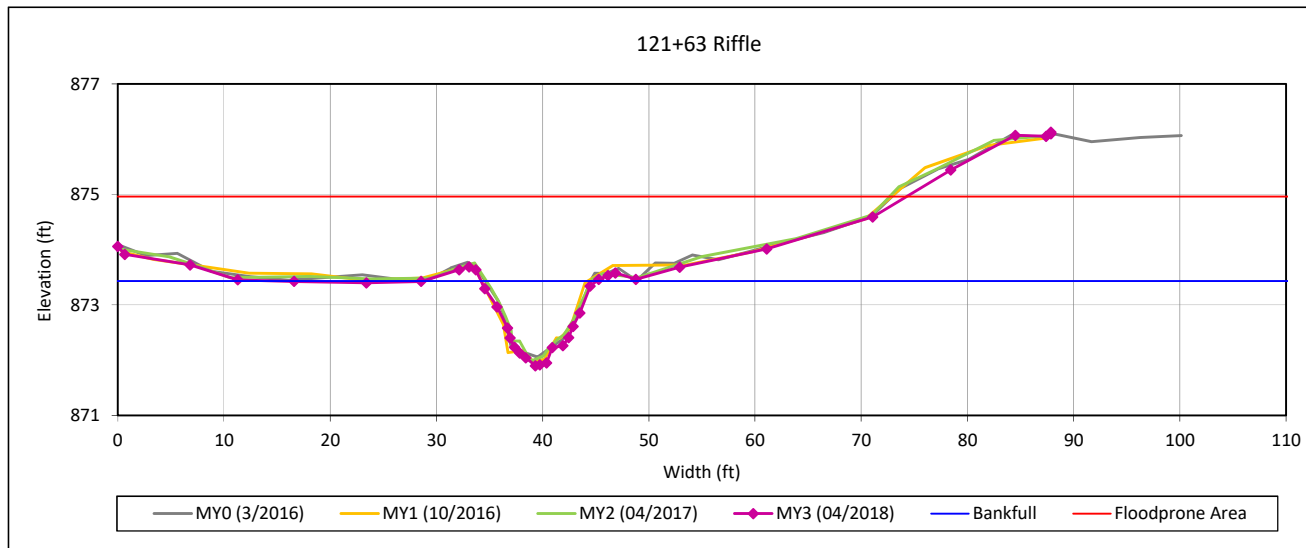
#### Cross-Section 5-UT1 R2

#### Bankfull Dimensions

9.7	x-section area (ft.sq.)
10.9	width (ft)
0.9	mean depth (ft)
1.5	max depth (ft)
11.4	wetted perimeter (ft)
0.8	hydraulic radius (ft)
12.2	width-depth ratio
76.0	W flood prone area (ft)
7.0	entrenchment ratio
1.1	low bank height ratio

Survey Date: 04/2018  
Field Crew: Wildlands Engineering

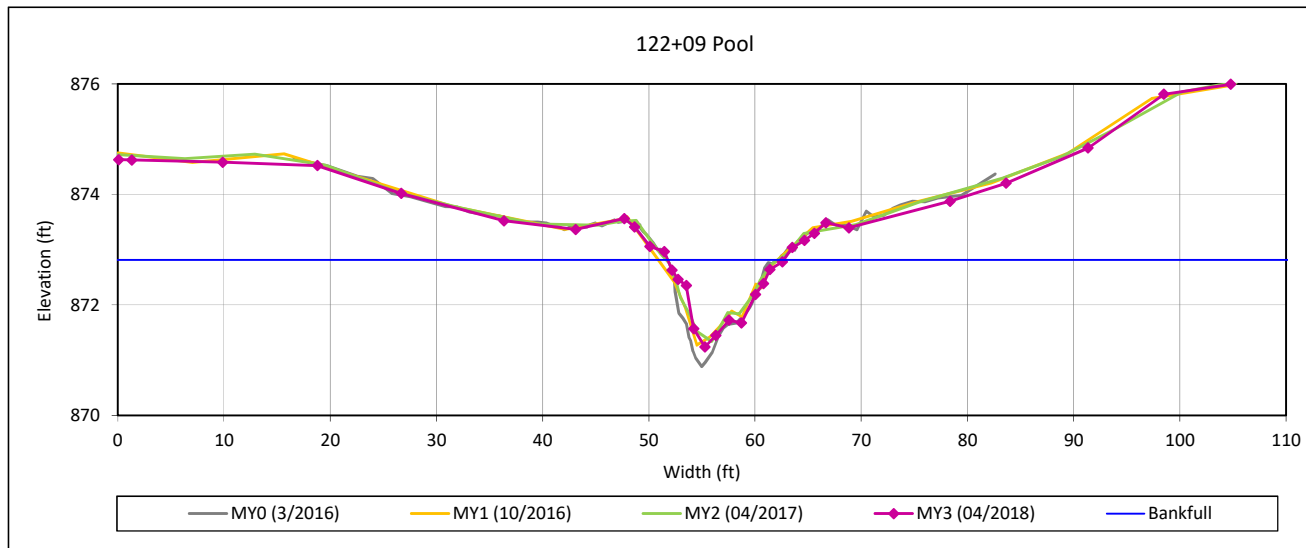
#### Cross-Section 6-UT1 R2

#### Bankfull Dimensions

8.8	x-section area (ft.sq.)
10.9	width (ft)
0.8	mean depth (ft)
1.6	max depth (ft)
11.6	wetted perimeter (ft)
0.8	hydraulic radius (ft)

Survey Date: 04/2018  
Field Crew: Wildlands Engineering

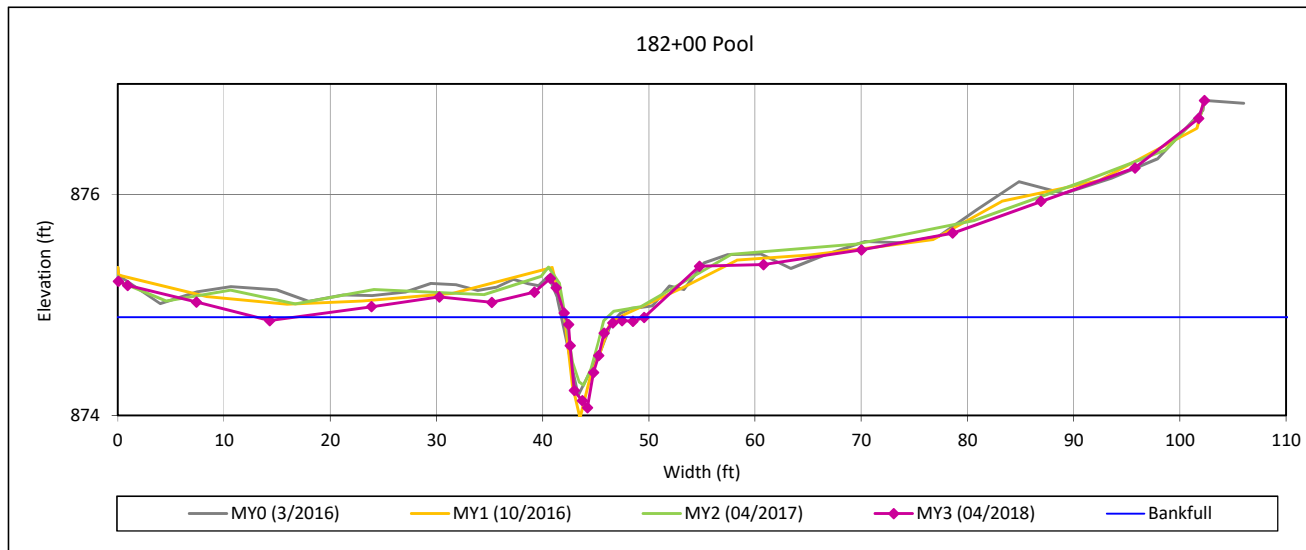
#### Cross-Section 7-UT1A

#### Bankfull Dimensions

2.0	x-section area (ft.sq.)
7.4	width (ft)
0.3	mean depth (ft)
0.8	max depth (ft)
7.8	wetted perimeter (ft)
0.3	hydraulic radius (ft)

Survey Date: 04/2018  
Field Crew: Wildlands Engineering

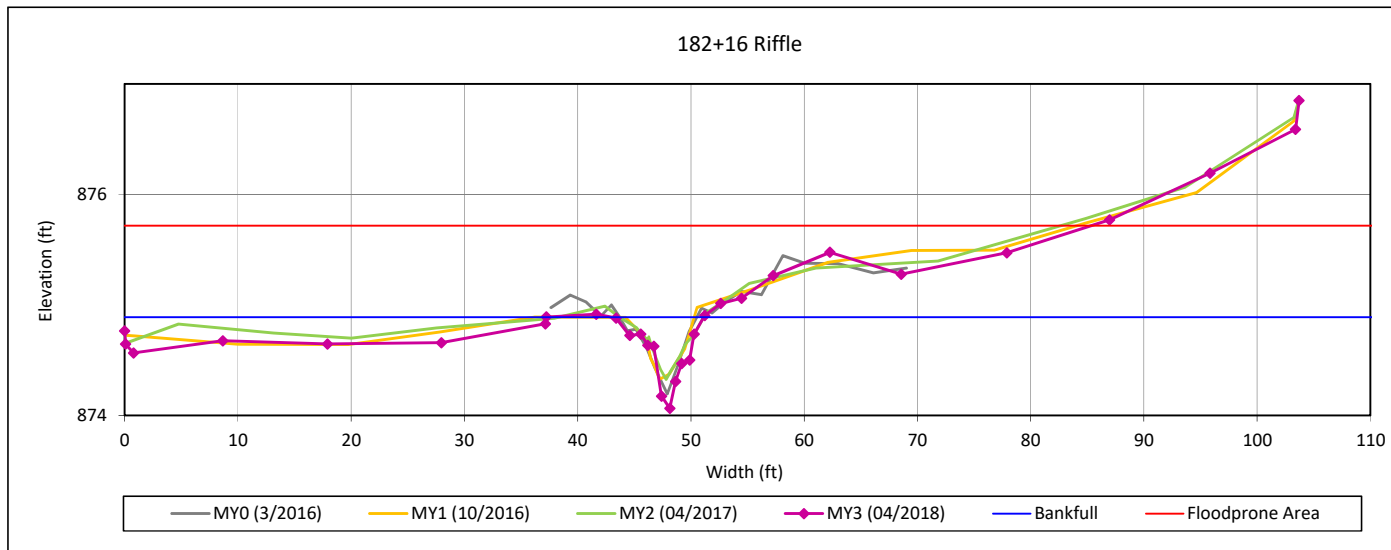
**Cross-Section 8-UT1A**

**Bankfull Dimensions**

2.5	x-section area (ft.sq.)
7.8	width (ft)
0.3	mean depth (ft)
0.8	max depth (ft)
8.1	wetted perimeter (ft)
0.3	hydraulic radius (ft)
23.9	width-depth ratio
89.2	W flood prone area (ft)
11.5	entrenchment ratio
1.0	low bank height ratio

Survey Date: 04/2018

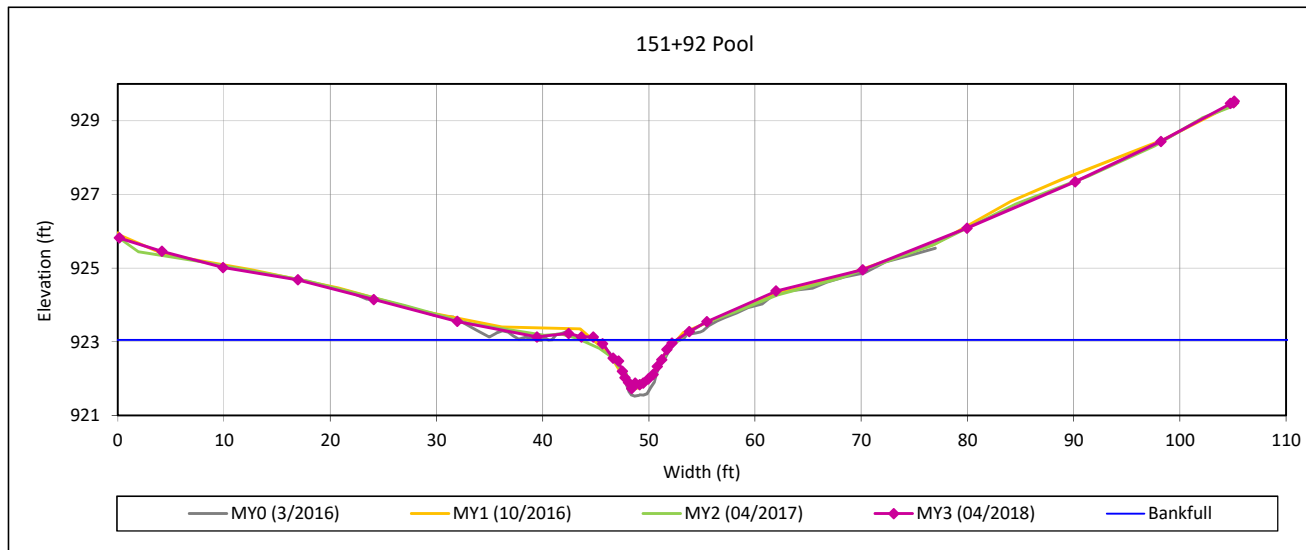
### Cross-Section 9-UT1B

#### Bankfull Dimensions

5.0	x-section area (ft.sq.)
7.5	width (ft)
0.7	mean depth (ft)
1.3	max depth (ft)
8.1	wetted perimeter (ft)
0.6	hydraulic radius (ft)

Survey Date: 04/2018  
Field Crew: Wildlands Engineering

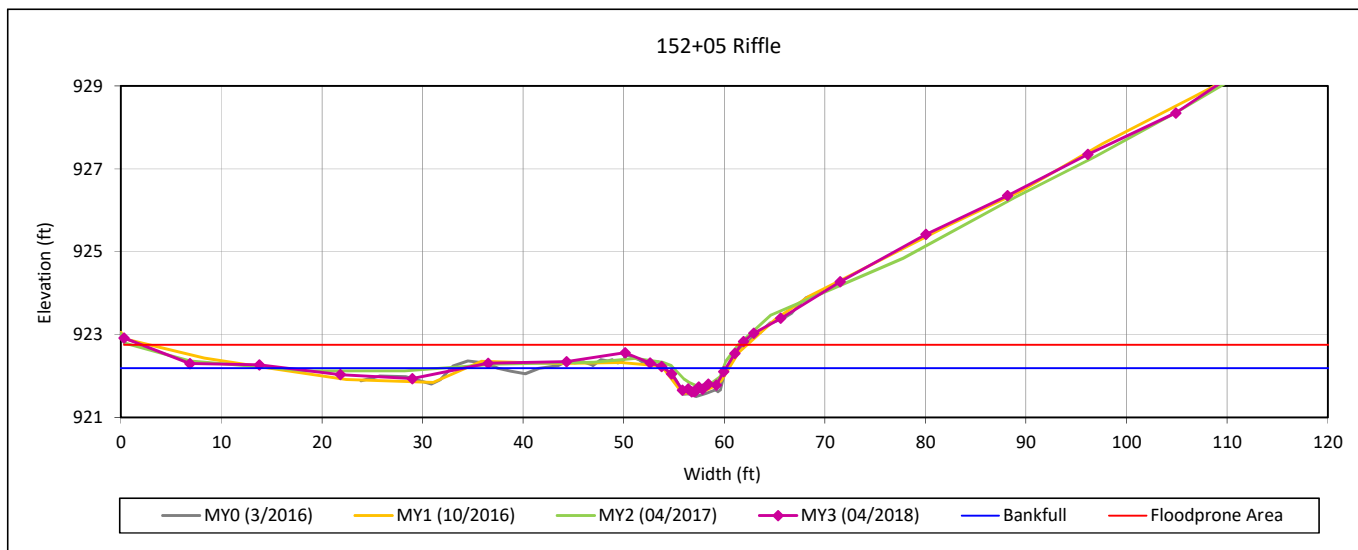
#### Cross-Section 10-UT1B

#### Bankfull Dimensions

2.2	x-section area (ft.sq.)
6.1	width (ft)
0.4	mean depth (ft)
0.6	max depth (ft)
6.3	wetted perimeter (ft)
0.3	hydraulic radius (ft)
17.1	width-depth ratio
56.0	W flood prone area (ft)
9.1	entrenchment ratio
1.0	low bank height ratio

Survey Date: 04/2018  
Field Crew: Wildlands Engineering

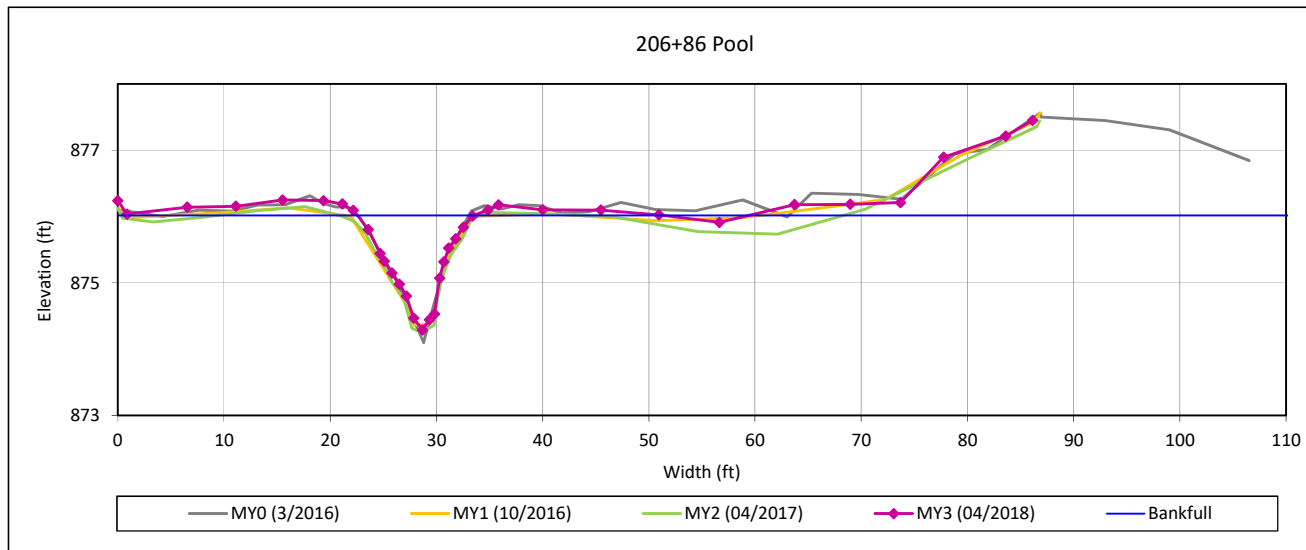
#### Cross-Section 11-UT2

#### Bankfull Dimensions

8.6	x-section area (ft.sq.)
11.0	width (ft)
0.8	mean depth (ft)
1.7	max depth (ft)
11.7	wetted perimeter (ft)
0.7	hydraulic radius (ft)

Survey Date: 04/2018  
Field Crew: Wildlands Engineering

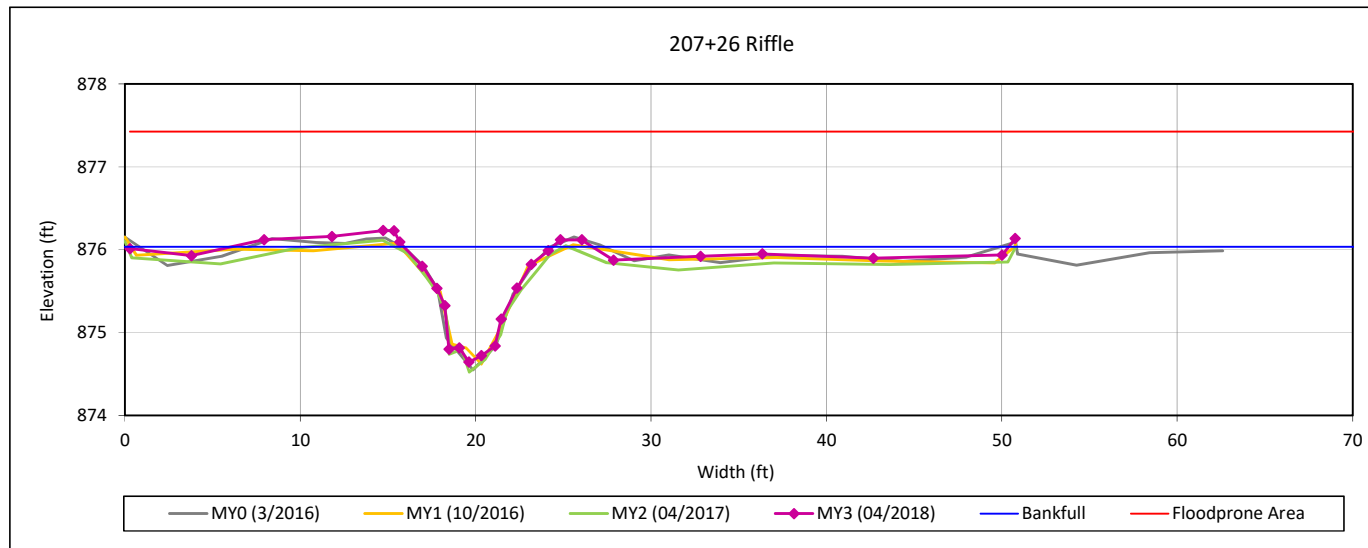
#### Cross-Section 12-UT2

#### Bankfull Dimensions

5.7	x-section area (ft.sq.)
8.2	width (ft)
0.7	mean depth (ft)
1.4	max depth (ft)
9.0	wetted perimeter (ft)
0.6	hydraulic radius (ft)
11.8	width-depth ratio
50.5	W flood prone area (ft)
6.1	entrenchment ratio
1.1	low bank height ratio

Survey Date: 04/2018  
Field Crew: Wildlands Engineering

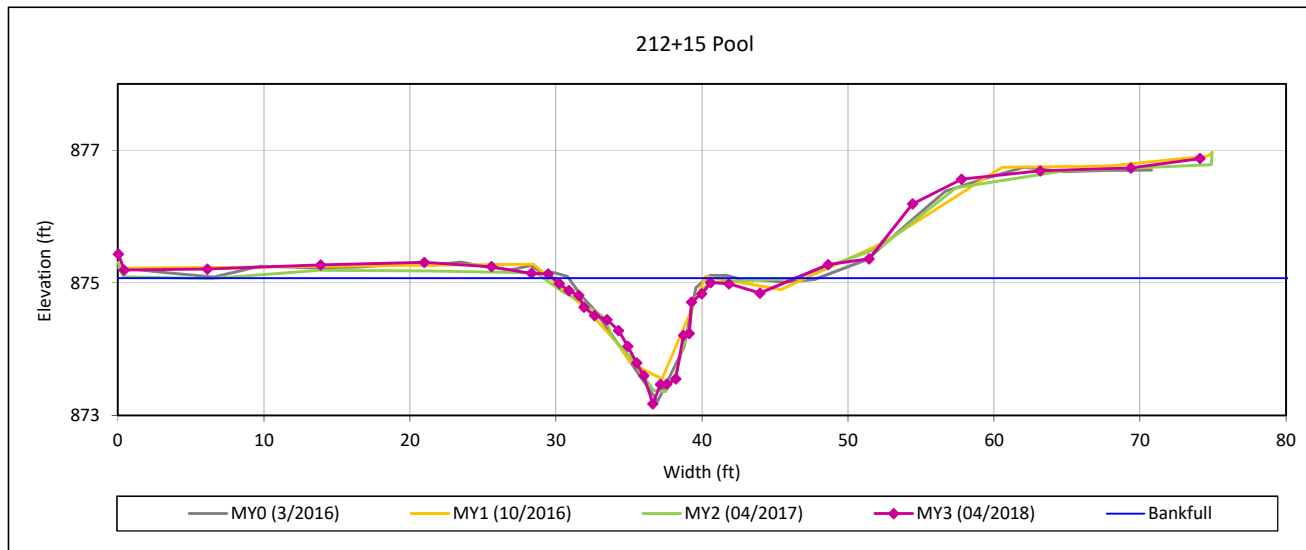
#### Cross-Section 13-UT2

#### Bankfull Dimensions

8.8	x-section area (ft.sq.)
12.0	width (ft)
0.7	mean depth (ft)
1.9	max depth (ft)
13.2	wetted perimeter (ft)
0.7	hydraulic radius (ft)

Survey Date: 04/2018  
Field Crew: Wildlands Engineering
