# MONITORING YEAR 3 ANNUAL REPORT

## HENRY FORK MITIGATION SITE

Catawba County, NC  
DEQ Contract No. 005782  
DMS Project No. 96306

Data Collection Period: April 2018 - November 2018  
Submission Date: December 4, 2018

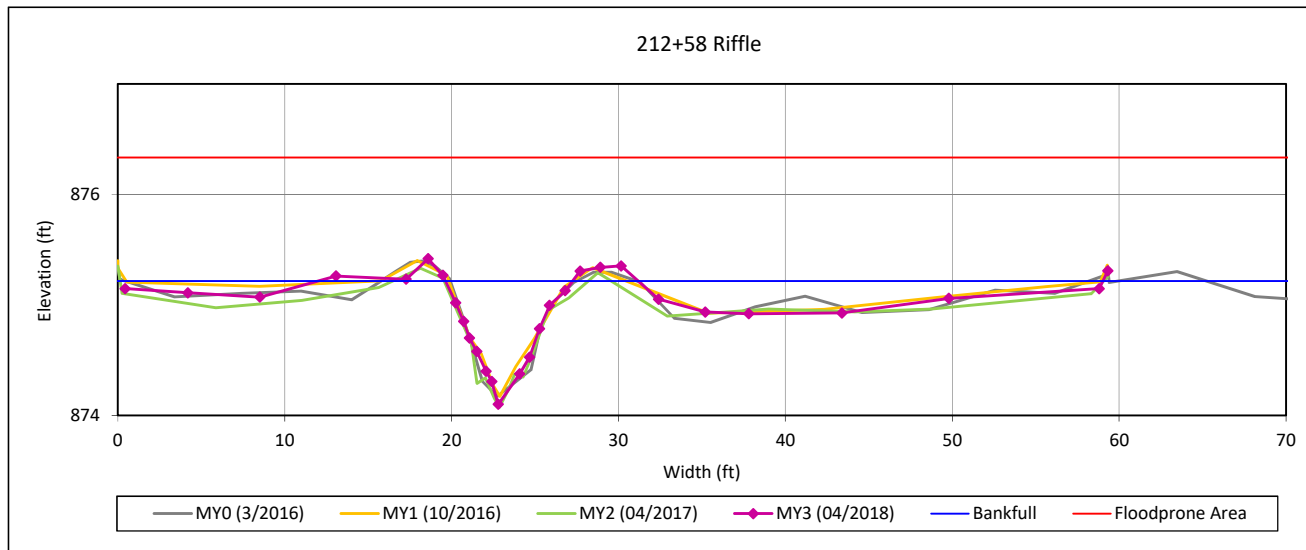
#### Cross-Section 14-UT2

#### Bankfull Dimensions

4.2	x-section area (ft.sq.)
8.8	width (ft)
0.5	mean depth (ft)
1.1	max depth (ft)
9.2	wetted perimeter (ft)
0.5	hydraulic radius (ft)
18.6	width-depth ratio
58.9	W flood prone area (ft)
6.7	entrenchment ratio
1.1	low bank height ratio

Survey Date: 04/2018  
Field Crew: Wildlands Engineering

In general, riffle cross sections show little to no change in the bankfull area, maximum depth ratio, or width-to-depth ratio. Surveyed riffle cross sections fell within the parameters defined for channels of the appropriate Rosgen (Rosgen, 1994 & 1996) stream type. Pebble counts in UT1 Reach 1 and UT1B indicate maintenance of coarser materials in the riffle features and finer particles in the pool features. Refer to Appendix 2 for the visual stability assessment table, Current Conditions Plan View (CCPV) map, and reference photographs. Refer to Appendix 4 for the morphological data and plots.

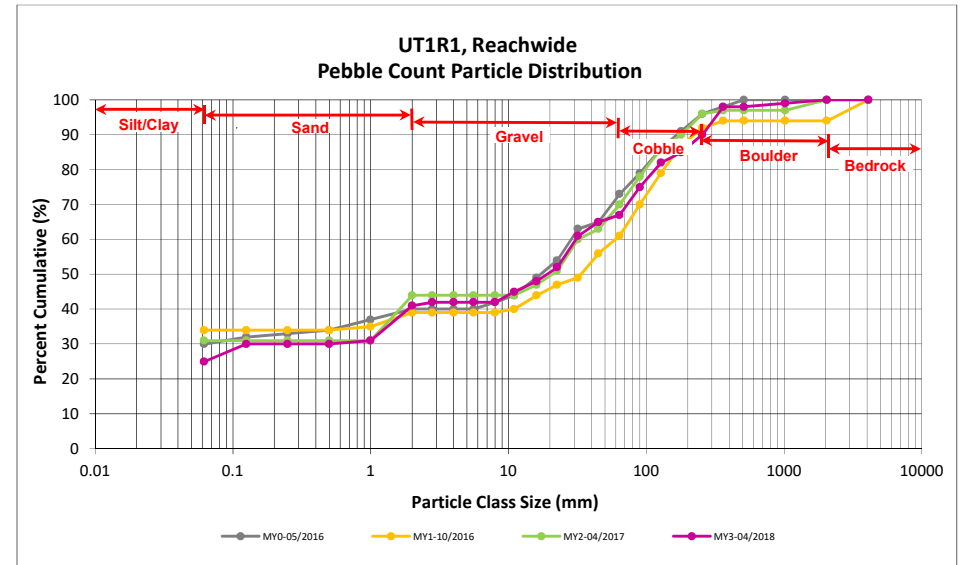
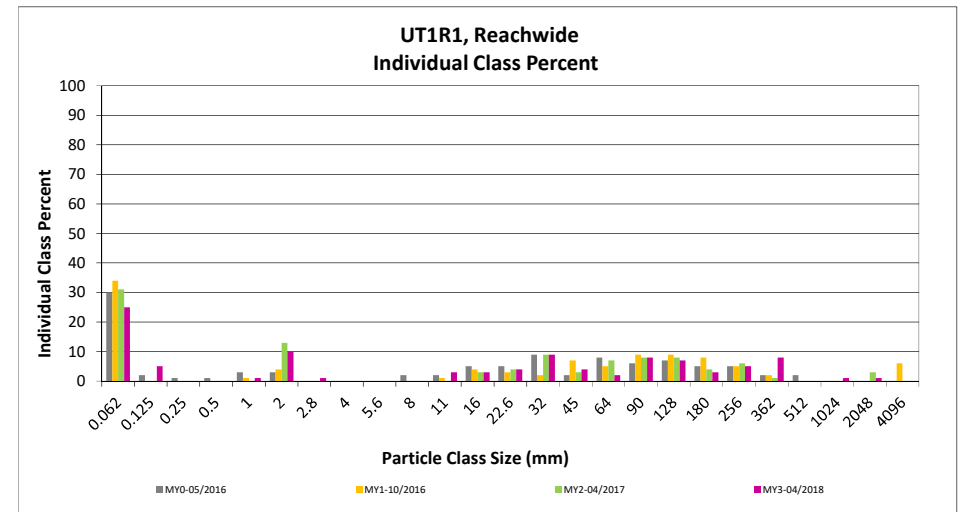
## Reachwide and Cross-Section Pebble Count Plots

Particle Class		Diameter (mm)		Particle Count			Reach Summary	
		min	max	Riffle	Pool	Total	Class Percentage	Percent Cumulative
<b>SILT/CLAY</b>	Silt/Clay	0.000	0.062	3	22	25	25	25
<b>SAND</b>	Very fine	0.062	0.125	1	4	5	5	30
	Fine	0.125	0.250					30
	Medium	0.25	0.50					30
	Coarse	0.5	1.0	1		1	1	31
	Very Coarse	1.0	2.0	3	7	10	10	41
<b>GRAVEL</b>	Very Fine	2.0	2.8		1	1	1	42
	Very Fine	2.8	4.0					42
	Fine	4.0	5.6					42
	Fine	5.6	8.0					42
	Medium	8.0	11.0	1	2	3	3	45
	Medium	11.0	16.0	1	2	3	3	48
	Coarse	16.0	22.6	2	2	4	4	52
	Coarse	22.6	32	3	6	9	9	61
	Very Coarse	32	45	3	1	4	4	65
	Very Coarse	45	64	1	1	2	2	67
<b>COBBLE</b>	Small	64	90	6	2	8	8	75
	Small	90	128	7		7	7	82
	Large	128	180	3		3	3	85
	Large	180	256	5		5	5	90
<b>BOULDER</b>	Small	256	362	8		8	8	98
	Small	362	512					98
	Medium	512	1024	1		1	1	99
	Large/Very Large	1024	2048	1		1	1	100
<b>BEDROCK</b>	Bedrock	2048	>2048					100
<b>Total</b>				<b>50</b>	<b>50</b>	<b>100</b>	<b>100</b>	<b>100</b>

Reachwide	
Channel materials (mm)	
D <sub>16</sub> =	Silt/Clay
D <sub>35</sub> =	1.32
D <sub>50</sub> =	19.0
D <sub>84</sub> =	160.7
D <sub>95</sub> =	317.9
D <sub>100</sub> =	2048.0

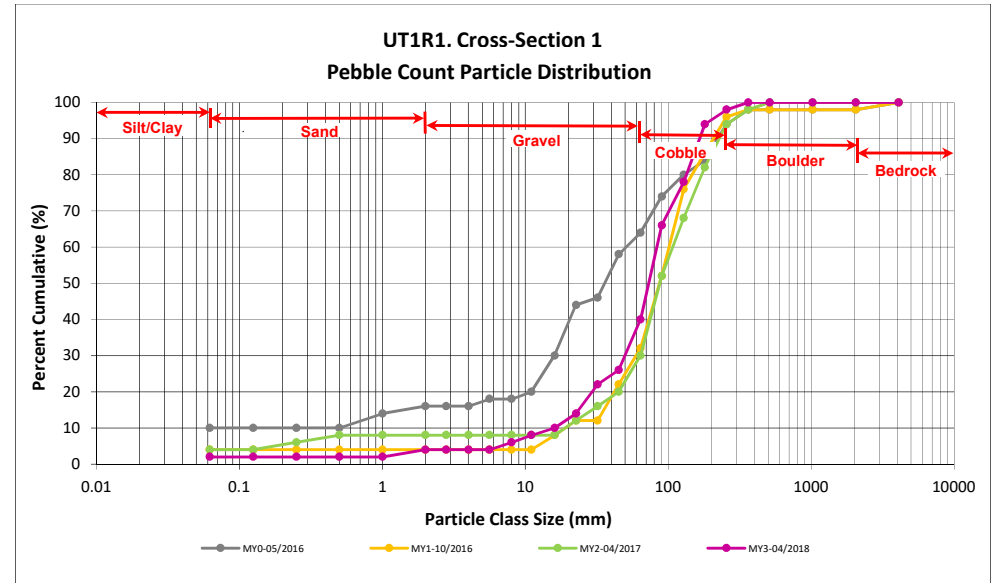
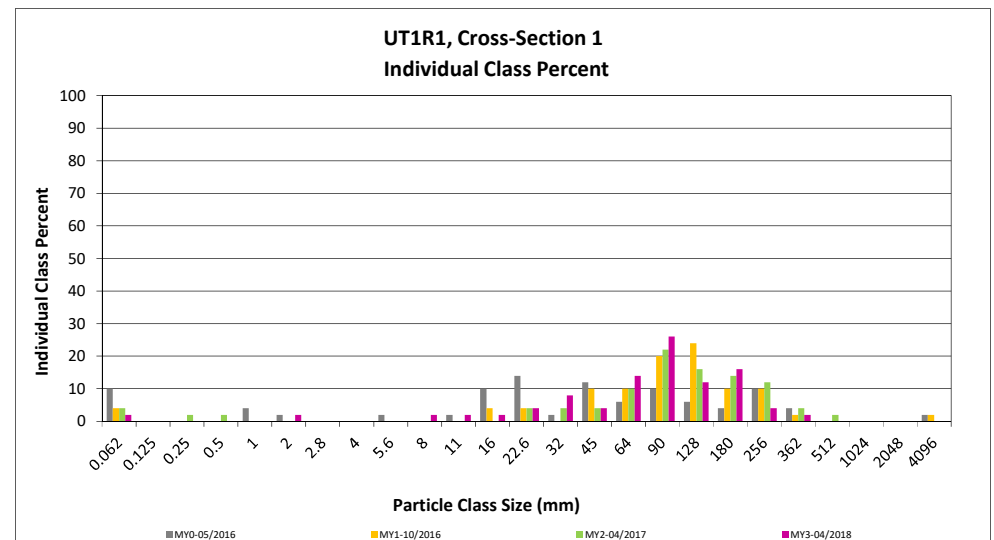
### Reachwide and Cross-Section Pebble Count Plots

Particle Class		Diameter (mm)		Riffle 100-Count	Summary	
		min	max		Class Percentage	Percent Cumulative
<b>SILT/CLAY</b>	Silt/Clay	0.000	0.062	1	2	2
<b>SAND</b>	Very fine	0.062	0.125			2
	Fine	0.125	0.250			2
	Medium	0.25	0.50			2
	Coarse	0.5	1.0			2
	Very Coarse	1.0	2.0	1	2	4
<b>GRAVEL</b>	Very Fine	2.0	2.8			4
	Very Fine	2.8	4.0			4
	Fine	4.0	5.6			4
	Fine	5.6	8.0	1	2	6
	Medium	8.0	11.0	1	2	8
	Medium	11.0	16.0	1	2	10
	Coarse	16.0	22.6	2	4	14
	Coarse	22.6	32	4	8	22
	Very Coarse	32	45	2	4	26
Very Coarse	45	64	7	14	40	
<b>COBBLE</b>	Small	64	90	13	26	66
	Small	90	128	6	12	78
	Large	128	180	8	16	94
	Large	180	256	2	4	98
<b>BOULDER</b>	Small	256	362	1	2	100
	Small	362	512			100
	Medium	512	1024			100
	Large/Very Large	1024	2048			100
<b>BEDROCK</b>	Bedrock	2048	>2048			100
<b>Total</b>				<b>50</b>	<b>100</b>	<b>100</b>

Cross-Section 1	
Channel materials (mm)	
D <sub>16</sub> =	24.65
D <sub>35</sub> =	56.44
D <sub>50</sub> =	73.0
D <sub>84</sub> =	145.5
D <sub>95</sub> =	196.6
D <sub>100</sub> =	362.0

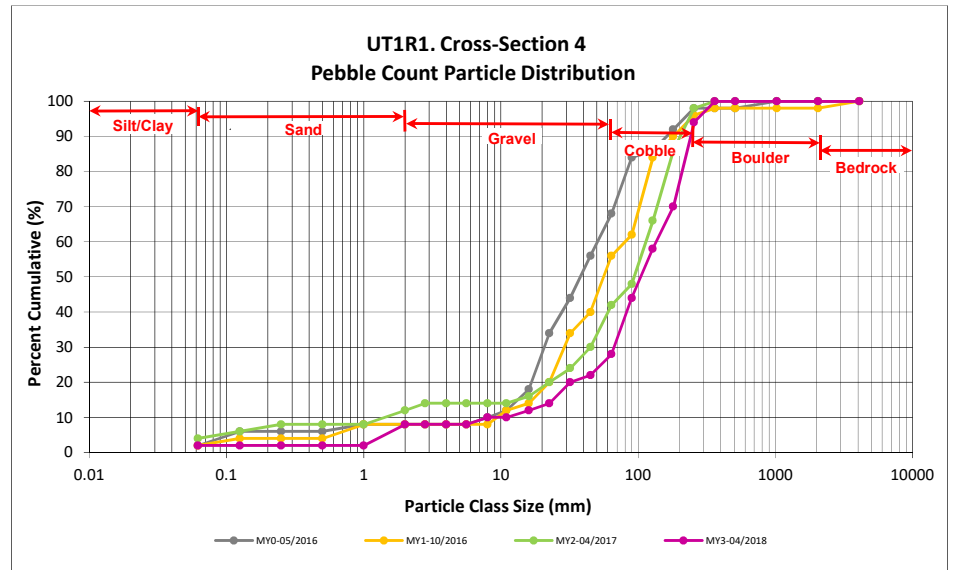
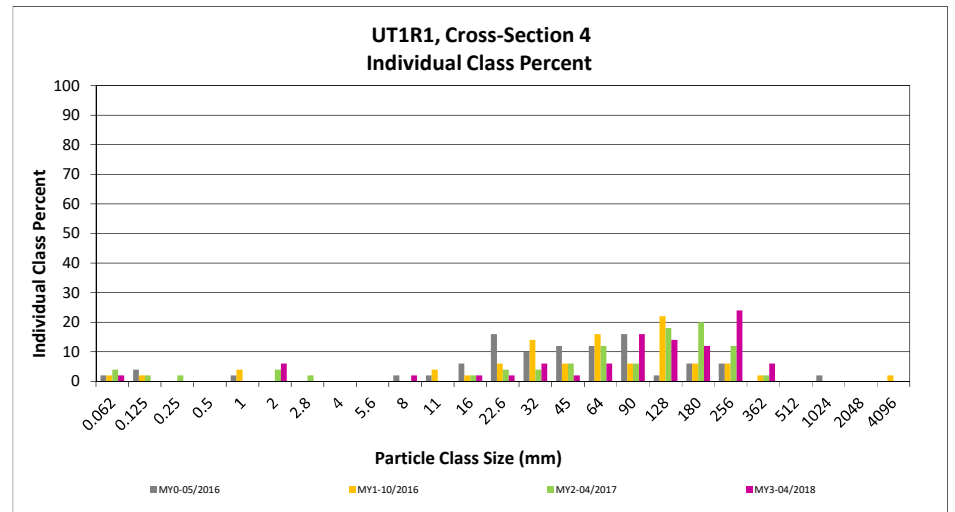
## Reachwide and Cross-Section Pebble Count Plots

Particle Class		Diameter (mm)		Riffle 100-Count	Summary	
		min	max		Class Percentage	Percent Cumulative
<i>SILT/CLAY</i>	Silt/Clay	0.000	0.062	1	2	2
<b>SAND</b>	Very fine	0.062	0.125			2
	Fine	0.125	0.250			2
	Medium	0.25	0.50			2
	Coarse	0.5	1.0			2
	Very Coarse	1.0	2.0	3	6	8
<b>GRAVEL</b>	Very Fine	2.0	2.8			8
	Very Fine	2.8	4.0			8
	Fine	4.0	5.6			8
	Fine	5.6	8.0	1	2	10
	Medium	8.0	11.0			10
	Medium	11.0	16.0	1	2	12
	Coarse	16.0	22.6	1	2	14
	Coarse	22.6	32	3	6	20
	Very Coarse	32	45	1	2	22
	Very Coarse	45	64	3	6	28
<b>COBBLE</b>	Small	64	90	8	16	44
	Small	90	128	7	14	58
	Large	128	180	6	12	70
	Large	180	256	12	24	94
<b>BOULDER</b>	Small	256	362	3	6	100
	Small	362	512			100
	Medium	512	1024			100
	Large/Very Large	1024	2048			100
<b>BEDROCK</b>	Bedrock	2048	>2048			100
<b>Total</b>				<b>50</b>	<b>100</b>	<b>100</b>

Cross-Section 4 Channel materials (mm)	
D <sub>16</sub> =	25.38
D <sub>35</sub> =	74.29
D <sub>50</sub> =	104.7
D <sub>84</sub> =	221.1
D <sub>95</sub> =	271.2
D <sub>100</sub> =	362.0

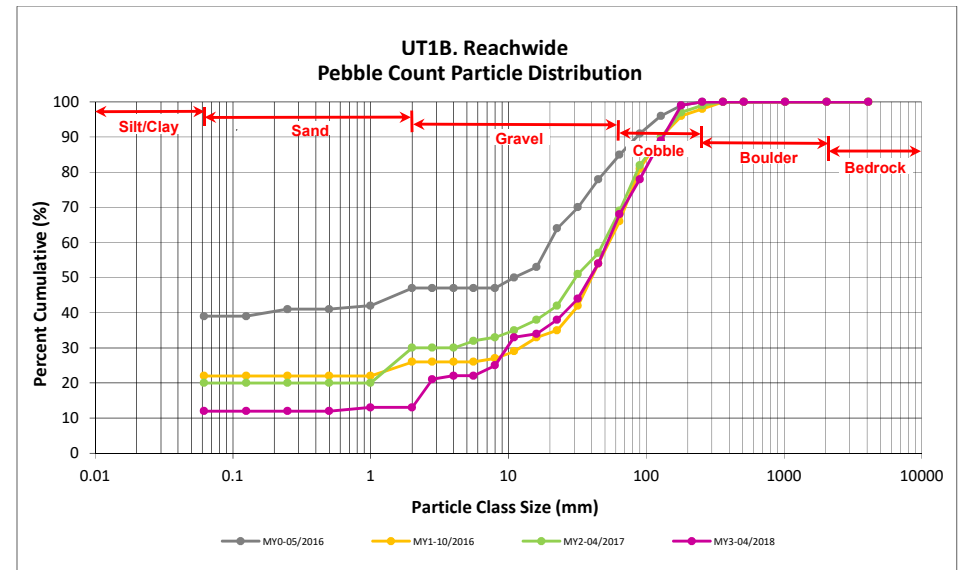
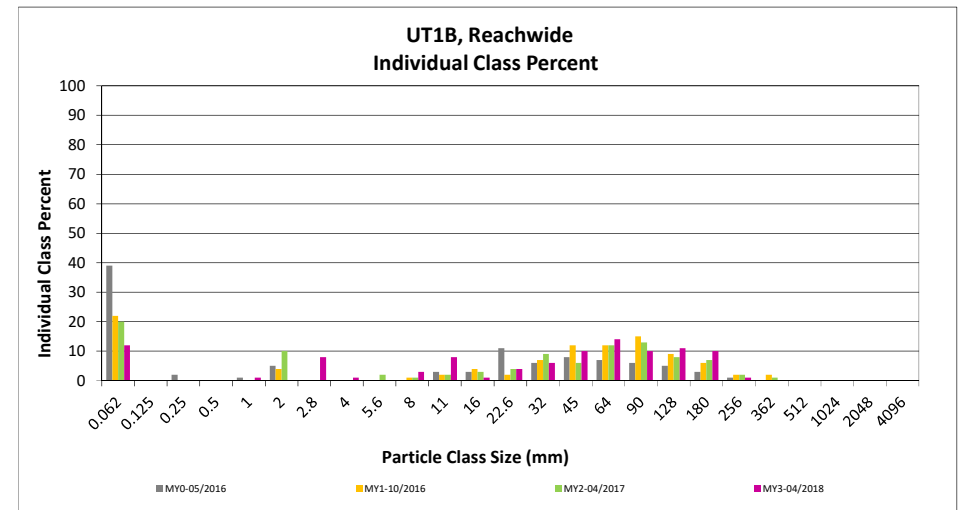
## Reachwide and Cross-Section Pebble Count Plots

Particle Class		Diameter (mm)		Particle Count			Reach Summary	
		min	max	Riffle	Pool	Total	Class Percentage	Percent Cumulative
<b>SILT/CLAY</b>	Silt/Clay	0.000	0.062	2	10	12	12	12
<b>SAND</b>	Very fine	0.062	0.125					12
	Fine	0.125	0.250					12
	Medium	0.25	0.50					12
	Coarse	0.5	1.0		1	1	1	13
	Very Coarse	1.0	2.0					13
<b>GRAVEL</b>	Very Fine	2.0	2.8		8	8	8	21
	Very Fine	2.8	4.0		1	1	1	22
	Fine	4.0	5.6					22
	Fine	5.6	8.0		3	3	3	25
	Medium	8.0	11.0	2	6	8	8	33
	Medium	11.0	16.0		1	1	1	34
	Coarse	16.0	22.6	1	3	4	4	38
	Coarse	22.6	32	2	4	6	6	44
	Very Coarse	32	45	2	8	10	10	54
	Very Coarse	45	64	11	3	14	14	68
<b>COBBLE</b>	Small	64	90	9	1	10	10	78
	Small	90	128	10	1	11	11	89
	Large	128	180	10		10	10	99
	Large	180	256	1		1	1	100
<b>BOULDER</b>	Small	256	362					100
	Small	362	512					100
	Medium	512	1024					100
	Large/Very Large	1024	2048					100
<b>BEDROCK</b>	Bedrock	2048	>2048					100
<b>Total</b>				<b>50</b>	<b>50</b>	<b>100</b>	<b>100</b>	<b>100</b>

Reachwide Channel materials (mm)	
D <sub>16</sub> =	2.27
D <sub>35</sub> =	17.44
D <sub>50</sub> =	39.3
D <sub>84</sub> =	109.1
D <sub>95</sub> =	157.1
D <sub>100</sub> =	256.0

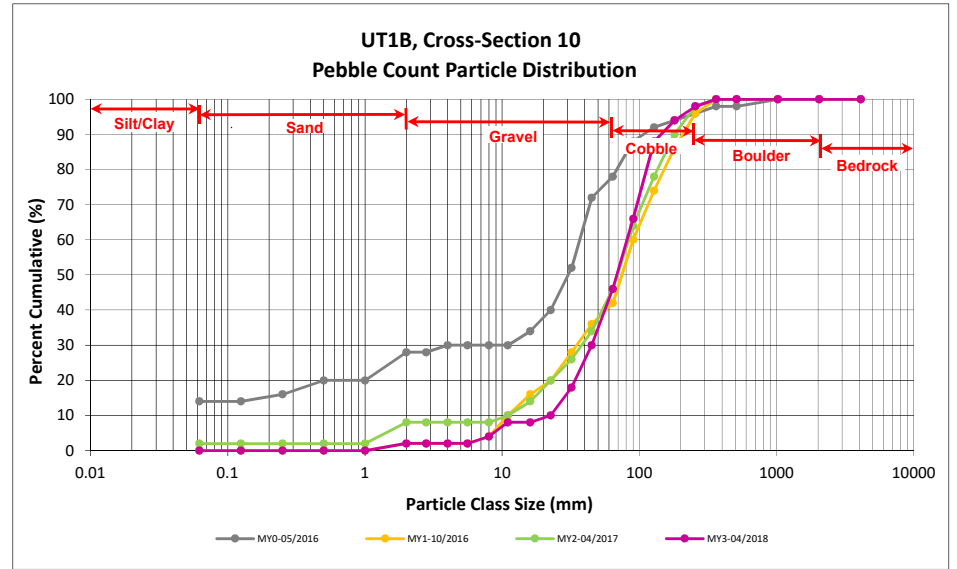
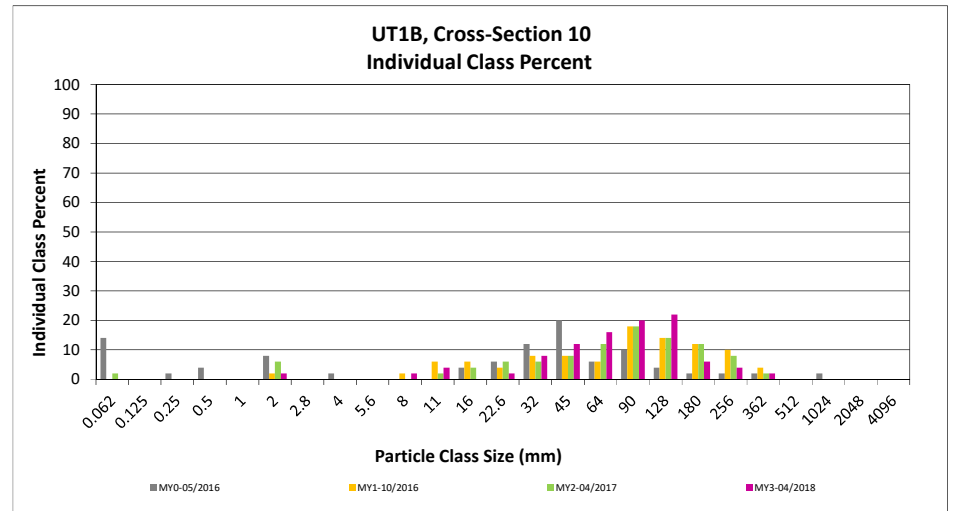
Particle Class		Diameter (mm)		Riffle 100-Count	Summary	
		min	max		Class Percentage	Percent Cumulative
<i>SILT/CLAY</i>	Silt/Clay	0.000	0.062			0
<b>SAND</b>	Very fine	0.062	0.125			0
	Fine	0.125	0.250			0
	Medium	0.25	0.50			0
	Coarse	0.5	1.0			0
	Very Coarse	1.0	2.0	1	2	2
<b>GRAVEL</b>	Very Fine	2.0	2.8			2
	Very Fine	2.8	4.0			2
	Fine	4.0	5.6			2
	Fine	5.6	8.0	1	2	4
	Medium	8.0	11.0	2	4	8
	Medium	11.0	16.0			8
	Coarse	16.0	22.6	1	2	10
	Coarse	22.6	32	4	8	18
	Very Coarse	32	45	6	12	30
	Very Coarse	45	64	8	16	46
<b>COBBLE</b>	Small	64	90	10	20	66
	Small	90	128	11	22	88
	Large	128	180	3	6	94
	Large	180	256	2	4	98
<b>BOULDER</b>	Small	256	362	1	2	100
	Small	362	512			100
	Medium	512	1024			100
	Large/Very Large	1024	2048			100
<b>BEDROCK</b>	Bedrock	2048	>2048			100
<b>Total</b>				<b>50</b>	<b>100</b>	<b>100</b>

Cross-Section Channel materials (mm)	
D <sub>16</sub> =	29.34
D <sub>35</sub> =	50.24
D <sub>50</sub> =	68.5
D <sub>84</sub> =	120.1
D <sub>95</sub> =	196.6
D <sub>100</sub> =	362.0

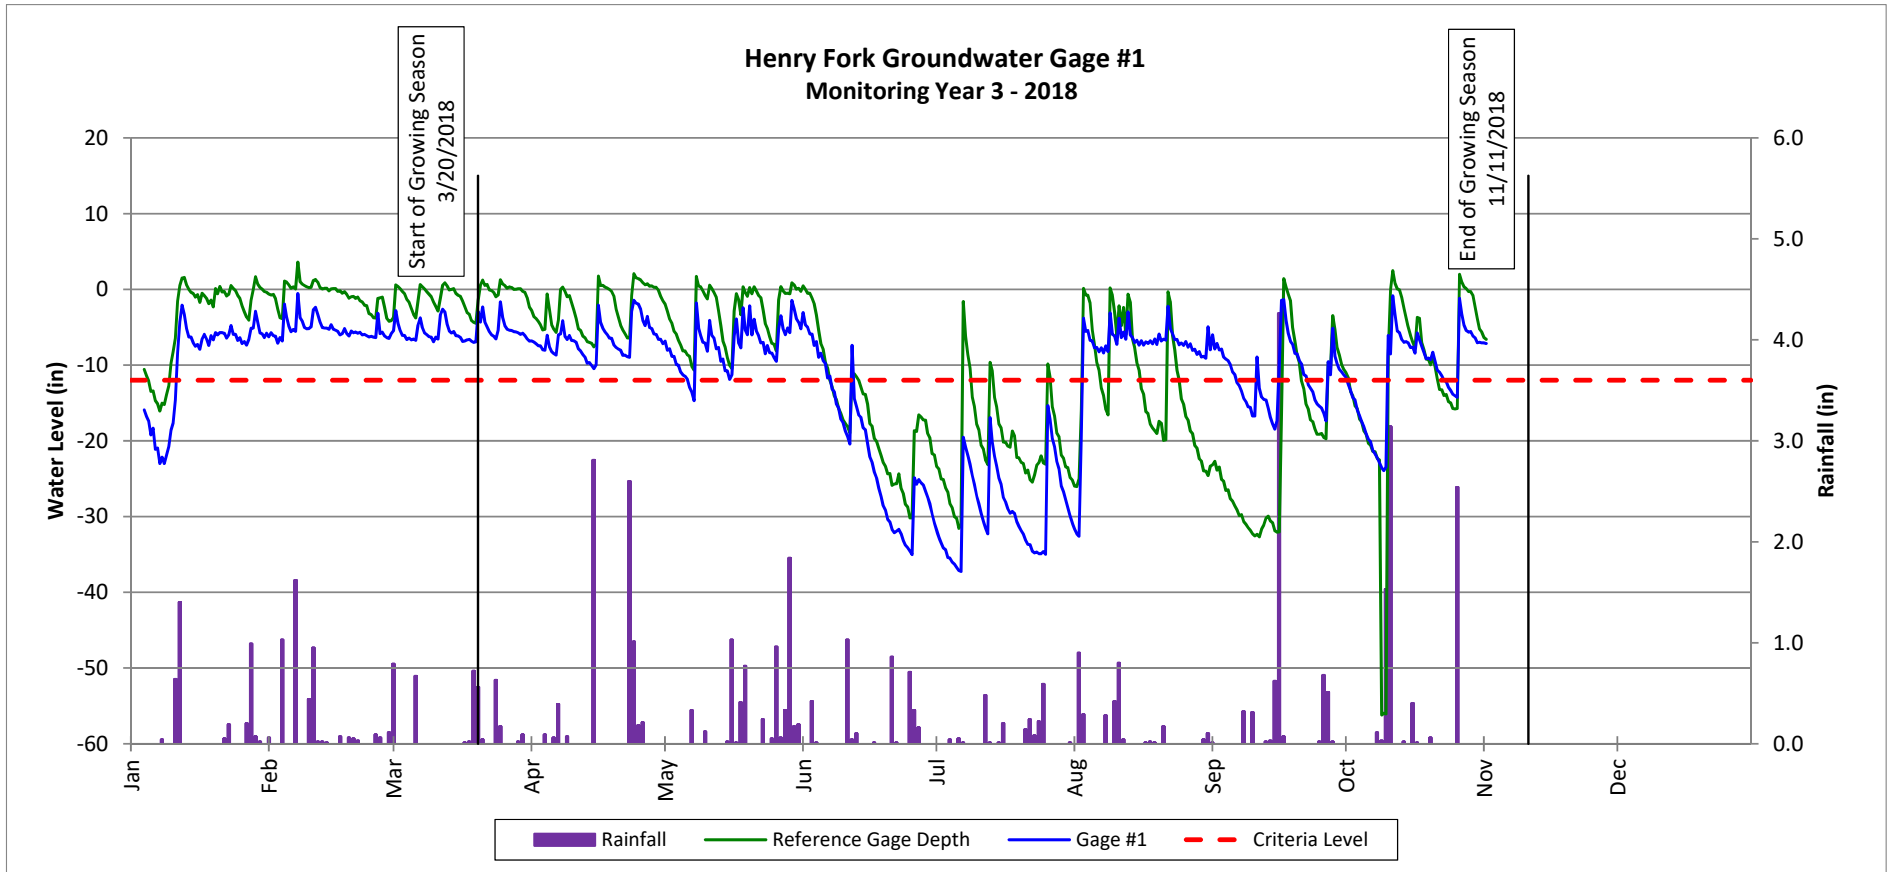
Henry Fork Mitigation Site (DMS Project No. 96306)

Monitoring Year 3 - 2018

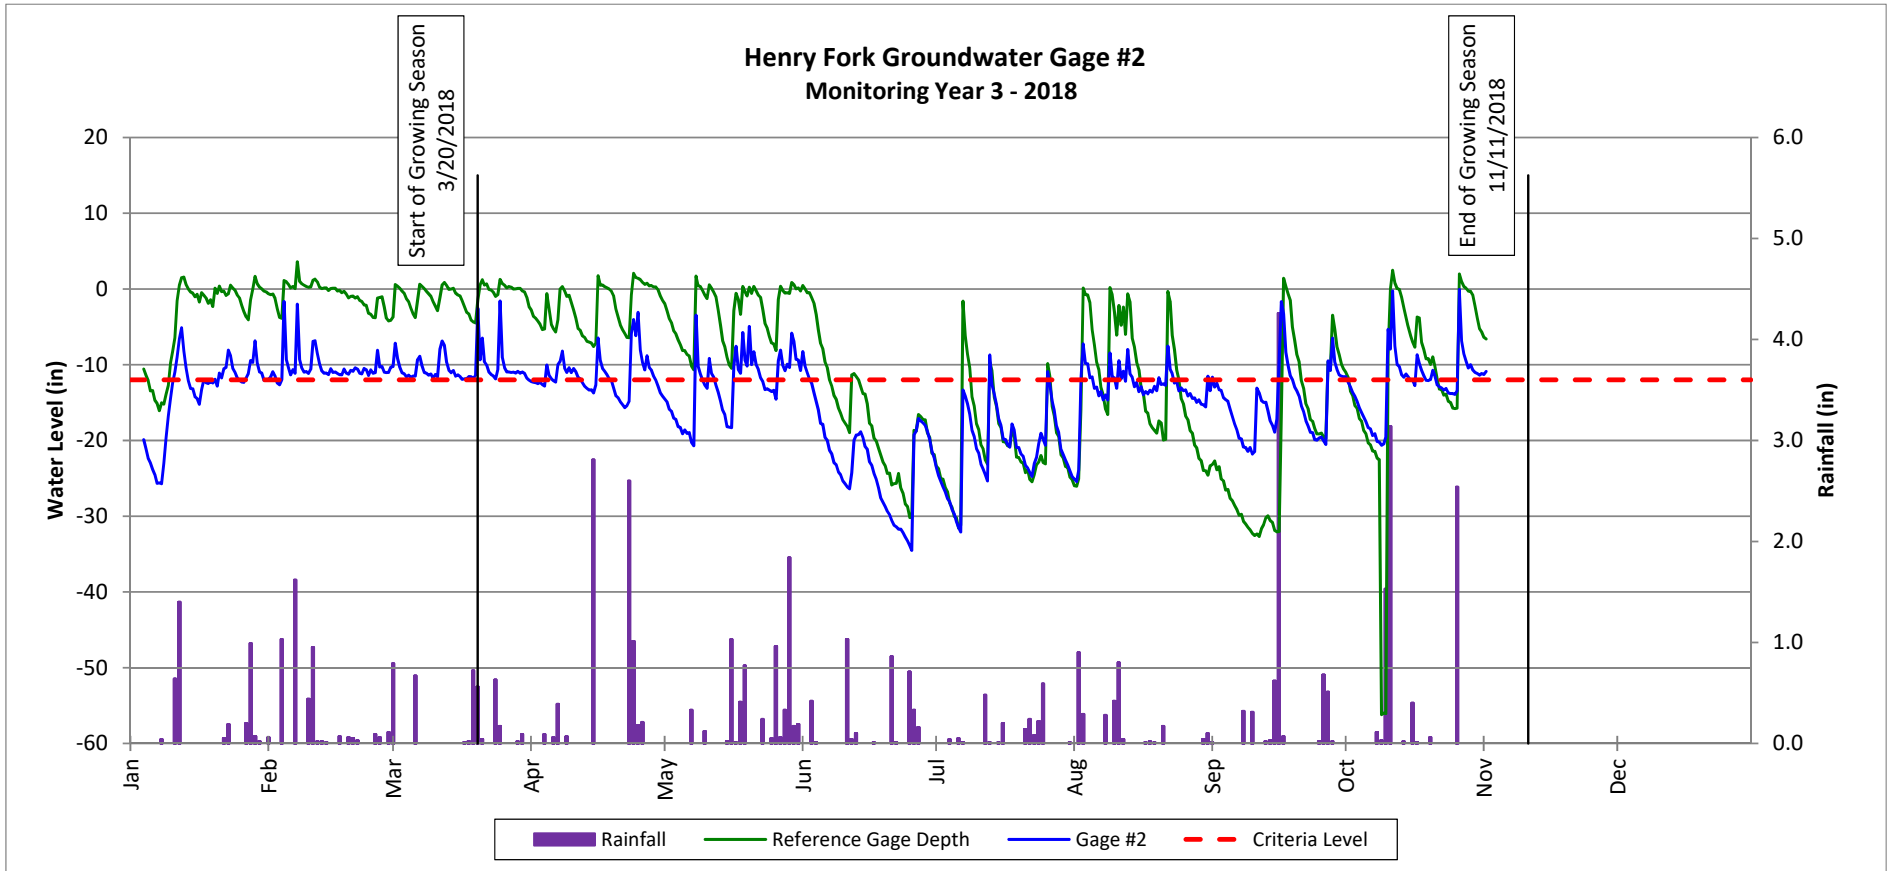
## Groundwater Gage Plots

Henry Fork Mitigation Site (DMS Project No. 96306)

Monitoring Year 3 - 2018

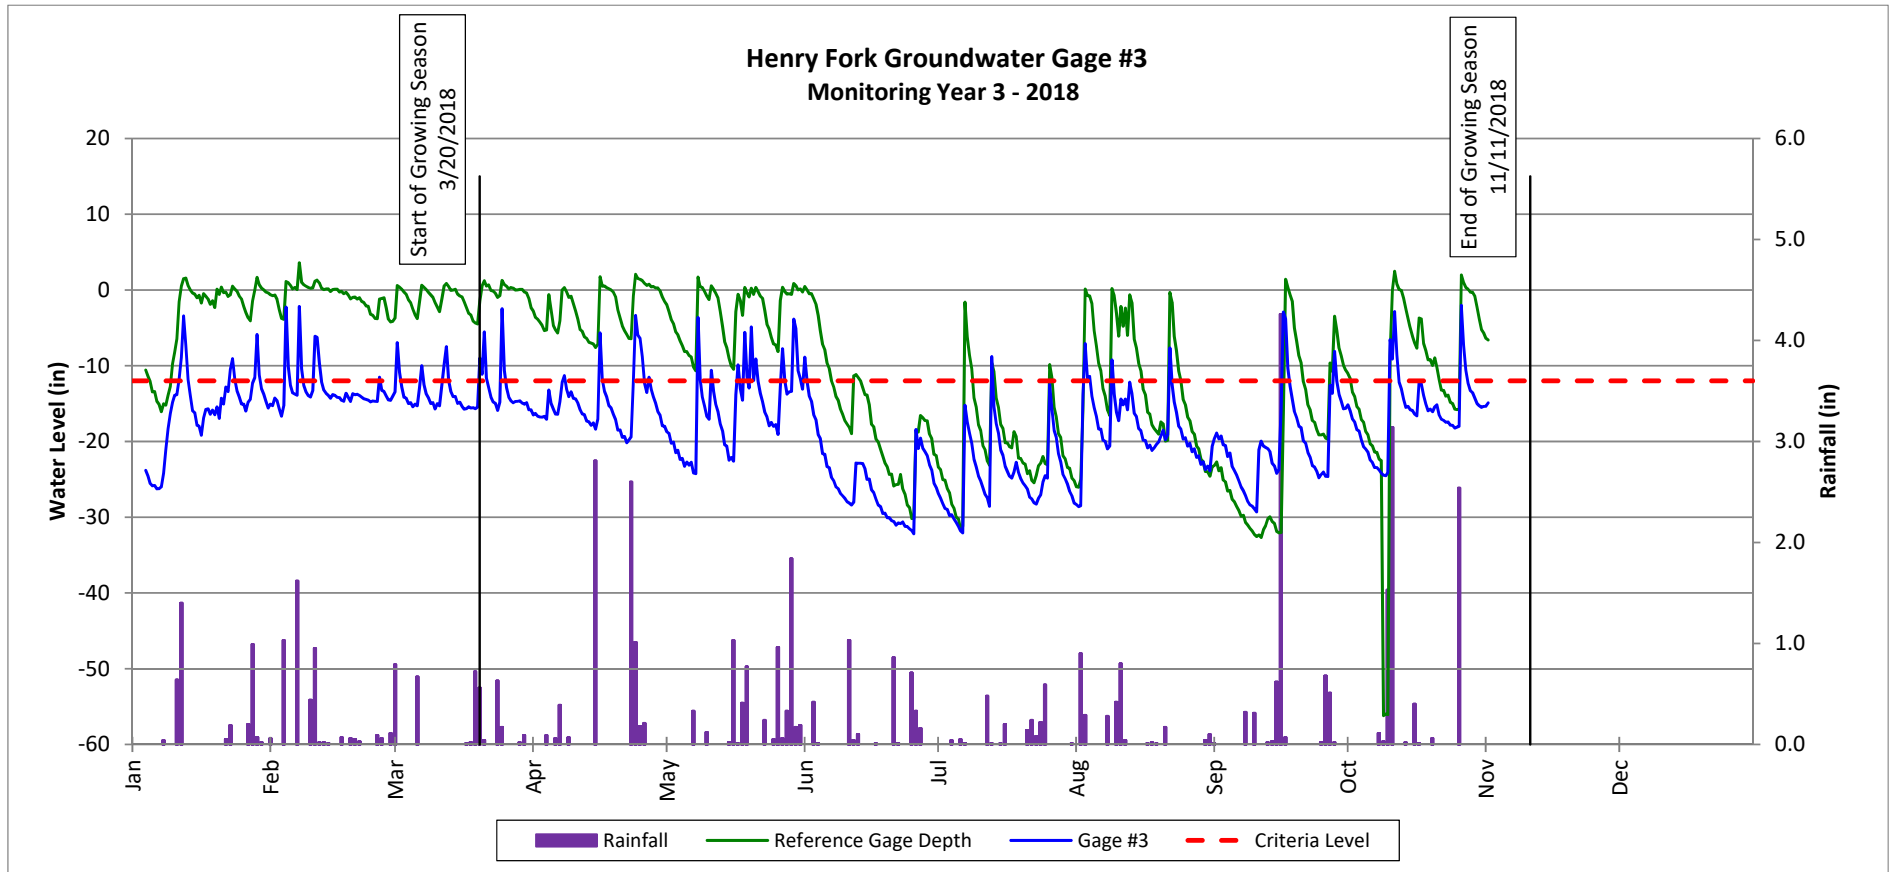
## Groundwater Gage Plots

Henry Fork Mitigation Site (DMS Project No. 96306)

Monitoring Year 3 - 2018

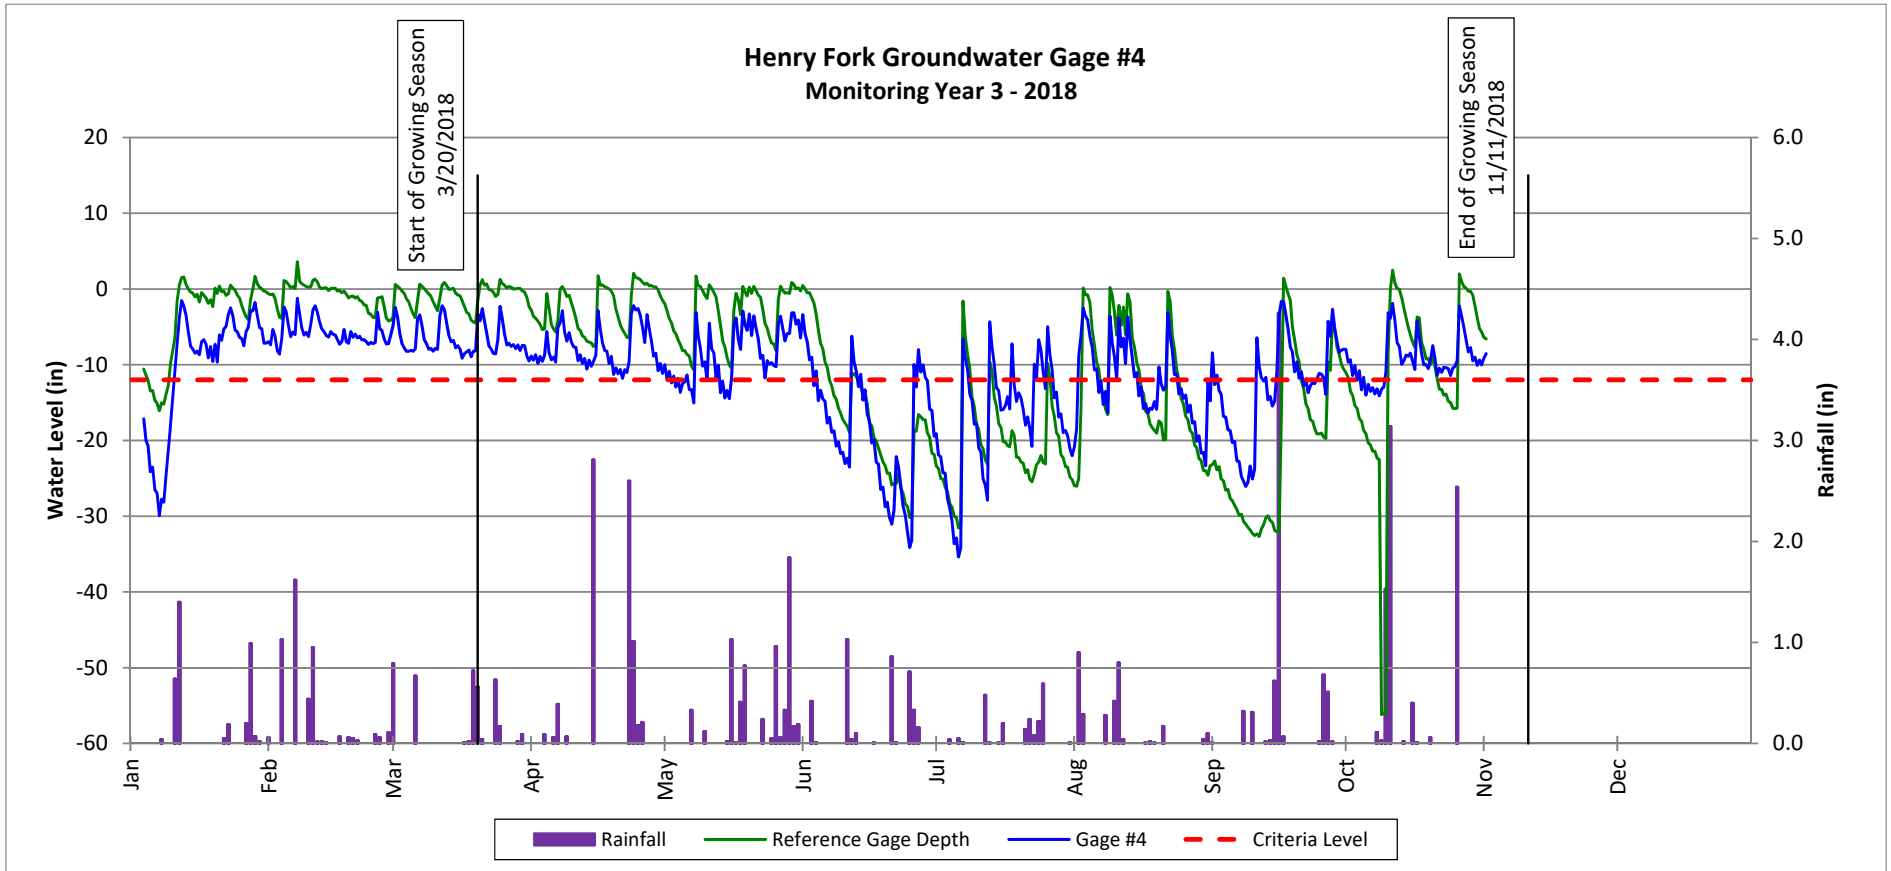
## Groundwater Gage Plots

Henry Fork Mitigation Site (DMS Project No. 96306)

Monitoring Year 3 - 2018

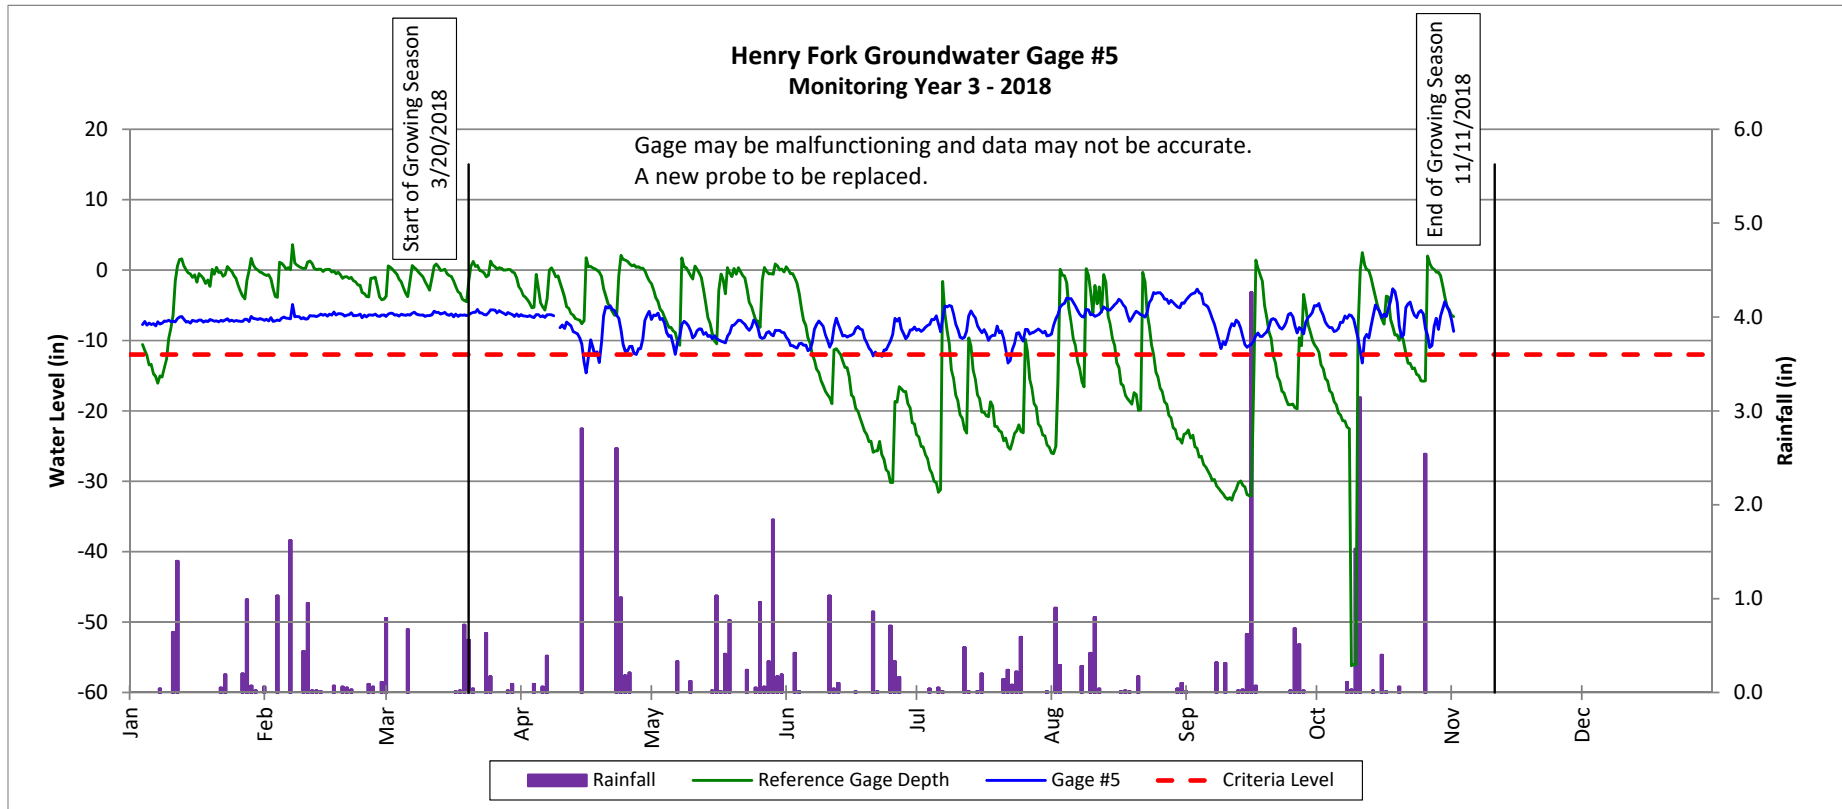
## Groundwater Gage Plots

Henry Fork Mitigation Site (DMS Project No. 96306)

Monitoring Year 3 - 2018

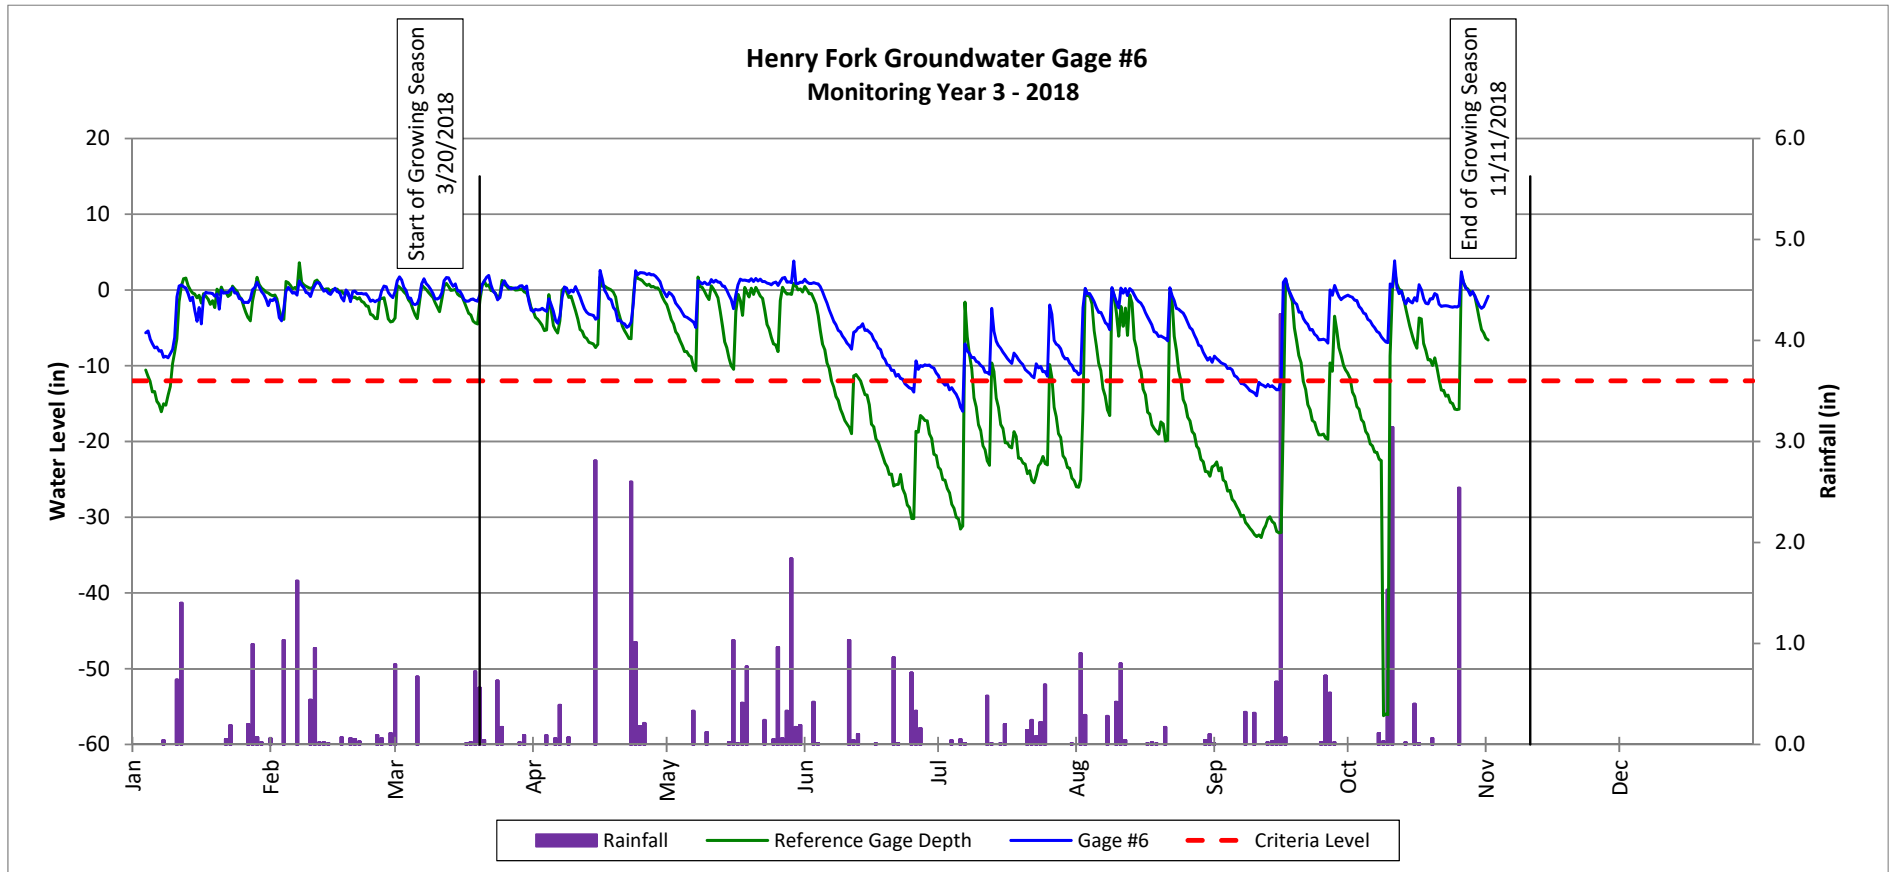
## Groundwater Gage Plots

Henry Fork Mitigation Site (DMS Project No. 96306)

Monitoring Year 3 - 2018

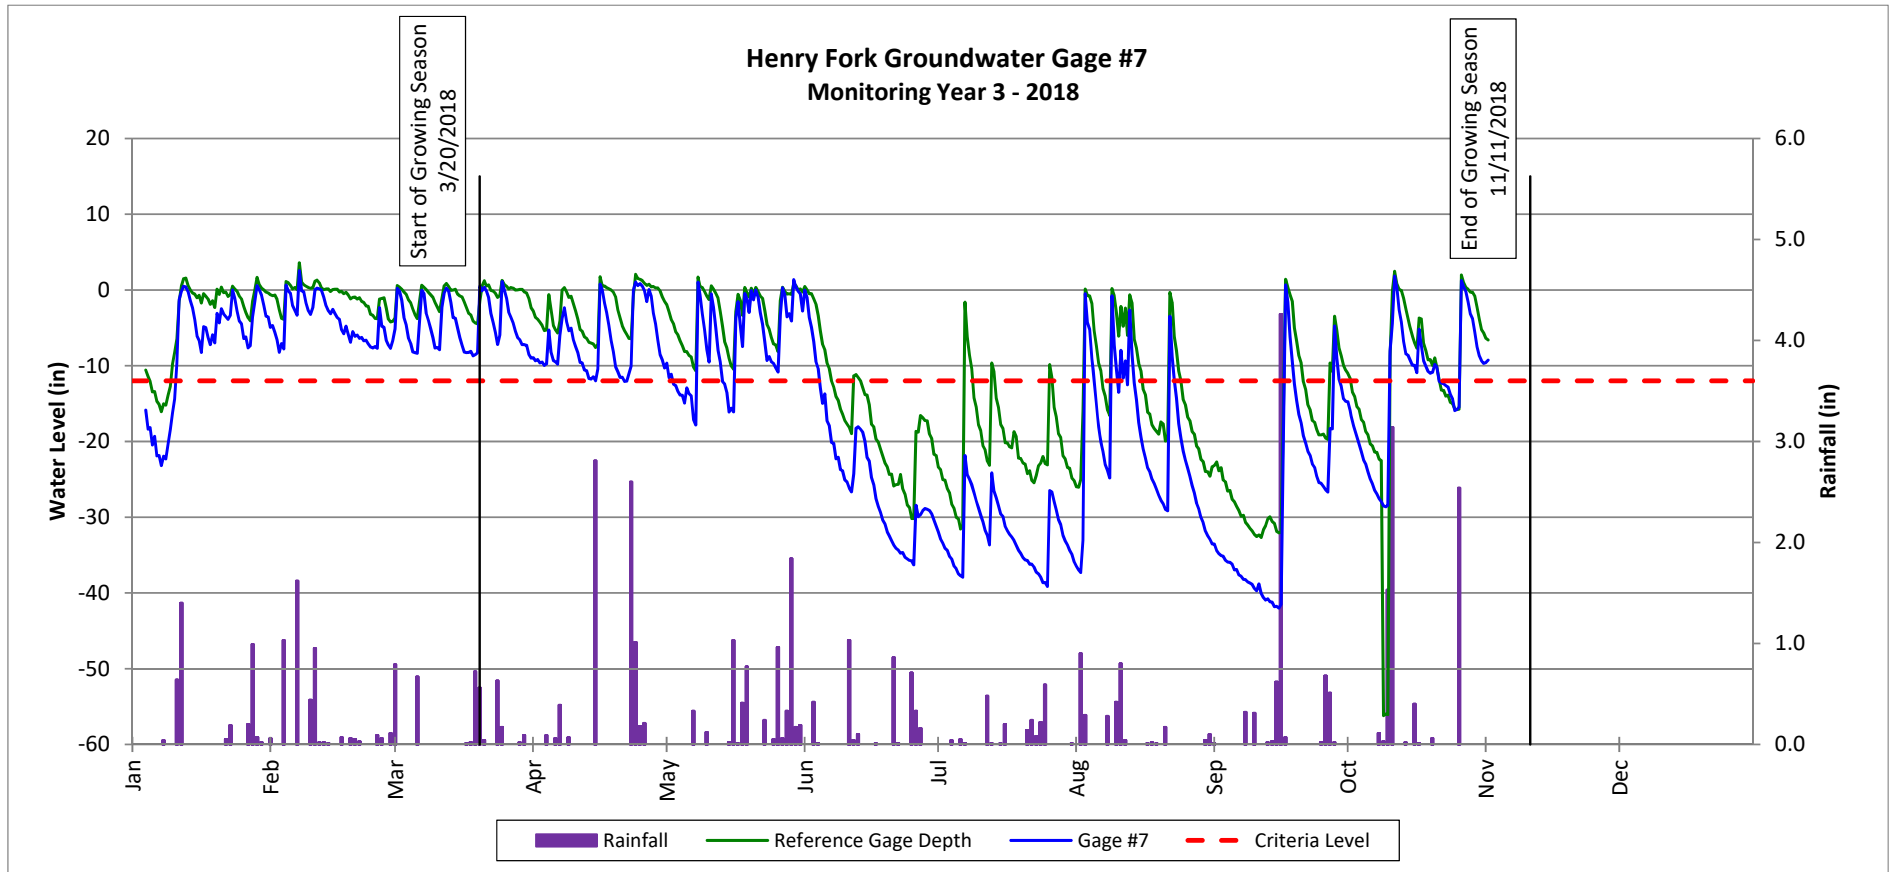
## Groundwater Gage Plots

Henry Fork Mitigation Site (DMS Project No. 96306)

Monitoring Year 3 - 2018

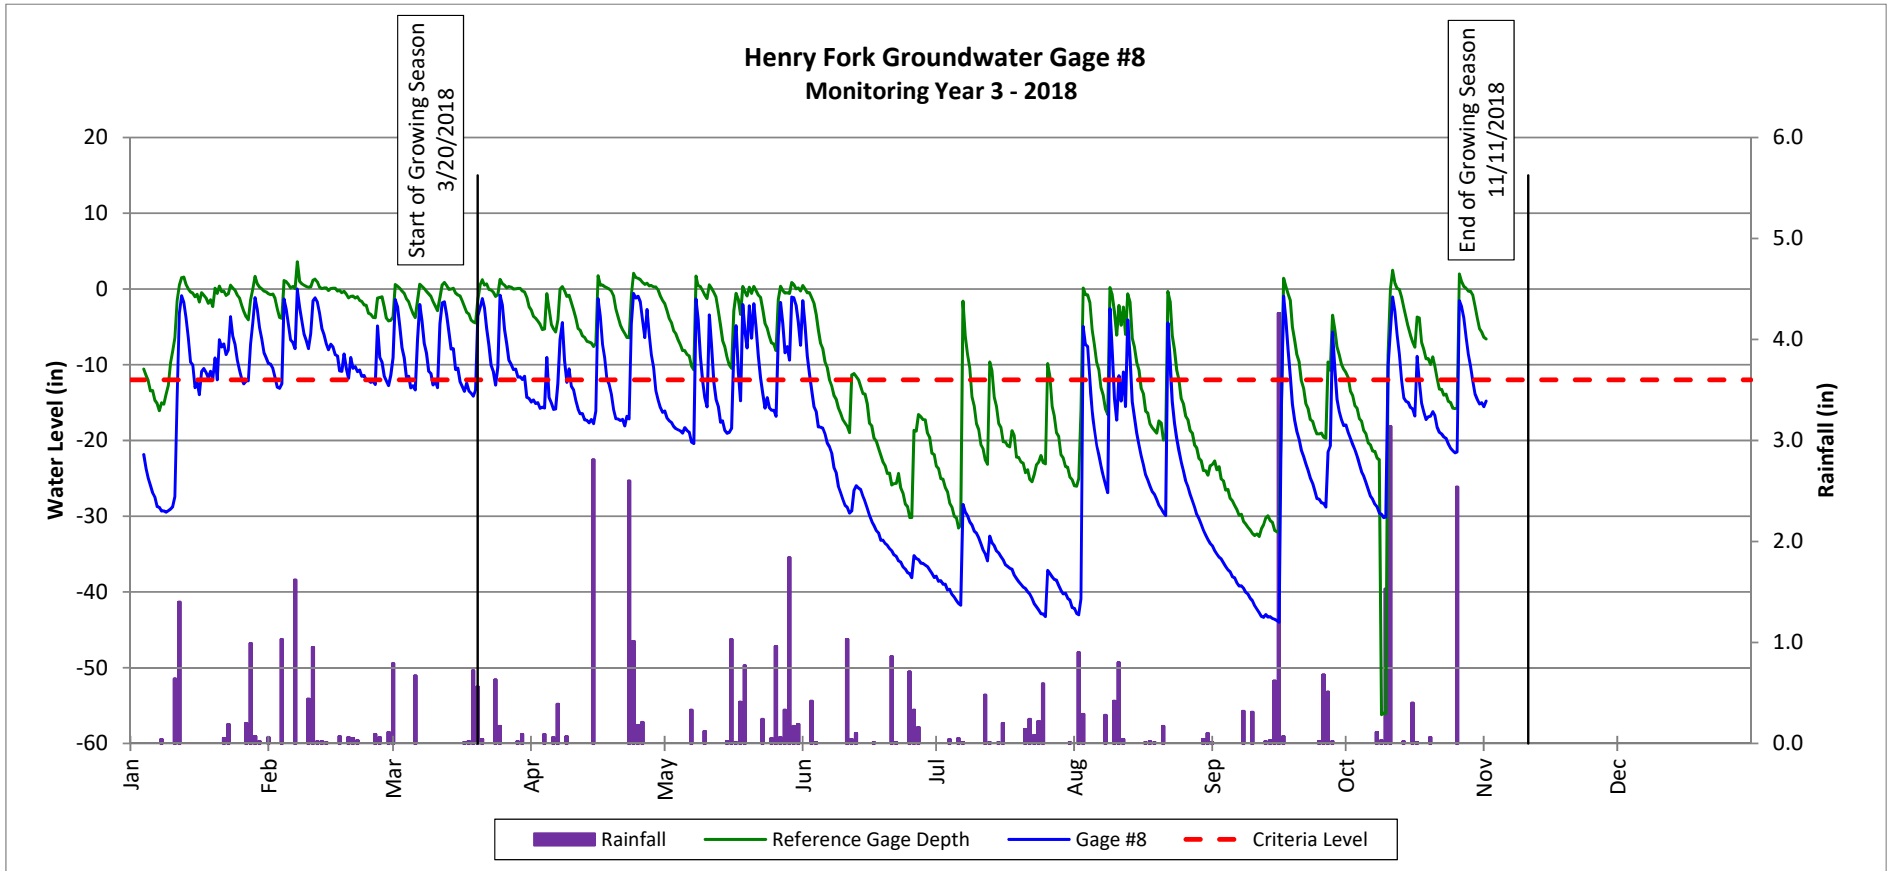
## Groundwater Gage Plots

Henry Fork Mitigation Site (DMS Project No. 96306)

Monitoring Year 3 - 2018

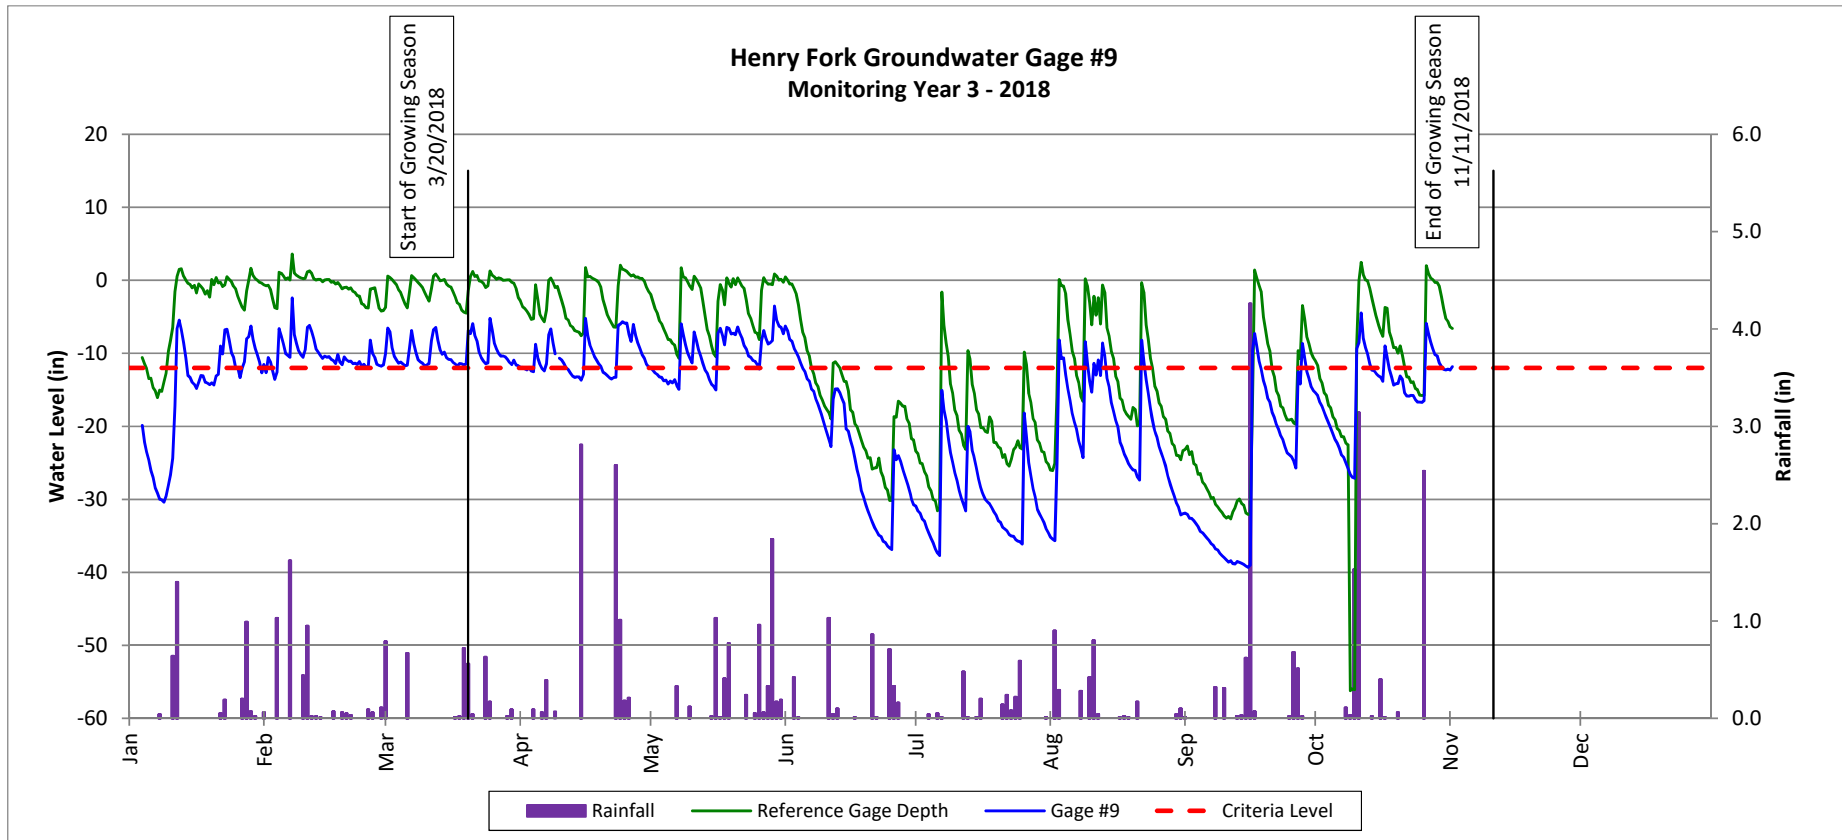
## Groundwater Gage Plots

Henry Fork Mitigation Site (DMS Project No. 96306)

Monitoring Year 3 - 2018
