# MONITORING YEAR 3 ANNUAL REPORT

## HENRY FORK MITIGATION SITE

Catawba County, NC  
DEQ Contract No. 005782  
DMS Project No. 96306

Data Collection Period: April 2018 - November 2018  
Submission Date: December 4, 2018

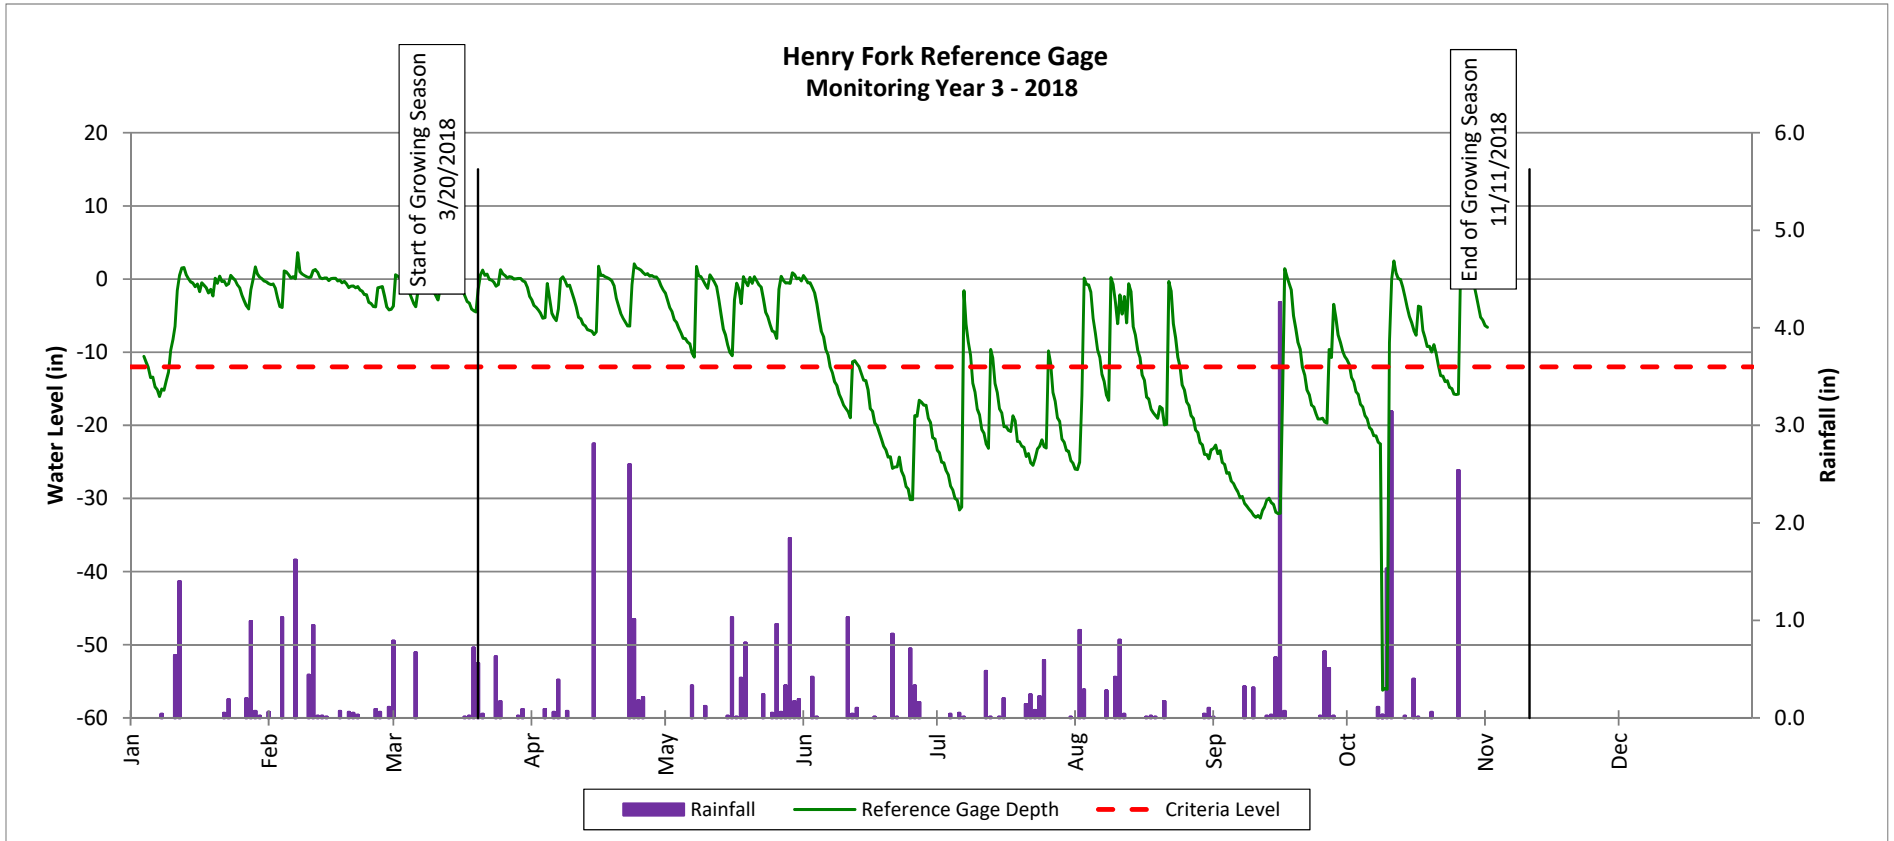
## Groundwater Gage Plots

Henry Fork Mitigation Site (DMS Project No. 96306)

### Monitoring Year 3 - 2018

Wetland Number

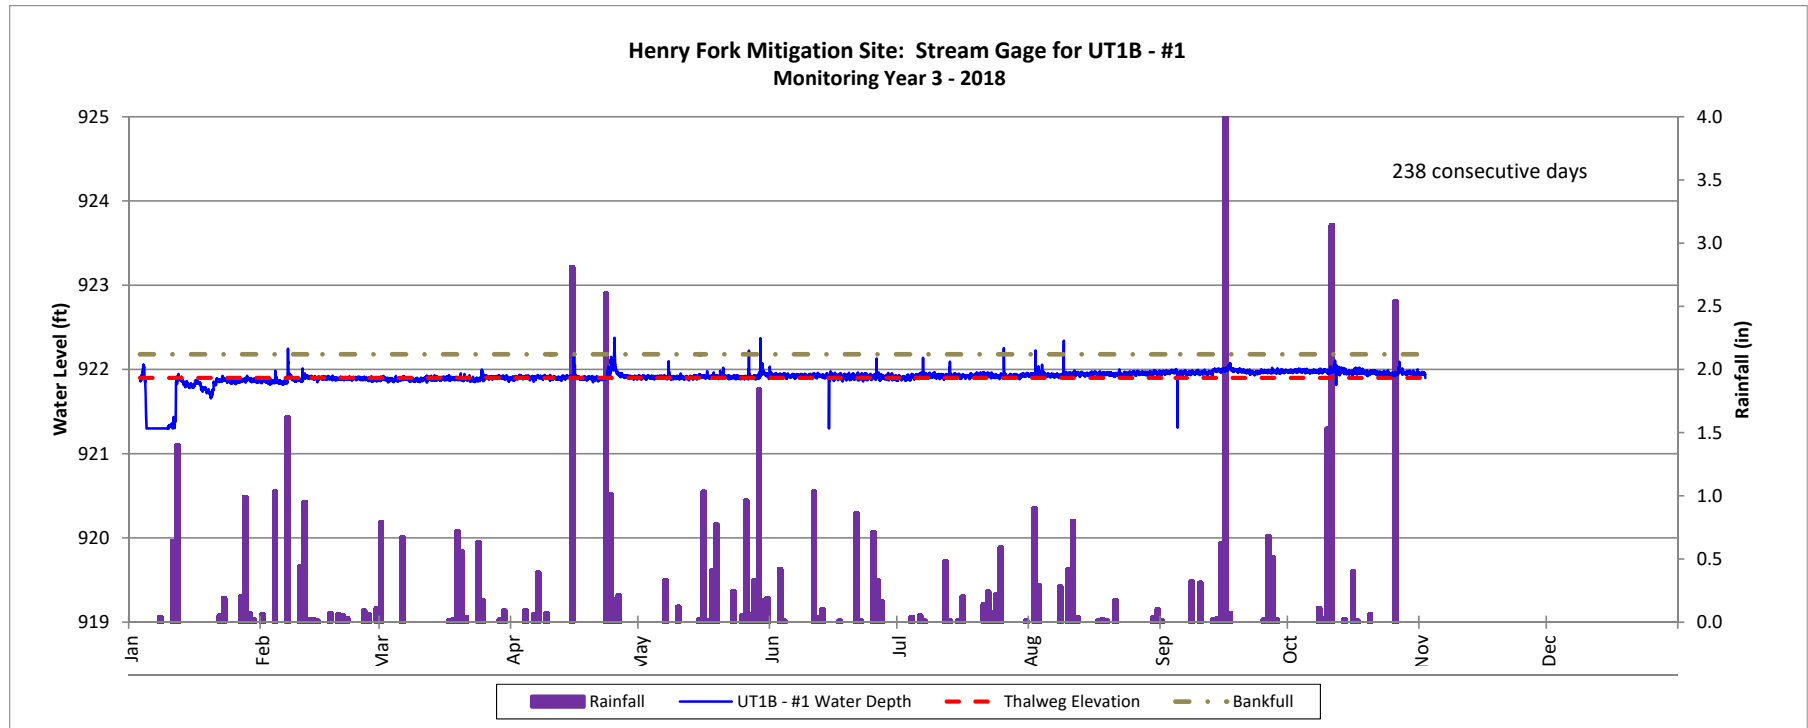
### Recorded Stream Gage Plots

Henry Fork Mitigation Site (DMS Project No. 96306)

Monitoring Year 3 - 2018

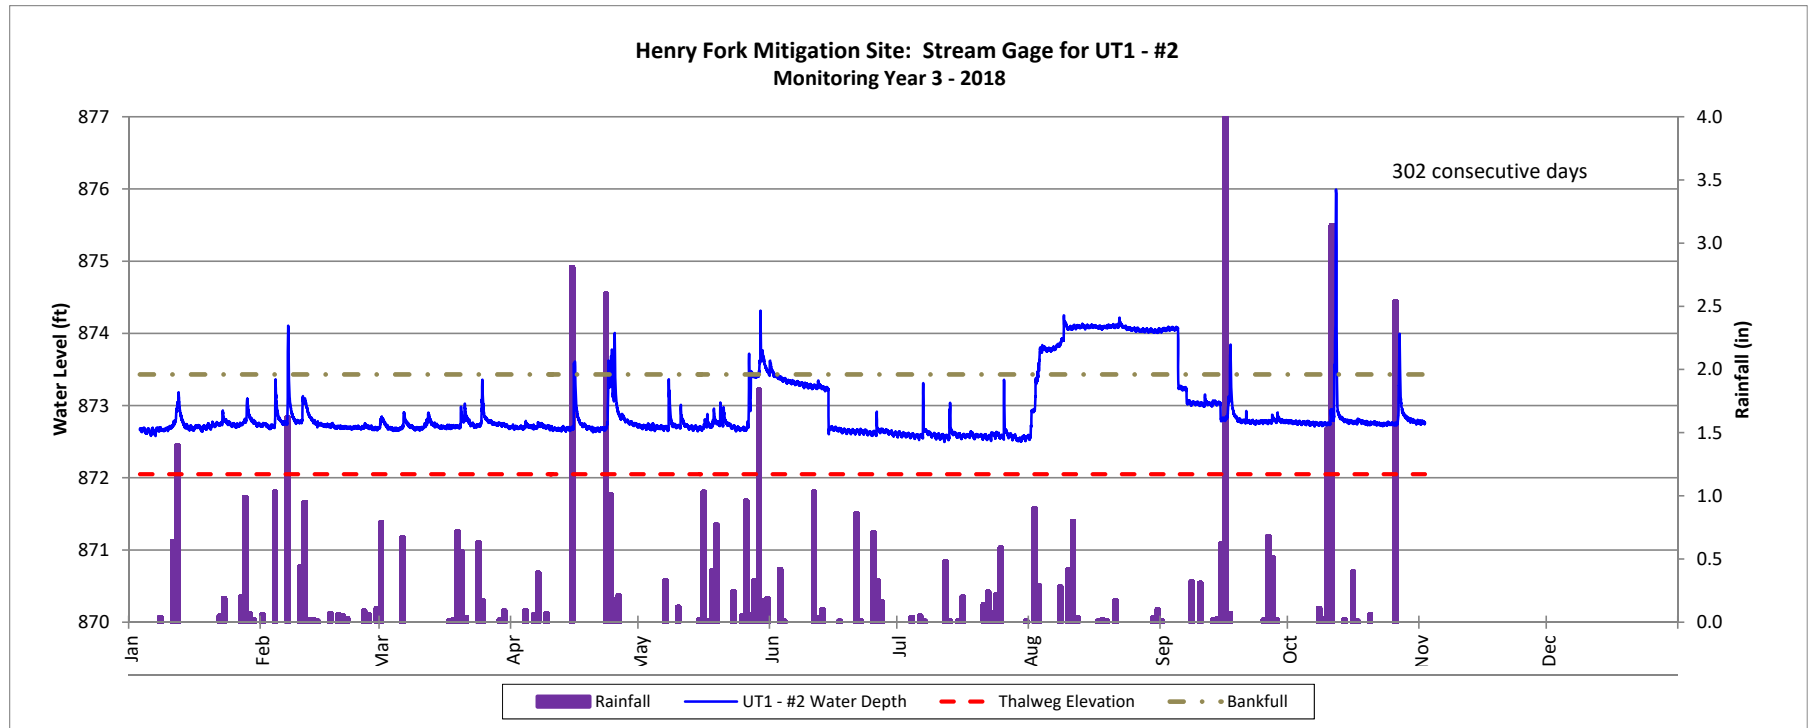
### Recorded Stream Gage Plots

Henry Fork Mitigation Site (DMS Project No. 96306)

Monitoring Year 3 - 2018

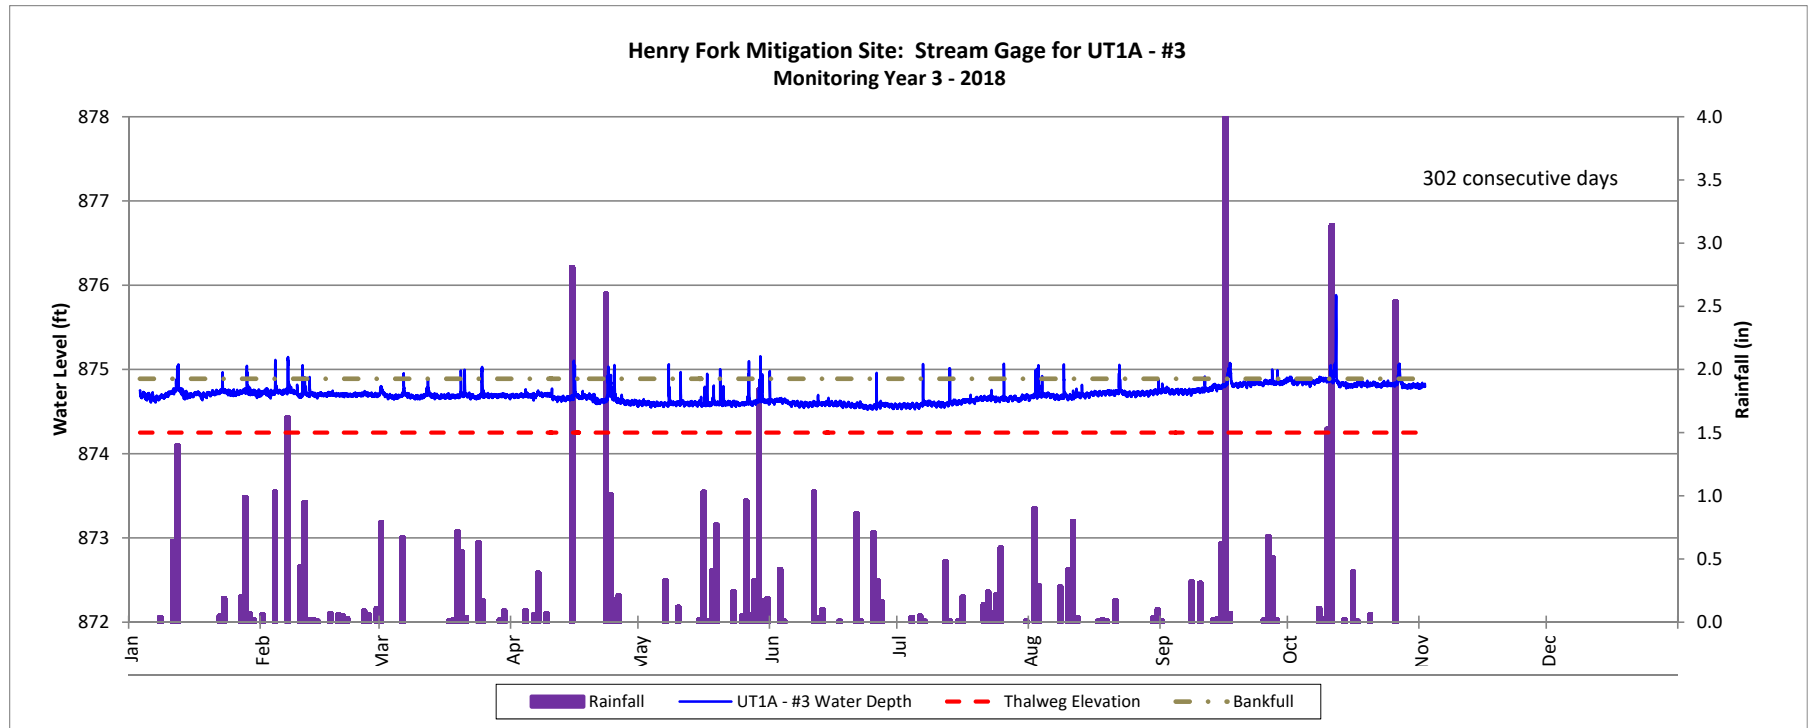
### Recorded Stream Gage Plots

Henry Fork Mitigation Site (DMS Project No. 96306)

Monitoring Year 3 - 2018

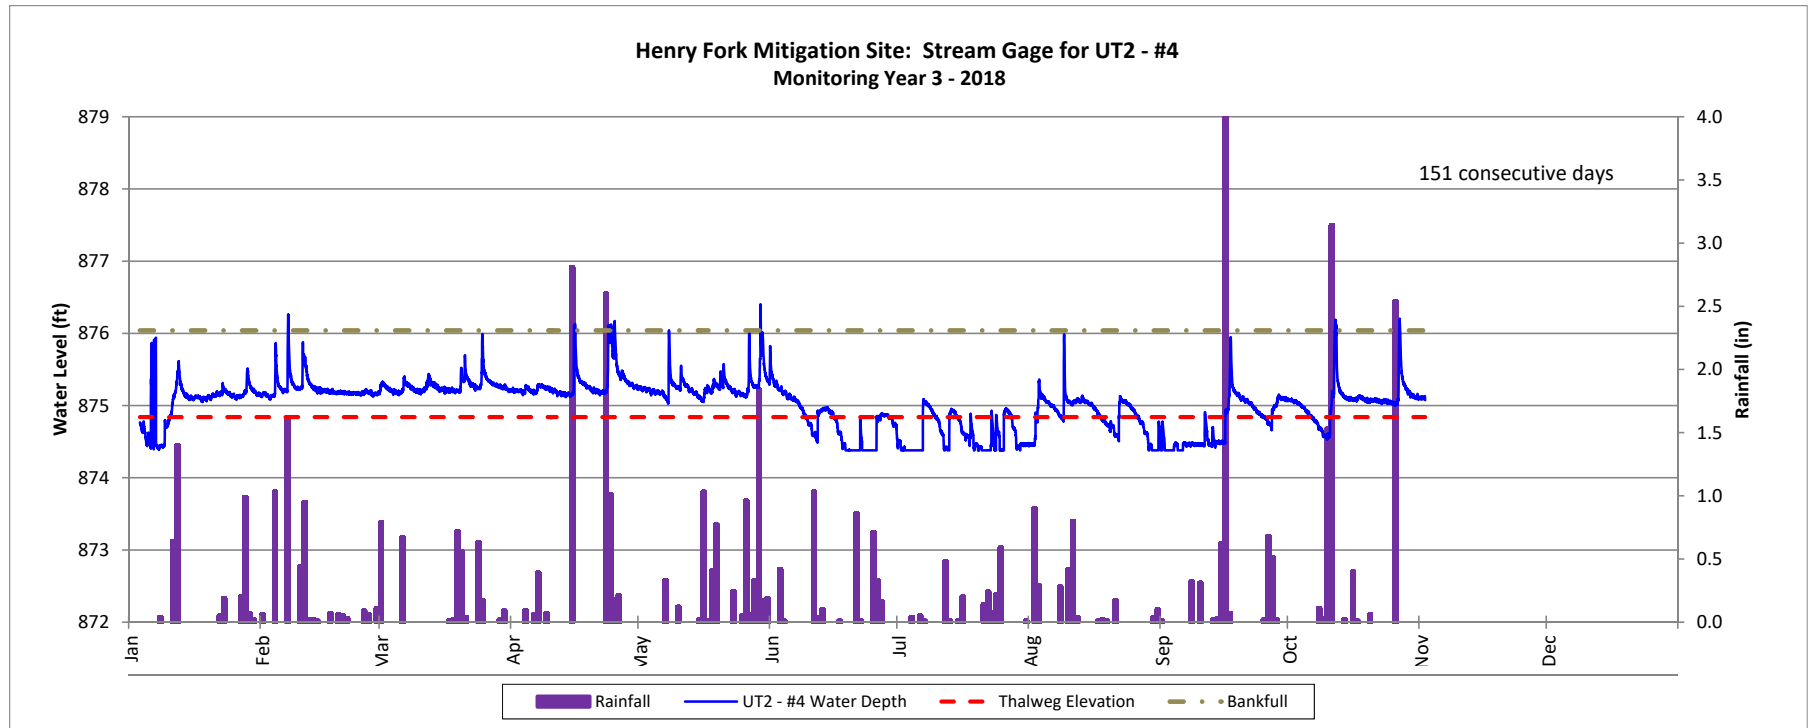
### Recorded Stream Gage Plots

Henry Fork Mitigation Site (DMS Project No. 96306)

Monitoring Year 3 - 2018

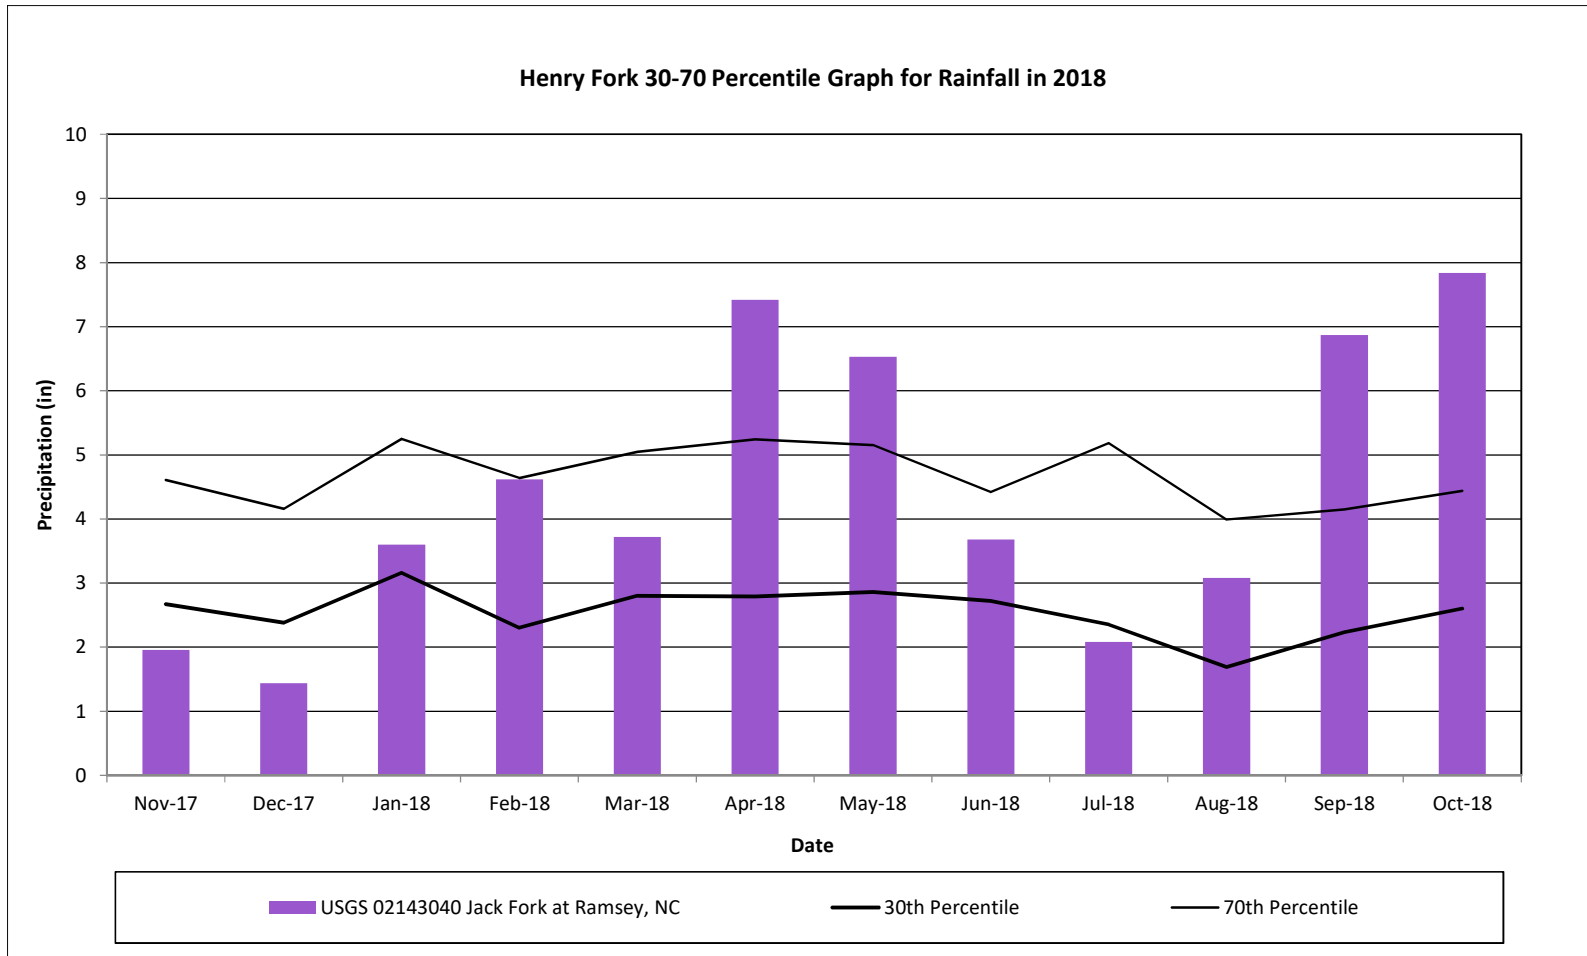
## Monthly Rainfall Data

Henry Fork Mitigation Site

DMS Project No. 96306

Monitoring Year 3 - 2018

<sup>1</sup> 2018 rainfall collected by USGS 02143040 Jacob Fork at Ramsey, NC

<sup>2</sup> 30th and 70th percentile rainfall data collected from WETS station Conover Oxford Shoal, NC
