YEAR 4 of 7 (2015)
ANNUAL MONITORING REPORT
HERMAN DAIRY STREAM AND WETLAND RESTORATION SITE

Alexander County, North Carolina
DMS Project No. 94642
Full Delivery Contract No. 003271

Catawba River Basin
Cataloging Unit and Targeted Local Watershed
03050101120030

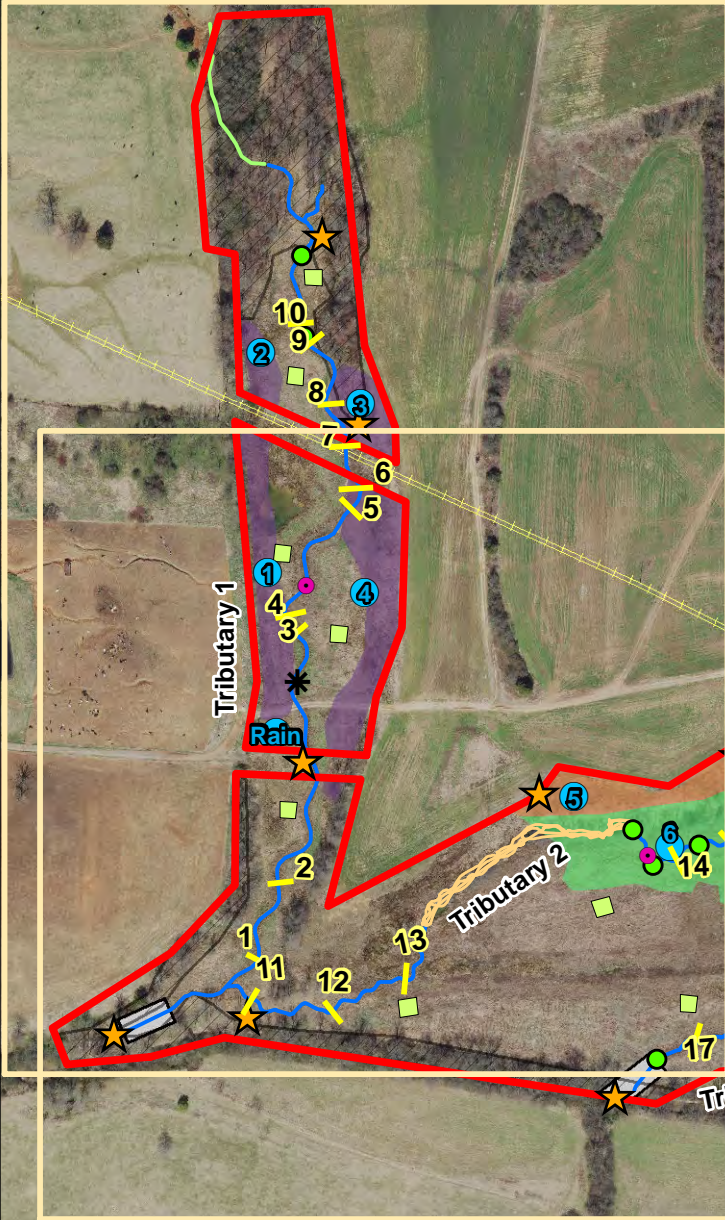
Fig 2A

HERMAN DAIRY
STREAM AND WETLAND MITIGATION SITE
CONSOLIDATED CURRENT CONDITION PLAN VIEW
Alexander County, North Carolina

Dwn. By: KRJ/CLF	FIGURE 2A
Date: Dec. 2015	
Project: 10-001

Vegetation Results: Vegetation sampling across the Site was above the required average density with 445 planted stems per acre surviving. In addition, 9 out of 10 individual plots exceeded success criteria, with plot 4 being two stems shy of the required stem density. However, when including natural recruits of American elm (*Ulmus americana*), plot four exceeds the required stem density. The number of native tree and shrub species observed in plots ranged from three (Plot 3) to seven (Plot 5), with 17 total native species observed. Treatment for invasive species, primarily Chinese privet (*Ligustrum sinense*) was initiated prior to construction and will continue as necessary, primarily within areas denoted on Figures 2 and 2A-2B (Appendix A).

Monitoring of the Site's restoration efforts will be performed until agreed upon success criteria are fulfilled. Monitoring is proposed for the stream channel, riparian vegetation, and hydrology (Figure 2, Appendix A). Stream morphology is proposed to be monitored for a period of five years. Riparian vegetation is proposed to be monitored for a period of seven years. Wetland hydrology is proposed to be monitored for a period of five years; at which time a request will be made to the IRT to discontinue groundwater hydrology monitoring. The IRT reserves the right to request additional groundwater monitoring if it deems necessary. Monitoring reports of the data collected will be submitted to the IRT no later than December of each monitoring year.

Ten groundwater monitoring gauges were installed within Site wetland restoration areas and one additional gauge was installed in a reference wetland to monitor groundwater hydrology (Figure 2, Appendix A). Hydrological sampling will continue for five years throughout the growing season at intervals necessary to satisfy the hydrology success criteria within each design unit (USEPA 1990). In addition, an onsite rain gauge will document rainfall data for comparison of groundwater conditions with extended drought conditions. Finally, groundwater gauges located within riverine wetlands adjacent to restored stream reaches will supplement crest gauge measurements to confirm overbank flooding events. Graphs of groundwater hydrology and precipitation from a nearby rain station are included in Appendix E.

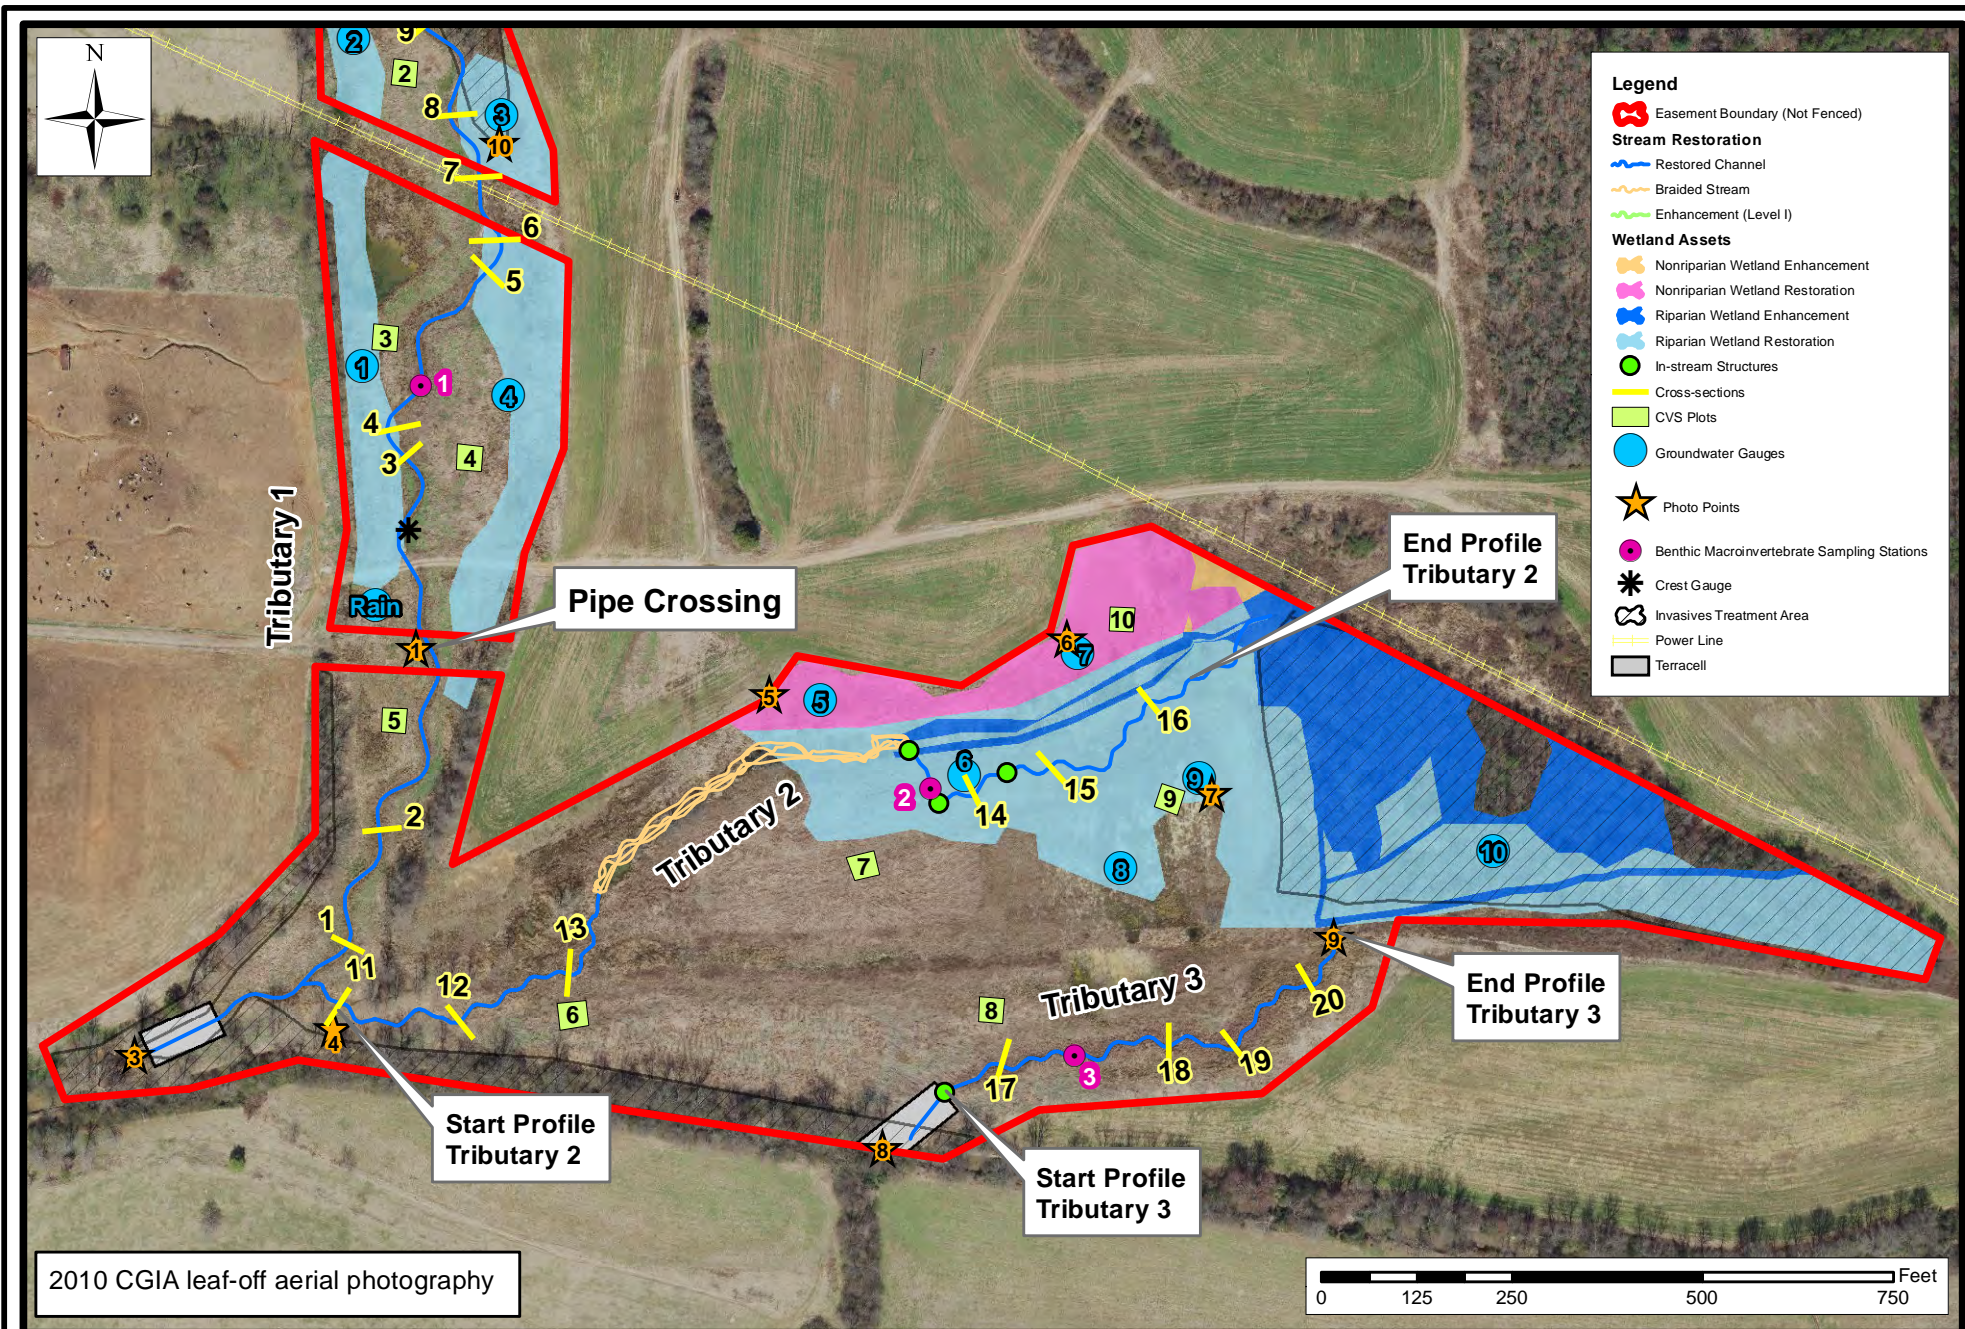
FIGURE
2B

HERMAN DAIRY
STREAM AND WETLAND MITIGATION SITE
CONSOLIDATED CURRENT CONDITION PLAN VIEW
 Alexander County, North Carolina

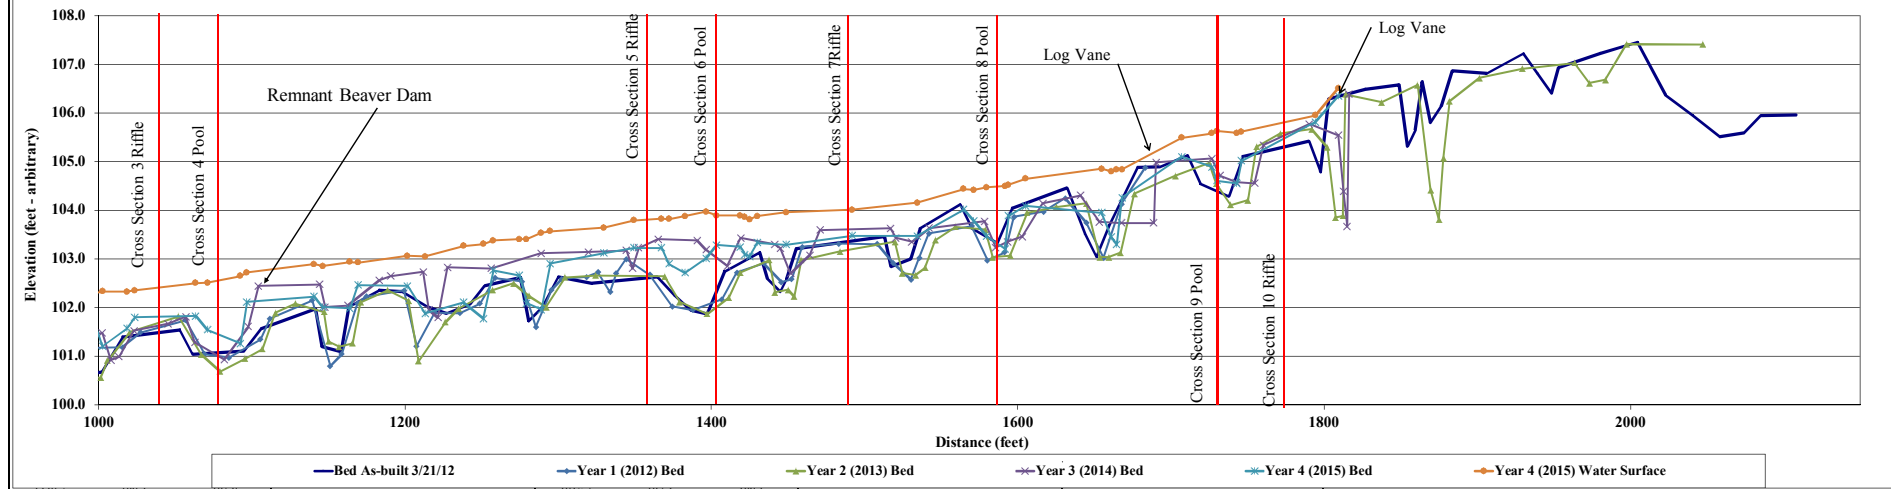
Project Name Herman Dairy - Year 4 (2015) Profile
 Reach Tributary 1
 Feature Profile
 Date 4/6/15
 Crew Perkinson, Jemigan

As-built	2012	2013	2014	2015
Avg. Water Surface Slope	0.0053	0.0045	0.0054	0.0051	0.0050
Rifle Length	36	28	36	38	49
Avg. Rifle Slope	0.0064	0.0057	0.0075	0.0049	0.0041
Pool Length	32	35	32	30	30

Herman Dairy (Tributary 1) Year 4 Profile - Reach 10+00 to 21+08

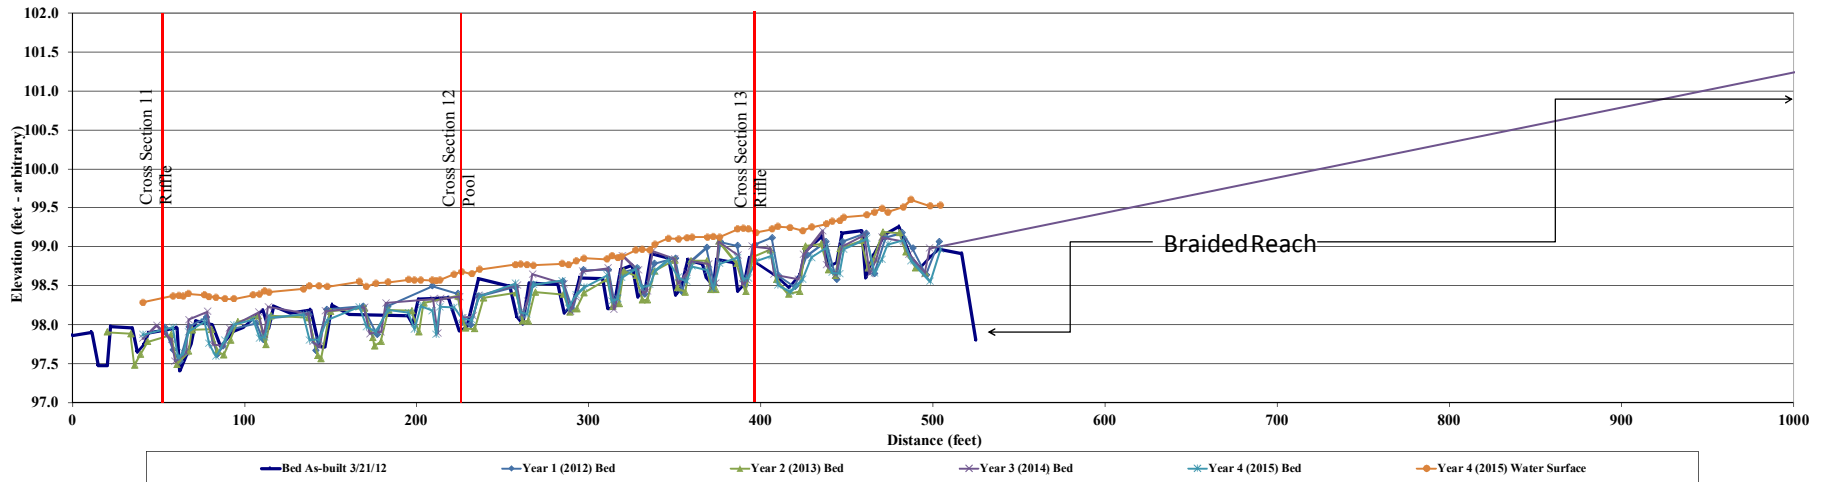
Project Name Herman Dairy - Year 4 (2015) Profile
 Reach Tributary 2
 Feature Profile
 Date 4/6/15
 Crew Perkinson, Jernigan

Avg. Water Surface Slope	As-built	2012	2013	2014	2015
Riffle Length	0.0040	0.0041	0.0042	0.0043	0.0044
Avg. Riffle Slope	14	13	13	14	12
Pool Length	0.0039	0.0042	0.0061	0.0057	0.0051
	13	12	11	11	13

Herman Dairy (Tributary 2) Year 4 Profile - Reach 00+00 to 10+00

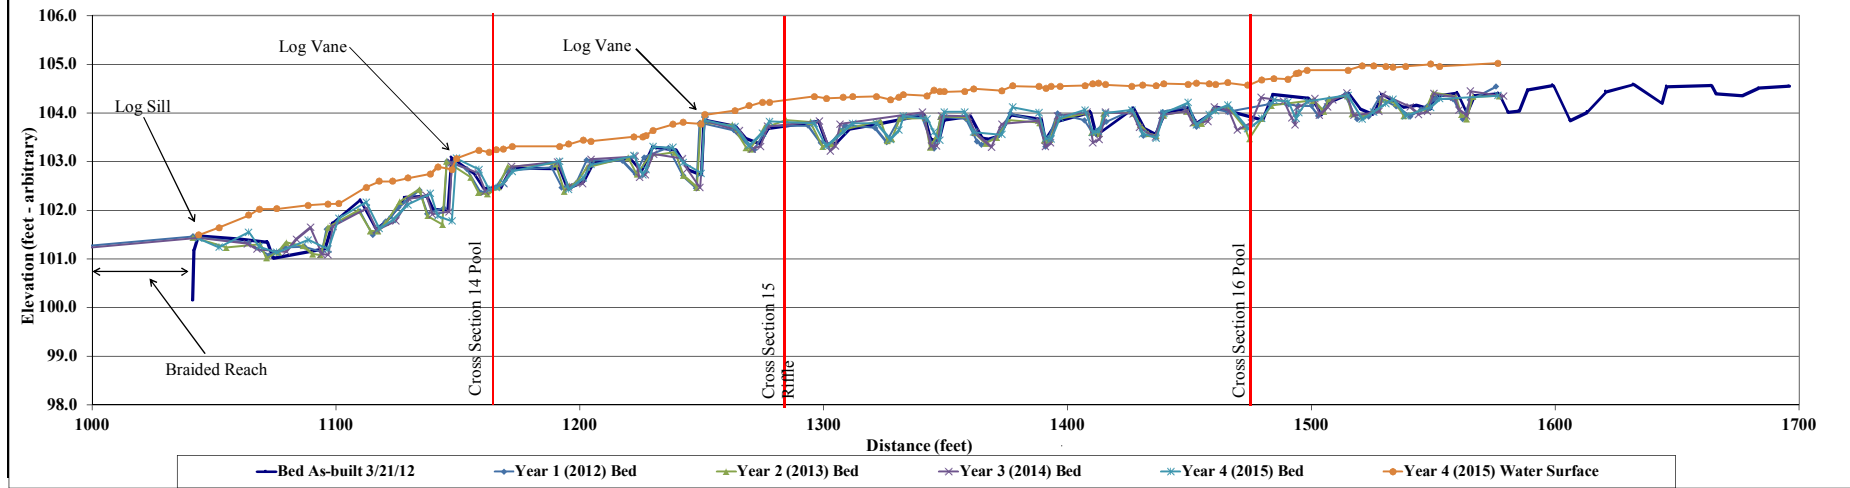
Project Name: Herman Dairy - Year 4 (2015) Profile
 Reach: Tributary 2
 Feature: Profile
 Date: 4/6/15
 Crew: Perkinson, Jernigan

As-built	2012	2013	2014	2015
Avg. Water Surface Slope	0.0040	0.0041	0.0042	0.0043	0.0044
Rifle Length	14	13	13	14	12
Avg. Rifle Slope	0.0039	0.0042	0.0061	0.0057	0.0051
Pool Length	13	12	11	11	13

Herman Dairy (Tributary 2) Year 4 Profile - Reach 10+00 to 16+96

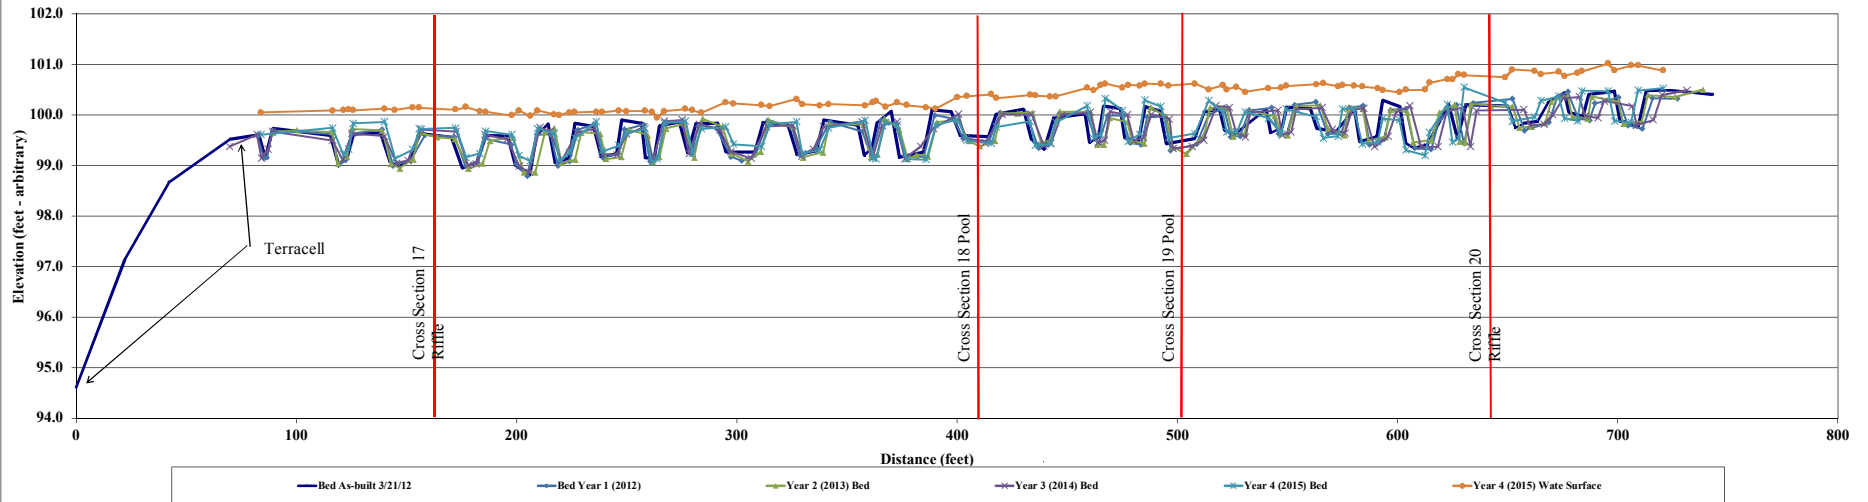
Project Name Herman Dairy - Year 4 (2015) Profile
 Reach Tributary 3
 Feature Profile
 Date 4/6/15
 Crew Perkinson, Jernigan

As-built	2012	2013	2014	2015
Avg. Water Surface Slope	0.0012	NA	0.0015	0.0015	0.0013
Riffle Length	11	10	11	11	11
Avg. Riffle Slope	0.0022	NA	0.0042	0.0040	0.0054
Pool Length	13	13	13	13	13

Herman Dairy (Tributary 3) Year 4 Profile - Reach 00+00 to 07+43

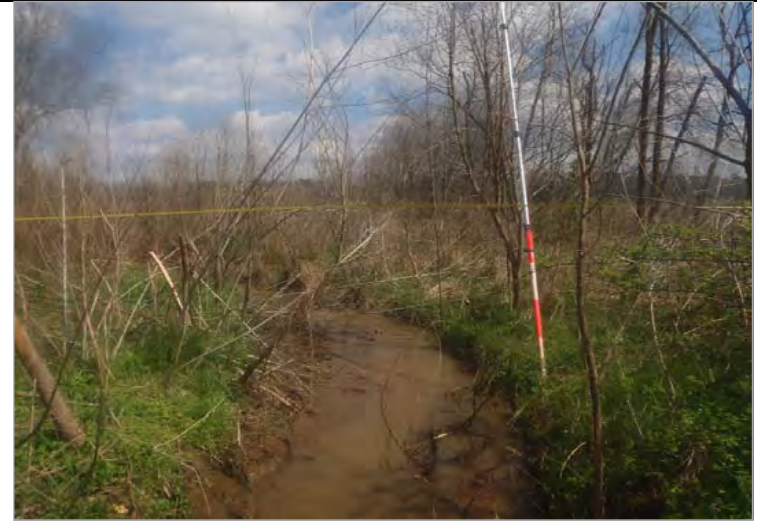
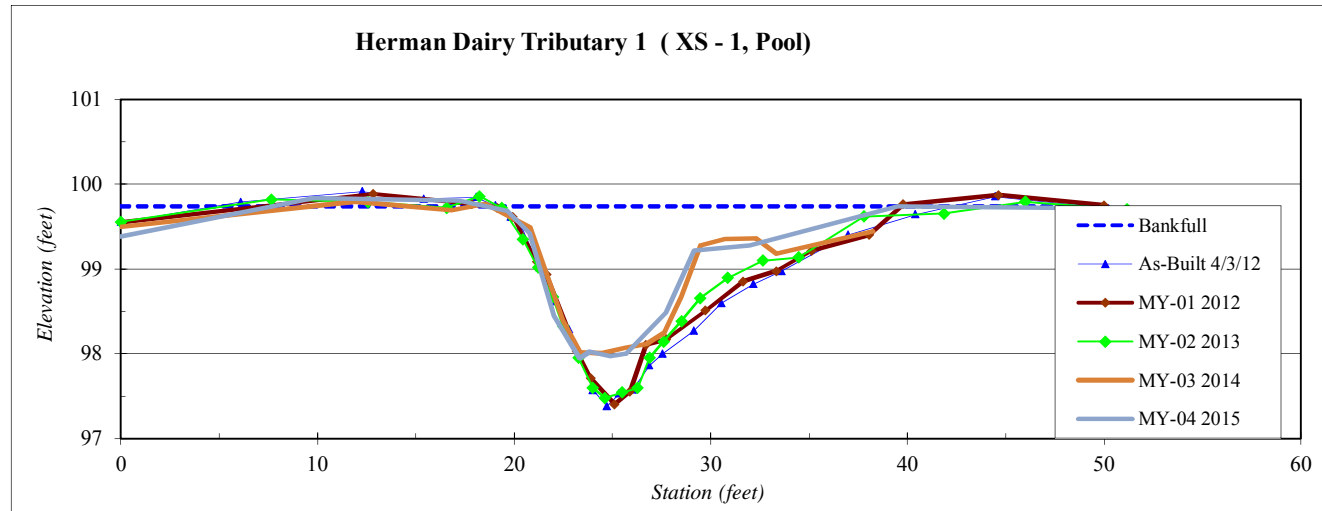
Site Name:	Herman Dairy
Watershed:	30501001120030
XS ID	Tributary 1 (XS - 1, Pool)
Drainage Area (sq mi):	1.01
Date:	4/6/2015
Field Crew:	Perkinson, Jernigan

Station	Elevation
0.00	99.39
9.82	99.84
17.19	99.81
19.64	99.69
20.78	99.42
22.03	98.45
23.32	97.95
23.85	98.02
24.88	97.97
25.69	98.00
26.54	98.21
27.72	98.49
29.16	99.22
31.99	99.28
39.50	99.74
50.17	99.72

SUMMARY DATA	
Bankfull Elevation:	99.7
Bankfull Cross-Sectional Area:	14.8
Bankfull Width:	20.9
Flood Prone Area Elevation:	-
Flood Prone Width:	-
Max Depth at Bankfull:	1.8
Mean Depth at Bankfull:	0.7
W / D Ratio:	-
Entrenchment Ratio:	-
Bank Height Ratio:	-

Stream Type	E
--------------------	---

Beaver activity surrounding the Site is prevalent, and a beaver dam was observed just upstream of Cross-section 1 on UT1 during Year 4 (2015) monitoring. The dam was present for less than a few weeks and was easily removed; no additional evidence of onsite beaver activity has been observed. Site streams and particularly this stream reach are walked and checked monthly (during all monitoring activities including vegetation surveys, stream surveys, and groundwater gauge downloads) for beaver activity and areas of concern. Beaver dams have been removed, as necessary, and will continue to be removed throughout the monitoring period. No adverse effects have resulted from beaver activity, subsequently beaver dam locations have not been added to the Current Conditions Plan View (Figures 2, 2A-2B) since no remedial action plan is expressly needed and no stream stability or sedimentation issues have arisen as the result of beaver activity.

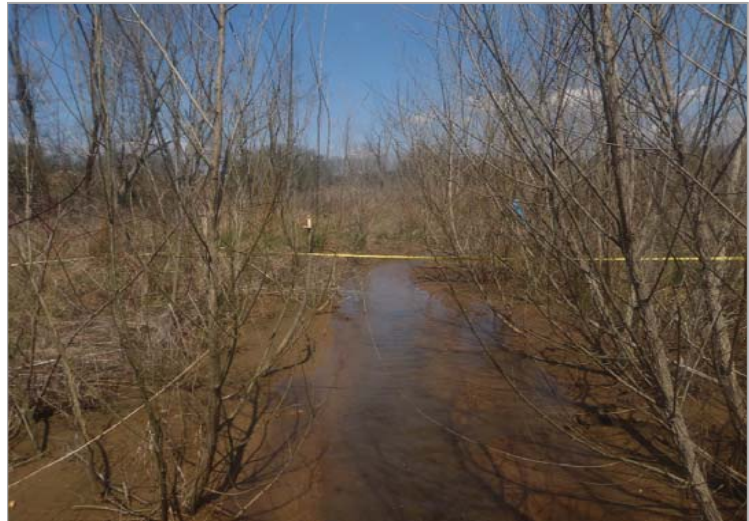
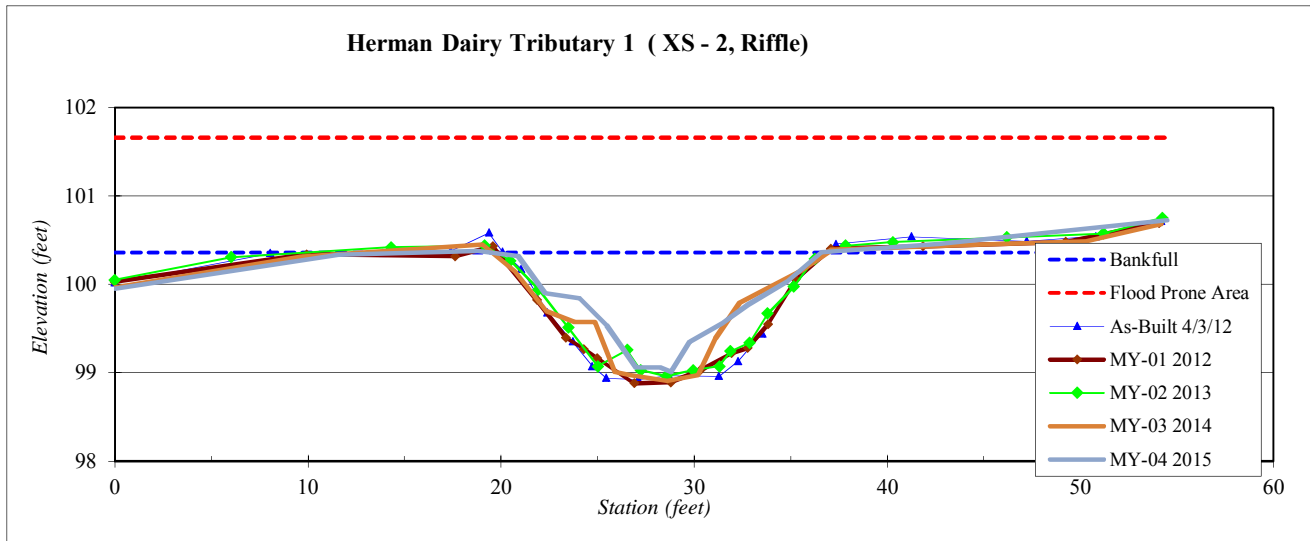
Site Name:	Herman Dairy
Watershed:	30501001120030
XS ID	Tributary 1 (XS - 2, Pool)
Drainage Area (sq mi):	1.01
Date:	4/6/2015
Field Crew:	Perkinson, Jernigan

Stream Type E

Station	Elevation
0.00	99.95
11.58	100.33
18.80	100.38
20.87	100.32
22.28	99.90
24.08	99.85
25.48	99.54
27.00	99.06
28.23	99.06
28.82	99.01
29.76	99.35
31.47	99.56
32.80	99.77
34.81	100.03
36.6	100.36
42.7	100.46
54.5	100.73

SUMMARY DATA	
Bankfull Elevation:	100.4
Bankfull Cross-Sectional Area:	11.0
Bankfull Width:	17.2
Flood Prone Area Elevation:	101.7
Flood Prone Width:	>80
Max Depth at Bankfull:	1.3
Mean Depth at Bankfull:	0.6
W / D Ratio:	26.9
Entrenchment Ratio:	>5
Bank Height Ratio:	1.0

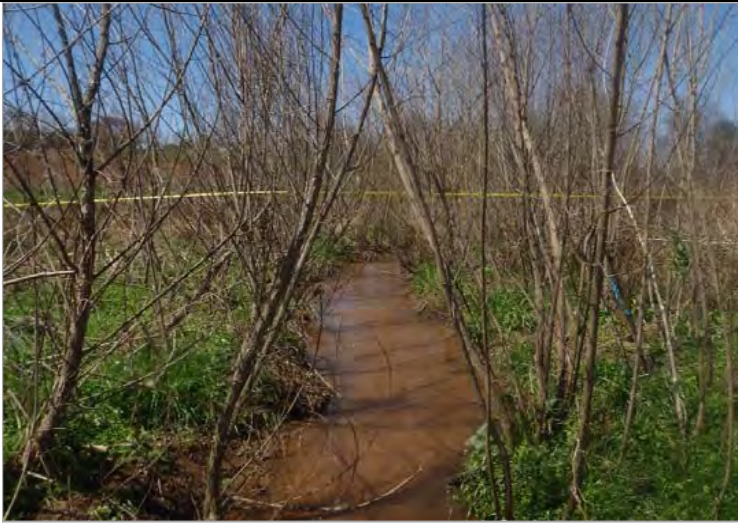
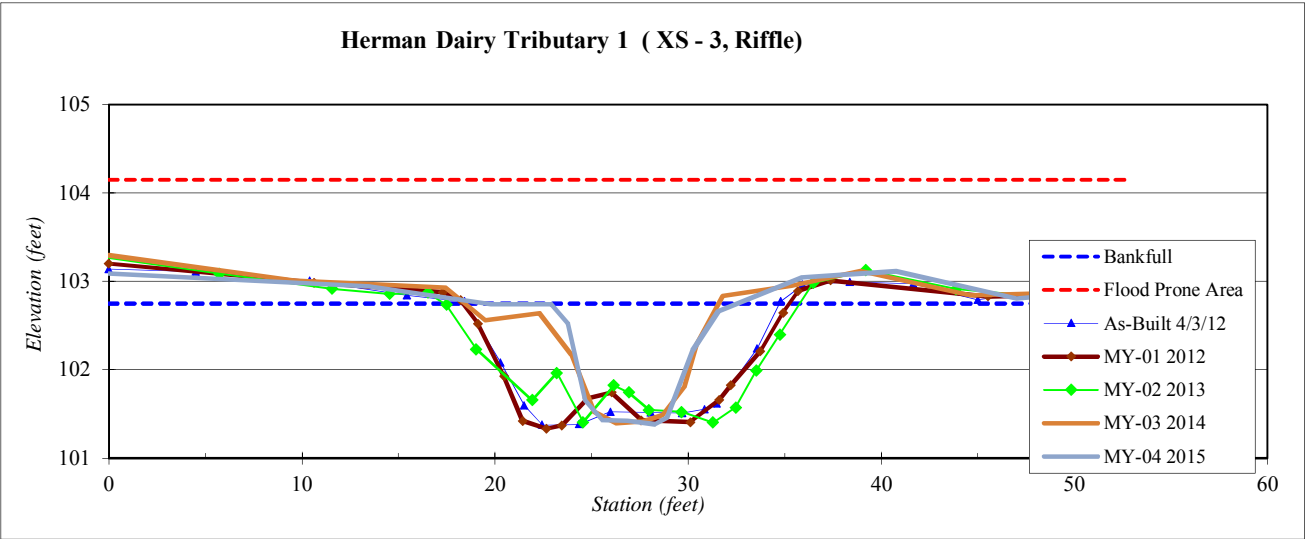
Herman Dairy Tributary 1 (XS - 3, Riffle)

Site Name:	Herman Dairy
Watershed:	30501001120030
XS ID	Tributary 1 (XS - 3, Riffle)
Drainage Area (sq mi):	1.01
Date:	4/6/2015
Field Crew:	Perkinson, Jernigan

Station	Elevation
0.00	103.09
13.44	102.94
19.79	102.74
22.91	102.75
23.77	102.53
24.66	101.66
25.56	101.43
26.86	101.42
28.26	101.38
28.89	101.46
30.23	102.22
31.56	102.66
35.90	103.04
40.78	103.12
47.0	102.81
52.9	102.92

SUMMARY DATA	
Bankfull Elevation:	102.8
Bankfull Cross-Sectional Area:	7.9
Bankfull Width:	13.0
Flood Prone Area Elevation:	104.2
Flood Prone Width:	>80
Max Depth at Bankfull:	1.4
Mean Depth at Bankfull:	0.6
W / D Ratio:	21.4
Entrenchment Ratio:	>5
Bank Height Ratio:	1.0

Stream Type	E/C
--------------------	-----

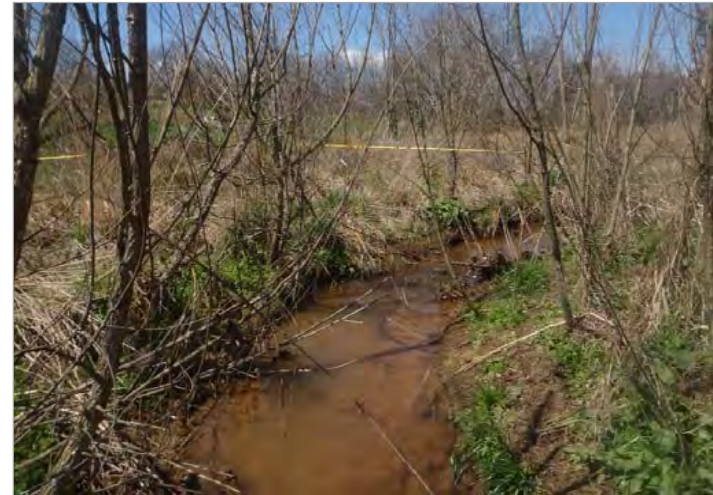
Herman Dairy Tributary 1 (XS - 4, Pool)

Site Name:	Herman Dairy
Watershed:	30501001120030
XS ID	Tributary 1 (XS - 4, Pool)
Drainage Area (sq mi):	1.01
Date:	4/6/2015
Field Crew:	Perkinson, Jernigan

Station	Elevation
0.0	103.2
6.6	103.2
14.9	103.0
17.0	102.9
19.8	102.5
21.6	101.9
22.5	101.6
23.4	101.5
24.4	101.4
25.7	101.5
26.3	101.7
27.5	103.0
29.1	103.2
35.1	103.2
44.4	102.96

SUMMARY DATA	
Bankfull Elevation:	103.1
Bankfull Cross-Sectional Area:	10.6
Bankfull Width:	14.0
Flood Prone Area Elevation:	-
Flood Prone Width:	-
Max Depth at Bankfull:	1.7
Mean Depth at Bankfull:	0.8
W / D Ratio:	-
Entrenchment Ratio:	-
Bank Height Ratio:	-

Stream Type	E
-------------	---

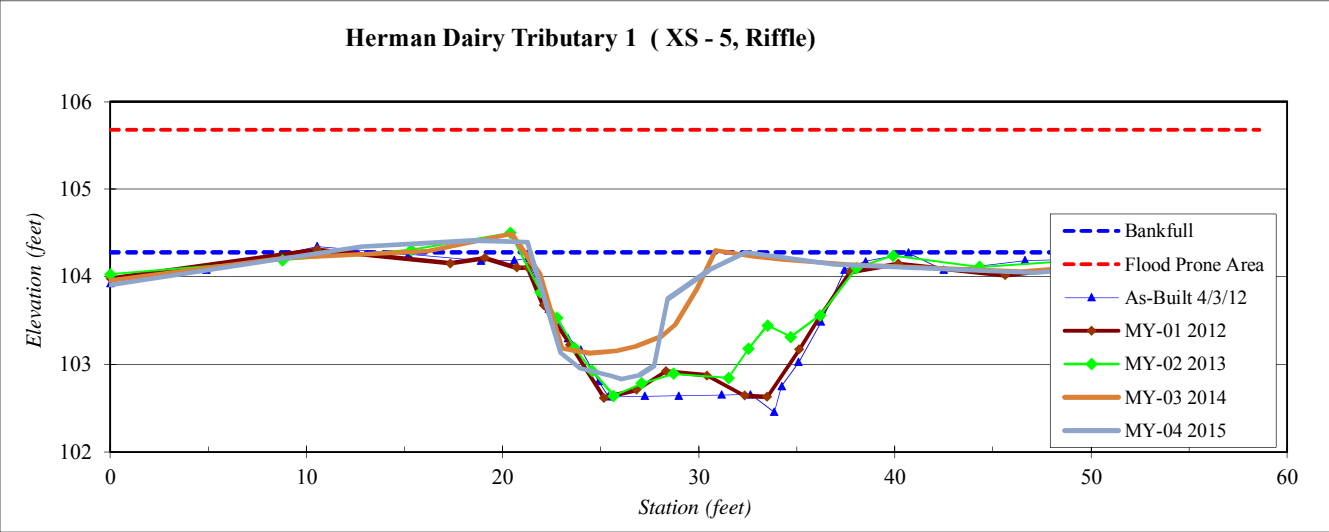
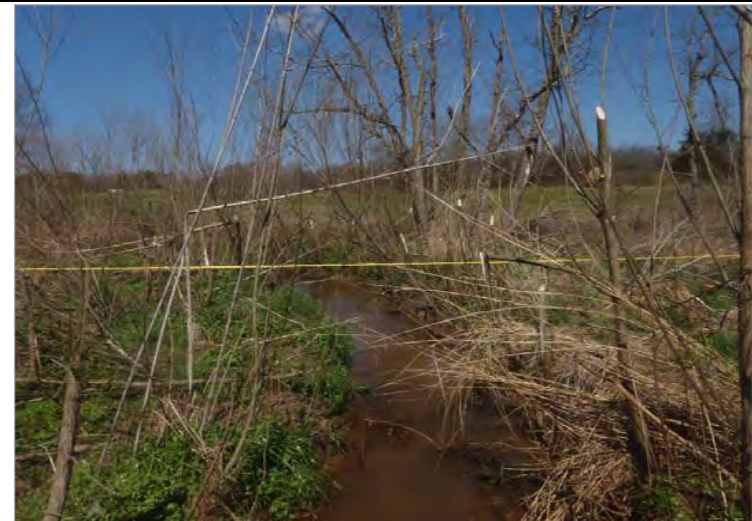
Herman Dairy Tributary 1 (XS - 5, Riffle)

Site Name:	Herman Dairy
Watershed:	30501001120030
XS ID	Tributary 1 (XS - 5, Riffle)
Drainage Area (sq mi):	1.01
Date:	4/6/2015
Field Crew:	Perkinson, Jernigan

Station	Elevation
0.0	103.9
12.8	104.3
18.6	104.4
21.3	104.4
23.0	103.1
24.0	103.0
25.5	102.9
26.1	102.8
27.0	102.9
27.7	103.0
28.4	103.7
30.6	104.1
32.4	104.3
36.9	104.14
47.1	104.04
58.6	104.26

SUMMARY DATA	
Bankfull Elevation:	104.3
Bankfull Cross-Sectional Area:	8.9
Bankfull Width:	11.0
Flood Prone Area Elevation:	105.7
Flood Prone Width:	>80
Max Depth at Bankfull:	1.4
Mean Depth at Bankfull:	0.8
W / D Ratio:	13.6
Entrenchment Ratio:	>5
Bank Height Ratio:	1.0

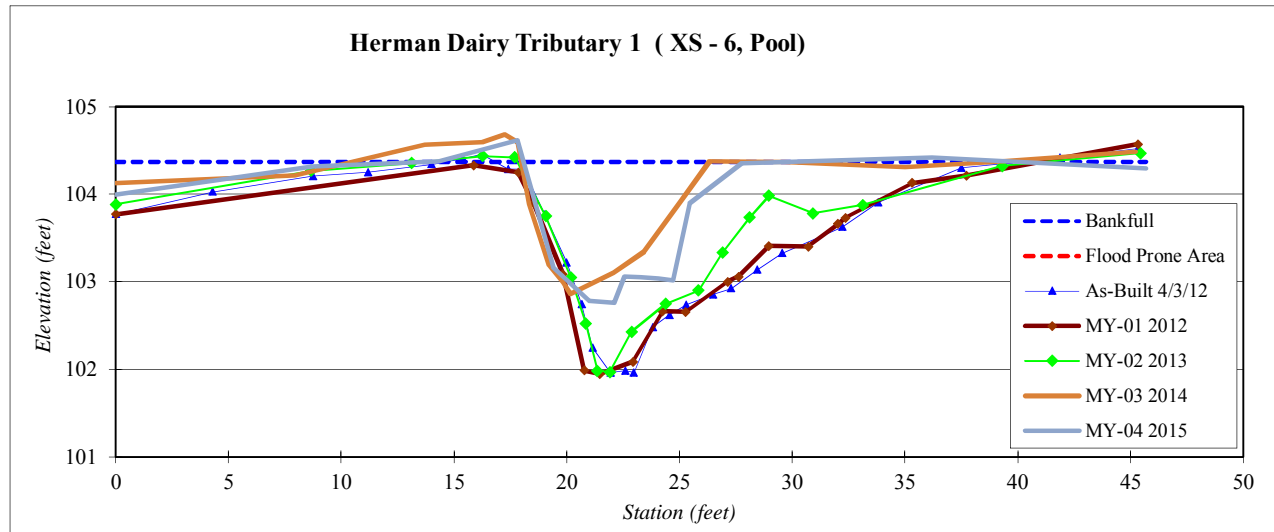
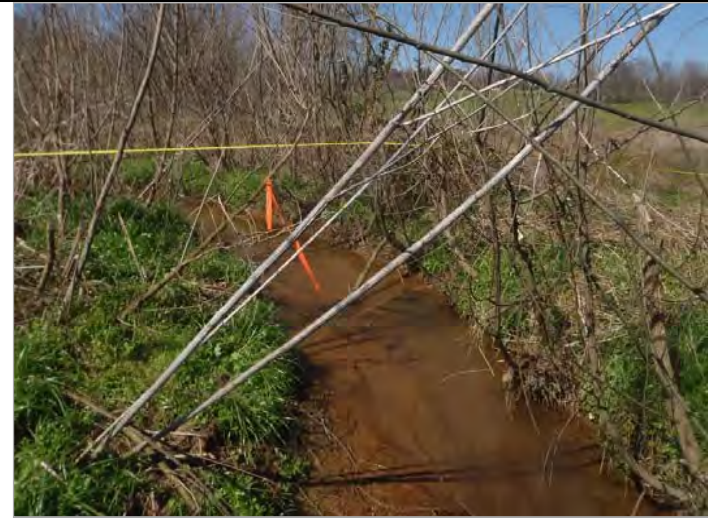
Site Name:	Herman Dairy
Watershed:	30501001120030
XS ID	Tributary 1 (XS - 6, Pool)
Drainage Area (sq mi):	1.01
Date:	4/6/2015
Field Crew:	Perkinson, Jernigan

Station	Elevation
0.0	104.0
8.7	104.3
14.3	104.4
17.8	104.6
19.4	103.2
21.0	102.8
22.1	102.8
22.6	103.1
23.3	103.1
24.1	103.0
24.7	103.0
25.5	103.9
27.8	104.4
36.2	104.4
45.7	104.3

SUMMARY DATA	
Bankfull Elevation:	104.4
Bankfull Cross-Sectional Area:	8.0
Bankfull Width:	14.8
Flood Prone Area Elevation:	-
Flood Prone Width:	-
Max Depth at Bankfull:	1.5
Mean Depth at Bankfull:	0.5
W / D Ratio:	-
Entrenchment Ratio:	-
Bank Height Ratio:	-

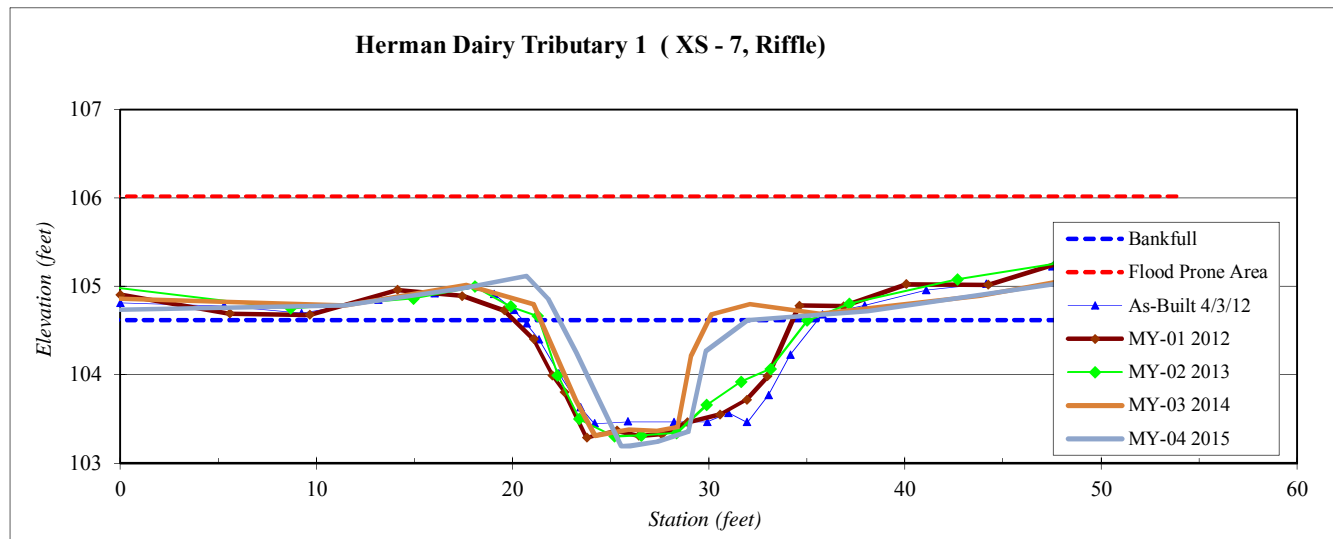
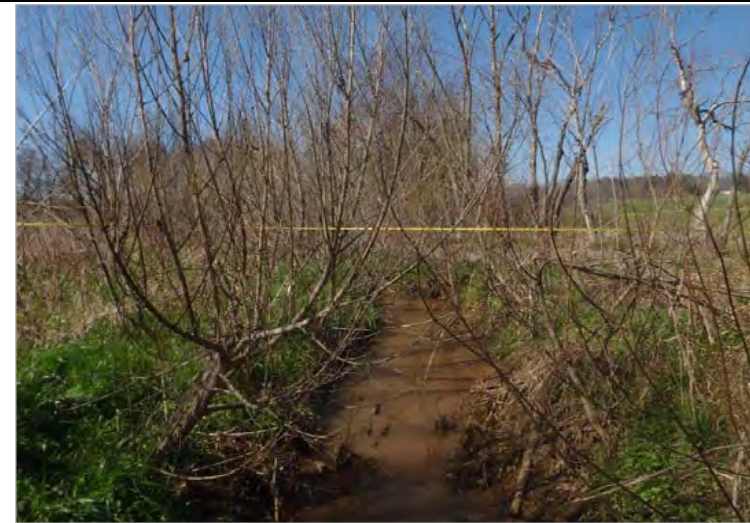
Site Name:	Herman Dairy
Watershed:	30501001120030
XS ID	Tributary 1 (XS - 7, Riffle)
Drainage Area (sq mi):	1.01
Date:	4/6/2015
Field Crew:	Perkinson, Jernigan

Station	Elevation
-0.5	104.7
11.4	104.8
17.3	105.0
20.7	105.1
21.8	104.9
23.2	104.2
24.3	103.8
25.5	103.2
26.0	103.2
27.4	103.2
29.0	103.4
29.9	104.3
32.0	104.6
38.1	104.72
53.9	105.23

SUMMARY DATA	
Bankfull Elevation:	104.6
Bankfull Cross-Sectional Area:	8.0
Bankfull Width:	9.7
Flood Prone Area Elevation:	106.0
Flood Prone Width:	>80
Max Depth at Bankfull:	1.4
Mean Depth at Bankfull:	0.8
W / D Ratio:	11.8
Entrenchment Ratio:	>5
Bank Height Ratio:	1.0

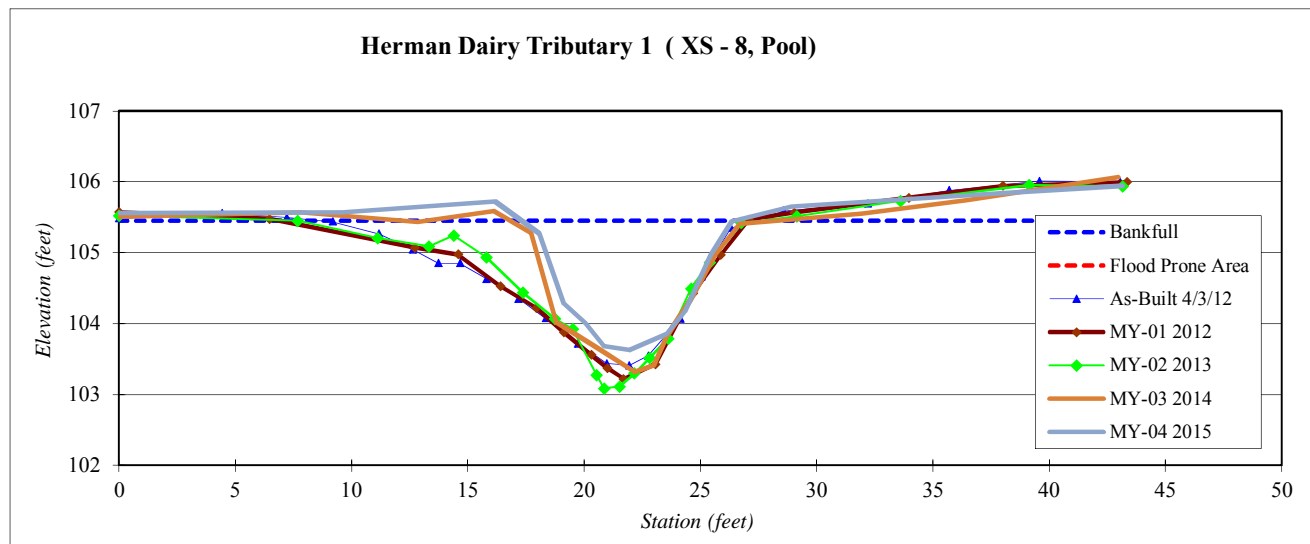
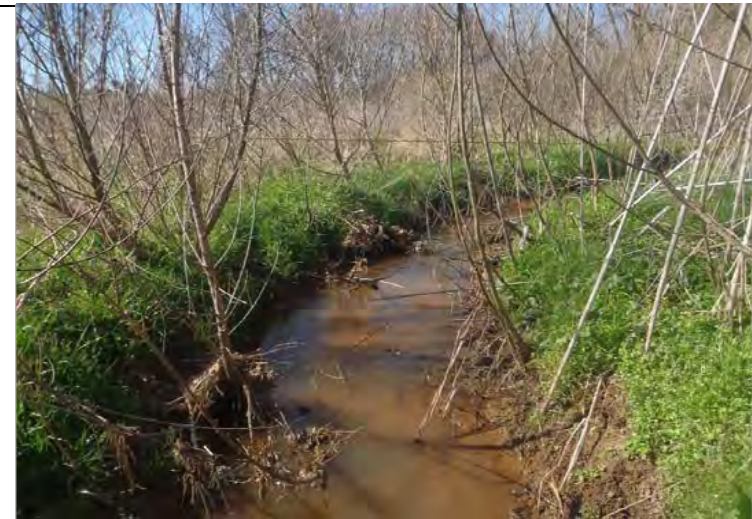
Site Name:	Herman Dairy
Watershed:	30501001120030
XS ID	Tributary 1 (XS - 8, Pool)
Drainage Area (sq mi):	1.01
Date:	4/6/2015
Field Crew:	Perkinson, Jernigan

Station	Elevation
0.0	105.6
9.6	105.6
16.2	105.7
18.1	105.3
19.1	104.3
20.1	104.0
20.9	103.7
21.9	103.6
23.6	103.9
24.3	104.2
25.4	105.0
26.4	105.4
28.9	105.6
36.2	105.81
43.2	105.95

SUMMARY DATA	
Bankfull Elevation:	105.5
Bankfull Cross-Sectional Area:	10.3
Bankfull Width:	9.1
Flood Prone Area Elevation:	-
Flood Prone Width:	-
Max Depth at Bankfull:	1.8
Mean Depth at Bankfull:	1.1
W / D Ratio:	-
Entrenchment Ratio:	-
Bank Height Ratio:	-

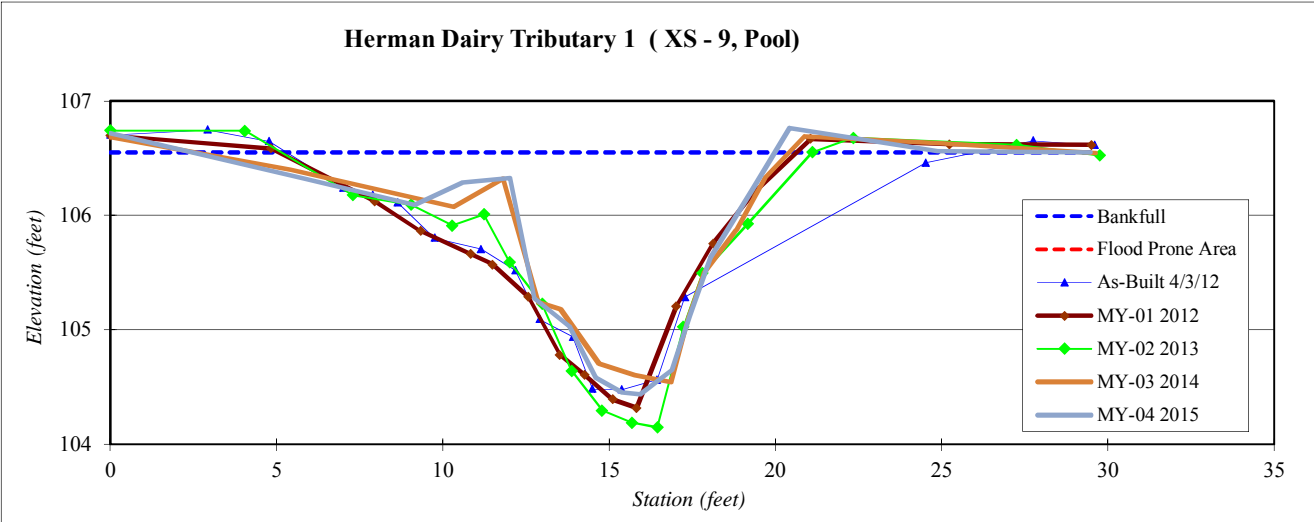
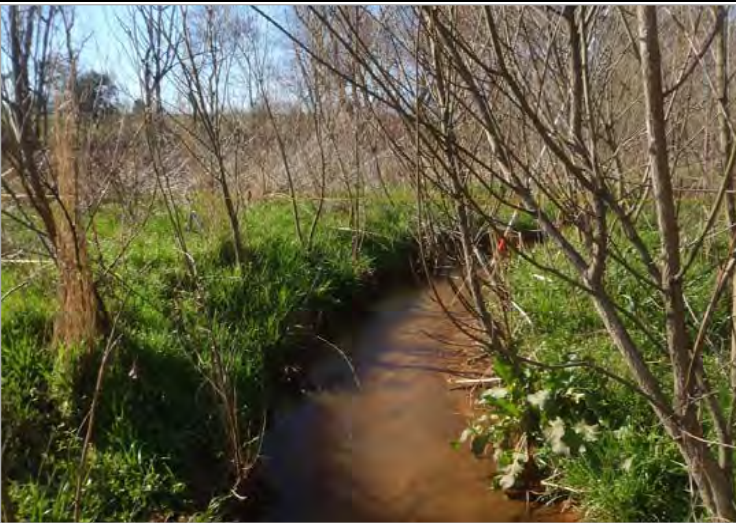
Site Name:	Herman Dairy
Watershed:	30501001120030
XS ID	Tributary 1 (XS -9, Pool)
Drainage Area (sq mi):	1.01
Date:	4/6/2015
Field Crew:	Perkinson, Jernigan

Station	Elevation
0.0	106.7
5.8	106.3
9.2	106.1
10.6	106.3
12.0	106.3
12.8	105.3
13.8	105.0
14.6	104.6
15.4	104.5
16.0	104.4
16.9	104.7
17.4	105.1
18.0	105.6
19.3	106.22
20.4	106.76
24.9	106.56
29.5	106.55

SUMMARY DATA	
Bankfull Elevation:	106.6
Bankfull Cross-Sectional Area:	13.0
Bankfull Width:	17.5
Flood Prone Area Elevation:	-
Flood Prone Width:	-
Max Depth at Bankfull:	2.1
Mean Depth at Bankfull:	0.7
W / D Ratio:	-
Entrenchment Ratio:	-
Bank Height Ratio:	-

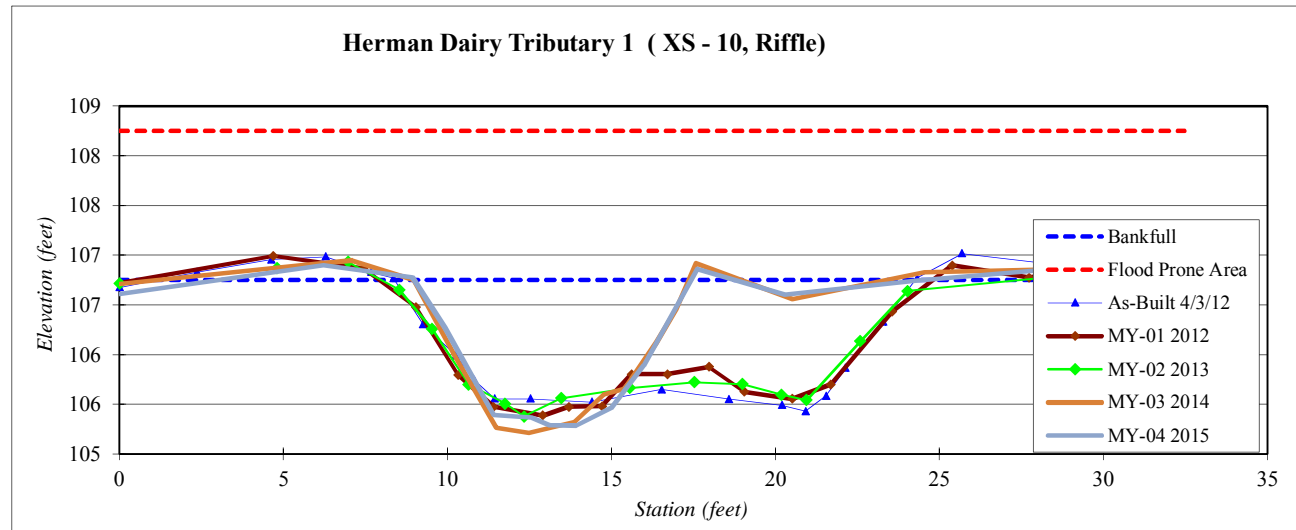
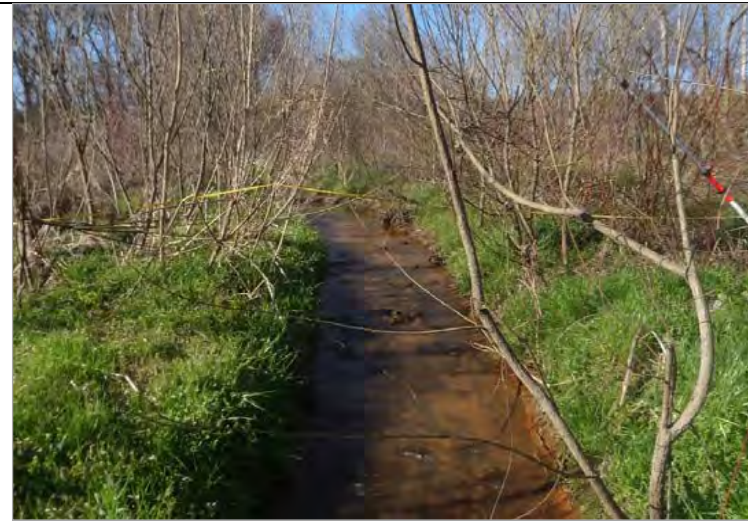
Site Name:	Herman Dairy
Watershed:	30501001120030
XS ID	Tributary 1 (XS - 10, Riffle)
Drainage Area (sq mi):	1.01
Date:	4/6/2015
Field Crew:	Perkinson, Jernigan

Station	Elevation
0.0	106.6
6.2	106.9
8.9	106.8
9.9	106.3
11.4	105.4
12.6	105.4
13.1	105.3
13.9	105.3
15.0	105.5
16.0	105.9
17.6	106.9
20.3	106.6
24.3	106.7
30.6	106.92
32.5	106.94

SUMMARY DATA	
Bankfull Elevation:	106.8
Bankfull Cross-Sectional Area:	8.3
Bankfull Width:	8.4
Flood Prone Area Elevation:	108.3
Flood Prone Width:	>80
Max Depth at Bankfull:	1.5
Mean Depth at Bankfull:	1.0
W / D Ratio:	8.5
Entrenchment Ratio:	>5
Bank Height Ratio:	1.0

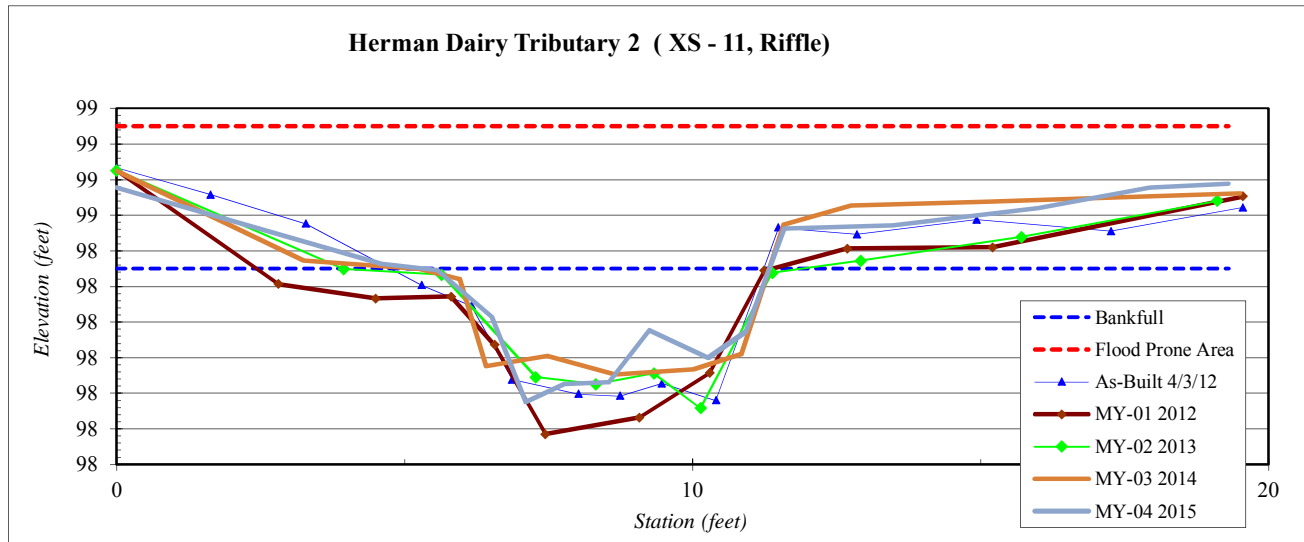
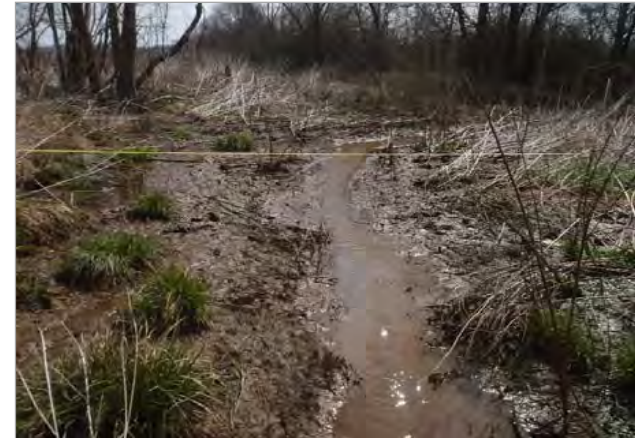
Site Name:	Herman Dairy
Watershed:	30501001120030
XS ID	Tributary 2 (XS - 11, Riffle)
Drainage Area (sq mi):	1.01
Date:	4/6/2015
Field Crew:	Perkinson, Jernigan

Station	Elevation
0.0	98.6
4.6	98.4
5.6	98.3
6.5	98.2
7.1	98.0
7.8	98.0
8.6	98.0
9.3	98.2
10.3	98.1
10.9	98.2
11.6	98.5
13.5	98.5
16.0	98.5
17.9	98.58
19.3	98.59

SUMMARY DATA	
Bankfull Elevation:	98.4
Bankfull Cross-Sectional Area:	1.3
Bankfull Width:	6.0
Flood Prone Area Elevation:	98.8
Flood Prone Width:	>80
Max Depth at Bankfull:	0.4
Mean Depth at Bankfull:	0.2
W / D Ratio:	27.7
Entrenchment Ratio:	>5
Bank Height Ratio:	1.0

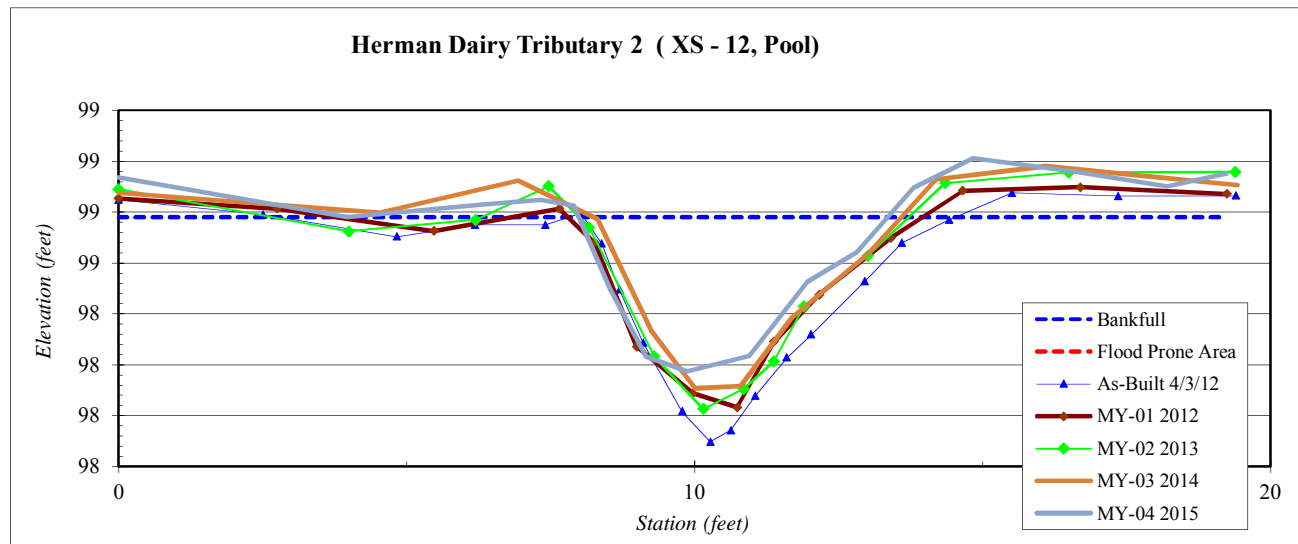
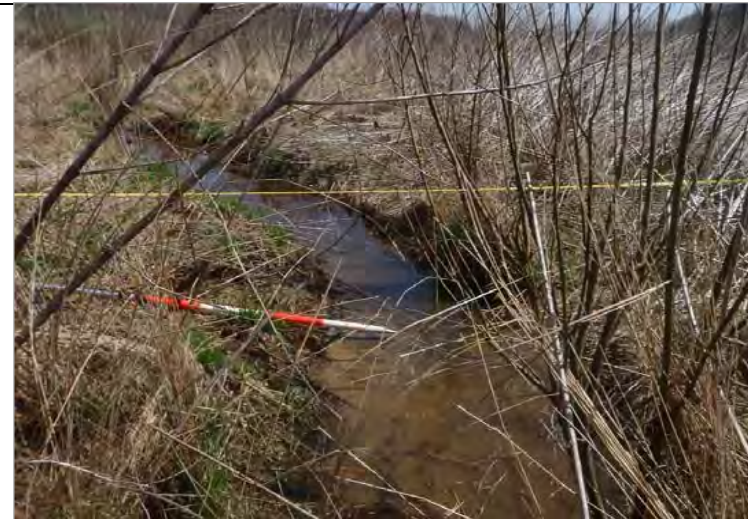
Site Name:	Herman Dairy
Watershed:	30501001120030
XS ID	Tributary 2 (XS - 12, Pool)
Drainage Area (sq mi):	1.01
Date:	4/6/2015
Field Crew:	Perkinson, Jernigan

Station	Elevation
0.0	98.9
4.0	98.8
6.2	98.8
7.3	98.8
7.9	98.8
8.5	98.5
9.2	98.2
9.9	98.2
11.0	98.2
12.0	98.5
12.8	98.6
13.8	98.9
14.8	99.0
16.6	98.96
18.2	98.90
19.2	98.95

SUMMARY DATA	
Bankfull Elevation:	98.8
Bankfull Cross-Sectional Area:	2.0
Bankfull Width:	5.4
Flood Prone Area Elevation:	-
Flood Prone Width:	-
Max Depth at Bankfull:	0.6
Mean Depth at Bankfull:	0.4
W / D Ratio:	-
Entrenchment Ratio:	-
Bank Height Ratio:	-
