YEAR 4 of 7 (2015)
ANNUAL MONITORING REPORT
HERMAN DAIRY STREAM AND WETLAND RESTORATION SITE

Alexander County, North Carolina
DMS Project No. 94642
Full Delivery Contract No. 003271

Catawba River Basin
Cataloging Unit and Targeted Local Watershed
03050101120030

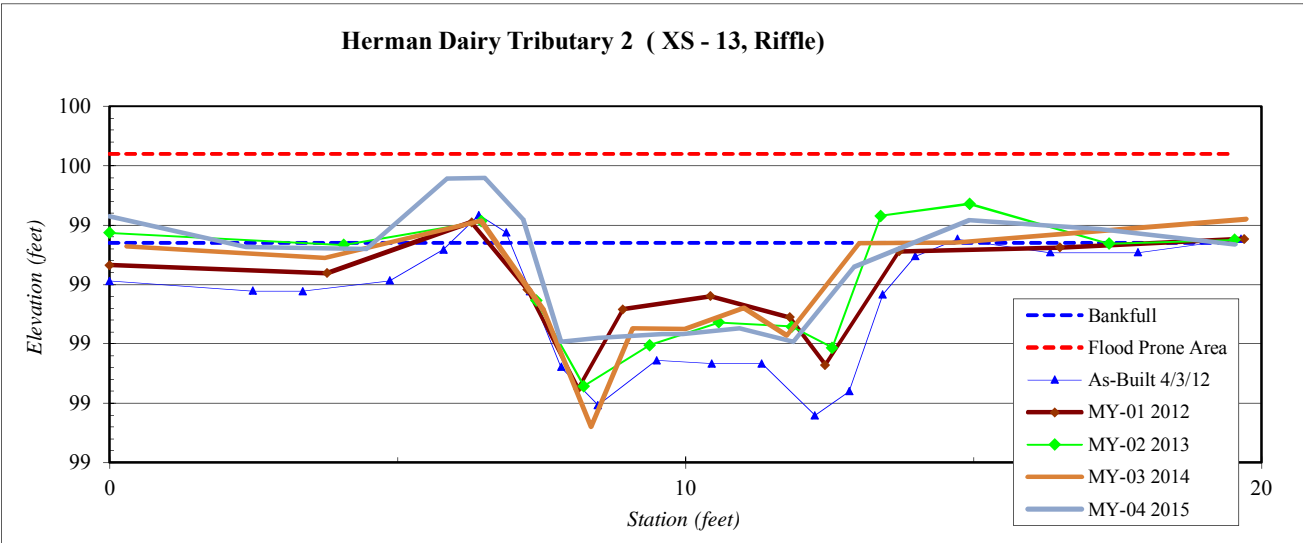
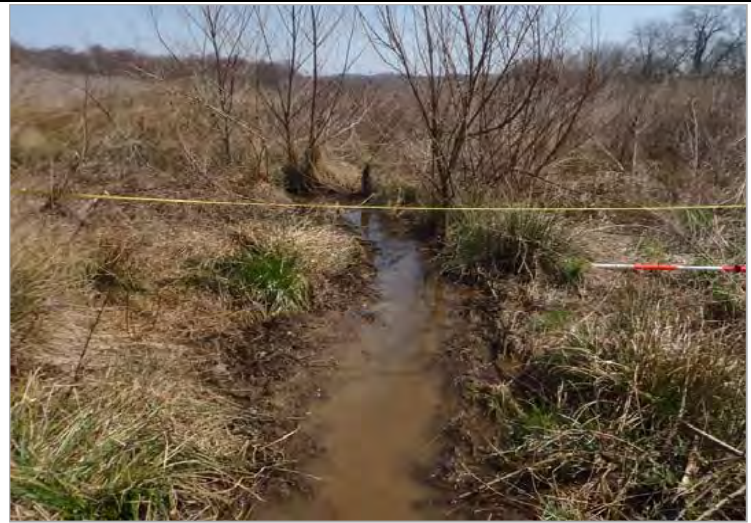
Site Name:	Herman Dairy
Watershed:	30501001120030
XS ID	Tributary 2 (XS - 13, Riffle)
Drainage Area (sq mi):	1.01
Date:	4/6/2015
Field Crew:	Perkinson, Jernigan

Station	Elevation
0.0	99.4
2.4	99.3
4.5	99.3
5.9	99.6
6.5	99.6
7.2	99.4
7.8	99.0
8.5	99.0
9.6	99.0
10.0	99.0
10.9	99.1
11.9	99.0
12.9	99.3
14.9	99.42
17.2	99.39
19.5	99.33

SUMMARY DATA	
Bankfull Elevation:	99.3
Bankfull Cross-Sectional Area:	1.6
Bankfull Width:	6.6
Flood Prone Area Elevation:	99.6
Flood Prone Width:	>80
Max Depth at Bankfull:	0.3
Mean Depth at Bankfull:	0.2
W / D Ratio:	27.2
Entrenchment Ratio:	>5
Bank Height Ratio:	1.0

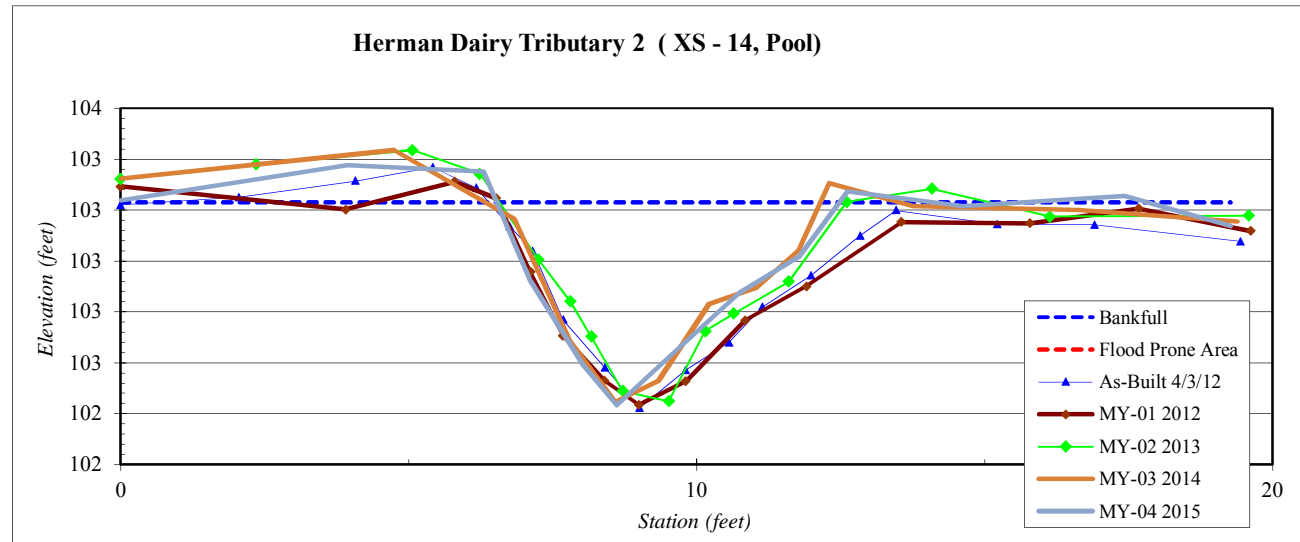
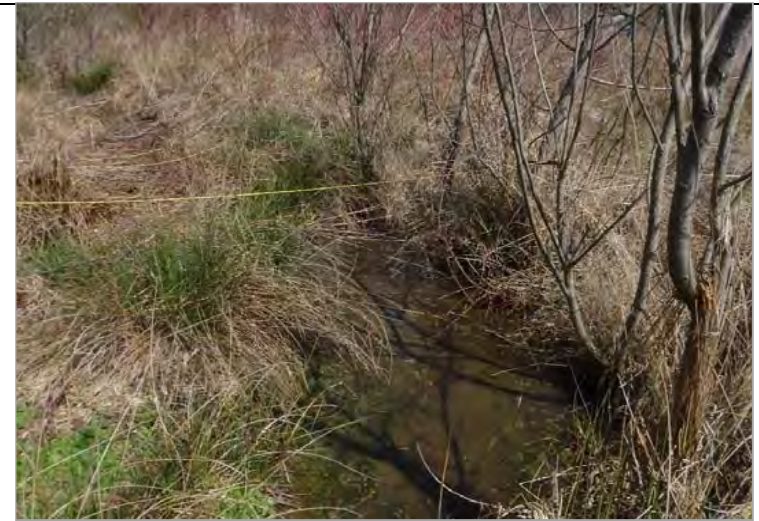
Site Name:	Herman Dairy
Watershed:	30501001120030
XS ID	Tributary 2 (XS - 14, Pool)
Drainage Area (sq mi):	1.01
Date:	4/6/2015
Field Crew:	Perkinson, Jernigan

Station	Elevation
0.0	103.2
3.9	103.4
6.3	103.4
7.1	102.9
8.0	102.6
8.6	102.4
9.6	102.6
10.8	102.9
11.8	103.0
12.6	103.3
14.6	103.2
17.4	103.3
19.3	103.1

SUMMARY DATA	
Bankfull Elevation:	103.2
Bankfull Cross-Sectional Area:	2.5
Bankfull Width:	6.0
Flood Prone Area Elevation:	-
Flood Prone Width:	-
Max Depth at Bankfull:	0.8
Mean Depth at Bankfull:	0.4
W / D Ratio:	-
Entrenchment Ratio:	-
Bank Height Ratio:	-

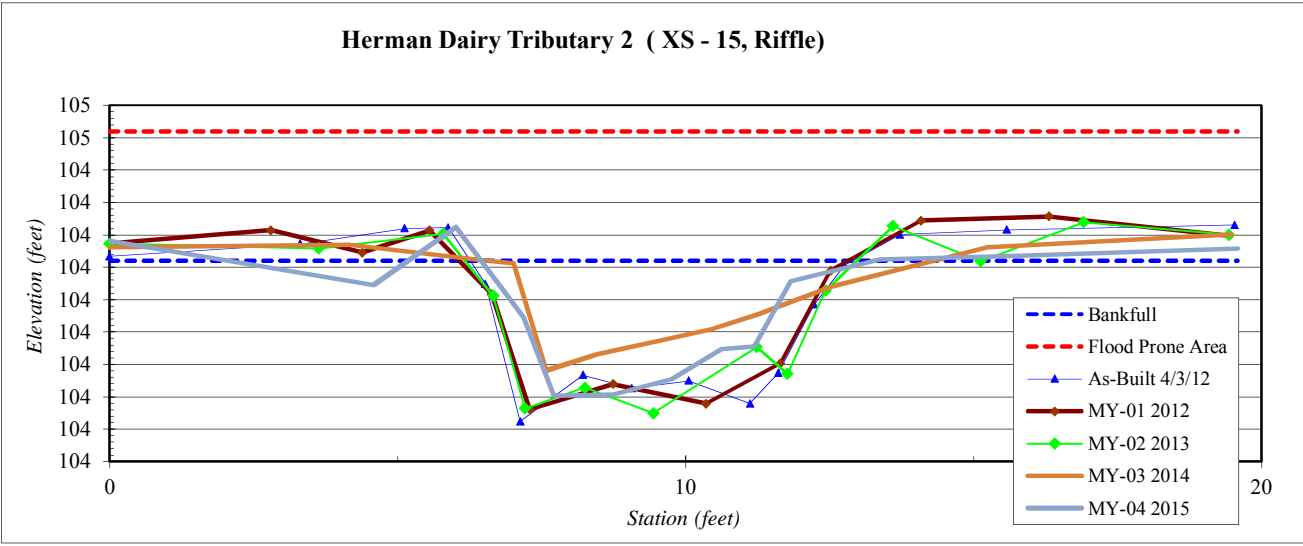
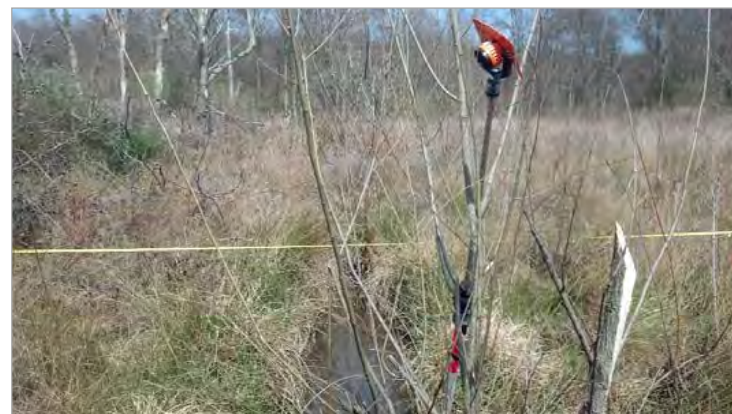
Site Name:	Herman Dairy
Watershed:	30501001120030
XS ID	Tributary 2 (XS - 15, Riffle)
Drainage Area (sq mi):	1.01
Date:	4/6/2015
Field Crew:	Perkinson, Jernigan

Station	Elevation
0.0	104.2
4.6	104.0
6.0	104.2
7.2	103.9
7.7	103.7
8.7	103.7
9.8	103.8
10.6	103.8
11.2	103.9
11.8	104.1
13.4	104.1
15.5	104.1
19.6	104.2

SUMMARY DATA	
Bankfull Elevation:	104.1
Bankfull Cross-Sectional Area:	1.6
Bankfull Width:	6.8
Flood Prone Area Elevation:	104.5
Flood Prone Width:	>80
Max Depth at Bankfull:	0.4
Mean Depth at Bankfull:	0.2
W / D Ratio:	28.9
Entrenchment Ratio:	>5
Bank Height Ratio:	1.0

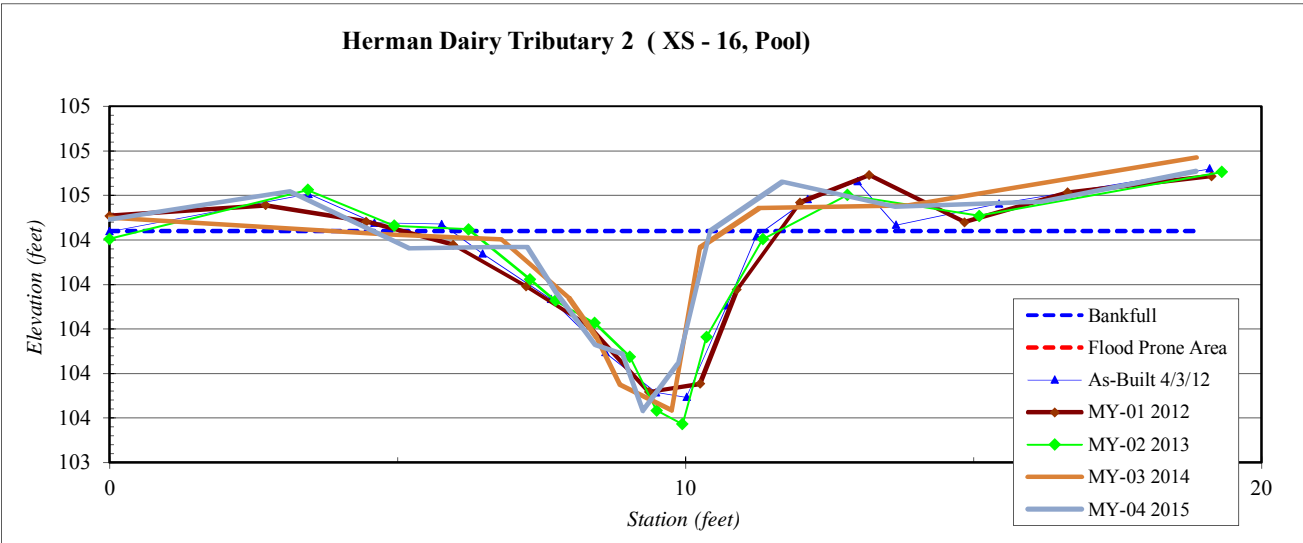
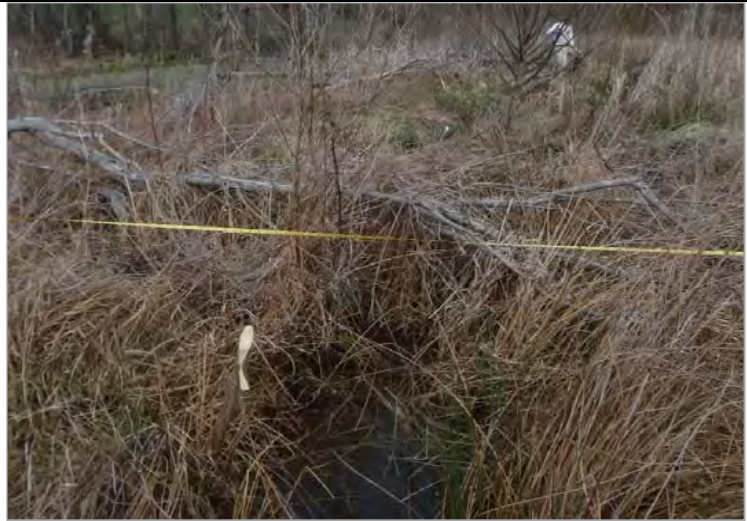
Herman Dairy Tributary 2 (XS - 16, Pool)

Site Name:	Herman Dairy
Watershed:	30501001120030
XS ID	Tributary 2 (XS - 16, Pool)
Drainage Area (sq mi):	1.01
Date:	4/6/2015
Field Crew:	Perkinson, Jernigan

Station	Elevation
-0.3	104.5
3.1	104.6
5.2	104.4
6.7	104.4
7.3	104.4
7.8	104.2
8.4	103.9
8.9	103.9
9.3	103.6
9.9	103.8
10.4	104.4
11.7	104.7
13.6	104.5
16.2	104.57
18.9	104.71

SUMMARY DATA	
Bankfull Elevation:	104.4
Bankfull Cross-Sectional Area:	1.6
Bankfull Width:	5.8
Flood Prone Area Elevation:	-
Flood Prone Width:	-
Max Depth at Bankfull:	0.8
Mean Depth at Bankfull:	0.3
W / D Ratio:	-
Entrenchment Ratio:	-
Bank Height Ratio:	-

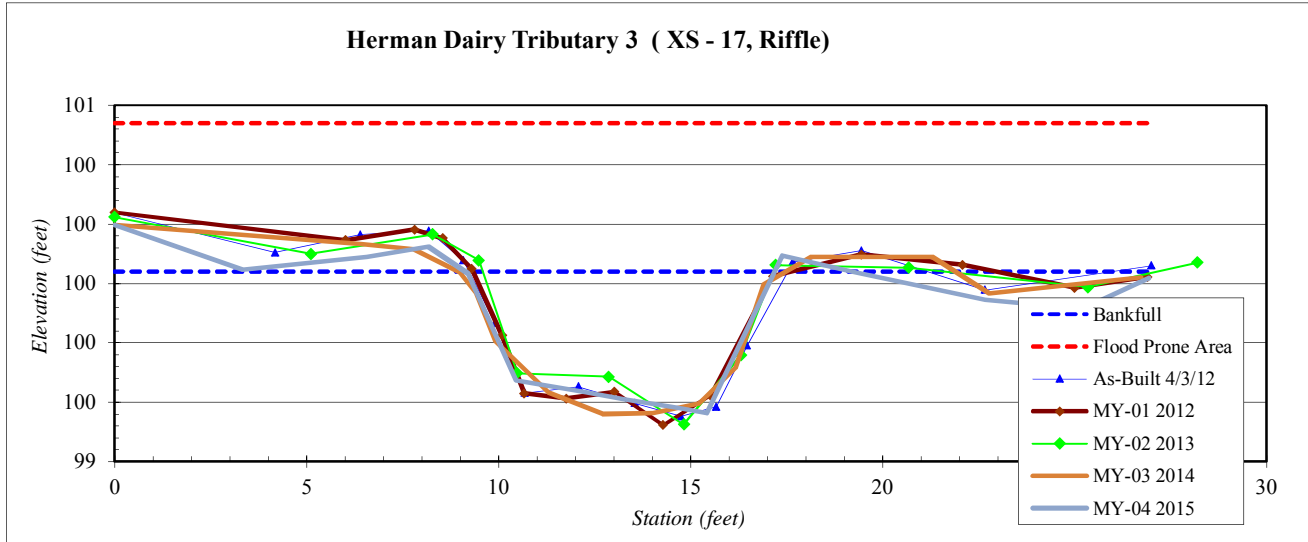
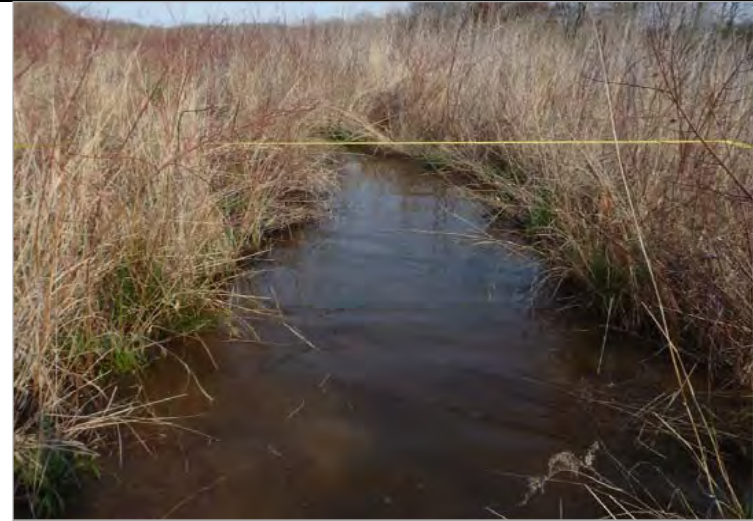
Site Name:	Herman Dairy
Watershed:	30501001120030
XS ID	Tributary 3 (XS - 17, Riffle)
Drainage Area (sq mi):	0.06
Date:	4/6/2015
Field Crew:	Perkinson, Jernigan

Station	Elevation
0.0	100.2
3.3	100.0
6.6	100.1
8.2	100.1
9.2	100.0
10.5	99.7
12.1	99.6
13.3	99.6
14.7	99.6
15.4	99.6
16.6	99.9
17.4	100.1
19.2	100.0
22.7	99.95
25.2	99.91
26.9	100.02

SUMMARY DATA	
Bankfull Elevation:	100.0
Bankfull Cross-Sectional Area:	2.7
Bankfull Width:	8.0
Flood Prone Area Elevation:	100.5
Flood Prone Width:	>80
Max Depth at Bankfull:	0.5
Mean Depth at Bankfull:	0.3
W / D Ratio:	23.7
Entrenchment Ratio:	>5
Bank Height Ratio:	1.0

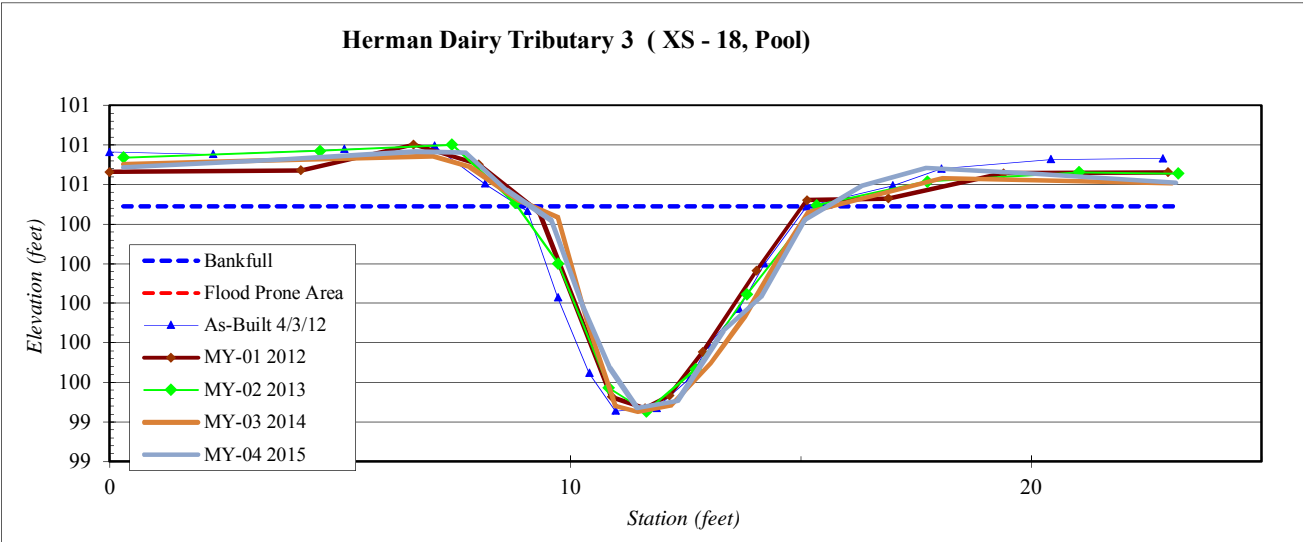
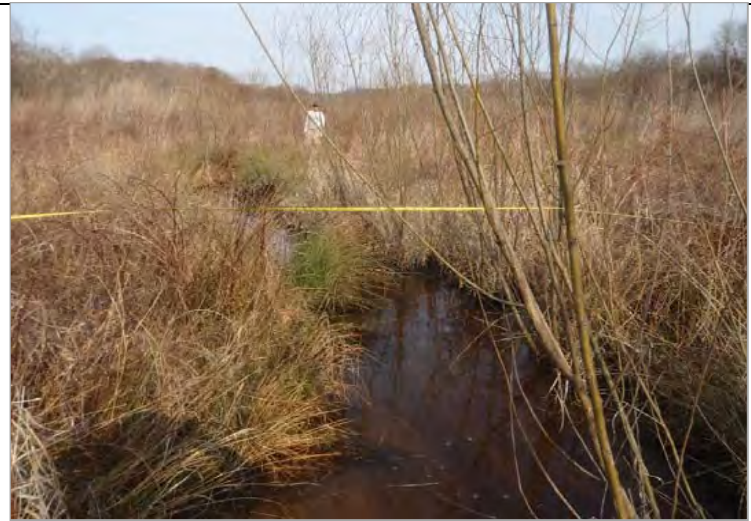
Herman Dairy Tributary 3 (XS - 18, Pool)

Site Name:	Herman Dairy
Watershed:	30501001120030
XS ID	Tributary 3 (XS - 18, Pool)
Drainage Area (sq mi):	0.06
Date:	4/6/2015
Field Crew:	Perkinson, Jernigan

Station	Elevation
0.3	100.7
3.7	100.7
6.6	100.8
7.7	100.8
8.6	100.6
9.6	100.4
10.3	100.0
10.9	99.7
11.4	99.5
12.3	99.5
13.3	99.9
14.1	100.0
15.1	100.4
16.3	100.59
17.7	100.68
20.1	100.66
23.1	100.61

SUMMARY DATA	
Bankfull Elevation:	100.5
Bankfull Cross-Sectional Area:	3.5
Bankfull Width:	6.4
Flood Prone Area Elevation:	-
Flood Prone Width:	-
Max Depth at Bankfull:	1.0
Mean Depth at Bankfull:	0.5
W / D Ratio:	-
Entrenchment Ratio:	-
Bank Height Ratio:	-

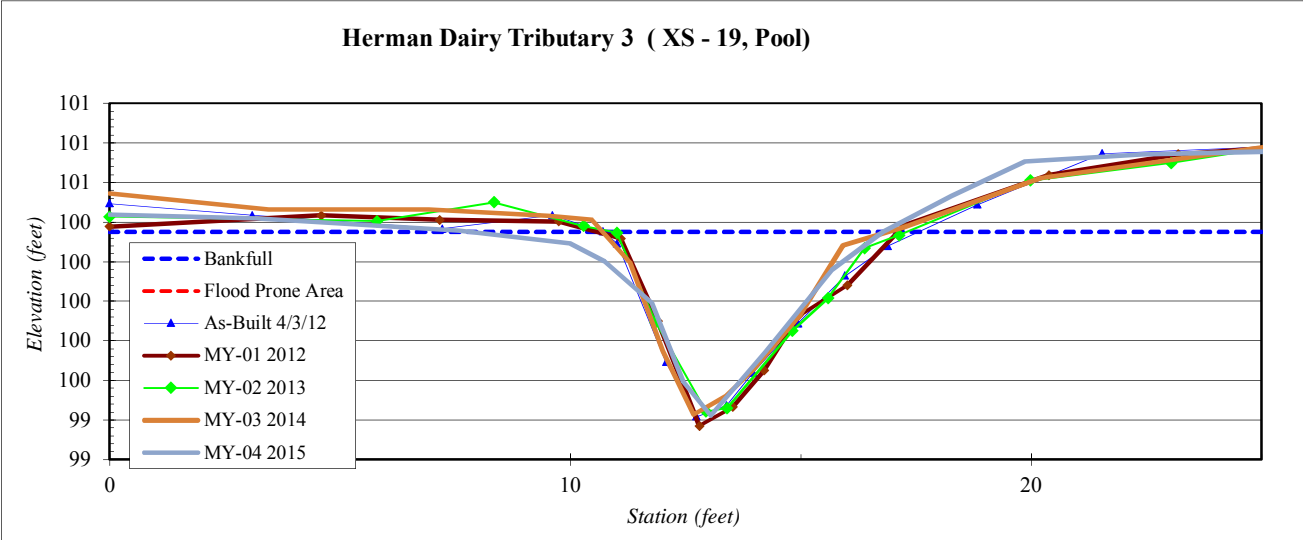
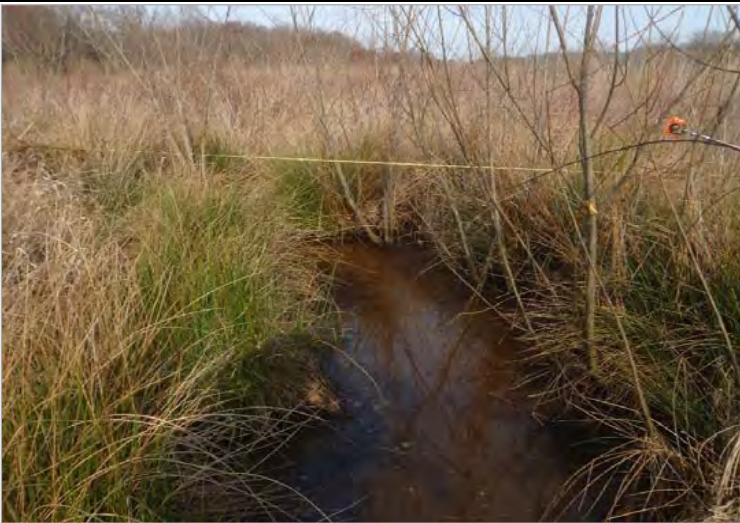
Site Name:	Herman Dairy
Watershed:	30501001120030
XS ID	Tributary 3 (XS - 19, Pool)
Drainage Area (sq mi):	0.06
Date:	4/6/2015
Field Crew:	Perkinson, Jernigan

Station	Elevation
0.0	100.4
3.2	100.4
7.6	100.4
10.0	100.3
10.7	100.2
11.8	100.0
12.5	99.6
13.0	99.4
14.2	99.7
15.7	100.2
16.8	100.4
18.3	100.5
19.9	100.7
22.4	100.74
25.7	100.76

SUMMARY DATA	
Bankfull Elevation:	100.4
Bankfull Cross-Sectional Area:	2.9
Bankfull Width:	9.0
Flood Prone Area Elevation:	-
Flood Prone Width:	-
Max Depth at Bankfull:	0.9
Mean Depth at Bankfull:	0.3
W / D Ratio:	-
Entrenchment Ratio:	-
Bank Height Ratio:	-

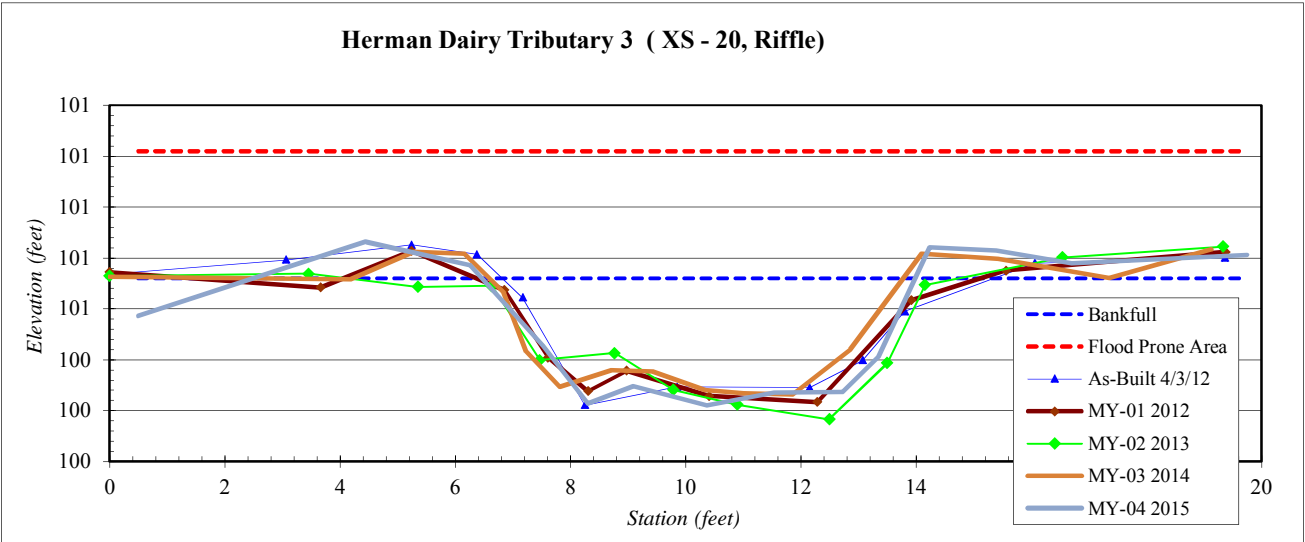
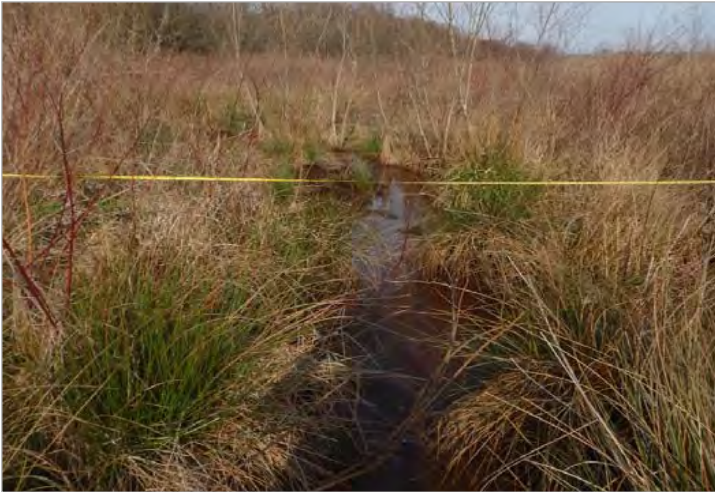
Herman Dairy Tributary 3 (XS - 20, Riffle)

Site Name:	Herman Dairy
Watershed:	30501001120030
XS ID	Tributary 3 (XS - 20, Riffle)
Drainage Area (sq mi):	0.06
Date:	4/6/2015
Field Crew:	Perkinson, Jernigan

Station	Elevation
0.5	100.6
4.5	100.9
6.3	100.8
7.5	100.5
8.3	100.2
9.1	100.3
10.4	100.2
11.5	100.3
12.7	100.3
13.4	100.4
14.2	100.8
15.4	100.8
16.7	100.8
19.7	100.81

SUMMARY DATA	
Bankfull Elevation:	100.7
Bankfull Cross-Sectional Area:	2.8
Bankfull Width:	7.5
Flood Prone Area Elevation:	101.2
Flood Prone Width:	>80
Max Depth at Bankfull:	0.5
Mean Depth at Bankfull:	0.4
W / D Ratio:	20.1
Entrenchment Ratio:	>5
Bank Height Ratio:	1.0

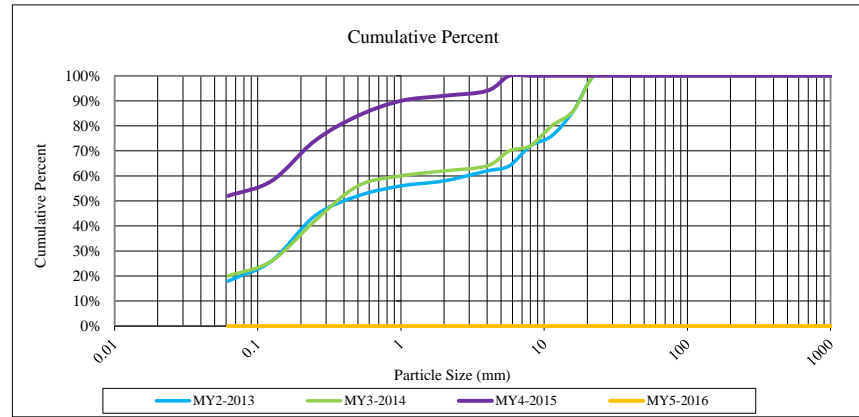
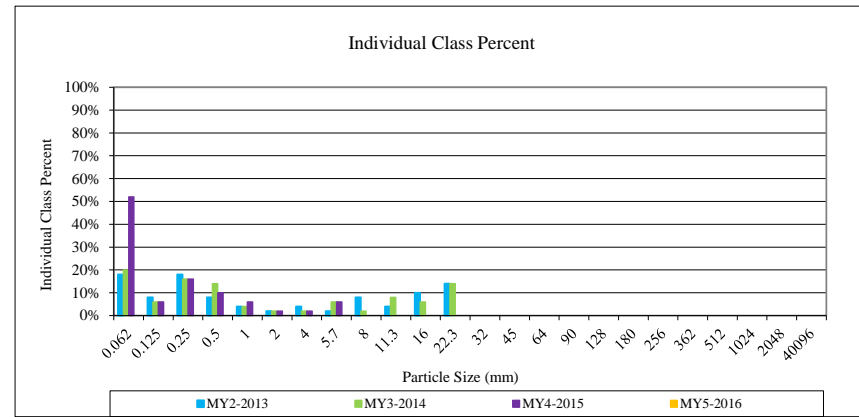
Project Name: Herman Dairy UT1					
Cross-Section: 2					
Feature: Riffle					
			2015		
Description	Material	Size (mm)	Total #	Item %	Cum %
Silt/Clay	silt/clay	0.062	26	52%	36%
Sand	very fine sand	0.125	3	6%	44%
	fine sand	0.250	8	16%	48%
	medium sand	0.50	5	10%	48%
	coarse sand	1.00	3	6%	56%
	very coarse sand	2.0	1	2%	60%
Gravel	very fine gravel	4.0	1	2%	68%
	fine gravel	5.7	3	6%	72%
	fine gravel	8.0	0	0%	84%
	medium gravel	11.3	0	0%	92%
	medium gravel	16.0	0	0%	92%
	course gravel	22.3	0	0%	96%
	course gravel	32.0	0	0%	96%
	very coarse gravel	45	0	0%	96%
	very coarse gravel	64	0	0%	100%
	very coarse gravel	90	0	0%	100%
Cobble	small cobble	90	0	0%	100%
	medium cobble	128	0	0%	100%
	large cobble	180	0	0%	100%
	very large cobble	256	0	0%	100%
Boulder	small boulder	362	0	0%	100%
	small boulder	512	0	0%	100%
	medium boulder	1024	0	0%	100%
	large boulder	2048	0	0%	100%
Bedrock	bedrock	40096	0	0%	100%
TOTAL % of whole count			50	100%	100%

Summary Data	
D50	NA
D84	1
D95	4

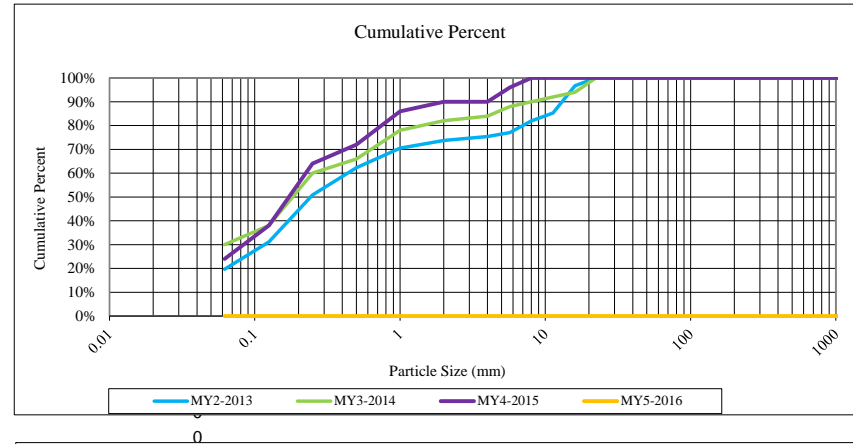
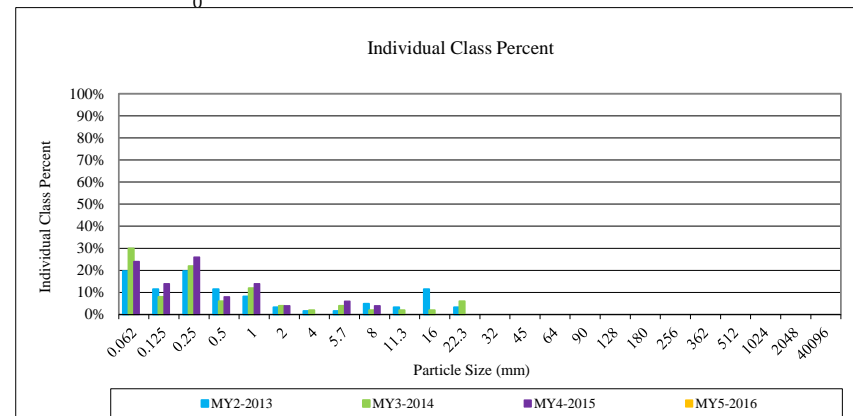
Project Name: Herman Dairy UT1					
Cross-Section: 3					
Feature: Riffle					
			2015		
Description	Material	Size (mm)	Total #	Item %	Cum %
Silt/Clay	silt/clay	0.062	12	24%	33%
Sand	very fine sand	0.125	7	14%	43%
	fine sand	0.250	13	26%	48%
	medium sand	0.50	4	8%	52%
	coarse sand	1.00	7	14%	62%
	very coarse sand	2.0	2	4%	67%
Gravel	very fine gravel	4.0	0	0%	67%
	fine gravel	5.7	3	6%	67%
	fine gravel	8.0	2	4%	71%
	medium gravel	11.3	0	0%	76%
	medium gravel	16.0	0	0%	86%
	course gravel	22.3	0	0%	90%
	course gravel	32.0	0	0%	95%
	very coarse gravel	45	0	0%	95%
	very coarse gravel	64	0	0%	95%
Cobble	small cobble	90	0	0%	100%
	medium cobble	128	0	0%	100%
	large cobble	180	0	0%	100%
	very large cobble	256	0	0%	100%
Boulder	small boulder	362	0	0%	100%
	small boulder	512	0	0%	100%
	medium boulder	1024	0	0%	100%
	large boulder	2048	0	0%	100%
Bedrock	bedrock	40096	0	0%	100%
TOTAL % of whole count			50	100%	100%

Summary Data	
D50	0.2
D84	1
D95	6

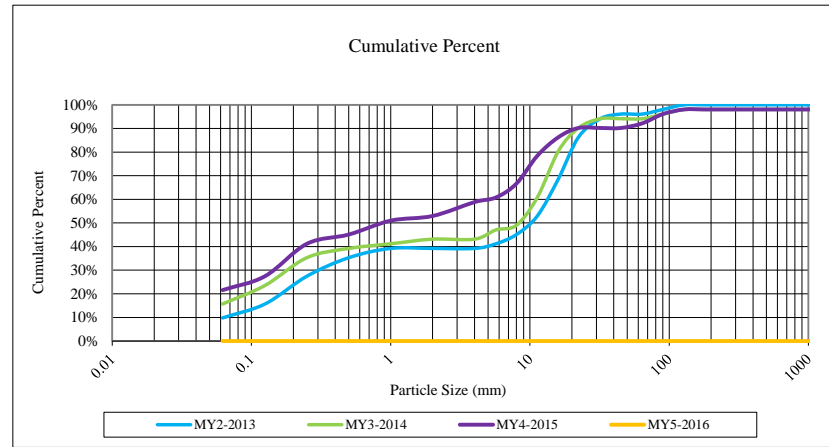
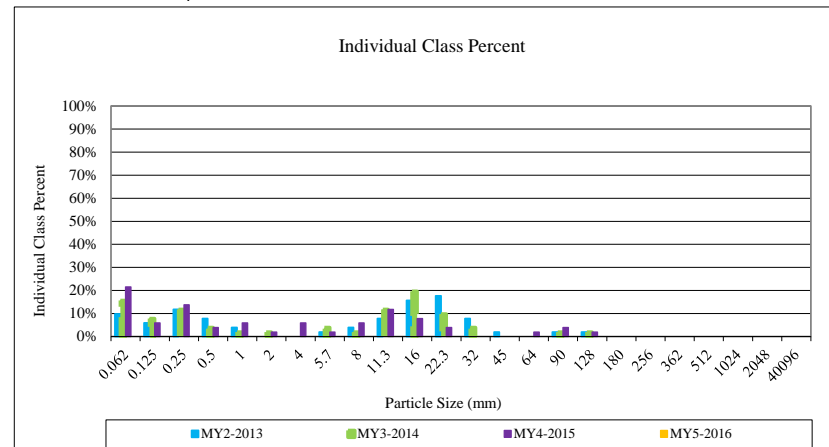
Project Name: Herman Dairy UT1					
Cross-Section: 10					
Feature: Riffle					
			2015		
Description	Material	Size (mm)	Total #	Item %	Cum %
Silt/Clay	silt/clay	0.062	11	22%	24%
Sand	very fine sand	0.125	3	6%	32%
	fine sand	0.250	7	14%	44%
	medium sand	0.50	2	4%	48%
	coarse sand	1.00	3	6%	56%
	very coarse sand	2.0	1	2%	60%
Gravel	very fine gravel	4.0	3	6%	68%
	fine gravel	5.7	1	2%	72%
	fine gravel	8.0	3	6%	80%
	medium gravel	11.3	6	12%	80%
	medium gravel	16.0	4	8%	84%
	course gravel	22.3	2	4%	96%
	course gravel	32.0	0	0%	96%
	very coarse gravel	45	0	0%	96%
	very coarse gravel	64	1	2%	100%
	very coarse gravel	90	2	4%	100%
Cobble	small cobble	90	2	4%	100%
	medium cobble	128	1	2%	100%
	large cobble	180	0	0%	100%
	very large cobble	256	0	0%	100%
Boulder	small boulder	362	0	0%	100%
	small boulder	512	0	0%	100%
	medium boulder	1024	0	0%	100%
	large boulder	2048	0	0%	100%
Bedrock	bedrock	40096	0	0%	100%
TOTAL % of whole count			50	100%	100%

Summary Data	
D50	0.8
D84	13
D95	70

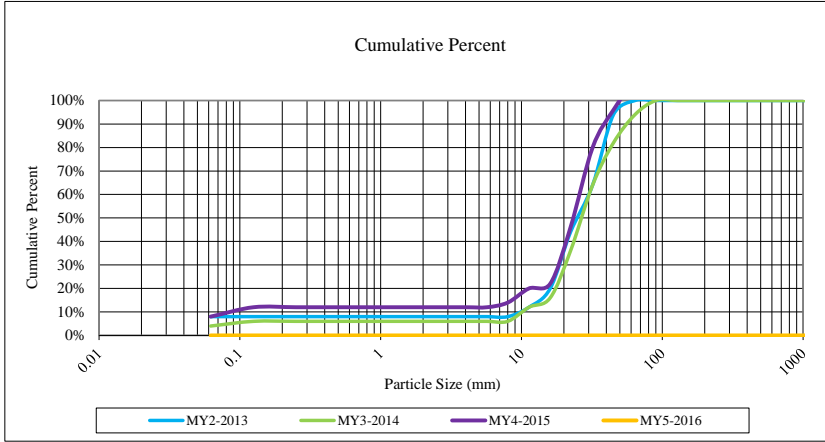
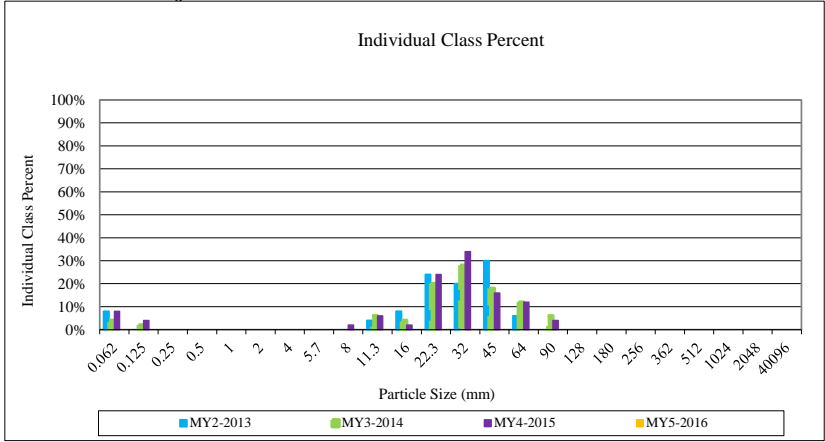
Project Name: Herman Dairy UT2					
Cross-Section: 13					
Feature: Riffle					
			2015		
Description	Material	Size (mm)	Total #	Item %	Cum %
Silt/Clay	silt/clay	0.062	4	7%	68%
Sand	very fine sand	0.125	2	4%	72%
	fine sand	0.250	0	0%	84%
	medium sand	0.50	0	0%	84%
	coarse sand	1.00	0	0%	88%
	very coarse sand	2.0	0	0%	92%
Gravel	very fine gravel	4.0	0	0%	100%
	fine gravel	5.7	0	0%	100%
	fine gravel	8.0	1	2%	100%
	medium gravel	11.3	3	5%	100%
	medium gravel	16.0	1	2%	100%
	course gravel	22.3	12	21%	100%
	course gravel	32.0	17	30%	100%
	very coarse gravel	45	8	14%	100%
	very coarse gravel	64	6	11%	100%
	Cobble	small cobble	90	2	4%
medium cobble		128	0	0%	100%
large cobble		180	0	0%	100%
very large cobble		256	0	0%	100%
Boulder	small boulder	362	0	0%	100%
	small boulder	512	0	0%	100%
	medium boulder	1024	0	0%	100%
	large boulder	2048	0	0%	100%
Bedrock	bedrock	40096	0	0%	100%
TOTAL % of whole count			56	100%	100%

Summary Data	
D50	24.6
D84	43
D95	61

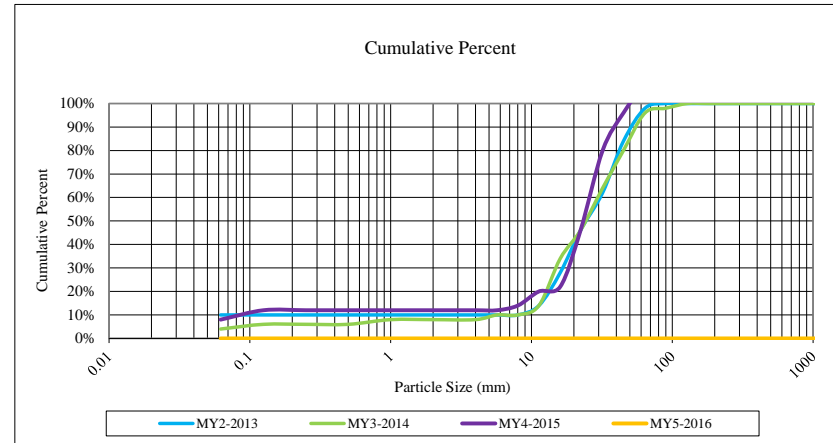
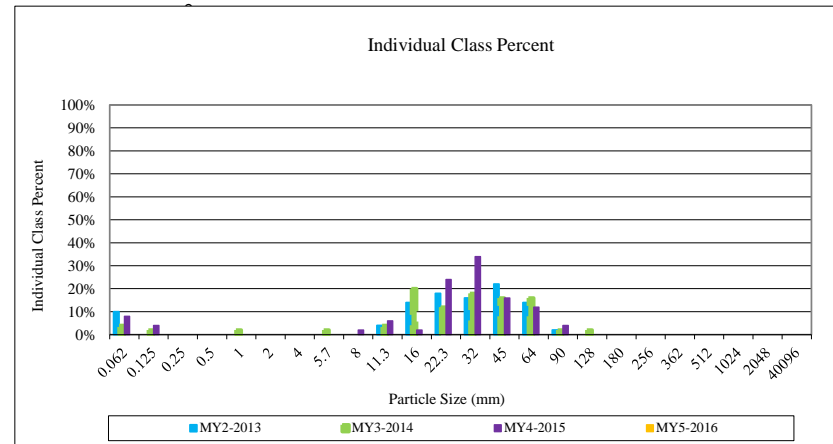
Project Name: Herman Dairy UT2					
Cross-Section: 15					
Feature: Riffle					
			2015		
Description	Material	Size (mm)	Total #	Item %	Cum %
Silt/Clay	silt/clay	0.062	4	8%	68%
Sand	very fine sand	0.125	1	2%	72%
	fine sand	0.250	0	0%	84%
	medium sand	0.50	2	4%	84%
	coarse sand	1.00	1	2%	88%
	very coarse sand	2.0	0	0%	92%
Gravel	very fine gravel	4.0	1	2%	100%
	fine gravel	5.7	0	0%	100%
	fine gravel	8.0	1	2%	100%
	medium gravel	11.3	3	6%	100%
	medium gravel	16.0	4	8%	100%
	course gravel	22.3	9	17%	100%
	course gravel	32.0	7	13%	100%
	very coarse gravel	45	11	21%	100%
	very coarse gravel	64	5	10%	100%
	Cobble	small cobble	90	1	2%
medium cobble		128	2	4%	100%
large cobble		180	0	0%	100%
very large cobble		256	0	0%	100%
Boulder	small boulder	362	0	0%	100%
	small boulder	512	0	0%	100%
	medium boulder	1024	0	0%	100%
	large boulder	2048	0	0%	100%
Bedrock	bedrock	40096	0	0%	100%
TOTAL % of whole count			52	100%	100%

Summary Data	
D50	22
D84	45
D95	73

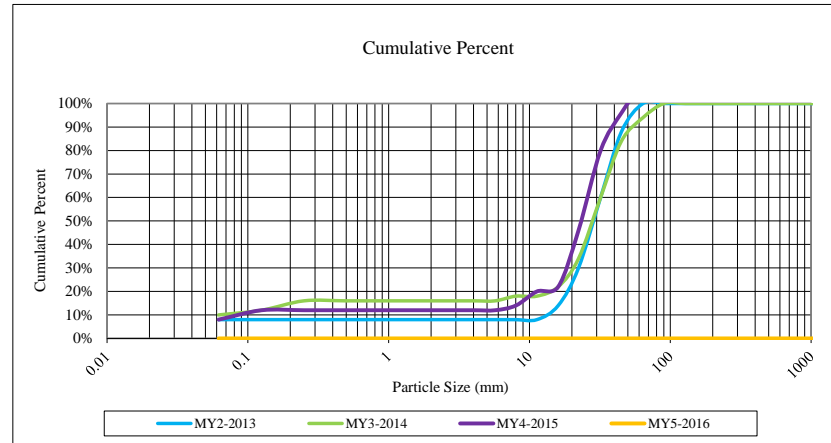
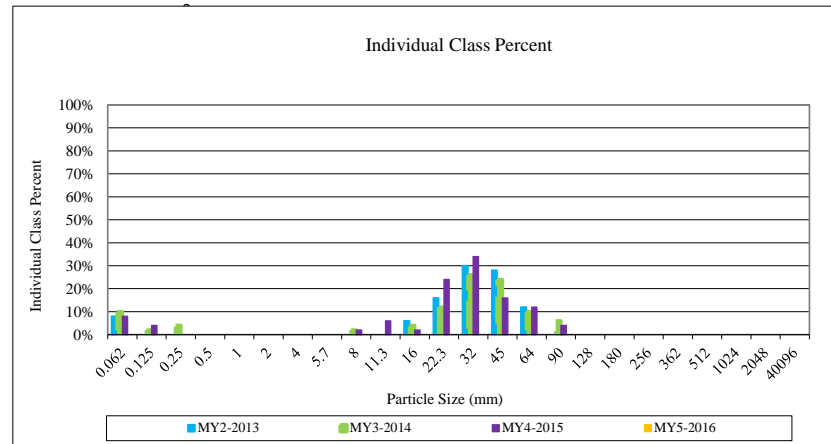
Project Name: Herman Dairy UT3					
Cross-Section: 17					
Feature: Riffle					
			2015		
Description	Material	Size (mm)	Total #	Item %	Cum %
Silt/Clay	silt/clay	0.062	7	12%	68%
Sand	very fine sand	0.125	2	4%	72%
	fine sand	0.250	3	5%	84%
	medium sand	0.50	1	2%	84%
	coarse sand	1.00	2	4%	88%
	very coarse sand	2.0	0	0%	92%
Gravel	very fine gravel	4.0	0	0%	100%
	fine gravel	5.7	2	4%	100%
	fine gravel	8.0	1	2%	100%
	medium gravel	11.3	0	0%	100%
	medium gravel	16.0	3	5%	100%
	course gravel	22.3	4	7%	100%
	course gravel	32.0	16	28%	100%
	very coarse gravel	45	5	9%	100%
	very coarse gravel	64	11	19%	100%
Cobble	small cobble	90	0	0%	100%
	medium cobble	128	0	0%	100%
	large cobble	180	0	0%	100%
	very large cobble	256	0	0%	100%
Boulder	small boulder	362	0	0%	100%
	small boulder	512	0	0%	100%
	medium boulder	1024	0	0%	100%
	large boulder	2048	0	0%	100%
Bedrock	bedrock	40096	0	0%	100%
TOTAL % of whole count			57	100%	100%

Summary Data	
D50	24
D84	48
D95	58

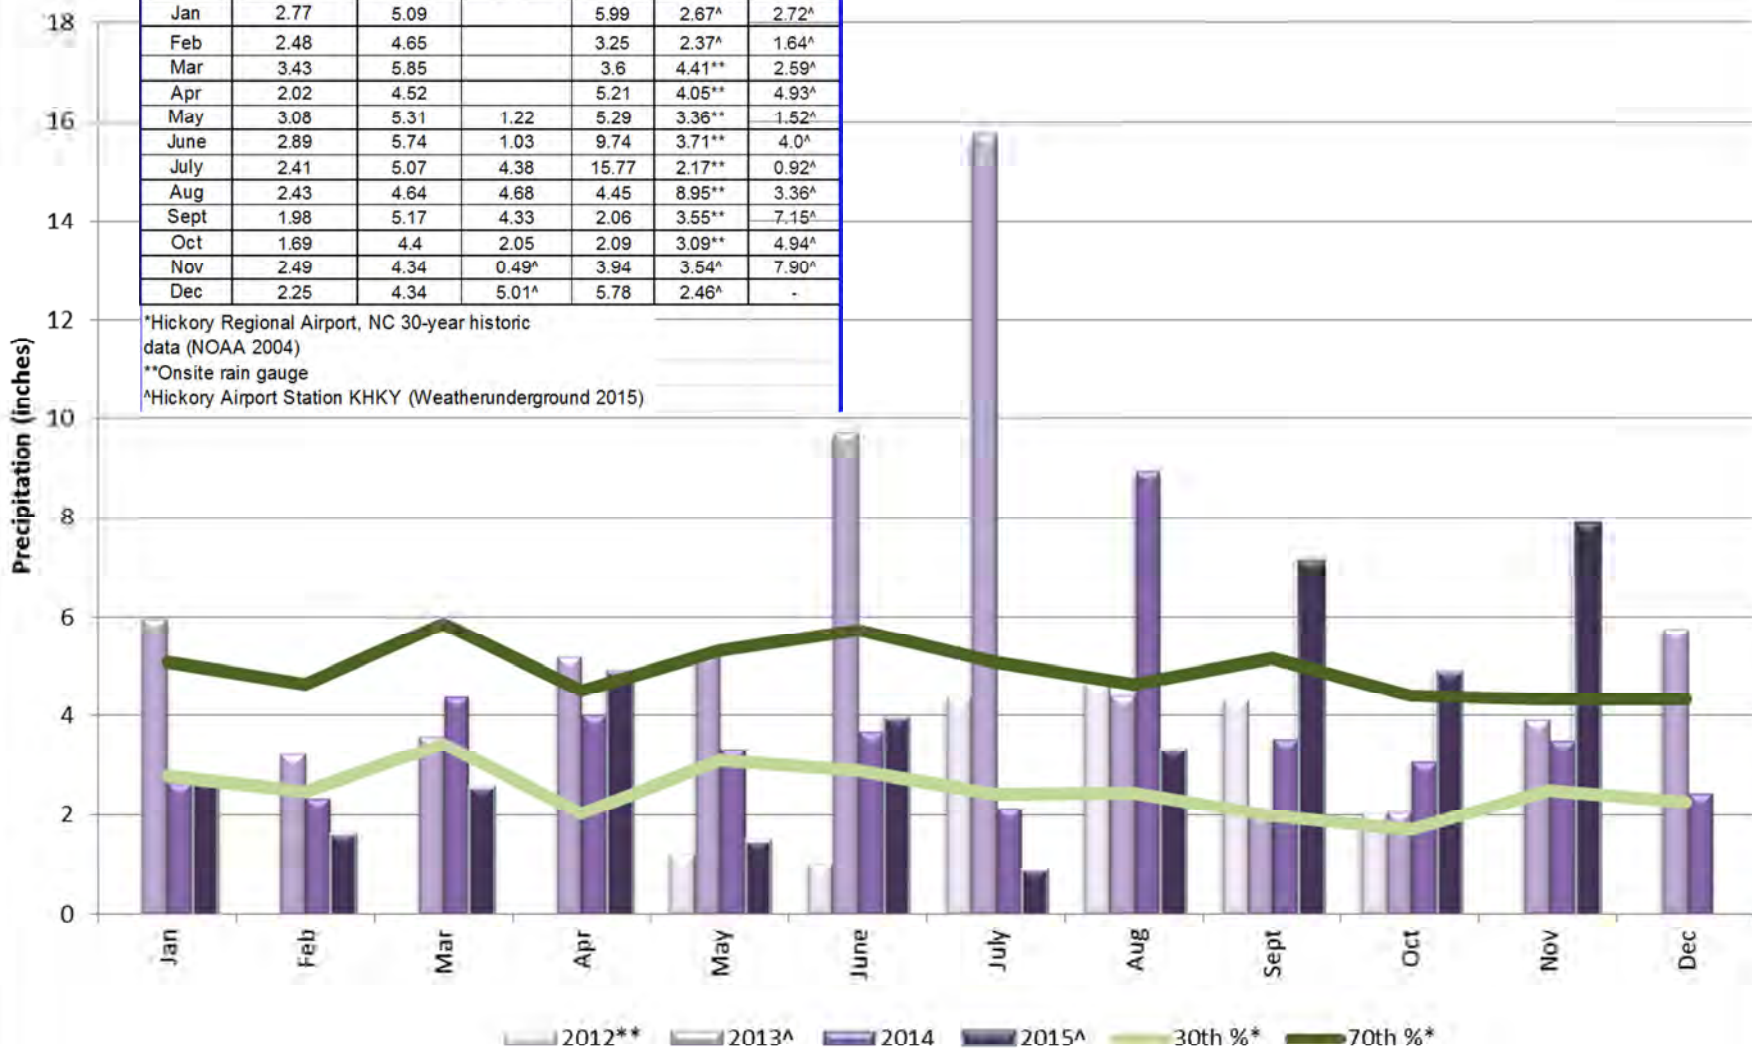
Figure E1. Annual Climatic Data vs. 30-year Historic Data

Month	30th %*	70th %*	2012**	2013^	2014	2015^
Jan	2.77	5.09		5.99	2.67^	2.72^
Feb	2.48	4.65		3.25	2.37^	1.64^
Mar	3.43	5.85		3.6	4.41**	2.59^
Apr	2.02	4.52		5.21	4.05**	4.93^
May	3.08	5.31	1.22	5.29	3.36**	1.52^
June	2.89	5.74	1.03	9.74	3.71**	4.0^
July	2.41	5.07	4.38	15.77	2.17**	0.92^
Aug	2.43	4.64	4.68	4.45	8.95**	3.36^
Sept	1.98	5.17	4.33	2.06	3.55**	7.15^
Oct	1.69	4.4	2.05	2.09	3.09**	4.94^
Nov	2.49	4.34	0.49^	3.94	3.54^	7.90^
Dec	2.25	4.34	5.01^	5.78	2.46^	-

**Onsite rain gauge

^Hickory Airport Station KHKY (Weatherunderground 2015)

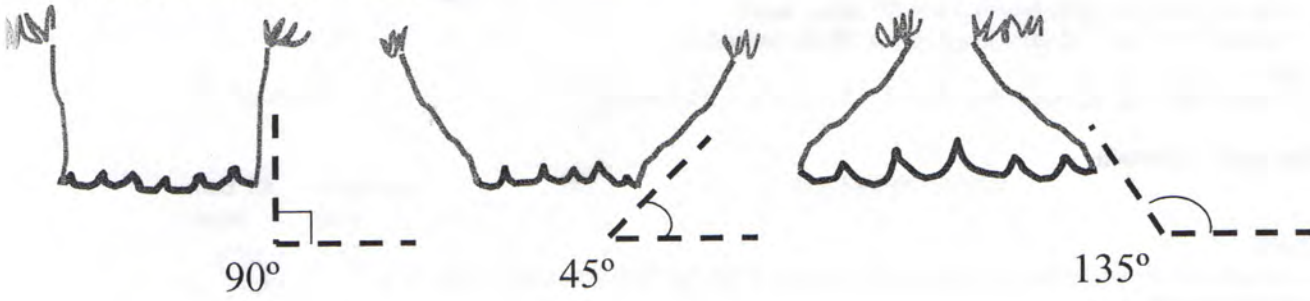
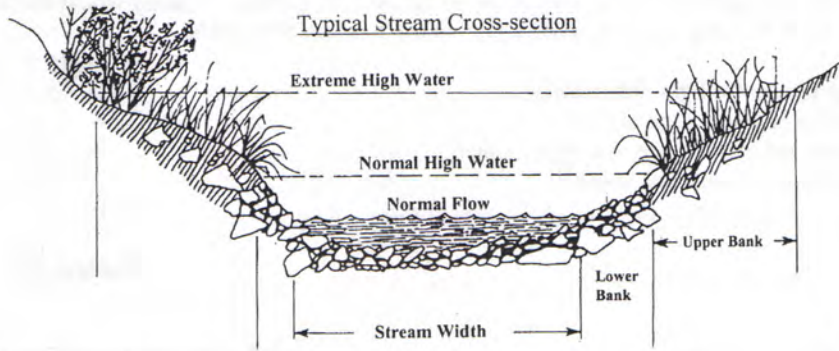
Diagram to determine bank angle:

This side is 45° bank angle.

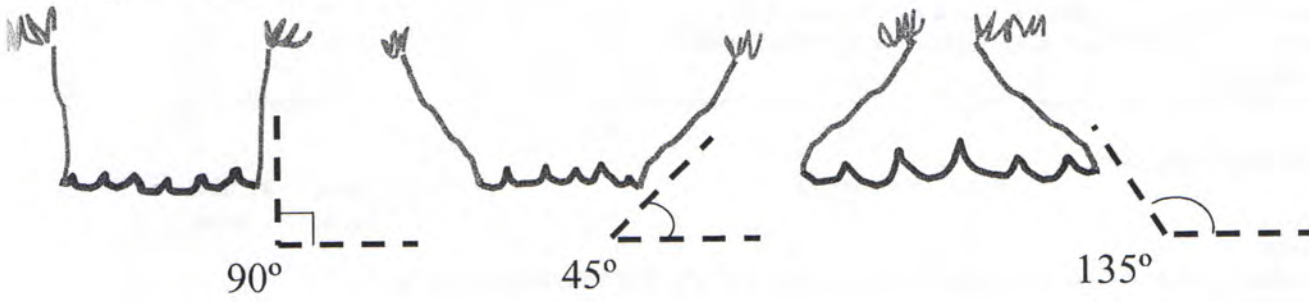
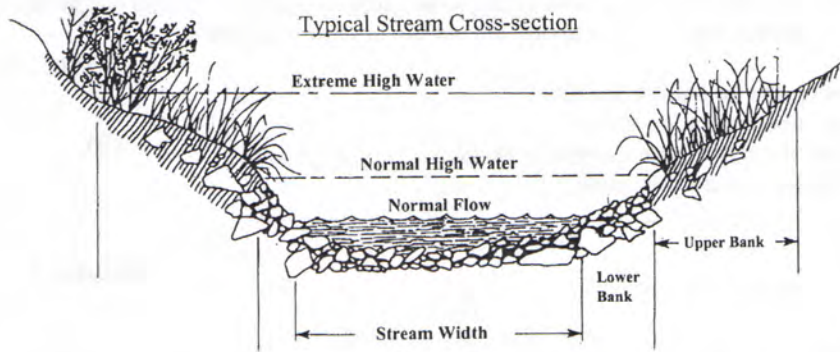
Diagram to determine bank angle:

This side is 45° bank angle.

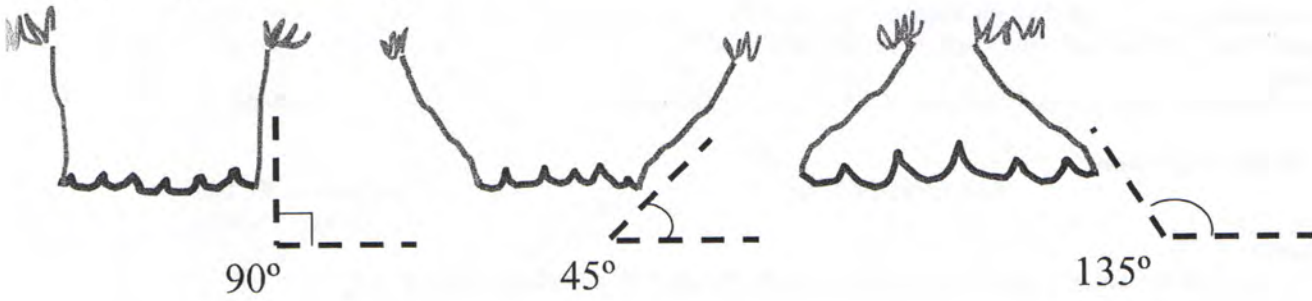
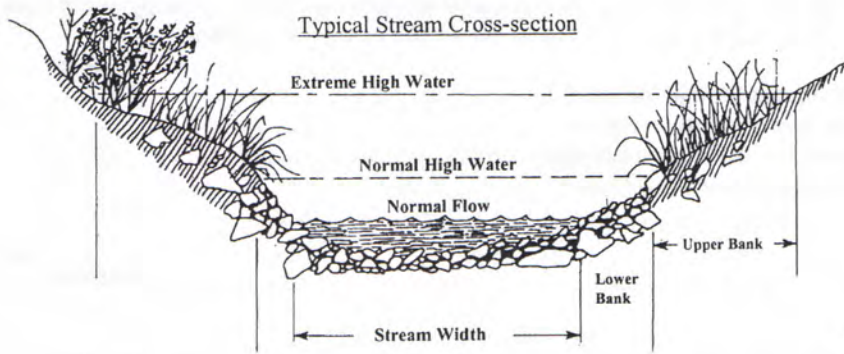
Diagram to determine bank angle:

This side is 45° bank angle.
