**FINAL**  
**MONITORING REPORT**  
**2019 (Year 1)**

**HERON STREAM AND WETLAND MITIGATION SITE**  
Alamance County, North Carolina

DMS Project ID No. 100014  
Full Delivery Contract No. 7192  
USACE Action ID No. SAW-2017-01471  
DWR No. 17-0290  
RFP No. 16-006990

Subject: Heron – Year 1 (2019) Monitoring Report  
Cape Fear 02 River Basin, Contract 007192, Alamance County, DMS Project No. 100014

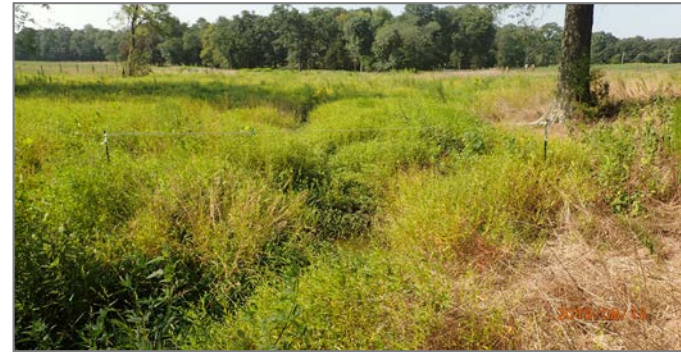
Station	Elevation
0.4	535.4
2.3	535.2
3.2	535.0
4.0	534.9
4.7	534.6
5.2	534.3
5.6	534.0
6.4	532.6
7.6	532.5
8.8	532.7
9.6	532.9
10.3	533.2
10.7	534.0
11.7	534.4
13.0	534.8
14.1	534.8
15.5	534.9
16.6	535.1
17.7	534.9

SUMMARY DATA	
<b>Bankfull Elevation:</b>	534.7
<b>LTOB Elevation:</b>	534.7
<b>Bankfull Cross-Sectional Area:</b>	10.5
<b>Bankfull Width:</b>	8.5
<b>Flood Prone Area Elevation:</b>	NA
<b>Flood Prone Width:</b>	NA
<b>Max Depth at Bankfull:</b>	2.2
<b>Low Bank Height:</b>	2.2
<b>Mean Depth at Bankfull:</b>	1.2
<b>W / D Ratio:</b>	NA
<b>Entrenchment Ratio:</b>	NA
<b>Bank Height Ratio:</b>	1.0

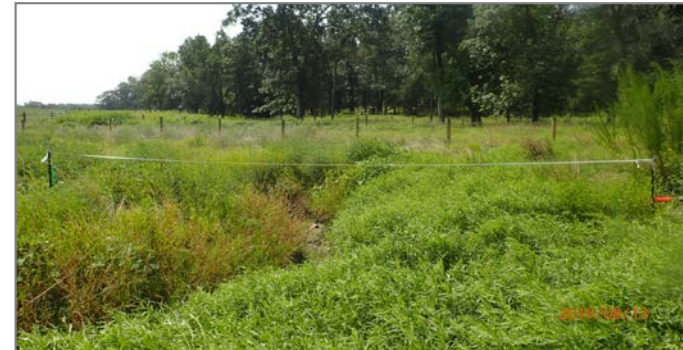
<b>Site</b>	Heron
<b>Watershed:</b>	Cape Fear, 0303002
<b>XS ID</b>	UT 1, XS - 4, Pool
<b>Feature</b>	Pool
<b>Date:</b>	8/13/2019
<b>Field Crew:</b>	Perkinson, Radecki

Station	Elevation
0.2	538.6
1.3	538.5
2.6	538.5
4.2	538.6
5.6	538.5
7.1	538.2
7.9	538.0
8.8	537.5
9.5	537.0
9.5	536.8
10.6	537.0
11.7	537.2
12.4	537.4
12.8	537.7
14.0	538.0
15.2	538.3
16.5	538.5
17.8	538.5
19.0	538.5
20.3	538.6
21.9	538.6

SUMMARY DATA	
<b>Bankfull Elevation:</b>	538.4
<b>LTOB Elevation:</b>	538.4
<b>Bankfull Cross-Sectional Area:</b>	6.8
<b>Bankfull Width:</b>	9.7
<b>Flood Prone Area Elevation:</b>	NA
<b>Flood Prone Width:</b>	NA
<b>Max Depth at Bankfull:</b>	1.6
<b>Low Bank Height:</b>	1.6
<b>Mean Depth at Bankfull:</b>	0.7
<b>W / D Ratio:</b>	NA
<b>Entrenchment Ratio:</b>	NA
<b>Bank Height Ratio:</b>	1.0

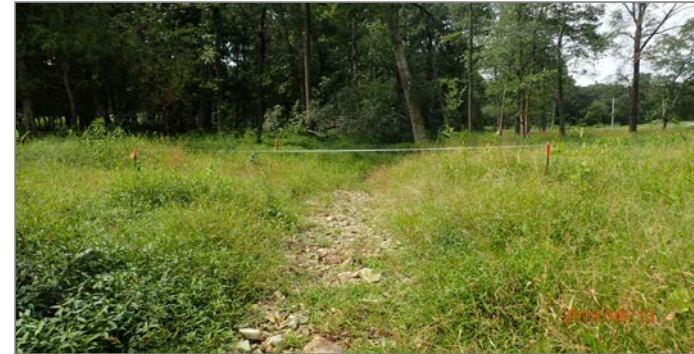
<b>Site</b>	Heron
<b>Watershed:</b>	Cape Fear, 0303002
<b>XS ID</b>	UT 1, XS - 5, Riffle
<b>Feature</b>	Riffle
<b>Date:</b>	8/13/2019
<b>Field Crew:</b>	Perkinson, Radecki

Station	Elevation
0.0	541.46
1.4	541.39
2.5	541.23
3.8	541.10
4.8	541.05
6.2	541.09
7.3	541.08
8.0	541.02
8.6	540.71
9.0	540.56
10.4	540.46
11.7	540.49
13.2	540.56
14.4	540.63
15.4	540.97
16.9	541.18
18.2	541.36
20.3	541.25
21.7	541.40
22.9	541.47
23.5	541.46

SUMMARY DATA	
<b>Bankfull Elevation:</b>	541.1
<b>LTOB Elevation:</b>	541.1
<b>Bankfull Cross-Sectional Area:</b>	3.7
<b>Bankfull Width:</b>	8.3
<b>Flood Prone Area Elevation:</b>	541.7
<b>Flood Prone Width:</b>	25.0
<b>Max Depth at Bankfull:</b>	0.6
<b>Low Bank Height:</b>	0.6
<b>Mean Depth at Bankfull:</b>	0.4
<b>W / D Ratio:</b>	18.6
<b>Entrenchment Ratio:</b>	3.0
<b>Bank Height Ratio:</b>	1.0

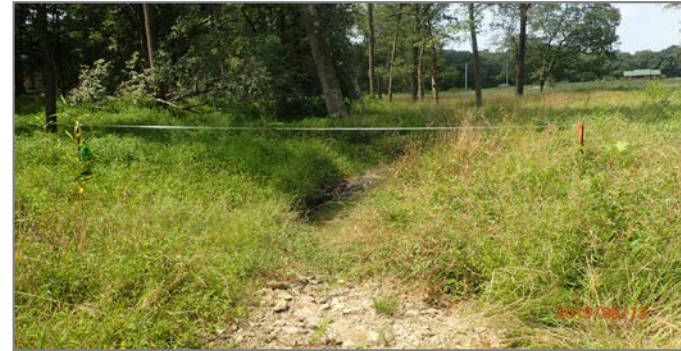
<b>Site</b>	Heron
<b>Watershed:</b>	Cape Fear, 0303002
<b>XS ID</b>	UT 1, XS - 6, Pool
<b>Feature</b>	Pool
<b>Date:</b>	8/13/2019
<b>Field Crew:</b>	Perkinson, Radecki

Station	Elevation
0.6	541.4
2.0	541.4
2.8	541.4
3.4	541.1
4.6	541.1
5.7	541.1
6.8	540.9
7.6	540.5
8.5	540.4
8.9	540.3
9.4	539.9
10.1	539.7
11.0	539.6
11.6	539.6
12.3	539.8
13.0	540.3
14.1	540.9
15.2	541.1
16.4	541.3
18.0	541.5
19.7	541.4
20.9	541.5
22.1	541.6

SUMMARY DATA	
<b>Bankfull Elevation:</b>	541.3
<b>LTOB Elevation:</b>	541.3
<b>Bankfull Cross-Sectional Area:</b>	9.4
<b>Bankfull Width:</b>	13.2
<b>Flood Prone Area Elevation:</b>	NA
<b>Flood Prone Width:</b>	NA
<b>Max Depth at Bankfull:</b>	1.7
<b>Low Bank Height:</b>	1.7
<b>Mean Depth at Bankfull:</b>	0.7
<b>W / D Ratio:</b>	NA
<b>Entrenchment Ratio:</b>	NA
<b>Bank Height Ratio:</b>	1.0

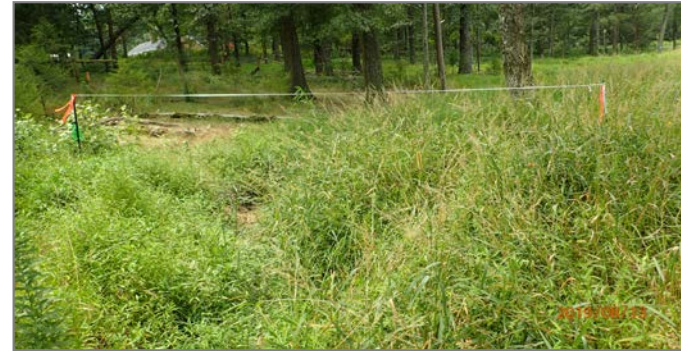
<b>Site</b>	Heron
<b>Watershed:</b>	Cape Fear, 0303002
<b>XS ID</b>	UT 1, XS - 7, Pool
<b>Feature</b>	Pool
<b>Date:</b>	8/13/2019
<b>Field Crew:</b>	Perkinson, Radecki

Station	Elevation
0.0	542.8
1.1	542.6
2.4	542.5
3.5	542.6
5.5	542.6
6.8	542.4
7.8	542.2
8.7	541.8
9.5	541.5
10.1	541.1
11.0	540.9
12.0	540.9
12.7	541.2
13.4	541.5
14.0	542.1
14.9	542.6
16.0	542.7
17.4	542.7
18.4	542.9
19.9	543.1
21.0	543.1

SUMMARY DATA	
<b>Bankfull Elevation:</b>	542.6
<b>LTOB Elevation:</b>	542.6
<b>Bankfull Cross-Sectional Area:</b>	8.0
<b>Bankfull Width:</b>	10.4
<b>Flood Prone Area Elevation:</b>	NA
<b>Flood Prone Width:</b>	NA
<b>Max Depth at Bankfull:</b>	1.7
<b>Low Bank Height:</b>	1.7
<b>Mean Depth at Bankfull:</b>	0.8
<b>W / D Ratio:</b>	NA
<b>Entrenchment Ratio:</b>	NA
<b>Bank Height Ratio:</b>	1.0

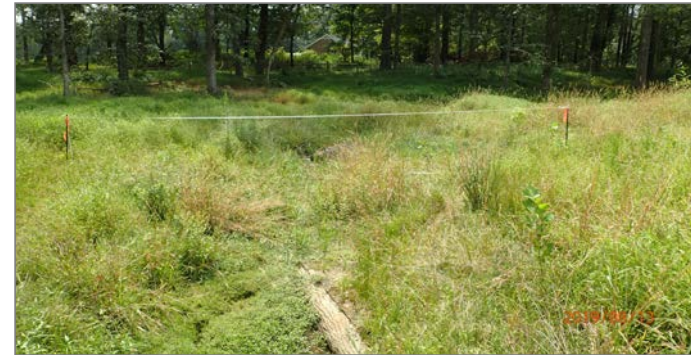
<b>Site</b>	Heron
<b>Watershed:</b>	Cape Fear, 0303002
<b>XS ID</b>	UT 1, XS - 8, Riffle
<b>Feature</b>	Riffle
<b>Date:</b>	8/13/2019
<b>Field Crew:</b>	Perkinson, Radecki

Station	Elevation
0.0	544.79
1.6	544.58
3.6	544.52
6.1	544.47
7.9	544.16
8.8	543.92
10.0	543.54
11.0	543.43
11.9	543.32
12.9	543.18
14.1	543.16
15.2	543.12
15.9	543.20
16.7	543.58
17.5	543.78
18.4	544.02
19.3	544.09
20.7	544.23
22.2	544.21
24.2	544.24
25.2	544.18
26.3	544.3

SUMMARY DATA	
<b>Bankfull Elevation:</b>	544.2
<b>LTOB Elevation:</b>	544.2
<b>Bankfull Cross-Sectional Area:</b>	7.2
<b>Bankfull Width:</b>	12.0
<b>Flood Prone Area Elevation:</b>	545.2
<b>Flood Prone Width:</b>	100.0
<b>Max Depth at Bankfull:</b>	1.0
<b>Low Bank Height:</b>	1.0
<b>Mean Depth at Bankfull:</b>	0.6
<b>W / D Ratio:</b>	20.0
<b>Entrenchment Ratio:</b>	8.3
<b>Bank Height Ratio:</b>	1.0

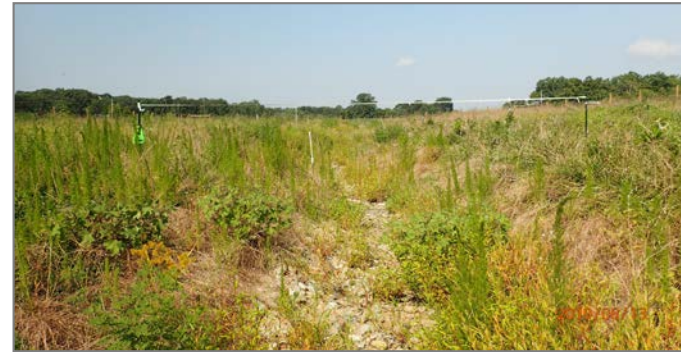
<b>Site</b>	Heron
<b>Watershed:</b>	Cape Fear, 0303002
<b>XS ID</b>	UT 3, XS - 9, Pool
<b>Feature</b>	Pool
<b>Date:</b>	8/13/2019
<b>Field Crew:</b>	Perkinson, Radecki

Station	Elevation
0.4	538.6
1.5	538.7
2.7	538.6
3.9	538.4
4.9	538.0
5.7	537.5
6.5	537.2
7.4	536.8
8.0	536.2
9.0	536.3
10.1	536.3
11.2	536.6
12.2	537.0
13.4	537.4
14.9	537.9
16.2	538.5
17.4	538.8
18.6	538.8
19.5	538.9
20.2	539.0

SUMMARY DATA	
<b>Bankfull Elevation:</b>	537.0
<b>LTOB Elevation:</b>	536.5
<b>Bankfull Cross-Sectional Area:</b>	2.9
<b>Bankfull Width:</b>	5.6
<b>Flood Prone Area Elevation:</b>	NA
<b>Flood Prone Width:</b>	NA
<b>Max Depth at Bankfull:</b>	0.8
<b>Low Bank Height:</b>	0.3
<b>Mean Depth at Bankfull:</b>	0.5
<b>W / D Ratio:</b>	NA
<b>Entrenchment Ratio:</b>	NA
<b>Bank Height Ratio:</b>	0.4

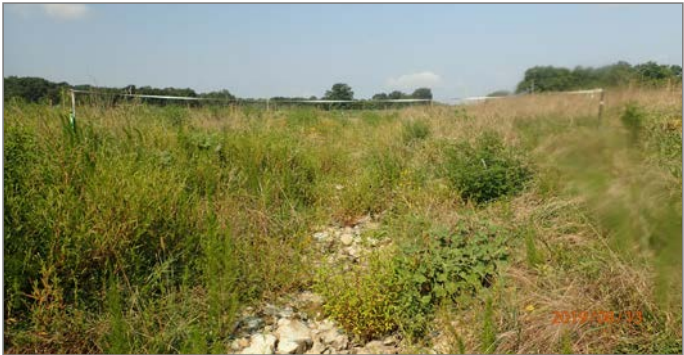
<b>Site</b>	Heron
<b>Watershed:</b>	Cape Fear, 0303002
<b>XS ID</b>	UT 3, XS - 10, Riffle
<b>Feature</b>	Riffle
<b>Date:</b>	8/13/2019
<b>Field Crew:</b>	Perkinson, Radecki

Station	Elevation
20.2	539.54
18.9	539.30
17.5	539.22
16.0	539.02
15.1	538.79
14.1	538.47
13.3	538.36
12.8	537.97
12.3	537.60
11.4	537.55
10.7	537.48
9.9	537.44
9.0	537.86
8.3	538.05
7.8	538.43
6.9	538.63
5.9	538.92
4.7	539.25
3.3	539.62
1.7	539.67
0.8	539.89
0.0	540.0

SUMMARY DATA	
<b>Bankfull Elevation:</b>	538.5
<b>LTOB Elevation:</b>	538.5
<b>Bankfull Cross-Sectional Area:</b>	4.5
<b>Bankfull Width:</b>	7.0
<b>Flood Prone Area Elevation:</b>	539.6
<b>Flood Prone Width:</b>	18.0
<b>Max Depth at Bankfull:</b>	1.1
<b>Low Bank Height:</b>	1.1
<b>Mean Depth at Bankfull:</b>	0.6
<b>W / D Ratio:</b>	10.9
<b>Entrenchment Ratio:</b>	2.6
<b>Bank Height Ratio:</b>	1.0

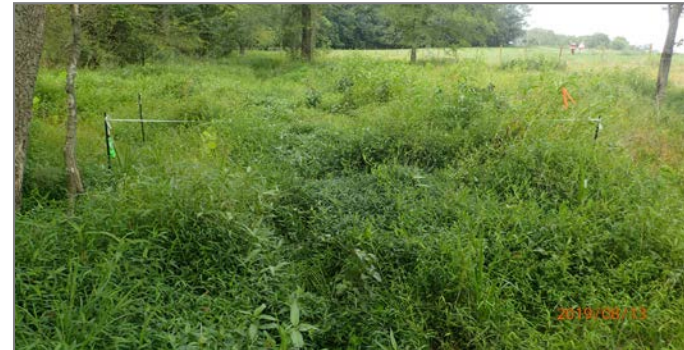
<b>Site</b>	Heron
<b>Watershed:</b>	Cape Fear, 0303002
<b>XS ID</b>	UT 4, XS - 11, Pool
<b>Feature</b>	Pool
<b>Date:</b>	8/13/2019
<b>Field Crew:</b>	Perkinson, Radecki

Station	Elevation
0.0	517.6
1.3	517.6
2.6	517.5
3.9	517.3
5.3	517.1
6.4	517.0
7.3	516.8
8.1	516.7
8.8	516.8
9.6	516.6
9.9	516.6
10.4	516.9
11.0	517.1
11.9	517.3
12.9	517.2
13.9	517.2
15.1	517.1
16.2	517.2
17.2	516.8

SUMMARY DATA	
<b>Bankfull Elevation:</b>	517.0
<b>LTOB Elevation:</b>	516.8
<b>Bankfull Cross-Sectional Area:</b>	4.8
<b>Bankfull Width:</b>	7.9
<b>Flood Prone Area Elevation:</b>	NA
<b>Flood Prone Width:</b>	NA
<b>Max Depth at Bankfull:</b>	1.1
<b>Low Bank Height:</b>	0.9
<b>Mean Depth at Bankfull:</b>	0.6
<b>W / D Ratio:</b>	NA
<b>Entrenchment Ratio:</b>	NA
<b>Bank Height Ratio:</b>	0.8

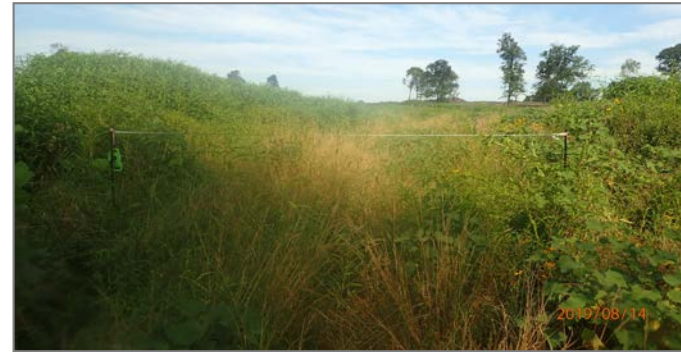
<b>Site</b>	Heron
<b>Watershed:</b>	Cape Fear, 0303002
<b>XS ID</b>	UT 7, XS - 29, Pool
<b>Feature</b>	Pool
<b>Date:</b>	8/14/2019
<b>Field Crew:</b>	Perkinson, Radecki

Station	Elevation
-0.1	513.2
1.3	513.0
2.2	512.8
3.0	512.7
4.1	512.5
4.9	512.2
5.2	512.1
5.7	511.1
6.6	511.0
7.3	511.0
7.8	511.0
8.3	512.1
9.2	512.4
10.3	512.7
11.6	512.8
12.9	512.9
14.2	513.0

SUMMARY DATA	
<b>Bankfull Elevation:</b>	512.3
<b>LTOB Elevation:</b>	512.2
<b>Bankfull Cross-Sectional Area:</b>	3.4
<b>Bankfull Width:</b>	4.1
<b>Flood Prone Area Elevation:</b>	NA
<b>Flood Prone Width:</b>	NA
<b>Max Depth at Bankfull:</b>	1.3
<b>Low Bank Height:</b>	1.2
<b>Mean Depth at Bankfull:</b>	0.8
<b>W / D Ratio:</b>	NA
<b>Entrenchment Ratio:</b>	NA
<b>Bank Height Ratio:</b>	0.9

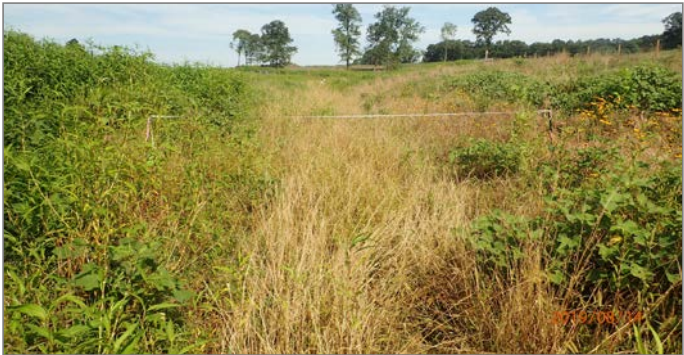
<b>Site</b>	Heron
<b>Watershed:</b>	Cape Fear, 0303002
<b>XS ID</b>	UT 7, XS - 30, Riffle
<b>Feature</b>	Riffle
<b>Date:</b>	8/14/2019
<b>Field Crew:</b>	Perkinson, Radecki

Station	Elevation
0.0	513.79
1.4	513.60
2.4	513.53
3.9	513.44
4.8	513.18
5.4	513.03
5.6	512.83
6.6	512.51
7.5	512.51
8.0	512.55
8.9	512.49
9.7	512.59
10.5	512.85
11.1	513.09
11.8	513.33
12.9	513.52
13.8	513.65
14.6	513.86
15.6	514.02

SUMMARY DATA	
<b>Bankfull Elevation:</b>	513.0
<b>LTOB Elevation:</b>	513.0
<b>Bankfull Cross-Sectional Area:</b>	2.3
<b>Bankfull Width:</b>	5.6
<b>Flood Prone Area Elevation:</b>	513.5
<b>Flood Prone Width:</b>	11.0
<b>Max Depth at Bankfull:</b>	0.5
<b>Low Bank Height:</b>	0.5
<b>Mean Depth at Bankfull:</b>	0.4
<b>W / D Ratio:</b>	13.6
<b>Entrenchment Ratio:</b>	2.0
<b>Bank Height Ratio:</b>	1.0

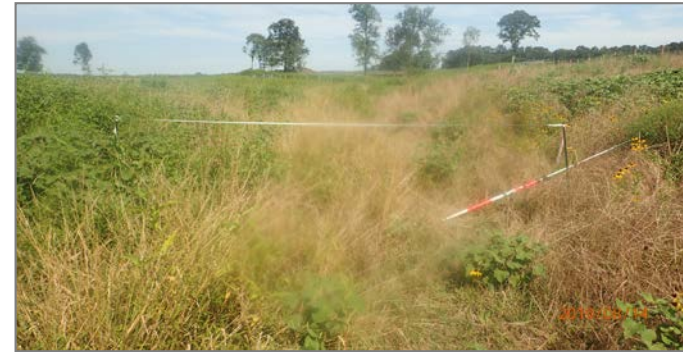
<b>Site</b>	Heron
<b>Watershed:</b>	Cape Fear, 0303002
<b>XS ID</b>	UT 7, XS - 31, Pool
<b>Feature</b>	Pool
<b>Date:</b>	8/14/2019
<b>Field Crew:</b>	Perkinson, Radecki

Station	Elevation
0.0	514.8
1.0	514.7
2.2	514.3
3.2	514.3
4.0	514.3
4.9	514.1
5.6	513.9
6.0	513.8
6.3	513.5
6.8	513.4
7.6	513.3
8.4	513.3
9.2	513.3
9.9	513.4
10.5	513.7
11.3	514.0
11.9	514.2
13.0	514.4
13.8	514.4
14.9	514.7
16.1	514.7

SUMMARY DATA	
<b>Bankfull Elevation:</b>	514.0
<b>LTOB Elevation:</b>	513.9
<b>Bankfull Cross-Sectional Area:</b>	3.0
<b>Bankfull Width:</b>	6.1
<b>Flood Prone Area Elevation:</b>	NA
<b>Flood Prone Width:</b>	NA
<b>Max Depth at Bankfull:</b>	0.7
<b>Low Bank Height:</b>	0.6
<b>Mean Depth at Bankfull:</b>	0.5
<b>W / D Ratio:</b>	NA
<b>Entrenchment Ratio:</b>	NA
<b>Bank Height Ratio:</b>	0.9

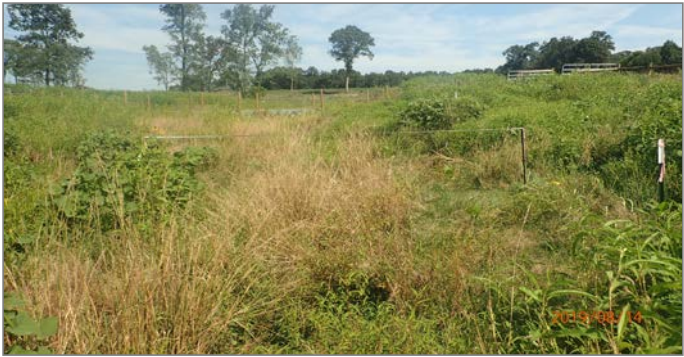
<b>Site</b>	Heron
<b>Watershed:</b>	Cape Fear, 0303002
<b>XS ID</b>	UT 7, XS - 32, Riffle
<b>Feature</b>	Riffle
<b>Date:</b>	8/14/2019
<b>Field Crew:</b>	Perkinson, Radecki

Station	Elevation
0.2	518.42
1.3	518.23
2.7	518.05
3.4	517.78
4.2	517.69
4.8	517.71
5.6	517.31
6.0	517.04
6.6	517.10
7.2	517.08
8.1	517.21
8.6	517.35
9.5	517.45
9.9	517.56
10.9	517.86
11.8	517.94
12.7	518.19
14.0	518.20
15.3	518.30

SUMMARY DATA	
<b>Bankfull Elevation:</b>	517.9
<b>LTOB Elevation:</b>	517.9
<b>Bankfull Cross-Sectional Area:</b>	3.3
<b>Bankfull Width:</b>	7.6
<b>Flood Prone Area Elevation:</b>	518.7
<b>Flood Prone Width:</b>	20.0
<b>Max Depth at Bankfull:</b>	0.8
<b>Low Bank Height:</b>	0.8
<b>Mean Depth at Bankfull:</b>	0.4
<b>W / D Ratio:</b>	17.5
<b>Entrenchment Ratio:</b>	2.6
<b>Bank Height Ratio:</b>	1.0

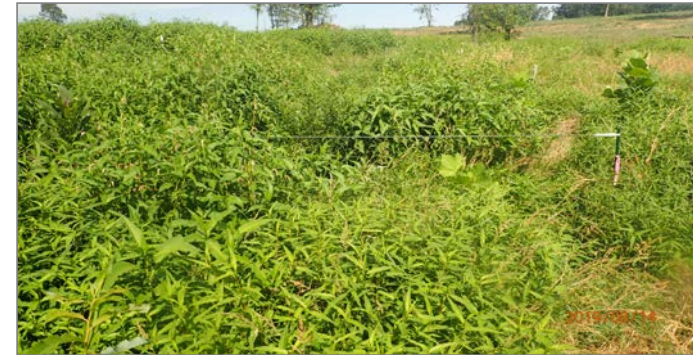
<b>Site</b>	Heron
<b>Watershed:</b>	Cape Fear, 0303002
<b>XS ID</b>	UT 7, XS - 33, Riffle
<b>Feature</b>	Riffle
<b>Date:</b>	8/14/2019
<b>Field Crew:</b>	Perkinson, Radecki

Station	Elevation
-0.2	523.21
1.4	523.12
2.3	523.22
3.3	523.21
4.1	523.09
4.4	523.06
4.8	522.84
5.1	522.82
5.5	522.63
6.2	522.63
6.7	522.70
7.2	522.88
7.8	522.95
8.5	523.04
9.3	523.30
10.0	523.30
10.8	523.30
11.7	523.30
12.6	523.46
13.5	523.43

SUMMARY DATA	
<b>Bankfull Elevation:</b>	523.2
<b>LTOB Elevation:</b>	523.2
<b>Bankfull Cross-Sectional Area:</b>	1.8
<b>Bankfull Width:</b>	5.8
<b>Flood Prone Area Elevation:</b>	523.8
<b>Flood Prone Width:</b>	20.0
<b>Max Depth at Bankfull:</b>	0.6
<b>Low Bank Height:</b>	0.5
<b>Mean Depth at Bankfull:</b>	0.3
<b>W / D Ratio:</b>	18.7
<b>Entrenchment Ratio:</b>	3.4
<b>Bank Height Ratio:</b>	0.8

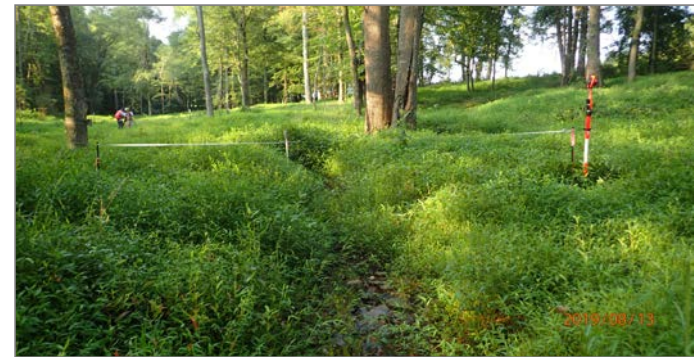
<b>Site</b>	Heron
<b>Watershed:</b>	Cape Fear, 0303002
<b>XS ID</b>	UT 8, XS - 34, Riffle
<b>Feature</b>	Riffle
<b>Date:</b>	8/13/2019
<b>Field Crew:</b>	Perkinson, Radecki

Station	Elevation
-2.5	515.41
-1.3	515.36
0.4	515.46
1.6	515.39
2.7	515.42
3.8	515.28
4.7	515.03
5.4	514.78
6.0	514.45
6.7	514.40
7.6	514.44
8.2	514.39
8.9	514.49
9.3	515.05
10.1	515.30
11.6	515.26
12.8	515.25
14.3	515.32
15.5	515.37

SUMMARY DATA	
<b>Bankfull Elevation:</b>	515.1
<b>LTOB Elevation:</b>	515.2
<b>Bankfull Cross-Sectional Area:</b>	2.6
<b>Bankfull Width:</b>	5.2
<b>Flood Prone Area Elevation:</b>	515.8
<b>Flood Prone Width:</b>	40.0
<b>Max Depth at Bankfull:</b>	0.7
<b>Low Bank Height:</b>	0.8
<b>Mean Depth at Bankfull:</b>	0.5
<b>W / D Ratio:</b>	10.4
<b>Entrenchment Ratio:</b>	7.7
<b>Bank Height Ratio:</b>	1.1

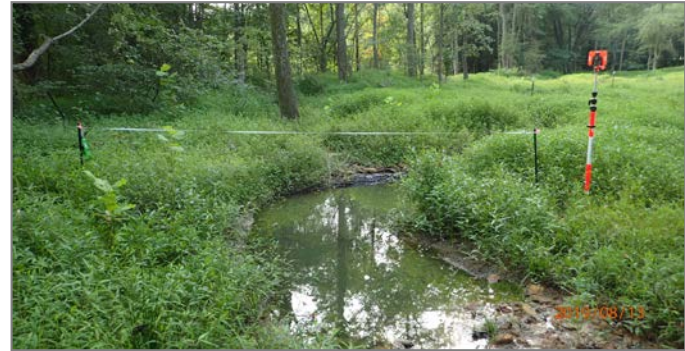
<b>Site</b>	Heron
<b>Watershed:</b>	Cape Fear, 0303002
<b>XS ID</b>	UT 8, XS - 35, Pool
<b>Feature</b>	Pool
<b>Date:</b>	8/13/2019
<b>Field Crew:</b>	Perkinson, Radecki

Station	Elevation
0.4	515.8
1.6	515.7
2.9	515.7
4.0	515.6
5.0	515.4
5.5	515.1
6.2	514.9
7.2	514.5
8.1	514.5
9.2	514.6
10.0	514.9
10.9	515.3
11.7	515.6
12.4	515.9
13.8	516.0
15.0	516.1
16.0	516.2

SUMMARY DATA	
<b>Bankfull Elevation:</b>	515.5
<b>LTOB Elevation:</b>	515.5
<b>Bankfull Cross-Sectional Area:</b>	4.1
<b>Bankfull Width:</b>	6.9
<b>Flood Prone Area Elevation:</b>	NA
<b>Flood Prone Width:</b>	NA
<b>Max Depth at Bankfull:</b>	1.0
<b>Low Bank Height:</b>	1.0
<b>Mean Depth at Bankfull:</b>	0.6
<b>W / D Ratio:</b>	NA
<b>Entrenchment Ratio:</b>	NA
<b>Bank Height Ratio:</b>	1.0

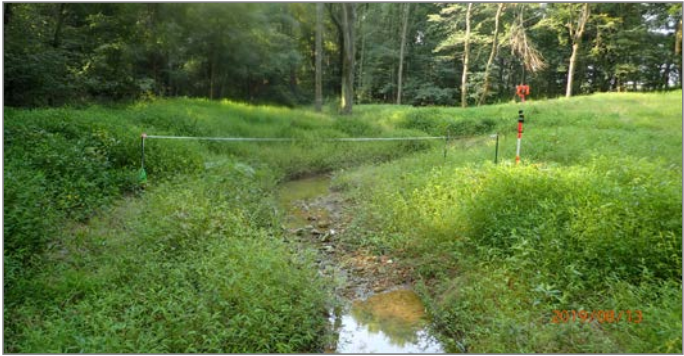
Site	Heron
Watershed:	Cape Fear, 0303002
XS ID	UT 8, XS - 36, Riffle
Feature	Riffle
Date:	8/13/2019
Field Crew:	Perkinson, Radecki

Station	Elevation
0.0	521.44
1.9	521.18
3.5	520.94
4.8	520.84
5.9	520.44
7.4	520.34
8.4	520.07
9.5	520.09
10.4	520.01
11.4	520.07
12.0	520.49
12.7	520.70
13.9	520.74
15.5	520.82
16.9	520.90
18.0	521.26

SUMMARY DATA	
Bankfull Elevation:	520.8
LTOB Elevation:	520.8
Bankfull Cross-Sectional Area:	3.7
Bankfull Width:	9.0
Flood Prone Area Elevation:	521.5
Flood Prone Width:	20.0
Max Depth at Bankfull:	0.7
Low Bank Height:	0.7
Mean Depth at Bankfull:	0.4
W / D Ratio:	21.9
Entrenchment Ratio:	2.2
Bank Height Ratio:	1.0

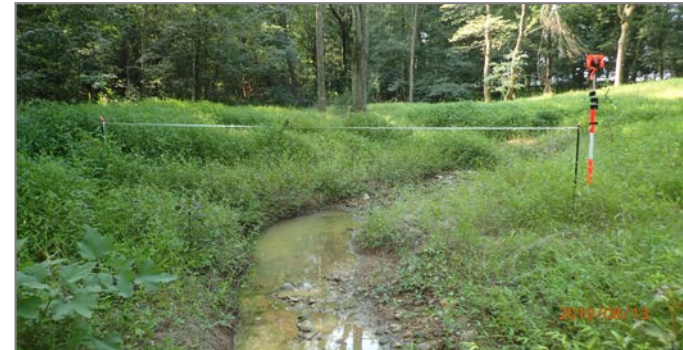
<b>Site</b>	Heron
<b>Watershed:</b>	Cape Fear, 0303002
<b>XS ID</b>	UT 8, XS - 37, Pool
<b>Feature</b>	Pool
<b>Date:</b>	8/13/2019
<b>Field Crew:</b>	Perkinson, Radecki

Station	Elevation
-0.2	521.3
1.9	521.2
3.8	521.1
4.9	521.0
6.0	520.6
6.8	520.3
7.7	520.1
8.5	519.8
9.5	519.4
10.6	519.3
11.3	519.6
11.9	520.1
12.5	520.5
13.2	520.9
14.6	521.0
15.8	521.2
17.2	521.6
18.0	521.7

SUMMARY DATA	
<b>Bankfull Elevation:</b>	520.9
<b>LTOB Elevation:</b>	520.9
<b>Bankfull Cross-Sectional Area:</b>	7.2
<b>Bankfull Width:</b>	8.7
<b>Flood Prone Area Elevation:</b>	NA
<b>Flood Prone Width:</b>	NA
<b>Max Depth at Bankfull:</b>	1.6
<b>Low Bank Height:</b>	1.6
<b>Mean Depth at Bankfull:</b>	0.8
<b>W / D Ratio:</b>	NA
<b>Entrenchment Ratio:</b>	NA
<b>Bank Height Ratio:</b>	1.0
