# Buffalo Creek Watershed Stream Restoration Projects Greensboro, North Carolina

North Carolina Department of Environment and Natural Resources  
Wetlands Restoration Program

Design Report Prepared By Buck Engineering PC

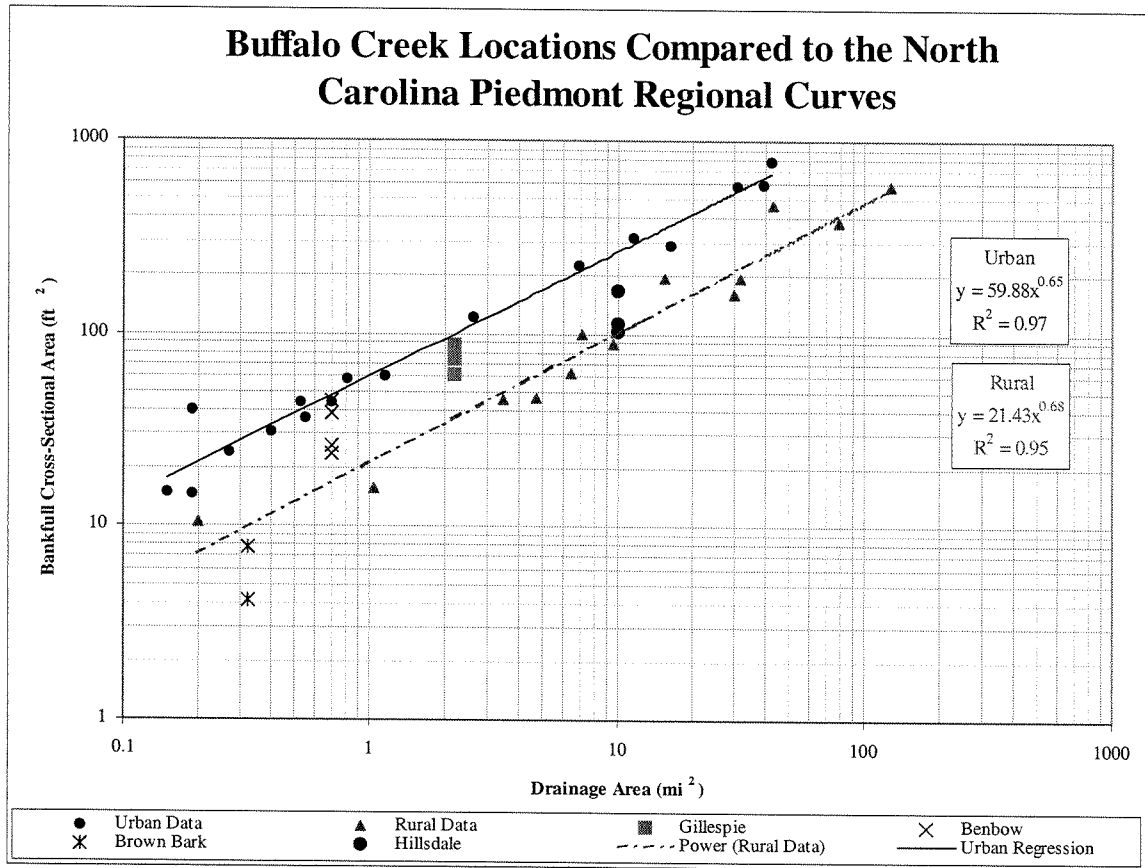
**Figure 3.1. Rural and Urban Piedmont Regional Curves with Surveyed Bankfull Cross-Section Areas for Project Reaches. (Project data points were not used in determining the regression line.)**

The bankfull indicators for the Buffalo Creek Watershed included the back of a depositional bench and an upper scour line. These indicators are consistent with other Piedmont streams that are at a Stage IV/V in Simon's Channel Evolution Model. Data for all the project sites are shown on Figure 3.1.

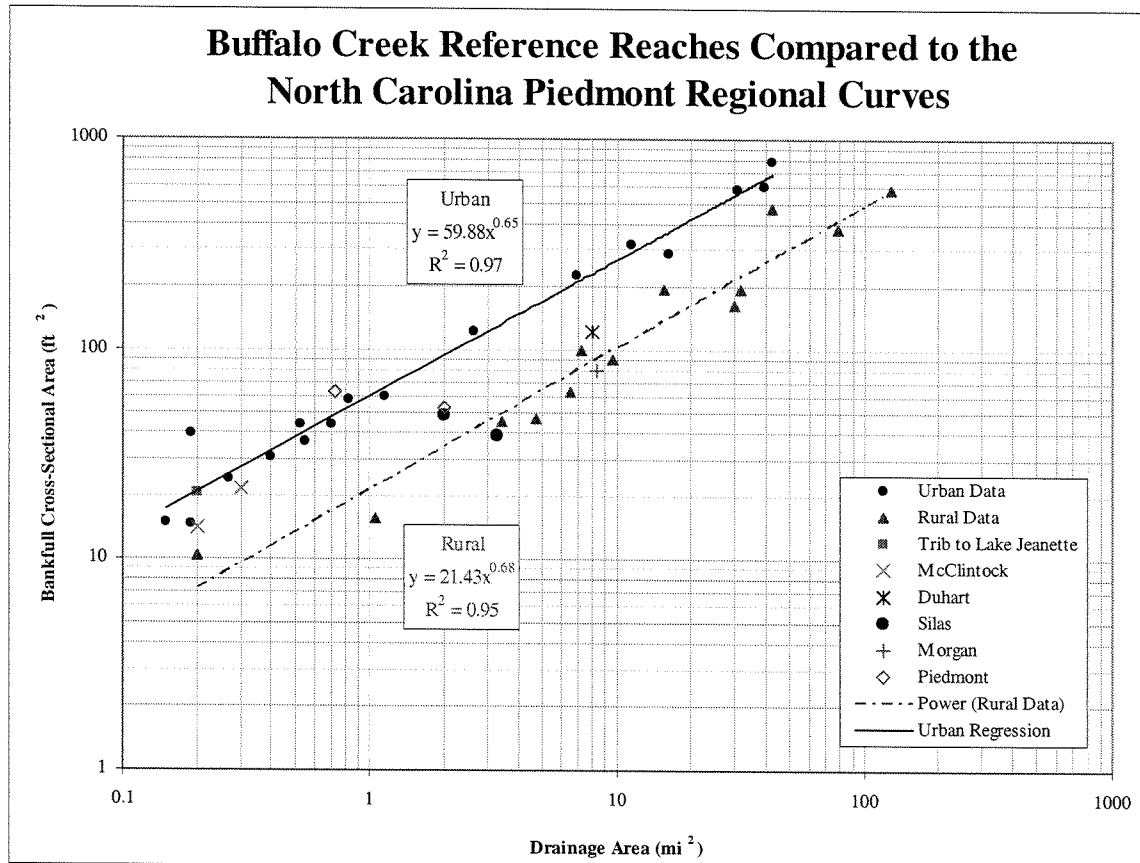
**Figure 4.1. Rural and Urban Piedmont Regional Curves with Surveyed Bankfull Cross-Section Areas for Project Reference Reaches. (Project data points were not used in determining the regression line.)**

The streams shown in Table 4.2 were taken from a reference reach database and represent stable urban Piedmont streams. The tributary to Lake Jeanette was surveyed by NC State University and is located near Greensboro, NC. Both reaches of McClintock Creek were surveyed by Buck Engineering and are located in Charlotte, NC (see Appendix 2 for location maps). These streams were overlaid with the North Carolina Piedmont Regional Curve to show that they are part of the same hydrophysiographic region (see Figure 4.1); however, some are closer to the urban curve and some are closer to the rural curve. This matches our study reaches fairly well in that Gillespie and Benbow are closer to the urban curve and Hillsdale and Brown Bark are closer to the rural curve.

Table 4.3 shows the reference reach values for the B stream types. Location maps are included in Appendix 2. DuHart Creek was surveyed by Buck Engineering and is located in Cramerton, NC. Silas Creek was surveyed by the Natural Resources Conservation Service and is located in Winston-Salem, NC. Morgan Creek was surveyed by NC State University and is located near Chapel Hill, NC. Piedmont Creek was surveyed by Buck Engineering and is located in Greensboro, NC near the project reaches. It is included in the B stream type reference reach table because it has low sinuosity and is more similar to a Bc stream than an E stream. It serves as the reference reach for Gillespie Golf Course. Again, these streams were overlaid with the regional curve to show that they are representative of the North Carolina Piedmont and are similar to the project streams (see Figure 4.1).

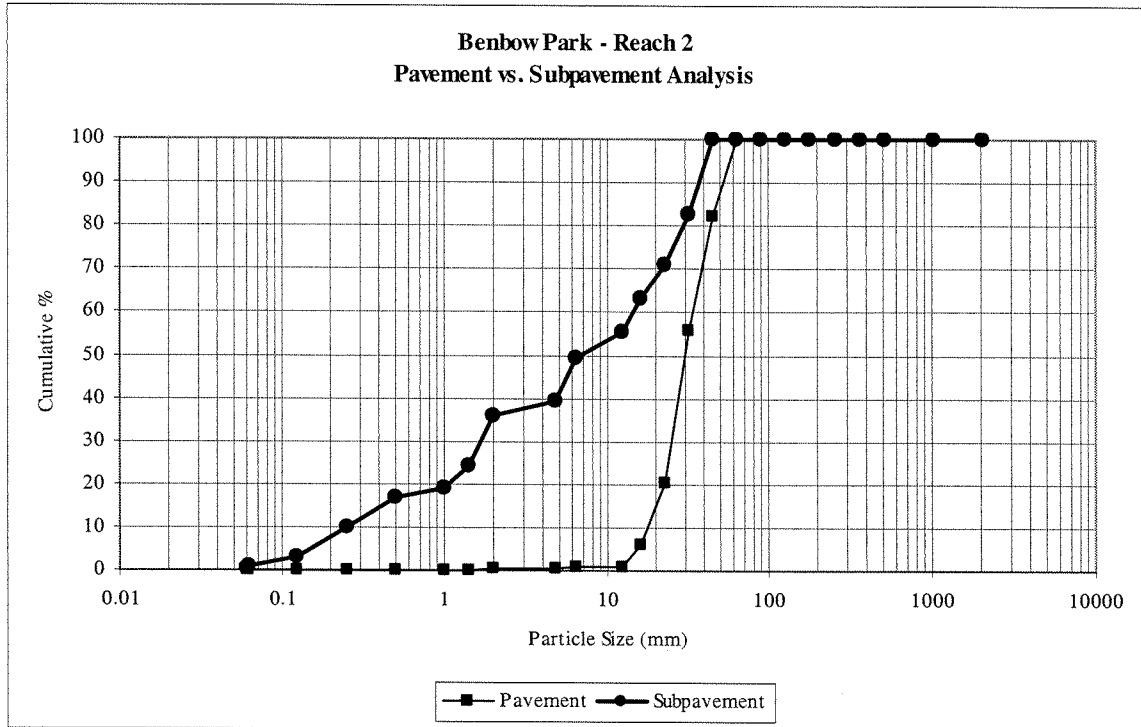
**Figure 6.1. Benbow Reach 2 Pavement / Subpavement Analysis**

Because the designs for both Benbow reaches are similar, we examined conditions at Reach 2 only. The critical dimensionless shear stress for Benbow Park Reach 2 was calculated using bed material samples from a stable riffle. The samples were taken near cross section 9+69 (existing stationing). The cumulative frequency curves of the samples are shown on Figure 6.1.

Data presented in Figure 6.1 was used to determine particle sizes for the various calculations. The  $D_{50}/D^{50}$  ratio is 5 for Reach 2, so Equation 1 is valid. Critical dimensionless shear stress was calculated using Equation 1 as  $\tau_{ci}^* = 0.022$ . This value of dimensionless shear stress is used in the aggradation analysis presented below.

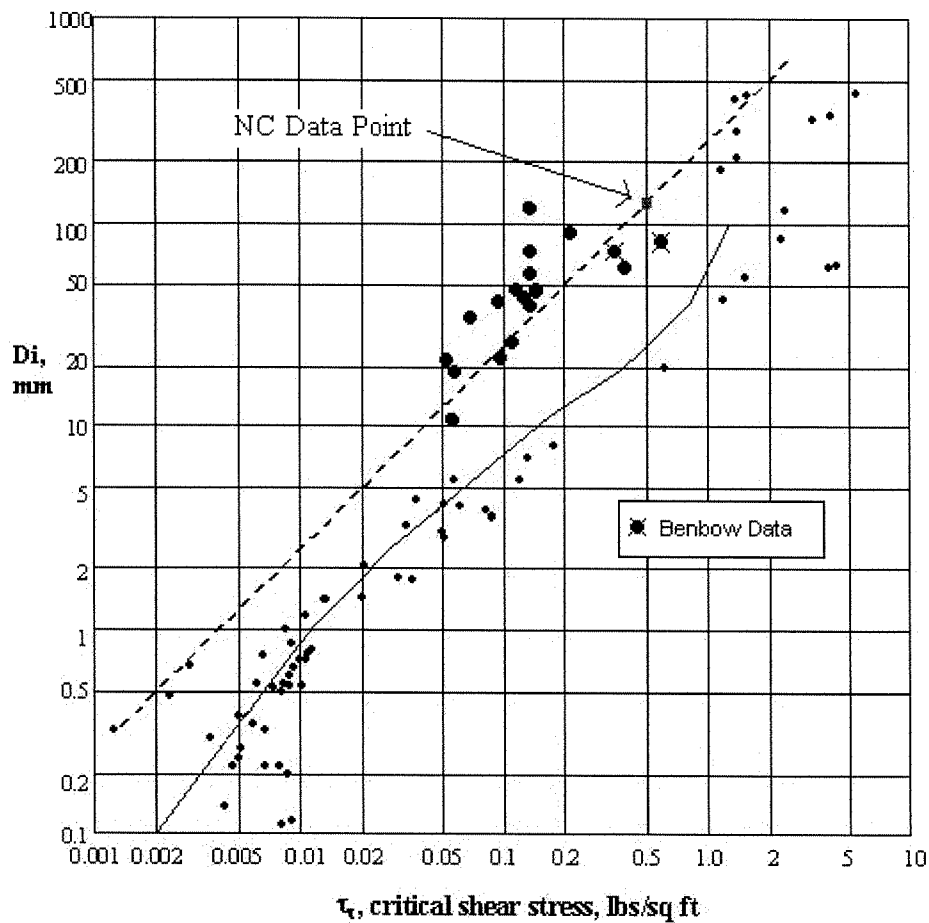
*(Data from: Leopold, Wolman, and Miller 1964; Rosgen, personal commun.; and Harman, personal commun.)*

**Figure 6.2. Modified Shield's Curve for Grain Diameter of Transported Particle in Relation to Critical Shear Stress.**

The boundary shear stress estimated for the design cross-section at Reach 2 is 0.58 lb/ft<sup>2</sup>. The measured  $D_i$  of the subpavement was 85 mm. As shown on the Modified Shield's Curve (Figure 6.3), this value of shear stress and  $D_i$  are well within the range of values used to calculate the regression equation. The Shield's Curve analysis supports the critical depth based conclusion that the design-cross sections can move sediment competently and prevent aggradation.

The calculated shear stress discussed in Section 6.2.2 can be used to describe the upper competency limits for the design channel. The estimated boundary shear stress was 0.62 lbs/ft<sup>2</sup> at Reach 2. Based on the Modified Shield's Curve (Figure 6.3), shear stress in this range will move particles up to about 150 mm in size, which corresponds to roughly the D<sub>95</sub> of the reach-wide pebble count sample. Preferably, this stress would correspond to

Using Equation 5, the boundary shear stress estimated for the design cross-section is 0.43 lb/ft<sup>2</sup>. The measured  $D_i$  of the subpavement was 32 mm. As shown on the Modified Shield’s Curve (Figure 6.3), these values of shear stress and  $D_i$  are below the modified curve. The Shield’s Curve analysis supports the critical depth based conclusion that the design-cross sections can move sediment competently and prevent aggradation.

The calculated shear stresses discussed in Section 6.4.2 can be used to describe the upper competency limits for the design channel. The estimated boundary shear stress was 0.43 lbs/ft<sup>2</sup>. Based on the Modified Shield’s Curve (Figure 6.3), shear stress values in this range will move particles up to about 120 mm in size. This is larger than the largest

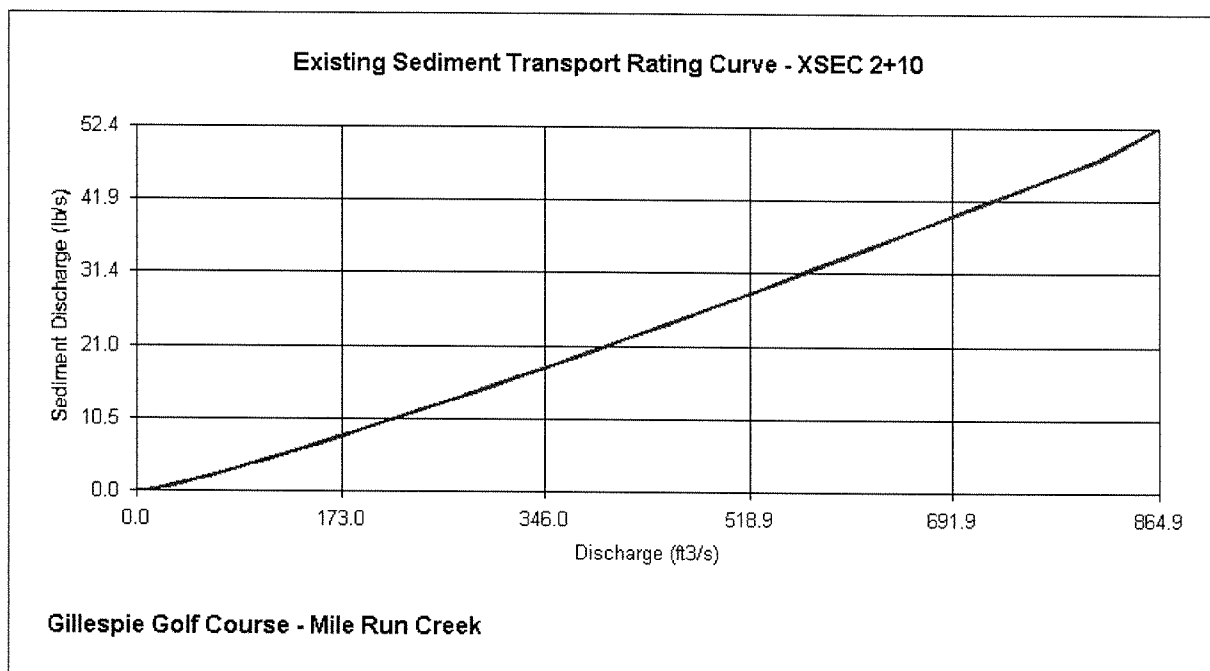
**Figure 6.3. Gillespie Golf Course: Existing Sediment Transport Rating Curve**

A sediment transport capacity analysis was completed on the project reach to determine if the design cross section had the same sediment transport rate of a stable existing cross section. Total sediment load was estimated using the Ackers and White (1973) function and data collected from the field survey. For a detailed report of the Ackers and White method, the reader is referred to Bunte (1994). The field data included an existing stable cross section and the cumulative frequency curve from the bed material sample. Cross section 2+10 was used as the existing stable section. Using a bankfull discharge of 350 cfs, the corresponding existing sediment discharge rate was 18 lb/sec. The existing sediment rating curve for the full range of flows is shown in Figure 6.3.

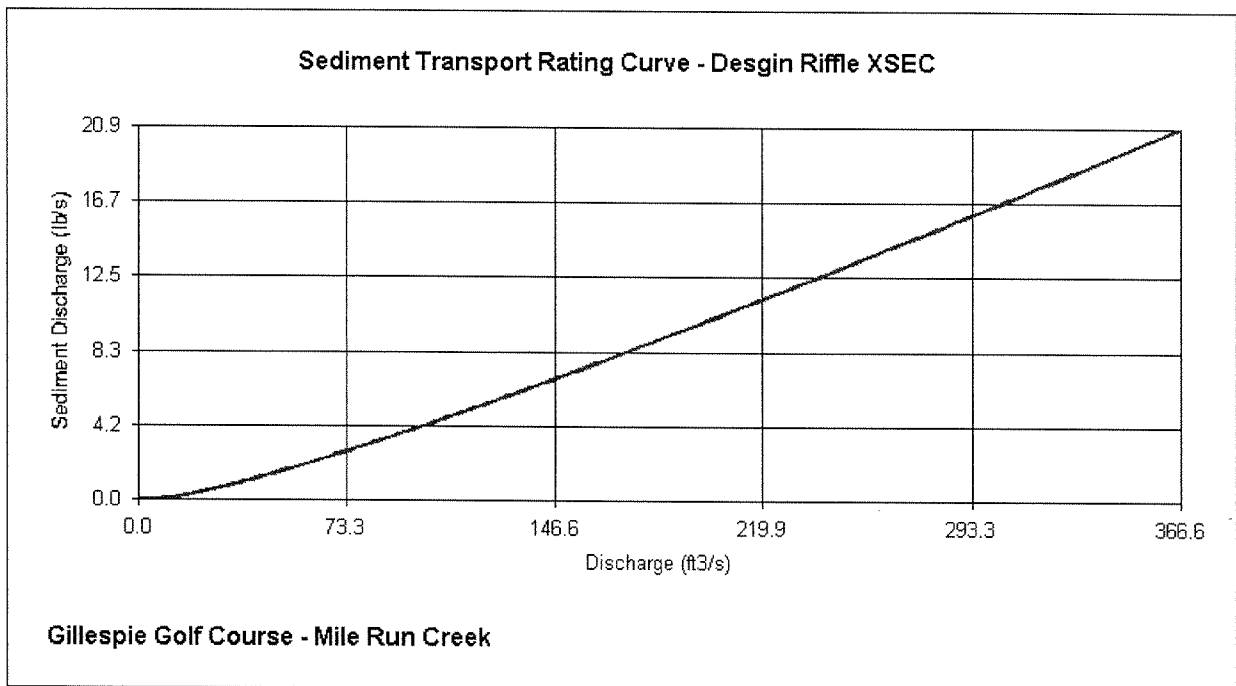
**Figure 6.4. Gillespie Golf Course: Design Sediment Transport Rating Curve**

As a comparison, the design riffle cross section was also modeled. Again, using a bankfull discharge of 350 cfs, the corresponding design sediment transport rate was 20 lb/sec. This is almost identical to the stable existing cross section. While these results are encouraging, it is not surprising given that the slope is the same for both the existing and design. The analysis does show, however, that the smaller design cross sectional area has the same amount of sediment transport capacity, which is likely due to the higher bankfull velocity. The design sediment transport rating curve is shown in Figure 6.4.

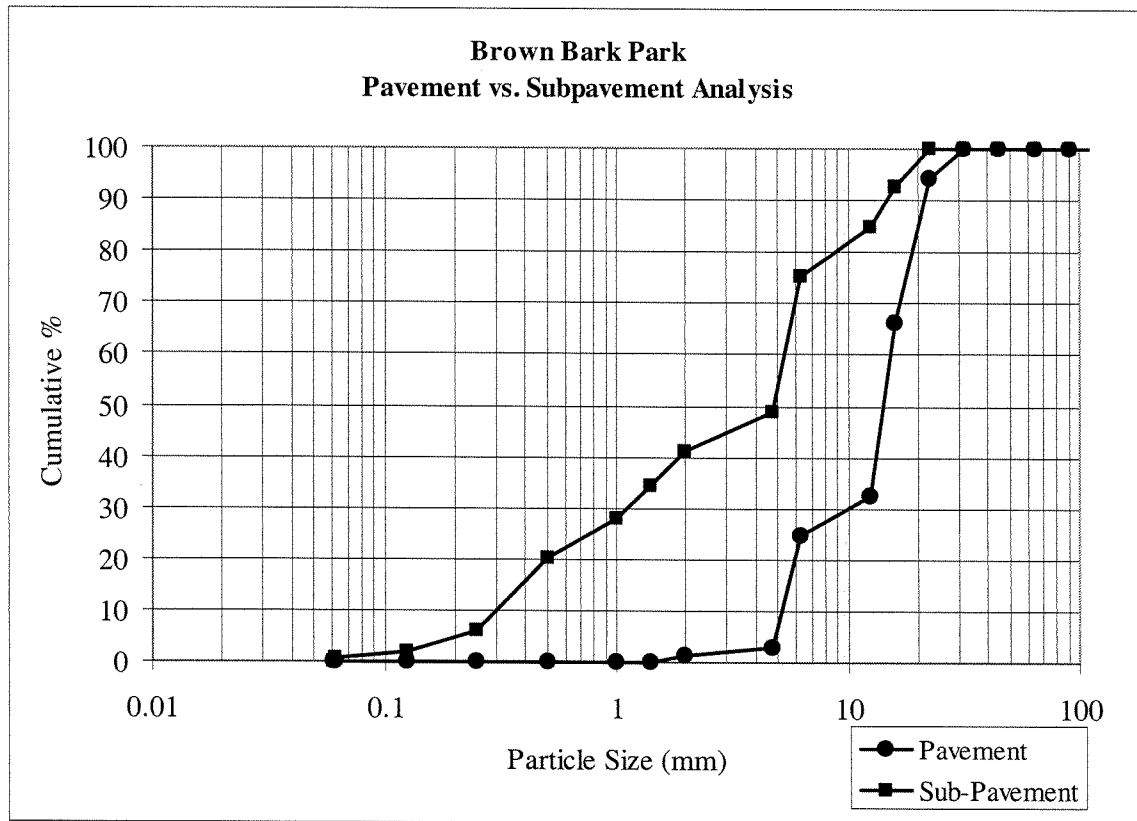
**Figure 6.5. Brown Bark Pavement / Subpavement Analysis**

Since Brown Bark Park is a gravel bed stream, the same competency and capacity analyses used for Benbow Park were completed. The critical dimensionless shear stress for the Brown Bark Park reach was calculated using bed material samples from a stable riffle within the project reach near station 9+00 (existing stationing). The cumulative frequency curve of the sample is shown in Figure 6.5

Data presented in Figure 6.5 were used to determine particle sizes for the various calculations. Using a pavement  $d_{50}$  of 11 mm and a subpavement  $d_{50}$  of 1.7 mm, the  $D_{50}/D_{50}$  equaled 6.5, indicating that Equation 1 was valid. Critical dimensionless shear stress was calculated using Equation 1 as  $\tau_{ci}^* = 0.032$ . The values of dimensionless shear stress are used in the aggradation analysis presented below.

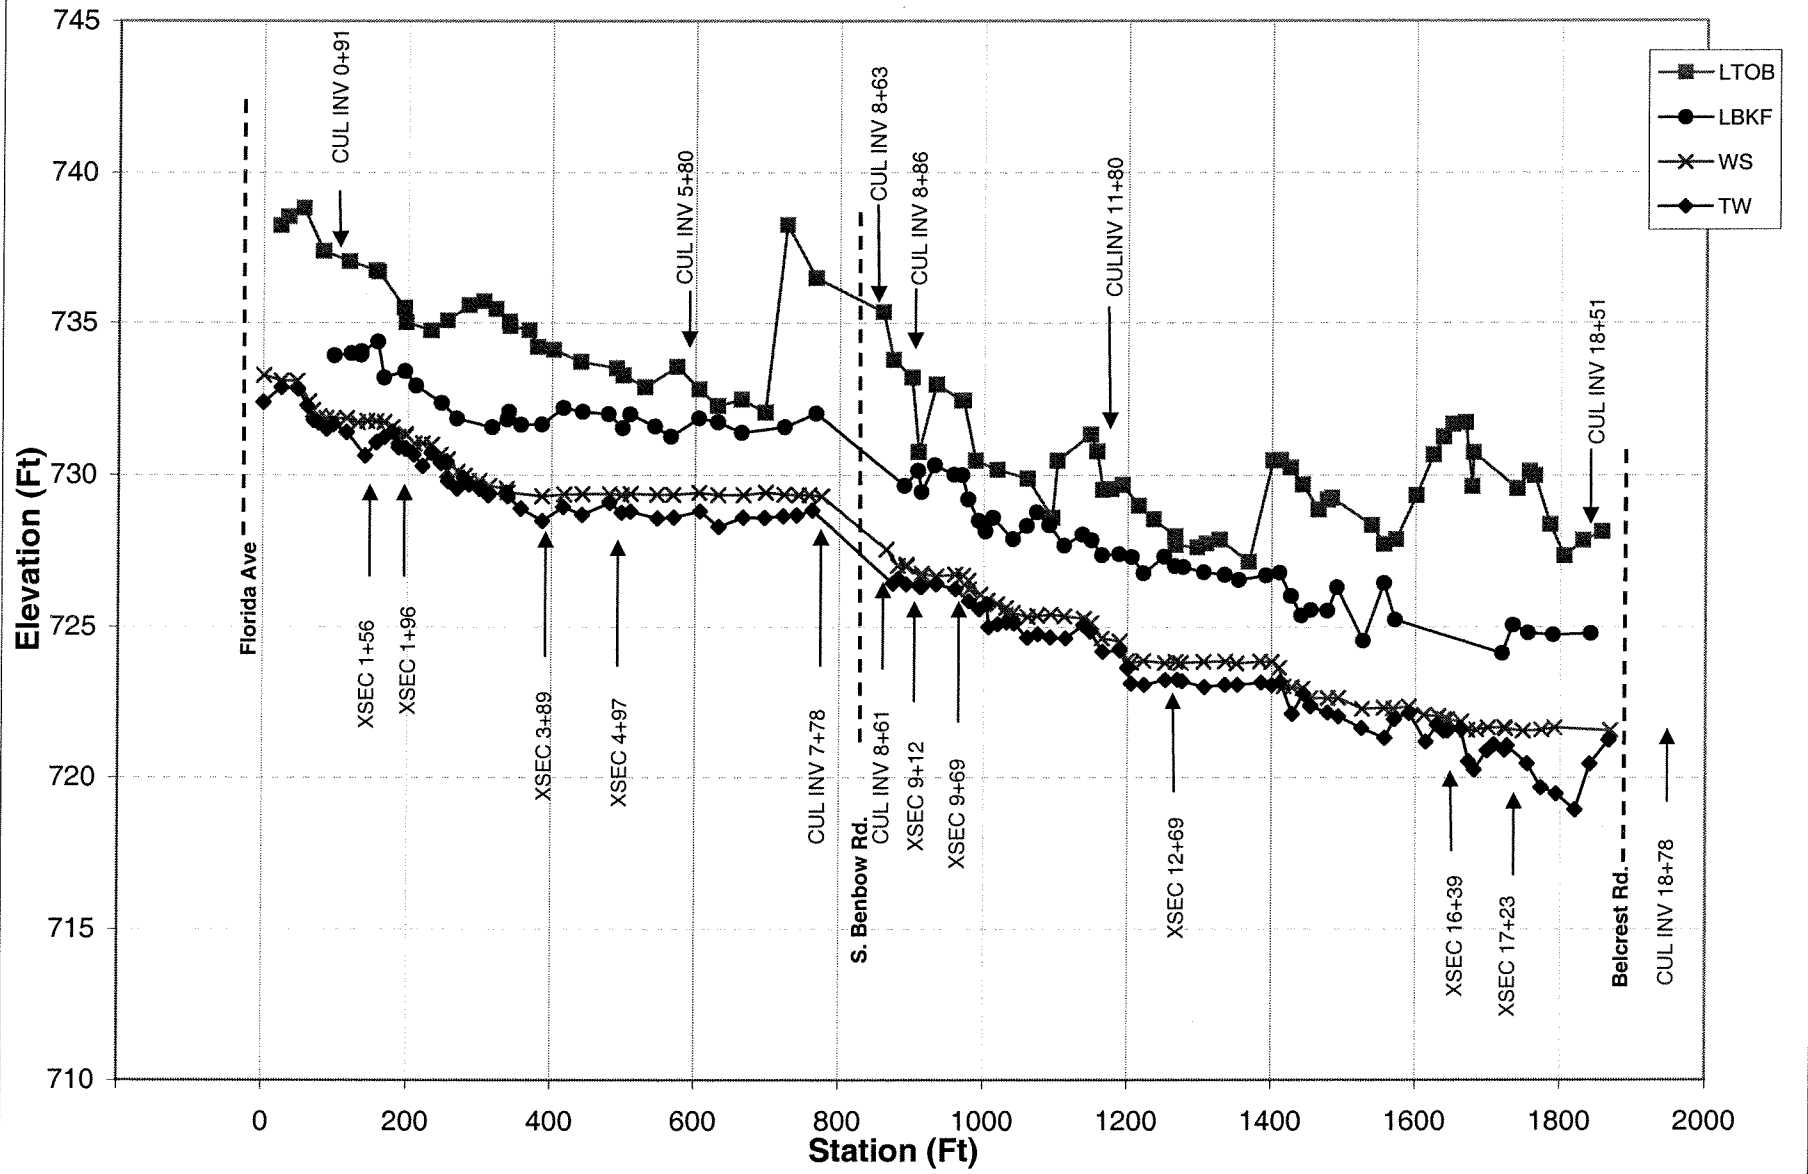
### Benbow Park -- Unnamed Tributary to South Buffalo Creek Longitudinal Profile

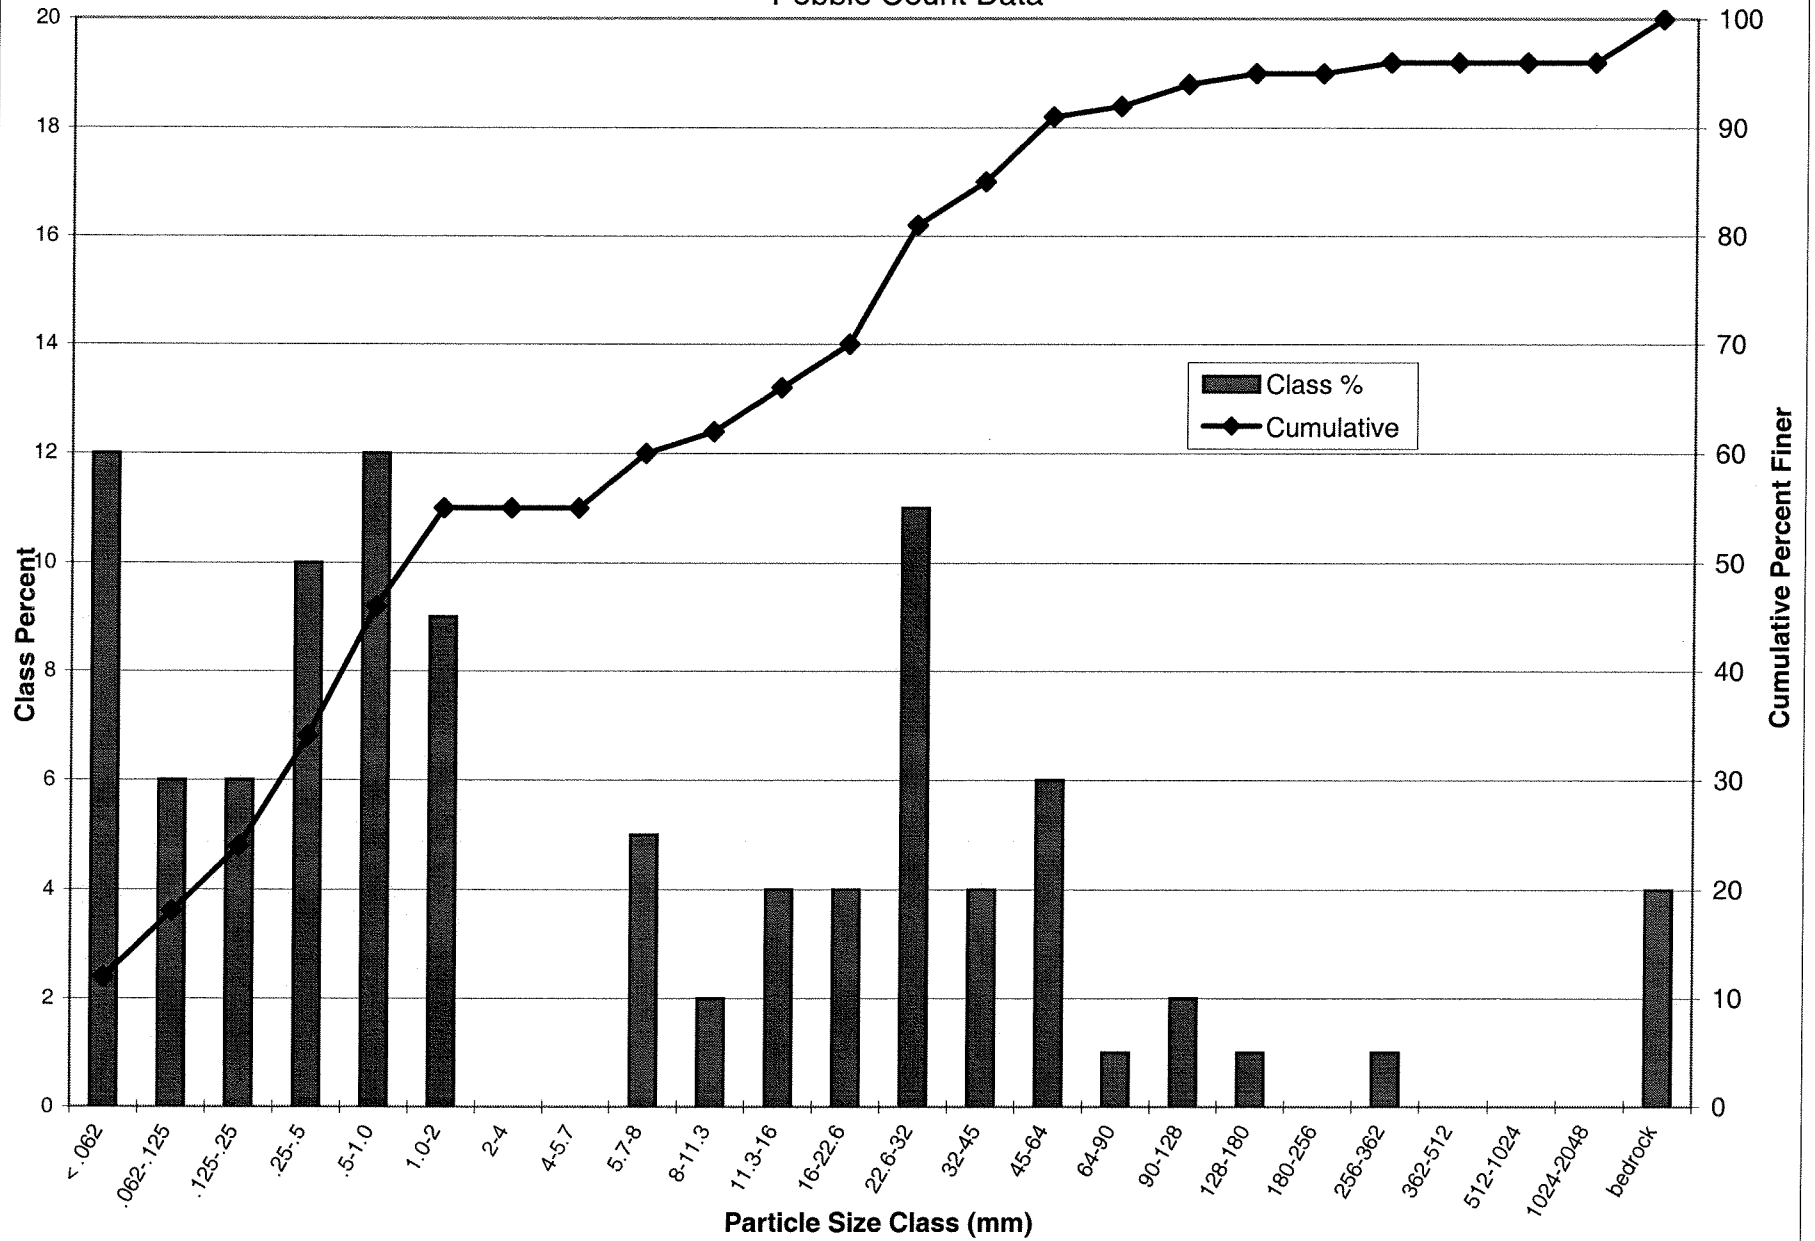
# Benbow Park - Unnamed Tributary to South Buffalo Creek

## Pebble Count Data

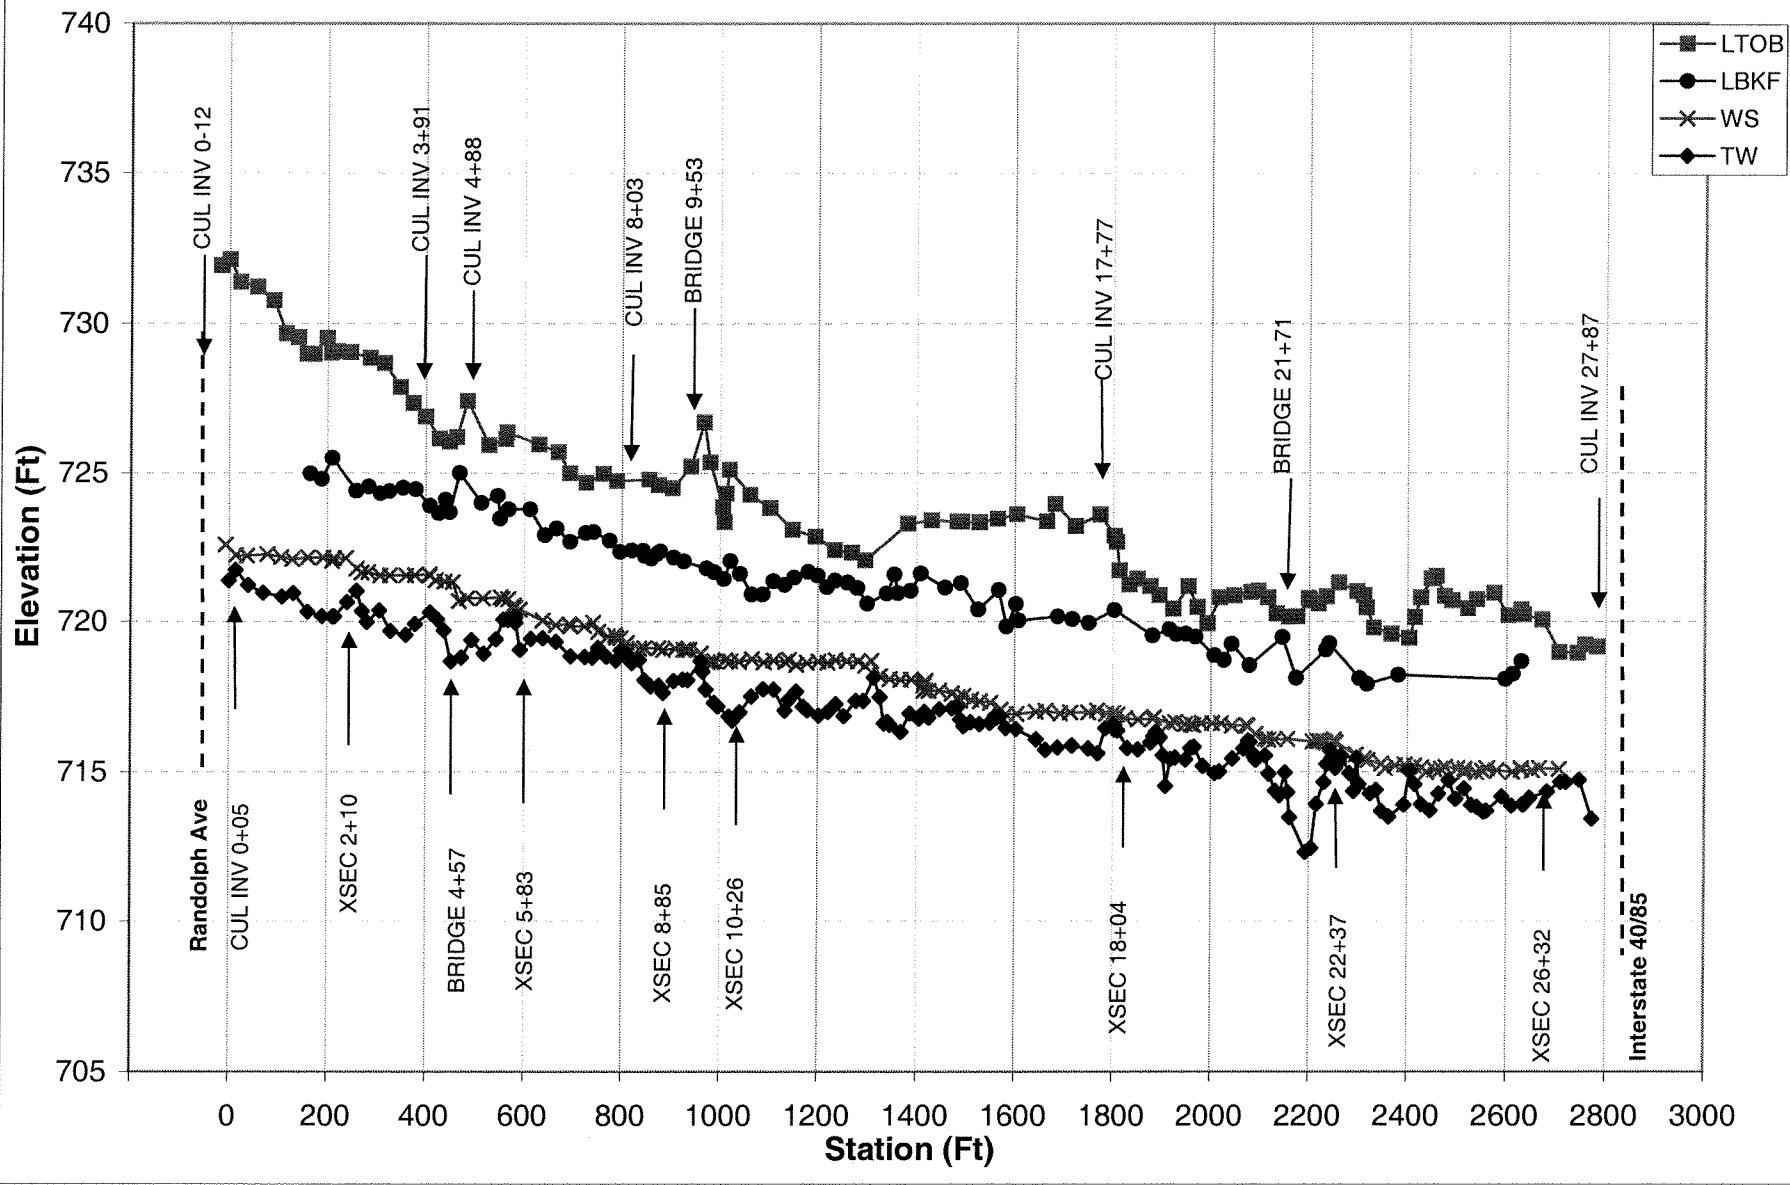
Gillespie Golf Course -- Mile Run Creek Longitudinal Profile

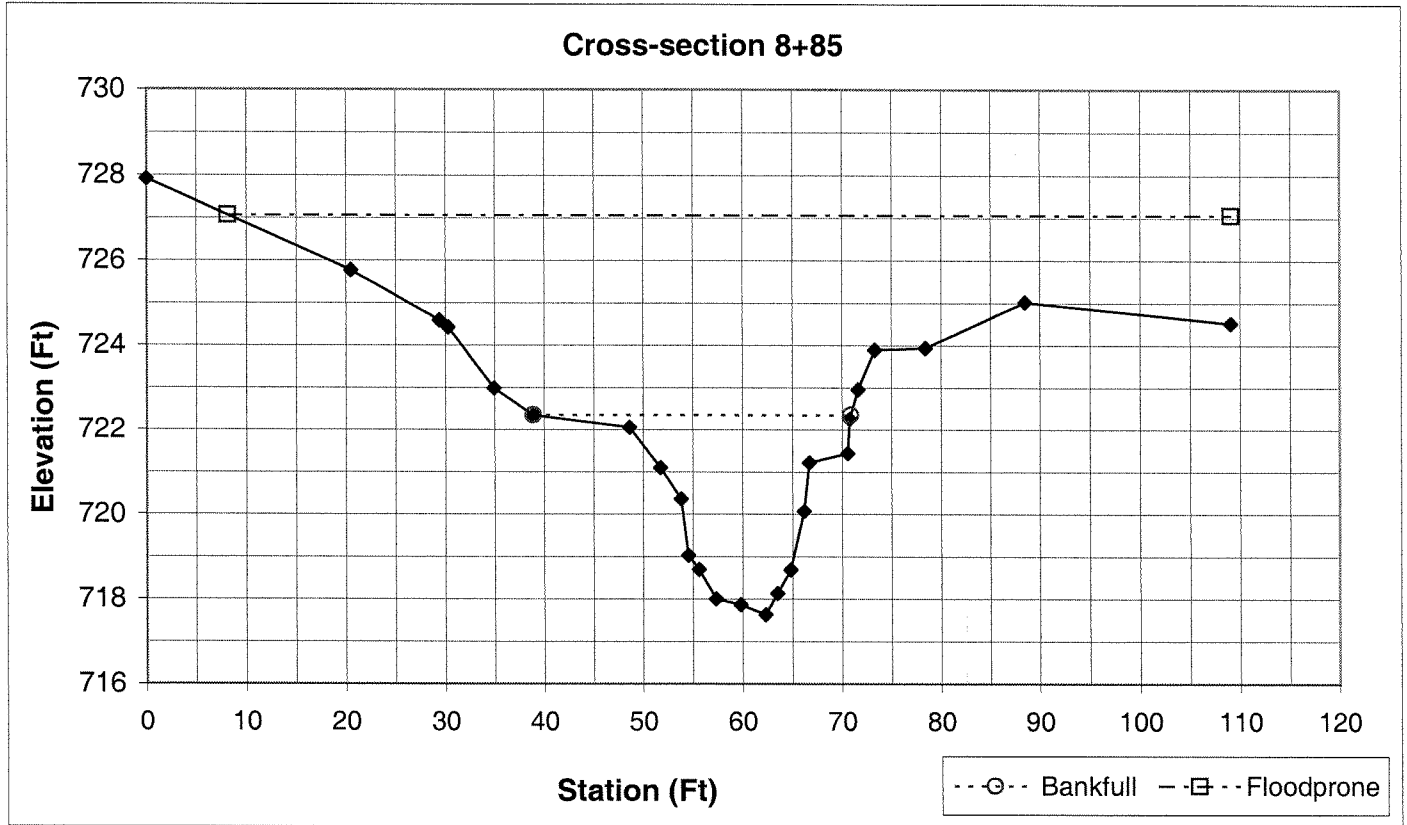
| Feature | Stream Type | BKF Area | BKF Width | BKF Depth | Max BKF Depth | W/D | BH Ratio | ER | BKF Elev | TOB Elev |
| Riffle | C5 | 61.5 | 32.0 | 1.9 | 4.7 | 16.6 | 1.3 | >3.2 | 722.35 | 723.89 |

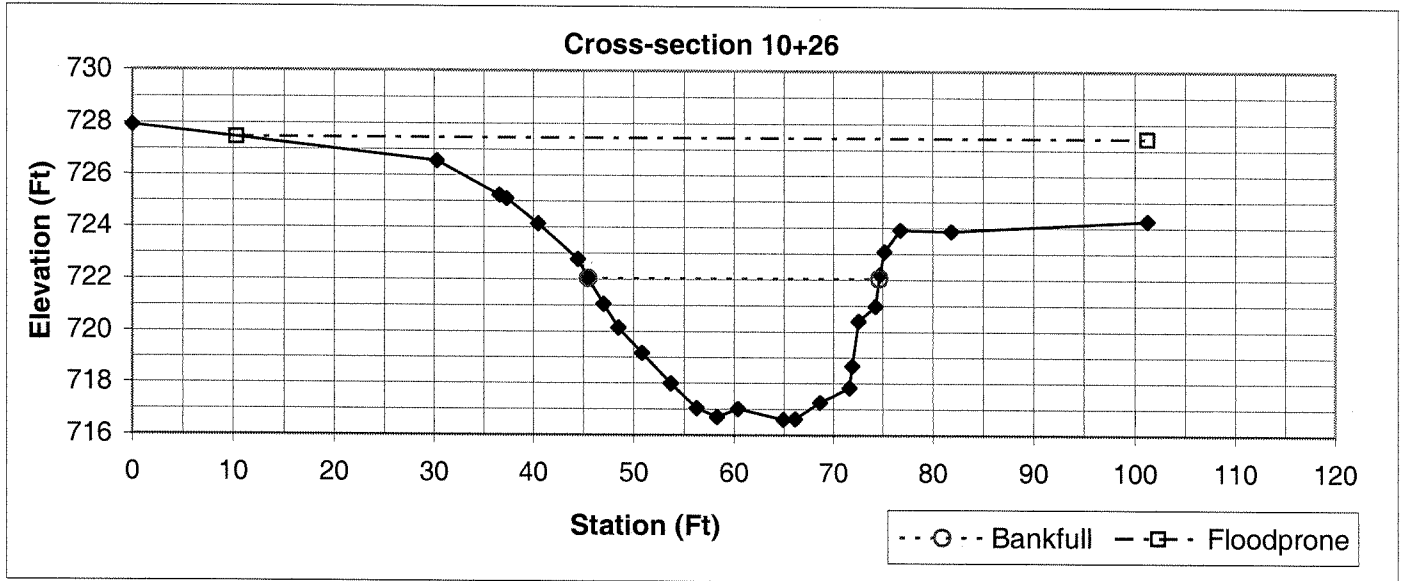
| Feature | Stream Type | BKF Area | BKF Width | BKF Depth | Max BKF Depth | W/D | BH Ratio | ER | BKF Elev | TOB Elev |
| Pool | E5 | 112.8 | 29.2 | 3.9 | 5.4 | 7.5 | 1.3 | >3.1 | 722.03 | 723.92 |

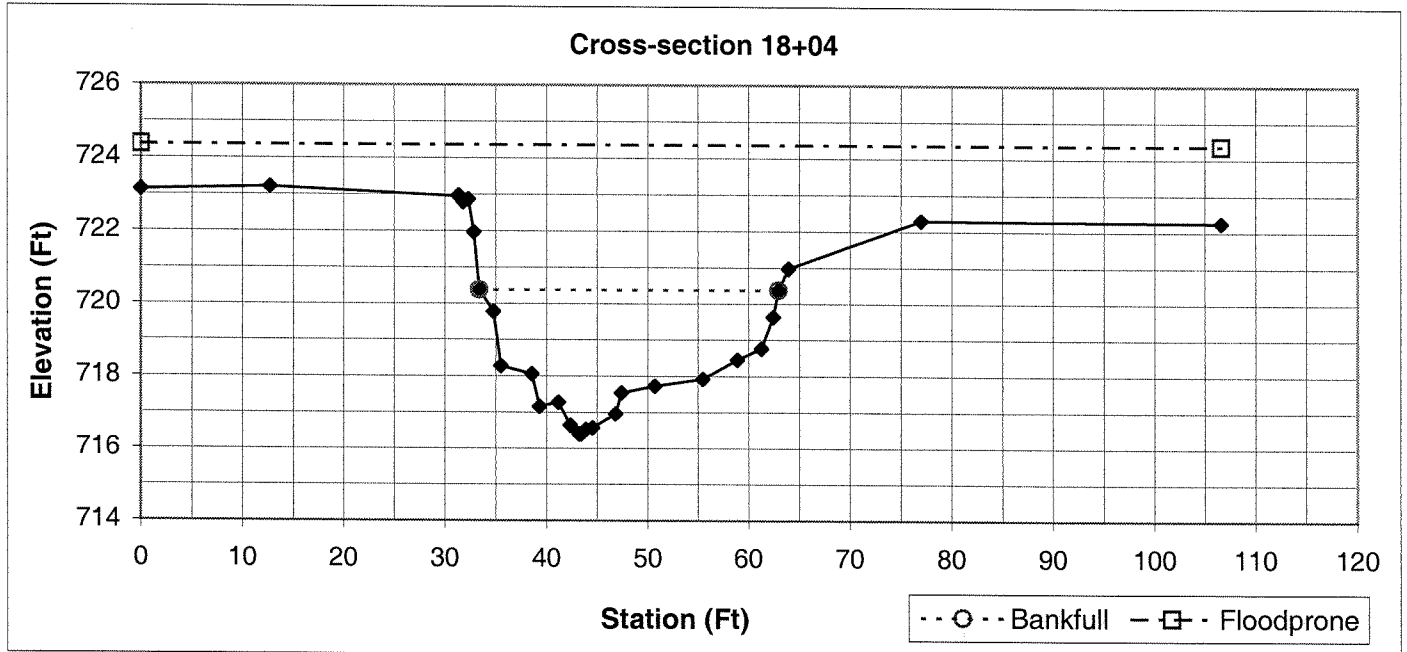
| Feature | Stream Type | BKF Area | BKF Width | BKF Depth | Max BKF Depth | W/D | BH Ratio | ER | BKF Elev | TOB Elev |
| Riffle | E5 | 73.3 | 29.6 | 2.5 | 4.0 | 11.9 | 1.1 | >3.6 | 720.38 | 720.97 |

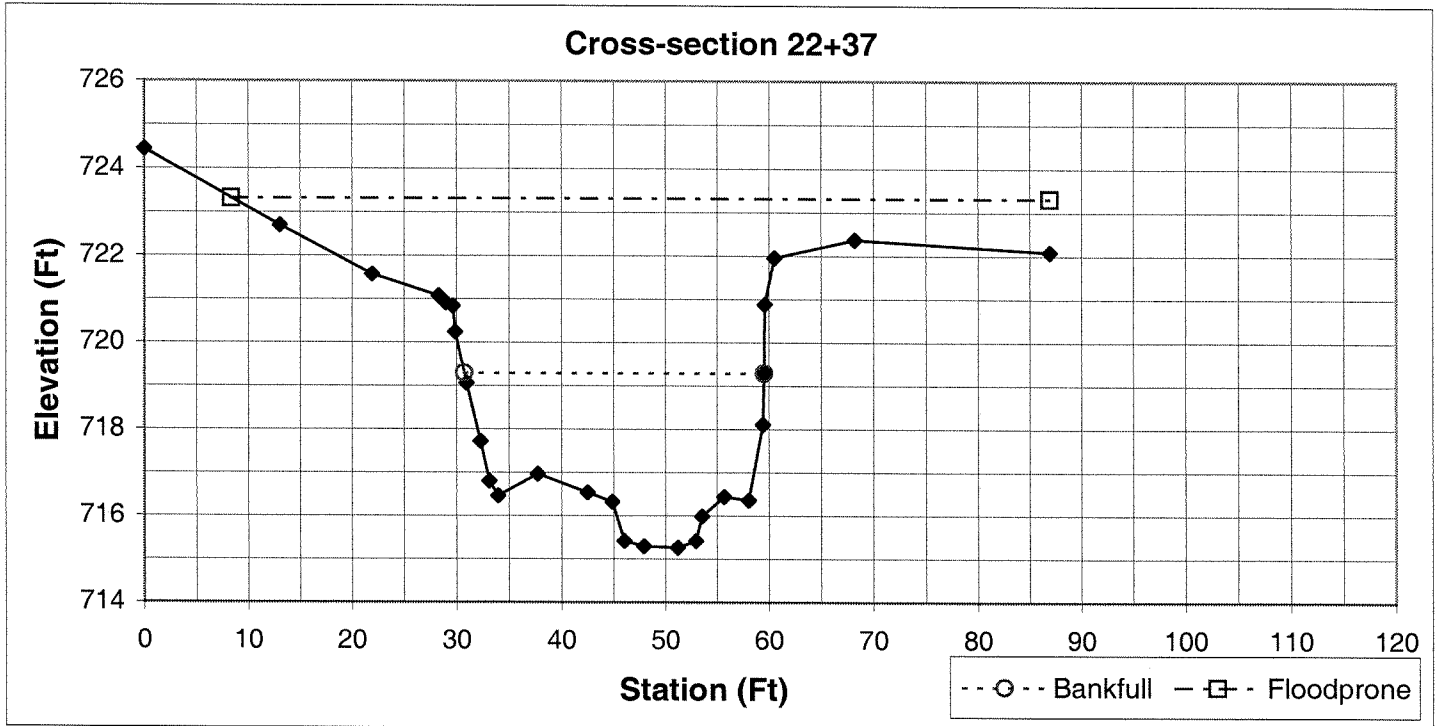
| Feature | Stream Type | BKF Area | BKF Width | BKF Depth | Max BKF Depth | W/D | BH Ratio | ER | BKF Elev | TOB Elev |
| Run | E5 | 83.8 | 28.8 | 2.9 | 4.0 | 9.9 | 1.4 | >2.7 | 719.29 | 720.83 |

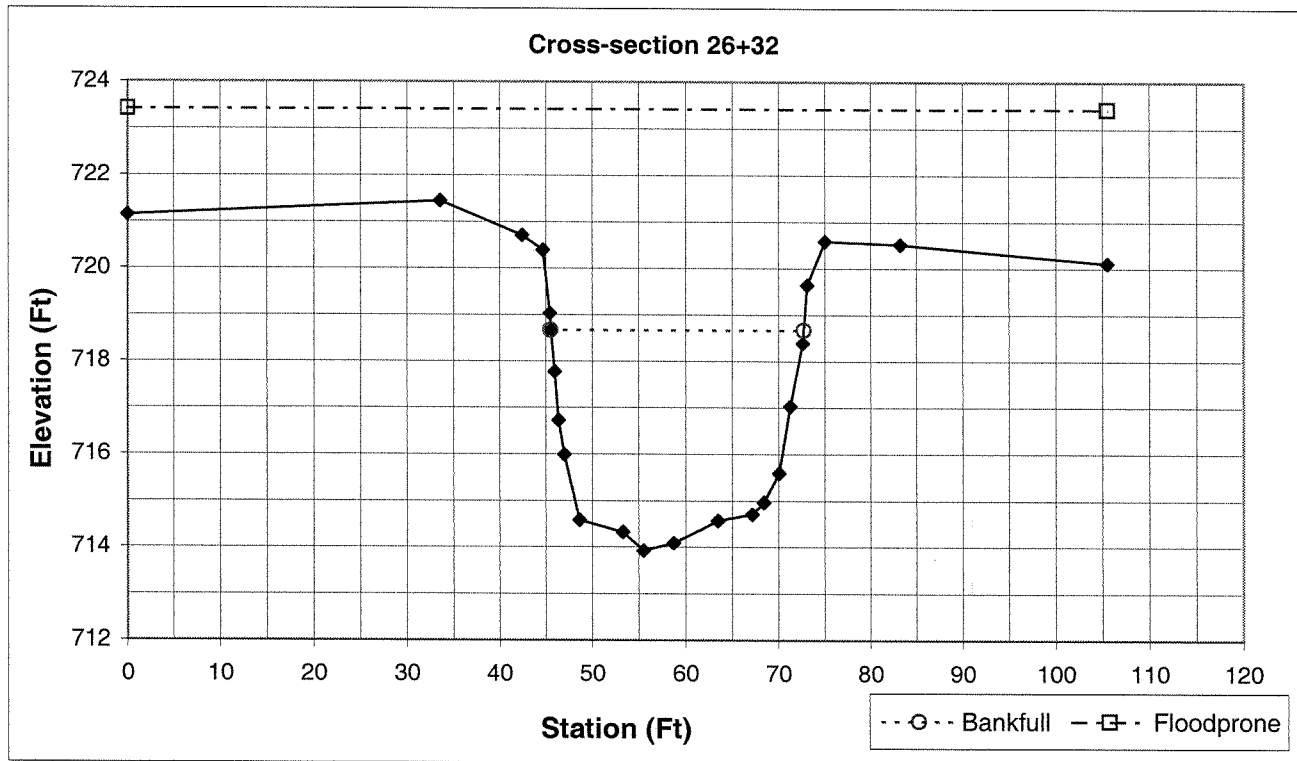
| Feature | Stream Type | BKF Area | BKF Width | BKF Depth | Max BKF Depth | W/D | BH Ratio | ER | BKF Elev | TOB Elev |
| Run | E5 | 102.6 | 27.2 | 3.8 | 4.8 | 7.2 | 1.4 | >3.9 | 718.67 | 720.39 |

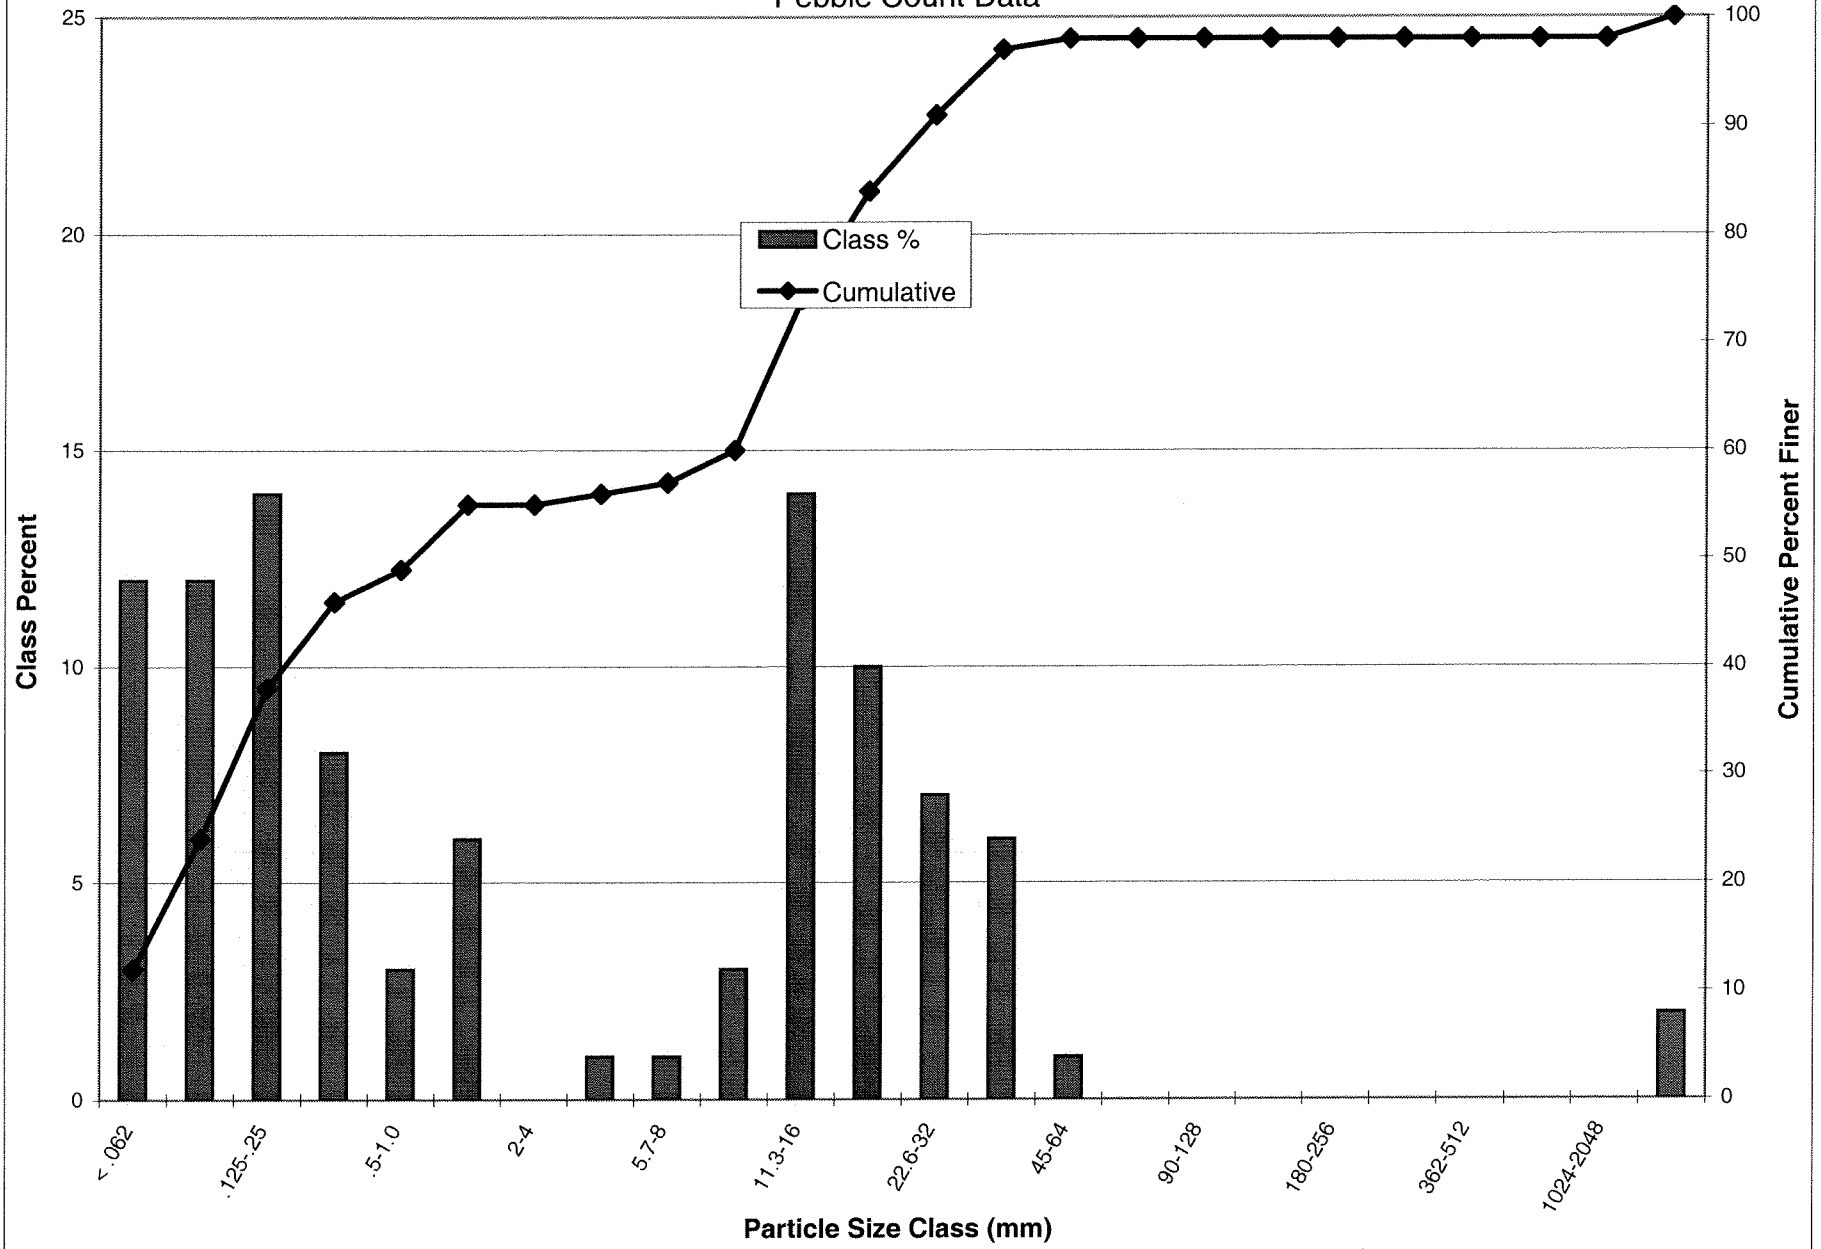
## Pebble Count Data

# Gillespie Golf Course - Mile Run Creek
