# Buffalo Creek Watershed Stream Restoration Projects Greensboro, North Carolina

North Carolina Department of Environment and Natural Resources  
Wetlands Restoration Program

Design Report Prepared By Buck Engineering PC

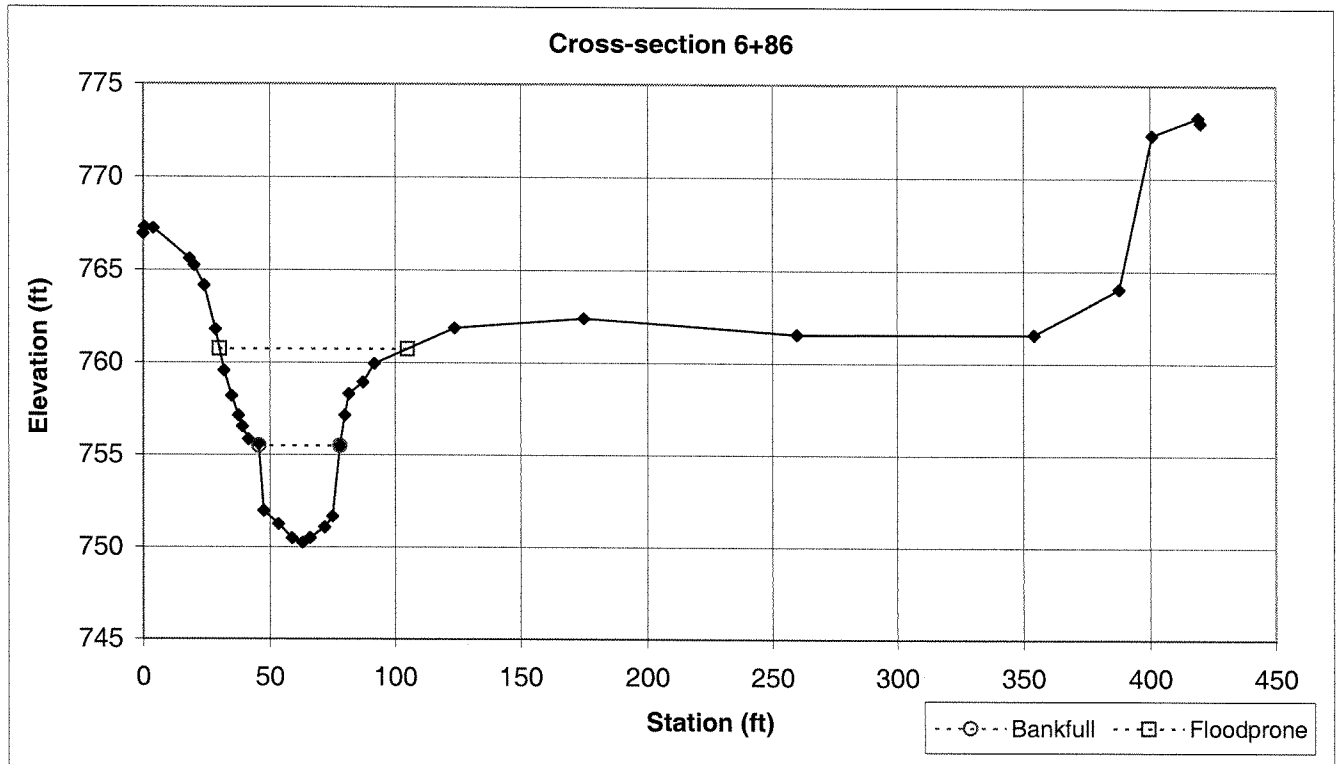
| Feature | Stream Type | BKF Area | BKF Width | BKF Depth | Max BKF Depth | W/D | BH Ratio | ER | BKF Elev | TOB Elev |
| Pool | E4 | 134.0 | 32.3 | 4.2 | 5.3 | 7.8 | 1.8 | 2.3 | 755.49 | 759.94 |

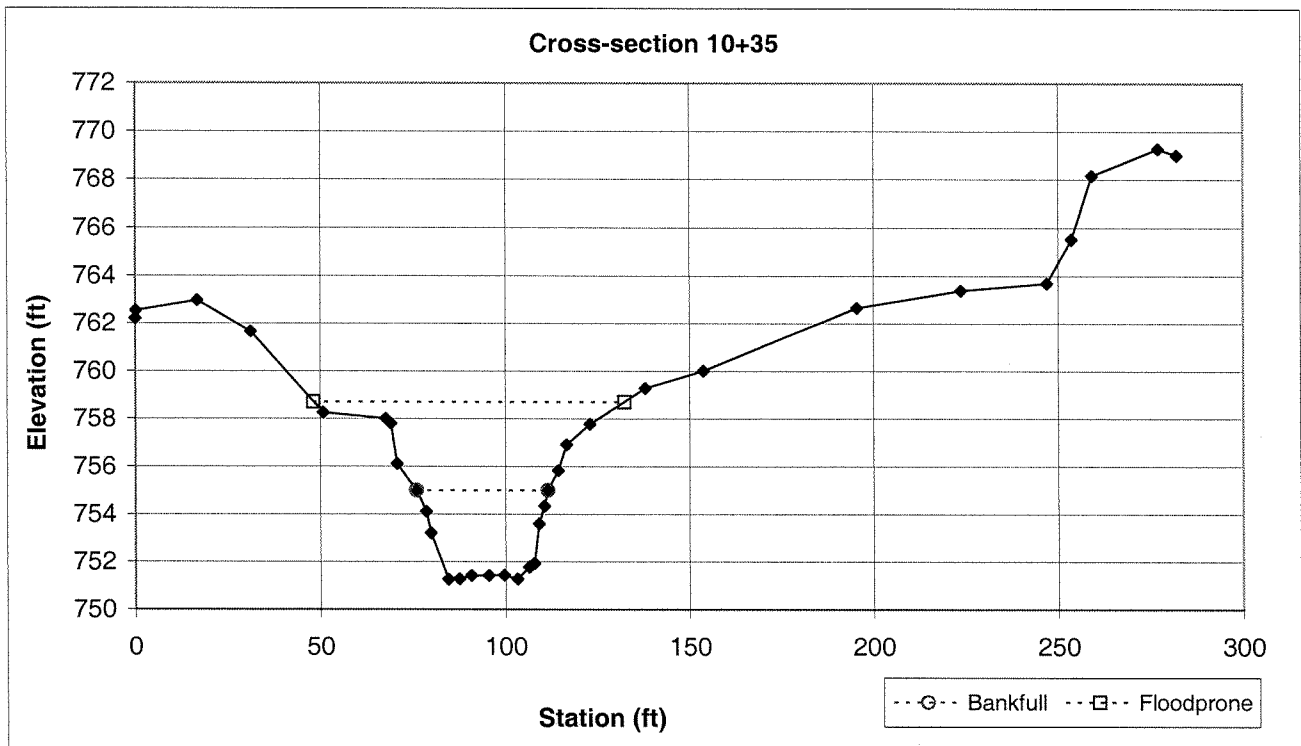
| Feature | Stream Type | BKF Area | BKF Width | BKF Depth | Max BKF Depth | W/D | BH Ratio | ER | BKF Elev | TOB Elev |
| Riffle | <del>ECA</del> | 103.2 | 35.5 | 2.9 | 3.7 | 12.2 | 1.7 | 2.4 | 754.99 | 757.77 |

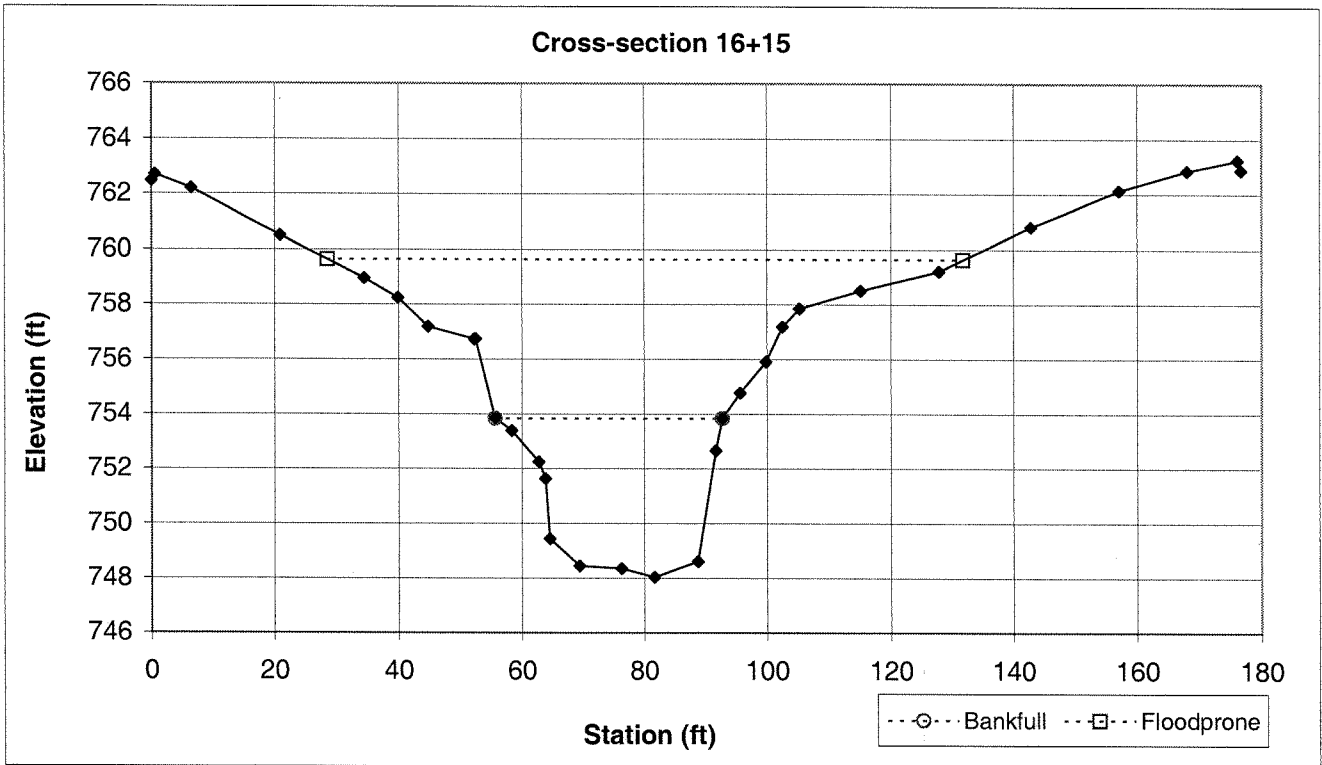
| Feature | Stream Type | BKF Area | BKF Width | BKF Depth | Max BKF Depth | W/D | BH Ratio | ER | BKF Elev | TOB Elev |
| Pool | E4 | 150.0 | 37.1 | 4.0 | 5.8 | 9.2 | 1.5 | 2.8 | 753.83 | 756.73 |

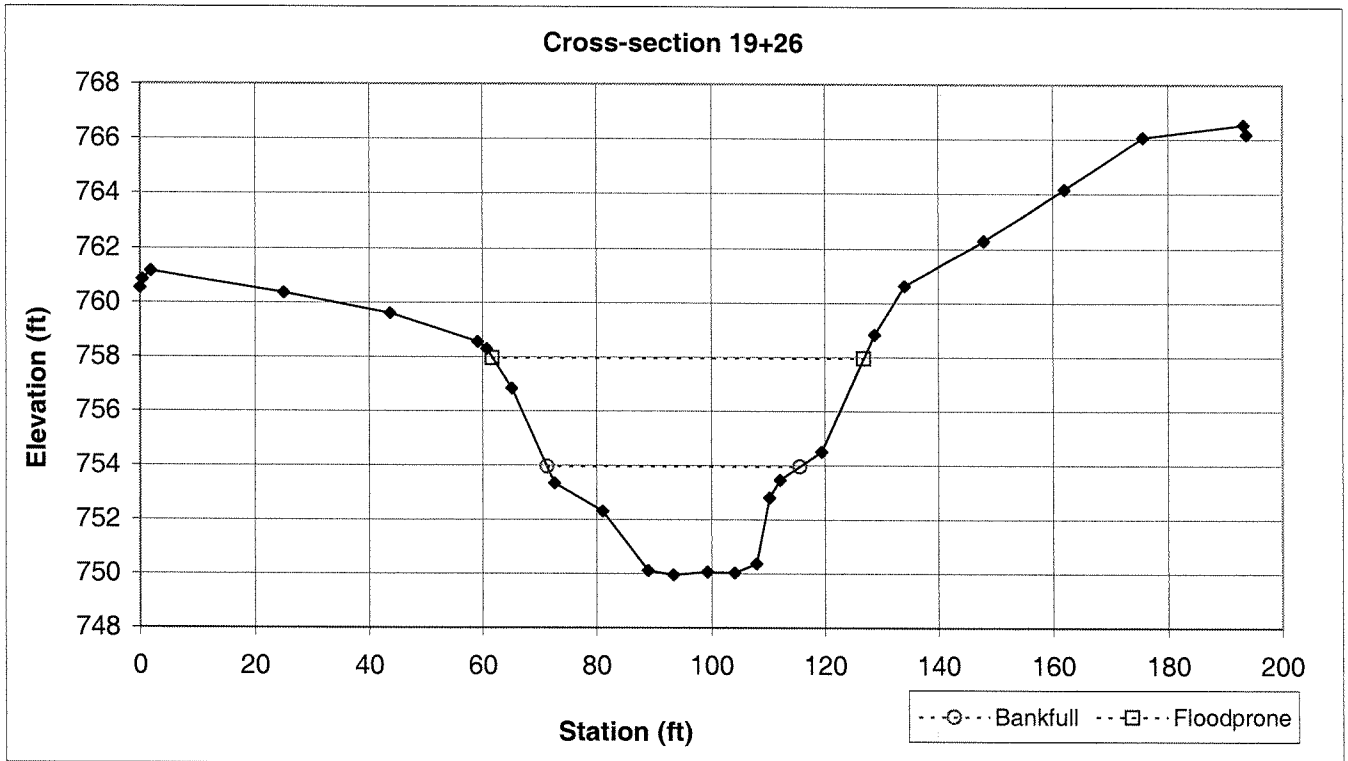
| Feature | Stream Type | BKF Area | BKF Width | BKF Depth | Max BKF Depth | W/D | BH Ratio | ER | BKF Elev | TOB Elev |
| Riffle | B4c | 113.4 | 44.2 | 2.6 | 4.0 | 17.3 | 2.1 | 1.5 | 753.96 | 758.28 |

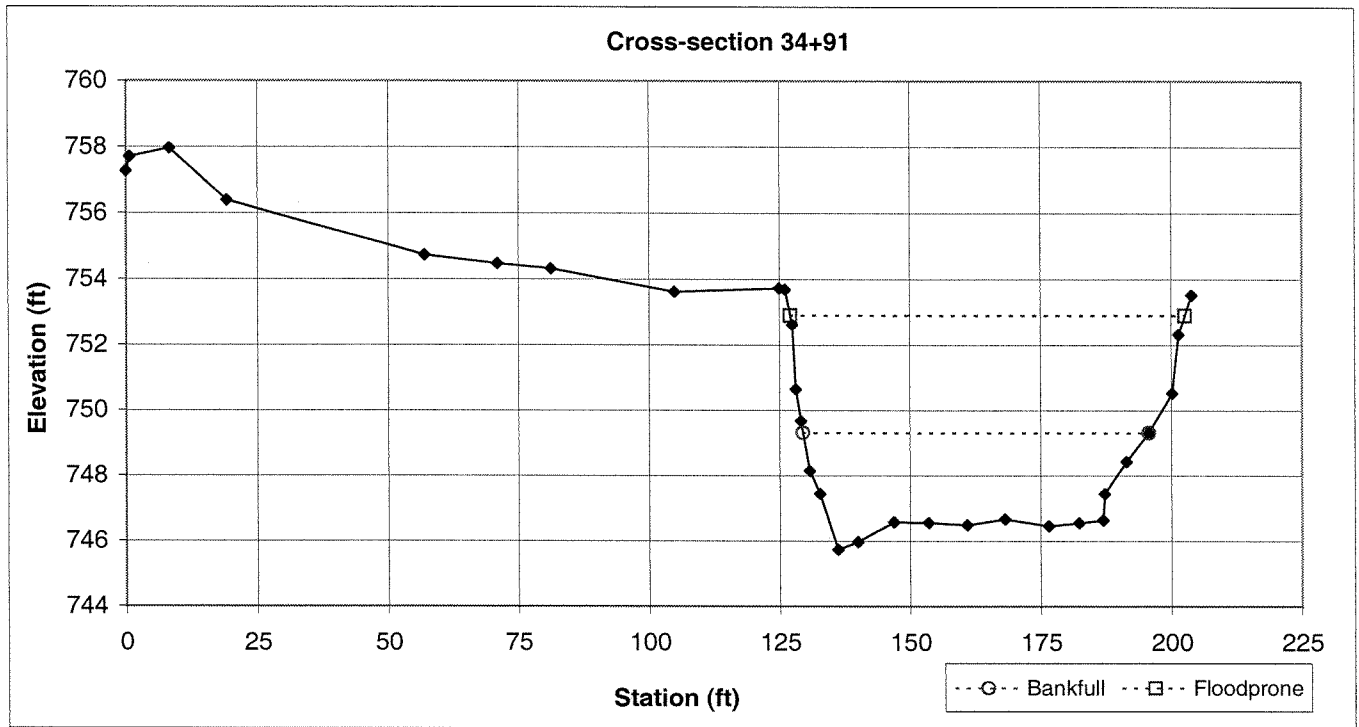
| Feature | Stream Type | BKF Area | BKF Width | BKF Depth | Max BKF Depth | W/D | BH Ratio | ER | BKF Elev | TOB Elev |
| Riffle | F4 | 166.0 | 66.2 | 2.5 | 3.6 | 26.4 | 2.2 | 1.1 | 749.32 | 753.51 |

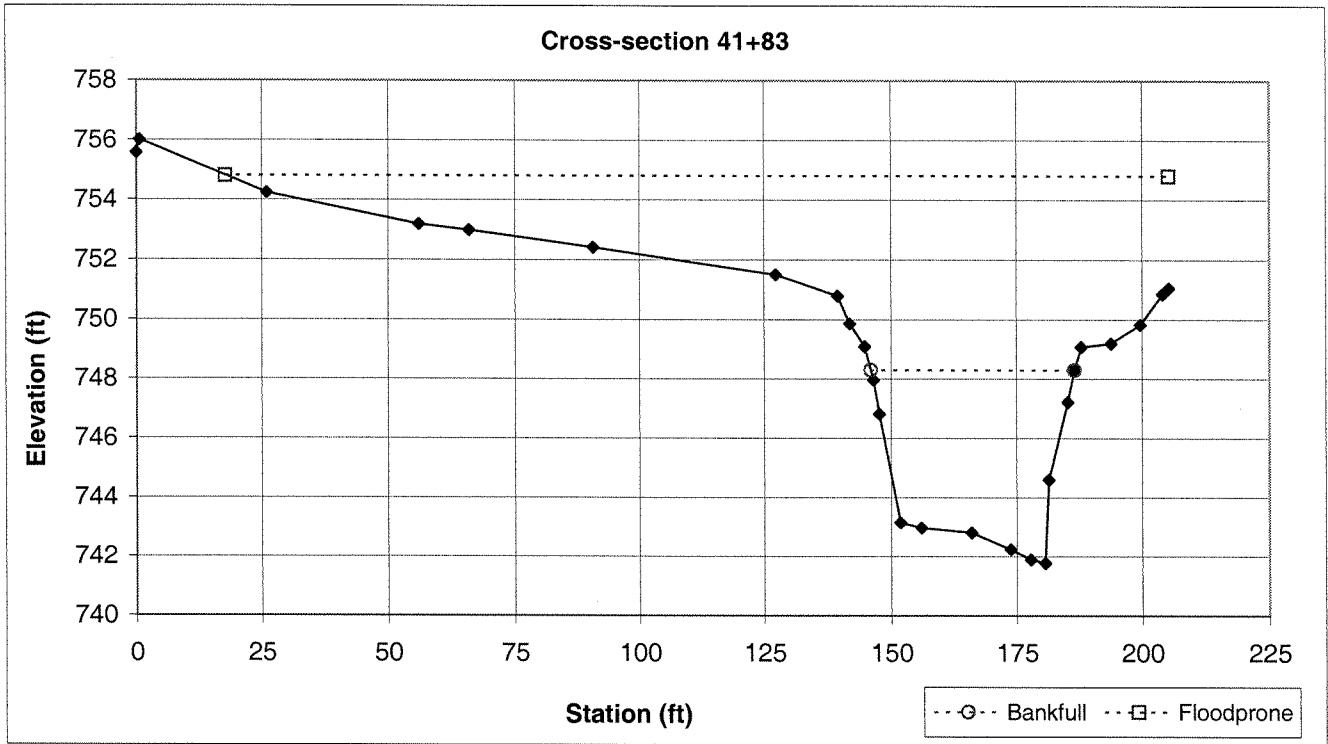
| Feature | Stream Type | BKF Area | BKF Width | BKF Depth | Max BKF Depth | W/D | BH Ratio | ER | BKF Elev | TOB Elev |
| Pool | E4 | 193.1 | 40.5 | 4.8 | 6.5 | 8.5 | 1.1 | >4.6 | 748.3 | 749.08 |

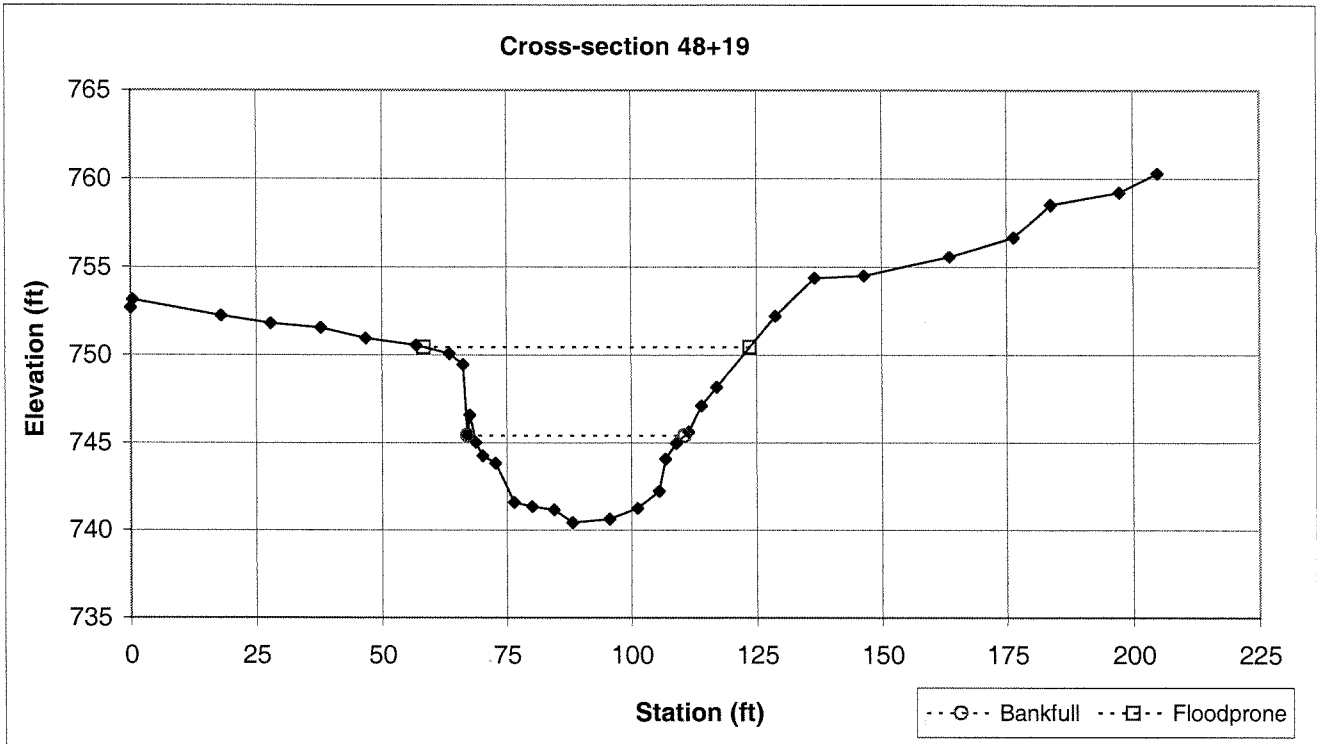
| Feature | Stream Type | BKF Area | BKF Width | BKF Depth | Max BKF Depth | W/D | BH Ratio | ER | BKF Elev | TOB Elev |
| Run | B4c | 147.9 | 43.6 | 3.4 | 5.0 | 12.9 | 1.9 | 1.5 | 745.43 | 750.07 |

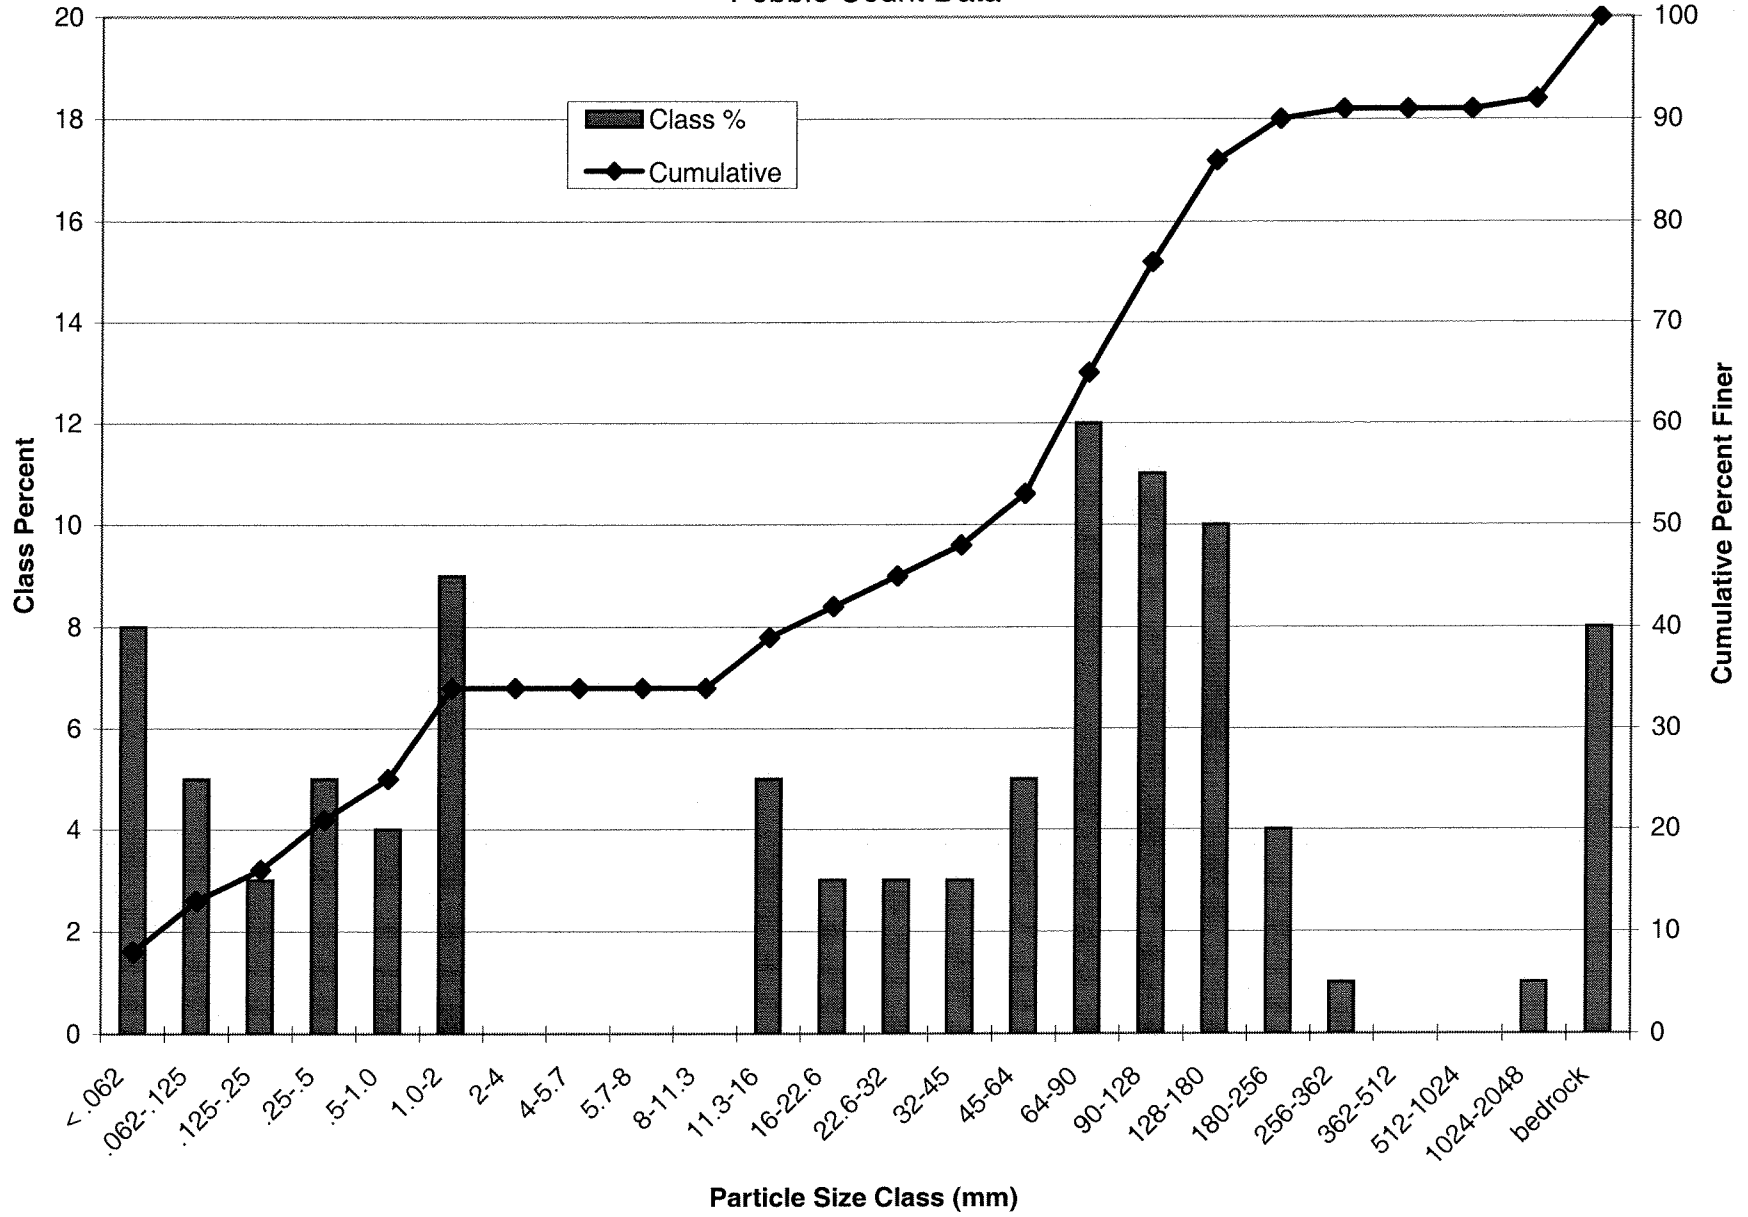
## Pebble Count Data

# Hillsdale Park - South Buffalo Creek

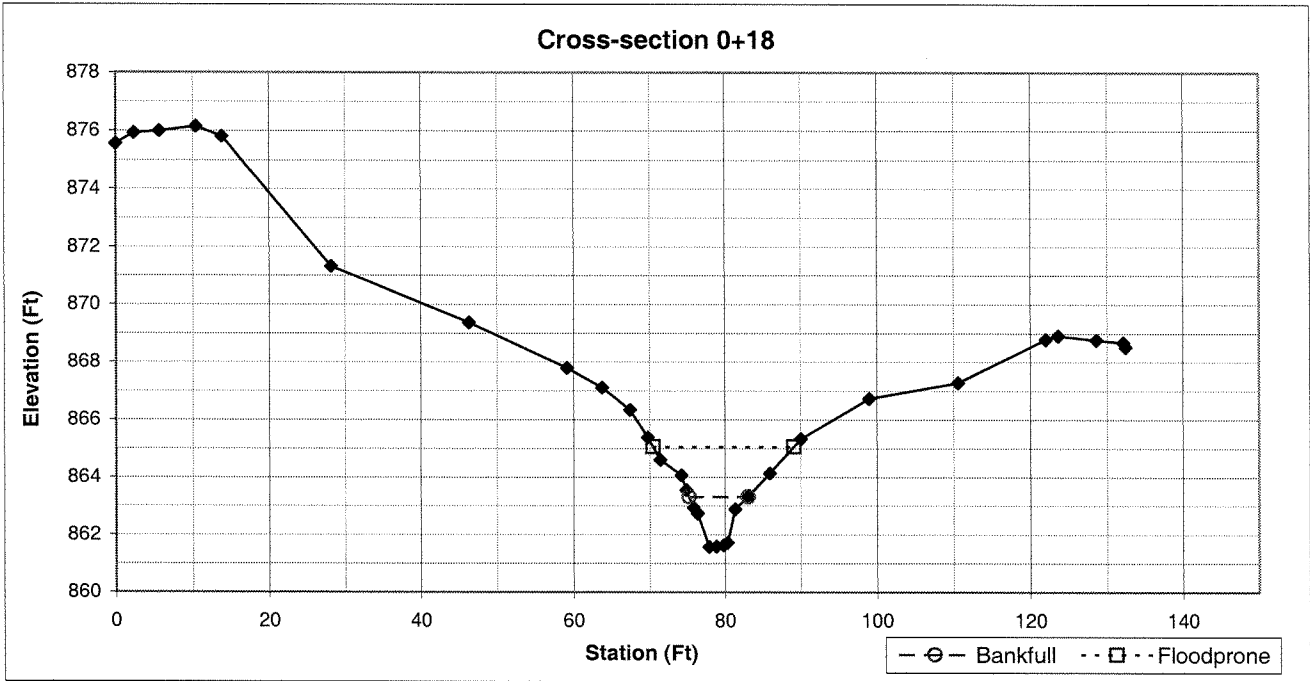
| Feature | Stream Type | BKF Area | BKF Width | BKF Depth | Max BKF Depth | W/D | BH Ratio | ER | BKF Elev | TOB Elev |
| Riffle | <i>PAEA</i> | 7.7 | 7.9 | 1.0 | 1.7 | 8.1 | 2.2 | 2.4 | 863.31 | 865.32 |

It should be noted that the cross-sectional area of 5 ft<sup>2</sup> measured at Brown Bark Park was taken at a cross-section near the beginning of the channel, e.g. the section upstream of the channel was culverted. The difference in water surface and the bankfull stage was similar here to other cross sections; however, the cross sectional area was low.

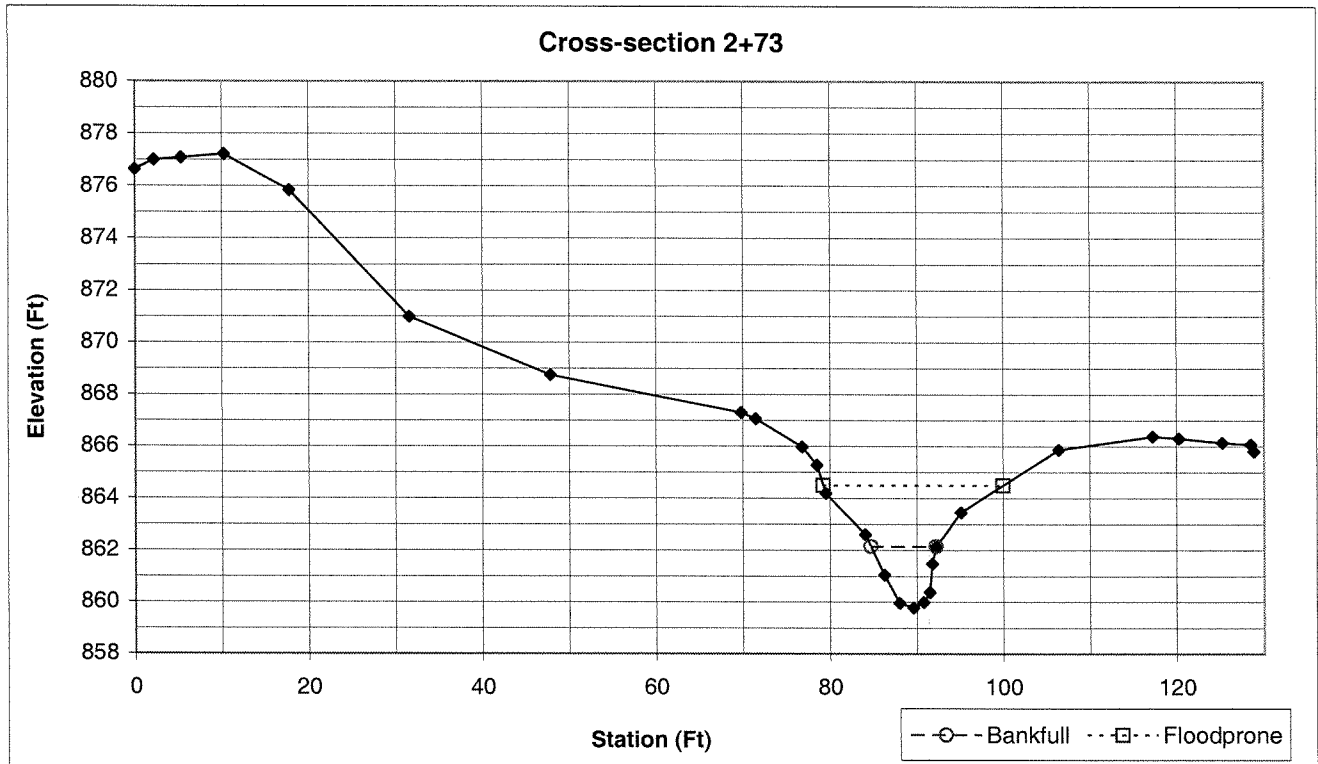
| Feature | Stream Type | BKF Area | BKF Width | BKF Depth | Max BKF Depth | W/D | BH Ratio | ER | BKF Elev | TOB Elev |
| Run | E4 | 11.9 | 7.5 | 1.6 | 2.4 | 4.8 | 1.6 | 2.8 | 862.14 | 863.46 |

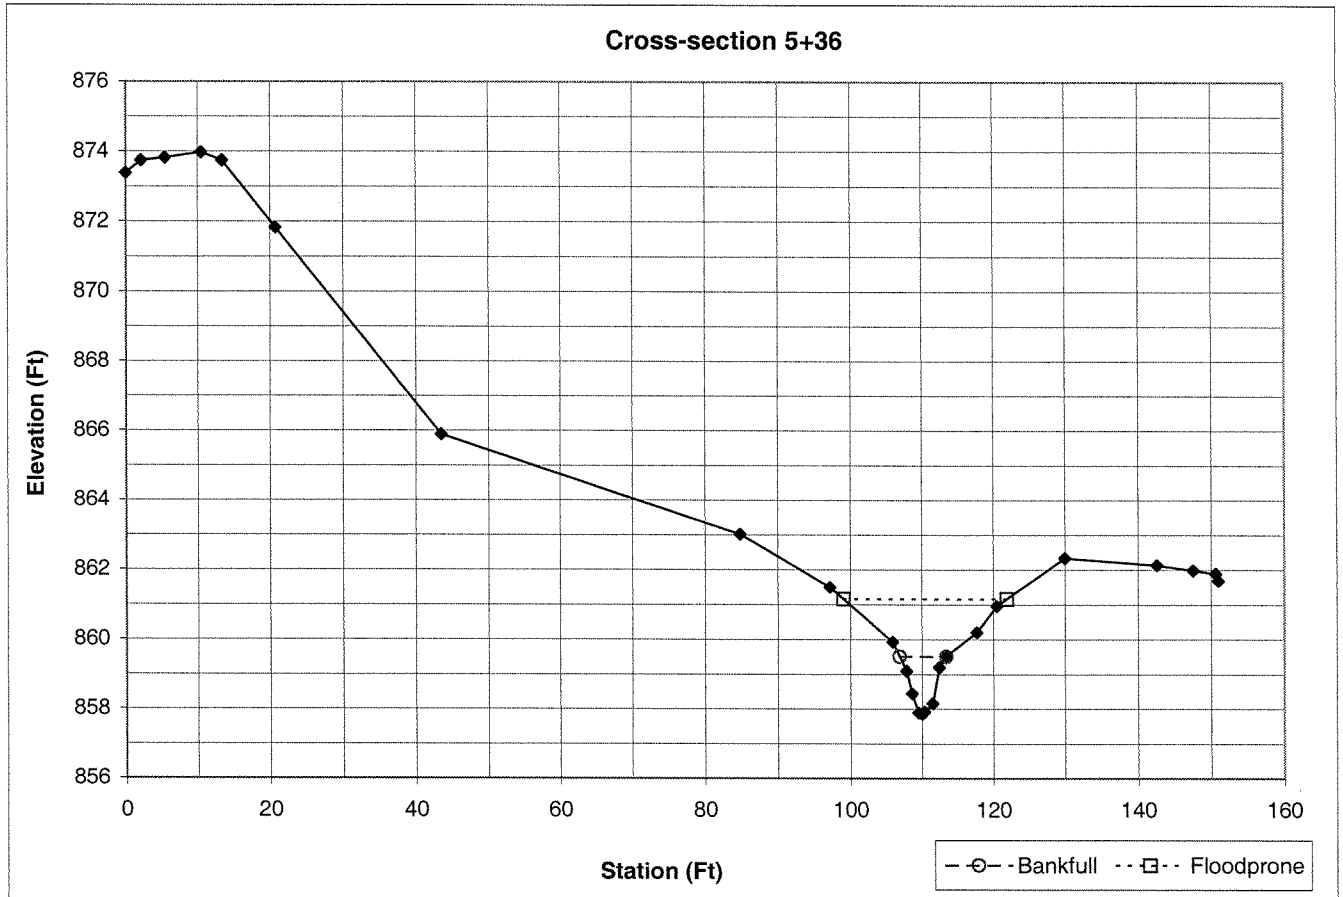
| Feature Run | Stream Type | BKF Area | BKF Width | BKF Depth | Max BKF Depth | W/D | BH Ratio | ER | BKF Elev | TOB Elev |
| | E4 | 6.0 | 6.5 | 0.9 | 1.7 | 7.1 | 1.3 | 3.5 | 859.5 | 859.92 |

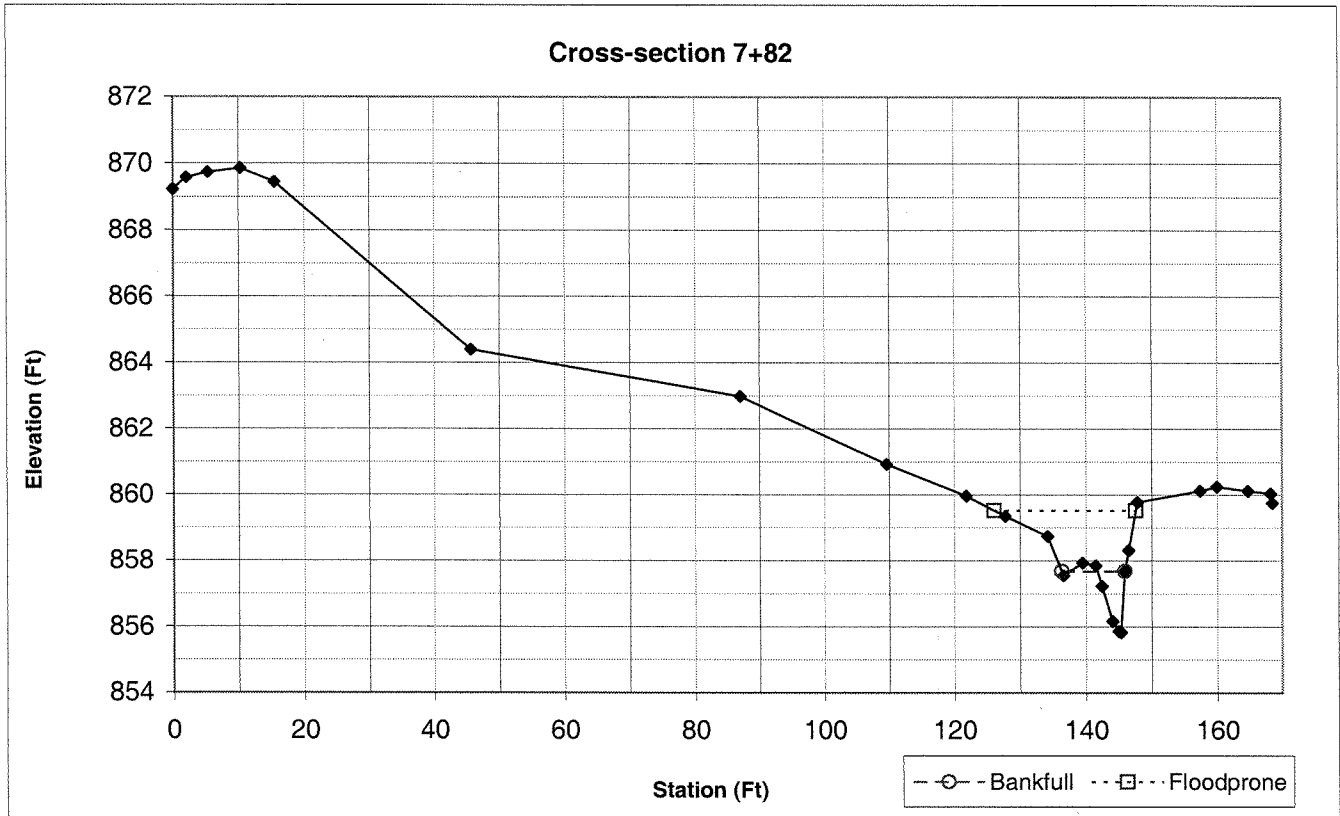
| Feature | Stream Type | BKF Area | BKF Width | BKF Depth | Max BKF Depth | W/D | BH Ratio | ER | BKF Elev | TOB Elev |
| Pool | C4 | 4.5 | 9.5 | 0.5 | 1.8 | 20.2 | 1.9 | 2.3 | 857.68 | 859.34 |

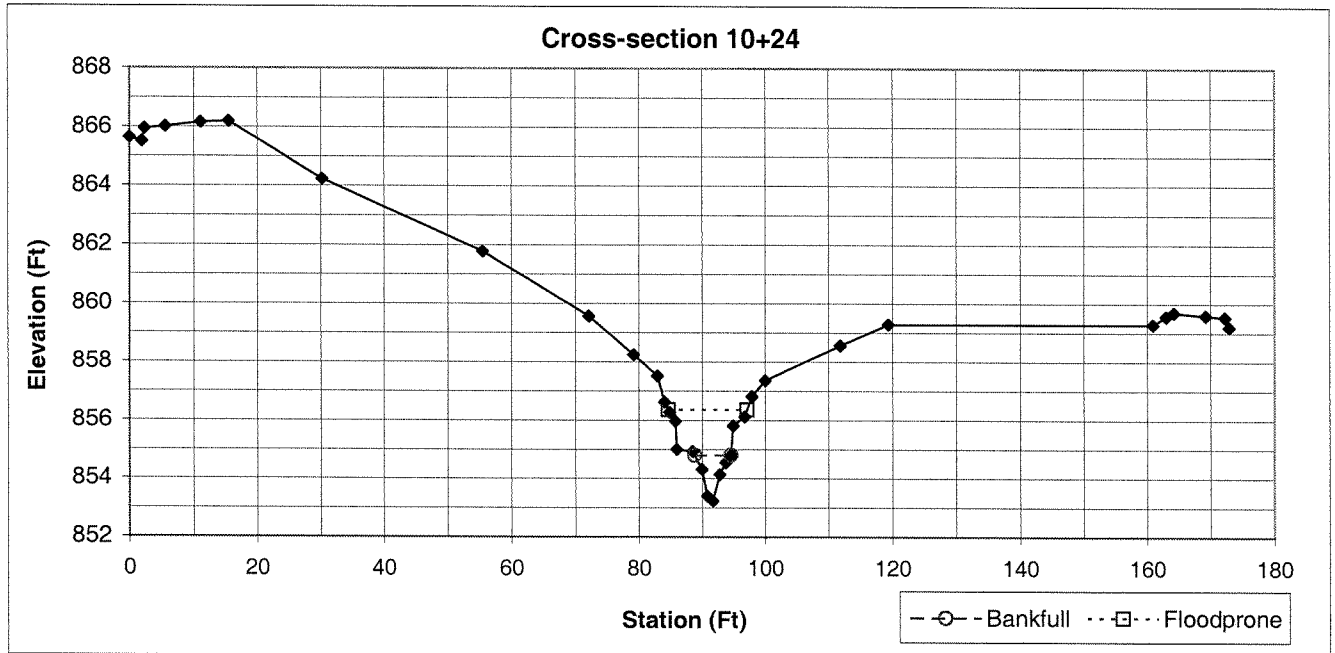
| Feature | Stream Type | BKF Area | BKF Width | BKF Depth | Max BKF Depth | W/D | BH Ratio | ER | BKF Elev | TOB Elev |
| Riffle | E4 | 4.1 | 5.7 | 0.7 | 1.6 | 8.0 | 2.6 | 2.2 | 854.80 | 857.36 |

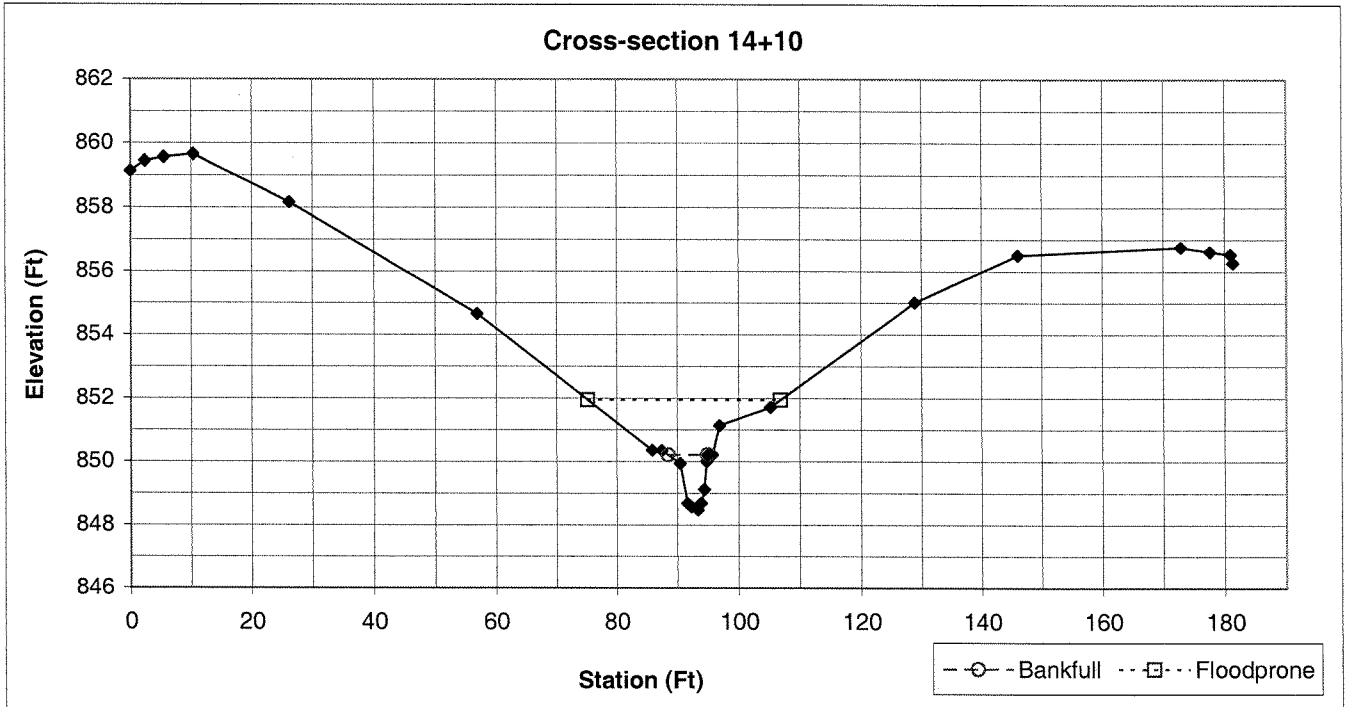
| Feature | Stream Type | BKF Area | BKF Width | BKF Depth | Max BKF Depth | W/D | BH Ratio | ER | BKF Elev | TOB Elev |
| Run | E4 | 6.0 | 6.6 | 0.9 | 1.7 | 7.2 | 1.1 | 4.8 | 850.21 | 850.34 |

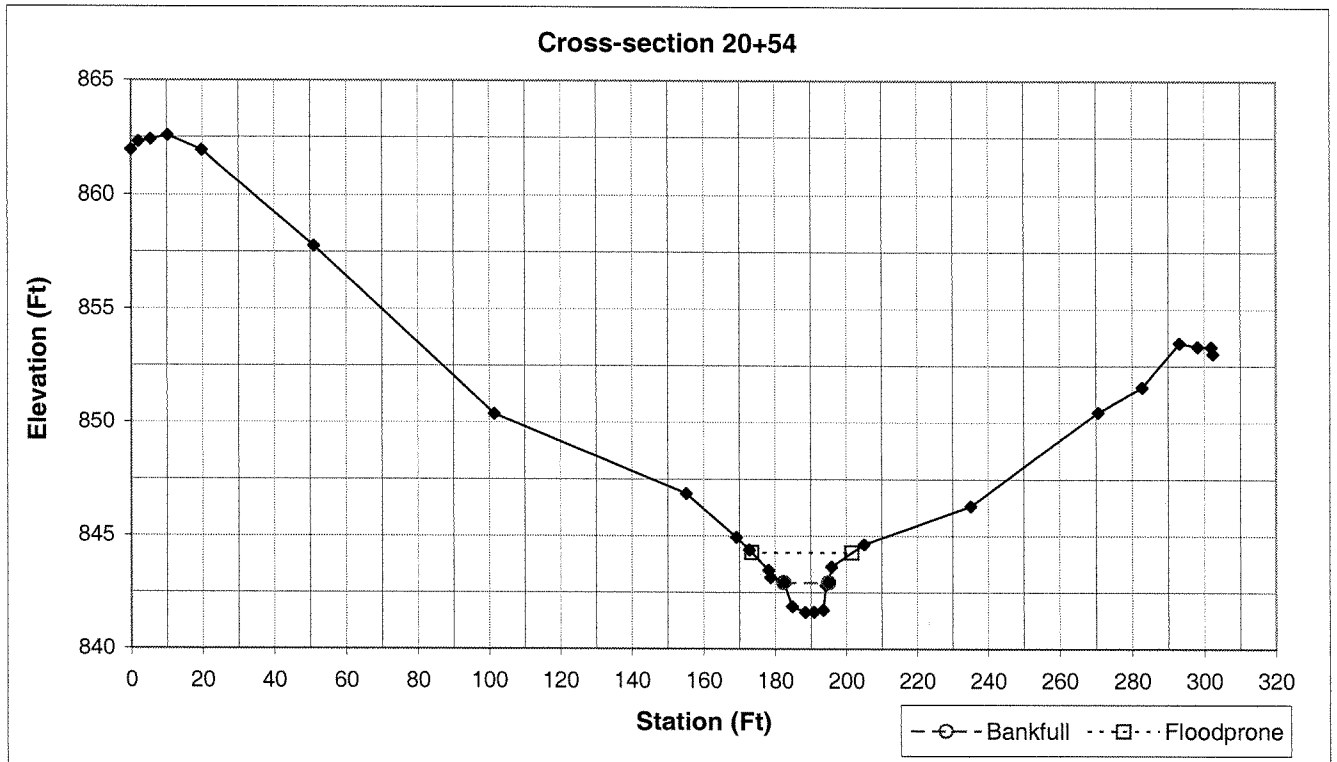
| Feature | Stream Type | BKF Area | BKF Width | BKF Depth | Max BKF Depth | W/D | BH Ratio | ER | BKF Elev | TOB Elev |
| Run | C4 | 12.6 | 12.6 | 1.0 | 1.3 | 12.7 | 1.0 | 2.2 | 842.94 | 842.95 |

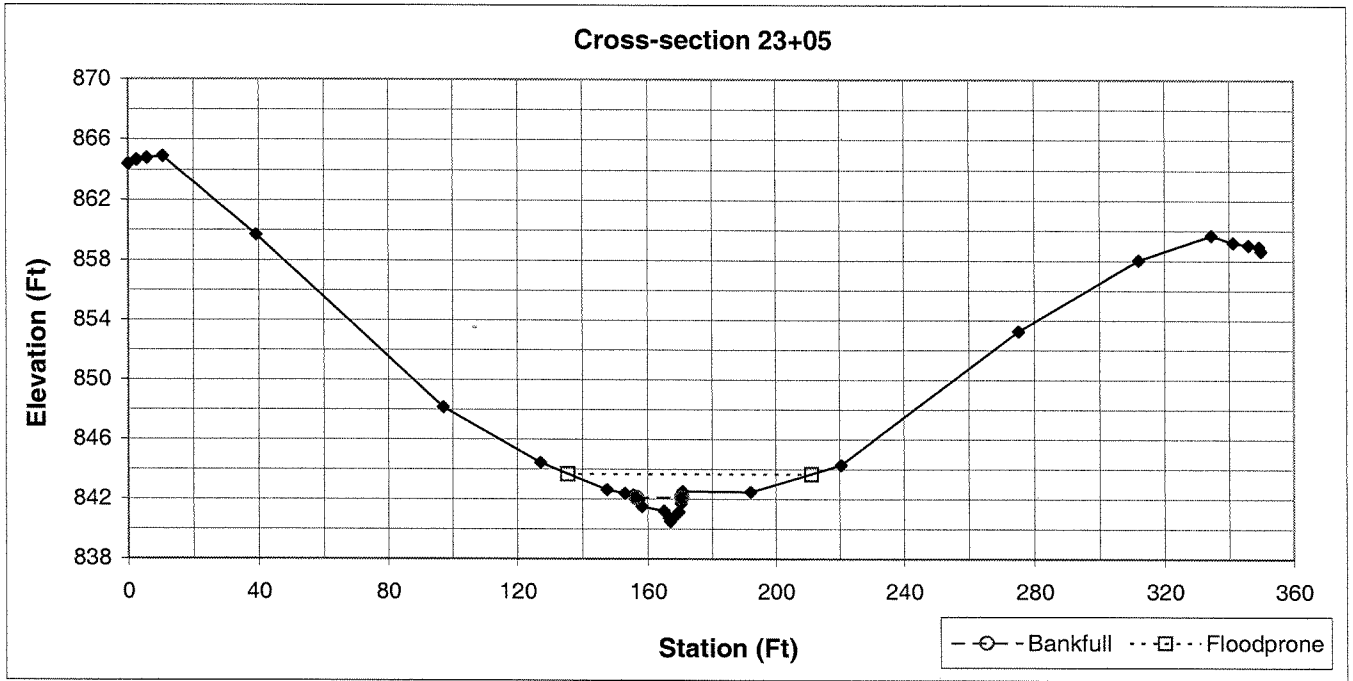
| Feature | Stream Type | BKF Area | BKF Width | BKF Depth | Max BKF Depth | W/D | BH Ratio | ER | BKF Elev | TOB Elev |
| Run | C4 | 11.5 | 14.1 | 0.8 | 1.6 | 17.3 | 1.1 | 5.4 | 842.10 | 842.29 |

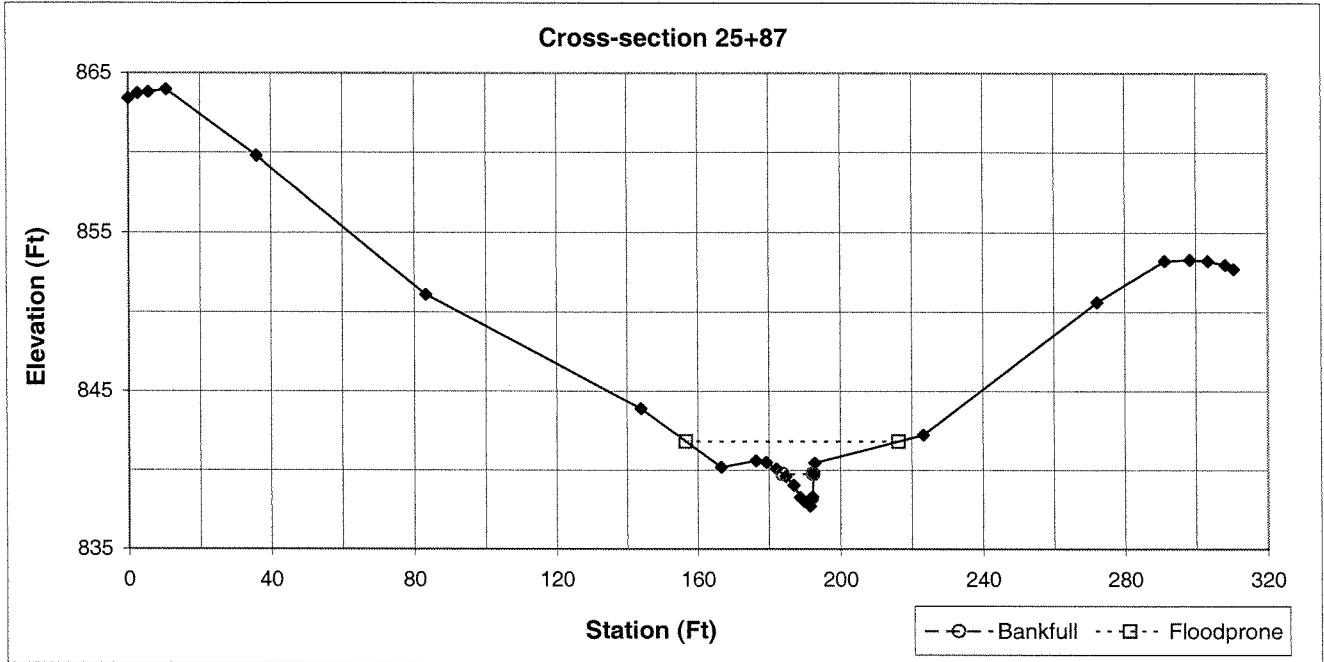
| Feature | Stream Type | BKF Area | BKF Width | BKF Depth | Max BKF Depth | W/D | BH Ratio | ER | BKF Elev | TOB Elev |
| Riffle | E4 | 9.4 | 8.6 | 1.1 | 2.1 | 7.8 | 1.1 | 7.0 | 839.76 | 840.07 |

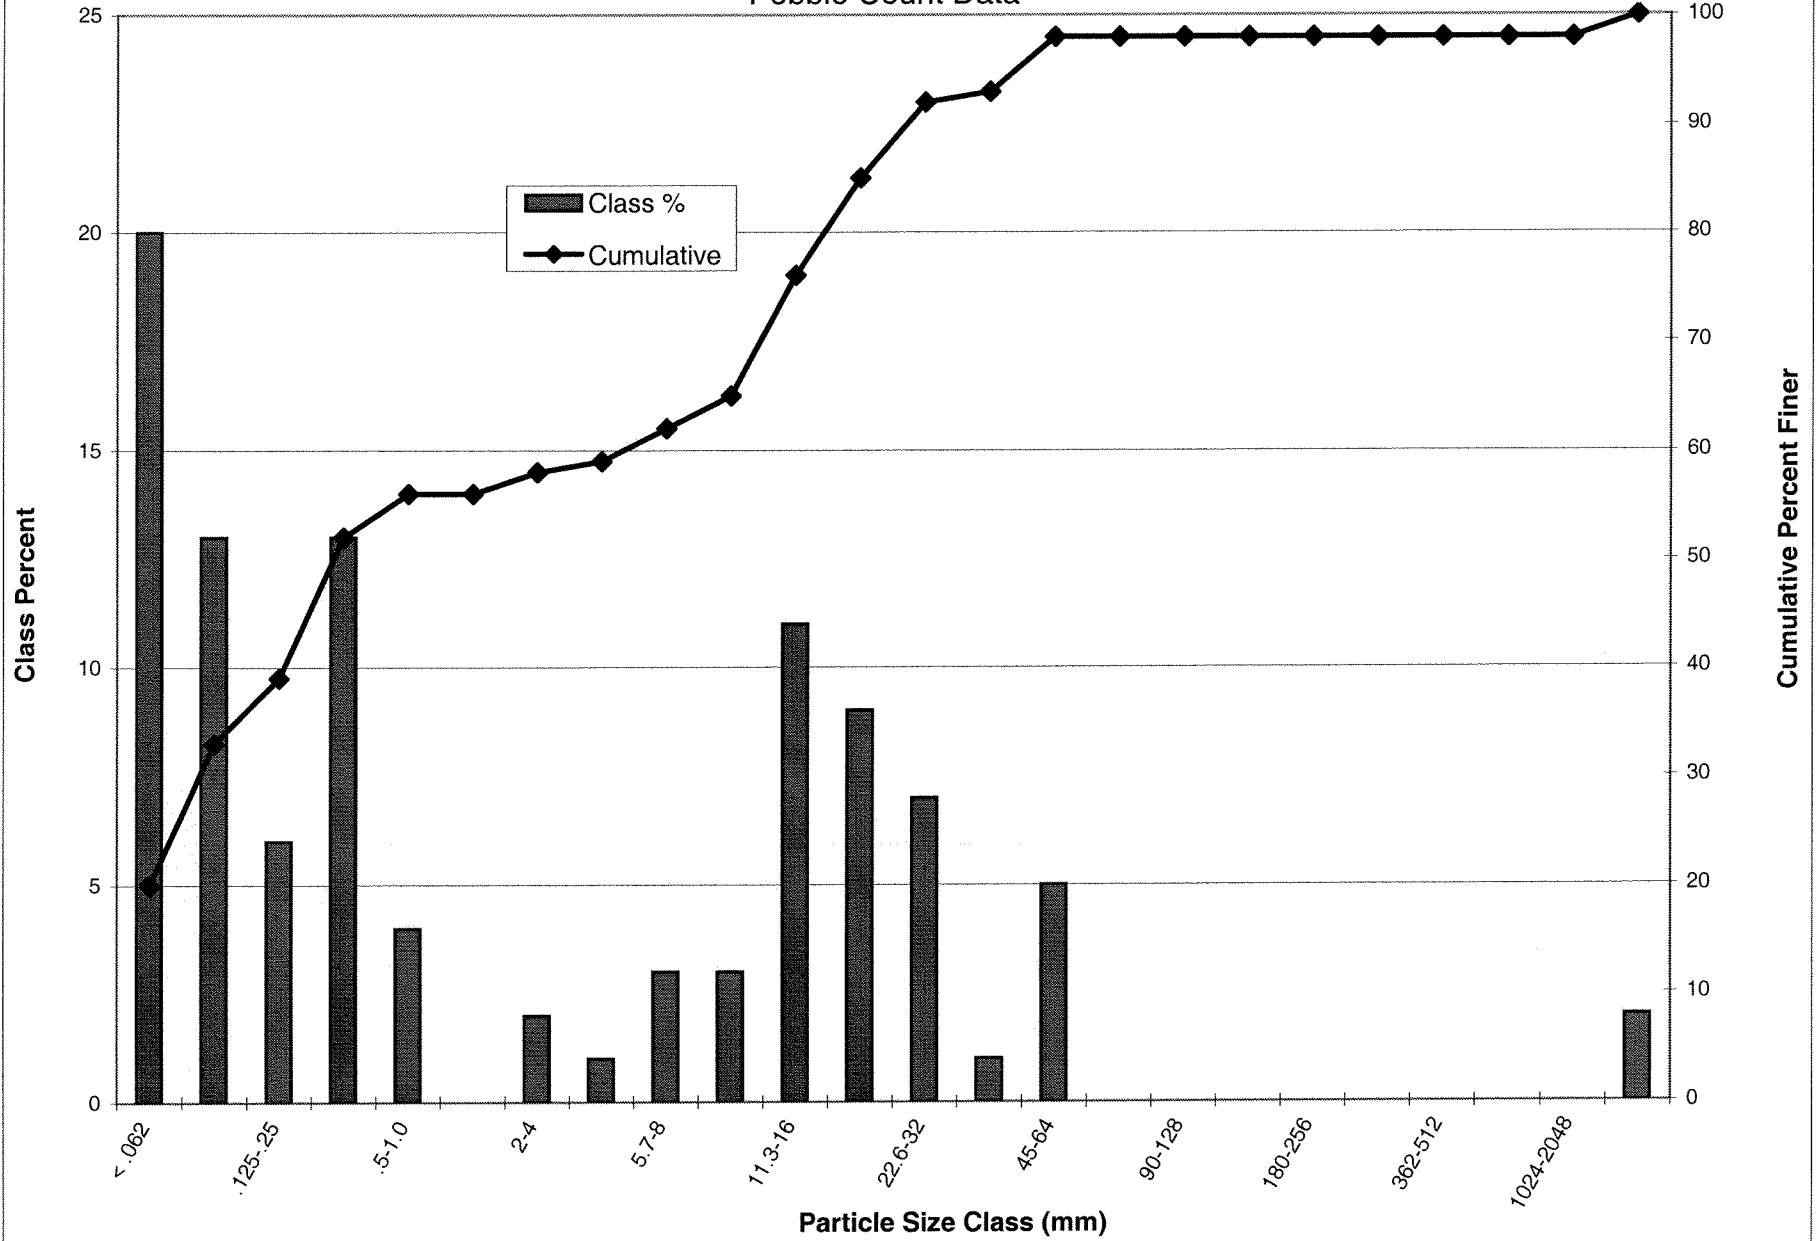
Pebble Count Data

Brown Bark Park - Unnamed Tributary to North Buffalo Creek

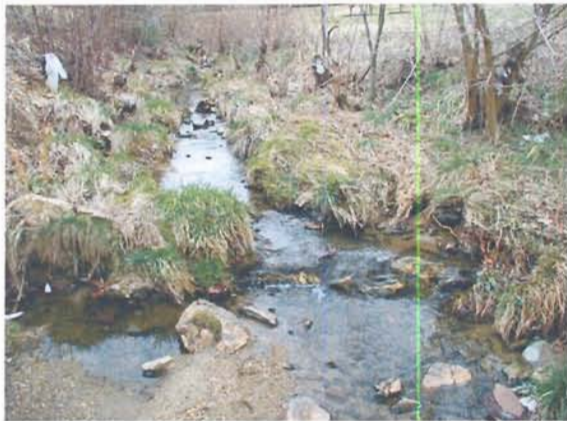
Upstream Knickpoint

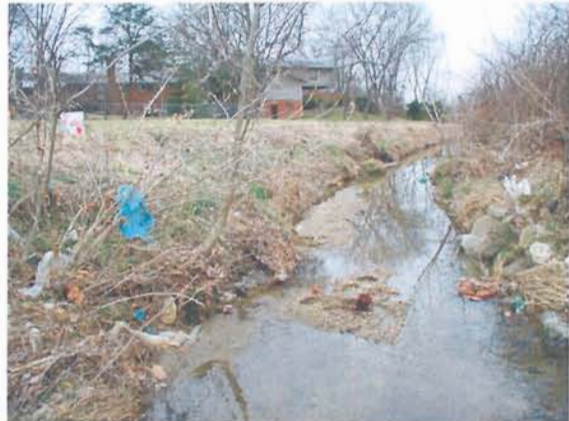
Cross Section 4+97

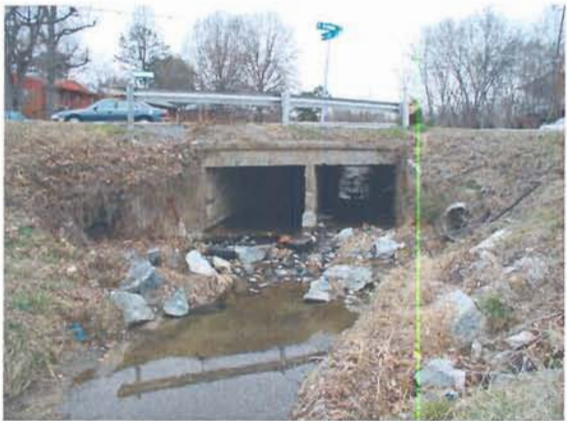
Culvert Downstream of S. Benbow Rd.

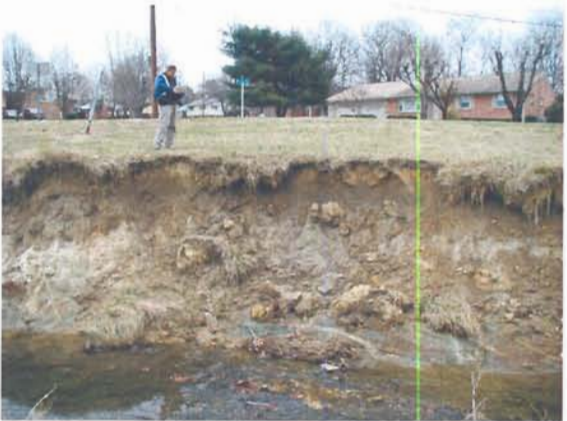
Bank Erosion Downstream

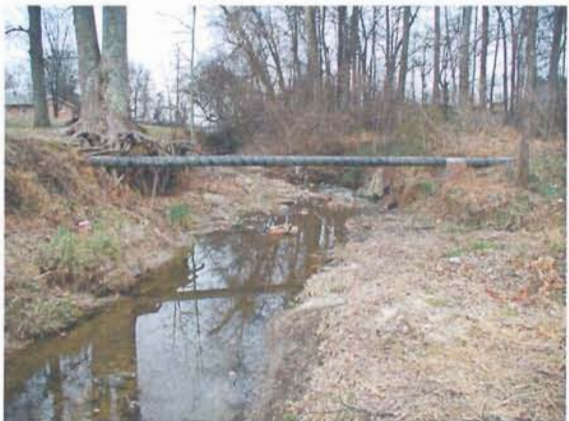
Sewer Line

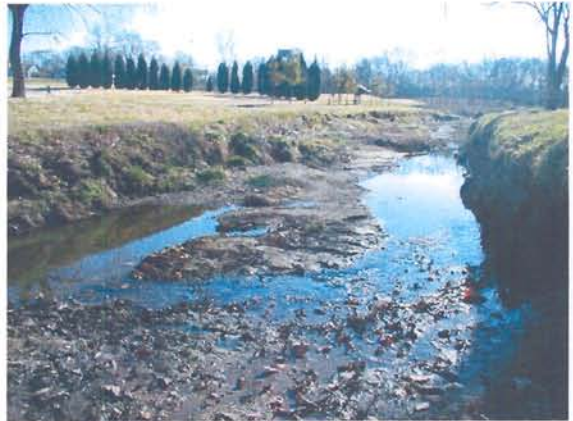
Mid-Channel Bar Forming

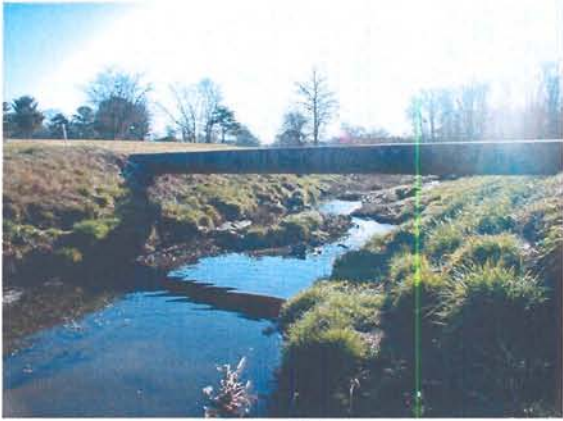
Sewer Line

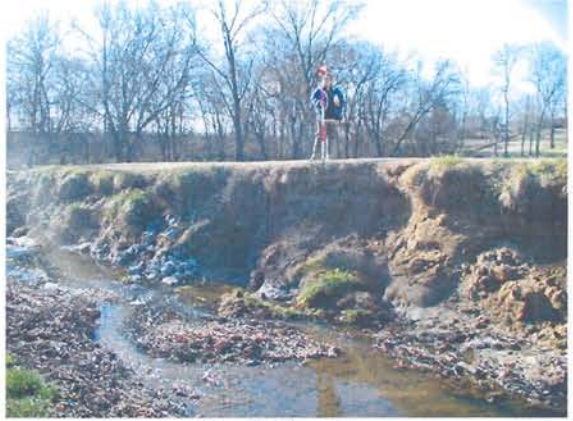
Bank Erosion
