# Buffalo Creek Watershed Stream Restoration Projects Greensboro, North Carolina

North Carolina Department of Environment and Natural Resources  
Wetlands Restoration Program

Design Report Prepared By Buck Engineering PC

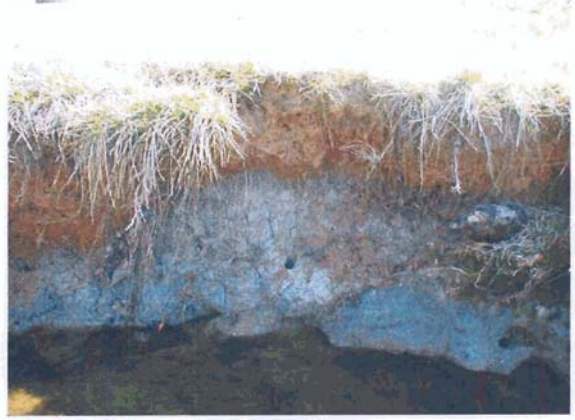
Bank Erosion

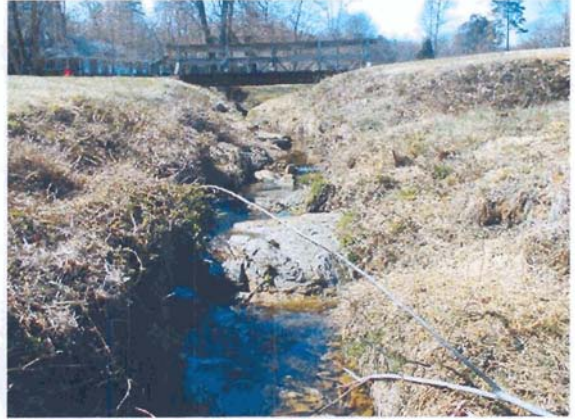
Bedrock Knickpoint

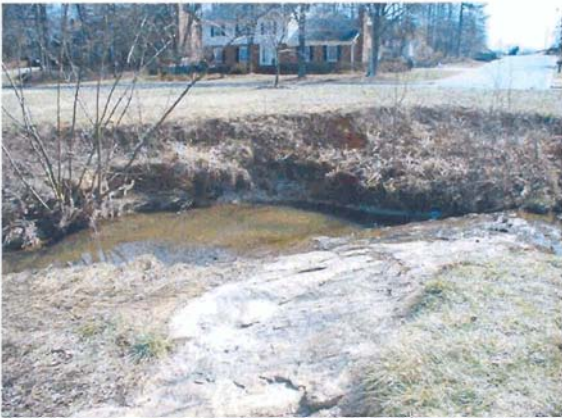
Bedrock Knickpoint

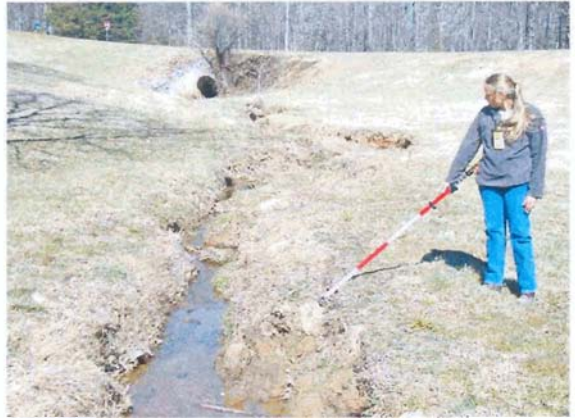
Bank Erosion - Downstream

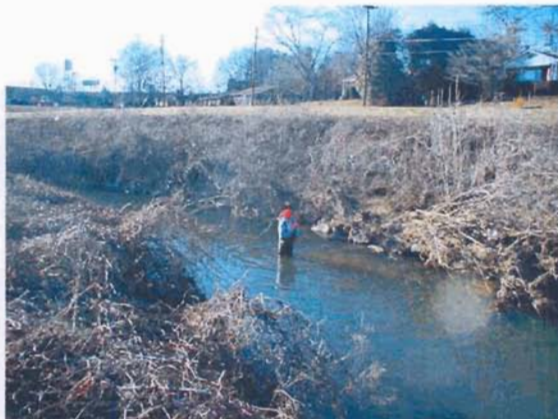
Reach 1 - Pool

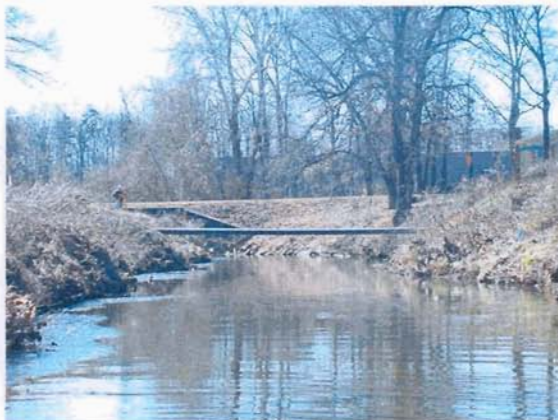
Sewer line

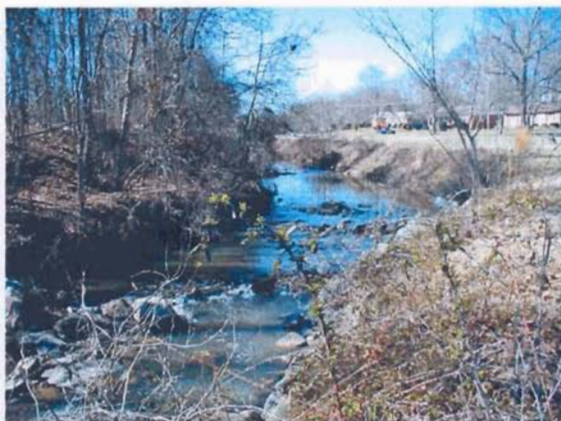
Riffle in Reach 3 Downstream
