Hip Bone Creek Baseline Monitoring Report

Hip Bone Creek Restoration Site
Cape Fear River Basin - 03030003
Monitoring Year 00
DMS Contract 7528
DMS Project Number 100059

DWR #: 2018-0785
USACE AID #: SAW-2018-01160
Chatham County, North Carolina

Baseline Data Collected: May 2021
Date Submitted: August 2021

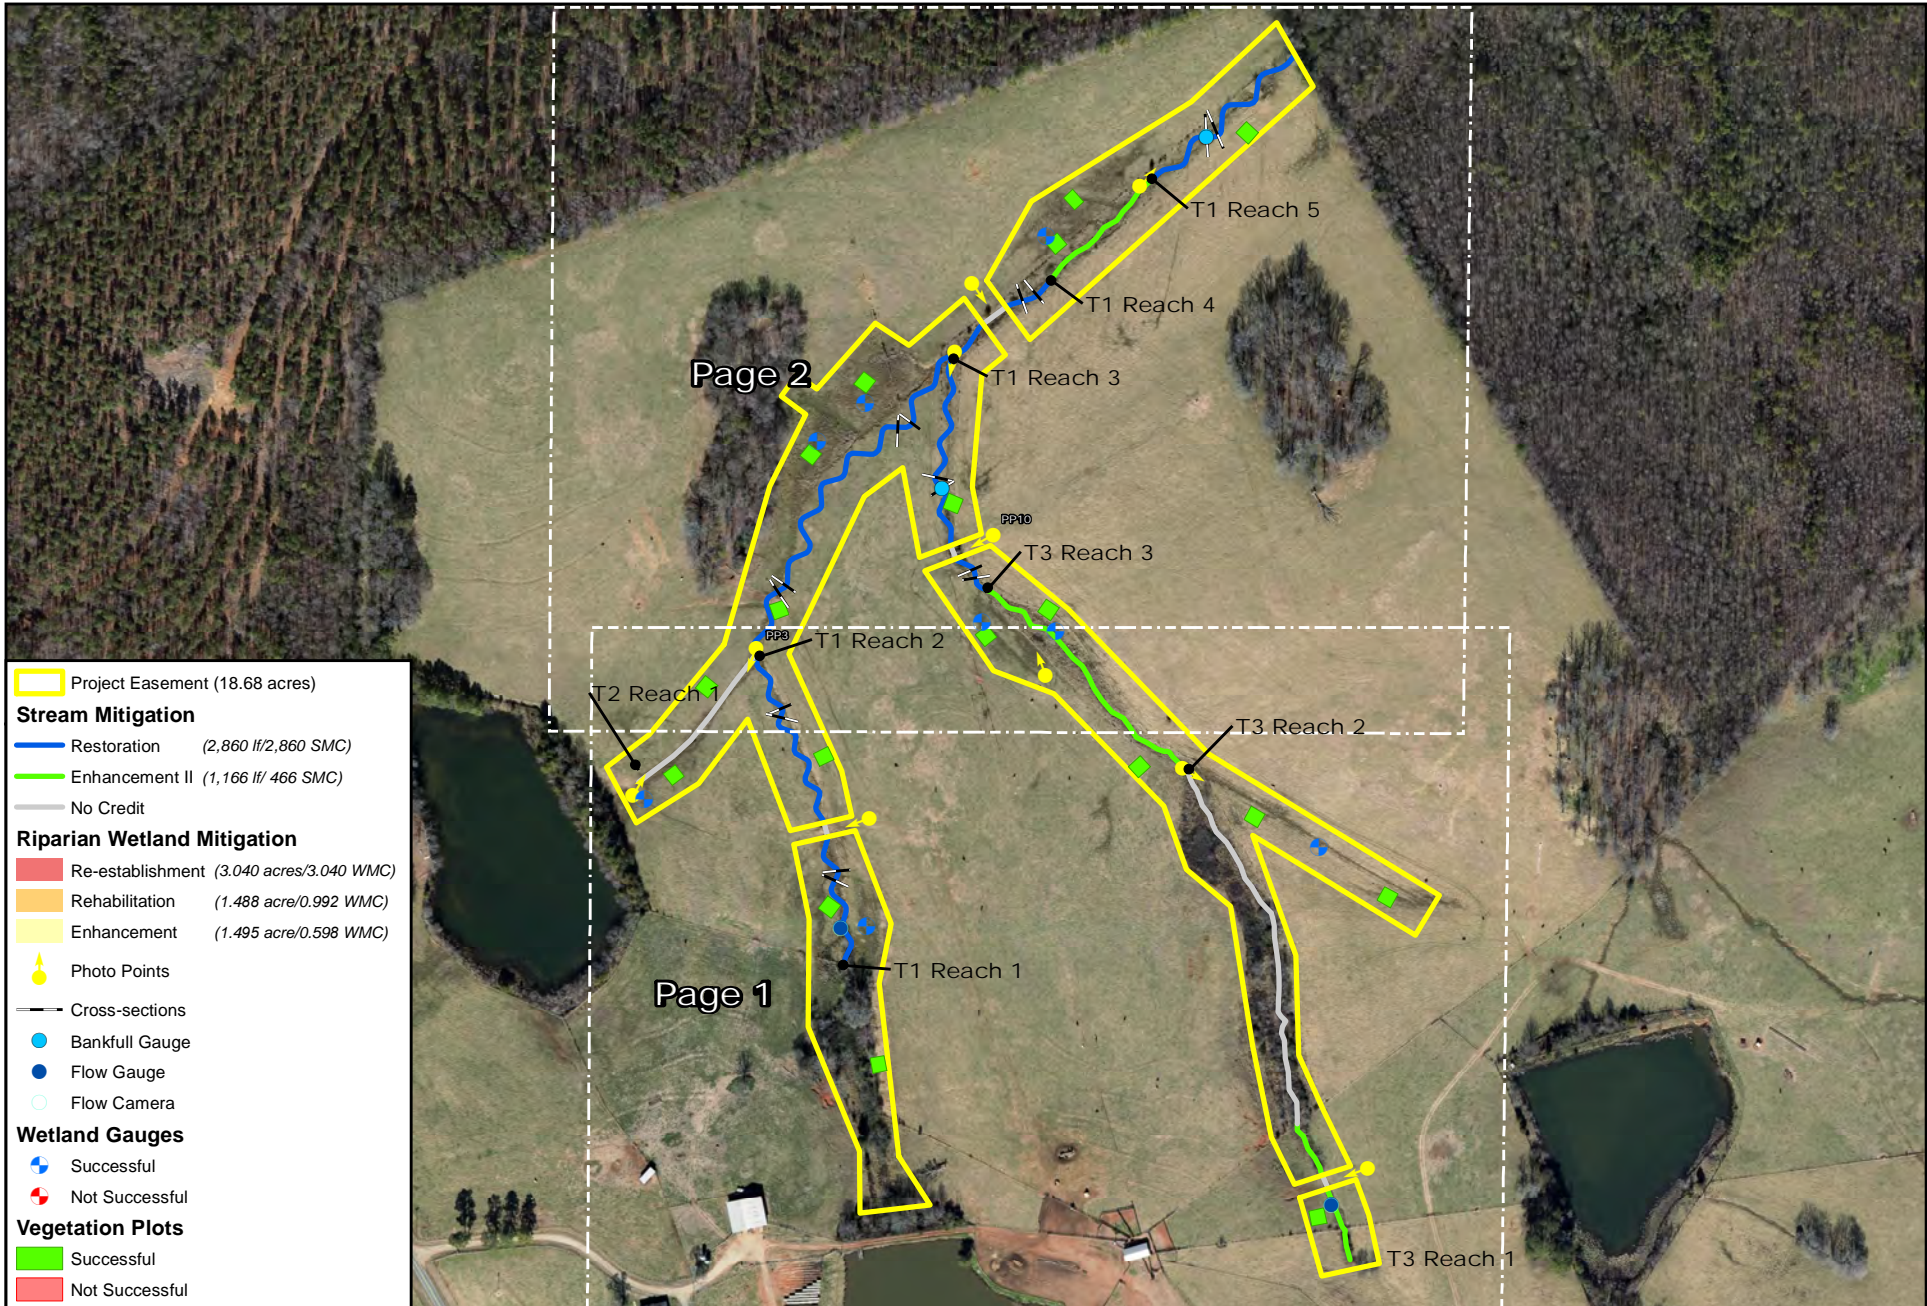
**CURRENT CONDITIONS PLANVIEW PAGE
HIP BONE CREEK RESTORATION SITE
CHATHAM COUNTY, NC**

Image Source: NC OneMap
2017 Orthoimagery.

- CCPV – The photo points should be labeled so they can be matched with the photo log.
KCI Response: The missing labels have been added to the CCPV.

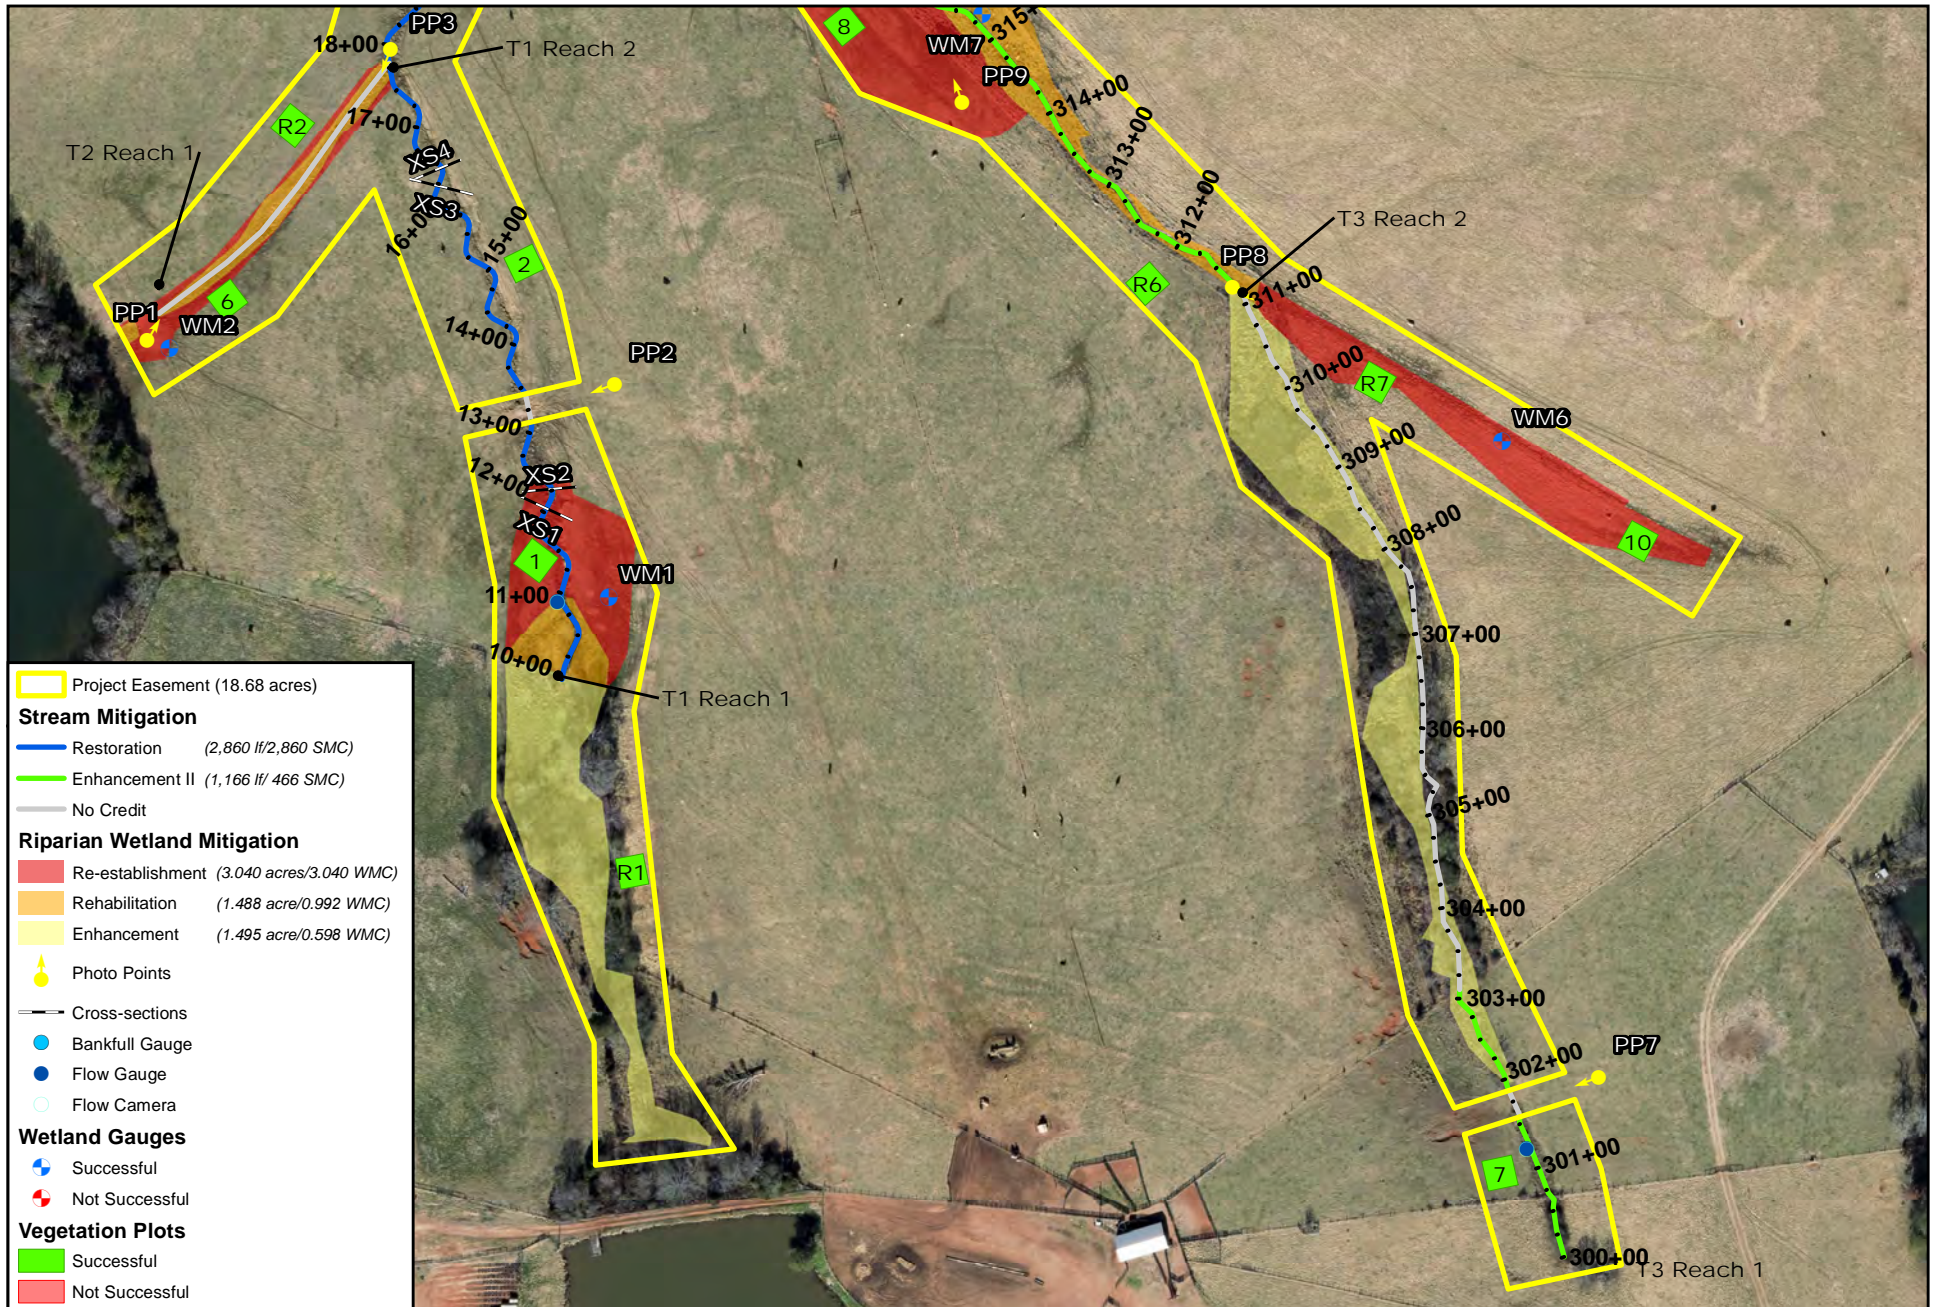
CURRENT CONDITIONS PLANVIEW PAGE
HIP BONE CREEK RESTORATION SITE
CHATHAM COUNTY, NC

Image Source: NC OneMap
 2017 Orthoimagery.

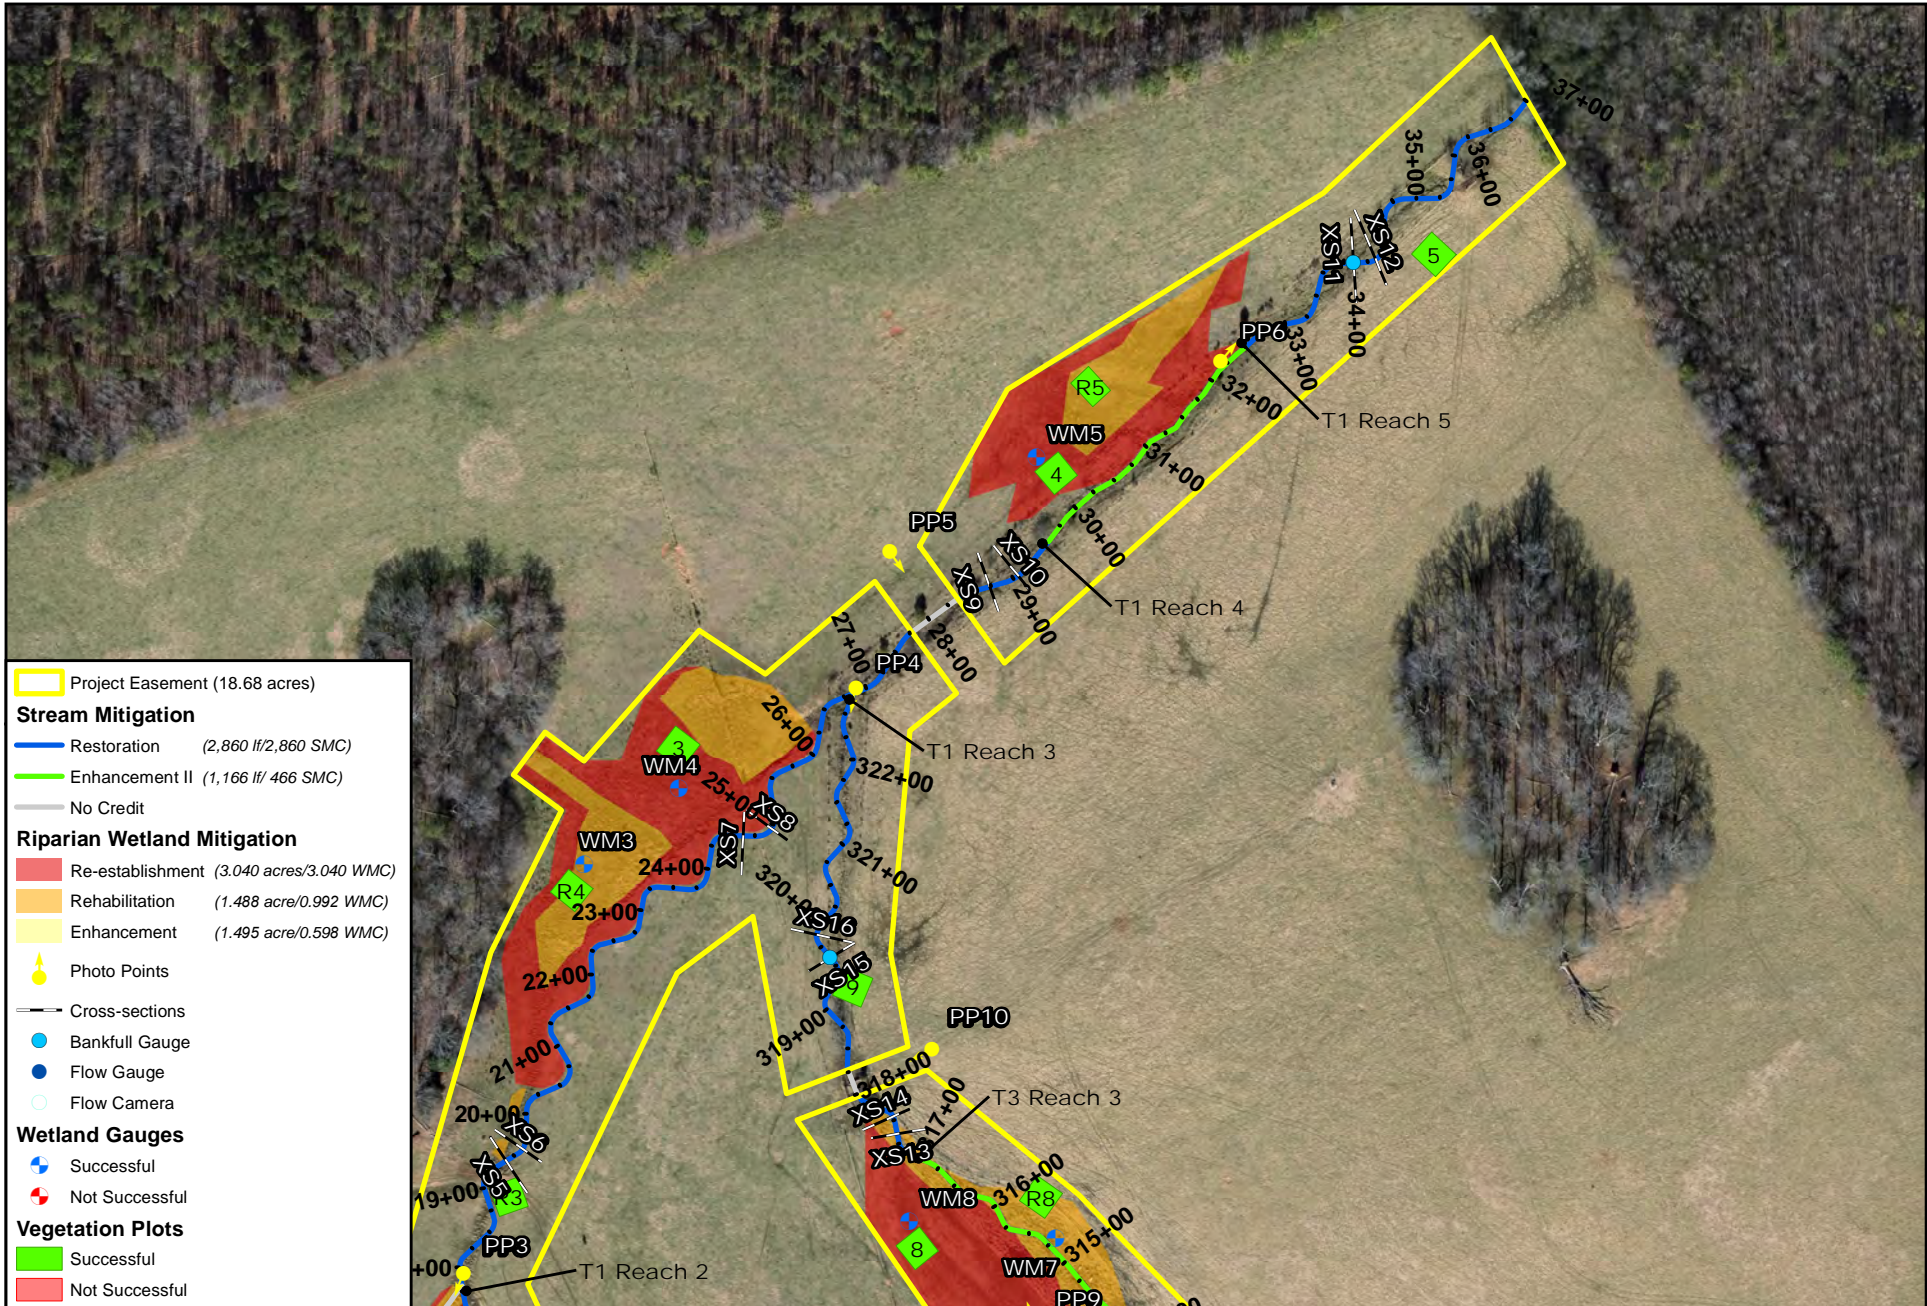
CURRENT CONDITIONS PLANVIEW PAGE
HIP BONE CREEK RESTORATION SITE
CHATHAM COUNTY, NC

Image Source: NC OneMap
 2017 Orthoimagery.

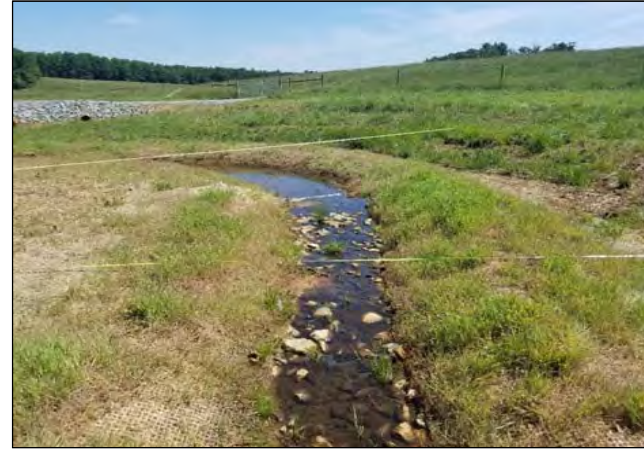
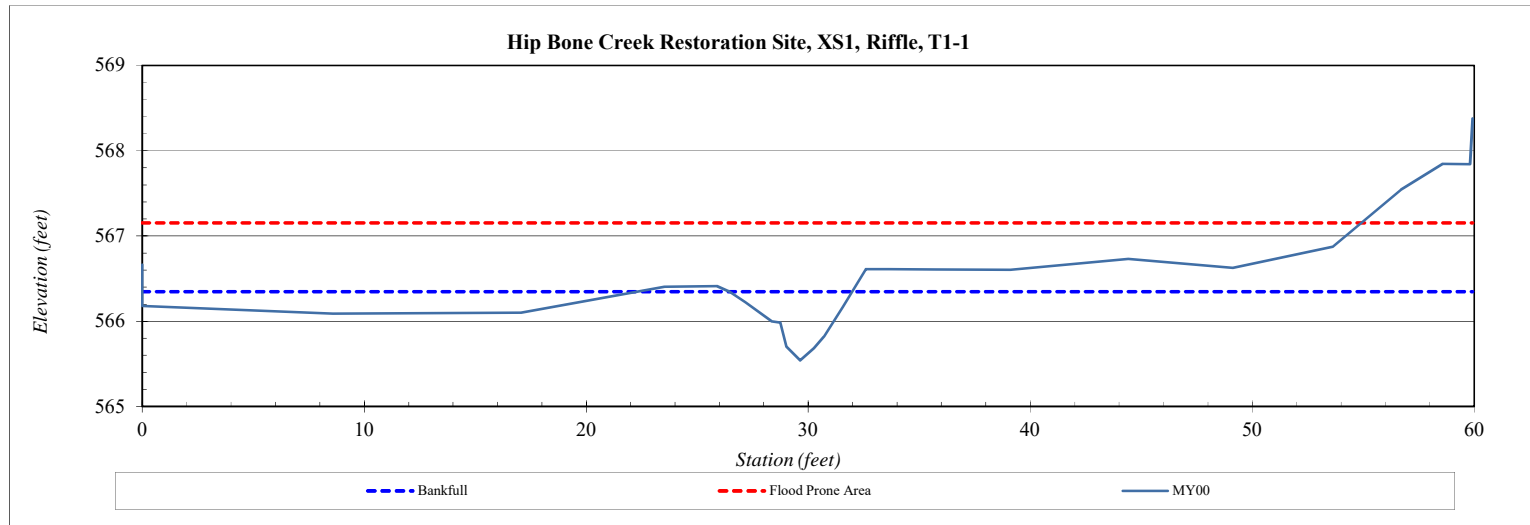
Cross-Section Plots

River Basin:	Cape Fear River
Site:	Hip Bone Creek Restoration Site
XS ID	XS1
Drainage Area (sq mi):	0.06
Date:	5/20/2021
Field Crew:	TS, KB, CP

SUMMARY DATA	
Bankfull Elevation (ft) - Based on AB-Bankfull Area	566.35
Bankfull Cross-Sectional Area (sq ft):	2.1
LTOB Cross-Sectional Area (sq ft):	2.1
Bankfull Width (ft):	5.5
Flood Prone Area Elevation (ft):	567.15
Flood Prone Width (ft):	55
Max Depth at Bankfull (ft):	0.8
Mean Depth at Bankfull (ft):	0.4
W / D Ratio (ft/ft):	14.5
Entrenchment Ratio (ft/ft):	9.9
Bank Height Ratio (ft/ft):	1.0
Thalweg Elevation (ft):	565.54

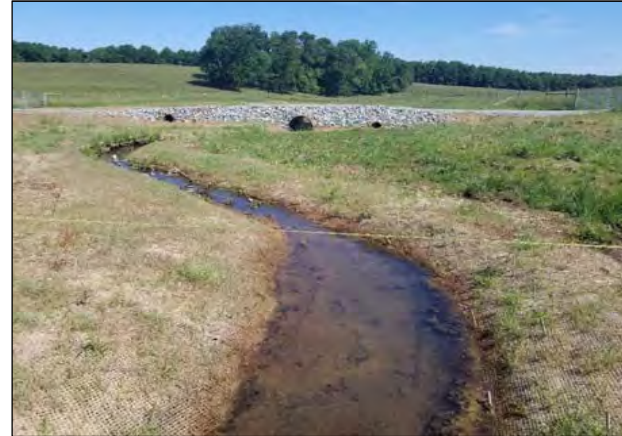
Station	Elevation
0.0	566.46
0.1	566.06
8.8	565.61
19.5	565.67
24.0	565.67
25.4	565.68
26.5	565.39
27.8	564.93
28.8	564.66
29.7	564.28
30.2	563.92
30.7	563.68
31.7	563.70
32.4	563.81
33.5	564.07
33.8	564.61
35.1	565.07
35.9	565.62
36.4	565.74
38.8	565.62
41.1	565.28
44.6	565.64
46.0	565.97
48.6	566.56
51.9	566.95
55.3	566.68
57.3	567.00
57.6	567.23

SUMMARY DATA	
Bankfull Elevation (ft) - Based on AB-Bankfull Area	565.65
Bankfull Cross-Sectional Area (sq ft):	10.9
LTOB Cross-Sectional Area (sq ft):	10.9
Bankfull Width (ft):	10.3
Flood Prone Area Elevation (ft):	---
Flood Prone Width (ft):	---
Max Depth at Bankfull (ft):	1.9
Mean Depth at Bankfull (ft):	1.1
W / D Ratio (ft/ft):	---
Entrenchment Ratio (ft/ft):	---
Bank Height Ratio (ft/ft):	1.0
Thalweg Elevation (ft):	563.71

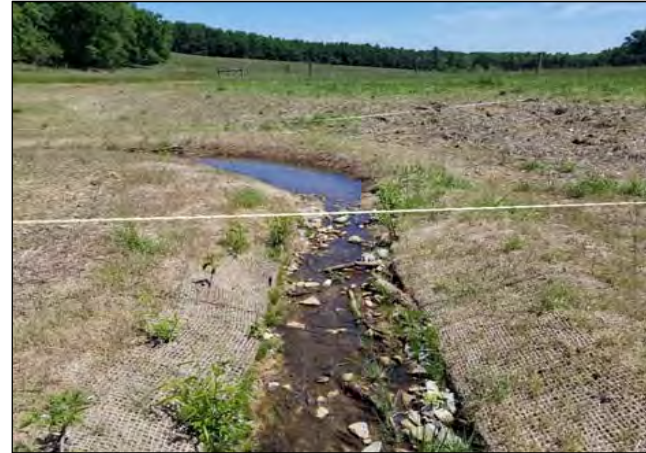
Hip Bone Creek Restoration Site, XS3, Riffle, T1-1

River Basin:	Cape Fear River
Site:	Hip Bone Creek Restoration Site
XS ID	XS3
Drainage Area (sq mi):	0.08
Date:	5/20/2021
Field Crew:	TS, KB, CP

Station	Elevation
0.0	557.59
0.2	557.29
2.0	557.24
4.2	556.77
8.3	556.16
11.9	555.48
17.3	555.64
23.5	555.64
26.6	555.78
27.4	555.66
28.0	555.59
29.0	555.11
29.2	554.75
30.2	554.69
30.9	554.56
31.3	554.72
32.1	554.97
33.4	555.45
34.4	555.98
35.3	555.84
39.4	555.81
43.5	555.86
49.4	555.90
55.9	556.32
58.8	556.67
61.2	557.19
63.9	557.71
66.1	558.04
68.6	558.09
68.9	558.57

SUMMARY DATA	
Bankfull Elevation (ft) - Based on AB-Bankfull Area	555.66
Bankfull Cross-Sectional Area (sq ft):	3.9
LTOB Cross-Sectional Area (sq ft):	3.9
Bankfull Width (ft):	6.4
Flood Prone Area Elevation (ft):	556.75
Flood Prone Width (ft):	55
Max Depth at Bankfull (ft):	1.1
Mean Depth at Bankfull (ft):	0.6
W / D Ratio (ft/ft):	10.7
Entrenchment Ratio (ft/ft):	8.5
Bank Height Ratio (ft/ft):	1.0
Thalweg Elevation (ft):	554.56

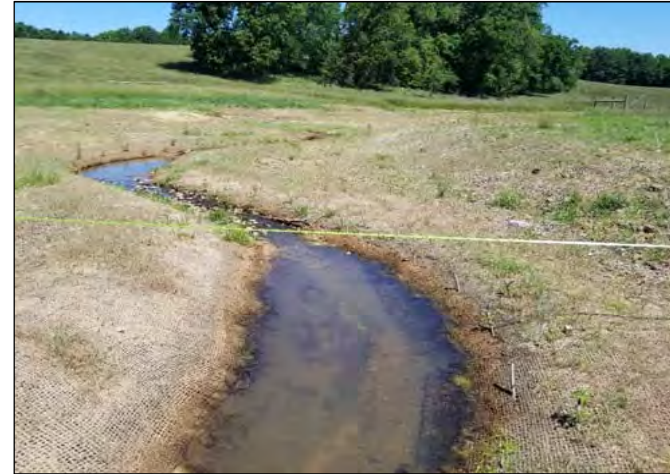
River Basin:	Cape Fear River
Site:	Hip Bone Creek Restoration Site
XS ID	XS4
Drainage Area (sq mi):	0.08
Date:	5/20/2021
Field Crew:	TS, KB, CP

Station	Elevation
0.0	557.60
0.1	557.14
2.4	556.85
5.6	556.15
9.7	555.28
18.4	554.94
24.7	555.27
27.2	555.29
28.5	555.21
29.3	555.07
31.1	554.69
32.4	554.22
32.8	554.07
33.4	553.68
34.4	553.71
34.8	553.55
35.1	553.96
36.2	553.67
36.6	553.71
37.0	553.74
37.5	554.08
38.4	554.51
39.3	555.02
39.9	555.18
41.0	555.09
43.0	555.17
44.9	555.66
48.0	556.63
51.2	556.98
53.4	557.32
56.1	557.31
56.3	557.52

SUMMARY DATA	
Bankfull Elevation (ft) - Based on AB-Bankfull Area	555.02
Bankfull Cross-Sectional Area (sq ft):	8.1
LTOB Cross-Sectional Area (sq ft):	8.1
Bankfull Width (ft):	9.8
Flood Prone Area Elevation (ft):	---
Flood Prone Width (ft):	---
Max Depth at Bankfull (ft):	1.5
Mean Depth at Bankfull (ft):	0.8
W / D Ratio (ft/ft):	---
Entrenchment Ratio (ft/ft):	---
Bank Height Ratio (ft/ft):	1.0
Thalweg Elevation (ft):	553.55

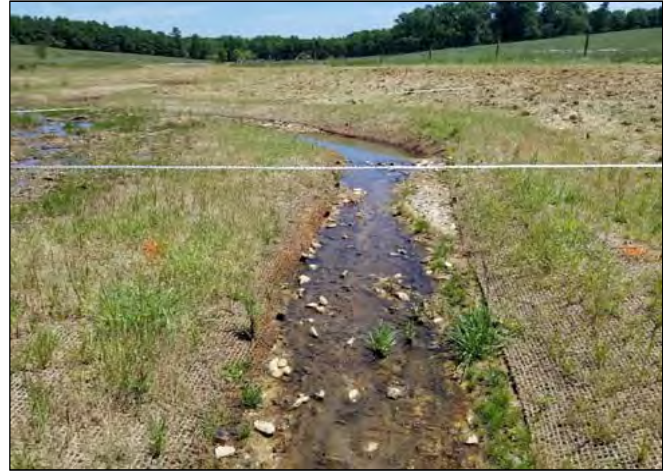
River Basin:	Cape Fear River
Site:	Hip Bone Creek Restoration Site
XS ID	XS5
Drainage Area (sq mi):	0.13
Date:	5/20/2021
Field Crew:	TS, KB, CP

Station	Elevation
0.0	551.89
0.1	551.45
3.1	551.34
5.2	551.21
5.4	550.82
8.4	550.33
12.7	550.06
18.0	550.03
21.5	550.15
24.9	550.33
26.1	550.34
27.0	549.88
28.1	549.41
28.6	549.15
29.5	549.20
29.7	549.21
30.3	549.47
30.6	549.26
31.5	549.30
32.0	549.59
33.3	549.98
34.2	550.26
35.0	550.30
37.2	550.28
41.1	550.39
44.6	550.68
49.1	550.73
57.4	551.20
63.2	552.10
66.5	552.94
70.9	553.08
71.1	553.58

SUMMARY DATA	
Bankfull Elevation (ft) - Based on AB-Bankfull Area	550.26
Bankfull Cross-Sectional Area (sq ft):	5.4
LTOB Cross-Sectional Area (sq ft):	5.4
Bankfull Width (ft):	7.9
Flood Prone Area Elevation (ft):	551.38
Flood Prone Width (ft):	57
Max Depth at Bankfull (ft):	1.1
Mean Depth at Bankfull (ft):	0.7
W / D Ratio (ft/ft):	11.7
Entrenchment Ratio (ft/ft):	7.1
Bank Height Ratio (ft/ft):	1.0
Thalweg Elevation (ft):	549.15

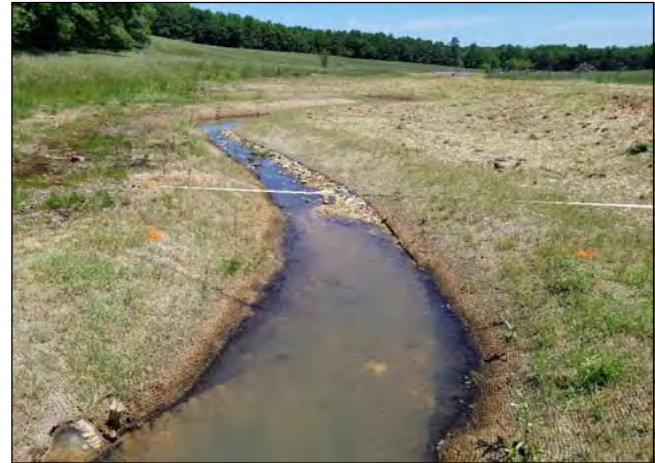
River Basin:	Cape Fear River
Site:	Hip Bone Creek Restoration Site
XS ID	XS6
Drainage Area (sq mi):	0.13
Date:	5/20/2021
Field Crew:	TS, KB, CP

Station	Elevation
0.0	551.46
0.0	550.95
2.5	550.95
4.8	550.31
6.3	549.88
9.2	549.71
11.1	550.02
15.4	549.64
18.6	549.40
23.0	549.63
27.0	549.90
28.8	549.83
29.7	549.75
30.9	549.40
32.0	548.90
33.0	548.38
33.9	548.13
34.4	547.77
35.1	547.64
36.0	547.70
36.8	547.75
37.7	548.01
38.7	548.33
39.5	548.79
40.6	549.52
41.2	549.87
42.8	549.95
44.6	549.96
49.1	550.19
53.2	551.44
56.8	552.34
58.3	552.51
60.7	552.37
60.8	552.66

SUMMARY DATA	
Bankfull Elevation (ft) - Based on AB-Bankfull Area	549.75
Bankfull Cross-Sectional Area (sq ft):	14.0
LTOB Cross-Sectional Area (sq ft):	14.0
Bankfull Width (ft):	11.3
Flood Prone Area Elevation (ft):	---
Flood Prone Width (ft):	---
Max Depth at Bankfull (ft):	2.1
Mean Depth at Bankfull (ft):	1.2
W / D Ratio (ft/ft):	---
Entrenchment Ratio (ft/ft):	---
Bank Height Ratio (ft/ft):	1.0
Thalweg Elevation (ft):	547.64

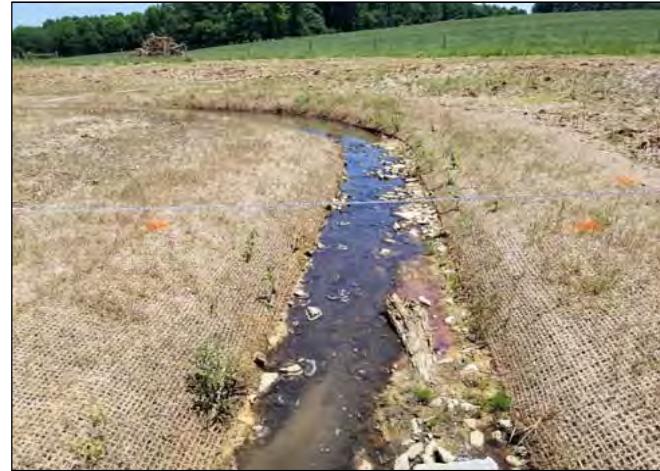
River Basin:	Cape Fear River
Site:	Hip Bone Creek Restoration Site
XS ID	XS7
Drainage Area (sq mi):	0.14
Date:	5/21/2021
Field Crew:	TS, KB, CP

Station	Elevation
0.0	542.73
0.1	542.62
7.2	542.64
14.4	542.60
19.2	542.69
20.8	542.61
21.6	542.65
22.2	542.40
23.3	542.06
23.9	541.81
24.2	541.56
24.8	541.59
25.4	541.69
26.0	541.72
26.7	541.75
27.6	542.07
28.5	542.57
29.1	542.81
29.9	542.84
32.9	542.82
37.6	542.67
42.9	542.91
47.5	543.13
52.8	542.84
55.8	543.21
58.9	544.35
63.2	545.58
65.4	546.11
67.1	546.17
67.2	546.65

SUMMARY DATA	
Bankfull Elevation (ft) - Based on AB-Bankfull Area	542.65
Bankfull Cross-Sectional Area (sq ft):	4.6
LTOB Cross-Sectional Area (sq ft):	4.6
Bankfull Width (ft):	6.5
Flood Prone Area Elevation (ft):	543.73
Flood Prone Width (ft):	57
Max Depth at Bankfull (ft):	1.1
Mean Depth at Bankfull (ft):	0.7
W / D Ratio (ft/ft):	9.3
Entrenchment Ratio (ft/ft):	8.7
Bank Height Ratio (ft/ft):	1.0
Thalweg Elevation (ft):	541.56

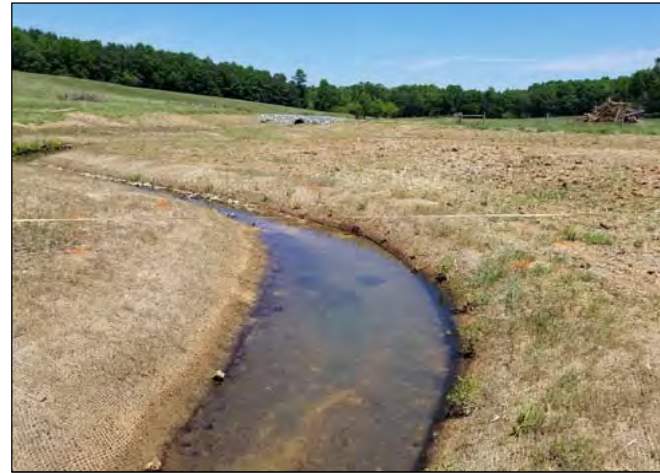
River Basin:	Cape Fear River
Site:	Hip Bone Creek Restoration Site
XS ID	XS8
Drainage Area (sq mi):	0.14
Date:	5/21/2021
Field Crew:	TS, KB, CP

Station	Elevation
0.0	542.86
0.0	542.49
7.0	542.49
14.3	542.55
20.8	542.25
24.6	542.36
25.6	542.47
26.6	542.23
28.7	541.71
30.5	541.17
31.3	540.92
32.1	540.69
32.5	540.40
33.6	540.31
34.3	540.23
35.3	540.26
36.1	540.50
37.0	541.12
38.0	542.00
38.8	542.59
40.5	542.64
42.5	542.69
44.8	542.74
46.6	543.23
48.1	543.66
50.0	544.25
51.6	544.65
54.1	544.70
54.3	544.97

SUMMARY DATA	
Bankfull Elevation (ft) - Based on AB-Bankfull Area	542.47
Bankfull Cross-Sectional Area (sq ft):	16.7
LTOB Cross-Sectional Area (sq ft):	16.7
Bankfull Width (ft):	13.1
Flood Prone Area Elevation (ft):	---
Flood Prone Width (ft):	---
Max Depth at Bankfull (ft):	2.2
Mean Depth at Bankfull (ft):	1.3
W / D Ratio (ft/ft):	---
Entrenchment Ratio (ft/ft):	---
Bank Height Ratio (ft/ft):	1.0
Thalweg Elevation (ft):	540.23

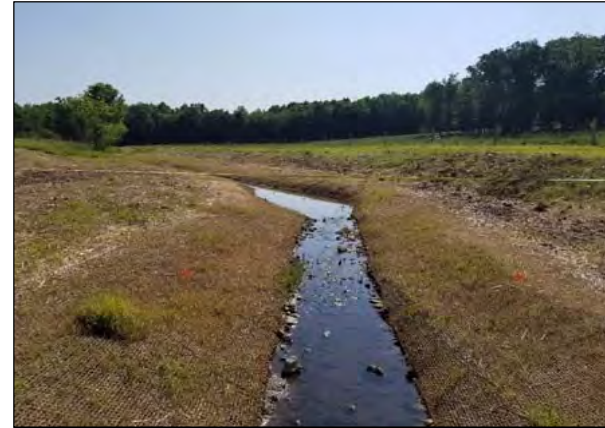
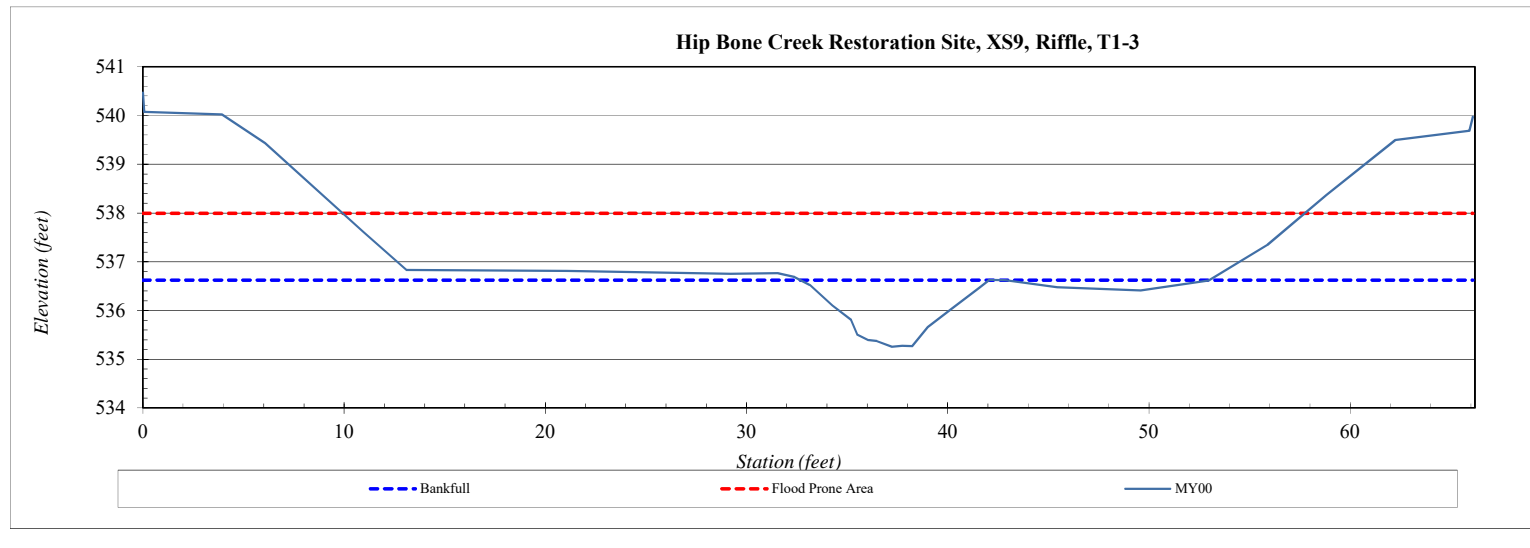
River Basin:	Cape Fear River
Site:	Hip Bone Creek Restoration Site
XS ID	XS9
Drainage Area (sq mi):	0.19
Date:	5/21/2021
Field Crew:	TS, KB, CP

Station	Elevation
0.0	540.47
0.1	540.07
3.9	540.02
6.1	539.44
10.9	537.62
13.1	536.83
21.1	536.81
29.2	536.75
31.5	536.76
32.4	536.69
33.2	536.52
34.3	536.10
35.2	535.81
35.5	535.51
36.0	535.39
36.5	535.37
37.2	535.26
37.7	535.27
38.2	535.27
39.0	535.66
40.2	536.03
41.6	536.46
42.1	536.62
42.9	536.62
45.4	536.48
49.6	536.41
53.0	536.61
55.9	537.35
58.8	538.37
62.2	539.49
65.9	539.68
66.1	539.98

SUMMARY DATA	
Bankfull Elevation (ft) - Based on AB-Bankfull Area	536.62
Bankfull Cross-Sectional Area (sq ft):	7.2
LTOB Cross-Sectional Area (sq ft):	7.2
Bankfull Width (ft):	9.4
Flood Prone Area Elevation (ft):	537.99
Flood Prone Width (ft):	48
Max Depth at Bankfull (ft):	1.4
Mean Depth at Bankfull (ft):	0.8
W / D Ratio (ft/ft):	12.3
Entrenchment Ratio (ft/ft):	5.1
Bank Height Ratio (ft/ft):	1.0
Thalweg Elevation (ft):	535.26

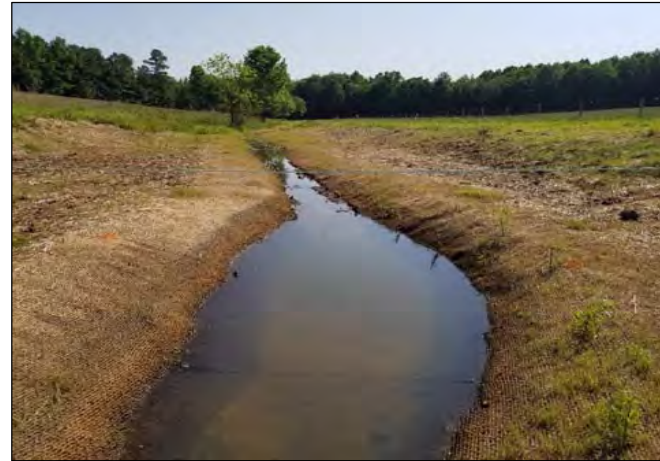
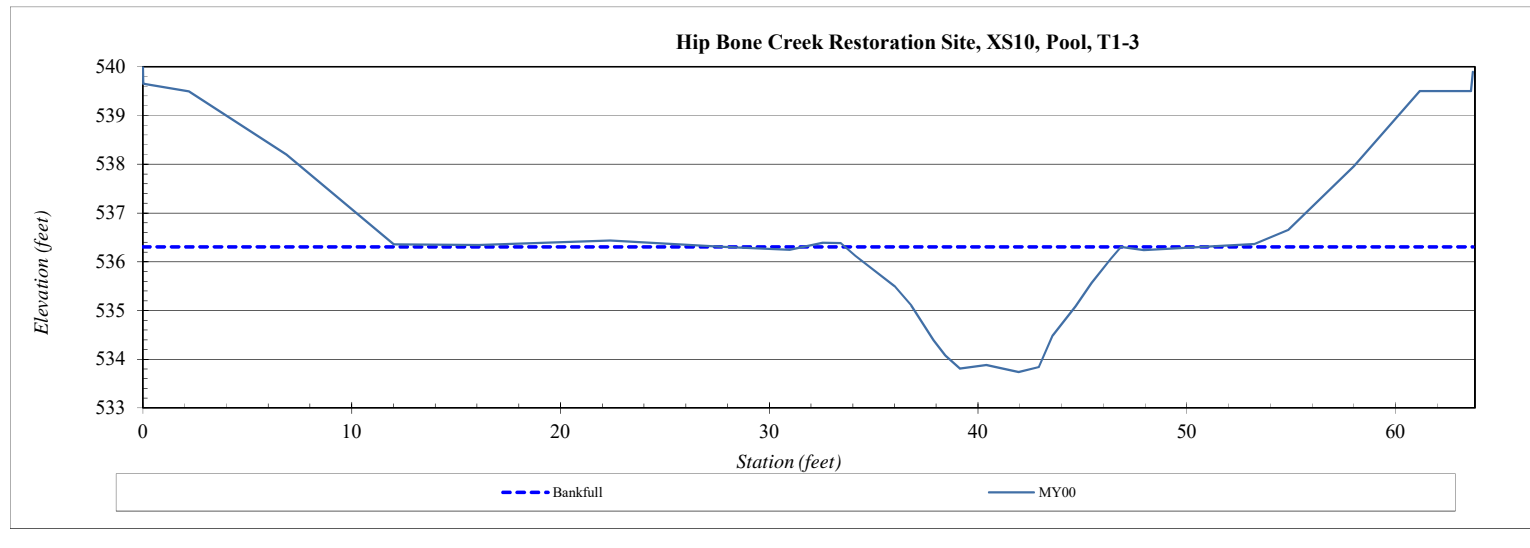
River Basin:	Cape Fear River
Site:	Hip Bone Creek Restoration Site
XS ID	XS10
Drainage Area (sq mi):	0.19
Date:	5/21/2021
Field Crew:	TS, KB, CP

Station	Elevation
0.0	539.99
0.0	539.65
2.2	539.50
6.9	538.20
12.0	536.36
16.1	536.34
22.4	536.43
27.9	536.31
31.0	536.24
32.6	536.39
33.4	536.38
34.1	536.12
36.0	535.50
36.8	535.10
37.9	534.39
38.4	534.08
39.1	533.81
40.4	533.88
41.9	533.74
42.9	533.84
43.6	534.49
44.7	535.09
45.4	535.56
46.4	536.07
46.8	536.31
47.9	536.24
53.2	536.36
54.9	536.66
58.0	537.96
61.2	539.50
63.6	539.50
63.7	539.90

SUMMARY DATA	
Bankfull Elevation (ft) - Based on AB-Bankfull Area	536.31
Bankfull Cross-Sectional Area (sq ft):	20.0
LTOB Cross-Sectional Area (sq ft):	20.0
Bankfull Width (ft):	12.7
Flood Prone Area Elevation (ft):	---
Flood Prone Width (ft):	---
Max Depth at Bankfull (ft):	2.6
Mean Depth at Bankfull (ft):	1.6
W / D Ratio (ft/ft):	---
Entrenchment Ratio (ft/ft):	---
Bank Height Ratio (ft/ft):	1.0
Thalweg Elevation (ft):	533.74

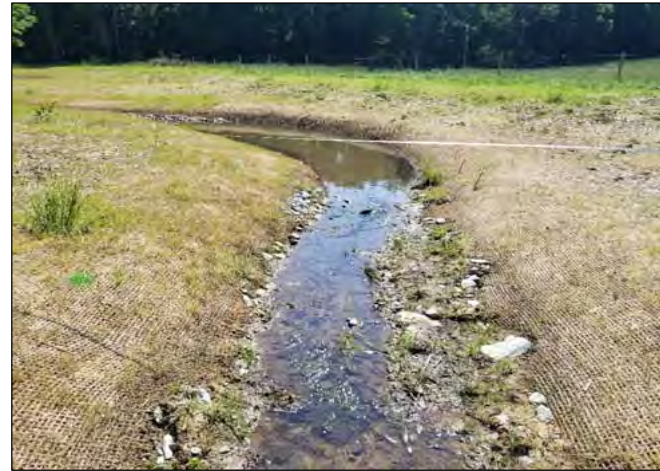
River Basin:	Cape Fear River
Site:	Hip Bone Creek Restoration Site
XS ID	XS11
Drainage Area (sq mi):	0.25
Date:	5/20/2021
Field Crew:	TS, KB, CP

Station	Elevation
0.0	534.63
0.0	534.22
1.8	533.89
6.0	532.80
11.1	531.74
14.4	531.52
22.0	531.47
30.5	531.50
37.4	531.36
41.7	531.44
42.9	531.45
44.1	530.82
45.0	530.45
45.6	530.21
46.2	530.24
46.8	530.26
47.4	530.34
47.9	530.35
48.8	530.46
50.3	530.76
51.8	531.39
52.7	531.56
54.1	531.57
60.1	531.33
69.0	531.43
76.0	531.66
80.2	531.91
82.7	532.38
85.6	533.11
87.9	533.76
89.3	534.02
90.5	534.04
90.4	534.30

SUMMARY DATA	
Bankfull Elevation (ft) - Based on AB-Bankfull Area	531.45
Bankfull Cross-Sectional Area (sq ft):	7.3
LTOB Cross-Sectional Area (sq ft):	7.3
Bankfull Width (ft):	9.3
Flood Prone Area Elevation (ft):	532.70
Flood Prone Width (ft):	77
Max Depth at Bankfull (ft):	1.2
Mean Depth at Bankfull (ft):	0.8
W / D Ratio (ft/ft):	11.8
Entrenchment Ratio (ft/ft):	8.3
Bank Height Ratio (ft/ft):	1.0
Thalweg Elevation (ft):	530.21

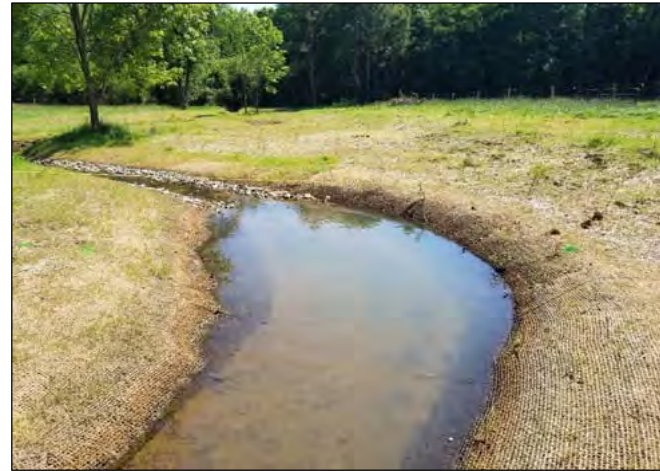
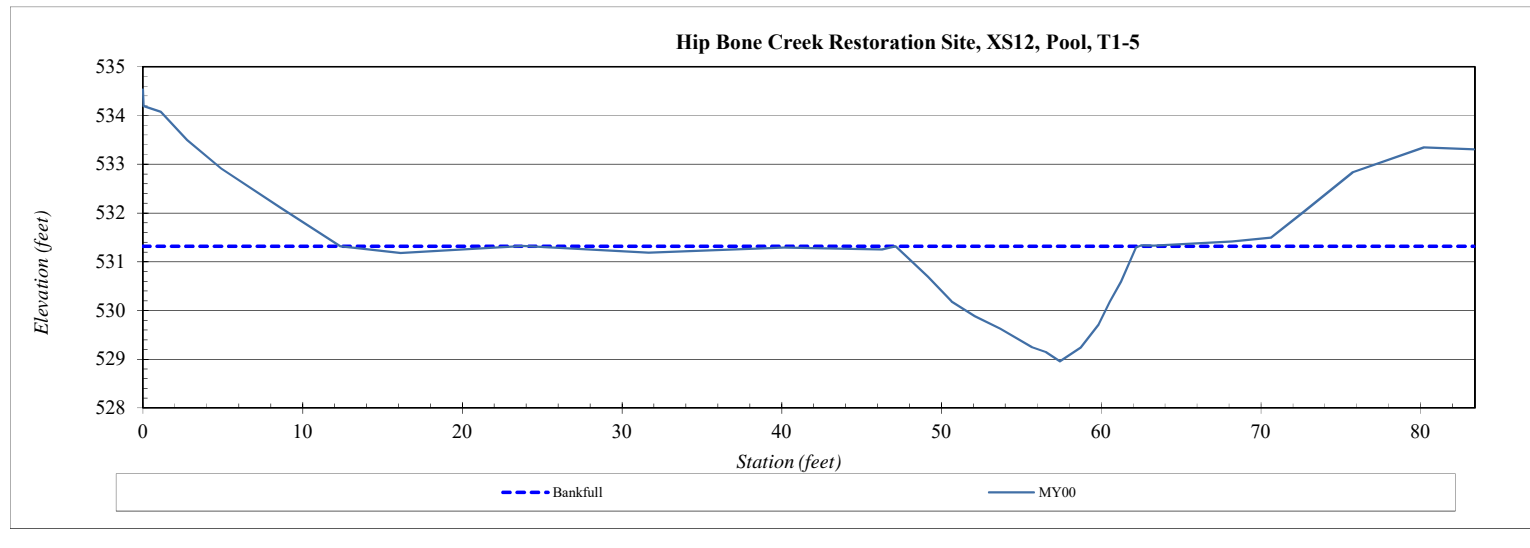
River Basin:	Cape Fear River
Site:	Hip Bone Creek Restoration Site
XS ID	XS12
Drainage Area (sq mi):	0.25
Date:	5/20/2021
Field Crew:	TS, KB, CP

Station	Elevation
0.0	534.53
0.1	534.19
1.1	534.08
2.8	533.50
4.9	532.91
8.7	532.10
12.4	531.31
16.1	531.17
23.8	531.32
31.7	531.18
40.1	531.29
46.3	531.25
47.1	531.32
47.8	531.12
49.1	530.69
50.6	530.19
52.1	529.88
53.7	529.63
55.7	529.25
56.5	529.15
57.4	528.96
58.7	529.24
59.8	529.71
60.5	530.18
61.3	530.59
62.2	531.30
62.5	531.34
63.3	531.33
68.2	531.41
70.6	531.49
72.7	532.02
75.8	532.84
80.2	533.34
83.3	533.30

SUMMARY DATA	
Bankfull Elevation (ft) - Based on AB-Bankfull Area	531.32
Bankfull Cross-Sectional Area (sq ft):	20.8
LTOB Cross-Sectional Area (sq ft):	20.8
Bankfull Width (ft):	15.1
Flood Prone Area Elevation (ft):	---
Flood Prone Width (ft):	---
Max Depth at Bankfull (ft):	2.4
Mean Depth at Bankfull (ft):	1.4
W / D Ratio (ft/ft):	---
Entrenchment Ratio (ft/ft):	---
Bank Height Ratio (ft/ft):	1.0
Thalweg Elevation (ft):	528.96

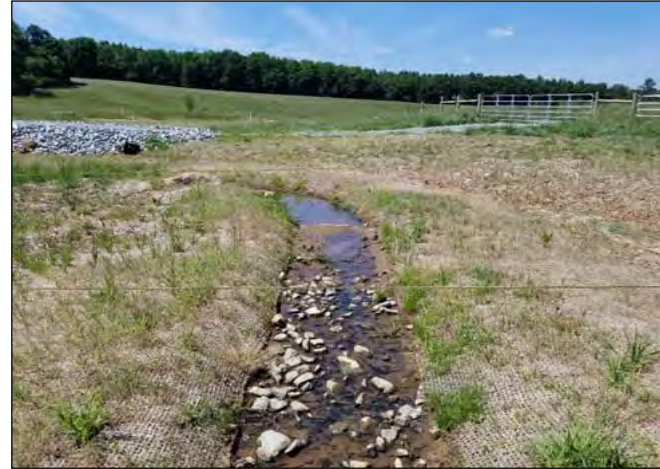
River Basin:	Cape Fear River
Site:	Hip Bone Creek Restoration Site
XS ID	XS13
Drainage Area (sq mi):	0.05
Date:	5/20/2021
Field Crew:	TS, KB, CP

Station	Elevation
0.0	550.98
0.1	550.53
2.4	550.58
5.6	549.77
11.0	548.71
15.7	548.70
21.5	548.83
24.1	548.88
24.9	548.93
25.7	548.69
26.5	548.42
26.9	548.17
27.3	548.00
28.0	548.02
28.8	548.07
29.5	548.03
29.6	548.01
30.4	548.45
31.2	548.63
31.7	548.84
32.6	548.89
34.9	548.96
37.8	549.00
41.8	548.93
47.4	549.10
52.3	549.80
56.2	550.56
58.4	550.69
58.6	551.16

SUMMARY DATA	
Bankfull Elevation (ft) - Based on AB-Bankfull Area	548.84
Bankfull Cross-Sectional Area (sq ft):	3.4
LTOB Cross-Sectional Area (sq ft):	3.4
Bankfull Width (ft):	6.5
Flood Prone Area Elevation (ft):	549.67
Flood Prone Width (ft):	45
Max Depth at Bankfull (ft):	0.8
Mean Depth at Bankfull (ft):	0.5
W / D Ratio (ft/ft):	12.3
Entrenchment Ratio (ft/ft):	7.0
Bank Height Ratio (ft/ft):	1.0
Thalweg Elevation (ft):	548.00

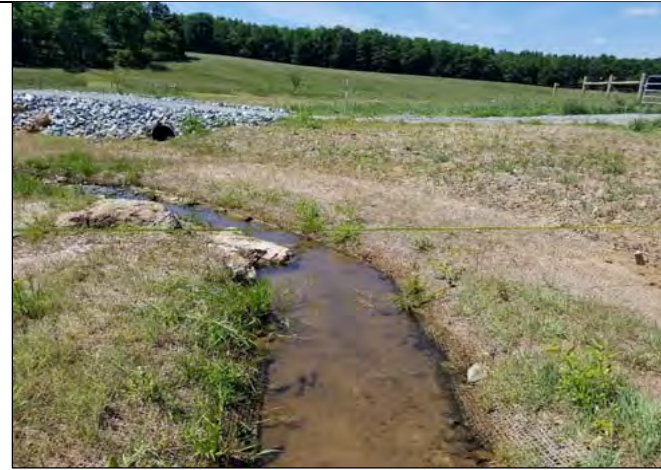
River Basin:	Cape Fear River
Site:	Hip Bone Creek Restoration Site
XS ID	XS14
Drainage Area (sq mi):	0.05
Date:	5/20/2021
Field Crew:	TS, KB, CP

Station	Elevation
0.0	550.47
0.2	550.06
5.3	549.64
9.8	548.70
14.5	548.16
20.0	548.40
25.8	548.35
29.9	548.20
32.3	548.47
33.5	548.41
34.7	547.98
35.0	547.58
35.7	547.28
36.3	547.16
36.8	547.26
38.1	547.19
38.8	547.64
39.3	547.88
40.1	548.25
41.2	548.26
43.6	548.38
45.5	548.41
46.9	548.84
48.3	549.06
49.2	549.65
51.0	549.70
54.7	549.78
54.8	550.10

SUMMARY DATA	
Bankfull Elevation (ft) - Based on AB-Bankfull Area	548.25
Bankfull Cross-Sectional Area (sq ft):	4.3
LTOB Cross-Sectional Area (sq ft):	4.3
Bankfull Width (ft):	6.2
Flood Prone Area Elevation (ft):	---
Flood Prone Width (ft):	---
Max Depth at Bankfull (ft):	1.1
Mean Depth at Bankfull (ft):	0.7
W / D Ratio (ft/ft):	---
Entrenchment Ratio (ft/ft):	---
Bank Height Ratio (ft/ft):	1.0
Thalweg Elevation (ft):	547.16

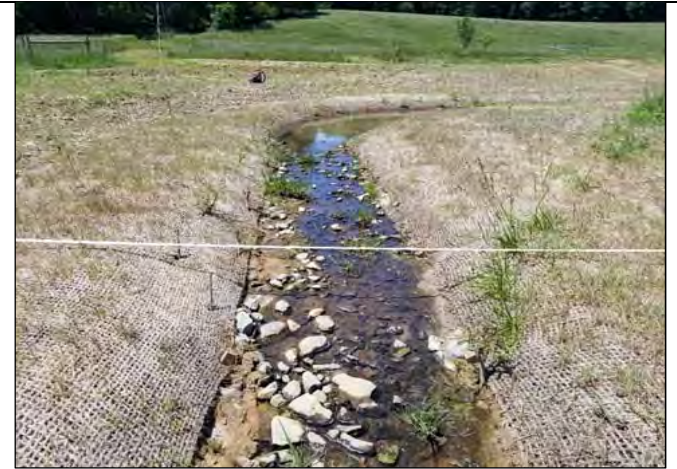
River Basin:	Cape Fear River
Site:	Hip Bone Creek Restoration Site
XS ID	XS15
Drainage Area (sq mi):	0.06
Date:	5/20/2021
Field Crew:	TS, KB, CP

Station	Elevation
0.0	546.56
0.1	546.23
1.5	545.95
5.4	545.31
6.7	545.26
9.8	545.15
14.7	544.97
19.2	544.93
21.4	544.85
23.2	544.79
23.7	544.77
24.3	544.62
25.2	544.31
25.9	544.04
26.5	543.87
26.9	543.86
27.7	543.83
28.4	543.80
29.0	543.97
29.8	544.38
30.5	544.72
31.0	544.70
32.2	544.66
35.6	544.53
40.6	544.36
44.1	544.46
46.5	544.50
48.3	544.76
50.9	545.12
53.2	545.33
54.3	546.11
56.7	546.03
56.7	546.49

SUMMARY DATA	
Bankfull Elevation (ft) - Based on AB-Bankfull Area	544.72
Bankfull Cross-Sectional Area (sq ft):	3.9
LTOB Cross-Sectional Area (sq ft):	3.9
Bankfull Width (ft):	7.2
Flood Prone Area Elevation (ft):	545.64
Flood Prone Width (ft):	50
Max Depth at Bankfull (ft):	0.9
Mean Depth at Bankfull (ft):	0.5
W / D Ratio (ft/ft):	13.3
Entrenchment Ratio (ft/ft):	7.0
Bank Height Ratio (ft/ft):	1.0
Thalweg Elevation (ft):	543.80

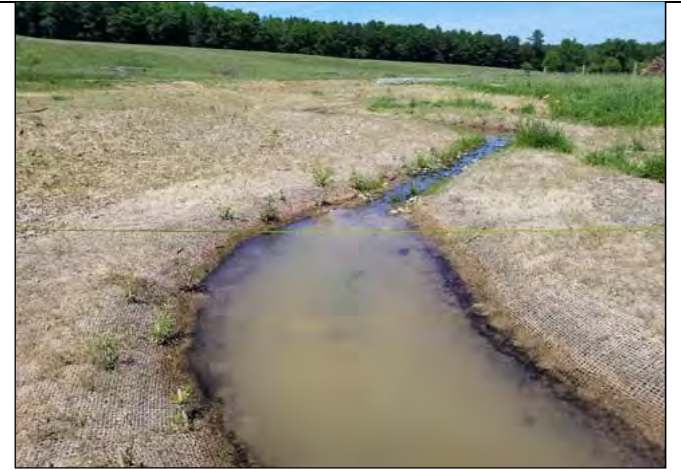
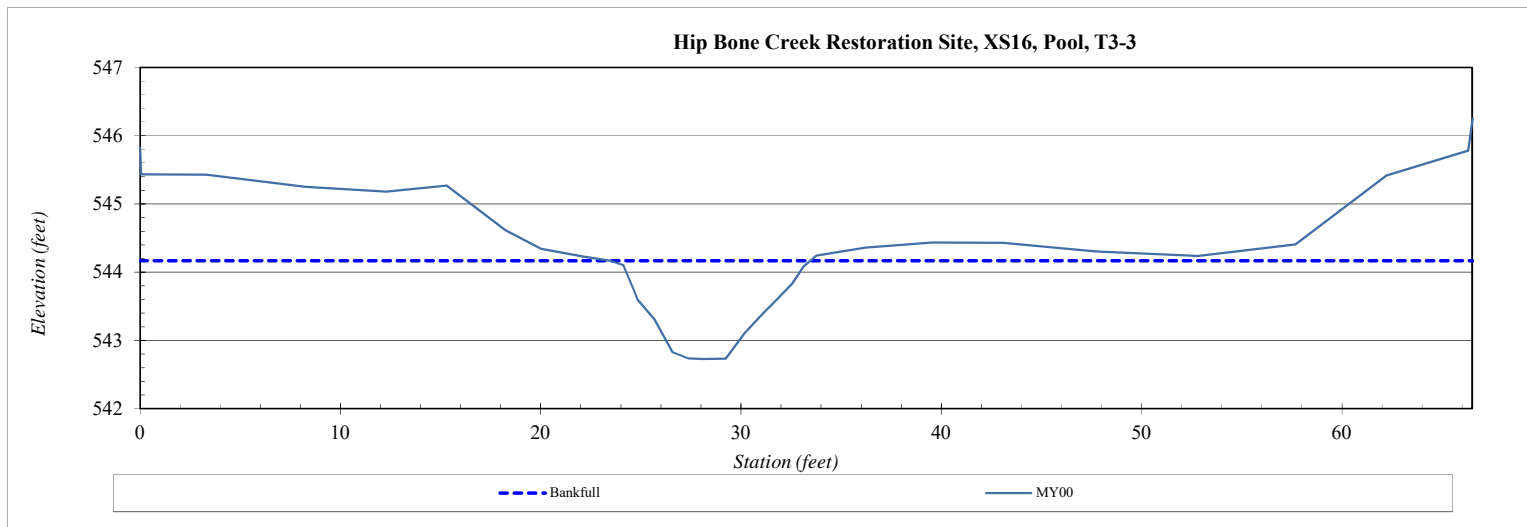
Station	Elevation
0.0	545.82
0.1	545.43
3.3	545.43
8.3	545.25
12.3	545.18
15.3	545.27
18.2	544.62
20.0	544.34
22.1	544.23
23.5	544.17
24.1	544.11
24.7	543.73
24.8	543.60
25.7	543.31
26.6	542.83
27.4	542.74
28.1	542.73
29.2	542.73
30.2	543.11
31.1	543.39
31.7	543.58
32.6	543.83
33.1	544.09
33.8	544.24
36.2	544.36
39.5	544.43
43.1	544.43
47.7	544.30
52.8	544.24
57.7	544.41
62.2	545.41
66.3	545.78
66.5	546.25

SUMMARY DATA	
Bankfull Elevation (ft) - Based on AB-Bankfull Area	544.17
Bankfull Cross-Sectional Area (sq ft):	8.6
LTOB Cross-Sectional Area (sq ft):	8.6
Bankfull Width (ft):	10.0
Flood Prone Area Elevation (ft):	---
Flood Prone Width (ft):	---
Max Depth at Bankfull (ft):	1.4
Mean Depth at Bankfull (ft):	0.9
W / D Ratio (ft/ft):	---
Entrenchment Ratio (ft/ft):	---
Bank Height Ratio (ft/ft):	1.0
Thalweg Elevation (ft):	542.73

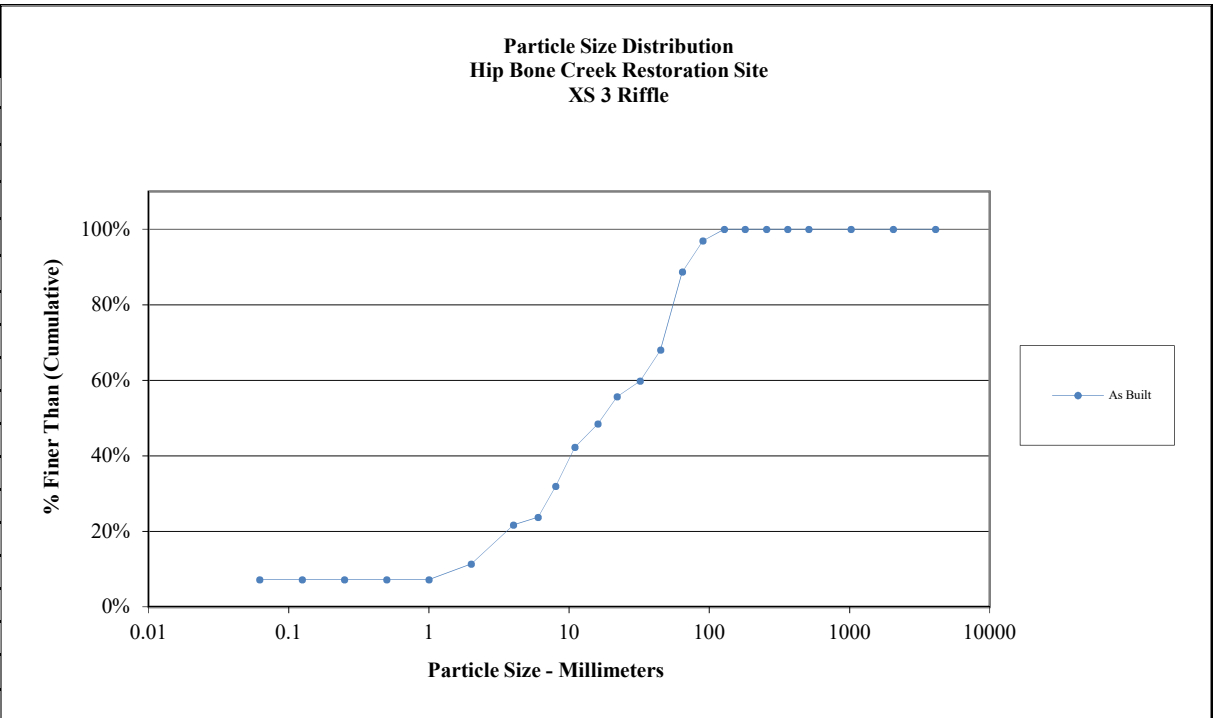
Cross-Section 3 Riffle - MY-00			
Particle	Millimeter		Count
Silt/Clay	< 0.062	S/C	7
Very Fine	.062 - .125	S	
Fine	.125 - .25	A	
Medium	.25 - .50	N	
Coarse	.50 - 1	D	
Very Coarse	1 - 2	S	4
Very Fine	2 - 4		10
Fine	4 - 5.7	G	2
Fine	5.7 - 8	R	8
Medium	8 - 11.3	A	10
Medium	11.3 - 16	V	6
Coarse	16 - 22.6	E	7
Coarse	22.6 - 32	L	4
Very Coarse	32 - 45	S	8
Very Coarse	45 - 64		20
Small	64 - 90	C	8
Small	90 - 128	O	3
Large	128 - 180	B	
Large	180 - 256	L	
Small	256 - 362	B	
Small	362 - 512	L	
Medium	512 - 1024	D	
Lrg- Very Lrg	1024 - 2048	R	
Bedrock	>2048	BDRK	
		Total	97

Size (mm)	
D16	2.7
D35	8.8
D50	17
D65	40
D84	59
D95	83

Size Distribution	
mean	12.6
dispersion	4.9
skewness	-0.11

Type	
silt/clay	7%
sand	4%
gravel	77%
cobble	11%
boulder	0%
bedrock	0%
hardpan	0%
wood/det	0%
artificial	0%

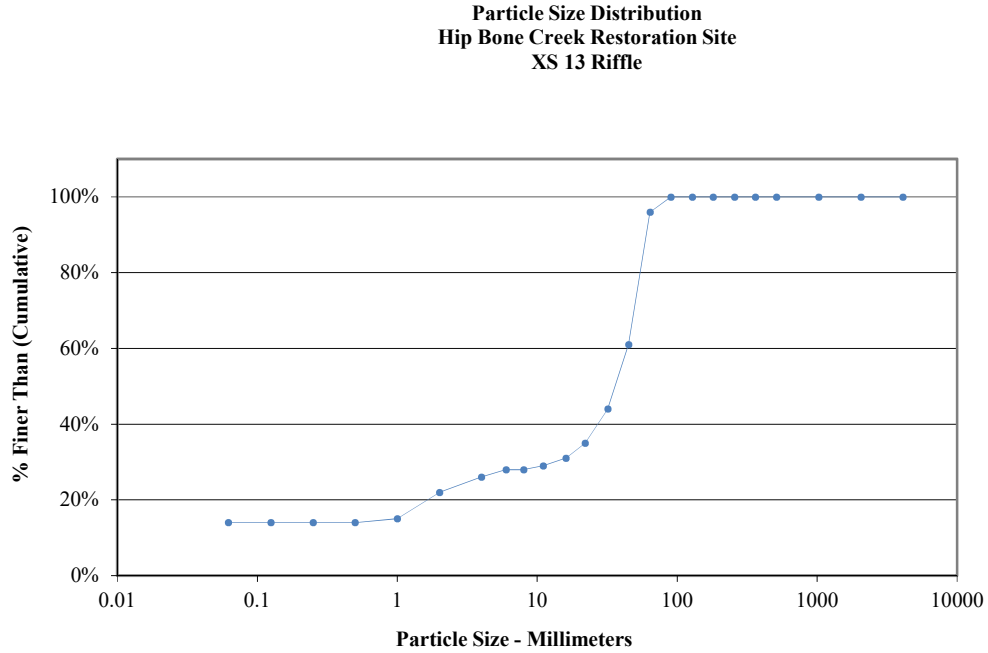
Cross-Section 13 Riffle - MY-00			
Particle	Millimeter		Count
Silt/Clay	< 0.062	S/C	14
Very Fine	.062 - .125	S	
Fine	.125 - .25	A	
Medium	.25 - .50	N	
Coarse	.50 - 1	D	1
Very Coarse	1 - 2	S	7
Very Fine	2 - 4		4
Fine	4 - 5.7	G	2
Fine	5.7 - 8	R	
Medium	8 - 11.3	A	1
Medium	11.3 - 16	V	2
Coarse	16 - 22.6	E	4
Coarse	22.6 - 32	L	9
Very Coarse	32 - 45	S	17
Very Coarse	45 - 64		35
Small	64 - 90	C	4
Small	90 - 128	O	
Large	128 - 180	B	
Large	180 - 256	L	
Small	256 - 362	B	
Small	362 - 512	L	
Medium	512 - 1024	D	
Lrg- Very Lrg	1024 - 2048	R	
Bedrock	>2048	BDRK	
		Total	100

Size (mm)	
D16	1.1
D35	22
D50	36
D65	47
D84	57
D95	63

Size Distribution	
mean	7.9
dispersion	17.2
skewness	-0.50

Type	
silt/clay	14%
sand	8%
gravel	74%
cobble	4%
boulder	0%
bedrock	0%
hardpan	0%
wood/det	0%
artificial	0%
