Hip Bone Creek Baseline Monitoring Report

Hip Bone Creek Restoration Site
Cape Fear River Basin - 03030003
Monitoring Year 00
DMS Contract 7528
DMS Project Number 100059

DWR #: 2018-0785
USACE AID #: SAW-2018-01160
Chatham County, North Carolina

Baseline Data Collected: May 2021
Date Submitted: August 2021

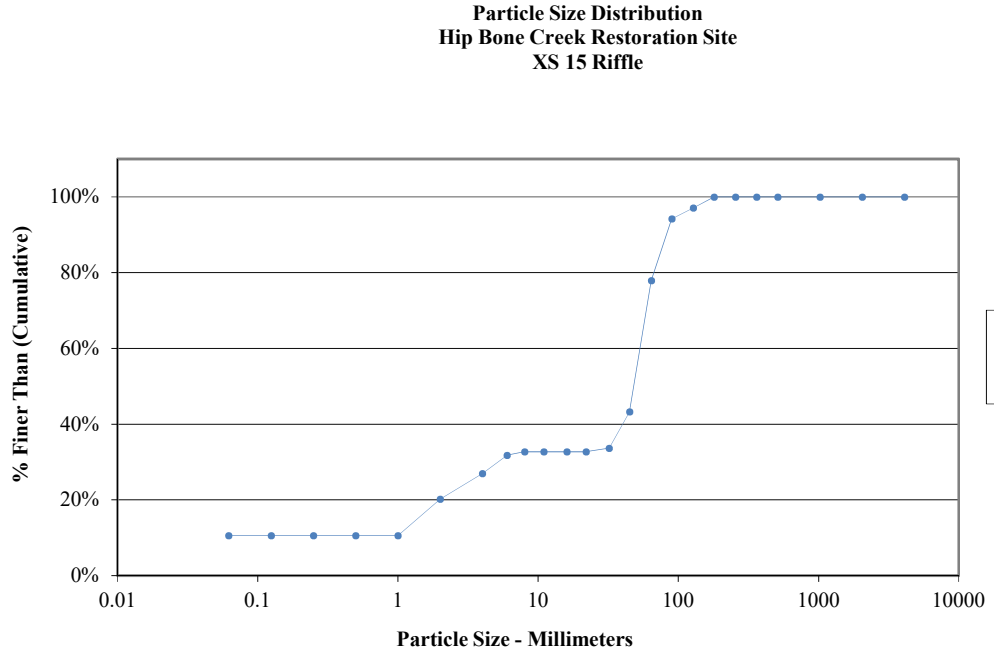
Cross-Section 15 Riffle - MY-00			
Particle	Millimeter		Count
Silt/Clay	< 0.062	S/C	11
Very Fine	.062 - .125	S	
Fine	.125 - .25	A	
Medium	.25 - .50	N	
Coarse	.50 - 1	D	
Very Coarse	1 - 2	S	10
Very Fine	2 - 4		7
Fine	4 - 5.7	G	5
Fine	5.7 - 8	R	1
Medium	8 - 11.3	A	
Medium	11.3 - 16	V	
Coarse	16 - 22.6	E	
Coarse	22.6 - 32	L	1
Very Coarse	32 - 45	S	10
Very Coarse	45 - 64		36
Small	64 - 90	C	17
Small	90 - 128	O	3
Large	128 - 180	B	3
Large	180 - 256	L	
Small	256 - 362	B	
Small	362 - 512	L	
Medium	512 - 1024	D	
Lrg- Very Lrg	1024 - 2048	R	
Bedrock	>2048	BDRK	
		Total	104

Size (mm)	
D16	1.5
D35	34
D50	48
D65	56
D84	73
D95	99

Size Distribution	
mean	10.5
dispersion	16.8
skewness	-0.51

Type	
silt/clay	11%
sand	10%
gravel	58%
cobble	22%
boulder	0%
bedrock	0%
hardpan	0%
wood/det	0%
artificial	0%

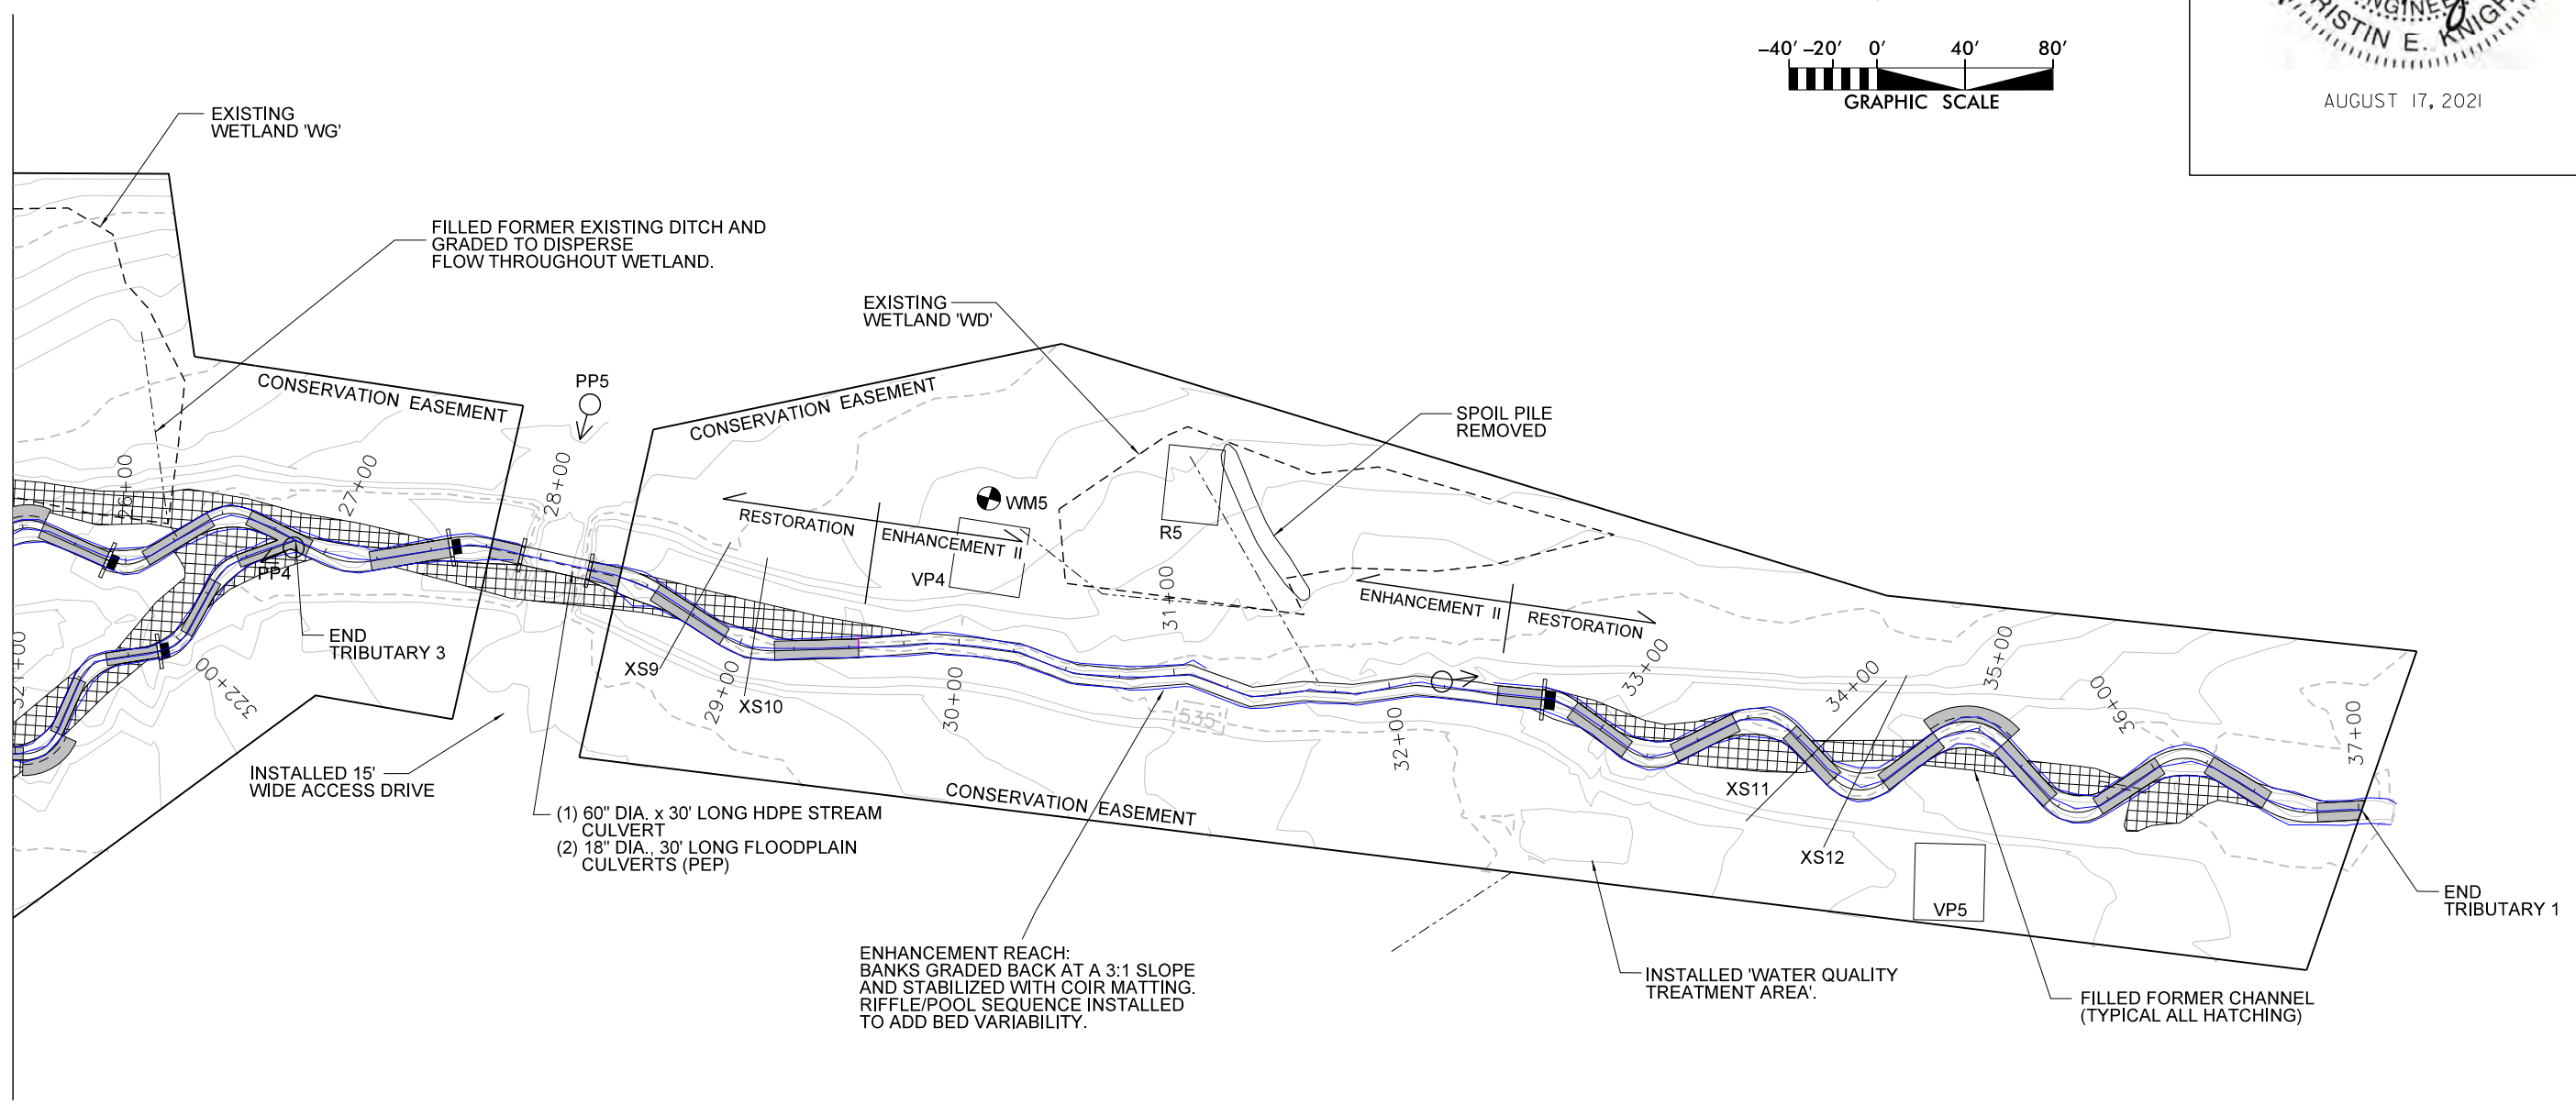
SITE PLAN

MATCHLINE - SEE SHEET 4 FOR TRIBUTARY 1 / SEE SHEETS 6-7 FOR TRIBUTARY 3

- (1) 60" DIA. x 30' LONG HDPE STREAM CULVERT
- (2) 18" DIA., 30' LONG FLOODPLAIN CULVERTS (PEP)

ENHANCEMENT REACH:
BANKS GRADED BACK AT A 3:1 SLOPE AND STABILIZED WITH COIR MATTING. RIFFLE/POOL SEQUENCE INSTALLED TO ADD BED VARIABILITY.

ALL TOPOGRAPHIC AND FEATURE DATA ARE BASED ON THE AS-BUILT SURVEY COMPLETED MAY 2021.

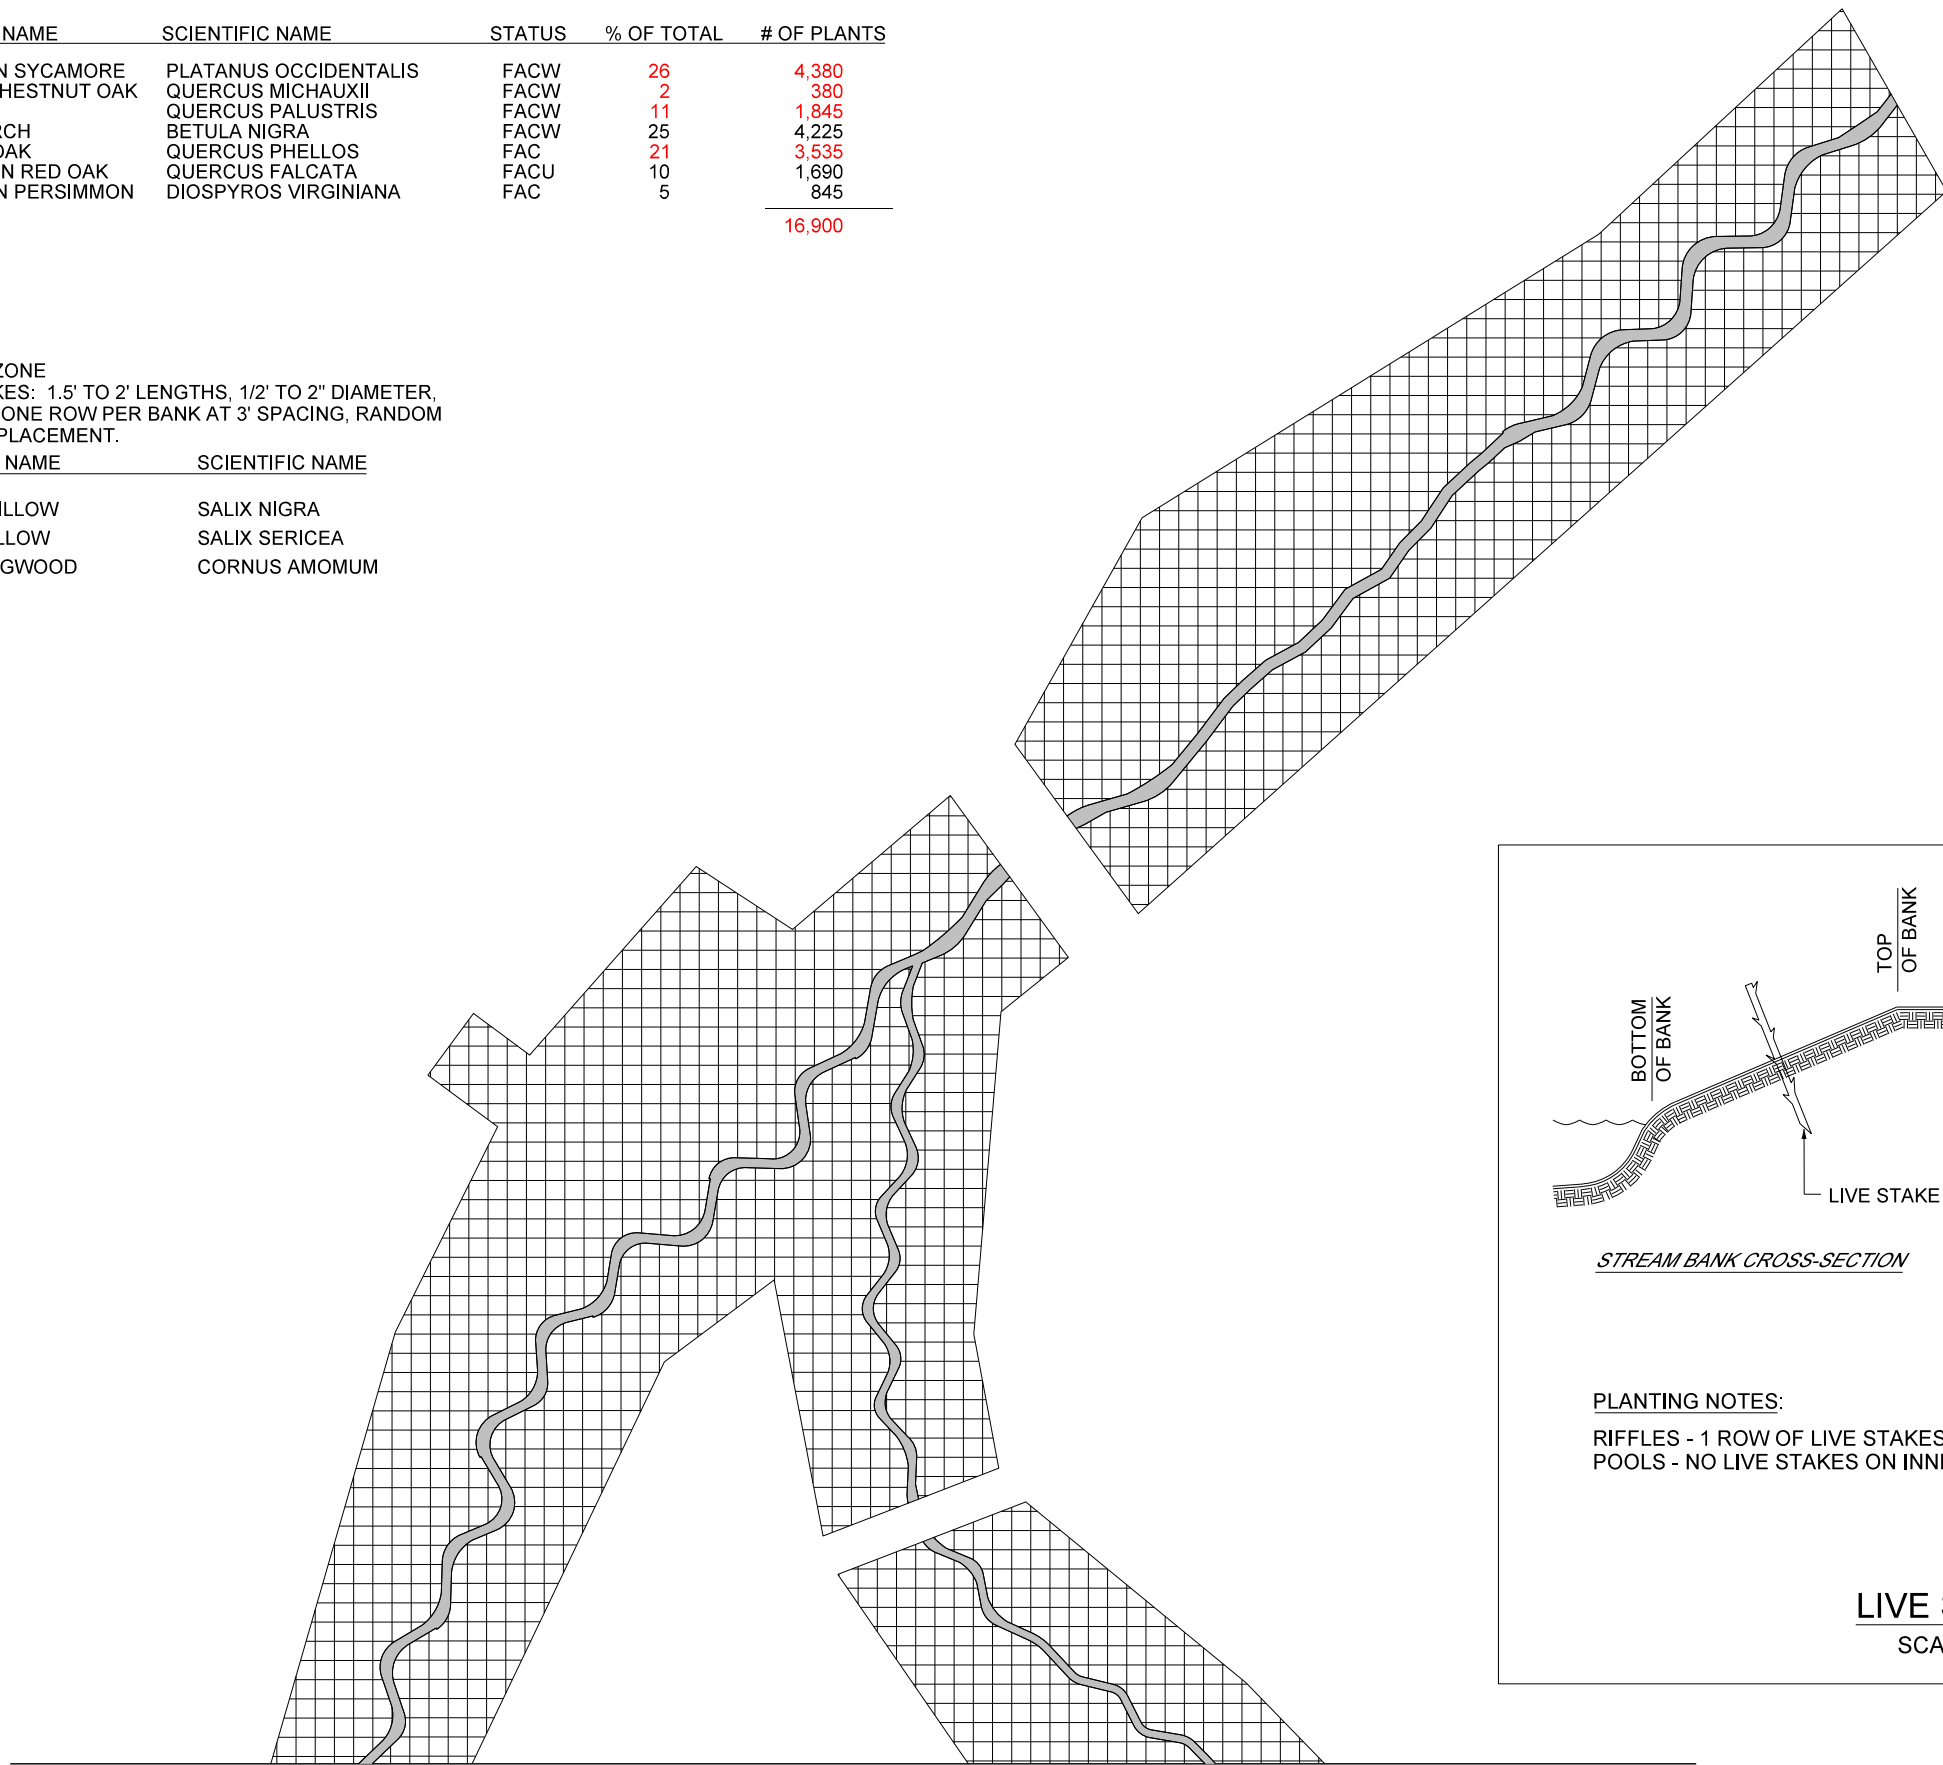
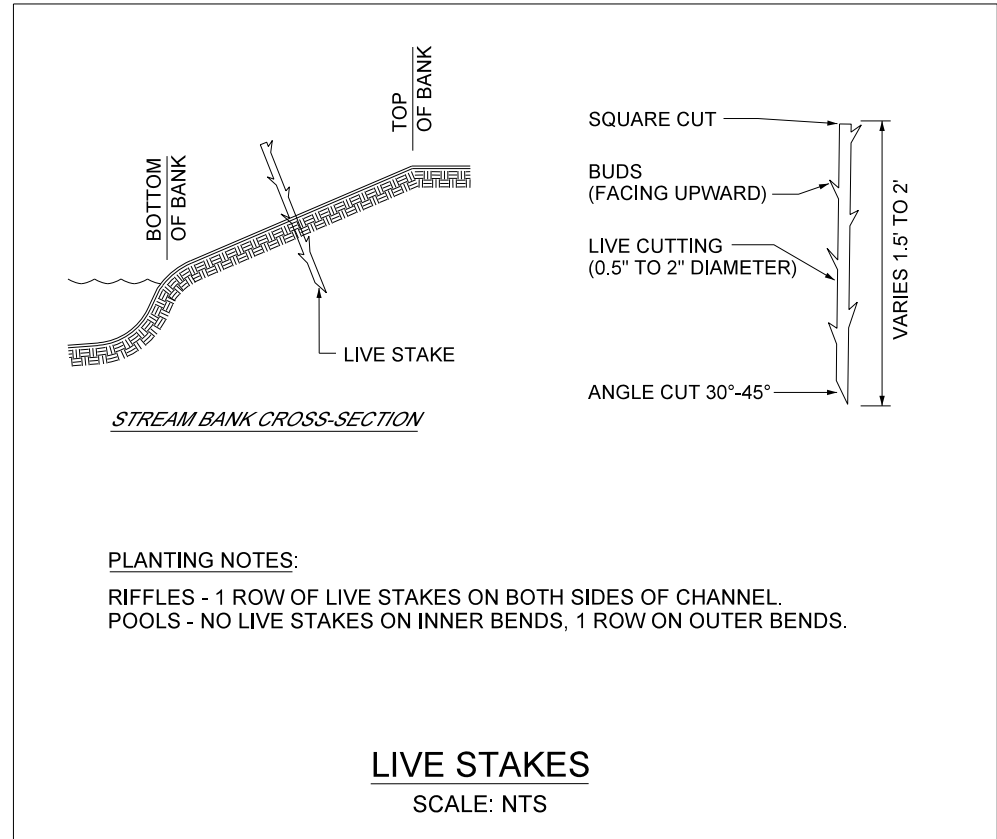
DATE	AUGUST 2021
SCALE	GRAPHIC
PLANTING PLAN	
SHEET 8 OF 11

RIPARIAN FOREST PLANTING:

PLANTING ZONE 1 = 17.4 ACRES
 12" - 18" BARE ROOT MATERIAL
 968 STEMS/ACRE (9' X 5' SPACING), RANDOM SPECIES PLACEMENT

COMMON NAME	SCIENTIFIC NAME	STATUS	% OF TOTAL	# OF PLANTS
AMERICAN SYCAMORE	PLATANUS OCCIDENTALIS	FACW	26	4,380
SWAMP CHESTNUT OAK	QUERCUS MICHAUXII	FACW	2	380
PIN OAK	QUERCUS PALUSTRIS	FACW	11	1,845
RIVER BIRCH	BETULA NIGRA	FACW	25	4,225
WILLOW OAK	QUERCUS PHELLOS	FAC	21	3,535
SOUTHERN RED OAK	QUERCUS FALCATA	FACU	10	1,690
AMERICAN PERSIMMON	DIOSPYROS VIRGINIANA	FAC	5	845
				16,900

STREAM ZONE
 LIVE STAKES: 1.5' TO 2' LENGTHS, 1/2" TO 2" DIAMETER,
 PLANTED ONE ROW PER BANK AT 3' SPACING, RANDOM
 SPECIES PLACEMENT.

COMMON NAME	SCIENTIFIC NAME
BLACK WILLOW	SALIX NIGRA
SILKY WILLOW	SALIX SERICEA
SILKY DOGWOOD	CORNUS AMOMUM

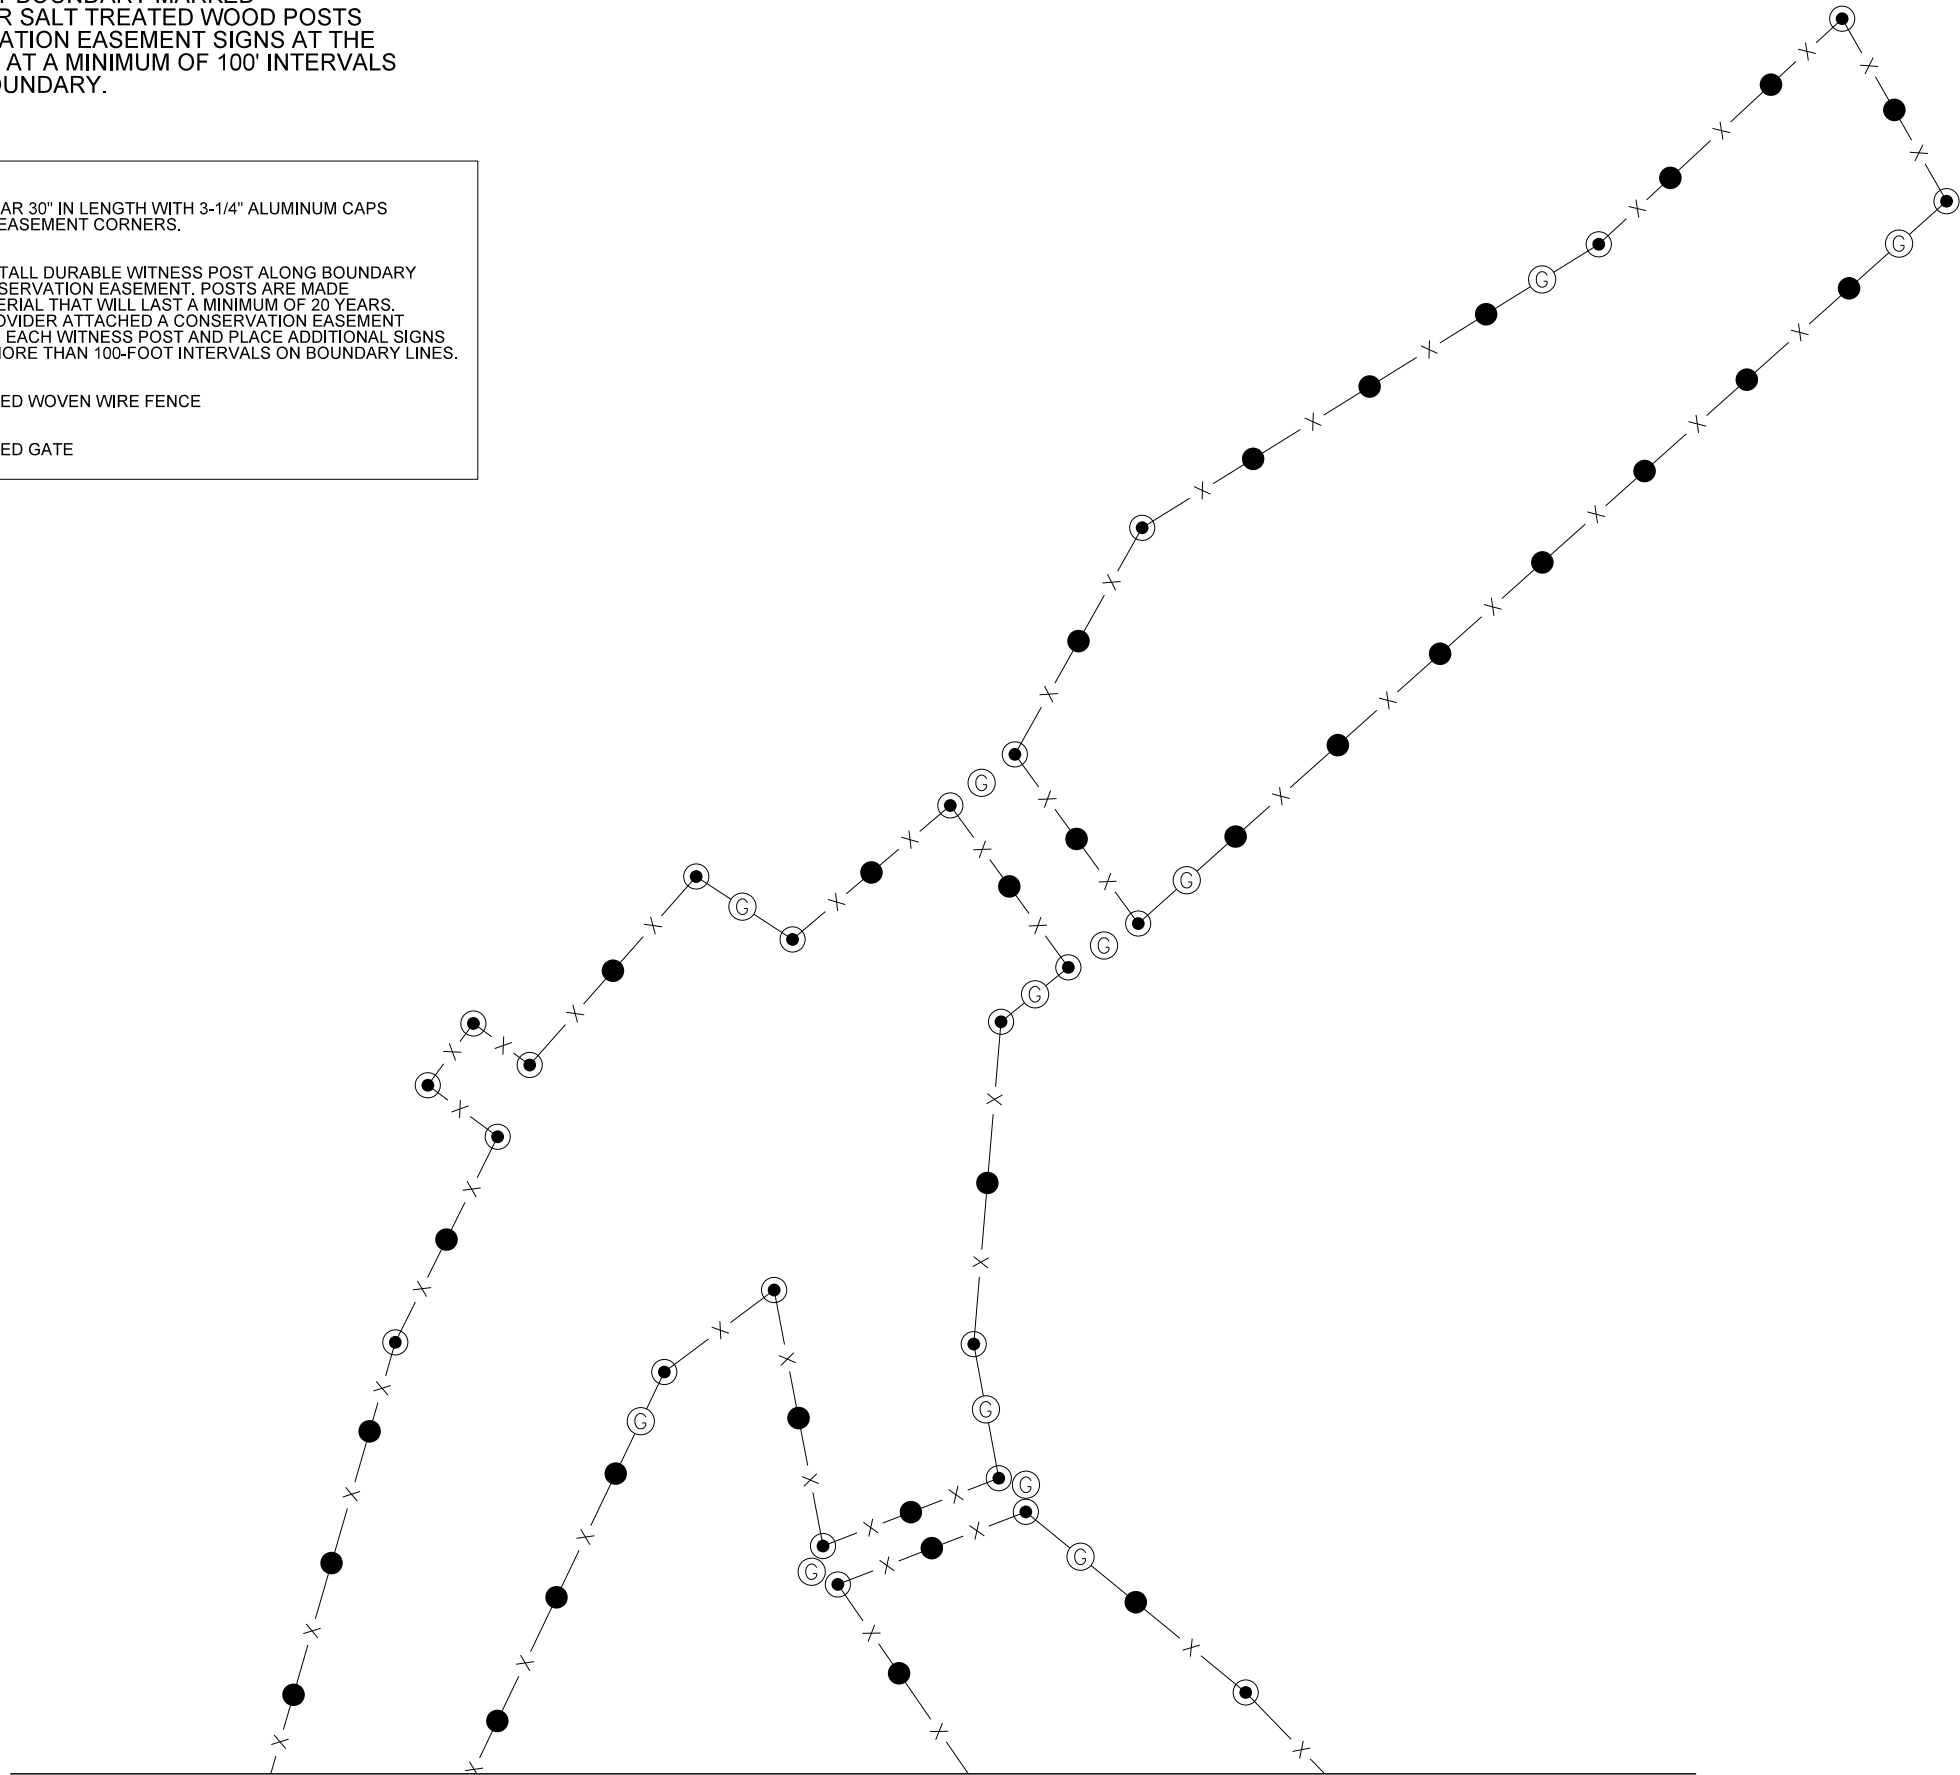
BOUNDARY MARKING PLAN

EASEMENT BOUNDARY MARKING

THE EASEMENT BOUNDARY MARKED WITH METAL OR SALT TREATED WOOD POSTS AND CONSERVATION EASEMENT SIGNS AT THE CORNERS AND AT A MINIMUM OF 100' INTERVALS ALONG THE BOUNDARY.

5/8" REBAR 30" IN LENGTH WITH 3-1/4" ALUMINUM CAPS ON ALL EASEMENT CORNERS.
-

6-FOOT TALL DURABLE WITNESS POST ALONG BOUNDARY OF CONSERVATION EASEMENT. POSTS ARE MADE OF MATERIAL THAT WILL LAST A MINIMUM OF 20 YEARS. THE PROVIDER ATTACHED A CONSERVATION EASEMENT SIGN TO EACH WITNESS POST AND PLACE ADDITIONAL SIGNS AT NO MORE THAN 100-FOOT INTERVALS ON BOUNDARY LINES.
-

INSTALLED WOVEN WIRE FENCE
-

INSTALLED GATE

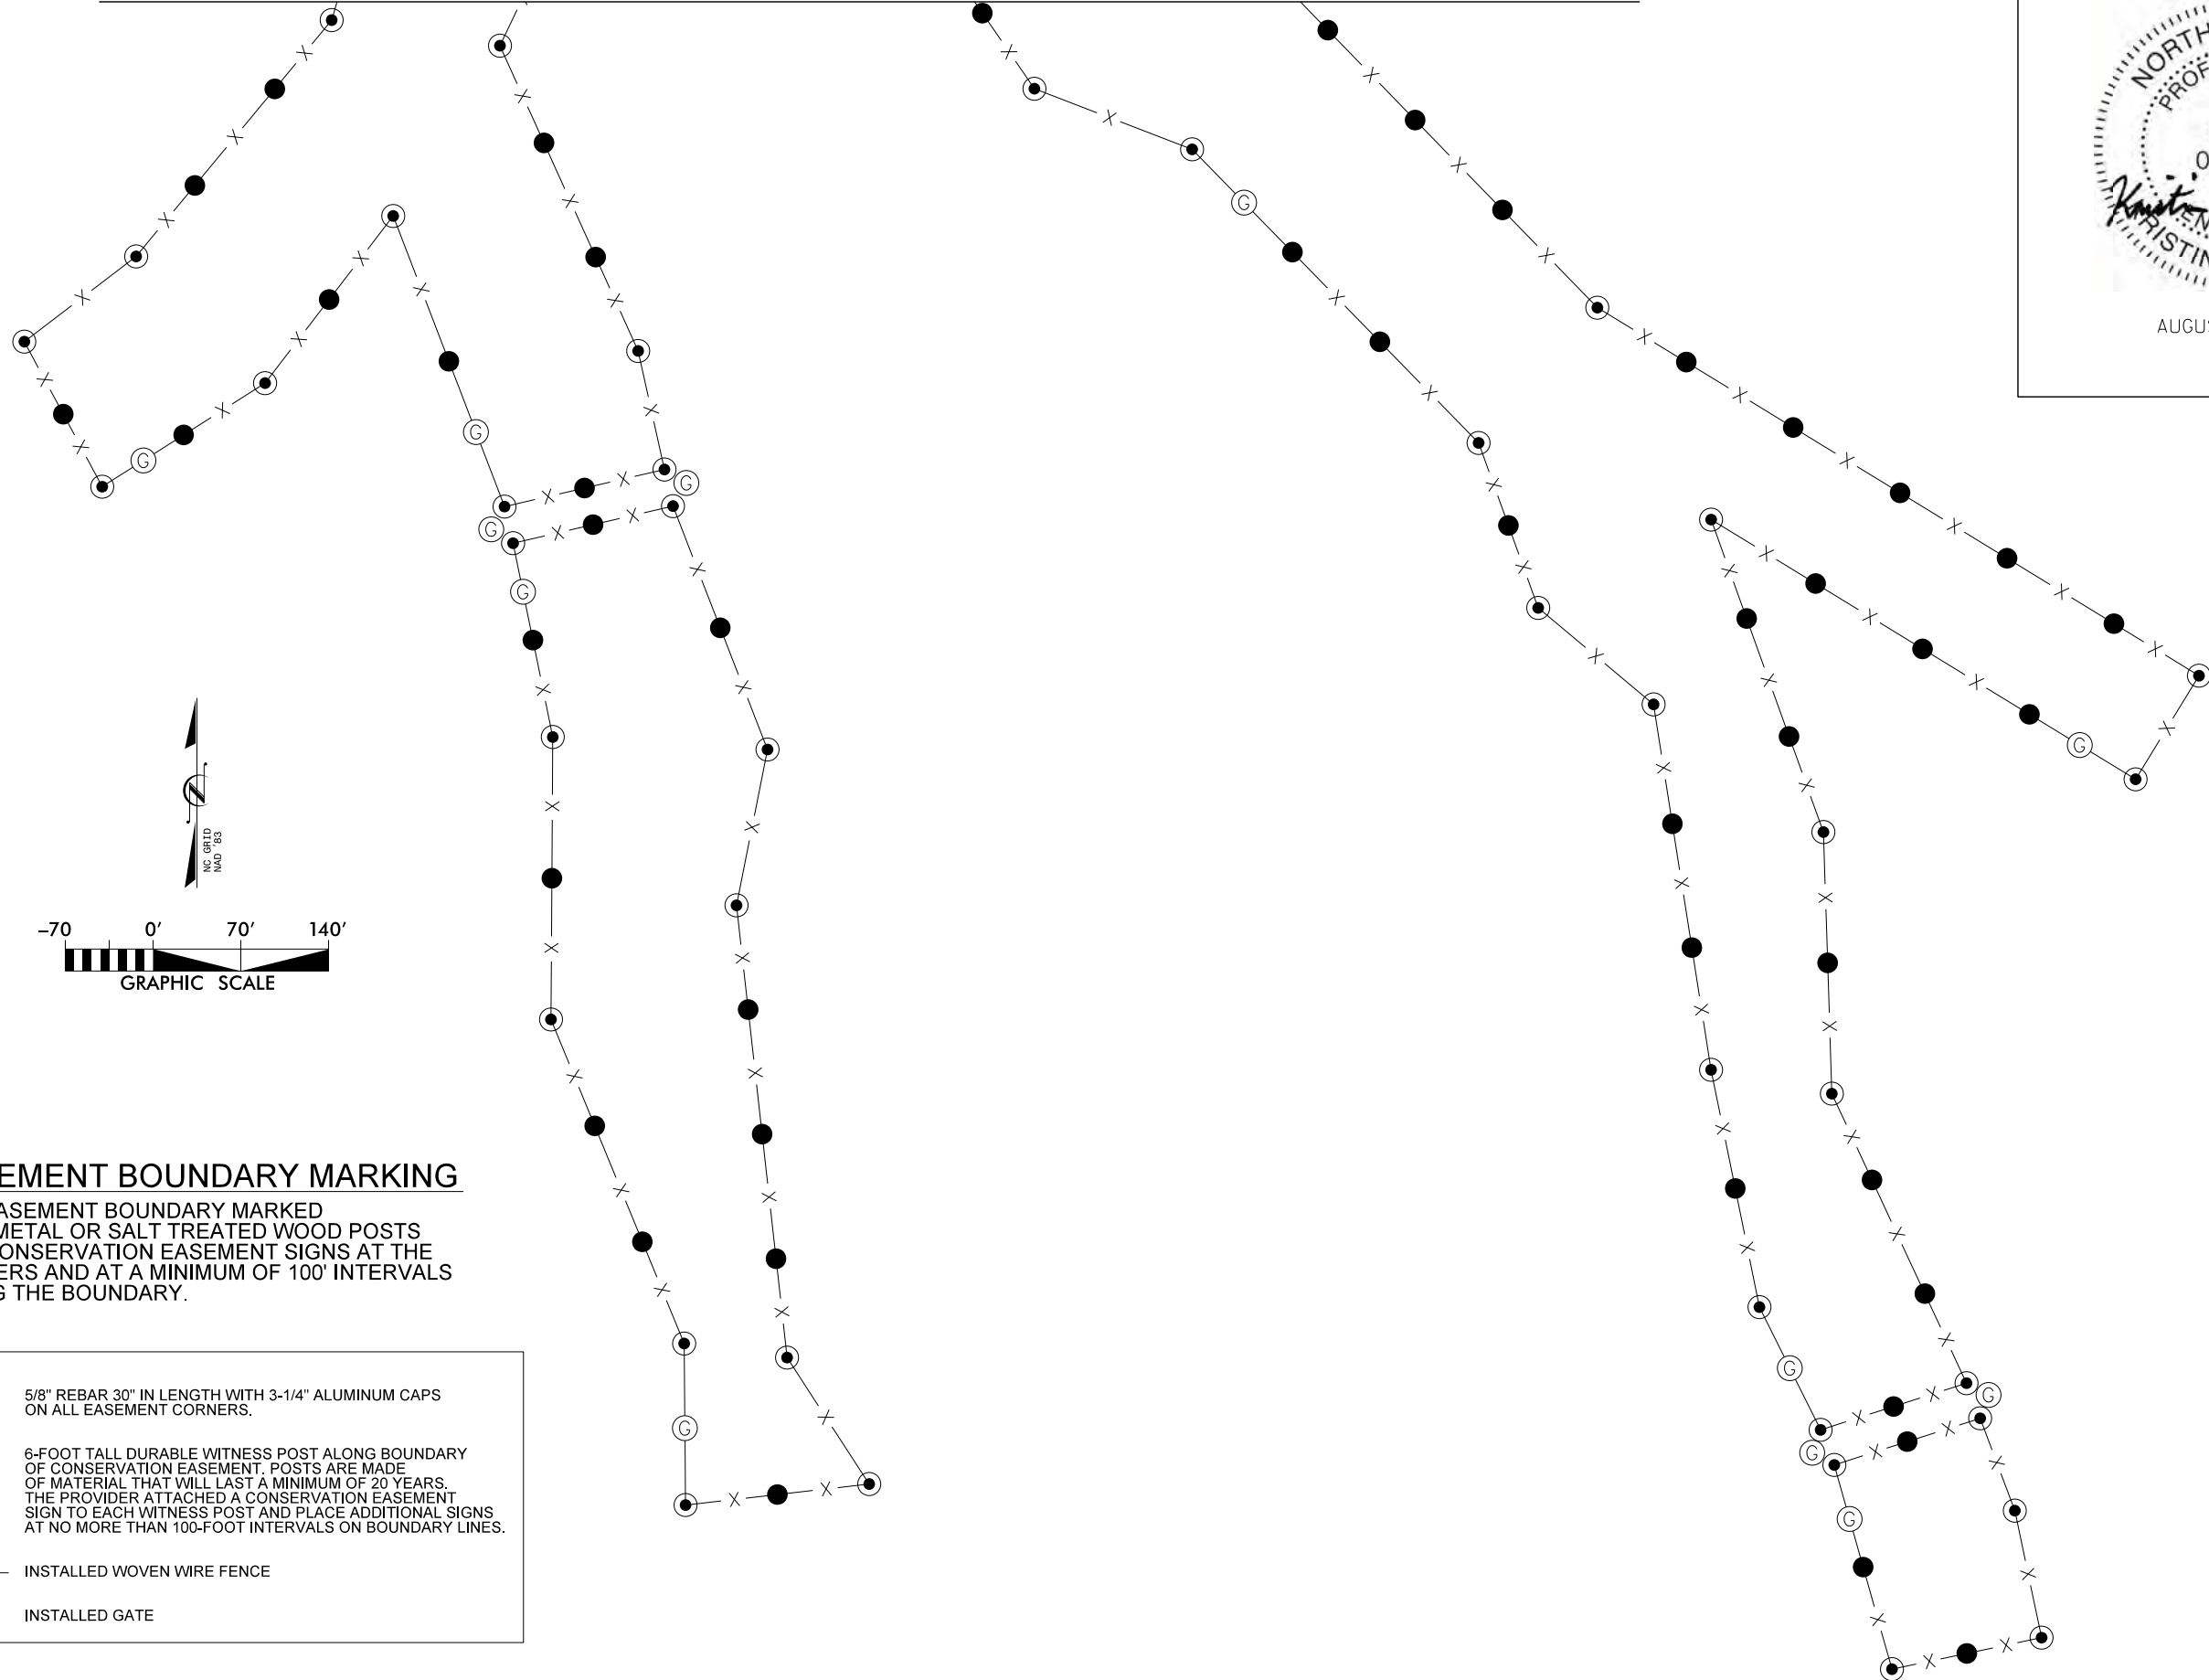
BOUNDARY MARKING PLAN

EASEMENT BOUNDARY MARKING

THE EASEMENT BOUNDARY MARKED WITH METAL OR SALT TREATED WOOD POSTS AND CONSERVATION EASEMENT SIGNS AT THE CORNERS AND AT A MINIMUM OF 100' INTERVALS ALONG THE BOUNDARY.
