FINAL RESTORATION PLAN

HOLLY GROVE RESTORATION SITE
GUILFORD COUNTY, NORTH CAROLINA
CAPE FEAR RIVER BASIN CATALOGING UNIT 03030002
EEP Contract No.: D06028-B

June 6, 2007

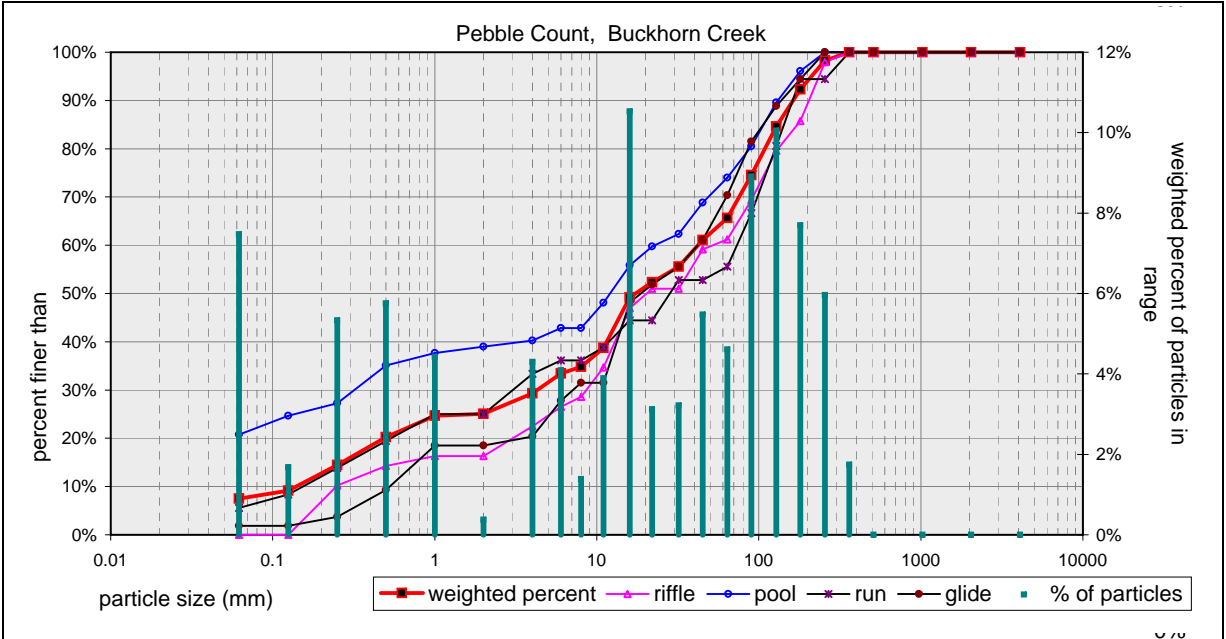
Pebble Count Weighted by Channel Feature										
Percent Riffle:	30	Percent Run:	20	Pebble Count,						
Percent Pool:	30	Percent Glide:	20							
Material	Size Range (mm)		weighted	Buckhorn Creek						
silt/clay	0	0.062	6.8	Holly Grove Restoration Site						
very fine sand	0.062	0.13	1.5	Note: 7%						
fine sand	0.13	0.25	4.8							
medium sand	0.25	0.5	5.2							
coarse sand	0.5	1	4.0							
very coarse sand	1	2	0.3							
very fine gravel	2	4	3.9							
fine gravel	4	6	3.7							
fine gravel	6	8	1.3							
medium gravel	8	11	3.5							
medium gravel	11	16	9.5							
coarse gravel	16	22	2.8							
coarse gravel	22	32	2.9							
very coarse gravel	32	45	5.0							
very coarse gravel	45	64	4.2							
small cobble	64	90	8.1							
medium cobble	90	128	9.1							
large cobble	128	180	7.0							
very large cobble	180	256	5.4							
small boulder	256	362	1.6							
small boulder	362	512	0.0							
medium boulder	512	1024	0.0

large boulder	1024	2048	0.0							
very large boulder	2048	4096	0.0							
weighted particle count:			90.6							
bedrock			9.4							
clay hardpan			0.0							
detritus/wood			0.0							
artificial			0.0							
weighted total count:			100							
based on sediment particles only		size percent less than (mm)					particle size distribution			
		D16	D35	D50	D65	D84	D95	gradation	geo mean	std dev

0.300	8.13	17.3	61	125	211	32.5	6.1	20.4
based on total count		percent by substrate type								
		silt/clay	sand	gravel	cobble	boulder	bedrock	hardpan	wood/det	artificial
		7%	16%	37%	30%	2%	9%	0%	0%	0%

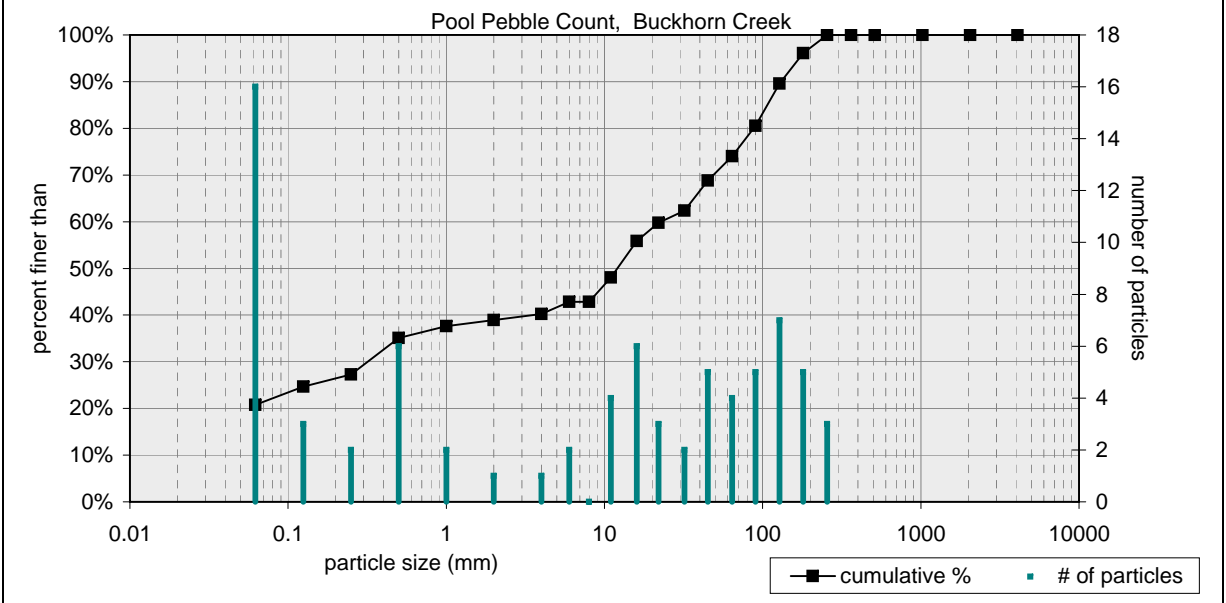
Pool Pebble Count,

based on sediment particles only	size percent less than (mm)						particle size distribution gradation		
	D16	D35	D50	D65	D84	D95	geo mean	std dev	
	0.062	0.50	12.1	37	103	170	101.7	2.5	40.8

based on total count	percent by substrate type									
	silt/clay	sand	gravel	cobble	boulder	bedrock	hardpan	wood/det	artificial	
	18%	16%	30%	22%	0%	13%	0%	0%	0%	0%

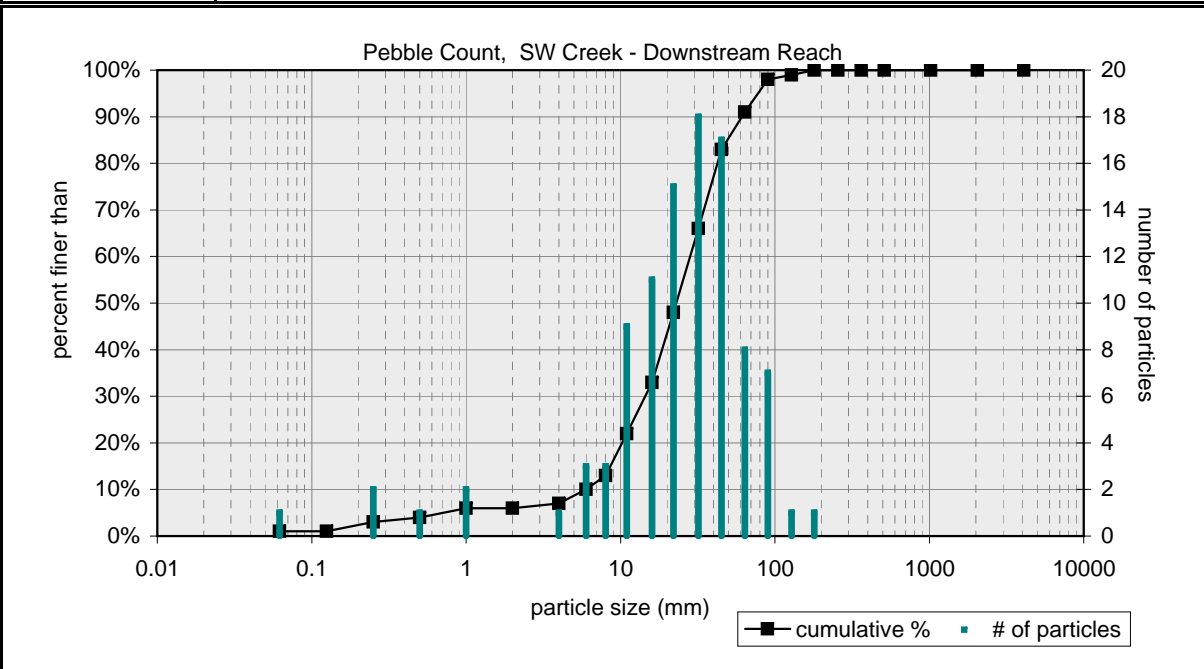
Pebble Count,	
	SW Creek - Downstream Reach
	Holly Grove Site
Note:

based on sediment particles only	size percent less than (mm)						particle size distribution		
	D16	D35	D50	D65	D84	D95	gradation	geo mean	std dev
	8.896	16.69	22.9	31	47	78	2.3	20.5	2.3
based on total count	percent by substrate type								
	silt/clay	sand	gravel	cobble	boulder	bedrock	hardpan	wood/det	artificial
	1%	5%	85%	9%	0%	0%	0%	0%	0%

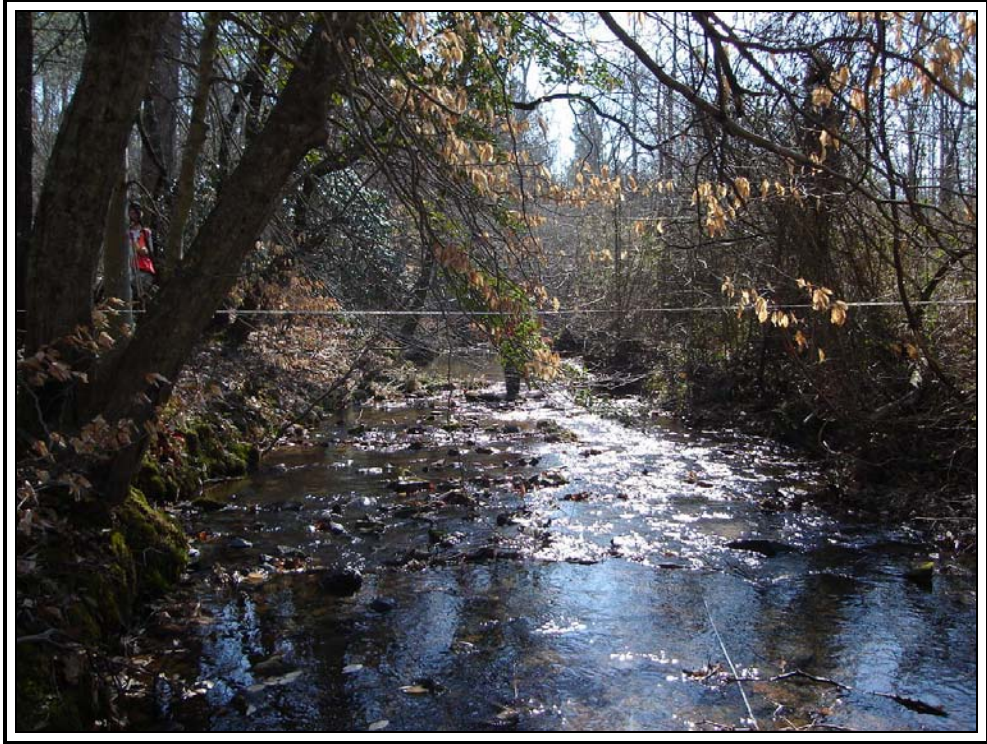
Fork Creek: Riffle

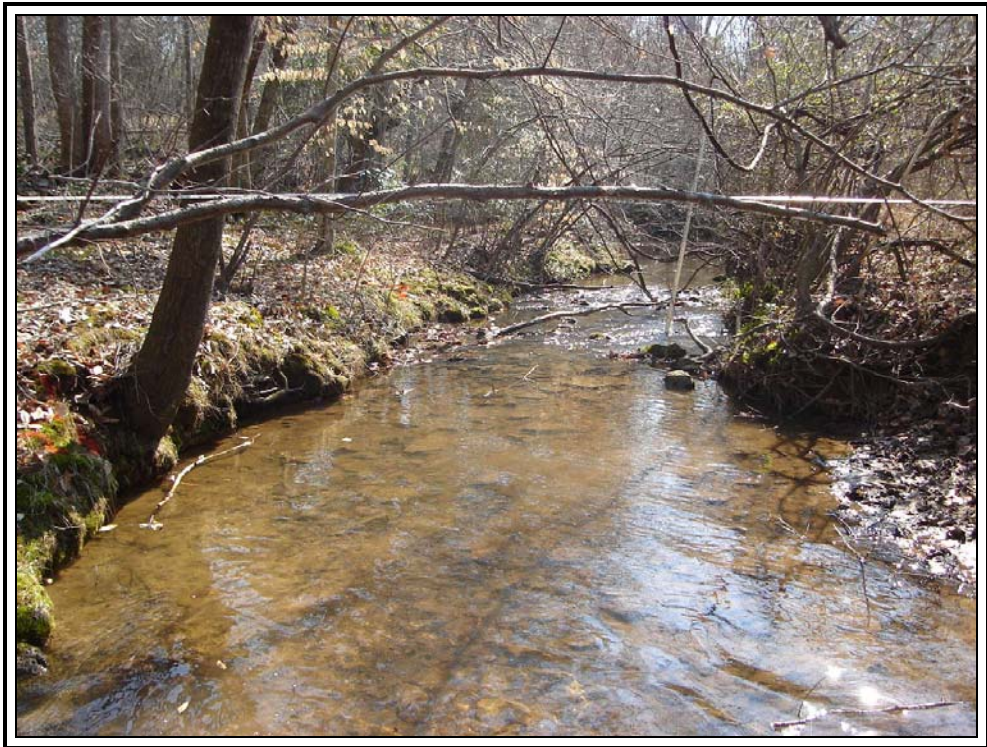
Fork Creek: Pool

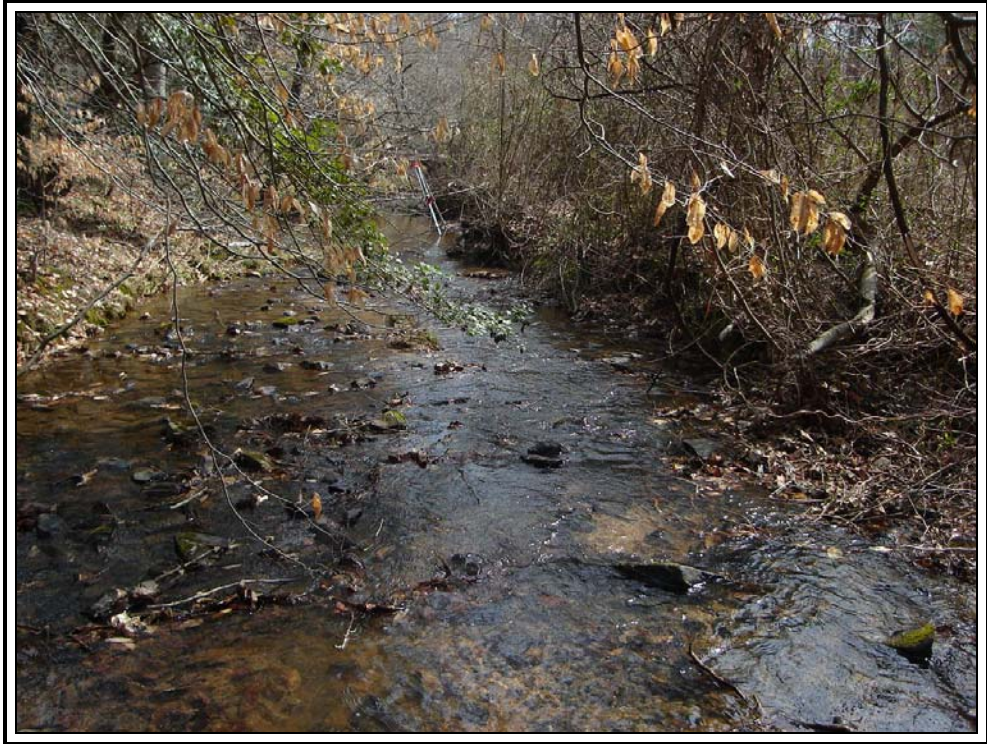
Fork Creek: Riffle

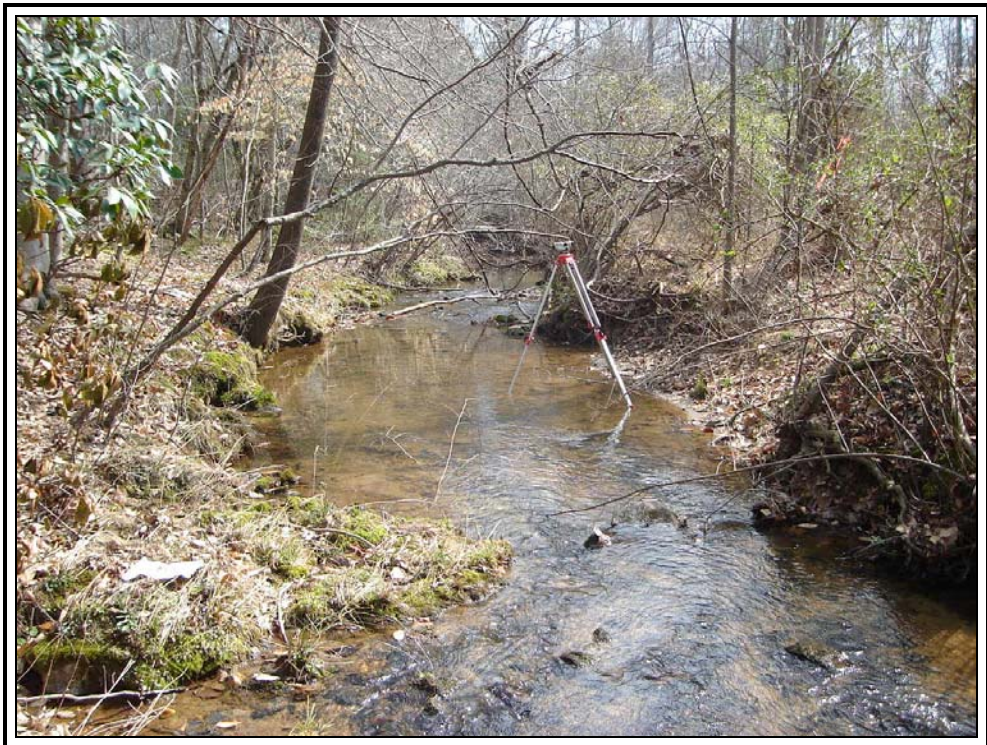
Fork Creek: Pool

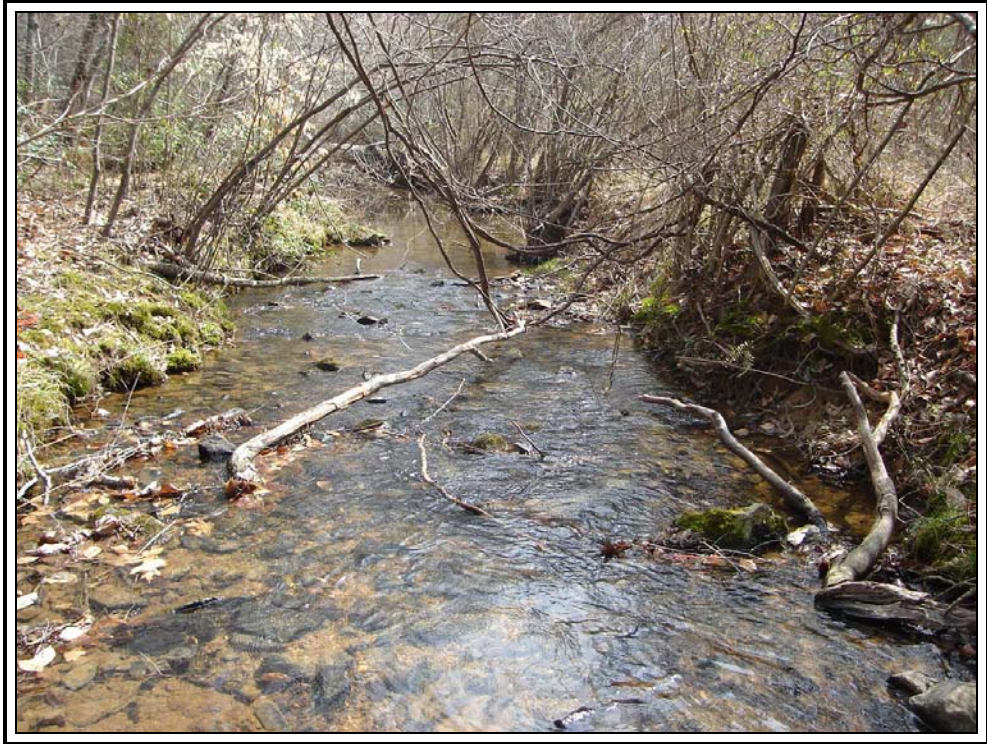
Fork Creek: Riffle

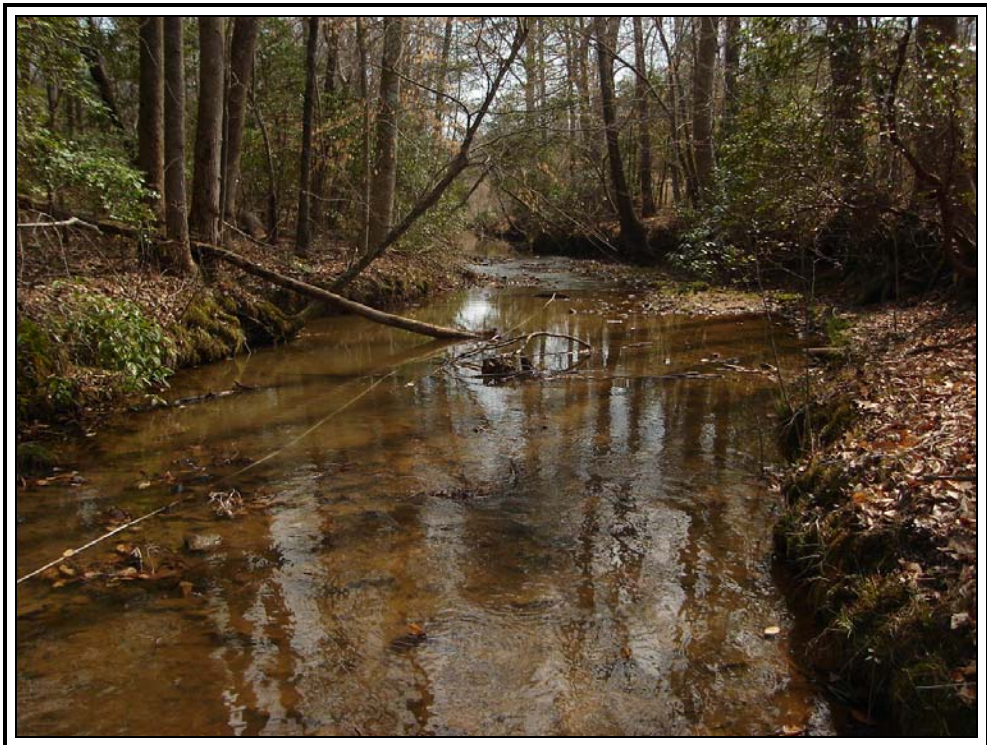
Fork Creek: Pool
