MITIGATION PLAN AND AS-BUILT BASELINE REPORT

Holly Grove Stream Restoration Site

Guilford County, North Carolina

December 16, 2008

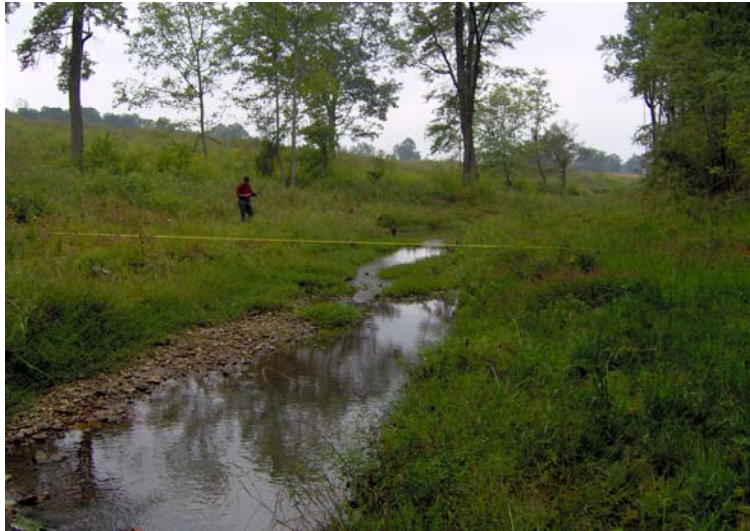
Cross Section RF1

Reach 1 - Buckhorn Creek - Sta 11+78

Facing Downstream

As-Built		Year 1		Year 2		Year 3		Year 4		Year 5	
Date	10/22/08	Date	0/0/0	Date	0/0/0	Date	0/0/0	Date	0/0/0	Date	0/0/0
Area	34.3	Area	0.0	Area	0.0	Area	0.0	Area	0.0	Area	0.0
Bkf W	23.4	Bkf W	10	Bkf W	10	Bkf W	10	Bkf W	10	Bkf W	10
Dmean	1.5	Dmean	0.0	Dmean	0.0	Dmean	0.0	Dmean	0.0	Dmean	0.0
Dmax	2.1	Dmax	0.0	Dmax	0.0	Dmax	0.0	Dmax	0.0	Dmax	0.0
W/d	16.0	W/d	0.0	W/d	0.0	W/d	0.0	W/d	0.0	W/d	0.0

Cross-section measurements should indicate little change from the as-built cross-sections. If changes do occur, they will be evaluated to determine whether the adjustments are associated with settling and increased stability or whether they indicate movement towards an unstable condition. The following thresholds will be considered indicators of concern:

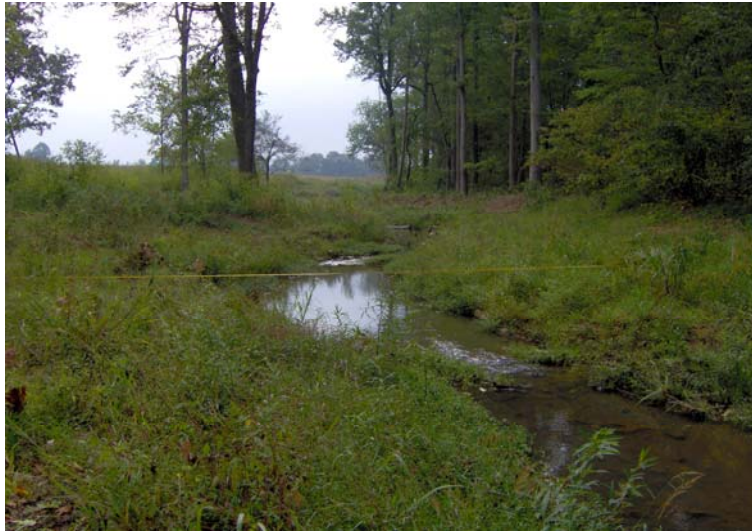
Cross Section PL1

Reach 1 - Buckhorn Creek - Sta 100+00

Facing Downstream

As-Built		Year 1		Year 2		Year 3		Year 4		Year 5	
Date	10/22/08	Date	11/17/06	Date	11/26/07	Date	0/0/0	Date	0/0/0	Date	0/0/0
Area	52.7	Area	0.0	Area	0.0	Area	0.0	Area	0.0	Area	0.0
Bkf W	23.2	Bkf W	10	Bkf W	10	Bkf W	10	Bkf W	10	Bkf W	10
Dmean	2.3	Dmean	0.0	Dmean	0.0	Dmean	0.0	Dmean	0.0	Dmean	0.0
Dmax	4.0	Dmax	0.0	Dmax	0.0	Dmax	0.0	Dmax	0.0	Dmax	0.0
W/d	10.2	W/d	0.0	W/d	0.0	W/d	0.0	W/d	0.0	W/d	0.0

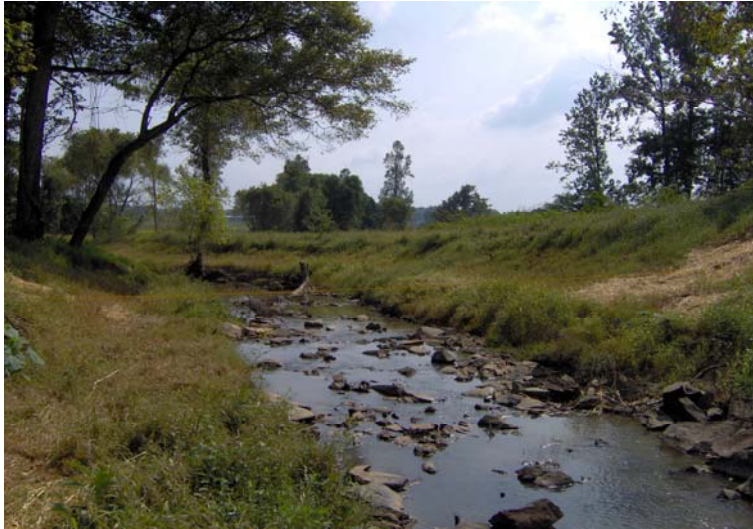
Cross Section RF2

Reach 2 - Buckhorn Creek - Sta 15+86

Facing Downstream

As-Built		Year 1		Year 2		Year 3		Year 4		Year 5	
Date	10/22/08	Date	0/0/0	Date	0/0/0	Date	0/0/0	Date	0/0/0	Date	0/0/0
Area	30.3	Area	0.0	Area	0.0	Area	0.0	Area	0.0	Area	0.0
Bkf W	23.4	Bkf W	10	Bkf W	10	Bkf W	10	Bkf W	10	Bkf W	10
Dmean	1.3	Dmean	0.0	Dmean	0.0	Dmean	0.0	Dmean	0.0	Dmean	0.0
Dmax	1.9	Dmax	0.0	Dmax	0.0	Dmax	0.0	Dmax	0.0	Dmax	0.0
W/d	18.1	W/d	0.0	W/d	0.0	W/d	0.0	W/d	0.0	W/d	0.0

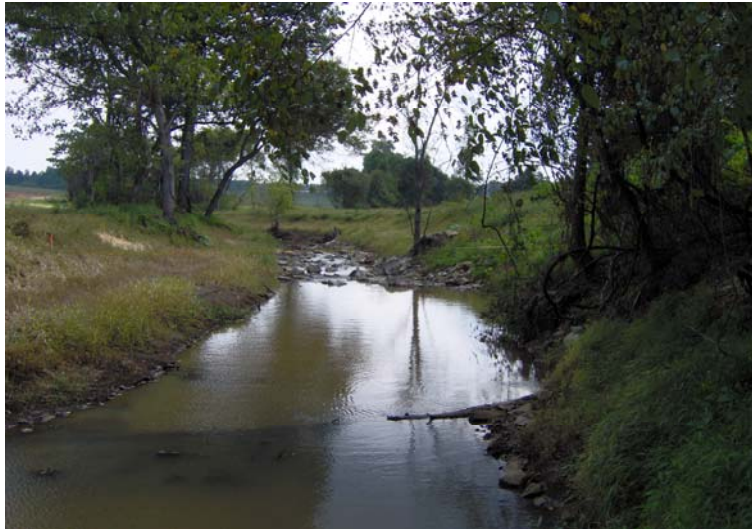
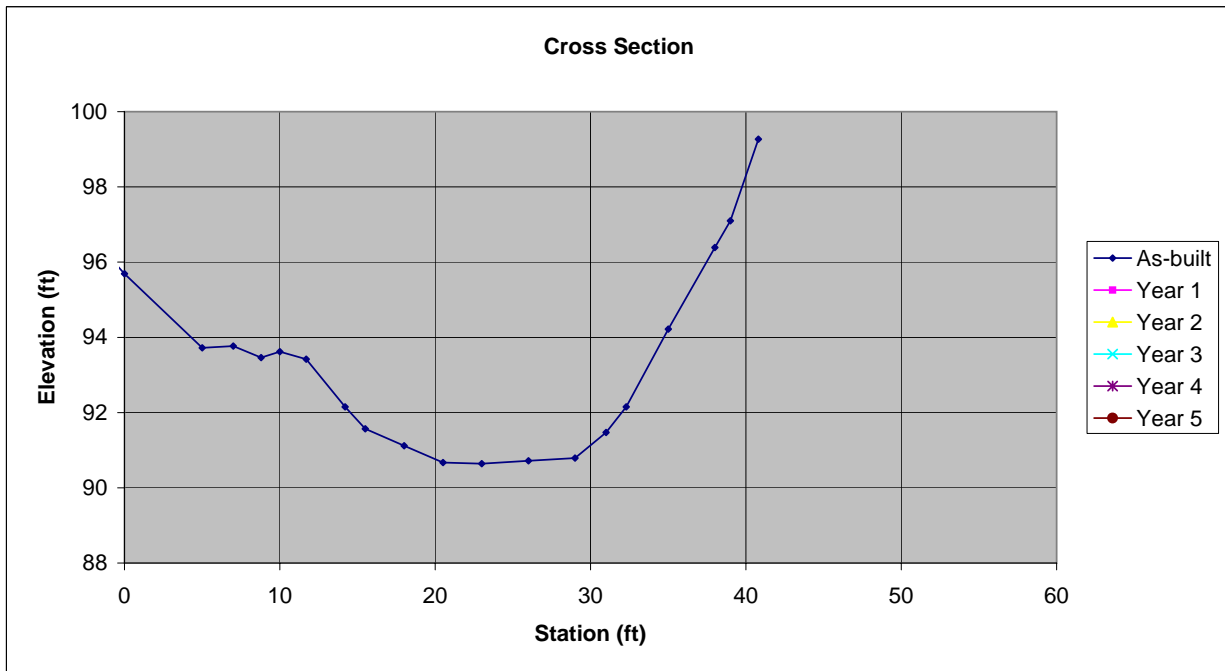
Cross Section PL2

Reach 2 - Buckhorn Creek - Sta 15+27

Facing Downstream

As-Built		Year 1		Year 2		Year 3		Year 4		Year 5	
Date	10/2/08	Date	11/17/06	Date	11/26/07	Date	0/0/0	Date	0/0/0	Date	0/0/0
Area	45.6	Area	0.0	Area	0.0	Area	0.0	Area	0.0	Area	0.0
Bkf W	23.3	Bkf W	10	Bkf W	10	Bkf W	10	Bkf W	10	Bkf W	10
Dmean	2.0	Dmean	0.0	Dmean	0.0	Dmean	0.0	Dmean	0.0	Dmean	0.0
Dmax	2.8	Dmax	0.0	Dmax	0.0	Dmax	0.0	Dmax	0.0	Dmax	0.0
W/d	11.9	W/d	0.0	W/d	0.0	W/d	0.0	W/d	0.0	W/d	0.0

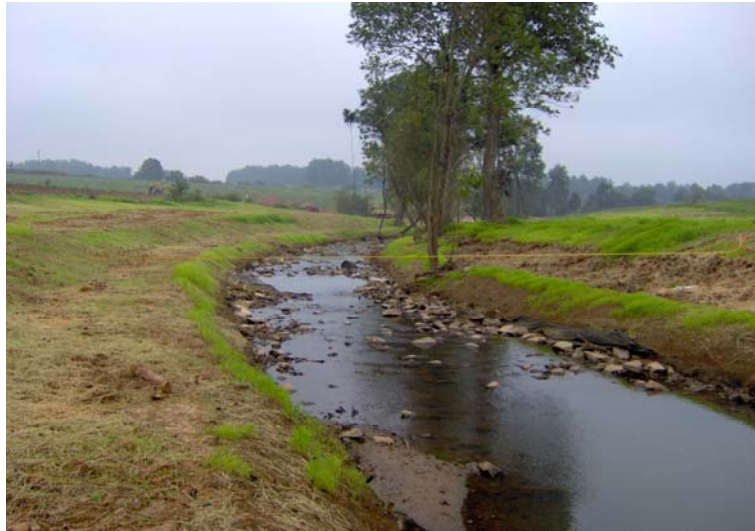
Cross Section RF3

Reach 3 - Buckhorn Creek - Sta 12+49

Facing Downstream

As-Built		Year 1		Year 2		Year 3		Year 4		Year 5	
Date	10/22/08	Date	0/0/0	Date	0/0/0	Date	0/0/0	Date	0/0/0	Date	0/0/0
Area	48.3	Area	0.0	Area	0.0	Area	0.0	Area	0.0	Area	0.0
Bkf W	25.4	Bkf W	10	Bkf W	10	Bkf W	10	Bkf W	10	Bkf W	10
Dmean	1.9	Dmean	0.0	Dmean	0.0	Dmean	0.0	Dmean	0.0	Dmean	0.0
Dmax	2.6	Dmax	0.0	Dmax	0.0	Dmax	0.0	Dmax	0.0	Dmax	0.0
W/d	13.4	W/d	0.0	W/d	0.0	W/d	0.0	W/d	0.0	W/d	0.0

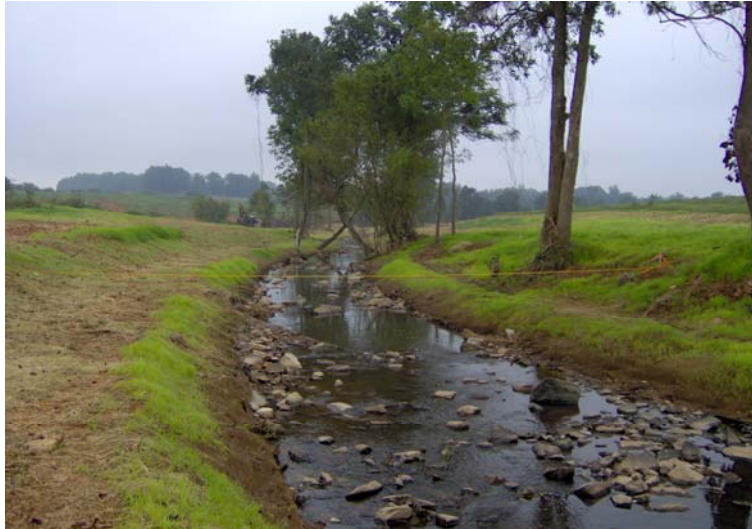
Cross Section PL3

Reach 3 - Buckhorn Creek - Sta 13+31

Facing Downstream

As-Built		Year 1		Year 2		Year 3		Year 4		Year 5	
Date	10/22/08	Date	11/17/06	Date	11/26/07	Date	0/0/0	Date	0/0/0	Date	0/0/0
Area	61.6	Area	0.0	Area	0.0	Area	0.0	Area	0.0	Area	0.0
Bkf W	22.2	Bkf W	10	Bkf W	10	Bkf W	10	Bkf W	10	Bkf W	10
Dmean	2.8	Dmean	0.0	Dmean	0.0	Dmean	0.0	Dmean	0.0	Dmean	0.0
Dmax	4.6	Dmax	0.0	Dmax	0.0	Dmax	0.0	Dmax	0.0	Dmax	0.0
W/d	8.0	W/d	0.0	W/d	0.0	W/d	0.0	W/d	0.0	W/d	0.0

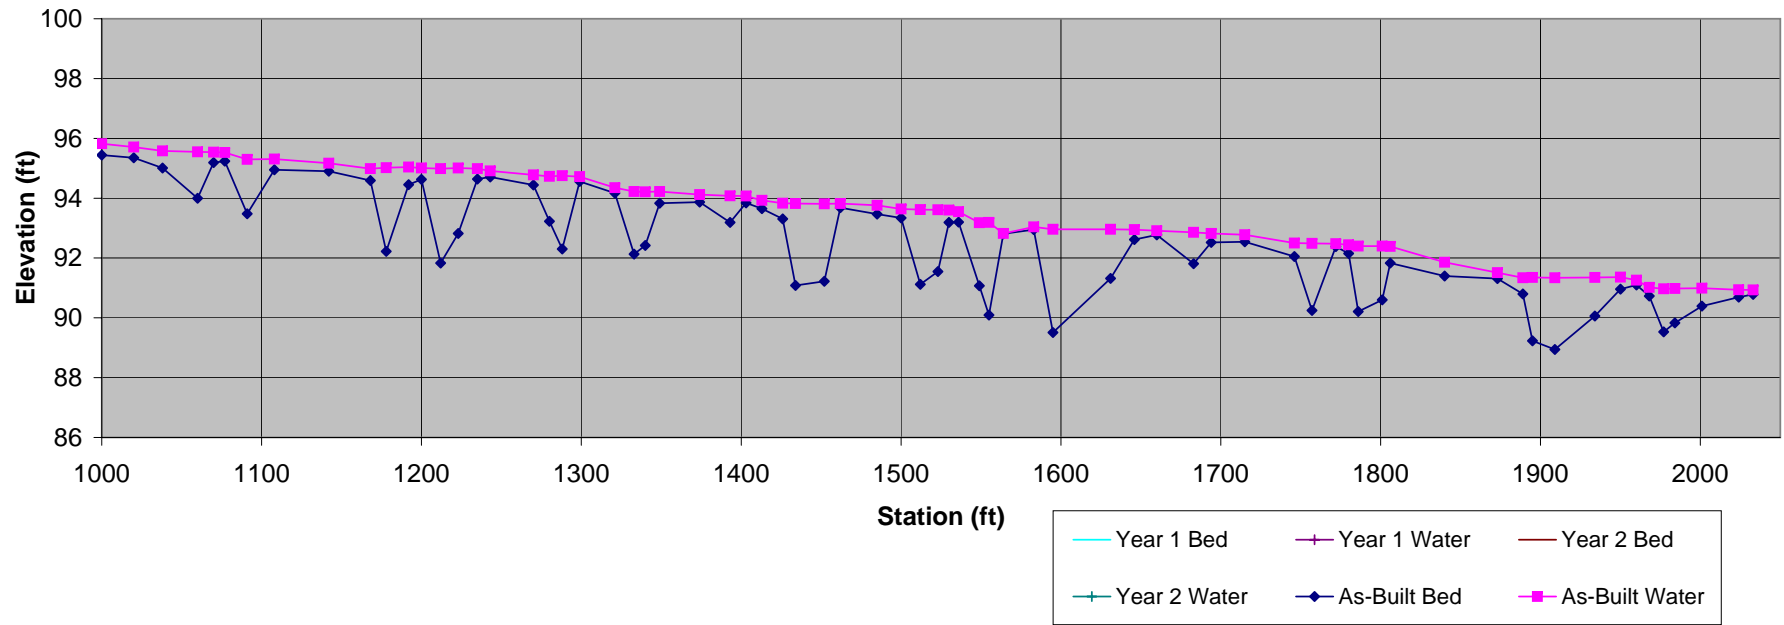
Guilford County, NC
Profile Reach 3 - Buckhorn Creek

Measurements and calculated values should indicate stability with little deviation from as-built conditions and established morphological ranges for the restored stream type. Annual measurements should indicate stable bed-form features with little change from the as-built survey. The pools should maintain their depth with flatter water surface

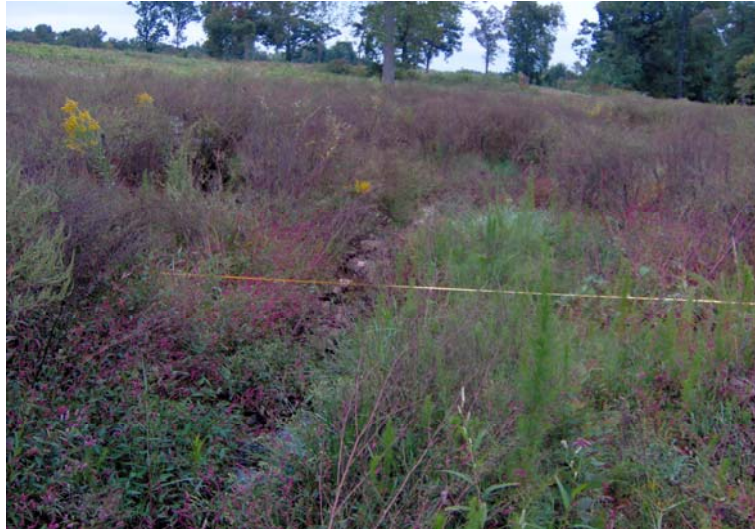
Cross Section RF4

Reach 4 - Middle Branch - Sta 10+88

Facing Downstream

As-Built	Year 1	Year 2	Year 3	Year 4	Year 5
Date 10/22/08	Date 0/0/0	Date 0/0/0	Date 0/0/0	Date 0/0/0	Date 0/0/0
Area 3.7	Area 0.0	Area 0.0	Area 0.0	Area 0.0	Area 0.0
Bkf W 6.2	Bkf W 10	Bkf W 10	Bkf W 10	Bkf W 10	Bkf W 10
Dmean 0.6	Dmean 0.0	Dmean 0.0	Dmean 0.0	Dmean 0.0	Dmean 0.0
Dmax 1.0	Dmax 0.0	Dmax 0.0	Dmax 0.0	Dmax 0.0	Dmax 0.0
W/d 10.4	W/d 0.0	W/d 0.0	W/d 0.0	W/d 0.0	W/d 0.0

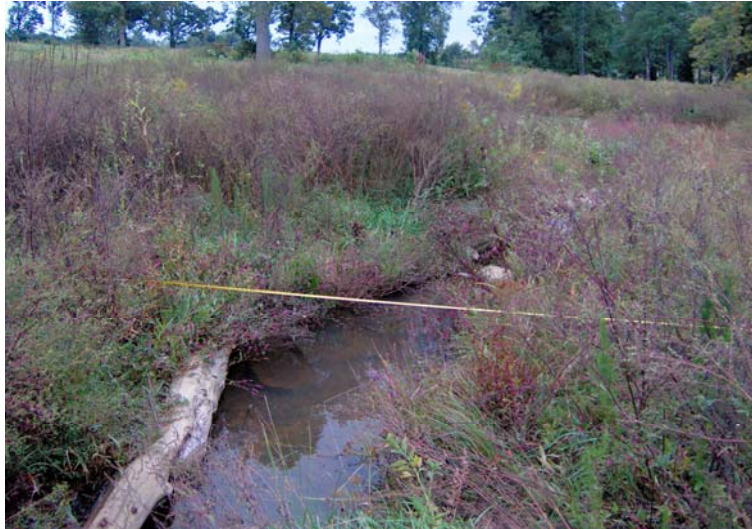
Cross Section PL4

Reach 4 - Middle Branch - Sta 11+14

Facing Downstream

As-Built		Year 1		Year 2		Year 3		Year 4		Year 5	
Date	5/4/06	Date	11/17/06	Date	11/26/07	Date	0/0/0	Date	0/0/0	Date	0/0/0
Area	11.1	Area	0.0	Area	0.0	Area	0.0	Area	0.0	Area	0.0
Bkf W	8.8	Bkf W	10	Bkf W	10	Bkf W	10	Bkf W	10	Bkf W	10
Dmean	1.3	Dmean	0.0	Dmean	0.0	Dmean	0.0	Dmean	0.0	Dmean	0.0
Dmax	2.4	Dmax	0.0	Dmax	0.0	Dmax	0.0	Dmax	0.0	Dmax	0.0
W/d	7.0	W/d	#DIV/0!	W/d	0.0	W/d	0.0	W/d	0.0	W/d	0.0

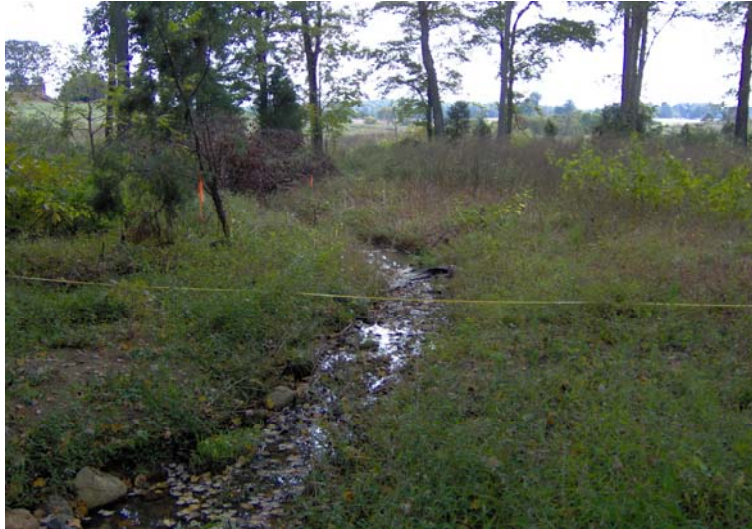
Cross Section RF5

Reach 5 - Middle Branch - Sta 100+00

Facing Downstream

As-Built		Year 1		Year 2		Year 3		Year 4		Year 5	
Date	10/22/08	Date	0/0/0	Date	0/0/0	Date	0/0/0	Date	0/0/0	Date	0/0/0
Area	5.2	Area	0.0	Area	0.0	Area	0.0	Area	0.0	Area	0.0
Bkf W	7.2	Bkf W	10	Bkf W	10	Bkf W	10	Bkf W	10	Bkf W	10
Dmean	0.7	Dmean	0.0	Dmean	0.0	Dmean	0.0	Dmean	0.0	Dmean	0.0
Dmax	1.1	Dmax	0.0	Dmax	0.0	Dmax	0.0	Dmax	0.0	Dmax	0.0
W/d	10.0	W/d	0.0	W/d	0.0	W/d	0.0	W/d	0.0	W/d	0.0

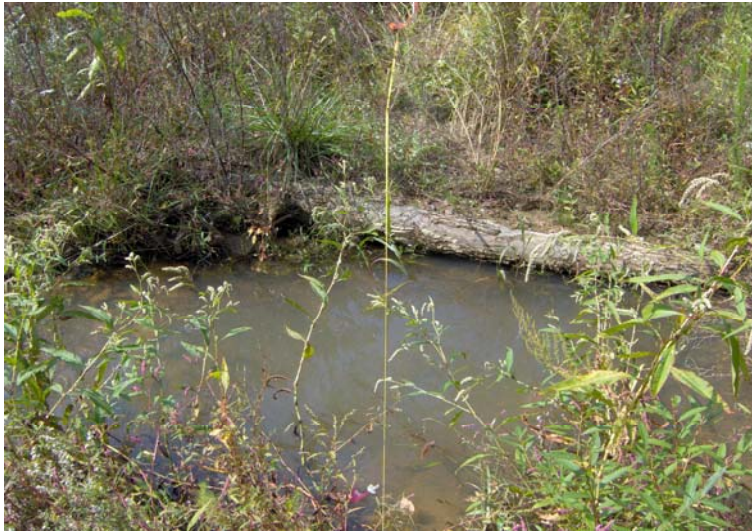
Cross Section PL5

Reach 5 - Middle Branch - Sta 100+00

Facing Downstream

As-Built		Year 1		Year 2		Year 3		Year 4		Year 5	
Date	10/22/08	Date	0/0/0	Date	0/0/0	Date	0/0/0	Date	0/0/0	Date	0/0/0
Area	9.1	Area	0.0	Area	0.0	Area	0.0	Area	0.0	Area	0.0
Bkf W	9.3	Bkf W	10	Bkf W	10	Bkf W	10	Bkf W	10	Bkf W	10
Dmean	1.0	Dmean	0.0	Dmean	0.0	Dmean	0.0	Dmean	0.0	Dmean	0.0
Dmax	1.8	Dmax	0.0	Dmax	0.0	Dmax	0.0	Dmax	0.0	Dmax	0.0
W/d	9.5	W/d	0.0	W/d	0.0	W/d	0.0	W/d	0.0	W/d	0.0

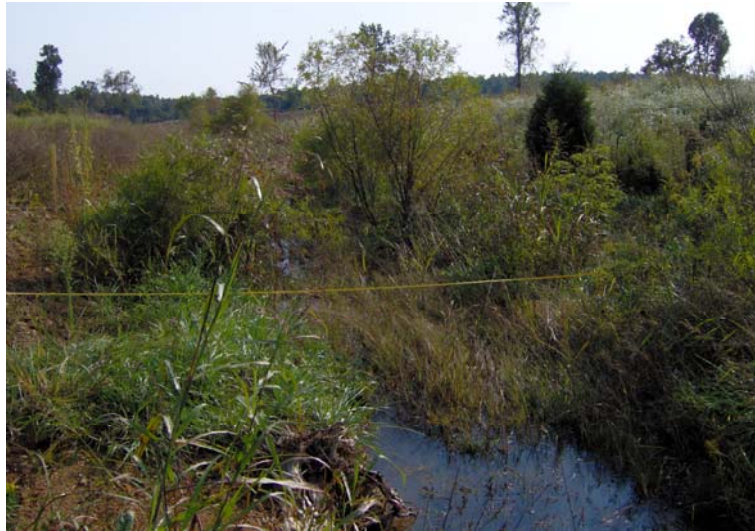
Holly Grove Stream Restoration Site
 Guilford County, NC
 Cross Section RF6
 Reach 6 - Lower East Branch - Sta 100+00

Facing Downstream

As-Built		Year 1		Year 2		Year 3		Year 4		Year 5	
Date	10/2/08	Date	0/0/0	Date	0/0/0	Date	0/0/0	Date	0/0/0	Date	0/0/0
Area	6.5	Area	0.0	Area	0.0	Area	0.0	Area	0.0	Area	0.0
Bkf W	8.6	Bkf W	10	Bkf W	10	Bkf W	10	Bkf W	10	Bkf W	10
Dmean	0.8	Dmean	0.0	Dmean	0.0	Dmean	0.0	Dmean	0.0	Dmean	0.0
Dmax	1.0	Dmax	0.0	Dmax	0.0	Dmax	0.0	Dmax	0.0	Dmax	0.0
W/d	11.4	W/d	0.0	W/d	0.0	W/d	0.0	W/d	0.0	W/d	0.0

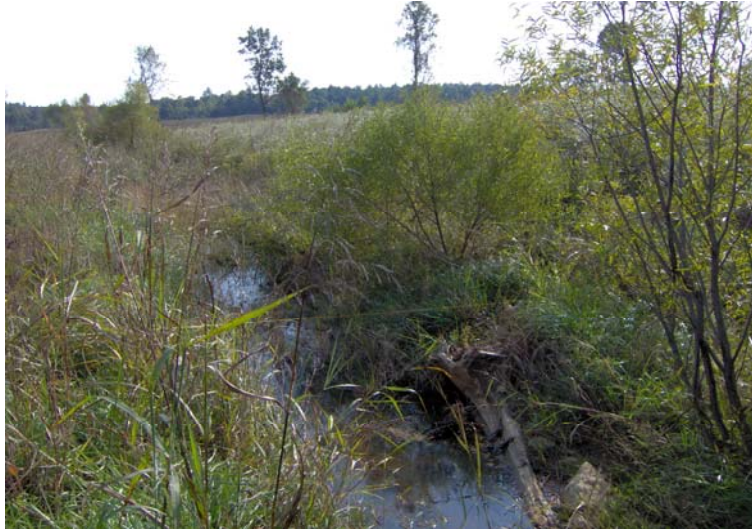
Holly Grove Stream Restoration Site
 Guilford County, NC
 Cross Section PL6
 Reach 6 - Lower East Branch - Sta 100+00

Facing Downstream

As-Built		Year 1		Year 2		Year 3		Year 4		Year 5	
Date	10/22/08	Date	0/0/0	Date	0/0/0	Date	0/0/0	Date	0/0/0	Date	0/0/0
Area	10.8	Area	0.0	Area	0.0	Area	0.0	Area	0.0	Area	0.0
Bkf W	8.5	Bkf W	10	Bkf W	10	Bkf W	10	Bkf W	10	Bkf W	10
Dmean	1.3	Dmean	0.0	Dmean	0.0	Dmean	0.0	Dmean	0.0	Dmean	0.0
Dmax	2.0	Dmax	0.0	Dmax	0.0	Dmax	0.0	Dmax	0.0	Dmax	0.0
W/d	6.7	W/d	0.0	W/d	0.0	W/d	0.0	W/d	0.0	W/d	0.0

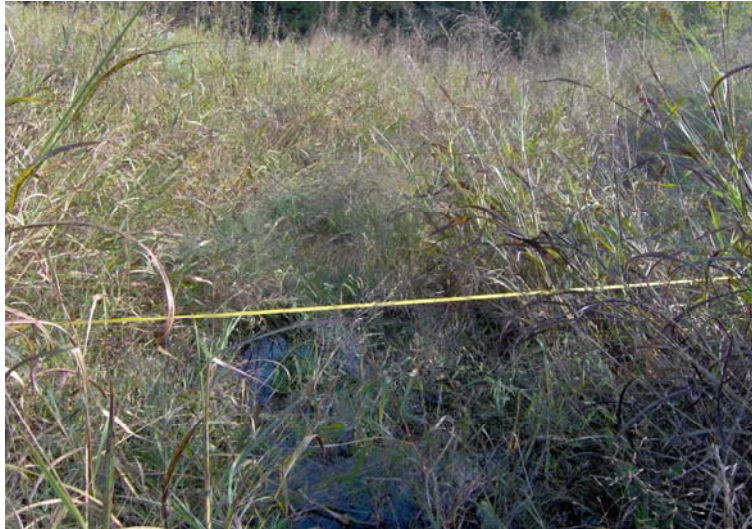
Holly Grove Stream Restoration Site
 Guilford County, NC
 Cross Section RF7
 Reach 7 - Southeast Creek - Sta 100+00

Facing Downstream

As-Built		Year 1		Year 2		Year 3		Year 4		Year 5	
Date	10/22/08	Date	0/0/0	Date	0/0/0	Date	0/0/0	Date	0/0/0	Date	0/0/0
Area	4.3	Area	0.0	Area	0.0	Area	0.0	Area	0.0	Area	0.0
Bkf W	8	Bkf W	10	Bkf W	10	Bkf W	10	Bkf W	10	Bkf W	10
Dmean	0.5	Dmean	0.0	Dmean	0.0	Dmean	0.0	Dmean	0.0	Dmean	0.0
Dmax	0.8	Dmax	0.0	Dmax	0.0	Dmax	0.0	Dmax	0.0	Dmax	0.0
W/d	15.0	W/d	0.0	W/d	0.0	W/d	0.0	W/d	0.0	W/d	0.0

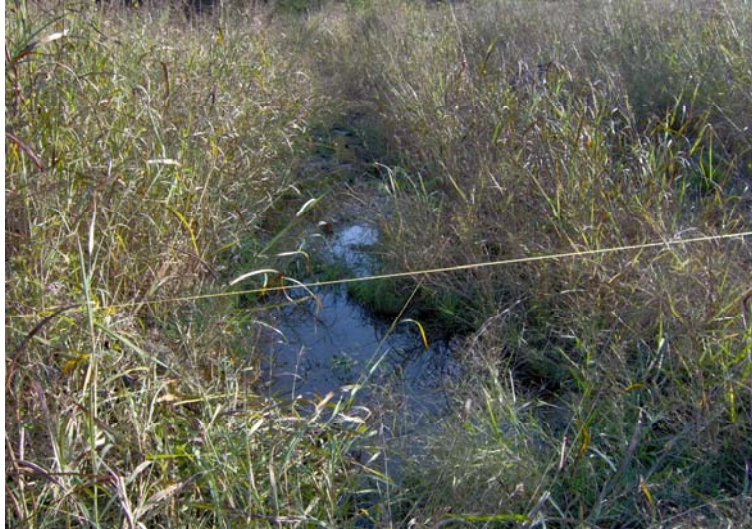
Cross Section PL7

Reach 7 - Southeast Creek - Sta 100+00

Facing Downstream

As-Built		Year 1		Year 2		Year 3		Year 4		Year 5	
Date	10/22/08	Date	0/0/0	Date	0/0/0	Date	0/0/0	Date	0/0/0	Date	0/0/0
Area	8.7	Area	0.0	Area	0.0	Area	0.0	Area	0.0	Area	0.0
Bkf W	8.3	Bkf W	10	Bkf W	10	Bkf W	10	Bkf W	10	Bkf W	10
Dmean	1.1	Dmean	0.0	Dmean	0.0	Dmean	0.0	Dmean	0.0	Dmean	0.0
Dmax	1.8	Dmax	0.0	Dmax	0.0	Dmax	0.0	Dmax	0.0	Dmax	0.0
W/d	7.9	W/d	0.0	W/d	0.0	W/d	0.0	W/d	0.0	W/d	0.0

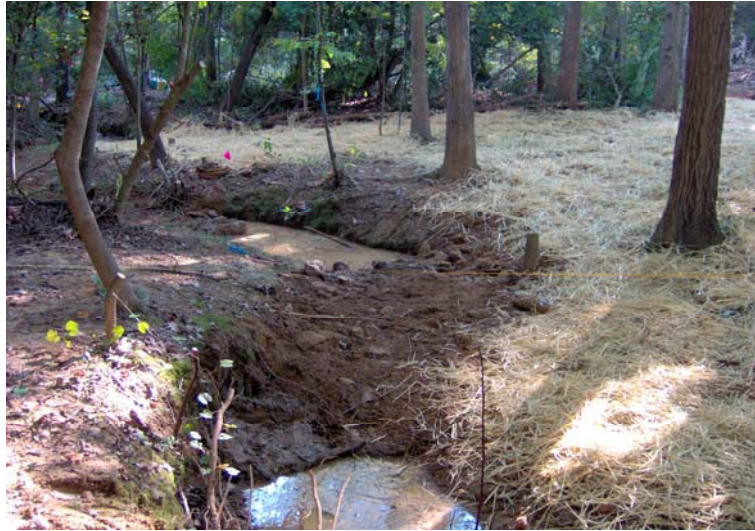
Holly Grove Stream Restoration Site
 Guilford County, NC
 Cross Section RF8
 Reach 8 - Southwest Creek - Sta 100+00

Facing Downstream

As-Built		Year 1		Year 2		Year 3		Year 4		Year 5	
Date	10/22/08	Date	0/0/0	Date	0/0/0	Date	0/0/0	Date	0/0/0	Date	0/0/0
Area	3.4	Area	0.0	Area	0.0	Area	0.0	Area	0.0	Area	0.0
Bkf W	8	Bkf W	10	Bkf W	10	Bkf W	10	Bkf W	10	Bkf W	10
Dmean	0.4	Dmean	0.0	Dmean	0.0	Dmean	0.0	Dmean	0.0	Dmean	0.0
Dmax	0.7	Dmax	0.0	Dmax	0.0	Dmax	0.0	Dmax	0.0	Dmax	0.0
W/d	18.6	W/d	0.0	W/d	0.0	W/d	0.0	W/d	0.0	W/d	0.0

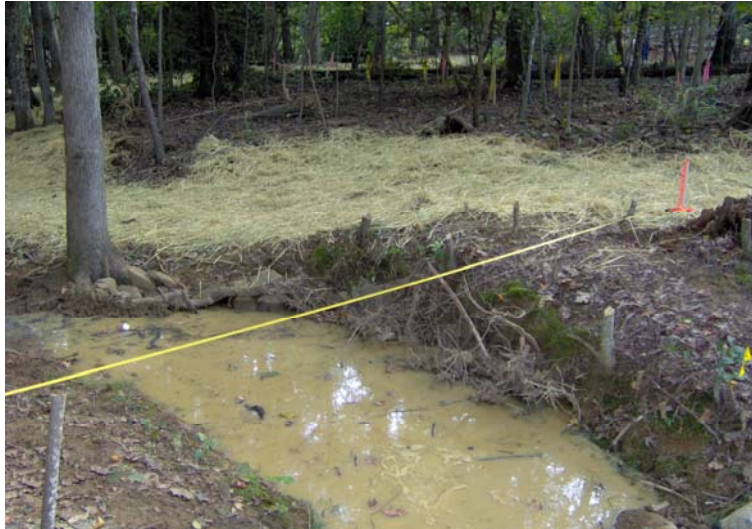
Holly Grove Stream Restoration Site
 Guilford County, NC
 Cross Section PL8
 Reach 8 - Southwest Creek - Sta 100+00

Facing Downstream

As-Built		Year 1		Year 2		Year 3		Year 4		Year 5	
Date	10/22/08	Date	0/0/0	Date	0/0/0	Date	0/0/0	Date	0/0/0	Date	0/0/0
Area	7.9	Area	0.0	Area	0.0	Area	0.0	Area	0.0	Area	0.0
Bkf W	7.1	Bkf W	10	Bkf W	10	Bkf W	10	Bkf W	10	Bkf W	10
Dmean	1.1	Dmean	0.0	Dmean	0.0	Dmean	0.0	Dmean	0.0	Dmean	0.0
Dmax	1.6	Dmax	0.0	Dmax	0.0	Dmax	0.0	Dmax	0.0	Dmax	0.0
W/d	6.4	W/d	0.0	W/d	0.0	W/d	0.0	W/d	0.0	W/d	0.0

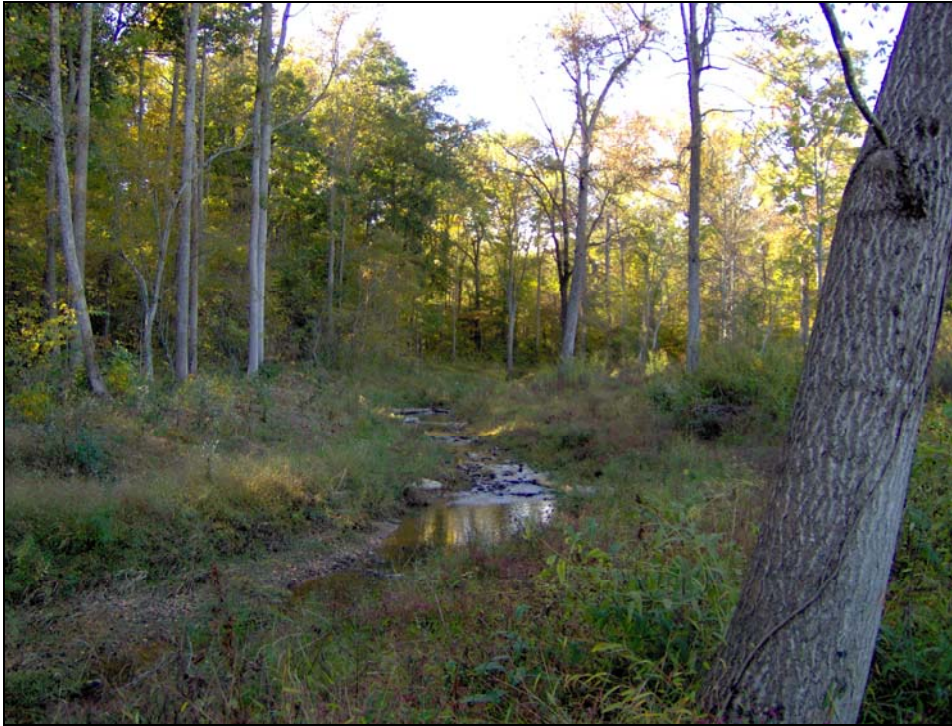
Photo No. 1

Photo Point 1

Buckhorn Creek facing upstream

Photograph reference points (PRPs) have been established to assist in characterizing the site and to allow qualitative evaluation of the site conditions. The location of each photo point has been permanently marked in the field and the bearing/orientation of the photograph is indicated on the As-built plans to allow for consistent repetition. A total of twenty-eight (28) PRP's have been established along the restored stream. Sixteen (16) of these PRP's have been located upstream of the permanent monitoring cross sections. These photographs will be taken facing downstream looking at the section, and will show as much of the banks and channel as possible. The survey tape used for cross-sectional measurements will be centered in each photograph and the water line will be located near the lower edge. An effort will be made to consistently photograph the same area in each subsequent monitoring event.

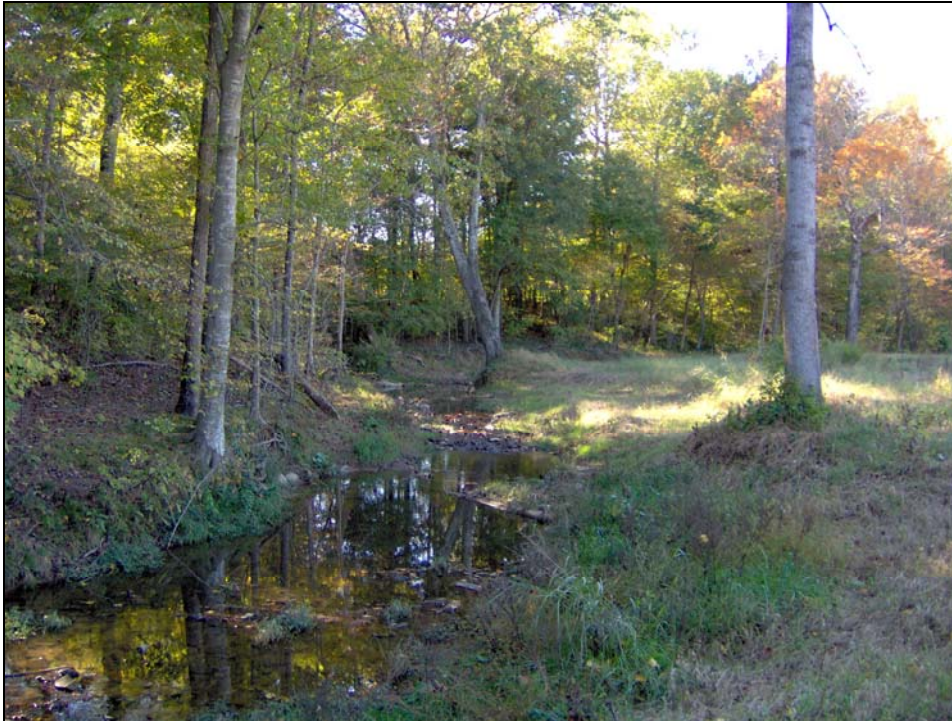
Photo No. 2

Photo Point 2

Buckhorn Creek facing upstream

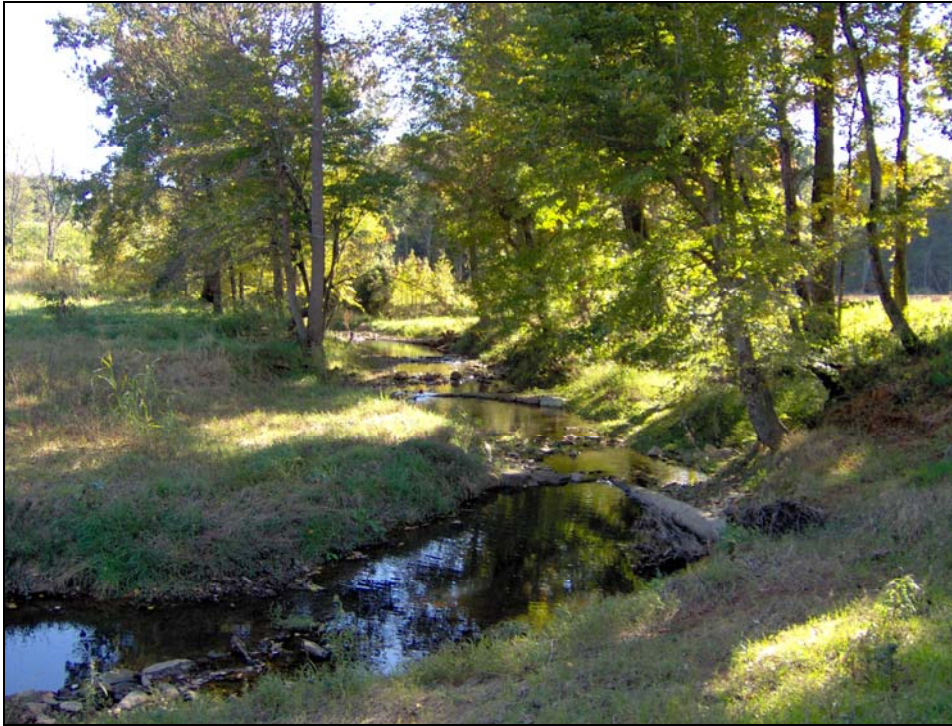
Photo No. 3

Photo Point 3

Buckhorn Creek facing upstream

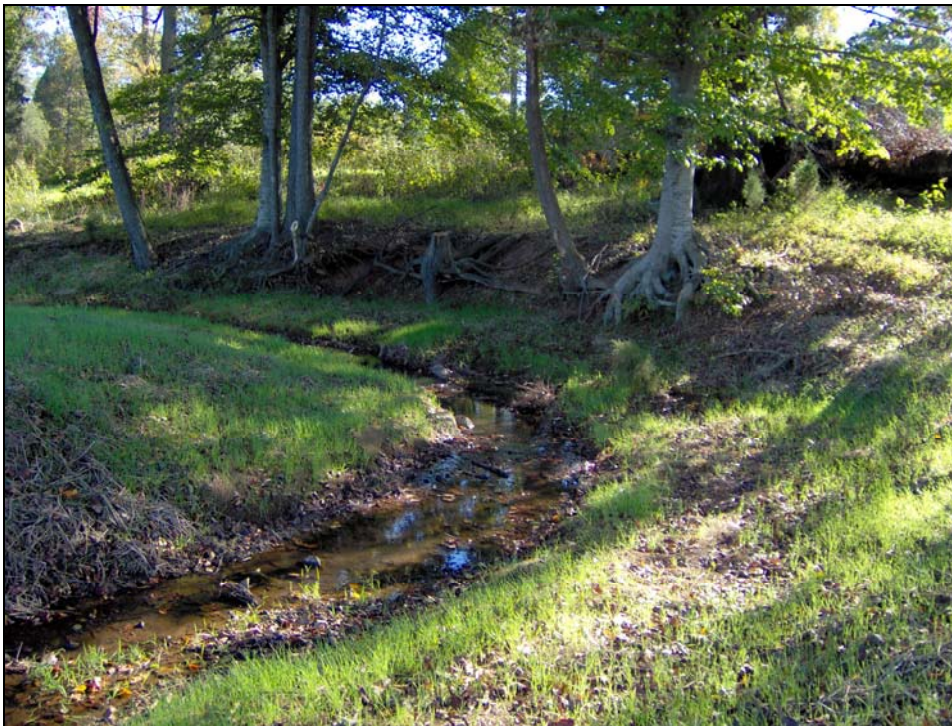
Photo No. 4

Photo Point 4

West Branch facing downstream

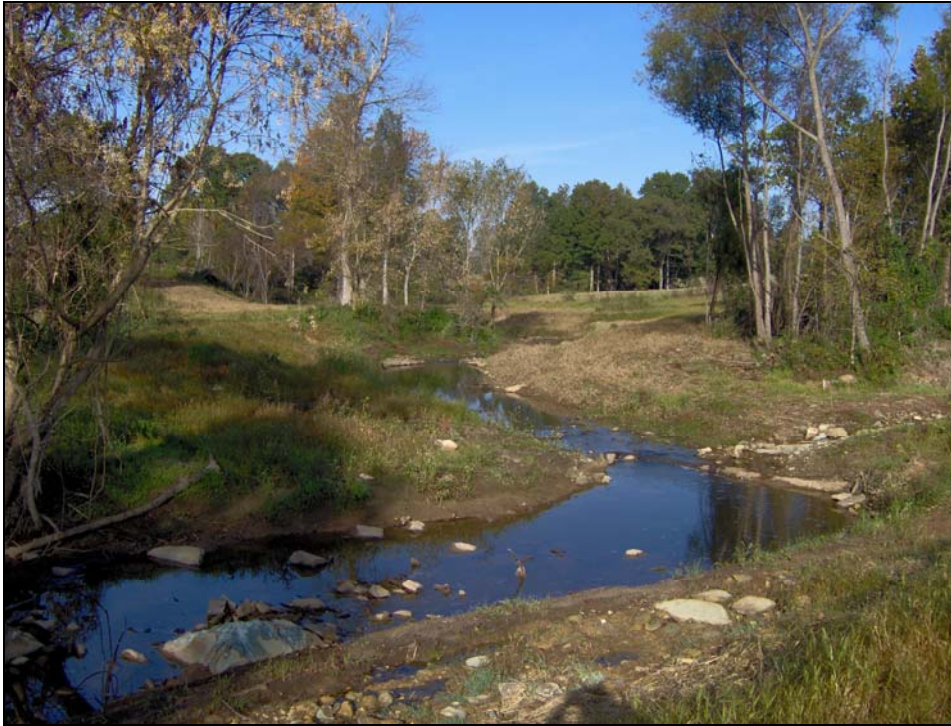
Photo No. 5

Photo Point 5

Buckhorn Creek facing upstream

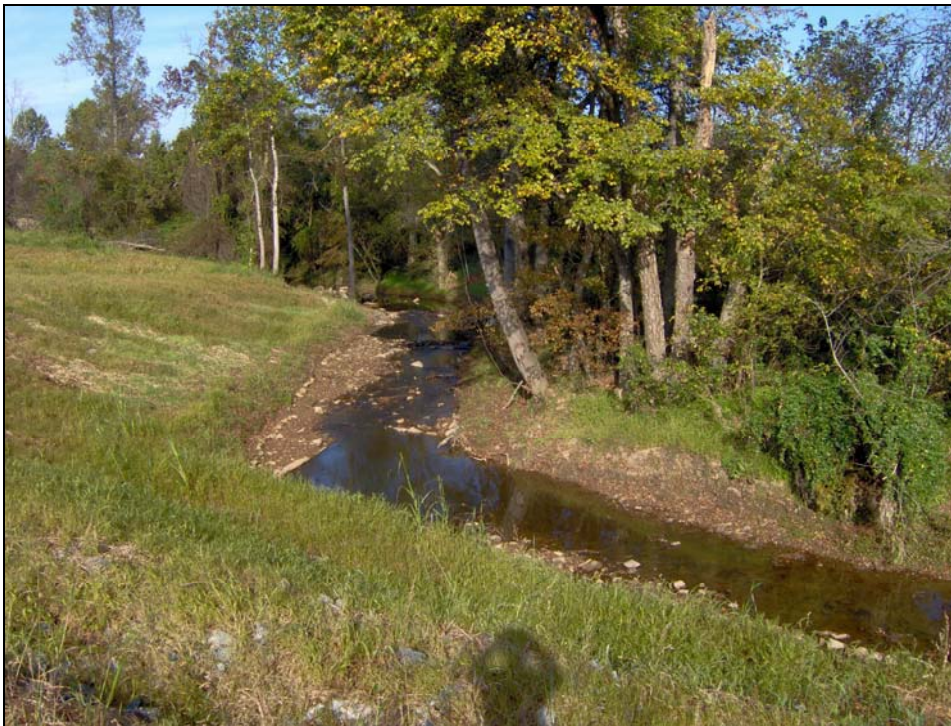
Photo No. 6

Photo Point 6

Buckhorn Creek at bridge, facing upstream

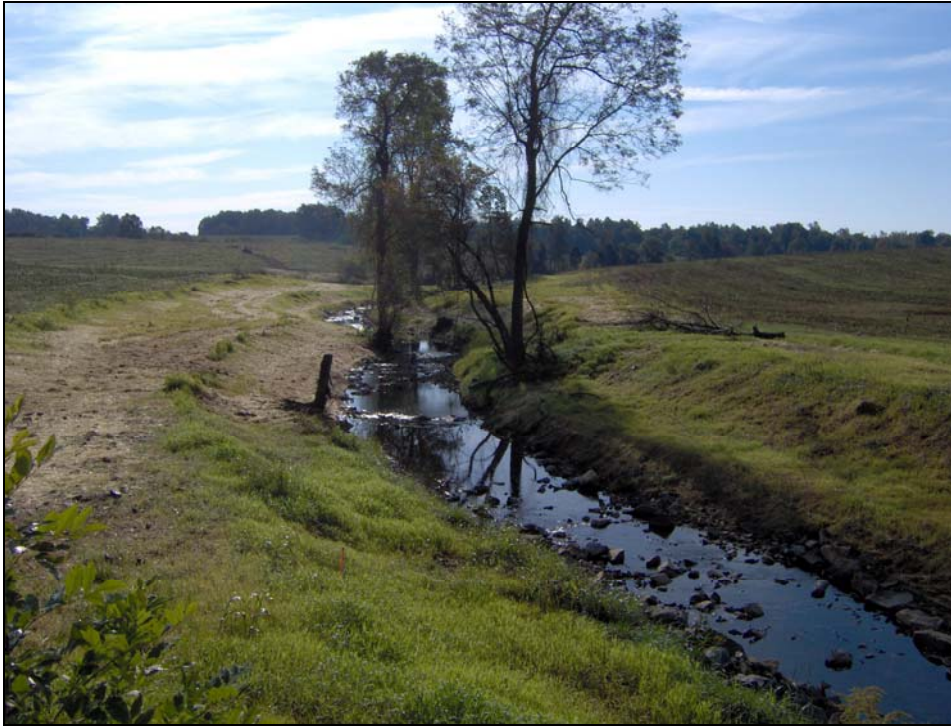
Photo No. 7

Photo Point 7

Buckhorn Creek at bridge, facing downstream

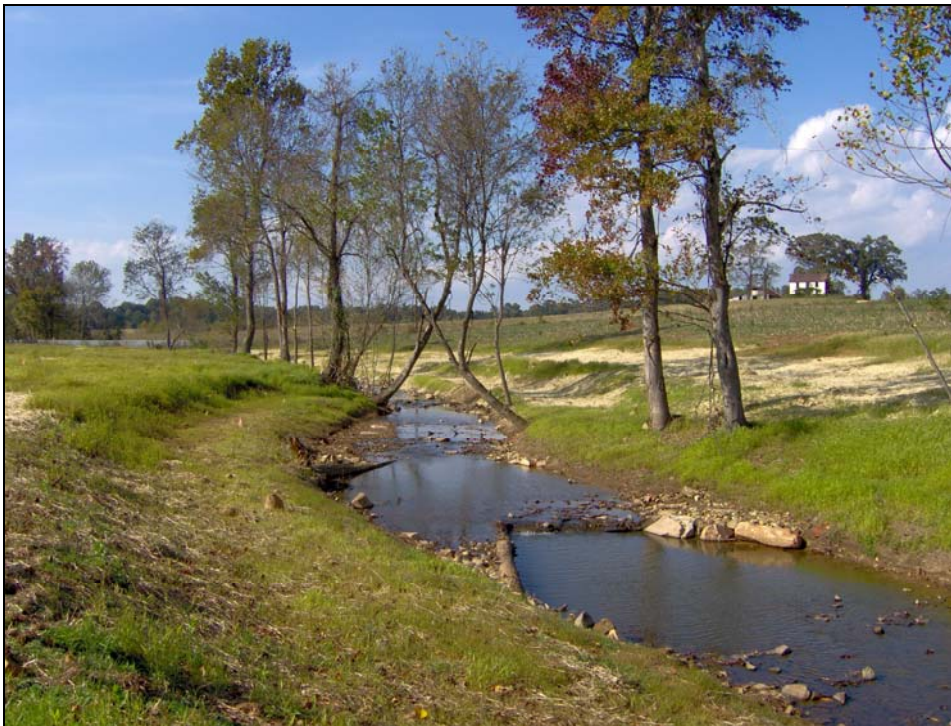
Photo Point 8

Buckhorn Creek facing upstream

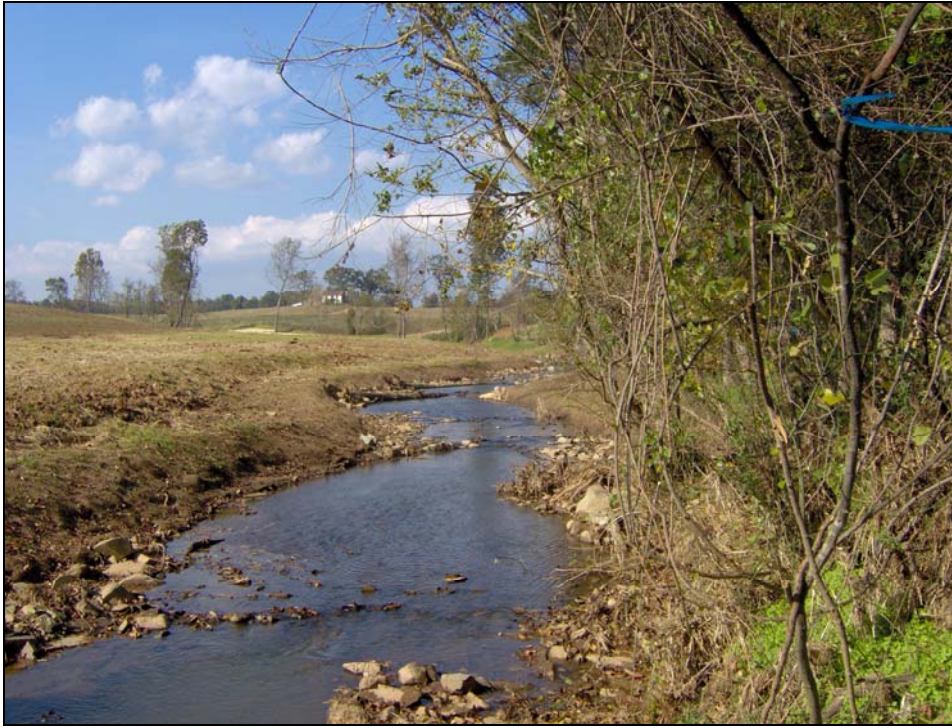
Photo Point 9

Buckhorn Creek facing upstream

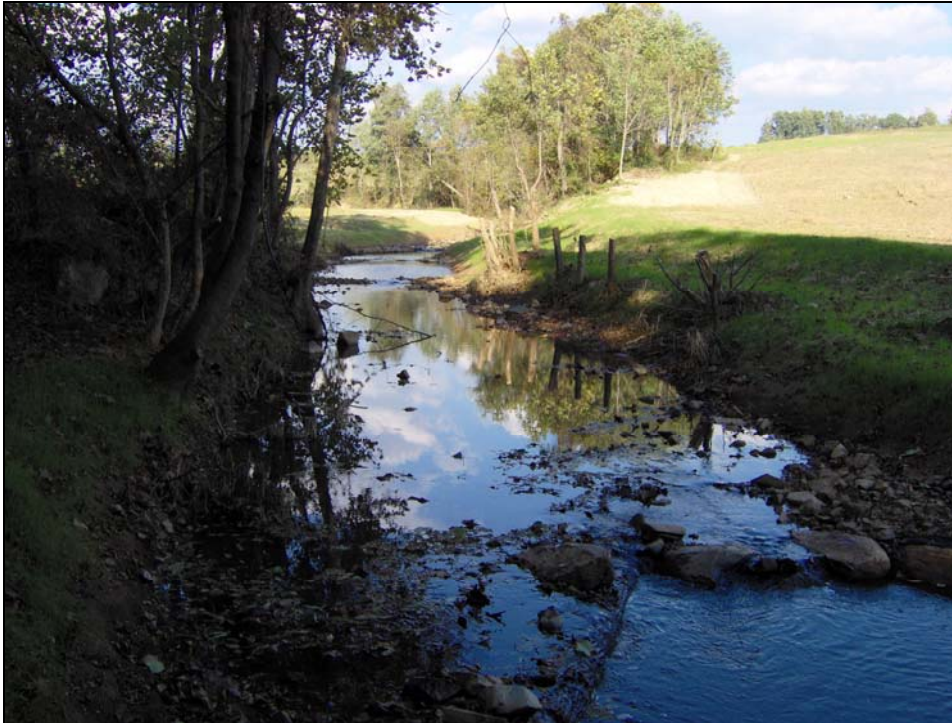
Photo Point 10

Buckhorn Creek facing upstream

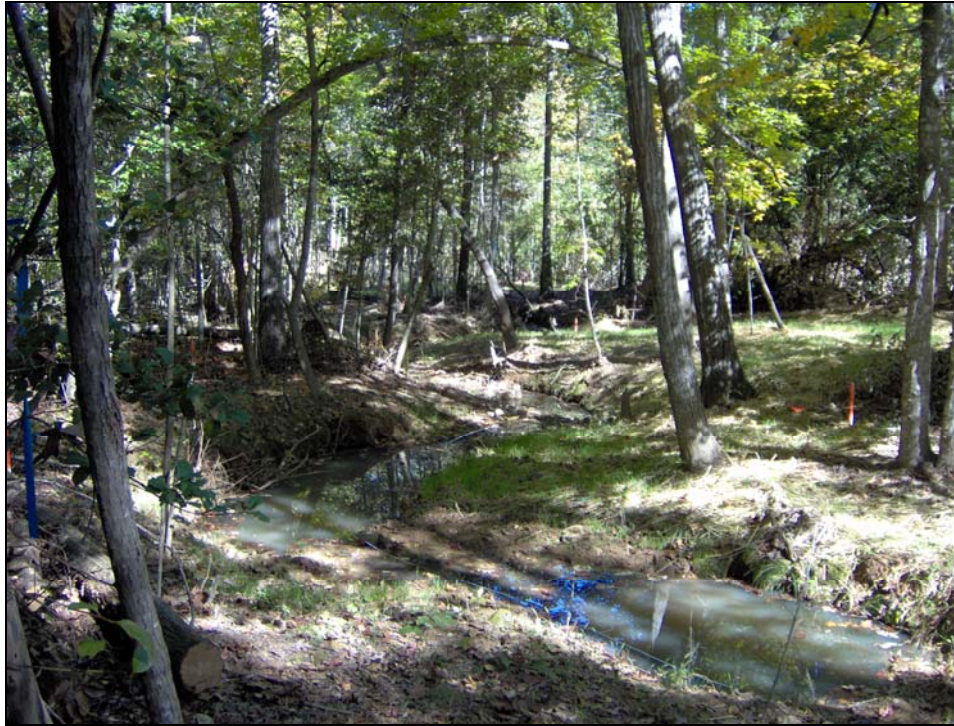
Photo Point 11

Southwest Creek facing downstream

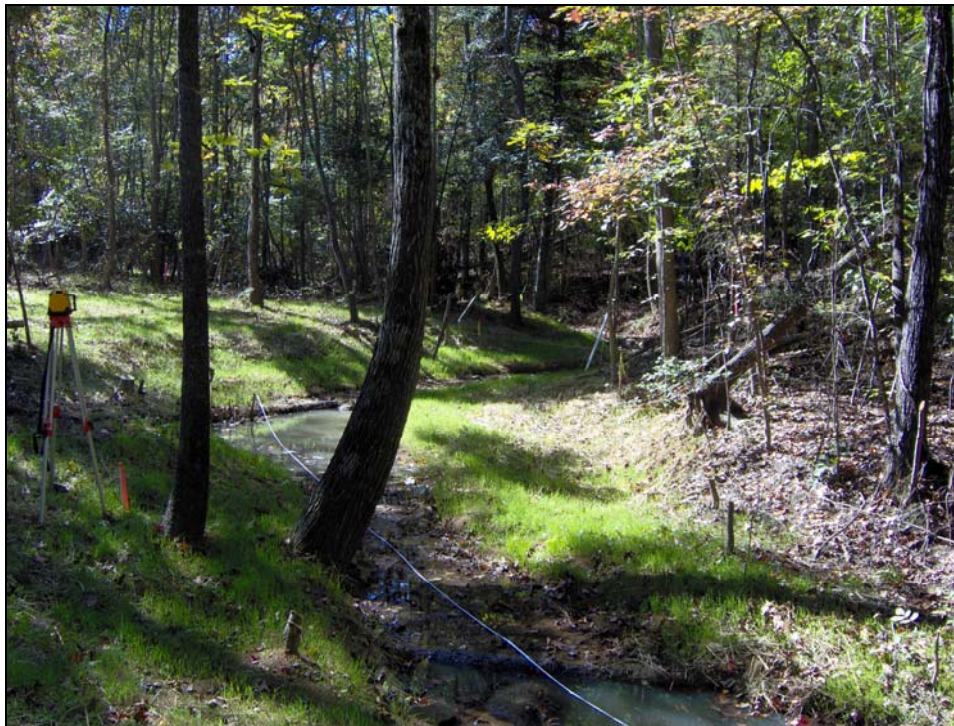
Photo Point 12

Southwest Creek facing upstream
