# AS-BUILT BASELINE MONITORING REPORT

## HONEY MILL MITIGATION SITE

Surry County, NC  
DEQ Contract No. 7619  
DMS Project No. 100083

Yadkin River Basin HUC 03040101  
USACE Action ID No. SAW-2018-01789  
NCDEQ DWR#: 18-1271  
RFP #: 16-007406 / Issued: December 7, 2017

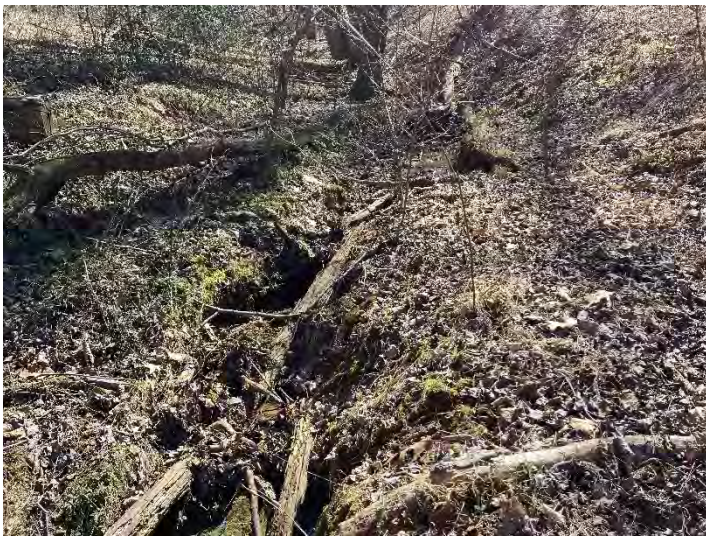
**PHOTO POINT 8 UT2 R1 Headcut – upstream (3/4/2021)**

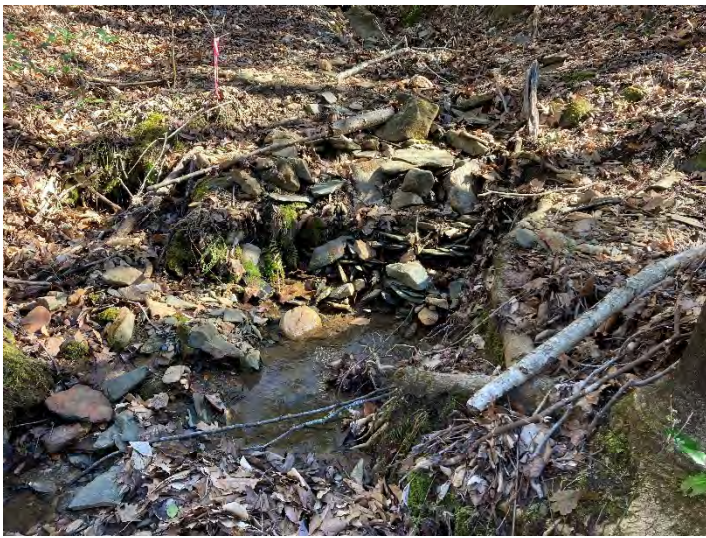
**PHOTO POINT 23 UT5 Headcut – upstream (3/4/2021)**

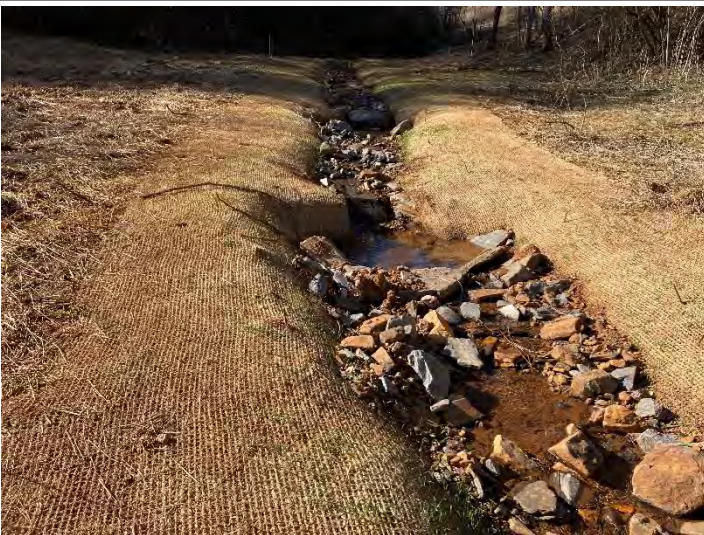
**PHOTO POINT 27 UT6 R2 – upstream (3/4/2021)**

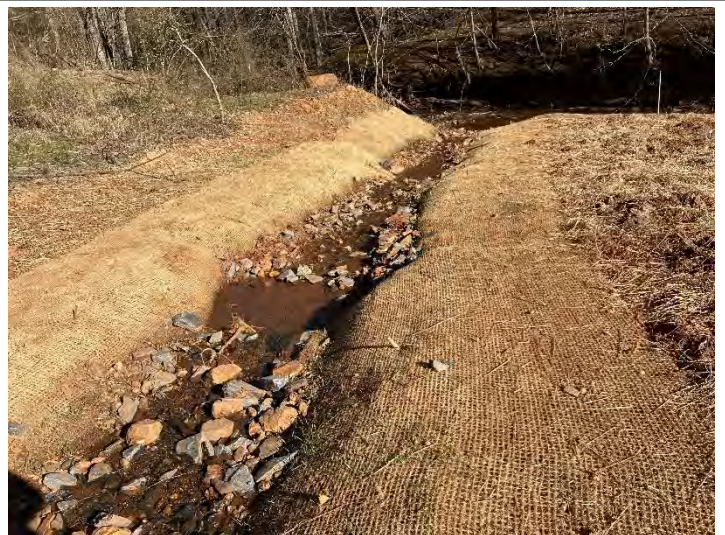
**PHOTO POINT 27 UT6 R2 – downstream (3/4/2021)**

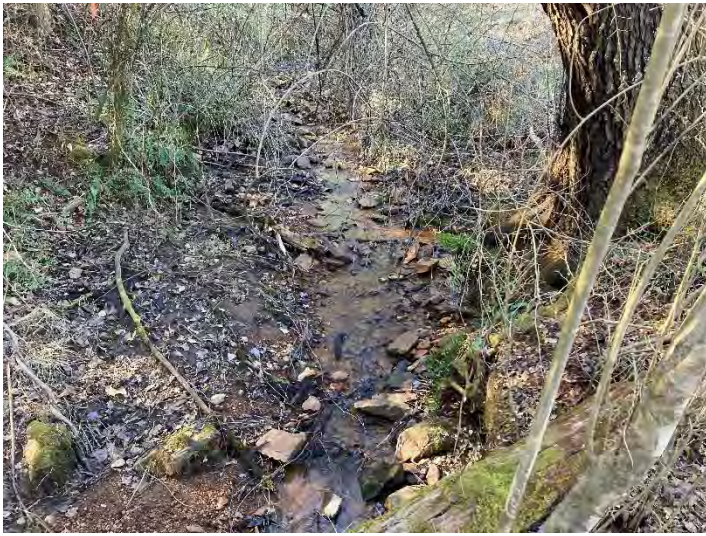
**PHOTO POINT 28 UT6 R1 – upstream (3/4/2021)**

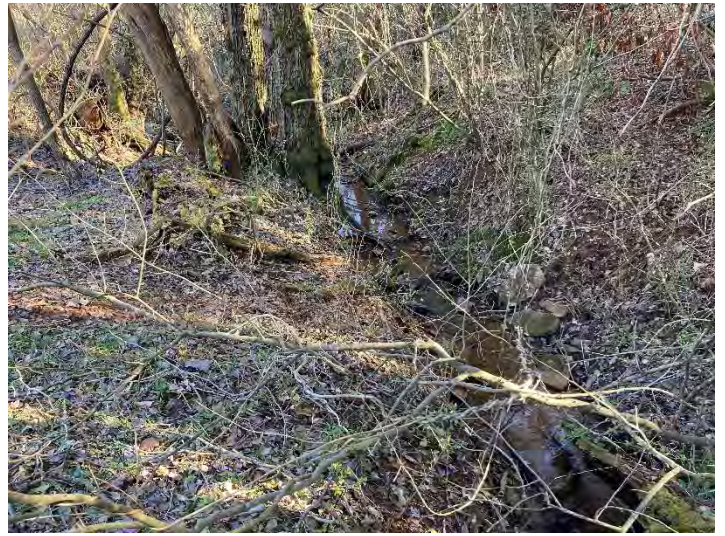
**PHOTO POINT 28 UT6 R1 – downstream (3/4/2021)**

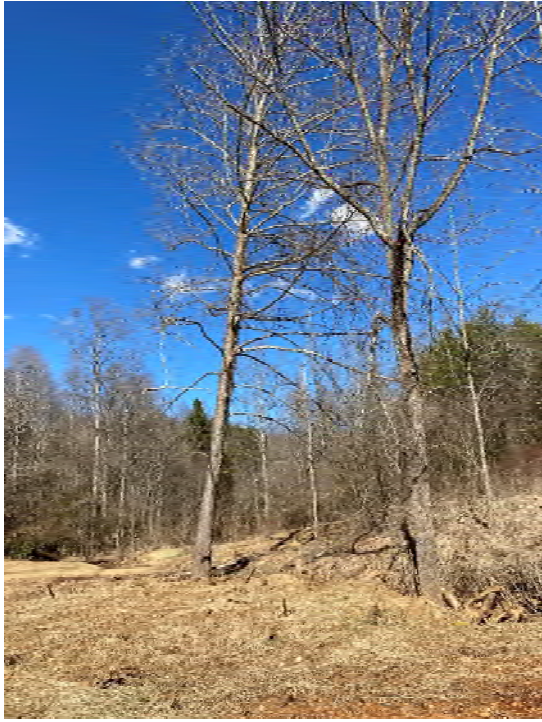
**Mature Tree Photo Point 1 (Northeast)** – Venable Creek Reach 3  
*(03/04/2021)*

6. Locations of exotic and nuisance vegetation are mapped.
7. Locations of vegetation damage, boundary encroachments, etc. are mapped.
8. Two additional photo points have been established to document mature tree save areas.

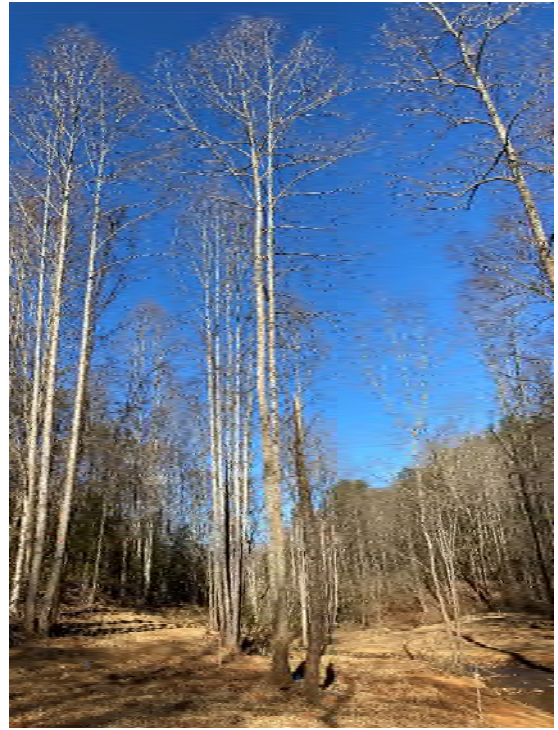
**Mature Tree Photo Point 2 (Northeast)** – Venable Creek Reach 4  
*(03/04/2021)*
