# **BASELINE MONITORING DOCUMENT AND AS-BUILT BASELINE REPORT**

## **HOPEWELL STREAM MITIGATION SITE**

Randolph County, NC  
DENR Contract 004642  
NCEEP Project Number 95352

Baseline Monitoring Document and As-Built Baseline Report-FINAL

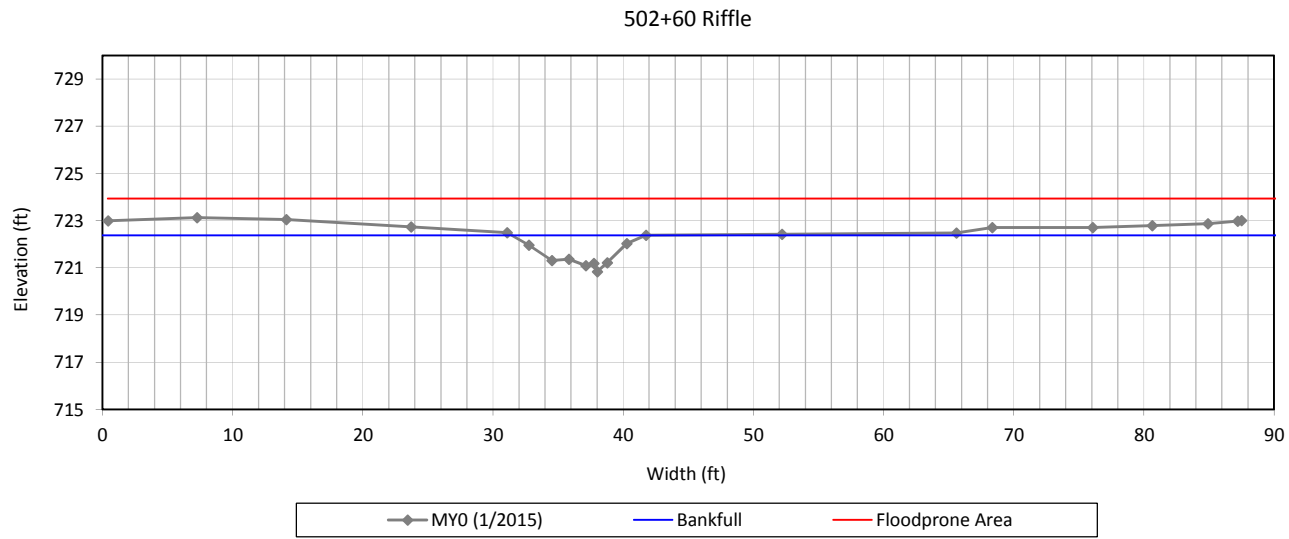
Cross Section 2, UT2A Reach 1

Cross Section Plots  
 Hopewell Stream Mitigation Site (NCEEP Project No. 95352)  
 Monitoring Year 0

Bankfull Dimensions

8.0	x-section area (ft.sq.)
10.3	width (ft)
0.8	mean depth (ft)
1.6	max depth (ft)
11.1	wetted perimeter (ft)
0.7	hyd radi (ft)
13.3	width-depth ratio
87.1	W flood prone area (ft)
8.4	entrenchment ratio
1.0	low bank height ratio

Survey Date: 1/2015  
 Field Crew: Turner Surveying

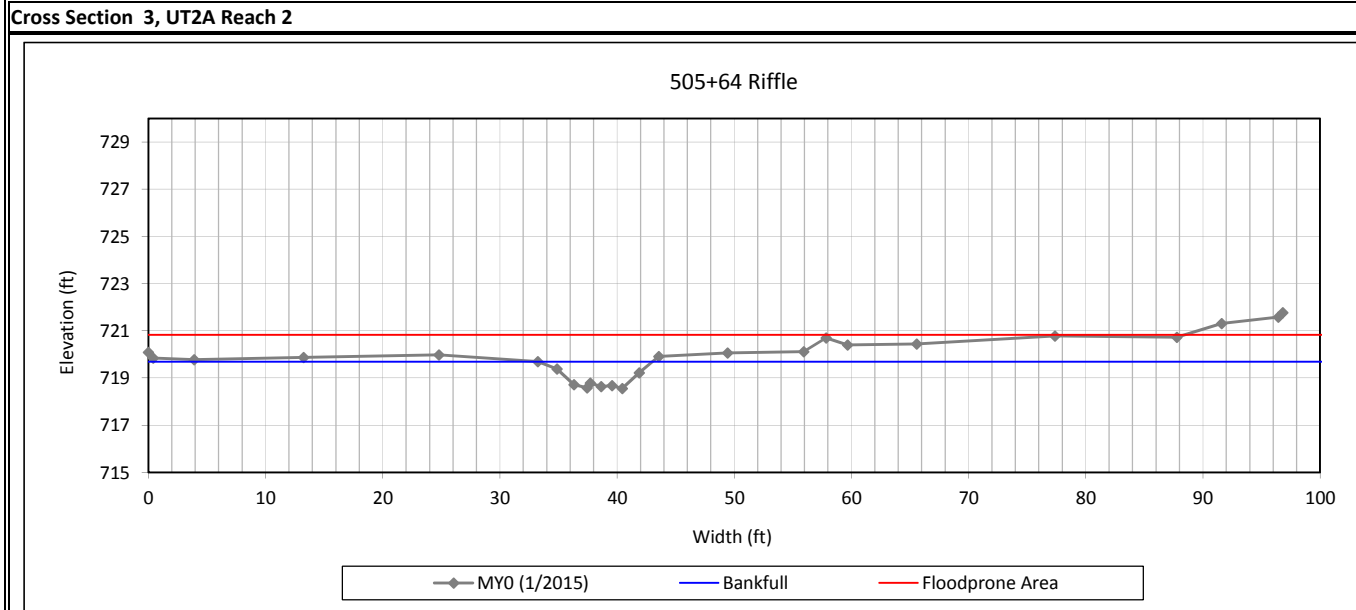
Cross Section Plots  
Hopewell Stream Mitigation Site (NCEEP Project No. 95352)  
Monitoring Year 0

**Bankfull Dimensions**

6.8	x-section area (ft.sq.)
9.8	width (ft)
0.7	mean depth (ft)
1.1	max depth (ft)
10.3	wetted perimeter (ft)
0.7	hyd radi (ft)
14.0	width-depth ratio
88.4	W flood prone area (ft)
9.1	entrenchment ratio
1.0	low bank height ratio

Survey Date: 1/2015  
Field Crew: Turner Surveying

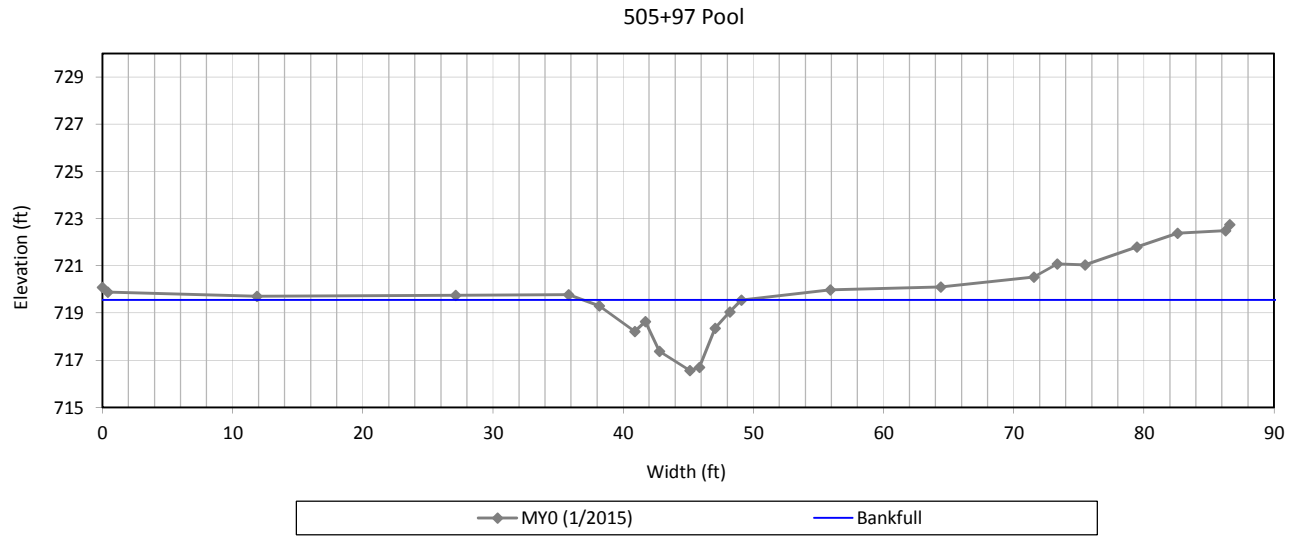
Cross Section 4, UT2A Reach 2

Cross Section Plots  
Hopewell Stream Mitigation Site (NCEEP Project No. 95352)  
Monitoring Year 0

Bankfull Dimensions

16.7	x-section area (ft.sq.)
12.1	width (ft)
1.4	mean depth (ft)
3.0	max depth (ft)
14.3	wetted perimeter (ft)
1.2	hyd radi (ft)
8.8	width-depth ratio
---	W flood prone area (ft)
---	entrenchment ratio
1.0	low bank height ratio

Survey Date: 1/2015  
Field Crew: Turner Surveying

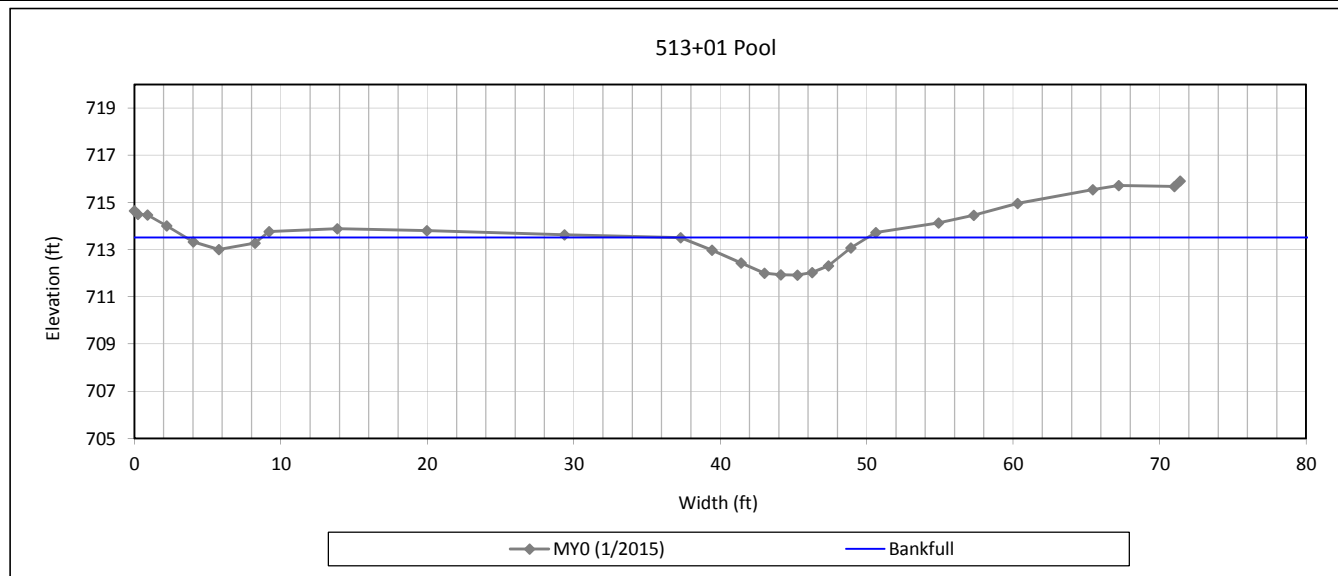
Cross Section 5, UT2A Reach 2

Cross Section Plots  
 Hopewell Stream Mitigation Site (NCEEP Project No. 95352)  
 Monitoring Year 0

Bankfull Dimensions

12.0	x-section area (ft.sq.)
11.9	width (ft)
1.0	mean depth (ft)
1.6	max depth (ft)
12.3	wetted perimeter (ft)
1.0	hyd radi (ft)
11.7	width-depth ratio
---	W flood prone area (ft)
---	entrenchment ratio
0.7	low bank height ratio

Survey Date: 1/2015  
 Field Crew: Turner Surveying

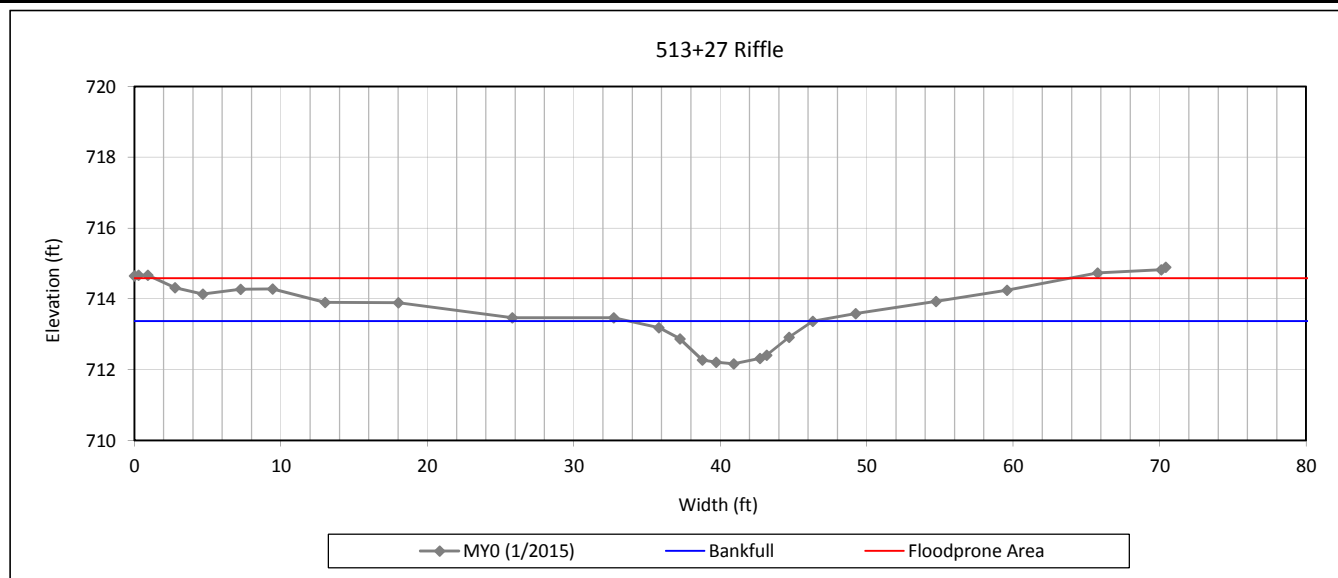
Cross Section 6, UT2A R2

Cross Section Plots  
 Hopewell Stream Mitigation Site (NCEEP Project No. 95352)  
 Monitoring Year 0

Bankfull Dimensions

7.8	x-section area (ft.sq.)
8.9	width (ft)
0.9	mean depth (ft)
1.2	max depth (ft)
9.1	wetted perimeter (ft)
0.9	hyd radi (ft)
10.2	width-depth ratio
62.5	W flood prone area (ft)
7.0	entrenchment ratio
1.0	low bank height ratio

Survey Date: 1/2015  
 Field Crew: Turner Surveying

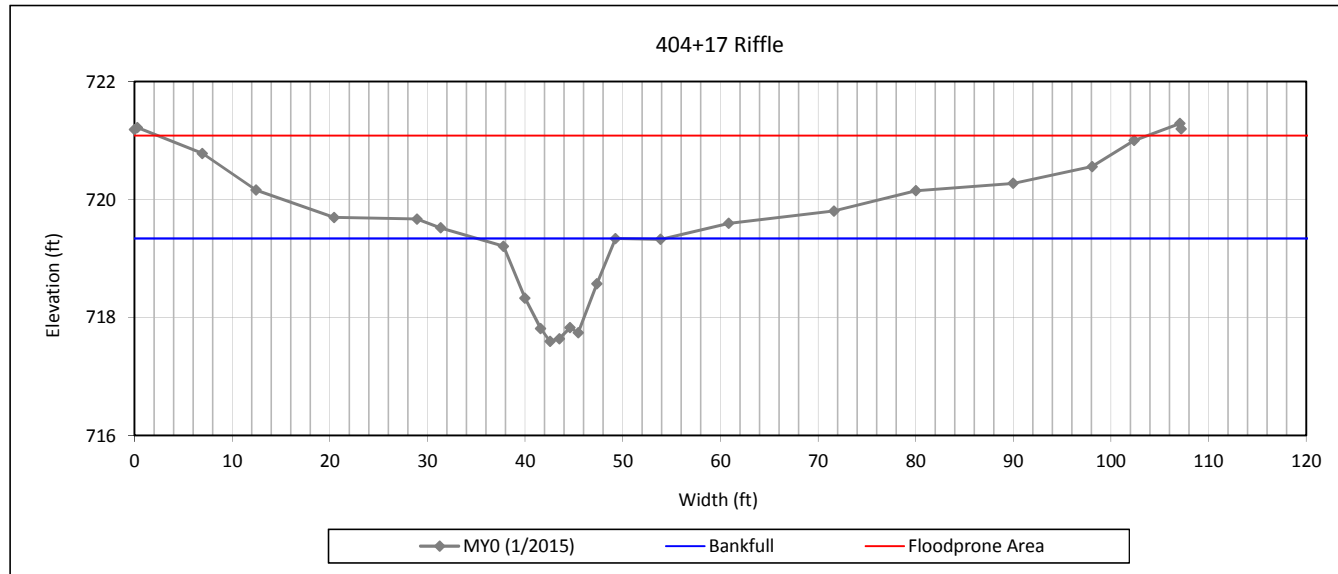
Cross Section 11, UT2 R1

Cross Section Plots  
 Hopewell Stream Mitigation Site (NCEEP Project No. 95352)  
 Monitoring Year 0

Bankfull Dimensions

12.7	x-section area (ft.sq.)
14.2	width (ft)
0.9	mean depth (ft)
1.7	max depth (ft)
14.8	wetted perimeter (ft)
0.9	hyd radi (ft)
15.8	width-depth ratio
94.3	W flood prone area (ft)
6.6	entrenchment ratio
1.0	low bank height ratio

Survey Date: 1/2015  
 Field Crew: Turner Surveying

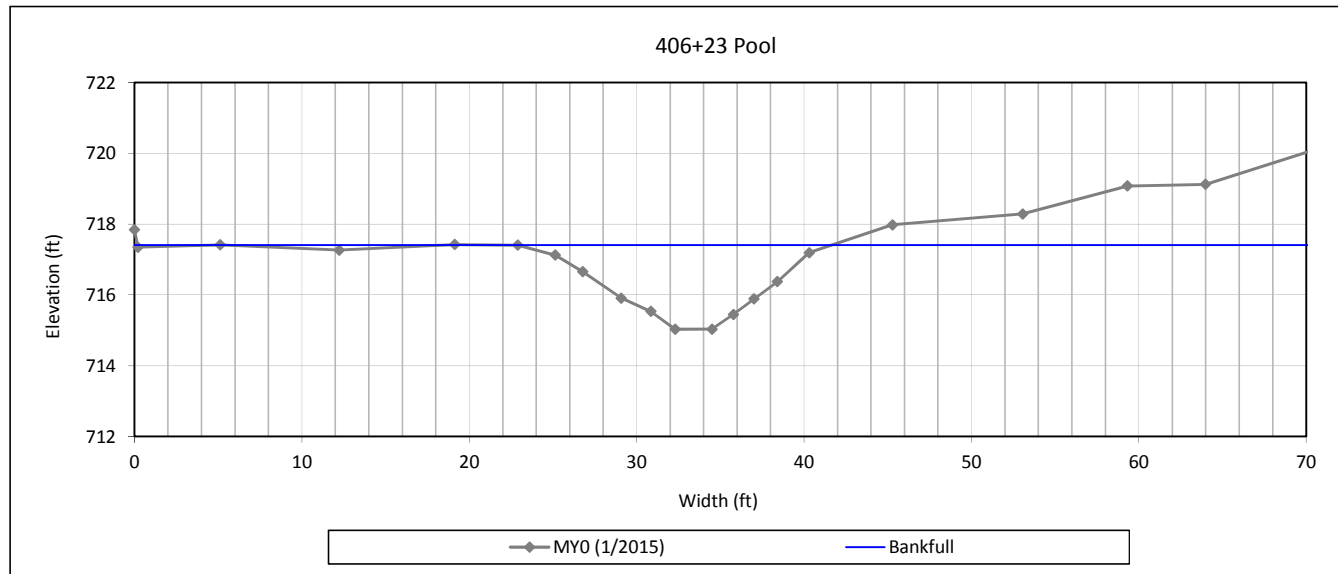
Cross Section 13, UT2 R1

Cross Section Plots  
Hopewell Stream Mitigation Site (NCEEP Project No. 95352)  
Monitoring Year 0

Bankfull Dimensions

23.1	x-section area (ft.sq.)
19.6	width (ft)
1.2	mean depth (ft)
2.4	max depth (ft)
20.4	wetted perimeter (ft)
1.1	hyd radi (ft)
16.7	width-depth ratio
---	W flood prone area (ft)
---	entrenchment ratio
1.0	low bank height ratio

Survey Date: 1/2015  
Field Crew: Turner Surveying

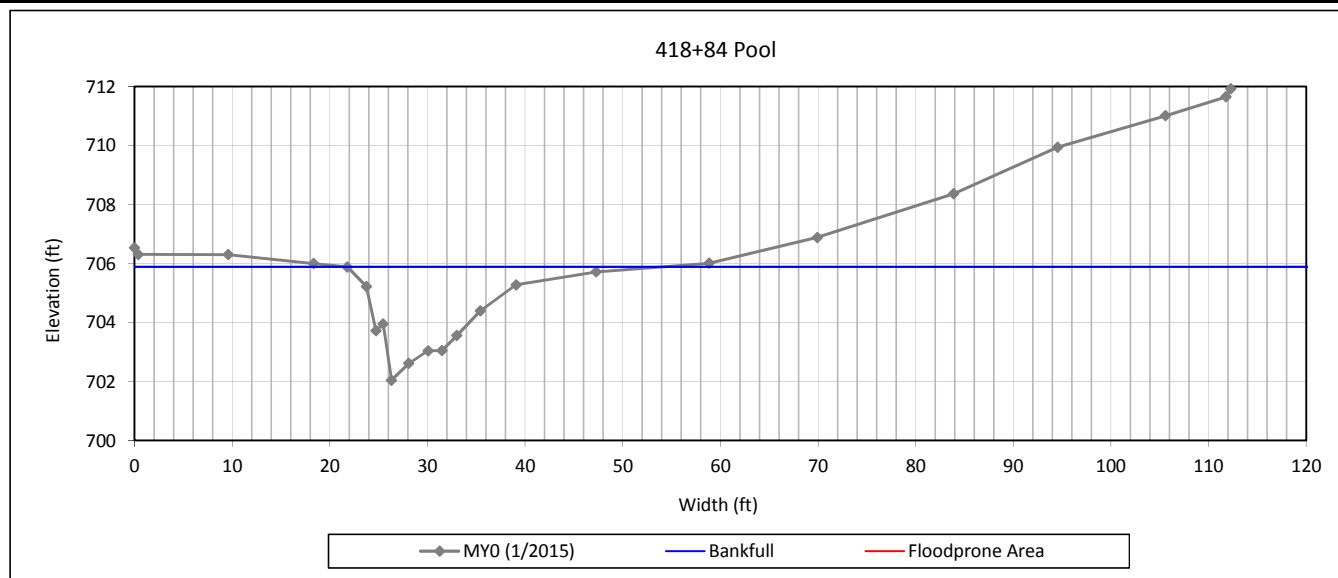
**Cross Section 7, UT2 R2**

Bankfull Dimensions

38.6	x-section area (ft.sq.)
32.2	width (ft)
1.2	mean depth (ft)
3.8	max depth (ft)
34.9	wetted perimeter (ft)
1.1	hyd radi (ft)
26.9	width-depth ratio
93.1	W flood prone area (ft)
2.9	entrenchment ratio
1.0	low bank height ratio

Survey Date: 1/2015  
 Field Crew: Turner Surveying

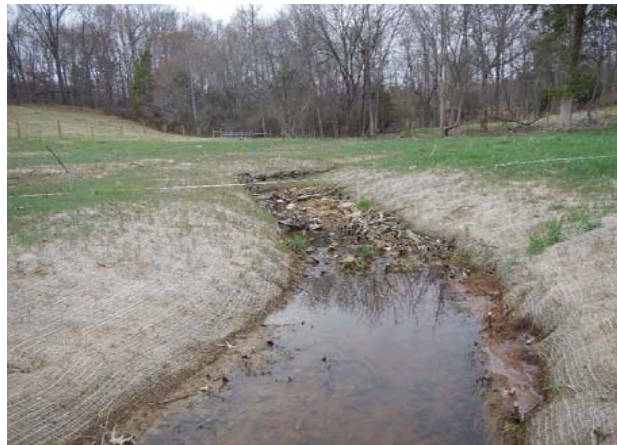
View Upstream

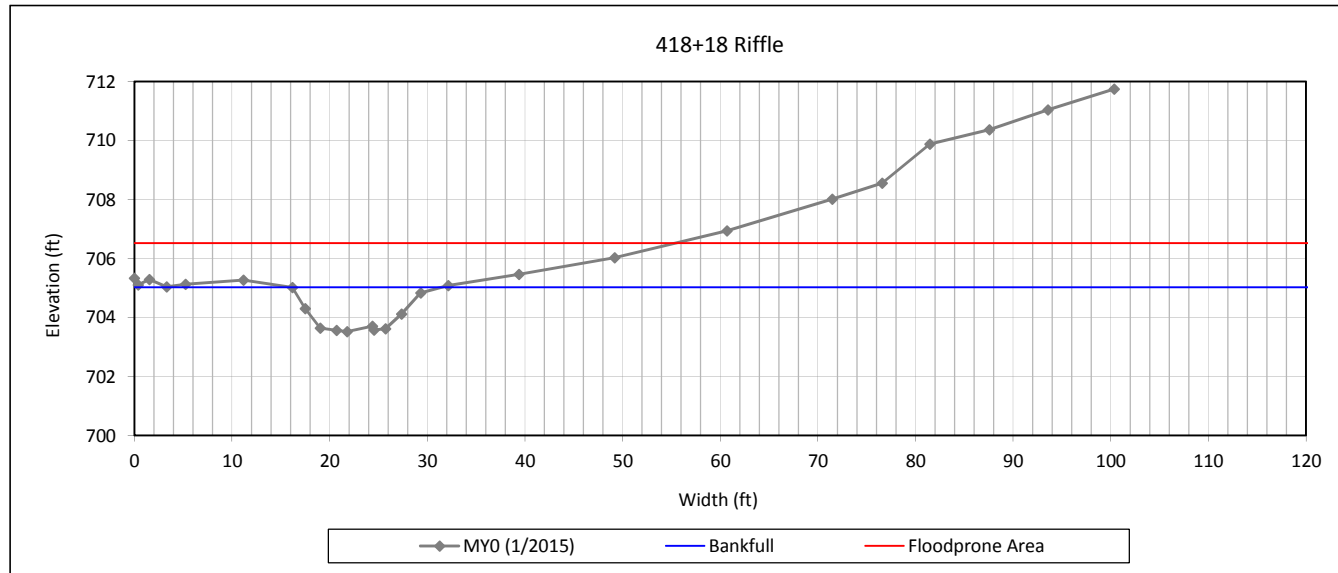
Cross Section 8, UT2 R2

Bankfull Dimensions

14.8	x-section area (ft.sq.)
15.3	width (ft)
1.0	mean depth (ft)
1.5	max depth (ft)
15.9	wetted perimeter (ft)
0.9	hyd radi (ft)
15.8	width-depth ratio
55.4	W flood prone area (ft)
3.6	entrenchment ratio
1.0	low bank height ratio

Survey Date: 1/2015  
Field Crew: Turner Surveying

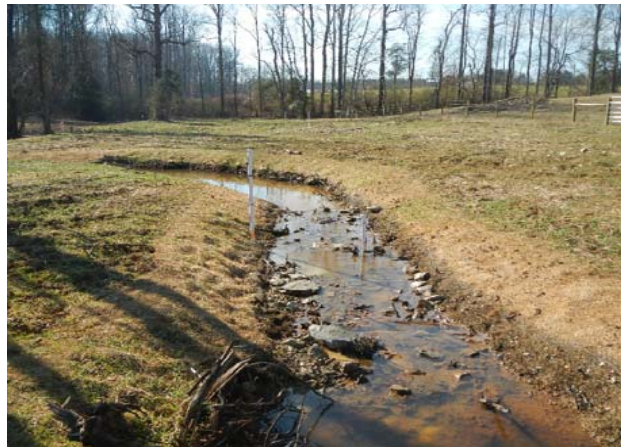
View Downstream

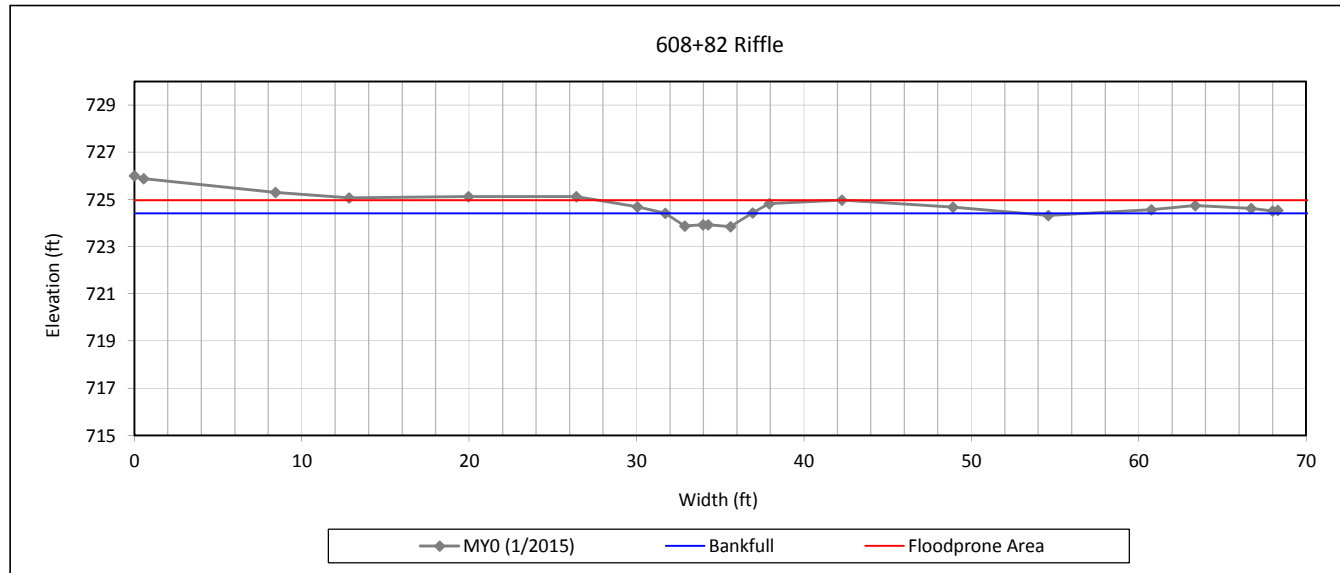
Cross Section 9, UT2B R2

Bankfull Dimensions

2.1	x-section area (ft.sq.)
5.2	width (ft)
0.4	mean depth (ft)
0.6	max depth (ft)
5.4	wetted perimeter (ft)
0.4	hyd radi (ft)
13.0	width-depth ratio
40.6	W flood prone area (ft)
7.8	entrenchment ratio
1.0	low bank height ratio

Survey Date: 1/2015  
 Field Crew: Turner Surveying

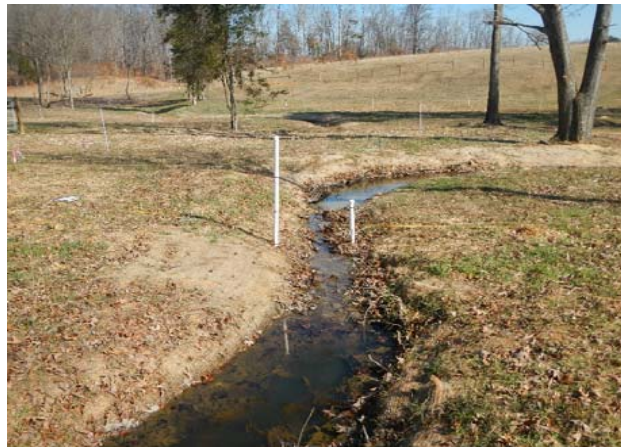
View Downstream

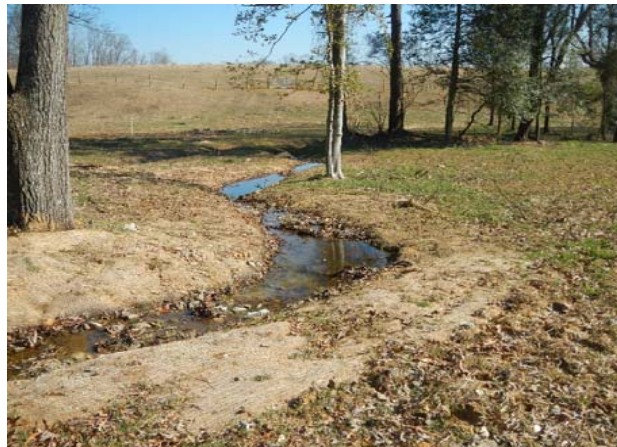
View Downstream

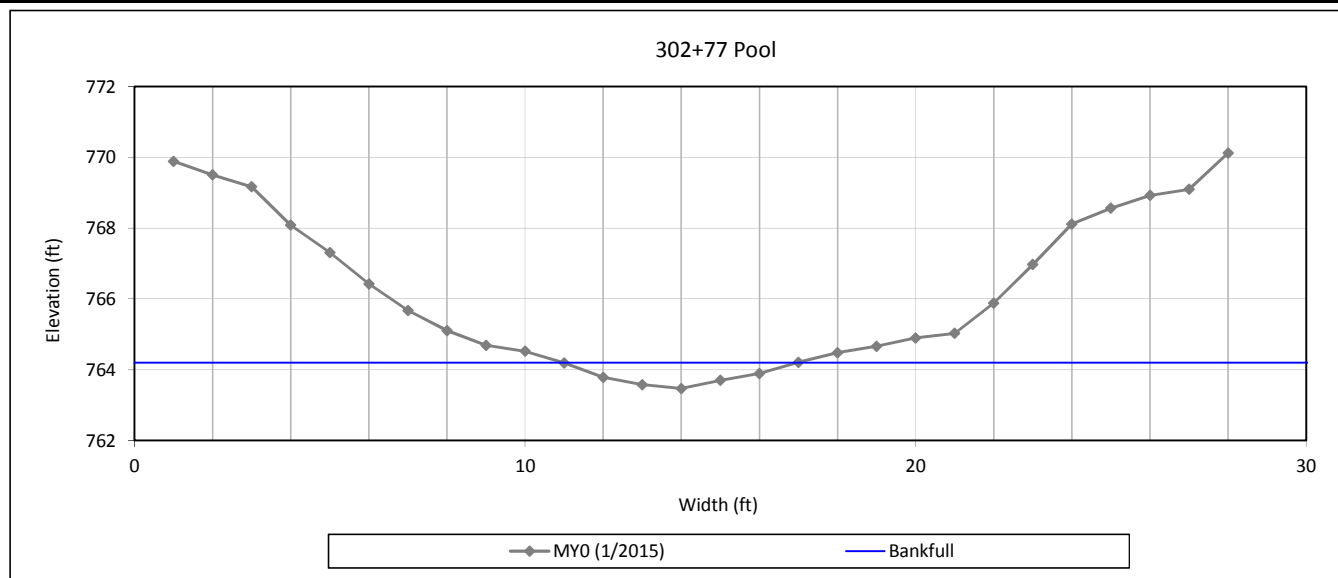
Cross Section 14, UT1B R1

Bankfull Dimensions

2.5	x-section area (ft.sq.)
5.2	width (ft)
0.5	mean depth (ft)
0.7	max depth (ft)
5.4	wetted perimeter (ft)
0.5	hyd radi (ft)
10.5	width-depth ratio
---	W flood prone area (ft)
---	entrenchment ratio
1.0	low bank height ratio

Survey Date: 1/2015  
 Field Crew: Turner Surveying

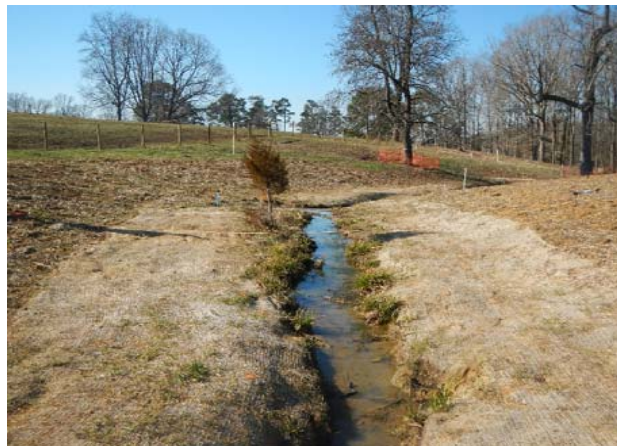
View Downstream

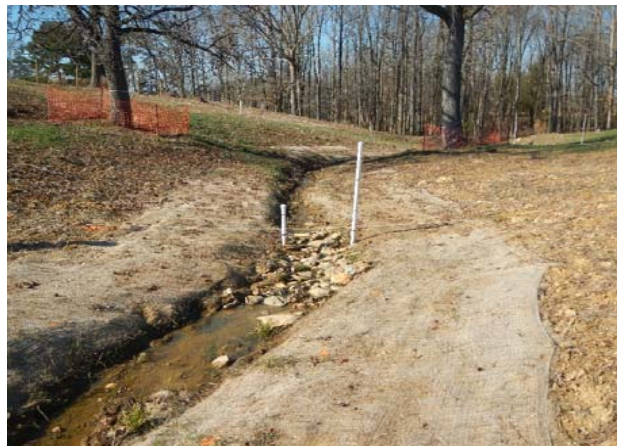
View Downstream

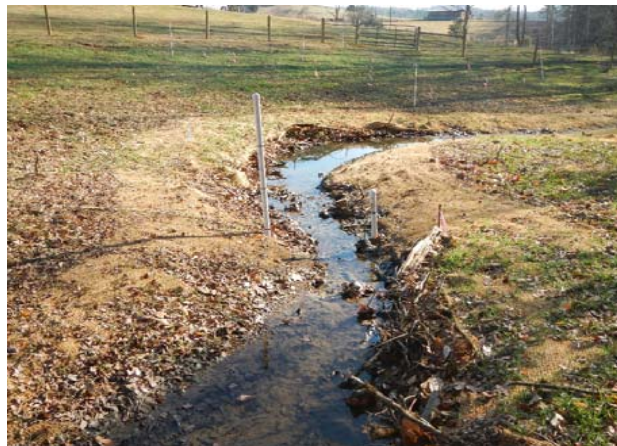
View Downstream

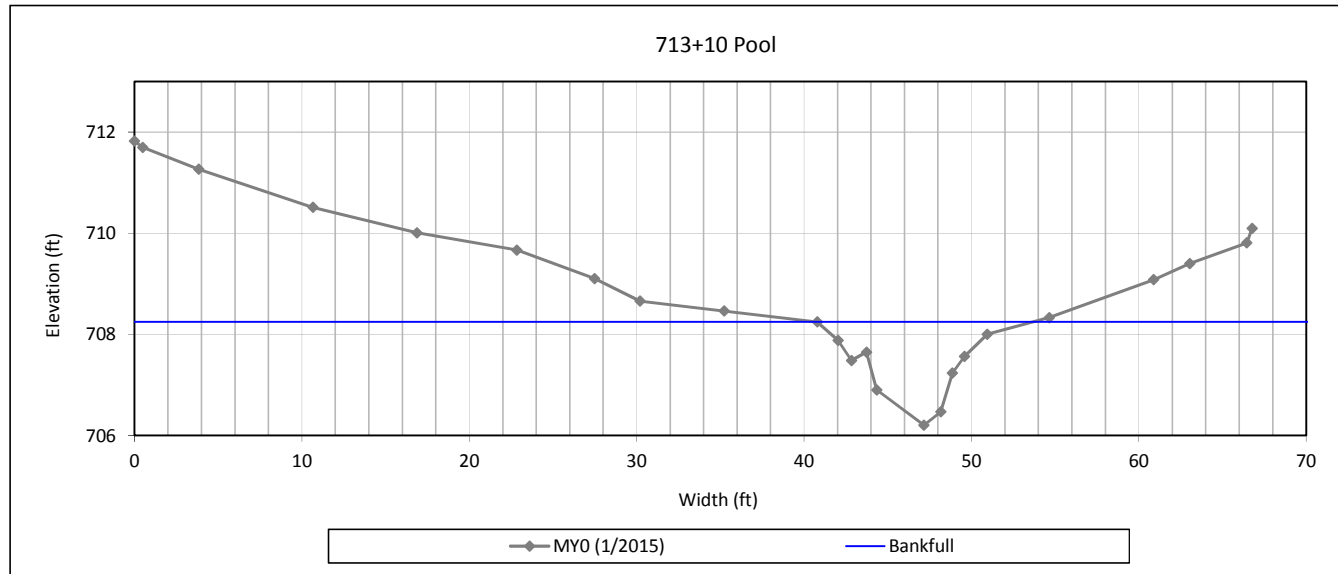
Cross Section 17, UT2C R2

Bankfull Dimensions

11.2	x-section area (ft.sq.)
13.0	width (ft)
0.9	mean depth (ft)
2.0	max depth (ft)
14.1	wetted perimeter (ft)
0.8	hyd radi (ft)
15.1	width-depth ratio
---	W flood prone area (ft)
---	entrenchment ratio
1.0	low bank height ratio

Survey Date: 1/2015  
 Field Crew: Turner Surveying

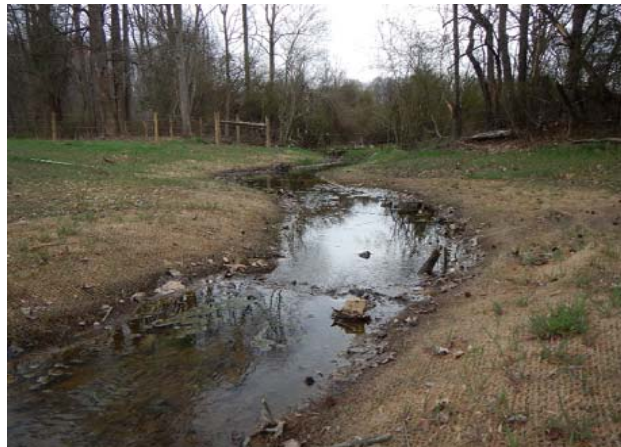
View Downstream

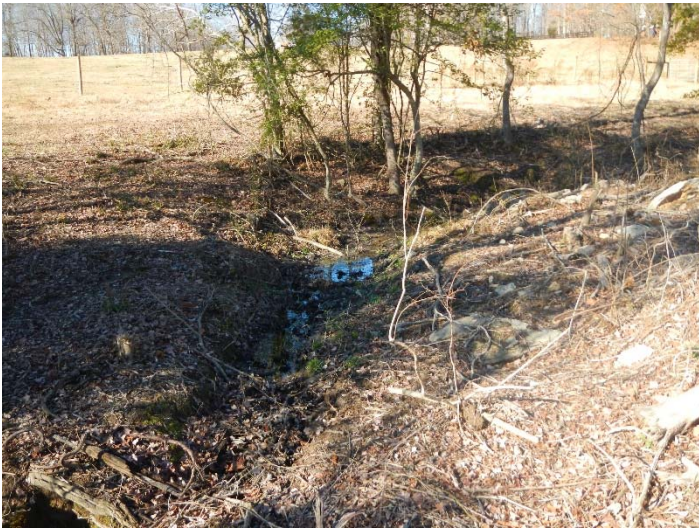
Photo Point 1 – looking upstream (01/19/2015)

Photographs should illustrate the Site's vegetation and morphological stability on an annual basis. Cross-section photos should demonstrate no excessive erosion or degradation of the banks. Longitudinal photos should indicate the absence of persistent bars within the channel or vertical incision. Grade control structures should remain stable. Deposition of sediment on the bank side of vane arms is preferable. Maintenance of scour pools on the channel side of vane arms is expected.

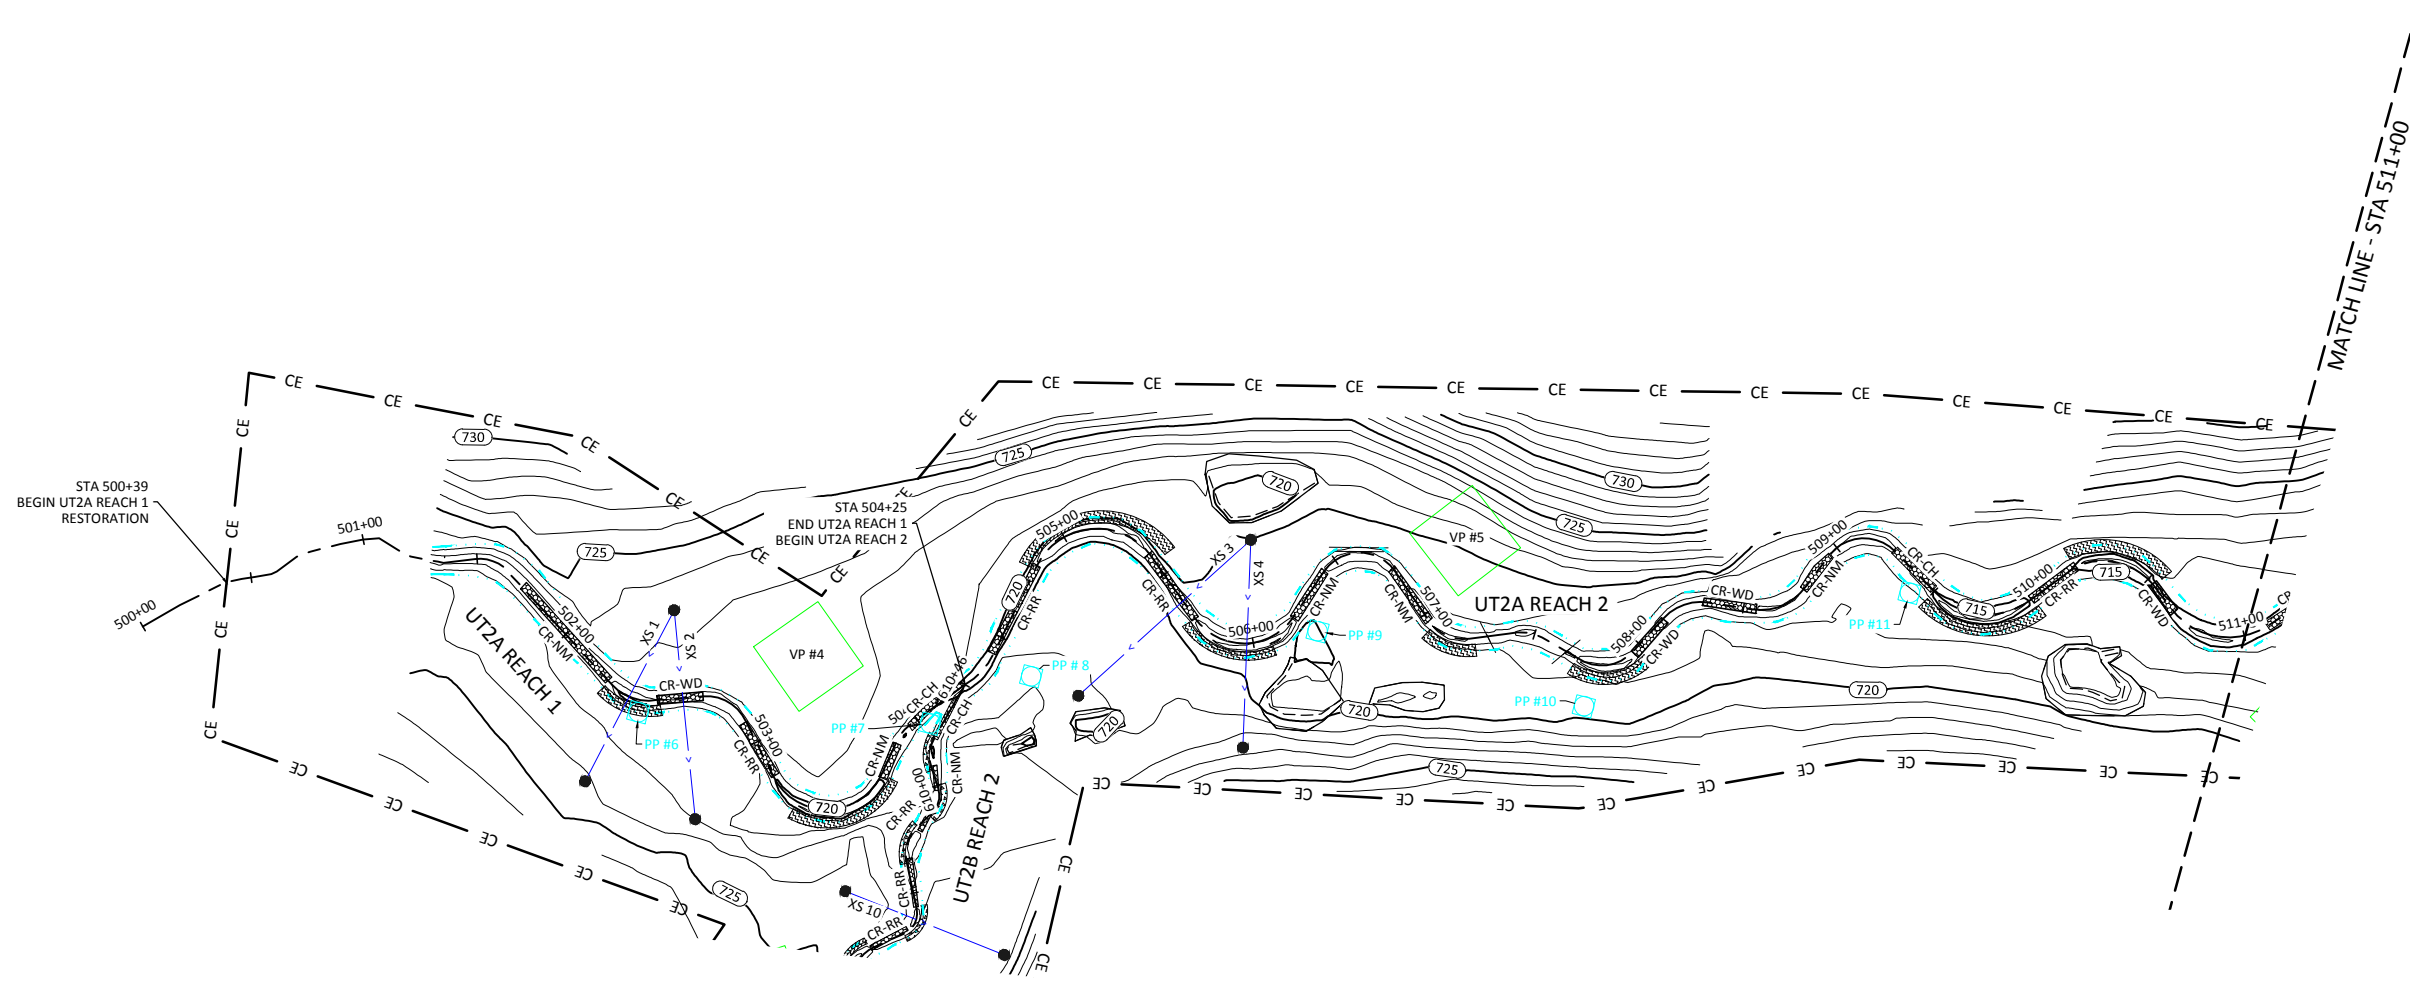
UT2A  
Baseline Drawings
