**IRWIN CREEK**

**STREAM RESTORATION**

**60% CONCEPTUAL DESIGN**

**MECKLENBURG COUNTY,  
NORTH CAROLINA**

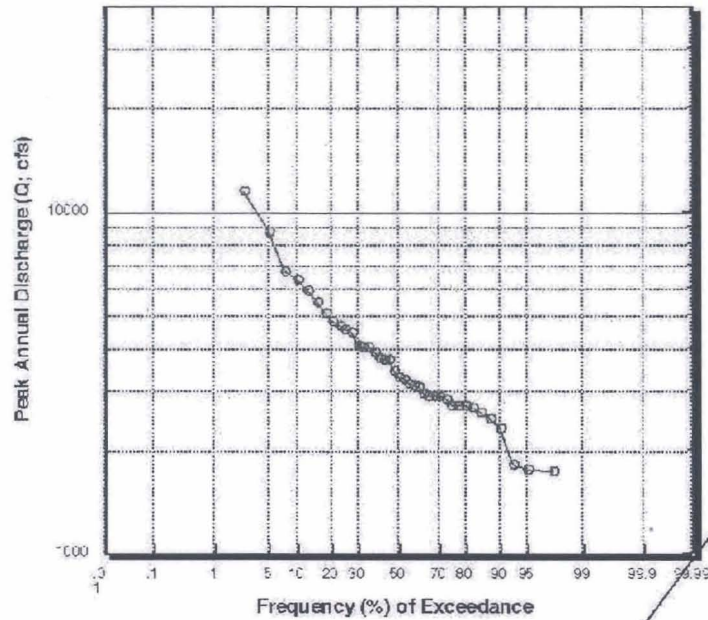
1963 to 2001 Annual Peak Flows  
USGS Gaging St. Irwin Ck at CMU WWTP

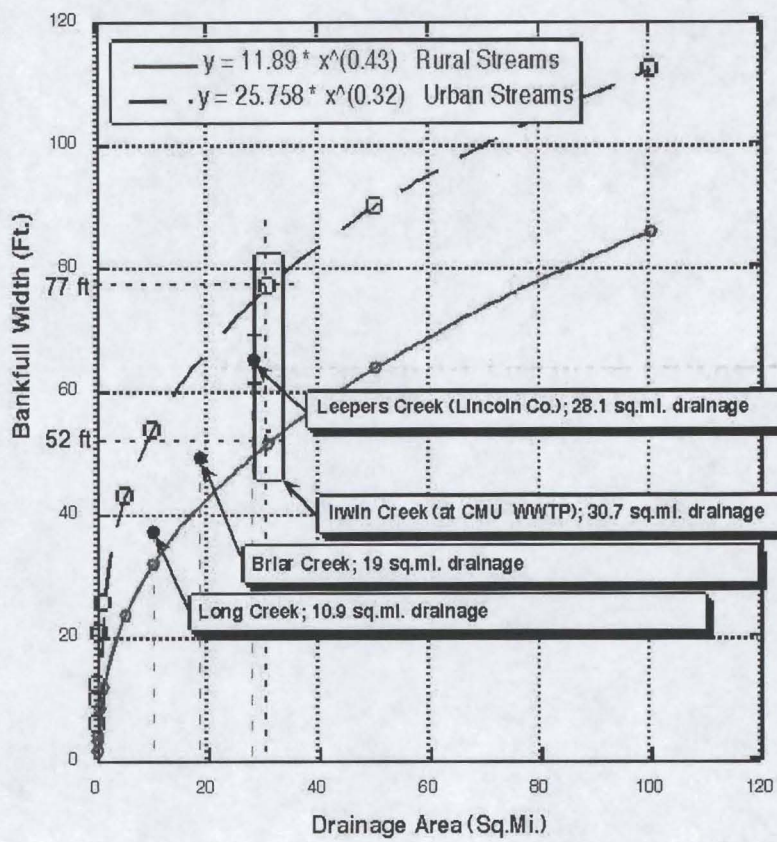
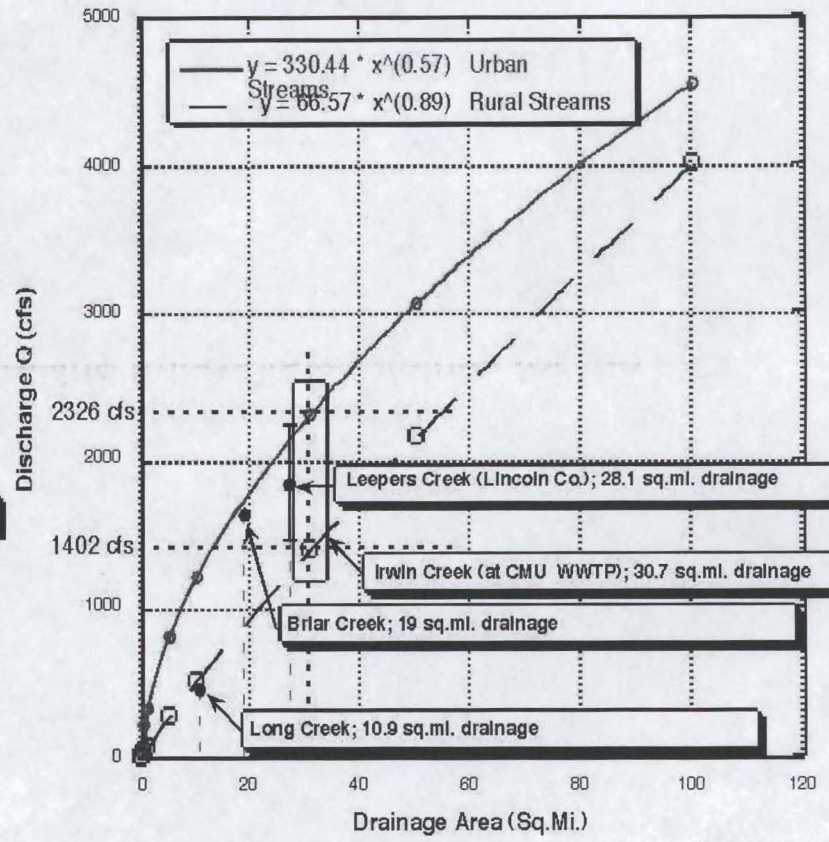
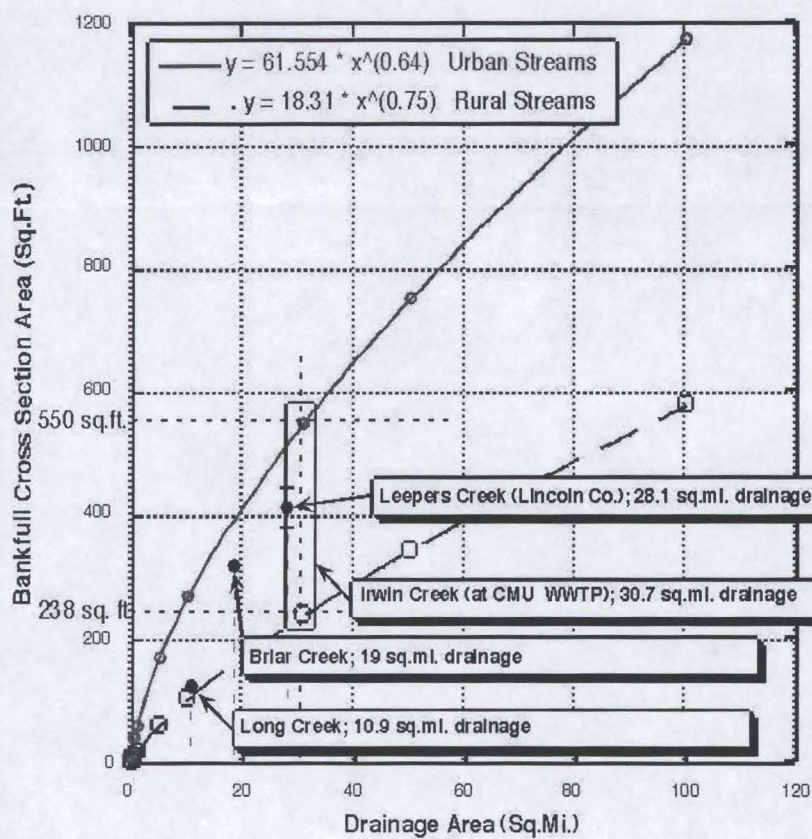
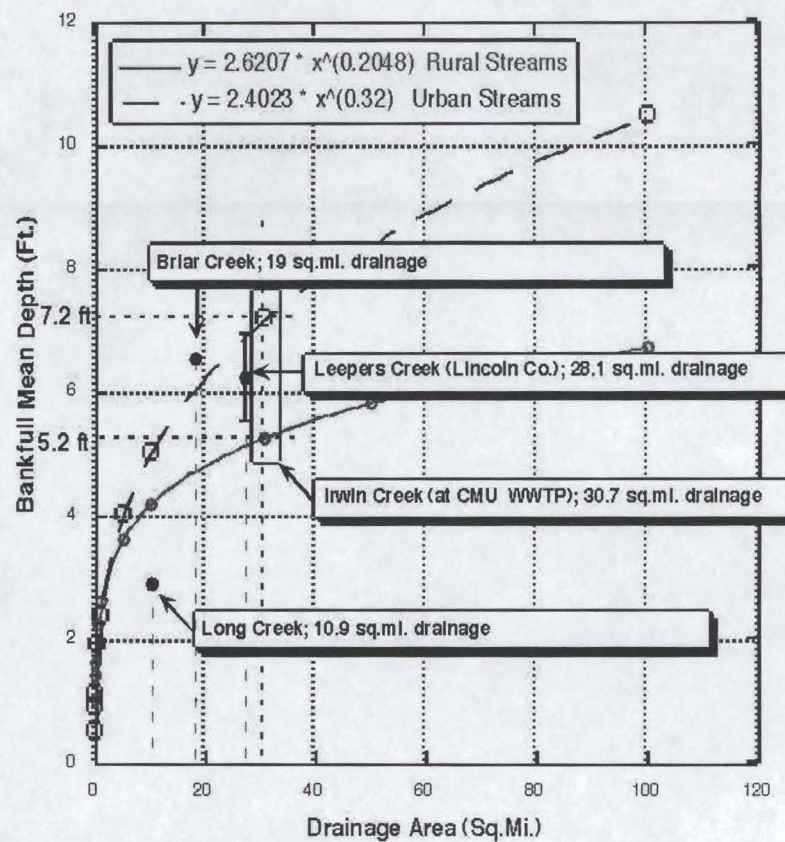
NC Piedmont Regime Curves showing Interpolated Values for the Irwin Creek Restoration Reach Watershed

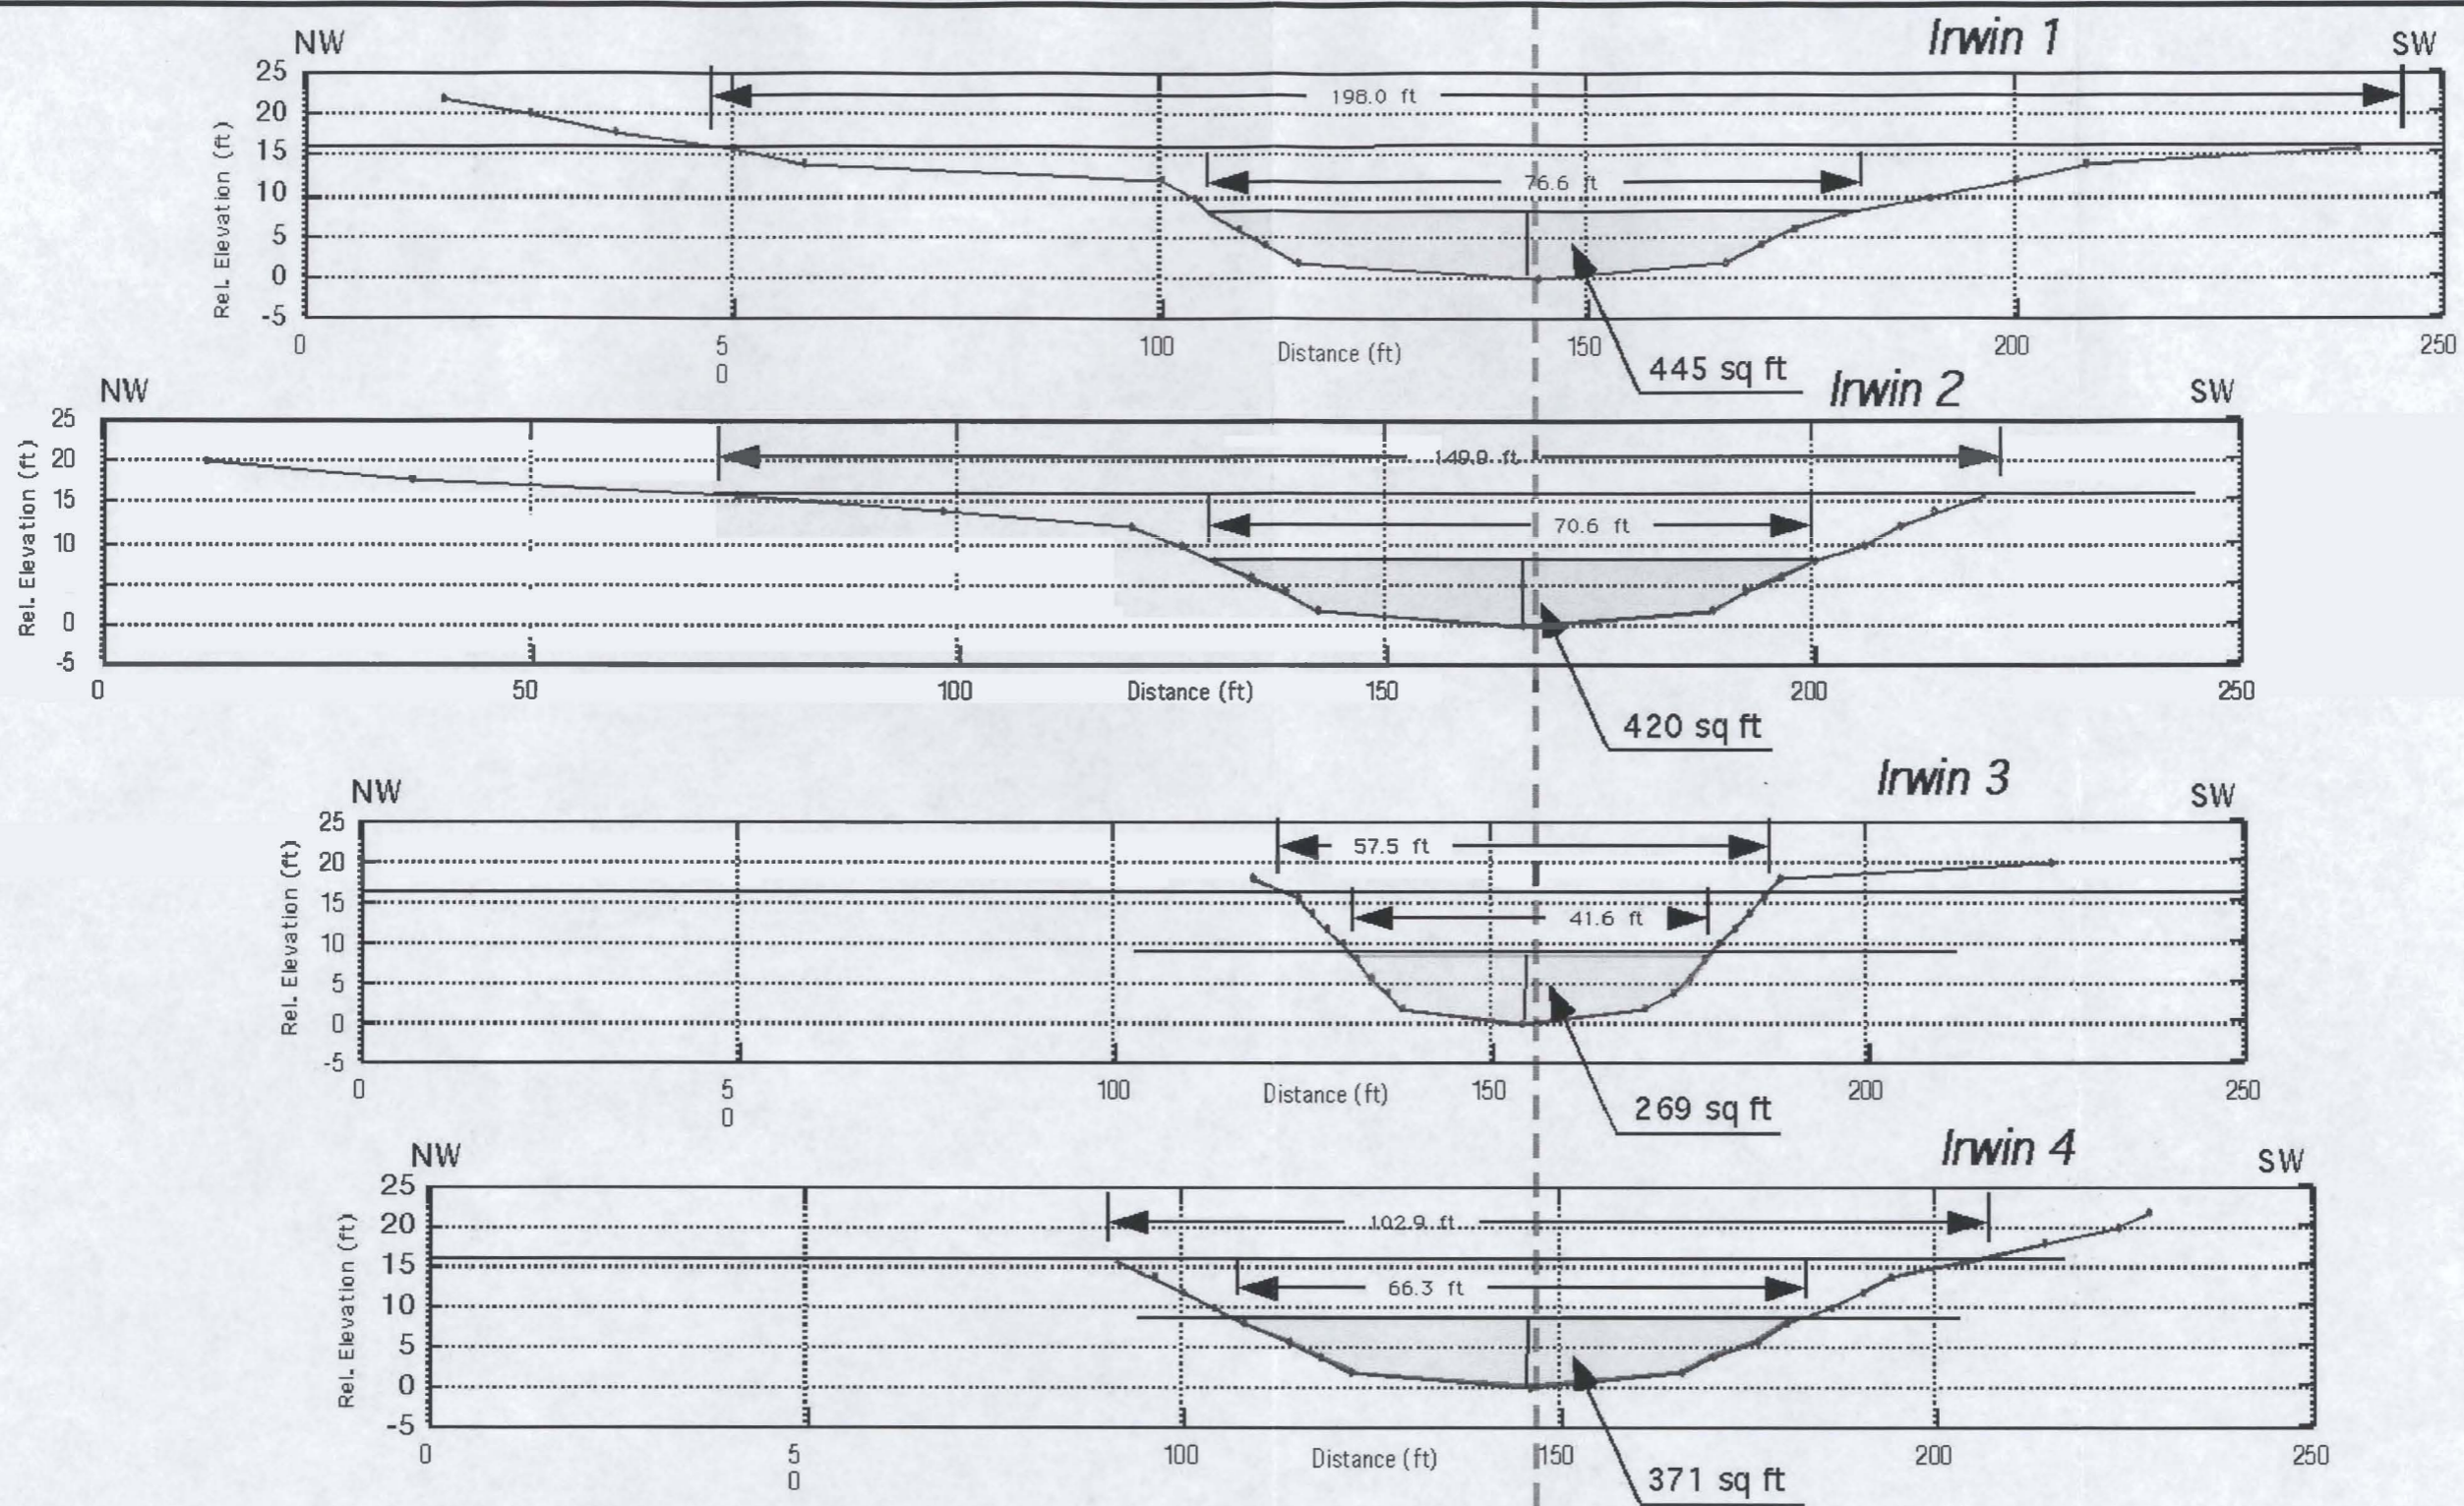
**Figure 7: Irwin Creek Cross Sections**  
Stream Restoration Plan  
Irwin Creek

Bankfull Area	Bankfull Width	Bankfull Mean Depth	Floodprone Width	W/D Ratio	Entrenchment Ratio	Wetted Perimeter
Irwin 1.	445 sq.ft.	76.6 ft.	5.8 ft	198 ft	13.2	2.58	78 ft
Irwin 2.	420 sq.ft.	70.6 ft.	5.9 ft	150 ft	12.0	2.12	73 ft
Irwin 3.	269 sq.ft.	41.6 ft.	6.5 ft	58 ft	6.4	1.37	48 ft
Irwin 4.	371 sq.ft.	66.3 ft.	5.6 ft	103 ft	11.9	1.55	69 ft

Zone 3 consists of the 1,500 feet of stream that traverses the WWTP. This area essentially has a sinuosity of one and has vegetated riprap from toe to top of bank. The cross-section 3 (Figure 7) was constructed from this zone just south of the bridge crossing, near the gaging station. The upper 1/3 to 1/2 of this WWTP reach has a constricted cross-section area in comparison to the areas north and south. The banks are also steeper in this area, suggesting that armor was aggradationally emplaced on top of a preexisting cross-section similar to that seen north or south of the constricted area. Photographs 3 and 4 illustrate this zone. The WWTP has facilities that encroach to edge of bank on both sides, and the east side has the constructed flood protection wall to heights sufficient for the 500-year flood. As noted in the photographs, lateral bars have formed in the lower portions of this reach. The channel is dominantly a sand bed run. The reach has a grade that increases slightly at the southern end. Due to the constricted profile in the upper zone and the lack of appreciable change in grade or roughness characteristics, it is highly probably that a hydraulic jump develops immediately north of the WWTP bridge during major storms.

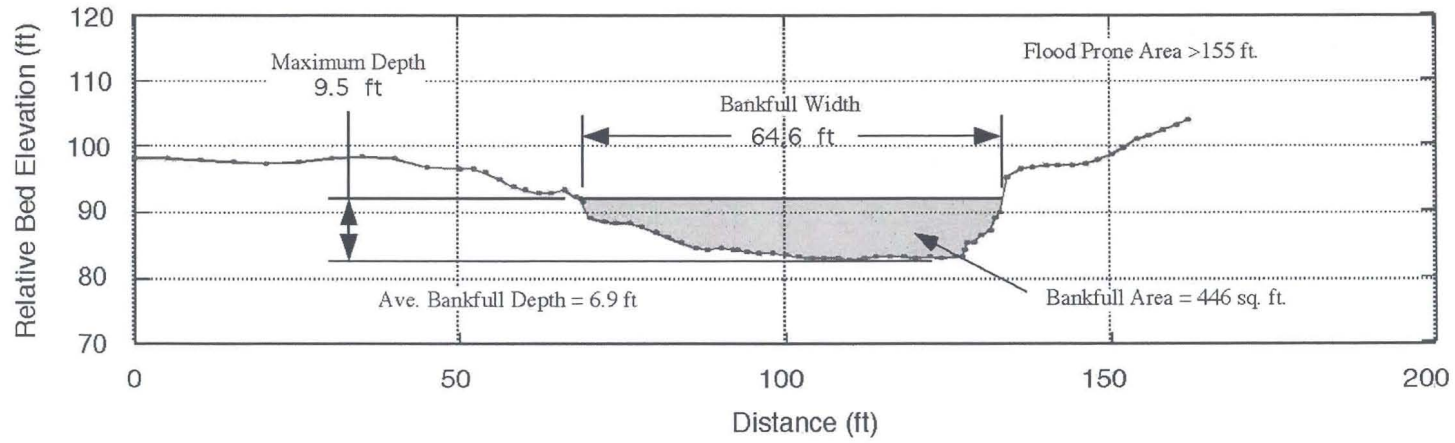
**Figure 7c: Cross Section 6**  
Stream Restoration Plan  
Irwin Creek

### ICX-Section 6

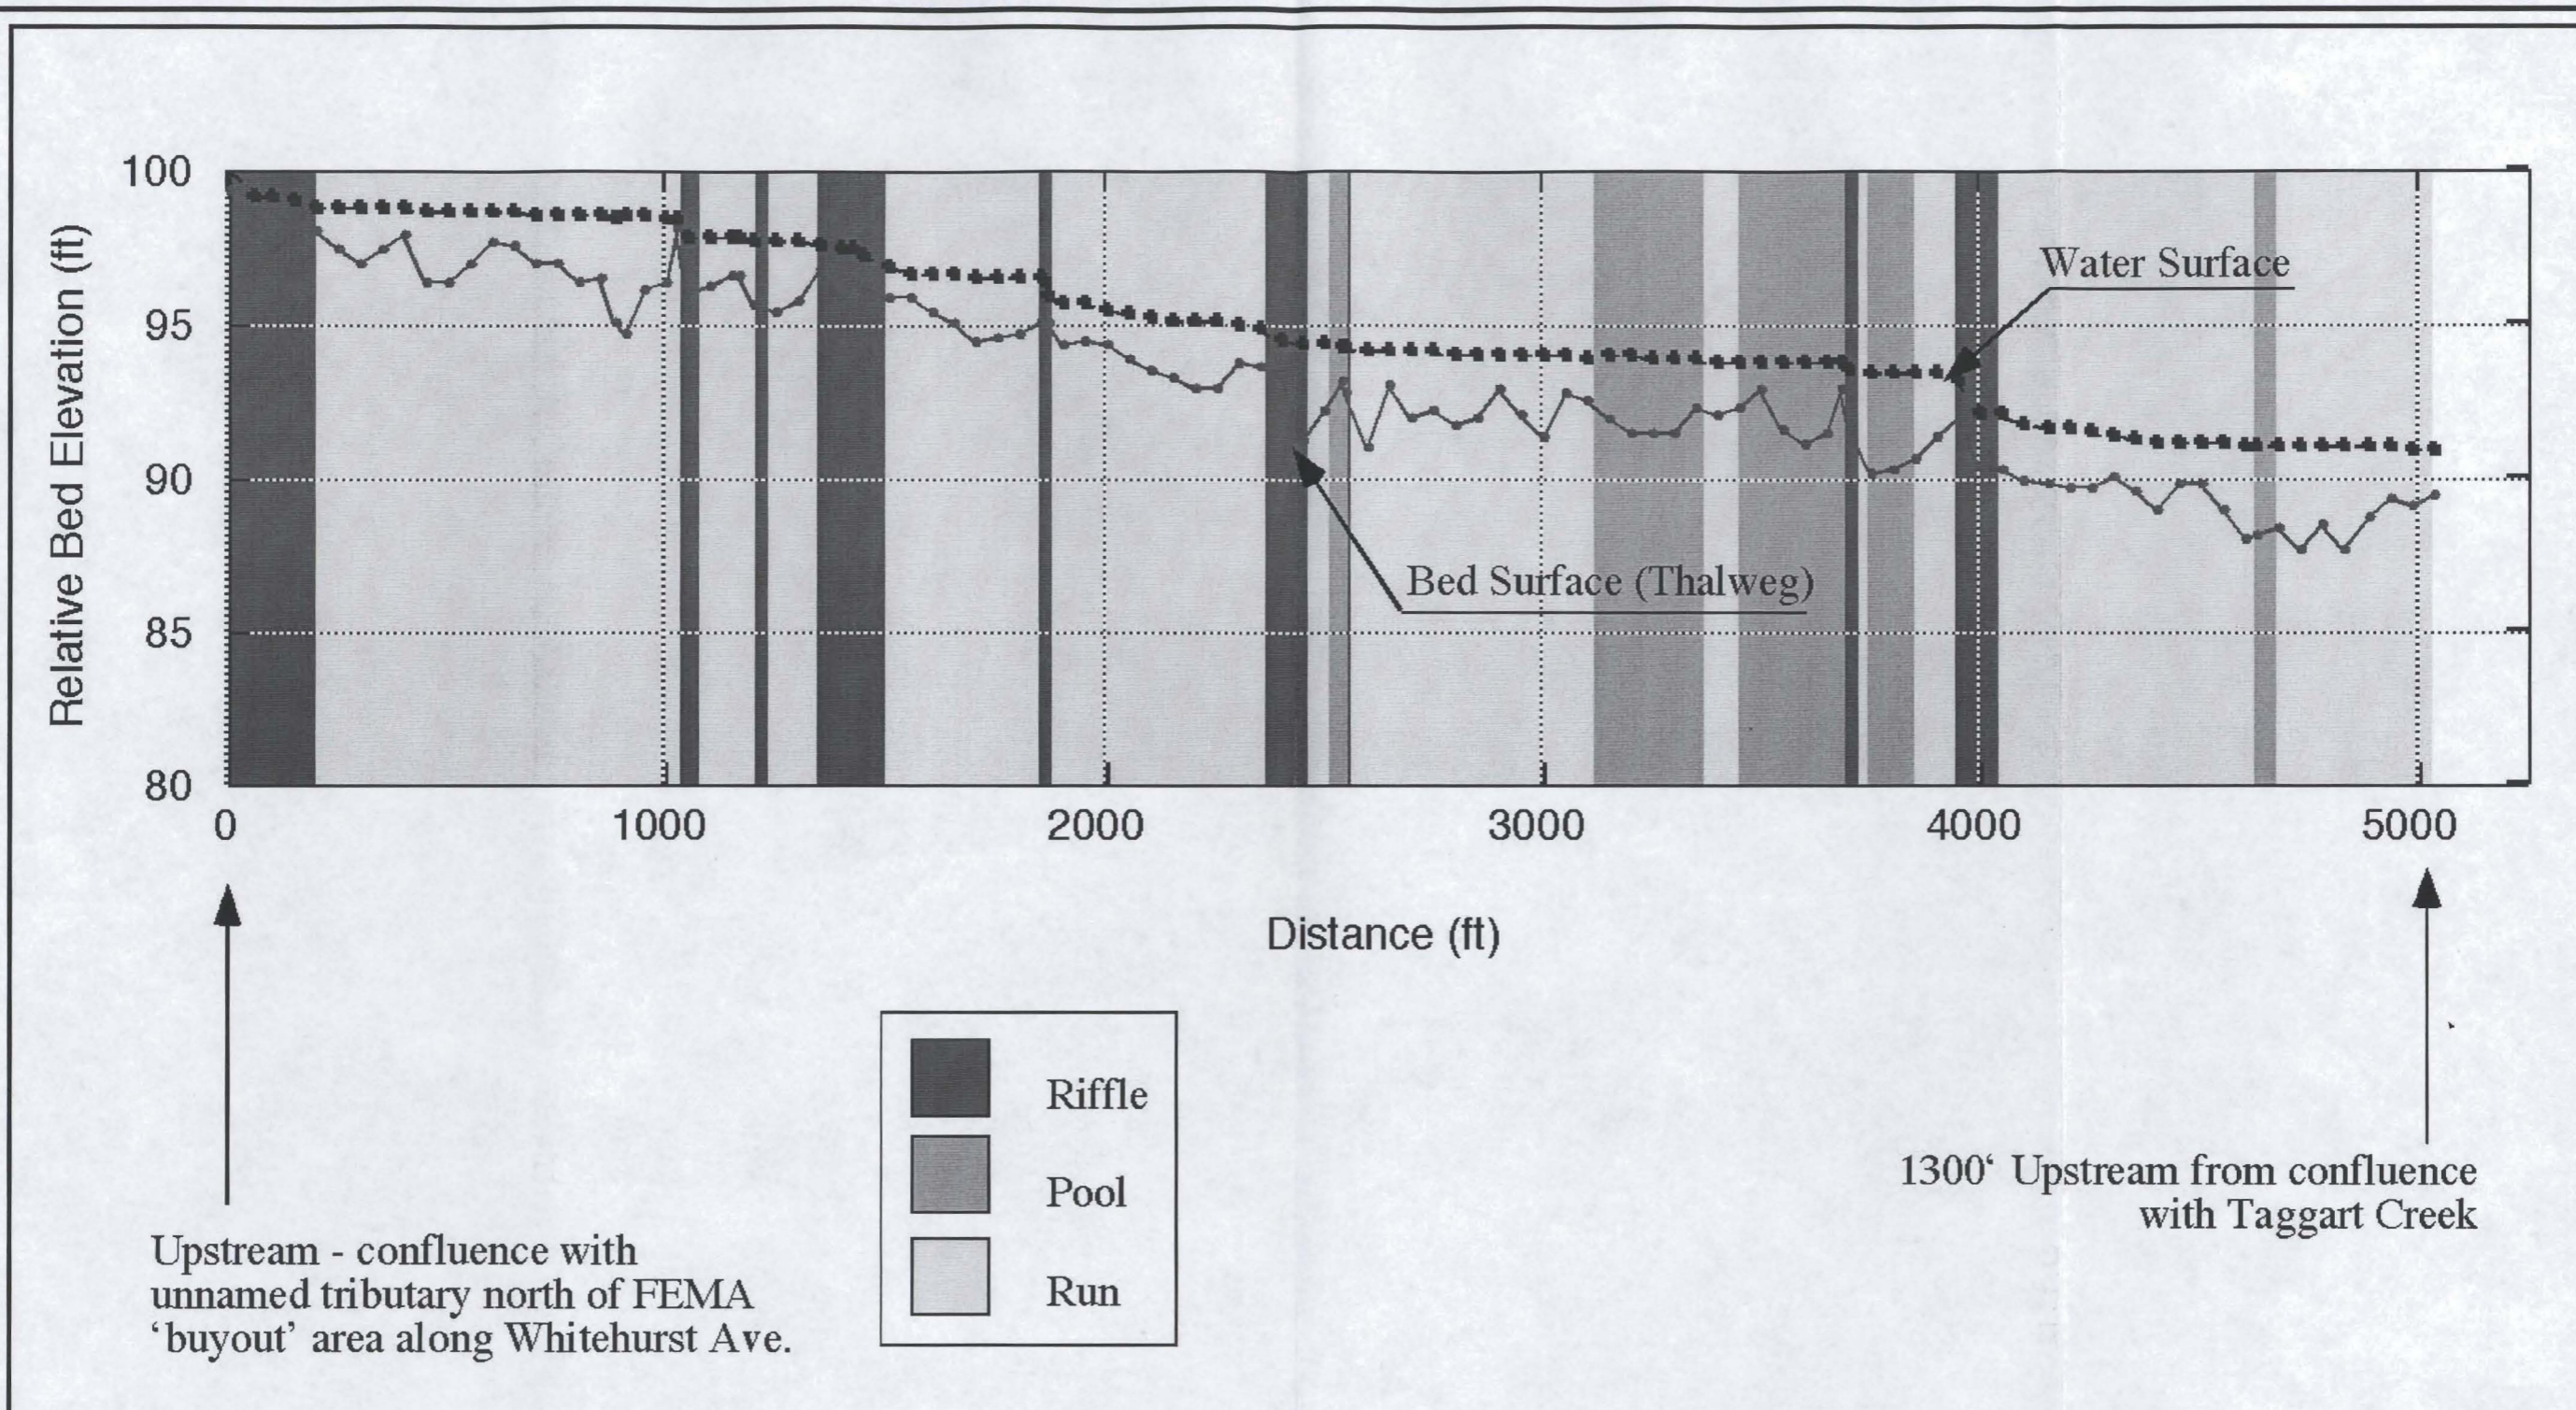
### Longitudinal Profile of Irwin Creek

Data collected using WAAS-enable (2-3 meter) GPS and laser range finder (+/- 1 m) for horizontal positioning and Lasermark laser level (1/8" at 100') for vertical positions.

The longitudinal profile for the Irwin Creek reach is shown in Figure 7d. The pool, run, and riffle areas have been overlain on this profile. This overlay allows for the calculation of the characteristic slopes for run, riffle, and pool areas. The individual values are shown in Table 5, and then summarized in Table 3.

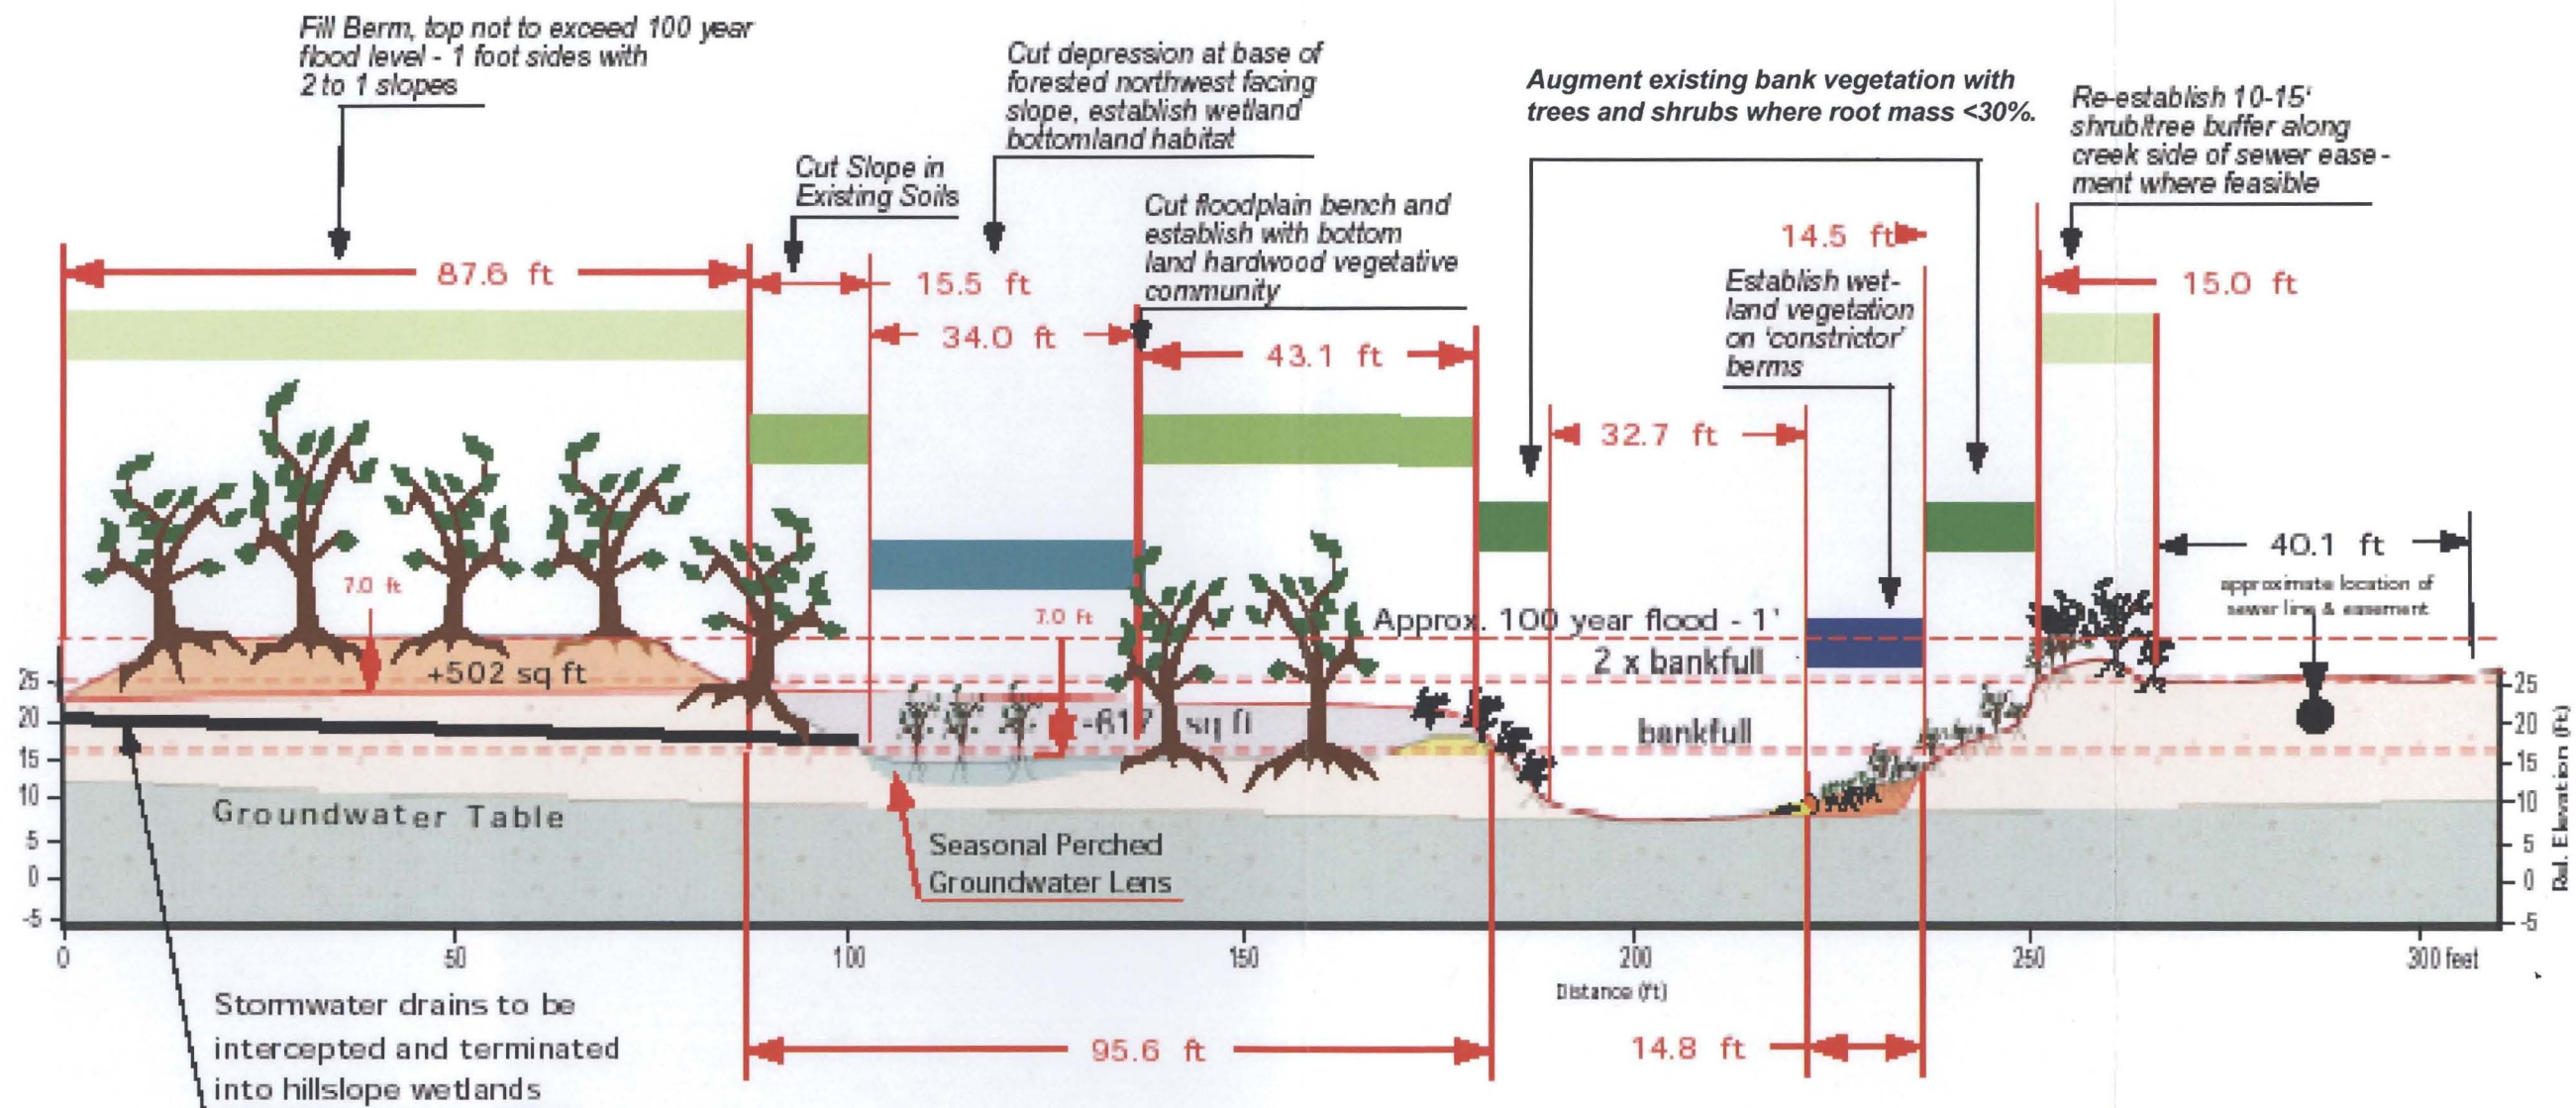
— Existing landsurface  
— Proposed landsurface  
 Cut cross section area 617 sq. ft.  
 Fill cross section area 502 sq. ft.

WRP Irwin Creek Restoration/Enhancement  
Schematic Cross Section for Zone 1

The design schematics for Zone 1 and 2 are shown in Figures 9 through 11. Figures 9 and 10 are plan views, and Figure 11 is a hypothetical cross-section for the flood plain bench to be cut into the FEMA buy-out area. Zone 1 design elements include: inner meander berms, hybrid cross vane riffles, augmented riffles, rock vanes, grade and energy controls on storm outfalls or the 1st order tributaries, and the flood plain bench in the FEMA buy-out area. The inner meander bends are based on reference reach studies in Long, Little Sugar, Briar and Leepers Creeks. The determination of the wavelength and radii of curvature for these inner meanders is shown in Figure 16. Riffles with built-in cross vanes are used in all inflection areas without bedrock, and augmented riffles are used in areas where bank and bed surveys revealed bedrock at the base of the channel. Each of the inner berm features helps to restore approximately 60 to 80 feet of pool habitat, and each riffle provides approximately 80 to 90 feet of riffle habitat. Berms, on average, provide approximately 5,000 square feet of riparian or potential transitional wetland habitat within 0 to 4 feet of the low flow water surface.

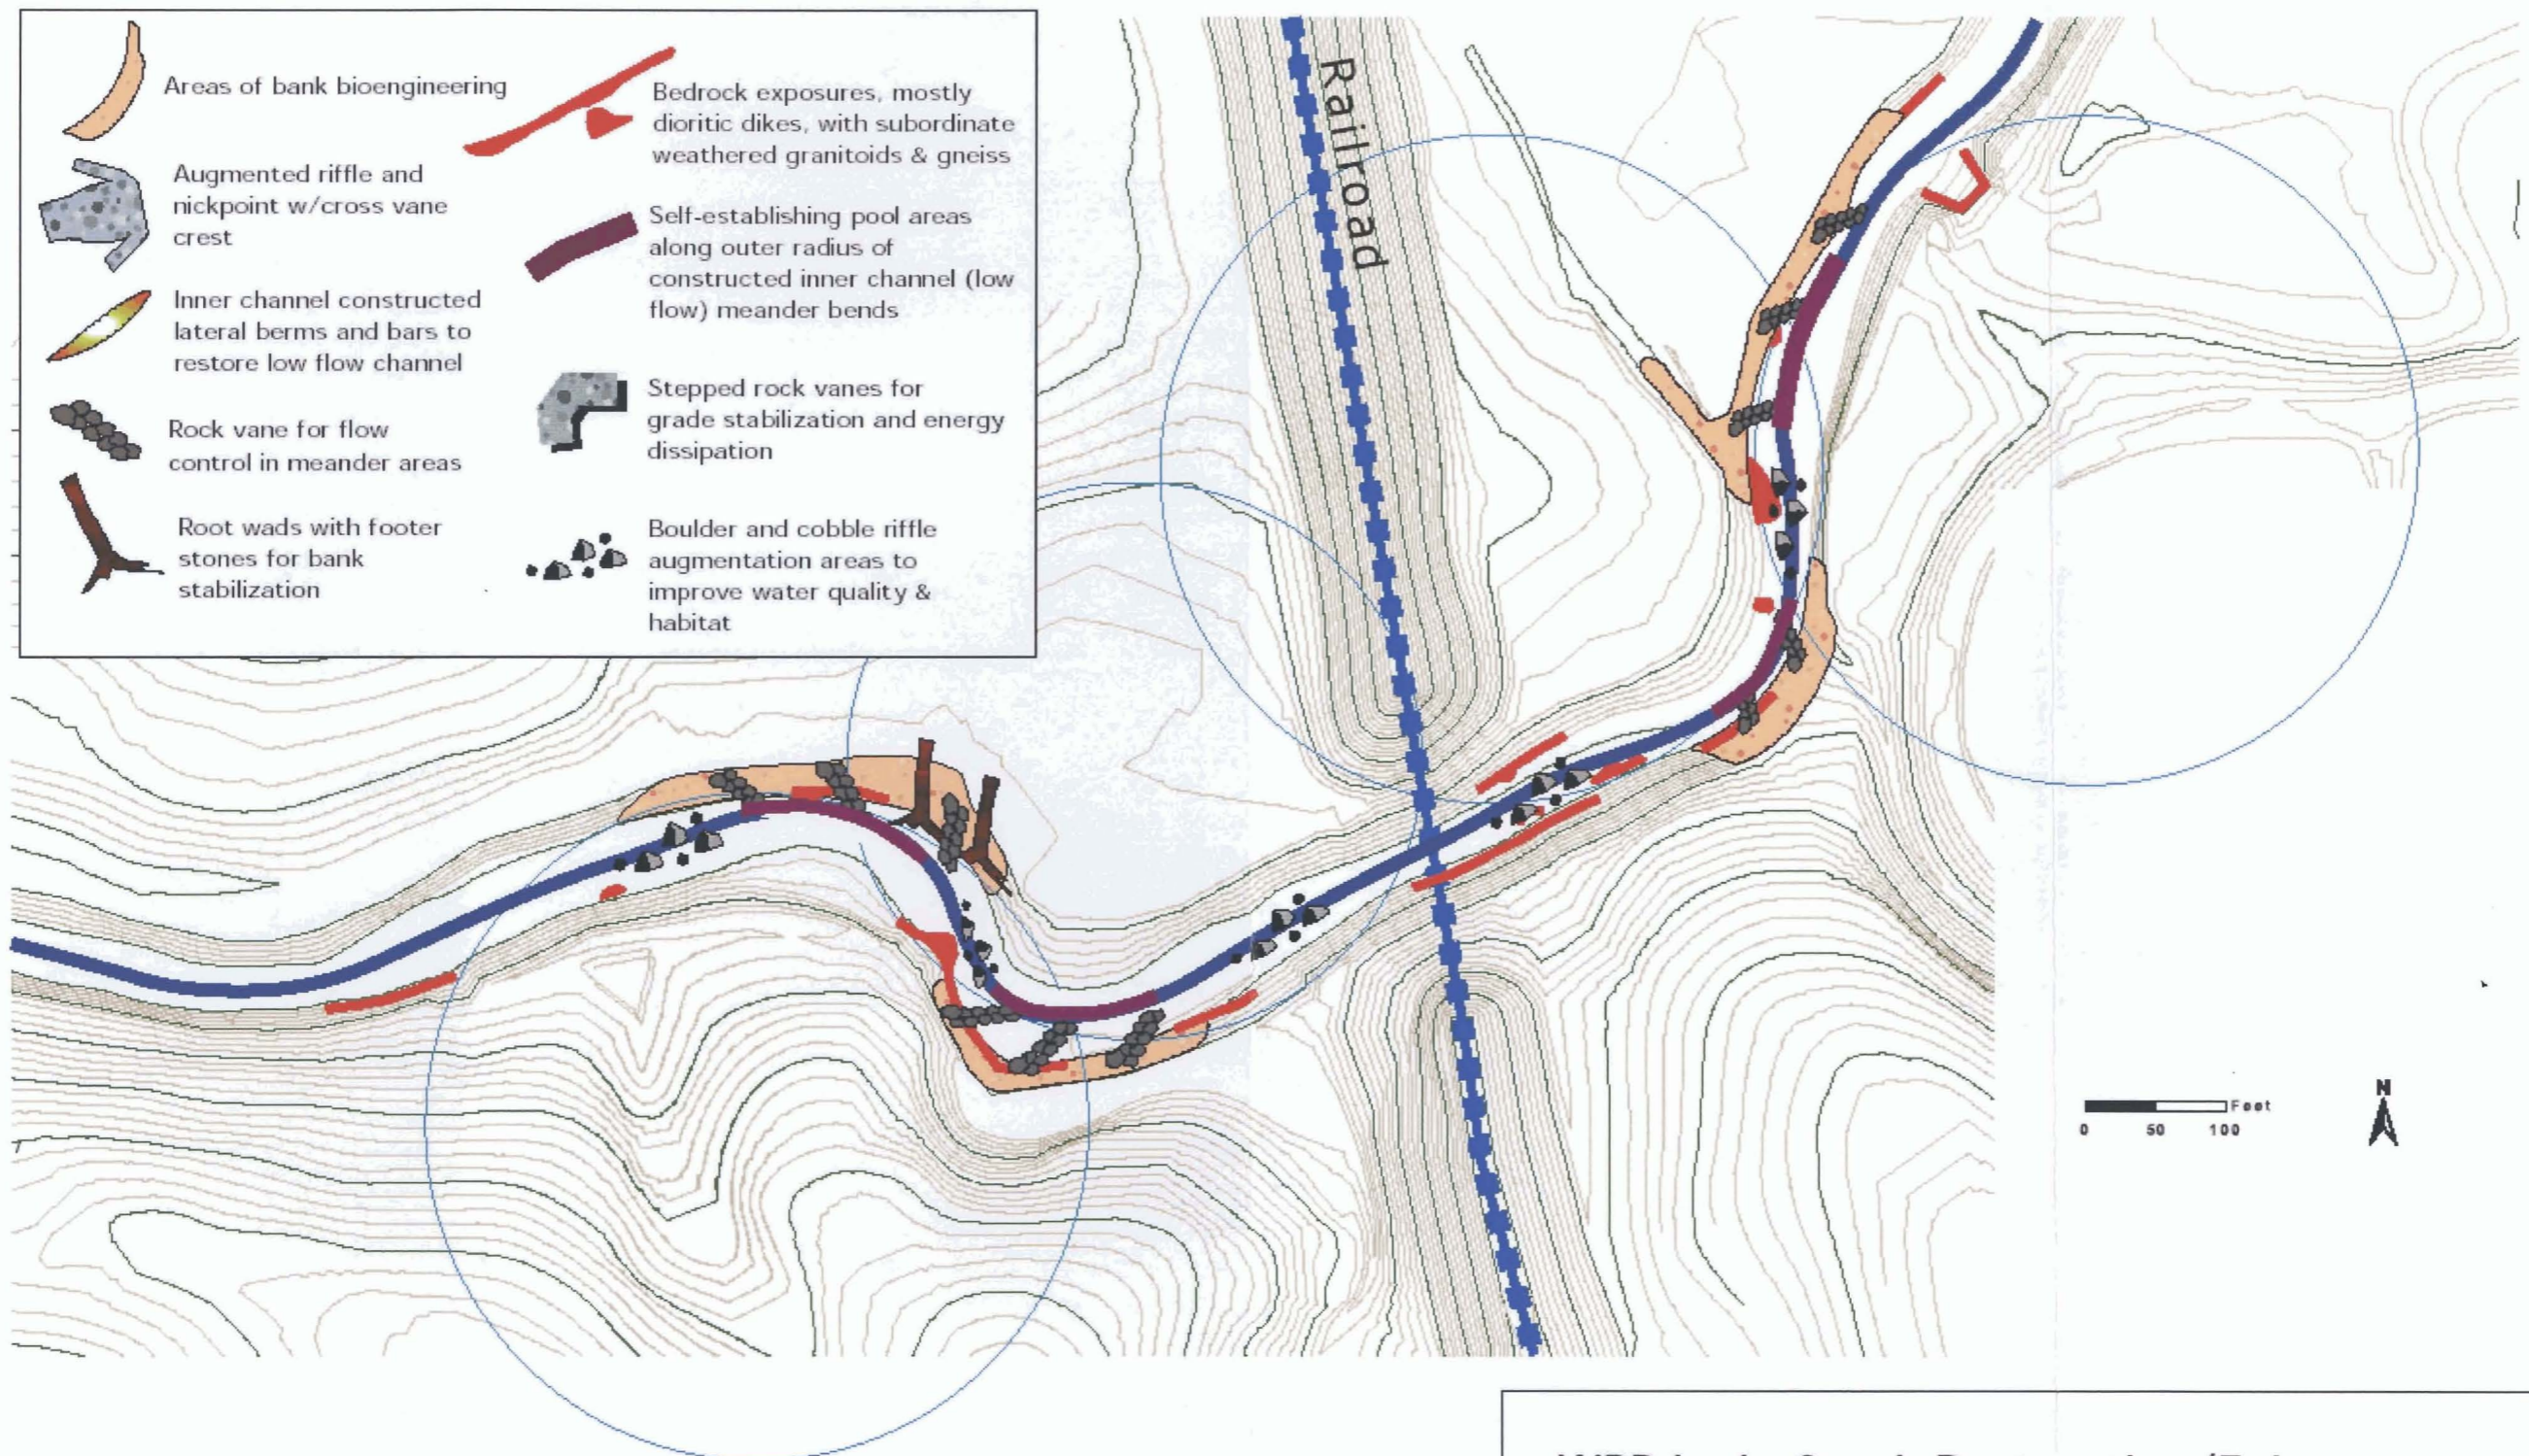
WRP Irwin Creek Restoration/Enhancement Schematic for Zone 4, Below WWTP

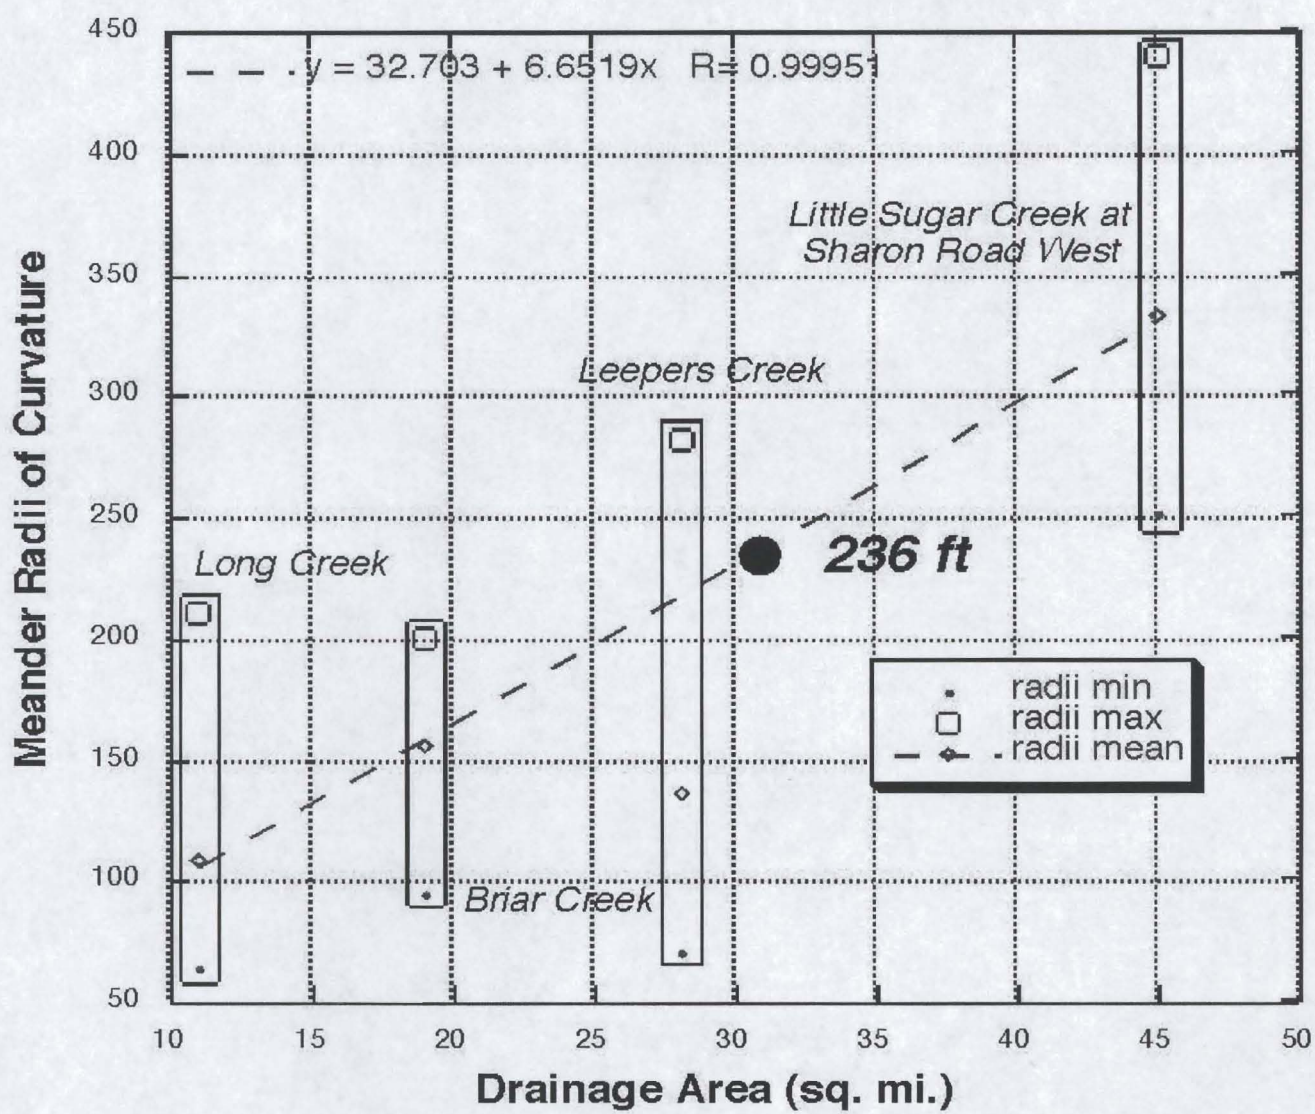
Interpolation Graphs for Preliminary Wavelength and Radius of Curvature Values for Irwin Creek Restoration

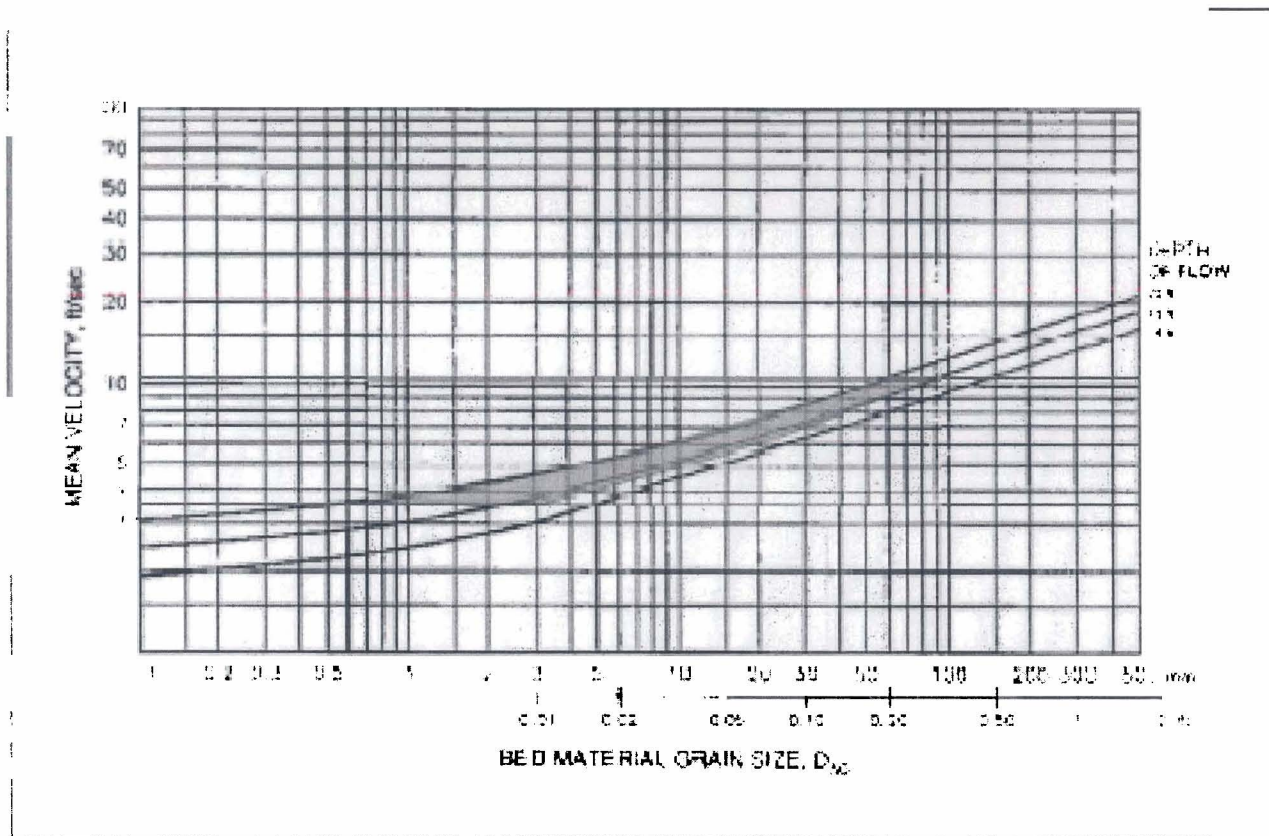
Example of allowable velocity-depth data for granular materials.  
From USACE 1994 Appendix A and B.

Range of estimated velocities for Irwin Creek bankfull to 10 year storm plotted on the Mean Velocity vs Bed Material Size (D<sub>50</sub>) chart from the USACE 1994 guide to stream stabilization.

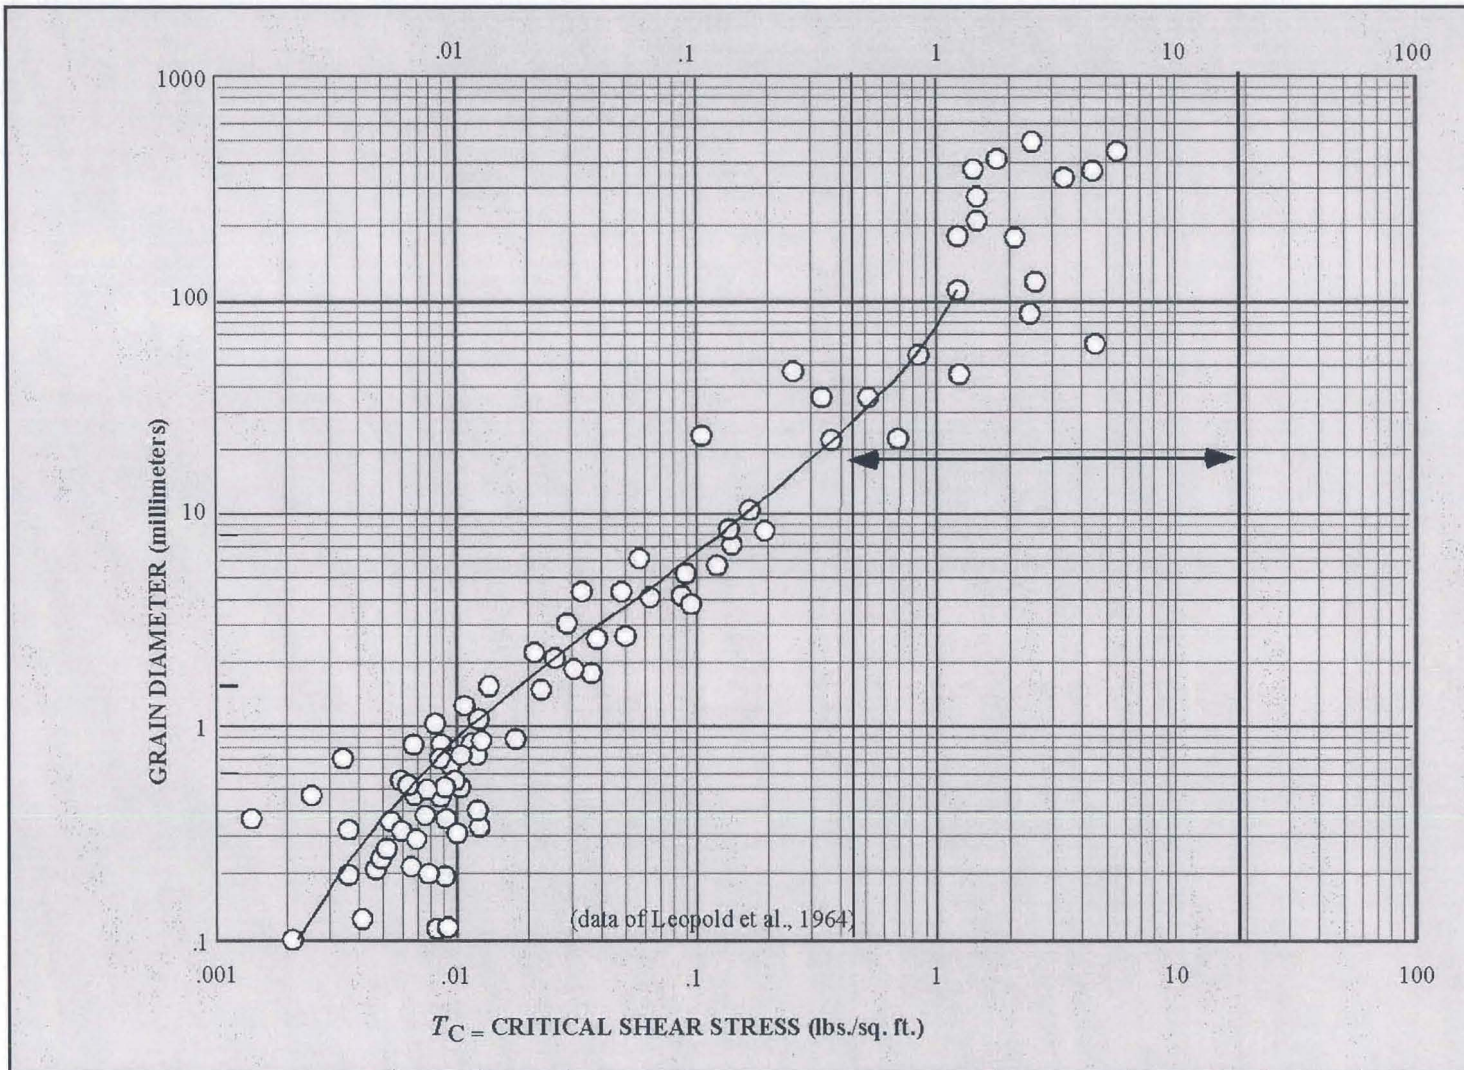
Shield Curve with Range of Conditions for Irwin Creek, WWTP Reach.
