**IRWIN CREEK**

**STREAM RESTORATION**

**60% CONCEPTUAL DESIGN**

**MECKLENBURG COUNTY,  
NORTH CAROLINA**

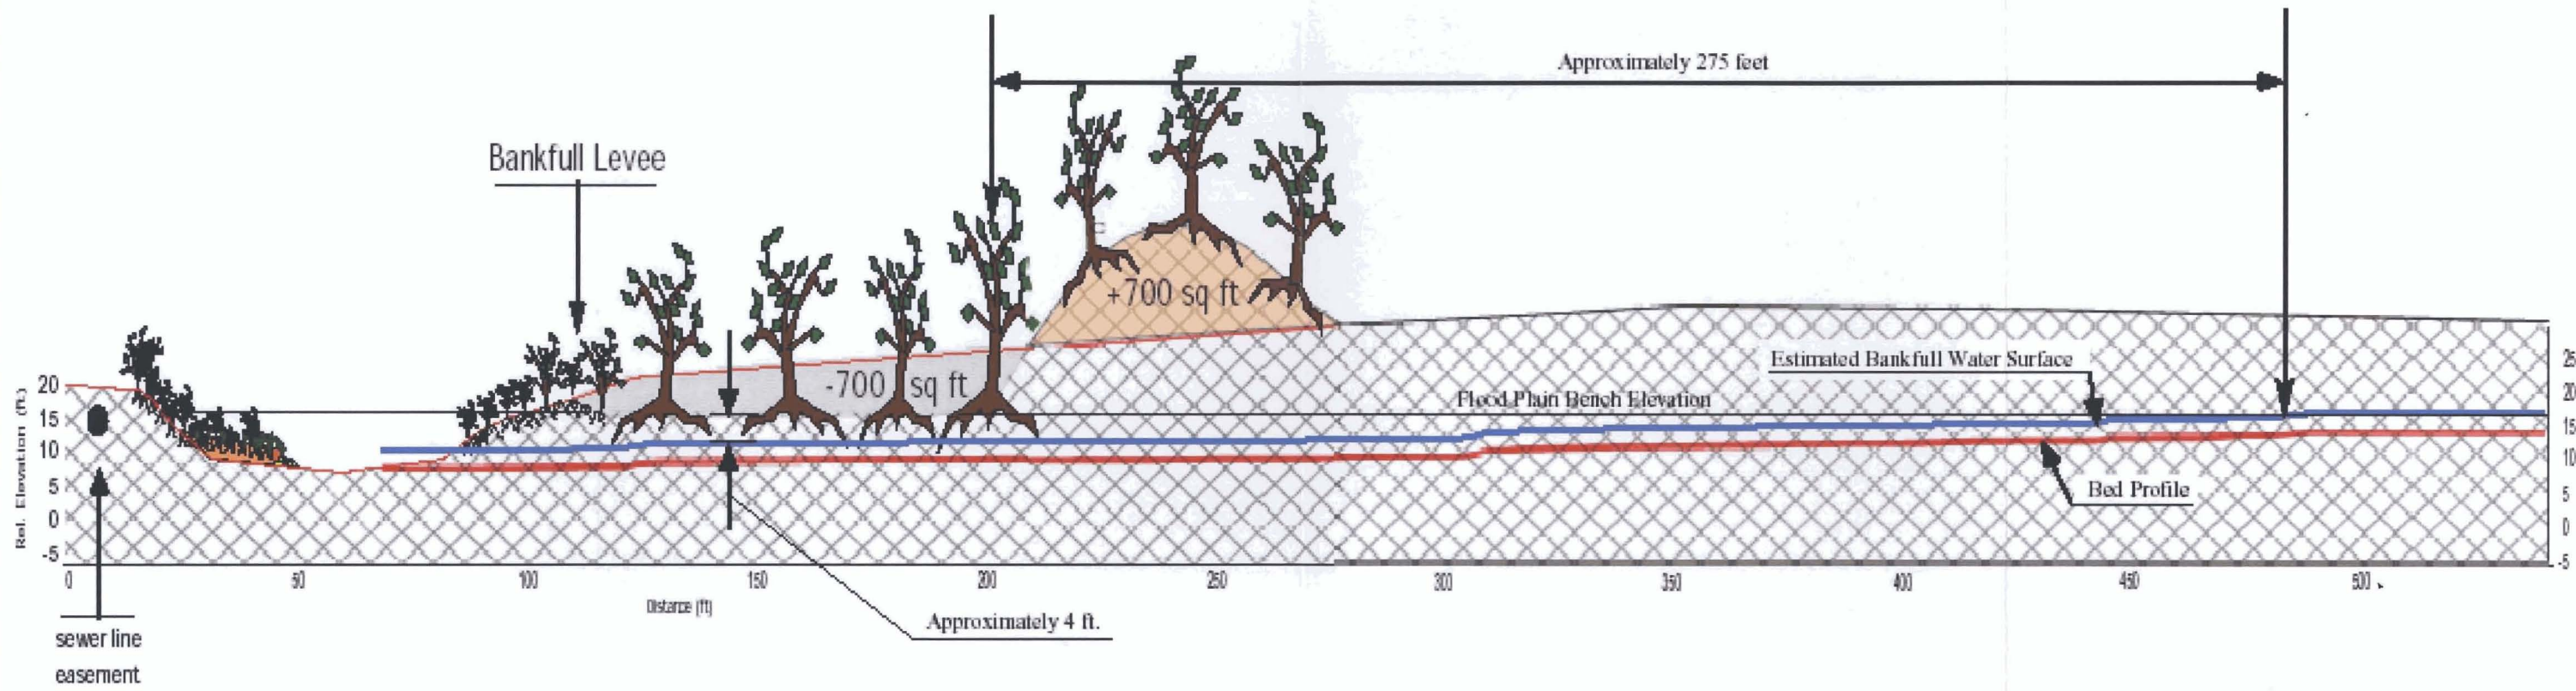
450 ft Longitudinal Profile of Tributary to Irwin Creek (WWTP) superimposed on the cross section for the proposed flood plain bench to be constructed in the FEMA buyout area, with an estimated bankfull water surface shown above the bed profile.

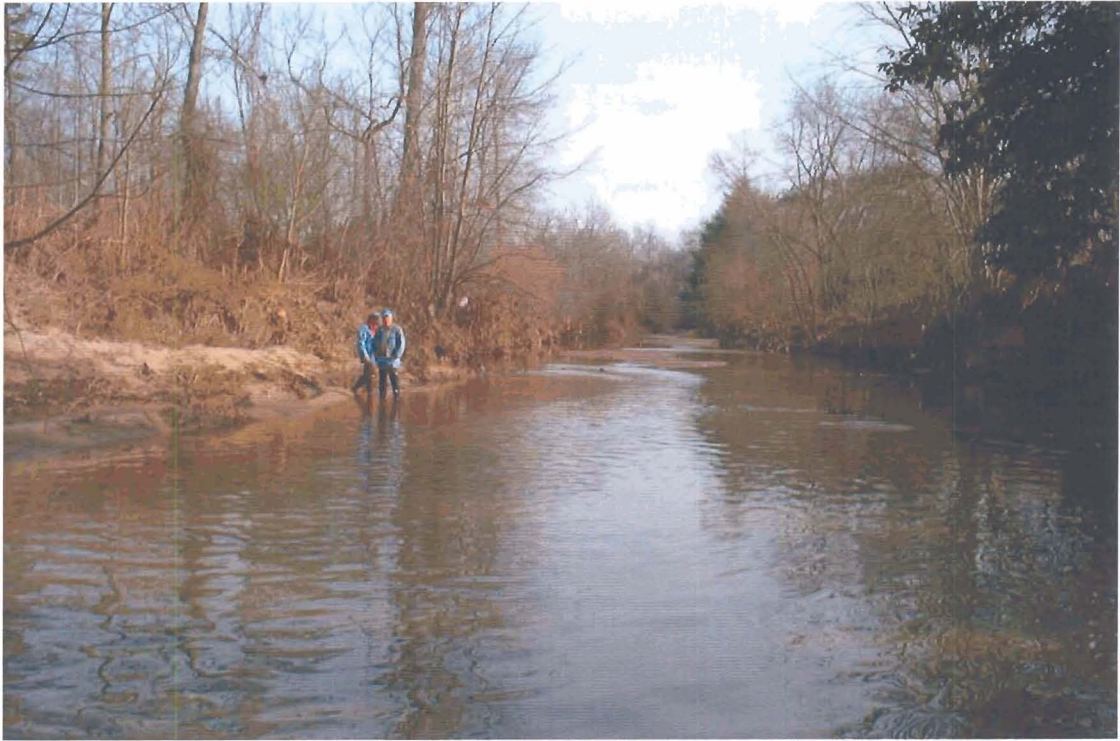
Photo 1. View looking north (upstream) along Irwin Creek north of the Irwin Creek WWTP, reach has no significant sinuosity, and has been widened and deepened by dredging operations early in the 21st Century authorized by the former Meck. Co. Drainage Commission.

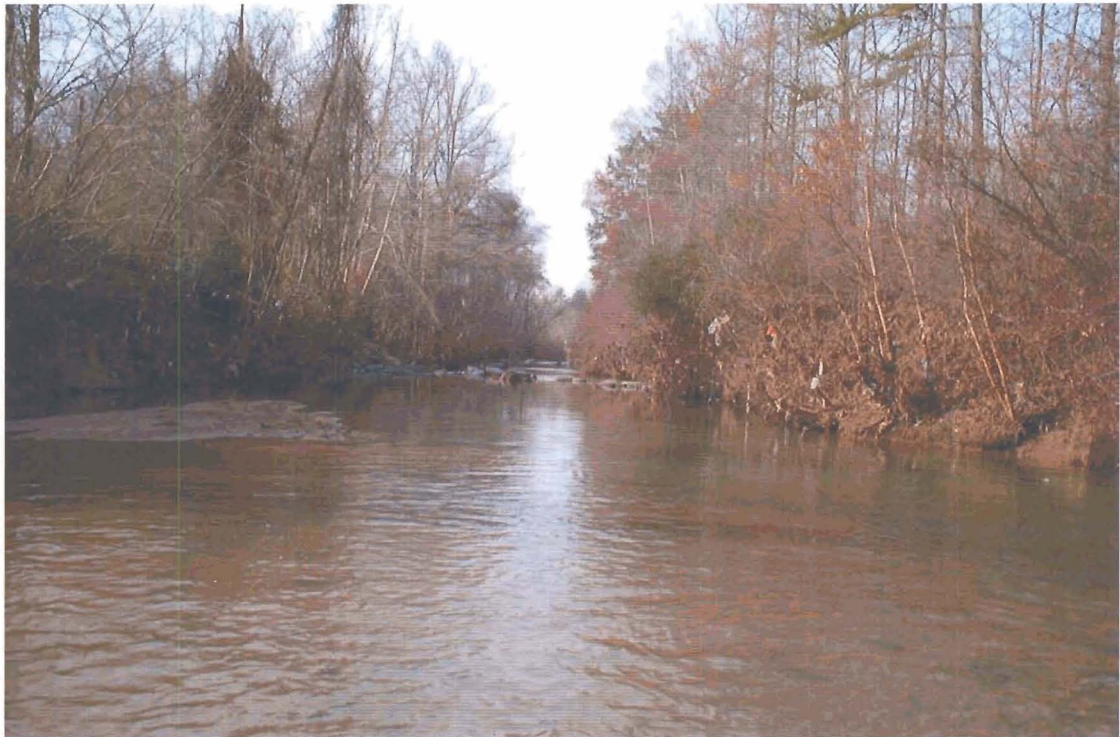
Photo 2. View looking south (downstream) along Irwin Creek north of the Irwin Creek WWTP, Lateral bars interspersed with bedrock nickpoints (granitoids with northwest striking diabase dikes) forming short riffle zones. Otherwise, reach is a sand to fine gravel bed run.

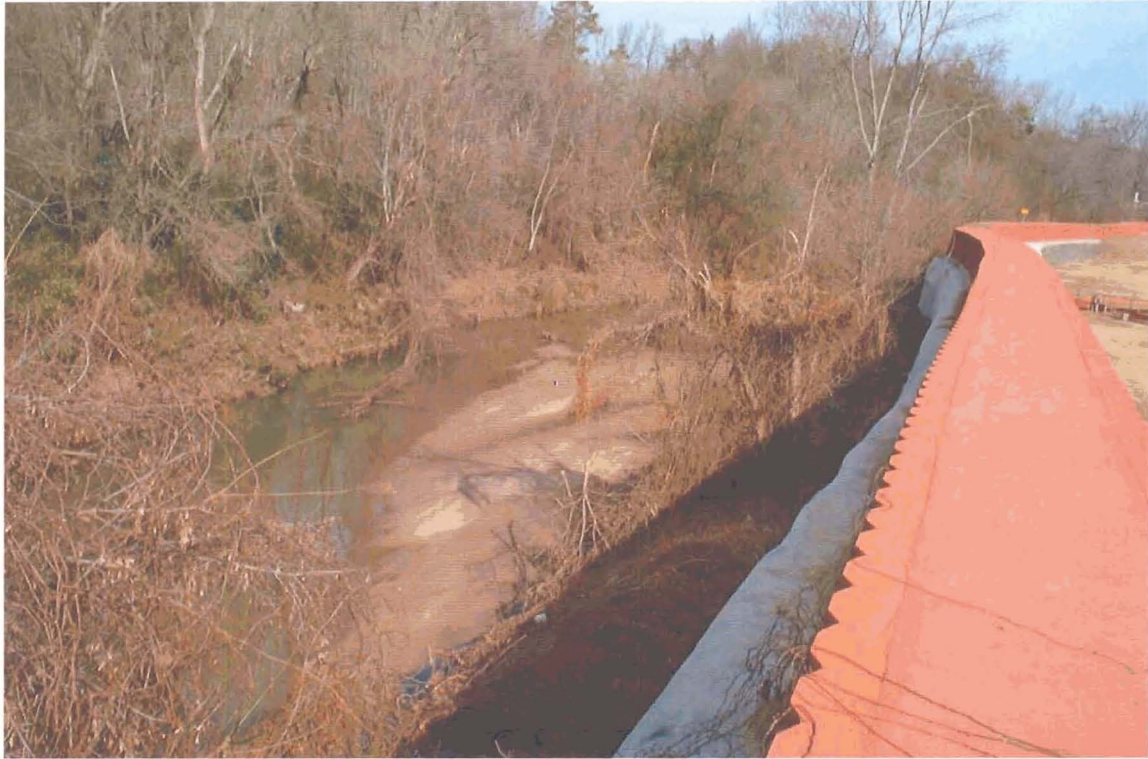
Photos 3 & 4. Views looking upstream along Irwin Creek within the Irwin Creek WWTP. Reach has been constricted in the upper half of this area (photo at right) compared to reach up- and downstream, probably by placement of additional rip-rap for bank protection within the WWTP area. New flood control levee built at top edge of east bank. Lower portion of this reach has lateral bars similar to areas north of the WWTP.

Zone 3 consists of the 1,500 feet of stream that traverses the WWTP. This area essentially has a sinuosity of one and has vegetated riprap from toe to top of bank. The cross-section 3 (Figure 7) was constructed from this zone just south of the bridge crossing, near the gaging station. The upper 1/3 to 1/2 of this WWTP reach has a constricted cross-section area in comparison to the areas north and south. The banks are also steeper in this area, suggesting that armor was aggradationally emplaced on top of a preexisting cross-section similar to that seen north or south of the constricted area. Photographs 3 and 4 illustrate this zone. The WWTP has facilities that encroach to edge of bank on both sides, and the east side has the constructed flood protection wall to heights sufficient for the 500-year flood. As noted in the photographs, lateral bars have formed in the lower portions of this reach. The channel is dominantly a sand bed run. The reach has a grade that increases slightly at the southern end. Due to the constricted profile in the upper zone and the lack of appreciable change in grade or roughness characteristics, it is highly probably that a hydraulic jump develops immediately north of the WWTP bridge during major storms.

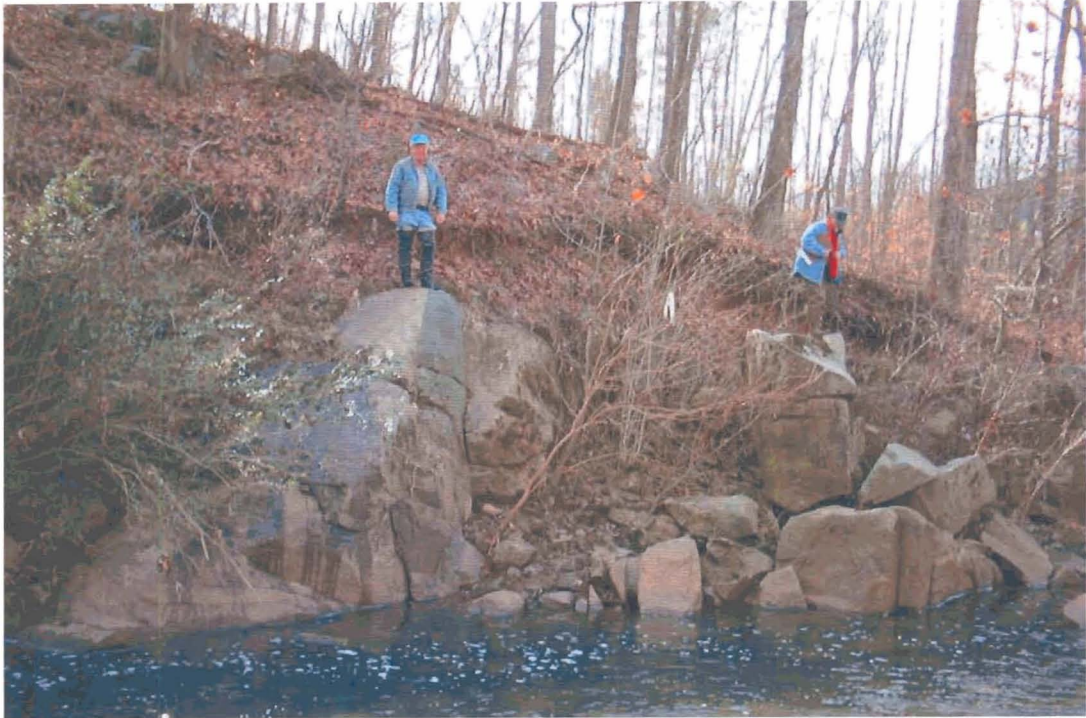
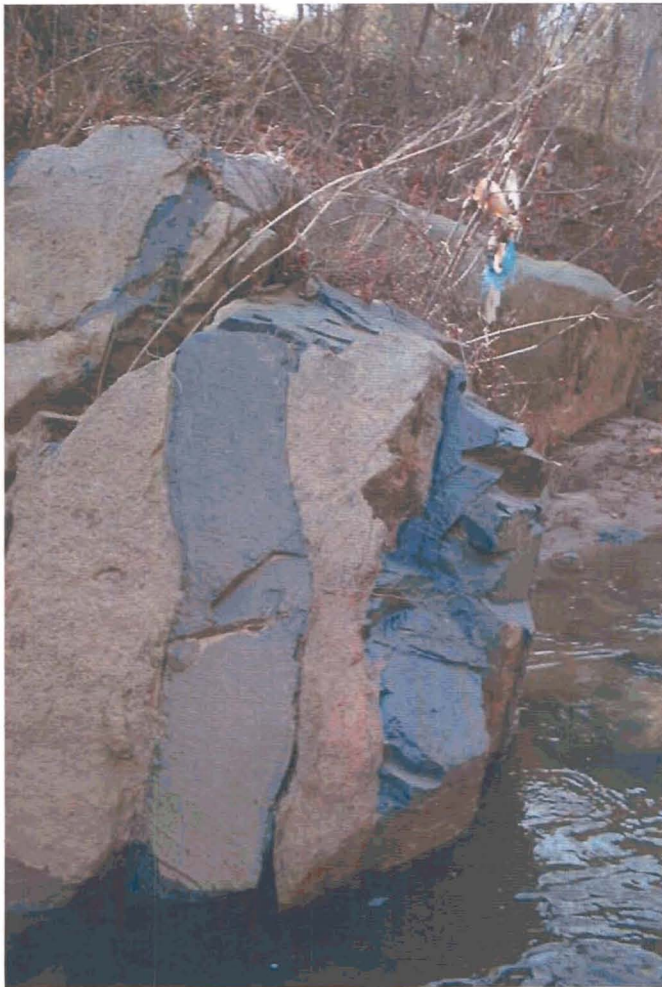
Photos 5 & 6. Bank exposures of the early Paleozoic granitoid rock formations that dominate the Irwin Creek watershed. Photo at left shows a series of 3 sub-parallel diabase dikes of probable Triassic or Early Jurassic age. Foam seen in view at top originates from the WWTP discharge point.

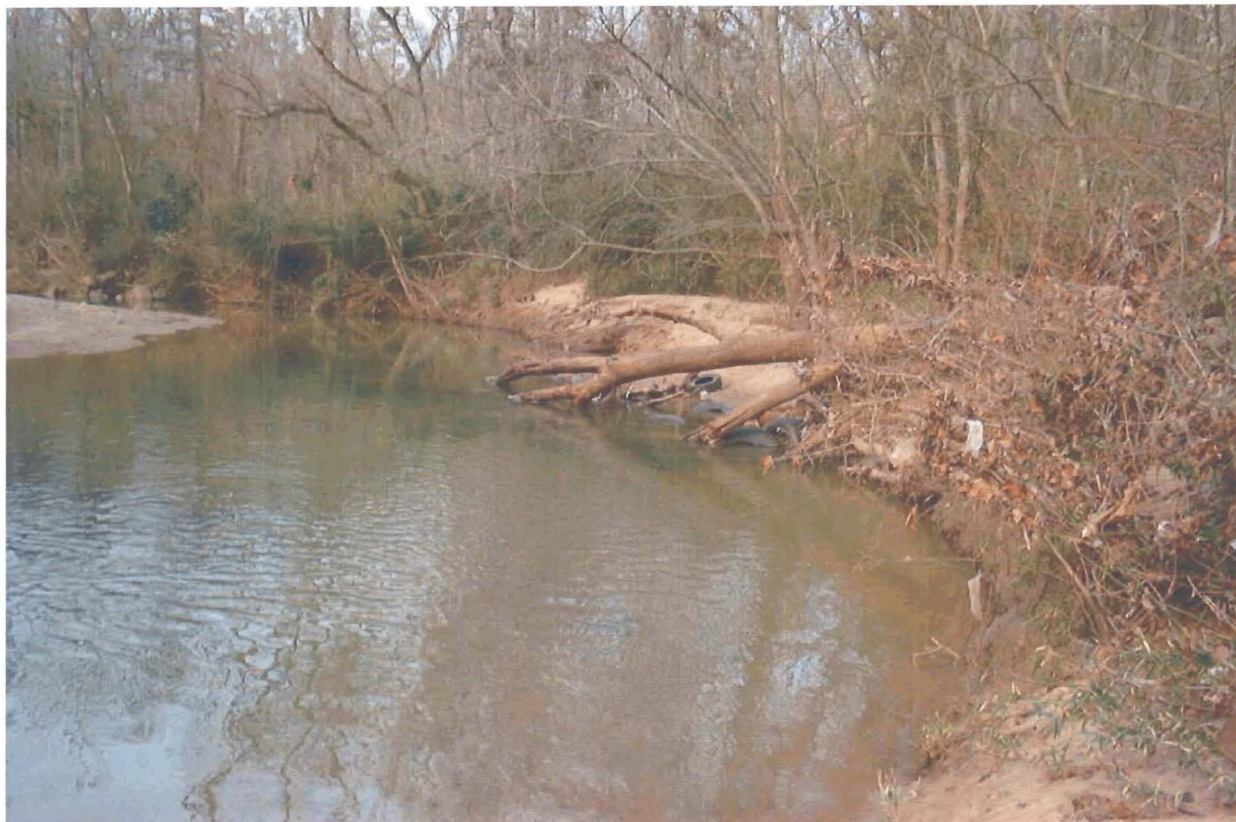
Photo 7. View of meander bend in Zone 4 south of Irwin Creek WWTP. The downed tree has acted as a flow deflector on eroding outer banks to meander and caused siltation downstream (tire dropout area).

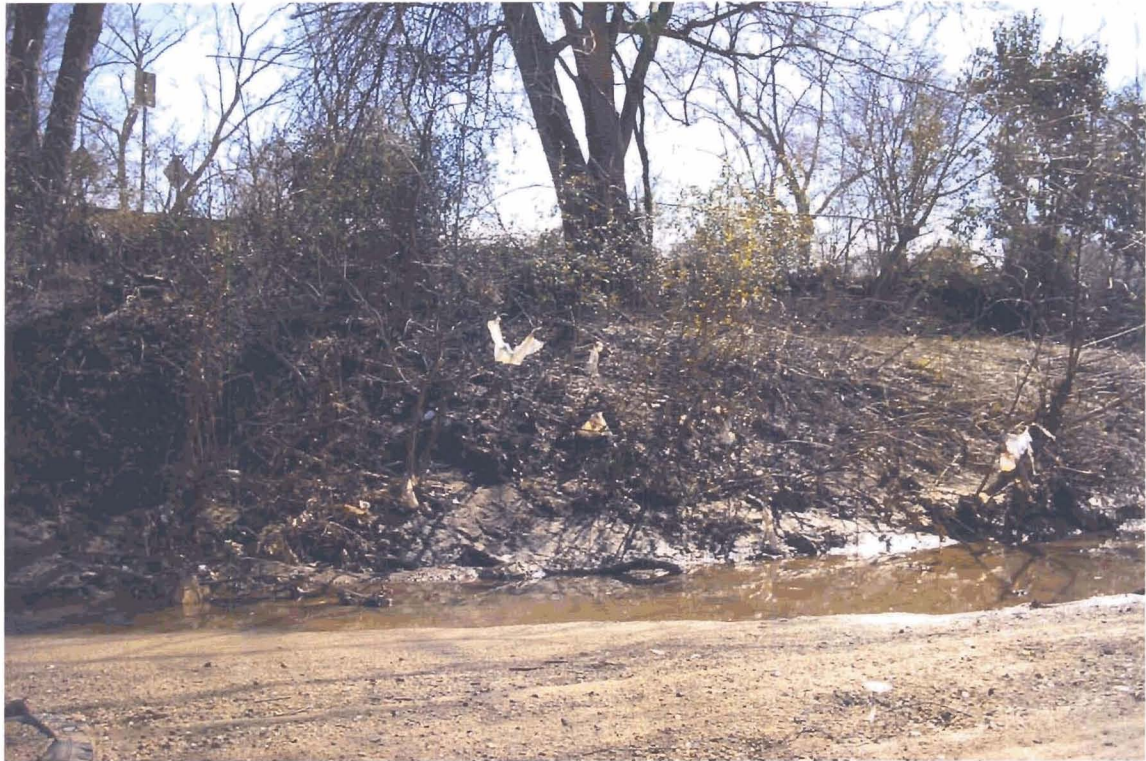
**March 3 - Photo 35: Taken at Segment 9, 160-180 m., Left Bank**

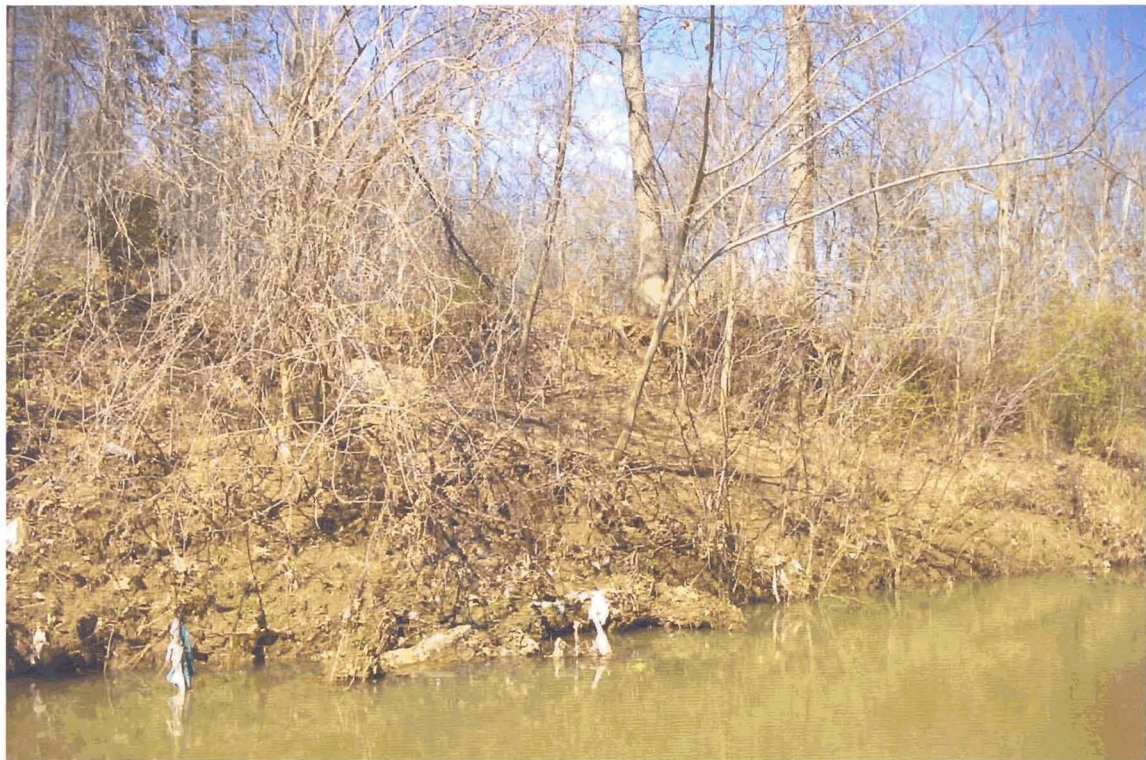
**March 3 - Photo 40: Taken at Segment 10, 180-200 m., Right Bank**

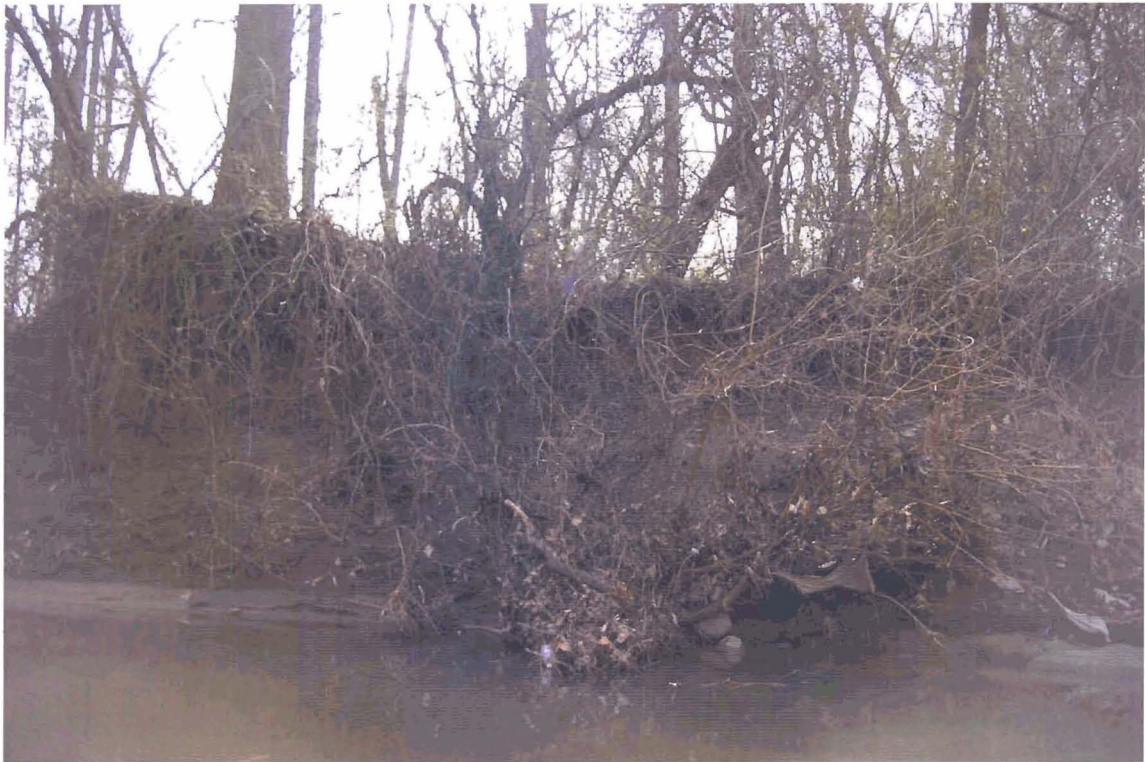
**March 4 - Photo 29: Taken at Segment 21, 400-420 m., Left Bank**

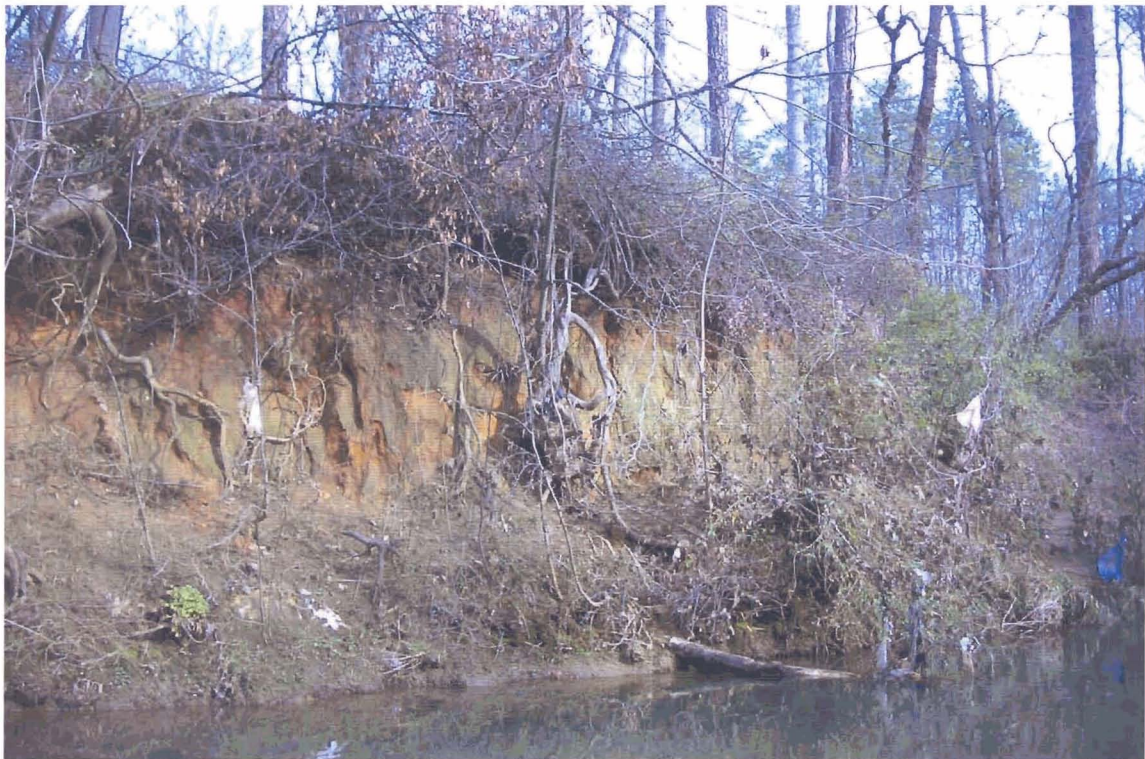
**March 4 - Photo 31: Taken at Segment 21, 400-420 m., Right Bank**

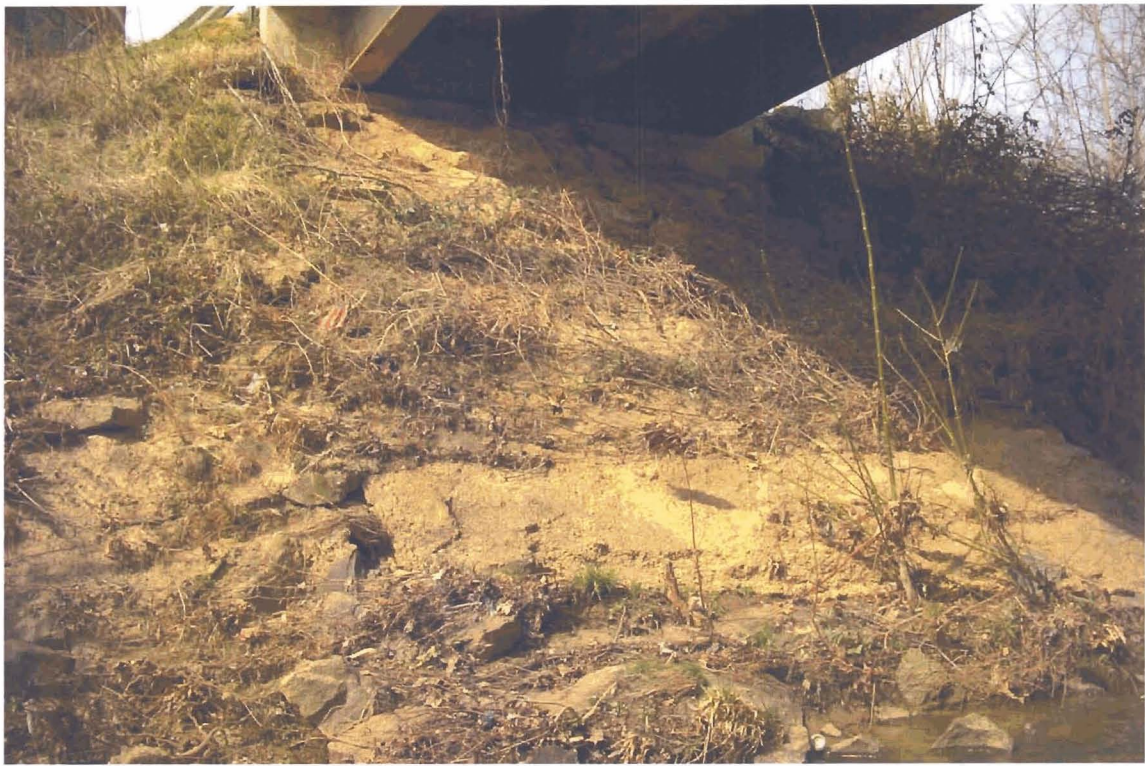
**March 4 - Photo 87: Taken at Segment 34, 660-680 m., Right Bank**

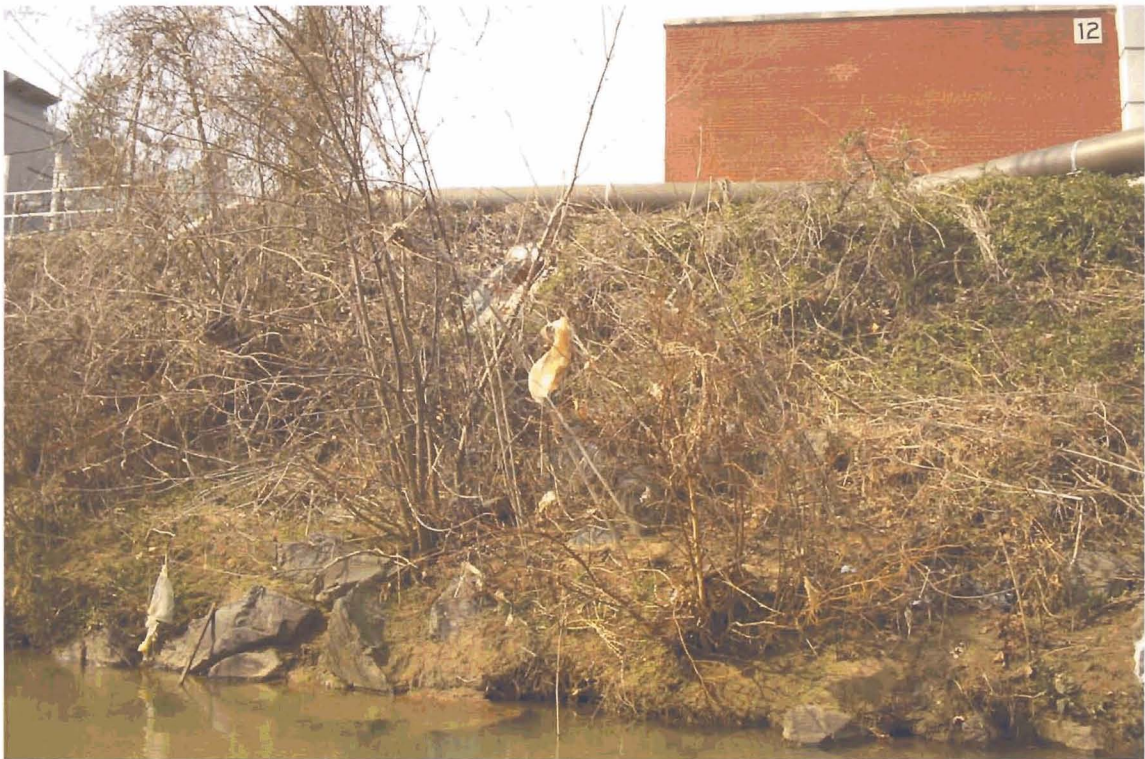
**March 4 - Photo 92: Taken at Segment 35, 680-700 m., Right Bank**

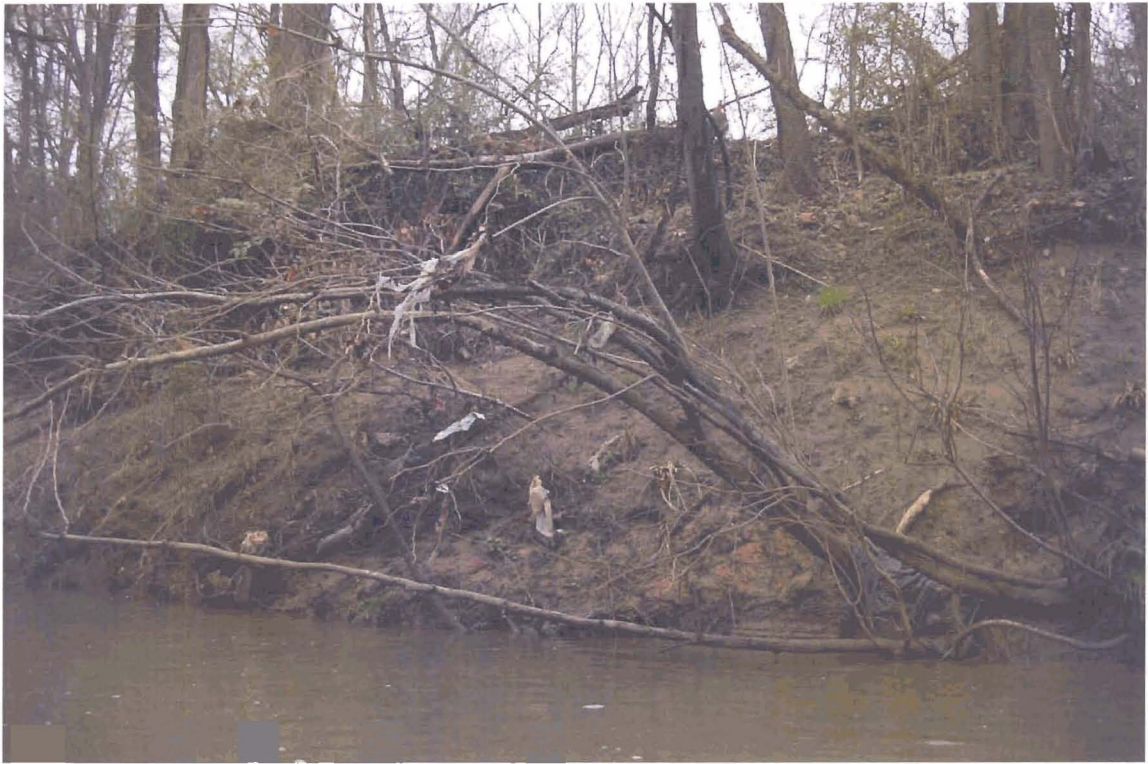
**March 5 - Photo 17: Taken at Segment 51, 1392-1412 m., Right Bank**

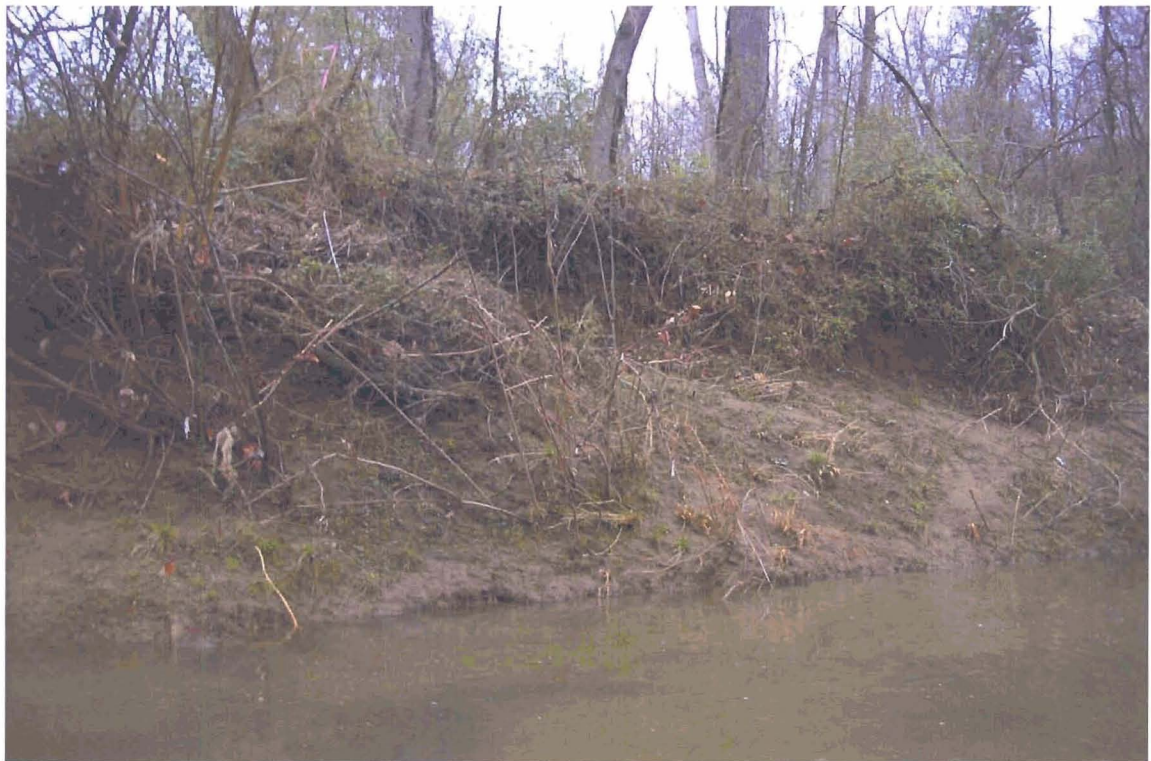
**March 5 - Photo 21: Taken at Segment 52, 1412 -1432 m., Right Bank**

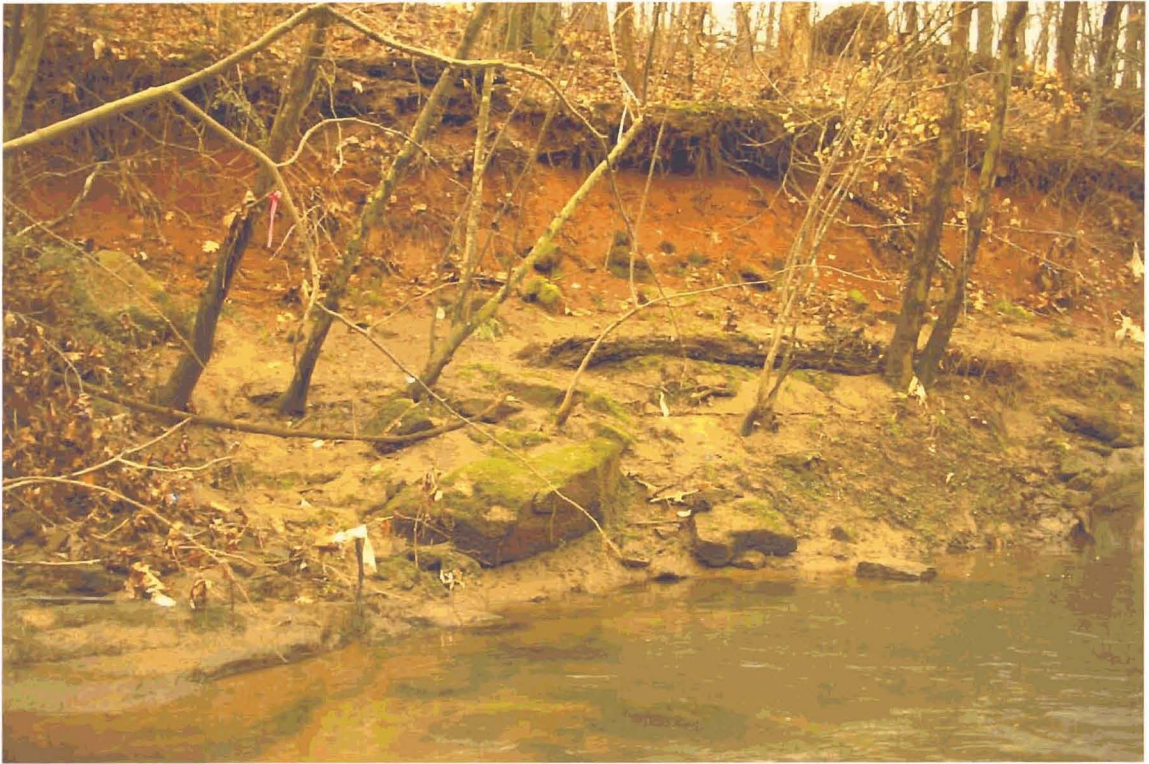
**March 5 - Photo 64: Taken at Segment 63, 1632-1652 m., Left Bank**

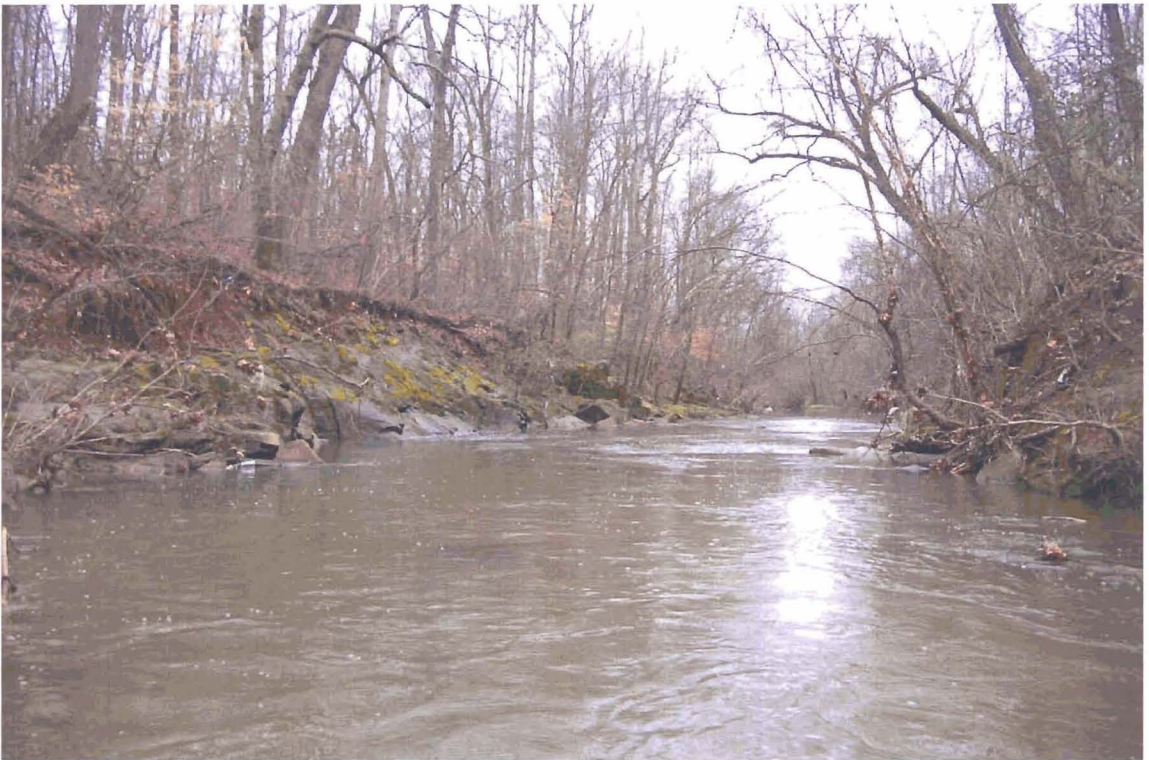
**March 5 - Photo 64: Taken at Segment 63, 1652 m., Left & Right Banks**

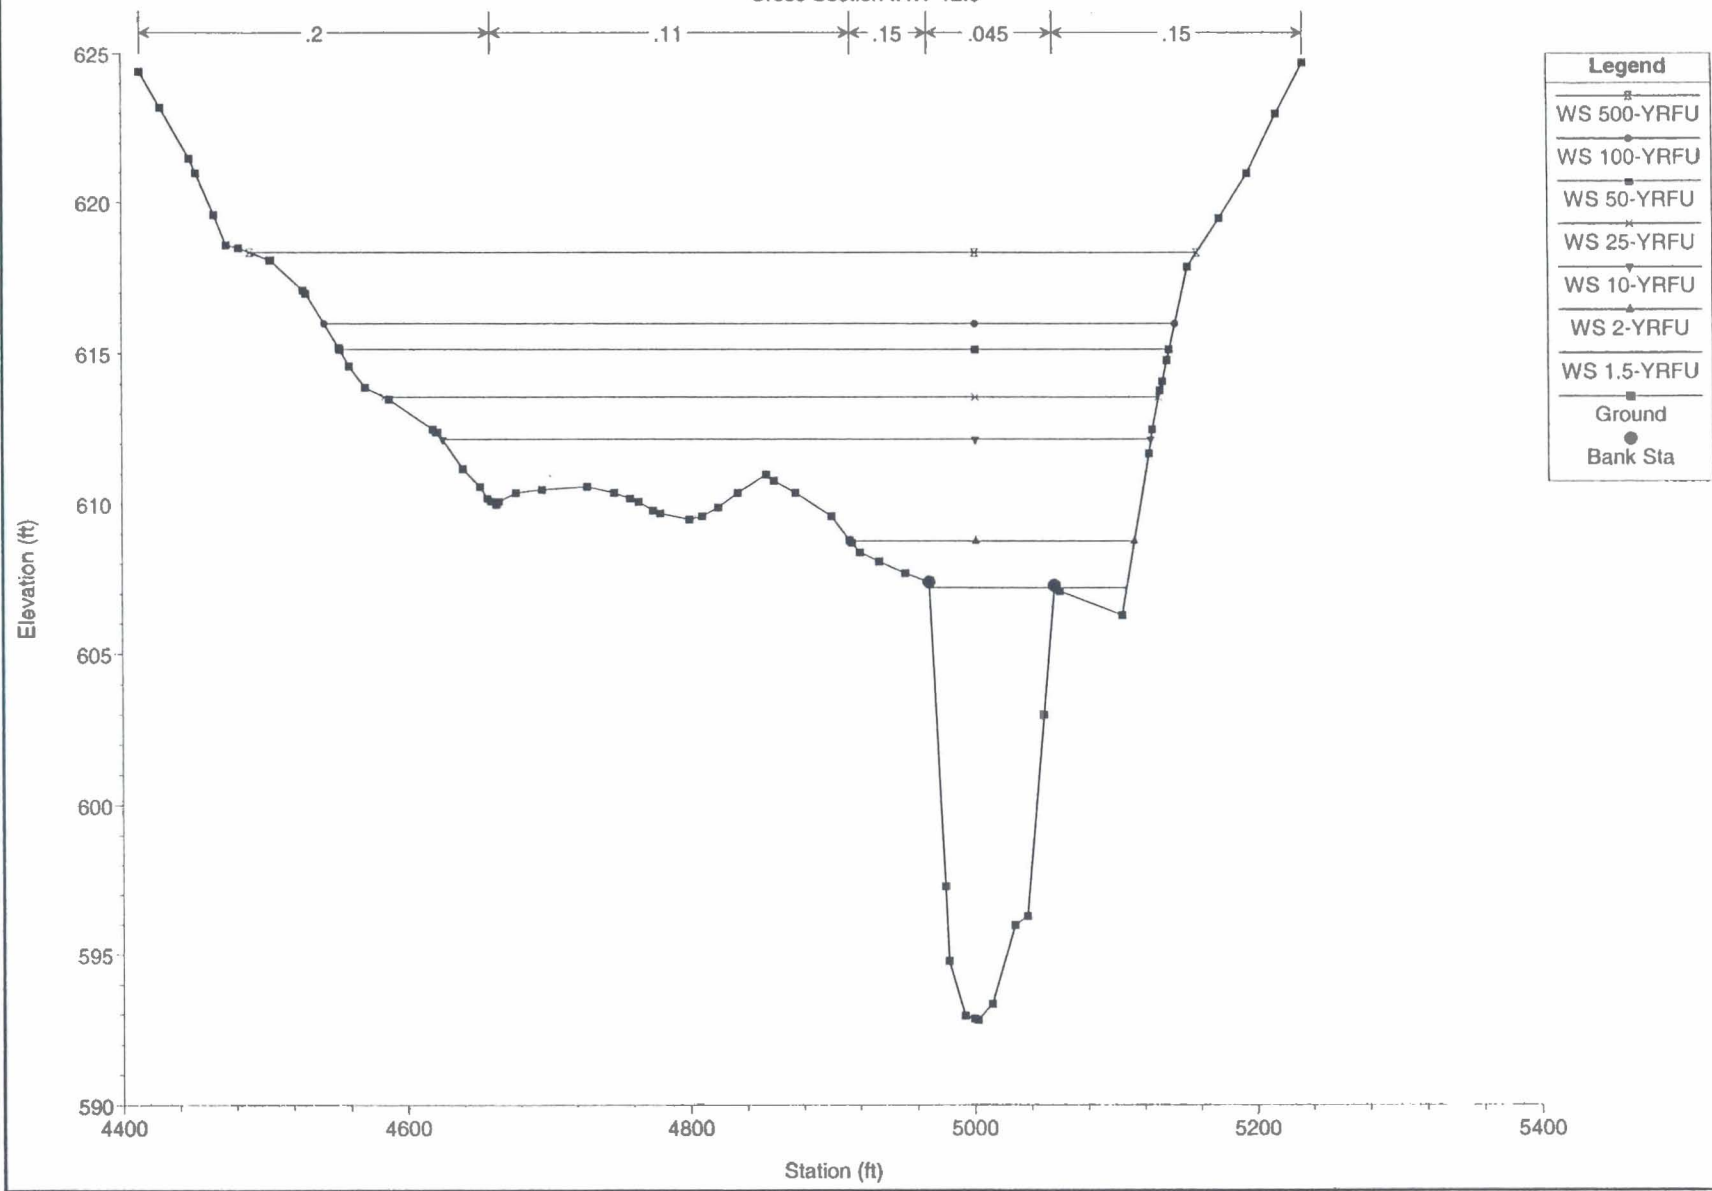
Irwin Creek - Future Conditions Plan: WRP Project - Future 5/15/2003  
 Cross Section IRW-12.0

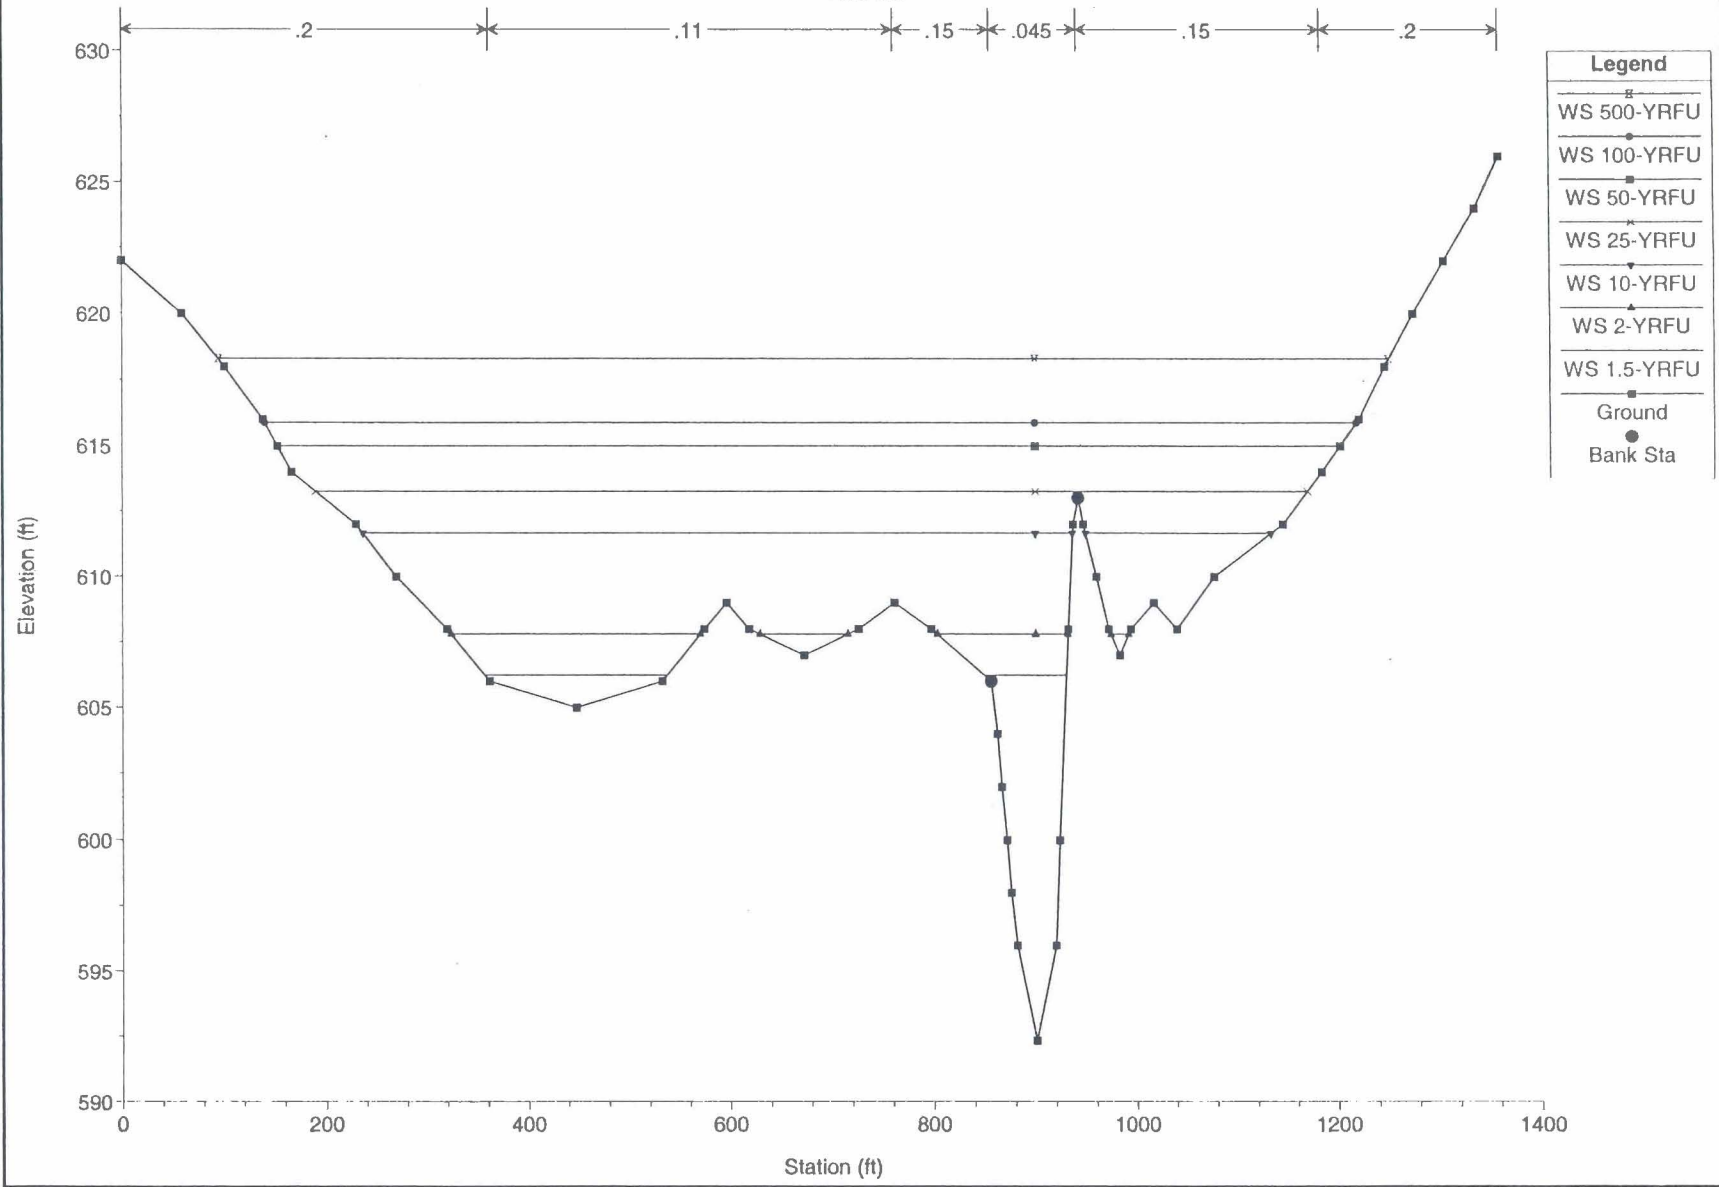
Irwin Creek - Future Conditions Plan: WRP Project - Future 5/15/2003  
New XS

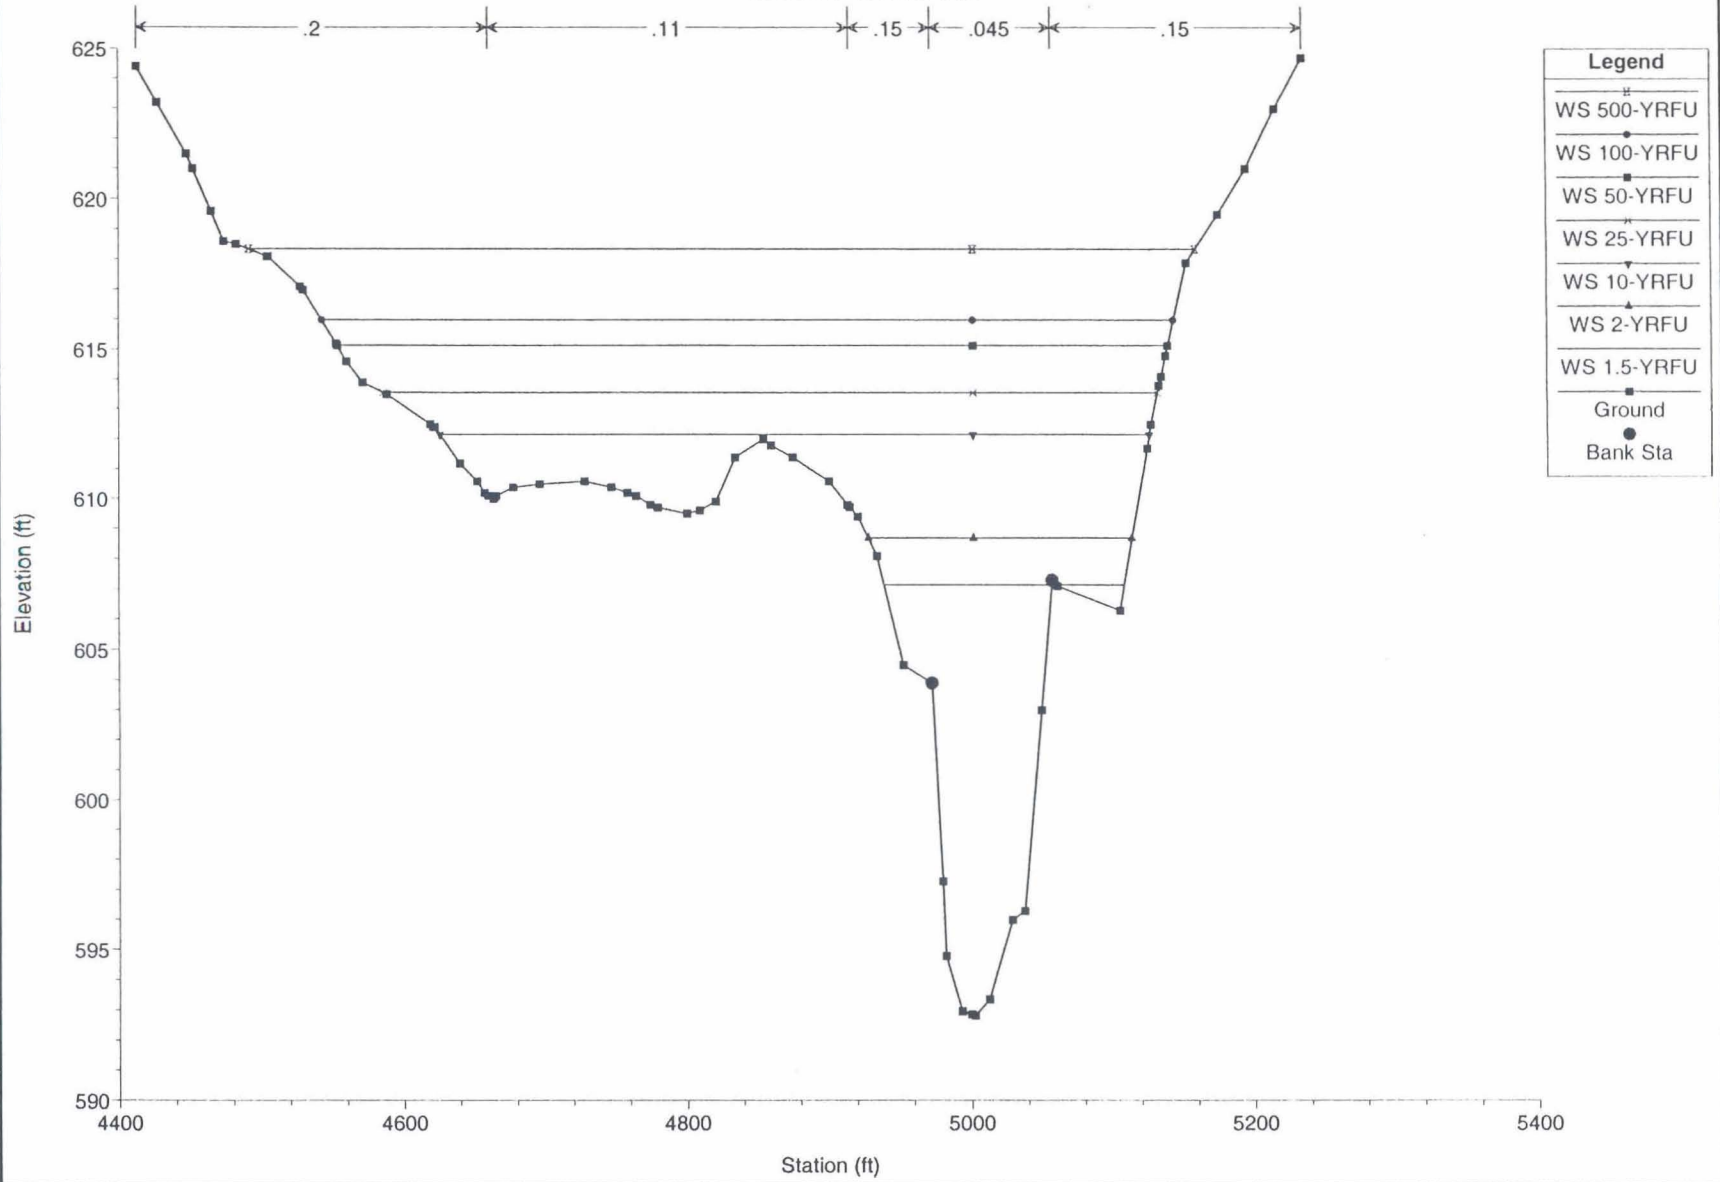
Cross Section IRW-12.0

Irwin Creek - Future and 20ft bench Plan: WRP Project - Future 5/14/2003
