**IRWIN CREEK**

**STREAM RESTORATION**

**60% CONCEPTUAL DESIGN**

**MECKLENBURG COUNTY,  
NORTH CAROLINA**

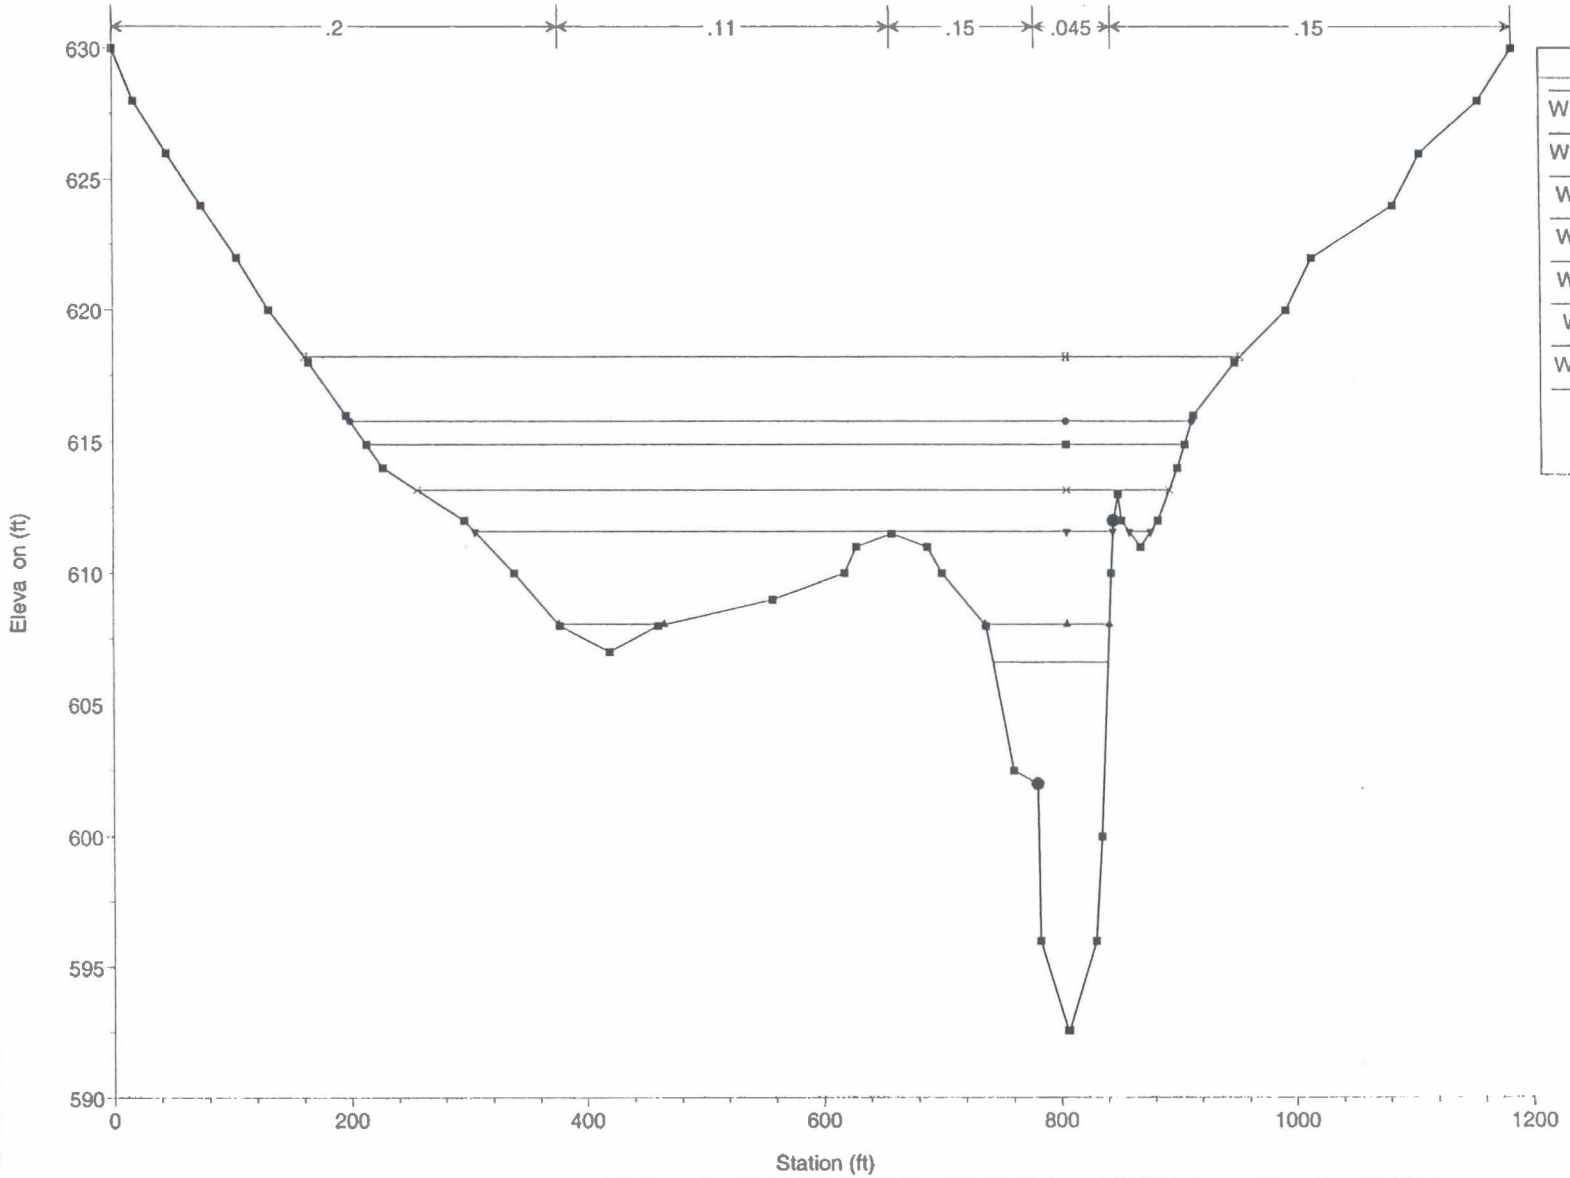
New XS

Irwin Creek - Future and 20ft bench Plan: WRP Project - Future 5/14/2003

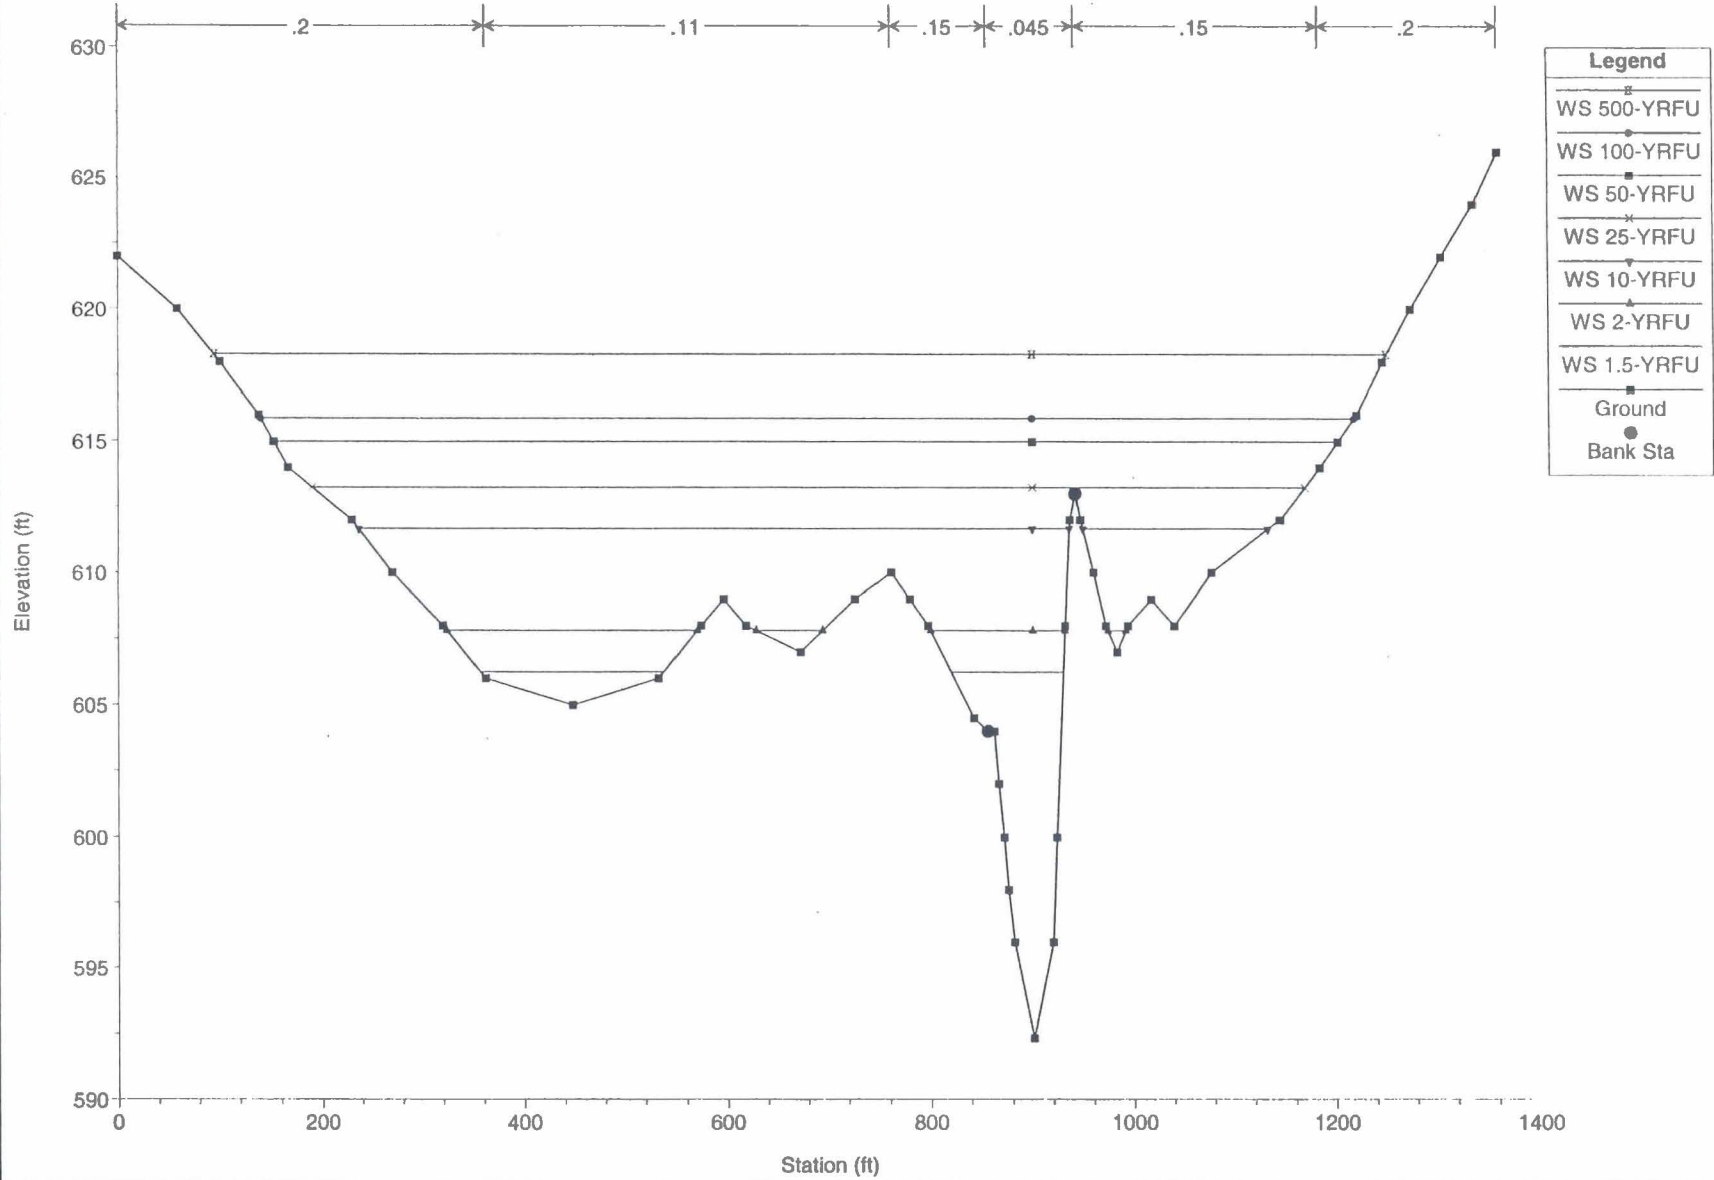
New XS

Irwin Creek - Future and 20ft bench Plan: WRP Project - Future 5/14/2003

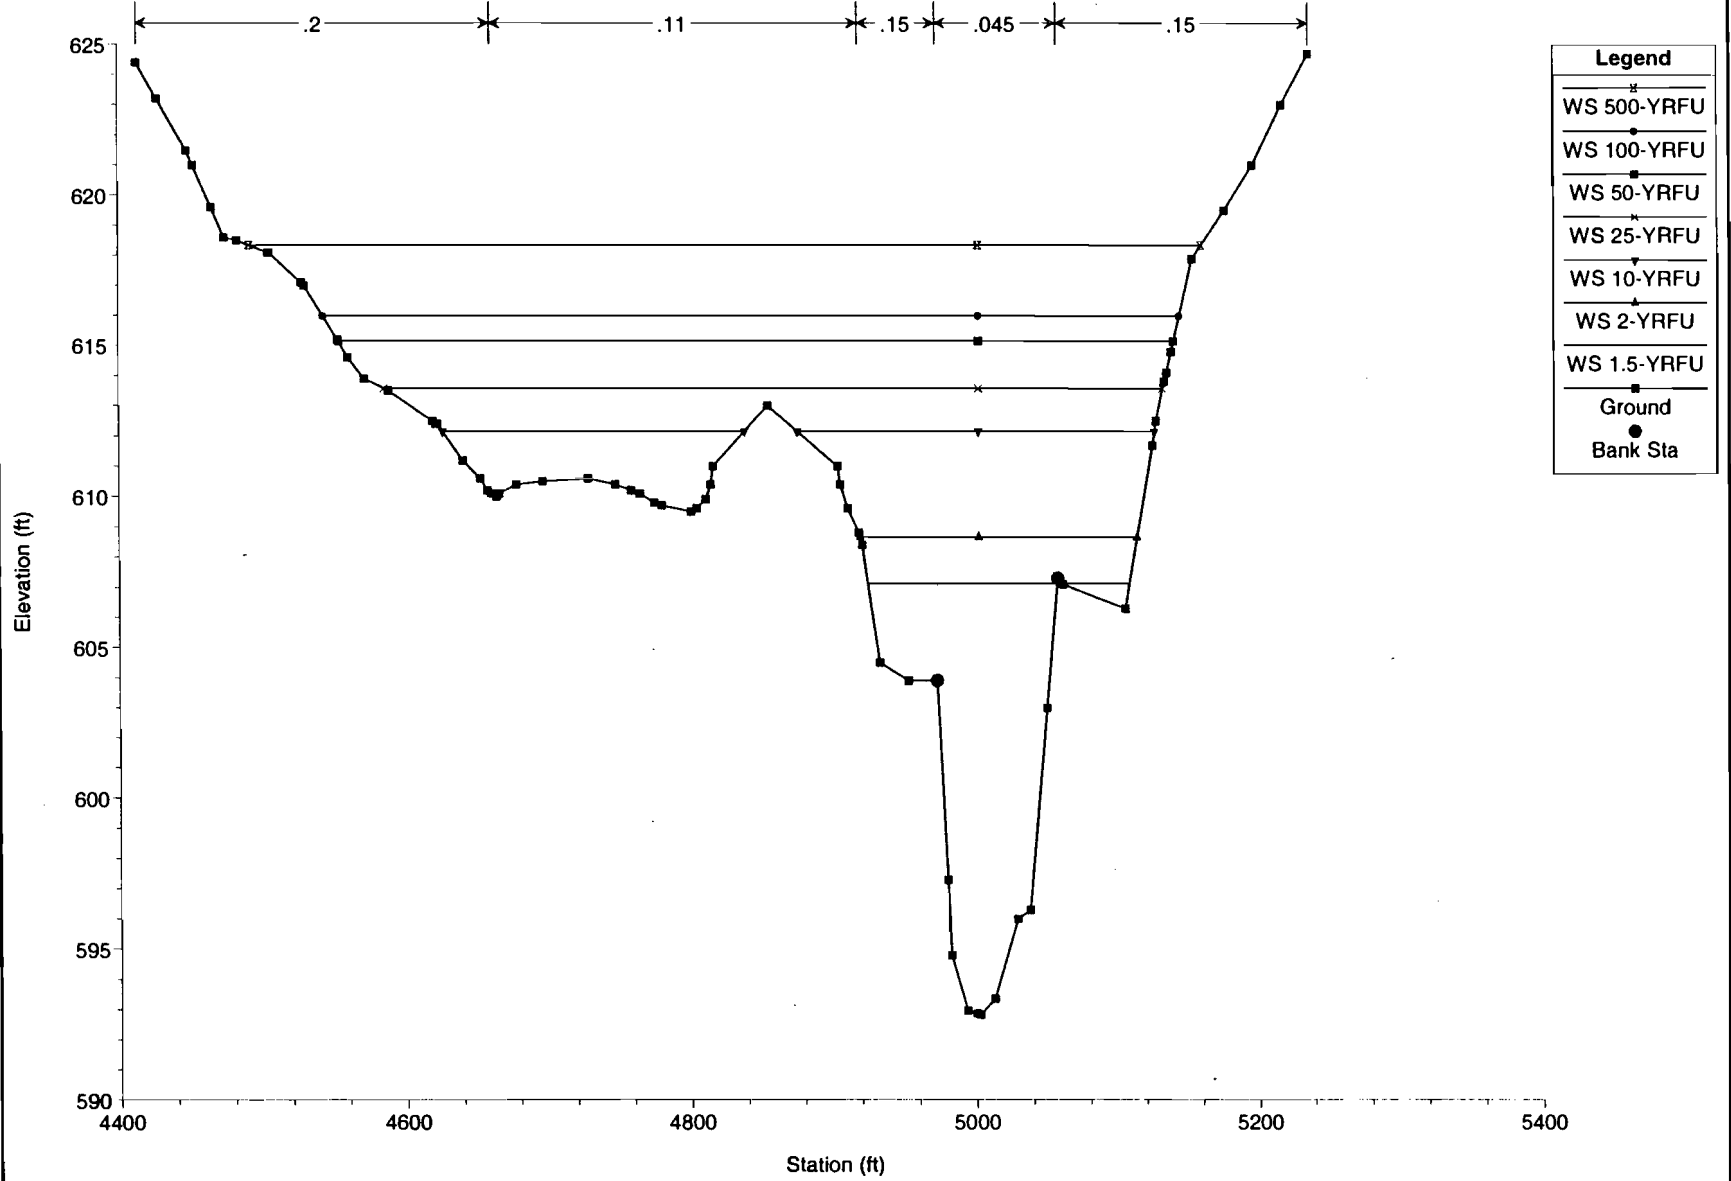
Cross Section IRW-12.0

Irwin Creek - Future and 40ft bench Plan: WRP Project - Future 5/15/2003

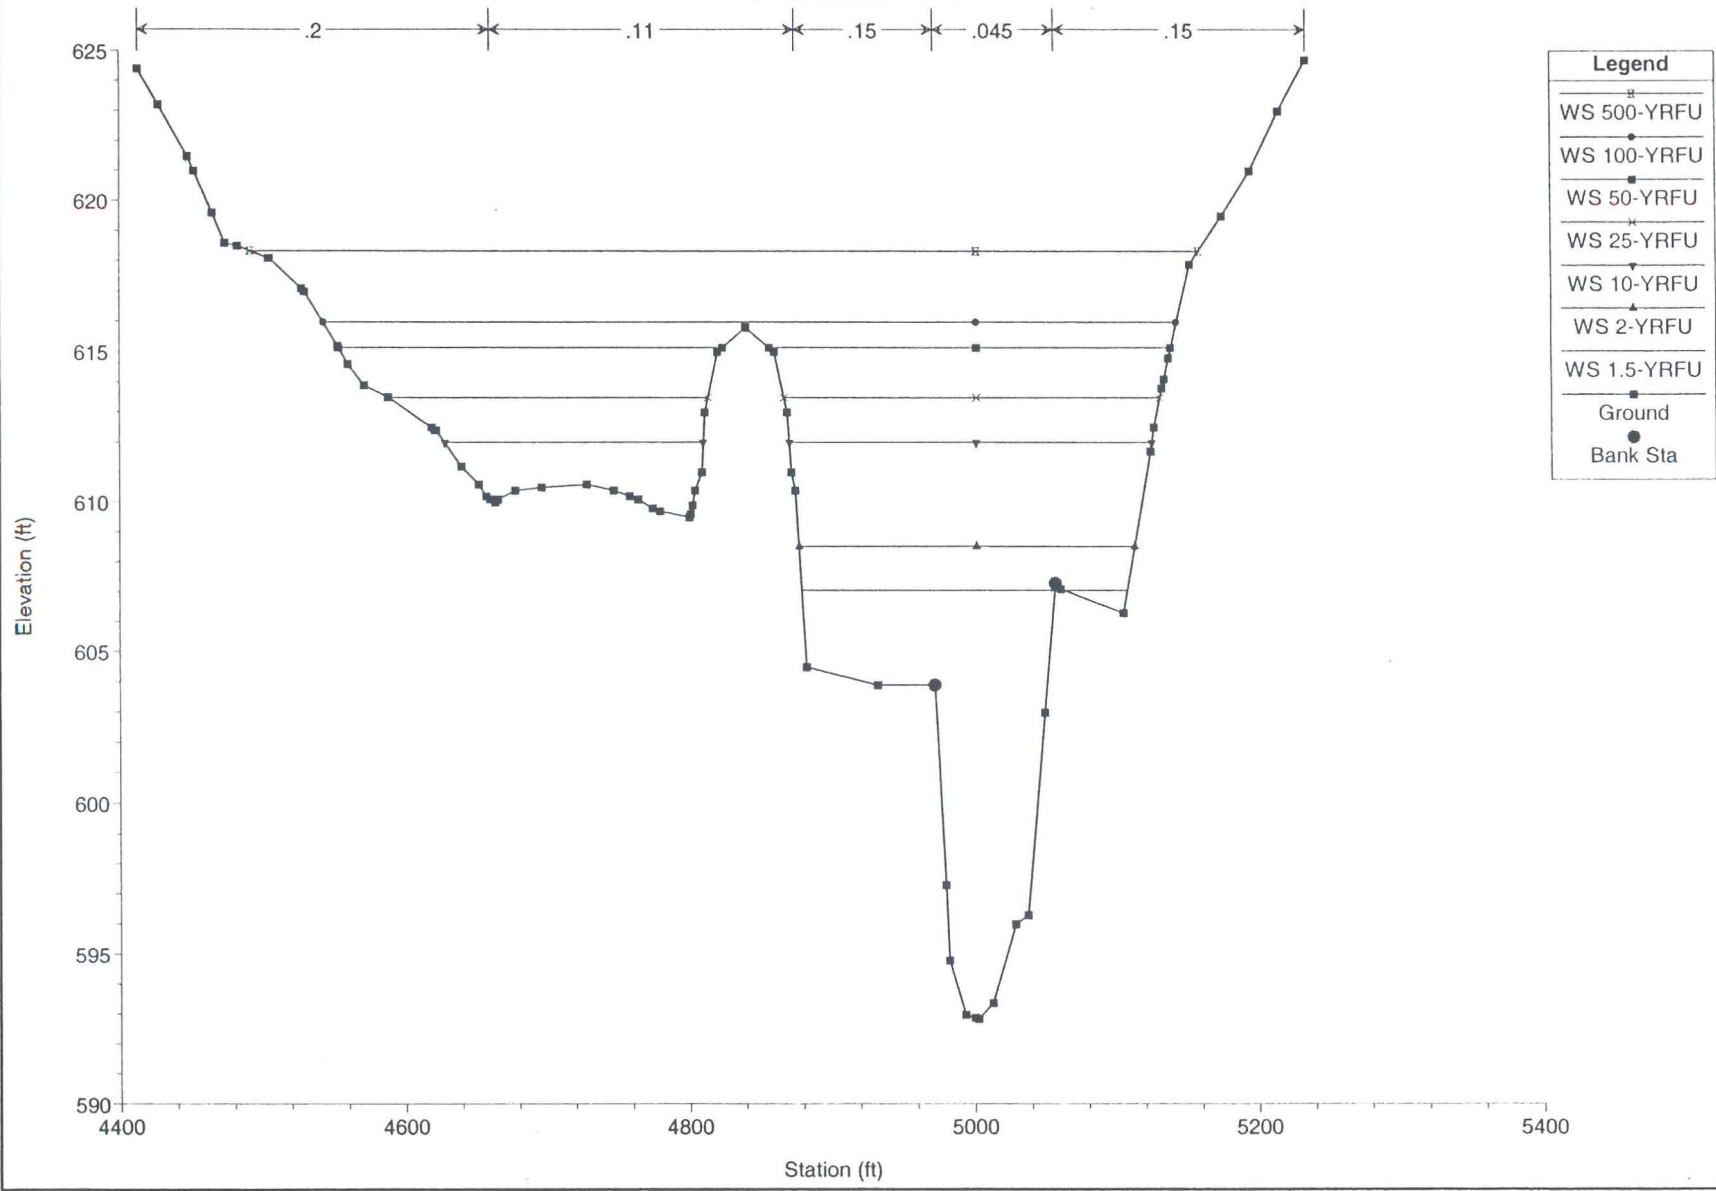
Irwin Creek - Future and 90ft bench Plan: WRP Project - Future 5/15/2003  
 Cross Section IRW-12.0

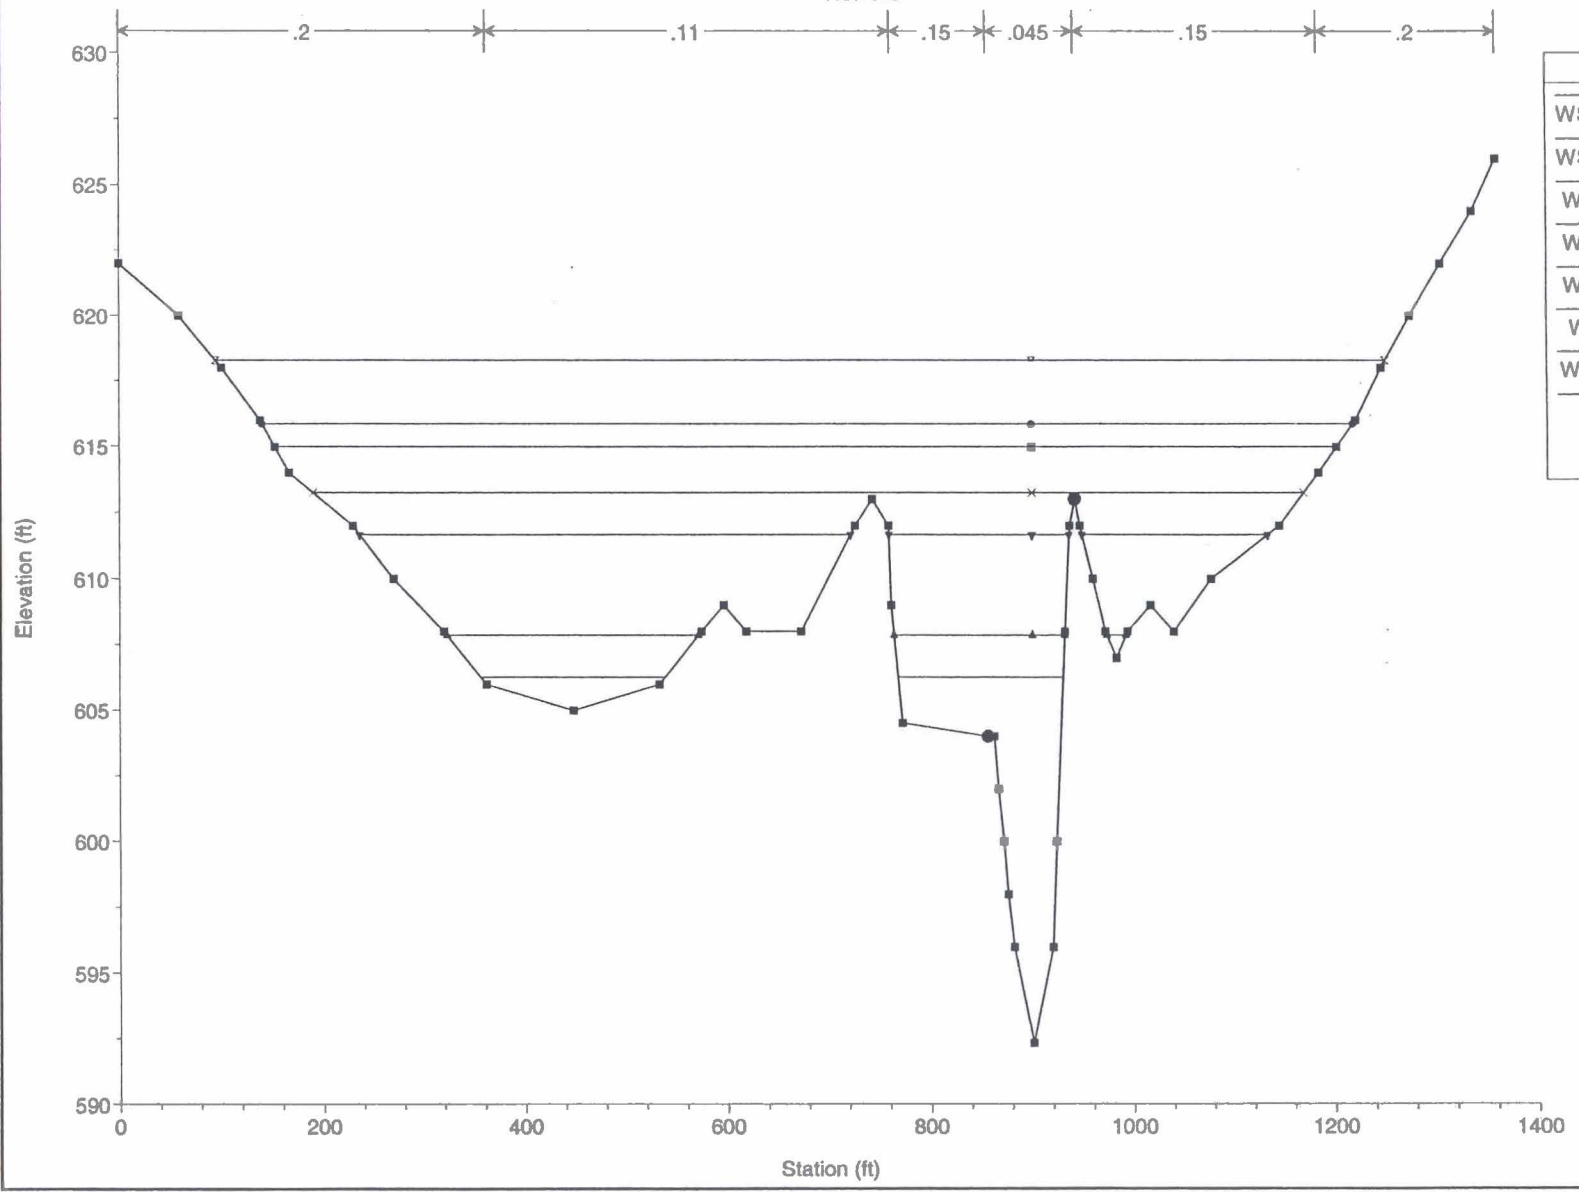
New XS

Irwin Creek - Future and 90ft bench Plan: WRP Project - Future 5/15/2003

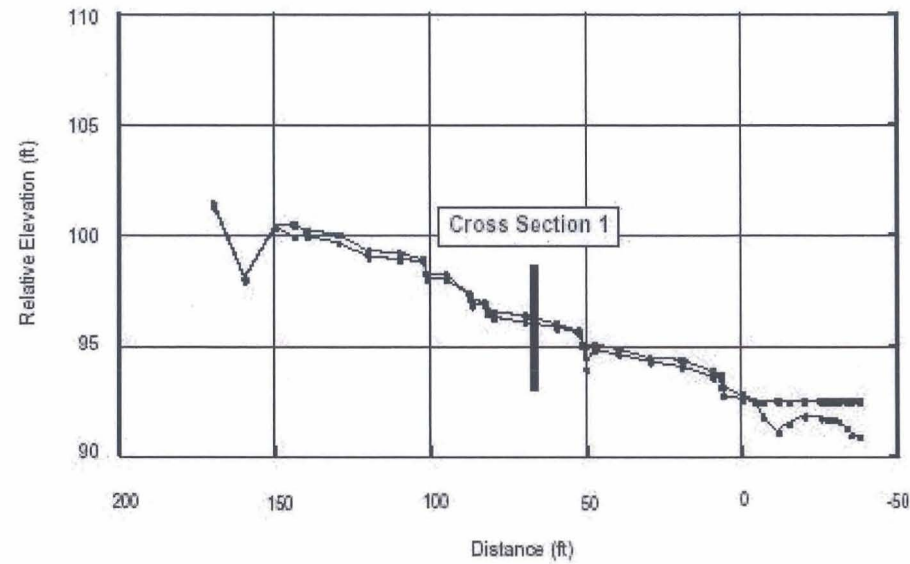
### Longitudinal Profile Irwin Creek Tributary 5

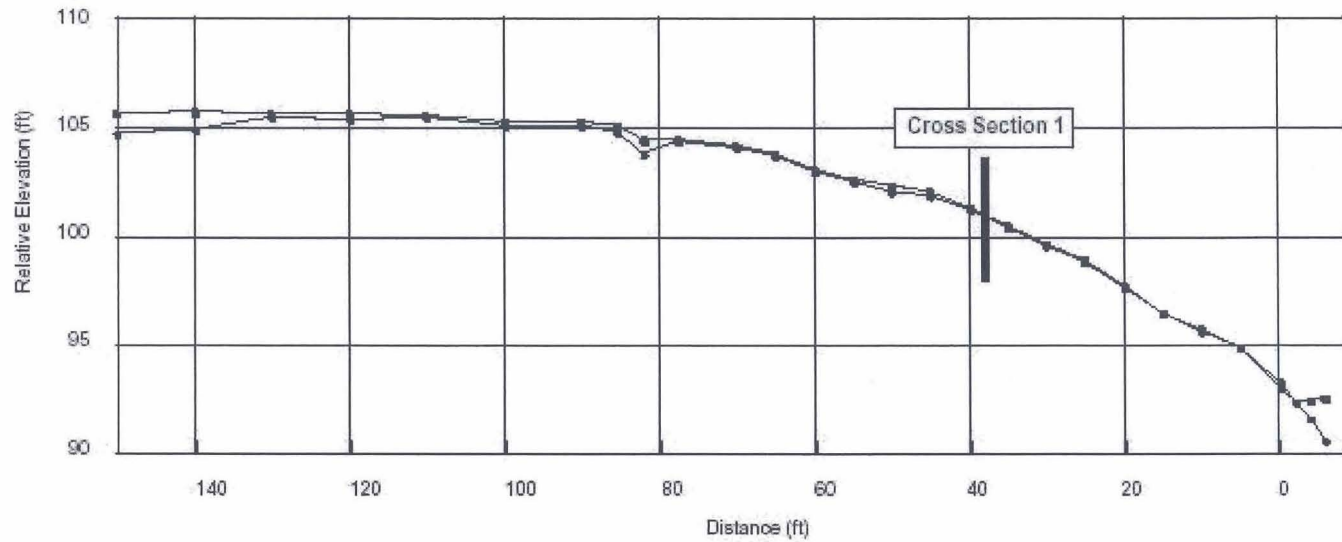
### Longitudinal Profile Irwin Creek Tributary 4

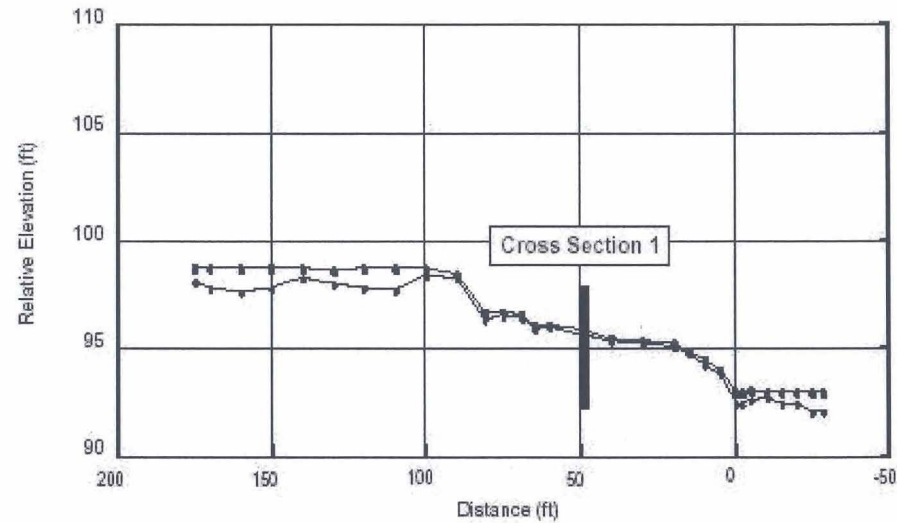
### Longitudinal Profile Irwin Creek Tributary 3

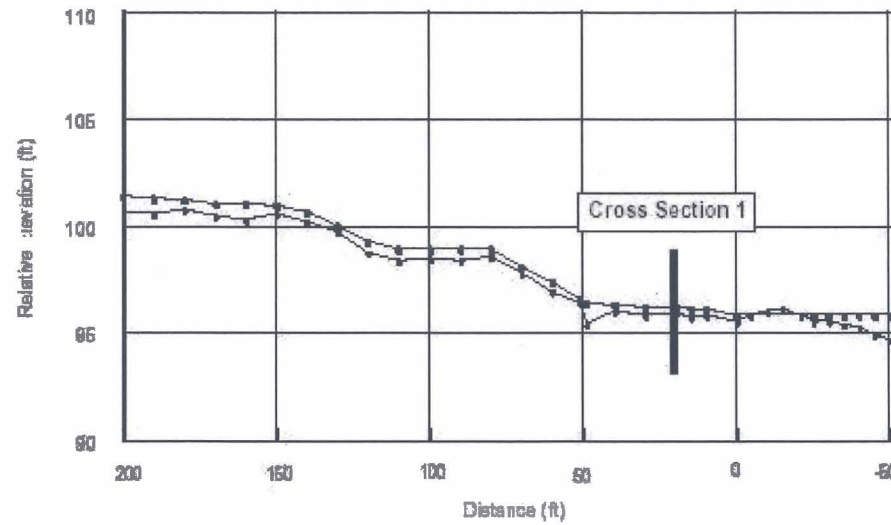
### Longitudinal Profile Irwin Creek Tributary 2

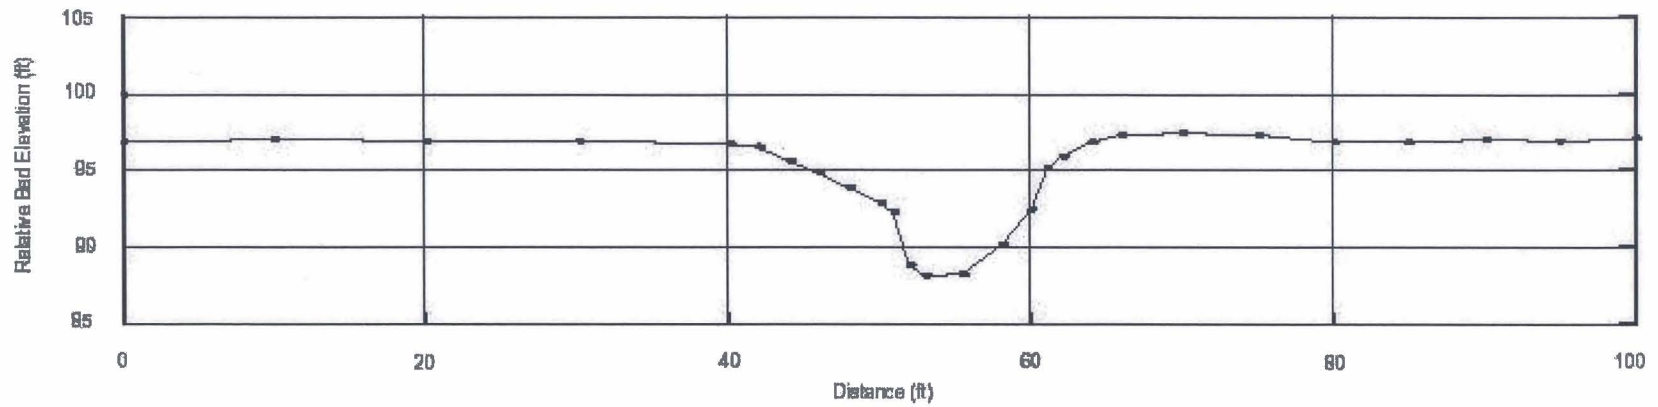
**Irwin Creek Tributary 3  
Cross Section 1**

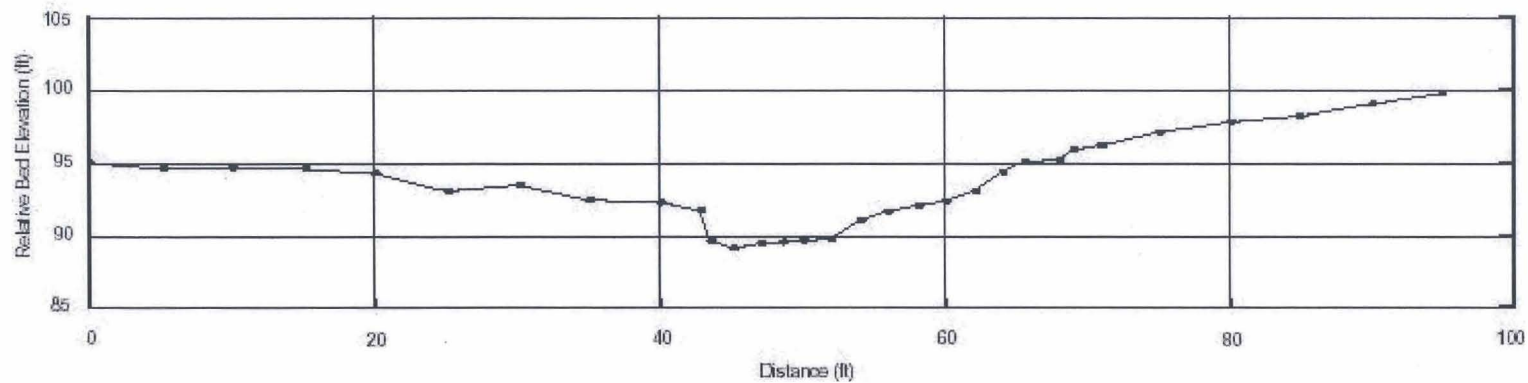
Irwin Creek Tributary 1  
Cross Section 3

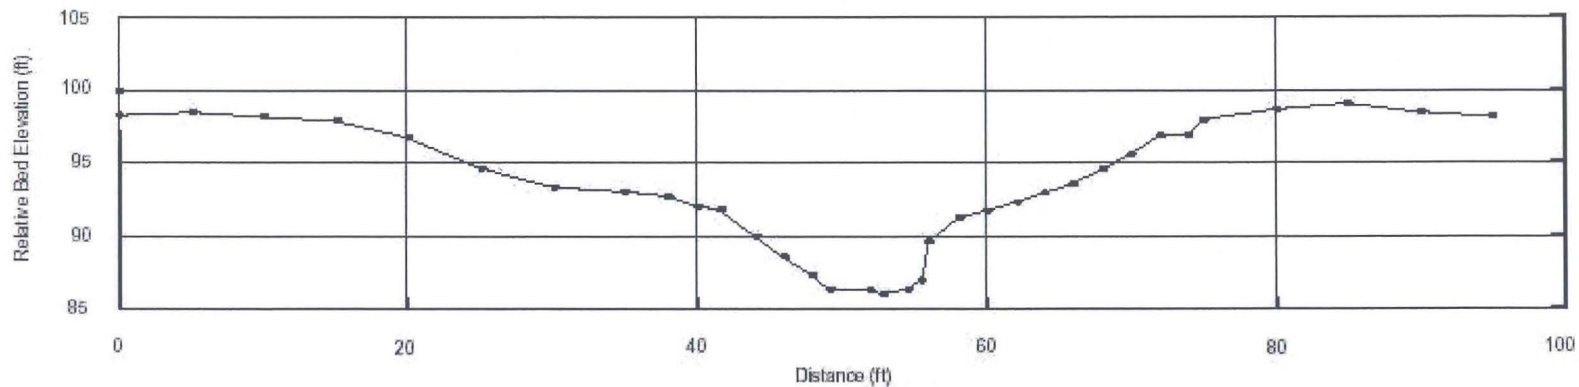
Irwin Creek Tributary 2  
Cross Section 1

Figure 11: Cross Section 1  
Irwin Tributary 2  
Stream Restoration Plan  
Irwin Creek

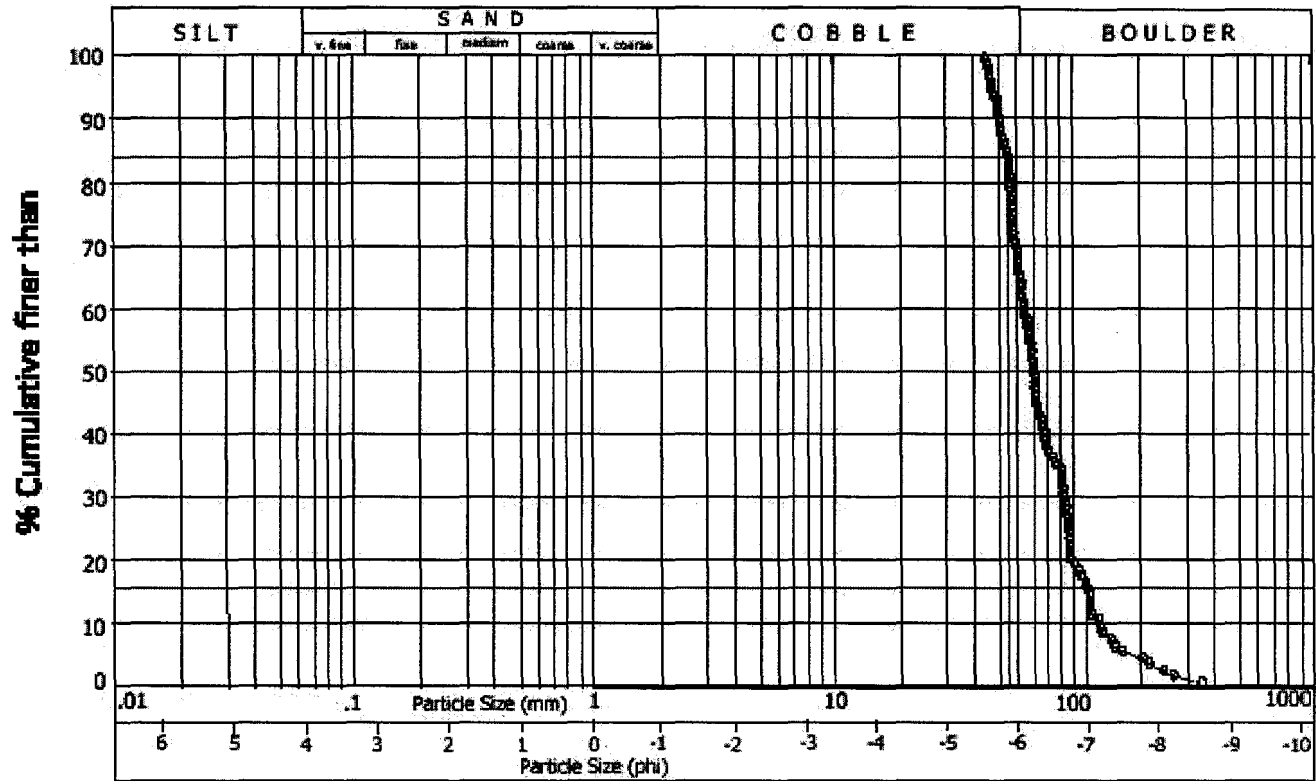
LOCALITY Irwin Creek Wastewater Treatment Plant  
 SITE Irwin Sample Riffle # 1

$D_{84(min)}$  52 mm       $D_{50}$  70 mm       $D_{84(max)}$  110 mm

Riffles and pools will also need to be sized using the aforementioned critical traction force estimates. The estimates for  $D_{50}$  and  $D_{84}$  for riffle and pool armor are noted in Table 4.

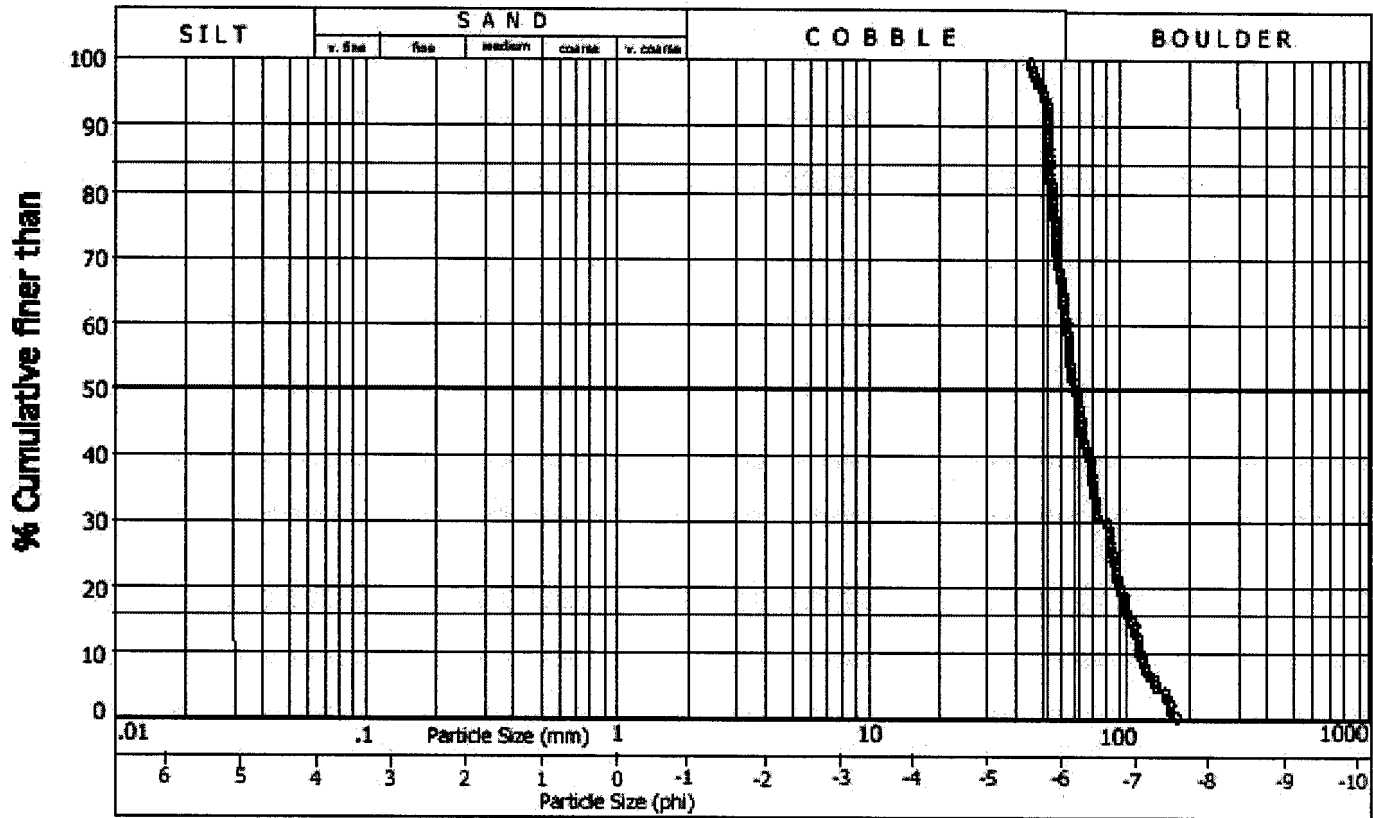
LOCALITY Irwin Creek Wastewater Treatment Plant  
 SITE Irwin Sample Riffle # 2

$D_{84(\min)}$  51 mm       $D_{50}$  69 mm       $D_{84(\max)}$  110 mm

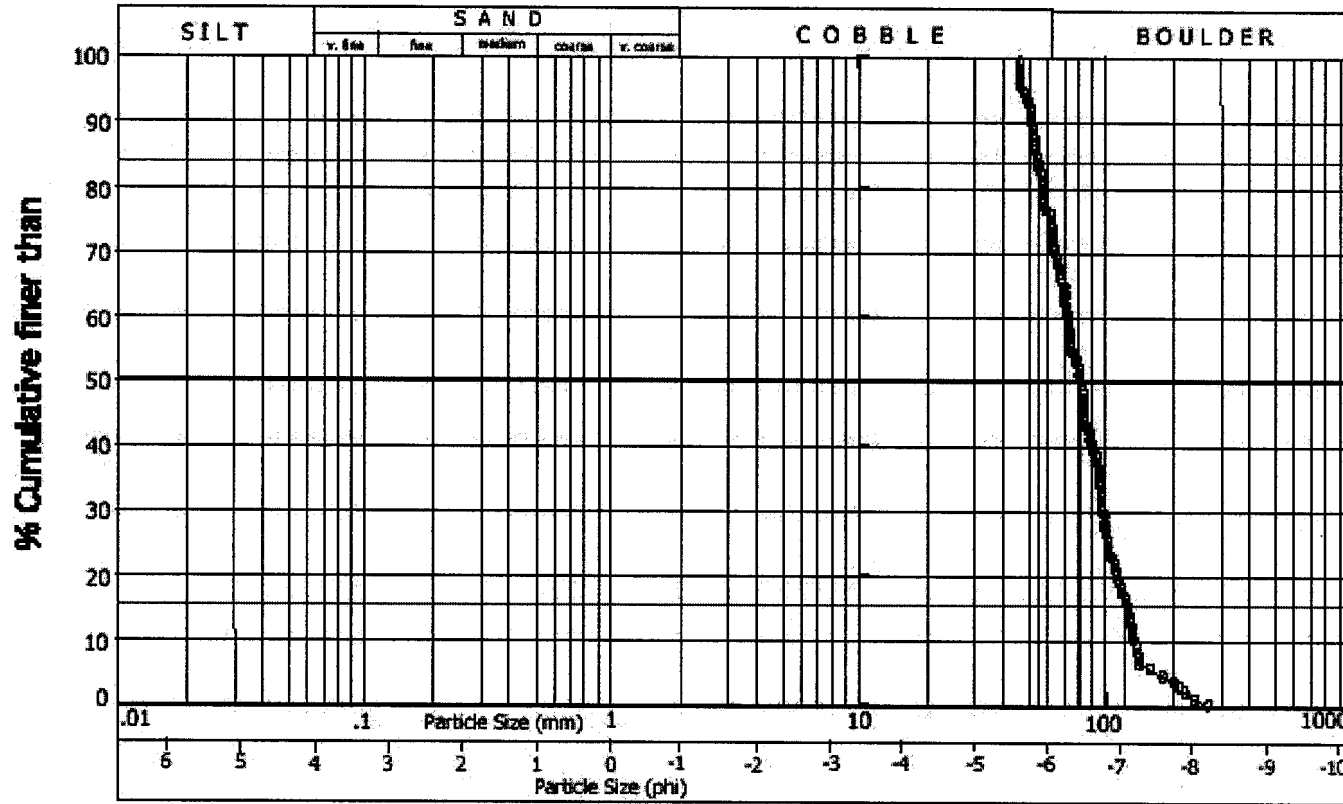
LOCALITY Irwin Creek Wastewater Treatment Plant  
 SITE Irwin Sample Riffle # 3

$D_{84(\min)}$  52 mm       $D_{50}$  81 mm       $D_{84(\max)}$  110 mm

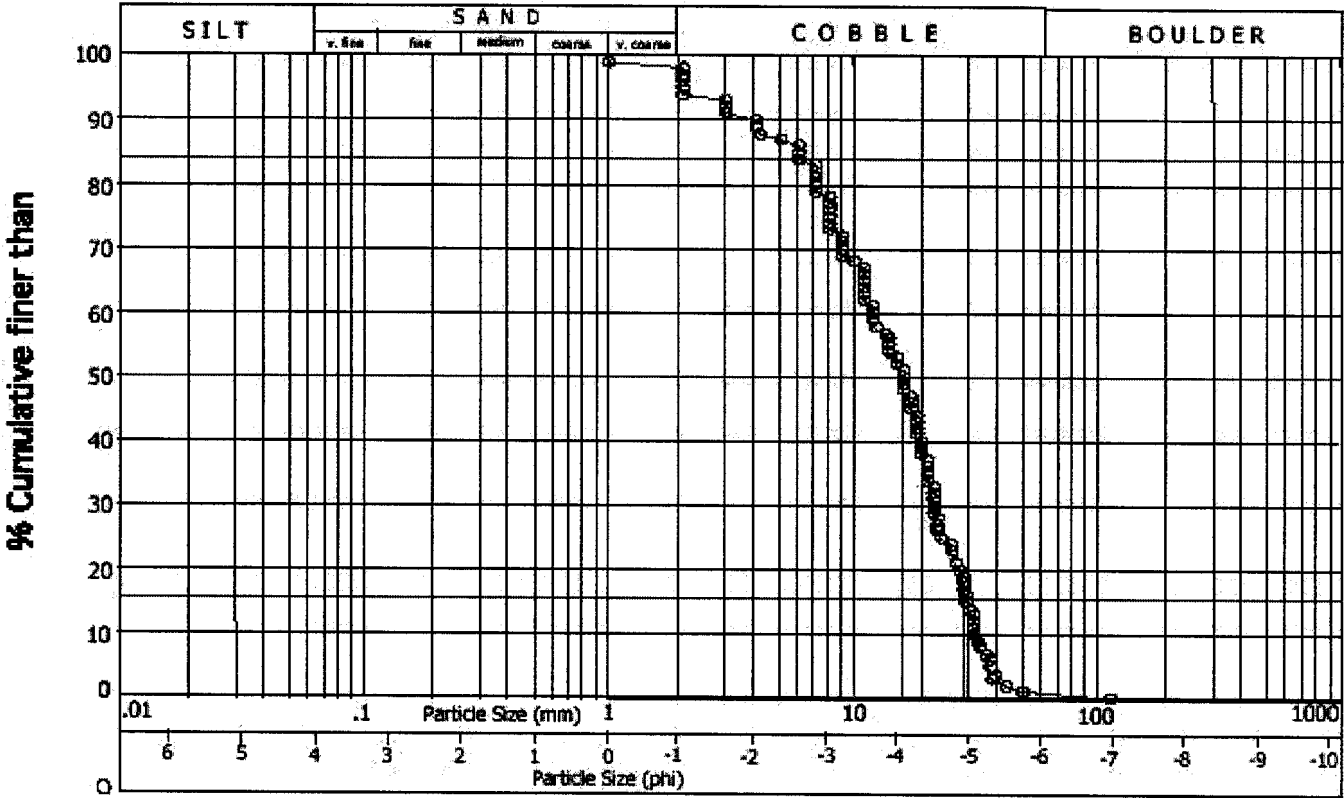
LOCALITY Leepers Reference Reach  
 SITE Leepers Sample Riffle # 1

$D_{84(\min)}$  6.0 mm

$D_{50}$  16 mm

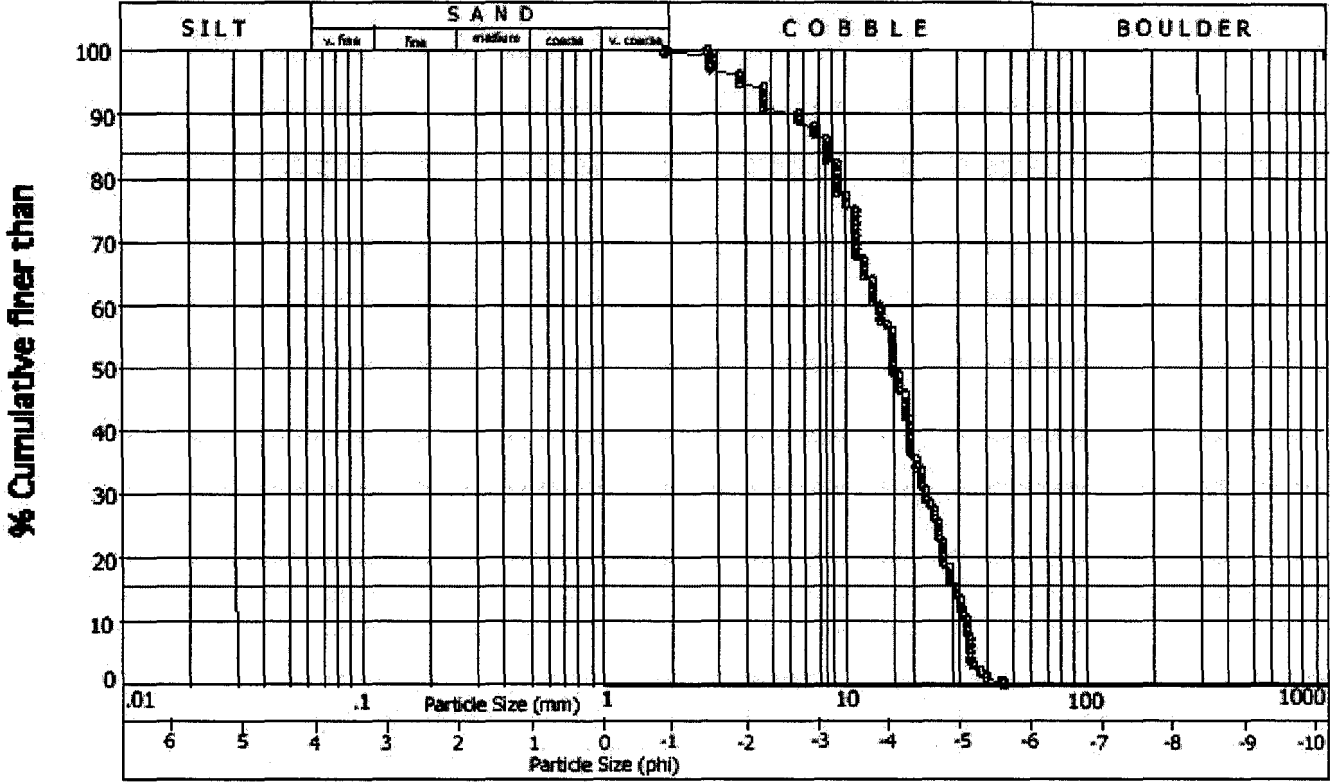
LOCALITY Leepers Reference Reach  
 SITE Leepers Sample Riffle # 2

$D_{84(\min)}$  8.5 mm       $D_{50}$  17 mm       $D_{84(\max)}$  28 mm

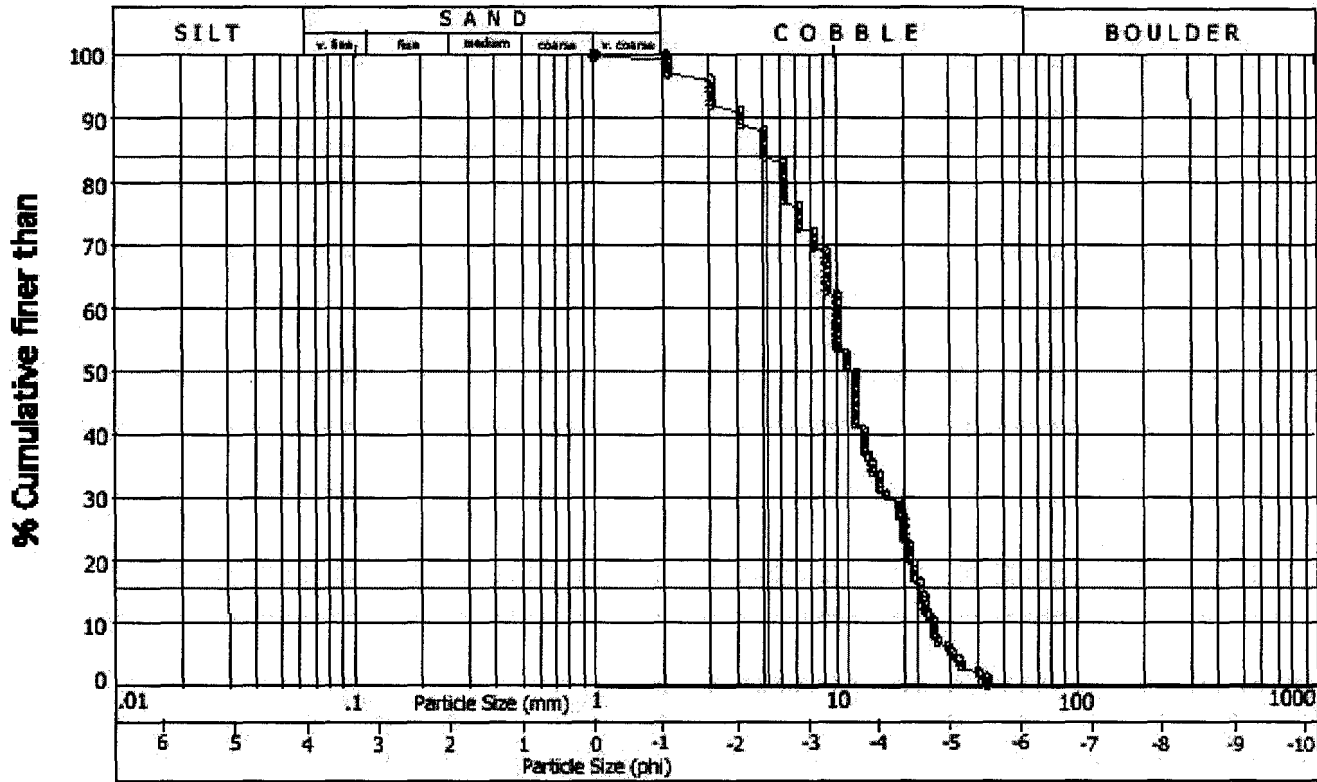
LOCALITY Leepers Reference Reach  
 SITE Leepers Sample Riffle # 3

$D_{84(\min)}$  5.1 mm       $D_{50}$  11 mm       $D_{84(\max)}$  22 mm

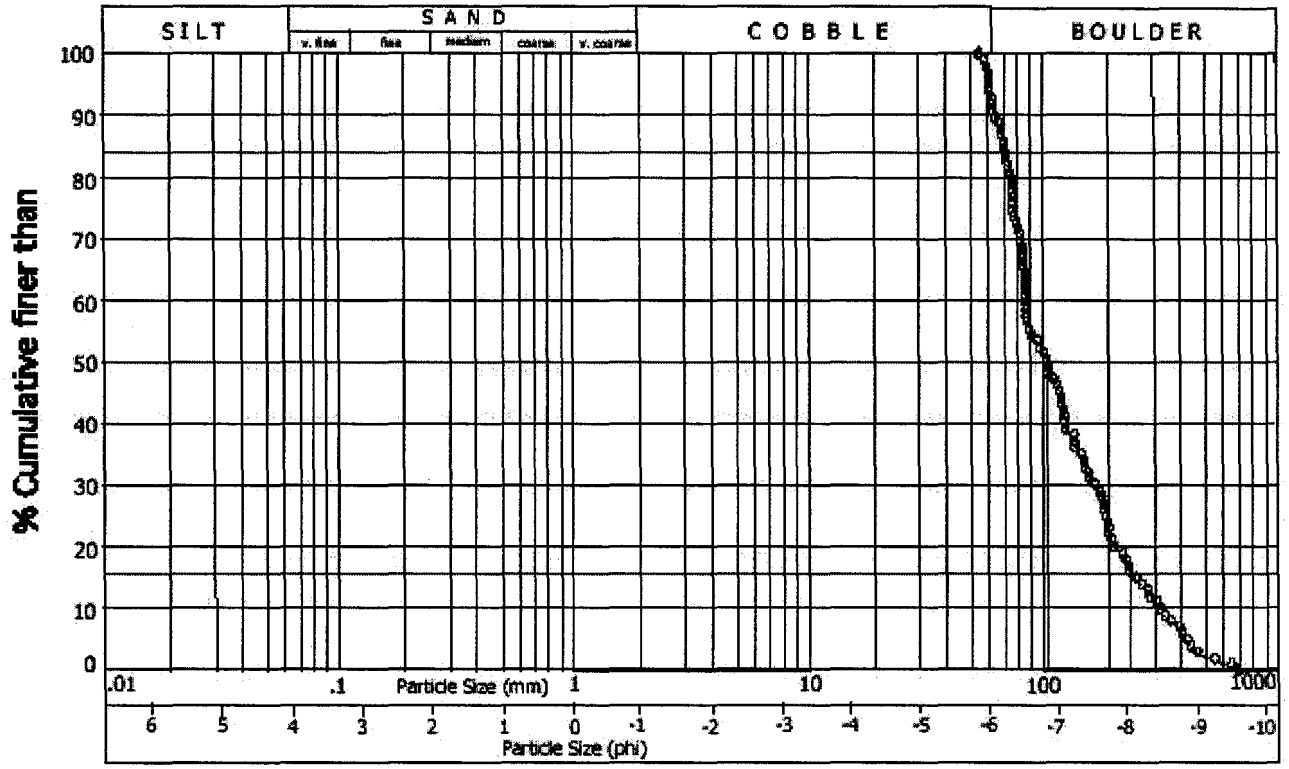
LOCALITY Leepers Reference Reach (Alba Mill Downstream Site)  
 SITE Leepers Sample Riffle # 4

$D_{84(min)}$  71 mm       $D_{50}$  100 mm       $D_{84(max)}$  260 mm

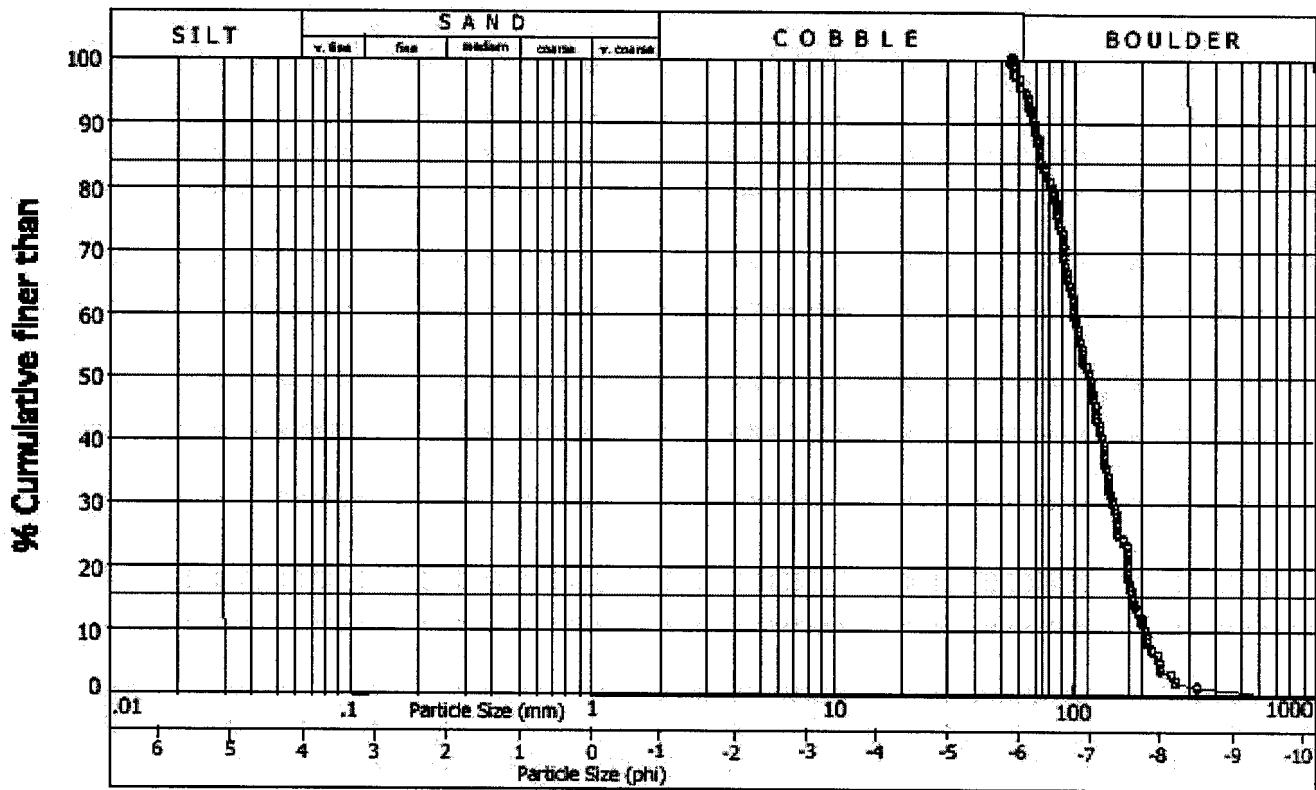
SITE Leepers Sample Riffle # 5

LOCALITY Leepers Reference Reach (Alba Mill Downstream Site)

$D_{84}(\min)$  77 mm

$D_{50}$  110 mm
