**IRWIN CREEK**

**STREAM RESTORATION**

**60% CONCEPTUAL DESIGN**

**MECKLENBURG COUNTY,  
NORTH CAROLINA**

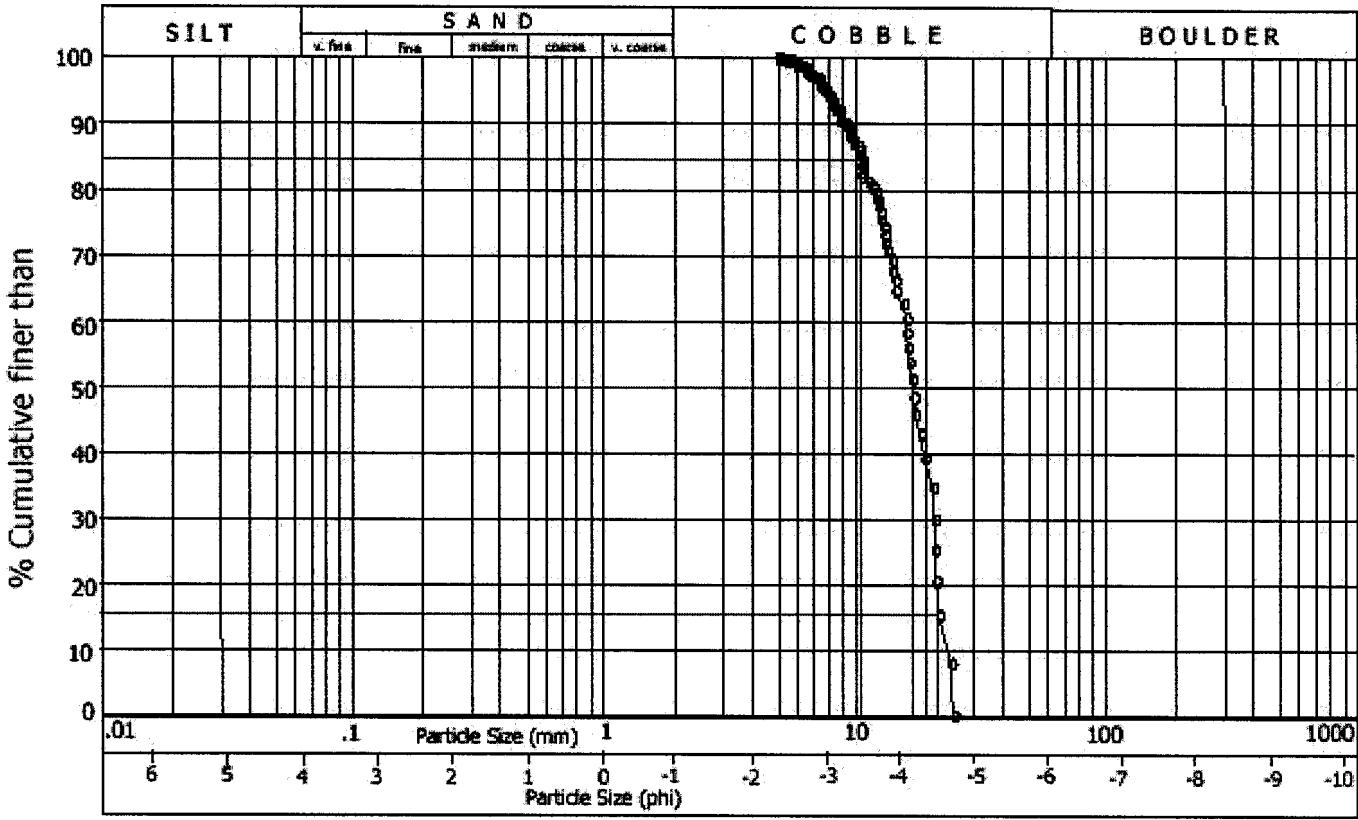
LOCALITY Irwin Creek Sandbar Armor  
 SITE SB-1-A

$D_{84(min)}$  10 mm                       $D_{50}$  18 mm                       $D_{84(max)}$  21 mm

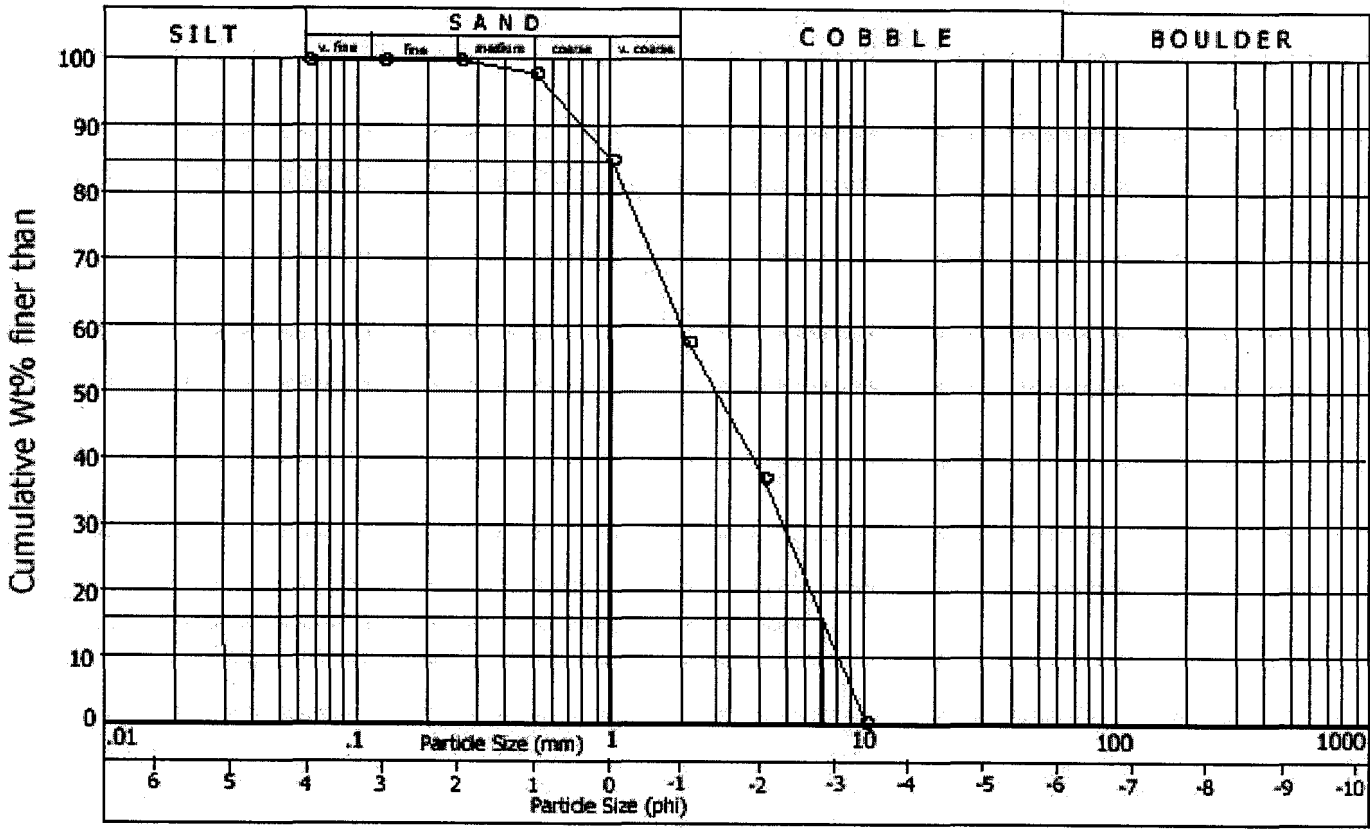
LOCALITY Irwin Creek Sandbar  
 SITE SB-1-B

$D_{84(\min)}$  1 mm                       $D_{50}$  2.6 mm                       $D_{84(\max)}$  5 mm

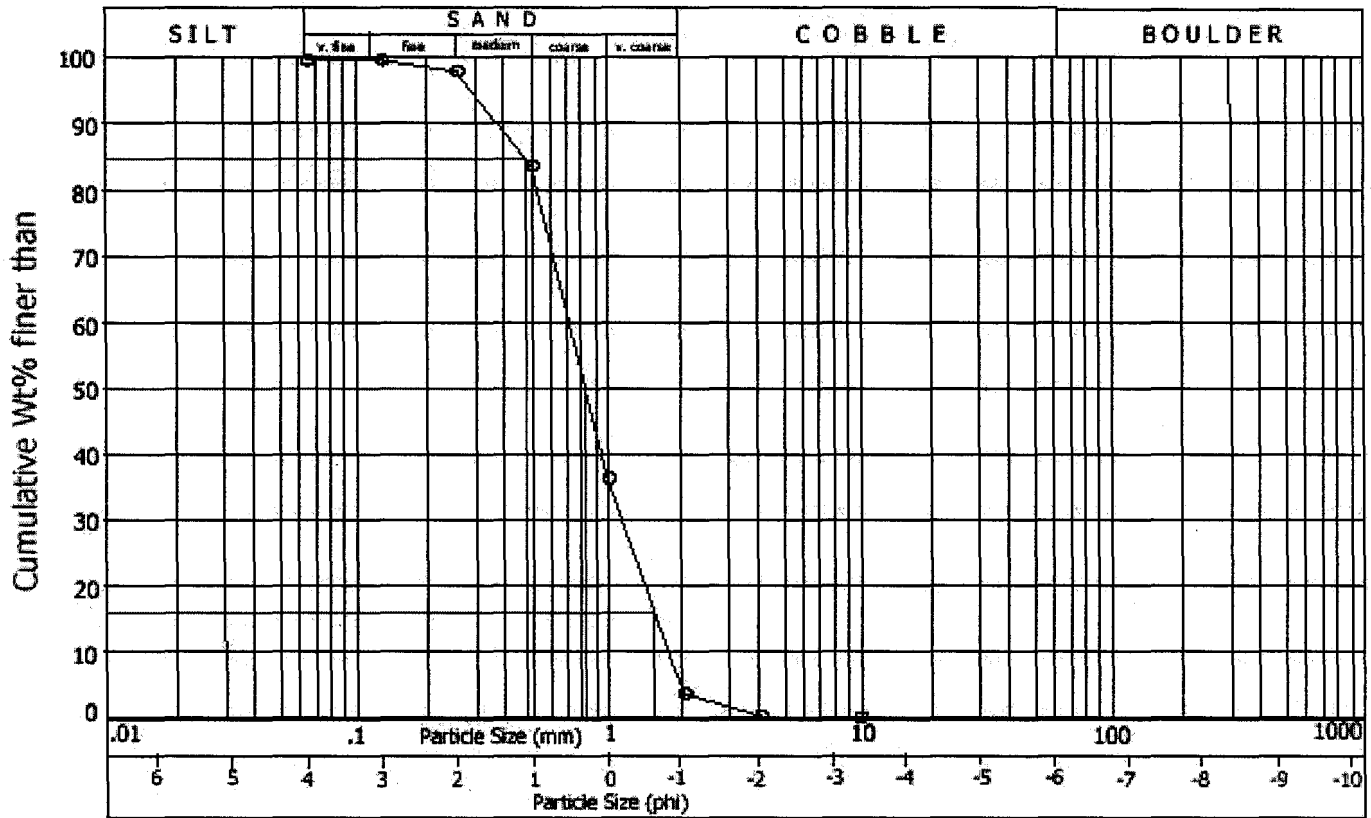
LOCALITY Irwin Creek Sandbar  
 SITE SB-1-C

$D_{84(min)}$  0.48mm

$D_{50}$  0.8mm

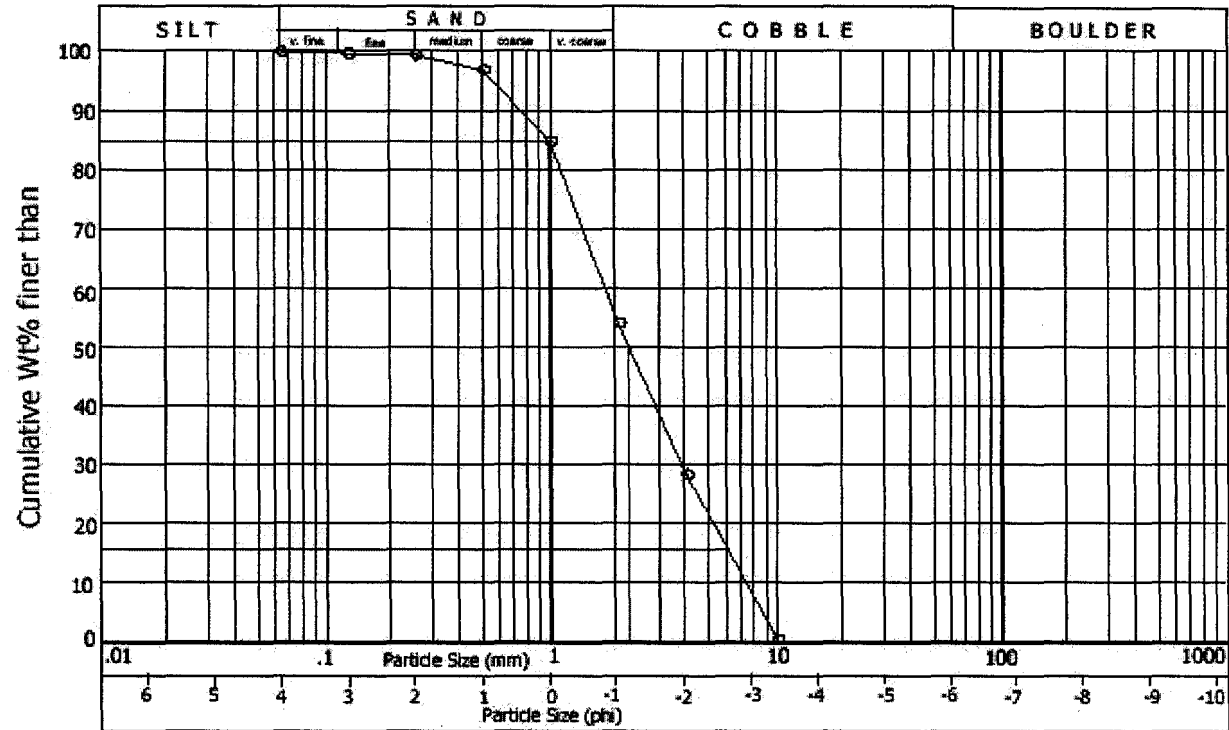
LOCALITY Irwin Creek Sandbar  
 SITE SB-2-A

$D_{84(min)}$  1.0 mm

Substrate  $D_{50}$  2.1 mm

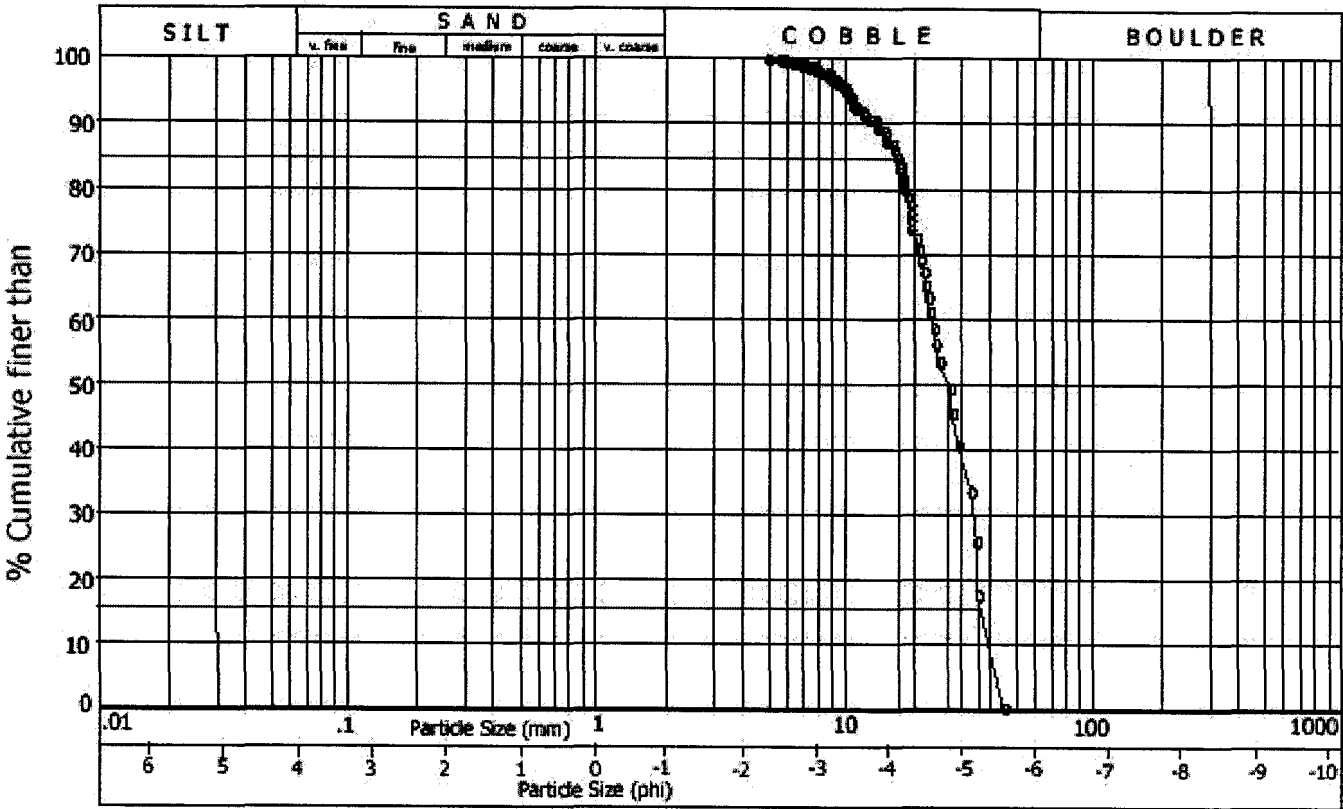
LOCALITY Irwin Creek Lateral Bar Armor  
 SITE SB-2-A

$D_{84(mm)}$  17 mm

$D_{50}$  27 mm

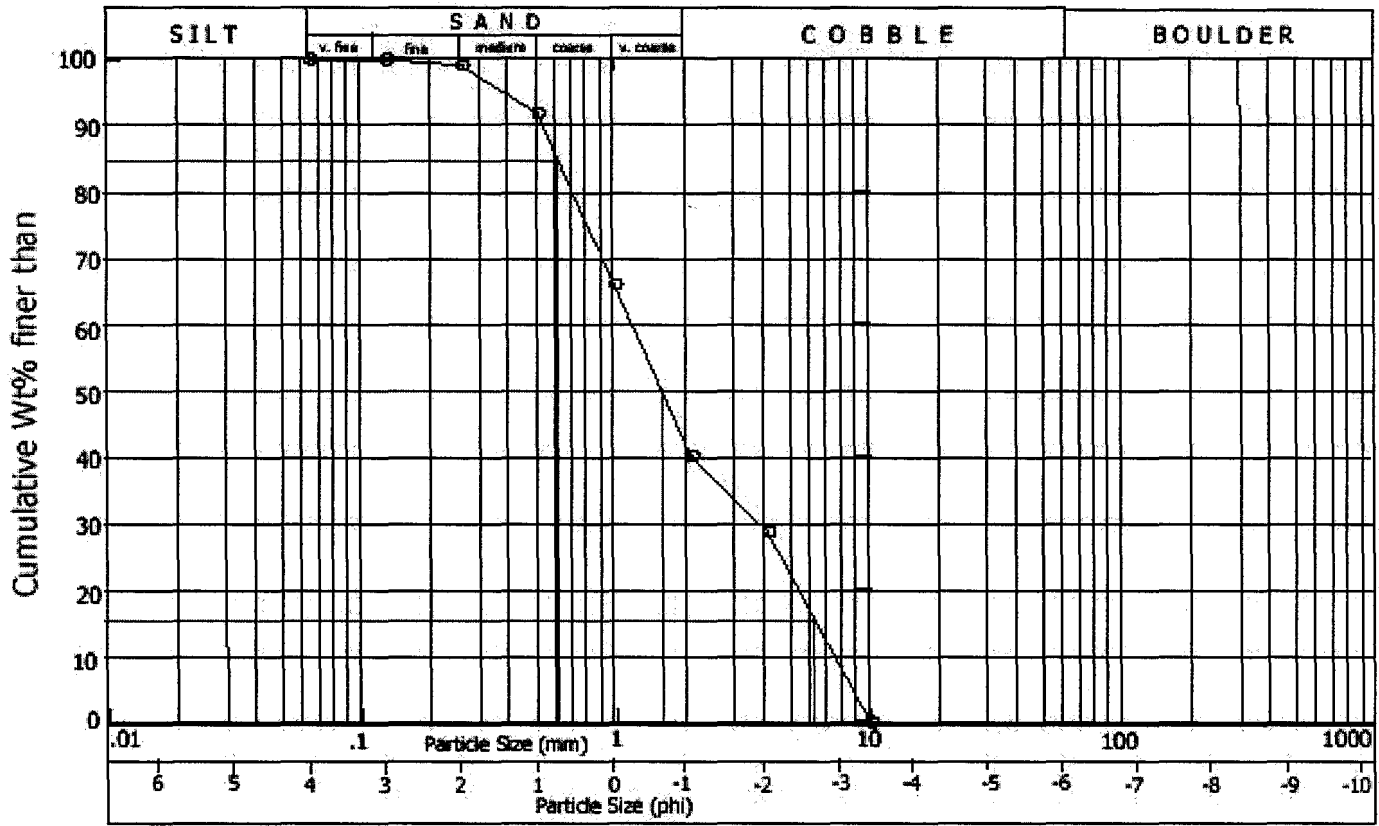
LOCALITY Irwin Creek Sandbar  
 SITE SB-2-B

$D_{84(min)}$  0.6 mm

$D_{50}$  1.7 mm

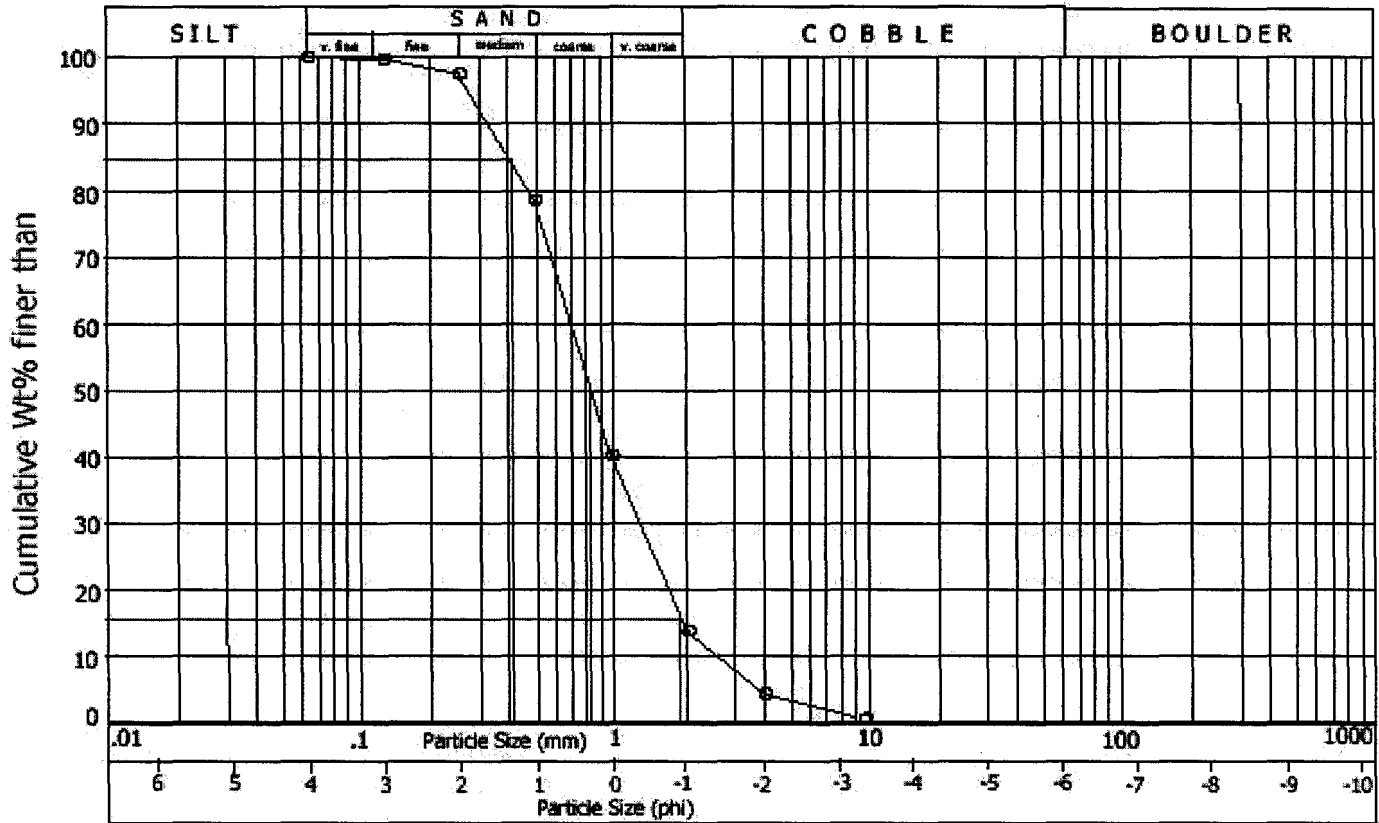
LOCALITY Irwin Creek Sandbar  
 SITE SB-2-C

$D_{84(min)}$  0.4 mm

$D_{50}$  0.81 mm

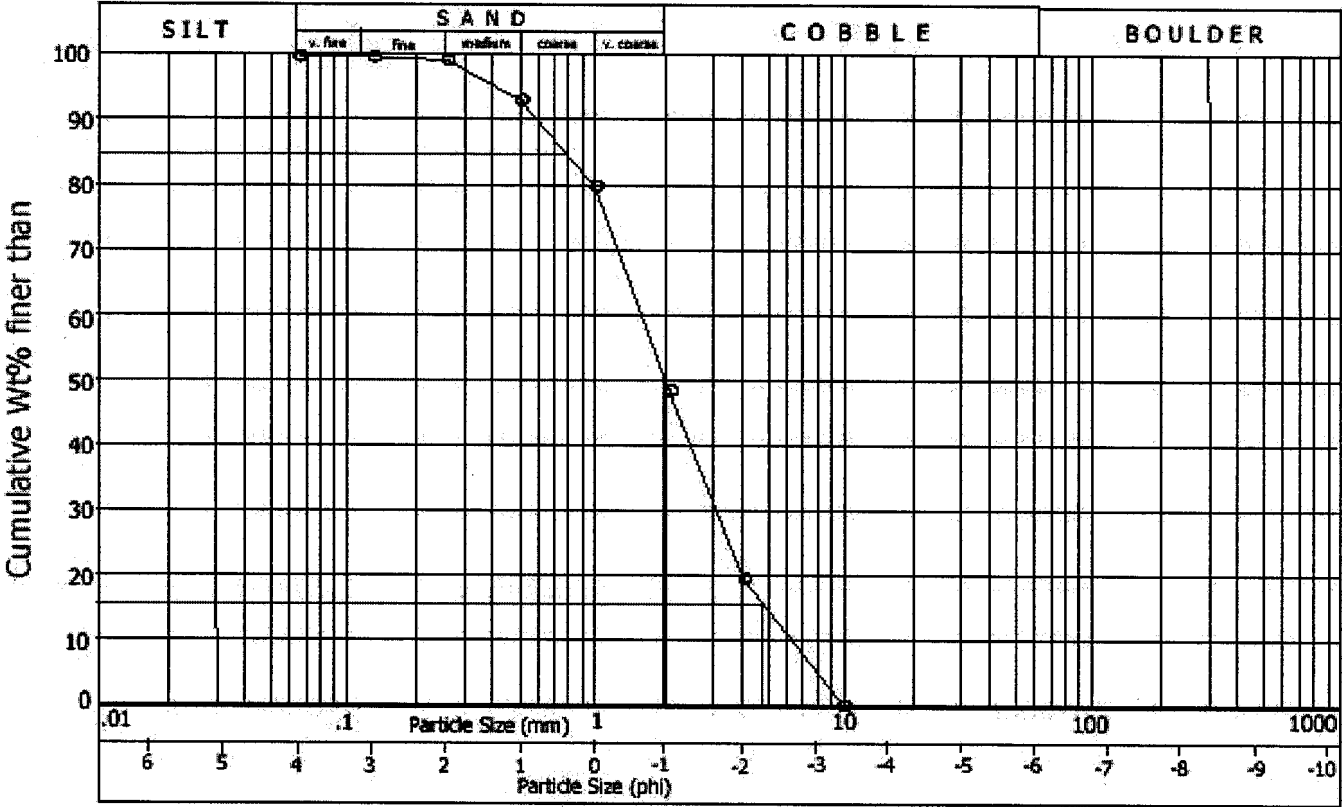
LOCALITY Irwin Creek Lateral Bar  
 SITE LB-1-A

$D_{84(min)}$  0.8 mm

$D_{50}$  2.0 mm

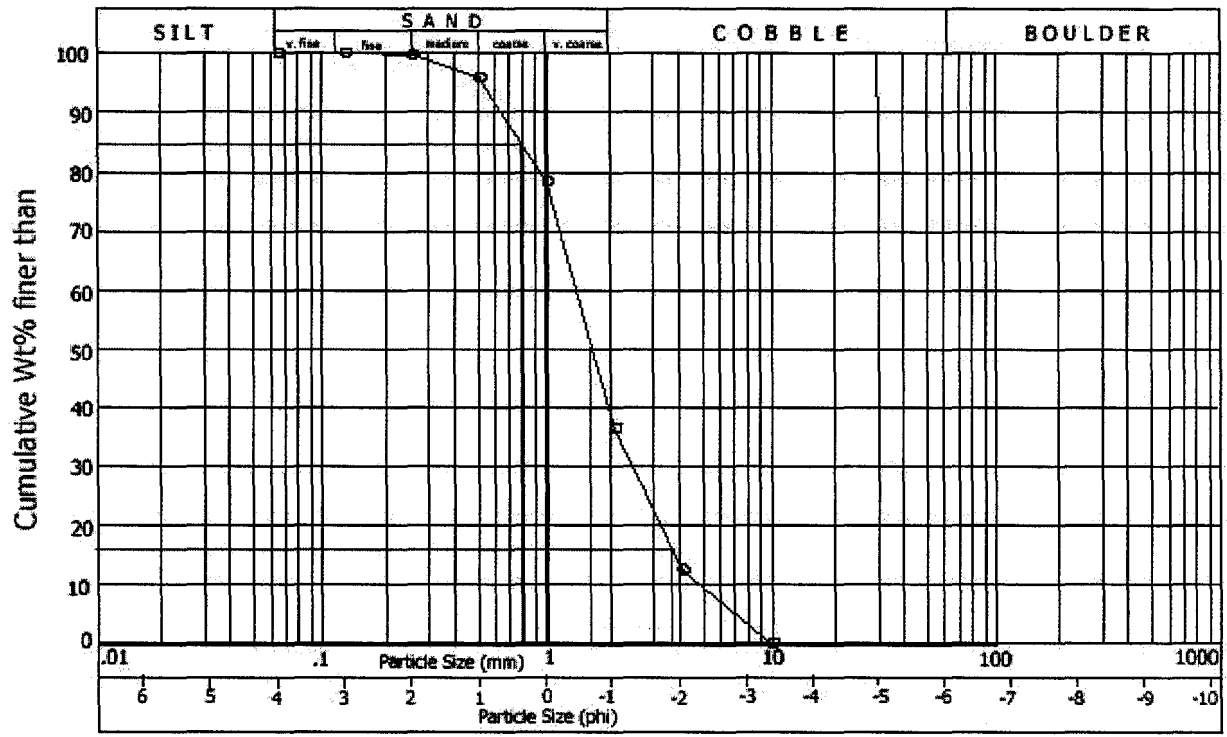
LOCALITY Irwin Creek Lateral Bar  
 SITE LB-1-B

$D_{84(\min)}$  0.8 mm      Substrate  $D_{50}$  1.6 mm       $D_{84(\max)}$  3.8 mm  
 Armor  $D_{50}$  9.2 mm

Integrated Armor & Substrate D50 Calculation  
 Armor/Substrate =  $1/266.67 = 0.375$   
 Integrated D50 = Substrate D50 (1.6) (0.625) + Armor D50 (9.2) (0.375) = 4.45mm

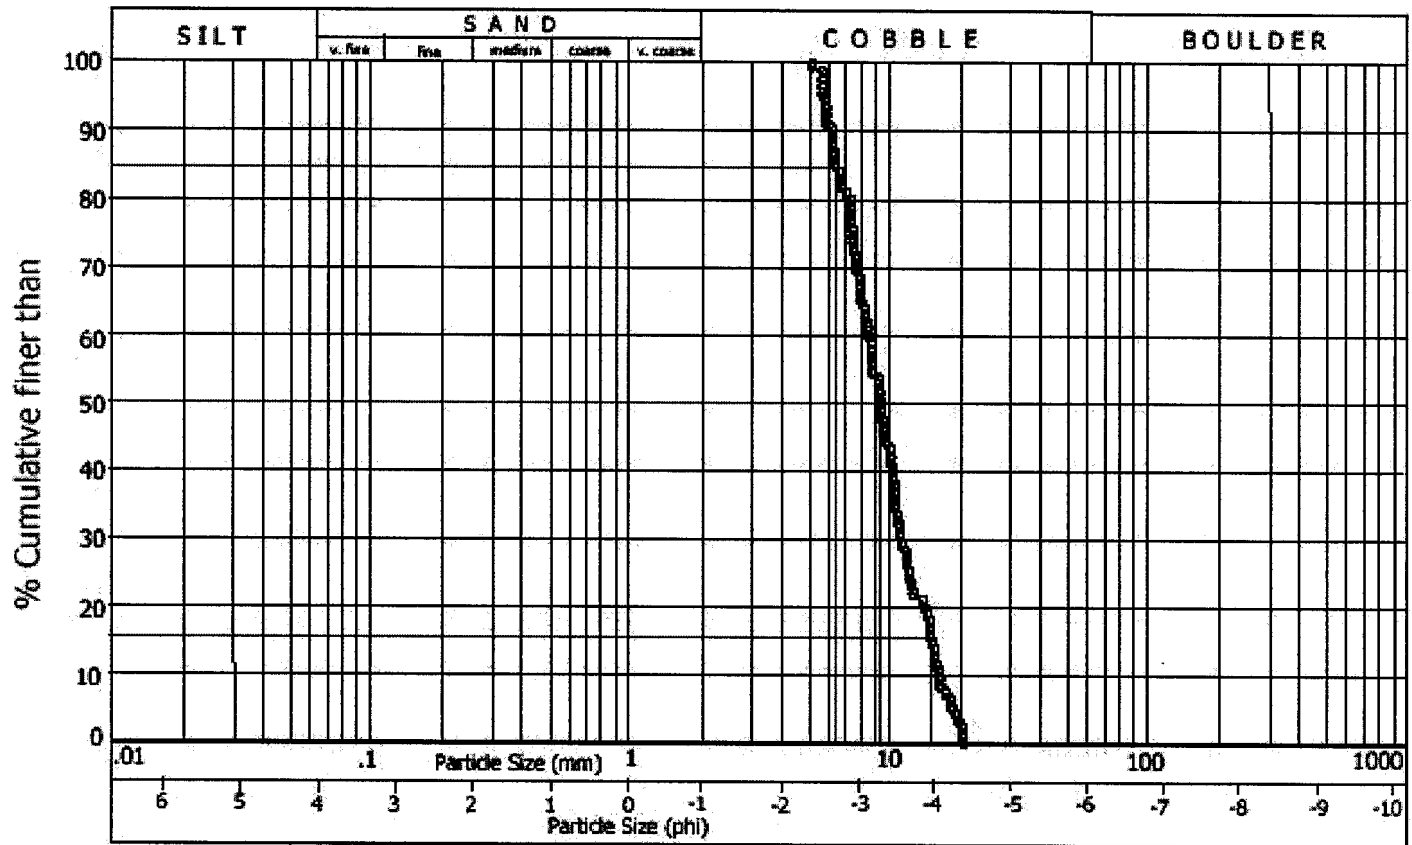
SITE LB-1-B

LOCALITY Irwin Creek Lateral Bar Armor

$D_{84(\min)}$  6.2 mm

$D_{50}$  9.2 mm

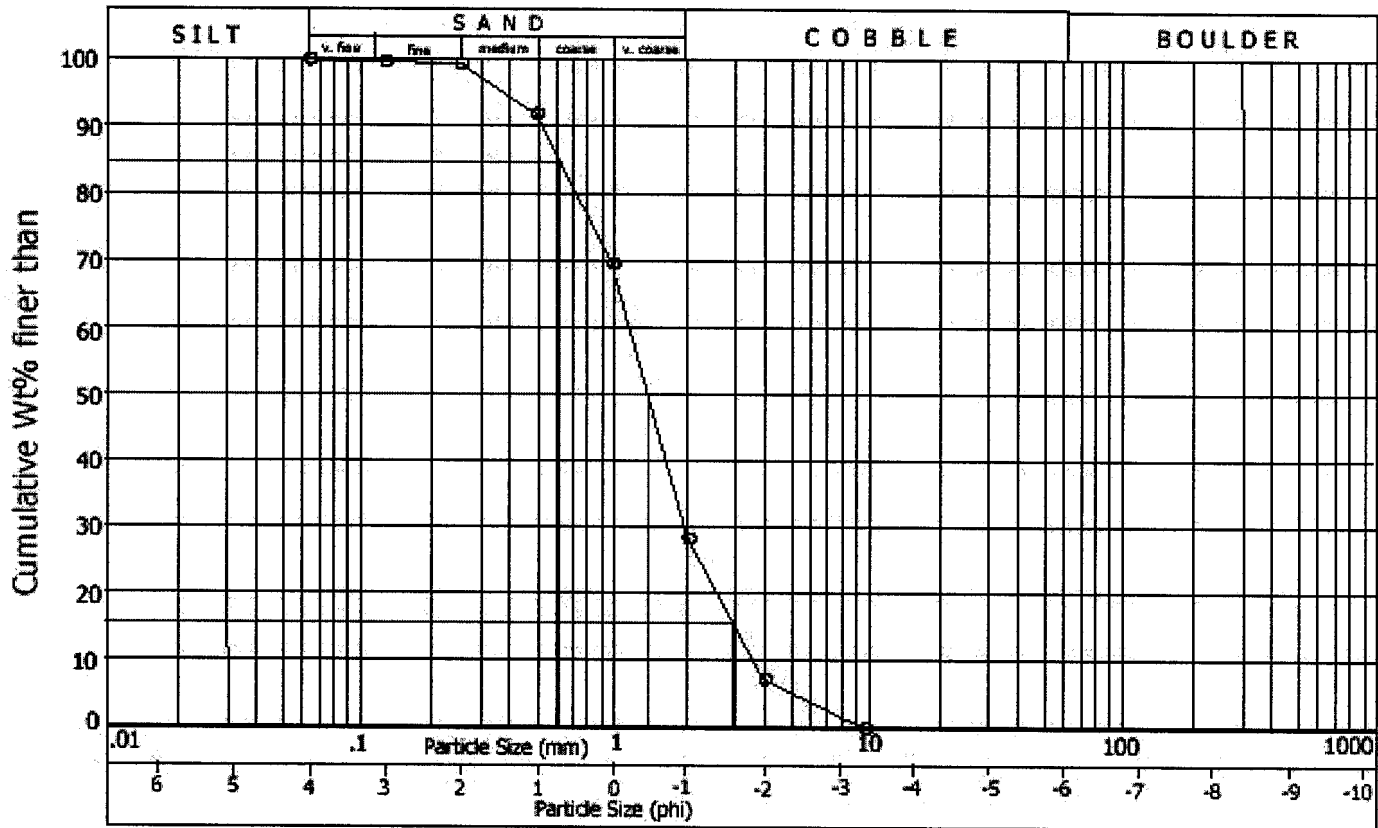
LOCALITY Irwin Creek Lateral Bar  
 SITE LB-1-C

$D_{84(min)}$  0.61 mm

$D_{50}$  1.2 mm

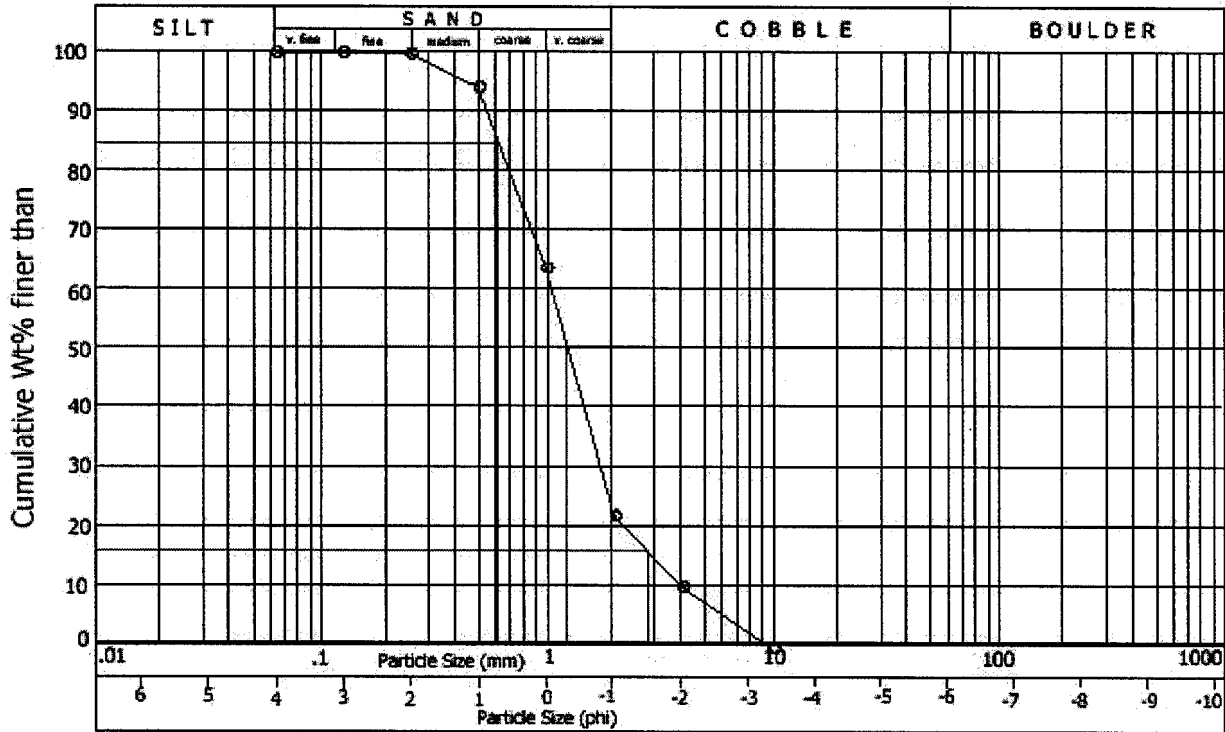
LOCALITY Irwin Creek Lateral Bar  
 SITE LB-2-A

$D_{84(\min)}$  0.6 mm      Substrate  $D_{50}$  1.1 mm       $D_{84(\max)}$  2.8 mm  
 Armor  $D_{50}$  13.0 mm

Integrated Armor & Substrate D50 Calculation  
 Armor/Substrate =  $1/1.24 = 0.806$   
 Integrated D50 = Substrate D50 (1.1)(0.194) + Armor D50 (13.0)(0.806) = 10.697mm

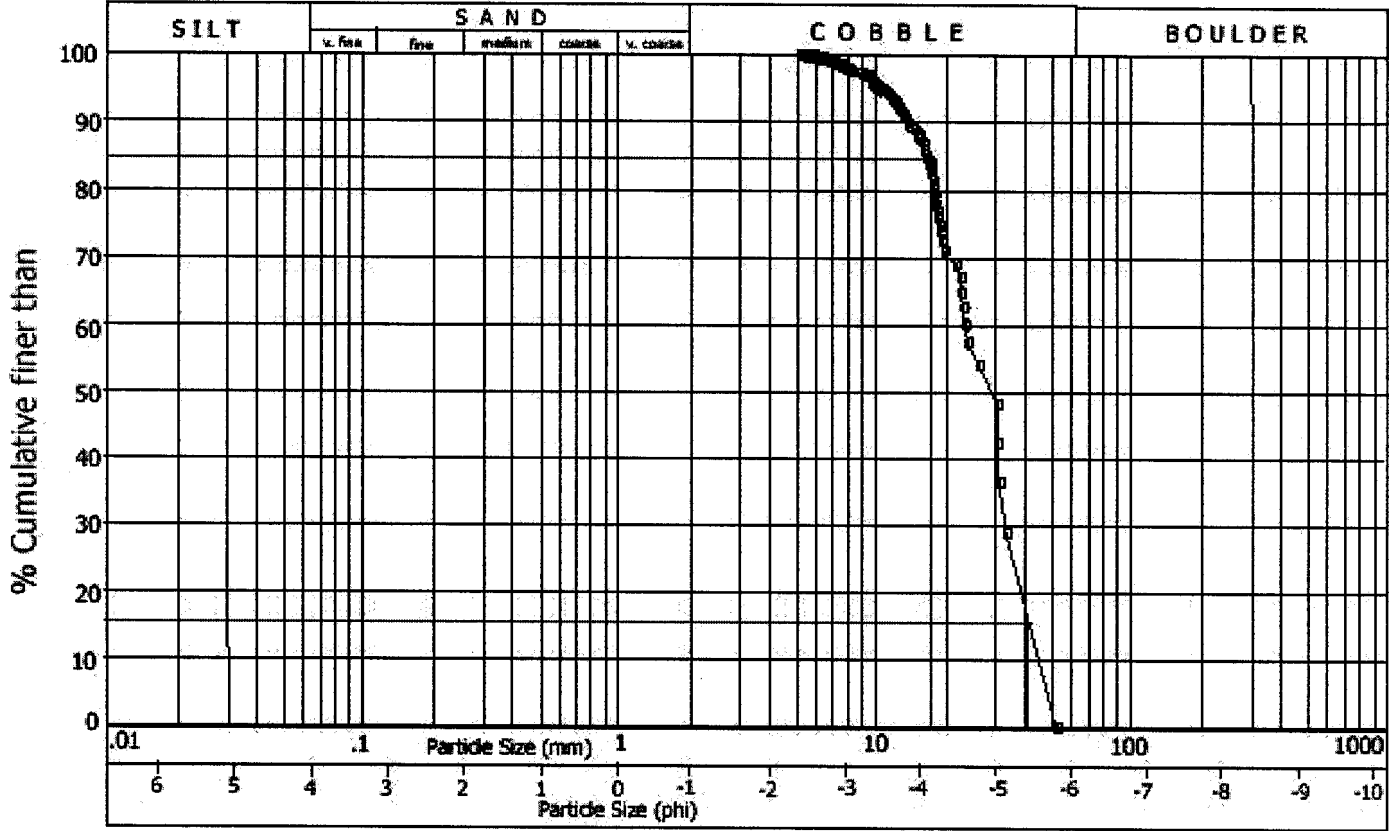
LOCALITY Irwin Creek Lateral Bar Armor  
 SITE LB-2-A

$D_{84(min)}$  17 mm

$D_{50}$  30 mm

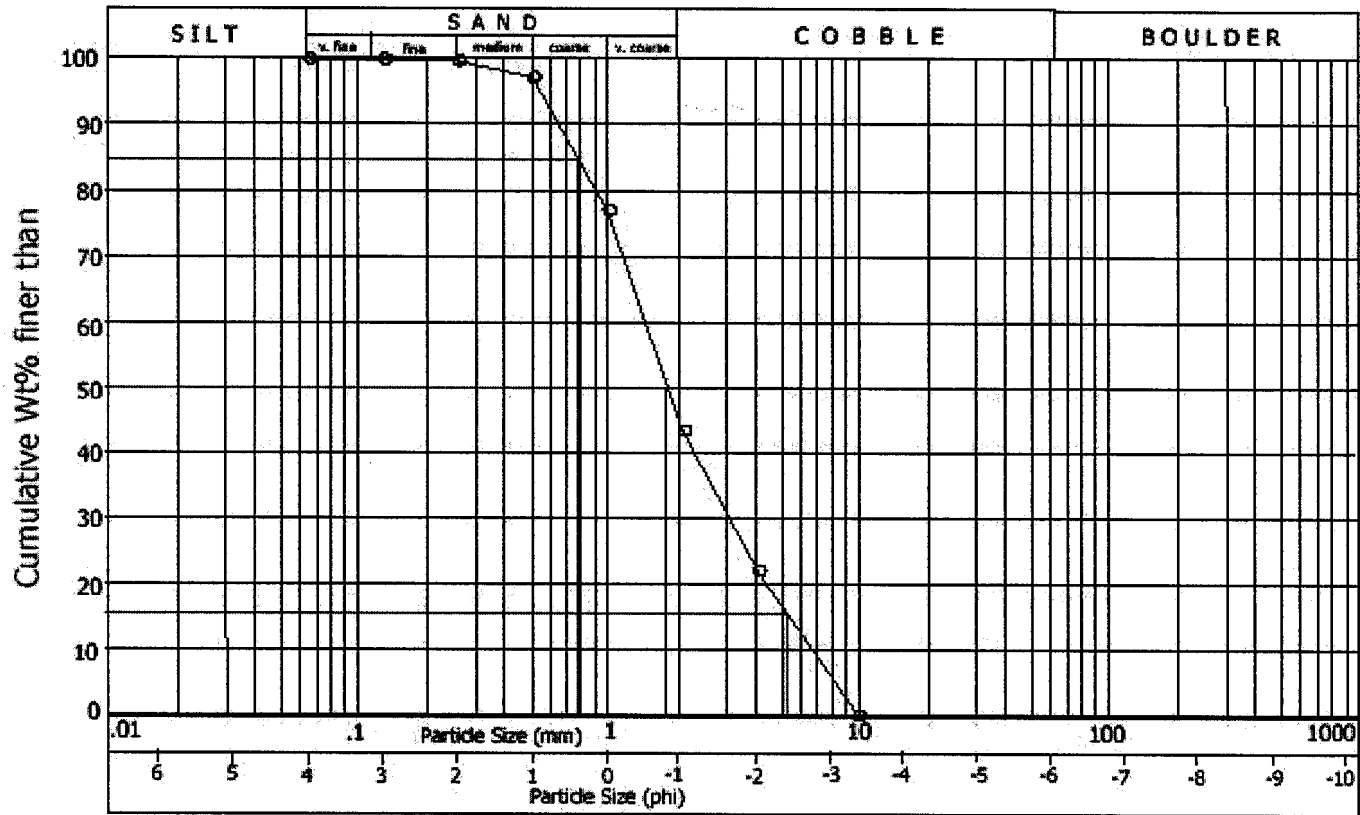
LOCALITY Irwin Creek Lateral Bar  
 SITE LB-2-B

$D_{84(min)}$  0.79 mm

$D_{50}$  1.8 mm

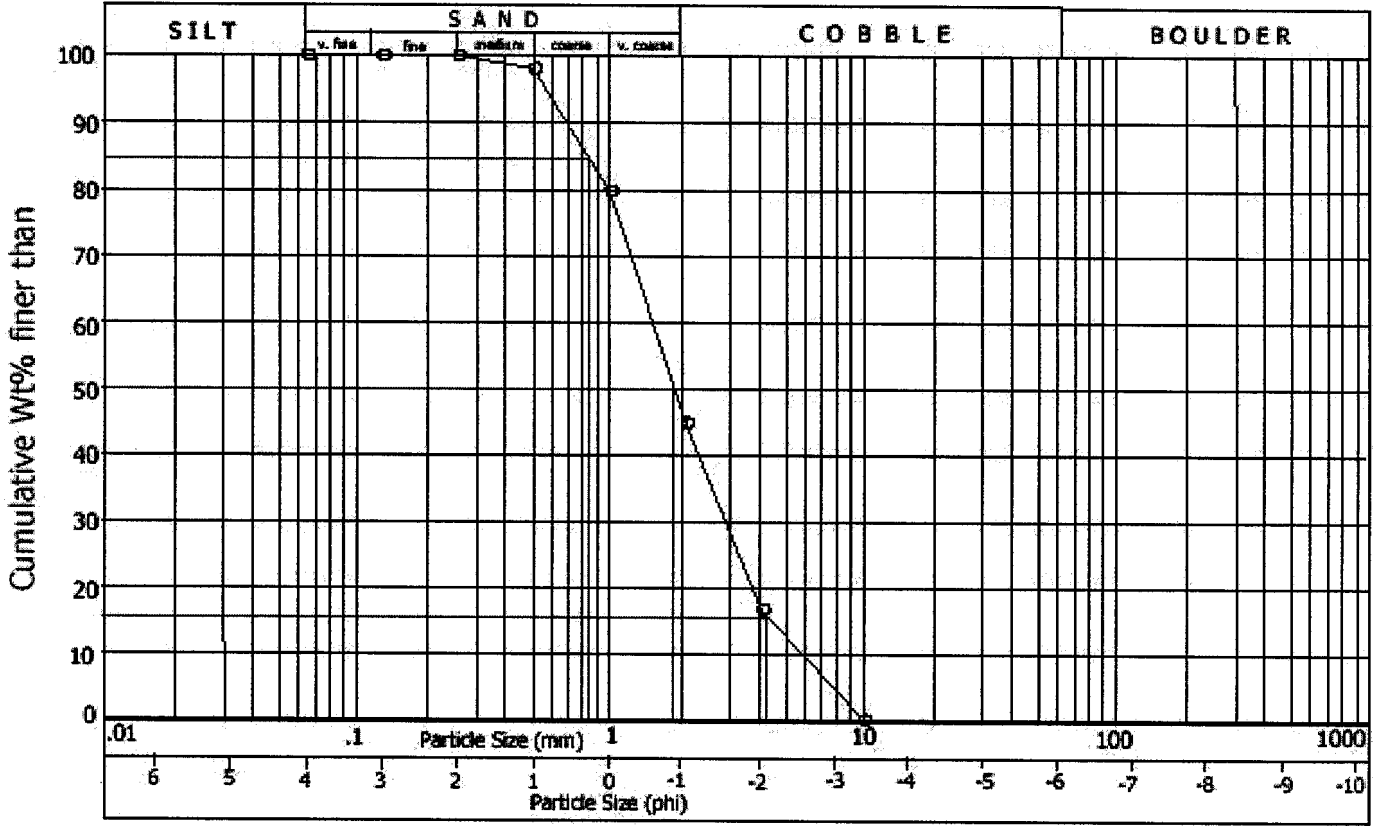
LOCALITY Irwin Creek Lateral Bar  
 SITE LB-2-C

$D_{84(min)}$  0.83 mm

$D_{50}$  1.9 mm

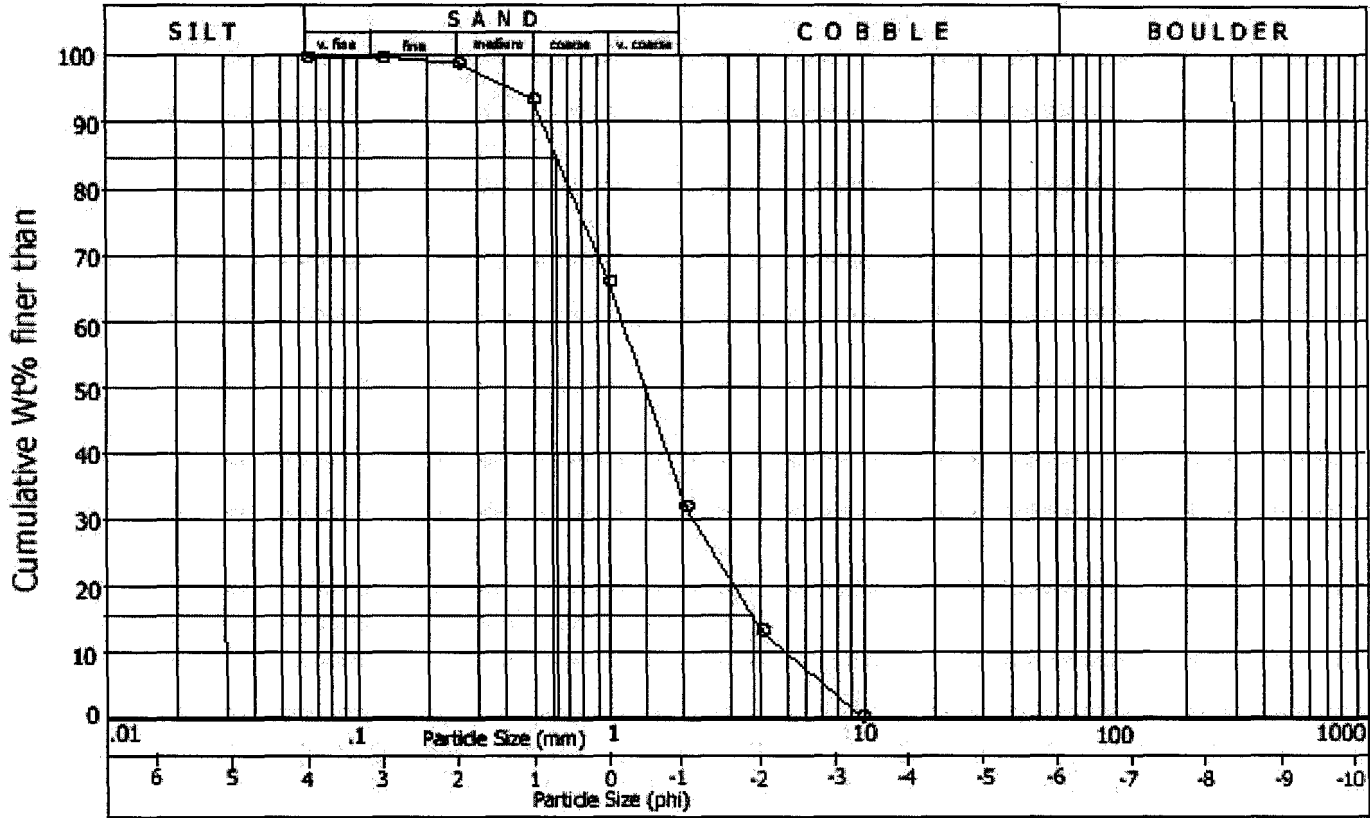
LOCALITY Leepers Creek Point Bar  
 SITE LC-1-A

$D_{84(min)}$  0.62 mm

$D_{50}$  1.2 mm

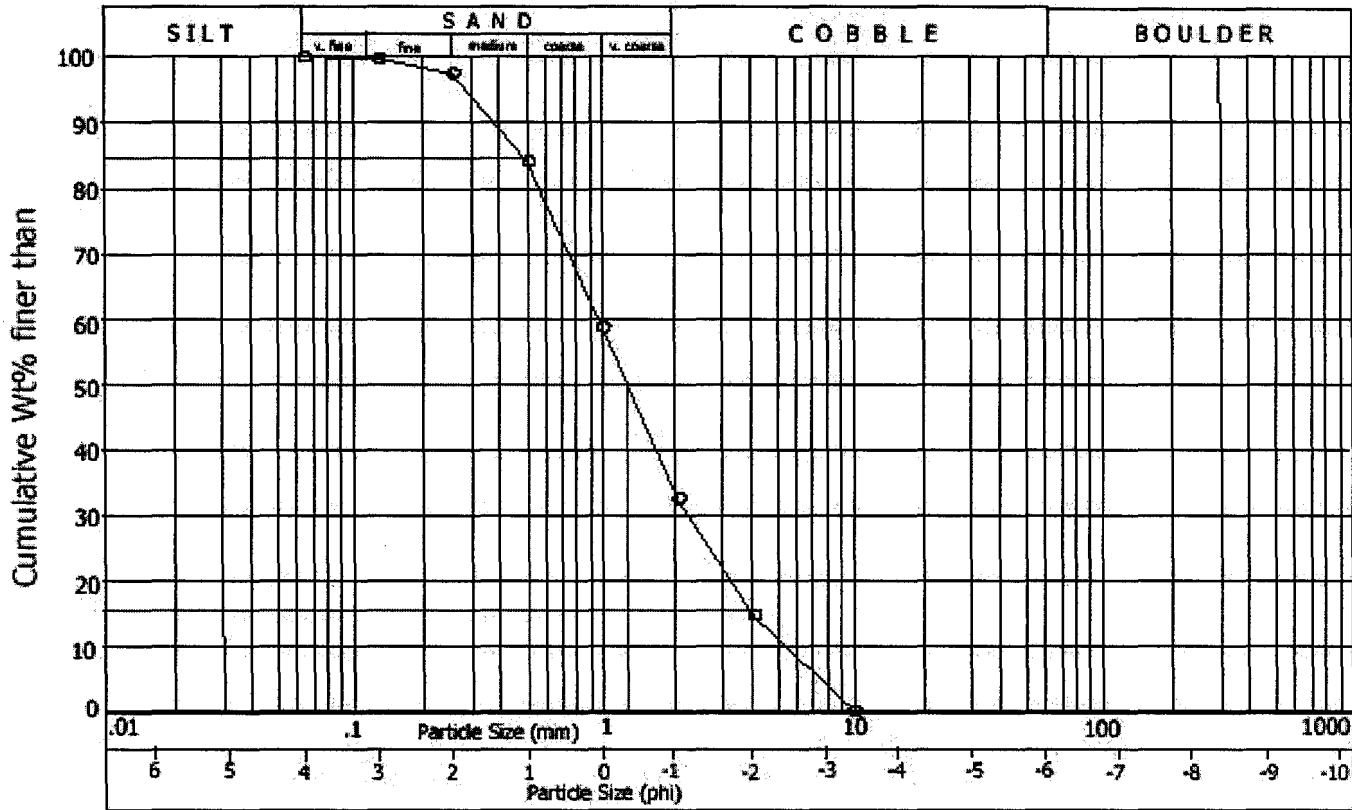
LOCALITY Leepers Creek Point Bar  
 SITE LC-1-B

$D_{84(min)}$  0.5 mm

$D_{50}$  1.1 mm

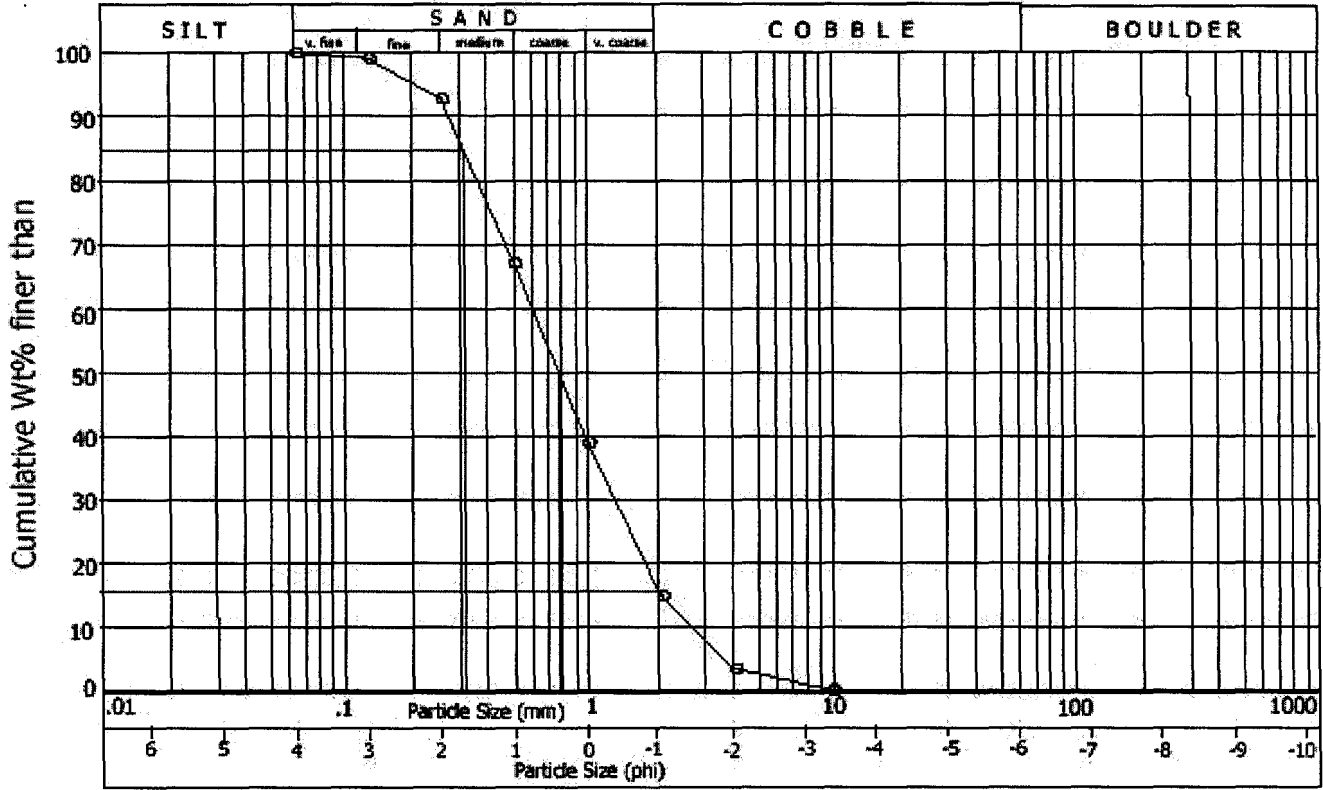
LOCALITY Leepers Creek Point Bar  
 SITE LC-1-C

$D_{84(min)}$  0.3 mm

$D_{50}$  0.75 mm

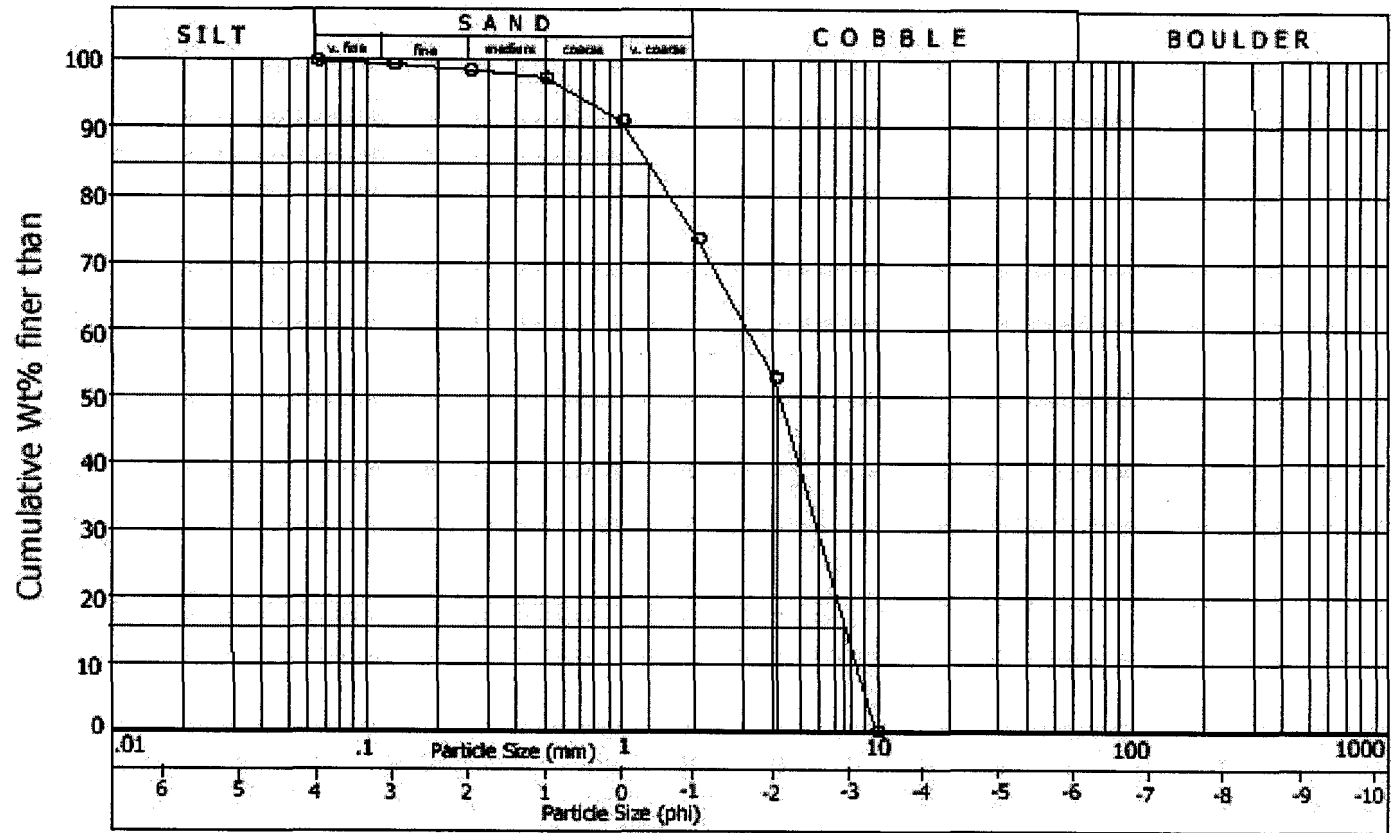
SITE LC-2-A

LOCALITY Leepers Creek Lateral Bar

$D_{84(\min)}$  1.2 mm

$D_{50}$  4.1 mm

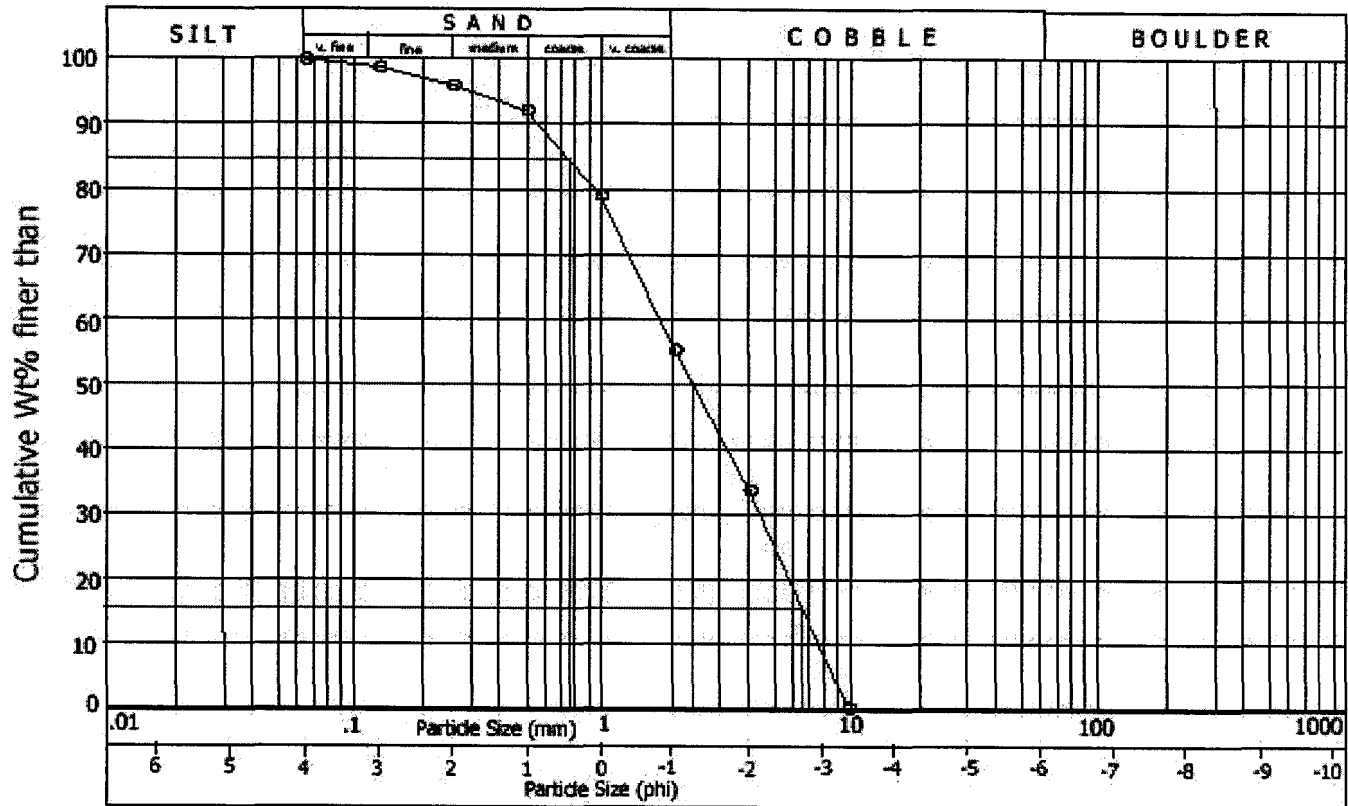
LOCALITY Leepers Creek Lateral Bar  
 SITE LC-2-B

$D_{84(min)}$  0.78 mm

$D_{50}$  2.2 mm
