**IRWIN CREEK**

**STREAM RESTORATION**

**60% CONCEPTUAL DESIGN**

**MECKLENBURG COUNTY,  
NORTH CAROLINA**

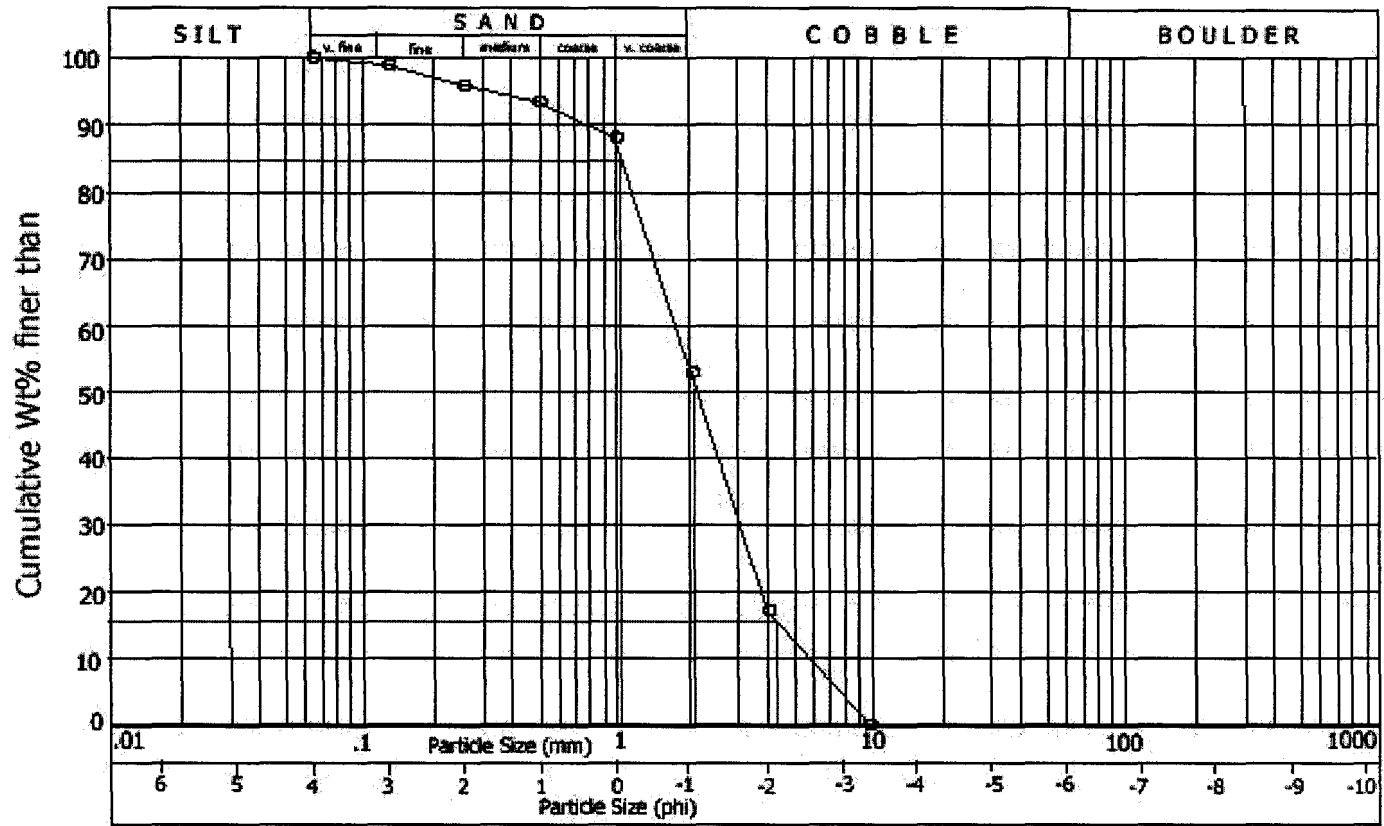
LOCALITY Leepers Creek Lateral Bar  
 SITE LC-2-C

$D_{84(\min)}$  1.0 mm

$D_{50}$  2.0 mm

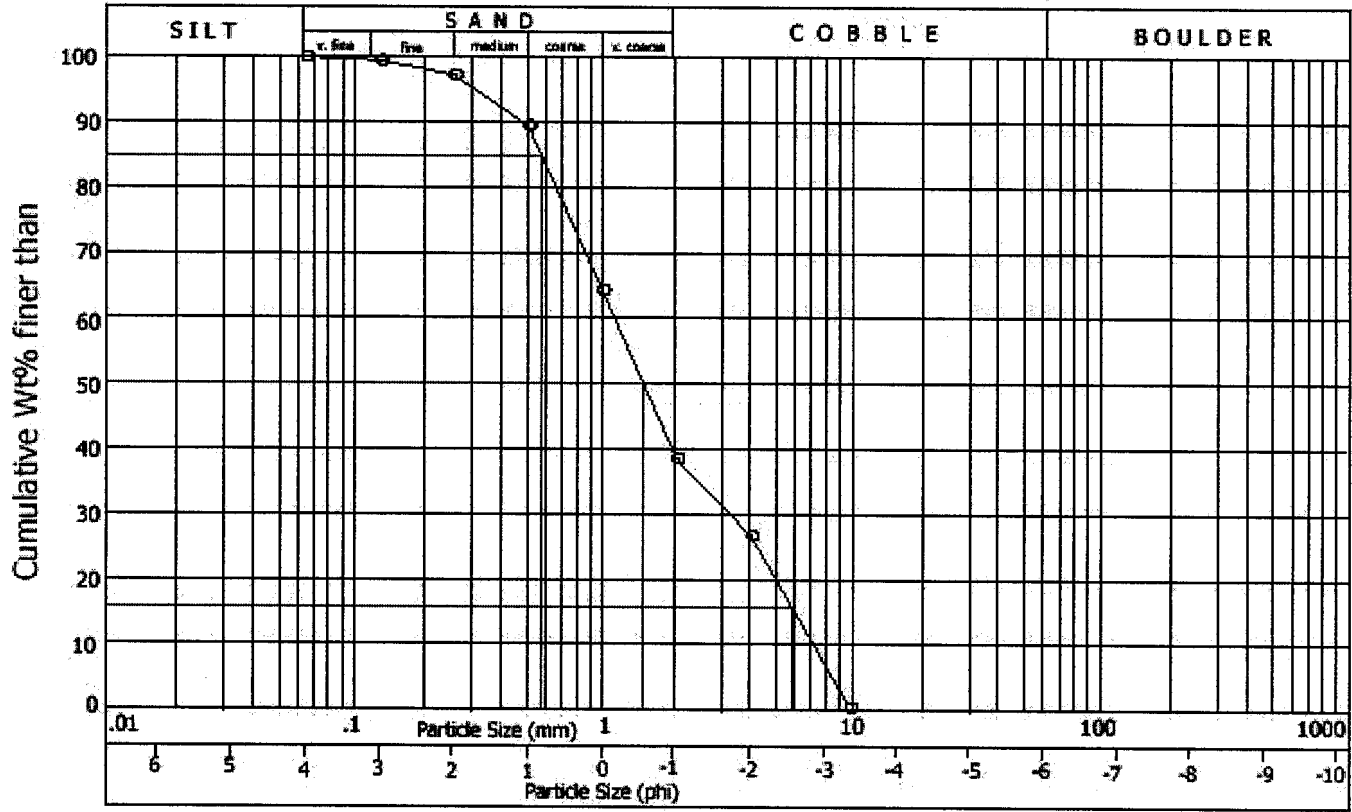
LOCALITY Leepers Creek Sand Bar  
 SITE LC-3-A

$D_{84(min)}$  0.58 mm

$D_{50}$  1.3 mm

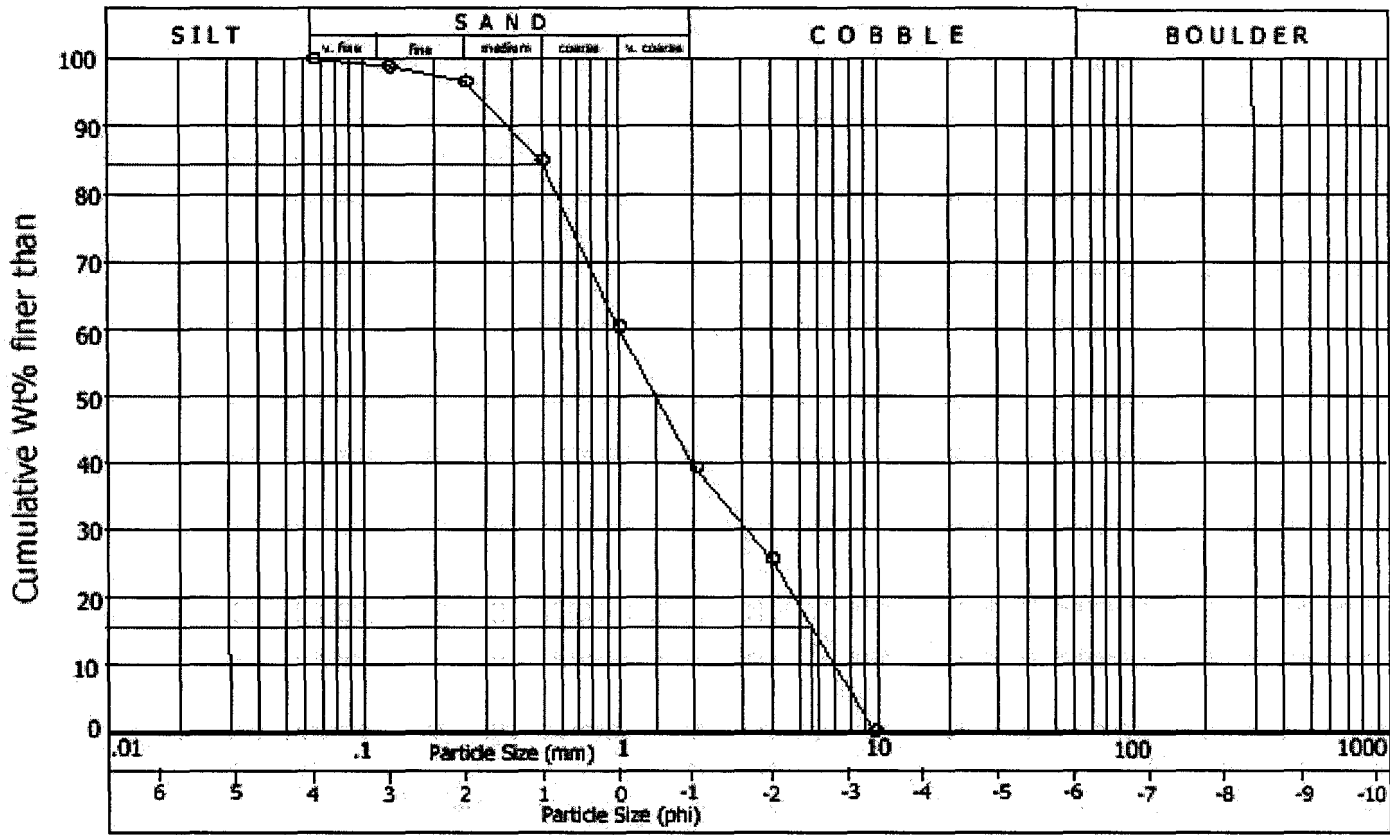
LOCALITY Leepers Creek Sandbar  
 SITE LC-3-B

$D_{84(min)}$  0.5 mm       $D_{50}$  1.2 mm       $D_{84(max)}$  5.7 mm

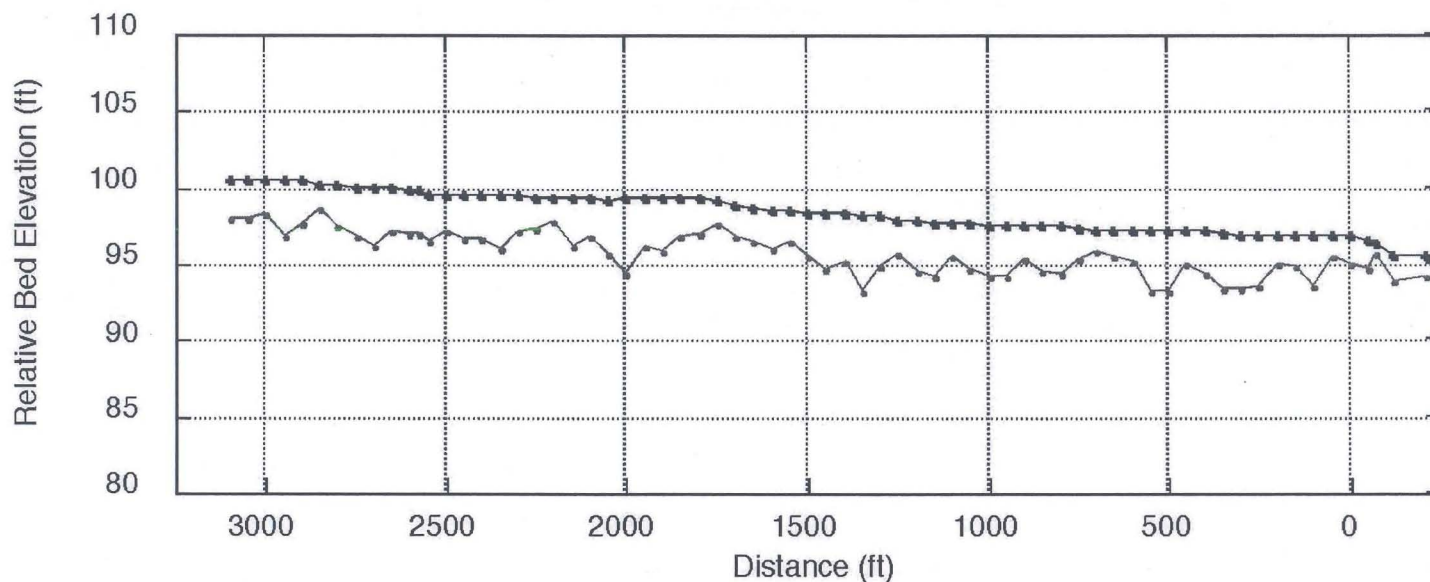
### Longitudinal Profile of Leepers Creek

Data collected using WAAS-enabled (2-3 meter) GPS and laser range finder (+/- 1 m) for horizontal positioning and Lasermark laser level (1/8" at 100') for vertical positions.

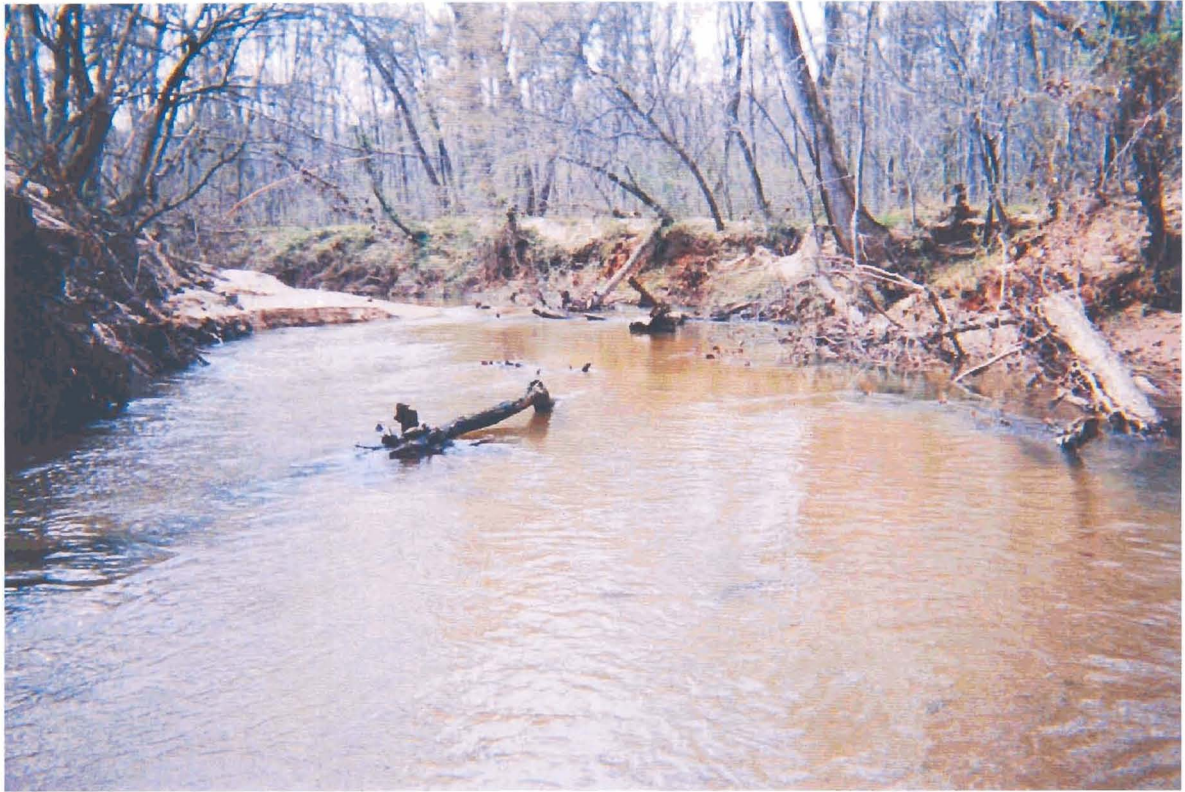
**Photo 1**

**Looking upstream from Leepers Creek cross-section two, a lower berm feature can be seen in the profile of the point bar along the inner bank of the meander.**

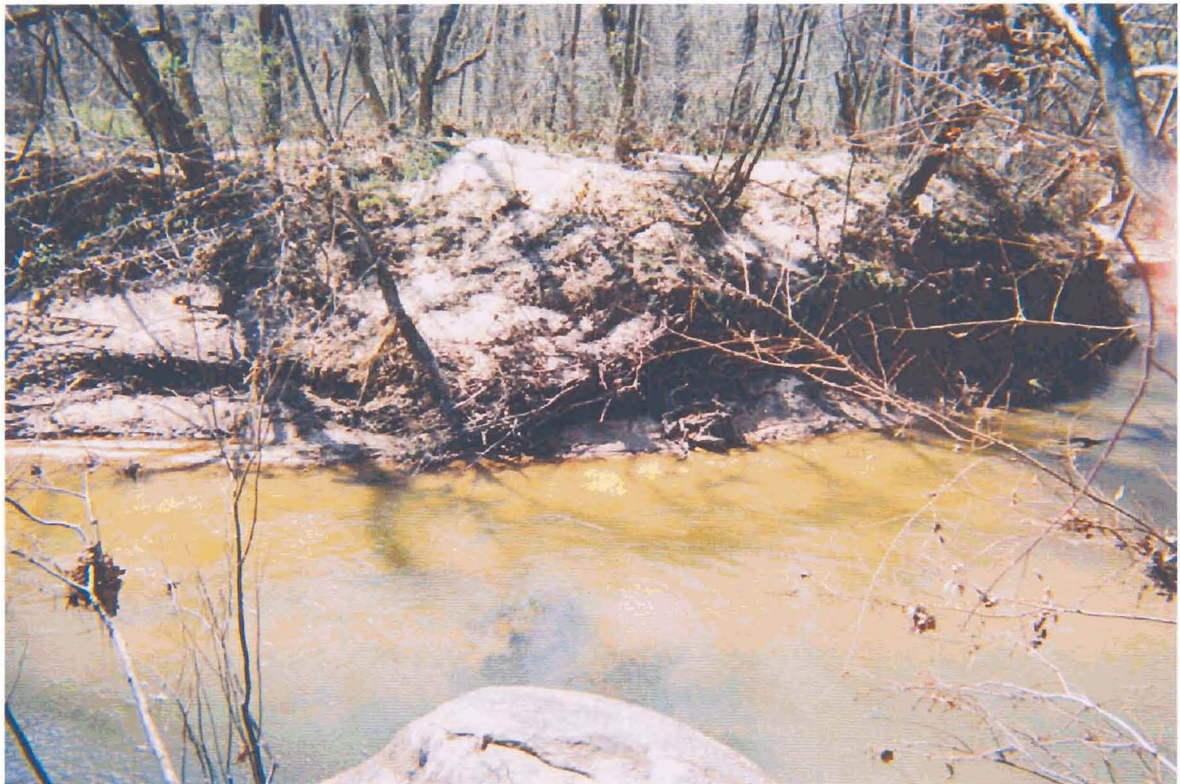
**Photo 2**

**A view of the right bank at Leepers Creek cross-section one. The creek flows around a meander from the top right and off to the left. A lower berm exists halfway up the bank here, as indicated by the topography.**

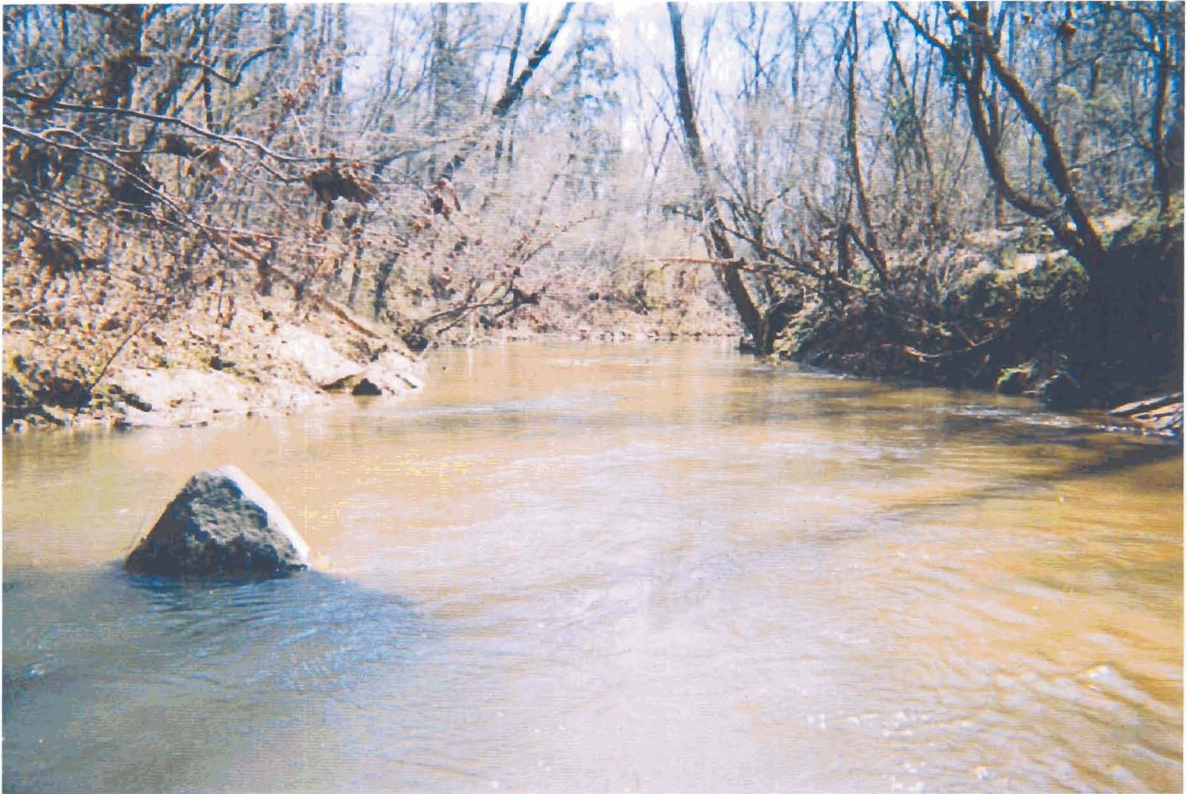
**Photo 3**

**An image downstream of Leepers Creek cross-section one. This image shows typical creek conditions for the reference reach.**

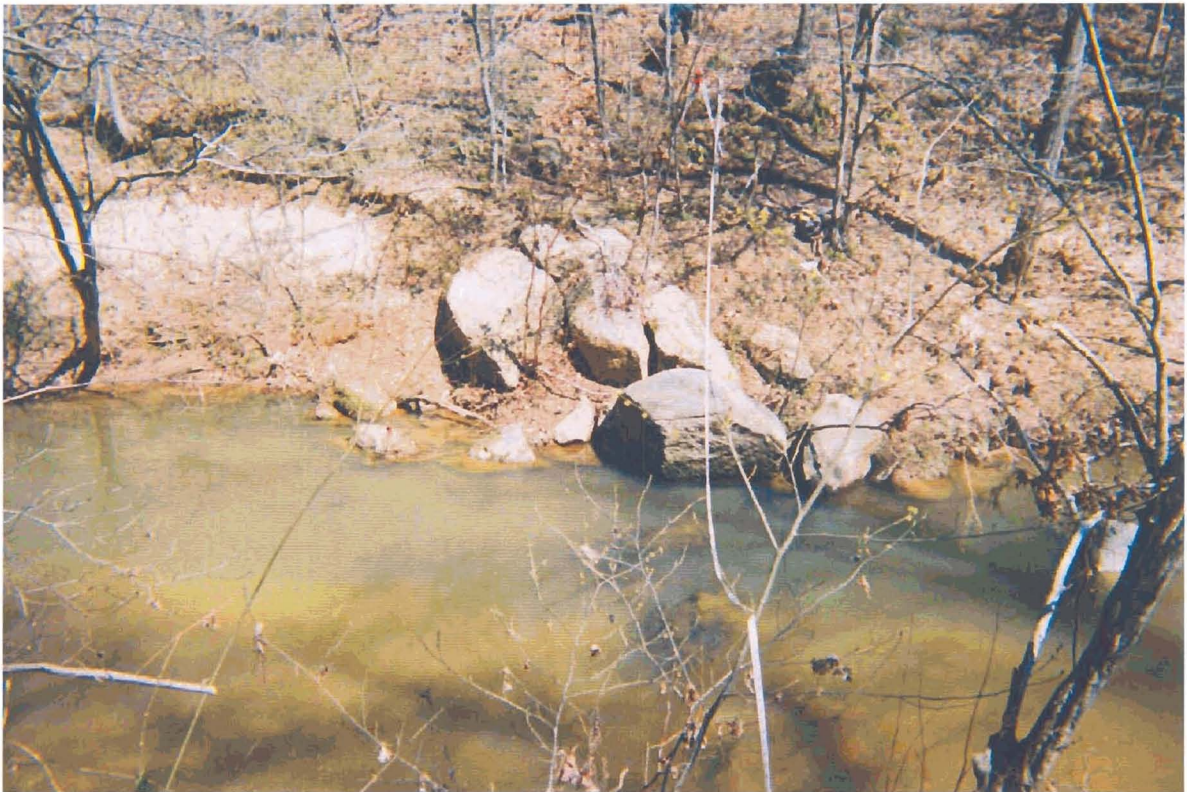
**Photo 4**

**A view of the left bank at Leepers Creek cross-section one. The creek flows around a meander from the left across the image and to the right. Here is an example of a typical bedrock outcrop, a feature which characterizes much of this stream.**

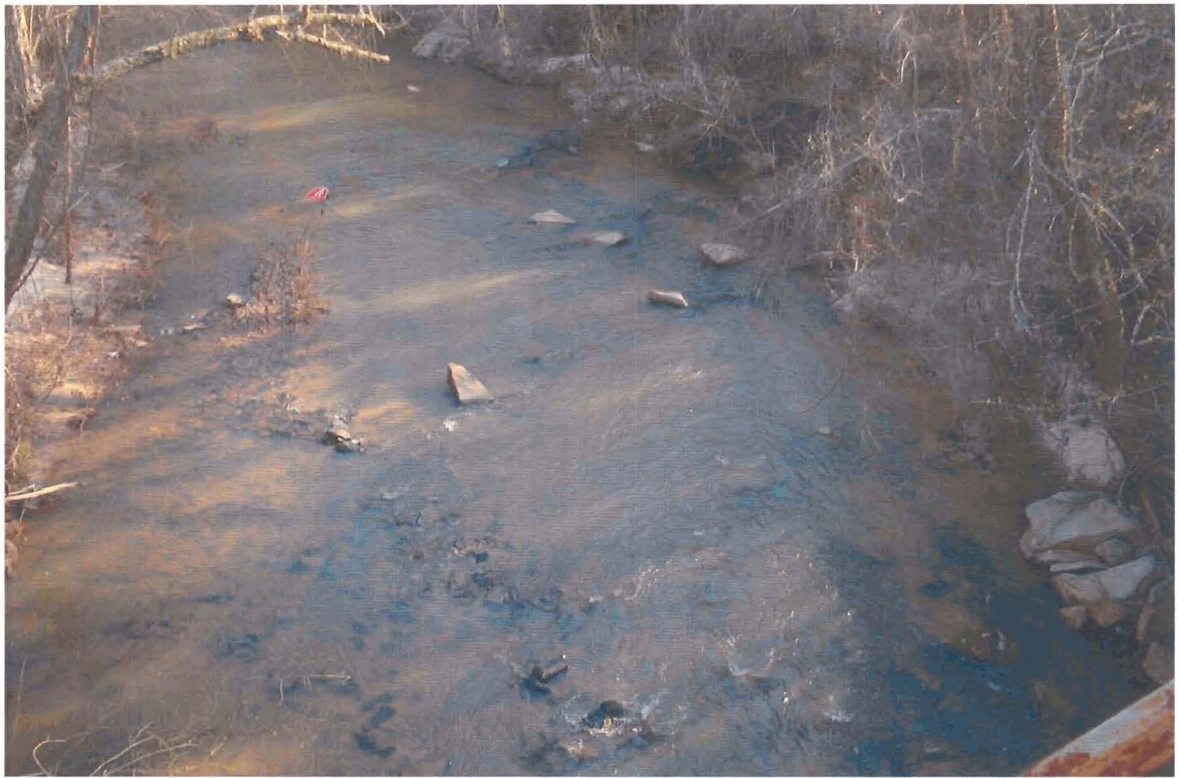
**Photo 6**

**A view of Leepers Creek downstream of the old Mariposa Rd. bridge. This section of Leepers is downstream of the reference reach and thus, has a much larger watershed. This riffle zone was found to have a mean D50 of 28 cm.**

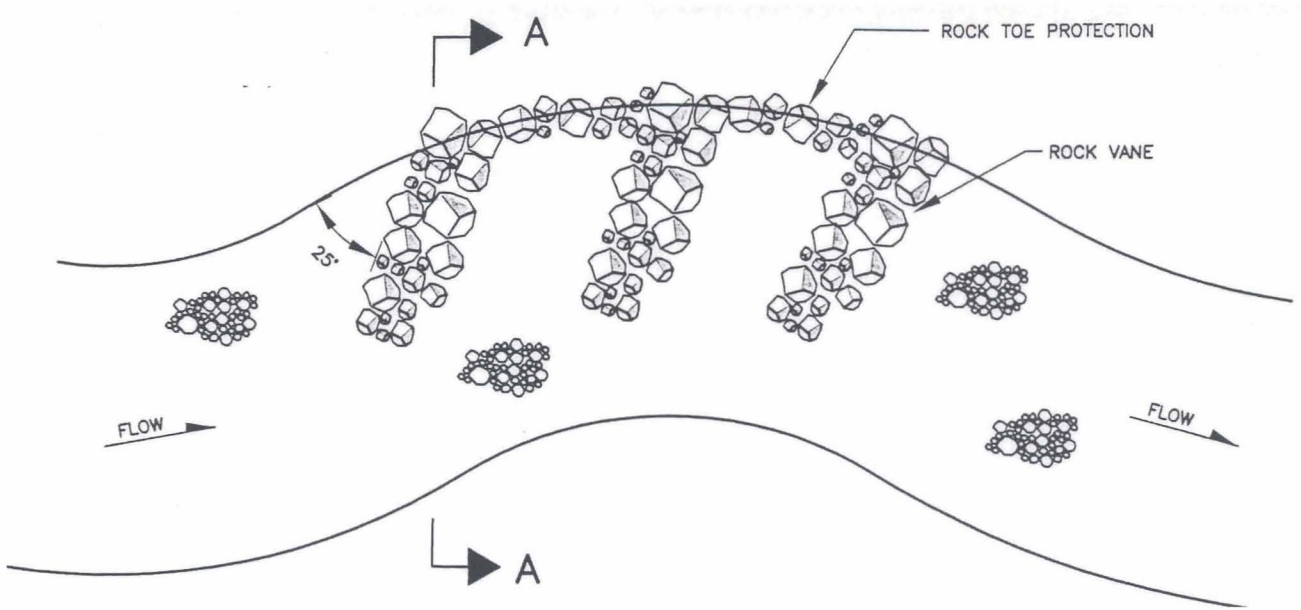
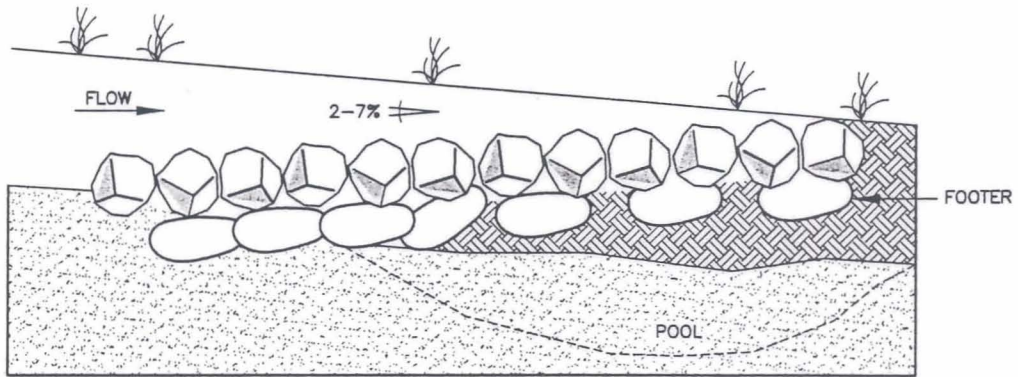
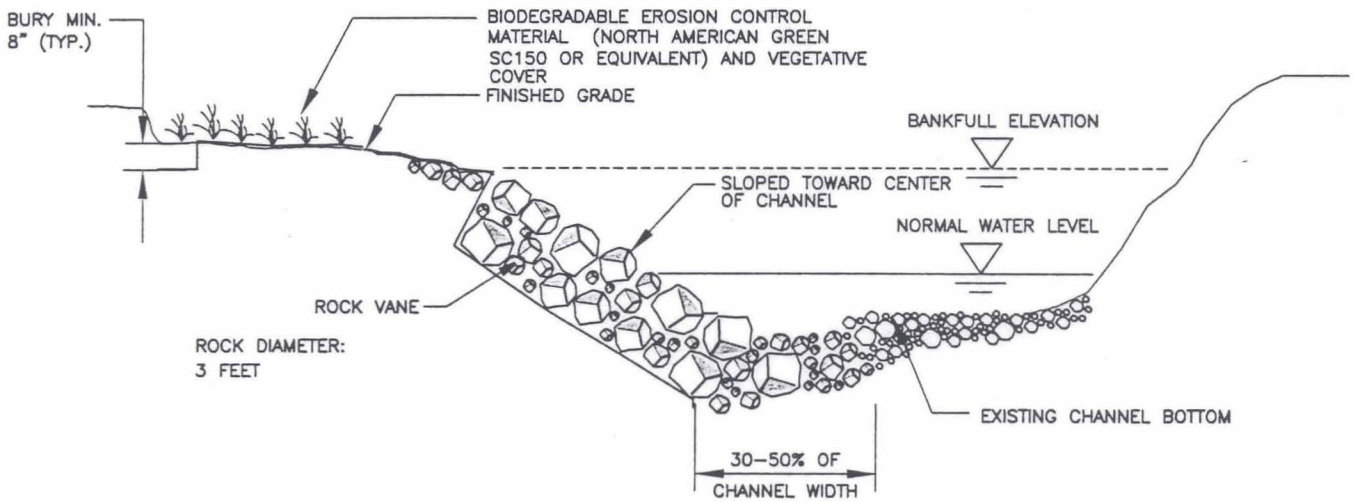
**ROCK VANE**

**PLAN VIEW**  
NOT TO SCALE

**PROFILE**  
NOT TO SCALE

**SECTION A-A**

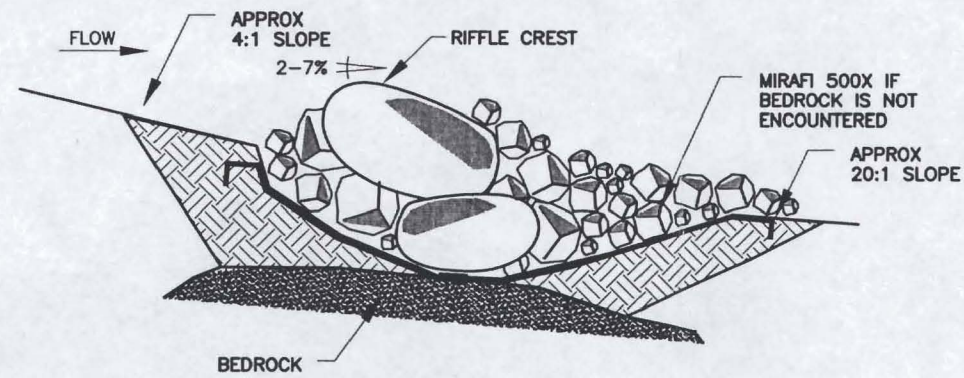
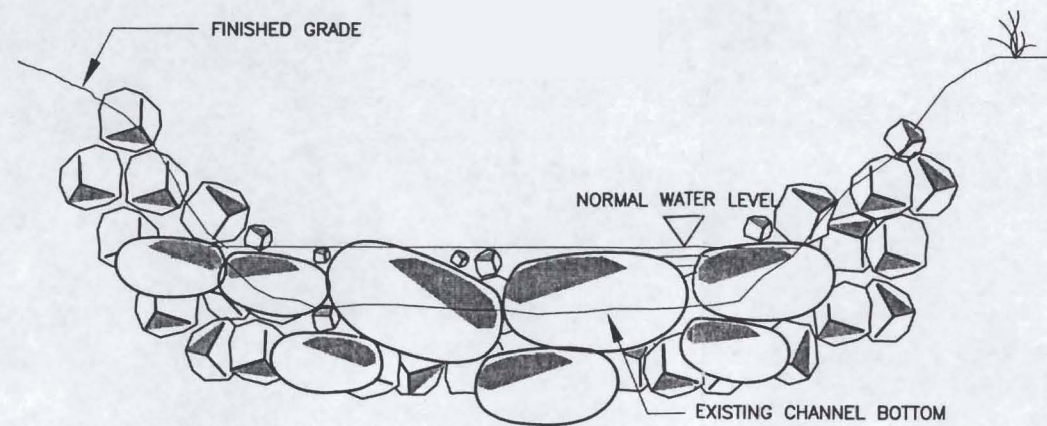
CONSTRUCTED BEDROCK RIFFLE

3. CROSS SECTION: V-SHAPED CREST CUT DOWN TOWARDS CENTER OF CHANNEL.
4. SURFACE: SPACE LARGE SURFACE ROCKS 20 TO 30 CM APART ON THE DOWNSTREAM FACE OF THE RIFFLE TO FORM LOW FISH PASSAGE CHANNELS.

5. BANKS: EXTEND RIFFLE SIDE SLOPE UP BANK TO LEVELS EQUAL TO HEIGHT OF COIR FIBER LOGS, AND THEN EXTEND CREST BACK WITH ROCK PLACED WITHIN BANDS AT 20 TO 30° ANGLE FROM BANK, AND WITH RISE ANGLE OF 2-7° (AS SEEN IN THE CROSS VANE STRUCTURE).
