## **Jacksonville Country Club**

Stream Restoration Project

Jacksonville, Onslow County, NC

### *Final Restoration Plan Report*

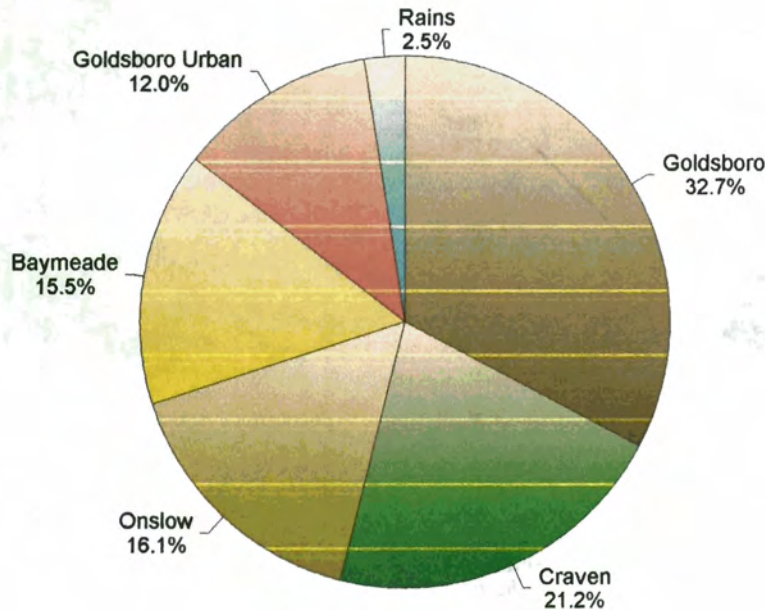
Chart 2-1 Soil Types (Onslow County Soil Survey)

Soil types (mapping units) from the USDA-NRCS Onslow County Soil Survey GIS layer were used to develop coverage of the watershed soils (Project Site Soil Survey, Figure 3). There are six soil types represented in the watershed. The most prevalent soil types are: Goldsboro (32.7%), Craven (21.2%), Onslow (16.1%) and Baymeade (15.5%). All of these four soil types have a fine sandy texture and are usually well-drained and located on uplands. Chart 2-1 indicates the distribution of soil types within the watershed.

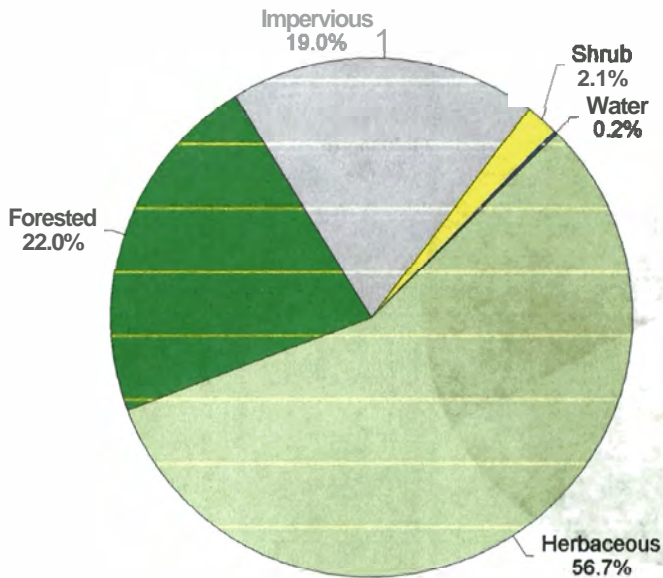
Chart 2-2 Land Use / Land Cover

Land Use/Land Cover (LULC) for the watershed was created from 2004 true aerial color imagery. The primary land cover in the watershed is herbaceous (Chart 2-2). This is mainly due to the golf course, which occupies the majority of the watershed. A forested area is located between the golf course and the community college. Scattered trees and small forested areas are also found throughout the golf course. Most of the impervious area is found in the headwater area of the main channel and the headwaters of one of the side tributaries. A large shrub area identified on the aerial imagery has since been developed into single-family homes.

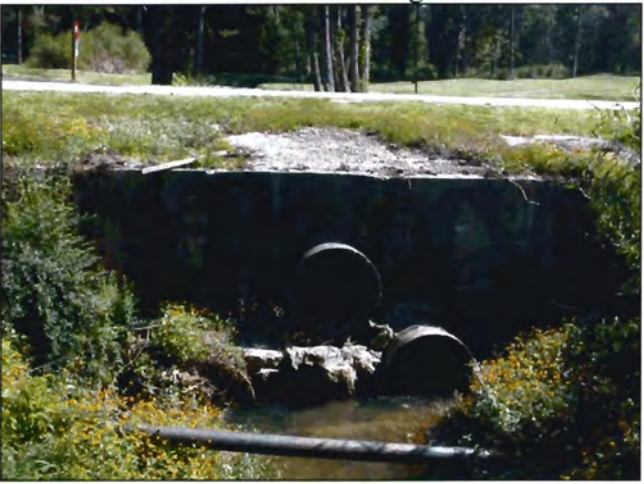
Channel A entrance road crossing/culverts

At the point where Channel A flows under the entrance road, additional flood plain culverts will be added. Culverts throughout the project area are undersized. The inadequate size has produced excessive scour downstream and flooding upstream, of these culverts. Currently, three culverts are located at the stream crossing. These culverts, in particularly, are not of an adequate capacity to handle the flows. Culverts will be both added and replaced to address these issues.

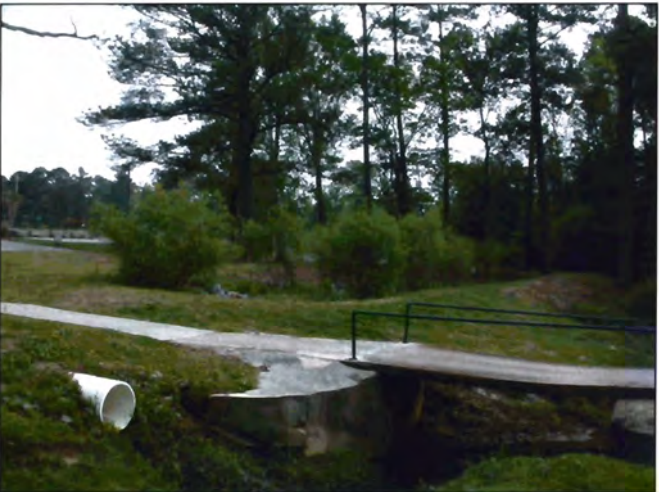
Stonewater retrofit

In addition to the stream component, there will be two stormwater best management practices (BMP's) installed. One is a retrofit to an existing, failing stormwater wetland that was installed during the construction of the new clubhouse and parking lots. It is located within the project boundary on Channel A. It will serve to reduce direct input and overland flows into the stream. The second BMP will be installed at the upper reach of Channel D. It will be placed in an area where overland flows concentrate to increase channel erosion. Currently, the site is being treated with the use of brick and concrete rubble.
