Re: NCIRT Review and USACE Approval of the Jacobs Ladder Mitigation Plan (SAW 2012-01007)

**Jacob's Ladder Stream Restoration Site
Rowan County, North Carolina
EEP Contract 003983**

**Yadkin-Pee Dee River Basin
Cataloging Unit 03040105**

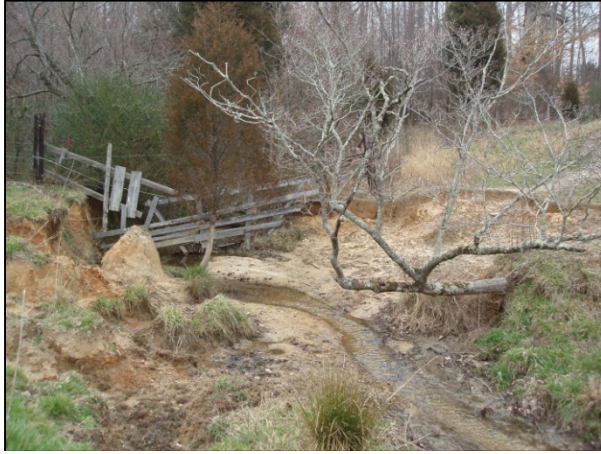
Looking upstream at cattle crossing located at the start of T1-1. 2/10/2012

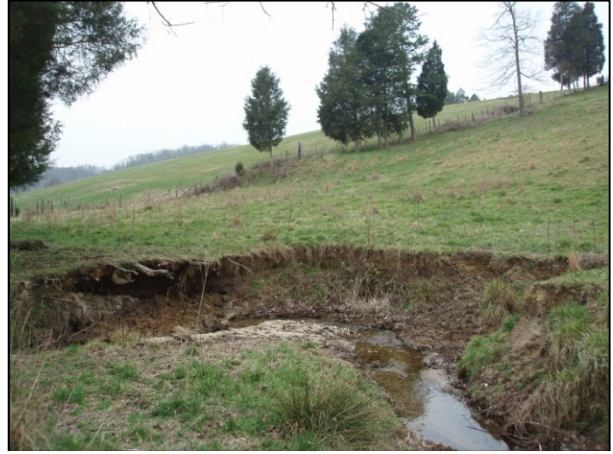
Looking downstream at degraded bank on T1-1. 2/10/2012

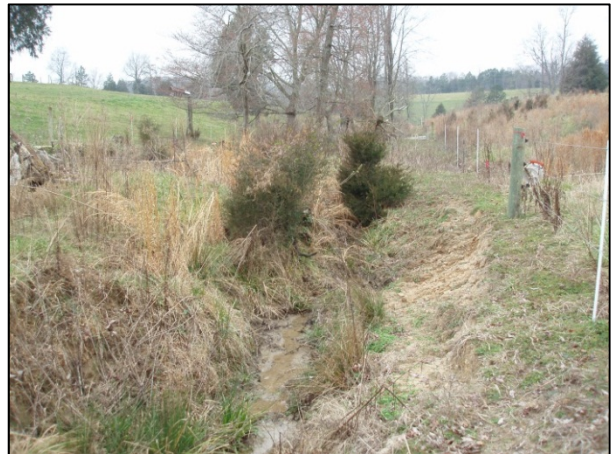
Looking downstream at cattle damage on T1A-1. 2/10/2012

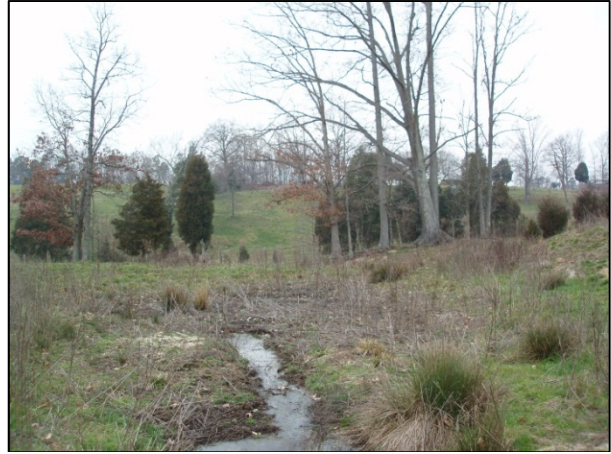
Looking downstream at the ponded area on T1A-3. 2/10/2012

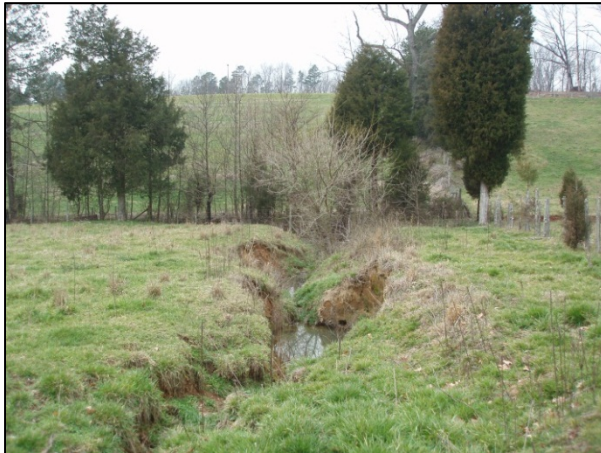
Looking downstream at the head cut section of T1A-3. 2/10/2012

T1A is a first-order, seep-driven stream that consists of project streams T1A-1, T1A-2, and T1A-3. T1A flows 916 linear feet toward the west before draining into T1-2. The project reach begins below a farm road crossing as a B-type channel and transitions from an intermittent channel to a perennial stream at the beginning of the project reach. The first 306 linear feet of T1A-1 have a stable channel pattern, but the stream is experiencing bed degradation as it flows down the valley. The lack of riparian vegetation has increased bank erosion due to lack of root material in the soils. After this first section, T1A-2 becomes less steep and has more mature trees along its banks. The pattern is stable, but there are still isolated areas of bank erosion. After 560 linear feet from the start of T1A, T1A-3 spreads out into a dispersed channel where a small farm pond exists with a breached berm. In this section of channel the banks and planform are poorly defined. After the stream flows through the old pond berm, it begins to quickly incise to reach the confluence with T1-2. It makes a sharp turn to the right and then the left as it downcuts. Approximately 60 linear feet upstream of the confluence with T1-2, there is a severe 4-foot head cut moving up from the base elevation of T1-2.

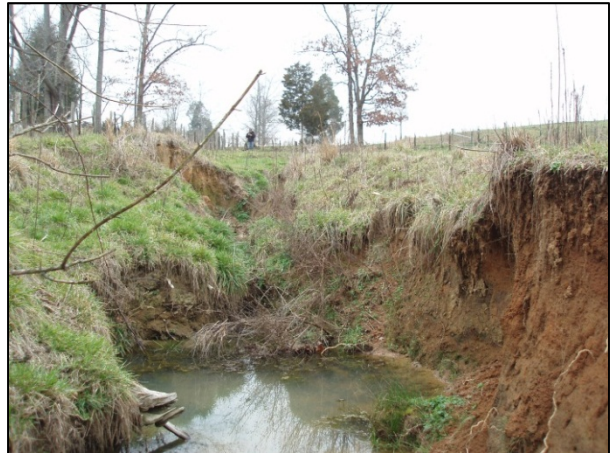
Looking upstream at the head cut section of T1A-3. 2/10/2012

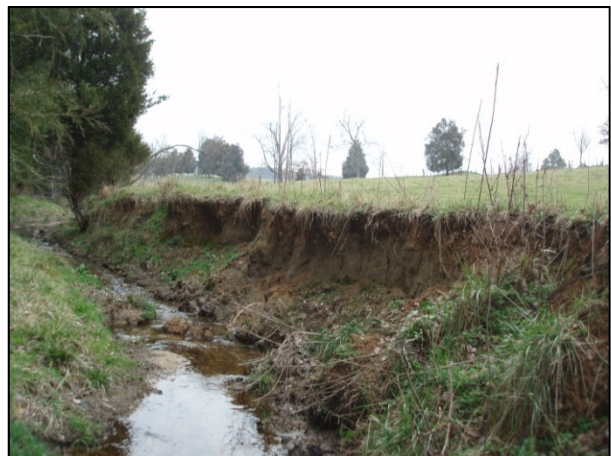
Looking upstream at degraded bank on T1-2. 2/10/2012

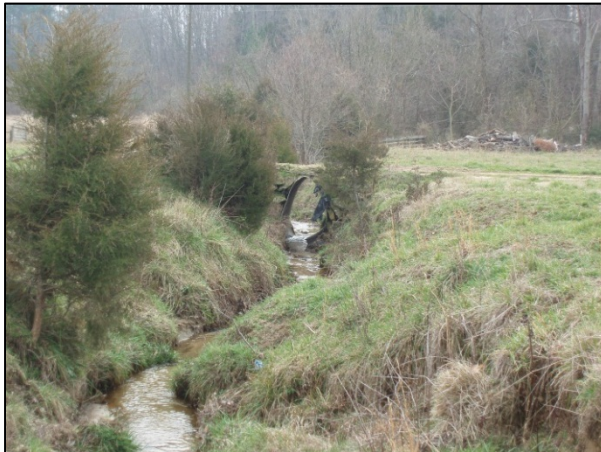
Looking downstream at culvert on T1-2. 2/10/2012

There will be two crossings excluded from the conservation easement on this reach. The first crossing will be located just below the T1-1/T1A-3 confluence. The second crossing is located just upstream of the confluence with Irish Buffalo Creek and will be replaced with a newly designed culvert.

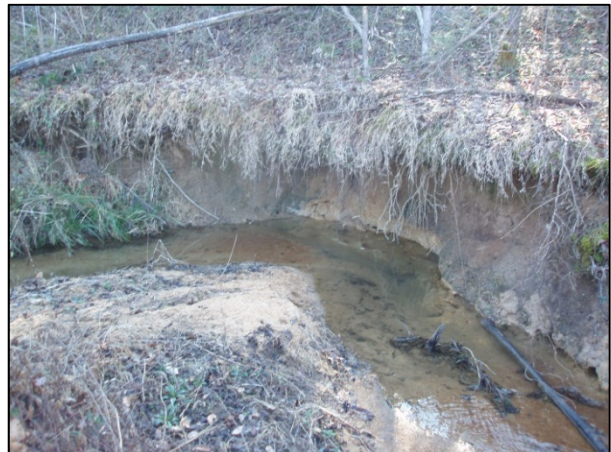
Looking at an eroded bank on T2-1. 2/10/2012

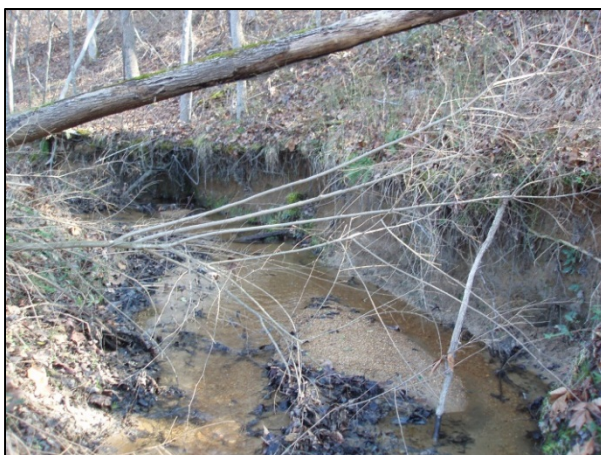
Looking upstream at an eroded bank on T2-1. 2/10/2012

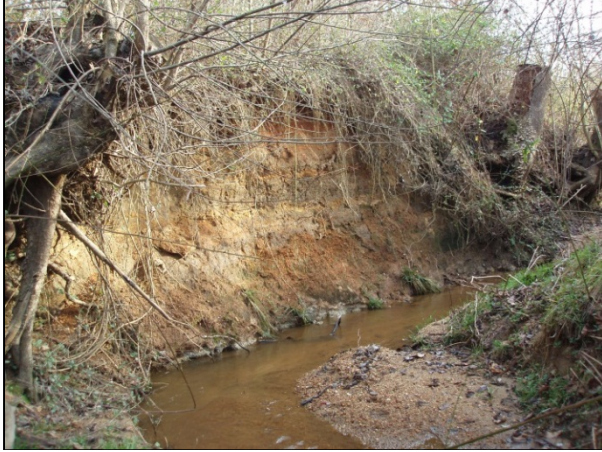
Looking downstream at eroded bank on T2-2. 2/10/2012

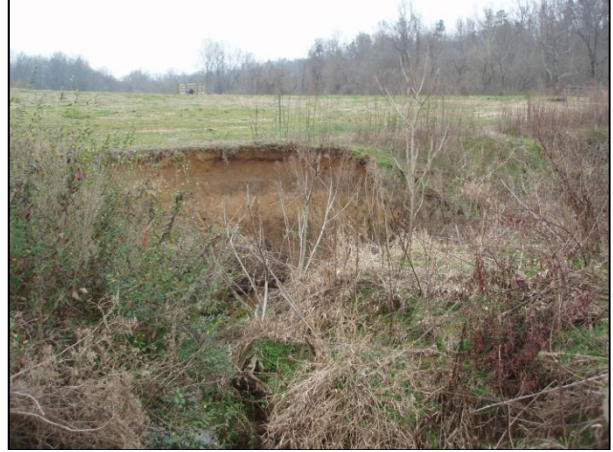
Looking at an eroded bank on T2-2. 2/10/2012

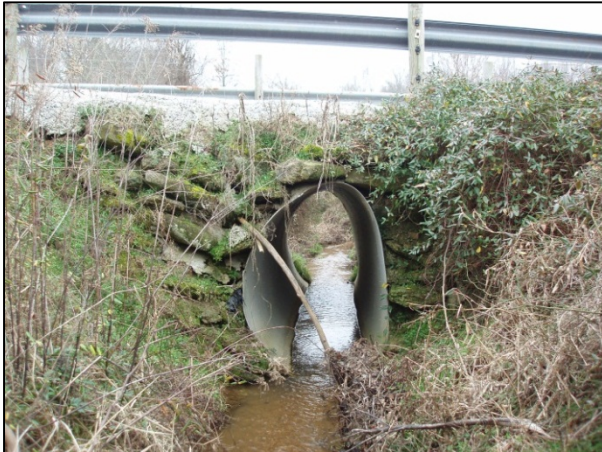
Looking downstream at culvert at the end of reach T2-2. 2/10/2012

There will be one crossing excluded from the conservation easement on this reach. There is a crossing already in place just upstream of the confluence with Irish Buffalo Creek. This crossing will be replaced with a new culvert.

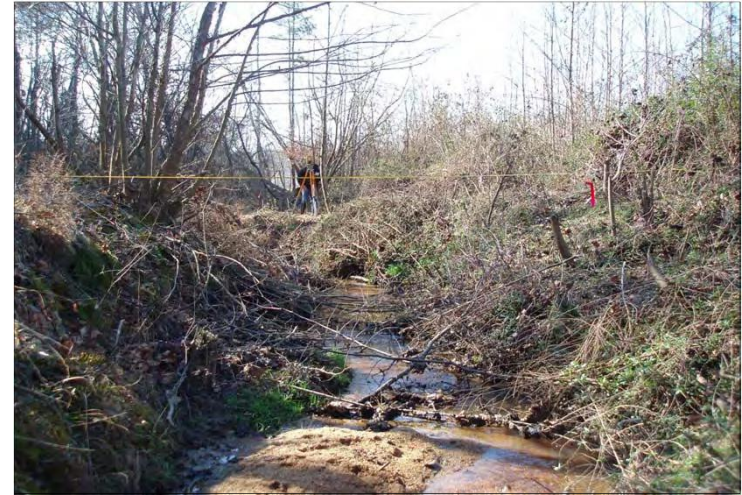
Jacob's Ladder Stream Restoration Site
XS1-Riffle

River Basin:	Yadkin-PeeDee
Watershed:	Jacobs Ladder Site, Existing Conditions, T2-1
XS ID	XS1-Riffle
Drainage Area (sq mi):	0.67
Date:	2/9/2012
Field Crew:	A. French, A. Helms

SUMMARY DATA	
Bankfull Elevation:	752.3
Bankfull Cross-Sectional Area:	18.5
Bankfull Width:	10.6
Flood Prone Area Elevation:	754.9
Flood Prone Width:	20
Max Depth at Bankfull:	2.6
Mean Depth at Bankfull:	1.7
W / D Ratio:	6.1
Entrenchment Ratio:	1.9
Bank Height Ratio:	2.0

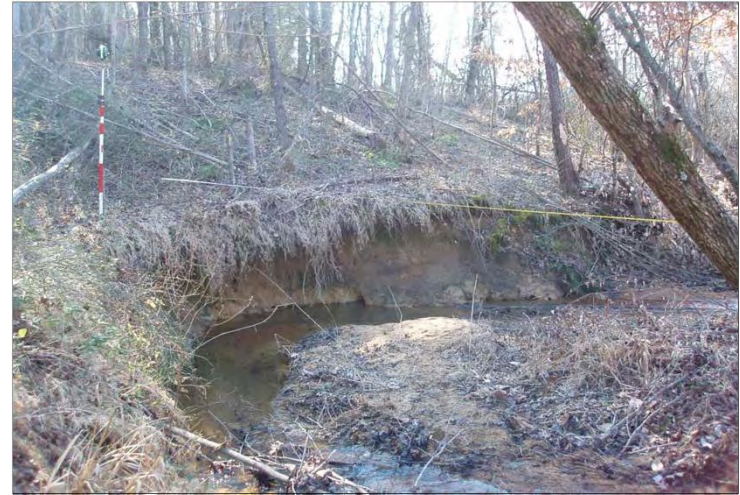
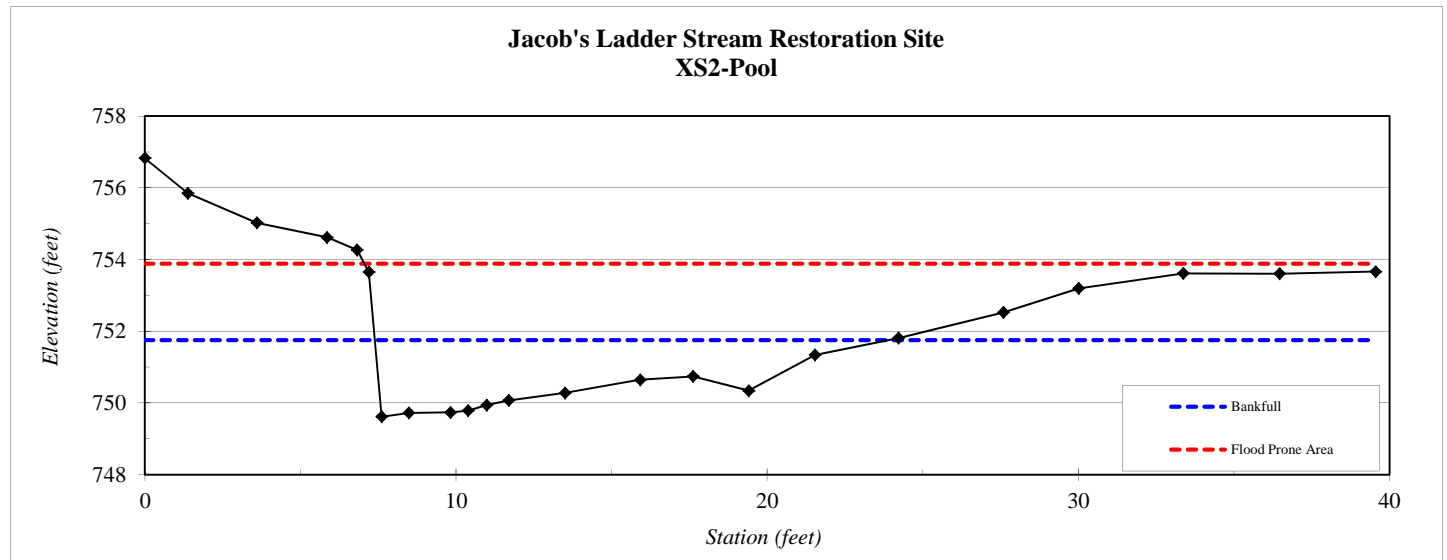
River Basin:	Yadkin-PeeDee
Watershed:	Irish Buffalo Creek, Existing Conditions, T2-1
XS ID	XS2-Pool
Drainage Area (sq mi):	0.67
Date:	2/9/2012
Field Crew:	A. French, A. Helms

Station	Elevation
0.0	756.83
1.4	755.85
3.6	755.02
5.9	754.62
6.8	754.26
7.2	753.65
7.6	749.61
8.5	749.72
9.8	749.74
10.4	749.78
11.0	749.94
11.7	750.07
13.5	750.28
15.9	750.65
17.6	750.74
19.4	750.34
21.5	751.34
24.2	751.81
27.6	752.52
30.0	753.20
33.4	753.61
36.5	753.60
39.6	753.66

SUMMARY DATA	
Bankfull Elevation:	751.8
Bankfull Cross-Sectional Area:	20.6
Bankfull Width:	16.5
Flood Prone Area Elevation:	753.9
Flood Prone Width:	>35
Max Depth at Bankfull:	2.1
Mean Depth at Bankfull:	1.2
W / D Ratio:	13.2
Entrenchment Ratio:	2.1
Bank Height Ratio:	1.9

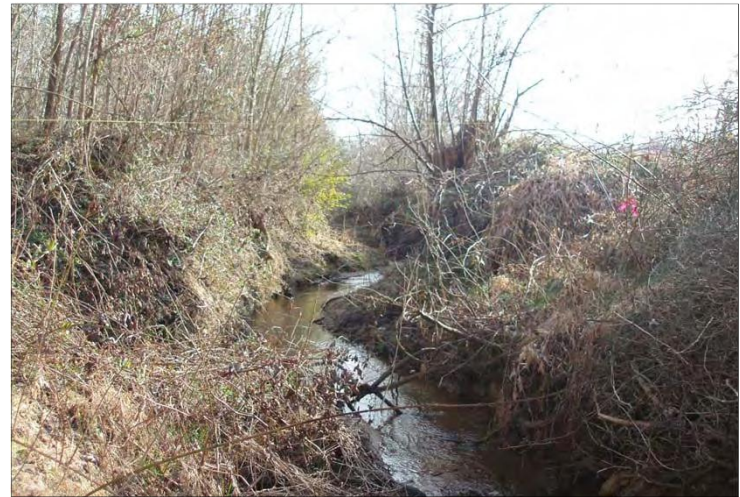
River Basin:	Yadkin-PeeDee
Watershed:	Irish Buffalo Creek, Existing Conditions, T2-2
XS ID	XS4-Riffle
Drainage Area (sq mi):	0.7
Date:	2/9/2012
Field Crew:	A. French, A. Helms

Station	Elevation
0.0	751.10
3.2	750.96
6.6	750.97
10.6	751.08
12.8	751.19
15.5	750.95
16.7	750.24
17.1	748.47
18.5	748.12
20.0	747.36
21.1	746.16
21.7	744.40
23.5	744.07
24.2	744.01
25.0	743.67
25.6	743.60
26.6	743.68
26.9	743.77
28.0	745.99
29.0	746.78
30.1	747.60
31.6	748.87
31.6	750.16
33.1	750.50
36.2	750.39
39.6	750.42
42.3	750.31

SUMMARY DATA	
Bankfull Elevation:	747.0
Bankfull Cross-Sectional Area:	25.0
Bankfull Width:	10.8
Flood Prone Area Elevation:	750.4
Flood Prone Width:	16
Max Depth at Bankfull:	3.4
Mean Depth at Bankfull:	2.3
W / D Ratio:	4.7
Entrenchment Ratio:	1.5
Bank Height Ratio:	2.0

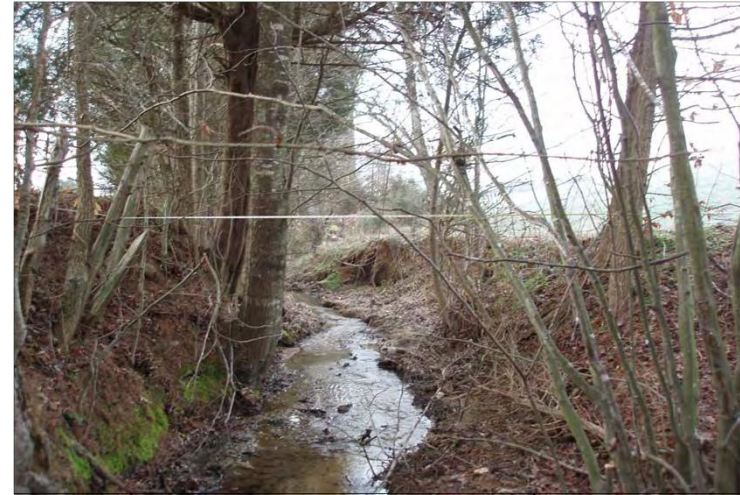
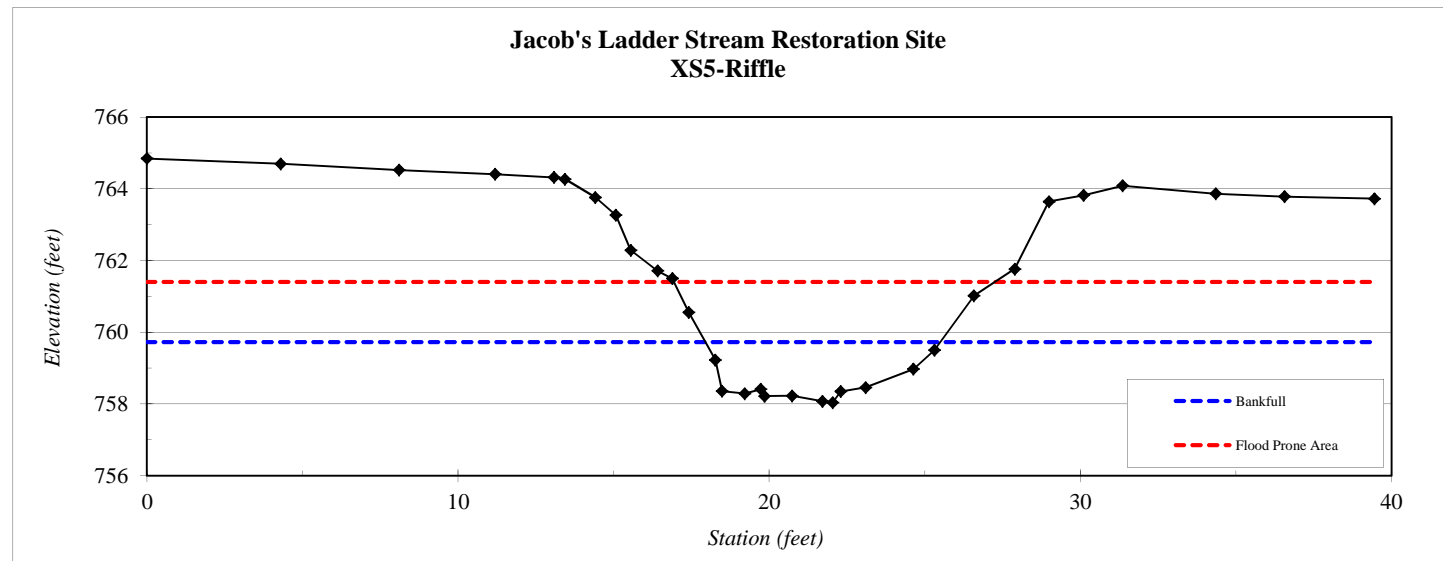
River Basin:	Yadkin-PeeDee
Watershed:	Irish Buffalo Creek, Existing Conditions, T1-2
XS ID	XS5-Riffle
Drainage Area (sq mi):	0.36
Date:	2/10/2012
Field Crew:	A. French, A. Helms

Station	Elevation
0.0	764.85
4.3	764.70
8.1	764.52
11.2	764.41
13.1	764.32
13.4	764.27
14.4	763.76
15.1	763.27
15.6	762.29
16.4	761.71
16.9	761.50
17.4	760.55
18.3	759.23
18.5	758.36
19.2	758.29
19.7	758.41
19.9	758.22
20.7	758.23
21.7	758.07
22.0	758.03
22.3	758.35
23.1	758.46
24.6	758.97
25.3	759.50
26.6	761.01
27.9	761.76
29.0	763.64
30.1	763.82
31.4	764.09
34.3	763.86
36.6	763.78
39.5	763.73

SUMMARY DATA	
Bankfull Elevation:	759.7
Bankfull Cross-Sectional Area:	10.2
Bankfull Width:	8.8
Flood Prone Area Elevation:	761.4
Flood Prone Width:	12
Max Depth at Bankfull:	1.7
Mean Depth at Bankfull:	1.2
W / D Ratio:	7.6
Entrenchment Ratio:	1.3
Bank Height Ratio:	3.3

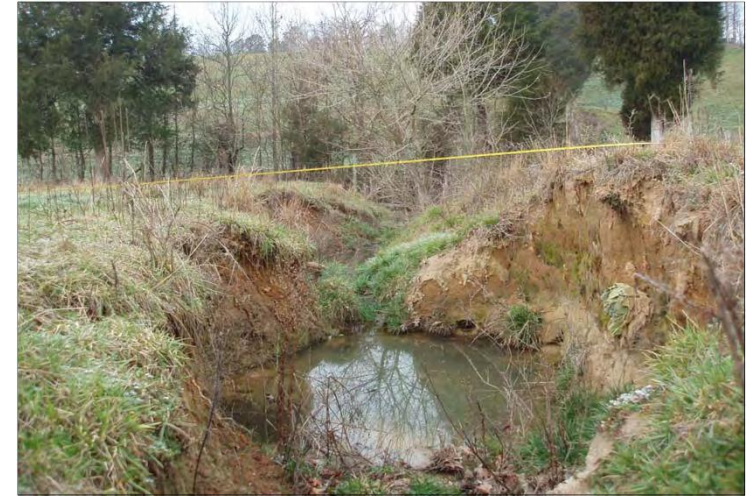
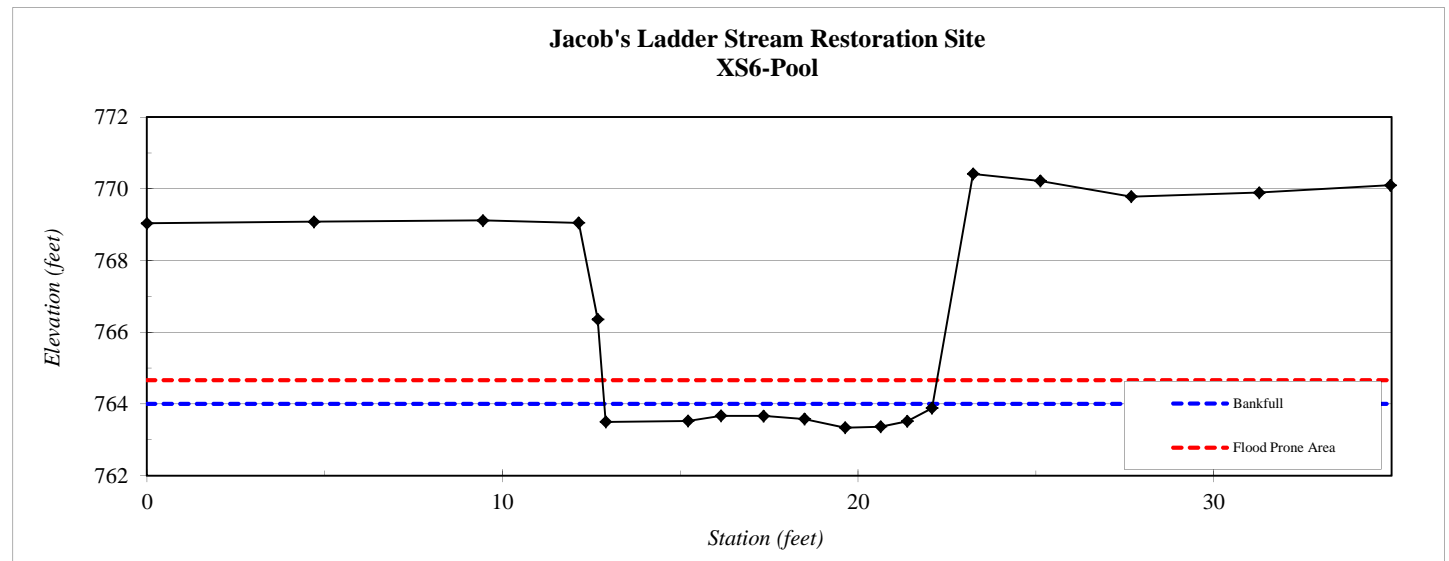
River Basin:	Yadkin-PeeDee
Watershed:	Irish Buffalo Creek, Existing Conditions, T1A-3
XS ID	XS6
Drainage Area (sq mi):	0.05
Date:	2/10/2012
Field Crew:	A. French, A. Helms

Station	Elevation
0.0	769.04
4.7	769.08
9.4	769.12
12.1	769.05
12.7	766.36
12.9	763.50
15.2	763.53
16.1	763.67
17.3	763.66
18.5	763.58
19.6	763.34
20.6	763.37
21.4	763.52
22.1	763.89
23.2	770.42
25.1	770.22
27.7	769.78
31.3	769.89
35.0	770.10

SUMMARY DATA	
Bankfull Elevation:	764.0
Bankfull Cross-Sectional Area:	4.3
Bankfull Width:	9.3
Flood Prone Area Elevation:	764.7
Flood Prone Width:	10
Max Depth at Bankfull:	0.7
Mean Depth at Bankfull:	0.5
W / D Ratio:	20.1
Entrenchment Ratio:	1.1
Bank Height Ratio:	8.6

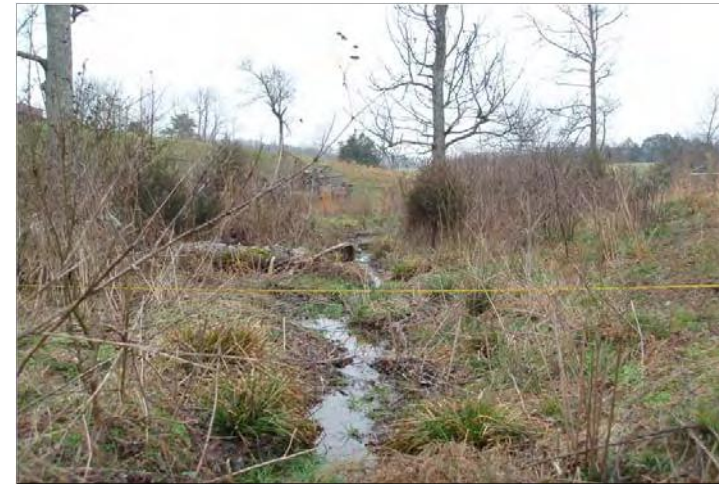
Jacob's Ladder Stream Restoration Site
XS7-Riffle

River Basin:	Yadkin-PeeDee
Watershed:	Irish Buffalo Creek, Existing Conditions, T1A-2
XS ID	XS7-Riffle
Drainage Area (sq mi):	0.05
Date:	2/10/2012
Field Crew:	A. French, A. Helms

Station	Elevation
0.0	781.20
3.3	780.99
6.6	780.84
8.5	780.81
10.6	780.69
12.4	780.56
14.2	780.46
15.8	780.47
17.0	780.43
17.7	780.26
18.7	780.02
19.2	779.90
19.6	779.82
19.9	779.81
20.4	779.94
21.2	780.01
21.8	780.28
22.8	780.61
24.0	780.95
25.2	781.19
26.4	781.30
28.5	782.14
30.5	782.80

SUMMARY DATA	
Bankfull Elevation:	780.7
Bankfull Cross-Sectional Area:	4.5
Bankfull Width:	12.7
Flood Prone Area Elevation:	781.6
Flood Prone Width:	>30
Max Depth at Bankfull:	0.9
Mean Depth at Bankfull:	0.4
W / D Ratio:	35.8
Entrenchment Ratio:	2.4
Bank Height Ratio:	0.7

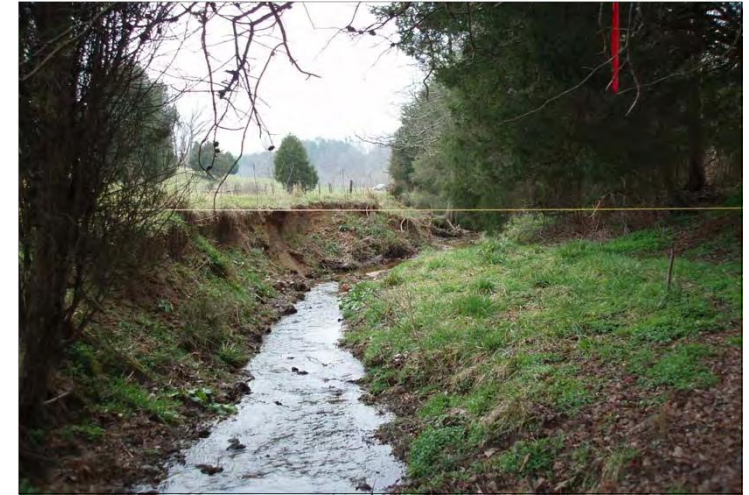
River Basin:	Yadkin-PeeDee
Watershed:	Irish Buffalo Creek, Existing Conditions, T1-2
XS ID	XS-9-Riffle
Drainage Area (sq mi):	0.36
Date:	2/10/2012
Field Crew:	A. French, A. Helms

Station	Elevation
0.0	760.03
4.4	760.12
7.7	760.38
11.8	760.50
14.4	760.57
16.7	760.17
18.4	759.84
19.2	757.97
20.7	756.70
21.4	756.14
21.8	755.94
22.3	755.76
22.7	755.48
23.1	755.48
23.8	755.47
24.6	755.45
25.3	755.37
25.9	755.47
26.4	755.68
27.0	755.87
28.0	756.51
28.6	756.86
29.2	756.99
30.8	757.36
33.0	757.87
36.1	758.11
39.1	758.25
40.3	758.79
42.2	760.46

SUMMARY DATA	
Bankfull Elevation:	757.1
Bankfull Cross-Sectional Area:	10.5
Bankfull Width:	9.6
Flood Prone Area Elevation:	758.9
Flood Prone Width:	16
Max Depth at Bankfull:	1.8
Mean Depth at Bankfull:	1.1
W / D Ratio:	8.8
Entrenchment Ratio:	1.7
Bank Height Ratio:	2.9

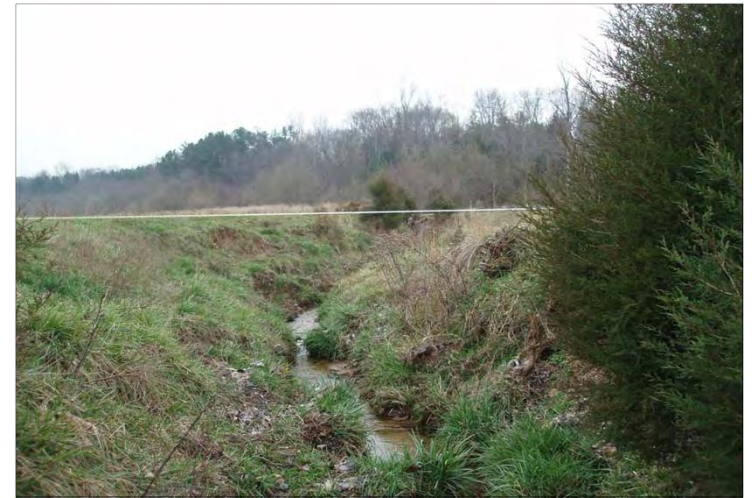
River Basin:	Yadkin-PeeDee
Watershed:	Irish Buffalo Creek, Existing Conditions, T1-2
XS ID	XS10-Pool
Drainage Area (sq mi):	0.36
Date:	2/10/2012
Field Crew:	A. French, A. Helms

Station	Elevation
0.0	752.38
5.7	752.78
10.0	752.83
12.6	752.73
14.4	752.49
15.8	752.01
17.5	750.95
19.2	750.33
20.6	749.58
21.2	749.18
21.5	748.12
22.2	747.76
22.3	747.34
22.6	747.11
23.1	746.98
23.6	747.12
24.0	747.12
24.5	747.30
24.9	747.55
25.3	748.09
26.2	748.40
27.0	748.96
27.8	749.68
28.3	750.98
28.8	751.89
30.3	752.18
31.4	752.68
33.5	752.87
36.6	752.72
39.3	752.63
41.5	752.47

SUMMARY DATA	
Bankfull Elevation:	749.4
Bankfull Cross-Sectional Area:	9.8
Bankfull Width:	6.7
Flood Prone Area Elevation:	751.8
Flood Prone Width:	15
Max Depth at Bankfull:	2.4
Mean Depth at Bankfull:	1.5
W / D Ratio:	4.6
Entrenchment Ratio:	2.2
Bank Height Ratio:	2.3

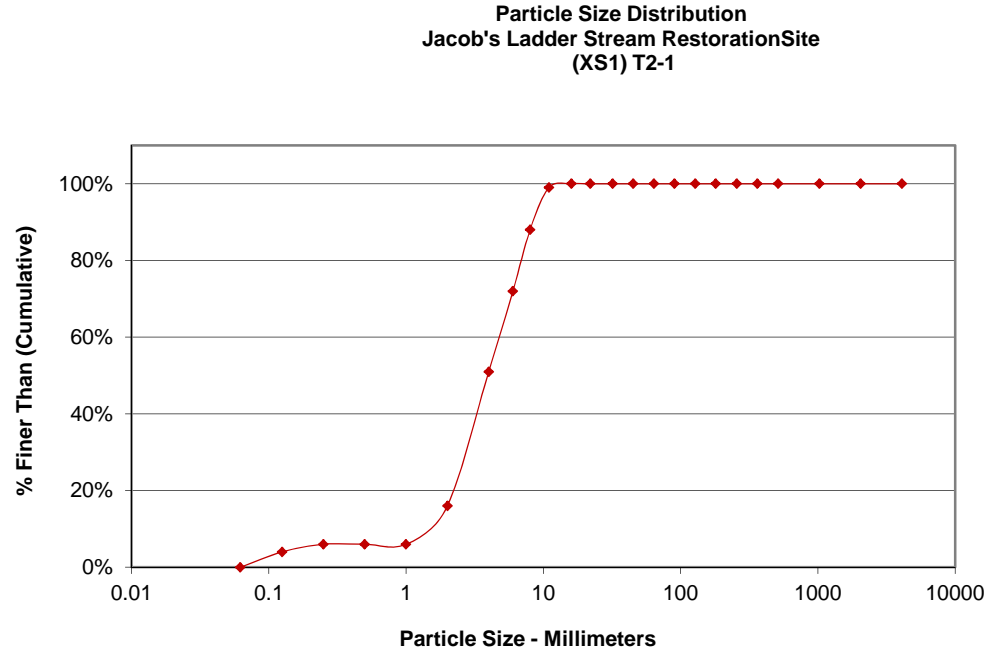
Cross-Section 1			
Particle	Millimeter		Count
Silt/Clay	< 0.062	S/C	
Very Fine	.062 - .125	S	4
Fine	.125 - .25	A	2
Medium	.25 - .50	N	
Coarse	.50 - 1	D	
Very Coarse	1 - 2	S	10
Very Fine	2 - 4		35
Fine	4 - 5.7	G	21
Fine	5.7 - 8	R	16
Medium	8 - 11.3	A	11
Medium	11.3 - 16	V	1
Coarse	16 - 22.6	E	
Coarse	22.6 - 32	L	
Very Coarse	32 - 45	S	
Very Coarse	45 - 64		
Small	64 - 90	C	
Small	90 - 128	O	
Large	128 - 180	B	
Large	180 - 256	L	
Small	256 - 362	B	
Small	362 - 512	L	
Medium	512 - 1024	D	
Lrg- Very Lrg	1024 - 2048	R	
Bedrock	>2048	BDRK	
		Total	100
Note:

Size (mm)	
D16	2
D35	2.9
D50	3.9
D65	5.2
D84	7.4
D95	9.8

Size Distribution	
mean	3.8
dispersion	1.9
skewness	-0.01

Type	
silt/clay	0%
sand	16%
gravel	84%
cobble	0%
boulder	0%
bedrock	0%
hardpan	0%
wood/det	0%
artificial	0%

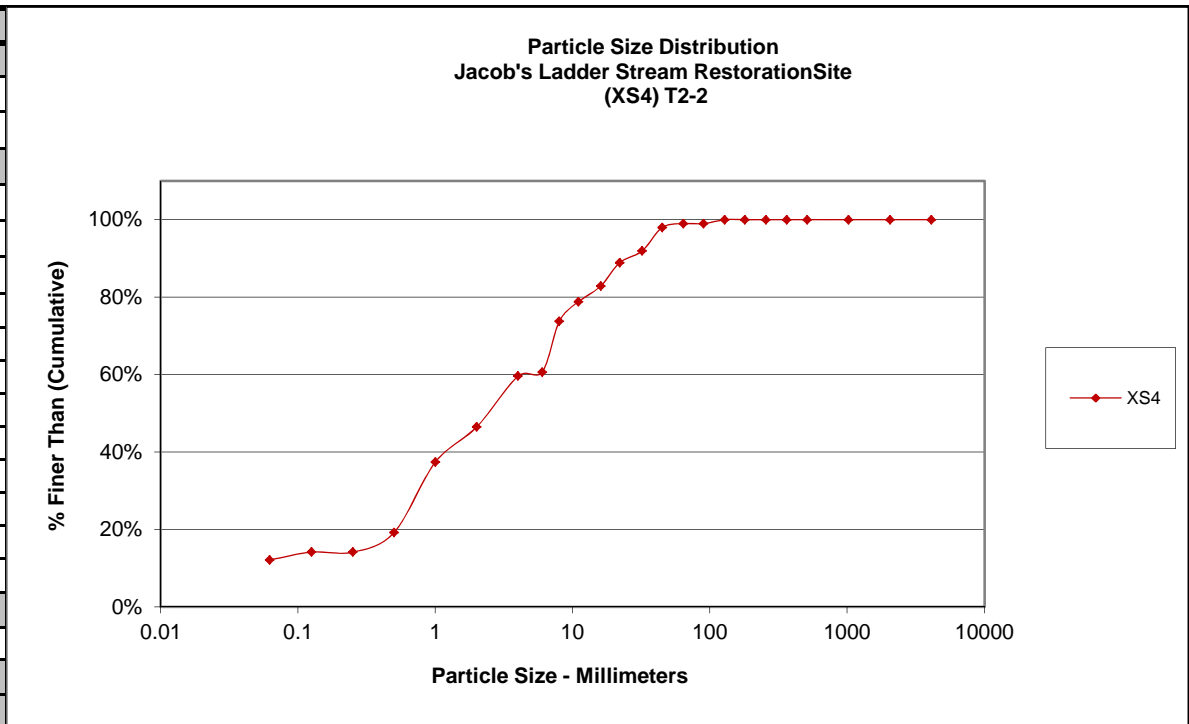
Cross-Section 4			
Particle	Millimeter		Count
Silt/Clay	< 0.062	S/C	12
Very Fine	.062 - .125	S	2
Fine	.125 - .25	A	
Medium	.25 - .50	N	5
Coarse	.50 - 1	D	18
Very Coarse	1 - 2	S	9
Very Fine	2 - 4		13
Fine	4 - 5.7	G	1
Fine	5.7 - 8	R	13
Medium	8 - 11.3	A	5
Medium	11.3 - 16	V	4
Coarse	16 - 22.6	E	6
Coarse	22.6 - 32	L	3
Very Coarse	32 - 45	S	6
Very Coarse	45 - 64		1
Small	64 - 90	C	
Small	90 - 128	O	1
Large	128 - 180	B	
Large	180 - 256	L	
Small	256 - 362	B	
Small	362 - 512	L	
Medium	512 - 1024	D	
Lrg- Very Lrg	1024 - 2048	R	
Bedrock	>2048	BDRK	
	Total		99
Note:

Size (mm)	
D16	0.32
D35	0.91
D50	2.4
D65	6.6
D84	17
D95	38

Size Distribution	
mean	2.3
dispersion	7.3
skewness	-0.01

Type	
silt/clay	12%
sand	34%
gravel	53%
cobble	1%
boulder	0%
bedrock	0%
hardpan	0%
wood/det	0%
artificial	0%

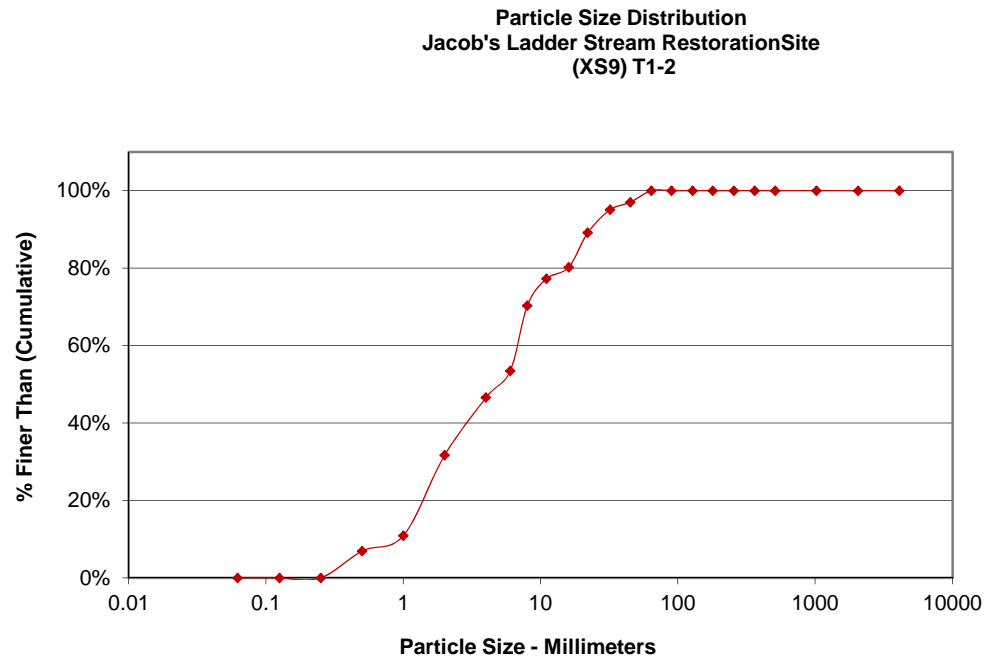
Cross-Section 9			
Particle	Millimeter		Count
Silt/Clay	< 0.062	S/C	
Very Fine	.062 - .125	S	
Fine	.125 - .25	A	
Medium	.25 - .50	N	7
Coarse	.50 - 1	D	4
Very Coarse	1 - 2	S	21
Very Fine	2 - 4		15
Fine	4 - 5.7	G	7
Fine	5.7 - 8	R	17
Medium	8 - 11.3	A	7
Medium	11.3 - 16	V	3
Coarse	16 - 22.6	E	9
Coarse	22.6 - 32	L	6
Very Coarse	32 - 45	S	2
Very Coarse	45 - 64		3
Small	64 - 90	C	
Small	90 - 128	O	
Large	128 - 180	B	
Large	180 - 256	L	
Small	256 - 362	B	
Small	362 - 512	L	
Medium	512 - 1024	D	
Lrg- Very Lrg	1024 - 2048	R	
Bedrock	>2048	BDRK	
		Total	101
Note:

Size (mm)	
D16	1.2
D35	2.3
D50	4.9
D65	7.3
D84	18
D95	32

Size Distribution	
mean	4.6
dispersion	3.9
skewness	-0.02

Type	
silt/clay	0%
sand	32%
gravel	68%
cobble	0%
boulder	0%
bedrock	0%
hardpan	0%
wood/det	0%
artificial	0%

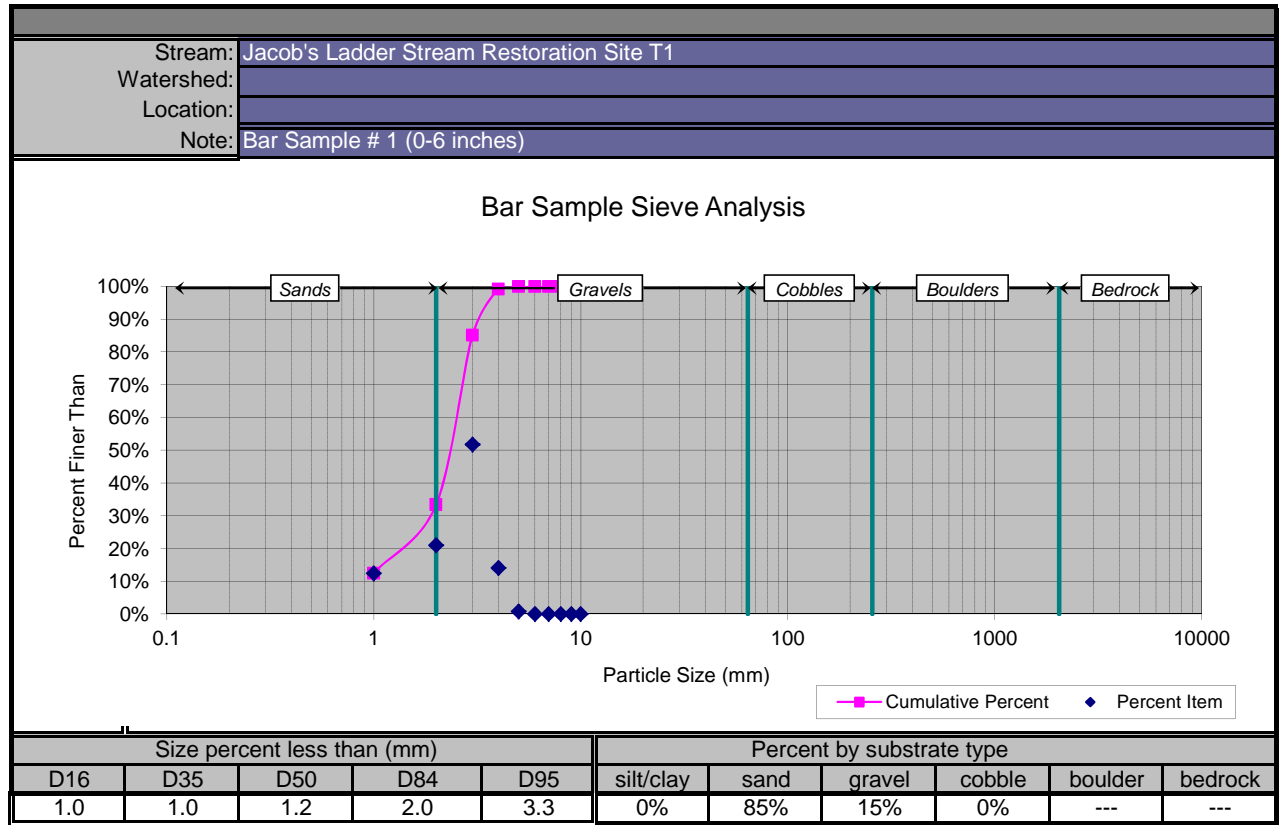
Bar Sample Sieve Analysis			
Smallest Sieve Passed (mm)	Weight (oz)	% Item	Percent Finer Than
<1	61	12.4%	12.4%
1.0	103.0	21.0%	33.4%
2.0	254.0	51.7%	85.1%
4.0	69.0	14.1%	99.2%
8.0	4.0	0.8%	100.0%
16.0	0.0	0.0%	100.0%
31.5	0.0	0.0%	100.0%
128.0	0.0	0.0%	100.0%
256.0	0.0	0.0%	100.0%
> 256.0	0.0	0.0%	100.0%
Total:	491.0	100%

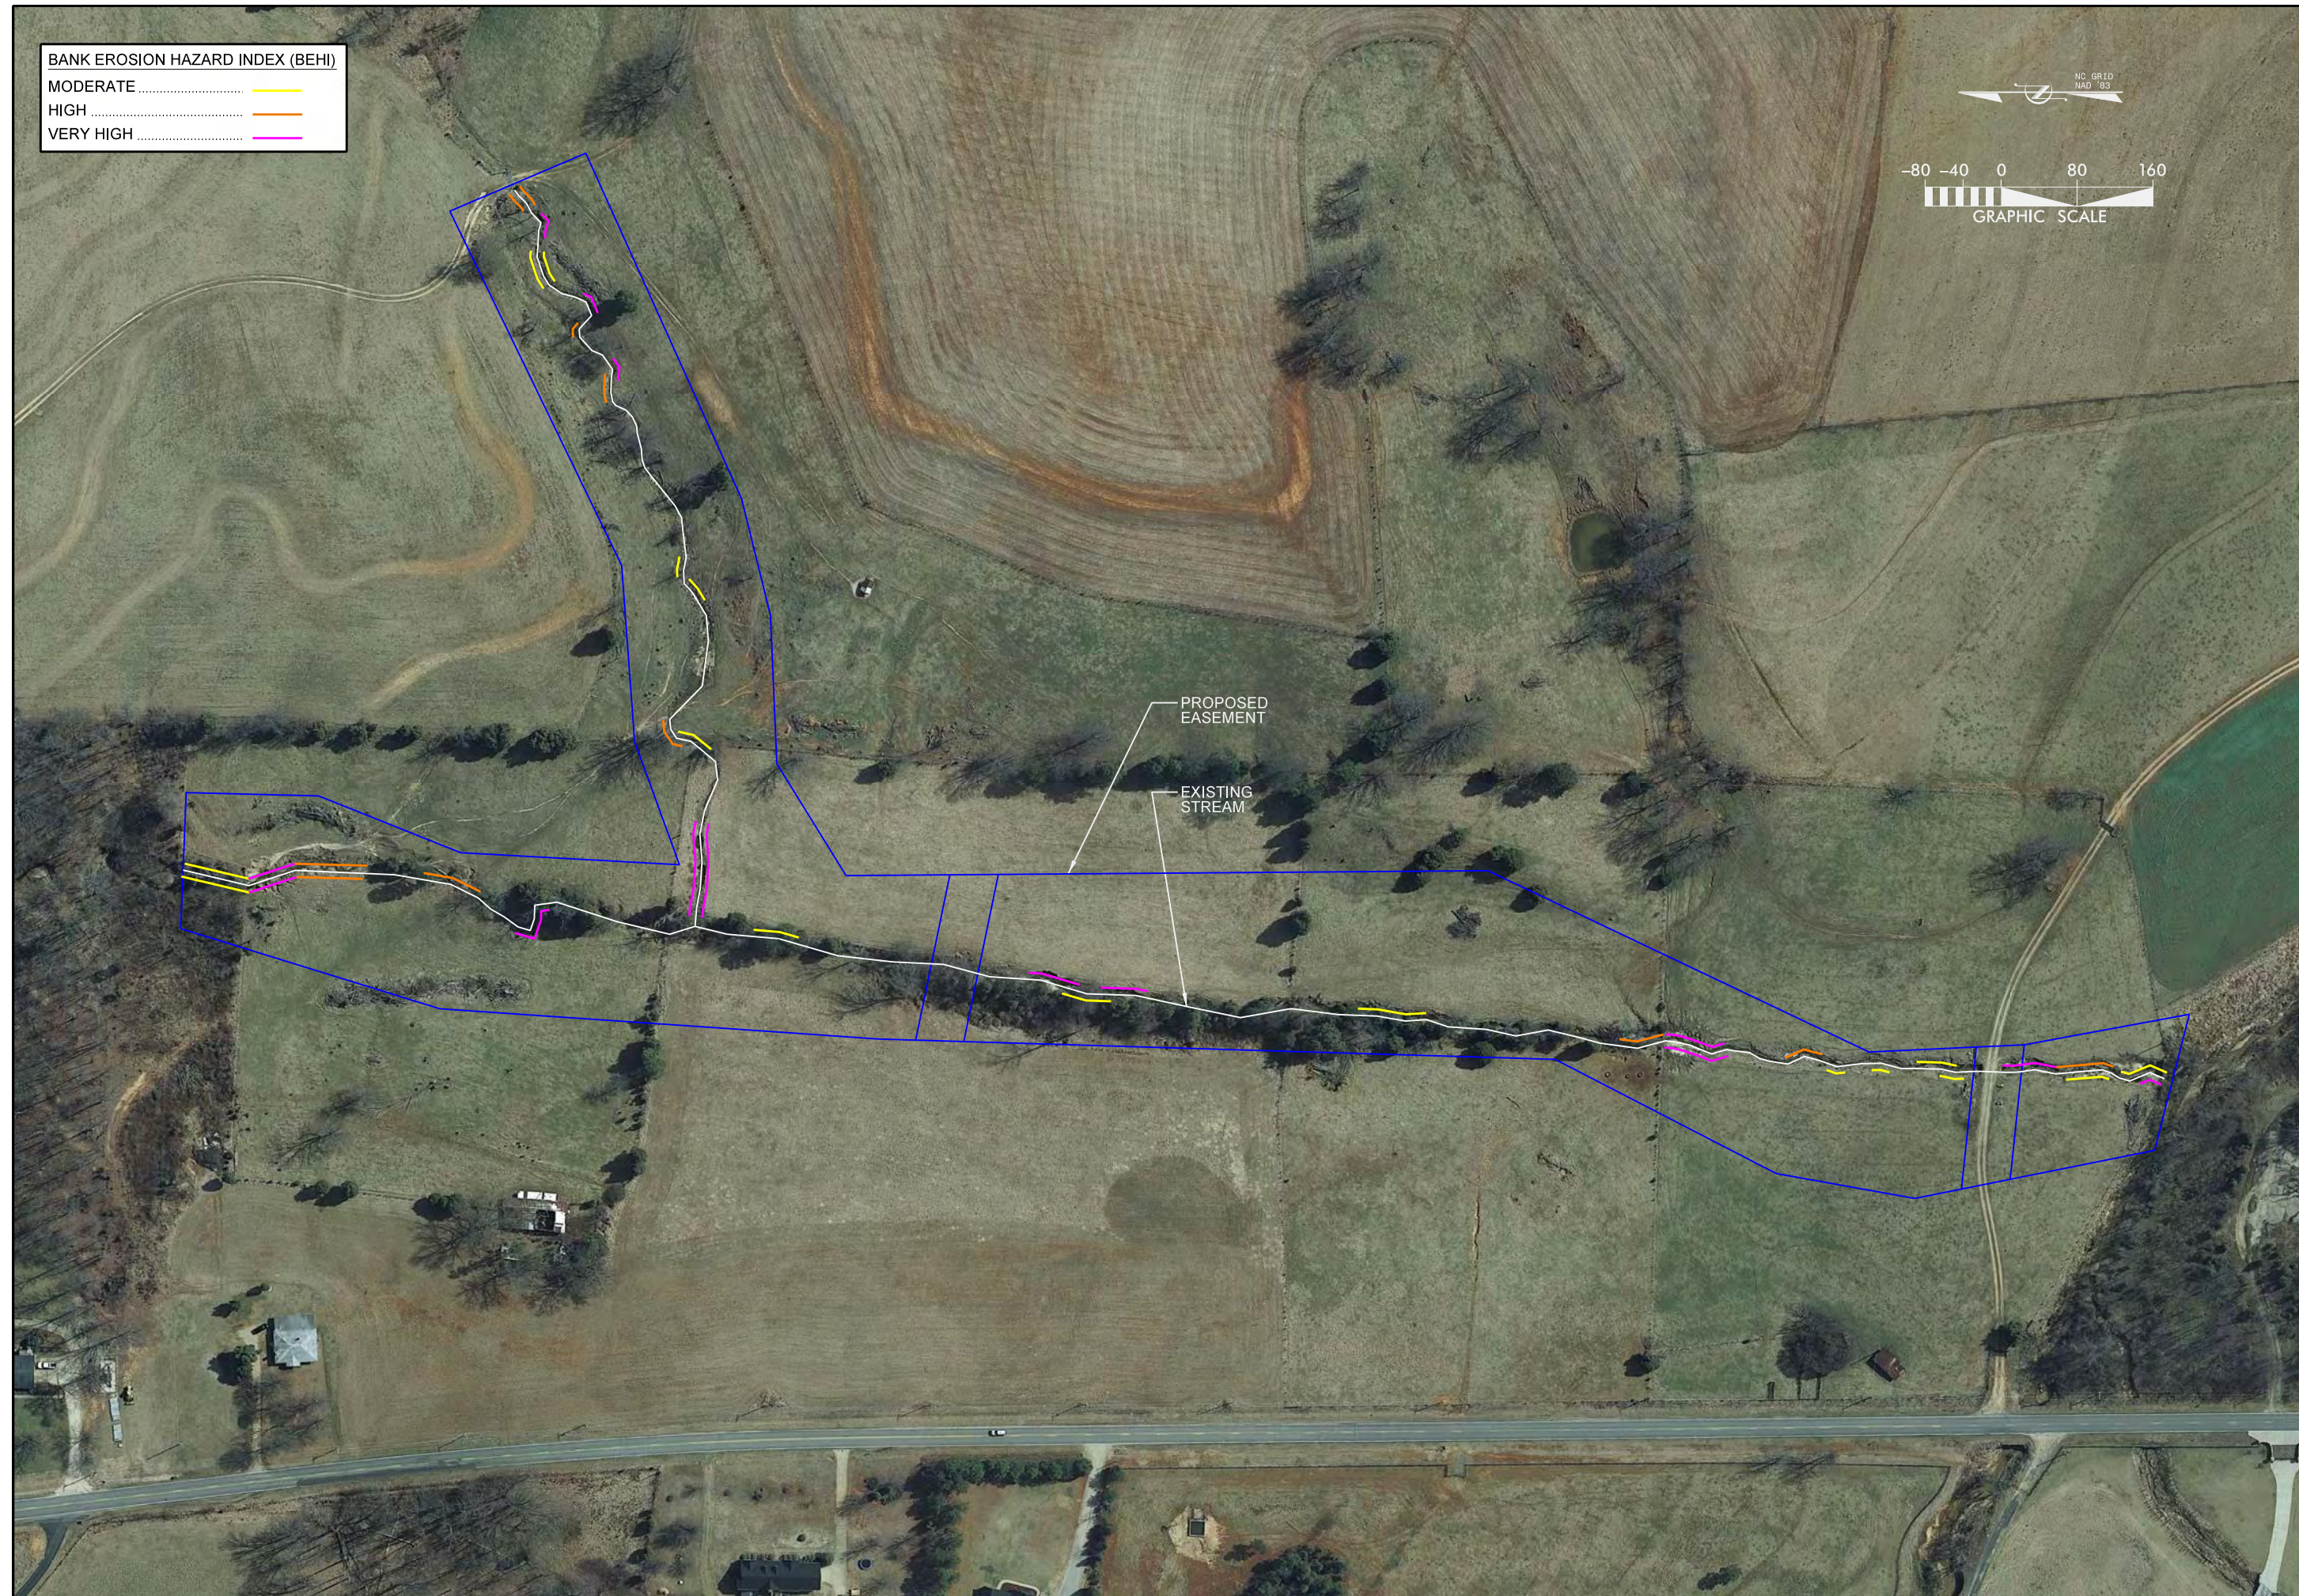
BEHI

BANK EROSION HAZARD INDEX (BEHI)
 MODERATE —
 HIGH —
 VERY HIGH —

PROPOSED EASEMENT
 EXISTING STREAM

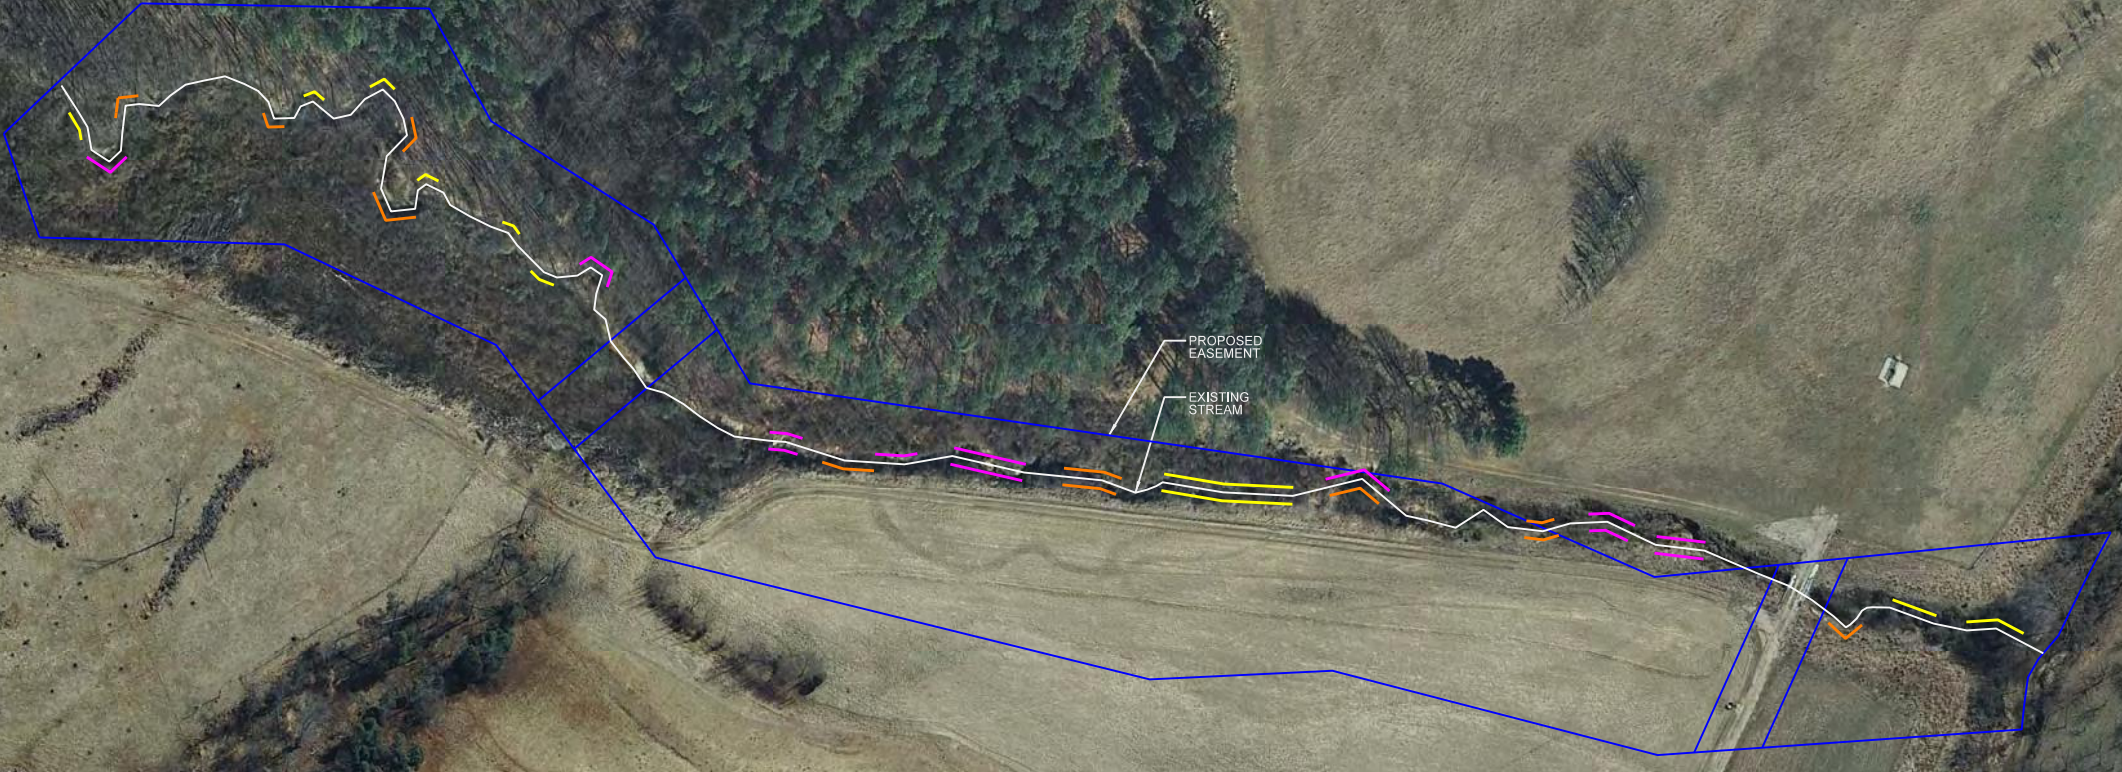
BANK EROSION HAZARD INDEX (BEHI)
 MODERATE

VERY HIGH

PROPOSED EASEMENT
 EXISTING STREAM

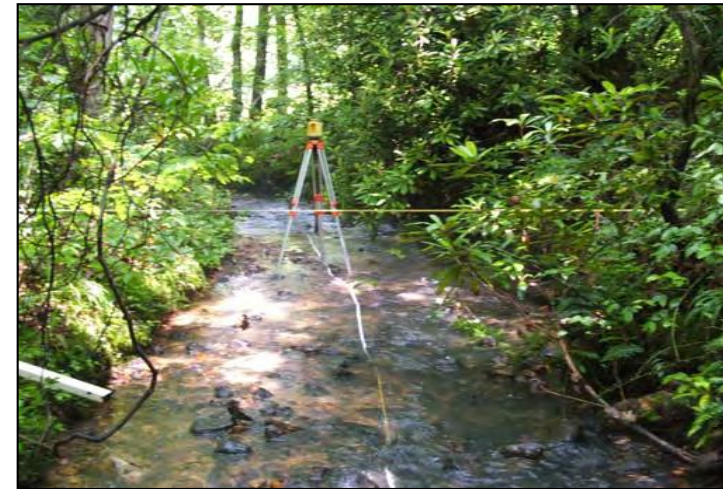
Station	Rod Ht.	Elevation
0.0	2.22	100.00
3.0	2.15	100.07
5.0	2.50	99.72
7.0	2.98	99.24
8.0	3.49	98.73
8.8	4.00	98.22
9.0	4.96	97.26
12.0	5.03	97.19
14.0	5.25	96.97
16.0	5.16	97.06
17.0	5.20	97.02
18.0	5.06	97.16
18.7	4.00	98.22
19.5	2.65	99.57
20.0	1.66	100.56

SUMMARY DATA	
Bankfull Elevation:	98.22
Bankfull Cross-Sectional Area:	10.40
Bankfull Width:	10.00
Flood Prone Area Elevation:	99.47
Flood Prone Width:	13.10
Max Depth at Bankfull:	1.25
Mean Depth at Bankfull:	1.04
W / D Ratio:	9.6
Entrenchment Ratio:	1.30
Bank Height Ratio:	2.08
Slope (ft/ft):	0.013
Discharge (cfs)	42

Stream Type:	B4c
---------------------	-----

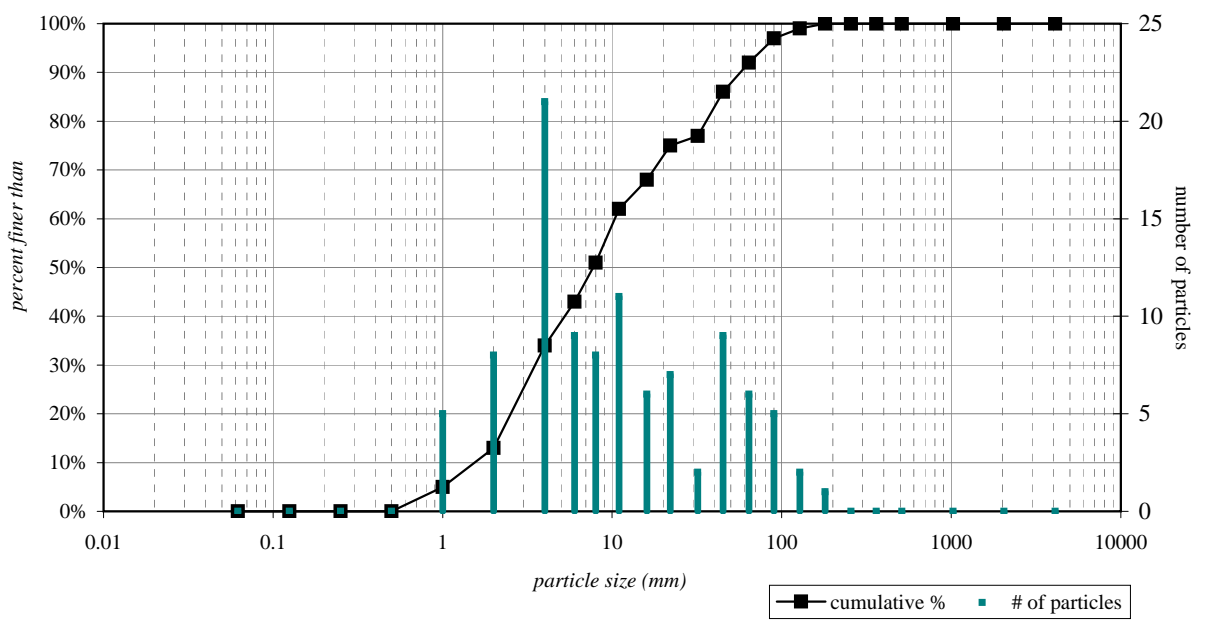
UT to Fsher River
 Surry County, NC
 Riffle #1 (Sta. 01+00)

Pebble Count

Material	Size Range (mm)		Count
silt/clay	0	0.062	0
very fine sand	0.062	0.13	0
fine sand	0.13	0.25	0
medium sand	0.25	0.5	0
coarse sand	0.5	1	5
very coarse sand	1	2	8
very fine gravel	2	4	21
fine gravel	4	6	9
fine gravel	6	8	8
medium gravel	8	11	11
medium gravel	11	16	6
coarse gravel	16	22	7
coarse gravel	22	32	2
very coarse gravel	32	45	9
very coarse gravel	45	64	6
small cobble	64	90	5
medium cobble	90	128	2
large cobble	128	180	1
very large cobble	180	256	0
small boulder	256	362	0
small boulder	362	512	0
medium boulder	512	1024	0
large boulder	1024	2048	0
very large boulder	2048	4096	0

total particle count: 100

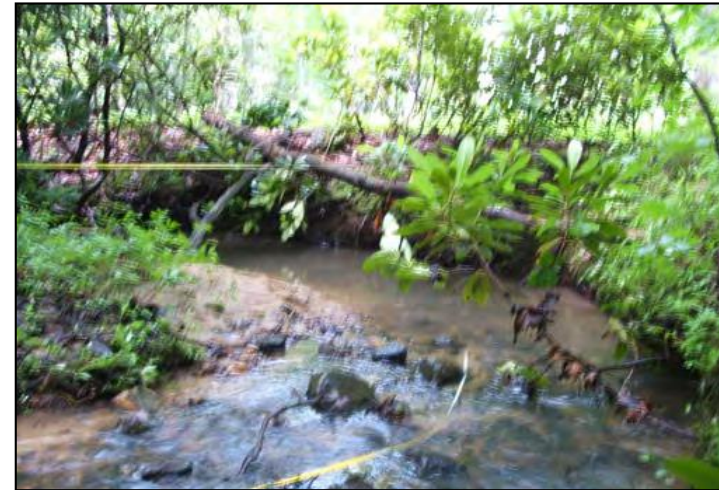
Yadkin River Basin, UT to Fisher River, XS#2 Pool

Station	Rod Ht.	Elevation
0.0	2.68	100.00
3.0	2.94	99.74
5.0	3.61	99.07
6.0	4.10	98.58
6.8	4.56	98.12
7.0	4.70	97.98
9.0	4.94	97.74
11.0	5.21	97.47
12.0	5.64	97.04
13.0	6.00	96.68
15.0	6.59	96.09
17.0	6.42	96.26
18.0	6.50	96.18
18.2	4.93	97.75
19.0	3.56	99.12
20.0	2.80	99.88

SUMMARY DATA	
Bankfull Elevation:	98.12
Bankfull Cross-Sectional Area:	13.40
Bankfull Width:	11.62
Flood Prone Area Elevation:	100.15
Flood Prone Width:	
Max Depth at Bankfull:	2.03
Mean Depth at Bankfull:	1.15
W / D Ratio:	10.1
Entrenchment Ratio:	
Bank Height Ratio:	0.81
Slope (ft/ft):	0.001
Discharge (cfs)	56

Stream Type:	B4c
---------------------	-----
