Re: NCIRT Review and USACE Approval of the Jacobs Ladder Mitigation Plan (SAW 2012-01007)

**Jacob's Ladder Stream Restoration Site
Rowan County, North Carolina
EEP Contract 003983**

**Yadkin-Pee Dee River Basin
Cataloging Unit 03040105**

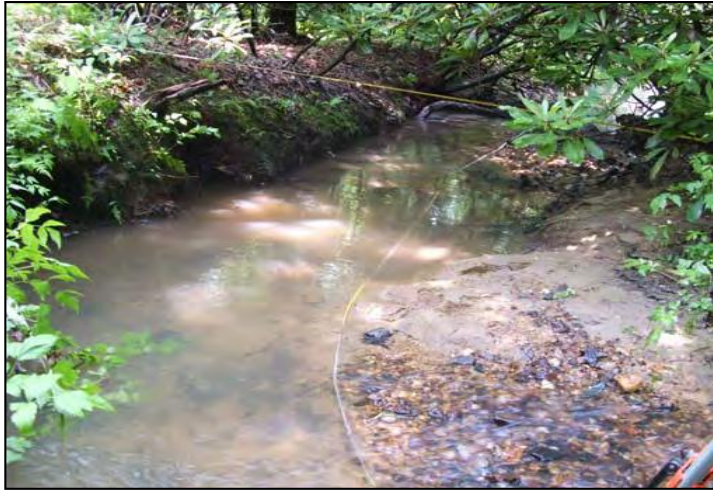
Yadkin River Basin, UT to Fisher River, XS#3 Pool

River Basin:	Yadkin
Watershed:	UT to Fisher River
XS ID	XS#3 Pool
Drainage Area (sq mi):	0.38
Date:	6/9/2005
Field Crew:	G. Mryncza, A. Spiller

Station	Rod Ht.	Elevation
0.0	1.33	100.00
3.0	1.78	99.55
5.0	2.35	98.98
5.5	2.82	98.51
5.7	3.81	97.52
6.0	4.52	96.81
6.5	5.79	95.54
8.0	5.82	95.51
9.0	5.50	95.83
10.0	5.02	96.31
11.5	4.80	96.53
13.0	3.90	97.43
14.0	3.55	97.78
16.0	3.03	98.30
20.0	2.66	98.67

SUMMARY DATA	
Bankfull Elevation:	97.78
Bankfull Cross-Sectional Area:	11.60
Bankfull Width:	8.35
Flood Prone Area Elevation:	100.05
Flood Prone Width:	
Max Depth at Bankfull:	2.27
Mean Depth at Bankfull:	1.39
W / D Ratio:	6.0
Entrenchment Ratio:	
Bank Height Ratio:	0.85
Slope (ft/ft):	0.001
Discharge (cfs)	52

Stream Type:	B4c
---------------------	-----

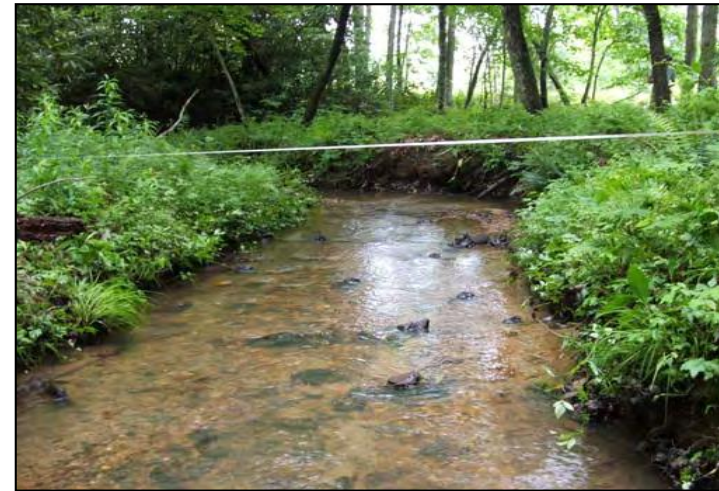
River Basin:	Yadkin
Watershed:	UT to Fisher River
XS ID	XS#4 Riffle
Drainage Area (sq mi):	0.38
Date:	6/9/2005
Field Crew:	G. Mryncza, A. Spiller

Station	Rod Ht.	Elevation
0.0	4.62	100.00
3.0	5.54	99.08
7.0	6.01	98.61
8.5	6.34	98.28
9.0	7.04	97.58
9.5	7.66	96.96
11.0	7.67	96.95
12.0	7.79	96.83
14.0	7.58	97.04
16.0	7.57	97.05
17.0	7.51	97.11
17.5	6.34	98.28
19.0	5.90	98.72
21.0	5.06	99.56
25.0	4.37	100.25

SUMMARY DATA	
Bankfull Elevation:	98.28
Bankfull Cross-Sectional Area:	10.70
Bankfull Width:	9.00
Flood Prone Area Elevation:	99.73
Flood Prone Width:	20.50
Max Depth at Bankfull:	1.45
Mean Depth at Bankfull:	1.19
W / D Ratio:	7.6
Entrenchment Ratio:	2.30
Bank Height Ratio:	1.00
Slope (ft/ft):	0.013
Discharge (cfs)	46

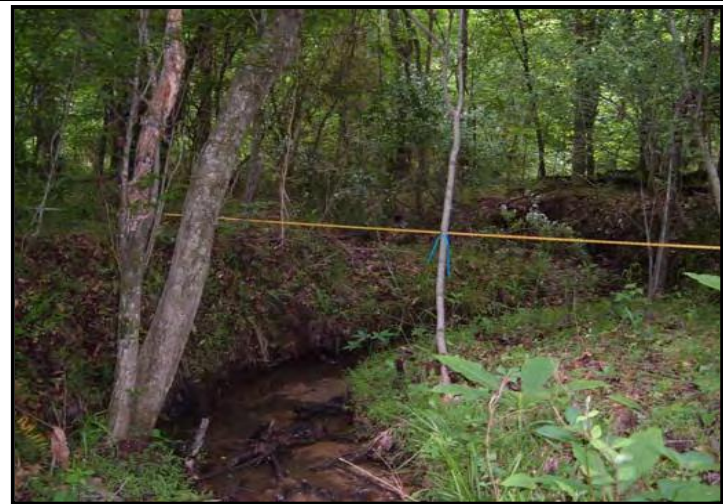
Cape Fear River Basin, UT Wilkinson-Reference Reach, XS - 1, Pool

Station	Elevation
0	99.89
3	99.77
7	99.90
9	99.66
10	99.01
10.8	96.30
11.3	96.22
12.6	96.62
13.3	96.87
14	97.34
15	97.86
18	98.19
21	98.40
25	99.15
30	99.66
33	99.72

SUMMARY DATA	
Bankfull Elevation:	98.4
Bankfull Cross-Sectional Area:	8.6
Bankfull Width:	10.8
Flood Prone Area Elevation:	-
Flood Prone Width:	-
Max Depth at Bankfull:	2.2
Mean Depth at Bankfull:	0.8
W / D Ratio:	-
Entrenchment Ratio:	-
Bank Height Ratio:	-
Water Surface Slope (ft/ft):	0.018

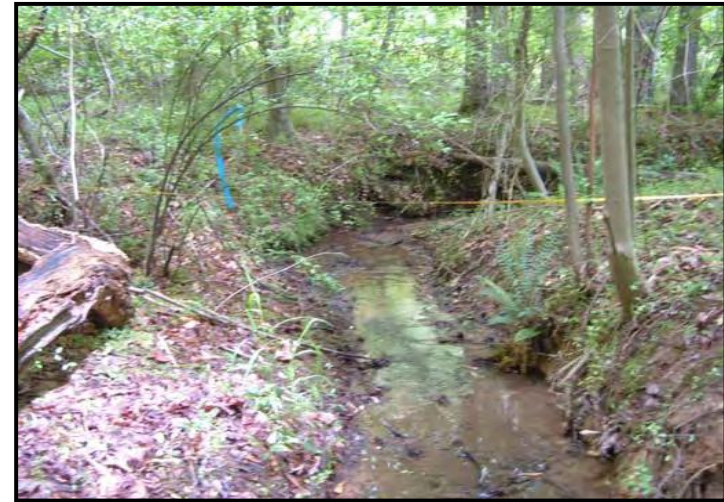
River Basin:	Cape Fear
Watershed:	UT Wilkinson-Reference Reach
XS ID	XS - 2, Riffle
Drainage Area (sq mi):	0.145
Date:	5/9/2006
Field Crew:	A. Helms, A. French

Station	Elevation
1	99.70
5	99.80
9	99.57
12	98.23
16	97.33
18	96.84
18.7	96.37
19.7	96.32
21	96.41
22	97.72
24	98.81
26	99.13
30	99.22
35	99.38

SUMMARY DATA	
Bankfull Elevation:	97.7
Bankfull Cross-Sectional Area:	6.2
Bankfull Width:	7.7
Flood Prone Area Elevation:	99.1
Flood Prone Width:	16.0
Max Depth at Bankfull:	1.4
Mean Depth at Bankfull:	0.8
W / D Ratio:	9.6
Entrenchment Ratio:	2.1
Bank Height Ratio:	2.0
Water Surface Slope (ft/ft):	0.018

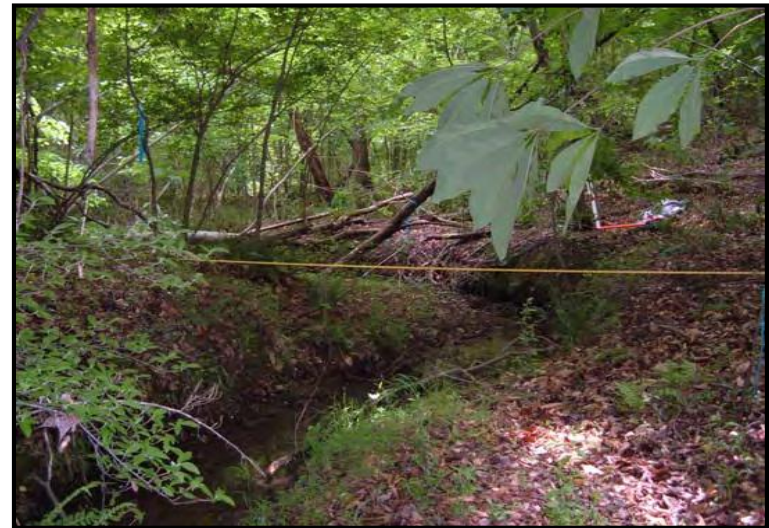
River Basin:	Cape Fear
Watershed:	UT Wilkinson-Reference Reach
XS ID	XS - 3, Riffle
Drainage Area (sq mi):	0.145
Date:	5/9/2006
Field Crew:	A. Helms, A. French

Station	Elevation
0	100.47
5	100.60
10	100.82
14	100.61
16	100.09
17	99.36
18	97.56
18.7	97.67
19.7	97.64
20.7	97.63
22	97.83
23.2	98.10
25	98.86
27	99.35
29	99.59
32	100.32
35	100.97
39	101.20

SUMMARY DATA	
Bankfull Elevation:	98.9
Bankfull Cross-Sectional Area:	7.0
Bankfull Width:	7.7
Flood Prone Area Elevation:	100.2
Flood Prone Width:	16.0
Max Depth at Bankfull:	1.3
Mean Depth at Bankfull:	0.9
W / D Ratio:	8.5
Entrenchment Ratio:	2.1
Bank Height Ratio:	2.3
Water Surface Slope (ft/ft):	0.018

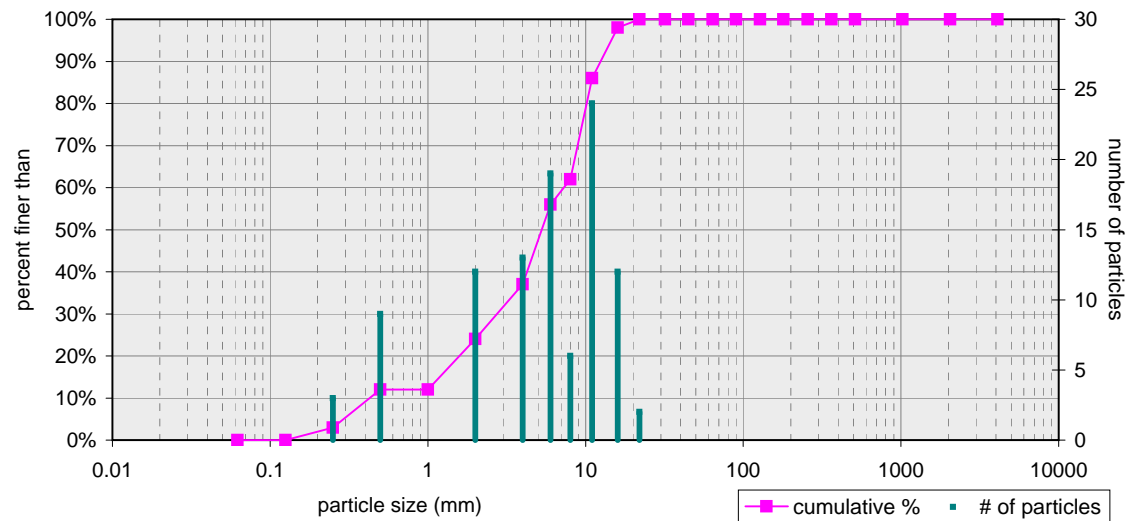
Note: XS 3

based on sediment particles only	size percent less than (mm)						particle size distribution gradation		
	D16	D35	D50	D65	D84	D95	geo mean	std dev	
	5.102	10.32	13.3	17	23	35	2.2	10.9	2.1
based on total count	percent by substrate type								
	silt/clay	sand	gravel	cobble	boulder	bedrock	hardpan	wood/det	artificial
	0%	12%	87%	1%	0%	0%	0%	0%	0%

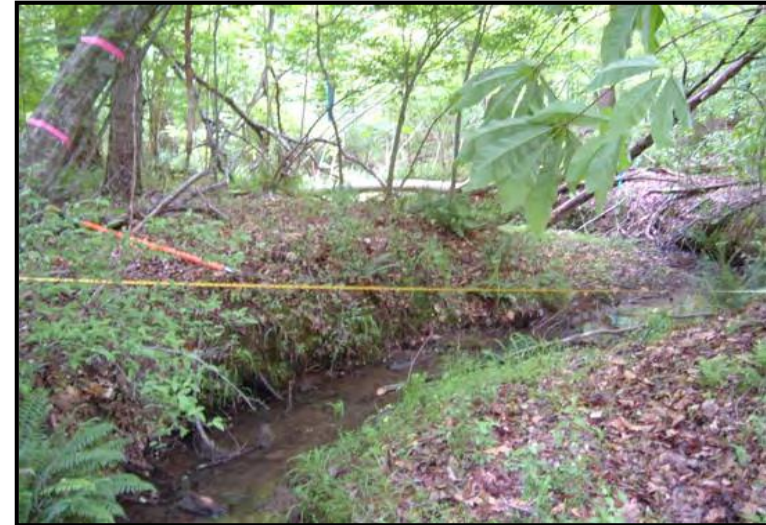
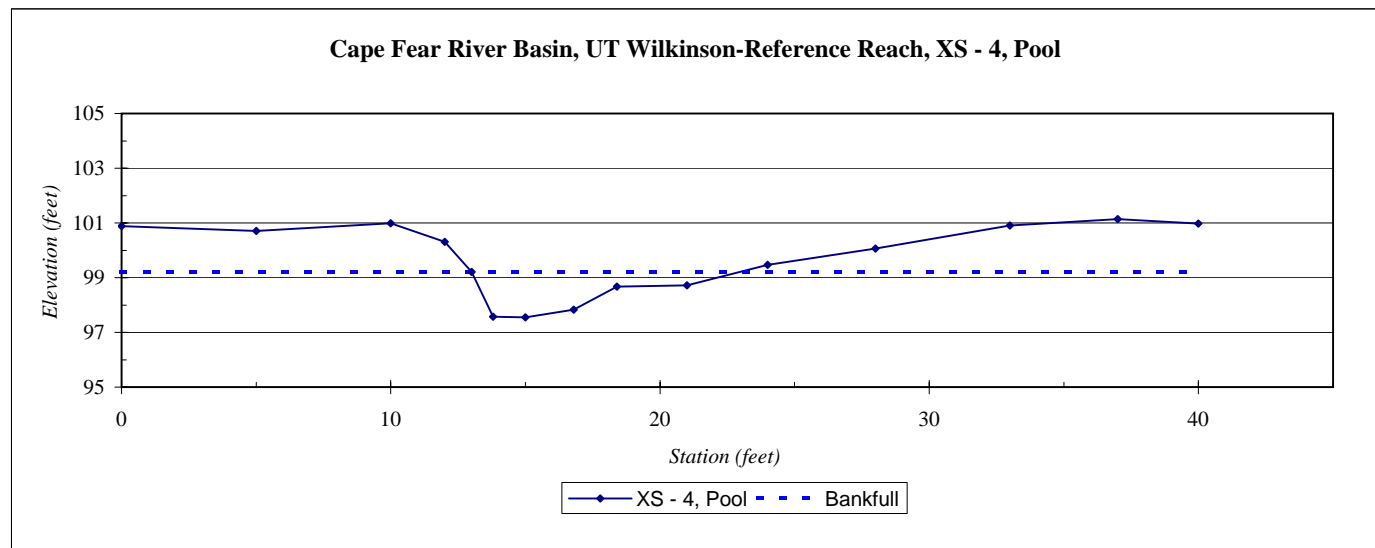
River Basin:	Cape Fear
Watershed:	UT Wilkinson-Reference Reach
XS ID	XS - 4, Pool
Drainage Area (sq mi):	0.145
Date:	5/9/2006
Field Crew:	A. Helms, A. French

Station	Elevation
0	100.88
5	100.71
10	100.98
12	100.31
13	99.22
13.8	97.58
15	97.55
16.8	97.84
18.4	98.67
21	98.72
24	99.47
28	100.07
33	100.90
37	101.15
40	100.98

SUMMARY DATA	
Bankfull Elevation:	99.2
Bankfull Cross-Sectional Area:	8.8
Bankfull Width:	10.0
Flood Prone Area Elevation:	-
Flood Prone Width:	-
Max Depth at Bankfull:	1.7
Mean Depth at Bankfull:	0.9
W / D Ratio:	-
Entrenchment Ratio:	-
Bank Height Ratio:	-
Water Surface Slope (ft/ft):	0.018

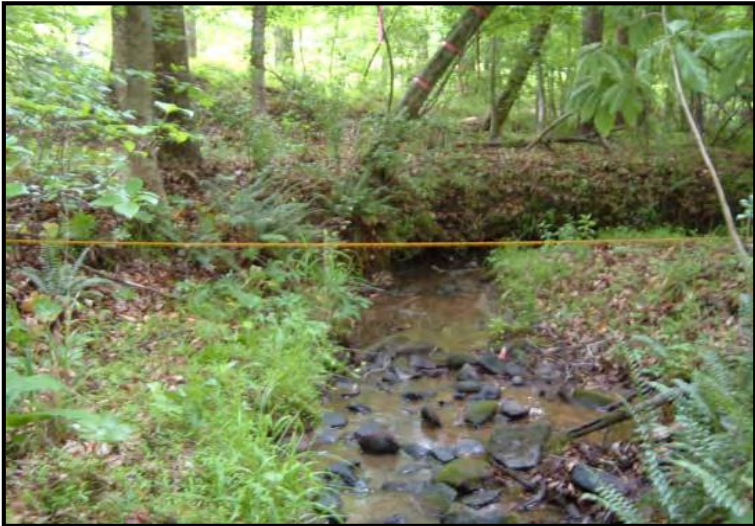
River Basin:	Cape Fear
Watershed:	UT Wilkinson-Reference Reach
XS ID	XS - 5, Riffle
Drainage Area (sq mi):	0.145
Date:	5/9/2006
Field Crew:	A. Helms, A. French

Station	Elevation
0.00	101.00
5.00	101.06
10.00	101.01
13.00	100.20
15.00	98.96
17.00	98.83
18.80	97.94
20.00	97.94
22.00	98.05
23.00	98.08
24.50	97.75
26.00	99.70
30.00	100.90
36.00	101.26

SUMMARY DATA	
Bankfull Elevation:	98.8
Bankfull Cross-Sectional Area:	6.1
Bankfull Width:	8.3
Flood Prone Area Elevation:	99.9
Flood Prone Width:	13.0
Max Depth at Bankfull:	1.1
Mean Depth at Bankfull:	0.7
W / D Ratio:	11.4
Entrenchment Ratio:	1.6
Bank Height Ratio:	2.7
Water Surface Slope (ft/ft):	0.018

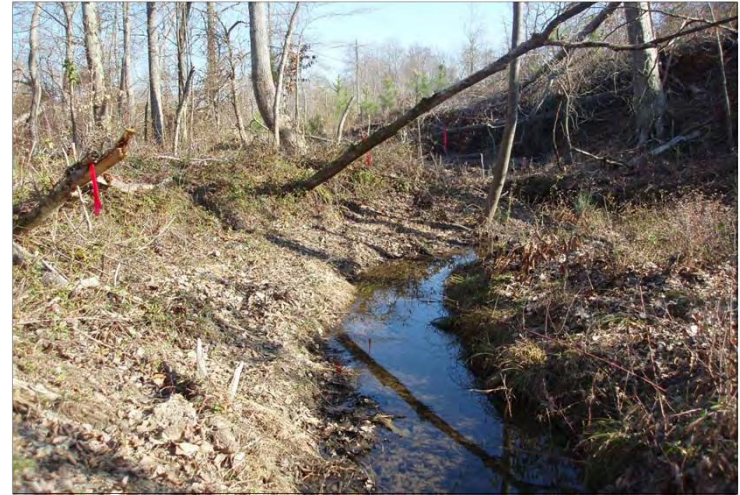
River Basin:	Yadkin-PeeDee
Watershed:	Irish Buffalo Creek, T1
XS ID	XS-Riffle (REFERENCE)
Drainage Area (sq mi):	0.16
Date:	2/17/2012
Field Crew:	A. French, K. O'Briant

Station	Elevation
0.0	804.36
1.3	804.11
3.0	804.18
4.1	803.88
4.9	802.68
6.2	801.85
7.8	801.91
9.1	801.56
10.2	801.30
10.7	801.05
11.3	800.38
11.8	799.94
12.4	799.89
13.1	799.86
13.8	799.86
14.5	799.89
15.2	800.17
15.4	800.52
16.3	801.50
17.5	801.77
20.0	801.79
23.1	801.81
24.7	802.02
26.4	802.18
28.3	803.75
30.9	804.12

SUMMARY DATA	
Bankfull Elevation:	801.6
Bankfull Cross-Sectional Area:	8.4
Bankfull Width:	8.0
Flood Prone Area Elevation:	803.4
Flood Prone Width:	23
Max Depth at Bankfull:	1.8
Mean Depth at Bankfull:	1.1
W / D Ratio:	7.6
Entrenchment Ratio:	2.9
Bank Height Ratio:	1.0

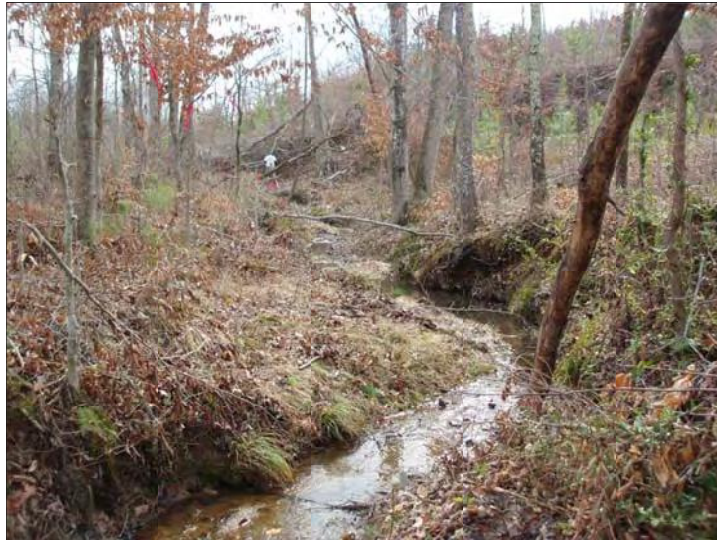
Looking downstream on reference reach. 2-17-2012

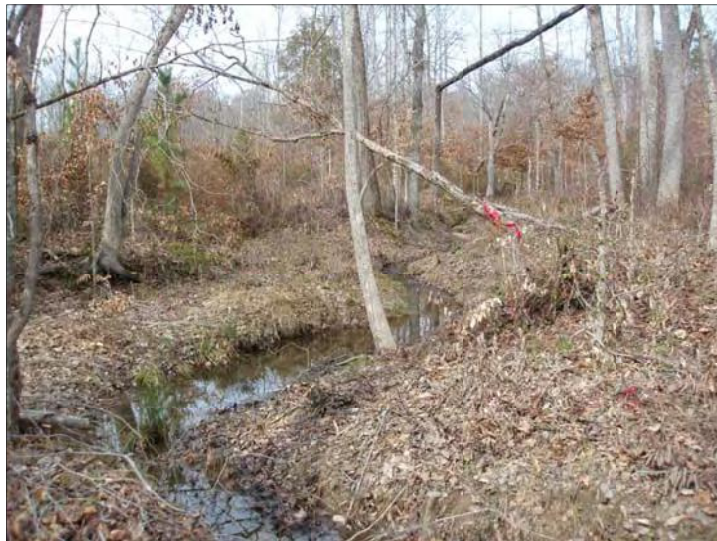
Looking downstream on reference reach. 2-17-2012

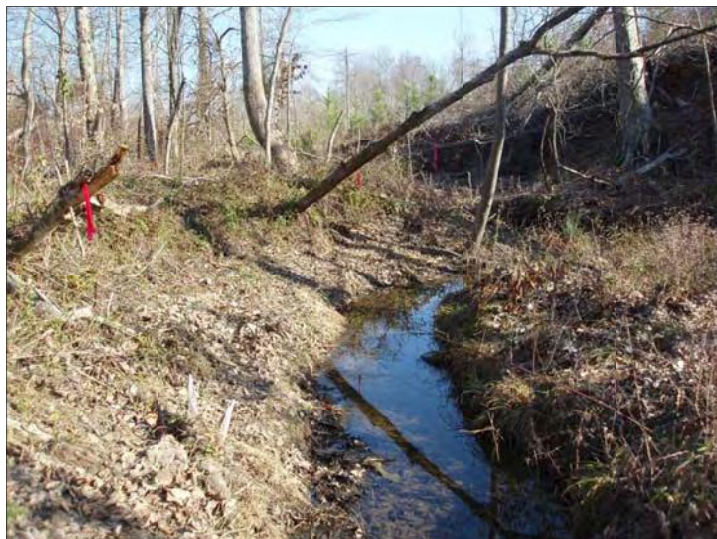
Looking downstream on reference reach. 2-17-2012

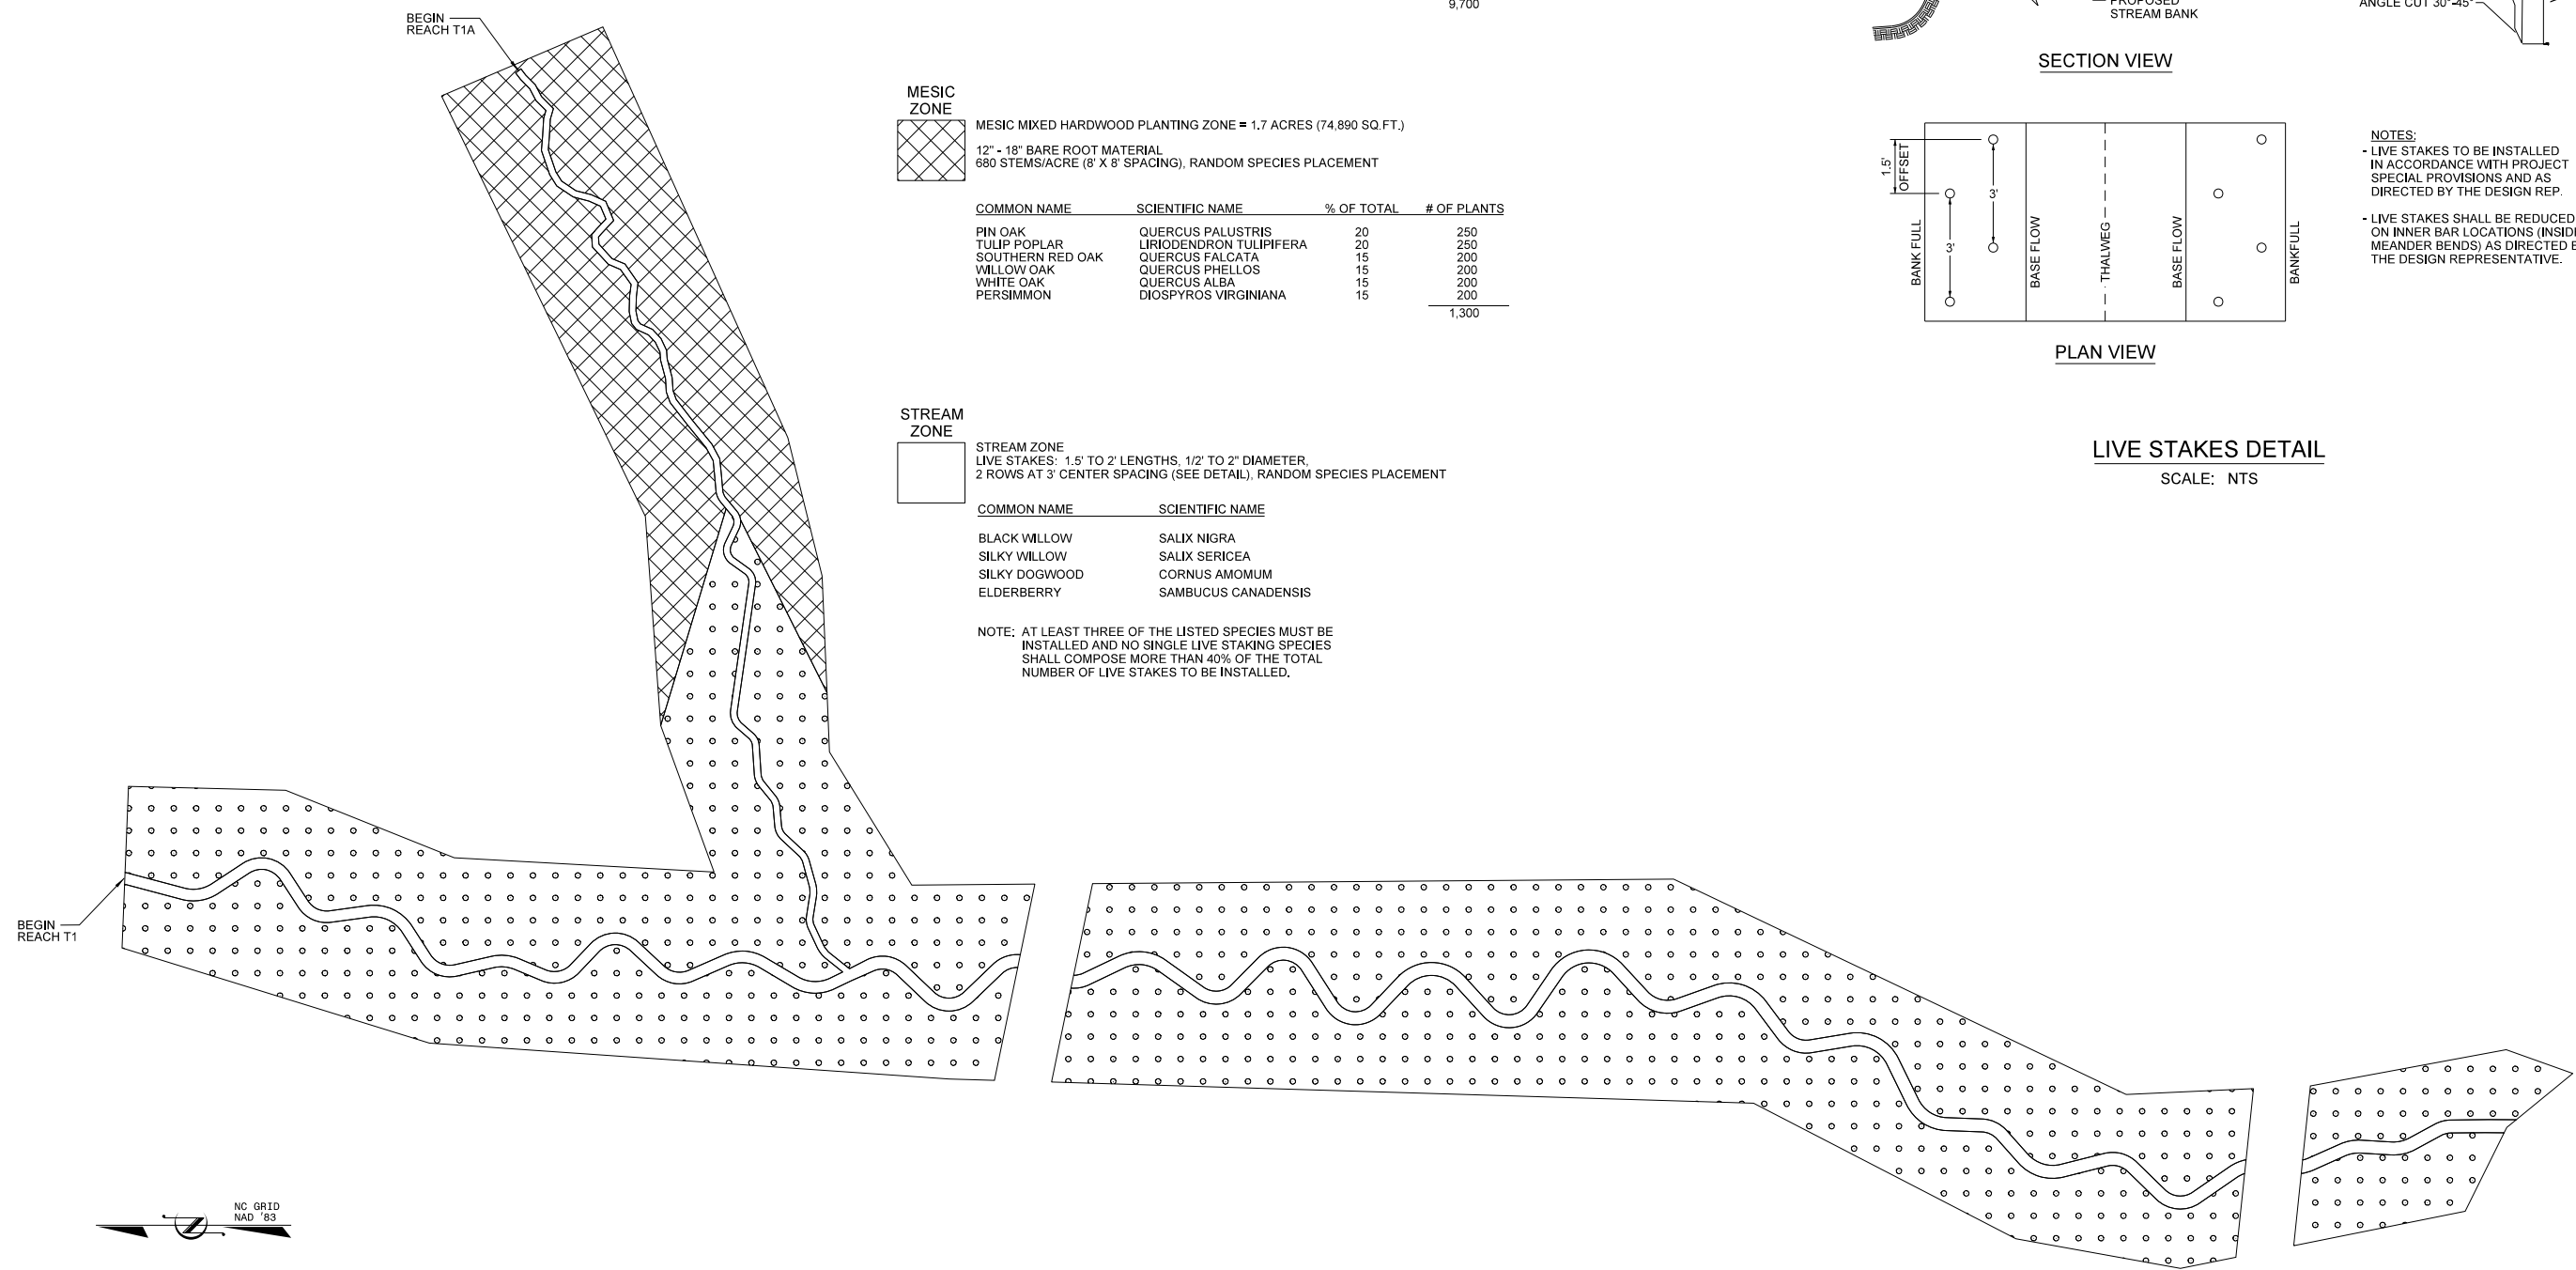
DATE: MAY 2012
SCALE: 1"=40'
SITE PLAN & PROFILE
SHEET 11 OF 23

JACOB'S LADDER
STREAM MITIGATION PROJECT
CHINA GROVE, ROMAN COUNTY, NORTH CAROLINA
REACH T2-2
