# Baseline Monitoring Document and As Built Baseline Report

**Jacob's Ladder Stream Restoration Site  
Rowan County, North Carolina  
EEP Contract 003983  
EEP Project Number 95023**

**Monitoring Data Collected: February/March 2014  
Date Submitted: September 2014**

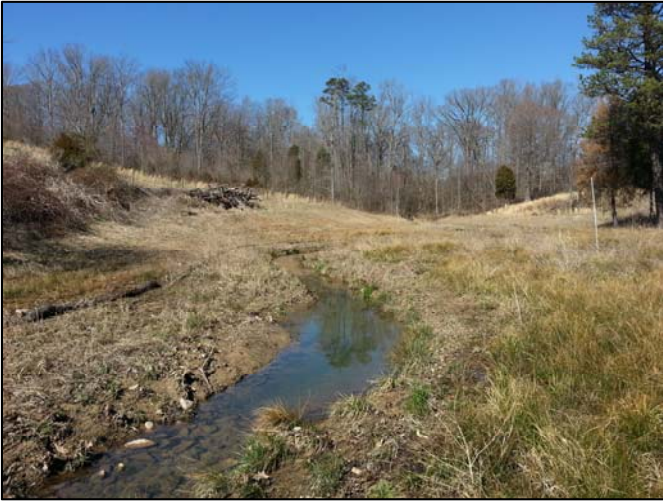
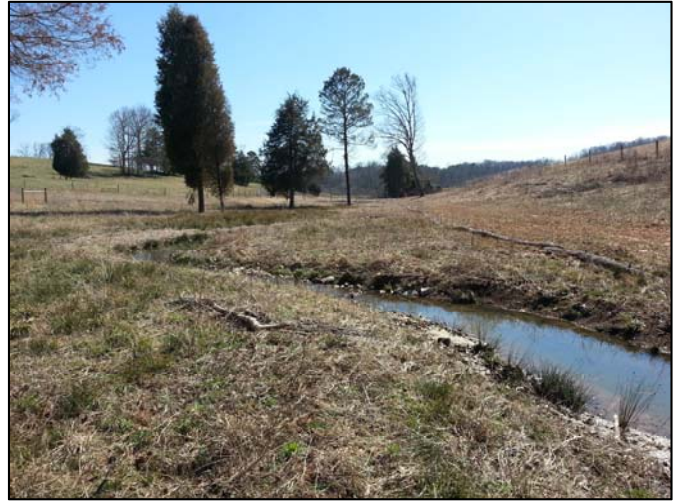
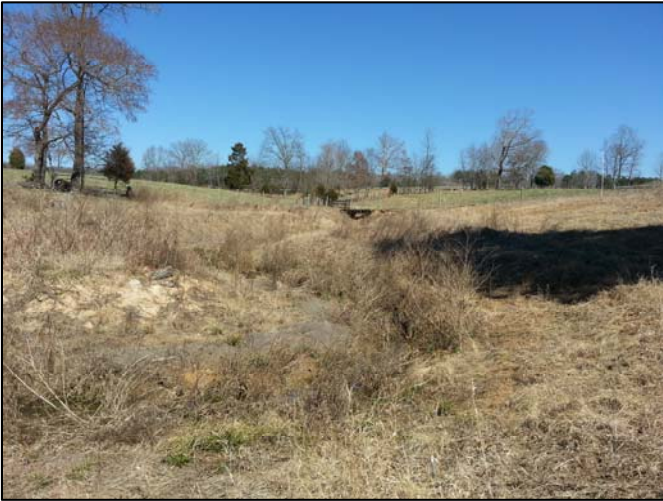
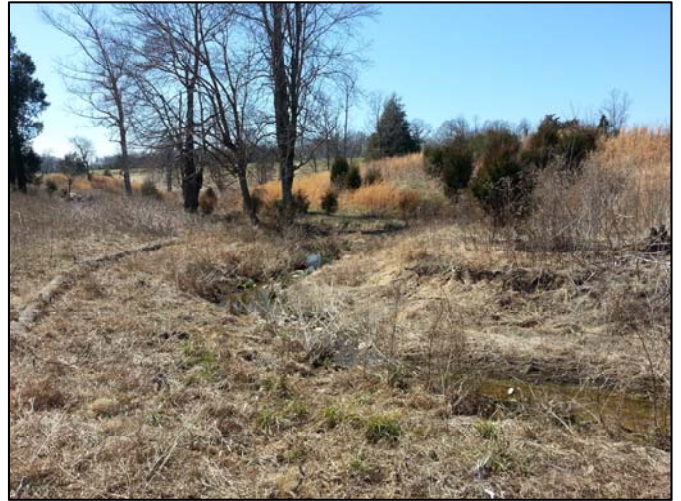
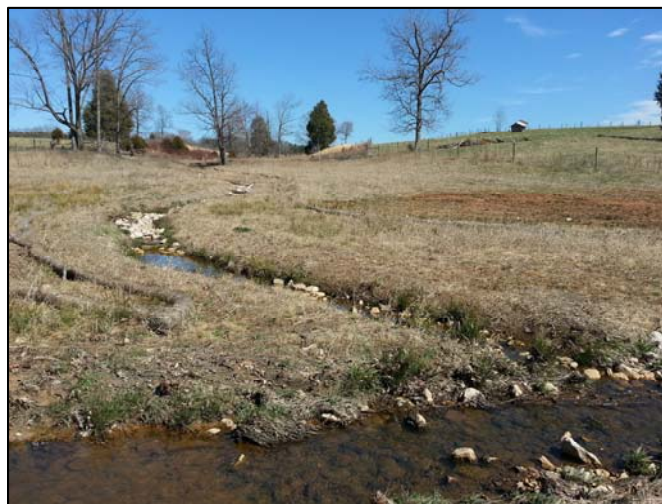
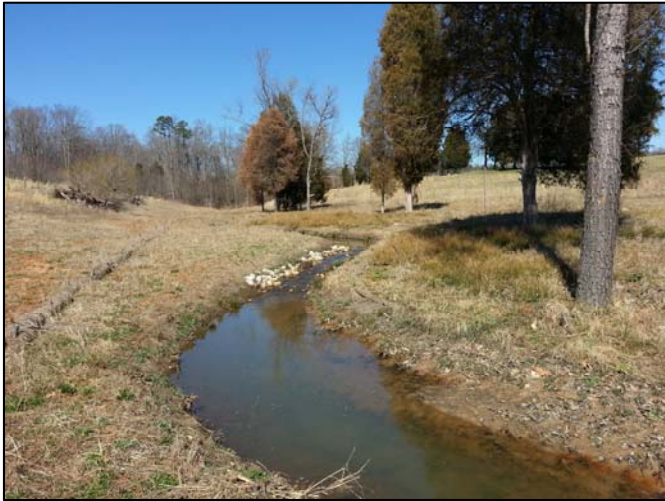
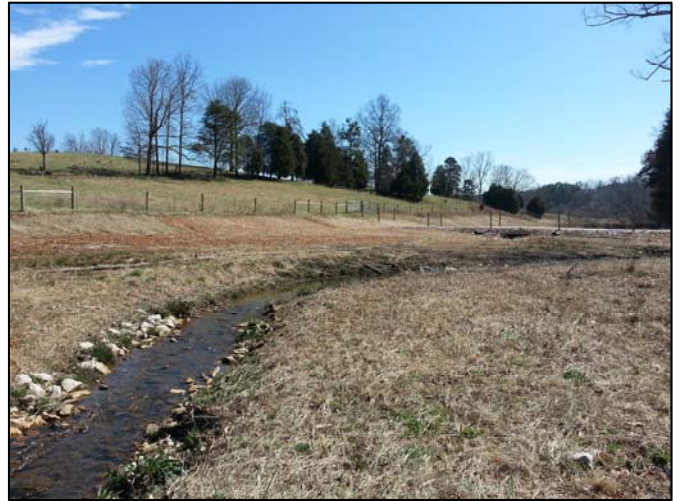
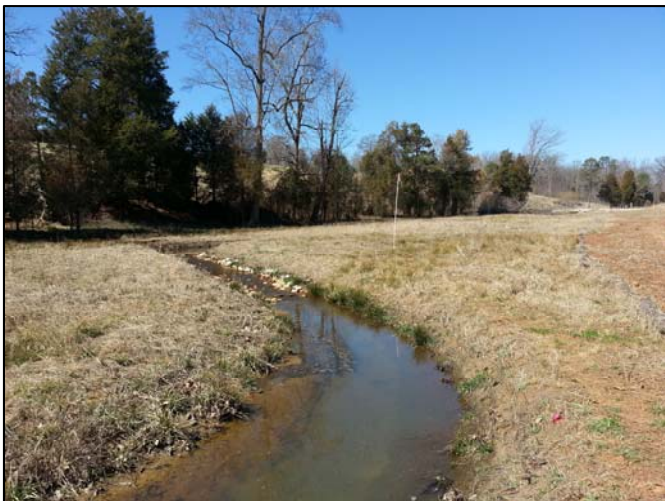
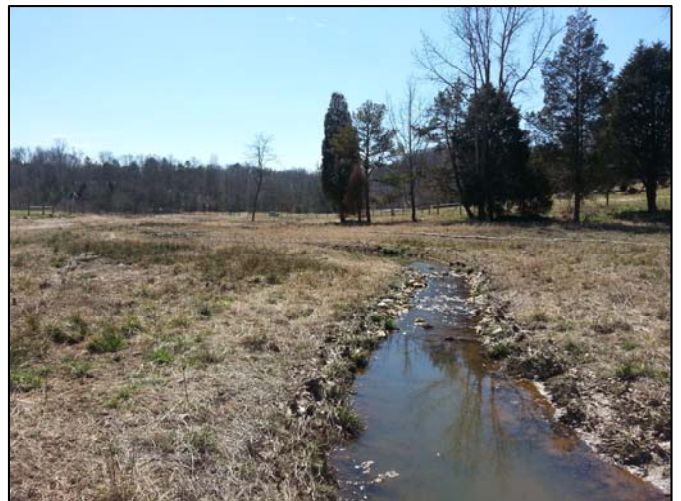
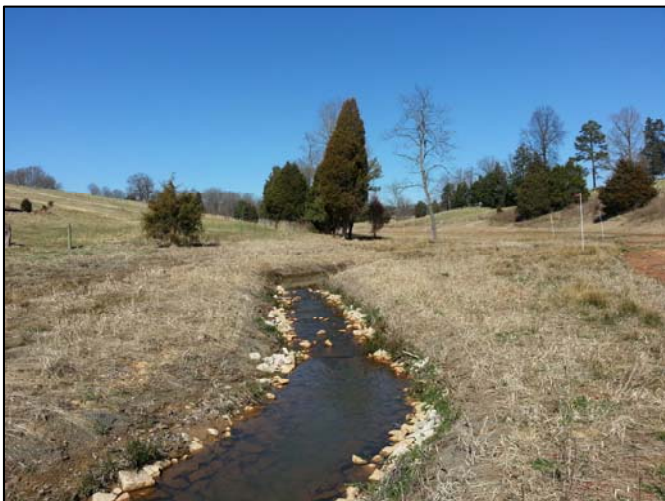
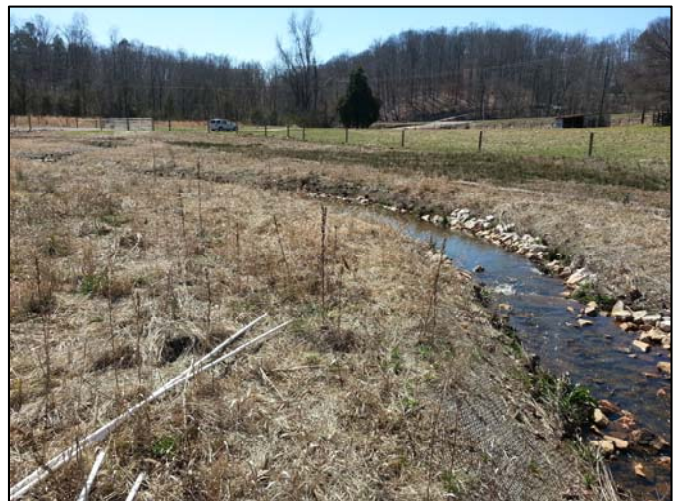
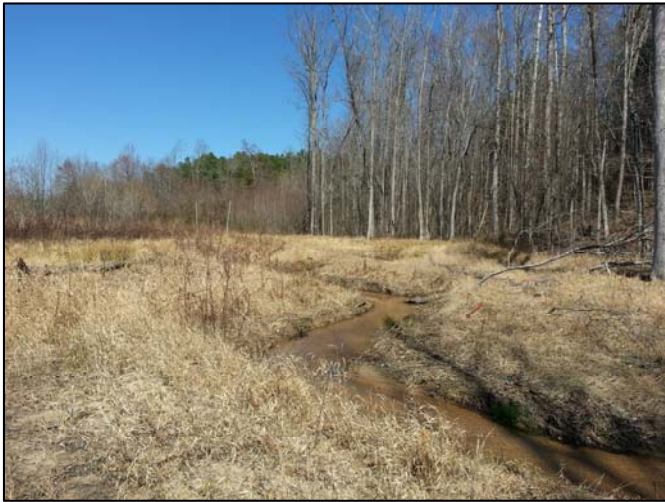
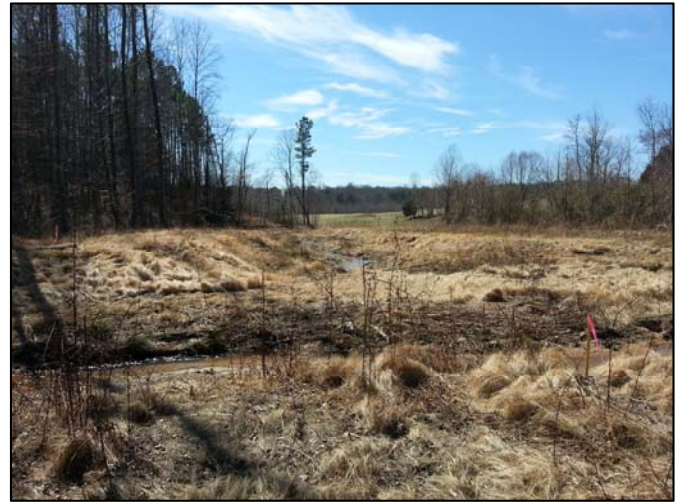
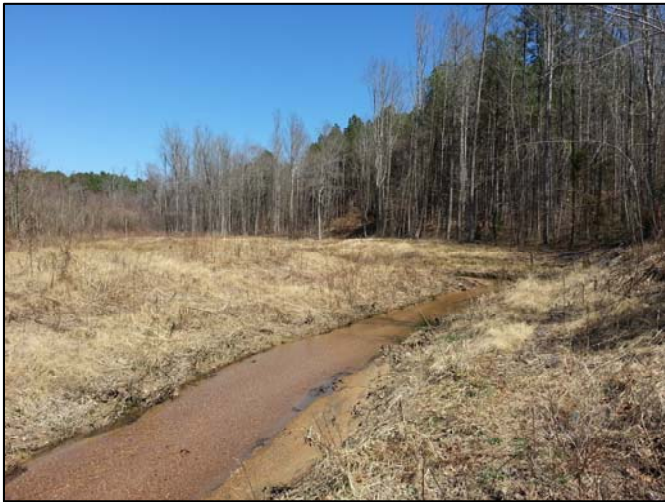
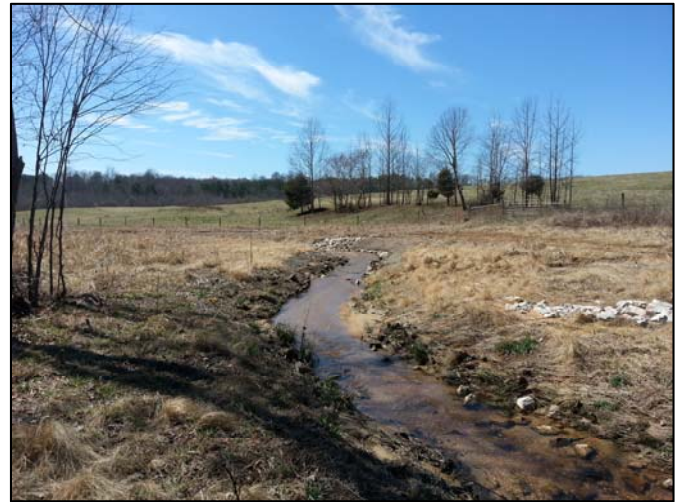
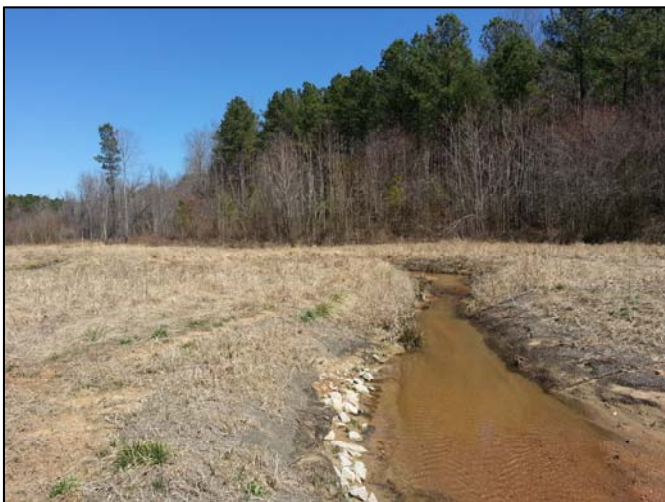
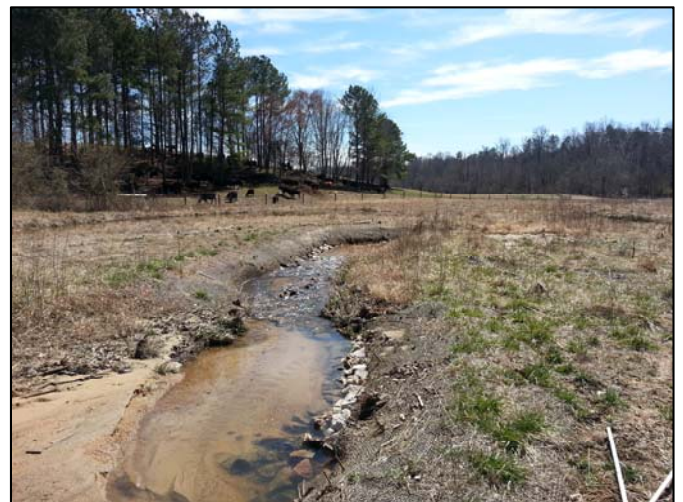
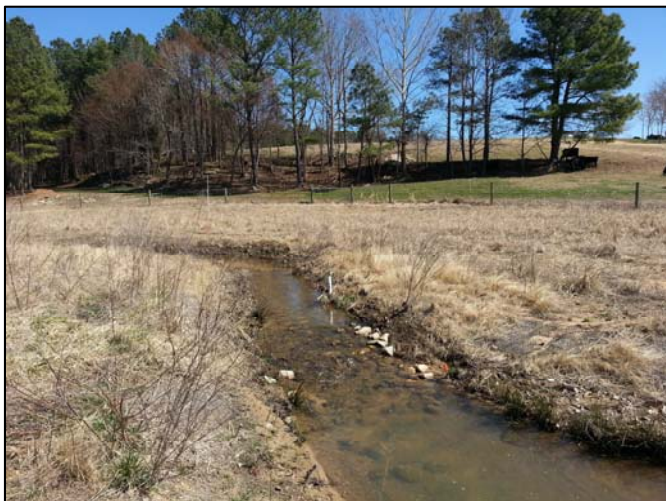
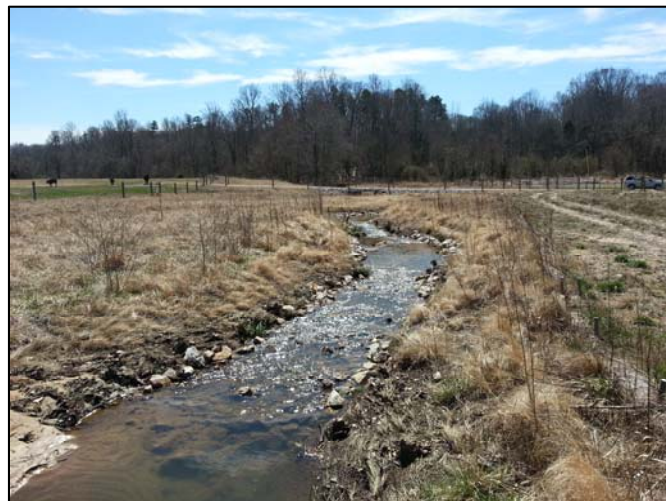
## Photo Reference Points

Nine photograph reference points (PRPs) have been established as part of the baseline monitoring to assist in characterizing the Site and to allow qualitative evaluation of the Site conditions. Starting in the first monitoring year, these photos will be taken in late summer, so that vegetative conditions are similar at the Site between monitoring years.

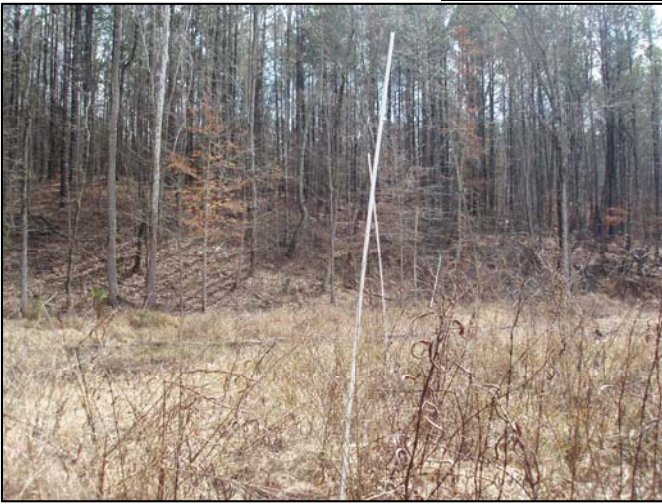
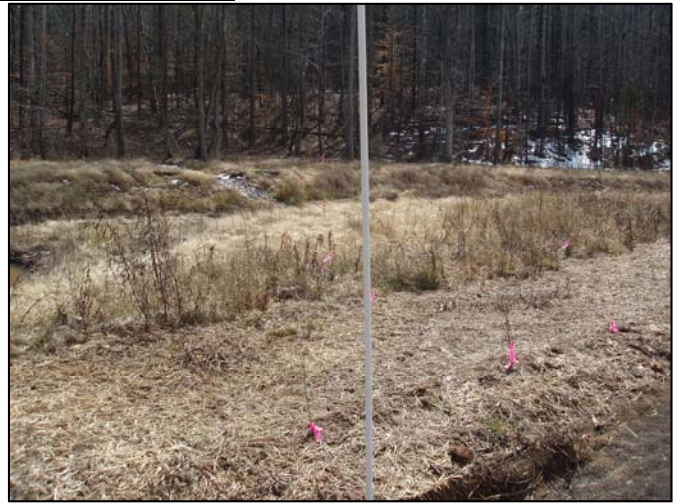
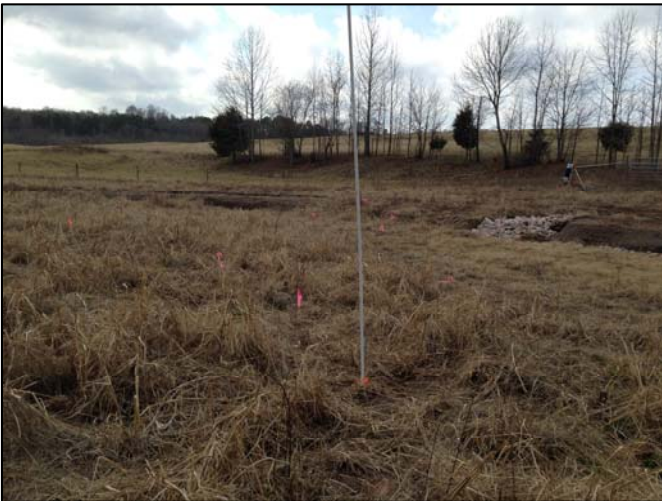
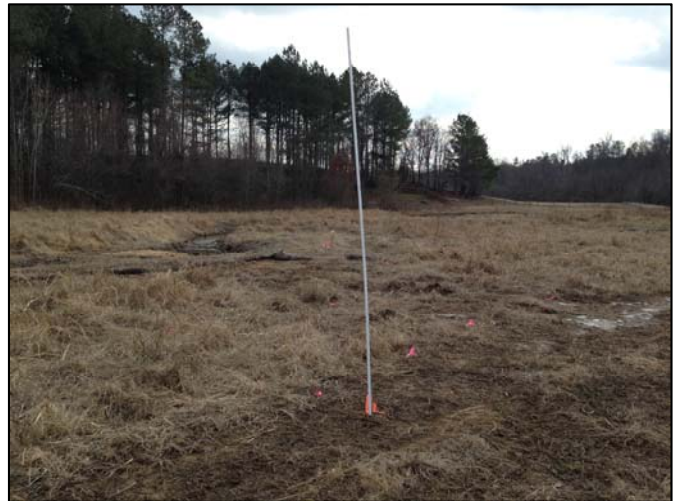
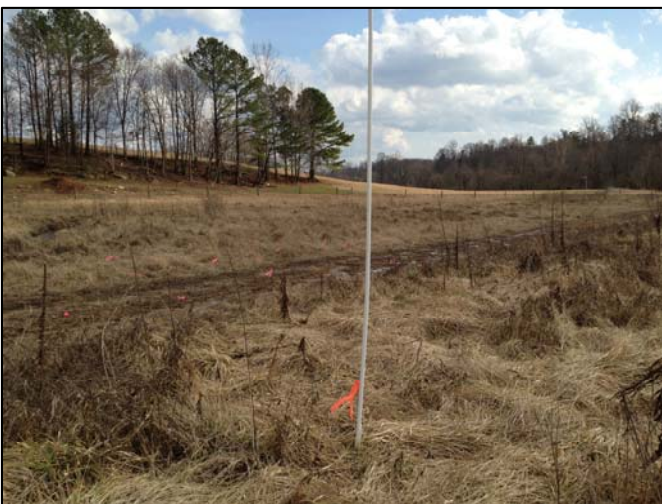
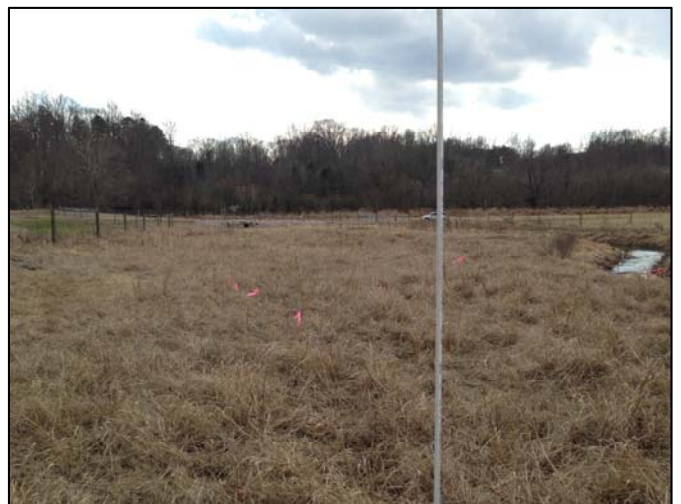
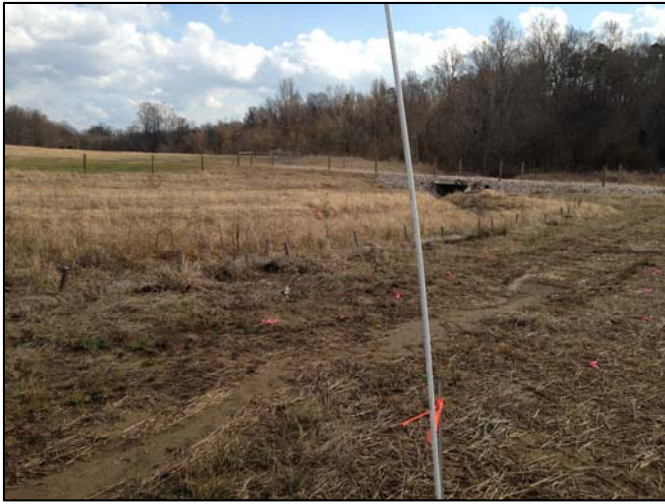
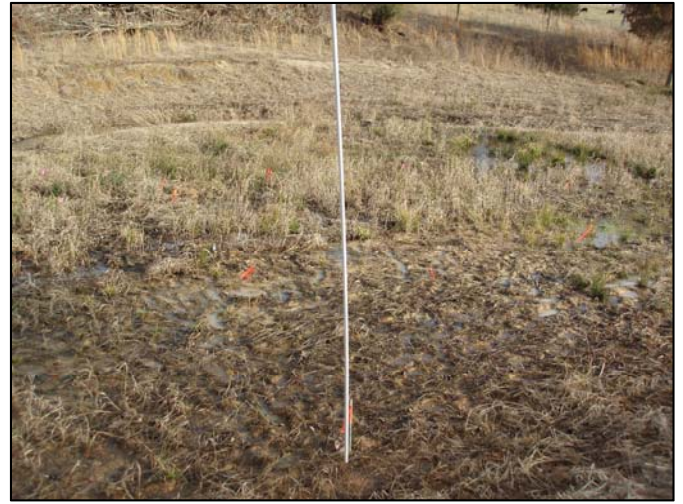
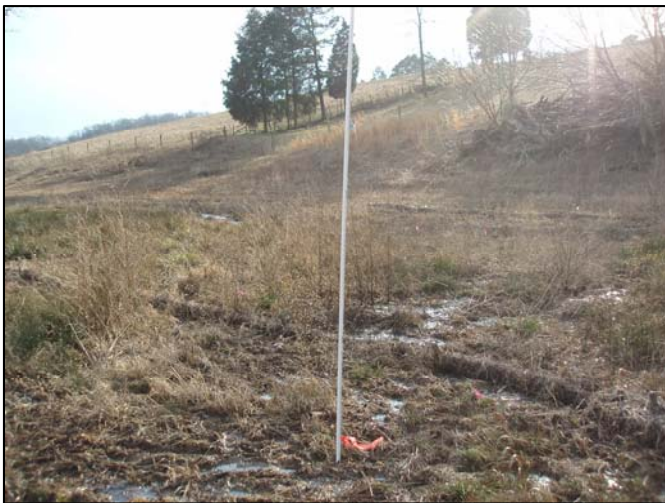
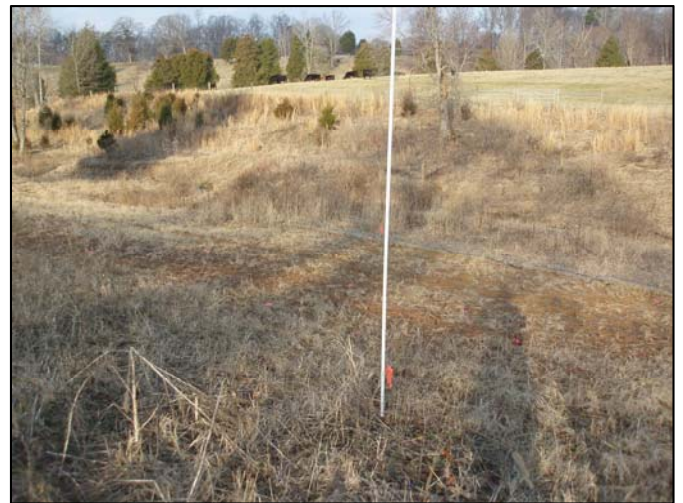
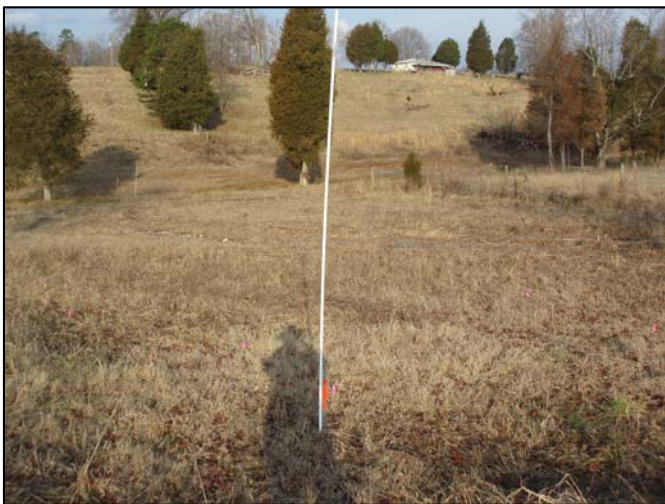
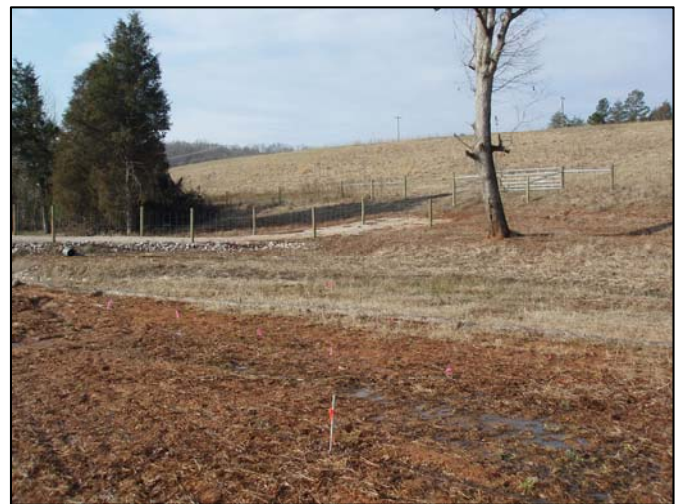
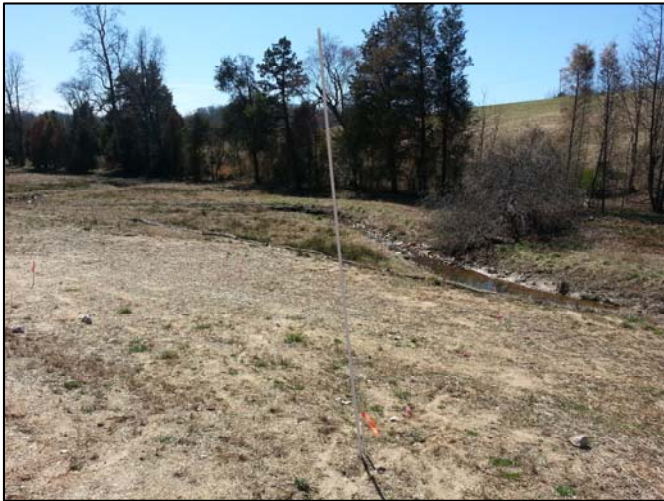
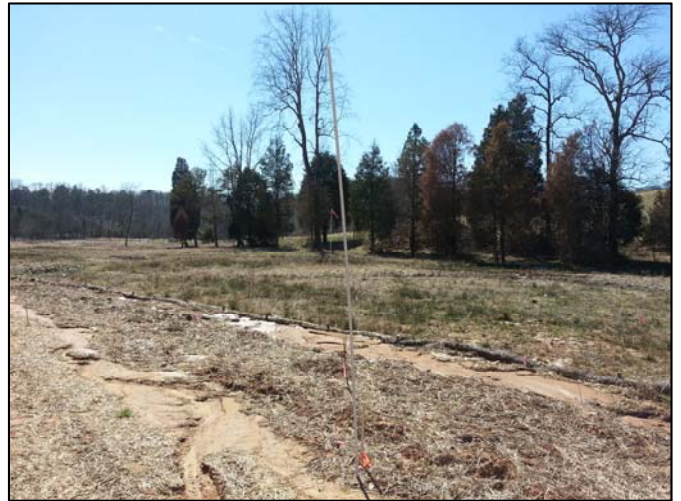
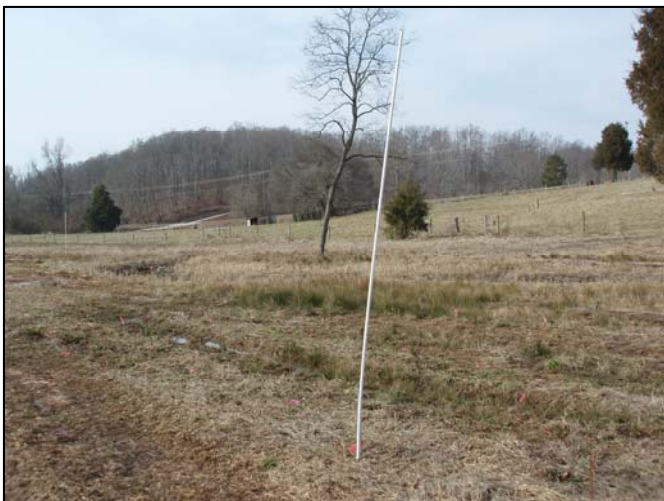
## Vegetation Monitoring Plot Photos

The Site was planted with a total of nine different species of bare root trees in January 2014. Baseline vegetation monitoring data were collected in February 2014. The Level 1 CVS-EEP protocol (<http://cvs.bio.unc.edu/methods.htm>) was used to collect vegetation data. Plot photos from all the vegetation plots can be found in Appendix C.
