Re: NCIRT Review and USACE Approval of the Jacobs Landing Mitigation Plan (SAW 2012-01006)

**Jacob's Landing Stream Restoration Site  
Rowan County, North Carolina  
EEP Contract 003984**

**Yadkin-Pee Dee River Basin  
Cataloging Unit 03040105**

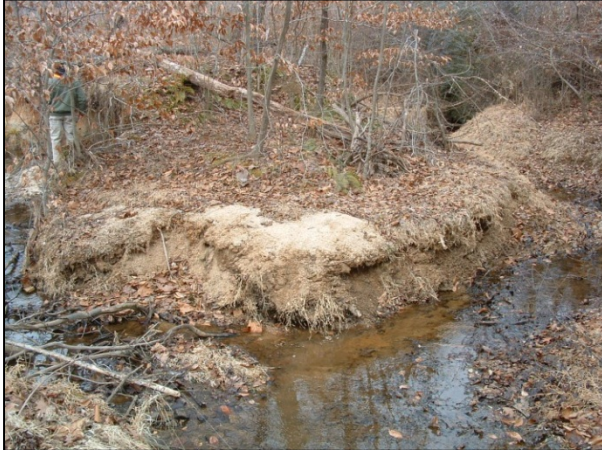
Looking upstream at the confluence of T1-1 and T1A.  
1/24/2011

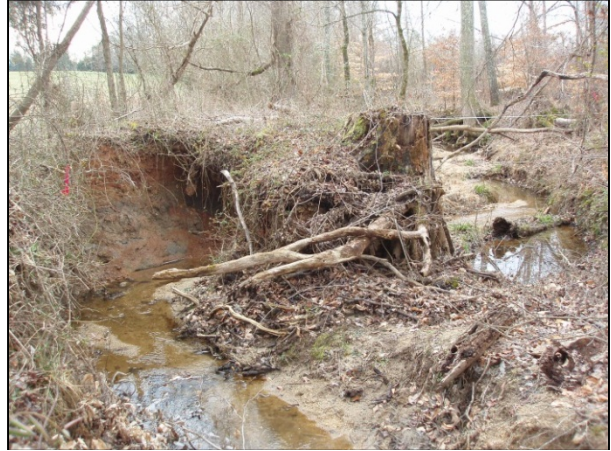
Looking downstream at T1-1. 2/21/2012

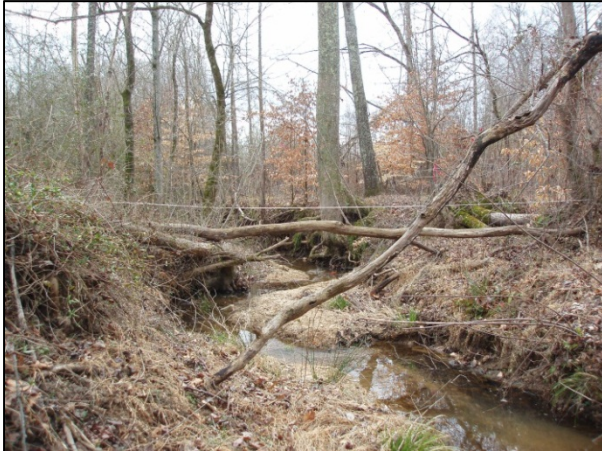
Looking downstream at T1-1. 2/21/2012

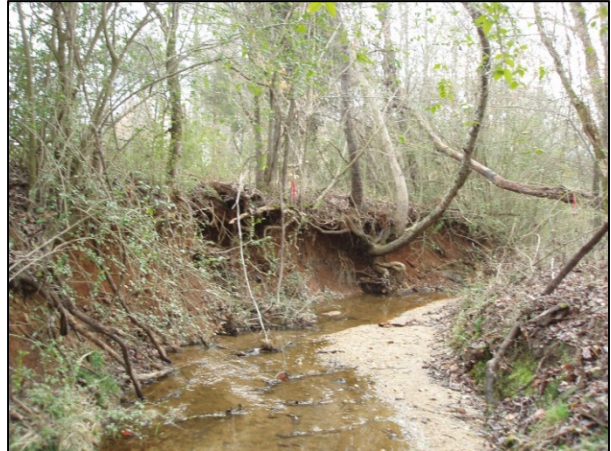
Looking downstream at T1-2. 2/21/2012

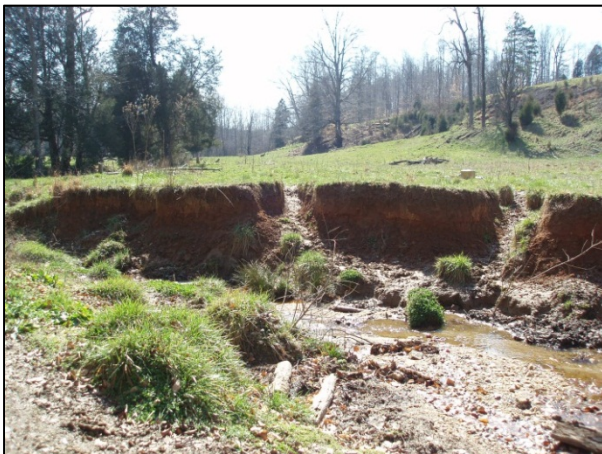
Looking downstream at T1-3. 2/21/2012

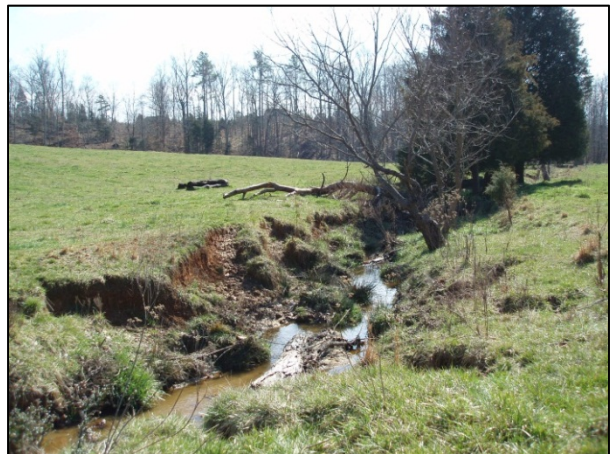
Looking downstream at T1-3. 2/21/2012

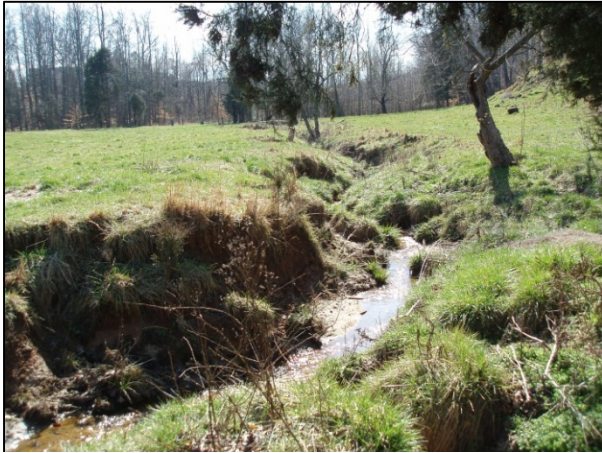
Looking downstream at T1-3. 2/21/2012

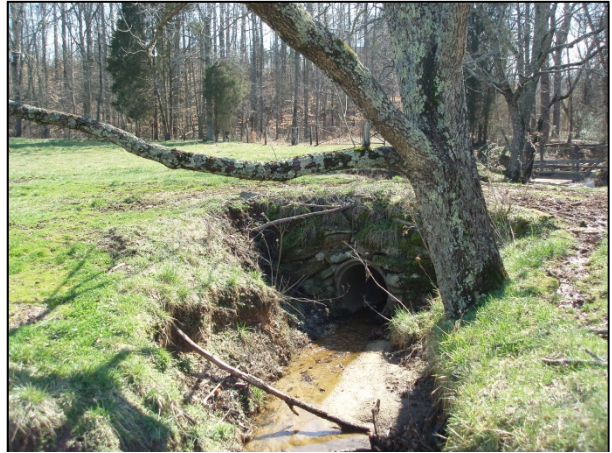
Looking downstream at the culvert on T1-3. 2/21/2012

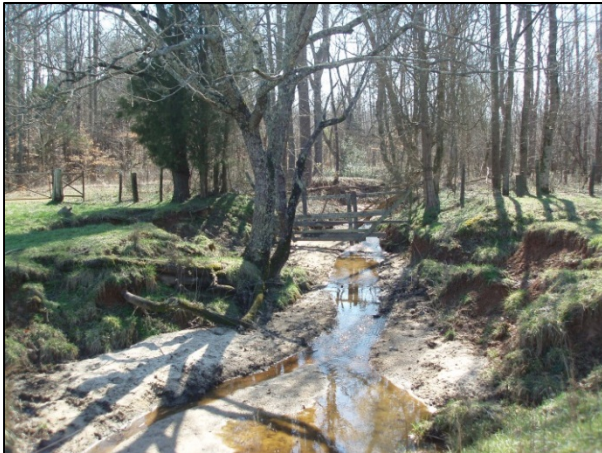
Looking downstream at the end of T1-3. 2/21/2012

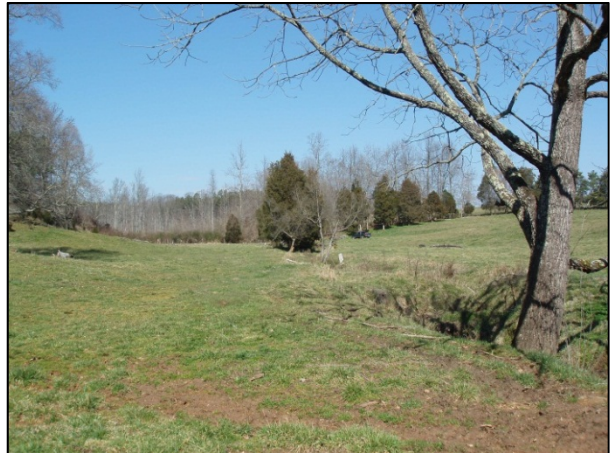
Looking upstream at T1-3. 2/21/2012

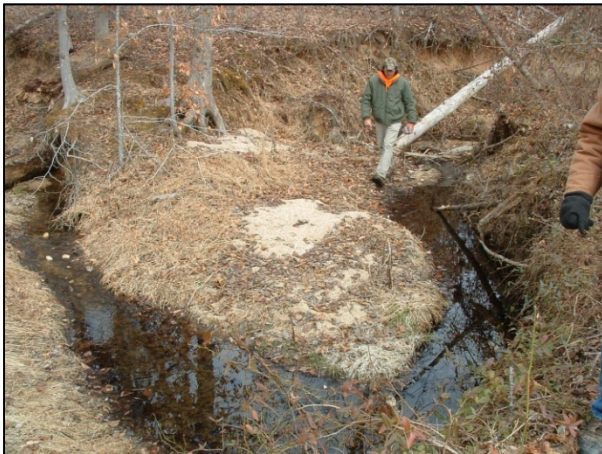
Looking downstream at the beginning of T1A. 1/24/2011

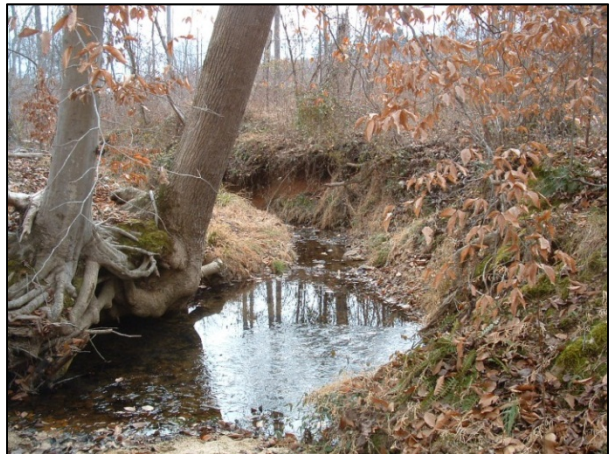
Looking downstream at T1A. 1/24/2011

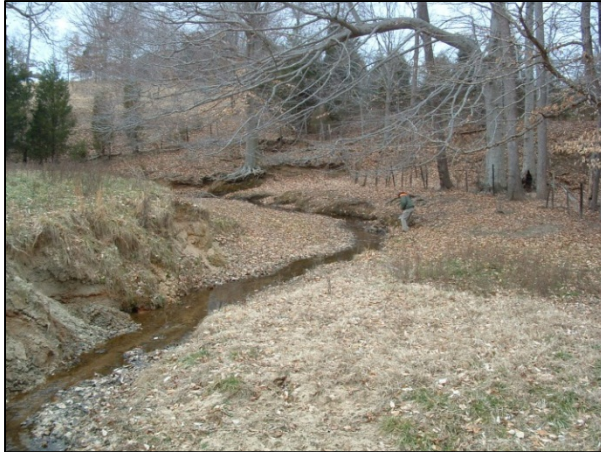
Looking downstream at the beginning of T2-1. 1/24/2011

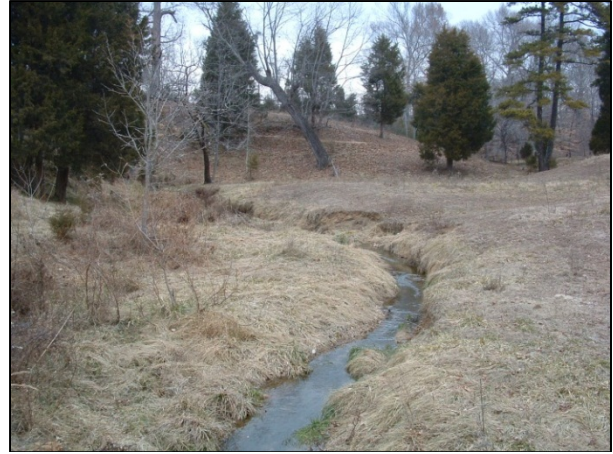
Looking downstream at T2-1. 1/24/2011

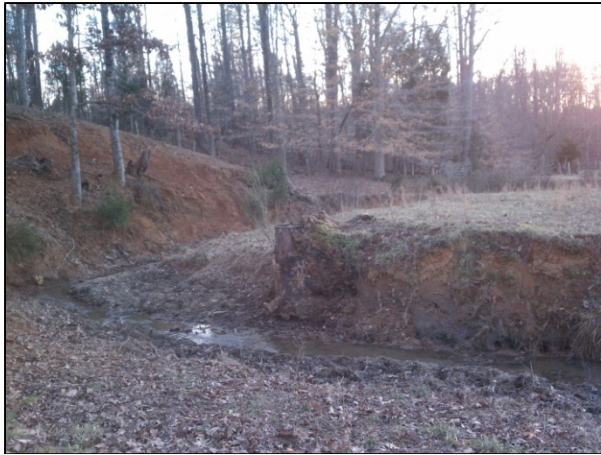
Looking downstream at T2-1. 2/15/2012

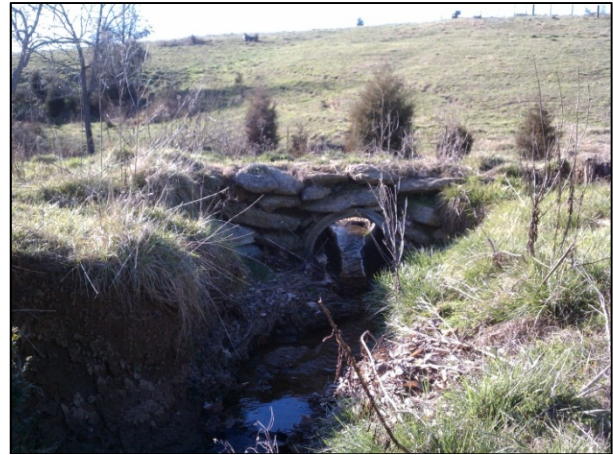
Looking downstream at a culvert on T2-1. 2/15/2012

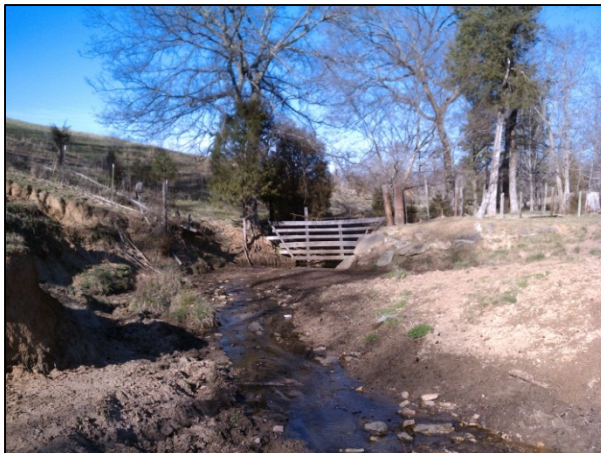
Looking upstream at cattle crossing on T2-1. 2/15/2012

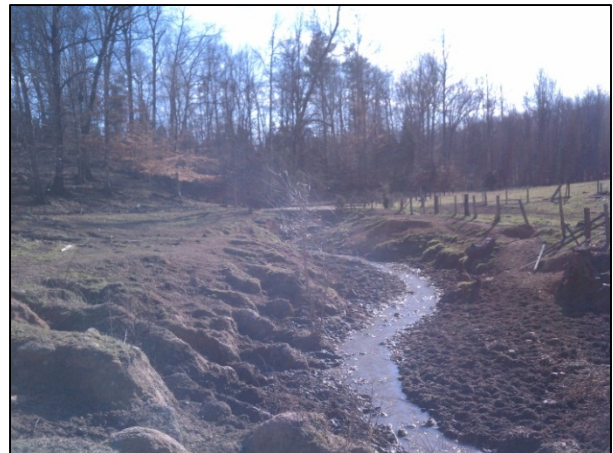
Looking downstream at cattle crossing on T2-1. 2/15/2012

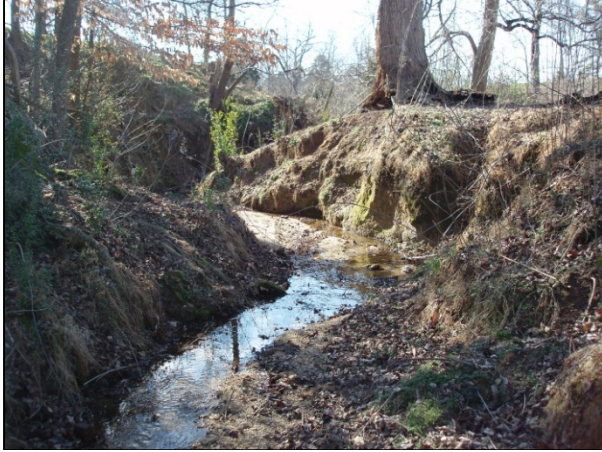
Looking downstream at incised banks on T2A. 2/21/2012

T2A is confined within a steep valley and the removal of riparian vegetation has led to bank erosion. The stream is also cutting down to meet the confluence with T2-2, which has caused bed degradation and an incised channel. This reach will be enhanced by shaping the banks to creating a bankfull bench, and installing grade control structures to gradually drop the bed elevation down. The reach will be stabilized by replanting the riparian buffer to achieve a mix of native tree species.

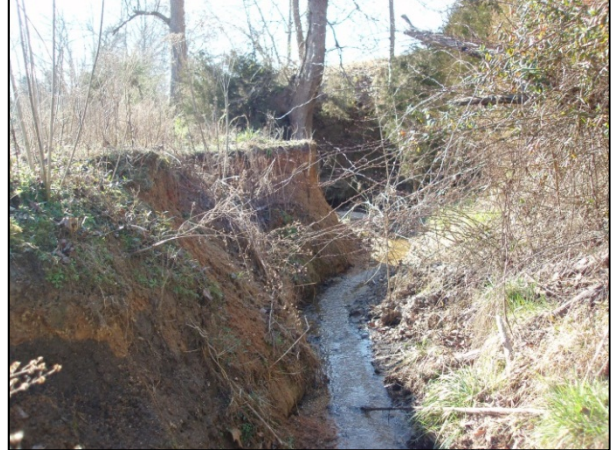
Looking downstream at incised banks on T2A. 2/21/2012

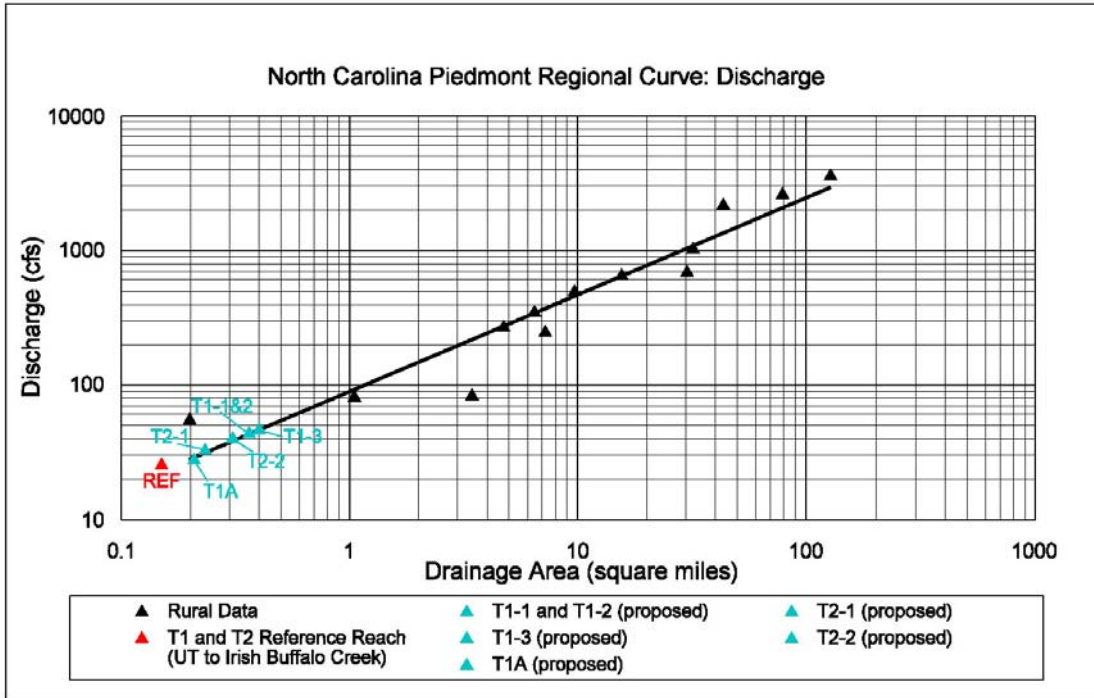
### 4.4 Regional Curve Discharge

Reference; Wildlands Engineering, Inc. 2010

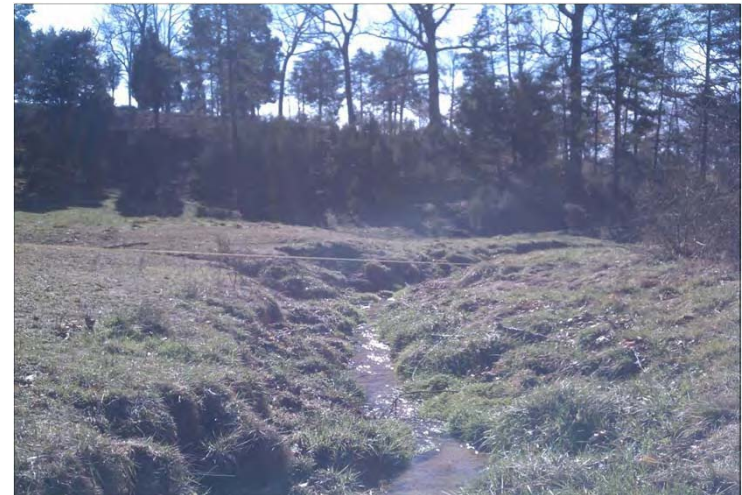
<b>River Basin:</b>	Yadkin-PeeDee
<b>Watershed:</b>	Irish Buffalo Creek, Existing Conditions, T2-1
<b>XS ID</b>	XS1 Riffle
<b>Drainage Area (sq mi):</b>	0.23
<b>Date:</b>	2/15/2012
<b>Field Crew:</b>	A. French, K. O'Briant

Station	Elevation
0.0	814.61
2.5	814.45
5.1	814.07
7.6	813.53
9.7	813.01
11.7	812.41
13.4	812.02
14.6	811.56
15.6	811.01
16.1	810.46
17.4	809.98
18.0	809.44
18.4	808.99
19.0	808.90
19.6	808.99
20.0	808.92
20.2	809.02
20.9	809.27
21.7	809.49
22.5	809.67
23.0	810.27
23.7	810.25
24.4	810.29
24.7	810.72
26.1	810.84
28.0	810.93
29.7	811.22
32.5	811.58
35.0	811.66

SUMMARY DATA	
<b>Bankfull Elevation:</b>	810.7
<b>Bankfull Cross-Sectional Area:</b>	9.2
<b>Bankfull Width:</b>	8.8
<b>Flood Prone Area Elevation:</b>	812.5
<b>Flood Prone Width:</b>	>20
<b>Max Depth at Bankfull:</b>	1.8
<b>Mean Depth at Bankfull:</b>	1.0
<b>W / D Ratio:</b>	8.4
<b>Entrenchment Ratio:</b>	2.3
<b>Bank Height Ratio:</b>	1.5

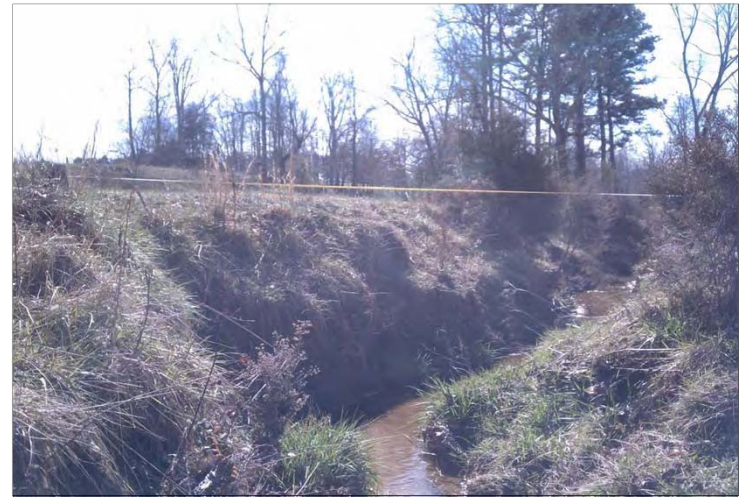
<b>River Basin:</b>	Yadkin-PeeDee
<b>Watershed:</b>	Irish Buffalo Creek, Existing Conditions, T2-1
<b>XS ID</b>	XS2-Pool
<b>Drainage Area (sq mi):</b>	0.23
<b>Date:</b>	2/15/2012
<b>Field Crew:</b>	A. French, K. O'Briant

Station	Elevation
0.0	806.17
3.0	806.08
6.3	806.01
8.7	805.91
10.0	805.76
11.1	805.31
12.0	804.60
12.9	803.61
13.6	803.03
14.6	800.29
15.2	800.02
16.0	800.18
16.6	800.32
17.6	800.45
18.3	800.54
18.9	801.76
19.5	802.02
20.6	801.94
21.3	802.86
23.3	803.32
26.5	803.83
30.1	804.32
32.7	804.46
34.3	804.50

SUMMARY DATA	
<b>Bankfull Elevation:</b>	802.3
<b>Bankfull Cross-Sectional Area:</b>	9.2
<b>Bankfull Width:</b>	7.0
<b>Flood Prone Area Elevation:</b>	804.5
<b>Flood Prone Width:</b>	14
<b>Max Depth at Bankfull:</b>	2.2
<b>Mean Depth at Bankfull:</b>	1.3
<b>W / D Ratio:</b>	5.3
<b>Entrenchment Ratio:</b>	1.9
<b>Bank Height Ratio:</b>	2.0

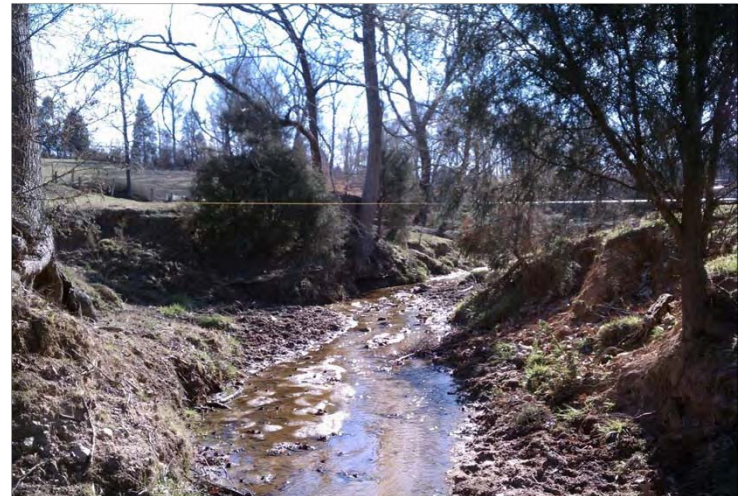
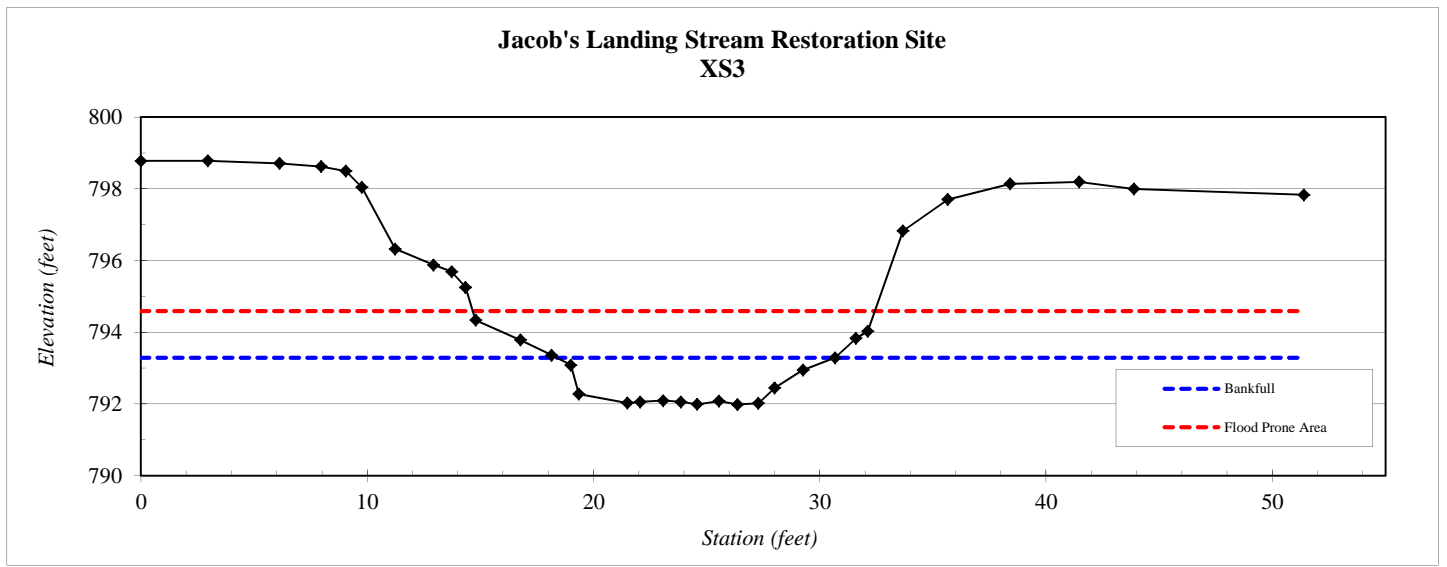
<b>River Basin:</b>	Yadkin-PeeDee
<b>Watershed:</b>	Irish Buffalo Creek, Existing Conditions, T2-2
<b>XS ID</b>	XS3 Riffle
<b>Drainage Area (sq mi):</b>	0.31
<b>Date:</b>	2/15/2012
<b>Field Crew:</b>	A. French, K. O'Briant

Station	Elevation
0.0	798.78
3.0	798.78
6.1	798.71
8.0	798.62
9.1	798.50
9.8	798.04
11.2	796.33
12.9	795.88
13.7	795.69
14.3	795.25
14.8	794.34
16.8	793.79
18.2	793.36
19.0	793.08
19.4	792.28
21.5	792.03
22.1	792.06
23.1	792.10
23.9	792.06
24.6	791.99
25.5	792.08
26.4	791.99
27.3	792.02
28.0	792.45
29.3	792.95
30.7	793.29
31.6	793.83
32.1	794.03
33.7	796.83
35.7	797.70
38.4	798.14
41.5	798.19
43.9	798.00
51.4	797.83

SUMMARY DATA	
<b>Bankfull Elevation:</b>	793.3
<b>Bankfull Cross-Sectional Area:</b>	11.7
<b>Bankfull Width:</b>	12.3
<b>Flood Prone Area Elevation:</b>	794.6
<b>Flood Prone Width:</b>	17
<b>Max Depth at Bankfull:</b>	1.3
<b>Mean Depth at Bankfull:</b>	1.0
<b>W / D Ratio:</b>	12.9
<b>Entrenchment Ratio:</b>	1.4
<b>Bank Height Ratio:</b>	4.7

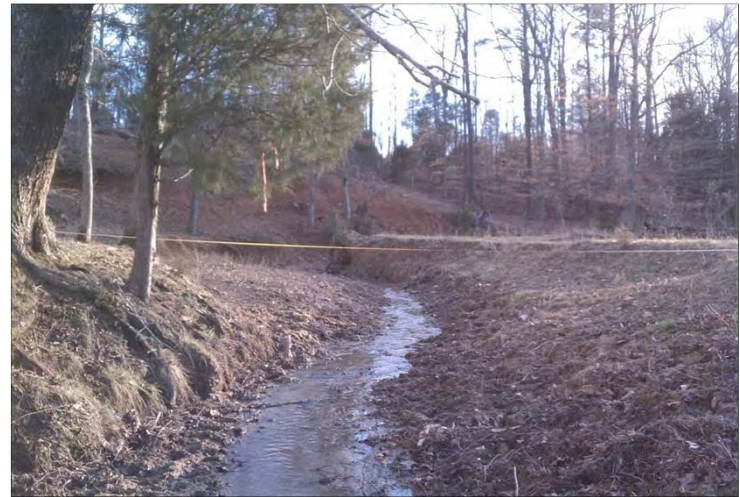
<b>River Basin:</b>	Yadkin-PeeDee
<b>Watershed:</b>	Irish Buffalo Creek, Existing Conditions, T2-2
<b>XS ID</b>	XS4 Riffle
<b>Drainage Area (sq mi):</b>	0.31
<b>Date:</b>	2/15/2012
<b>Field Crew:</b>	A. French, K. O'Briant

Station	Elevation
0.0	795.64
3.5	795.12
5.7	794.66
8.0	794.62
10.5	794.34
12.2	793.96
13.6	793.42
14.7	792.87
15.3	792.25
16.3	791.72
17.0	790.86
17.7	789.75
18.6	789.77
19.5	789.53
20.8	789.66
21.7	789.51
22.5	789.54
23.2	789.72
23.8	790.20
25.4	790.36
26.7	790.61
28.7	791.32
30.2	791.77
32.5	792.10
34.6	792.76
35.7	793.13
36.3	793.75
37.3	793.94
39.7	793.90
42.6	793.73
44.8	793.79
46.6	793.73

SUMMARY DATA	
<b>Bankfull Elevation:</b>	791.1
<b>Bankfull Cross-Sectional Area:</b>	11.3
<b>Bankfull Width:</b>	11.1
<b>Flood Prone Area Elevation:</b>	792.6
<b>Flood Prone Width:</b>	19
<b>Max Depth at Bankfull:</b>	1.5
<b>Mean Depth at Bankfull:</b>	1.0
<b>W / D Ratio:</b>	10.9
<b>Entrenchment Ratio:</b>	1.7
<b>Bank Height Ratio:</b>	2.9

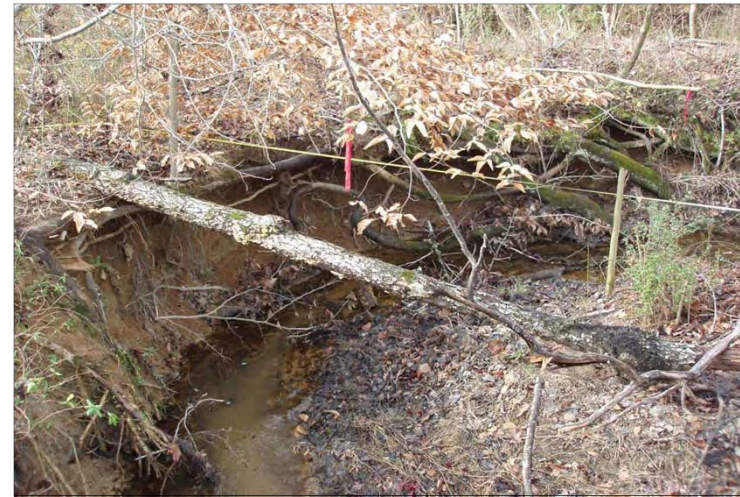
<b>River Basin:</b>	Yadkin-PeeDee
<b>Watershed:</b>	Irish Buffalo Creek, Existing Conditions, T1A
<b>XS ID</b>	XS5
<b>Drainage Area (sq mi):</b>	0.21
<b>Date:</b>	2/17/2012
<b>Field Crew:</b>	A. French, K. O'Briant

Station	Elevation
0.0	803.97
4.8	803.57
6.4	803.05
7.1	798.79
8.0	798.49
9.0	798.48
10.2	798.63
11.3	798.92
12.7	798.91
13.7	799.41
15.9	800.05
18.3	800.71
21.5	801.15
25.3	801.18
28.0	801.16

SUMMARY DATA	
<b>Bankfull Elevation:</b>	799.7
<b>Bankfull Cross-Sectional Area:</b>	6.4
<b>Bankfull Width:</b>	7.7
<b>Flood Prone Area Elevation:</b>	800.9
<b>Flood Prone Width:</b>	15
<b>Max Depth at Bankfull:</b>	1.2
<b>Mean Depth at Bankfull:</b>	0.8
<b>W / D Ratio:</b>	9.3
<b>Entrenchment Ratio:</b>	1.9
<b>Bank Height Ratio:</b>	2.2

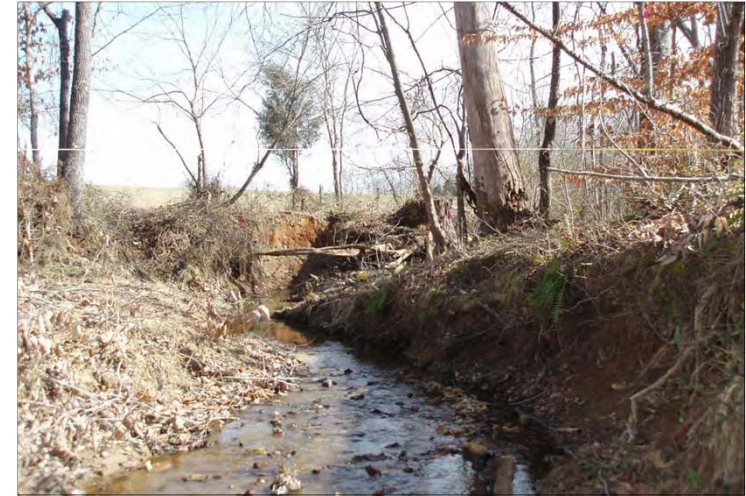
Jacob's Landing Stream Restoration Site  
XS6

<b>River Basin:</b>	Yadkin-PeeDee
<b>Watershed:</b>	Irish Buffalo Creek, Existing Conditions, T1-1
<b>XS ID</b>	XS6 Riffle
<b>Drainage Area (sq mi):</b>	0.37
<b>Date:</b>	2/17/2012
<b>Field Crew:</b>	A. French, K. O'Briant

Station	Elevation
0.0	802.00
2.7	802.27
4.8	801.88
6.3	801.65
8.5	801.41
10.1	800.59
11.2	799.73
12.2	799.05
14.0	798.47
15.7	798.06
16.9	797.95
17.9	797.79
18.6	797.66
19.1	796.12
20.0	796.03
20.7	795.95
21.6	795.85
22.4	795.90
23.4	795.90
24.1	795.86
26.9	796.06
27.7	796.32
27.9	796.56
28.2	799.35
29.2	799.94
30.1	800.28
32.2	801.15
33.5	801.34

SUMMARY DATA	
<b>Bankfull Elevation:</b>	797.0
<b>Bankfull Cross-Sectional Area:</b>	8.6
<b>Bankfull Width:</b>	9.1
<b>Flood Prone Area Elevation:</b>	798.0
<b>Flood Prone Width:</b>	14
<b>Max Depth at Bankfull:</b>	1.1
<b>Mean Depth at Bankfull:</b>	0.9
<b>W / D Ratio:</b>	9.6
<b>Entrenchment Ratio:</b>	1.5
<b>Bank Height Ratio:</b>	1.6

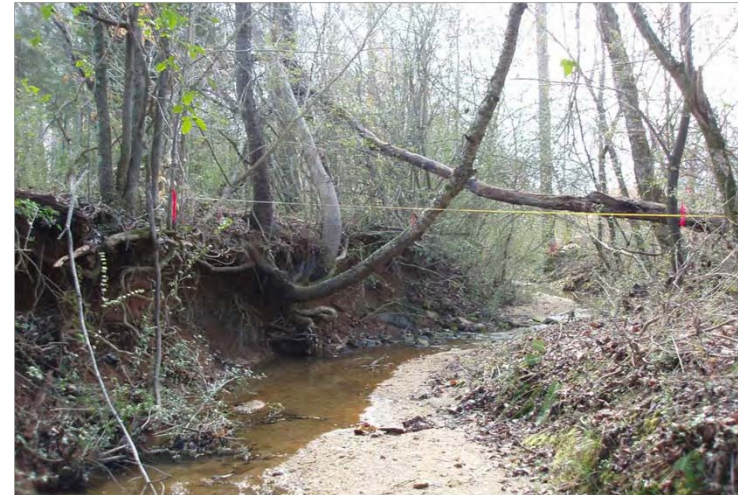
<b>River Basin:</b>	Yadkin-PeeDee
<b>Watershed:</b>	Irish Buffalo Creek, Existing Conditions, T1-2
<b>XS ID</b>	XS8
<b>Drainage Area (sq mi):</b>	0.37
<b>Date:</b>	2/10/2012
<b>Field Crew:</b>	A. French, A. Helms

Station	Elevation
0.0	800.07
0.9	799.93
1.7	799.83
2.3	799.33
2.8	798.55
3.6	793.78
3.7	793.35
4.1	793.04
4.5	793.11
5.2	793.15
5.6	793.19
6.2	793.31
6.5	793.42
7.1	793.56
8.1	794.47
8.3	794.99
9.5	795.56
10.3	795.99
11.2	796.26
12.1	796.57
12.7	797.02
14.0	797.18
14.9	797.56
15.9	798.12
16.9	798.08
18.1	797.86

SUMMARY DATA	
<b>Bankfull Elevation:</b>	795.7
<b>Bankfull Cross-Sectional Area:</b>	11.4
<b>Bankfull Width:</b>	6.5
<b>Flood Prone Area Elevation:</b>	798.4
<b>Flood Prone Width:</b>	>16
<b>Max Depth at Bankfull:</b>	2.7
<b>Mean Depth at Bankfull:</b>	1.8
<b>W / D Ratio:</b>	3.7
<b>Entrenchment Ratio:</b>	2.5
<b>Bank Height Ratio:</b>	1.9

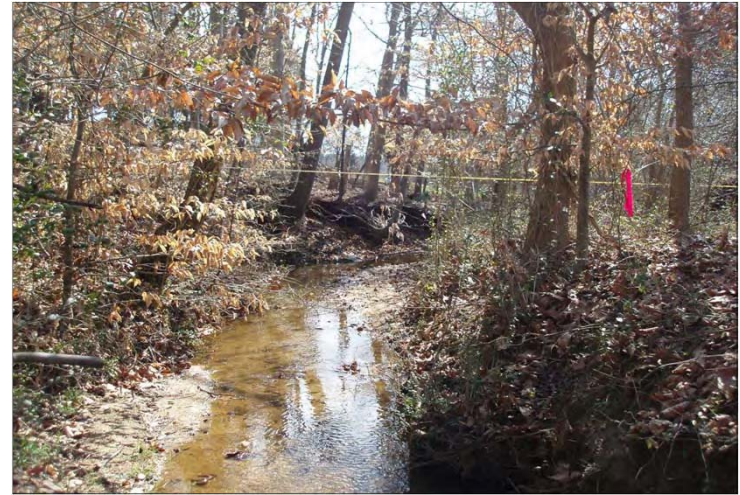
<b>River Basin:</b>	Yadkin-PeeDee
<b>Watershed:</b>	Irish Buffalo Creek, Existing Conditions, T1-2
<b>XS ID</b>	XS9 Riffle
<b>Drainage Area (sq mi):</b>	0.38
<b>Date:</b>	2/10/2012
<b>Field Crew:</b>	A. French, A. Helms

Station	Elevation
0.0	798.28
2.4	798.04
3.9	798.05
5.4	797.88
7.3	797.61
7.9	797.17
9.5	796.56
11.3	795.46
12.7	794.76
13.8	794.02
14.3	793.66
14.8	792.25
15.8	792.15
16.6	792.19
17.7	792.22
19.1	792.27
20.3	792.34
21.5	792.54
22.2	792.67
23.3	793.99
24.1	794.78
25.7	795.45
26.9	795.76
30.0	795.93
33.1	796.04
36.2	797.29
40.0	797.15

SUMMARY DATA	
<b>Bankfull Elevation:</b>	793.8
<b>Bankfull Cross-Sectional Area:</b>	12.0
<b>Bankfull Width:</b>	9.0
<b>Flood Prone Area Elevation:</b>	795.5
<b>Flood Prone Width:</b>	15
<b>Max Depth at Bankfull:</b>	1.7
<b>Mean Depth at Bankfull:</b>	1.3
<b>W / D Ratio:</b>	6.8
<b>Entrenchment Ratio:</b>	1.6
<b>Bank Height Ratio:</b>	2.2

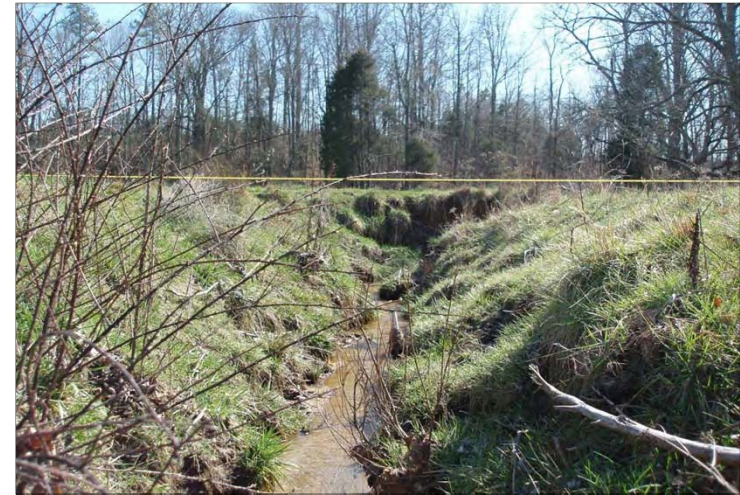
<b>River Basin:</b>	Yadkin-PeeDee
<b>Watershed:</b>	Irish Buffalo Creek, Existing Conditions, T1-3
<b>XS ID</b>	XS10 Riffle
<b>Drainage Area (sq mi):</b>	0.4
<b>Date:</b>	2/10/2012
<b>Field Crew:</b>	A. French, A. Helms

Station	Elevation
0.0	791.28
3.3	791.47
9.6	791.72
11.4	791.62
13.0	791.18
14.4	790.60
15.6	790.23
17.2	789.71
18.3	788.88
19.0	788.18
19.8	787.71
20.6	787.15
20.7	786.32
21.4	786.20
22.2	786.15
22.8	786.12
23.2	786.80
24.1	787.43
25.0	788.17
25.8	788.74
26.7	789.06
27.5	789.75
28.7	790.36
30.3	790.95
31.7	791.28
33.7	791.28
35.5	791.29
37.8	791.69
41.0	791.78
44.0	791.64
46.7	791.45

SUMMARY DATA	
<b>Bankfull Elevation:</b>	788.9
<b>Bankfull Cross-Sectional Area:</b>	12.1
<b>Bankfull Width:</b>	7.9
<b>Flood Prone Area Elevation:</b>	791.6
<b>Flood Prone Width:</b>	26
<b>Max Depth at Bankfull:</b>	2.8
<b>Mean Depth at Bankfull:</b>	1.5
<b>W / D Ratio:</b>	5.2
<b>Entrenchment Ratio:</b>	3.3
<b>Bank Height Ratio:</b>	1.9

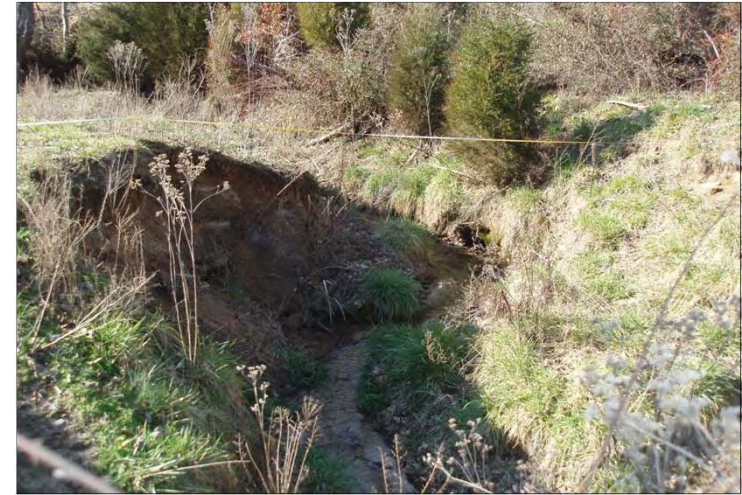
<b>River Basin:</b>	Yadkin-PeeDee
<b>Watershed:</b>	Irish Buffalo Creek, Existing Conditions, T2A
<b>XS ID</b>	XS11
<b>Drainage Area (sq mi):</b>	0.06
<b>Date:</b>	2/10/2012
<b>Field Crew:</b>	A. French, A. Helms

Station	Elevation
0.0	806.20
2.5	806.06
4.7	805.84
6.4	805.80
7.5	805.75
8.6	805.79
9.3	805.64
10.0	802.94
10.3	801.55
11.2	800.93
12.1	800.10
12.7	799.54
13.2	798.93
13.8	798.89
14.3	798.87
14.8	798.90
15.1	798.94
15.5	799.68
16.3	799.58
17.8	799.83
18.8	799.94
19.9	800.22
21.2	800.70
22.8	800.99
24.0	801.52
25.5	802.72
26.8	803.65
28.9	804.55
30.9	805.47
33.2	805.75
35.5	805.79
37.7	805.85

SUMMARY DATA	
<b>Bankfull Elevation:</b>	799.95
<b>Bankfull Cross-Sectional Area:</b>	3.4
<b>Bankfull Width:</b>	6.6
<b>Flood Prone Area Elevation:</b>	801.0
<b>Flood Prone Width:</b>	11
<b>Max Depth at Bankfull:</b>	1.1
<b>Mean Depth at Bankfull:</b>	0.5
<b>W / D Ratio:</b>	12.8
<b>Entrenchment Ratio:</b>	1.7
<b>Bank Height Ratio:</b>	6.3

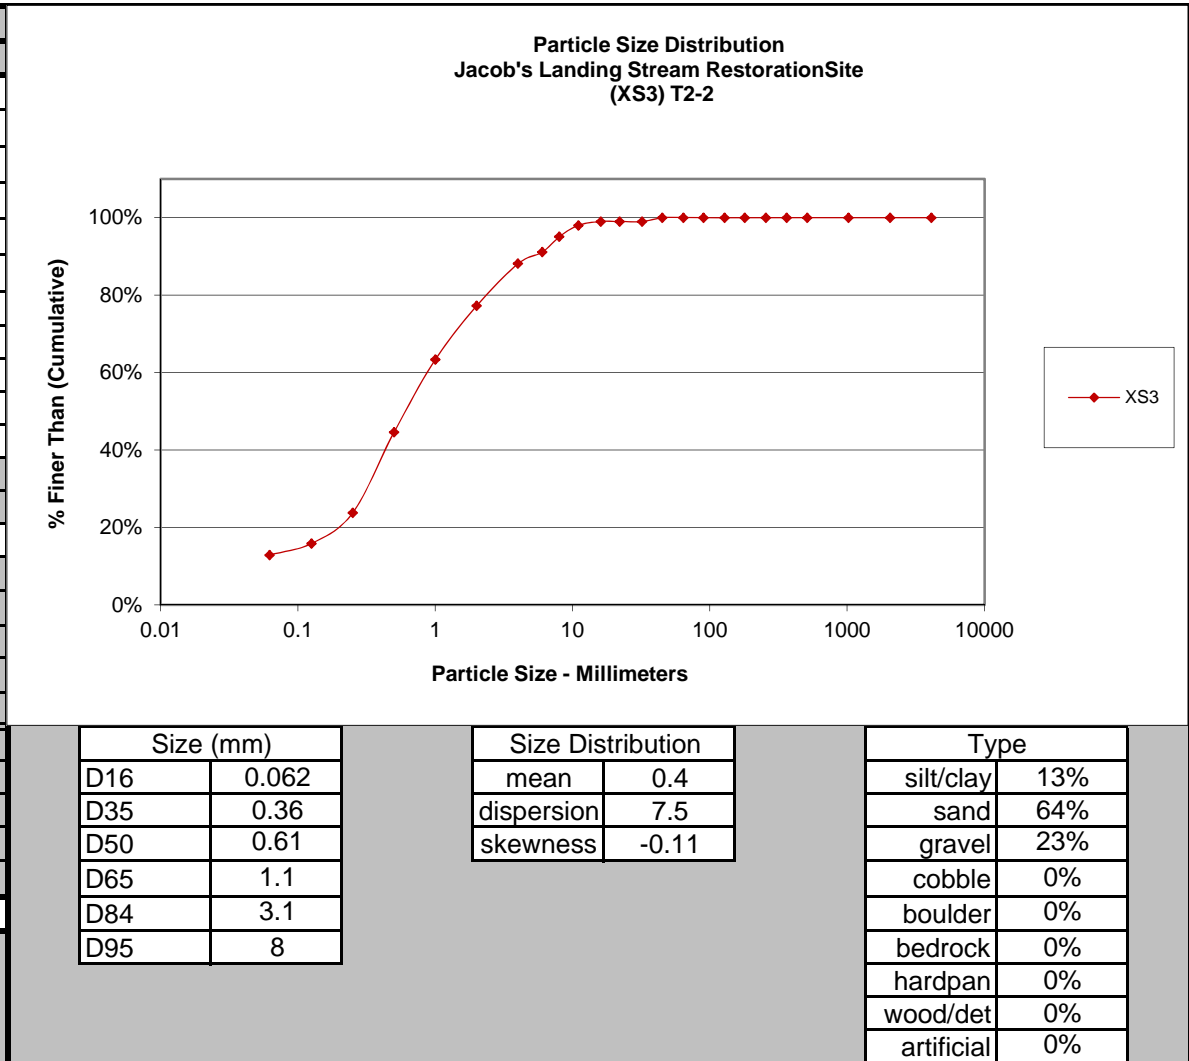
Cross-Section 3			
Particle	Millimeter		Count
Silt/Clay	< 0.062	S/C	13
Very Fine	.062 - .125	S	3
Fine	.125 - .25	A	8
Medium	.25 - .50	N	21
Coarse	.50 - 1	D	19
Very Coarse	1 - 2	S	14
Very Fine	2 - 4		11
Fine	4 - 5.7	G	3
Fine	5.7 - 8	R	4
Medium	8 - 11.3	A	3
Medium	11.3 - 16	V	1
Coarse	16 - 22.6	E	
Coarse	22.6 - 32	L	
Very Coarse	32 - 45	S	1
Very Coarse	45 - 64		
Small	64 - 90	C	
Small	90 - 128	O	
Large	128 - 180	B	
Large	180 - 256	L	
Small	256 - 362	B	
Small	362 - 512	L	
Medium	512 - 1024	D	
Lrg- Very Lrg	1024 - 2048	R	
Bedrock	>2048	BDRK	
		<b>Total</b>	101
Note:

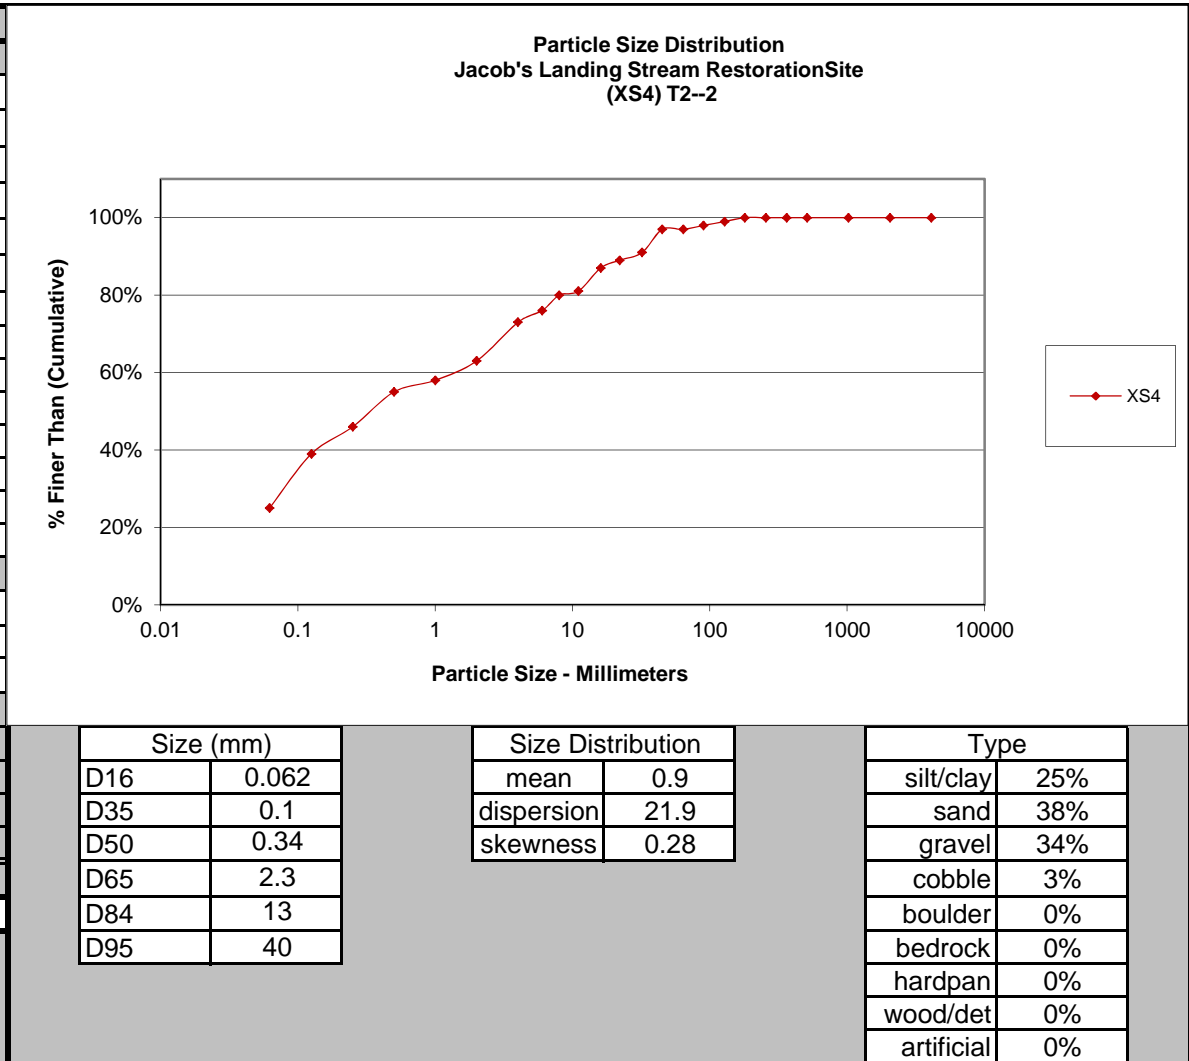
Cross-Section 4			
Particle	Millimeter		Count
Silt/Clay	< 0.062	S/C	25
Very Fine	.062 - .125	S	14
Fine	.125 - .25	A	7
Medium	.25 - .50	N	9
Coarse	.50 - 1	D	3
Very Coarse	1 - 2	S	5
Very Fine	2 - 4		10
Fine	4 - 5.7	G	3
Fine	5.7 - 8	R	4
Medium	8 - 11.3	A	1
Medium	11.3 - 16	V	6
Coarse	16 - 22.6	E	2
Coarse	22.6 - 32	L	2
Very Coarse	32 - 45	S	6
Very Coarse	45 - 64		
Small	64 - 90	C	1
Small	90 - 128	O	1
Large	128 - 180	B	1
Large	180 - 256	L	
Small	256 - 362	B	
Small	362 - 512	L	
Medium	512 - 1024	D	
Lrg- Very Lrg	1024 - 2048	R	
Bedrock	>2048	BDRK	
		<b>Total</b>	100
Note:

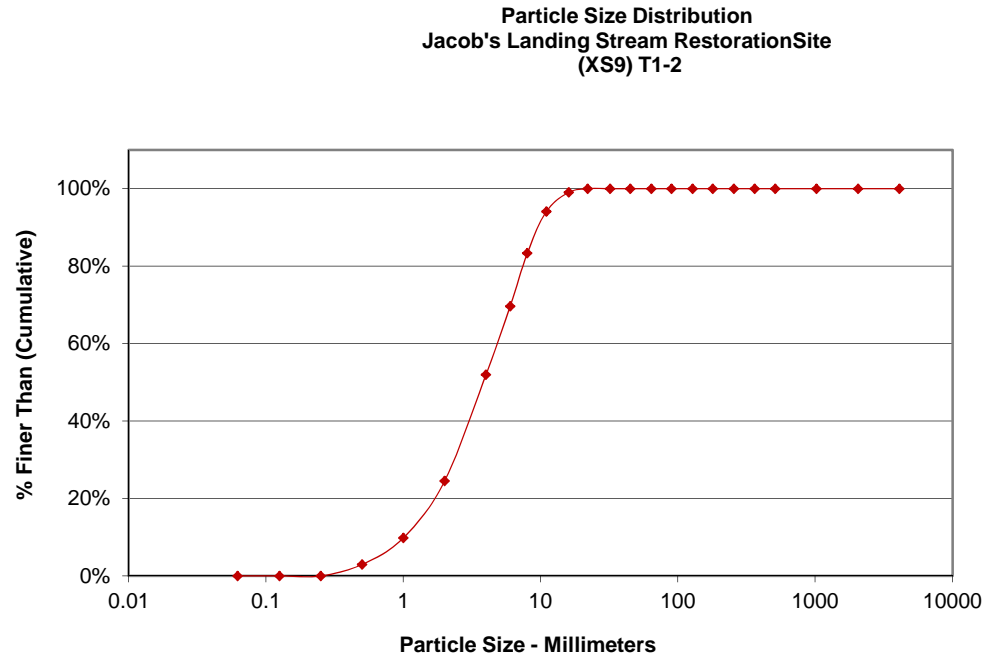
Cross-Section 9			
Particle	Millimeter		Count
Silt/Clay	< 0.062	S/C	
Very Fine	.062 - .125	S	
Fine	.125 - .25	A	
Medium	.25 - .50	N	3
Coarse	.50 - 1	D	7
Very Coarse	1 - 2	S	15
Very Fine	2 - 4		28
Fine	4 - 5.7	G	18
Fine	5.7 - 8	R	14
Medium	8 - 11.3	A	11
Medium	11.3 - 16	V	5
Coarse	16 - 22.6	E	1
Coarse	22.6 - 32	L	
Very Coarse	32 - 45	S	
Very Coarse	45 - 64		
Small	64 - 90	C	
Small	90 - 128	O	
Large	128 - 180	B	
Large	180 - 256	L	
Small	256 - 362	B	
Small	362 - 512	L	
Medium	512 - 1024	D	
Lrg- Very Lrg	1024 - 2048	R	
Bedrock	>2048	BDRK	
		<b>Total</b>	102
Note:

Size (mm)	
D16	1.3
D35	2.6
D50	3.8
D65	5.4
D84	8.2
D95	12

Size Distribution	
mean	3.3
dispersion	2.5
skewness	-0.07

Type	
silt/clay	0%
sand	25%
gravel	75%
cobble	0%
boulder	0%
bedrock	0%
hardpan	0%
wood/det	0%
artificial	0%

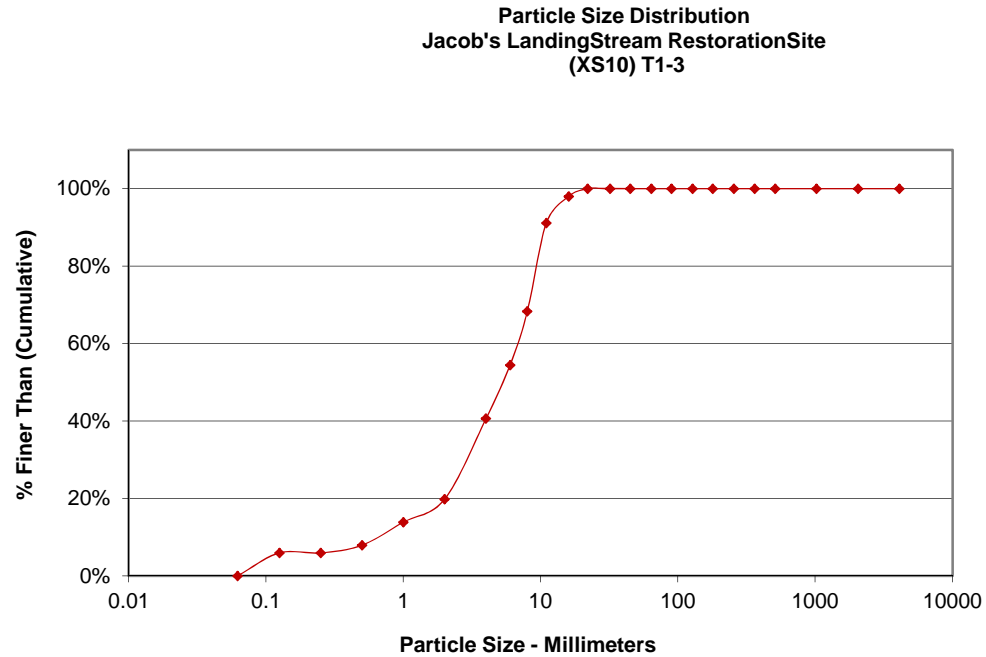
Cross-Section 10			
Particle	Millimeter		Count
Silt/Clay	< 0.062	S/C	
Very Fine	.062 - .125	S	6
Fine	.125 - .25	A	
Medium	.25 - .50	N	2
Coarse	.50 - 1	D	6
Very Coarse	1 - 2	S	6
Very Fine	2 - 4		21
Fine	4 - 5.7	G	14
Fine	5.7 - 8	R	14
Medium	8 - 11.3	A	23
Medium	11.3 - 16	V	7
Coarse	16 - 22.6	E	2
Coarse	22.6 - 32	L	
Very Coarse	32 - 45	S	
Very Coarse	45 - 64		
Small	64 - 90	C	
Small	90 - 128	O	
Large	128 - 180	B	
Large	180 - 256	L	
Small	256 - 362	B	
Small	362 - 512	L	
Medium	512 - 1024	D	
Lrg- Very Lrg	1024 - 2048	R	
Bedrock	>2048	BDRK	
		<b>Total</b>	101
Note:

Size (mm)	
D16	1.3
D35	3.3
D50	5.3
D65	7.5
D84	10
D95	14

Size Distribution	
mean	3.6
dispersion	3.0
skewness	-0.18

Type	
silt/clay	0%
sand	20%
gravel	80%
cobble	0%
boulder	0%
bedrock	0%
hardpan	0%
wood/det	0%
artificial	0%

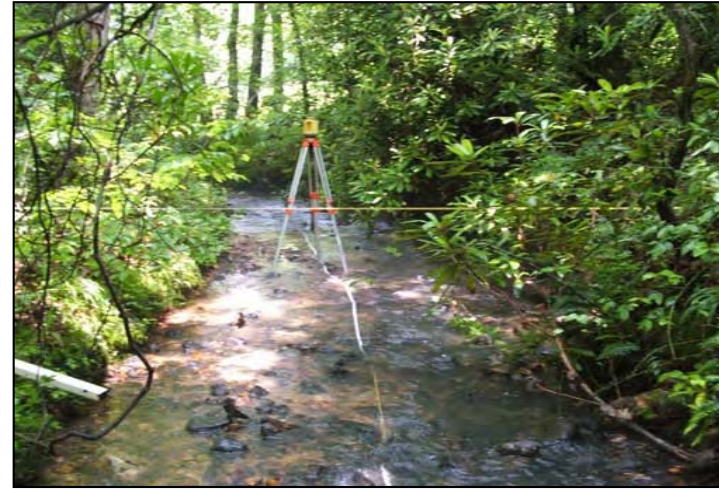
Station	Rod Ht.	Elevation
0.0	2.22	100.00
3.0	2.15	100.07
5.0	2.50	99.72
7.0	2.98	99.24
8.0	3.49	98.73
8.8	4.00	98.22
9.0	4.96	97.26
12.0	5.03	97.19
14.0	5.25	96.97
16.0	5.16	97.06
17.0	5.20	97.02
18.0	5.06	97.16
18.7	4.00	98.22
19.5	2.65	99.57
20.0	1.66	100.56

SUMMARY DATA	
<b>Bankfull Elevation:</b>	98.22
<b>Bankfull Cross-Sectional Area:</b>	10.40
<b>Bankfull Width:</b>	10.00
<b>Flood Prone Area Elevation:</b>	99.47
<b>Flood Prone Width:</b>	13.10
<b>Max Depth at Bankfull:</b>	1.25
<b>Mean Depth at Bankfull:</b>	1.04
<b>W / D Ratio:</b>	9.6
<b>Entrenchment Ratio:</b>	1.30
<b>Bank Height Ratio:</b>	2.08
<b>Slope (ft/ft):</b>	0.013
<b>Discharge (cfs)</b>	42

<b>Stream Type:</b>	B4c
---------------------	-----

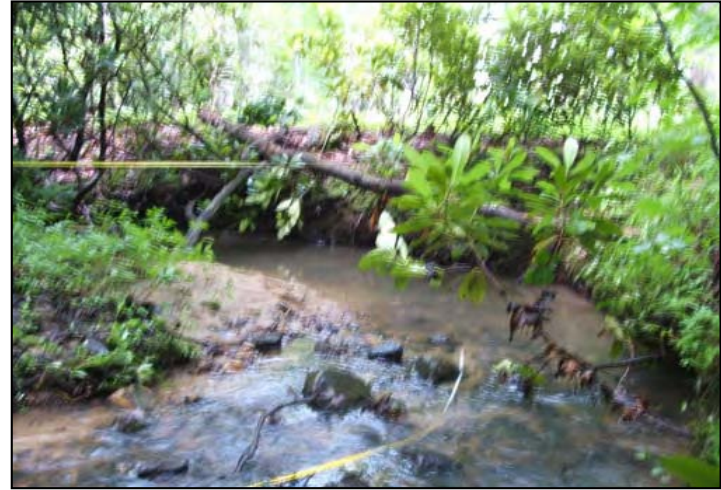
**Yadkin River Basin, UT to Fisher River, XS#2 Pool**

<b>River Basin:</b>	Yadkin
<b>Watershed:</b>	UT to Fisher River
<b>XS ID</b>	XS#2 Pool
<b>Drainage Area (sq mi):</b>	0.38
<b>Date:</b>	6/9/2005
<b>Field Crew:</b>	G. Mryncza, A. Spiller

Station	Rod Ht.	Elevation
0.0	2.68	100.00
3.0	2.94	99.74
5.0	3.61	99.07
6.0	4.10	98.58
6.8	4.56	98.12
7.0	4.70	97.98
9.0	4.94	97.74
11.0	5.21	97.47
12.0	5.64	97.04
13.0	6.00	96.68
15.0	6.59	96.09
17.0	6.42	96.26
18.0	6.50	96.18
18.2	4.93	97.75
19.0	3.56	99.12
20.0	2.80	99.88

SUMMARY DATA	
<b>Bankfull Elevation:</b>	98.12
<b>Bankfull Cross-Sectional Area:</b>	13.40
<b>Bankfull Width:</b>	11.62
<b>Flood Prone Area Elevation:</b>	100.15
<b>Flood Prone Width:</b>	
<b>Max Depth at Bankfull:</b>	2.03
<b>Mean Depth at Bankfull:</b>	1.15
<b>W / D Ratio:</b>	10.1
<b>Entrenchment Ratio:</b>	
<b>Bank Height Ratio:</b>	0.81
<b>Slope (ft/ft):</b>	0.001
<b>Discharge (cfs)</b>	56

**Stream Type:** B4c

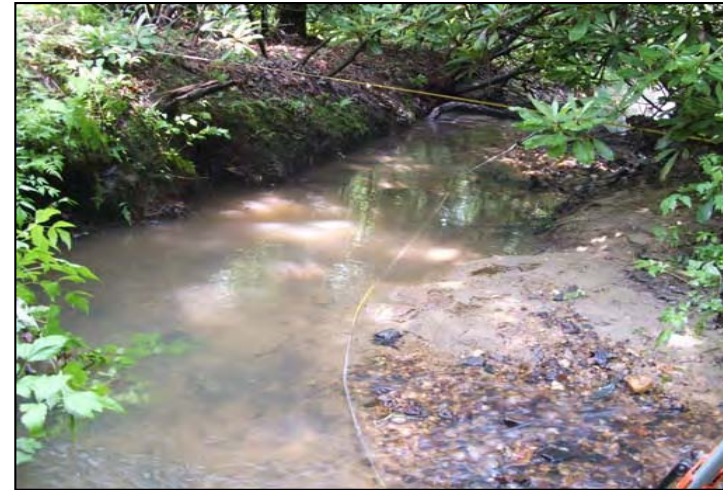
**Yadkin River Basin, UT to Fisher River, XS#3 Pool**

<b>River Basin:</b>	Yadkin
<b>Watershed:</b>	UT to Fisher River
<b>XS ID</b>	XS#3 Pool
<b>Drainage Area (sq mi):</b>	0.38
<b>Date:</b>	6/9/2005
<b>Field Crew:</b>	G. Mryncza, A. Spiller

Station	Rod Ht.	Elevation
0.0	1.33	100.00
3.0	1.78	99.55
5.0	2.35	98.98
5.5	2.82	98.51
5.7	3.81	97.52
6.0	4.52	96.81
6.5	5.79	95.54
8.0	5.82	95.51
9.0	5.50	95.83
10.0	5.02	96.31
11.5	4.80	96.53
13.0	3.90	97.43
14.0	3.55	97.78
16.0	3.03	98.30
20.0	2.66	98.67

SUMMARY DATA	
<b>Bankfull Elevation:</b>	97.78
<b>Bankfull Cross-Sectional Area:</b>	11.60
<b>Bankfull Width:</b>	8.35
<b>Flood Prone Area Elevation:</b>	100.05
<b>Flood Prone Width:</b>	
<b>Max Depth at Bankfull:</b>	2.27
<b>Mean Depth at Bankfull:</b>	1.39
<b>W / D Ratio:</b>	6.0
<b>Entrenchment Ratio:</b>	
<b>Bank Height Ratio:</b>	0.85
<b>Slope (ft/ft):</b>	0.001
<b>Discharge (cfs)</b>	52

**Stream Type:** B4c

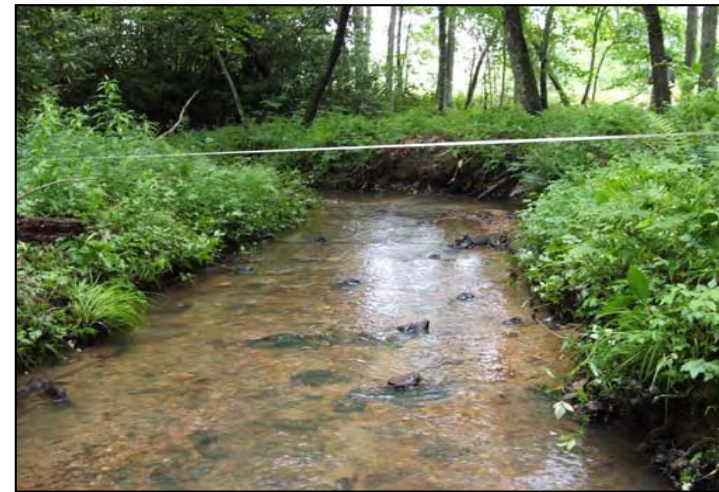
<b>River Basin:</b>	Yadkin
<b>Watershed:</b>	UT to Fisher River
<b>XS ID</b>	XS#4 Riffle
<b>Drainage Area (sq mi):</b>	0.38
<b>Date:</b>	6/9/2005
<b>Field Crew:</b>	G. Mryncza, A. Spiller

Station	Rod Ht.	Elevation
0.0	4.62	100.00
3.0	5.54	99.08
7.0	6.01	98.61
8.5	6.34	98.28
9.0	7.04	97.58
9.5	7.66	96.96
11.0	7.67	96.95
12.0	7.79	96.83
14.0	7.58	97.04
16.0	7.57	97.05
17.0	7.51	97.11
17.5	6.34	98.28
19.0	5.90	98.72
21.0	5.06	99.56
25.0	4.37	100.25

SUMMARY DATA	
<b>Bankfull Elevation:</b>	98.28
<b>Bankfull Cross-Sectional Area:</b>	10.70
<b>Bankfull Width:</b>	9.00
<b>Flood Prone Area Elevation:</b>	99.73
<b>Flood Prone Width:</b>	20.50
<b>Max Depth at Bankfull:</b>	1.45
<b>Mean Depth at Bankfull:</b>	1.19
<b>W / D Ratio:</b>	7.6
<b>Entrenchment Ratio:</b>	2.30
<b>Bank Height Ratio:</b>	1.00
<b>Slope (ft/ft):</b>	0.013
<b>Discharge (cfs)</b>	46

<b>Stream Type:</b>	B4c
---------------------	-----

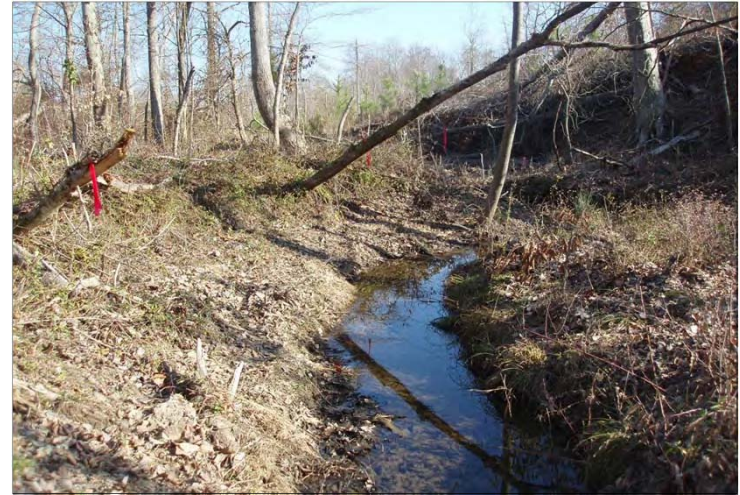
UT to Irish Buffalo Creek Reference Site

<b>River Basin:</b>	Yadkin-PeeDee
<b>Watershed:</b>	Irish Buffalo Creek, T1
<b>XS ID</b>	XS-Riffle (REFERENCE)
<b>Drainage Area (sq mi):</b>	0.16
<b>Date:</b>	2/17/2012
<b>Field Crew:</b>	A. French, K. O'Briant

Station	Elevation
0.0	804.36
1.3	804.11
3.0	804.18
4.1	803.88
4.9	802.68
6.2	801.85
7.8	801.91
9.1	801.56
10.2	801.30
10.7	801.05
11.3	800.38
11.8	799.94
12.4	799.89
13.1	799.86
13.8	799.86
14.5	799.89
15.2	800.17
15.4	800.52
16.3	801.50
17.5	801.77
20.0	801.79
23.1	801.81
24.7	802.02
26.4	802.18
28.3	803.75
30.9	804.12

SUMMARY DATA	
<b>Bankfull Elevation:</b>	801.6
<b>Bankfull Cross-Sectional Area:</b>	8.4
<b>Bankfull Width:</b>	8.0
<b>Flood Prone Area Elevation:</b>	803.4
<b>Flood Prone Width:</b>	23
<b>Max Depth at Bankfull:</b>	1.8
<b>Mean Depth at Bankfull:</b>	1.1
<b>W / D Ratio:</b>	7.6
<b>Entrenchment Ratio:</b>	2.9
<b>Bank Height Ratio:</b>	1.0

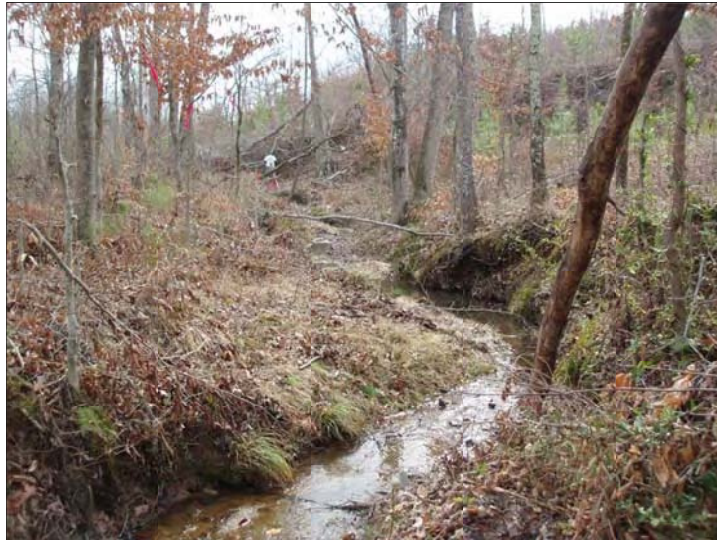
Looking downstream on reference reach. 2-17-2012

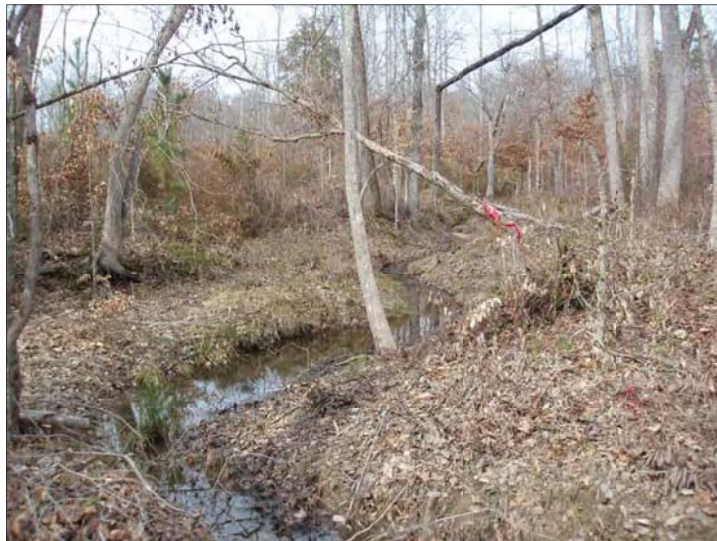
Looking downstream on reference reach. 2-17-2012

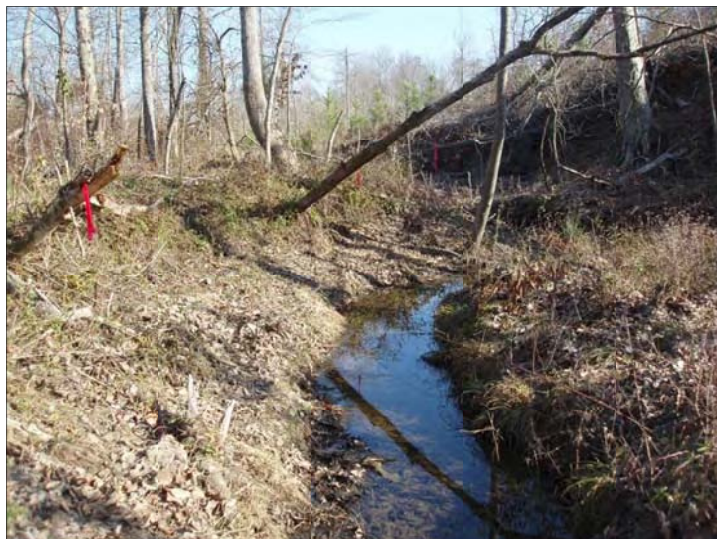
Looking downstream on reference reach. 2-17-2012
