Baseline Monitoring Document and As Built Baseline Report

**Jacob's Landing Stream Restoration Site
Rowan County, North Carolina
EEP Contract 003984
EEP Project Number 95024**

**Monitoring Data Collected: February 2014
Date Submitted: September 2014**

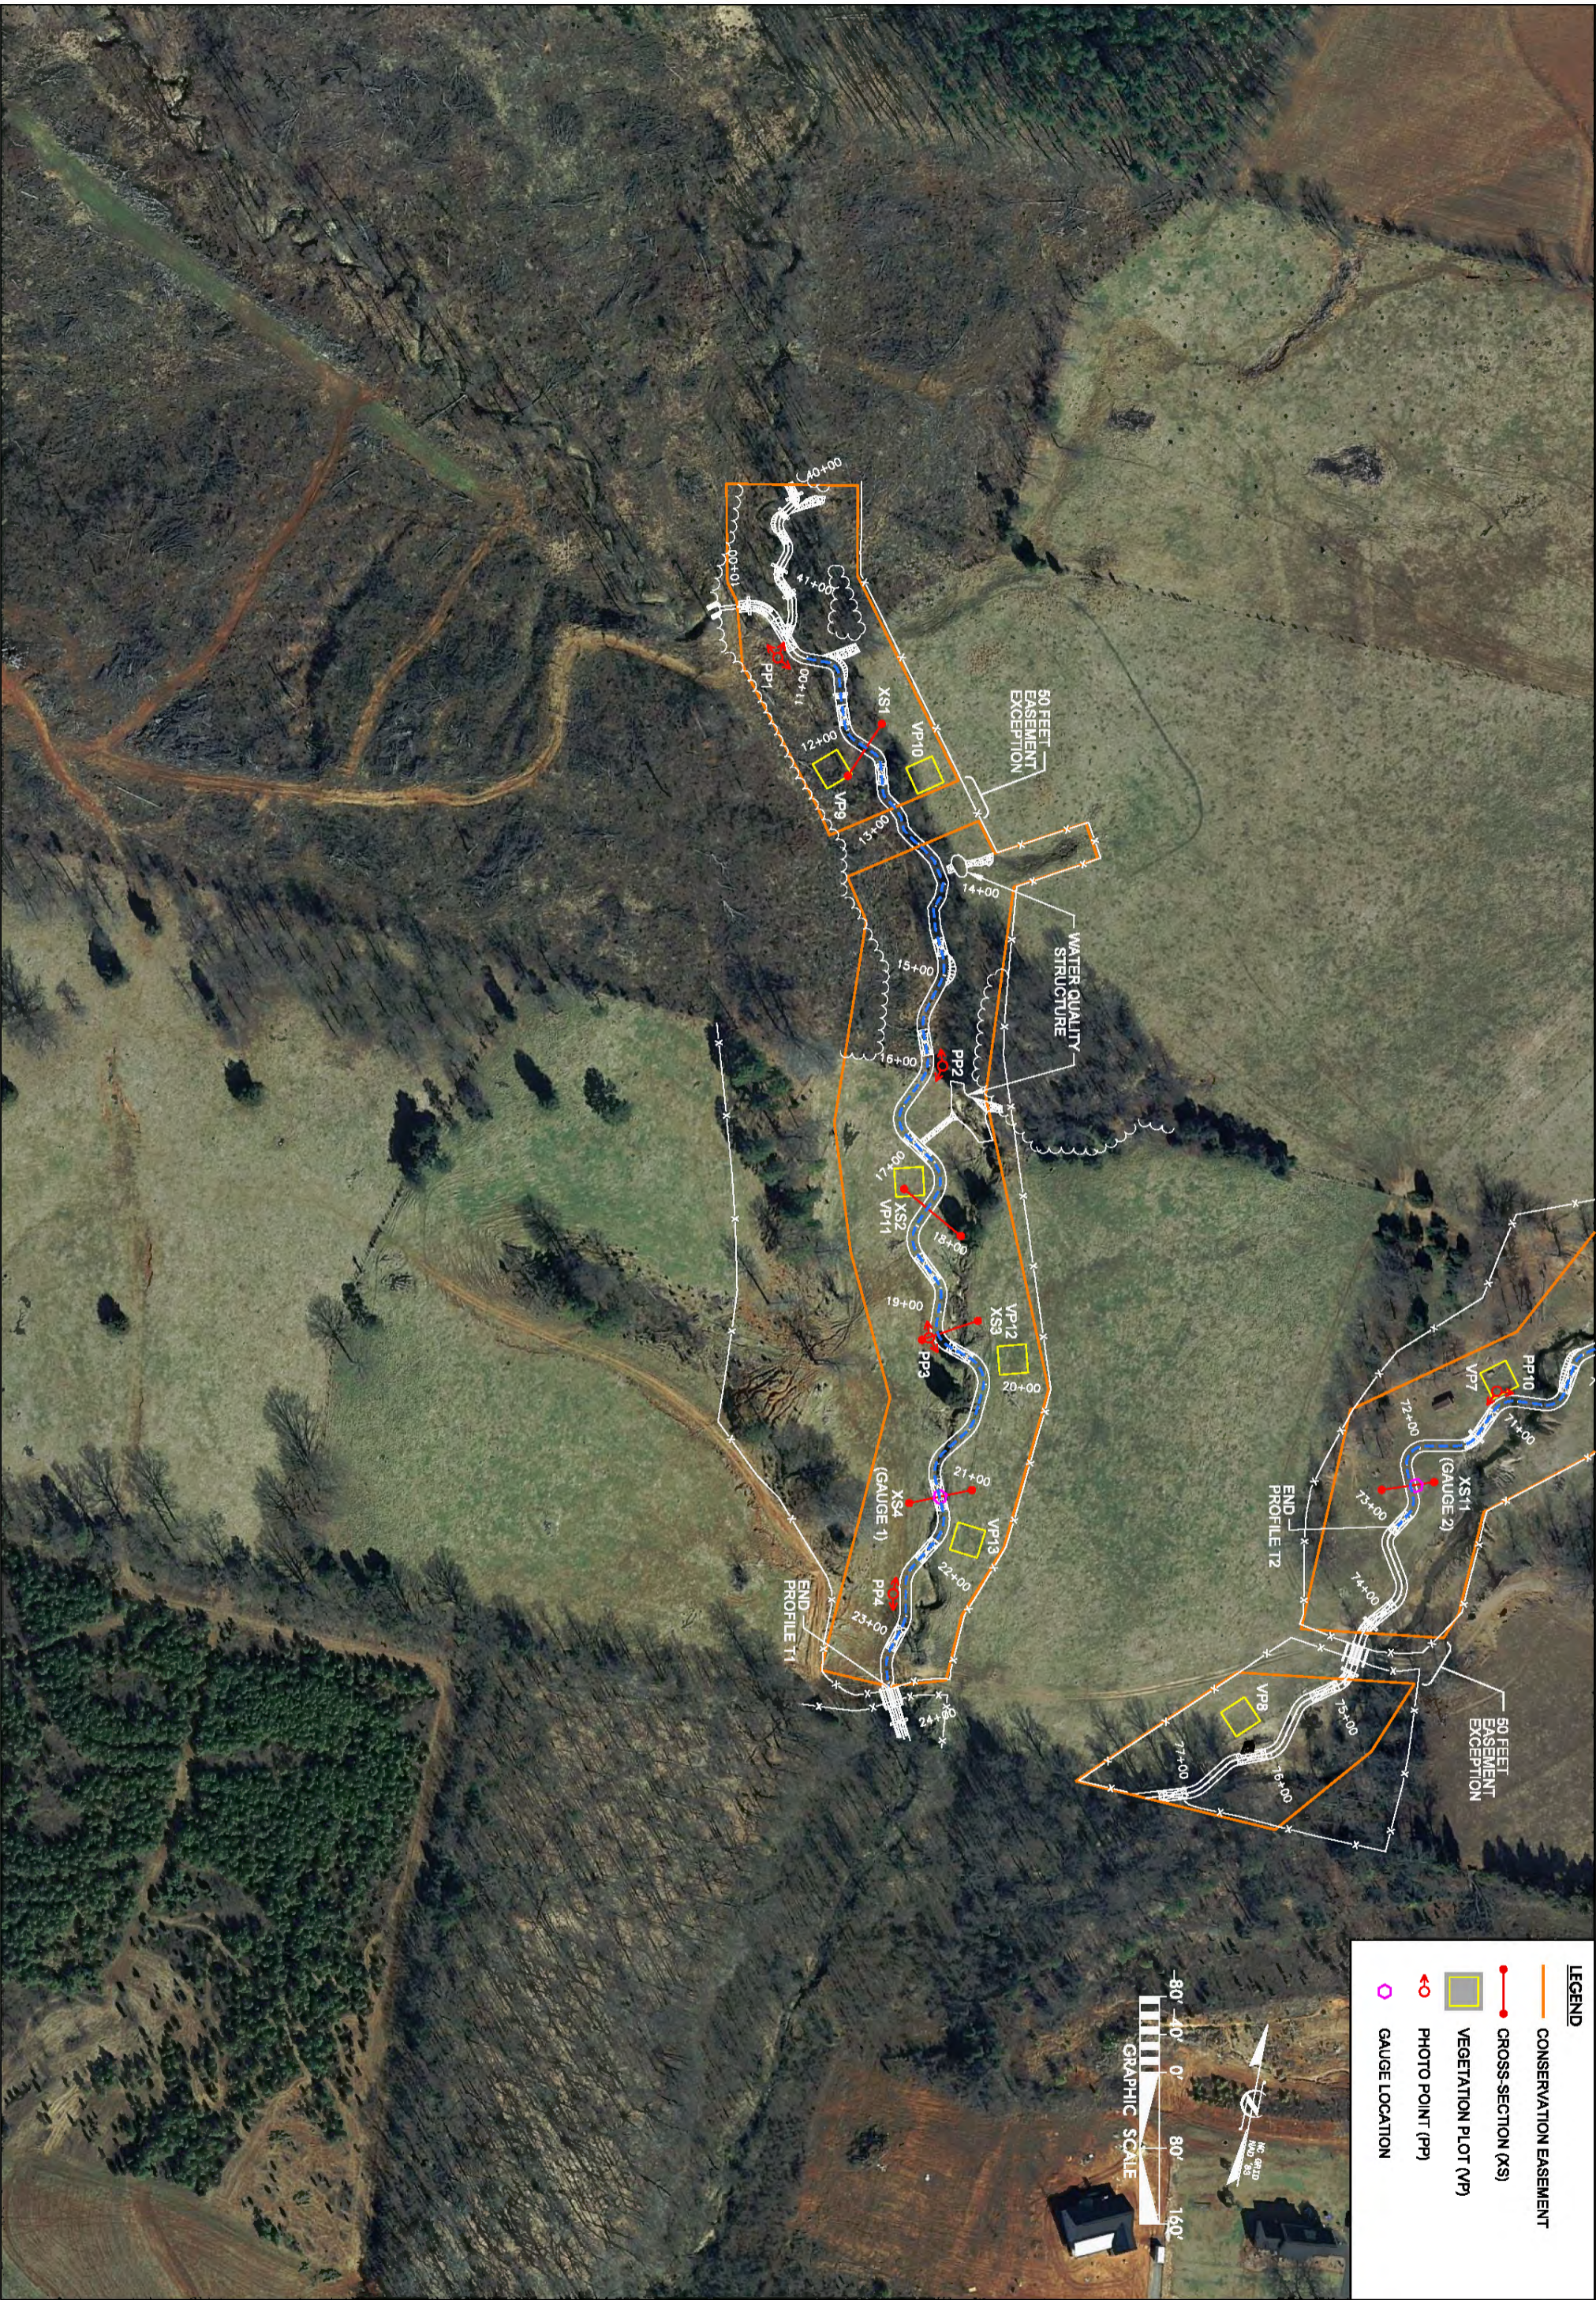
JACOB'S LANDING STREAM MITIGATION PROJECT CHINA GROVE, ROWAN COUNTY, NORTH CAROLINA REACH T1	KCI ASSOCIATES OF NC ENGINEERS • PLANNERS • SCIENTISTS 4601 SIX FORKS ROAD RALEIGH, NORTH CAROLINA 27609		DATE: FEB 2014 SCALE: GRAPHIC SHEET 1 OF 2 FIGURE 3
			DATE: SEPT 2012
		REVISIONS

- CONSERVATION EASEMENT
- CROSS-SECTION (XS)
- VEGETATION PLOT (VP)
- PHOTO POINT (PP)
- ◻ GAUGE LOCATION

Annual monitoring will be conducted during the first full growing season following project completion. Monitoring of the Site restoration efforts will be performed for stream, vegetation, and hydrology components of the Site until success criteria are fulfilled. The establishment, collection, and summarization of monitoring data shall be conducted in accordance with the most current version of the EEP document entitled *Procedural Guidance and Content Requirements for EEP Monitoring Reports (version 1.5)* (NCEEP 2012). Permanent monuments, marking monitoring feature locations, were established on-site in February 2014. The locations of these monitoring features are marked in Figure 3 in Appendix A.

Two longitudinal profiles have been established on T1 and T2 for a total of approximately 3,000 linear feet. These profiles will be used to evaluate stream pattern and longitudinal profile each monitoring year (see Figure 3, Appendix A for locations). The profile will be surveyed in detail, documenting the elevations of the thalweg, water surface, and bankfull. Pool and riffle features will be called out to calculate feature slopes and lengths.

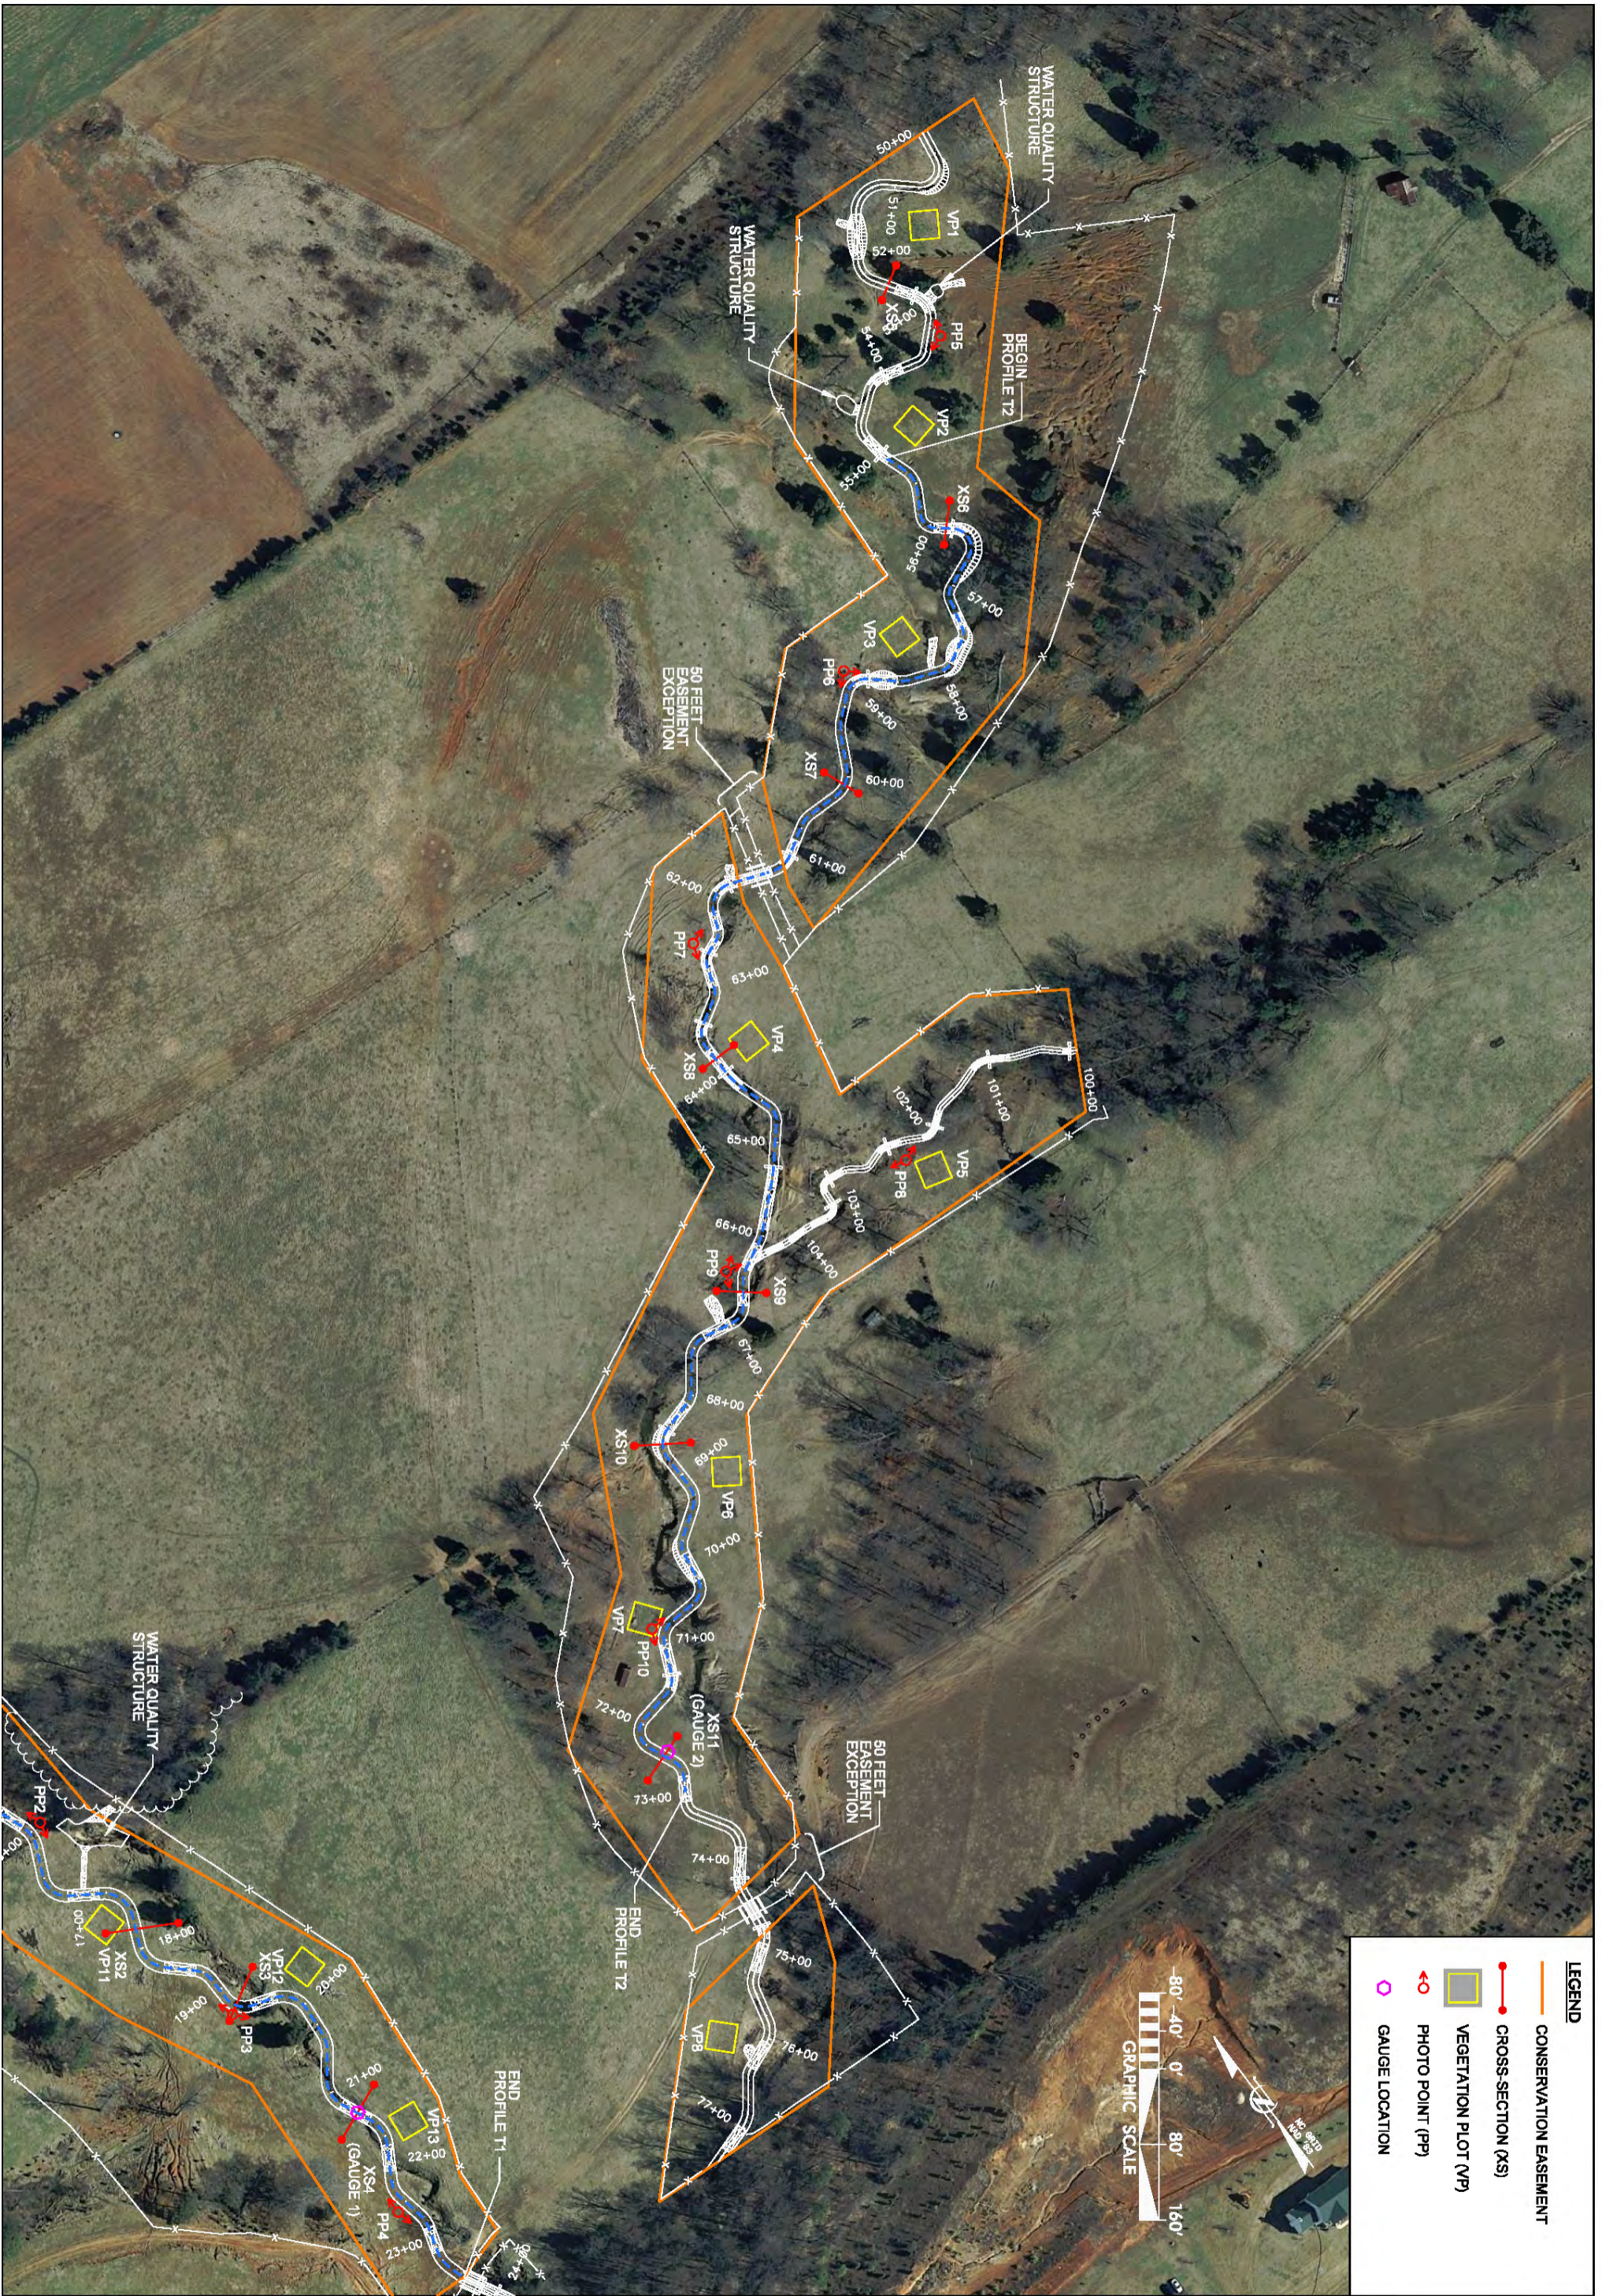
SHEET 2 OF 2
FIGURE 3

- CONSERVATION EASEMENT
- CROSS-SECTION (XS)
- VEGETATION PLOT (VP)
- PHOTO POINT (PP)
- GAUGE LOCATION

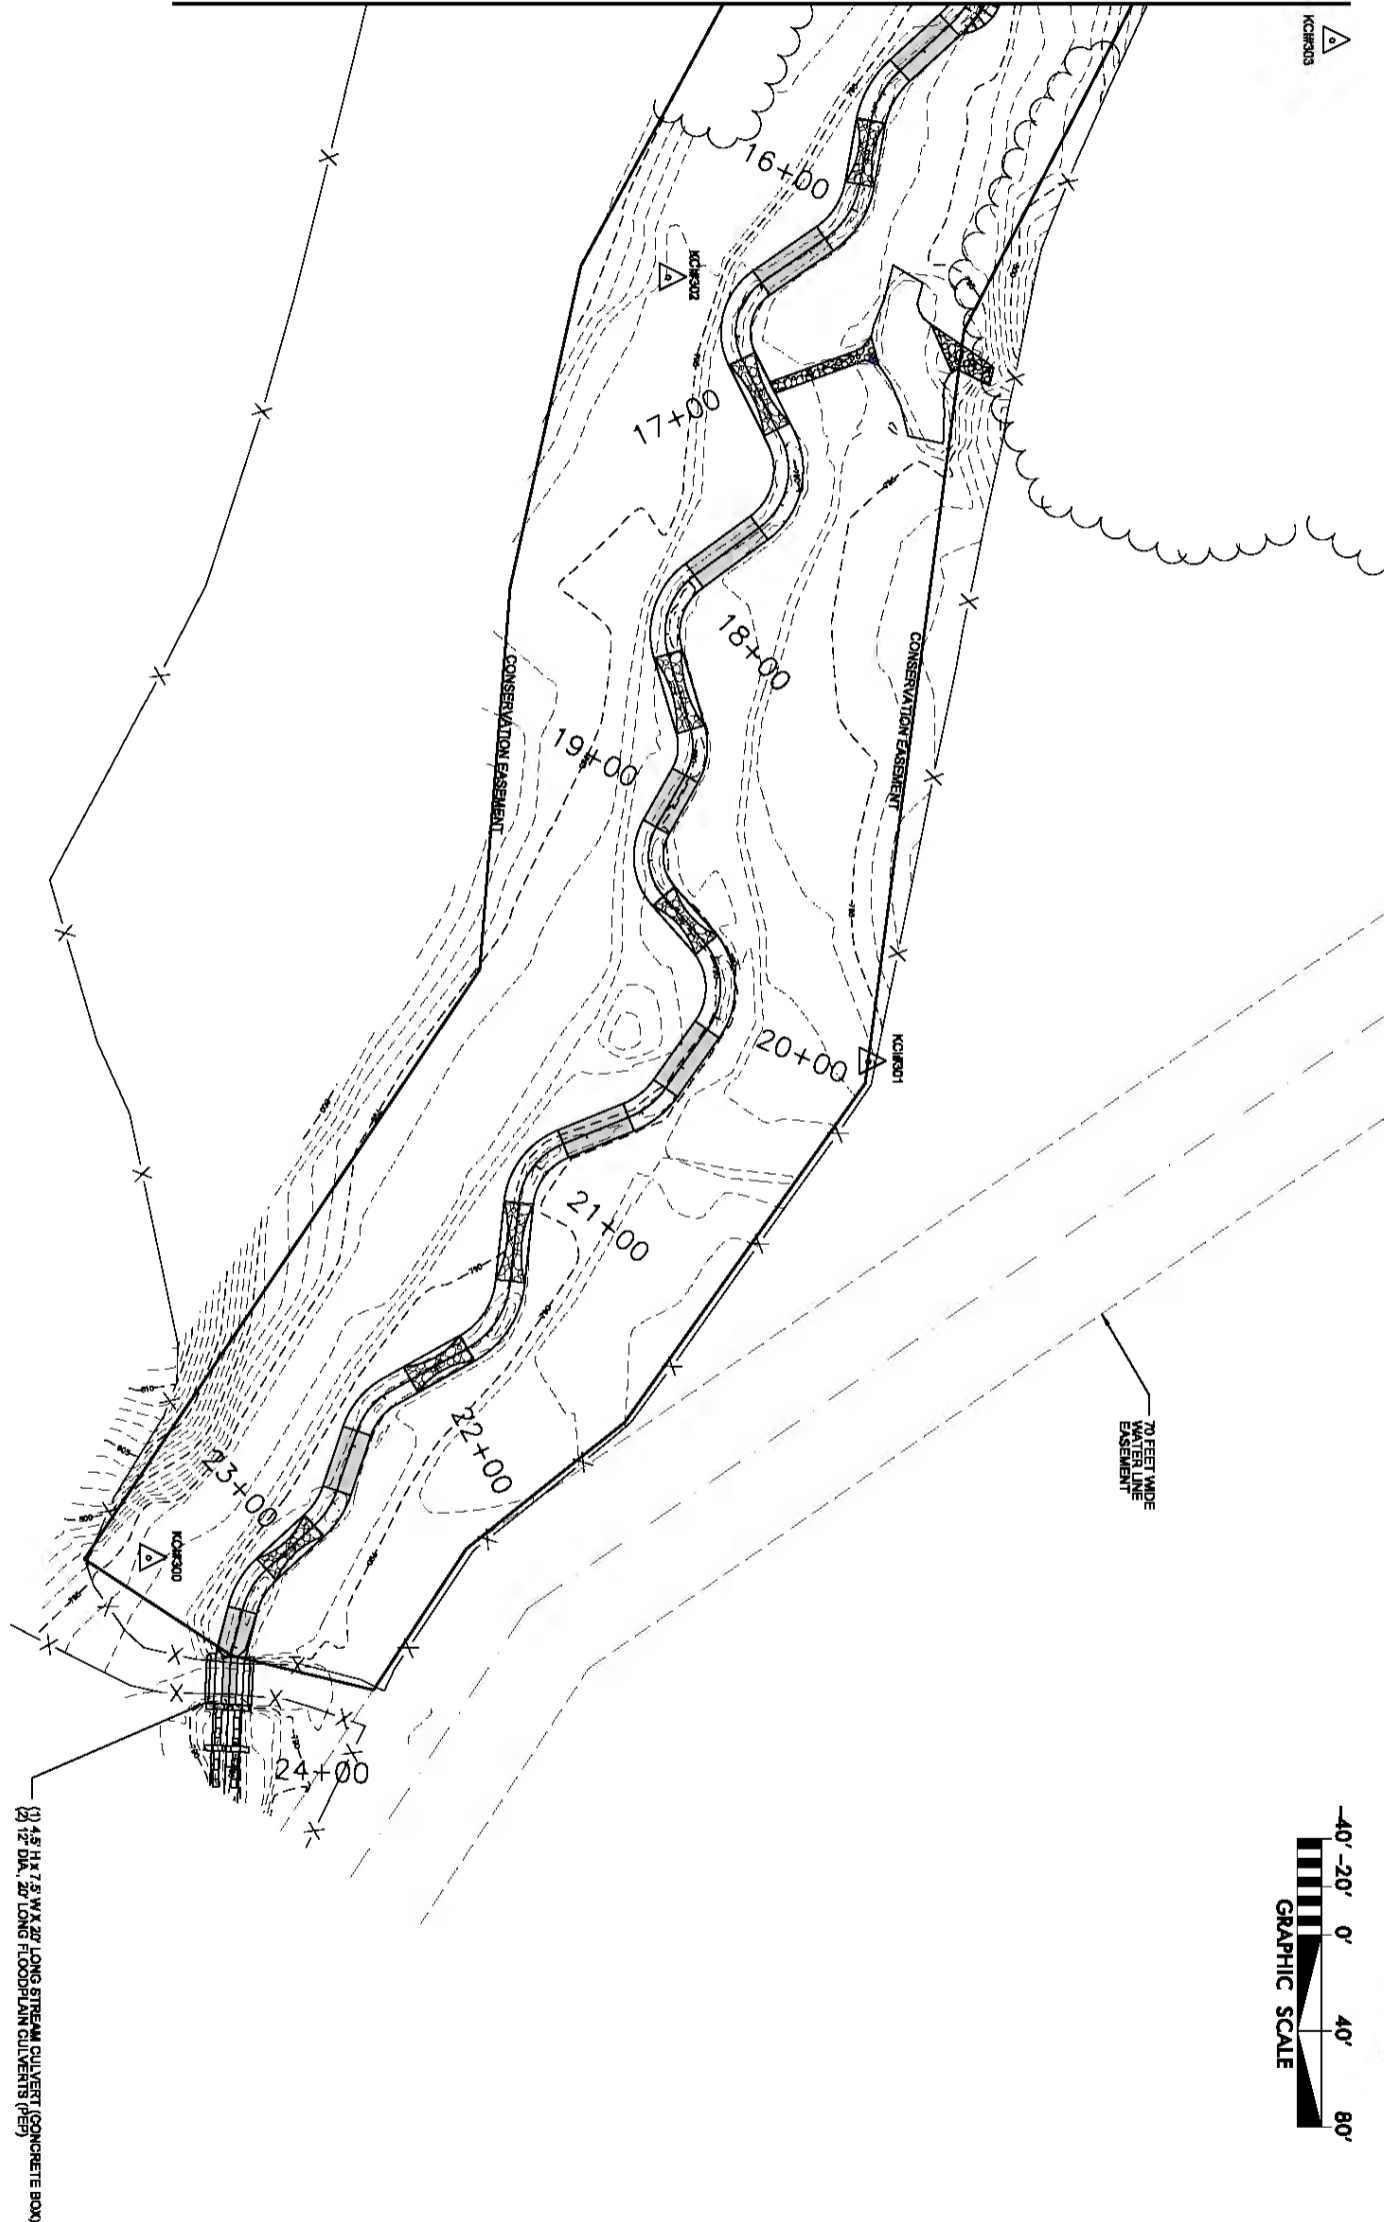
DATE: MARCH 2013
SCALE: 1"=40'
SHEET 5 OF 8
AS-BUILT
SITE PLAN

**JACOB'S LANDING
STREAM MITIGATION PROJECT**
CHINA GROVE, ROWAN COUNTY, NORTH CAROLINA
REACH T1

Baseline stream monitoring data were collected in February 2014. Any changes made to the design during construction are shown on the As-Built Site Plan in Appendix D. Limited modifications were made to the design plan during construction. Two step pools were removed and five boulder step pools were replaced with log step pools on T2A. Due to the extra structures and additional work required to define the pattern on T2A, the mitigation type has been changed from Enhancement I as described in the mitigation plan to restoration. For photos of restored T2A, see Photo Point 8 on page in Appendix B. On T2, one additional log drop was installed near STA 65+00. In addition to the channel work, there were multiple areas of slope stabilization outside of the easement that were completed as a part of the project to reduce sediment inputs from the surrounding property.

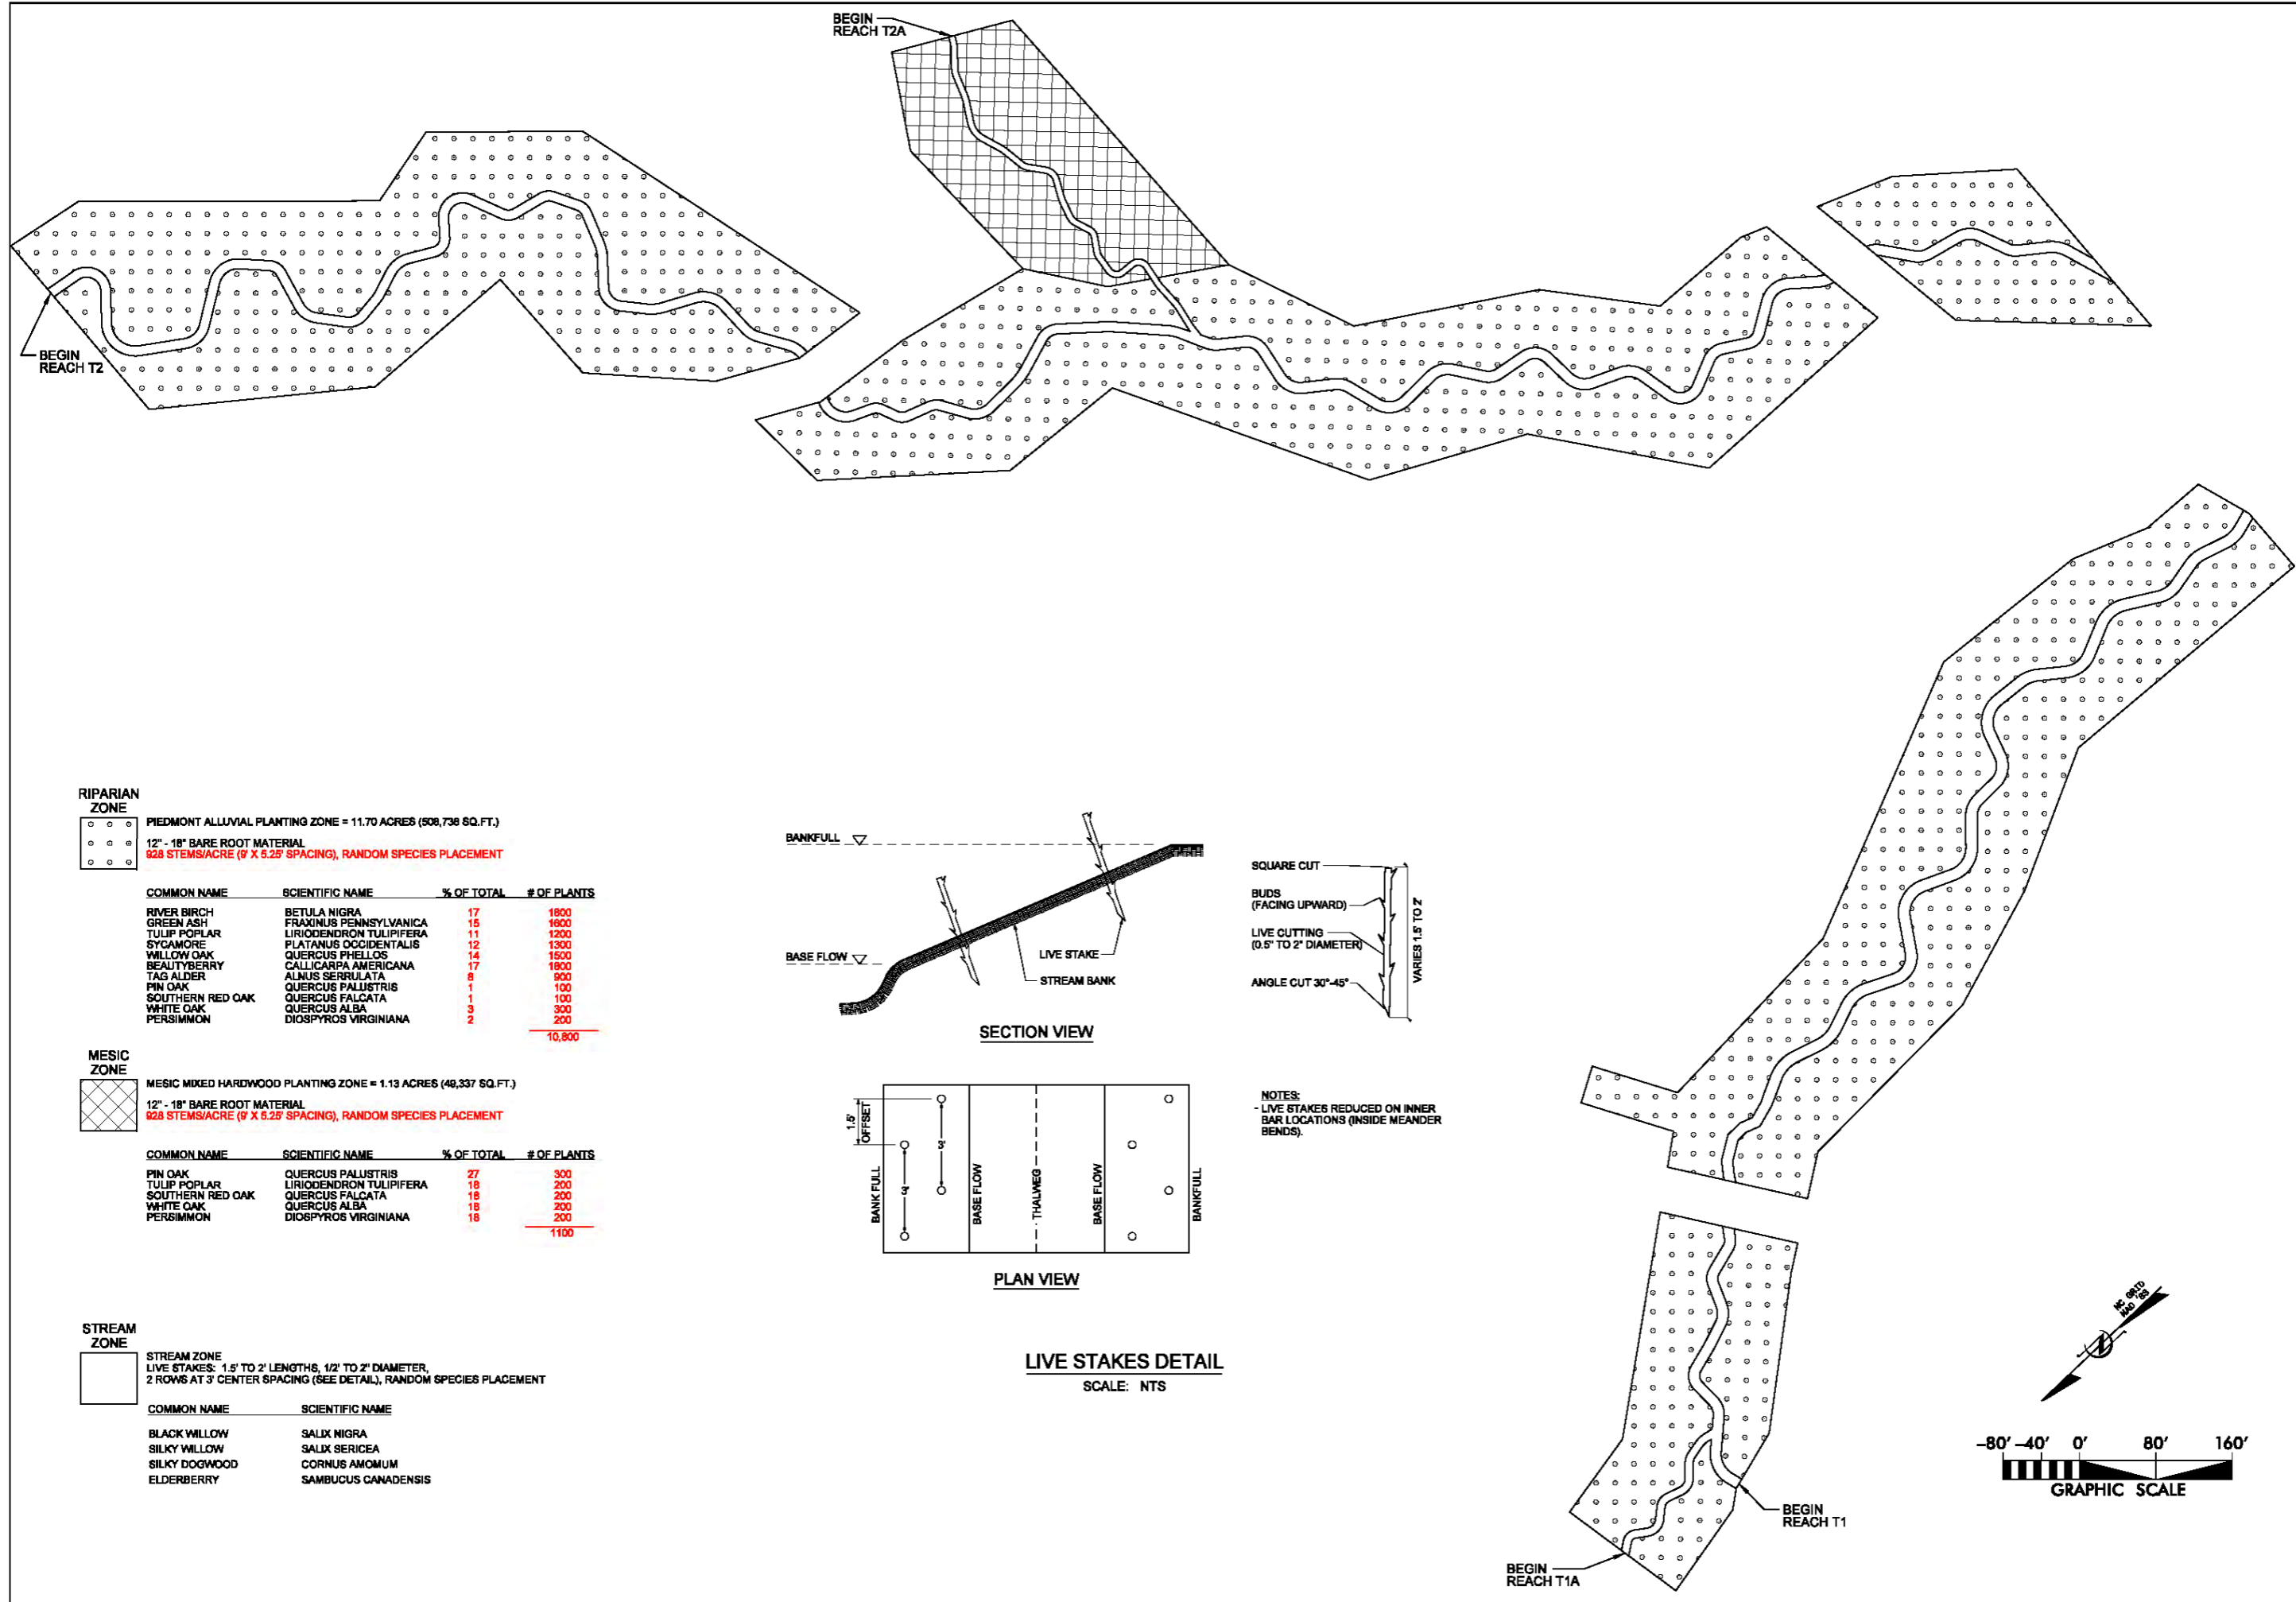
RIPARIAN ZONE

PIEDMONT ALLUVIAL PLANTING ZONE = 11.70 ACRES (508,738 SQ.FT.)
 12" - 18" BARE ROOT MATERIAL
 828 STEMS/ACRE (9' X 5.25' SPACING), RANDOM SPECIES PLACEMENT

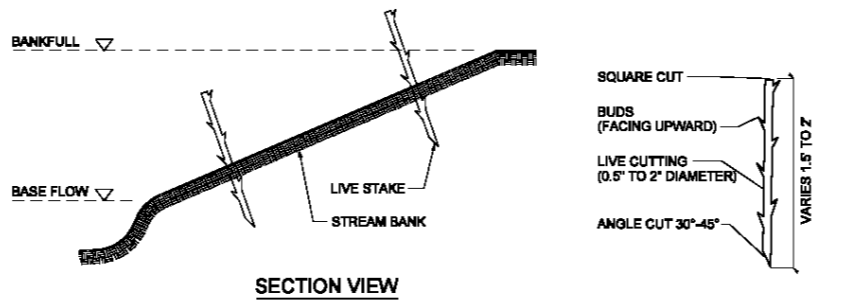
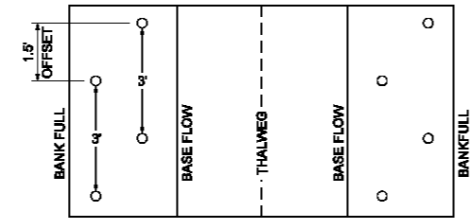
STREAM ZONE
 LIVE STAKES: 1.5' TO 2' LENGTHS, 1/2" TO 2" DIAMETER,
 2 ROWS AT 3' CENTER SPACING (SEE DETAIL), RANDOM SPECIES PLACEMENT

SECTION VIEW

PLAN VIEW

NOTES:
 - LIVE STAKES REDUCED ON INNER BANK LOCATIONS (INSIDE MEANDER BENDS).
