**Jacob's Landing  
Stream Restoration Monitoring Report  
EEP Project # 95024  
EEP Contract # 003984  
Monitoring Year 01**

**Construction Completed: January 2014  
Data Collection: 2014  
Submitted: January 2015**

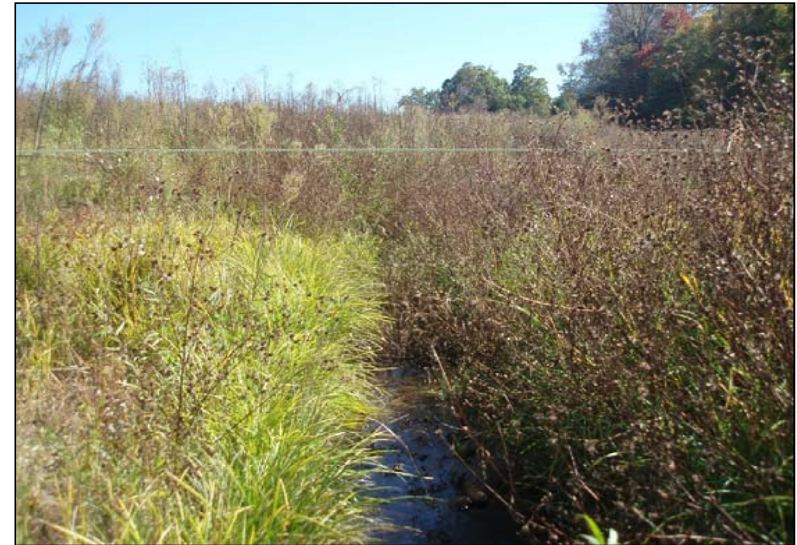
<b>River Basin:</b>	Yadkin-Pee Dee
<b>Watershed:</b>	Jacob's Landing
<b>XS ID</b>	XS-1, Riffle (T1)
<b>Drainage Area (sq mi):</b>	0.37
<b>Date:</b>	10/27/2014
<b>Field Crew:</b>	T. Seelinger and M. Underwood

Station	Elevation
0.0	800.54
2.0	800.36
5.0	799.84
6.5	799.30
9.6	797.97
13.2	796.55
14.9	795.91
19.4	795.62
22.2	795.93
24.1	795.31
25.6	795.15
25.8	795.03
26.3	794.81
26.9	794.50
28.1	794.39
28.9	794.45
29.4	794.66
30.3	794.77
30.8	795.00
31.7	795.19
33.2	795.62
34.3	795.83
36.9	795.66
42.6	795.78
46.0	795.90
49.0	796.09
52.2	797.08
56.2	798.76
59.0	799.43
60.9	799.77
63.7	799.76
65.0	799.88

SUMMARY DATA	
<b>Bankfull Elevation:</b>	795.8
<b>Bankfull Cross-Sectional Area:</b>	8.9
<b>Bankfull Width:</b>	11.8
<b>Flood Prone Area Elevation:</b>	797.3
<b>Flood Prone Width:</b>	41.2
<b>Max Depth at Bankfull:</b>	1.4
<b>Mean Depth at Bankfull:</b>	0.8
<b>W / D Ratio:</b>	15.6
<b>Entrenchment Ratio:</b>	3.5
<b>Bank Height Ratio:</b>	1.0

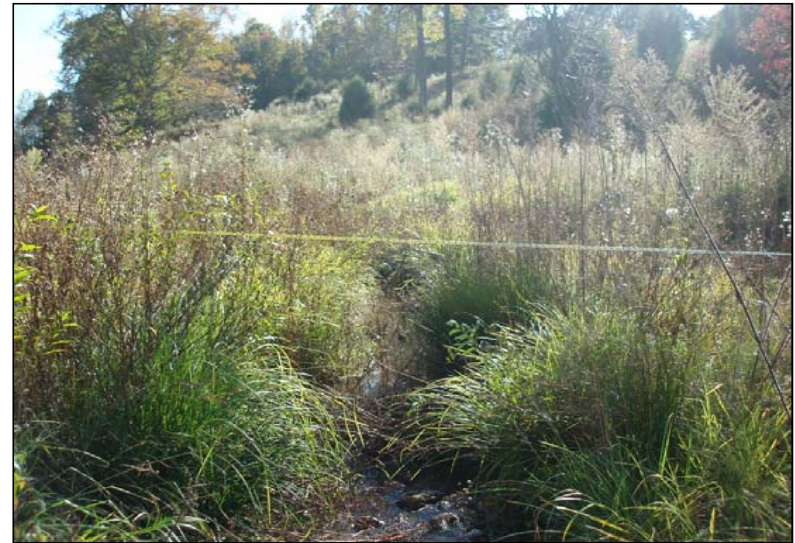
<b>River Basin:</b>	Yadkin-Pee Dee
<b>Watershed:</b>	Jacob's Landing
<b>XS ID</b>	XS-2, Riffle (T1)
<b>Drainage Area (sq mi):</b>	0.38
<b>Date:</b>	10/27/2014
<b>Field Crew:</b>	T. Seelinger and M. Underwood

Station	Elevation
0.0	794.46
3.1	794.24
6.6	793.49
10.9	792.47
15.1	792.26
18.0	792.28
21.8	792.31
25.3	792.35
31.3	792.17
35.9	792.23
38.5	792.14
38.8	792.10
40.7	791.33
41.1	791.16
42.4	790.99
43.6	790.95
44.7	790.99
45.5	790.97
46.1	791.28
46.6	791.66
48.2	791.99
49.7	792.49
54.1	792.50
57.8	792.63
61.9	792.74
65.9	792.82
70.8	792.96
74.8	793.58
77.8	794.38
77.9	794.93

SUMMARY DATA	
<b>Bankfull Elevation:</b>	792.4
<b>Bankfull Cross-Sectional Area:</b>	10.3
<b>Bankfull Width:</b>	10.9
<b>Flood Prone Area Elevation:</b>	793.8
<b>Flood Prone Width:</b>	70.7
<b>Max Depth at Bankfull:</b>	1.4
<b>Mean Depth at Bankfull:</b>	0.9
<b>W / D Ratio:</b>	11.5
<b>Entrenchment Ratio:</b>	6.5
<b>Bank Height Ratio:</b>	1.0

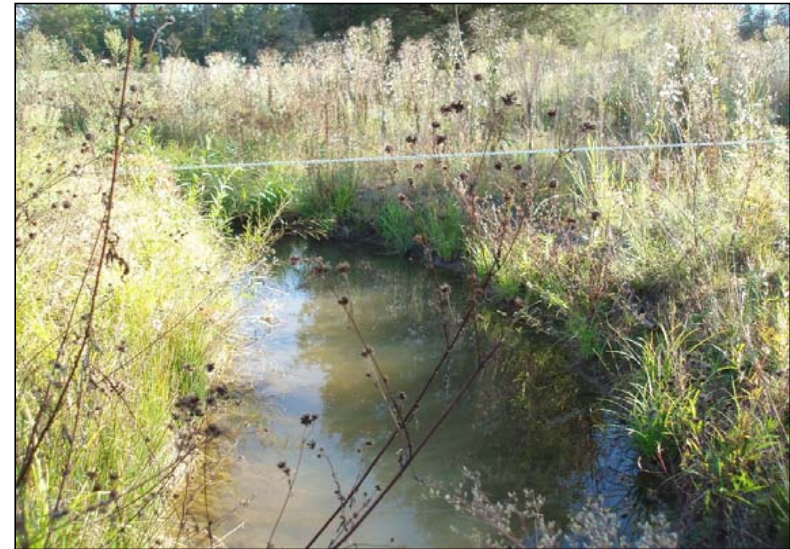
<b>River Basin:</b>	Yadkin-Pee Dee
<b>Watershed:</b>	Jacob's Landing
<b>XS ID</b>	XS-3, Pool (T1)
<b>Drainage Area (sq mi):</b>	0.4
<b>Date:</b>	10/27/2014
<b>Field Crew:</b>	T. Seelinger and M. Underwood

Station	Elevation
0.0	794.12
0.8	794.02
3.6	793.16
5.8	792.52
7.9	791.64
10.2	791.14
14.5	791.24
18.0	791.18
22.4	791.36
27.4	791.30
30.1	791.31
33.0	791.11
36.3	790.82
37.3	790.32
38.4	790.08
39.3	789.23
40.4	788.81
41.1	788.43
42.0	788.51
42.6	788.38
42.7	788.54
43.4	789.11
43.6	789.59
44.3	790.05
45.1	790.68
45.8	791.08
46.9	791.38
48.6	791.66
52.5	791.79
54.1	791.89
56.8	793.06
58.4	793.31
60.2	793.94
62.5	793.87
62.4	794.36

SUMMARY DATA	
<b>Bankfull Elevation:</b>	791.3
<b>Bankfull Cross-Sectional Area:</b>	17.2
<b>Bankfull Width:</b>	15.5
<b>Flood Prone Area Elevation:</b>	-
<b>Flood Prone Width:</b>	-
<b>Max Depth at Bankfull:</b>	2.9
<b>Mean Depth at Bankfull:</b>	1.1
<b>W / D Ratio:</b>	-
<b>Entrenchment Ratio:</b>	-
<b>Bank Height Ratio:</b>	-

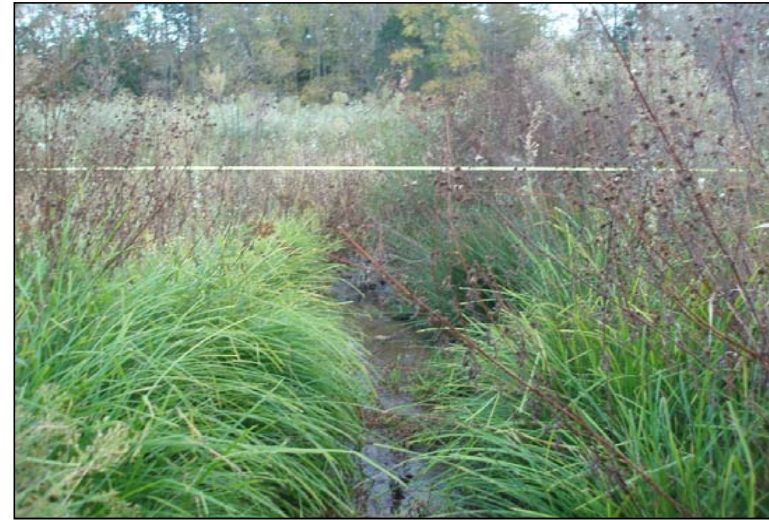
<b>River Basin:</b>	Yadkin-Pee Dee
<b>Watershed:</b>	Jacob's Landing
<b>XS ID</b>	XS-4, Riffle (T1)
<b>Drainage Area (sq mi):</b>	0.40
<b>Date:</b>	10/27/2014
<b>Field Crew:</b>	T. Seelinger and M. Underwood

Station	Elevation
0.0	792.17
1.2	792.12
3.8	791.09
7.3	790.15
10.8	789.95
16.0	790.02
21.3	789.79
25.5	789.84
26.8	789.65
28.4	789.20
28.9	789.01
29.7	788.91
30.6	788.59
31.6	788.58
32.9	788.59
33.4	788.74
33.7	788.95
34.5	789.13
35.0	789.34
36.3	789.79
37.4	790.15
40.1	789.95
44.7	790.16
48.7	790.30
54.5	790.22
58.6	790.13
60.9	790.49
63.9	791.43
66.2	792.34
67.8	792.93
67.6	793.51

SUMMARY DATA	
<b>Bankfull Elevation:</b>	789.9
<b>Bankfull Cross-Sectional Area:</b>	8.7
<b>Bankfull Width:</b>	11.2
<b>Flood Prone Area Elevation:</b>	791.2
<b>Flood Prone Width:</b>	59.8
<b>Max Depth at Bankfull:</b>	1.3
<b>Mean Depth at Bankfull:</b>	0.8
<b>W / D Ratio:</b>	14.4
<b>Entrenchment Ratio:</b>	5.3
<b>Bank Height Ratio:</b>	1.0

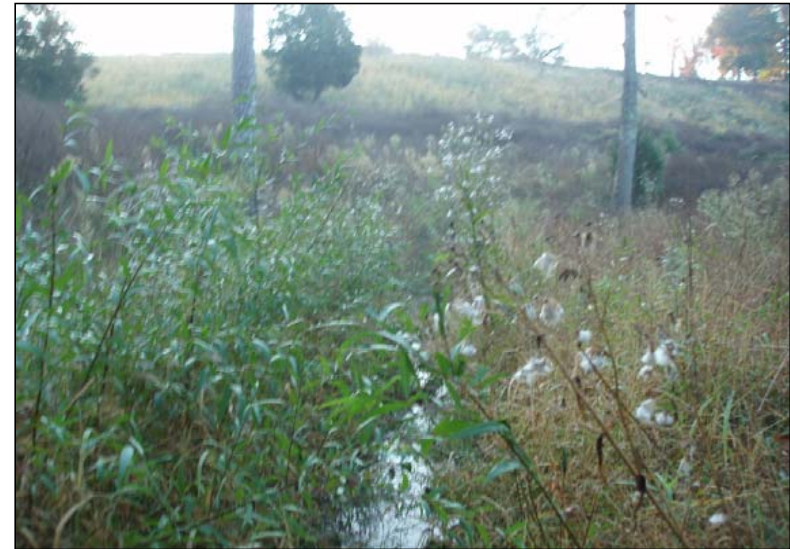
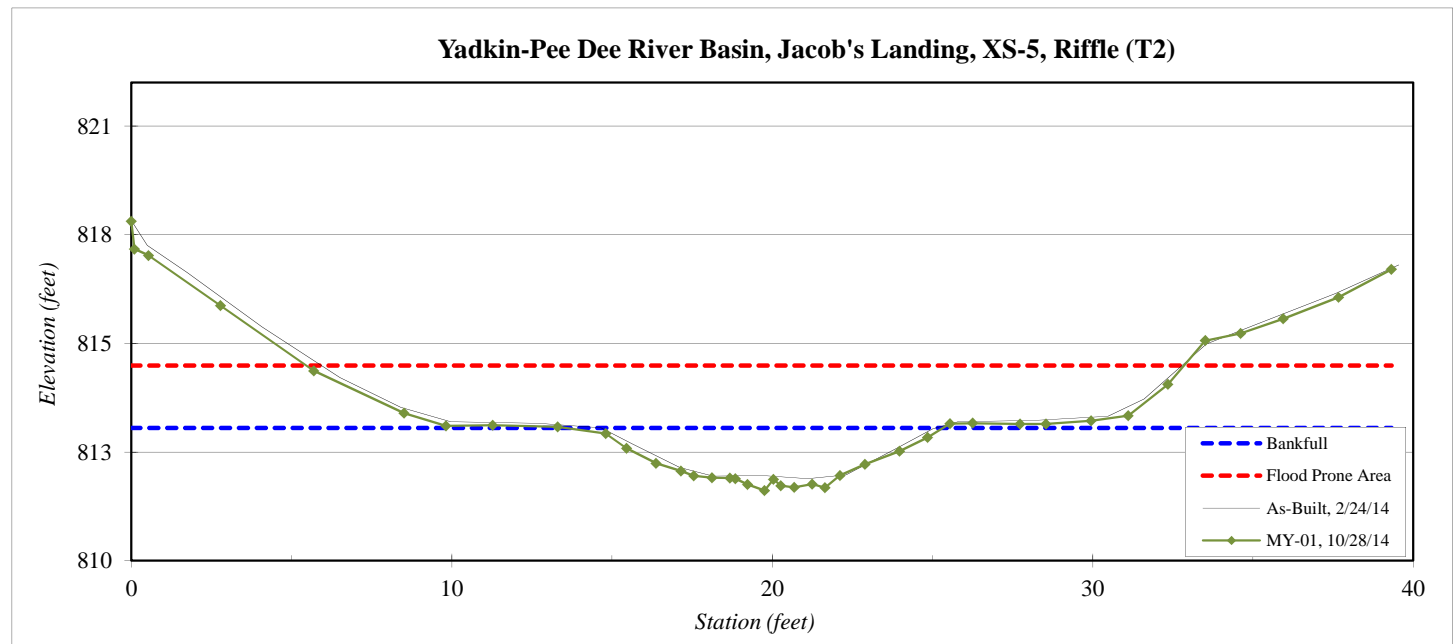
<b>River Basin:</b>	Yadkin-Pee Dee
<b>Watershed:</b>	Jacob's Landing
<b>XS ID</b>	XS-5, Riffle (T2)
<b>Drainage Area (sq mi):</b>	0.23
<b>Date:</b>	10/28/2014
<b>Field Crew:</b>	T. Seelinger and M. Underwood

Station	Elevation
0.0	818.52
0.1	817.82
0.5	817.66
2.8	816.40
8.5	813.70
9.8	813.38
11.3	813.40
13.3	813.36
14.8	813.19
15.5	812.82
17.2	812.25
17.6	812.13
18.1	812.08
18.7	812.07
18.9	812.06
19.2	811.91
19.8	811.76
20.0	812.04
20.3	811.88
20.7	811.84
21.3	811.92
21.7	811.83
22.1	812.14
22.9	812.42
24.9	813.09
25.6	813.44
26.3	813.45
28.5	813.43
31.1	813.64
32.3	814.42
33.5	815.52
34.6	815.70
37.7	816.61
39.3	817.31

SUMMARY DATA	
<b>Bankfull Elevation:</b>	813.3
<b>Bankfull Cross-Sectional Area:</b>	10.5
<b>Bankfull Width:</b>	11.8
<b>Flood Prone Area Elevation:</b>	814.9
<b>Flood Prone Width:</b>	27.4
<b>Max Depth at Bankfull:</b>	1.6
<b>Mean Depth at Bankfull:</b>	0.9
<b>W / D Ratio:</b>	13.3
<b>Entrenchment Ratio:</b>	2.3
<b>Bank Height Ratio:</b>	1.0

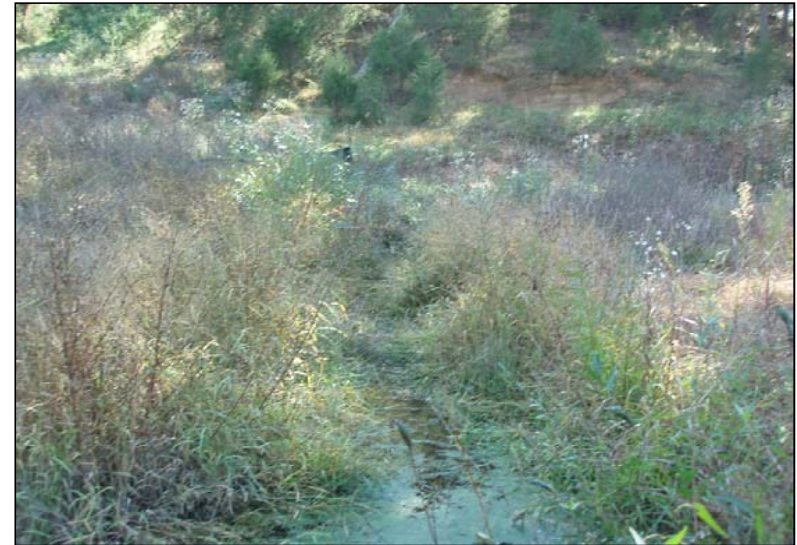
<b>River Basin:</b>	Yadkin-Pee Dee
<b>Watershed:</b>	Jacob's Landing
<b>XS ID</b>	XS-6, Riffle (T2)
<b>Drainage Area (sq mi):</b>	0.23
<b>Date:</b>	10/28/2014
<b>Field Crew:</b>	T. Seelinger and M. Underwood

Station	Elevation
0.0	812.22
3.4	811.84
6.2	811.50
10.0	810.94
15.1	809.81
16.7	809.67
18.9	809.64
20.0	809.49
21.0	809.13
22.2	808.71
22.9	808.72
23.4	808.50
23.7	808.25
24.8	808.40
25.3	808.23
25.6	808.09
26.3	808.09
26.3	808.25
27.4	808.59
28.0	808.91
28.9	808.76
29.2	808.88
31.1	809.46
32.2	809.9
32.5	810.08
34.8	810.1
37.5	810.29
39.1	810.4
40.0	810.67
42.2	811.0
43.6	811.2
46.3	812.37
46.9	812.62
46.8	813.82

SUMMARY DATA	
<b>Bankfull Elevation:</b>	809.5
<b>Bankfull Cross-Sectional Area:</b>	8.8
<b>Bankfull Width:</b>	11.4
<b>Flood Prone Area Elevation:</b>	811.0
<b>Flood Prone Width:</b>	32.0
<b>Max Depth at Bankfull:</b>	1.4
<b>Mean Depth at Bankfull:</b>	0.8
<b>W / D Ratio:</b>	14.8
<b>Entrenchment Ratio:</b>	2.8
<b>Bank Height Ratio:</b>	1.0

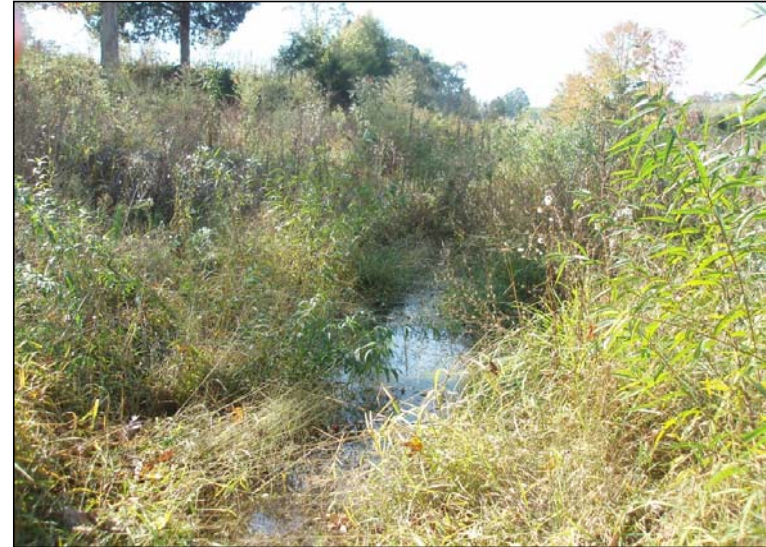
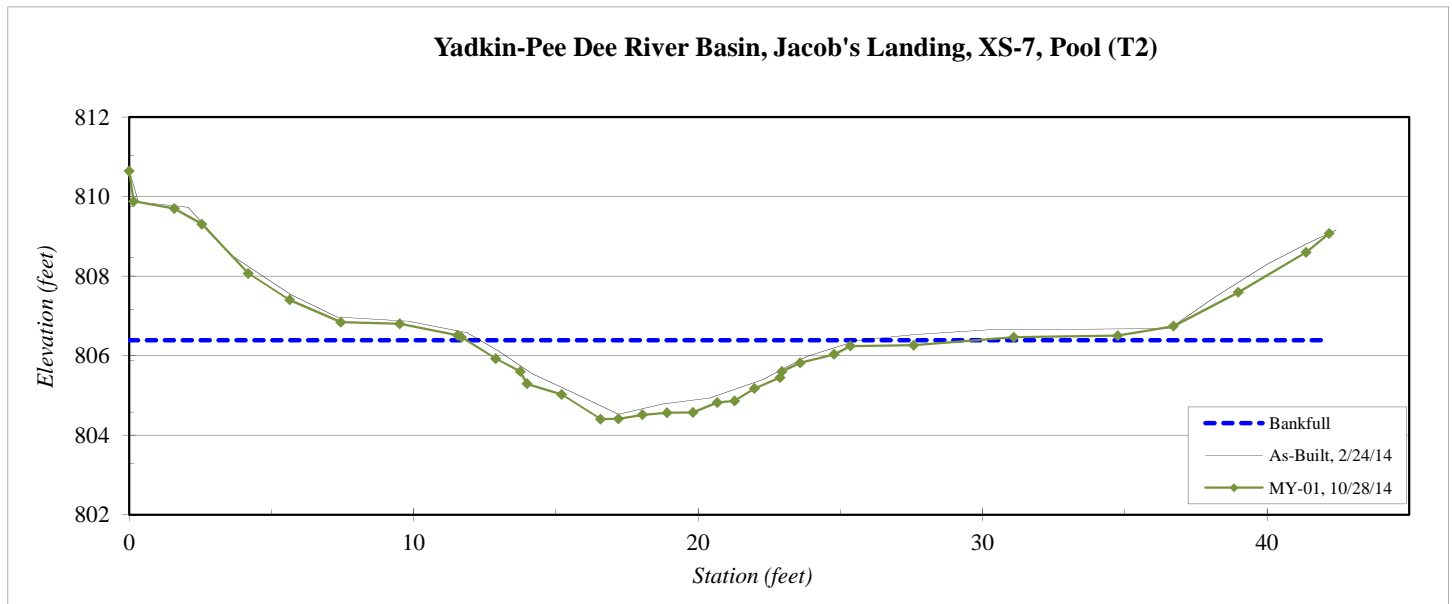
Yadkin-Pee Dee River Basin, Jacob's Landing, XS-7, Pool (T2)

<b>River Basin:</b>	Yadkin-Pee Dee
<b>Watershed:</b>	Jacob's Landing
<b>XS ID</b>	XS-7, Pool (T2)
<b>Drainage Area (sq mi):</b>	0.23
<b>Date:</b>	10/27/2014
<b>Field Crew:</b>	T. Seelinger and M. Underwood

Station	Elevation
0.0	810.64
0.2	809.88
1.6	809.70
2.6	809.31
4.2	808.07
5.7	807.40
7.5	806.84
9.5	806.80
11.6	806.51
11.7	806.46
12.9	805.92
13.8	805.60
14.0	805.29
15.2	805.02
16.6	804.40
17.2	804.41
18.1	804.51
18.9	804.56
19.8	804.57
20.7	804.82
21.3	804.86
22.0	805.17
22.9	805.45
23.0	805.60
23.6	805.82
24.8	806.03
25.4	806.24
27.6	806.26
31.1	806.46
34.8	806.50
36.7	806.74
39.0	807.59
41.4	808.60
42.2	809.07

SUMMARY DATA	
<b>Bankfull Elevation:</b>	806.4
<b>Bankfull Cross-Sectional Area:</b>	16.9
<b>Bankfull Width:</b>	13.5
<b>Flood Prone Area Elevation:</b>	-
<b>Flood Prone Width:</b>	-
<b>Max Depth at Bankfull:</b>	2.0
<b>Mean Depth at Bankfull:</b>	1.3
<b>W / D Ratio:</b>	-
<b>Entrenchment Ratio:</b>	-
<b>Bank Height Ratio:</b>	-

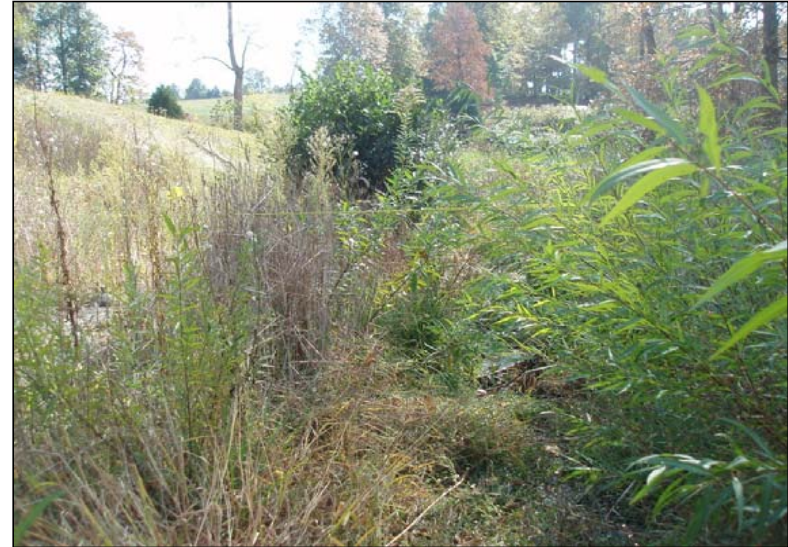
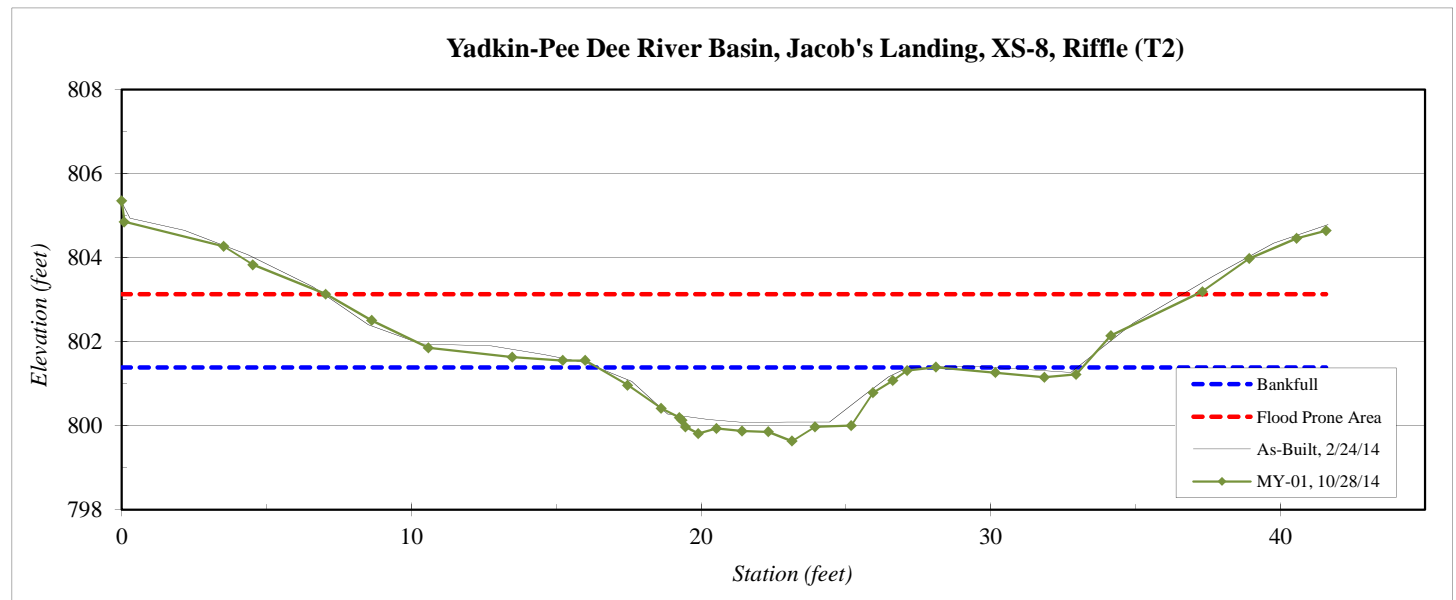
<b>River Basin:</b>	Yadkin-Pee Dee
<b>Watershed:</b>	Jacob's Landing
<b>XS ID</b>	XS-8, Riffle (T2)
<b>Drainage Area (sq mi):</b>	0.23
<b>Date:</b>	10/28/2014
<b>Field Crew:</b>	T. Seelinger and M. Underwood

Station	Elevation
0.0	805.35
0.1	804.85
3.5	804.27
4.5	803.83
7.0	803.13
8.6	802.50
10.6	801.85
13.5	801.63
15.2	801.55
16.0	801.55
17.5	800.96
18.6	800.41
19.3	800.19
19.3	800.13
19.5	799.97
19.9	799.81
20.5	799.93
21.4	799.87
22.3	799.85
23.1	799.63
23.9	799.97
25.2	800.00
25.9	800.78
26.6	801.07
27.1	801.31
28.1	801.39
30.2	801.26
31.9	801.15
33.0	801.22
34.2	802.14
37.3	803.19
38.9	803.98
40.6	804.46
41.6	804.64

SUMMARY DATA	
<b>Bankfull Elevation:</b>	801.4
<b>Bankfull Cross-Sectional Area:</b>	11.8
<b>Bankfull Width:</b>	11.6
<b>Flood Prone Area Elevation:</b>	803.1
<b>Flood Prone Width:</b>	30.1
<b>Max Depth at Bankfull:</b>	1.8
<b>Mean Depth at Bankfull:</b>	1.0
<b>W / D Ratio:</b>	11.4
<b>Entrenchment Ratio:</b>	2.6
<b>Bank Height Ratio:</b>	1.0

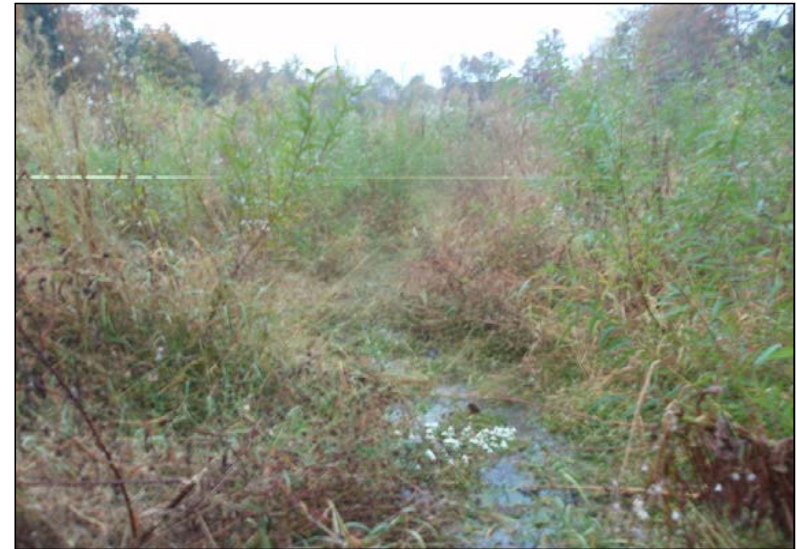
Station	Elevation
0.0	801.48
1.5	801.10
2.3	800.89
4.3	800.20
6.6	798.97
8.2	798.38
10.5	798.07
13.2	797.95
15.0	797.83
16.2	797.78
16.8	797.76
17.7	797.43
18.5	797.23
18.7	797.16
19.2	796.98
19.8	797.05
20.3	796.84
20.5	796.67
21.4	796.51
22.0	796.67
23.2	796.47
24.2	797.02
26.2	797.13
27.3	797.62
28.7	798.11
30.2	798.09
32.6	798.18
36.3	797.93
39.6	798.04
41.7	798.21
46.0	798.18
48.4	798.66
50.6	799.40
52.6	799.74
52.6	800.24

SUMMARY DATA	
<b>Bankfull Elevation:</b>	797.8
<b>Bankfull Cross-Sectional Area:</b>	8.0
<b>Bankfull Width:</b>	10.9
<b>Flood Prone Area Elevation:</b>	799.1
<b>Flood Prone Width:</b>	43.1
<b>Max Depth at Bankfull:</b>	1.3
<b>Mean Depth at Bankfull:</b>	0.7
<b>W / D Ratio:</b>	14.9
<b>Entrenchment Ratio:</b>	4.0
<b>Bank Height Ratio:</b>	1.0

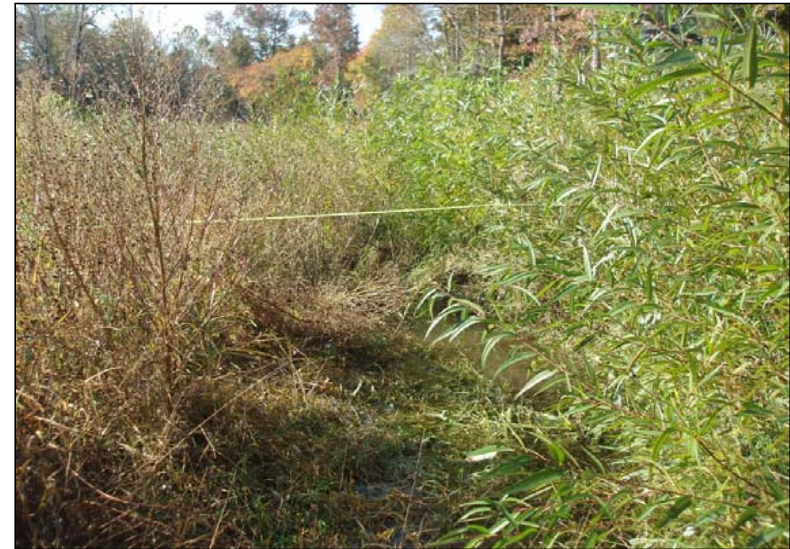
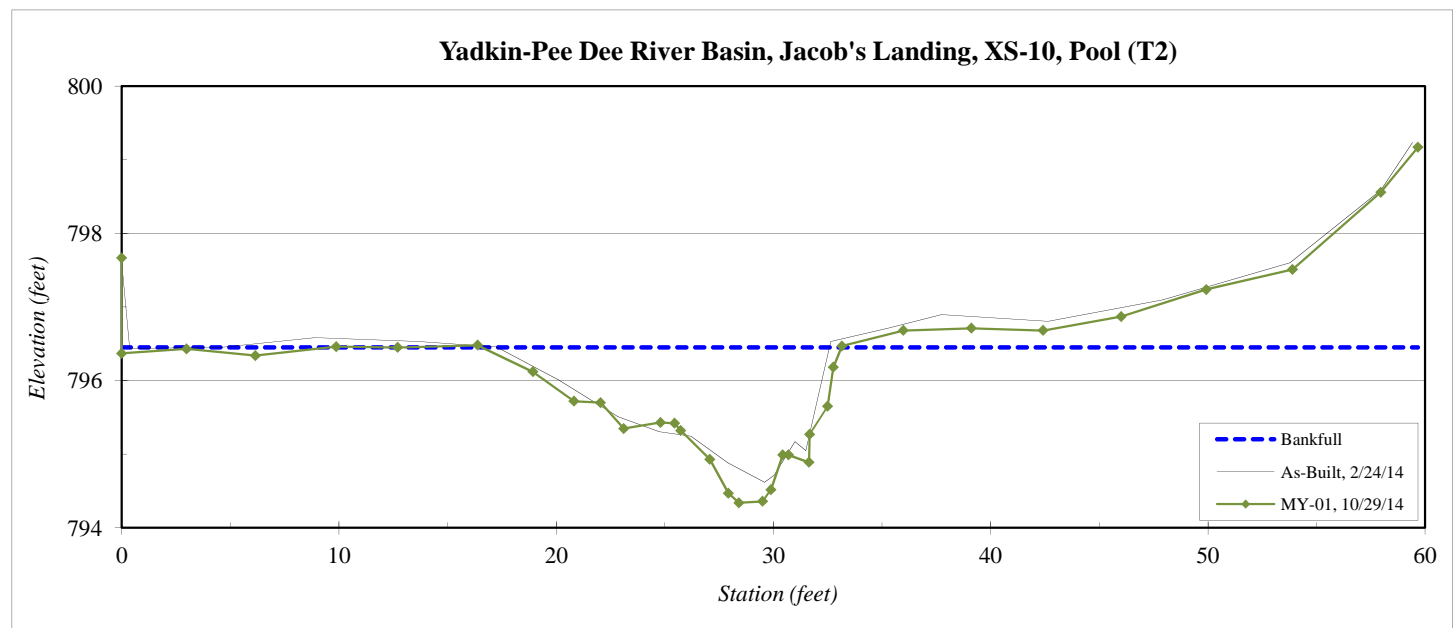
<b>River Basin:</b>	Yadkin-Pee Dee
<b>Watershed:</b>	Jacob's Landing
<b>XS ID</b>	XS-10, Pool (T2)
<b>Drainage Area (sq mi):</b>	0.31
<b>Date:</b>	10/29/2014
<b>Field Crew:</b>	T. Seelinger and M. Underwood

Station	Elevation
0.0	797.67
0.0	796.37
3.0	796.43
6.2	796.34
9.9	796.46
12.7	796.45
16.4	796.48
18.9	796.12
20.8	795.72
22.0	795.70
23.1	795.35
24.8	795.43
25.5	795.42
25.7	795.32
27.1	794.93
27.9	794.47
28.4	794.34
29.5	794.36
29.9	794.52
30.4	794.99
30.7	794.99
31.6	794.89
31.7	795.27
32.5	795.65
32.8	796.18
33.2	796.47
36.0	796.68
39.1	796.71
42.4	796.68
46.0	796.87
49.9	797.24
53.9	797.51
58.0	798.56
59.7	799.17

SUMMARY DATA	
<b>Bankfull Elevation:</b>	796.5
<b>Bankfull Cross-Sectional Area:</b>	17.1
<b>Bankfull Width:</b>	16.5
<b>Flood Prone Area Elevation:</b>	-
<b>Flood Prone Width:</b>	-
<b>Max Depth at Bankfull:</b>	2.1
<b>Mean Depth at Bankfull:</b>	1.0
<b>W / D Ratio:</b>	-
<b>Entrenchment Ratio:</b>	-
<b>Bank Height Ratio:</b>	-

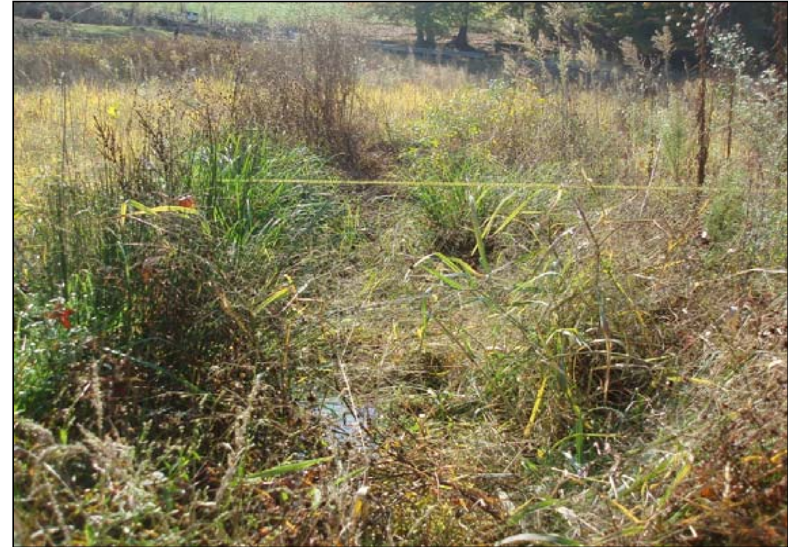
<b>River Basin:</b>	Yadkin-Pee Dee
<b>Watershed:</b>	Jacob's Landing
<b>XS ID</b>	XS-11, Riffle (T2)
<b>Drainage Area (sq mi):</b>	0.31
<b>Date:</b>	10/29/2014
<b>Field Crew:</b>	T. Seelinger and M. Underwood

Station	Elevation
0.0	794.13
3.6	793.89
7.4	793.84
11.1	793.76
14.7	793.60
16.7	793.37
18.1	792.54
19.0	792.41
19.7	792.15
20.4	792.31
21.2	792.00
21.8	792.00
22.3	792.14
22.8	792.22
23.4	792.39
24.1	792.50
25.3	792.93
26.9	793.41
28.6	793.58
31.0	793.26
35.0	793.33
38.6	793.20
42.6	793.41
46.7	793.57
50.6	794.48
53.0	795.15
54.7	795.60
55.9	795.94
55.8	796.40

SUMMARY DATA	
<b>Bankfull Elevation:</b>	793.5
<b>Bankfull Cross-Sectional Area:</b>	9.6
<b>Bankfull Width:</b>	11.9
<b>Flood Prone Area Elevation:</b>	795.0
<b>Flood Prone Width:</b>	52
<b>Max Depth at Bankfull:</b>	1.5
<b>Mean Depth at Bankfull:</b>	0.8
<b>W / D Ratio:</b>	14.8
<b>Entrenchment Ratio:</b>	4.4
<b>Bank Height Ratio:</b>	1.0

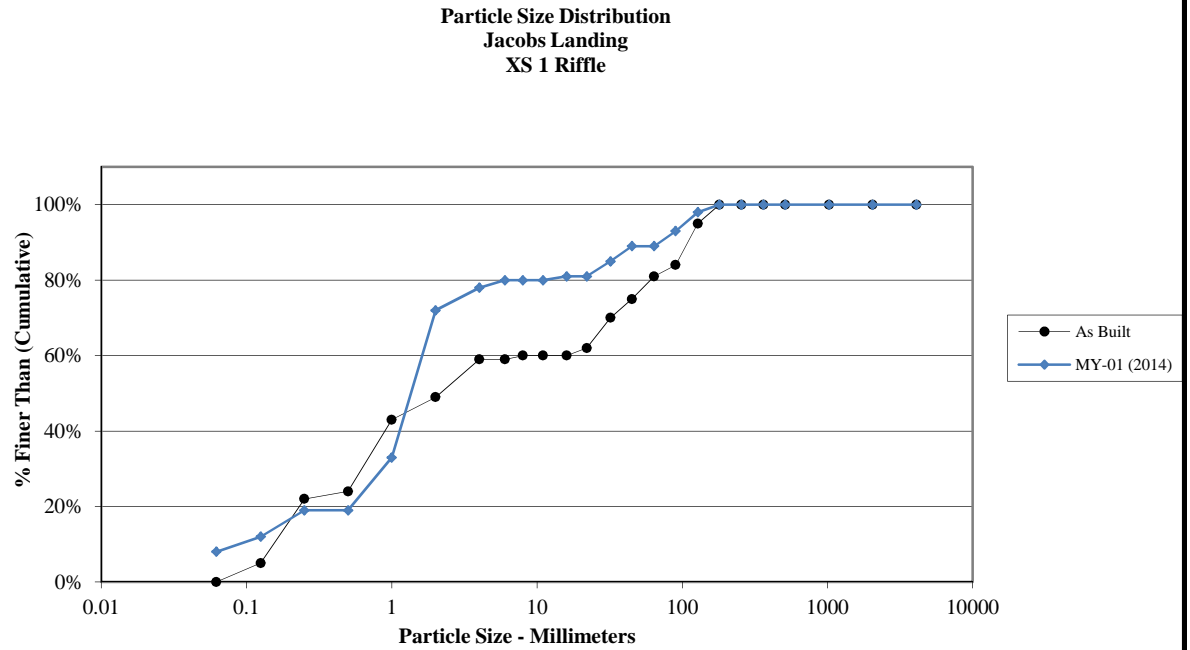
Cross-Section 1 Riffle - MY-01			
Particle	Millimeter		Count
Silt/Clay	< 0.062	S/C	8
Very Fine	.062 - .125	S	4
Fine	.125 - .25	A	7
Medium	.25 - .50	N	
Coarse	.50 - 1	D	14
Very Coarse	1 - 2	S	39
Very Fine	2 - 4		6
Fine	4 - 5.7	G	2
Fine	5.7 - 8	R	
Medium	8 - 11.3	A	
Medium	11.3 - 16	V	1
Coarse	16 - 22.6	E	
Coarse	22.6 - 32	L	4
Very Coarse	32 - 45	S	4
Very Coarse	45 - 64		
Small	64 - 90	C	4
Small	90 - 128	O	5
Large	128 - 180	B	2
Large	180 - 256	L	
Small	256 - 362	B	
Small	362 - 512	L	
Medium	512 - 1024	D	
Lrg- Very Lrg	1024 - 2048	R	
Bedrock	>2048	BDRK	
		<b>Total</b>	100
Note:

Size (mm)	
D16	0.19
D35	1
D50	1.4
D65	1.8
D84	29
D95	100

Size Distribution	
mean	2.3
dispersion	14.0
skewness	0.15

Type	
silt/clay	8%
sand	64%
gravel	17%
cobble	11%
boulder	0%
bedrock	0%
hardpan	0%
wood/det	0%
artificial	0%

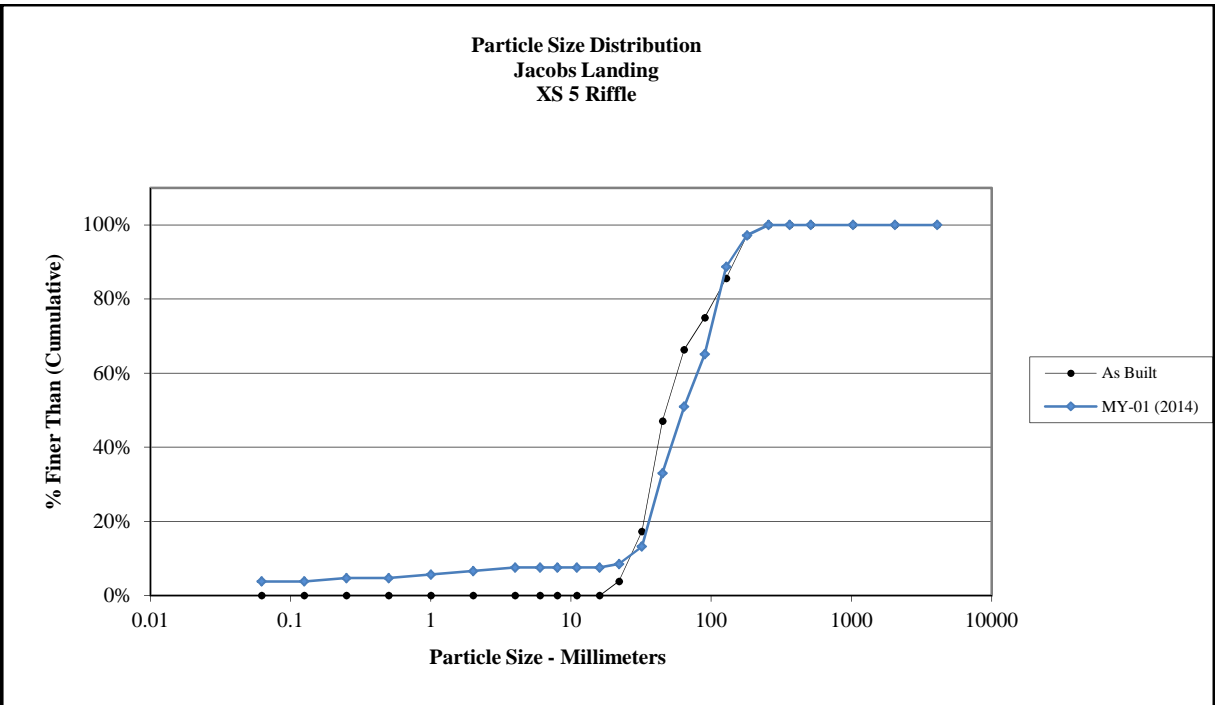
Cross-Section 5 Riffle - MY-01			
Particle	Millimeter		Count
Silt/Clay	< 0.062	S/C	4
Very Fine	.062 - .125	S	
Fine	.125 - .25	A	1
Medium	.25 - .50	N	
Coarse	.50 - 1	D	1
Very Coarse	1 - 2	S	1
Very Fine	2 - 4		1
Fine	4 - 5.7	G	
Fine	5.7 - 8	R	
Medium	8 - 11.3	A	
Medium	11.3 - 16	V	
Coarse	16 - 22.6	E	1
Coarse	22.6 - 32	L	5
Very Coarse	32 - 45	S	21
Very Coarse	45 - 64		19
Small	64 - 90	C	15
Small	90 - 128	O	25
Large	128 - 180	B	9
Large	180 - 256	L	3
Small	256 - 362	B	
Small	362 - 512	L	
Medium	512 - 1024	D	
Lrg- Very Lrg	1024 - 2048	R	
Bedrock	>2048	BDRK	
		<b>Total</b>	106
Note:

Size (mm)	
D16	34
D35	47
D50	63
D65	90
D84	120
D95	160

Size Distribution	
mean	63.9
dispersion	1.9
skewness	0.01

Type	
silt/clay	4%
sand	3%
gravel	44%
cobble	49%
boulder	0%
bedrock	0%
hardpan	0%
wood/det	0%
artificial	0%

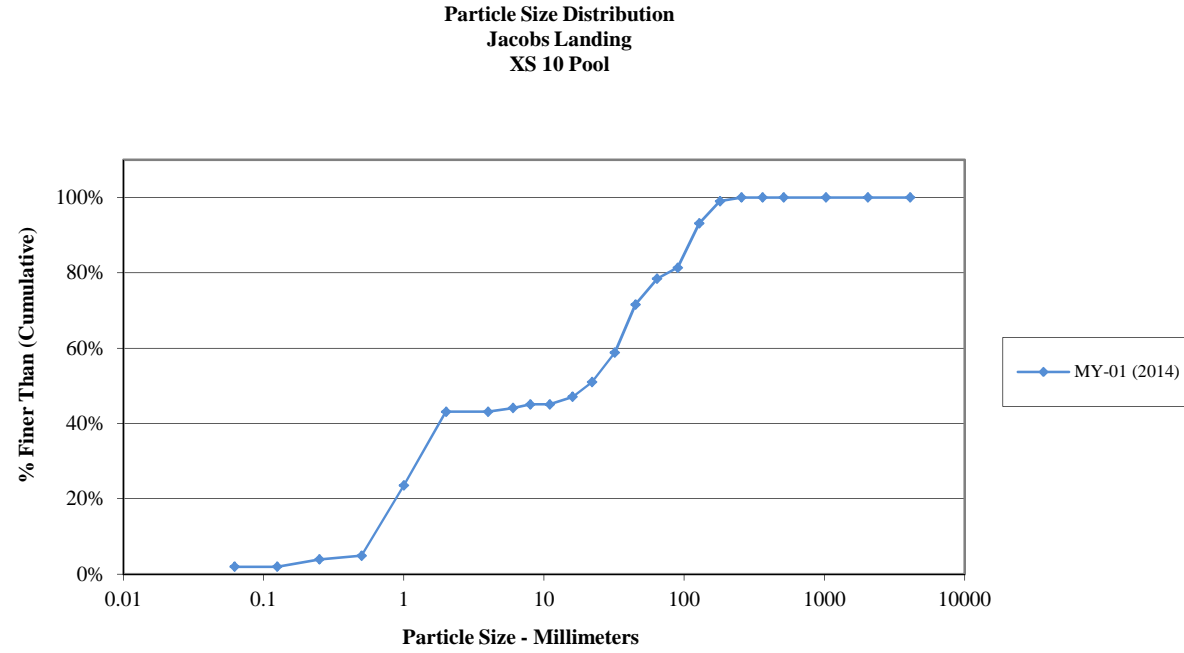
Cross-Section 10 Pool - MY-01			
Particle	Millimeter		Count
Silt/Clay	< 0.062	S/C	2
Very Fine	.062 - .125	S	
Fine	.125 - .25	A	2
Medium	.25 - .50	N	1
Coarse	.50 - 1	D	19
Very Coarse	1 - 2	S	20
Very Fine	2 - 4		
Fine	4 - 5.7	G	1
Fine	5.7 - 8	R	1
Medium	8 - 11.3	A	
Medium	11.3 - 16	V	2
Coarse	16 - 22.6	E	4
Coarse	22.6 - 32	L	8
Very Coarse	32 - 45	S	13
Very Coarse	45 - 64		7
Small	64 - 90	C	3
Small	90 - 128	O	12
Large	128 - 180	B	6
Large	180 - 256	L	1
Small	256 - 362	B	
Small	362 - 512	L	
Medium	512 - 1024	D	
Lrg- Very Lrg	1024 - 2048	R	
Bedrock	>2048	BDRK	
		<b>Total</b>	102

Size (mm)	
D16	0.76
D35	1.5
D50	20
D65	38
D84	97
D95	140

Size Distribution	
mean	8.6
dispersion	15.6
skewness	-0.25

Type	
silt/clay	2%
sand	41%
gravel	35%
cobble	22%
boulder	0%
bedrock	0%
hardpan	0%
wood/det	0%
artificial	0%
