**MITIGATION PLAN WITH AS-BUILT DRAWINGS**  
**JARMANS OAK RESTORATION SITE**  
**ONslow COUNTY, NORTH CAROLINA**

**(CONTRACT #D06069-A)**  
**FULL DELIVERY PROJECT**  
**WHITE OAK RIVER BASIN**  
**CATALOGING UNIT 03030001**

**JARMANS OAK STREAM AND WETLAND RESTORATION SITE  
AS-BUILT MITIGATION PLAN  
ONslow COUNTY**

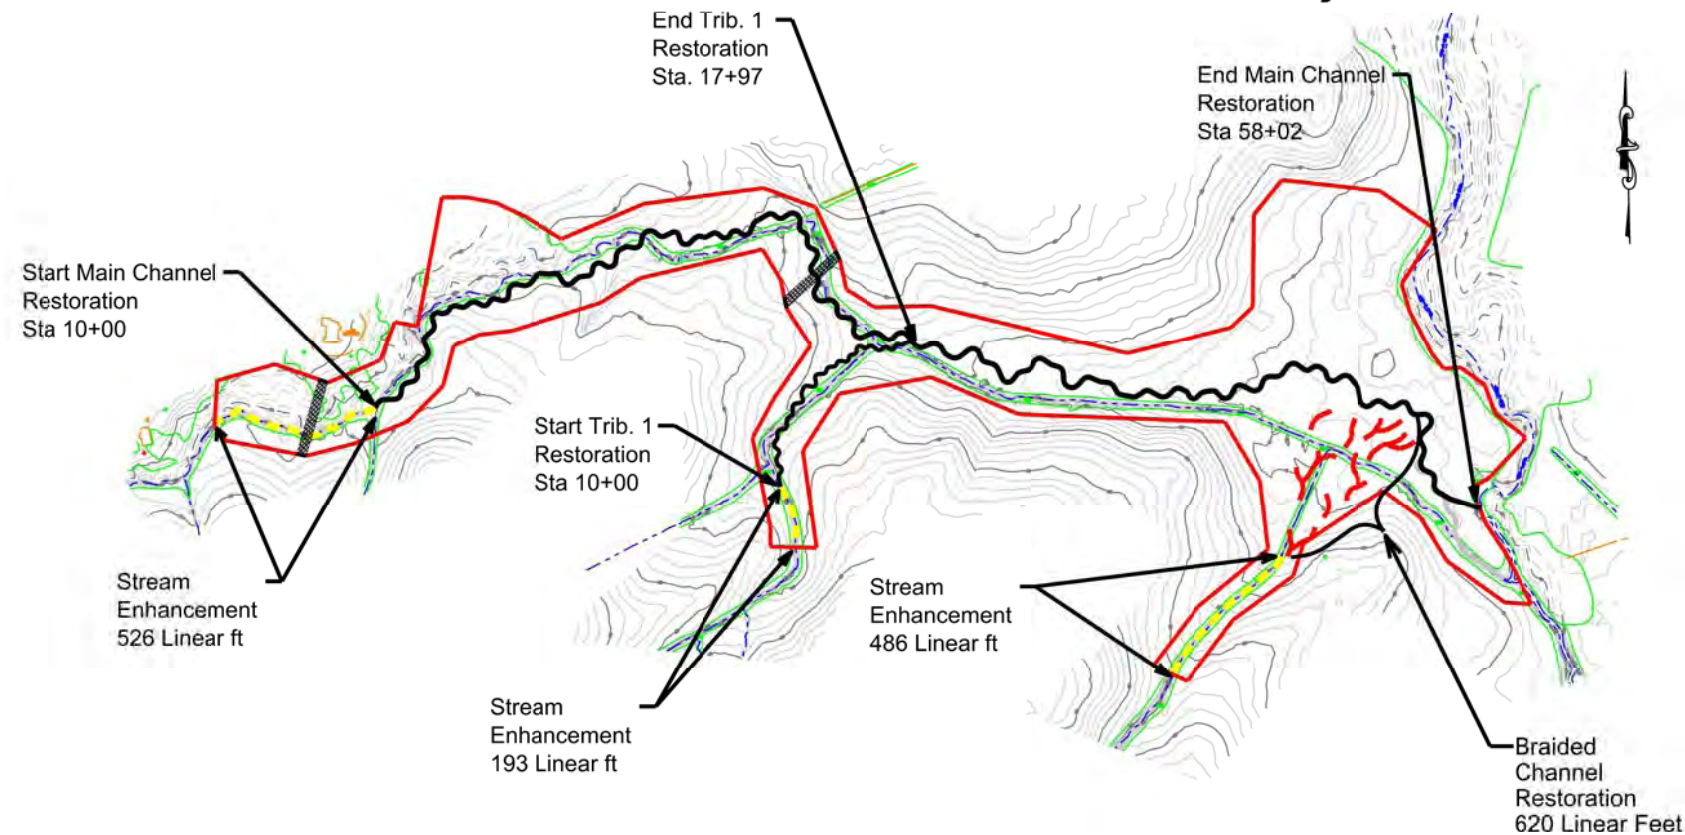
Scale:	NA	FIGURE NO. <b>T-1</b>
Date:	DEC 2007	
Project No.:	06-018

The Jarmans Oak Stream and Wetland Restoration Site, located less than 2 miles east of the Onslow/Duplin County line and approximately 3 miles west of the Town of Richlands, in Onslow County, provides 6701 stream mitigation units and 13 riverine wetland mitigation units. An approximately 35-acre conservation easement has been placed on the Site to incorporate all restoration activities. The Site contains 24 acres of hydric soil, three unnamed tributaries (UTs) to the New River, and adjacent floodplains. Site streams had been degraded by dredging and straightening of the stream channels. Additional evidence of stream deterioration included bank collapse and erosion, channel incision, changes in stream power and sediment transport, and loss of characteristic riffle/pool complex morphology. Site floodplains and wetlands had been impacted by deforestation, vegetation maintenance, and groundwater draw-down from ditching and stream channel downcutting. The primary components of this restoration project include 1) establishing a conservation easement encompassing the floodplain; 2) elevating a restored system of streams and wetlands back onto the historic (abandoned) floodplain surfaces; 3) construction of a stable, riffle-pool stream channel; 4) backfilling the old entrenched ditch/stream system; 5) reforestation of 32.5 acres of agricultural fields with native forest vegetation; 6) installation of a monitoring program to track stream and wetland development on the Site. Earthwork and grading at the Site was performed over a four month period from early June to late September 2007. Site planting occurred during the week of January 7, 2008.

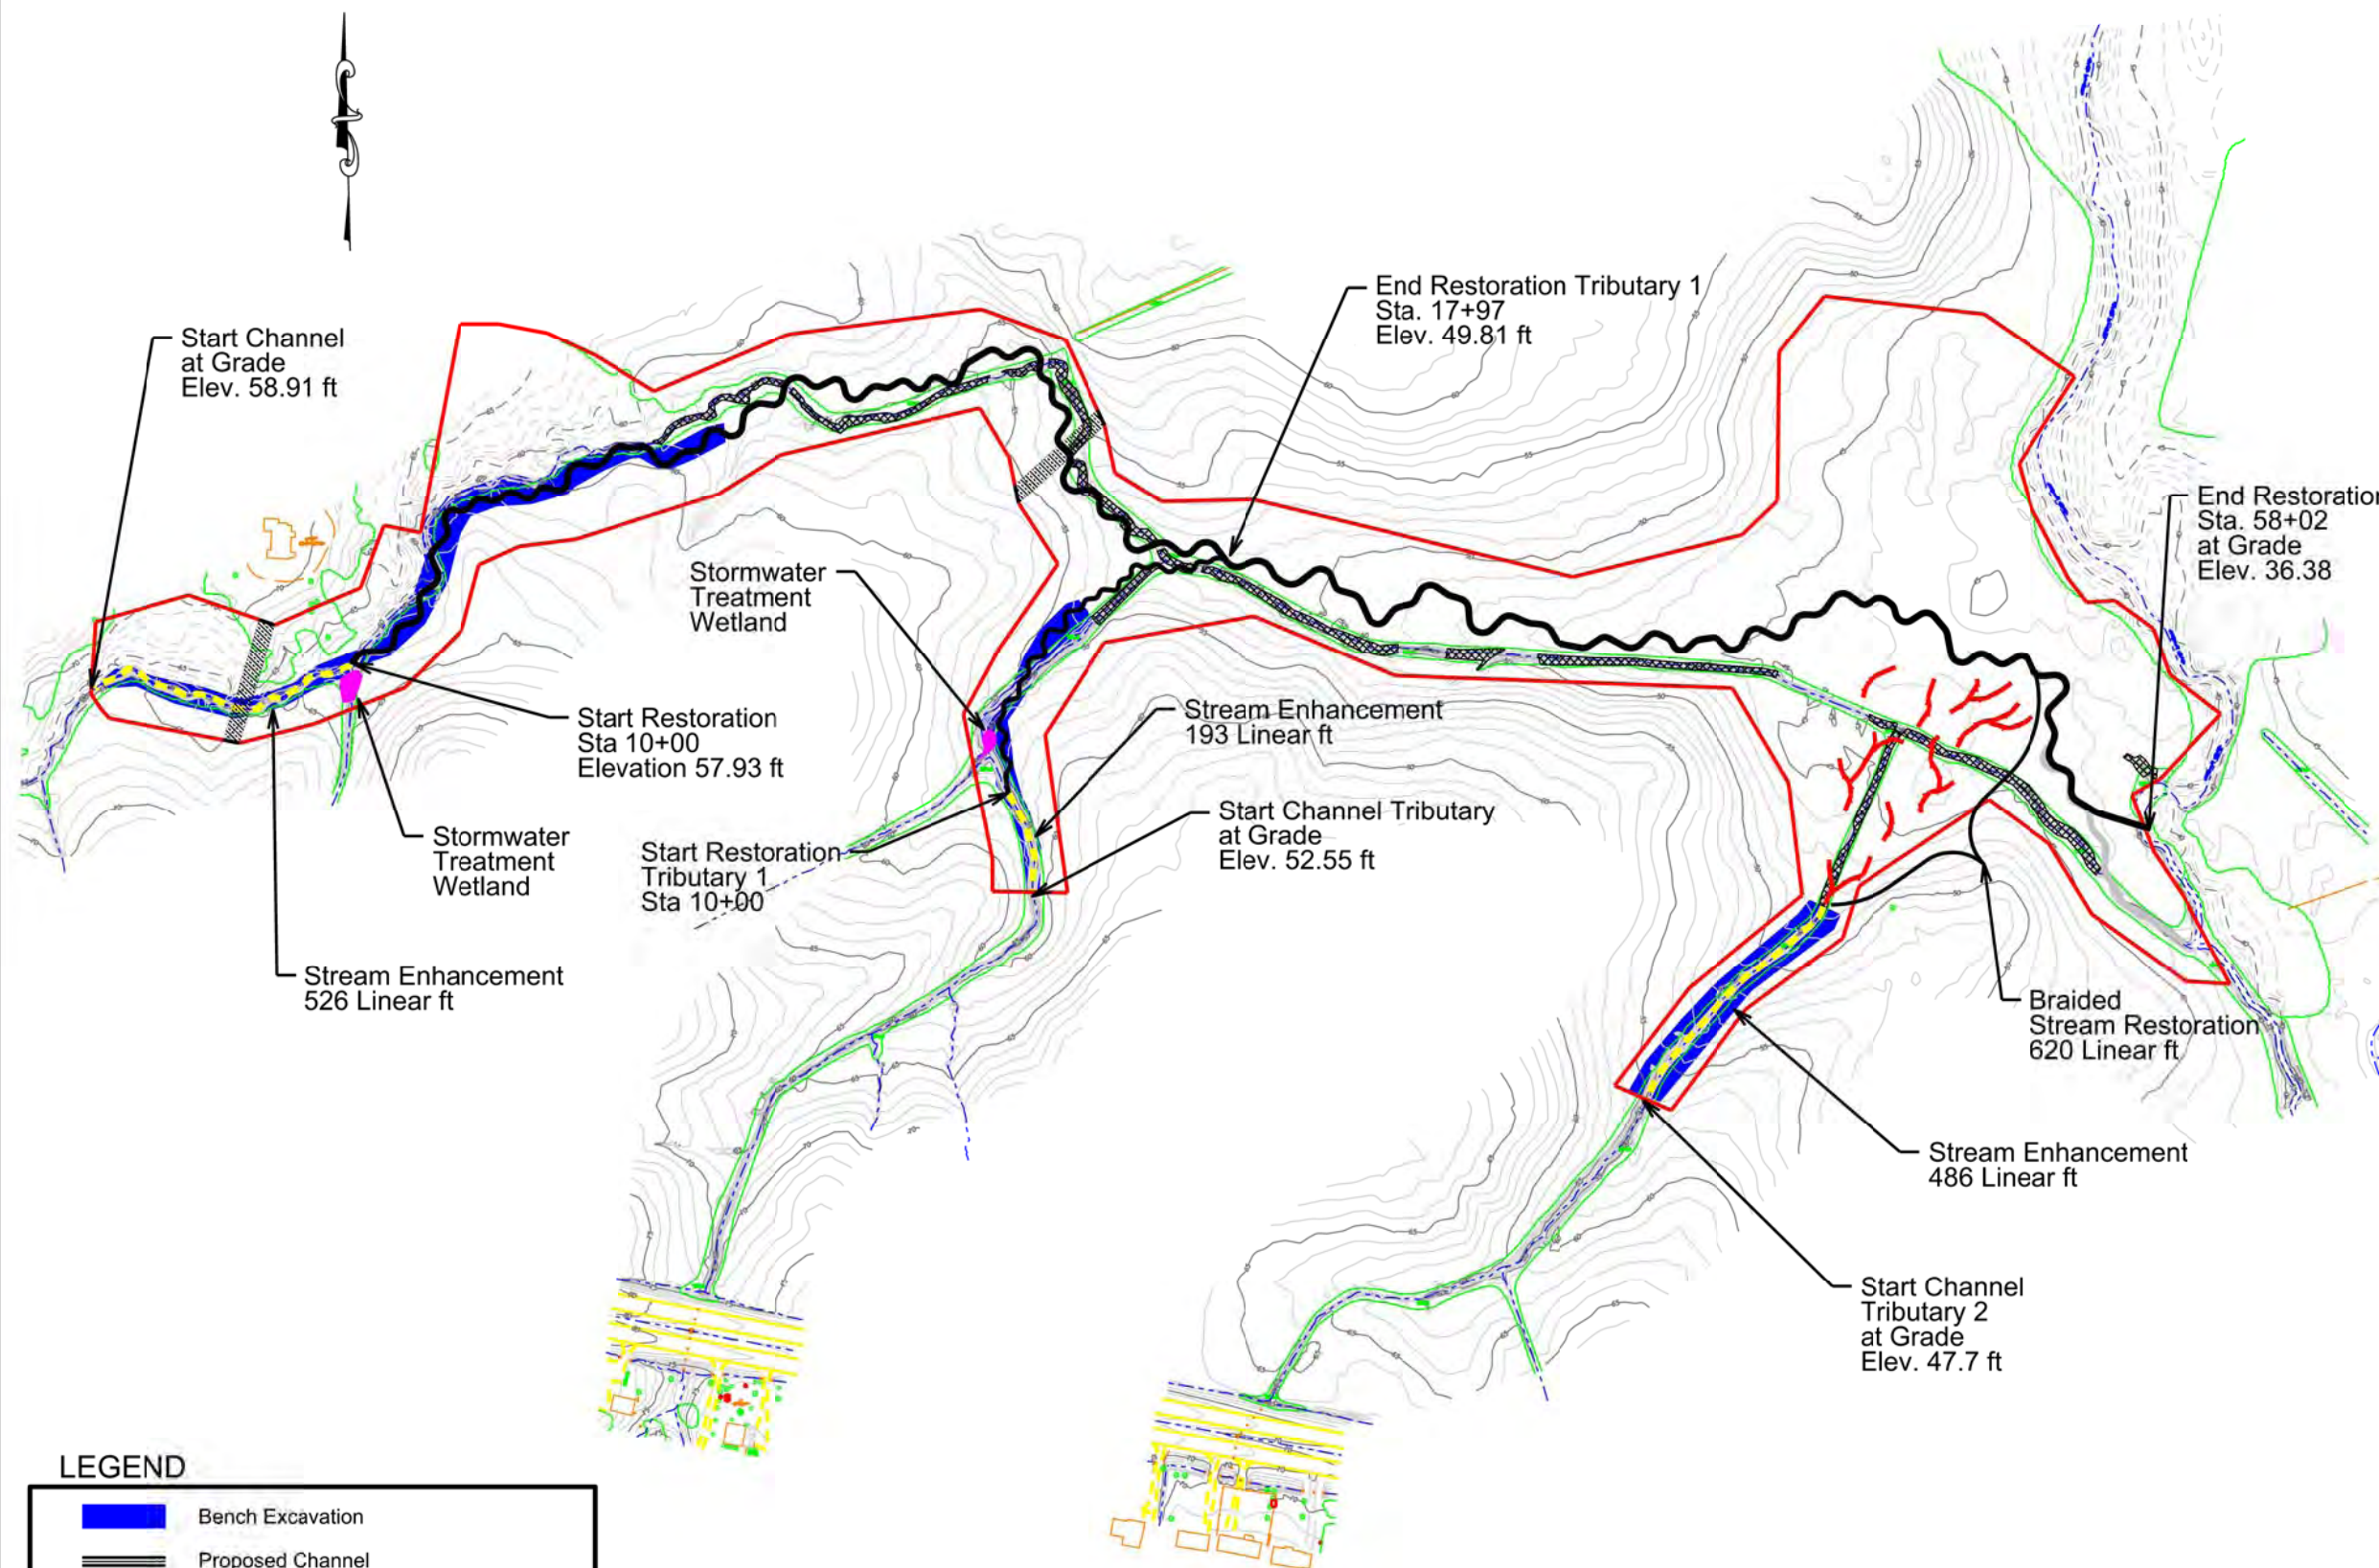
P-2

Bench Excavation
	Proposed Channel
	Stream Enhancement (Level II)
	Stormwater Treatment Wetland
	Abandoned Channel Backfill

The stream restoration plan involved the reconstruction of three UTs to the New River by diverting stream flow through its historic floodplain. Existing channels were backfilled to restore the water table to historic conditions. However, some portions of the existing channels remain open for the creation of wetland “oxbow lake-like” features. These features were plugged on each side of the open channel and will function as open water systems. They are expected to provide habitat for a variety of wildlife as well as create open water/freshwater marsh within the Site.

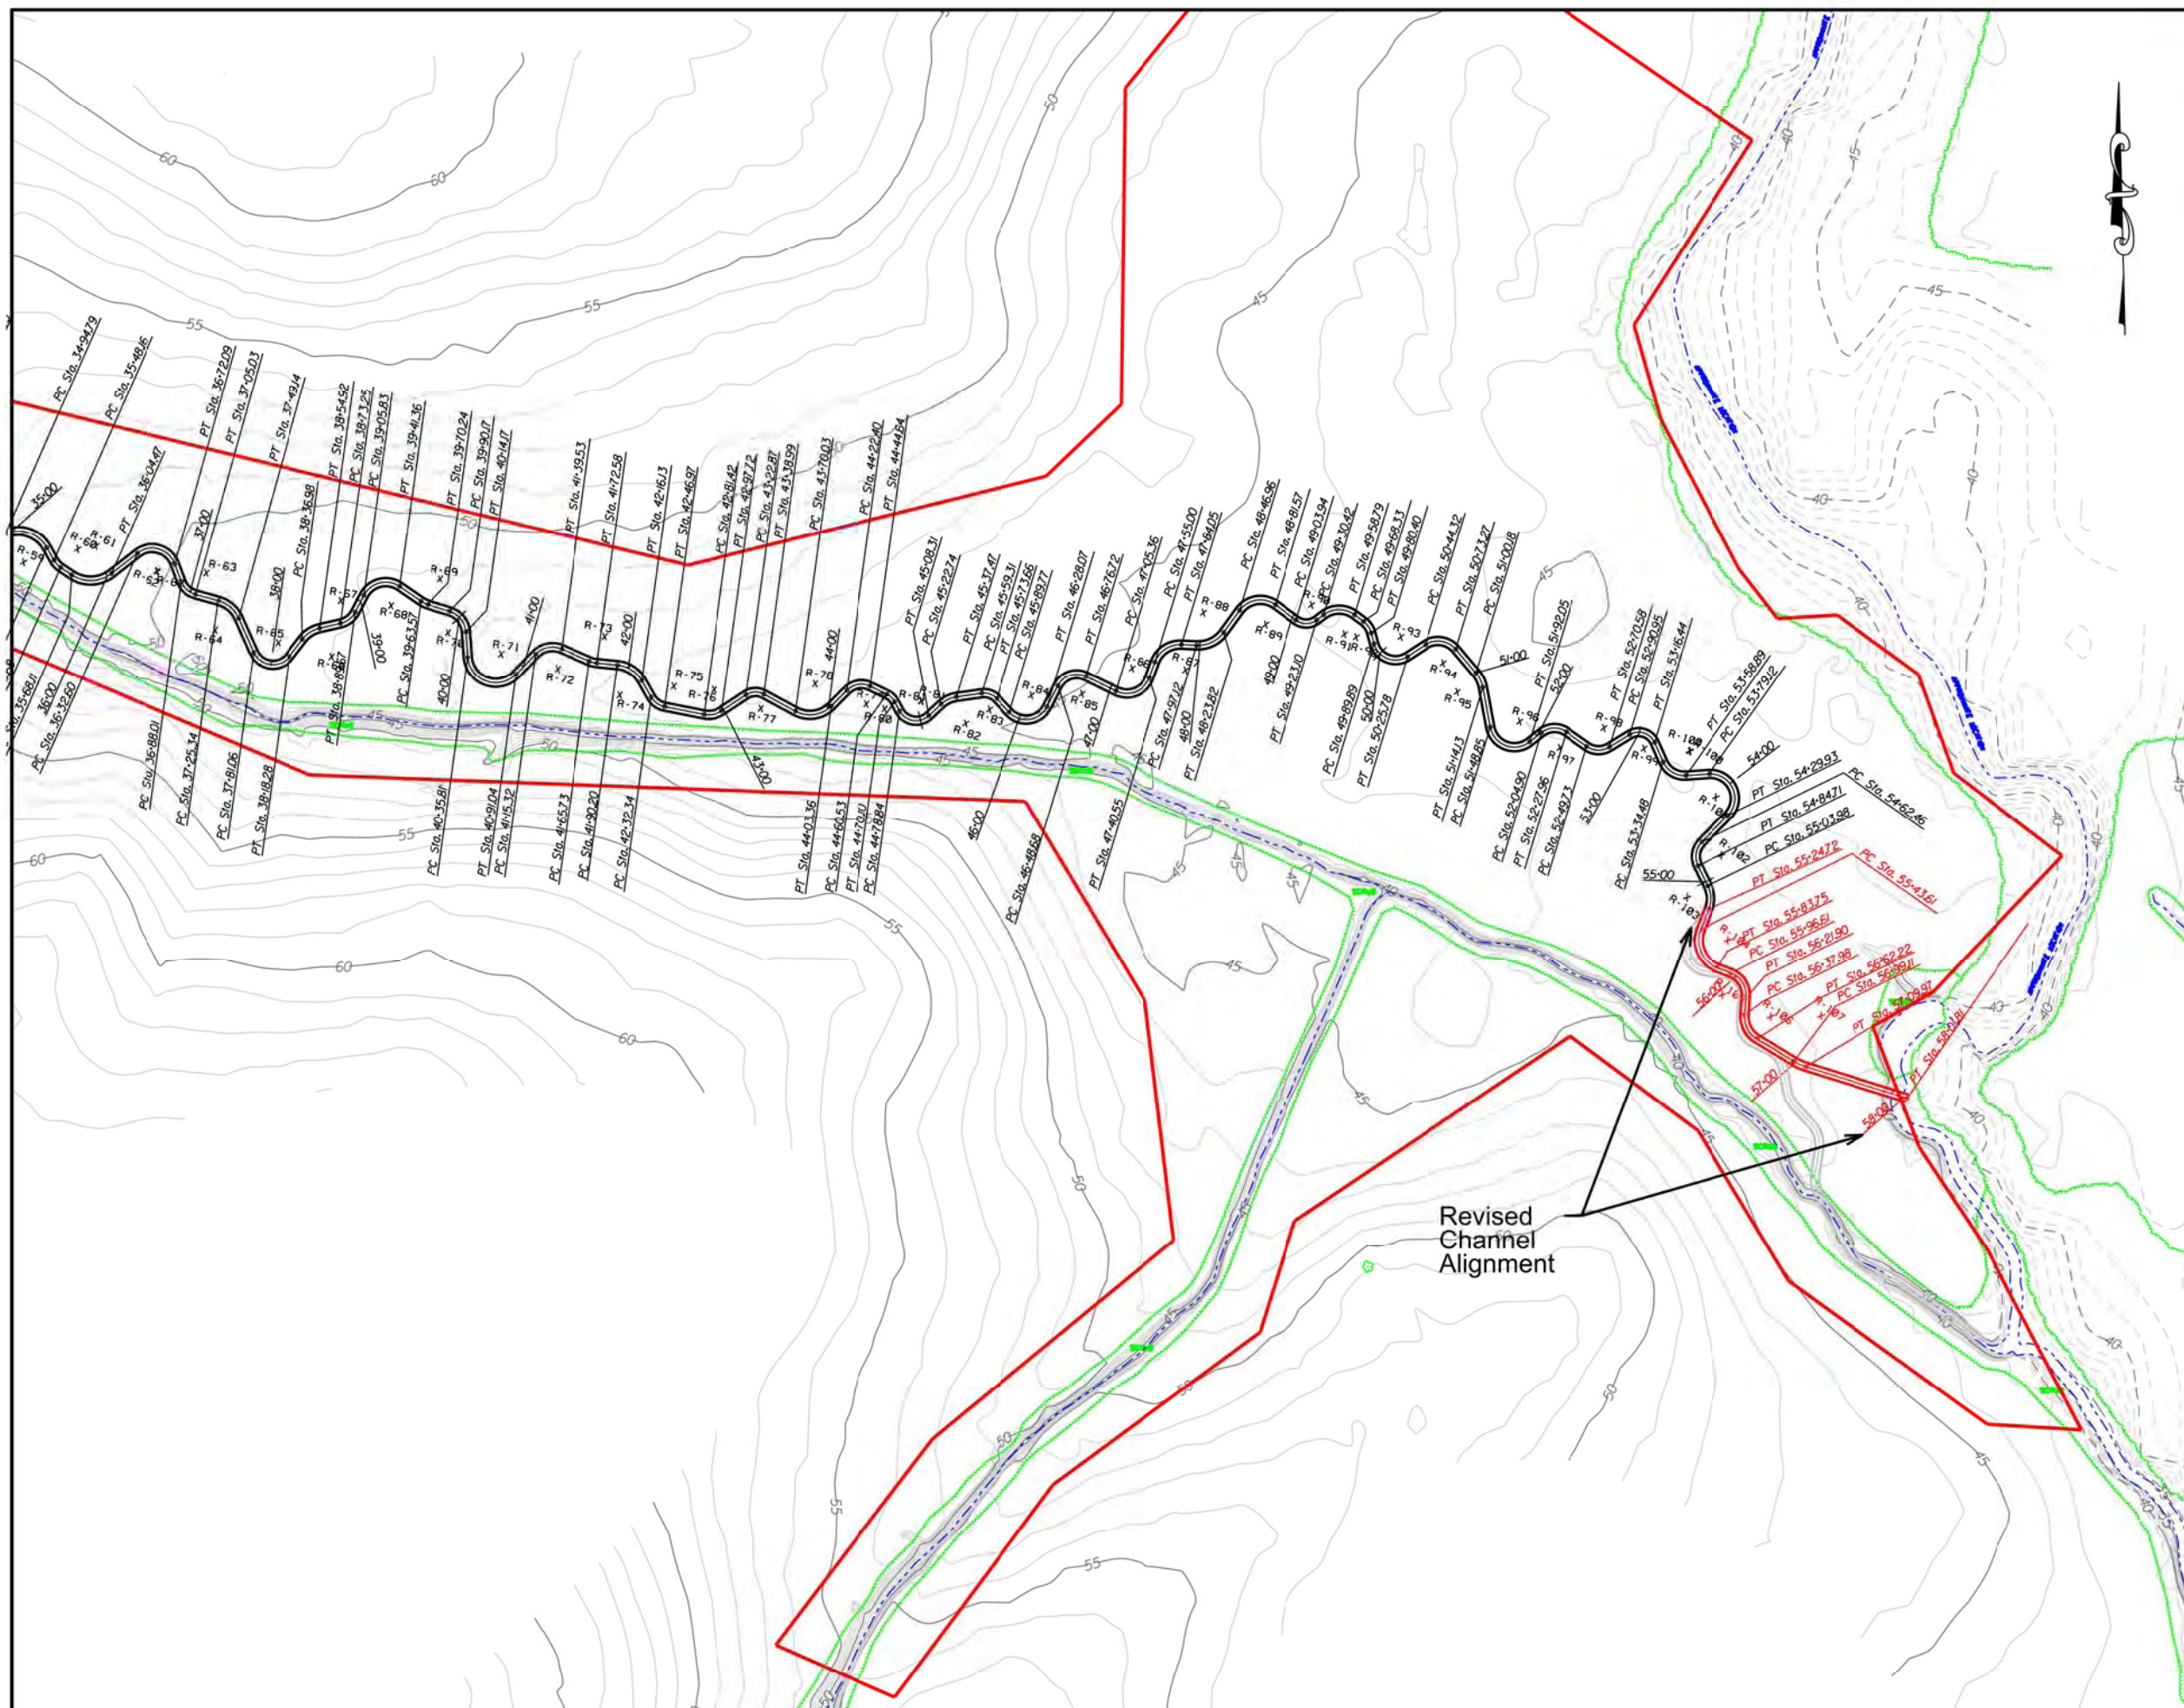
L-2

Revised  
Channel  
Alignment

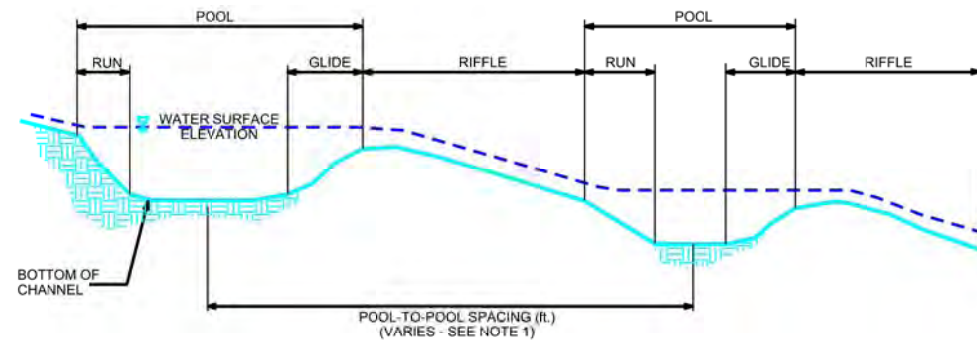
TYPICAL CHANNEL PROFILE

1. POOL-TO-POOL SPACING IS MEASURED FROM CENTER OF POOL BEND TO CENTER OF POOL BEND.

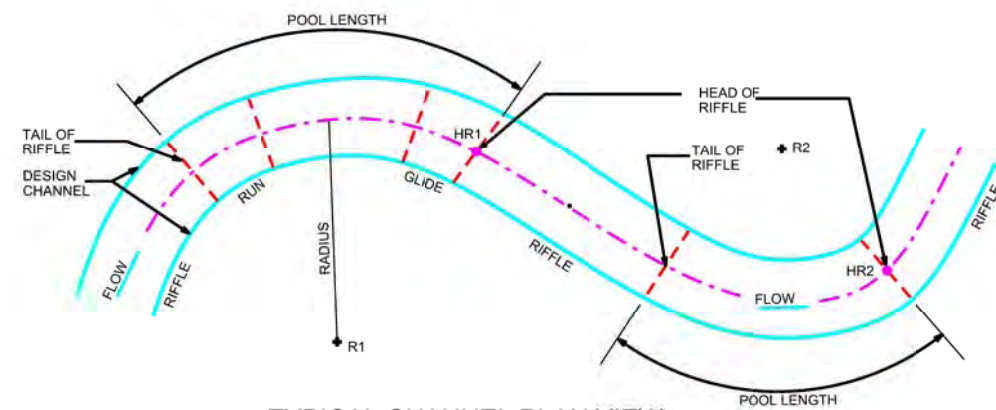
TYPICAL CHANNEL PLAN VIEW

1. CHANNEL ALIGNMENT LAYOUT INCLUDED LOCATING THE RADII AND SCRIBING THE CENTER LINE FOR EACH POOL BEND. THE CONNECTING TANGENT SECTIONS WERE UTILIZED TO COMPLETE THE CHANNEL LAYOUT.

Particular attention was directed toward providing vegetative cover and root growth along the outer bends of each stream meander. Live willow stake revetments, available root mats, and/or biodegradable, erosion-control matting were embedded into the break-in-slope to promote more rapid development of an overhanging bank.

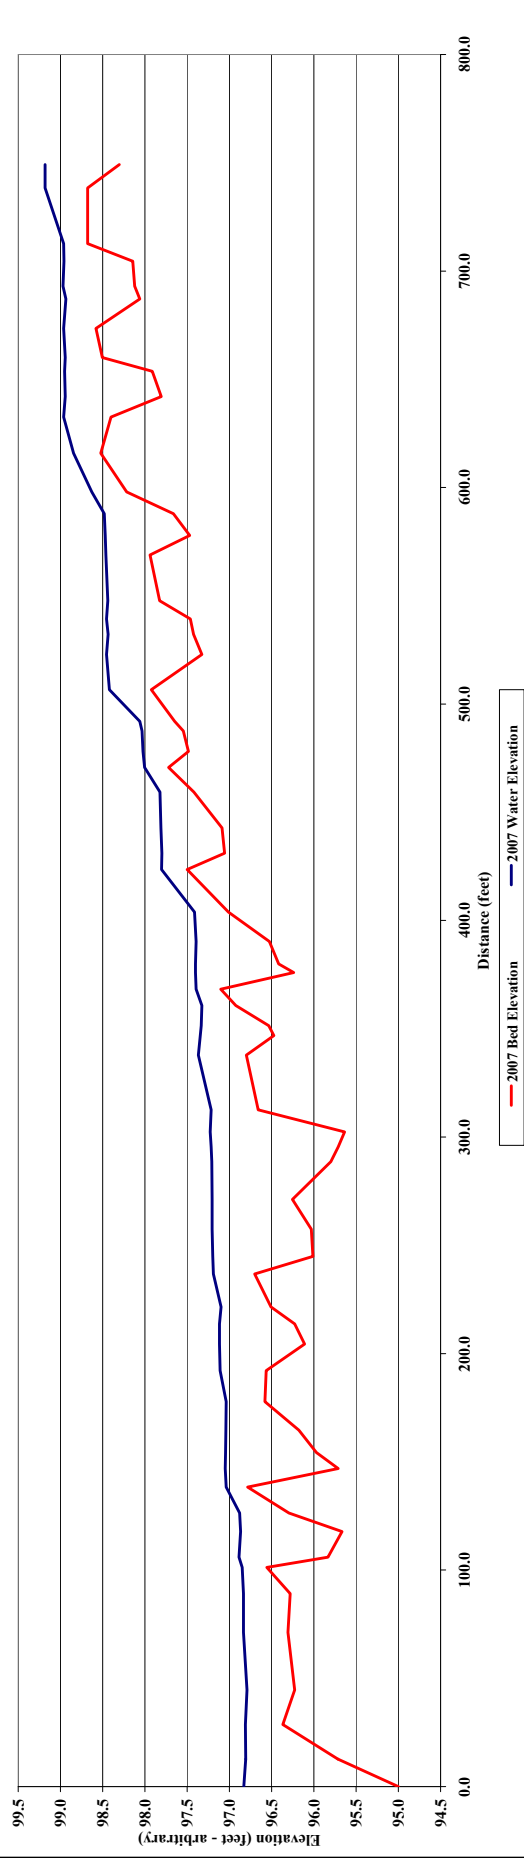
Jarman's Oak Profile - Reach 1

Jarman's Oak											
Reach 1											
Profile											
Date 10/24/07											
Crew Adams, Jeffers											
As-built			2008			2009			2010		
Station	Bed Elevation	Water Elevation	Station	Bed Elevation	Water Elevation	Station	Bed Elevation	Water Elevation	Station	Bed Elevation	Water Elevation

As-built	2008	2009	2010
Avg. Water Surface Slope	0.0031		
Avg. Bed Slope	0.0093		
Avg. Pool Slope	0.0006		
Avg. Run Slope	0.0021		
Avg. Citter Slope	0.0013

Baseline/as-built measurements were performed in October and November 2007. As-built channels emulated the proposed channel morphology; cross-section and longitudinal profile plots can be found in Appendix C.

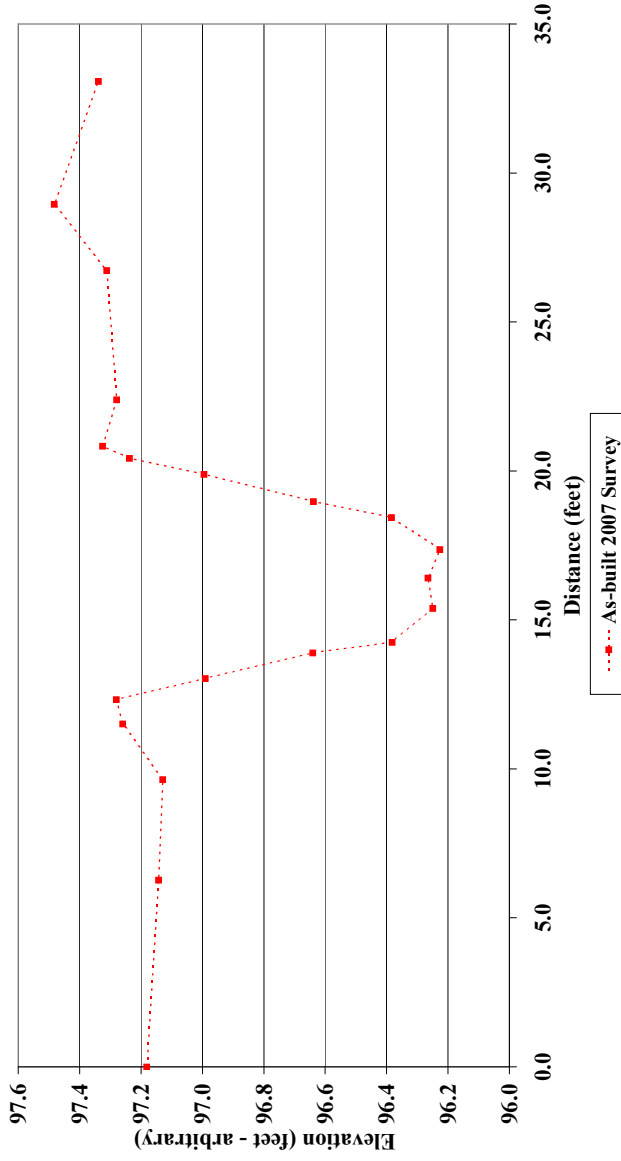
### Jarman's Oak Reach 1 - XS1 Riffle

<b>Project Name</b> Jarman's Oak <b>Cross Section</b> R1-XS1 <b>Feature</b> Riffle <b>Date</b> 10/24/07 <b>Crew</b> Adamsme, Jeffers			
<b>As-built</b> 2007 Survey Station      Elevation 0.0          97.2 6.3          97.1 9.6          97.1 11.5         97.3 12.3         97.3 13.0         97.0 13.9         96.6 14.3         96.4 15.4         96.2 16.4         96.3 17.4         96.2 18.4         96.4 19.0         96.6 19.9         97.0 20.4         97.2 20.8         97.3 22.4         97.3 26.7         97.3 29.0         97.5 33.1         97.3	<b>2008</b> 2008 Survey Station      Elevation	<b>2009</b> 2009 Survey Station      Elevation	<b>2010</b> 2010 Survey Station      Elevation

Area	As-built	2008	2009	2010
Width	5.9			
Mean Depth	9.1			
Max Depth	0.6			
W/D Ratio	1.1			
	14.1

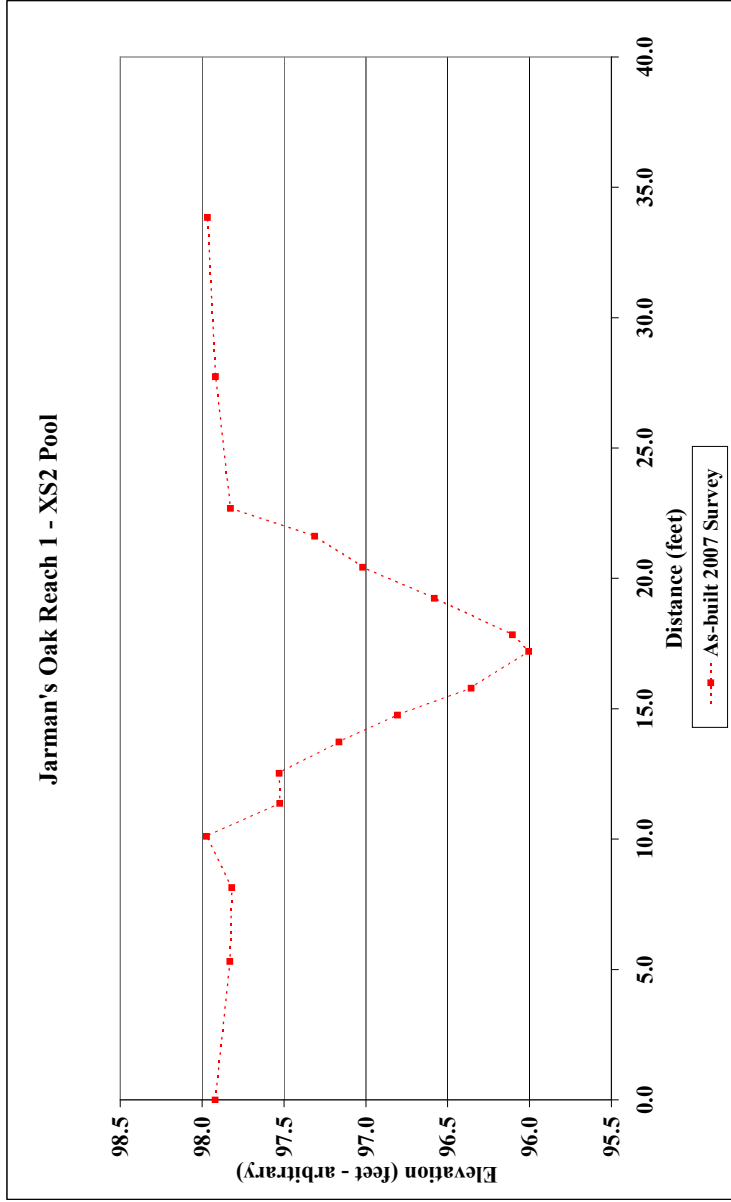
<b>Project Name</b> Jarman's Oak				
<b>Cross Section</b> R1-XS2				
<b>Feature</b> Pool				
<b>Date</b> 10/24/07				
<b>Crew</b> Adamsme, Jeffers				
	<b>2008</b>	<b>2009</b>	<b>2010</b>	
<b>As-built</b>	<b>2008 Survey</b>	<b>2009 Survey</b>	<b>2010 Survey</b>	
<b>Station</b>	<b>Station</b>	<b>Station</b>	<b>Station</b>	<b>Elevation</b>
0.0	97.9			
5.3	97.8			
8.1	97.8			
10.1	98.0			
11.4	97.5			
12.5	97.5			
13.7	97.2			
14.8	96.8			
15.8	96.4			
17.2	96.0			
17.8	96.1			
19.2	96.6			
20.4	97.0			
21.6	97.3			
22.7	97.8			
27.8	97.9			
33.9	98.0

<b>Area</b>	<b>As-built</b>	<b>2008</b>	<b>2009</b>	<b>2010</b>
<b>Width</b>	7.6			
<b>Mean Depth</b>	9.5			
<b>Max Depth</b>	0.8			
<b>W/D Ratio</b>	1.5			
	N/A

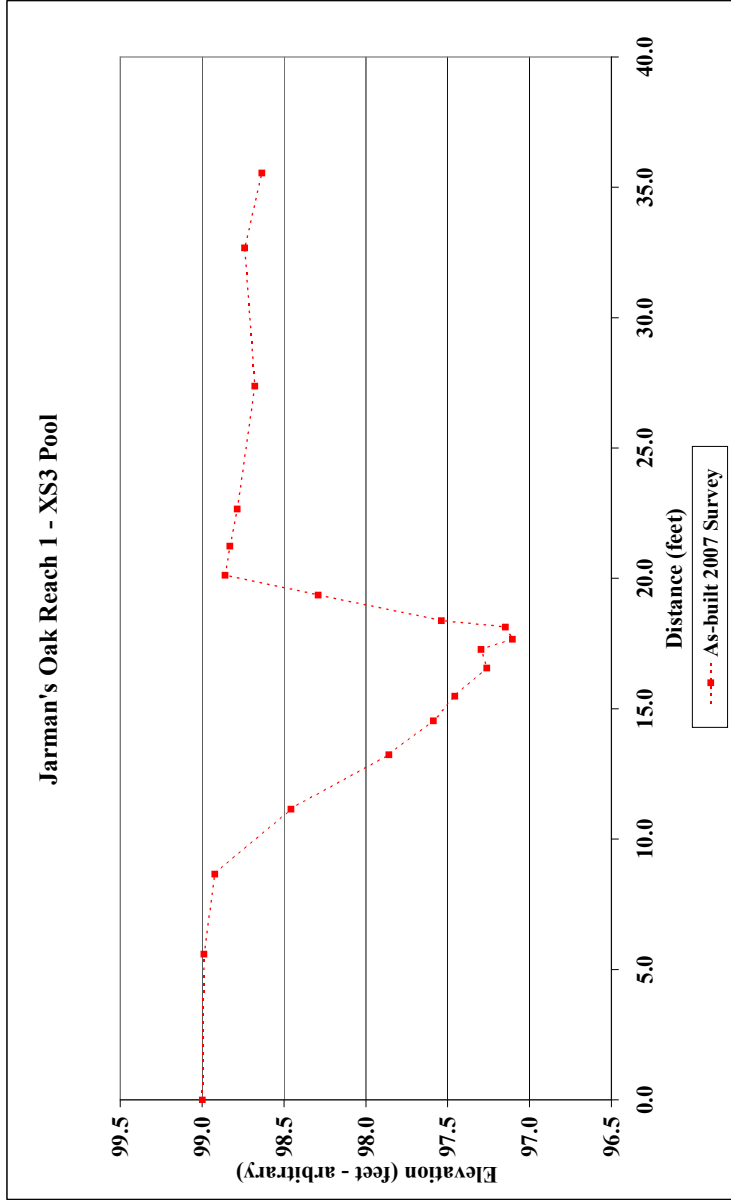
<b>Project Name</b> Jarman's Oak			
<b>Cross Section</b> R1-XS3			
<b>Feature</b> Pool			
<b>Date</b> 10/24/07			
<b>Crew</b> Adams, Jeffers			
<b>As-built</b>	<b>2008</b>	<b>2009</b>	<b>2010</b>
<b>2007 Survey</b>	<b>2008 Survey</b>	<b>2009 Survey</b>	<b>2010 Survey</b>
<b>Station</b>	<b>Station</b>	<b>Station</b>	<b>Station</b>
<b>Elevation</b>	<b>Elevation</b>	<b>Elevation</b>	<b>Elevation</b>
0.0 99.0			
5.6 99.0			
8.7 98.9			
11.2 98.5			
13.2 97.9			
14.5 97.6			
15.5 97.5			
16.6 97.3			
17.3 97.3			
17.7 97.1			
18.1 97.1			
18.4 97.5			
19.4 98.3			
20.1 98.9			
21.3 98.8			
22.7 98.8			
27.4 98.7			
32.7 98.7			
35.6 98.6

<b>Area</b>	<b>As-built</b>	<b>2008</b>	<b>2009</b>	<b>2010</b>
<b>Width</b>	10.4			
<b>Mean Depth</b>	12.3			
<b>Max Depth</b>	0.8			
<b>W/D Ratio</b>	1.8			
	N/A

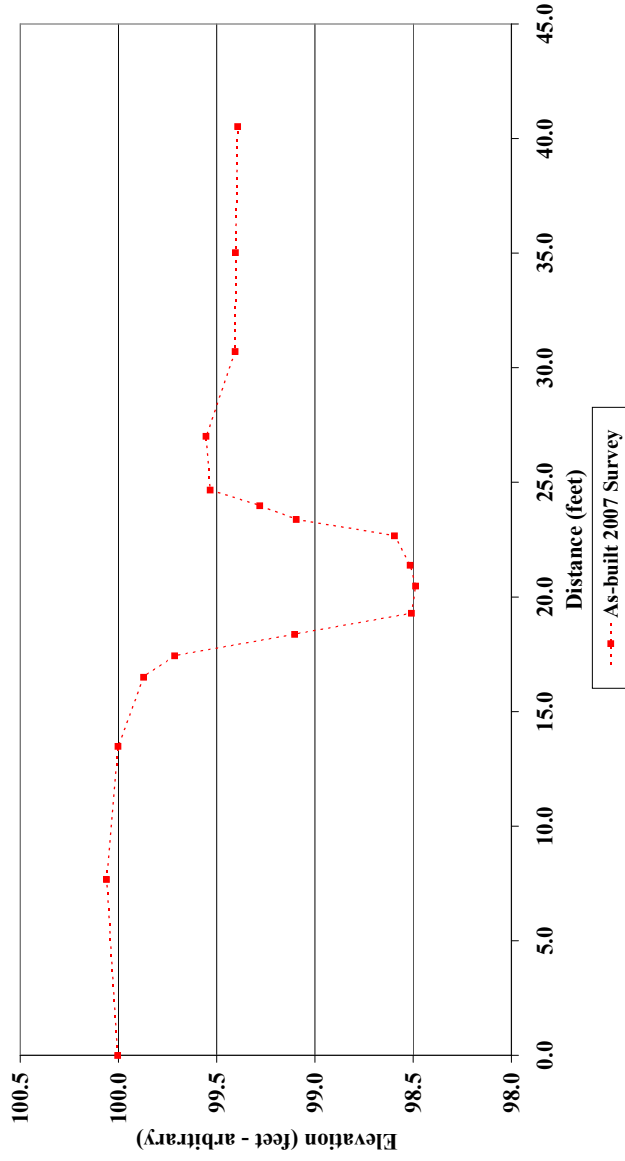
### Jarman's Oak Reach 1 - XS4 Riffle

Project Name Jarman's Oak  
 Cross Section R1-XS4  
 Feature Riffle  
 Date 10/24/07  
 Crew Adams, Jeffers

As-built 2007 Survey Station	2008 Survey Station	2009 Survey Station	2010 Survey Station
Elevation	Elevation	Elevation	Elevation
0.0	100.0		
7.7	100.1		
13.5	100.0		
16.5	99.9		
17.4	99.7		
18.4	99.1		
19.3	98.5		
20.5	98.5		
21.4	98.5		
22.7	98.6		
23.4	99.1		
24.0	99.3		
24.7	99.5		
27.0	99.6		
30.7	99.4		
35.0	99.4		
40.5	99.4

As-built	2008	2009	2010
Area	5.0			
Width	6.9			
Mean Depth	0.7			
Max Depth	1.0			
W/D Ratio	9.6

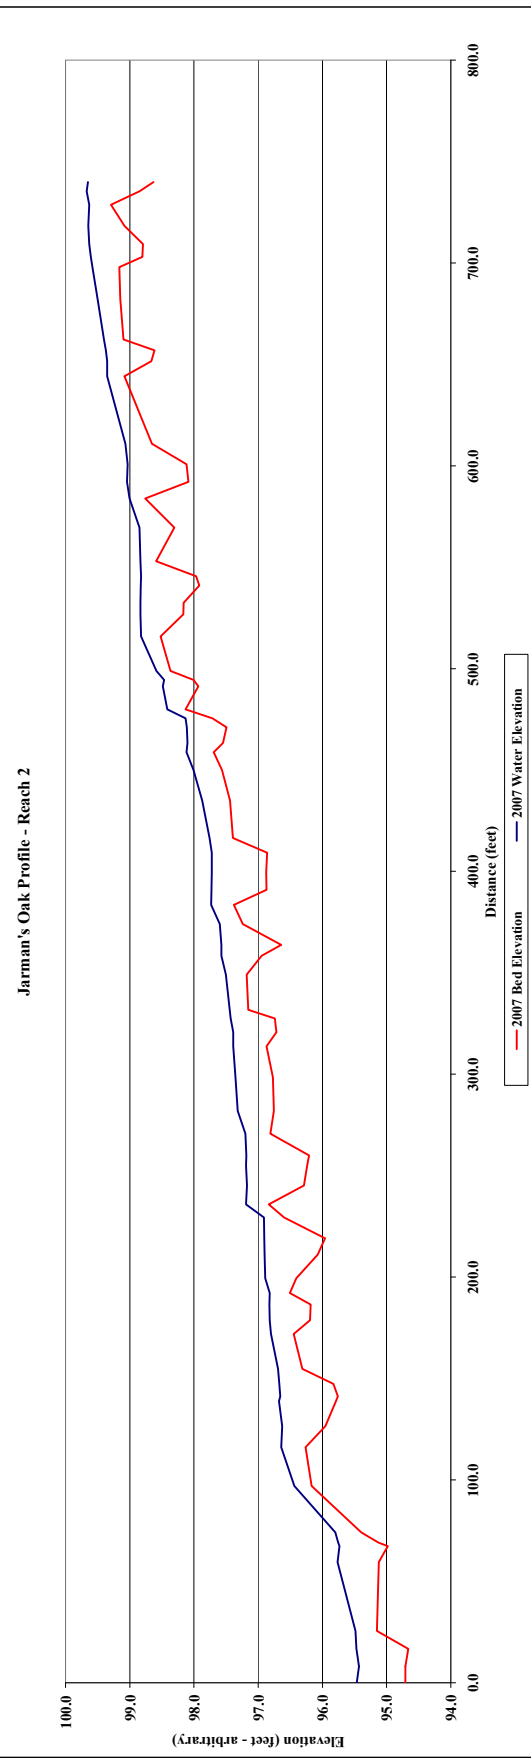
Project Name Jarman's Oak															
Reach 2 Profile															
Date 10/24/07															
Crew Adams, Jeffers															
Station	Asphalt			2007 Survey			2008 Survey			2009 Survey			2010 Survey		
	Bed Elevation	Water Elevation	Station	Bed Elevation	Water Elevation	Station	Bed Elevation	Water Elevation	Station	Bed Elevation	Water Elevation	Station	Bed Elevation	Water Elevation

Asphalt	2008	2009	2010
Avg. Water Surface Slope	0.0057		
Avg. Riffle Slope	0.0143		
Avg. Pool Slope	0.0020		
Avg. Run Slope	0.0047		
Avg. Glide Slope	0.0023

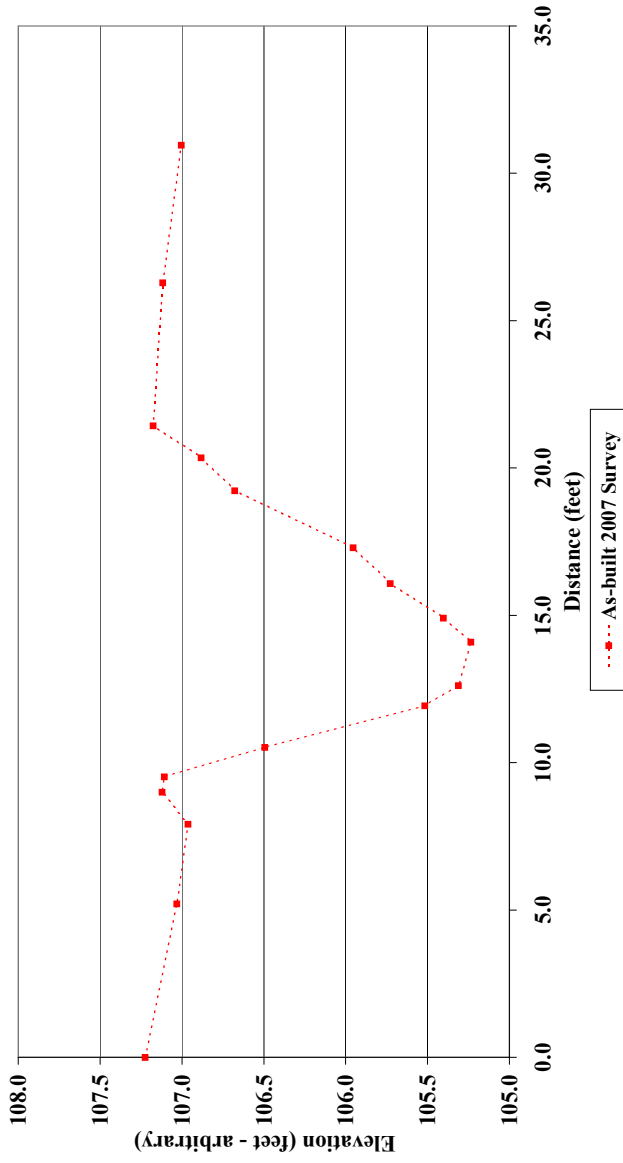
### Jarman's Oak Reach 2 - XS1 Pool

Project Name Jarman's Oak  
 Cross Section R2-XS1  
 Feature Pool  
 Date 10/24/07  
 Crew Adams, Jeffers

As-built	2008	2009	2010
Area	12.7			
Width	11.7			
Mean Depth	1.1			
Max Depth	1.9			
W/D Ratio	N/A

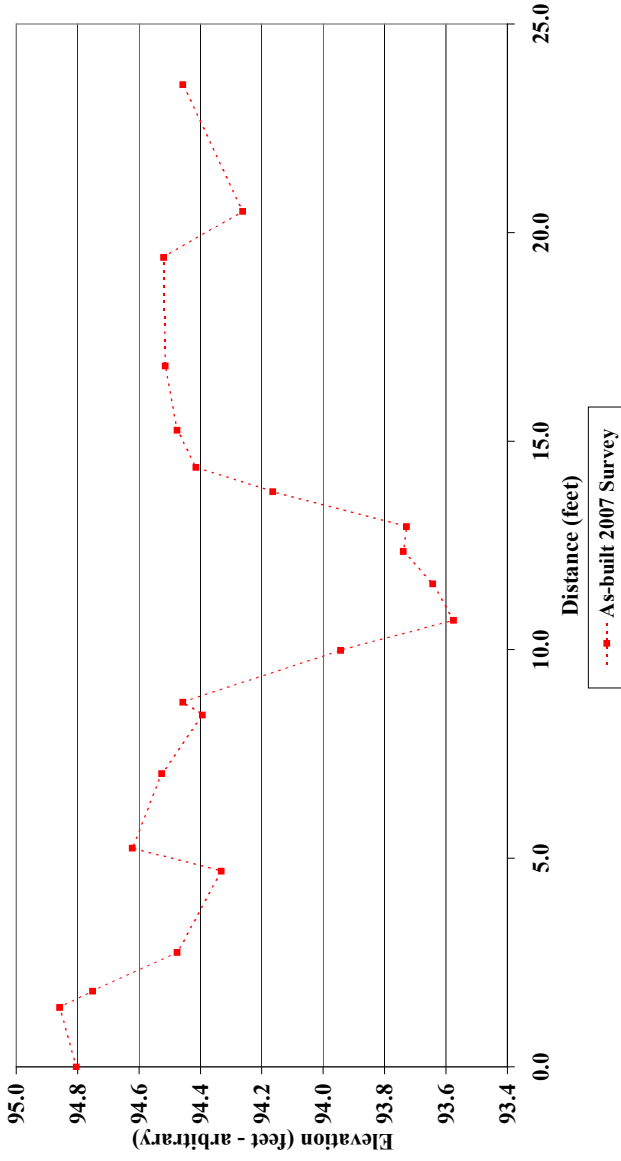
**Jarman's Oak Reach 2 - XS2 Riffle**

Project Name Jarman's Oak  
 Cross Section R2-XS2  
 Feature Riffle  
 Date 10/24/07  
 Crew Adams, Jeffers

As-built	2008	2009	2010
Area	5.7			
Width	7.4			
Mean Depth	0.8			
Max Depth	1.1			
W/D Ratio	9.6

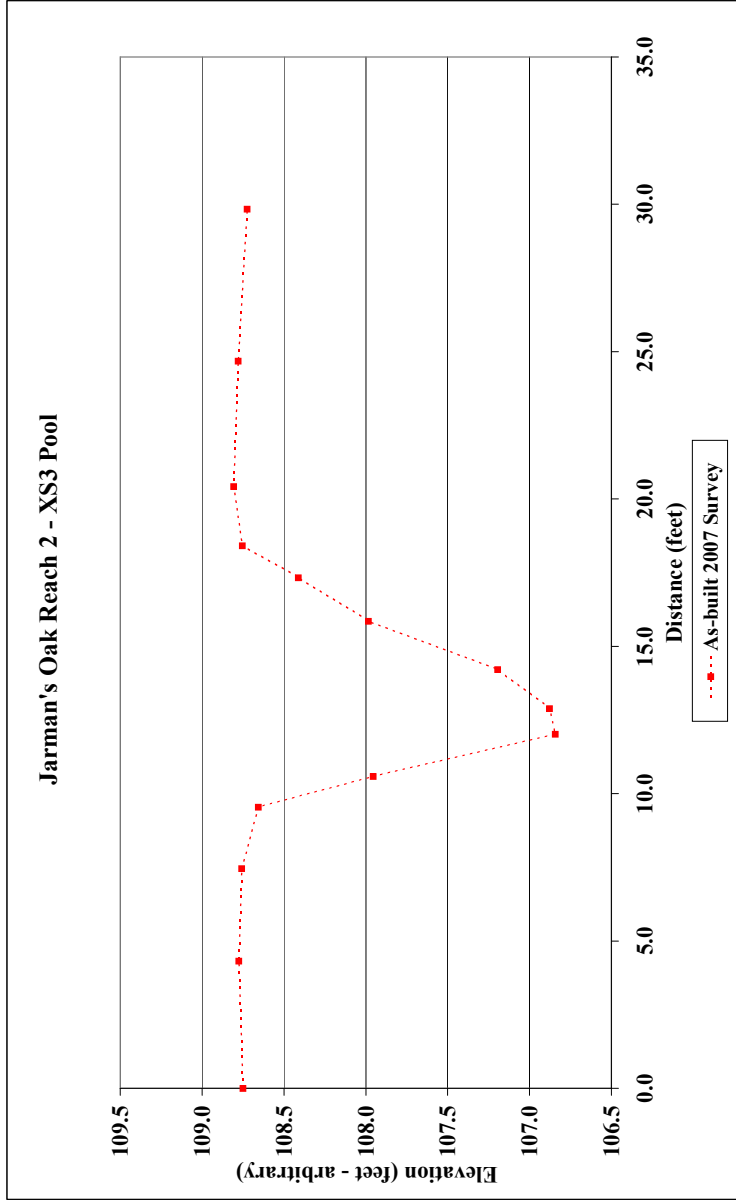
<b>Project Name</b> Jarman's Oak <b>Cross Section</b> R2-XS3 <b>Feature</b> Pool <b>Date</b> 10/24/07 <b>Crew</b> Adams, Jeffers			
<b>As-built</b> <b>2007 Survey</b> <b>Station</b> <b>Elevation</b> 0.0    108.8 4.3    108.8 7.5    108.8 9.5    108.7 10.6    108.0 12.0    106.8 12.9    106.9 14.2    107.2 15.9    108.0 17.3    108.4 18.4    108.8 20.4    108.8 24.7    108.8 29.8    108.7	<b>2008</b> <b>2008 Survey</b> <b>Station</b> <b>Elevation</b>	<b>2009</b> <b>2009 Survey</b> <b>Station</b> <b>Elevation</b>	<b>2010</b> <b>2010 Survey</b> <b>Station</b> <b>Elevation</b>

<b>Area</b>	As-built	2008	2009	2010
<b>Width</b>	8.4			
<b>Mean Depth</b>	8.7			
<b>Max Depth</b>	1.0			
<b>W/D Ratio</b>	1.8			
	N/A

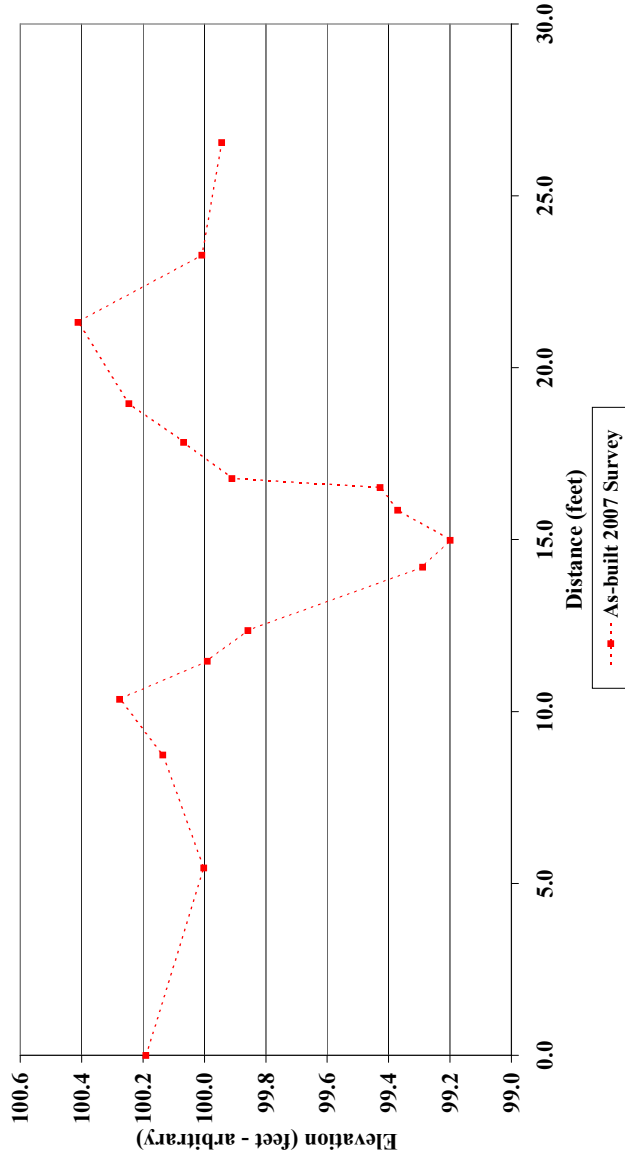
**Jarman's Oak Reach 2 - XS4 Riffle**

<b>Project Name</b> Jarman's Oak <b>Cross Section</b> R2-XS4 <b>Feature</b> Riffle <b>Date</b> 10/24/07 <b>Crew</b> Adamsme, Jeffers			
<b>As-built</b> <b>2007 Survey</b> <b>Station</b> <b>Elevation</b> 0.0        100.2 5.5        100.0 8.7        100.1 10.4       100.3 11.5       100.0 12.4       99.9 14.2       99.3 15.0       99.2 15.9       99.4 16.5       99.4 16.8       99.9 17.8       100.1 19.0       100.2 21.3       100.4 23.3       100.0 26.6       99.9	<b>2008</b> <b>2008 Survey</b> <b>Station</b> <b>Elevation</b>	<b>2009</b> <b>2009 Survey</b> <b>Station</b> <b>Elevation</b>	<b>2010</b> <b>2010 Survey</b> <b>Station</b> <b>Elevation</b>

<b>Area</b>	<b>As-built</b>	<b>2008</b>	<b>2009</b>	<b>2010</b>
<b>Width</b>	4.7			
<b>Mean Depth</b>	8.6			
<b>Max Depth</b>	0.5			
<b>W/D Ratio</b>	1.1			
	15.9

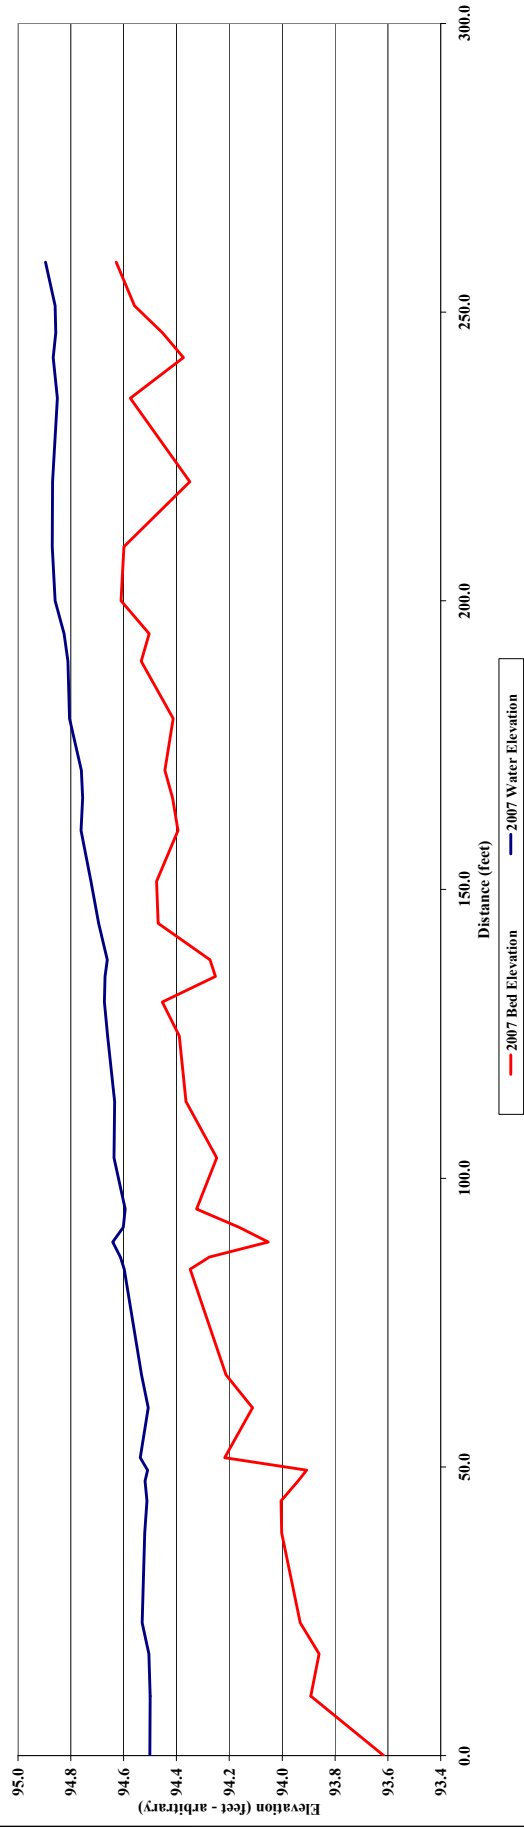
Jarman's Oak Profile - Reach 3

Project Name		Jarman's Oak																
Reach		3																
Profile		Jarman's Oak																
Feature		Jarman's Oak																
Date		10/24/07																
Crew		Adams, Jeffers																
Station	As-built	2007 Survey	Water Elevation	2008	Station	2008 Survey	Bed Elevation	Water Elevation	2009	Station	2009 Survey	Bed Elevation	Water Elevation	2010	Station	2010 Survey	Bed Elevation	Water Elevation
0+0	93.6	93.6	94.3

As-built	2008	2009	2010
Avg. Water Surface Slope	0.0015		
Avg. RFFH Slope	0.0023		
Avg. Pool Slope	0.0000		
Avg. Run Slope	0.0045		
Avg. C&G Slope	0.0037

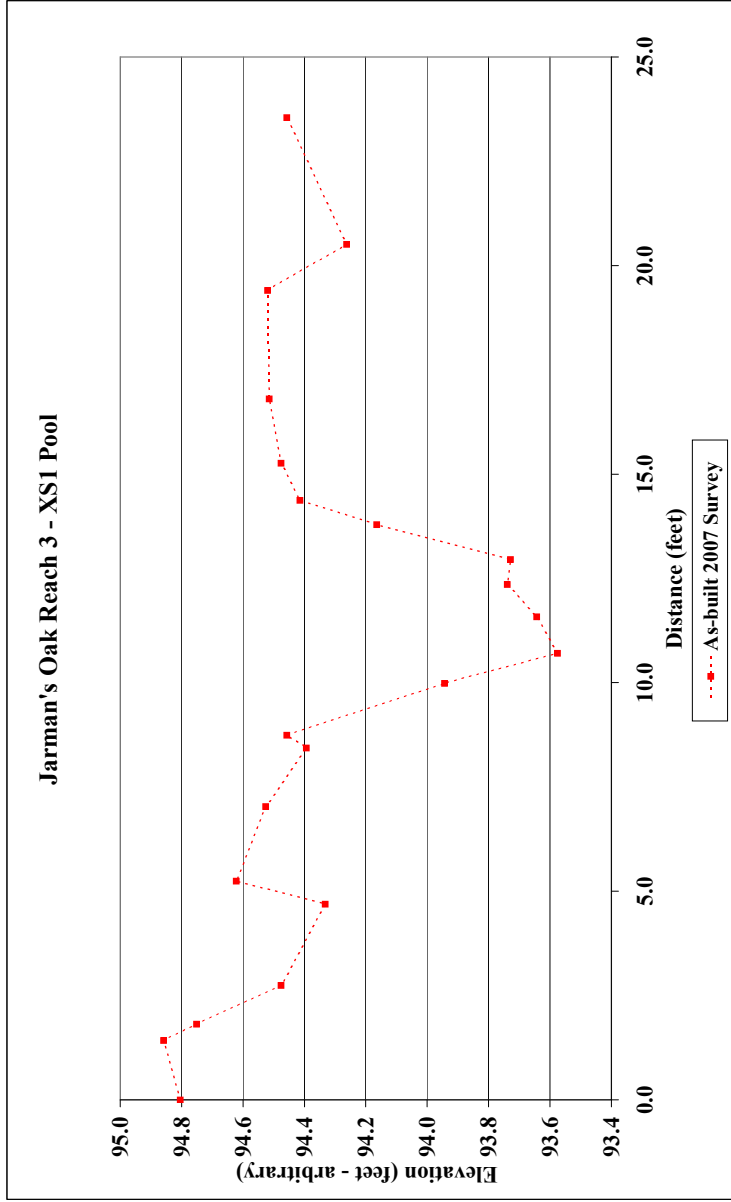
<b>Project Name</b> Jarman's Oak			
<b>Cross Section</b> R3-XS1			
<b>Feature</b> Pool			
<b>Date</b> 10/24/07			
<b>Crew</b> Adams, Jeffers			
<b>As-built</b>	<b>2008</b>	<b>2009</b>	<b>2010</b>
<b>2007 Survey</b>	<b>2008 Survey</b>	<b>2009 Survey</b>	<b>2010 Survey</b>
<b>Station</b>	<b>Station</b>	<b>Station</b>	<b>Station</b>
<b>Elevation</b>	<b>Elevation</b>	<b>Elevation</b>	<b>Elevation</b>
0.0 94.8			
1.4 94.9			
1.8 94.8			
2.7 94.5			
4.7 94.3			
5.2 94.6			
7.0 94.5			
8.4 94.4			
8.7 94.5			
10.0 93.9			
10.7 93.6			
11.6 93.6			
12.4 93.7			
13.0 93.7			
13.8 94.2			
14.4 94.4			
15.3 94.5			
16.8 94.5			
19.4 94.5			
20.5 94.3			
23.6 94.5

<b>Area</b>	<b>As-built</b>	<b>2008</b>	<b>2009</b>	<b>2010</b>
<b>Width</b>	2.9			
<b>Mean Depth</b>	5.6			
<b>Max Depth</b>	0.5			
<b>W/D Ratio</b>	0.8			
	N/A
