**MITIGATION PLAN WITH AS-BUILT DRAWINGS**  
**JARMANS OAK RESTORATION SITE**  
**ONslow COUNTY, NORTH CAROLINA**

**(CONTRACT #D06069-A)**  
**FULL DELIVERY PROJECT**  
**WHITE OAK RIVER BASIN**  
**CATALOGING UNIT 03030001**

**JARMANS OAK STREAM AND WETLAND RESTORATION SITE  
AS-BUILT MITIGATION PLAN  
ONslow COUNTY**

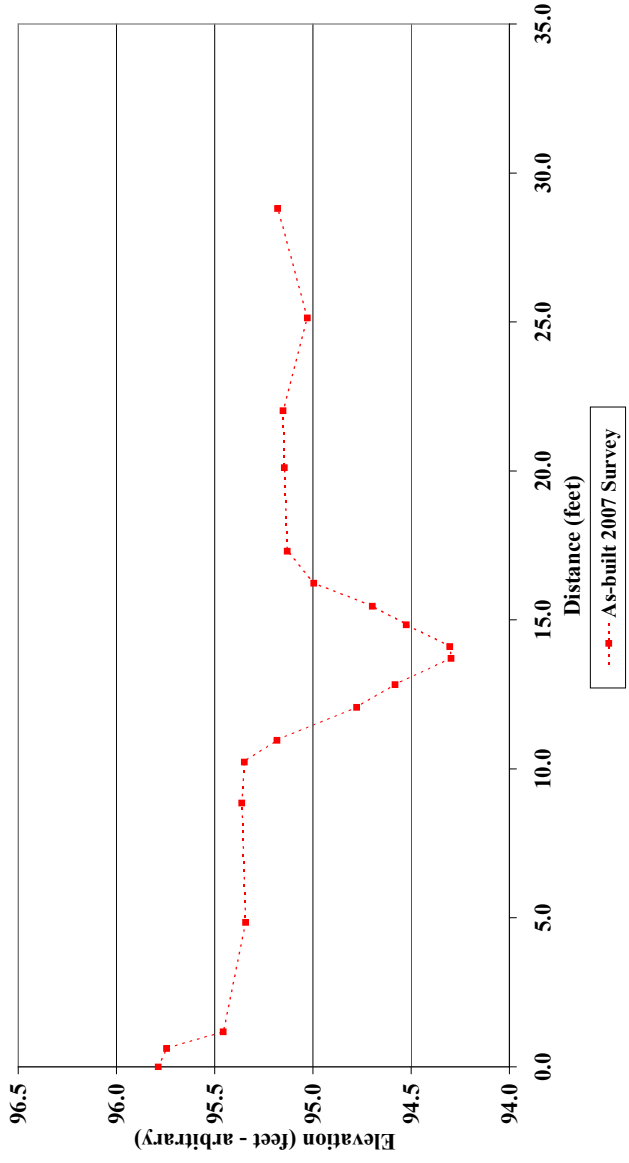
### Jarman's Oak Reach 3 - XS2 Riffle

Project Name Jarman's Oak  
 Cross Section R3-XS2  
 Feature Riffle  
 Date 10/24/07  
 Crew Adams, Jeffers

As-built 2007 Survey Station	2008 Survey Station	2009 Survey Station	2010 Survey Station
0.0	95.8		
0.6	95.7		
1.2	95.5		
4.9	95.3		
8.9	95.4		
10.2	95.3		
11.0	95.2		
12.1	94.8		
12.8	94.6		
13.7	94.3		
14.1	94.3		
14.8	94.5		
15.5	94.7		
16.2	95.0		
17.3	95.1		
20.1	95.1		
22.0	95.2		
25.1	95.0		
28.8	95.2

As-built	2008	2009	2010
Area	2.6			
Width	6.2			
Mean Depth	0.4			
Max Depth	0.8			
W/D Ratio	14.9

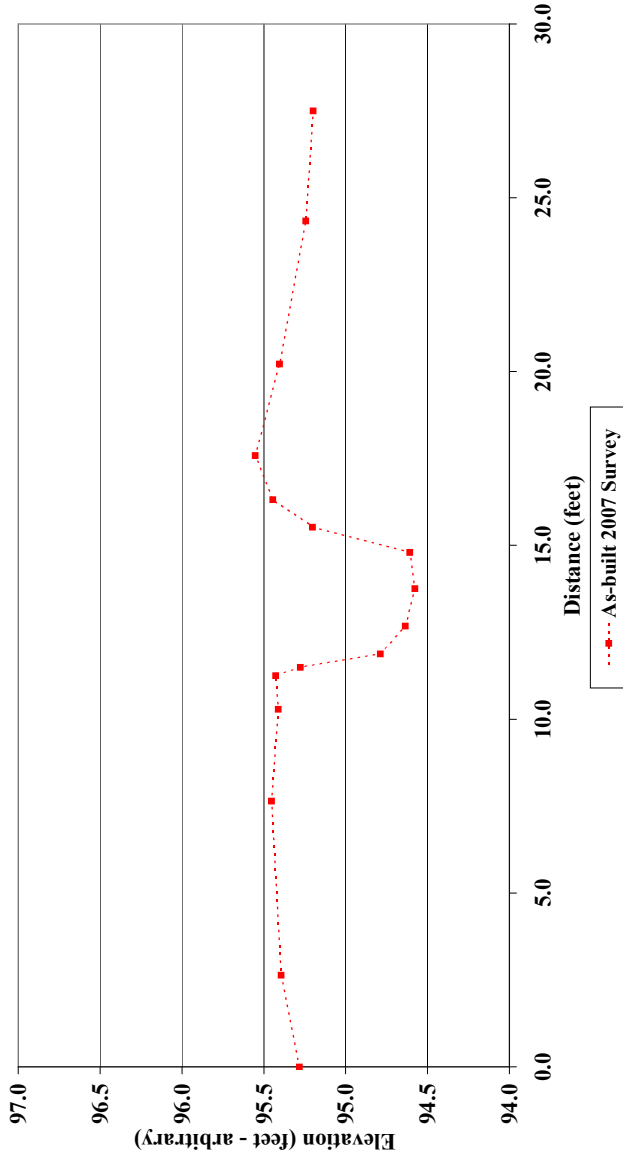
### Jarman's Oak Reach 3 - XS3 Riffle

Project Name Jarman's Oak  
 Cross Section R3-XS3  
 Feature Riffle  
 Date 10/24/07  
 Crew Adams, Jeffers

As-built 2007 Survey Station Elevation	2008 2008 Survey Station Elevation	2009 2009 Survey Station Elevation	2010 2010 Survey Station Elevation
0.0	95.3		
2.6	95.4		
7.6	95.5		
10.3	95.4		
11.3	95.4		
11.5	95.3		
11.9	94.8		
12.7	94.6		
13.8	94.6		
14.8	94.6		
15.5	95.2		
16.3	95.4		
17.6	95.6		
20.2	95.4		
24.3	95.2		
27.5	95.2

As-built	2008	2009	2010
Area	3.0			
Width	5.0			
Mean Depth	0.6			
Max Depth	0.9			
W/D Ratio	8.5

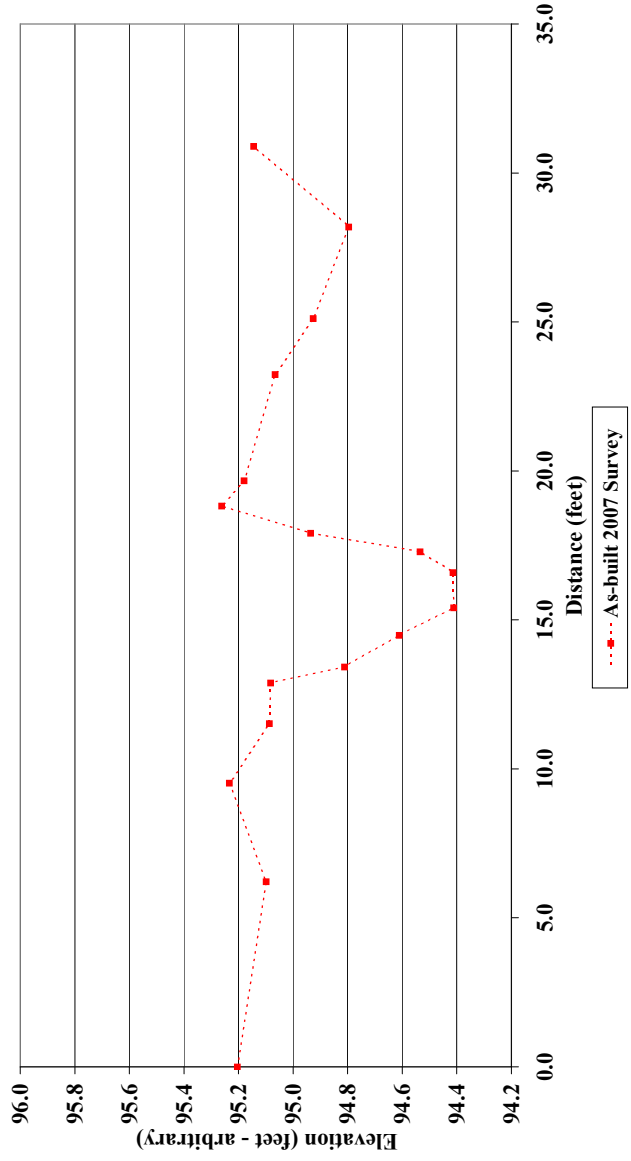
### Jarman's Oak Reach 3 - XS4 Pool

Project Name Jarman's Oak  
 Cross Section R3-XS4  
 Feature Pool  
 Date 10/24/07  
 Crew Adams, Jeffers

As-built 2007 Survey Station	2008 Survey Station	2009 Survey Station	2010 Survey Station
Elevation	Elevation	Elevation	Elevation
0.0	95.2		
6.2	95.1		
9.5	95.2		
11.5	95.1		
12.9	95.1		
13.4	94.8		
14.5	94.6		
15.4	94.4		
16.6	94.4		
17.3	94.5		
17.9	94.9		
18.8	95.3		
19.7	95.2		
23.2	95.1		
25.1	94.9		
28.2	94.8		
30.9	95.1

As-built	2008	2009	2010
Area	2.4			
Width	5.4			
Mean Depth	0.5			
Max Depth	0.7			
W/D Ratio	N/A

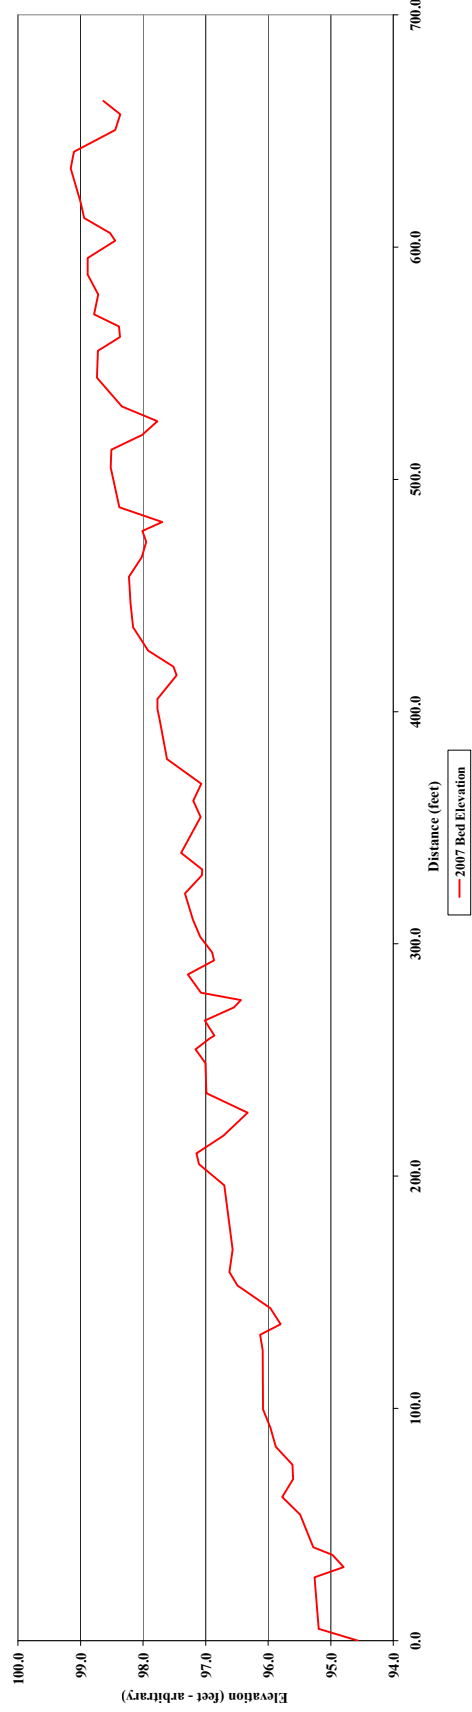
Jarman's Oak Profile - Reach 4

Project Name		Jarman's Oak												
Reach		4												
Feature		Profile												
Point		E24007												
Crew		Adams, Jeffers												
Station	As-built Bed Elevation	2007 Survey Water Elevation	2008 Survey Bed Elevation	2008 Survey Water Elevation	2009 Survey Bed Elevation	2009 Survey Water Elevation	2010 Survey Bed Elevation	2010 Survey Water Elevation	Station	2010 Survey Bed Elevation	2010 Survey Water Elevation	Station	2010 Survey Bed Elevation	2010 Survey Water Elevation

\*\*\* Insufficient water in stream to determine

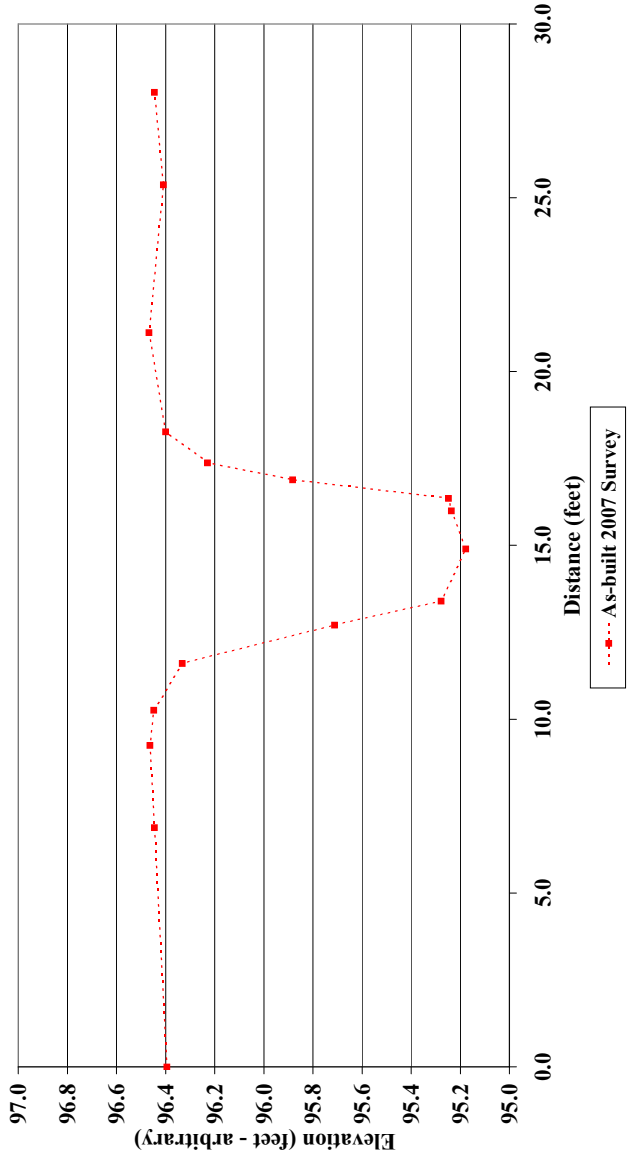
### Jarman's Oak Reach 4 - XS1 Riffle

As-built 2007 Survey Station	2008 Survey Station	2009 Survey Station	2010 Survey Station
Elevation	Elevation	Elevation	Elevation
0.0 96.4			
6.9 96.4			
9.3 96.5			
10.3 96.4			
11.6 96.3			
12.7 95.7			
13.4 95.3			
14.9 95.2			
16.0 95.2			
16.4 95.2			
16.9 95.9			
17.4 96.2			
18.3 96.4			
21.1 96.5			
25.4 96.4			
28.0 96.4

As-built	2008	2009	2010
Area	5.2			
Width	7.5			
Mean Depth	0.7			
Max Depth	1.2			
W/D Ratio	10.6

Baseline/as-built measurements were performed in October and November 2007. As-built channels emulated the proposed channel morphology; cross-section and longitudinal profile plots can be found in Appendix C.

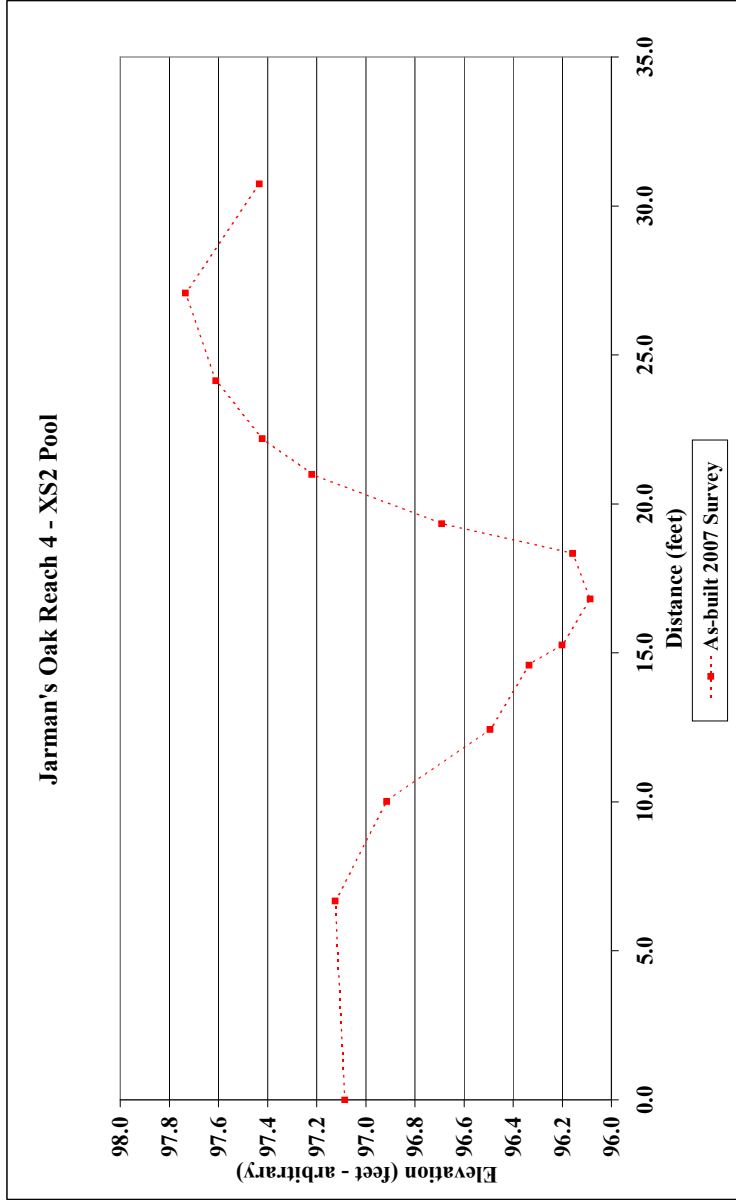
<b>Project Name</b> Jarman's Oak			
<b>Cross Section</b> R4-XS2			
<b>Feature</b> Pool			
<b>Date</b> 10/24/07			
<b>Crew</b> Adamsme, Jeffers			
<b>As-built</b>	<b>2008</b>	<b>2009</b>	<b>2010</b>
<b>2007 Survey</b>	<b>2008 Survey</b>	<b>2009 Survey</b>	<b>2010 Survey</b>
<b>Station</b>	<b>Station</b>	<b>Station</b>	<b>Station</b>
<b>Elevation</b>	<b>Elevation</b>	<b>Elevation</b>	<b>Elevation</b>
0.0 97.1			
6.7 97.1			
10.0 96.9			
12.4 96.5			
14.6 96.3			
15.3 96.2			
16.8 96.1			
18.3 96.2			
19.3 96.7			
21.0 97.2			
22.2 97.4			
24.1 97.6			
27.1 97.7			
30.7 97.4

<b>Area</b>	<b>As-built</b>	<b>2008</b>	<b>2009</b>	<b>2010</b>
<b>Width</b>	7.5			
<b>Mean Depth</b>	13.9			
<b>Max Depth</b>	0.5			
<b>W/D Ratio</b>	1.0			
	N/A

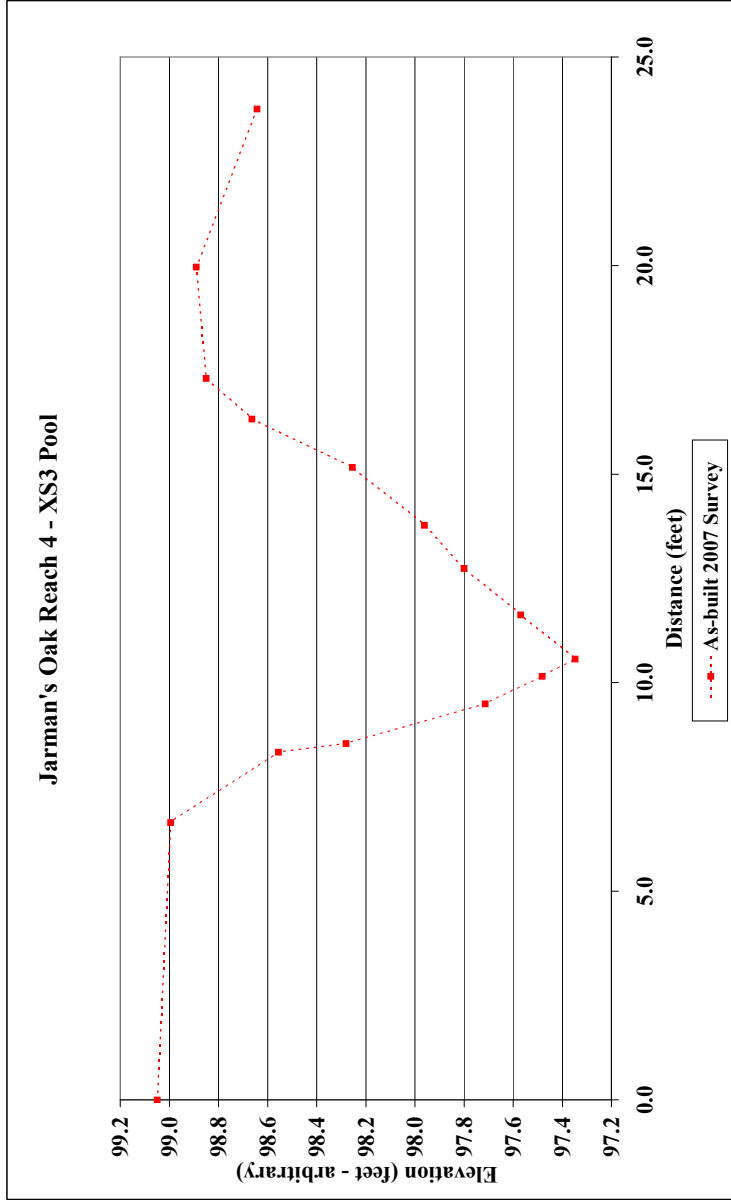
<b>Project Name</b> Jarman's Oak				
<b>Cross Section</b> R4-XS3				
<b>Feature</b> Pool				
<b>Date</b> 10/24/07				
<b>Crew</b> Adams, Jeffers				
<b>As-built</b>	<b>2008</b>	<b>2009</b>	<b>2010</b>	
<b>2007 Survey</b>	<b>2008 Survey</b>	<b>2009 Survey</b>	<b>2010 Survey</b>	
<b>Station</b>	<b>Station</b>	<b>Station</b>	<b>Station</b>	<b>Elevation</b>
0.0	99.0			
6.7	99.0			
8.3	98.6			
8.5	98.3			
9.5	97.7			
10.2	97.5			
10.6	97.3			
11.6	97.6			
12.7	97.8			
13.8	98.0			
15.2	98.3			
16.3	98.7			
17.3	98.8			
20.0	98.9			
23.8	98.6

<b>Area</b>	<b>As-built</b>	<b>2008</b>	<b>2009</b>	<b>2010</b>
<b>Width</b>	7.8			
<b>Mean Depth</b>	10.1			
<b>Max Depth</b>	0.8			
<b>W/D Ratio</b>	1.5			
	N/A

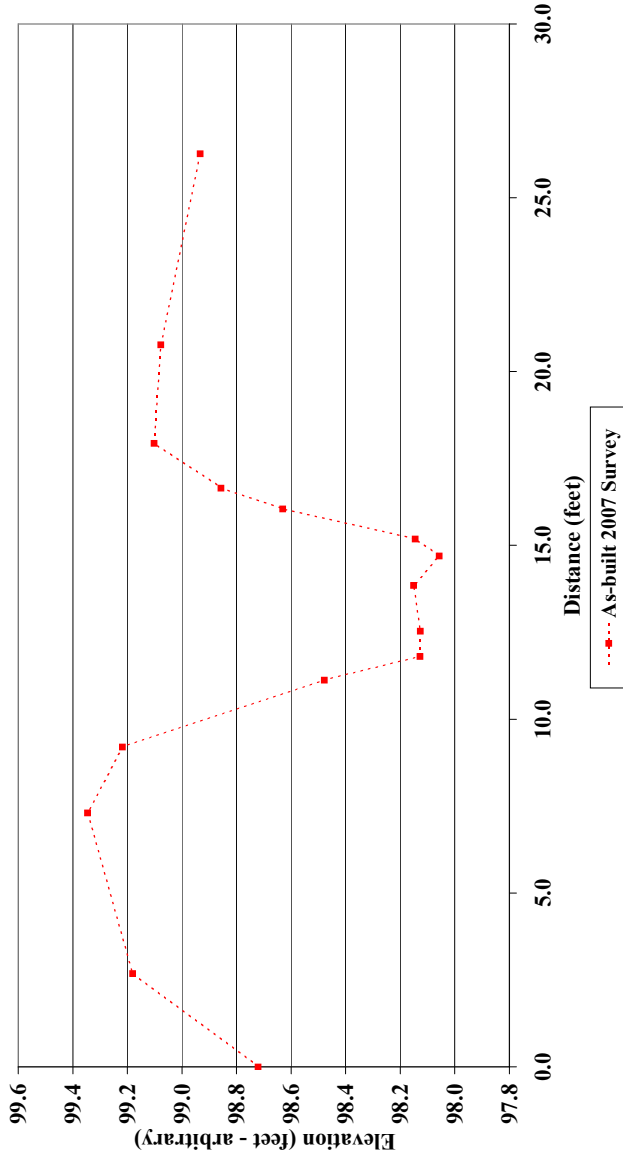
**Jarman's Oak Reach 4 - XS4 Riffle**

<b>Project Name</b> Jarman's Oak <b>Cross Section</b> R4-XS4 <b>Feature</b> Riffle <b>Date</b> 10/24/07 <b>Crew</b> Adams, Jeffers			
<b>As-built</b> <b>2007 Survey</b> <b>Station</b> <b>Elevation</b> 0.0        98.7 2.7        99.2 7.3        99.3 9.2        99.2 11.1       98.5 11.8       98.1 12.5       98.1 13.8       98.2 14.7       98.1 15.2       98.1 16.1       98.6 16.6       98.9 17.9       99.1 20.8       99.1 26.3       98.9	<b>2008</b> <b>2008 Survey</b> <b>Station</b> <b>Elevation</b>	<b>2009</b> <b>2009 Survey</b> <b>Station</b> <b>Elevation</b>	<b>2010</b> <b>2010 Survey</b> <b>Station</b> <b>Elevation</b>

<b>Area</b> <b>Width</b> <b>Mean Depth</b> <b>Max Depth</b> <b>W/D Ratio</b>	<b>As-built</b>	<b>2008</b>	<b>2009</b>	<b>2010</b>
	5.3			
	8.4			
	0.6			
	1.0			
	13.3

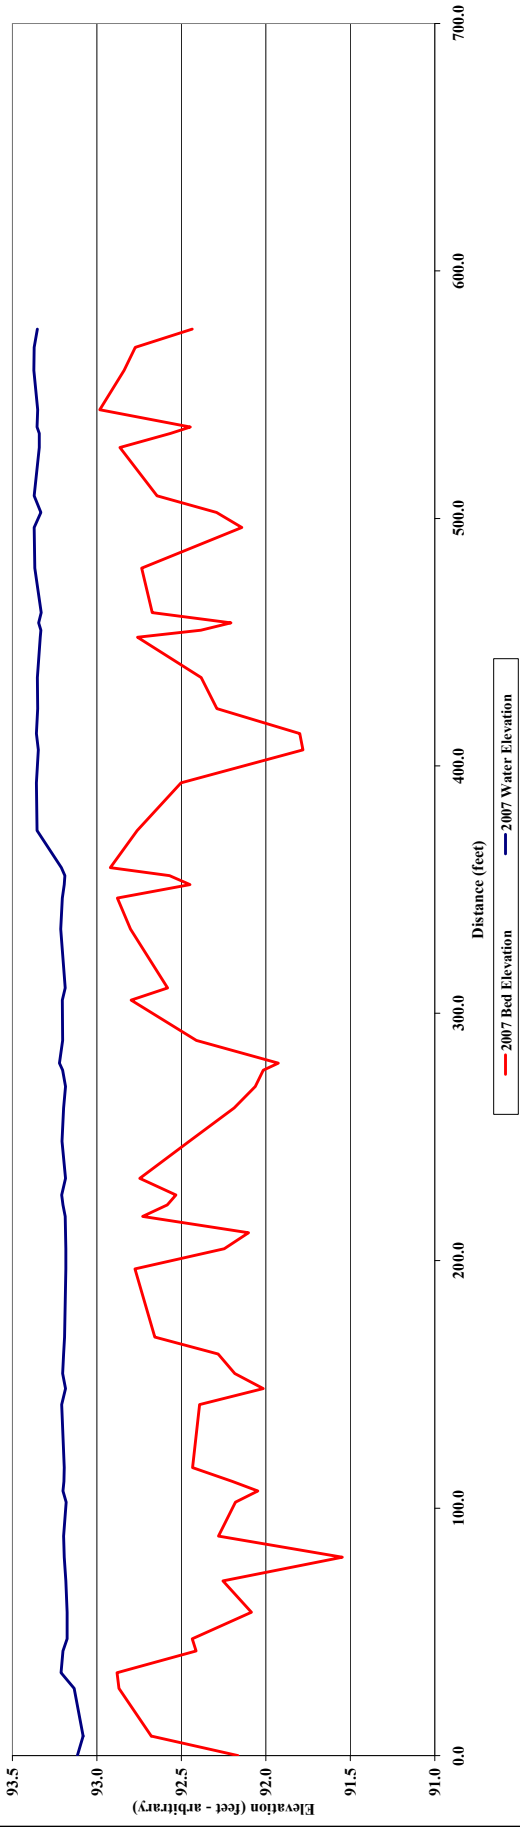
Jarman's Oak Profile - Reach 5

Jarman's Oak											
Reach 5											
Profile											
Date 10/24/07											
Crew Adams, Jeffers											
As-built			2008			2009			2010		
Station	Bed Elevation	Water Elevation	Station	Bed Elevation	Water Elevation	Station	Bed Elevation	Water Elevation	Station	Bed Elevation	Water Elevation
0.0	92.2	93.1									
7.9	92.7	93.1									
27.2	92.9	93.1									
33.5	92.9	93.2									
42.3	92.4	93.2									
47.4	92.4	93.2									
57.0	92.1	93.2									
70.7	92.3	93.2									
80.1	91.5	93.2									
88.7	92.3	93.2									
102.4	92.2	93.2									
107.0	92.0	93.2									
110.8	92.2	93.2									
116.4	92.4	93.2									
141.8	92.4	93.2									
148.3	92.0	93.2									
154.4	92.2	93.2									
162.3	92.3	93.2									
169.2	92.7	93.2									
196.7	92.8	93.2									
204.9	92.2	93.2									
211.4	92.1	93.2

As-built	2008	2009	2010
Avg. Water Surface Slope	0.0004			
Avg. Riffle Slope	0.0013			
Avg. Pool Slope	0.0014			
Avg. Run Slope	0.0013			
Avg. Ciliate Slope	0.0004

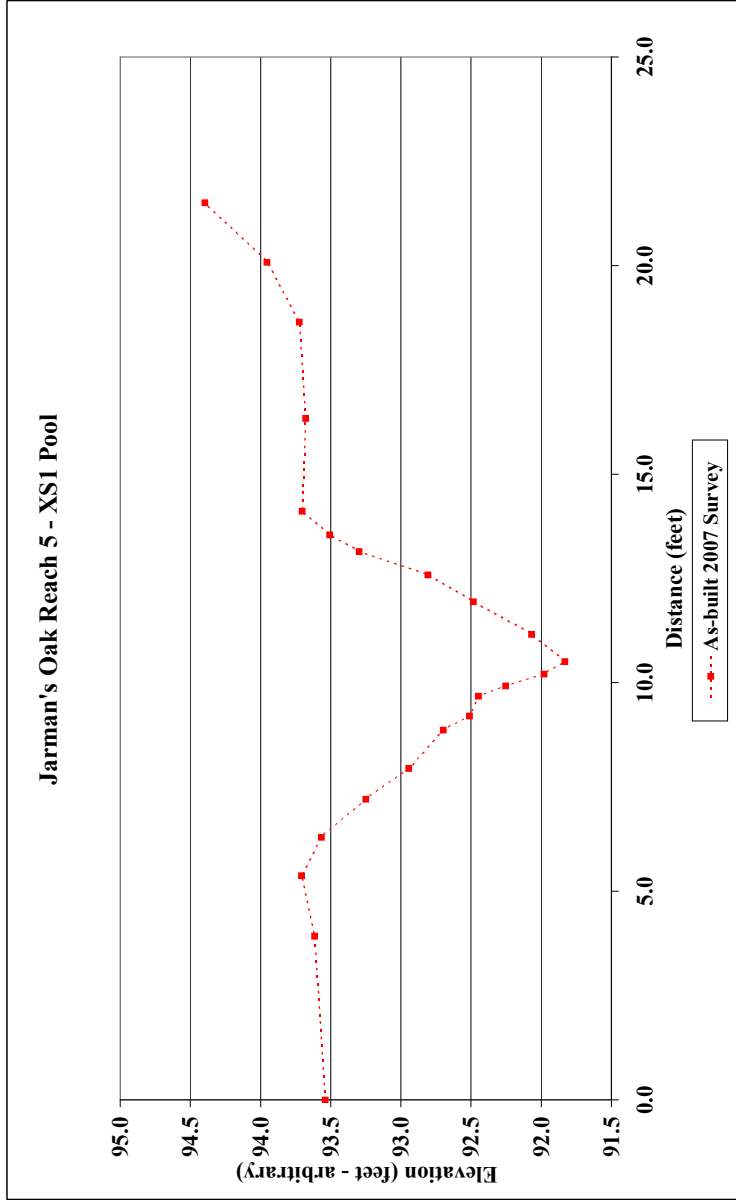
<b>Project Name</b> Jarman's Oak			
<b>Cross Section</b> R5-XS1			
<b>Feature</b> Pool			
<b>Date</b> 10/24/07			
<b>Crew</b> Adams, Jeffers			
<b>As-built</b>	<b>2008</b>	<b>2009</b>	<b>2010</b>
<b>2007 Survey</b>	<b>2008 Survey</b>	<b>2009 Survey</b>	<b>2010 Survey</b>
<b>Station</b>	<b>Station</b>	<b>Station</b>	<b>Station</b>
<b>Elevation</b>	<b>Elevation</b>	<b>Elevation</b>	<b>Elevation</b>
0.0 93.5			
3.9 93.6			
5.4 93.7			
6.3 93.6			
7.2 93.2			
7.9 92.9			
8.9 92.7			
9.2 92.5			
9.7 92.4			
9.9 92.3			
10.2 92.0			
10.5 91.8			
11.2 92.1			
11.9 92.5			
12.6 92.8			
13.2 93.3			
13.5 93.5			
14.1 93.7			
16.3 93.7			
18.6 93.7			
20.1 94.0			
21.5 94.4

<b>Area</b>	<b>As-built</b>	<b>2008</b>	<b>2009</b>	<b>2010</b>
<b>Width</b>	7.3			
<b>Mean Depth</b>	8.7			
<b>Max Depth</b>	0.8			
<b>W/D Ratio</b>	1.9			
	N/A

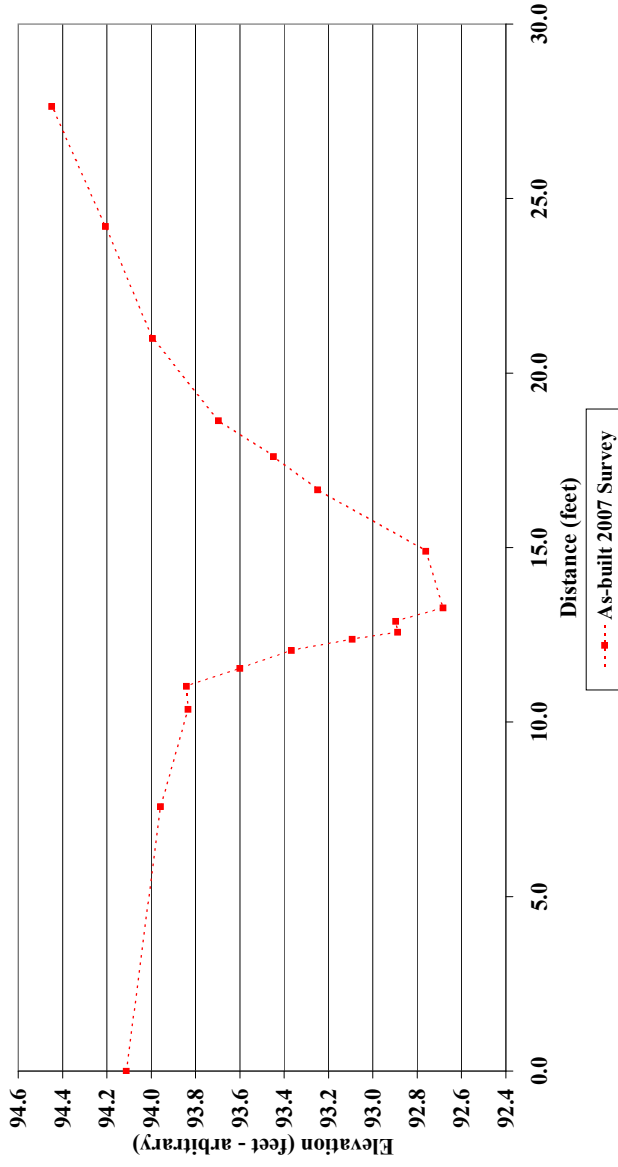
### Jarman's Oak Reach 5 - XS2 Riffle

<b>Project Name</b> Jarman's Oak <b>Cross Section</b> R5-XS2 <b>Feature</b> Riffle <b>Date</b> 10/24/07 <b>Crew</b> Adamsme, Jeffers			
<b>As-built</b> 2007 Survey Station Elevation 0.0 94.1 7.6 94.0 10.4 93.8 11.0 93.8 11.5 93.6 12.1 93.4 12.4 93.1 12.6 92.9 12.9 92.9 13.3 92.7 14.9 92.8 16.7 93.2 17.6 93.4 18.6 93.7 21.0 94.0 24.2 94.2 27.6 94.4	<b>2008</b> 2008 Survey Station Elevation	<b>2009</b> 2009 Survey Station Elevation	<b>2010</b> 2010 Survey Station Elevation

As-built	2008	2009	2010
Area	5.4			
Width	8.7			
Mean Depth	0.6			
Max Depth	1.2			
W/D Ratio	14.1

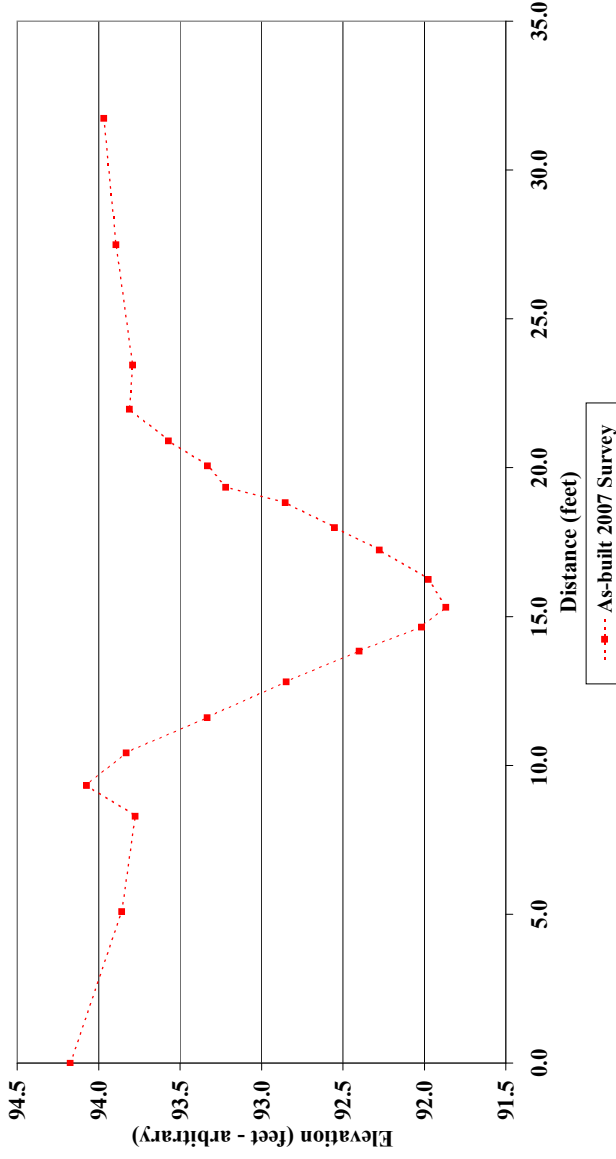
### Jarman's Oak Reach 5 - XS3 Pool

Project Name Jarman's Oak  
 Cross Section R5-XS3  
 Feature Pool  
 Date 10/24/07  
 Crew Adams, Jeffers

As-built 2007 Survey Station	2008 Survey Station	2009 Survey Station	2010 Survey Station
Elevation	Elevation	Elevation	Elevation
0.0	94.2		
5.1	93.9		
8.3	93.8		
9.3	94.1		
10.4	93.8		
11.6	93.3		
12.8	92.8		
13.8	92.4		
14.7	92.0		
15.3	91.9		
16.3	92.0		
17.2	92.3		
18.0	92.6		
18.8	92.9		
19.3	93.2		
20.1	93.3		
20.9	93.6		
22.0	93.8		
23.5	93.8		
27.5	93.9		
31.7	94.0

As-built	2008	2009	2010
Area	11.5			
Width	11.5			
Mean Depth	1.0			
Max Depth	1.9			
W/D Ratio	N/A

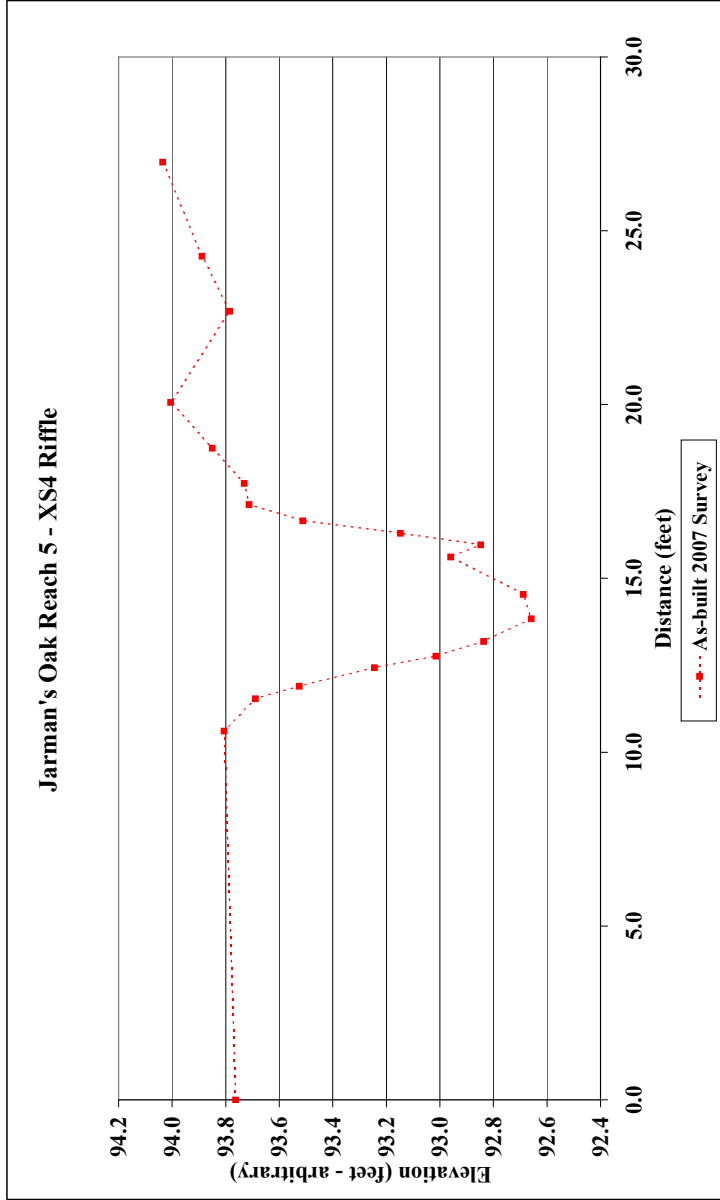
<b>Project Name</b> Jarman's Oak			
<b>Cross Section</b> R5-XS4			
<b>Feature</b> Riffle			
<b>Date</b> 10/24/07			
<b>Crew</b> Adams, Jeffers			
<b>As-built</b>	<b>2008</b>	<b>2009</b>	<b>2010</b>
<b>2007 Survey</b>	<b>2008 Survey</b>	<b>2009 Survey</b>	<b>2010 Survey</b>
<b>Station</b>	<b>Station</b>	<b>Station</b>	<b>Station</b>
<b>Elevation</b>	<b>Elevation</b>	<b>Elevation</b>	<b>Elevation</b>
0.0 93.8			
10.6 93.8			
11.5 93.7			
11.9 93.5			
12.4 93.2			
12.8 93.0			
13.2 92.8			
13.8 92.7			
14.5 92.7			
15.6 93.0			
16.0 92.8			
16.3 93.1			
16.7 93.5			
17.1 93.7			
17.7 93.7			
18.8 93.8			
20.1 94.0			
22.7 93.8			
24.3 93.9			
27.0 94.0

<b>Area</b>	<b>As-built</b>	<b>2008</b>	<b>2009</b>	<b>2010</b>
<b>Width</b>	3.7			
<b>Mean Depth</b>	5.6			
<b>Max Depth</b>	0.7			
<b>W/D Ratio</b>	1.1			
	8.3
