YEAR 1 (2008)
ANNUAL MONITORING REPORT
JARMANS OAK RESTORATION SITE
ONslow COUNTY, NORTH CAROLINA

(CONTRACT D06069-A)
FULL DELIVERY PROJECT
WHITE OAK RIVER BASIN
CATALOGING UNIT 03030001

November 2008

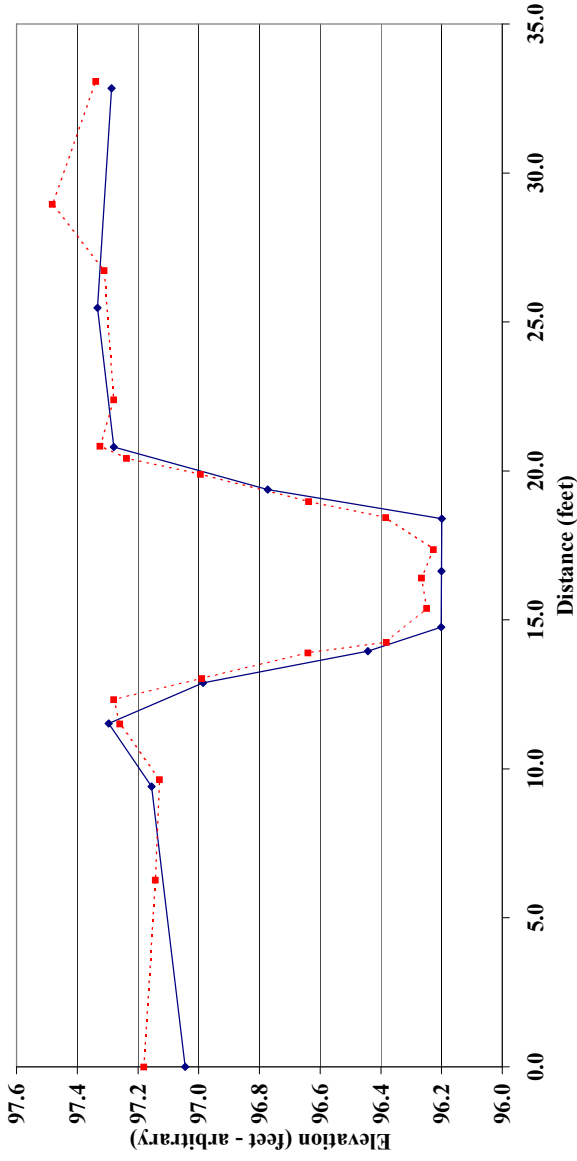
Jarman's Oak Reach 1 - XS1 Riffle

Project Name Jarman's Oak			
Cross Section R1-XS1			
Feature Riffle			
Date 6/20/08			
Crew Adams, Jeffers			
As-built	2008	2009	2010
2007 Survey	2008 Survey	2009 Survey	2010 Survey
Station	Station	Station	Station
Elevation	Elevation	Elevation	Elevation
0.0 97.2	0.0 97.0		
6.3 97.1	9.4 97.2		
9.6 97.1	11.5 97.3		
11.5 97.3	12.9 97.0		
12.3 97.3	13.9 96.4		
13.0 97.0	14.8 96.2		
13.9 96.6	16.6 96.2		
14.3 96.4	18.4 96.2		
15.4 96.2	19.4 96.8		
16.4 96.3	20.8 97.3		
17.4 96.2	25.5 97.3		
18.4 96.4	32.8 97.3		
19.0 96.6			
19.9 97.0			
20.4 97.2			
20.8 97.3			
22.4 97.3			
26.7 97.3			
29.0 97.5			
33.1 97.3

Area Width Mean Depth Max Depth W/D Ratio	As-built	2008	2009	2010
	5.9	6.4		
	9.1	9.0		
	0.6	0.7		
	1.1	1.1		
	14.1	12.7

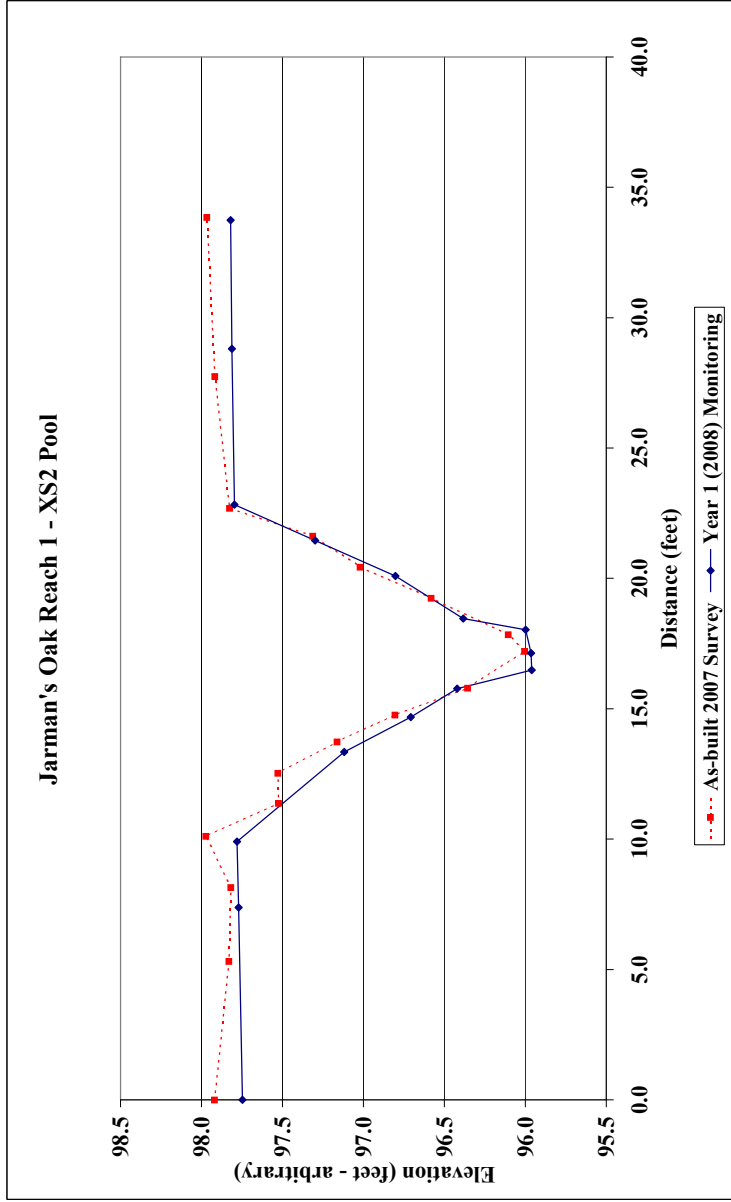
Project Name Jarman's Oak			
Cross Section R1-XS2			
Feature Pool			
Date 6/20/08			
Crew Adams, Jeffers			
As-built	2008	2009	2010
2007 Survey	2008 Survey	2009 Survey	2010 Survey
Station	Station	Station	Station
Elevation	Elevation	Elevation	Elevation
0.0 97.9	0.0 97.7		
5.3 97.8	7.4 97.8		
8.1 97.8	9.9 97.8		
10.1 98.0	13.3 97.1		
11.4 97.5	14.7 96.7		
12.5 97.5	15.8 96.4		
13.7 97.2	16.5 96.0		
14.8 96.8	17.1 96.0		
15.8 96.4	18.0 96.0		
17.2 96.0	18.5 96.4		
17.8 96.1	20.1 96.8		
19.2 96.6	21.4 97.3		
20.4 97.0	22.8 97.8		
21.6 97.3	28.8 97.8		
22.7 97.8	33.7 97.8		
27.8 97.9			
33.9 98.0

As-built	2008	2009	2010
Area	7.6	11.4		
Width	9.5	12.8		
Mean Depth	0.8	0.9		
Max Depth	1.5	1.8		
W/D Ratio	N/A	N/A

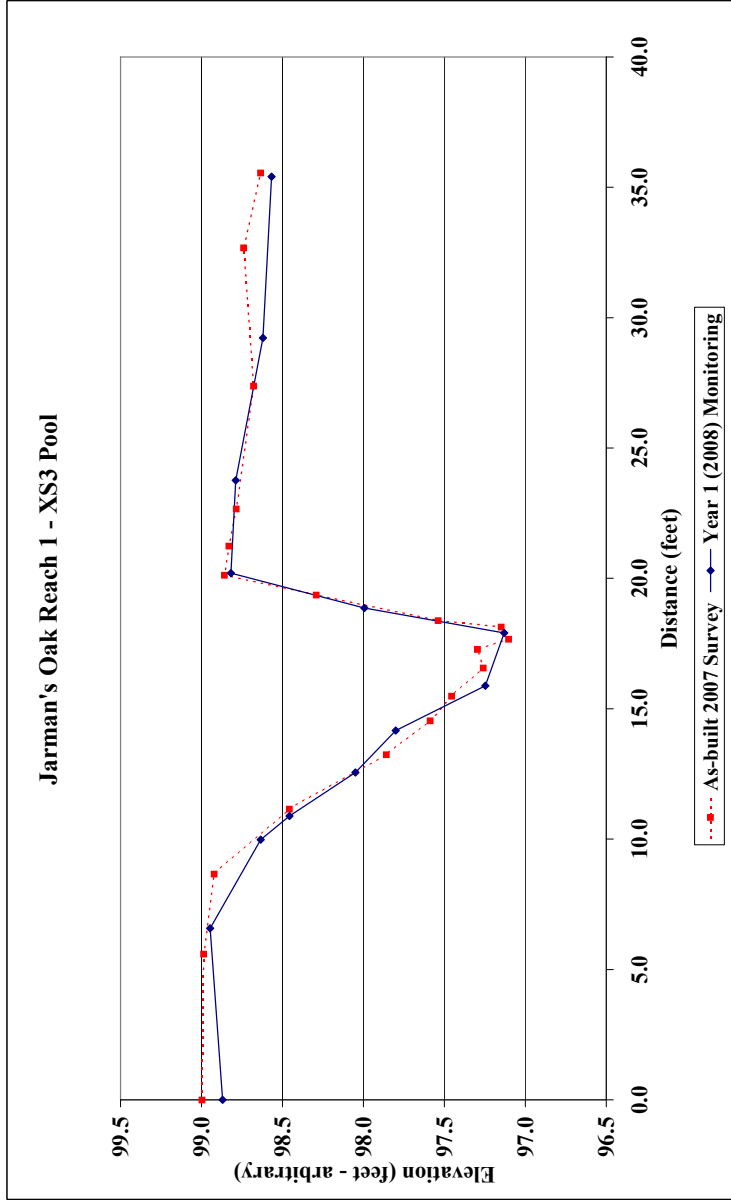
Project Name Jarman's Oak		2010 Survey	
Cross Section R1-XS3	2009 Survey		2010 Survey
Feature Pool	2008 Survey		2010 Survey
Date 6/20/08	Station Elevation		Station Elevation
Crew Adams, Jeffers	Station Elevation		Station Elevation
	As-built	2007 Survey	2008 Survey
	Station	Station	Station
	Elevation	Elevation	Elevation
	0.0 99.0	0.0 98.9	
	5.6 99.0	6.6 98.9	
	8.7 98.9	10.0 98.6	
	11.2 98.5	10.9 98.5	
	13.2 97.9	12.6 98.0	
	14.5 97.6	14.2 97.8	
	15.5 97.5	15.9 97.2	
	16.6 97.3	17.9 97.1	
	17.3 97.3	18.9 98.0	
	17.7 97.1	20.2 98.8	
	18.1 97.1	23.8 98.8	
	18.4 97.5	29.2 98.6	
	19.4 98.3	35.4 98.6	
	20.1 98.9		
	21.3 98.8		
	22.7 98.8		
	27.4 98.7		
	32.7 98.7		
	35.6 98.6

As-built	2008	2009	2010
Area	10.4	10.0		
Width	12.3	12.1		
Mean Depth	0.8	0.8		
Max Depth	1.8	1.7		
W/D Ratio	N/A	N/A

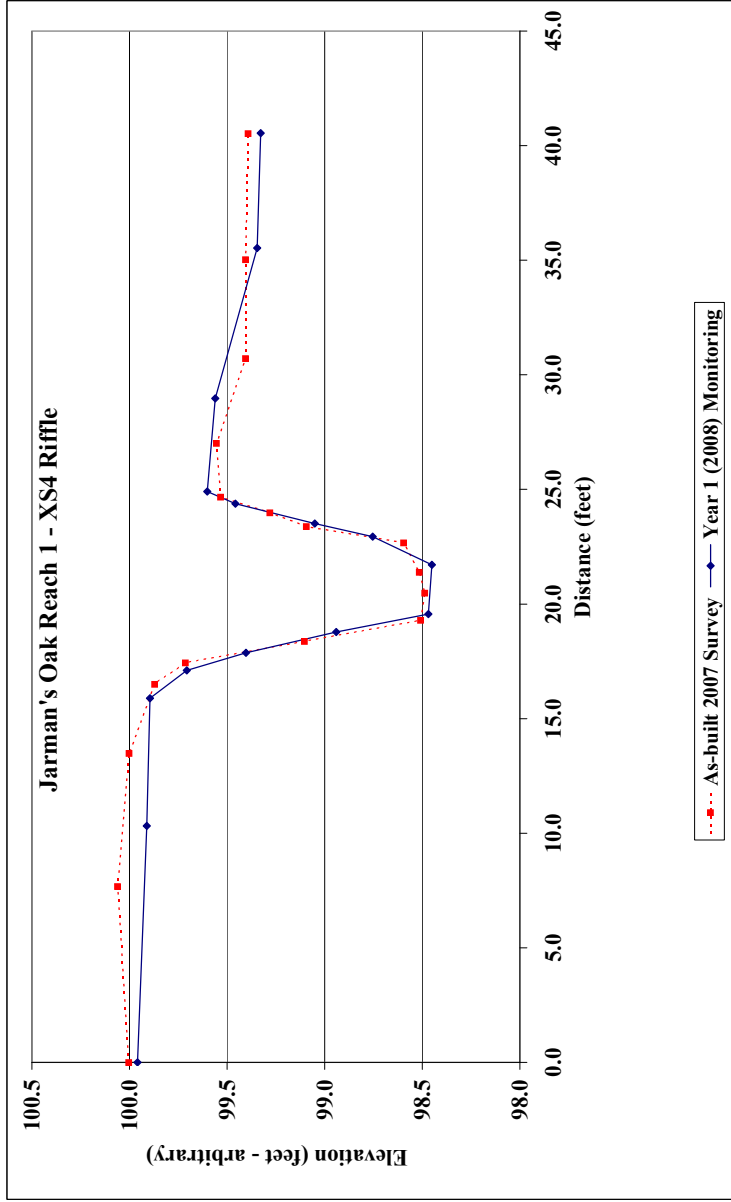
Project Name Jarman's Oak		2010 Survey	
Cross Section R1-XS4	2009 Survey		2010 Survey
Feature Riffle	Station	Elevation	Station Elevation
Date 6/20/08	0.0	100.0	0.0
Crew Adamsme, Jeffers	7.7	100.1	10.3
	13.5	100.0	15.9
	16.5	99.9	17.1
	17.4	99.7	17.9
	18.4	99.1	18.8
	19.3	98.5	19.6
	20.5	98.5	21.7
	21.4	98.5	22.9
	22.7	98.6	23.5
	23.4	99.1	24.4
	24.0	99.3	24.9
	24.7	99.5	29.0
	27.0	99.6	35.5
	30.7	99.4	40.5
	35.0	99.4	
	40.5	99.4

As-built	2008	2009	2010
Area	5.0	5.6		
Width	6.9	7.5		
Mean Depth	0.7	0.7		
Max Depth	1.0	1.1		
W/D Ratio	9.6	10.2

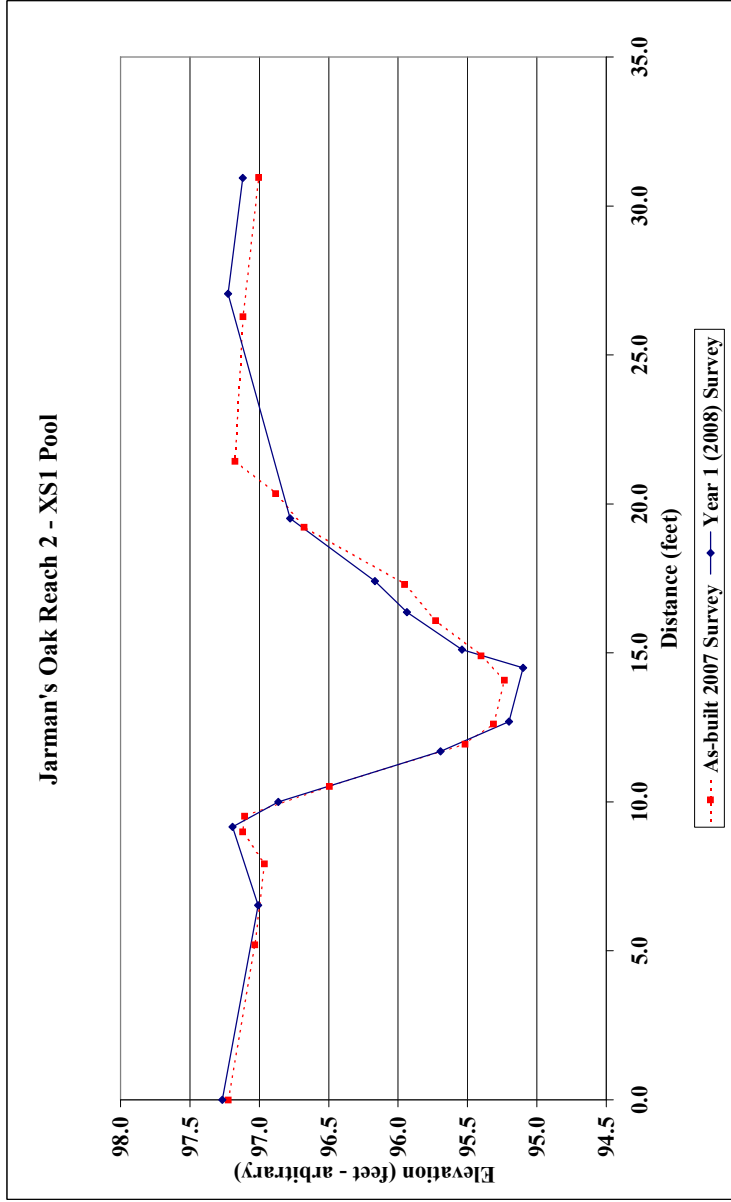
Project Name Jarman's Oak		2010 Survey	
Cross Section R2-XS1	2009 Survey		2010 Survey
Feature Pool	2008 Survey		2010 Survey
Date 6/23/08	2007 Survey		2010 Survey
Crew Adams, Jeffers	2007 Survey		2010 Survey
	Station	Elevation	Station
	0.0	97.2	0.0
	5.2	97.0	6.5
	7.9	97.0	9.2
	9.0	97.1	10.0
	9.5	97.1	11.7
	10.5	96.5	12.7
	11.9	95.5	14.5
	12.6	95.3	15.1
	14.1	95.2	16.4
	14.9	95.4	17.4
	16.1	95.7	19.5
	17.3	96.0	27.1
	19.2	96.7	30.9
	20.4	96.9	97.1
	21.4	97.2	
	26.3	97.1	
	31.0	97.0

As-built	2008	2009	2010
Area	12.7	11.3		
Width	11.7	13.6		
Mean Depth	1.1	0.8		
Max Depth	1.9	1.9		
W/D Ratio	N/A	N/A

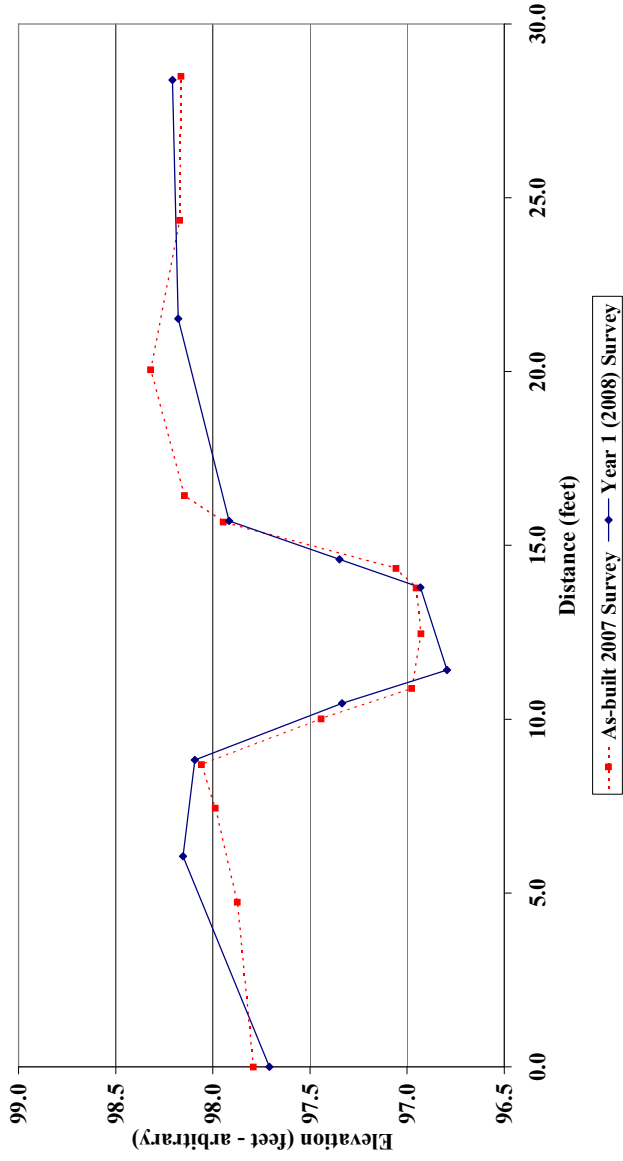
Jarman's Oak Reach 2 - XS2 Riffle

Project Name Jarman's Oak
 Cross Section R2-XS2
 Feature Riffle
 Date 6/23/08
 Crew Adams, Jeffers

As-built	2008	2009	2010
Area	5.7	4.6		
Width	7.4	6.6		
Mean Depth	0.8	0.7		
Max Depth	1.1	1.1		
W/D Ratio	9.6	9.3

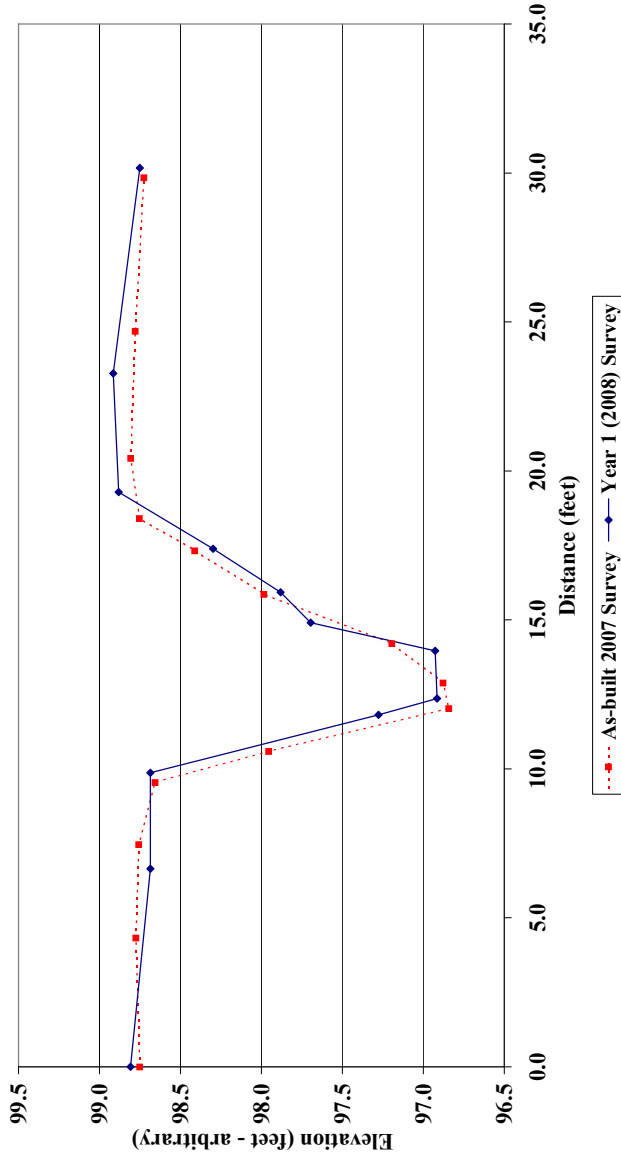
Jarman's Oak Reach 2 - XS3 Pool

Project Name Jarman's Oak
 Cross Section R2-XS3
 Feature Pool
 Date 6/23/08
 Crew Adams, Jeffers

As-built	2008	2009	2010
Area	8.4	8.3		
Width	8.7	8.8		
Mean Depth	1.0	1.0		
Max Depth	1.8	1.8		
W/D Ratio	N/A	N/A

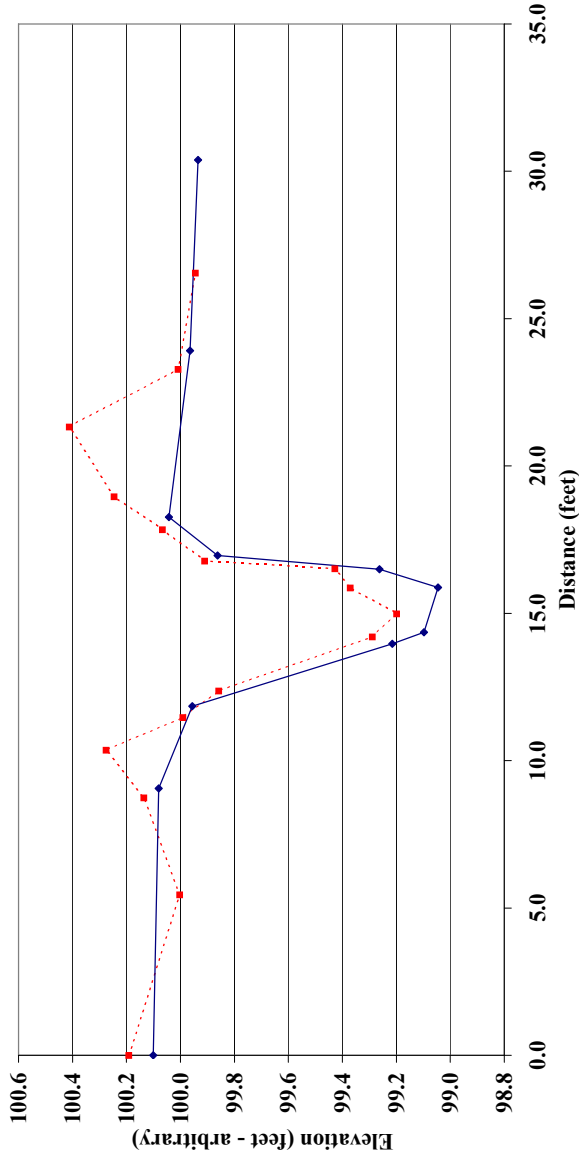
Jarman's Oak Reach 2 - XS4 Riffle

Project Name Jarman's Oak
 Cross Section R2-XS4
 Feature Riffle
 Date 6/23/08
 Crew Adams, Jeffers

As-built	2008	2009	2010
Area	4.7	3.7		
Width	8.6	8.3		
Mean Depth	0.5	0.5		
Max Depth	1.1	1.0		
W/D Ratio	15.9	18.3

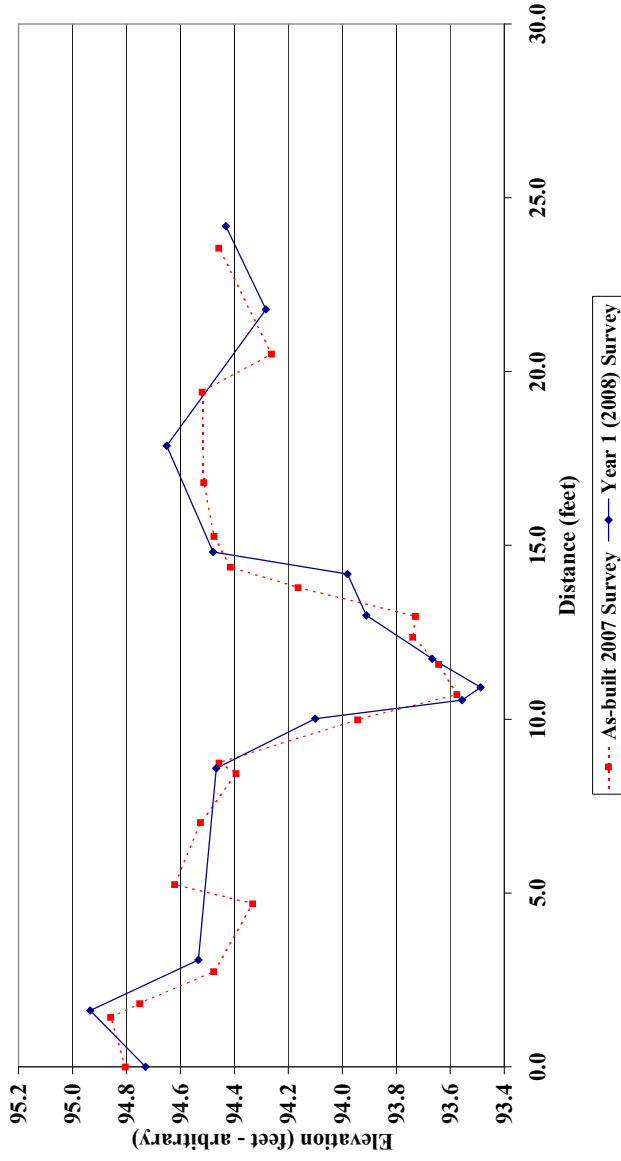
Jarman's Oak Reach 3 - XS1 Pool

Project Name Jarman's Oak			
Cross Section R3-XS1			
Feature Pool			
Date 6/23/08			
Crew Adams, Jeffers			
As-built	2008	2009	2010
2007 Survey	2008 Survey	2009 Survey	2010 Survey
Station	Station	Station	Station
Elevation	Elevation	Elevation	Elevation
0.0 94.8	0.0 94.7		
1.4 94.9	1.6 94.9		
1.8 94.8	3.1 94.5		
2.7 94.5	8.6 94.5		
4.7 94.3	10.0 94.1		
5.2 94.6	10.5 93.6		
7.0 94.5	10.9 93.5		
8.4 94.4	11.7 93.7		
8.7 94.5	13.0 93.9		
10.0 93.9	14.2 94.0		
10.7 93.6	14.8 94.5		
11.6 93.6	17.9 94.7		
12.4 93.7	21.8 94.3		
13.0 93.7	24.2 94.4		
13.8 94.2			
14.4 94.4			
15.3 94.5			
16.8 94.5			
19.4 94.5			
20.5 94.3			
23.6 94.5

As-built	2008	2009	2010
Area	2.9	3.3		
Width	5.6	6.2		
Mean Depth	0.5	0.5		
Max Depth	0.8	1.0		
W/D Ratio	N/A	N/A

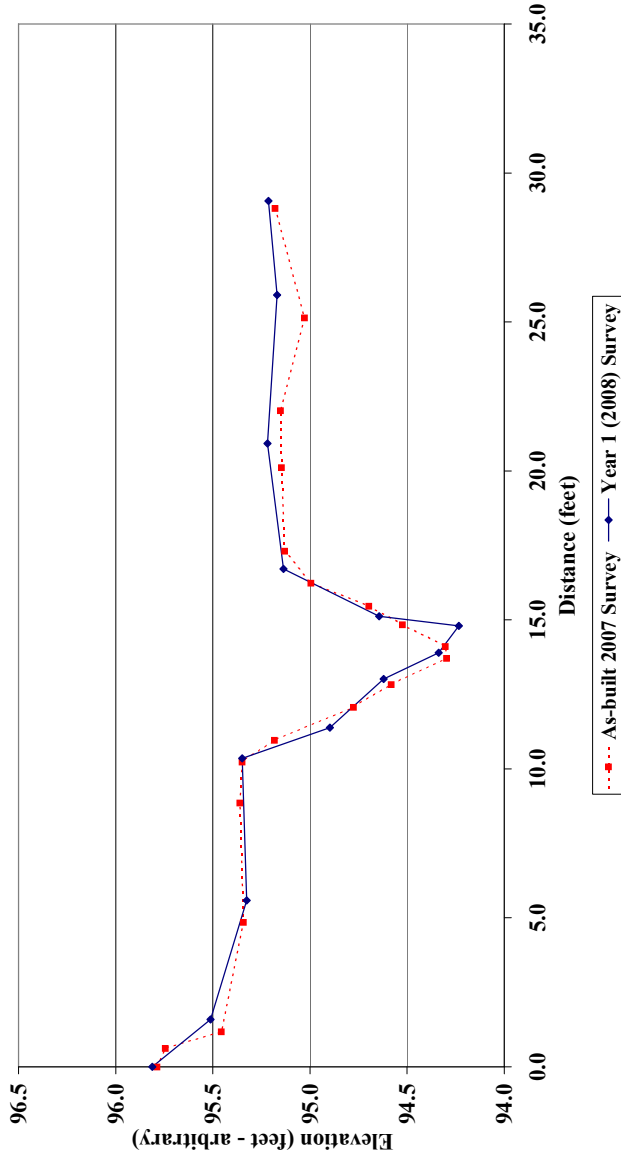
Jarman's Oak Reach 3 - XS2 Riffle

Project Name Jarman's Oak
 Cross Section R3-XS2
 Feature Riffle
 Date 6/23/08
 Crew Adams, Jeffers

As-built	2008	2009	2010
Area	2.6	2.7		
Width	6.2	6.1		
Mean Depth	0.4	0.4		
Max Depth	0.8	0.9		
W/D Ratio	14.9	13.8

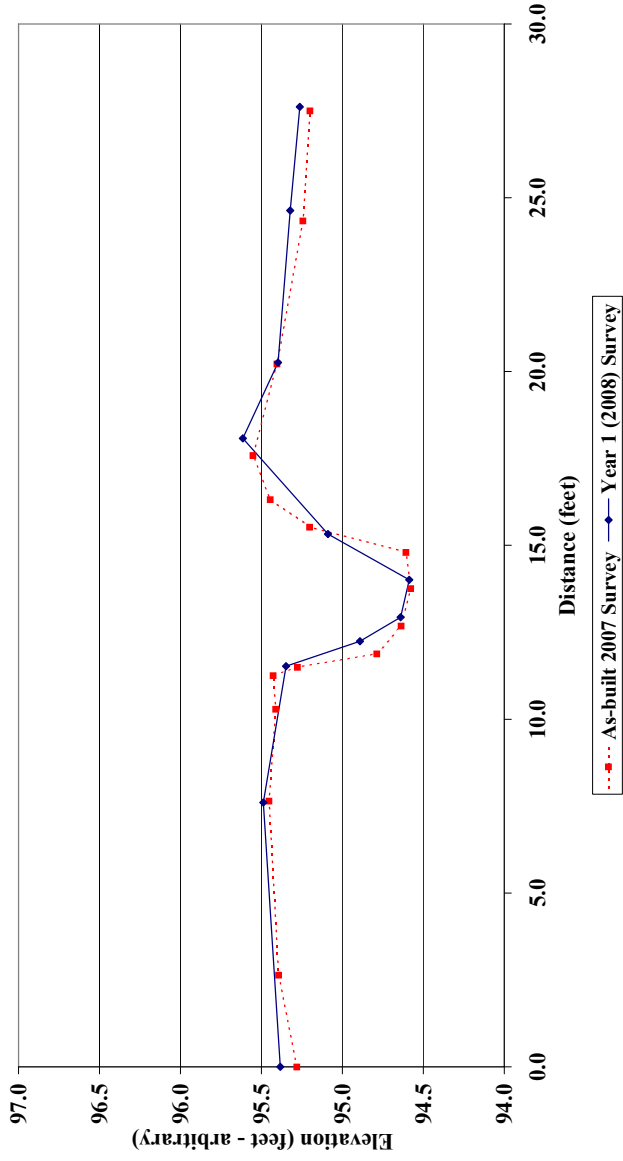
Jarman's Oak Reach 3 - XS3 Riffle

Project Name Jarman's Oak
 Cross Section R3-XS3
 Feature Riffle
 Date 6/23/08
 Crew Adams, Jeffers

As-built	2008	2009	2010
Area	3.0	2.2		
Width	5.0	5.2		
Mean Depth	0.6	0.4		
Max Depth	0.9	0.8		
W/D Ratio	8.5	12.3

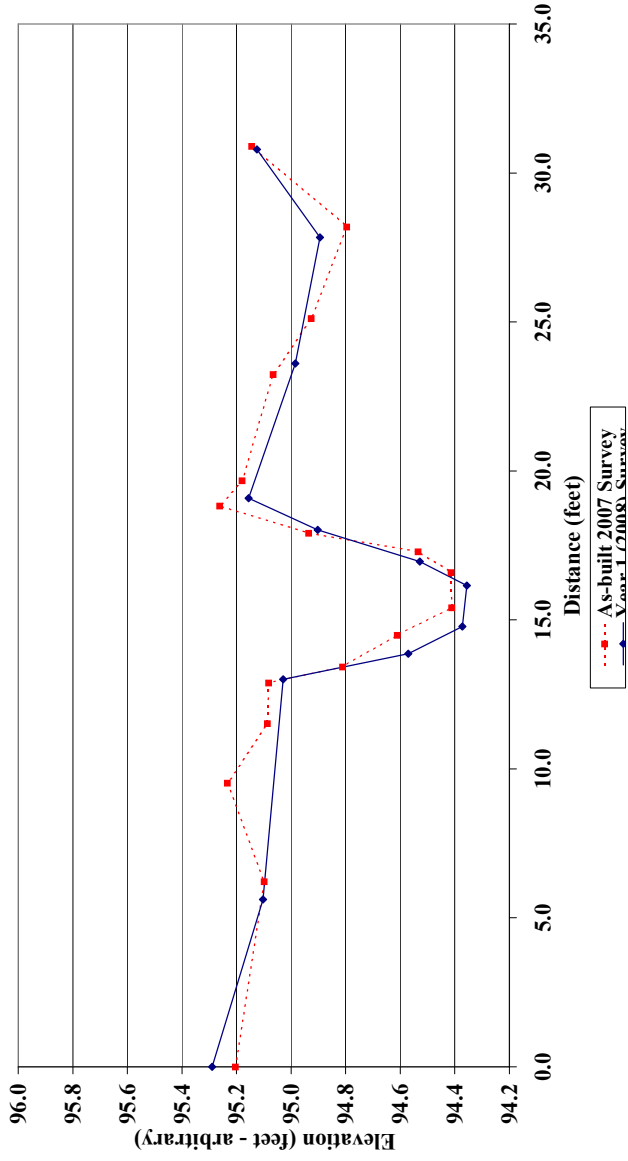
Jarman's Oak Reach 3 - XS4 Pool

Project Name Jarman's Oak
 Cross Section R3-XS4
 Feature Pool
 Date 6/23/08
 Crew Adams, Jeffers

As-built	2008	2009	2010
Area	2.4	2.5		
Width	5.4	5.6		
Mean Depth	0.5	0.4		
Max Depth	0.7	0.7		
W/D Ratio	N/A	N/A

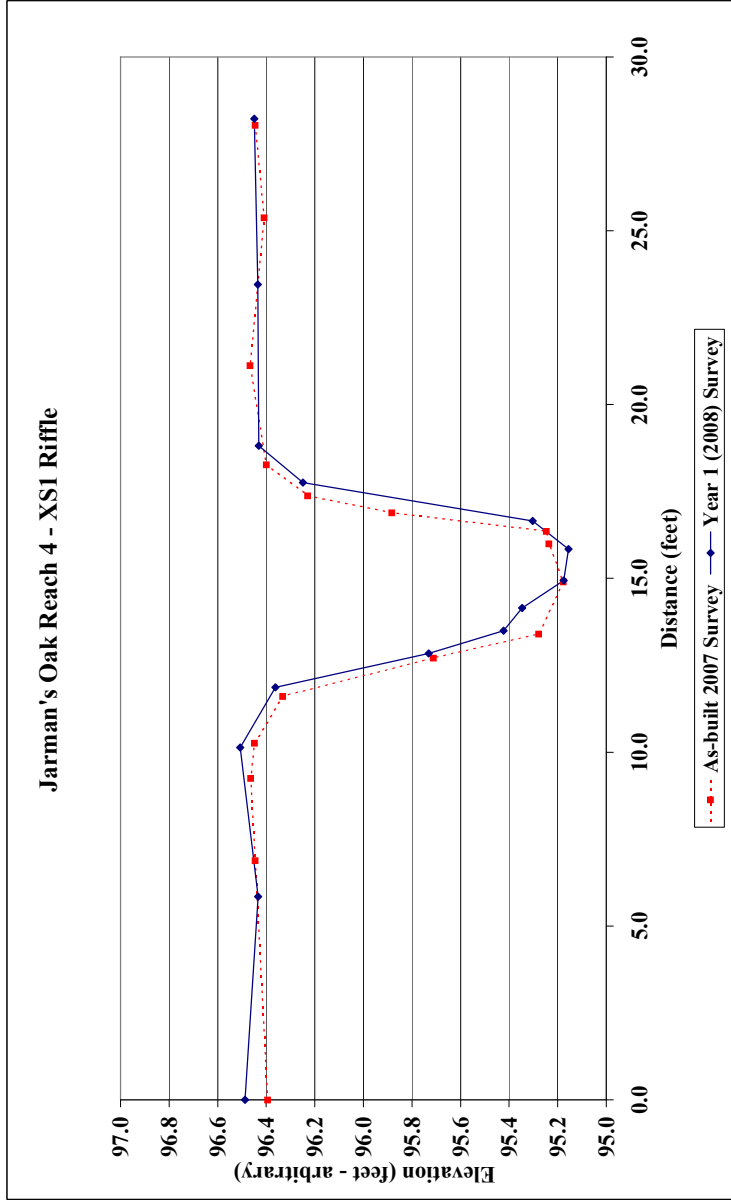
Project Name Jarman's Oak			
Cross Section R4-XS1			
Feature Riffle			
Date 6/24/08			
Crew Adamsme, Jeffers			
As-built	2008	2009	2010
2007 Survey	2008 Survey	2009 Survey	2010 Survey
Station	Station	Station	Station
Elevation	Elevation	Elevation	Elevation
0.0 96.4	0.0 96.5		
6.9 96.4	5.8 96.4		
9.3 96.5	10.1 96.5		
10.3 96.4	11.9 96.4		
11.6 96.3	12.8 95.7		
12.7 95.7	13.5 95.4		
13.4 95.3	14.2 95.3		
14.9 95.2	14.9 95.2		
16.0 95.2	15.8 95.2		
16.4 95.2	16.7 95.3		
16.9 95.9	17.8 96.2		
17.4 96.2	18.8 96.4		
18.3 96.4	23.5 96.4		
21.1 96.5	28.2 96.4		
25.4 96.4			
28.0 96.4

As-built	2008	2009	2010
Area	5.2	5.0		
Width	7.5	6.5		
Mean Depth	0.7	0.8		
Max Depth	1.2	1.2		
W/D Ratio	10.6	8.6

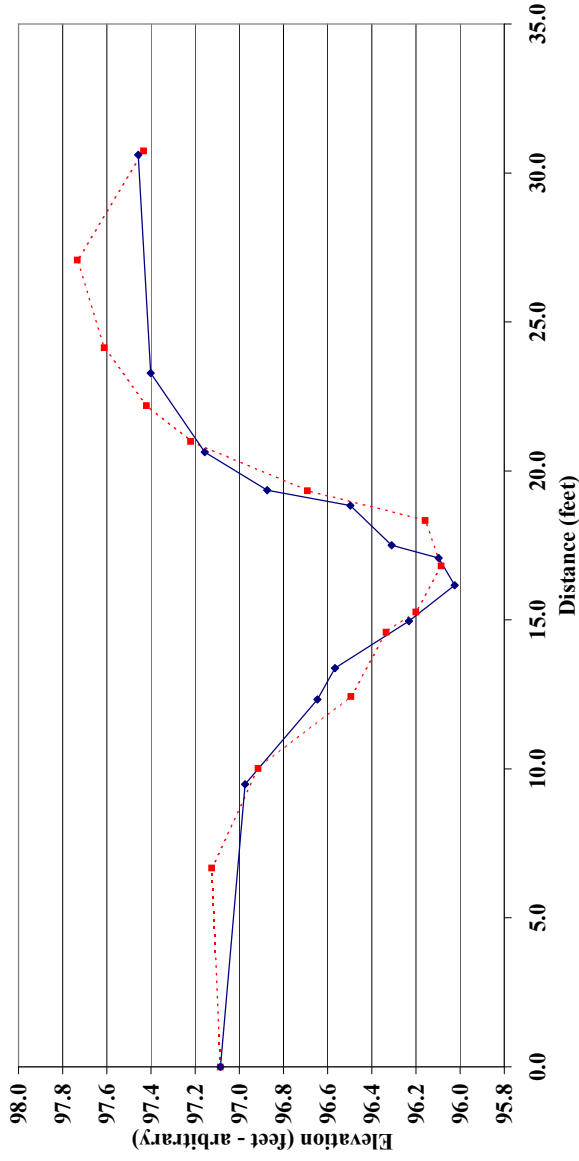
Jarman's Oak Reach 4 - XS2 Pool

Project Name Jarman's Oak Cross Section R4-XS2 Feature Pool Date 6/24/08 Crew Adams, Jeffers			
As-built 2007 Survey Station Elevation 0.0 97.1 6.7 97.1 10.0 96.9 12.4 96.5 14.6 96.3 15.3 96.2 16.8 96.1 18.3 96.2 19.3 96.7 21.0 97.2 22.2 97.4 24.1 97.6 27.1 97.7 30.7 97.4	2008 2008 Survey Station Elevation 0.0 97.1 9.5 97.0 12.3 96.6 13.4 96.6 15.0 96.2 16.2 96.0 17.1 96.1 17.5 96.3 18.8 96.5 19.3 96.9 20.6 97.2 23.3 97.4 30.6 97.5	2009 2009 Survey Station Elevation 20.0 97.0 21.0 96.9 22.2 97.4 23.3 97.4 27.1 97.7 30.7 97.4	2010 2010 Survey Station Elevation 20.0 97.0 21.0 96.9 22.2 97.4 23.3 97.4 27.1 97.7 30.7 97.4

As-built	2008	2009	2010
Area	7.5	4.8		
Width	13.9	10.3		
Mean Depth	0.5	0.5		
Max Depth	1.0	0.9		
W/D Ratio	N/A	N/A

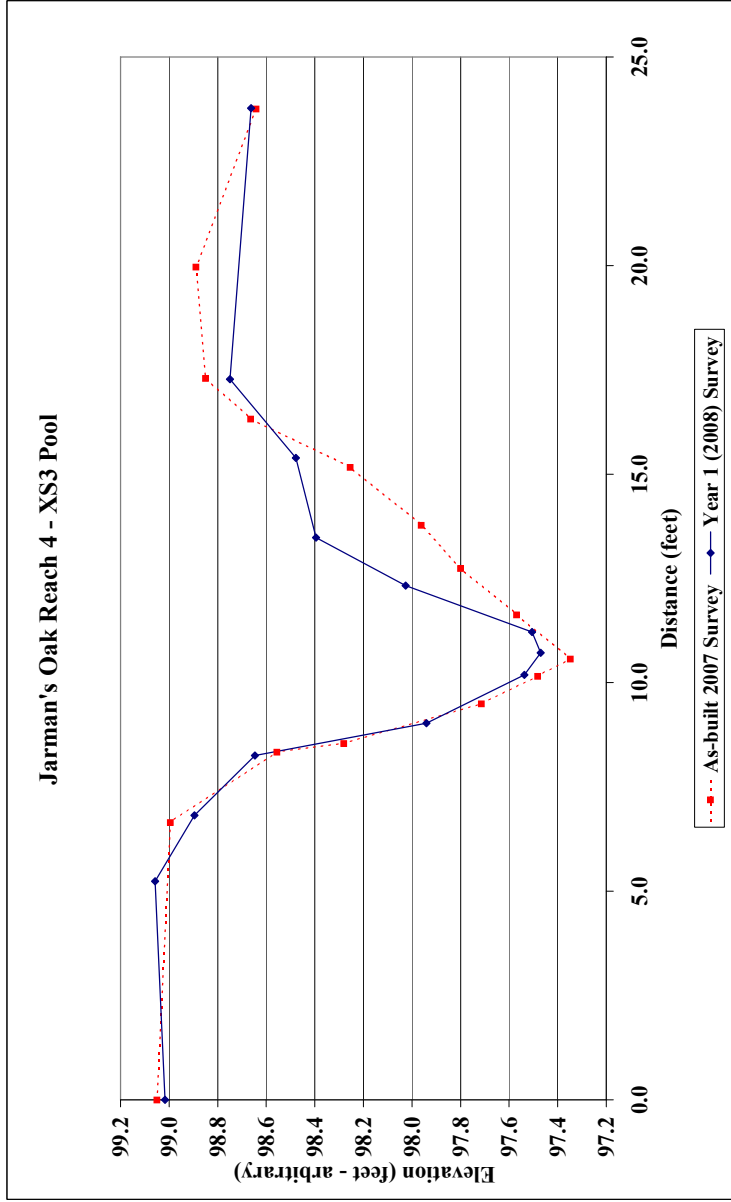
Project Name Jarman's Oak				
Cross Section R4-XS3				
Feature Pool				
Date 6/24/08				
Crew Adams, Jeffers				
As-built	2007 Survey	2008 Survey	2009 Survey	2010 Survey
Station	Station	Station	Station	Station
Elevation	Elevation	Elevation	Elevation	Elevation
0.0	99.0	0.0	99.0	
6.7	99.0	5.2	99.1	
8.3	98.6	6.8	98.9	
8.5	98.3	8.3	98.6	
9.5	97.7	9.0	97.9	
10.2	97.5	10.2	97.5	
10.6	97.3	10.7	97.5	
11.6	97.6	11.2	97.5	
12.7	97.8	12.3	98.0	
13.8	98.0	13.5	98.4	
15.2	98.3	15.4	98.5	
16.3	98.7	17.3	98.7	
17.3	98.8	23.8	98.7	
20.0	98.9			
23.8	98.6

As-built	2008	2009	2010
Area	7.8	5.3		
Width	10.1	9.5		
Mean Depth	0.8	0.6		
Max Depth	1.5	1.3		
W/D Ratio	N/A	N/A

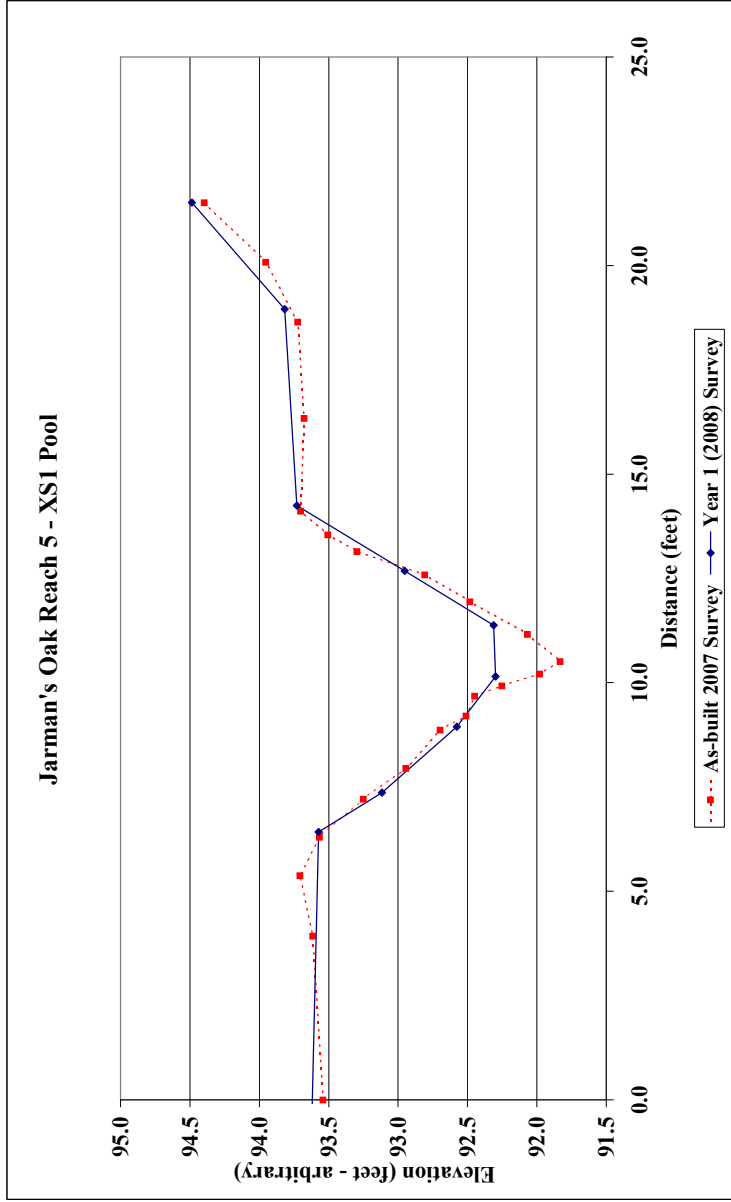
Project Name Jarman's Oak		2010 Survey	
Cross Section R5-XS1	2009 Survey		2010 Survey
Feature Pool	2008 Survey		2010 Survey
Date 7/7/08	2008 Survey		2010 Survey
Crew Adamsme, Jeffers	2008 Survey		2010 Survey
	As-built	2007 Survey	2008 Survey
	Station	Station	Station
	Elevation	Elevation	Elevation
	0.0 93.5	-5.3 93.7	
	3.9 93.6	6.4 93.6	
	5.4 93.7	7.4 93.1	
	6.3 93.6	8.9 92.6	
	7.2 93.2	10.1 92.3	
	7.9 92.9	11.4 92.3	
	8.9 92.7	12.7 93.0	
	9.2 92.5	14.2 93.7	
	9.7 92.4	19.0 93.8	
	9.9 92.3	21.5 94.5	
	10.2 92.0		
	10.5 91.8		
	11.2 92.1		
	11.9 92.5		
	12.6 92.8		
	13.2 93.3		
	13.5 93.5		
	14.1 93.7		
	16.3 93.7		
	18.6 93.7		
	20.1 94.0		
	21.5 94.4

As-built	2008	2009	2010
Area	7.3	5.9		
Width	8.7	7.5		
Mean Depth	0.8	0.8		
Max Depth	1.9	1.3		
W/D Ratio	N/A	N/A

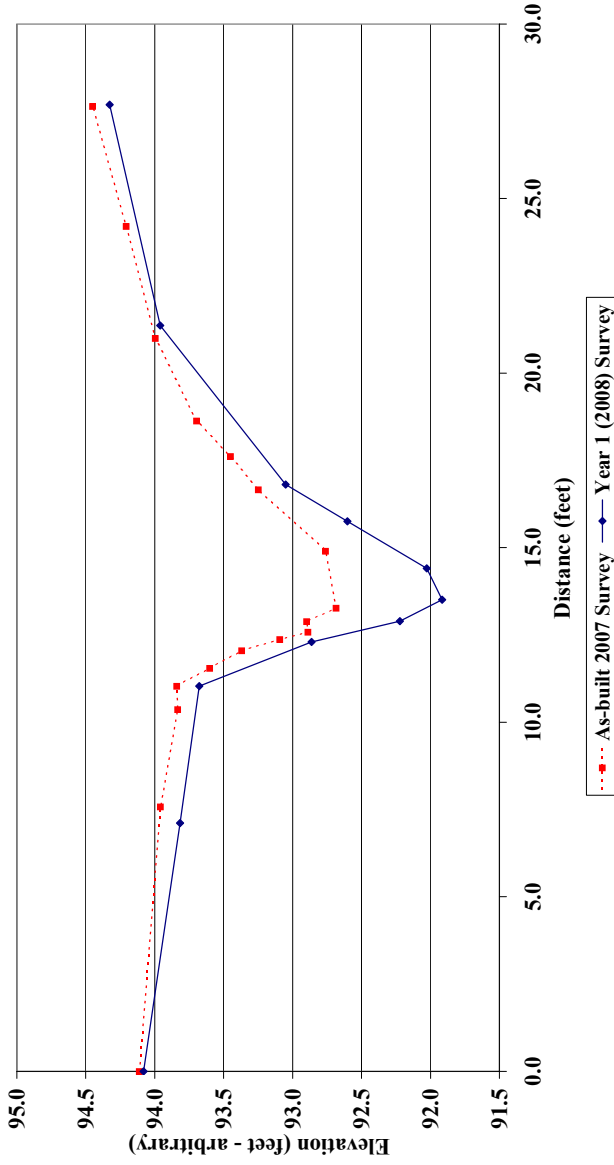
Jarman's Oak Reach 5 - XS2 Riffle

Project Name Jarman's Oak
 Cross Section R5-XS2
 Feature Riffle
 Date 7/7/2008
 Crew Adams, Jeffers

As-built	2008	2009	2010
Area	5.4	7.4		
Width	8.7	8.9		
Mean Depth	0.6	0.8		
Max Depth	1.2	1.8		
W/D Ratio	14.1	10.7

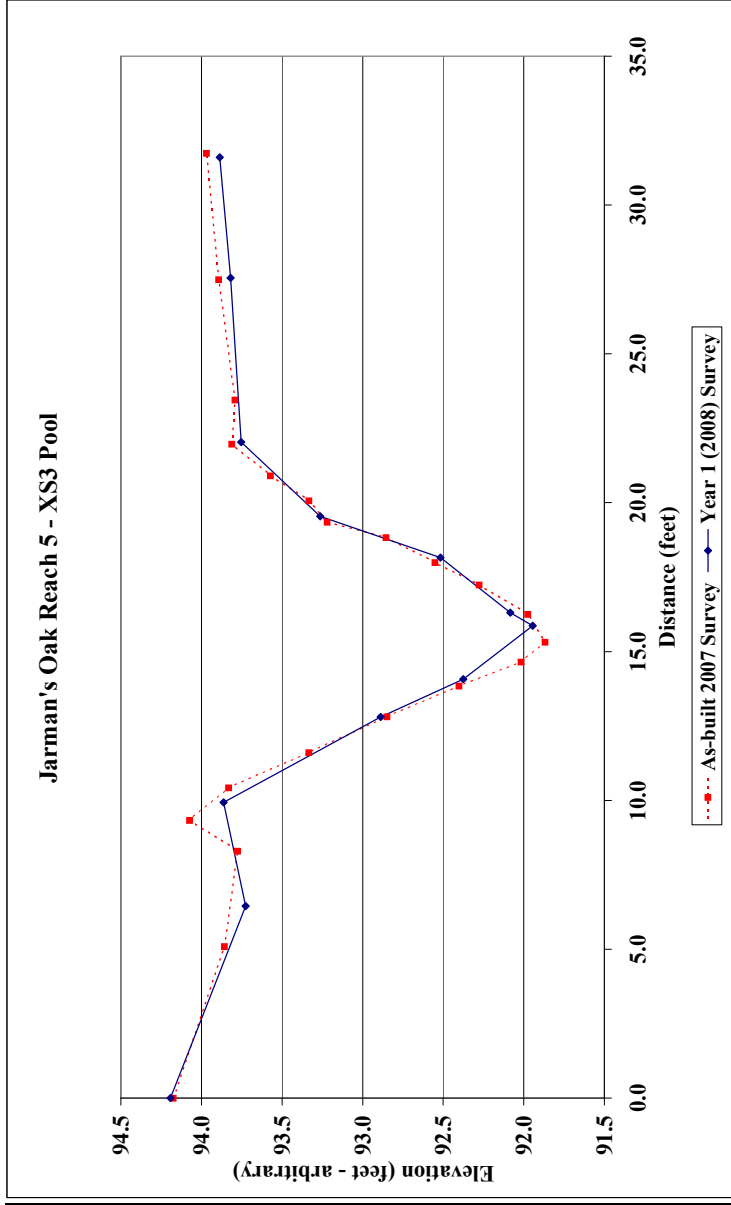
Project Name Jarman's Oak		2010 Survey	
Cross Section R5-XS3	2009 Survey		2010 Survey
Feature Pool	2008 Survey		2010 Survey
Date 7/7/08	Station Elevation		Station Elevation
Crew Adamsme, Jeffers	Station Elevation		Station Elevation
As-built	2007 Survey	2008 Survey	2009 Survey
Station	0.0	0.0	0.0
Elevation	94.2	94.2	94.2
	5.1	93.9	6.4
	8.3	93.8	9.9
	9.3	94.1	12.8
	10.4	93.8	14.1
	11.6	93.3	15.9
	12.8	92.8	16.3
	13.8	92.4	18.2
	14.7	92.0	19.5
	15.3	91.9	22.0
	16.3	92.0	27.5
	17.2	92.3	31.6
	18.0	92.6	
	18.8	92.9	
	19.3	93.2	
	20.1	93.3	
	20.9	93.6	
	22.0	93.8	
	23.5	93.8	
	27.5	93.9	
	31.7	94.0

As-built	2008	2009	2010
Area	11.5	10.6		
Width	11.5	11.8		
Mean Depth	1.0	0.9		
Max Depth	1.9	1.8		
W/D Ratio	N/A	N/A

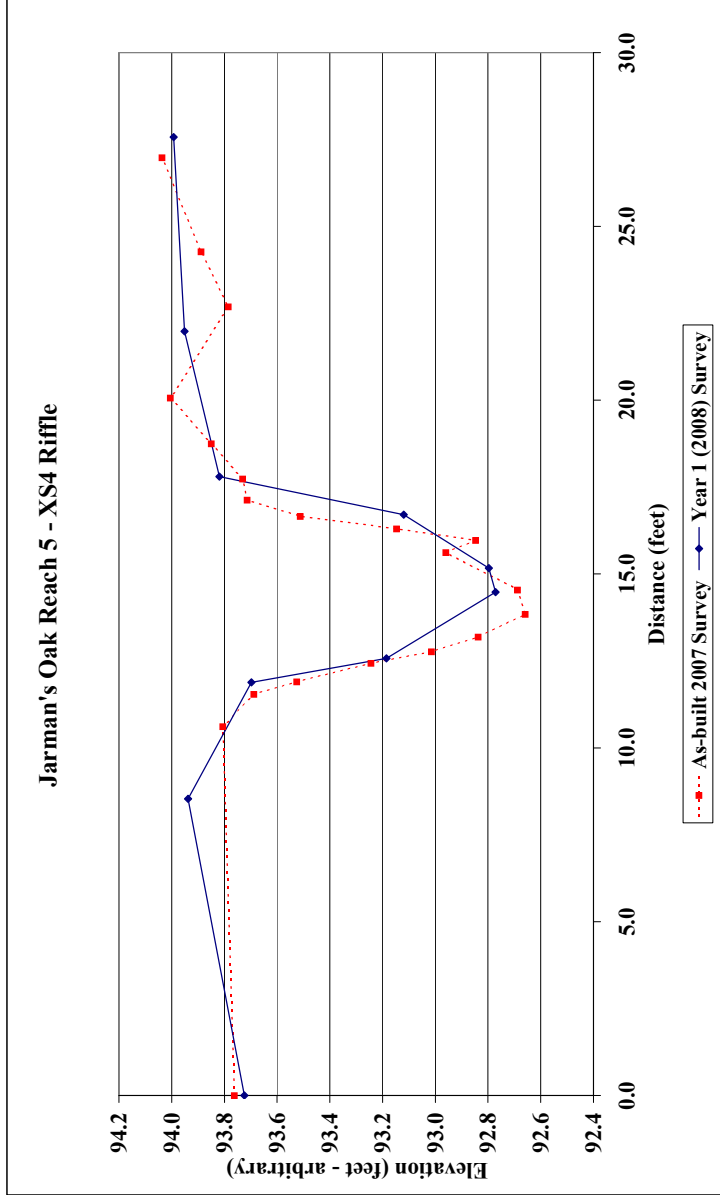
Project Name Jarman's Oak		2008 Survey		2009 Survey		2010 Survey	
Cross Section R5-XS4		Station		Station		Station	
Feature Riffle		Elevation		Elevation		Elevation	
Date 7/7/08		0.0 93.8		0.0 93.7		0.0 93.7	
Crew Adamsme, Jeffers		10.6 93.8		8.5 93.9		10.6 93.9	
		11.5 93.7		11.9 93.7		11.5 93.7	
		11.9 93.5		12.6 93.2		12.4 93.2	
		12.4 93.2		14.5 92.8		14.5 92.8	
		12.8 93.0		15.2 92.8		15.2 92.8	
		13.2 92.8		16.7 93.1		16.7 93.1	
		13.8 92.7		17.8 93.8		17.8 93.8	
		14.5 92.7		22.0 94.0		22.0 94.0	
		15.6 93.0		27.6 94.0		27.6 94.0	
		16.0 92.8					
		16.3 93.1					
		16.7 93.5					
		17.1 93.7					
		17.7 93.7					
		18.8 93.8					
		20.1 94.0					
		22.7 93.8					
		24.3 93.9					
		27.0 94.0

Area	As-built	2008	2009	2010
Width	3.7	3.6		
Mean Depth	5.6	5.8		
Max Depth	0.7	0.6		
W/D Ratio	1.1	0.9		
	8.3	9.2

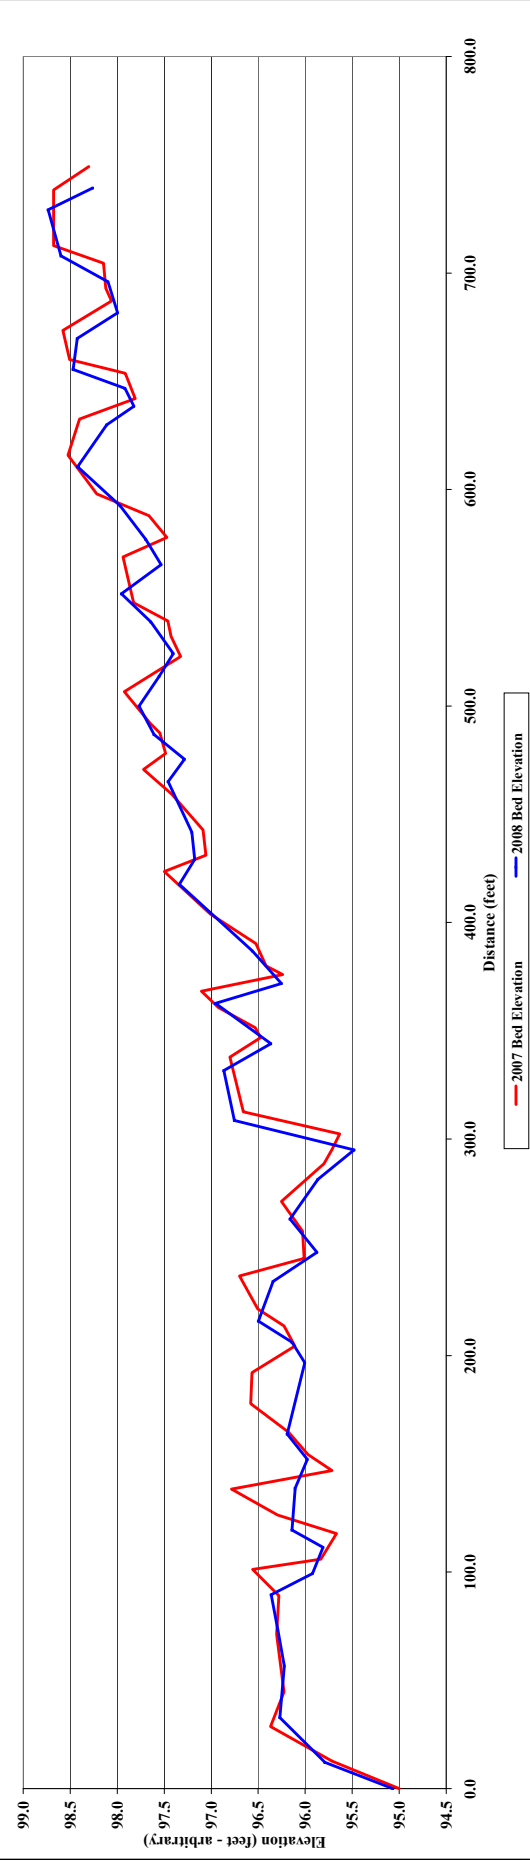
Jarman's Oak Profile - Reach 1

Project Name		Jarman's Oak									
Reach		1									
Feature		Profile									
Date	6/23/08										
Crew	Adams, Jeffers										
Station	2007 Survey	Water Elevation	2008 Survey	Bed Elevation	Water Elevation	2009 Survey	Bed Elevation	Water Elevation	2010 Survey	Bed Elevation	Water Elevation
0+0	95.0	96.8	95.1	95.1	***

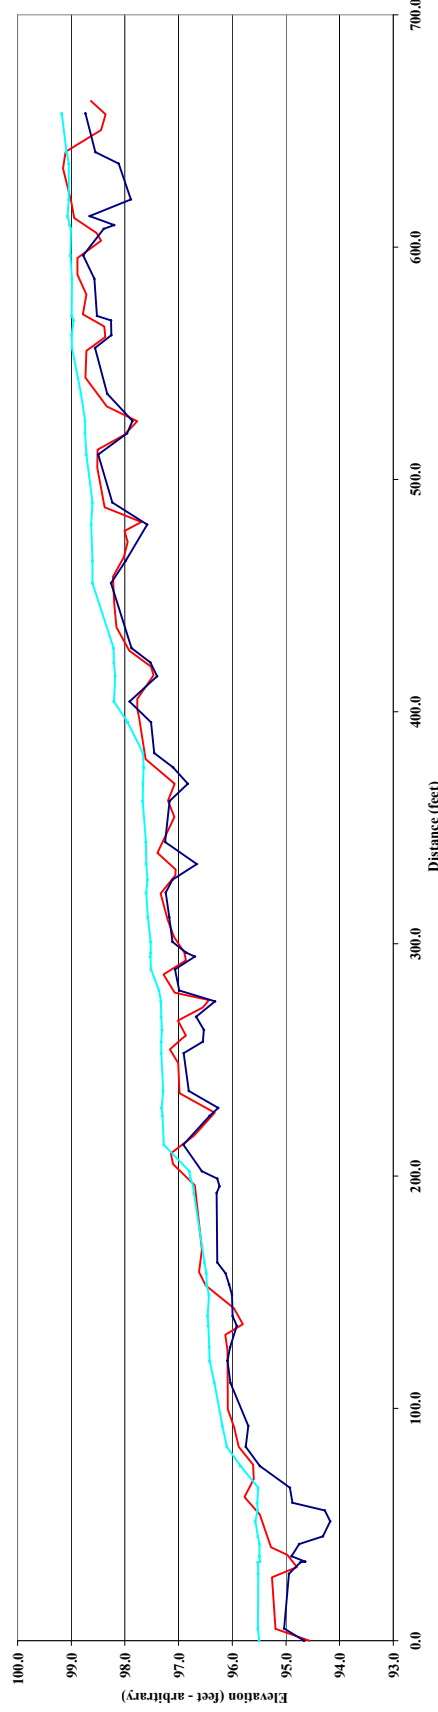
Jarman's Oak Profile - Reach 4

— 2007 Bed Elevation — 2008 Bed Elevation — 2008 Water Elevation

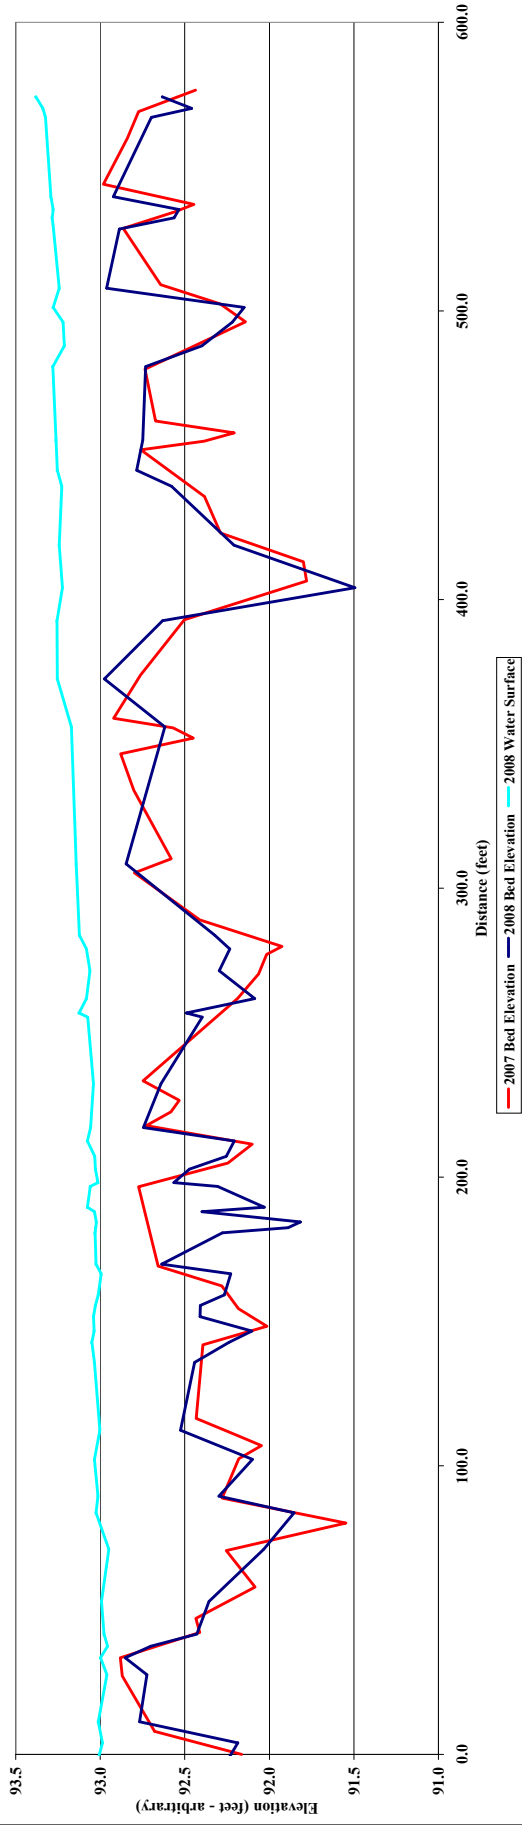
Jarman's Oak Profile - Reach 5

As-built	2008	2009	2010
Avg. Water Surface Slope	0.0004	0.0006		
Avg. Riffle Slope	0.0013	0.0011		
Avg. Pool Slope	0.0014	0.0013		
Avg. Run Slope	0.0013	0.0030		
Avg. Cleft Slope	0.0004	0.0039
