YEAR 1 (2008)
ANNUAL MONITORING REPORT
JARMANS OAK RESTORATION SITE
ONslow COUNTY, NORTH CAROLINA

(CONTRACT D06069-A)
FULL DELIVERY PROJECT
WHITE OAK RIVER BASIN
CATALOGING UNIT 03030001

November 2008

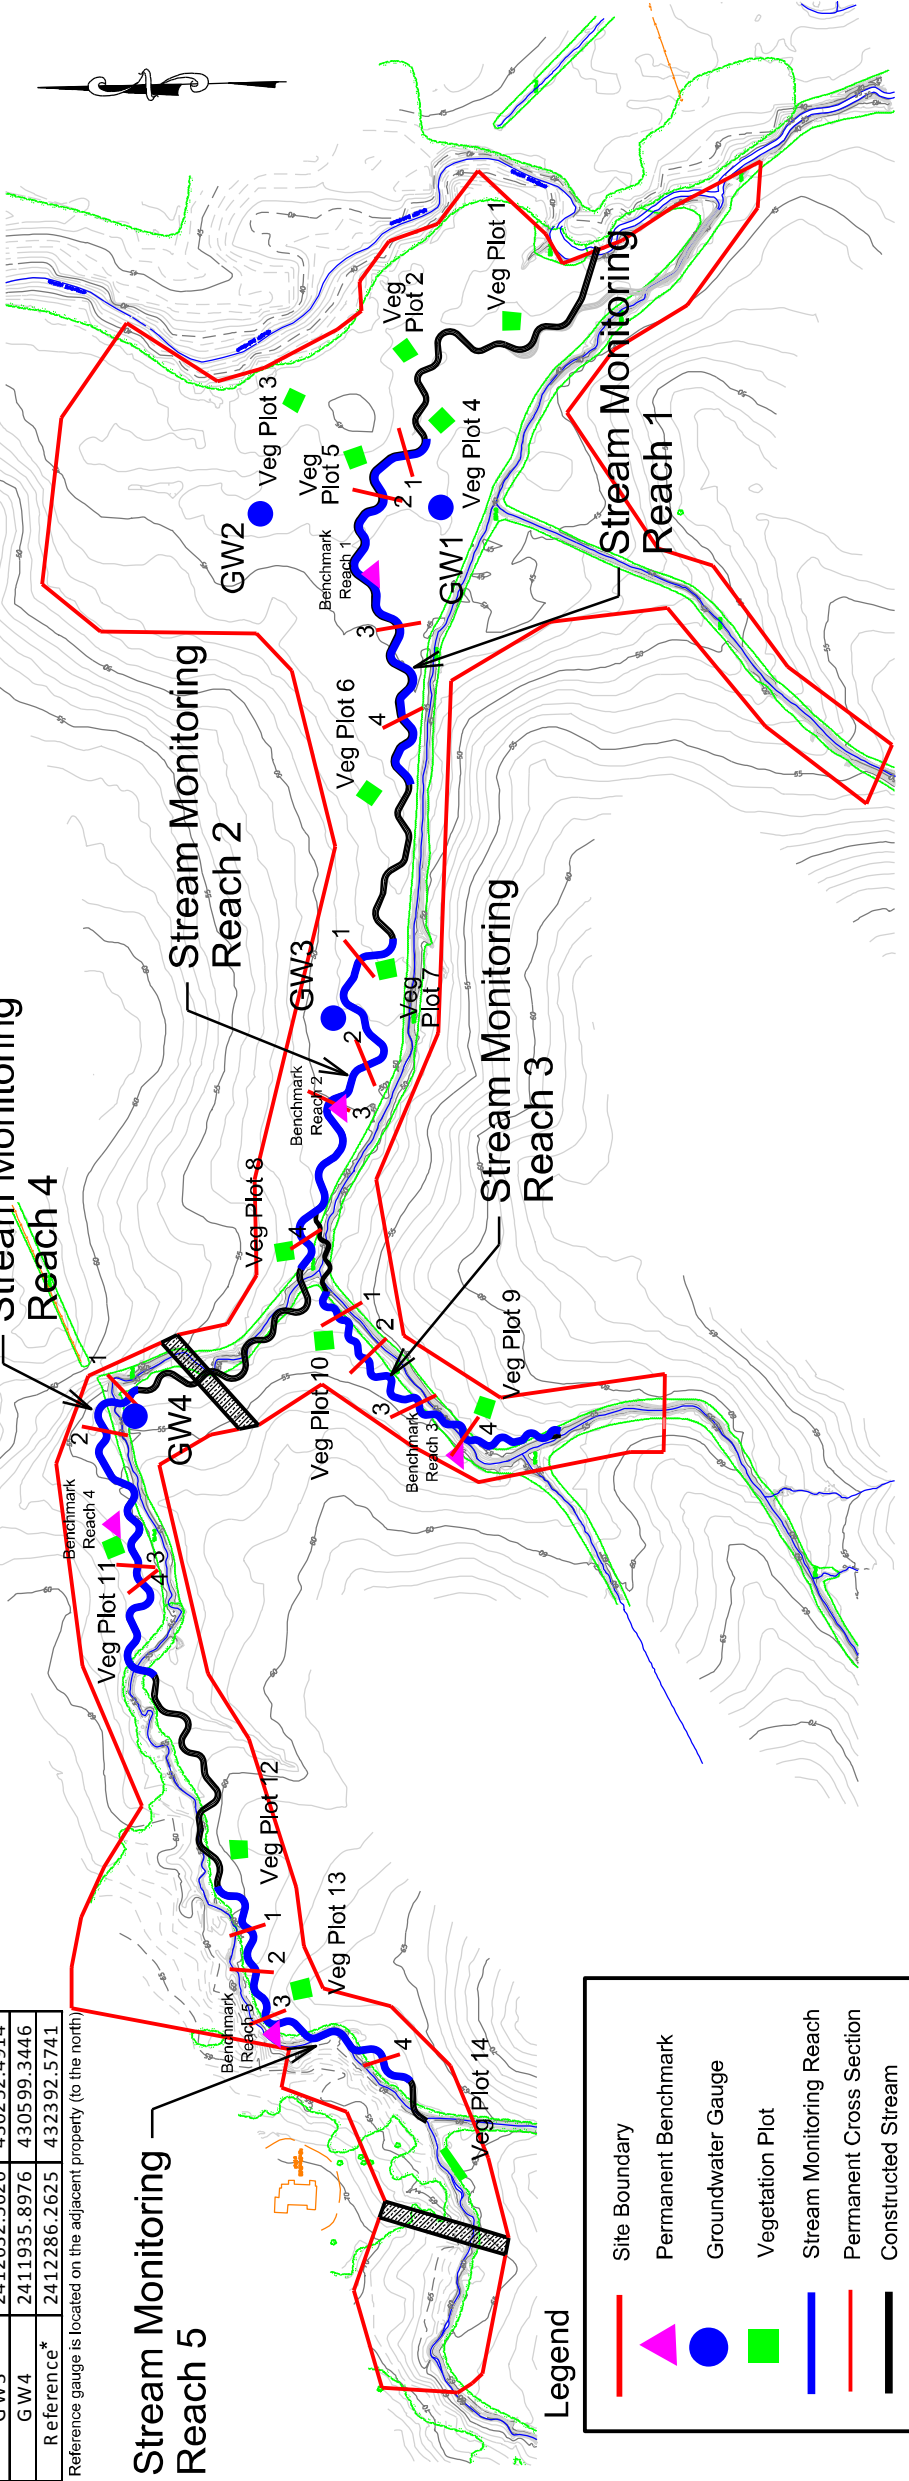
**APPENDIX D
MONITORING PLAN VIEW**

Groundwater Gauges	Northing	Easting
Description		
GW1	2413525.7156	430064.8042
GW2	2413514.5197	430380.5295
GW3	2412632.5626	430252.4914
GW4	2411935.8976	430599.3446
Reference*	2412286.2625	432392.5741

* Reference gauge is located on the adjacent property (to the north)

Stream Monitoring Reach 5
