**YEAR 2 (2009)**  
**ANNUAL MONITORING REPORT**  
**JARMANS OAK RESTORATION SITE**  
**ONslow COUNTY, NORTH CAROLINA**

**(CONTRACT D06069-A)**  
**FULL DELIVERY PROJECT**  
**WHITE OAK RIVER BASIN**  
**CATALOGING UNIT 03030001**

Restoration Systems, L.L.C. has completed restoration of stream and riverine wetlands at the Jarmans Oak Stream and Wetland Restoration Site to assist the North Carolina Ecosystem Enhancement Program in fulfilling stream and wetland mitigation goals in the region. The Site is located less than 2 miles east of the Onslow/Duplin County line and approximately 3 miles west of the Town of Richlands in Onslow County. The Site is located in United States Geological Survey (USGS) Cataloging Unit (CU) and Targeted Local Watershed 03030001010010 (North Carolina Division of Water Quality Subbasin 03-05-02) of the White Oak River Basin and will service the USGS 8-digit CU 03030001. This report serves as the Year 2 (2009) annual monitoring report.

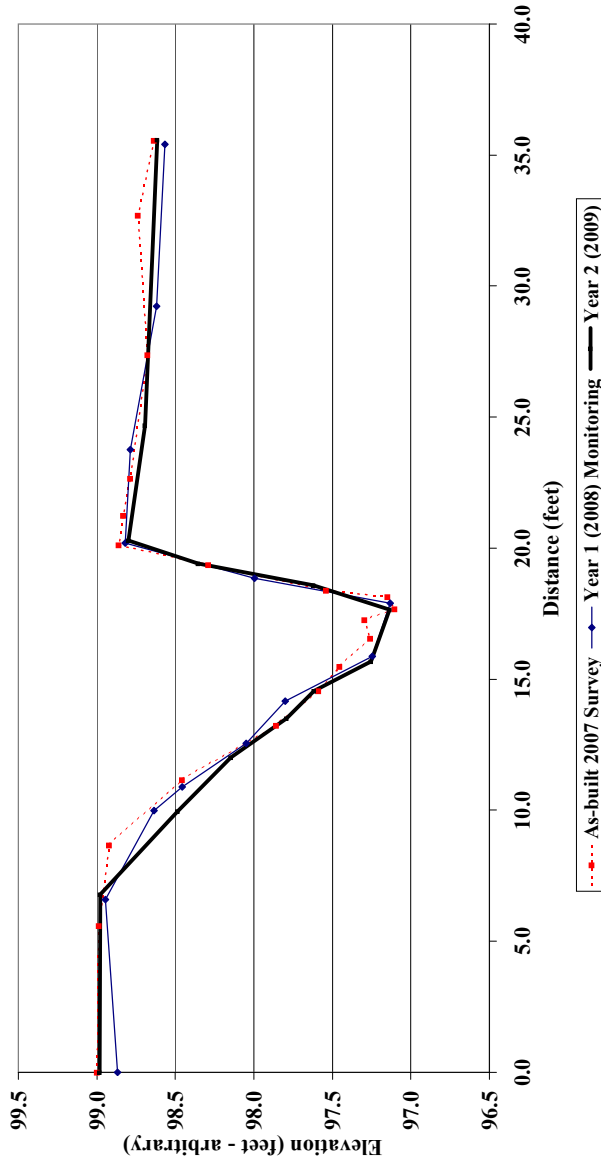
Jarman's Oak Reach 1 - XS3 Pool

Project Name Jarman's Oak  
 Cross Section RI-XS3  
 Feature Pool  
 Date 5/14/09  
 Crew Dean, Lewis

As-built	2008	2009	2010
Area	10.4	10.0	10.6	
Width	12.3	12.1	12.4	
Mean Depth	0.8	0.8	0.9	
Max Depth	1.8	1.7	1.7	
W/D Ratio	N/A	N/A	N/A
