OVERHILLS STREAM AND WETLAND RESTORATION

MITIGATION PLAN

Harnett County, North Carolina
EEP Project Number 199

2.0 As-Builts

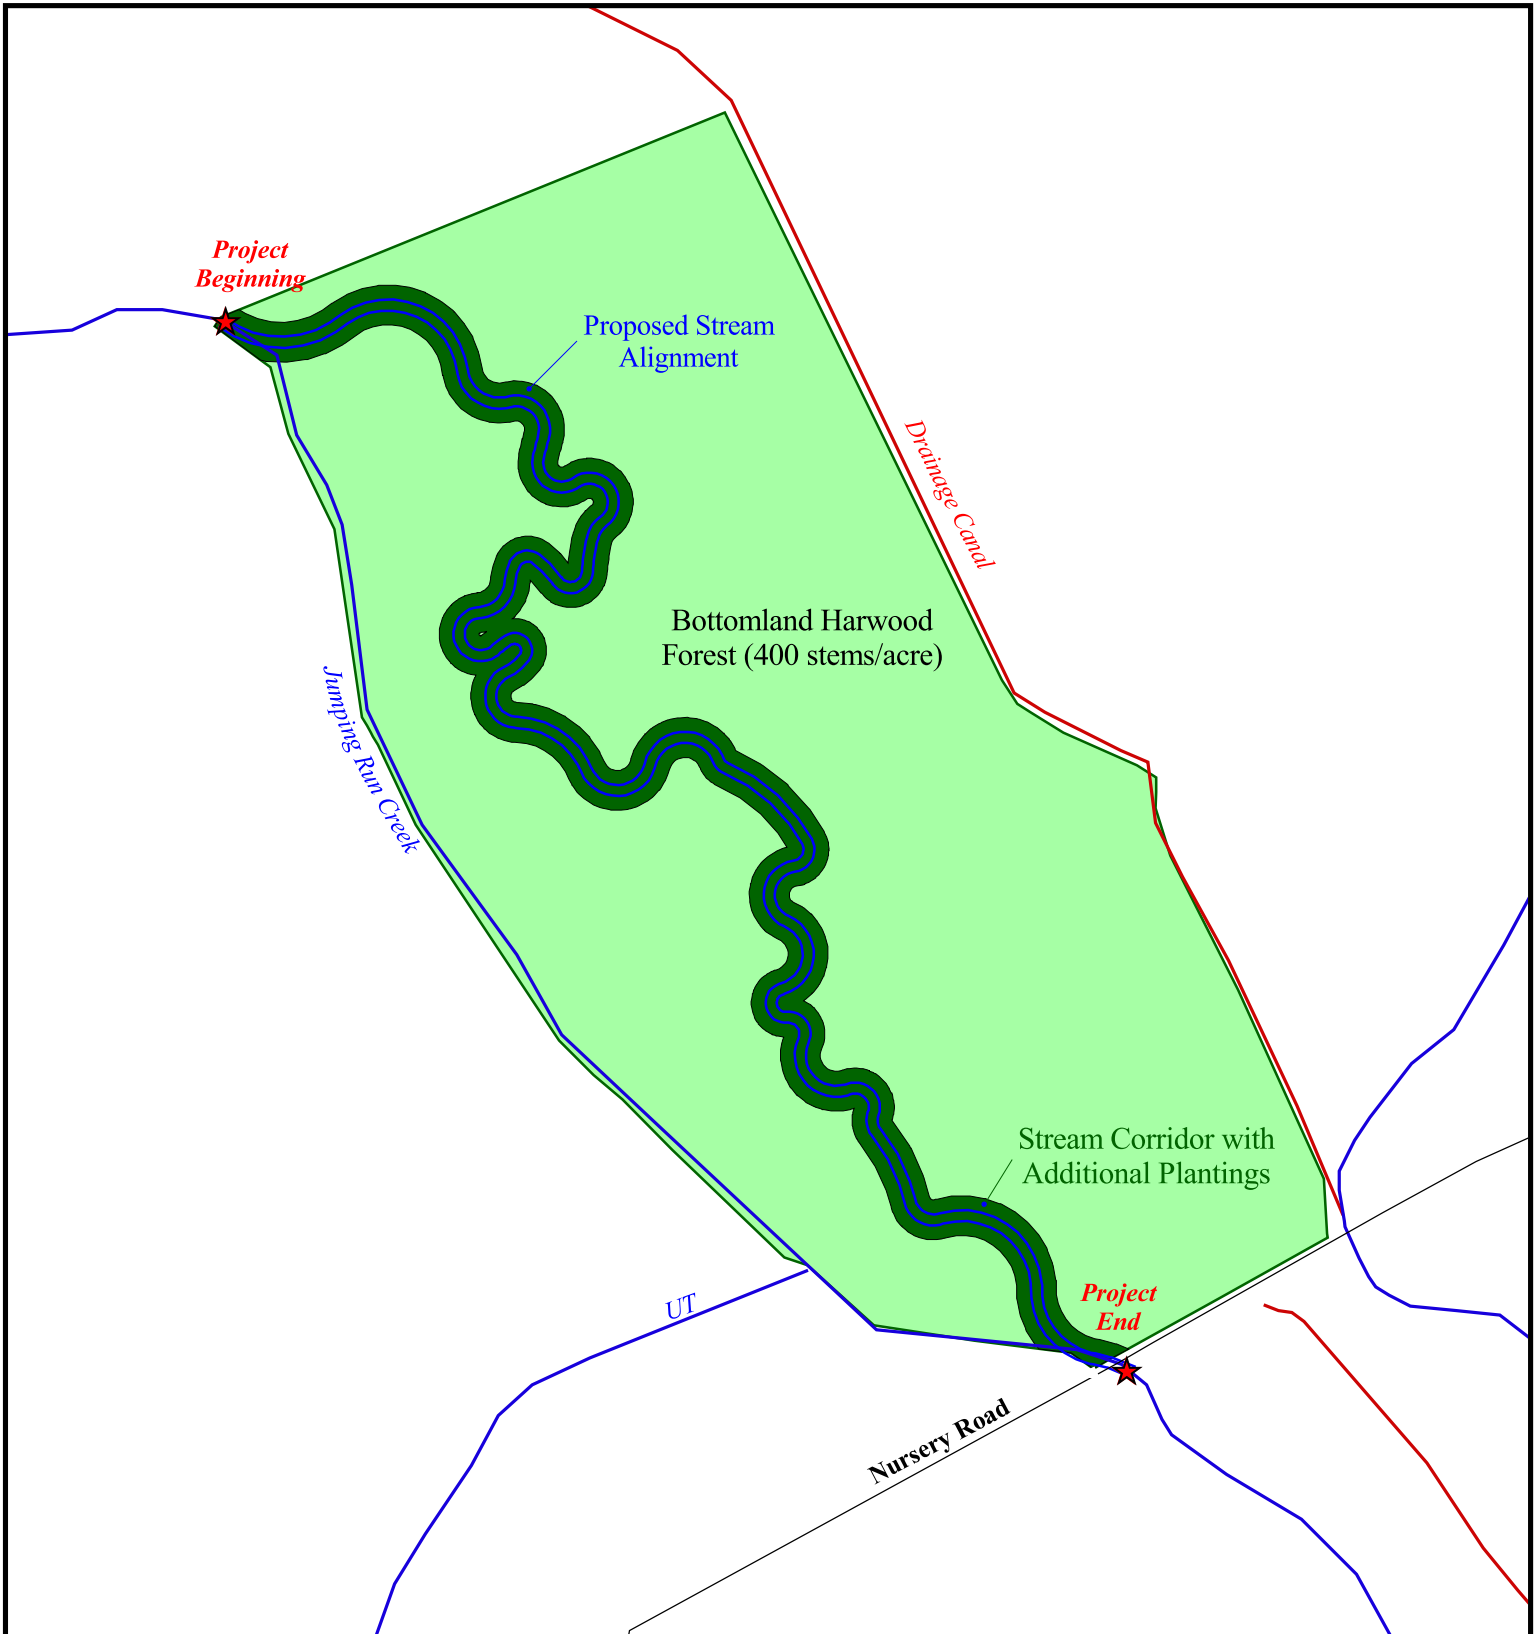
Proposed Vegetative Communities

Overhills Stream and Wetland Restoration Project - Restoration Plan
March 14, 2003

Two vegetative communities or zones were planted in the project area. One was the bottomland hardwood forest planted through the riparian wetland and the second was the stream corridor. The planting list is available in Table 2. The planting plan is provided in Figure 1.4.

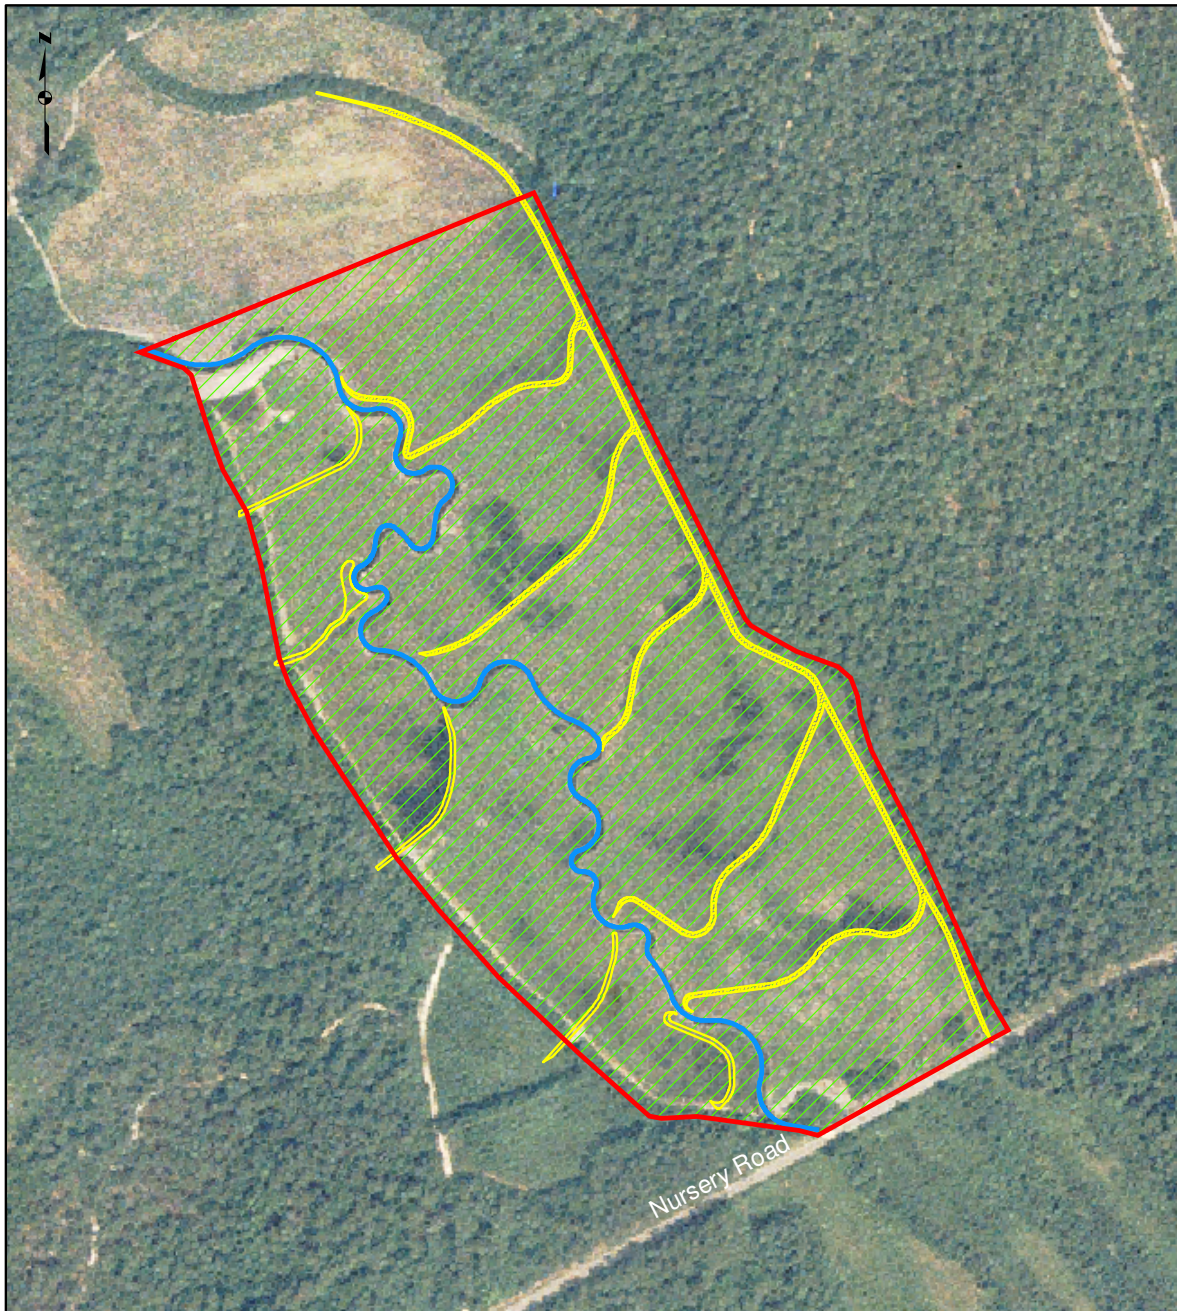
Figure 3. Site Map
Overhills/Jumping Run Creek Stream
and Wetland Restoration Project
EEP #: 199
Harnett County, North Carolina

Project Site
35.258N, 79.000W
 -

Wetland Restoration Limits
 -

Restored Stream Reach
 -

Berms
- 2006 NAIP Aerial Imagery

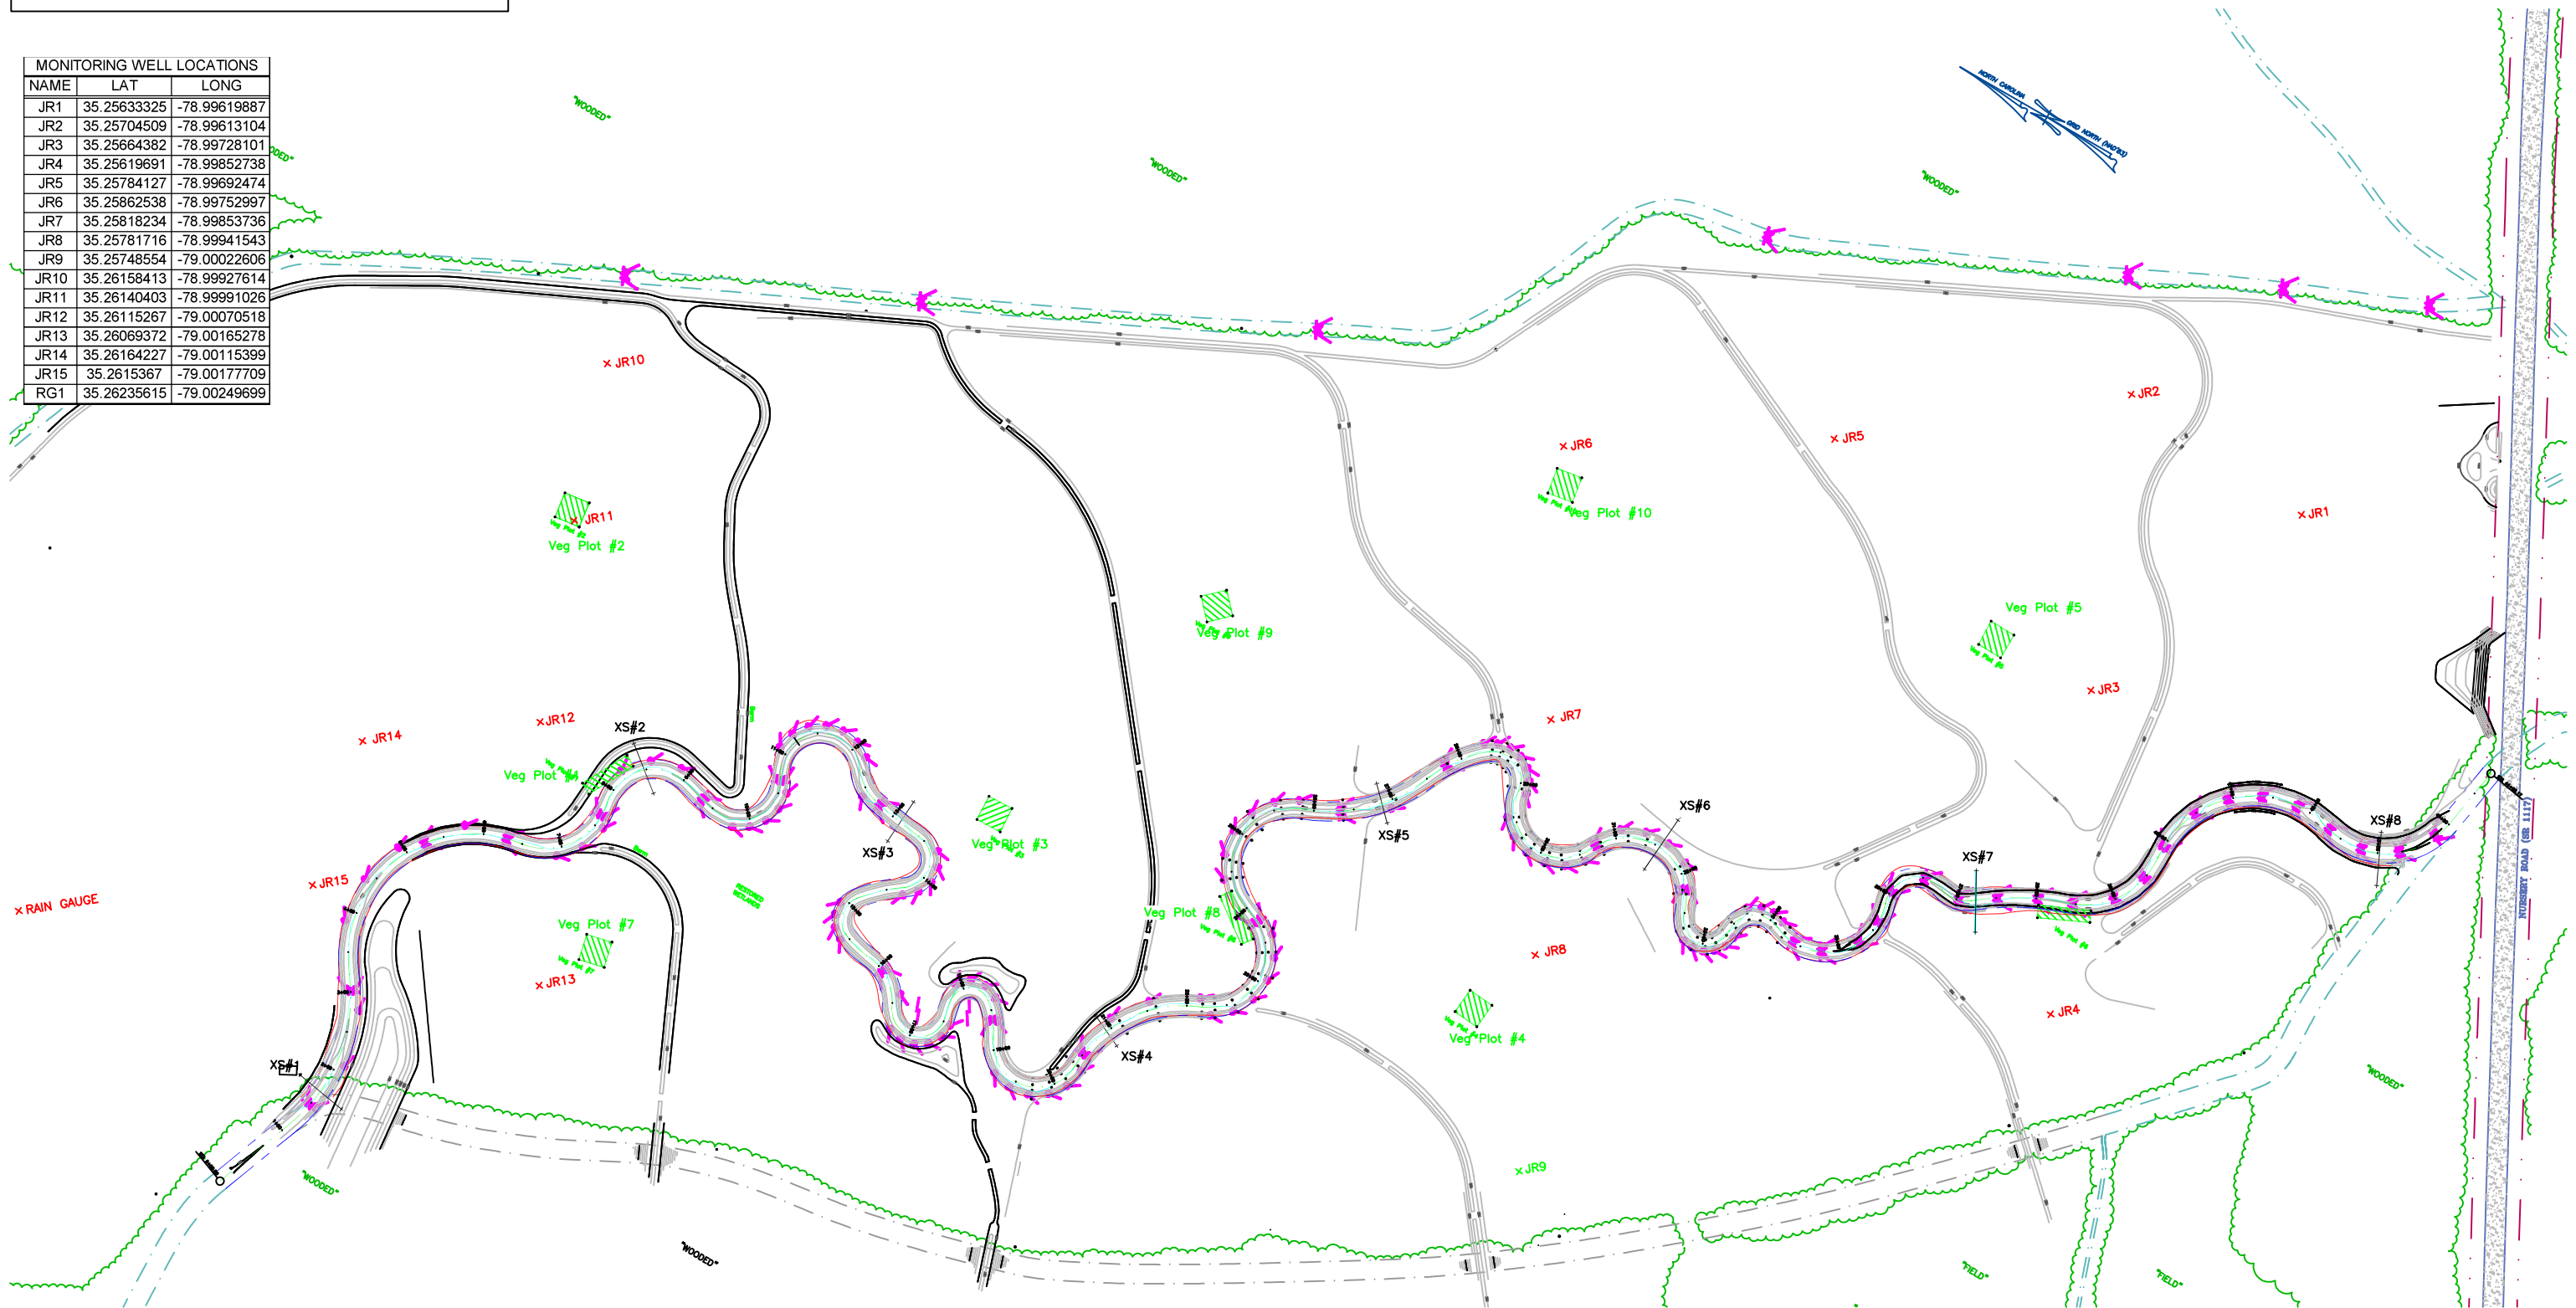
PROJECT NO.	SHEET NO.
SCO#070695701	06
AS-BUILT PROJECT ENGINEER

MONITORING WELLS

MONITORING WELL LOCATIONS		
NAME	LAT	LONG
JR1	35.25633325	-78.99619887
JR2	35.25704509	-78.99613104
JR3	35.25664382	-78.99728101
JR4	35.25619691	-78.99852738
JR5	35.25784127	-78.99692474
JR6	35.25862538	-78.99752997
JR7	35.25818234	-78.99853736
JR8	35.25781716	-78.99941543
JR9	35.25748554	-79.00022606
JR10	35.26158413	-78.99927614
JR11	35.26140403	-78.99991026
JR12	35.26115267	-79.00070518
JR13	35.26069372	-79.00165278
JR14	35.26164227	-79.00115399
JR15	35.2615367	-79.00177709
RG1	35.26235615	-79.00249699

An as-built survey was not provided by the design firm after construction was completed on the site. The following sheets contain survey data collected in July 2007 (pages 9-16). The survey data focused on the stream channel and did not include a topographic survey of the entire site.

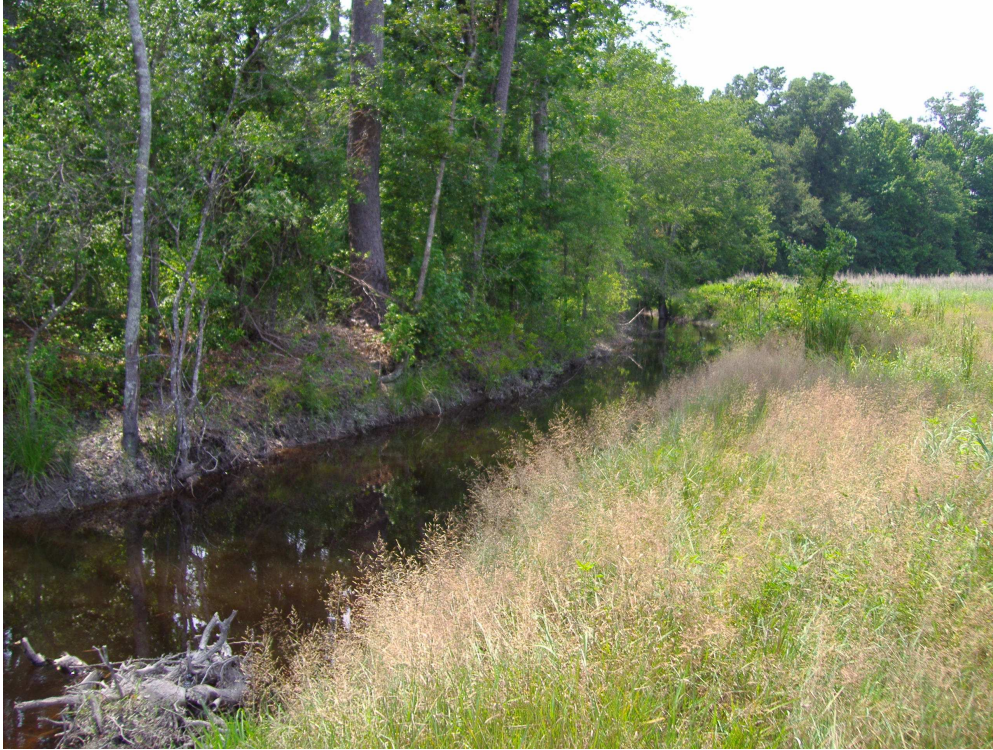
Photo Station 1. Beginning of Reach – Upstream

(Note: Locations of stations are shown on the as-builts)

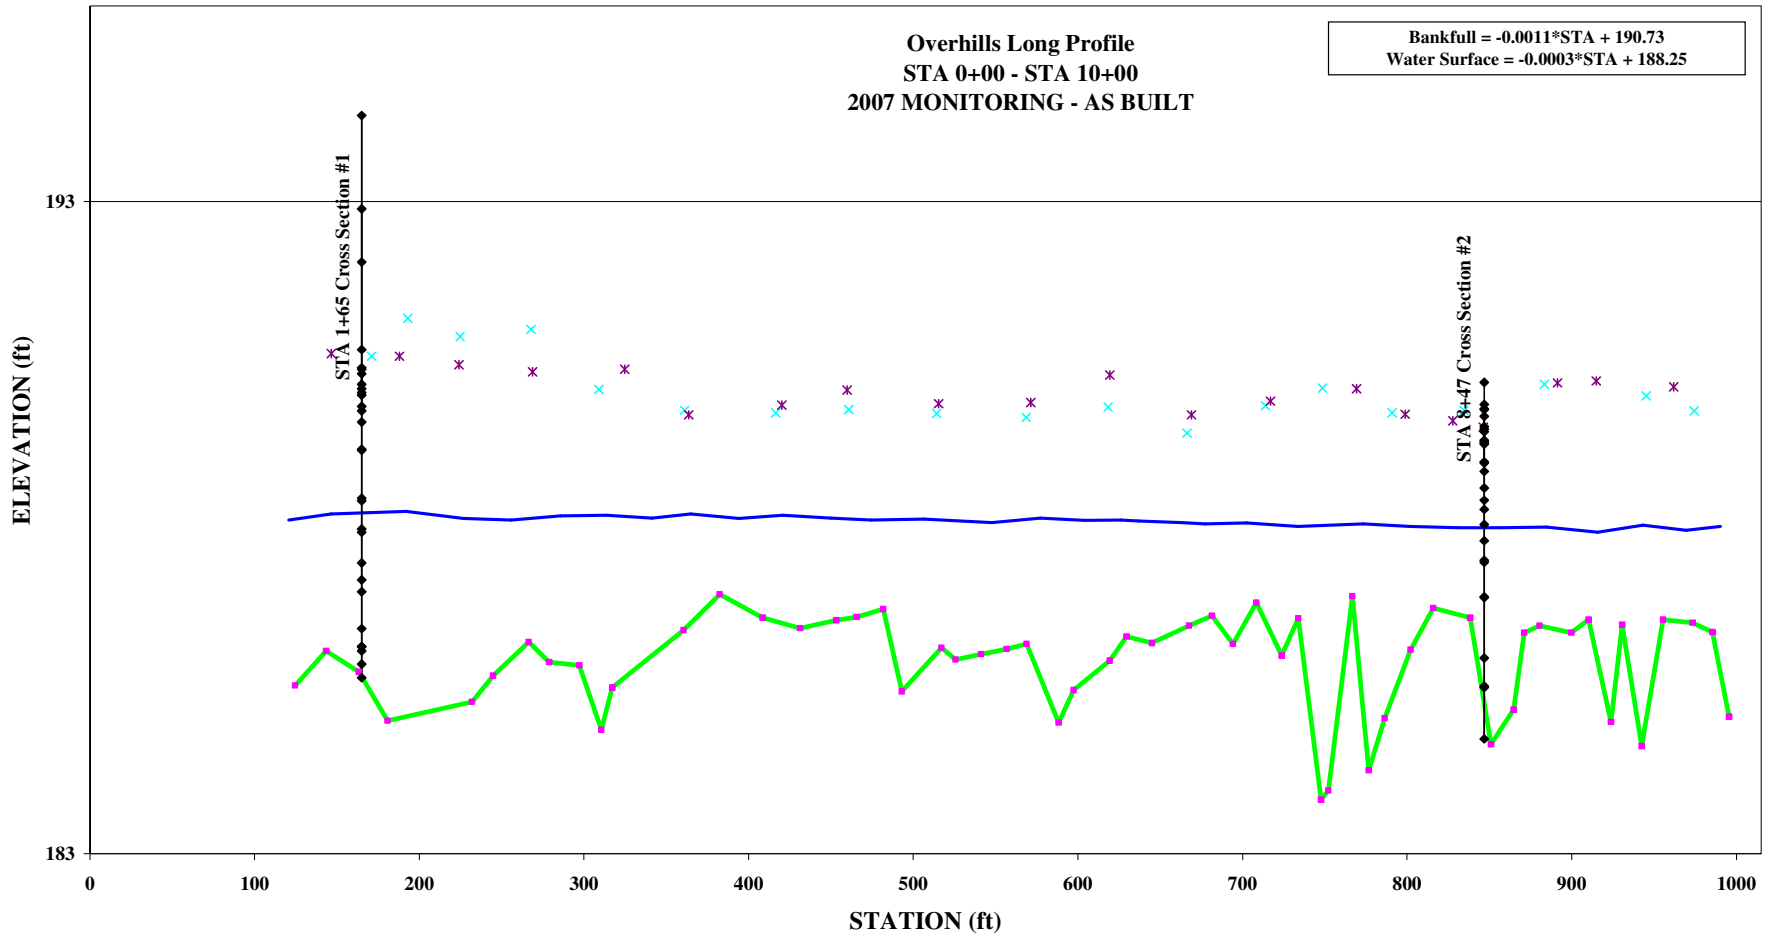
Overhills Long Profile
STA 0+00 - STA 10+00
2007 MONITORING - AS BUILT

Bankfull = $-0.0011 \cdot \text{STA} + 190.73$
 Water Surface = $-0.0003 \cdot \text{STA} + 188.25$

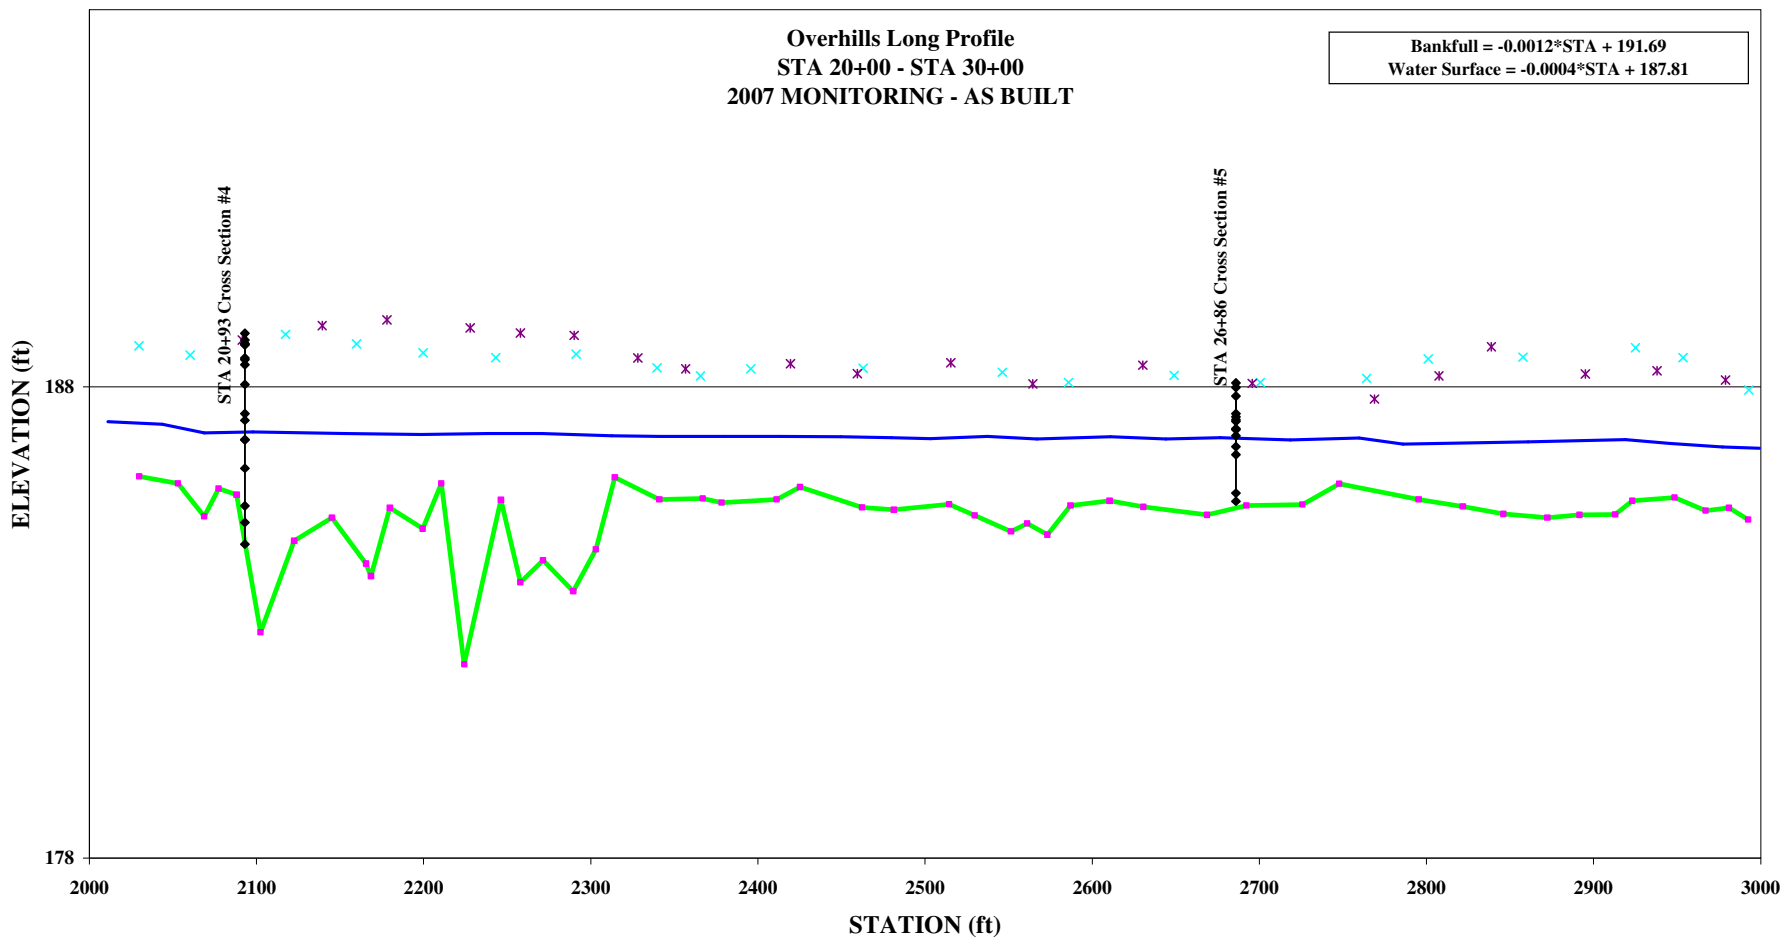
**Overhills Long Profile
 STA 20+00 - STA 30+00
 2007 MONITORING - AS BUILT**

Bankfull = $-0.0012 \cdot \text{STA} + 191.69$
 Water Surface = $-0.0004 \cdot \text{STA} + 187.81$

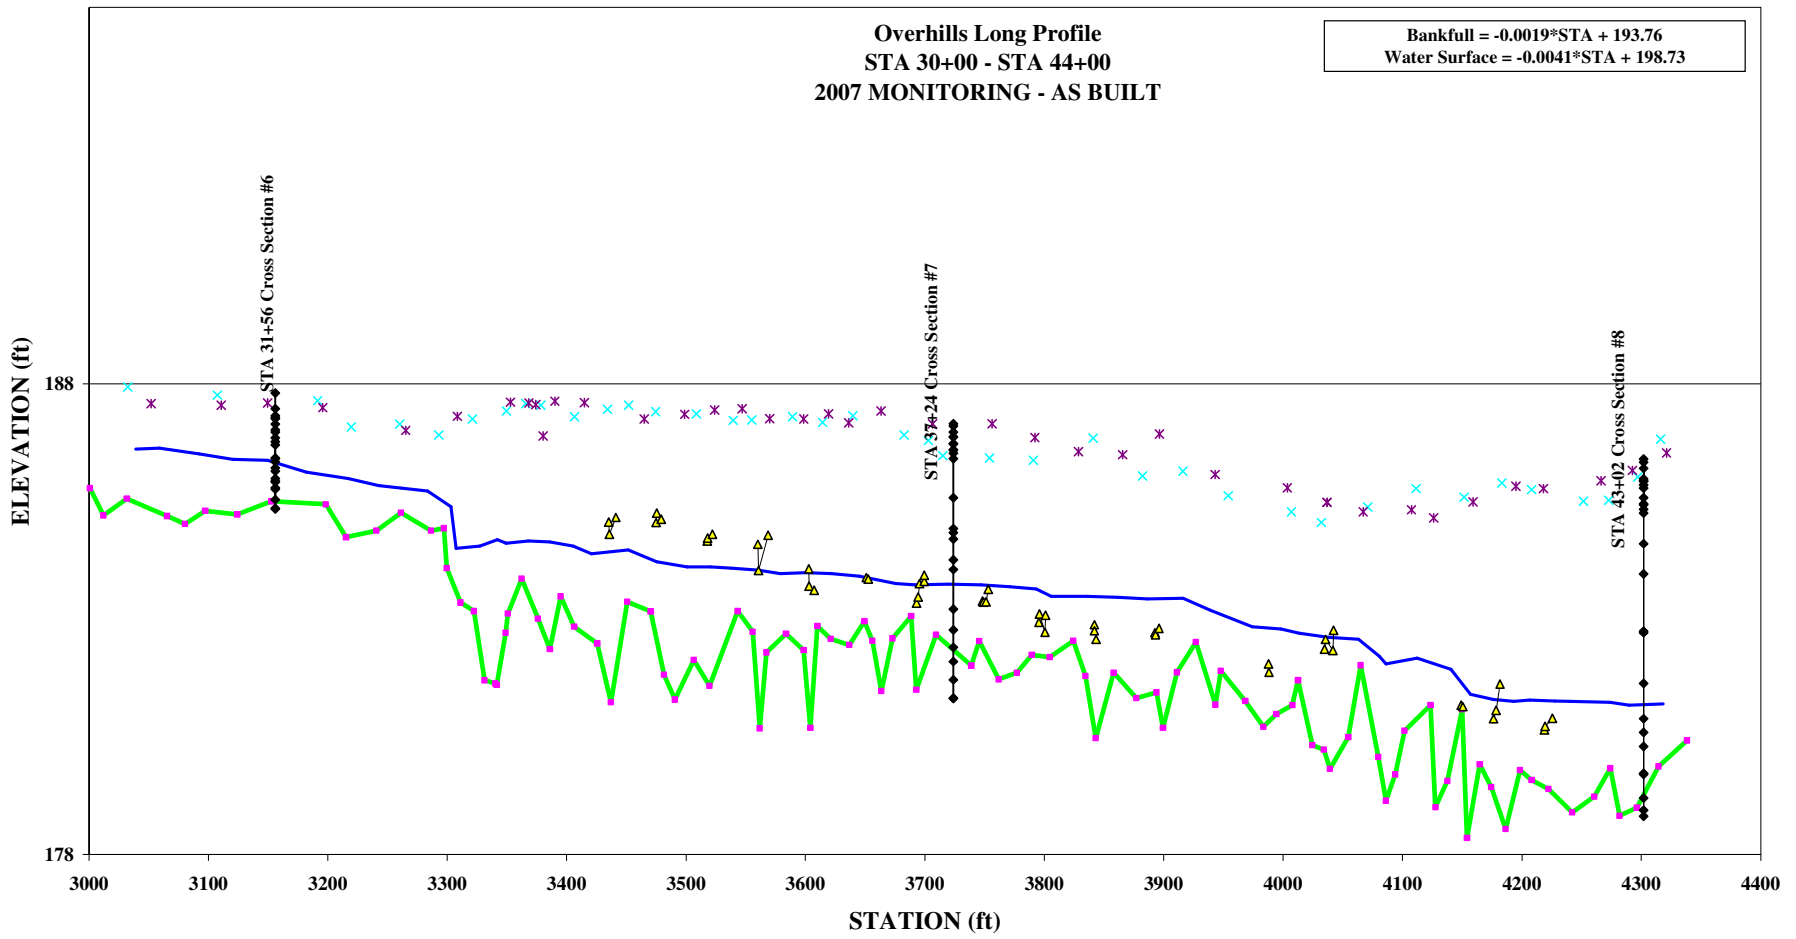
**Overhills Long Profile
 STA 30+00 - STA 44+00
 2007 MONITORING - AS BUILT**

Bankfull = $-0.0019 \cdot \text{STA} + 193.76$
 Water Surface = $-0.0041 \cdot \text{STA} + 198.73$

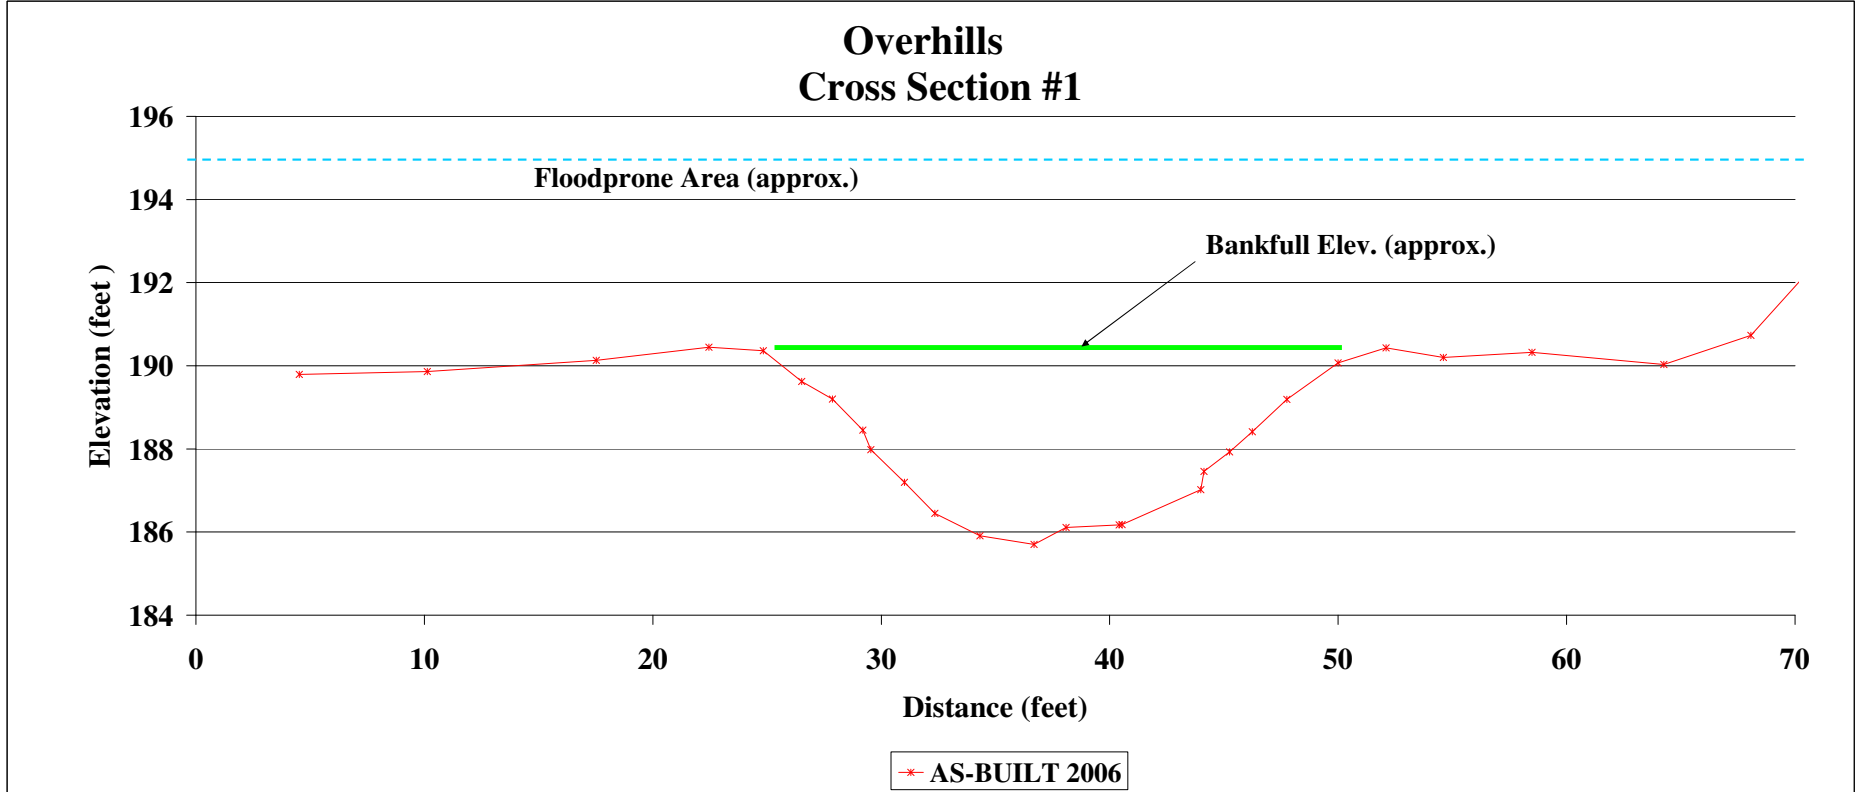
Project Name: Overhills		Feature: Riffle		Date: As Built -7/4/2007	
Cross Section: Cross Section 1		Crew: AS Built - Bidelspach, Jean, Geenen			
Year 5 - 2011 2011 Survey		Year 4 - 2010 2010 Survey		Year 3 - 2009 2009 Survey	
Station	Elevation	Notes	Station	Elevation	Notes
Year 2 - 2008 2008 Survey		Year 1 - 2007 2007 Survey		AS-BUILT 2006 AS-BUILT Survey	
Station	Elevation	Notes	Station	Elevation	Notes
				Station	Elevation
				Notes

Year 5 - 2011	Year 4 - 2010	Year 3 - 2009	Year 2 - 2008	Year 1 - 2007	AS-BUILT 2006
Area						71.89
Width						26.87
Mean Depth						2.68
Max Depth						4.66
W/D						10.04

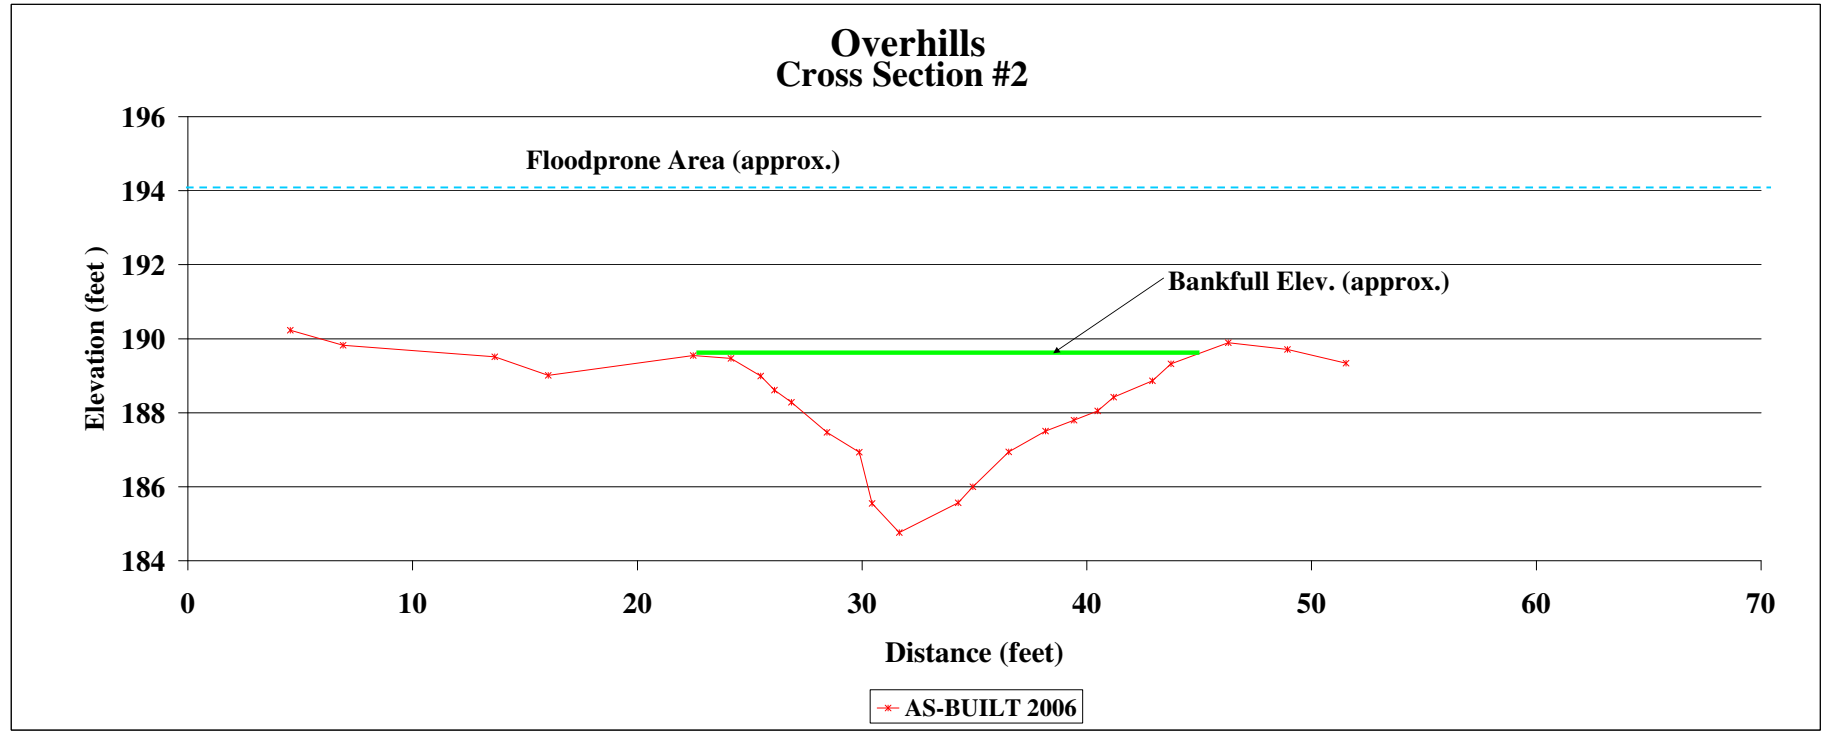
Project Name: Overhills			Feature: Pool			Date: As Built -7/4/2007																																																																																												
Cross Section: Cross Section 2			Crew: AS Built - Bidelspach, Jean, Geenen																																																																																															
Year 5 - 2011 2011 Survey			Year 4 - 2010 2010 Survey			Year 3 - 2009 2009 Survey			Year 2 - 2008 2008 Survey			Year 1 - 2007 2007 Survey			AS-BUILT 2006 AS-BUILT Survey																																																																																			
Station	Elevation	Notes	Station	Elevation	Notes	Station	Elevation	Notes	Station	Elevation	Notes	Station	Elevation	Notes	Station	Elevation	Notes	Station	Elevation	Notes

Area	Year 5 - 2011	Year 4 - 2010	Year 3 - 2009	Year 2 - 2008	Year 1 - 2007	AS-BUILT 2006	Bench
Width						44.82	
Mean Depth						2.01	
Max Depth						4.79	
W/D						11.07

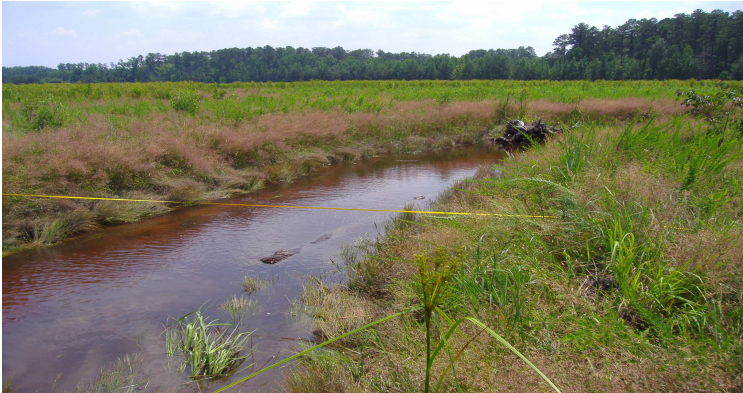
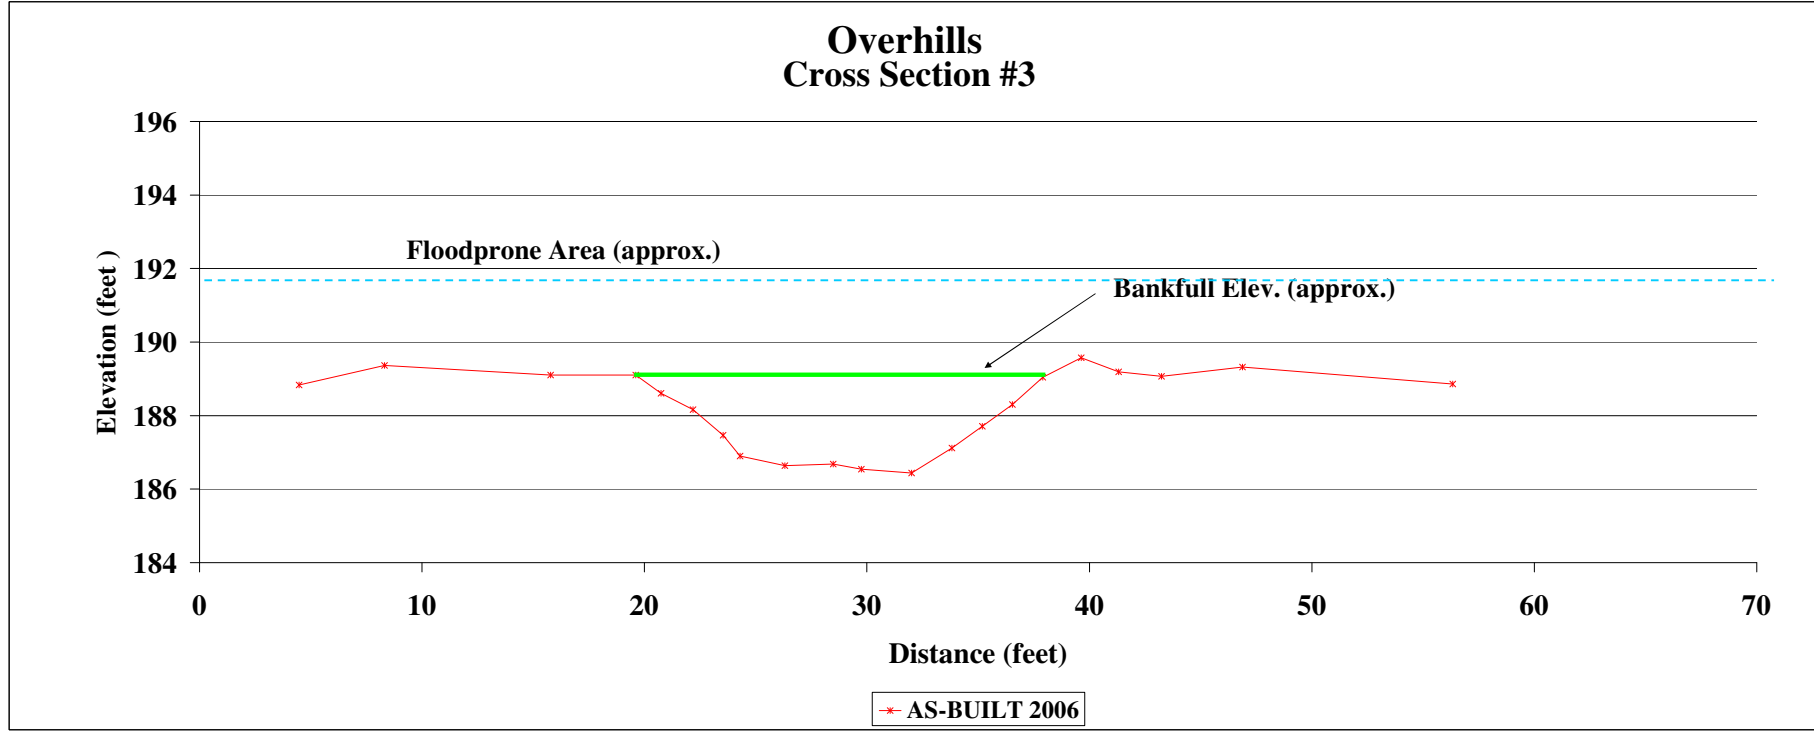
Project Name: Overhills			Feature: Riffle			Date: As Built -7/4/2007																																																																							
Cross Section: Cross Section 3			Crew: AS Built - Bidelspach, Jean, Geenen																																																																										
Year 5 - 2011 2011 Survey			Year 4 - 2010 2010 Survey			Year 3 - 2009 2009 Survey			Year 2 - 2008 2008 Survey			Year 1 - 2007 2007 Survey			AS-BUILT 2006 AS-BUILT Survey																																																														
Station	Elevation	Notes	Station	Elevation	Notes	Station	Elevation	Notes	Station	Elevation	Notes	Station	Elevation	Notes	Station	Elevation	Notes	Station	Elevation	Notes

Photo of Cross-Section 3 - Looking Downstream @ STA 13+12							
	Year 5 - 2011	Year 4 - 2010	Year 3 - 2009	Year 2 - 2008	Year 1 - 2007	AS-BUILT 2006	Bench
Area						31.03	
Width						18.15	
Mean Depth						1.71	
Max Depth						2.60	
W/D						10.62

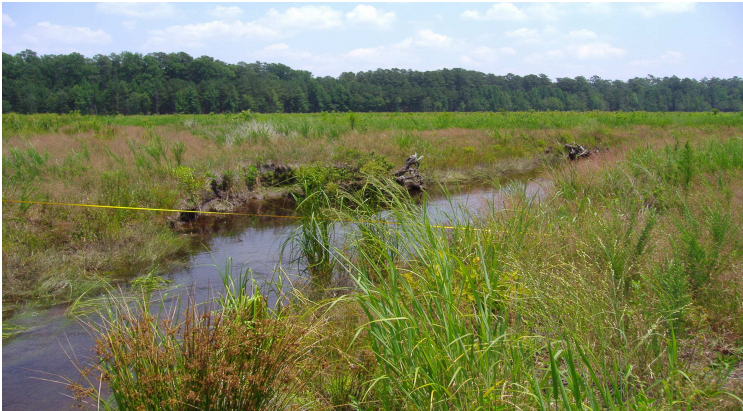
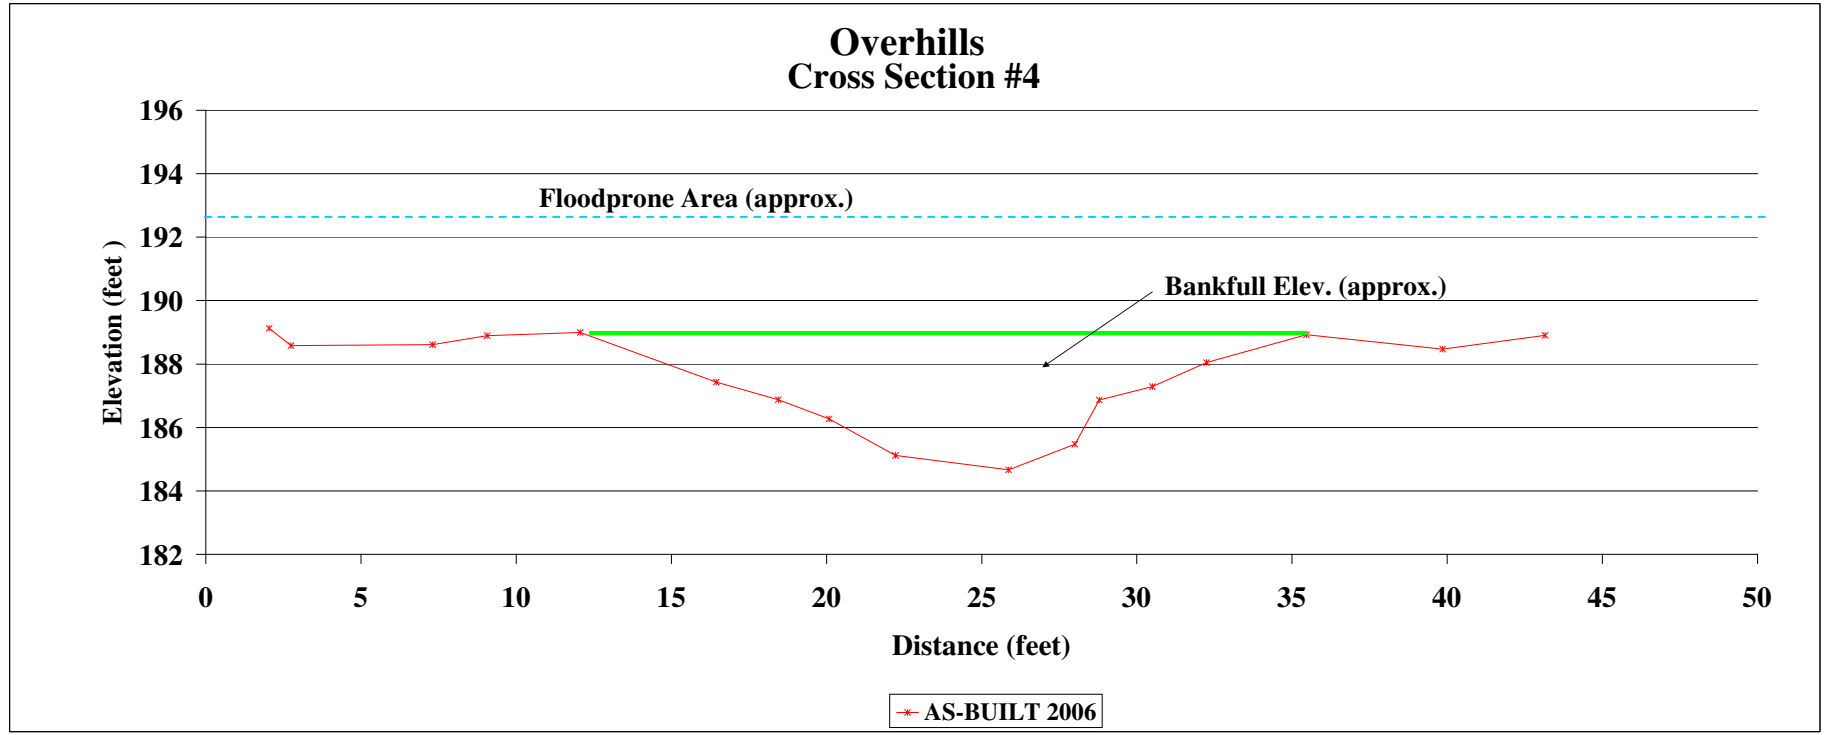
Project Name: Overhills			Feature: Pool			Date: As Built -7/4/2007																																																											
Cross Section: Cross Section 4			Crew: AS Built - Bidelspach, Jean, Geenen																																																														
Year 5 - 2011 2011 Survey			Year 4 - 2010 2010 Survey			Year 3 - 2009 2009 Survey			Year 2 - 2008 2008 Survey			Year 1 - 2007 2007 Survey			AS-BUILT 2006 AS-BUILT Survey																																																		
Station	Elevation	Notes	Station	Elevation	Notes	Station	Elevation	Notes	Station	Elevation	Notes	Station	Elevation	Notes	Station	Elevation	Notes

Photo of Cross-Section 4 - Looking Upstream @ STA 20+93							
Area	Year 5 - 2011	Year 4 - 2010	Year 3 - 2009	Year 2 - 2008	Year 1 - 2007	AS-BUILT 2006	Bench
Width						49.19	
Mean Depth						2.12	
Max Depth						4.26	
W/D						10.93

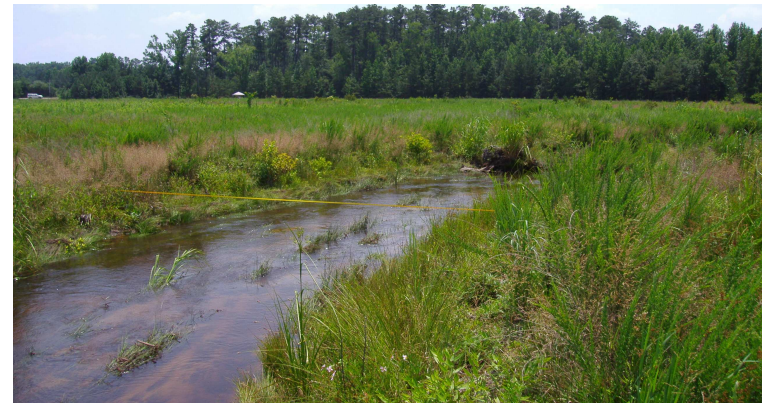
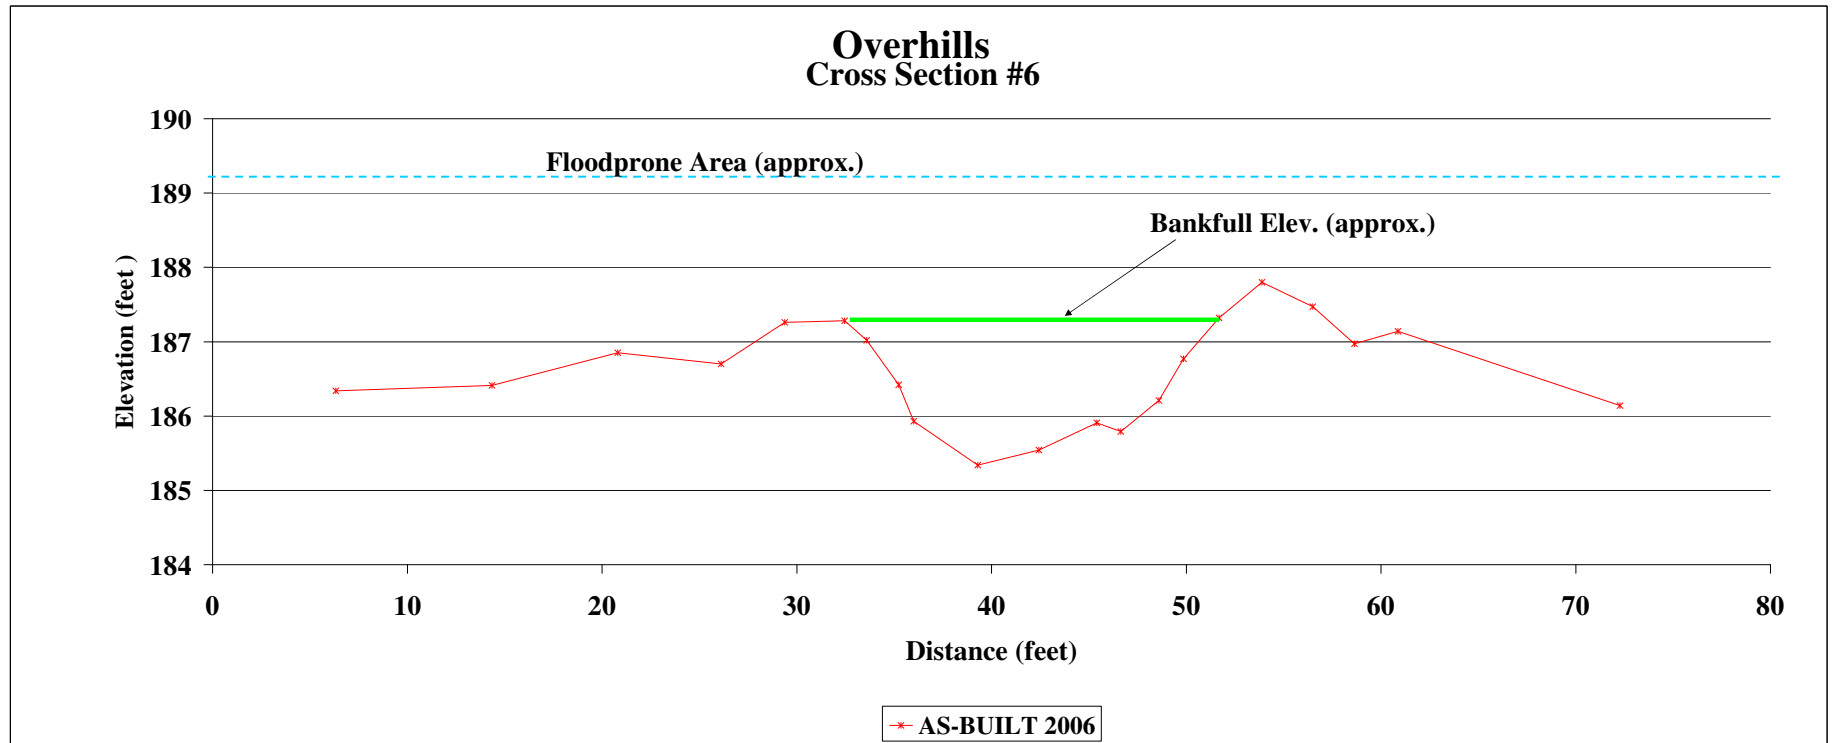
Project Name: Overhills		Feature: Pool		Date: As Built -7/4/2007							
Cross Section: Cross Section 6		Crew: AS Built - Bidelspach, Jean, Geenen									
Year 5 - 2011 2011 Survey		Year 4 - 2010 2010 Survey		Year 3 - 2009 2009 Survey		Year 2 - 2008 2008 Survey		Year 1 - 2007 2007 Survey		AS-BUILT 2006 AS-BUILT Survey	
Station	Elevation	Notes	Station	Elevation	Notes	Station	Elevation	Notes	Station	Elevation	Notes
										6.32	186.34
										14.35	186.41
										20.81	186.85
										26.11	186.7
										29.39	187.26
										32.45	187.28
										33.59	187.02
										35.23	186.42
										36.01	185.93
										39.3	185.34
										42.44	185.54
										45.4	185.91
										46.64	185.79
										48.59	186.21
										49.86	186.77
										51.69	187.32
										53.89	187.8
										56.5	187.47
										58.64	186.97
										60.87	187.14
										72.27	186.14

Photo of Cross-Section 6 - Looking Downstream @ STA 31+56							
Area	Year 5 - 2011	Year 4 - 2010	Year 3 - 2009	Year 2 - 2008	Year 1 - 2007	AS-BUILT 2006	Bench
Width						23.43	
Mean Depth						1.23	
Max Depth						1.94	
W/D						15.51
