OVERHILLS STREAM AND WETLAND RESTORATION

MITIGATION PLAN

Harnett County, North Carolina
EEP Project Number 199

2.0 As-Builts

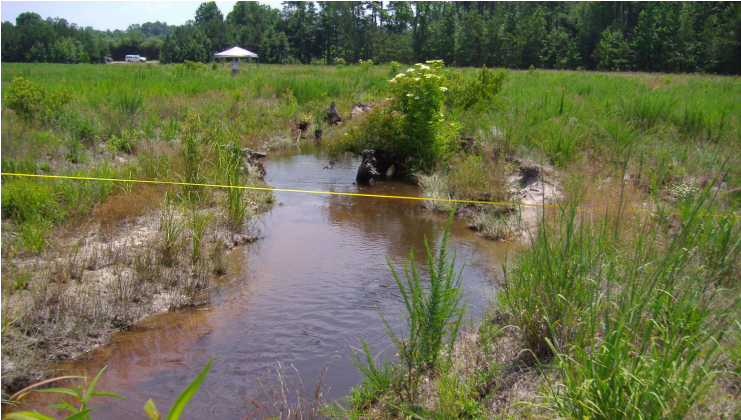
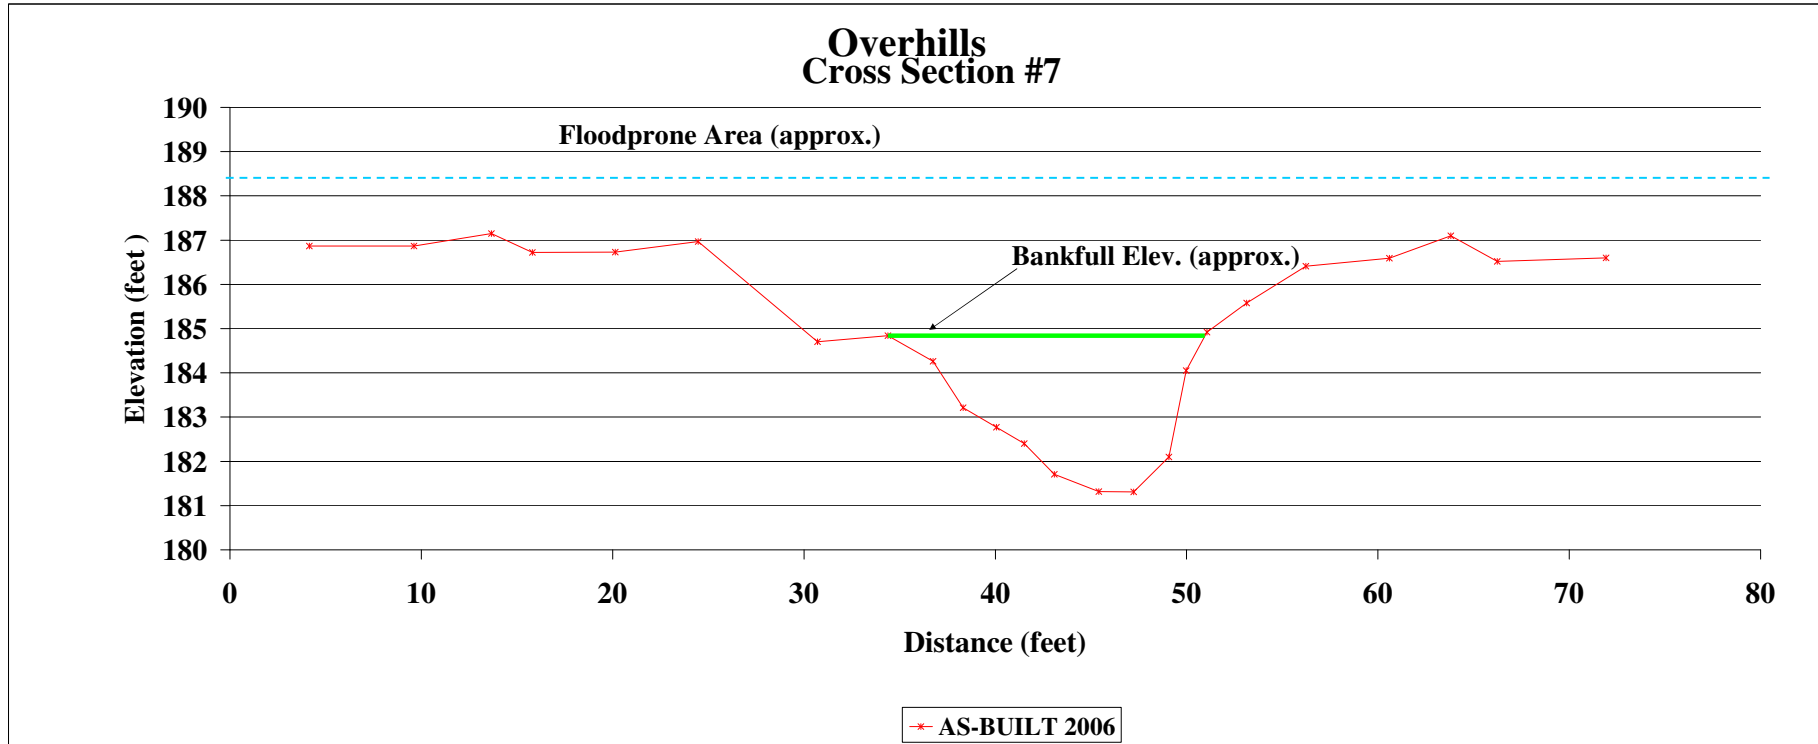
Project Name: Overhills		Feature: Riffle		Date: As Built -7/4/2007													
Cross Section: Cross Section 7		Crew: AS Built - Bidelspach, Jean, Geenen															
Year 5 - 2011 2011 Survey			Year 4 - 2010 2010 Survey			Year 3 - 2009 2009 Survey			Year 2 - 2008 2008 Survey			Year 1 - 2007 2007 Survey			AS-BUILT 2006 AS-BUILT Survey		
Station	Elevation	Notes	Station	Elevation	Notes	Station	Elevation	Notes	Station	Elevation	Notes	Station	Elevation	Notes	Station	Elevation	Notes

Photo of Cross-Section 7 - Looking Downstream @ STA 37+24							
	Year 5 - 2011	Year 4 - 2010	Year 3 - 2009	Year 2 - 2008	Year 1 - 2007	AS-BUILT 2006	Bench
Area						35.21	
Width						16.54	
Mean Depth						2.13	
Max Depth						3.53	
W/D						7.77

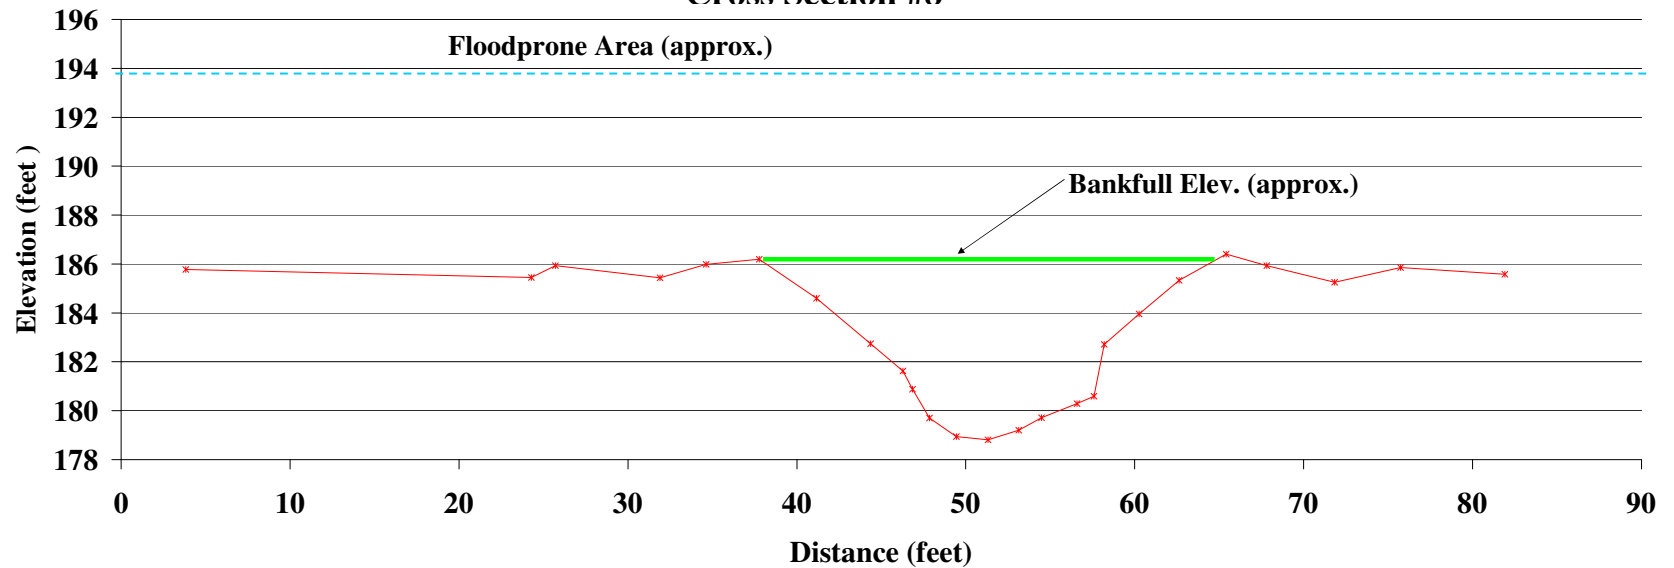
Overhills Cross Section #8

Project Name: Overhills			Feature: Pool			Date: As Built -7/4/2007																																																																																						
Cross Section: Cross Section 8						Crew: AS Built - Bidelspach, Jean, Geenen																																																																																						
Year 5 - 2011 2011 Survey			Year 4 - 2010 2010 Survey			Year 3 - 2009 2009 Survey			Year 2 - 2008 2008 Survey			Year 1 - 2007 2007 Survey			AS-BUILT 2006 AS-BUILT Survey																																																																													
Station	Elevation	Notes	Station	Elevation	Notes	Station	Elevation	Notes	Station	Elevation	Notes	Station	Elevation	Notes	Station	Elevation	Notes

Year 5 - 2011	Year 4 - 2010	Year 3 - 2009	Year 2 - 2008	Year 1 - 2007	AS-BUILT 2006	Bench
Area						106.10	
Width						27.10	
Mean Depth						3.92	
Max Depth						7.38	
W/D						6.92

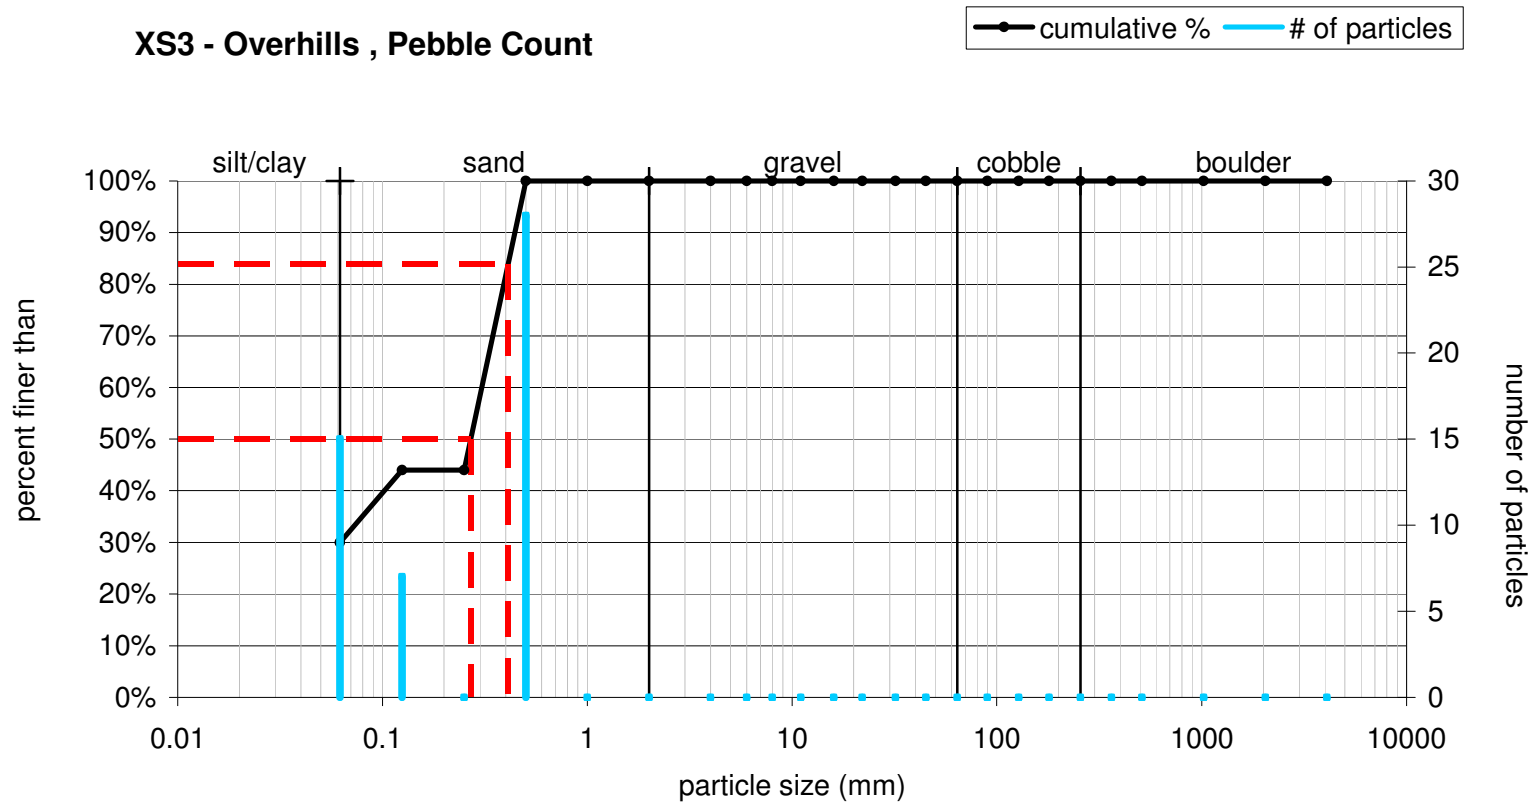
XS3 - Overhills , Pebble Count

Size (mm)		Size Distribution		Type	
D16	0.062	mean	0.2	silt/clay	30%
D35	0.08	dispersion	2.9	sand	70%
D50	0.27	skewness	-0.25	gravel	0%
D65	0.32			cobble	0%
D84	0.41			boulder	0%
D95	0.47

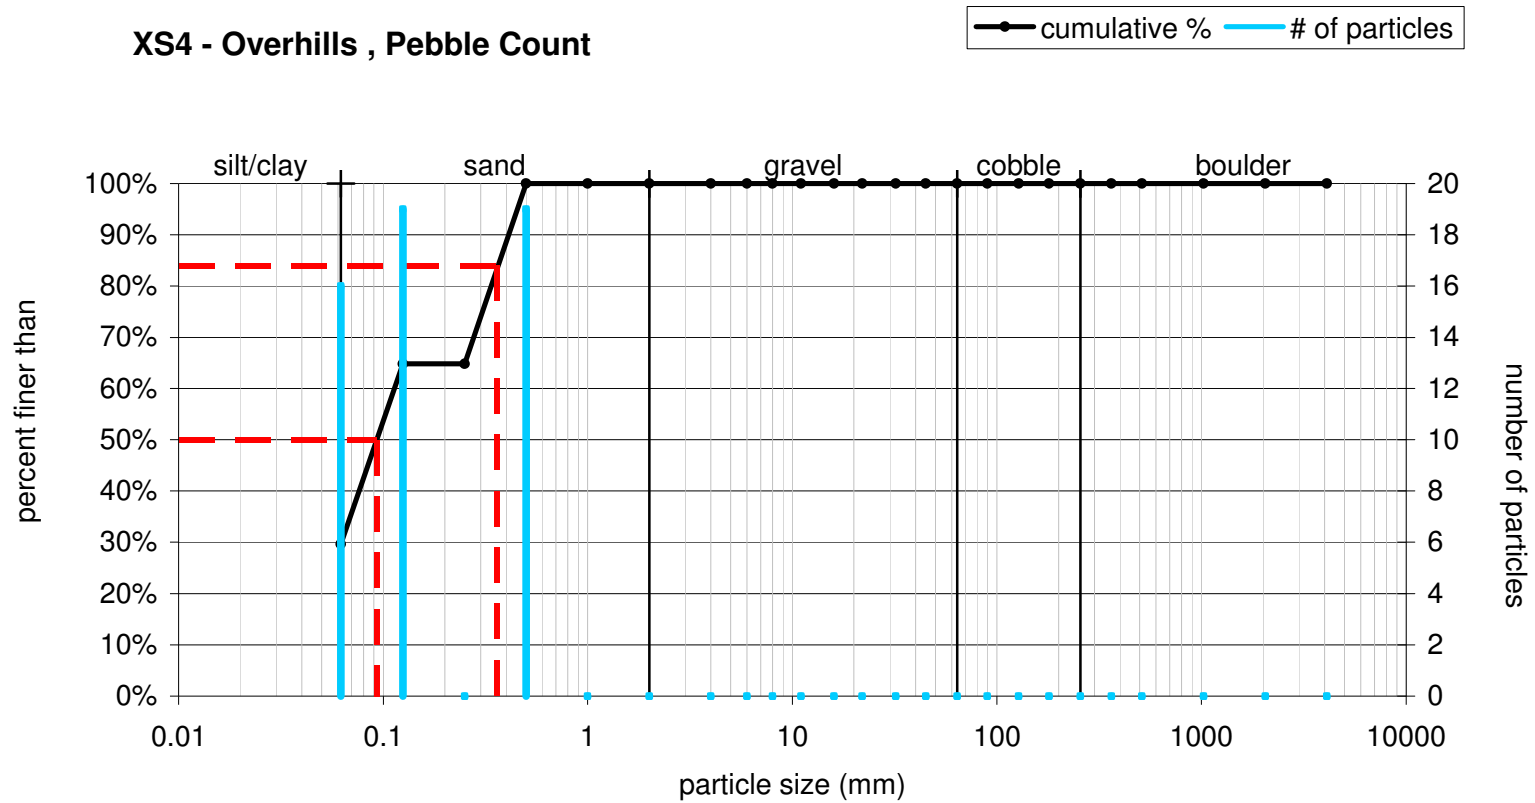
XS4 - Overhills , Pebble Count

Size (mm)		Size Distribution		Type	
D16	0.062	mean	0.1	silt/clay	30%
D35	0.069	dispersion	2.7	sand	70%
D50	0.093	skewness	0.24	gravel	0%
D65	0.25			cobble	0%
D84	0.36			boulder	0%
D95	0.45

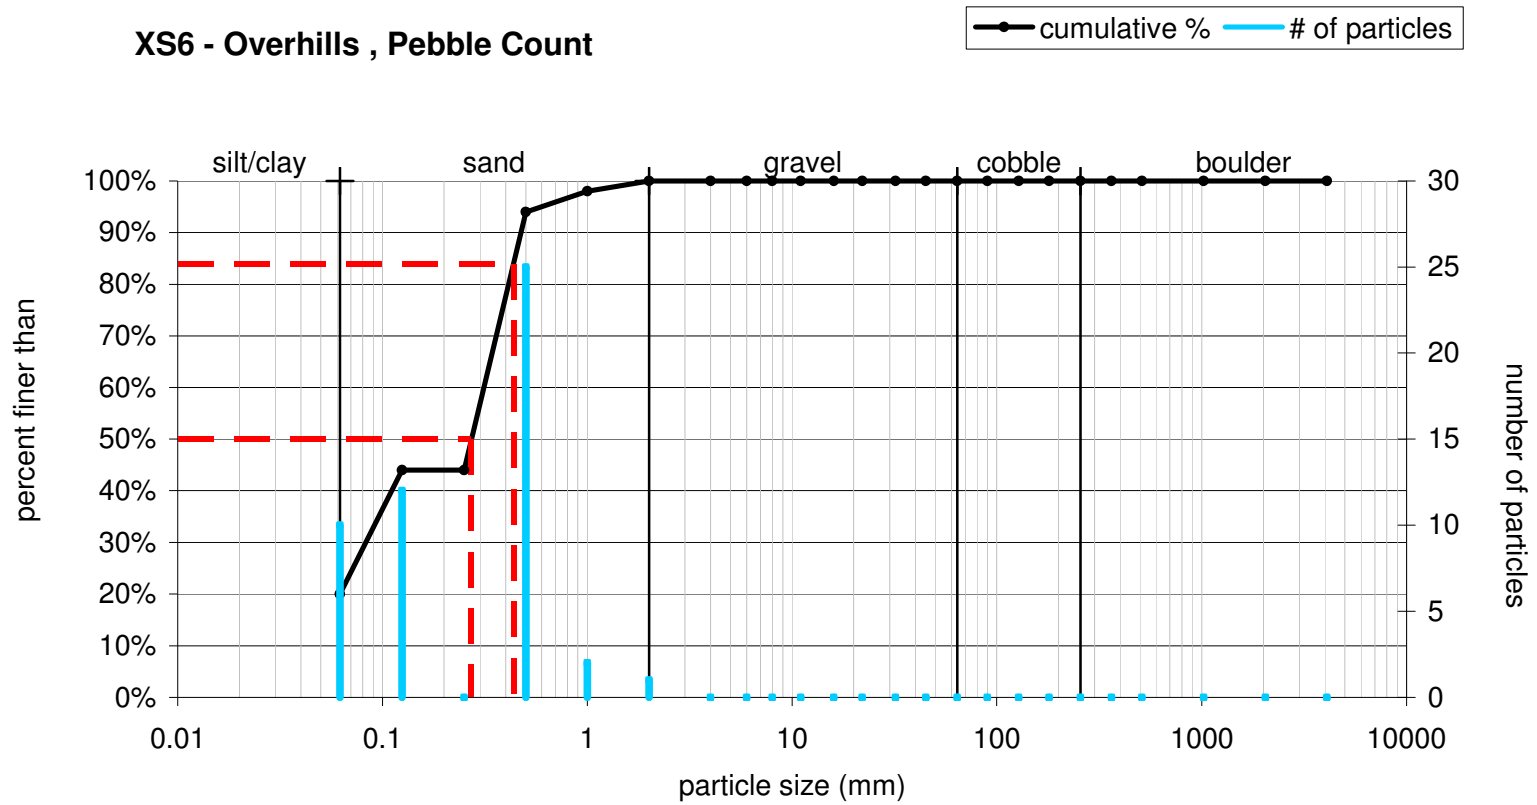
XS6 - Overhills , Pebble Count

Size (mm)		Size Distribution		Type	
D16	0.062	mean	0.2	silt/clay	20%
D35	0.096	dispersion	3.0	sand	80%
D50	0.27	skewness	-0.23	gravel	0%
D65	0.33			cobble	0%
D84	0.44			boulder	0%
D95	0.59
