Monitoring Report

Monitoring Year 1 of 5

Project Name: Junes Branch Stream Restoration

EEP Project No.: 95027

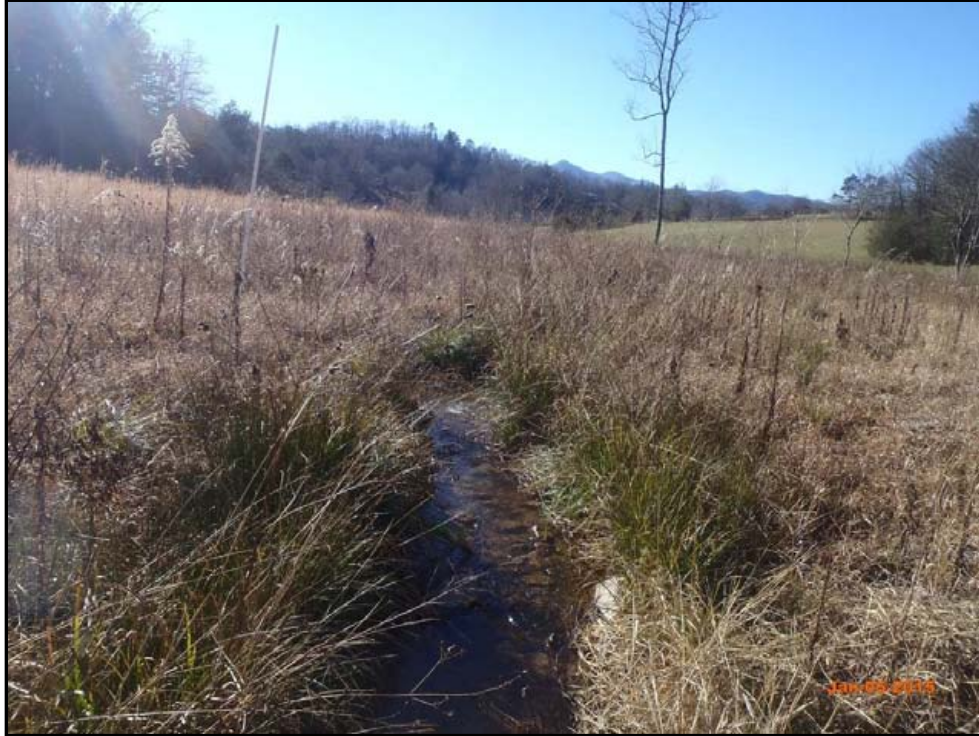
Junes Branch – Permanent Photo Station 1
Station 202+60 - Downstream

Visual assessment of the stream was performed at the beginning of the monitoring period. Permanent photo station photos were collected during the initial visual assessment during leaf-off conditions. Additional photos of vegetation or stream problem areas were documented with photographs throughout the project area.

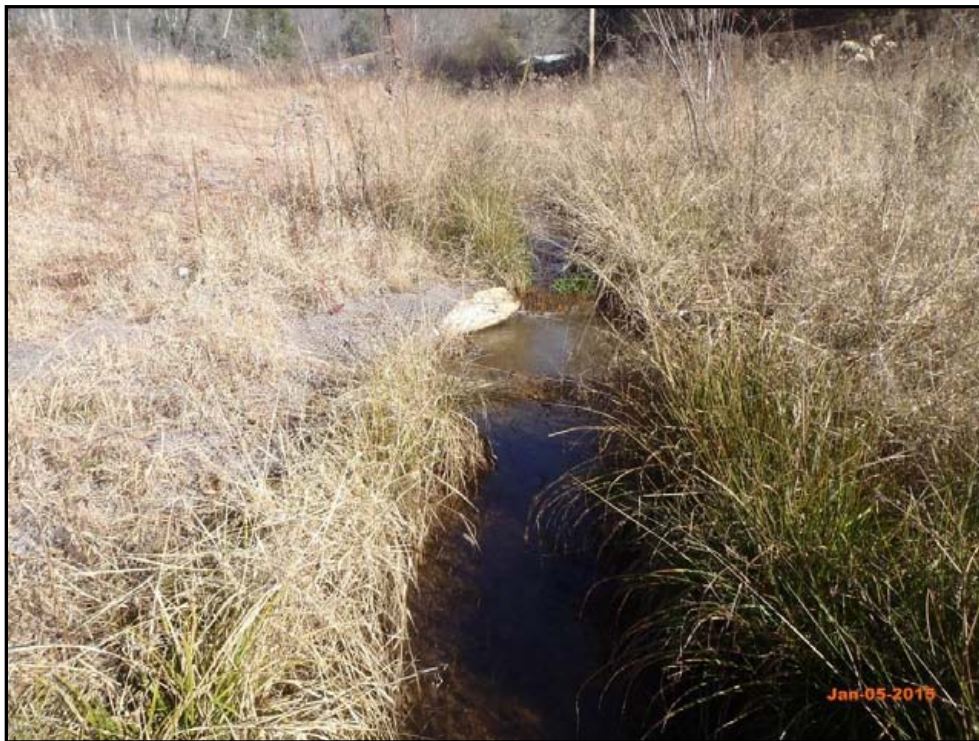
Junes Branch – Permanent Photo Station 1
Station 202+60 - Upstream

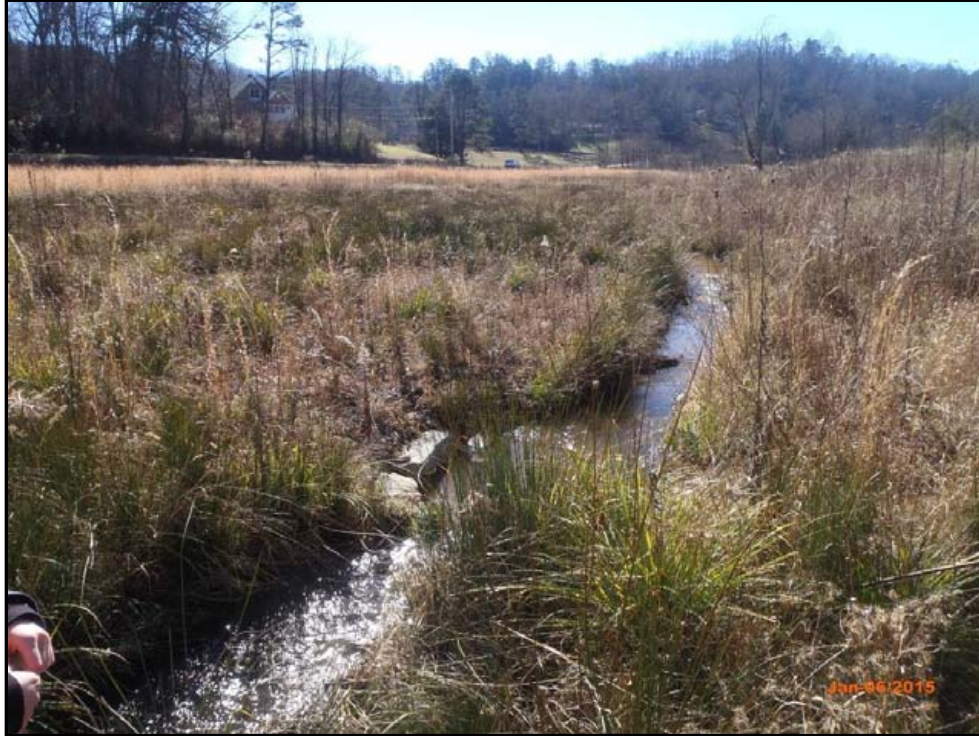
Junes Branch – Permanent Photo Station 2
Station 206+30 - Downstream

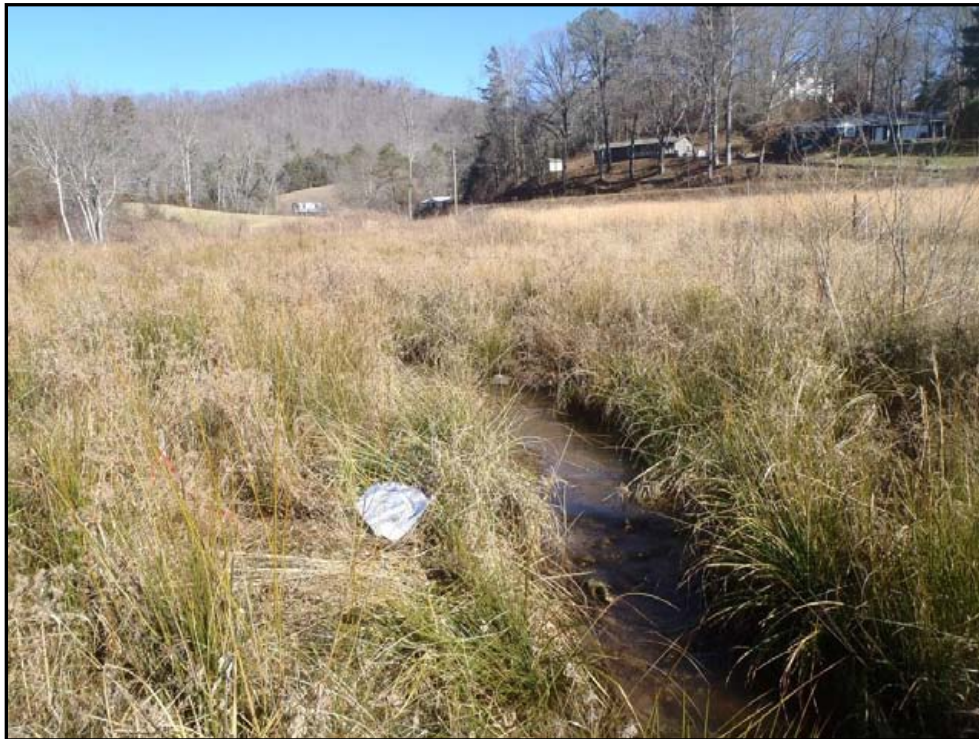
Junes Branch – Permanent Photo Station 2
Station 206+30 - Upstream

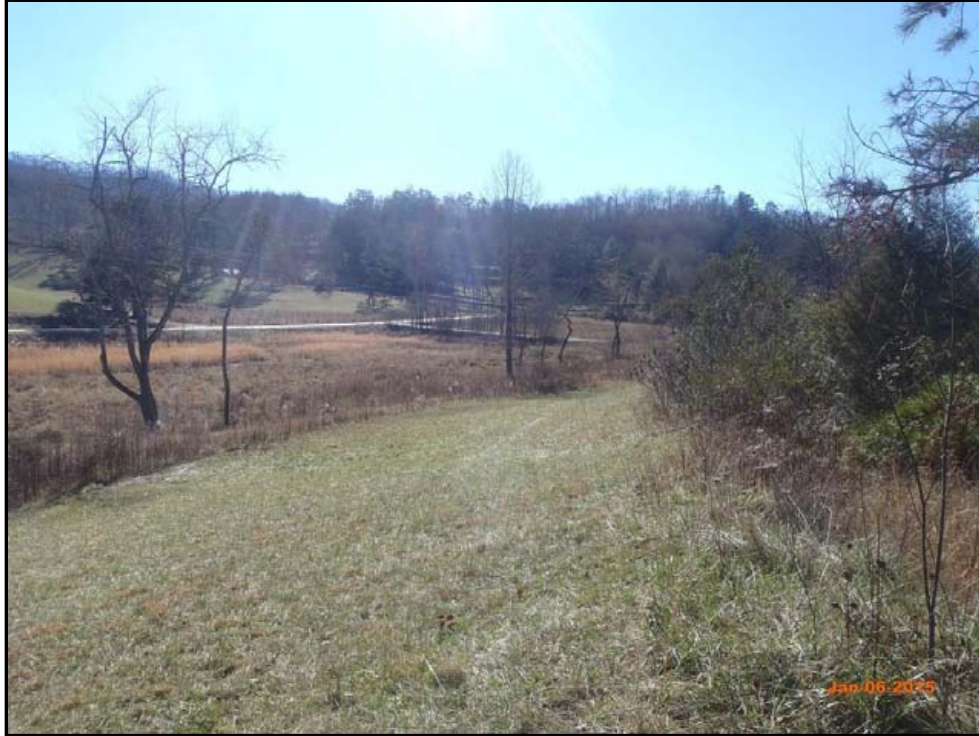
Junes Branch – Permanent Photo Station 3
Looking South/Downstream Junes Branch

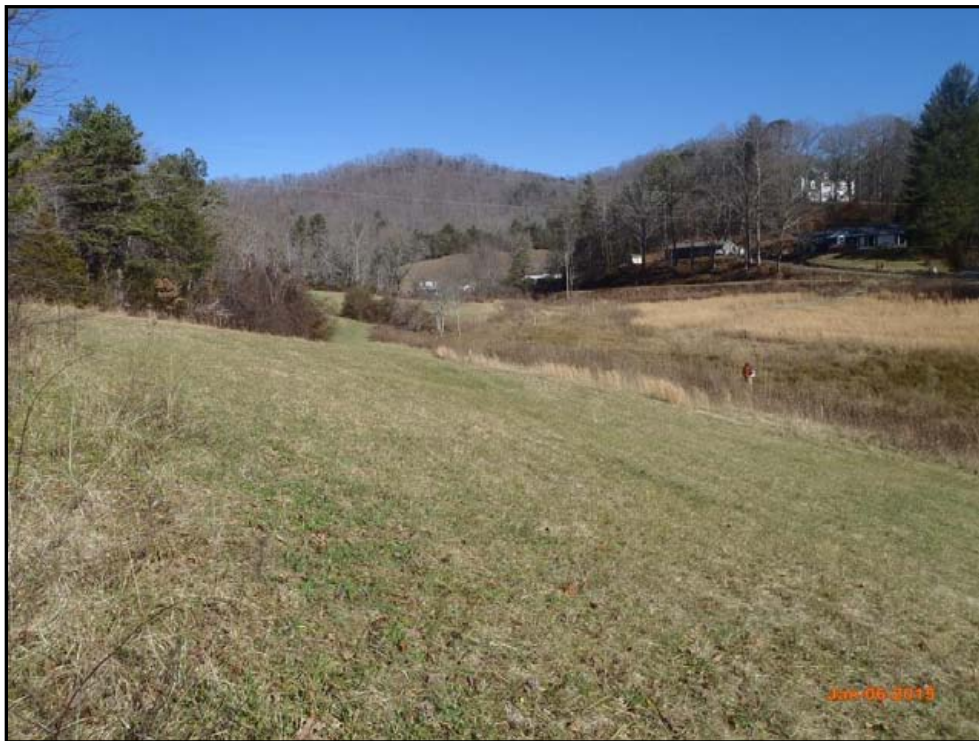
Junes Branch – Permanent Photo Station 3
Looking South/Downstream - Upstream

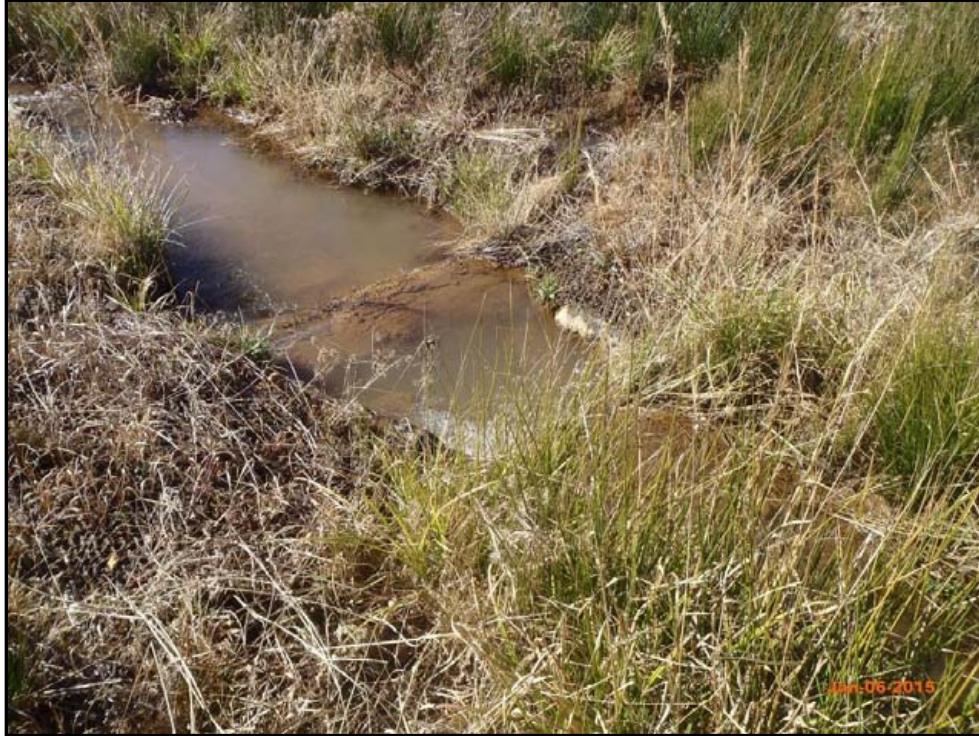
Junes Branch – Permanent Photo Station 4
Station 210+60 - Downstream

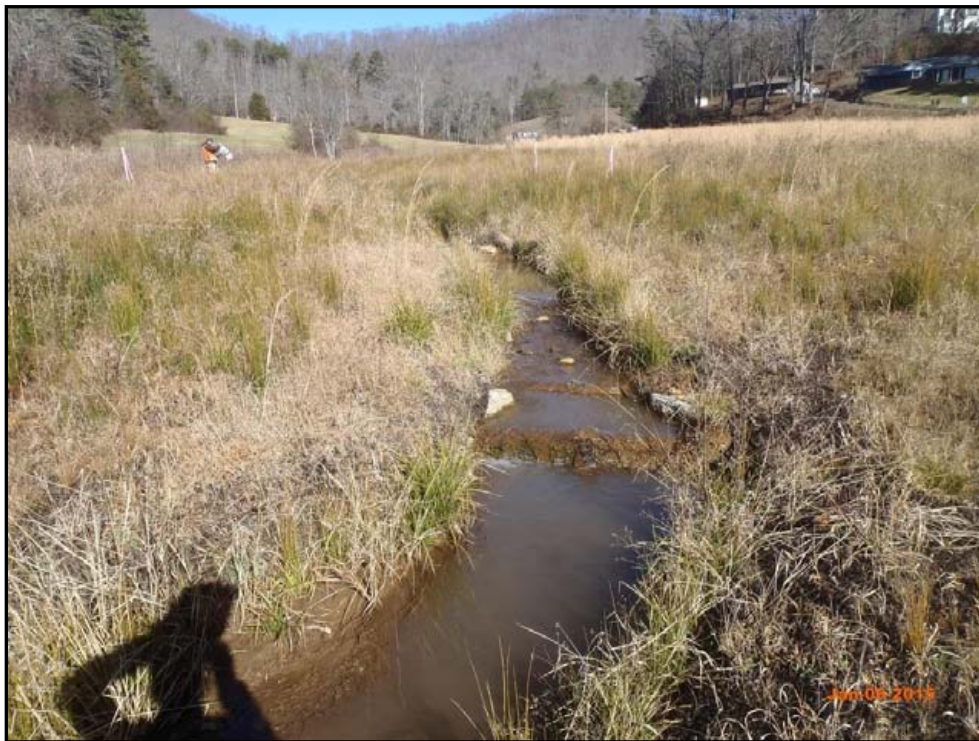
Junes Branch – Permanent Photo Station 4
Station 210+60 - Upstream

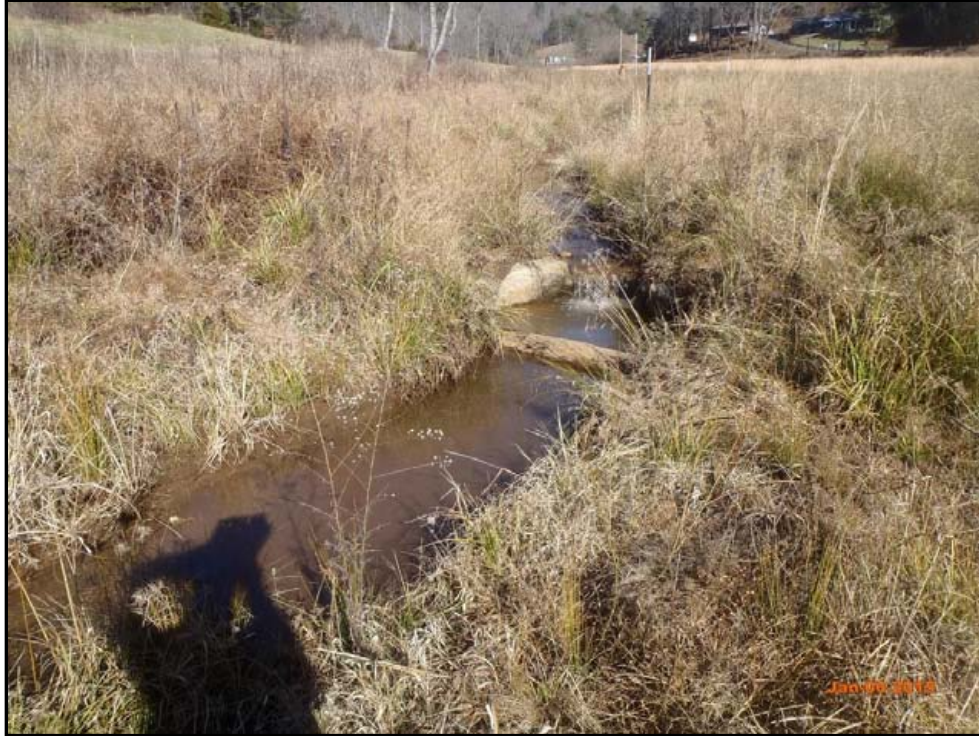
Junes Branch – Permanent Photo Station 5
Station 211+10 - Upstream

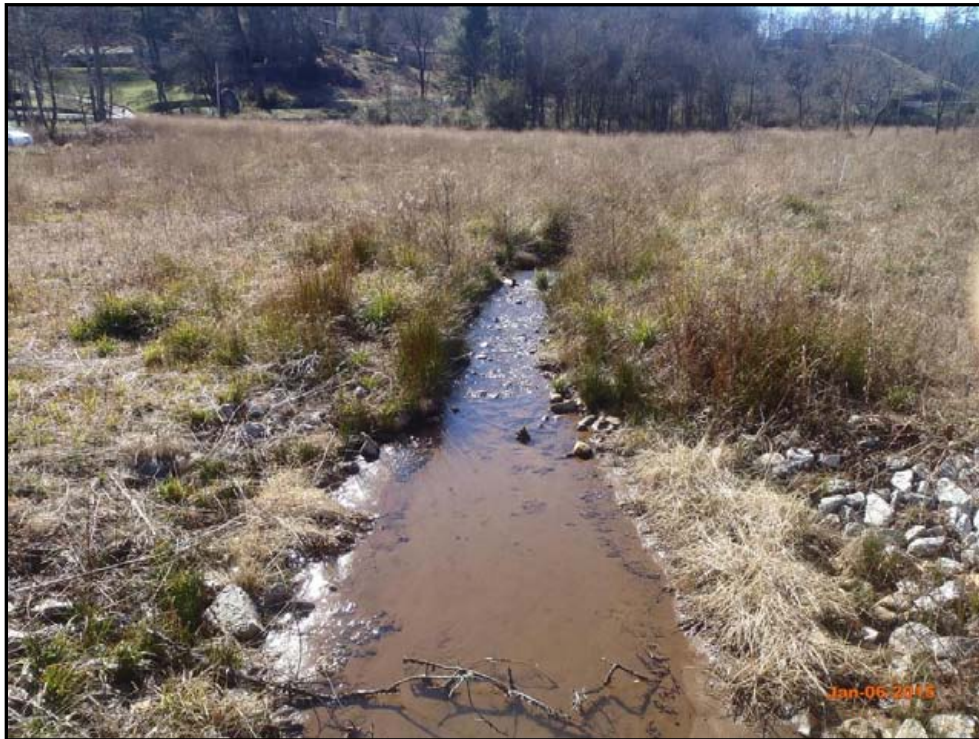
Junes Branch – Permanent Photo Station 6
Station 214+00 - Downstream

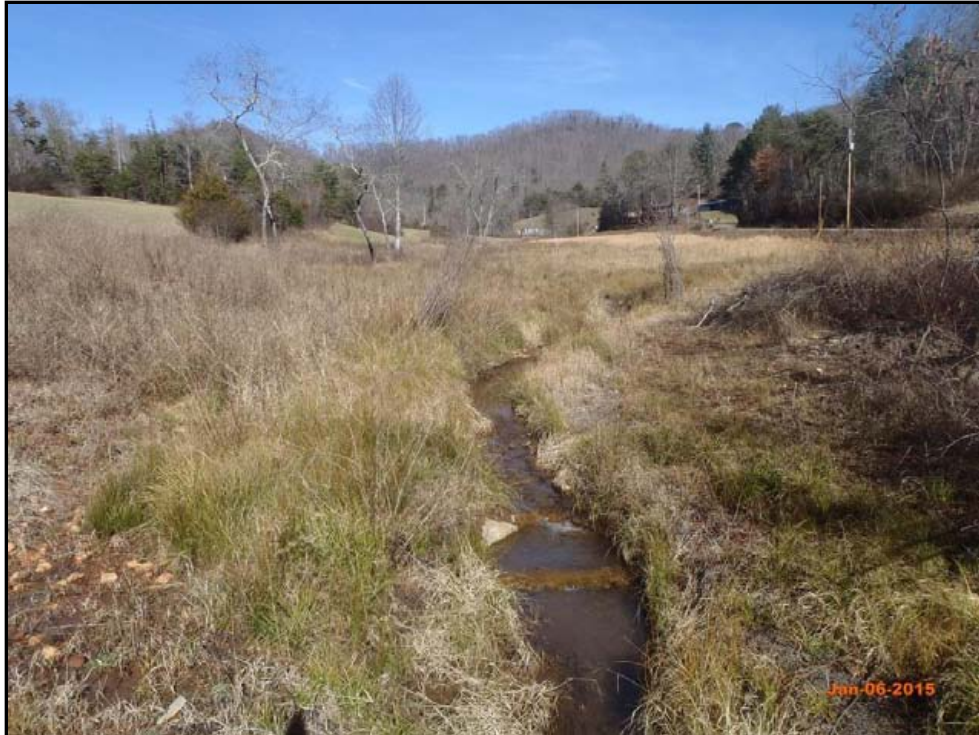
Junes Branch – Permanent Photo Station 6
Station 214+00 - Upstream

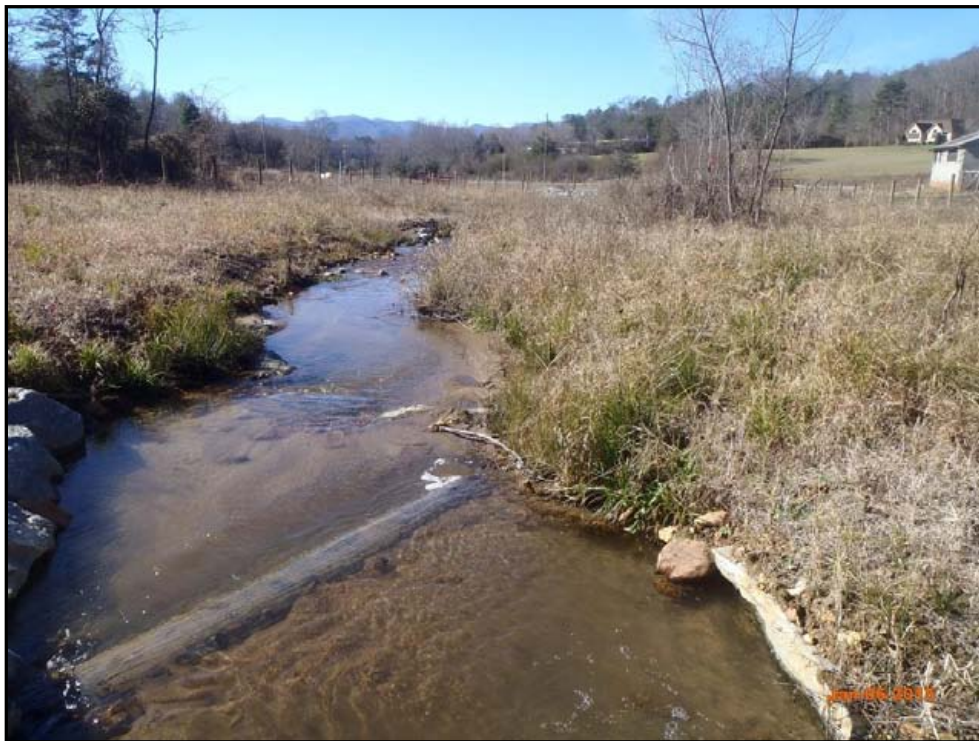
Bumgarner Branch I – Permanent Photo Station 7
Station 100+21 - Downstream

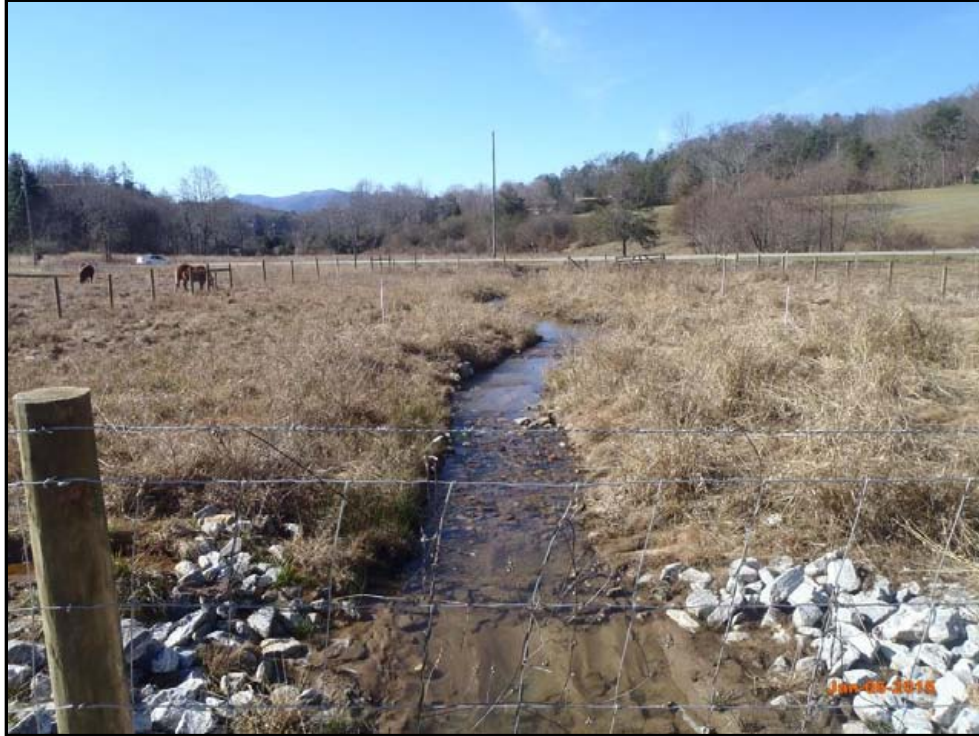
Bumgarner Branch I – Permanent Photo Station 8
Station 102+70 - Downstream

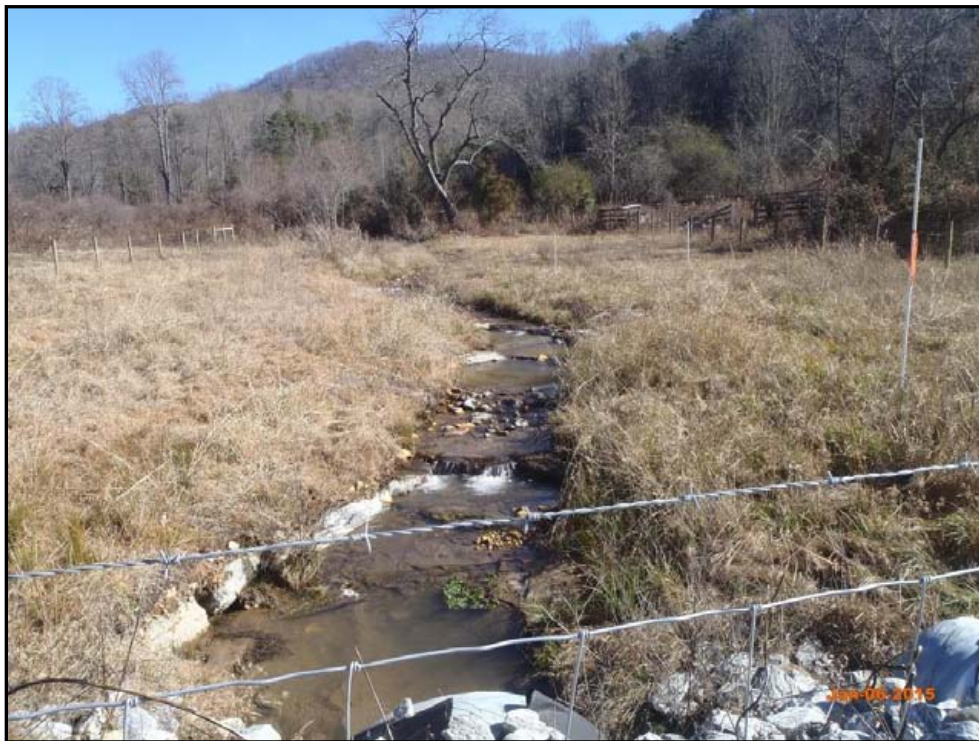
Bumgarner Branch I – Permanent Photo Station 8
Station 102+70- Upstream

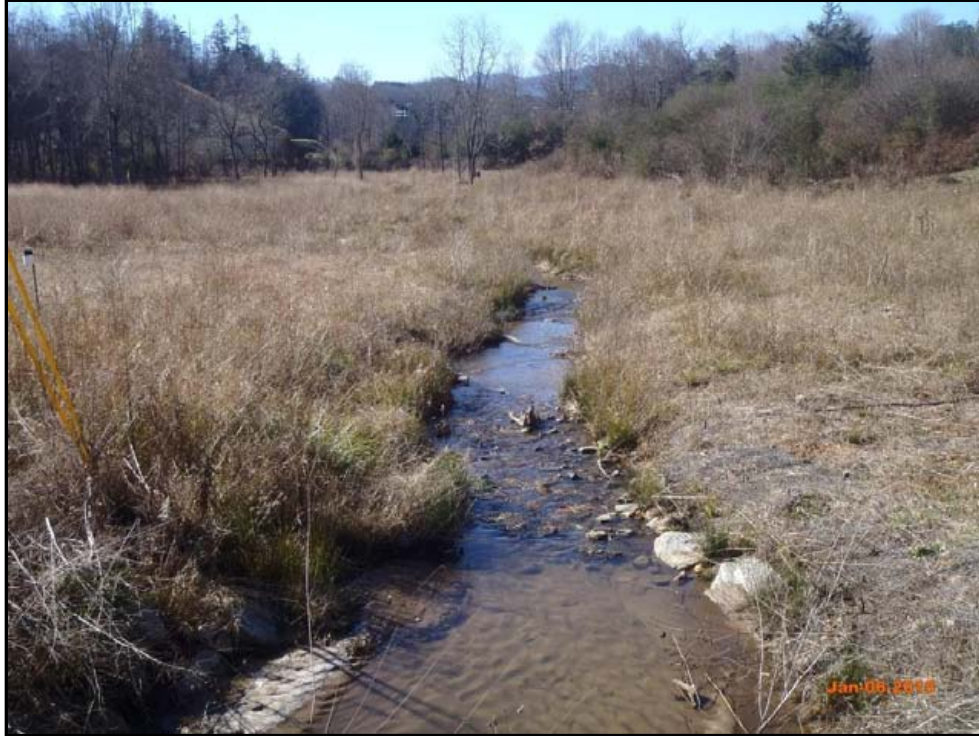
Bumgarner Branch I – Permanent Photo Station 9
Station 105+25 - Downstream

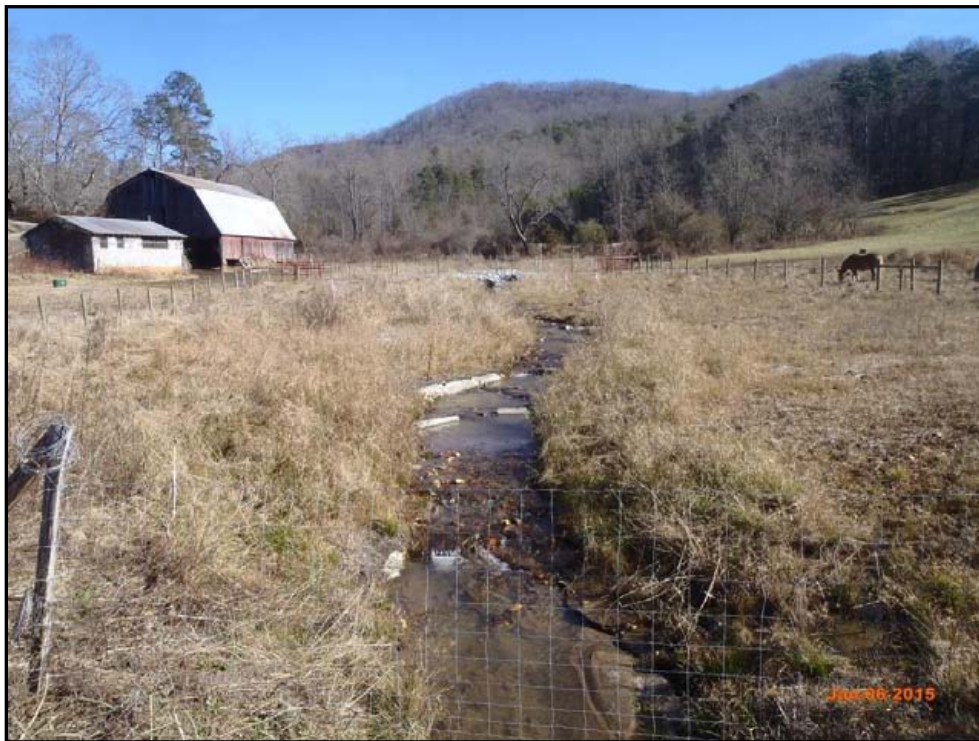
Bumgarner Branch I – Permanent Photo Station 9
Station 105+25 – Upstream

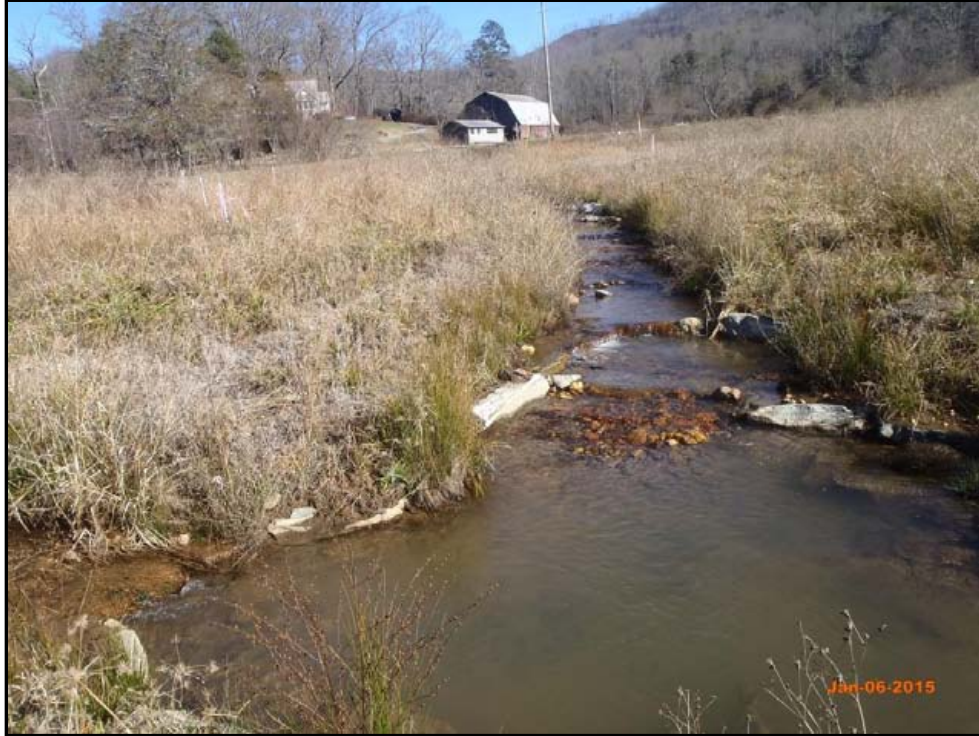
Bumgarner Branch I – Permanent Photo Station 10
Looking Upstream from Confluence with Junes Branch

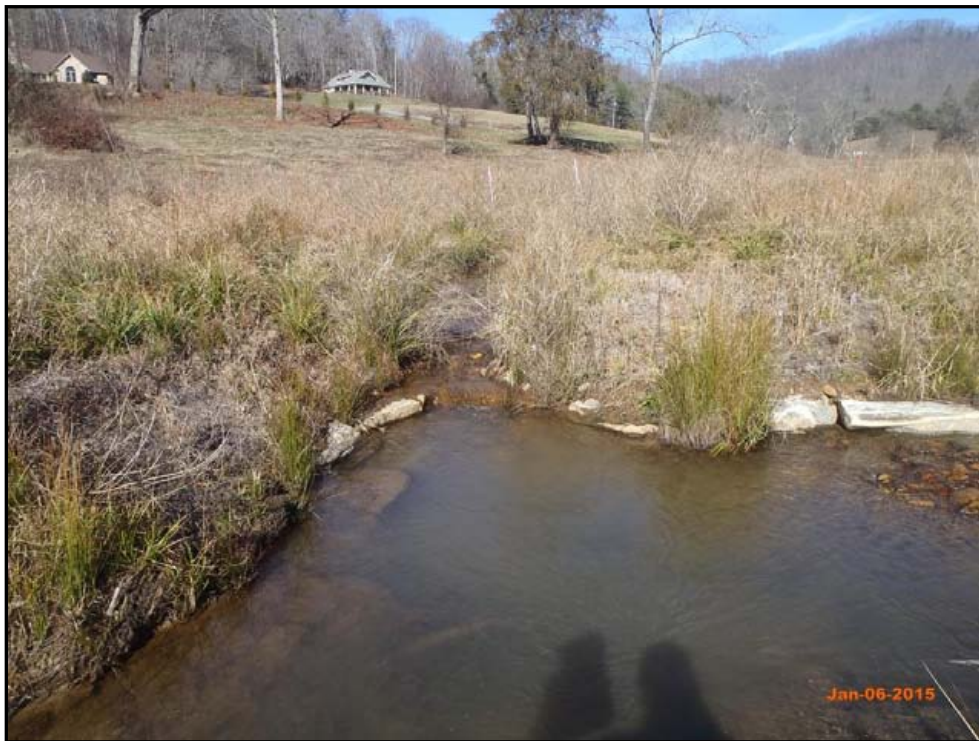
Junes Branch – Permanent Photo Station 10
Looking Upstream from Confluence with Bumgarner Branch

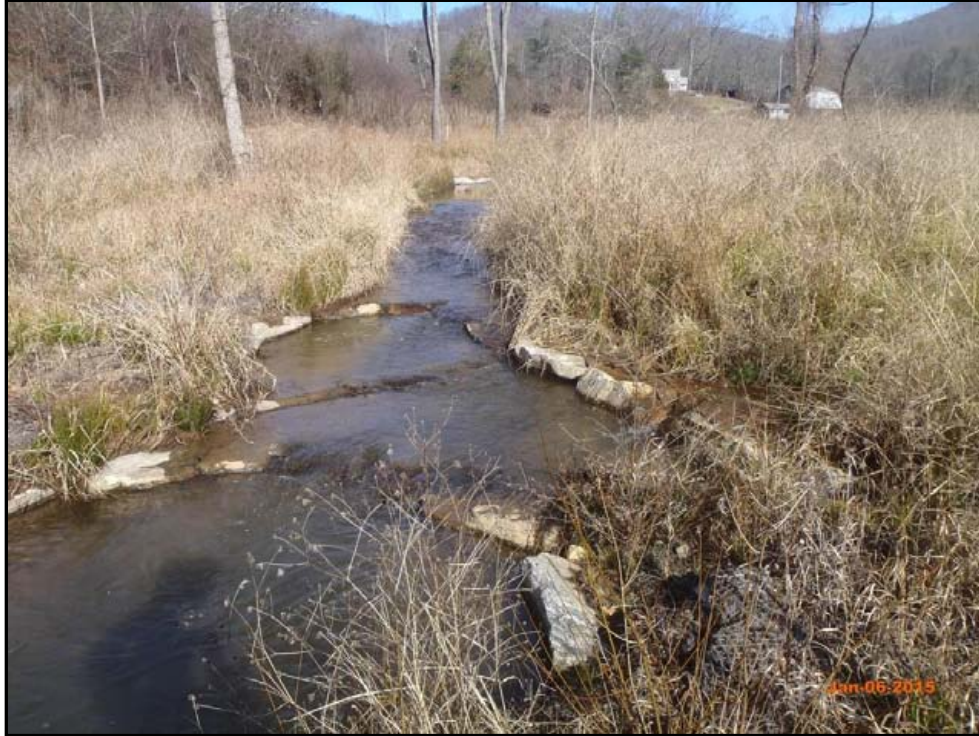
Bumgarner Branch II – Permanent Photo Station 11
Looking Upstream from Confluence with Higdon Branch

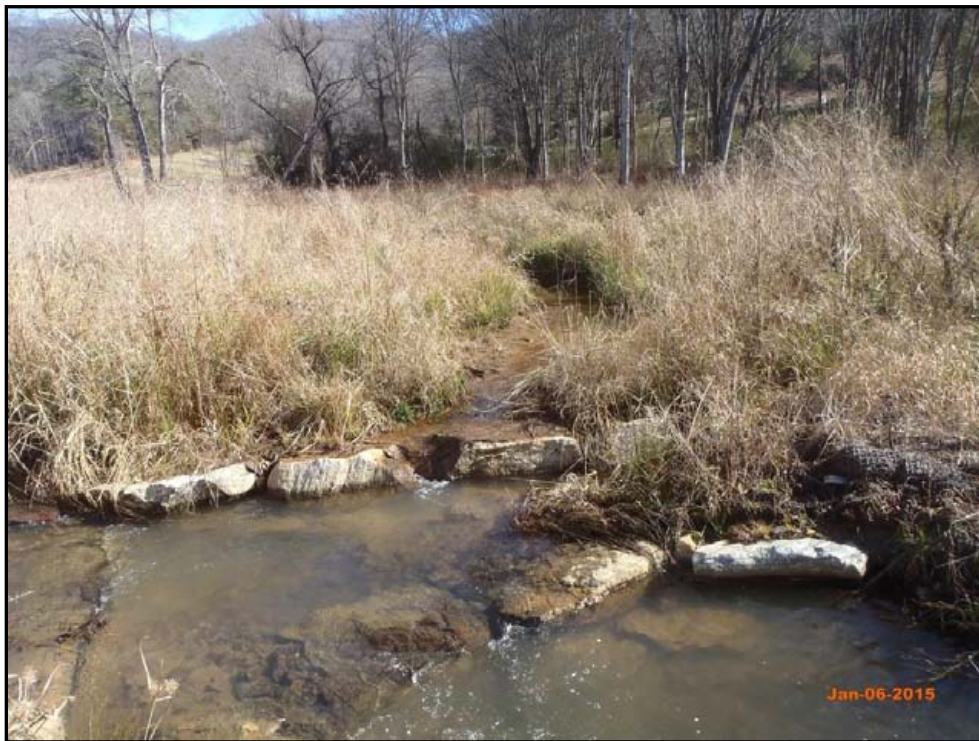
Higdon Creek – Permanent Photo Station 11
Looking Upstream from Confluence with Bumgarner Branch II

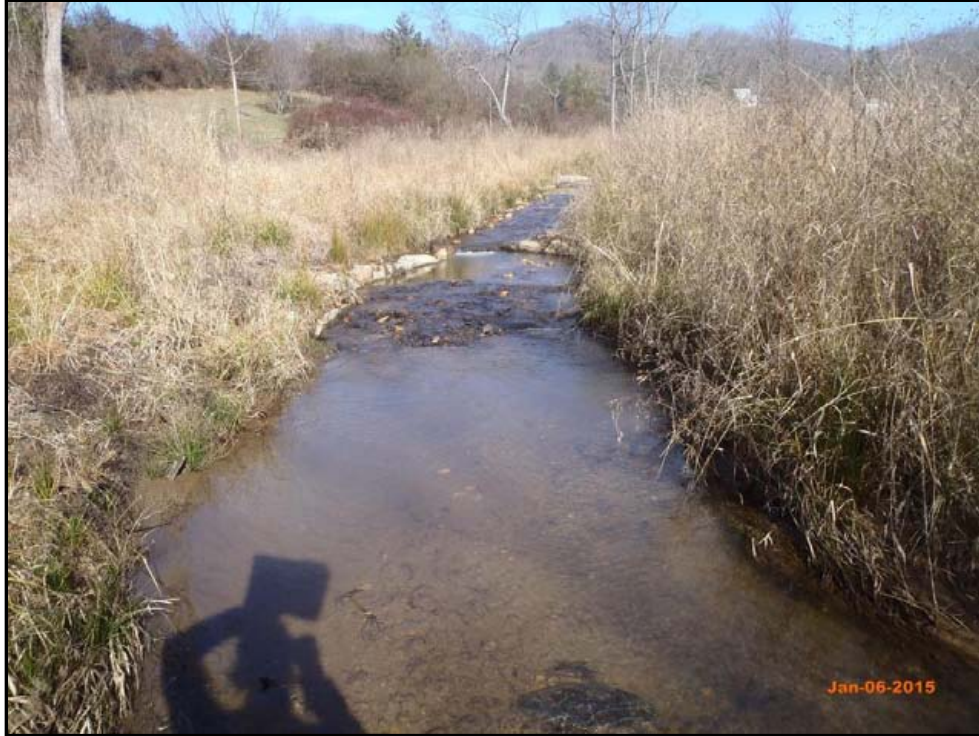
Bumgarner Branch II – Permanent Photo Station 12
Looking Upstream from Confluence with Doris Branch

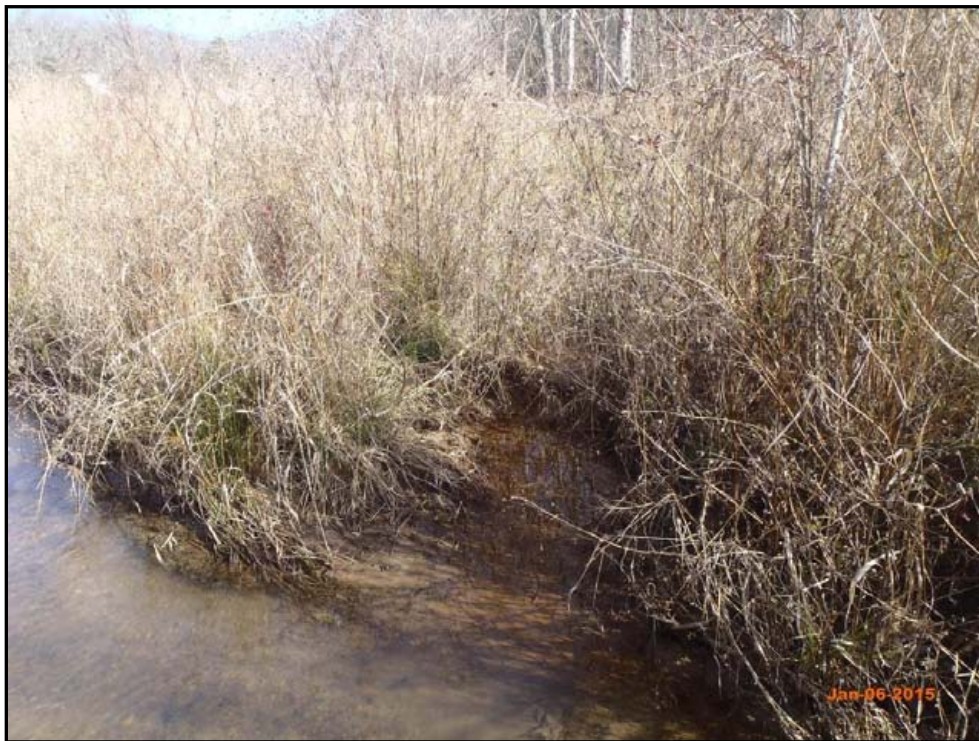
Doris Creek – Permanent Photo Station 12
Looking Upstream from Confluence with Bumgarner Branch II

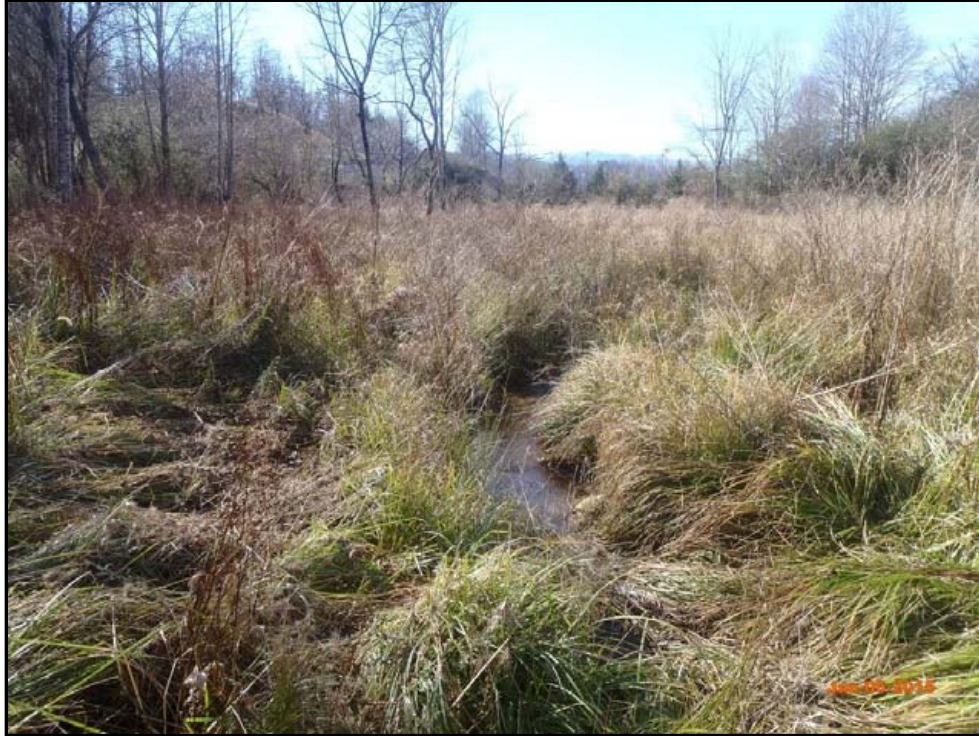
Higdon Creek – Permanent Photo Station 13
Station 302+80 - Downstream

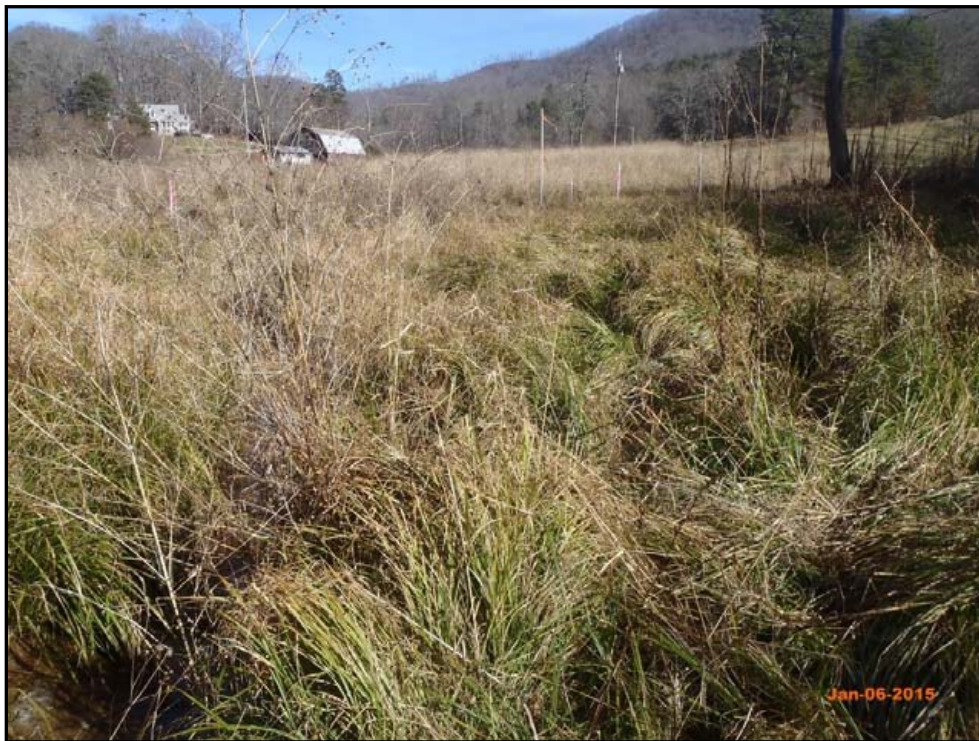
Higdon Creek – Permanent Photo Station 13
Station 302+80 - Upstream

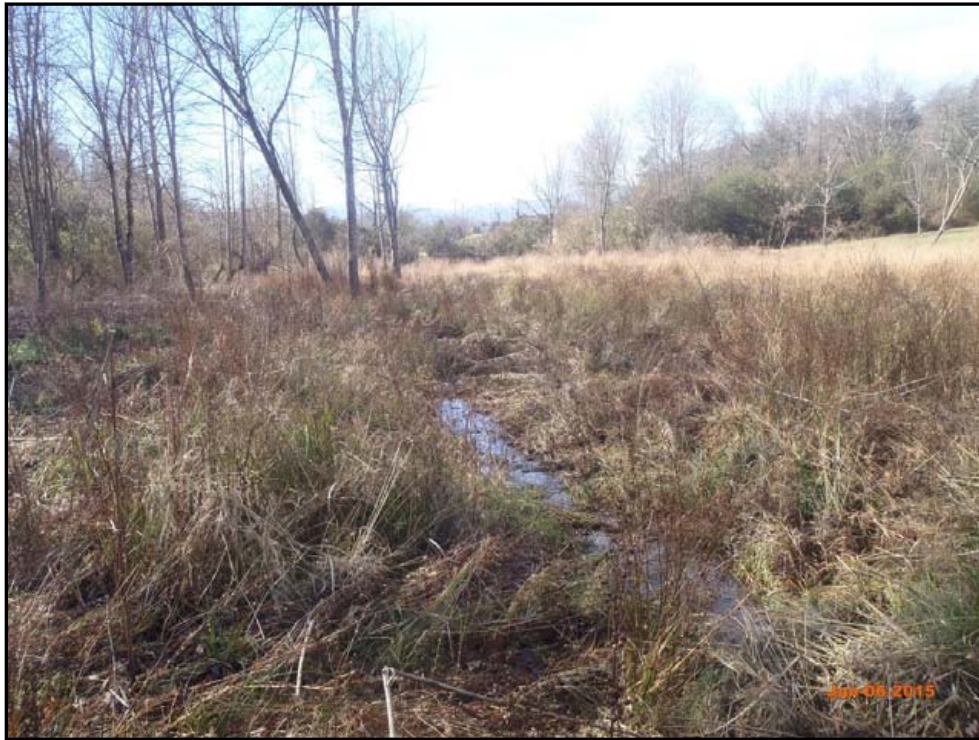
Doris Creek – Permanent Photo Station 14
Station 400+00 - Downstream

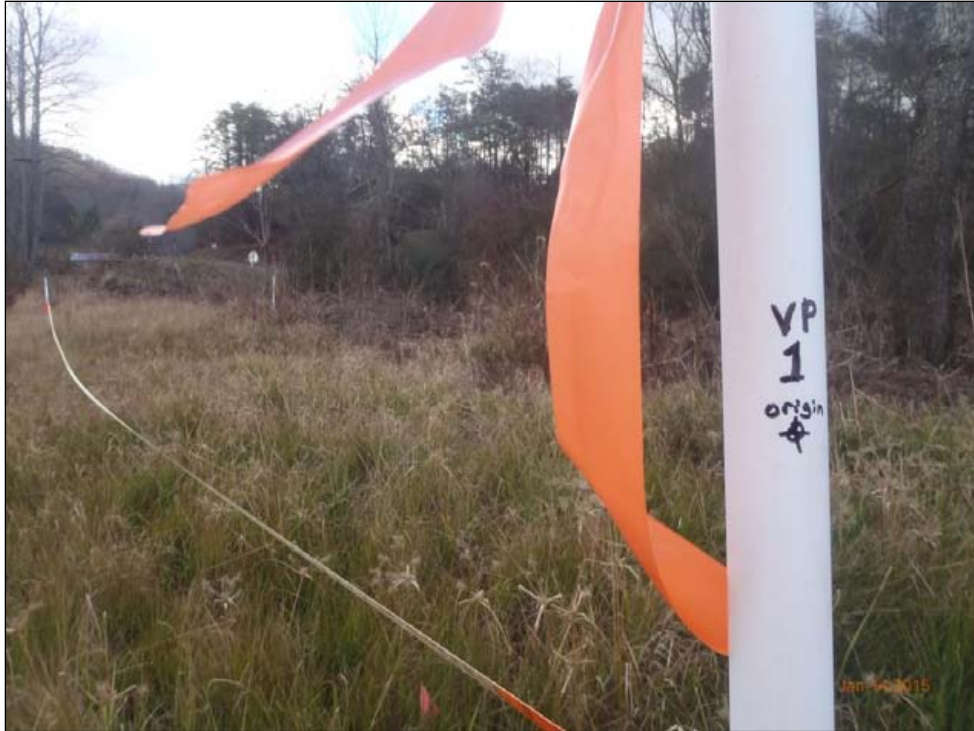
Junes Branch - Vegetation Monitoring Plot 1
January 15, 2015

Table 7. Vegetation Plot Criteria Attainment		
Junes Branch / Project No. 95027		
Vegetation Plot ID	Vegetation Survival Threshold Met?	Tract Mean
1	Yes	100%
2	Yes	
3	Yes	
4	Yes	
5	Yes

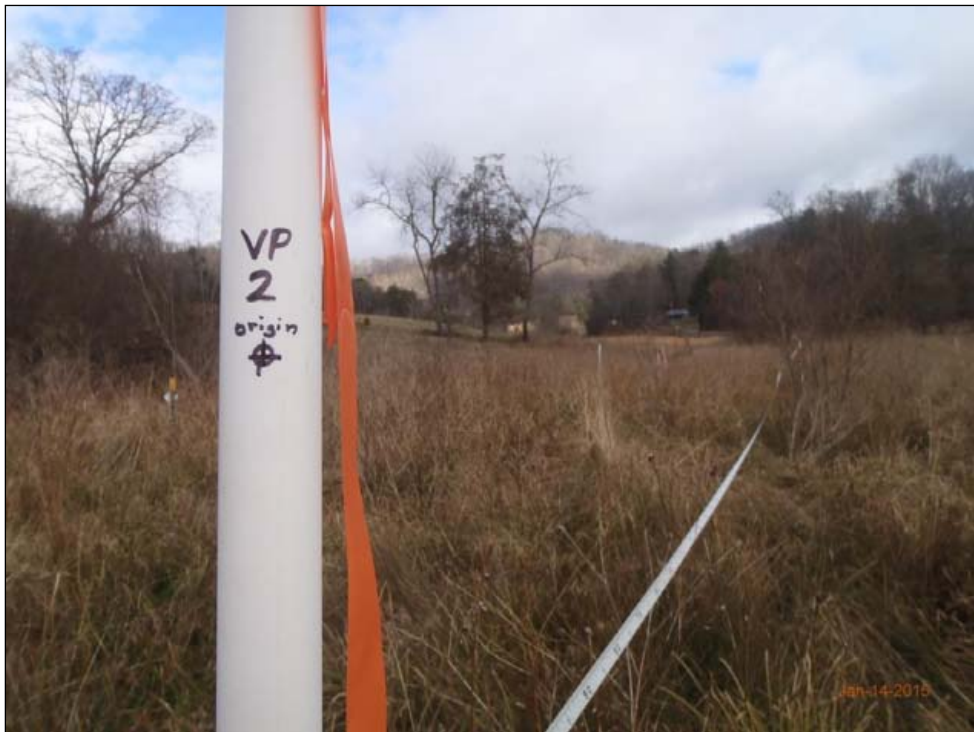
Junes Branch - Vegetation Monitoring Plot 2
January 15, 2015

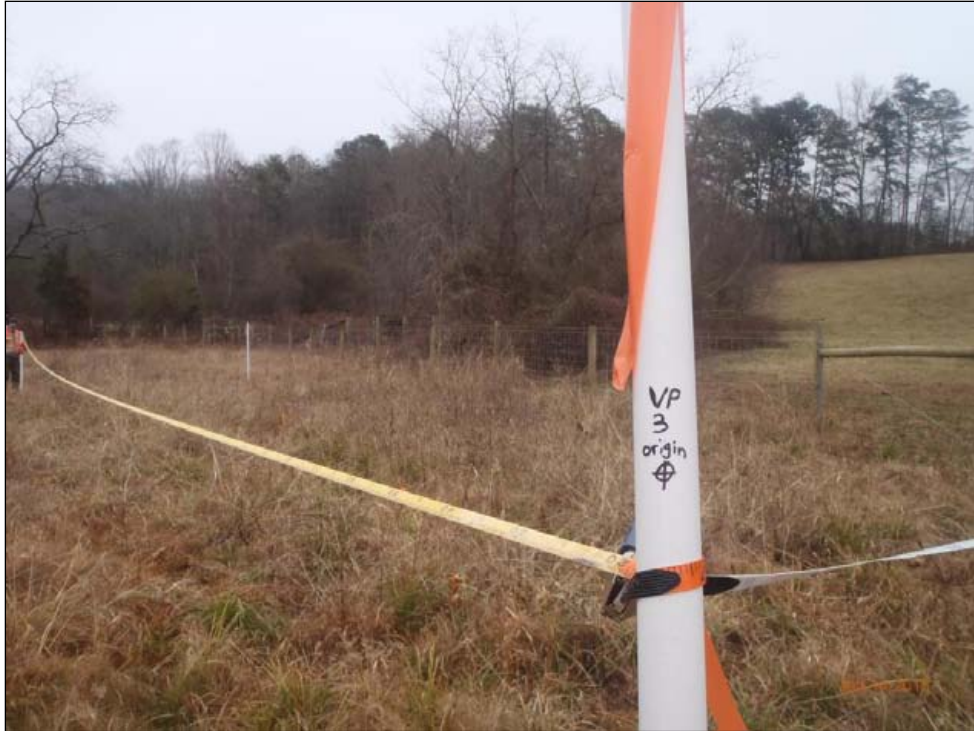
Junes Branch - Vegetation Monitoring Plot 3
January 15, 2015

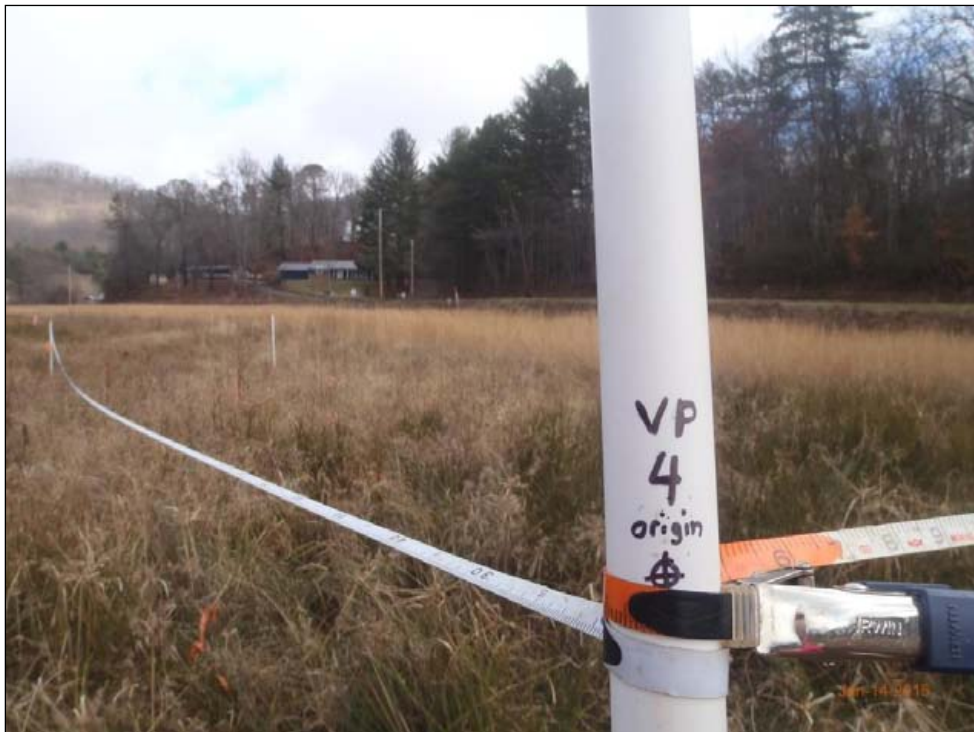
Junes Branch - Vegetation Monitoring Plot 4
January 15, 2015

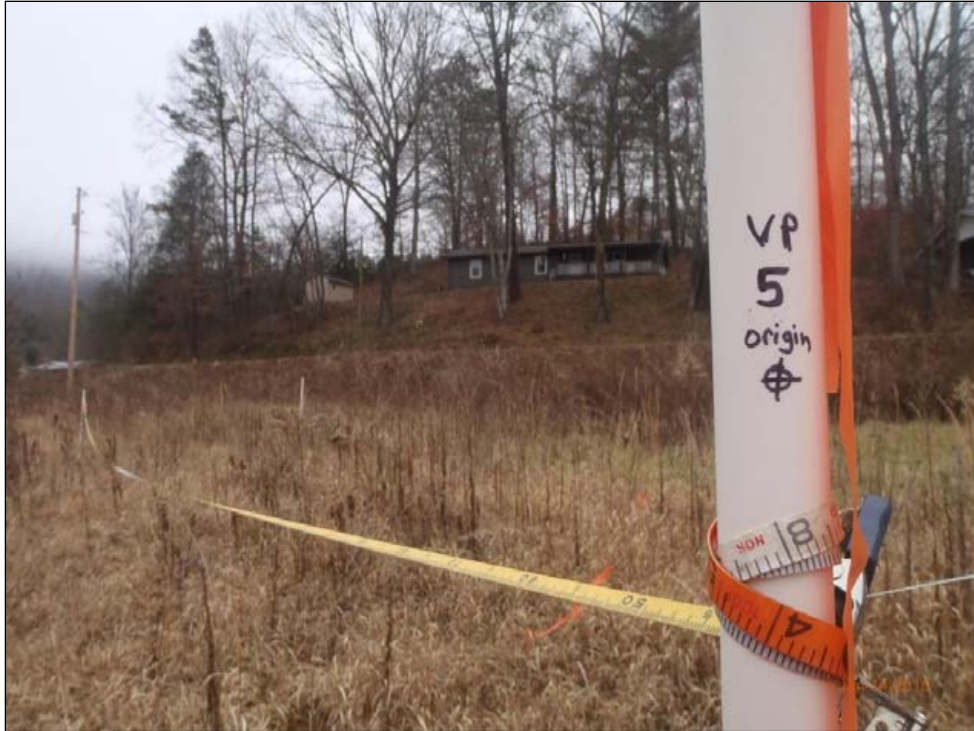
Junes Branch - Vegetation Monitoring Plot 5
January 15, 2015

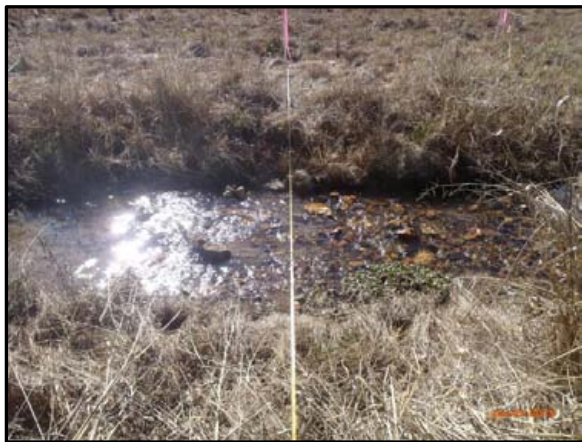
Left Descending Bank

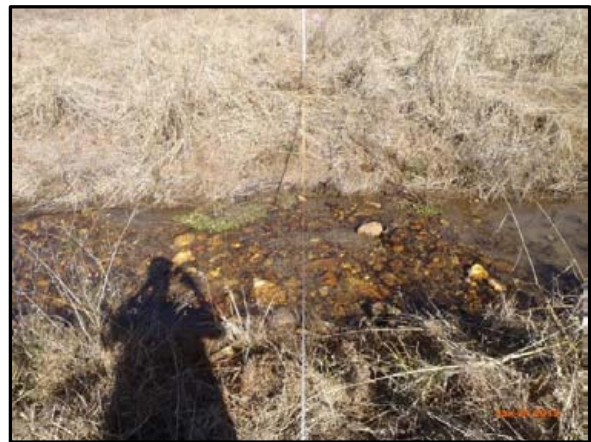
Right Descending Bank
