Monitoring Report

Monitoring Year 1 of 5

Project Name: Junes Branch Stream Restoration

EEP Project No.: 95027

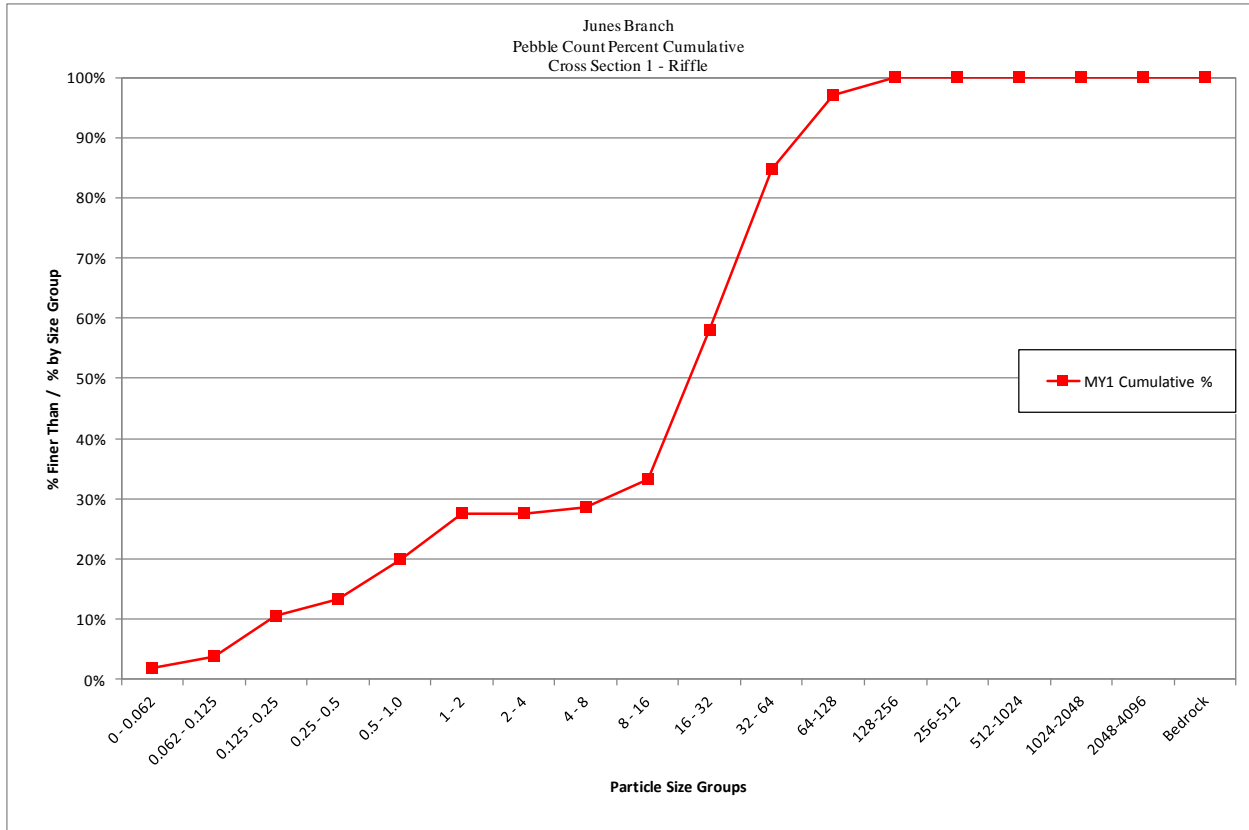
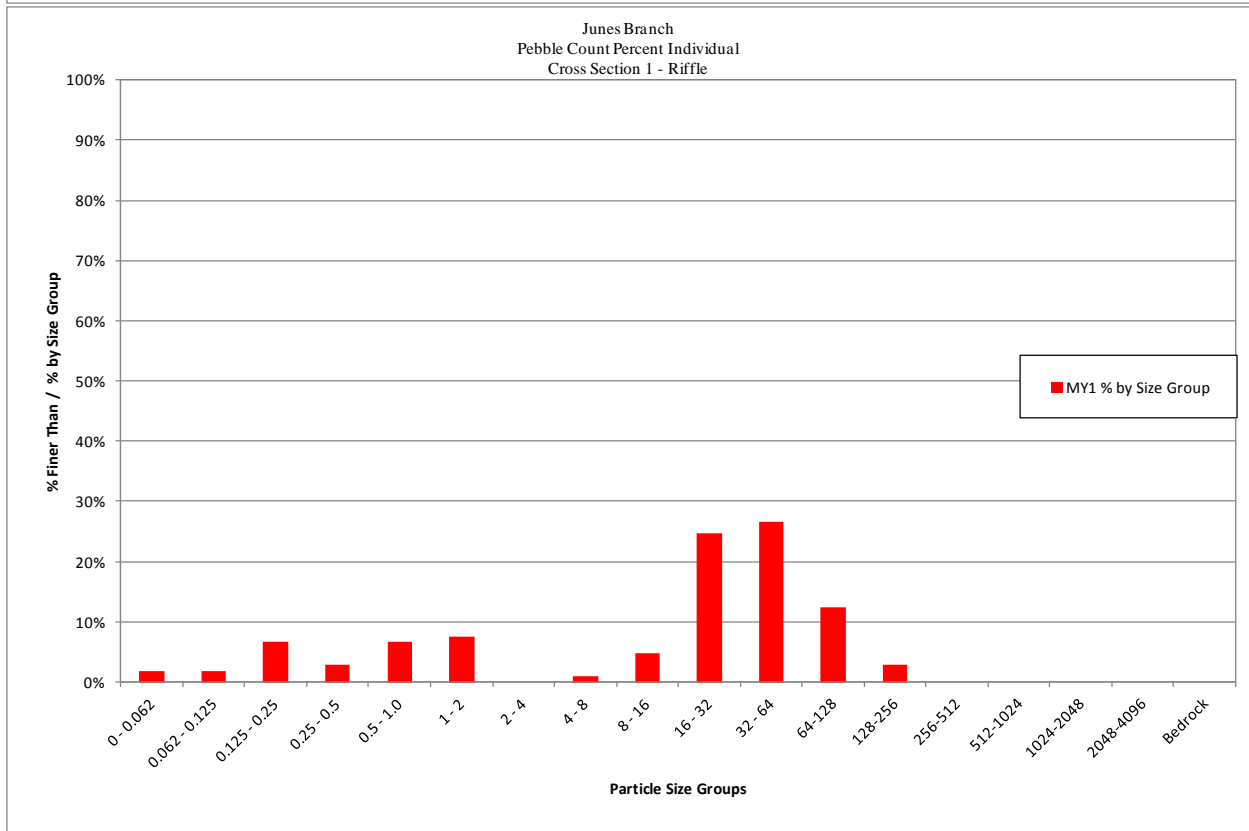
Junes Branch			
Cross Section 1 - Riffle			
Monitoring Year - 2015; MY1			
Bed Surface Material Particle Size Class (mm)	Number	% Individual	% Cumulative
0 - 0.062	2	1.9%	2%
0.062 - 0.125	2	1.9%	4%
0.125 - 0.25	7	6.7%	10%
0.25 - 0.5	3	2.9%	13%
0.5 - 1.0	7	6.7%	20%
1 - 2	8	7.6%	28%
2 - 4	0	0.0%	28%
4 - 8	1	1.0%	29%
8 - 16	5	4.8%	33%
16 - 32	26	24.8%	58%
32 - 64	28	26.7%	85%
64-128	13	12.4%	97%
128-256	3	2.9%	100%
256-512	0	0.0%	100%
512-1024	0	0.0%	100%
1024-2048	0	0.0%	100%
2048-4096	0	0.0%	100%
Bedrock	0	0.0%	100%
Total	105	100%	100%
		Summary Data	
		D50	27
		D84	63
		D95	98

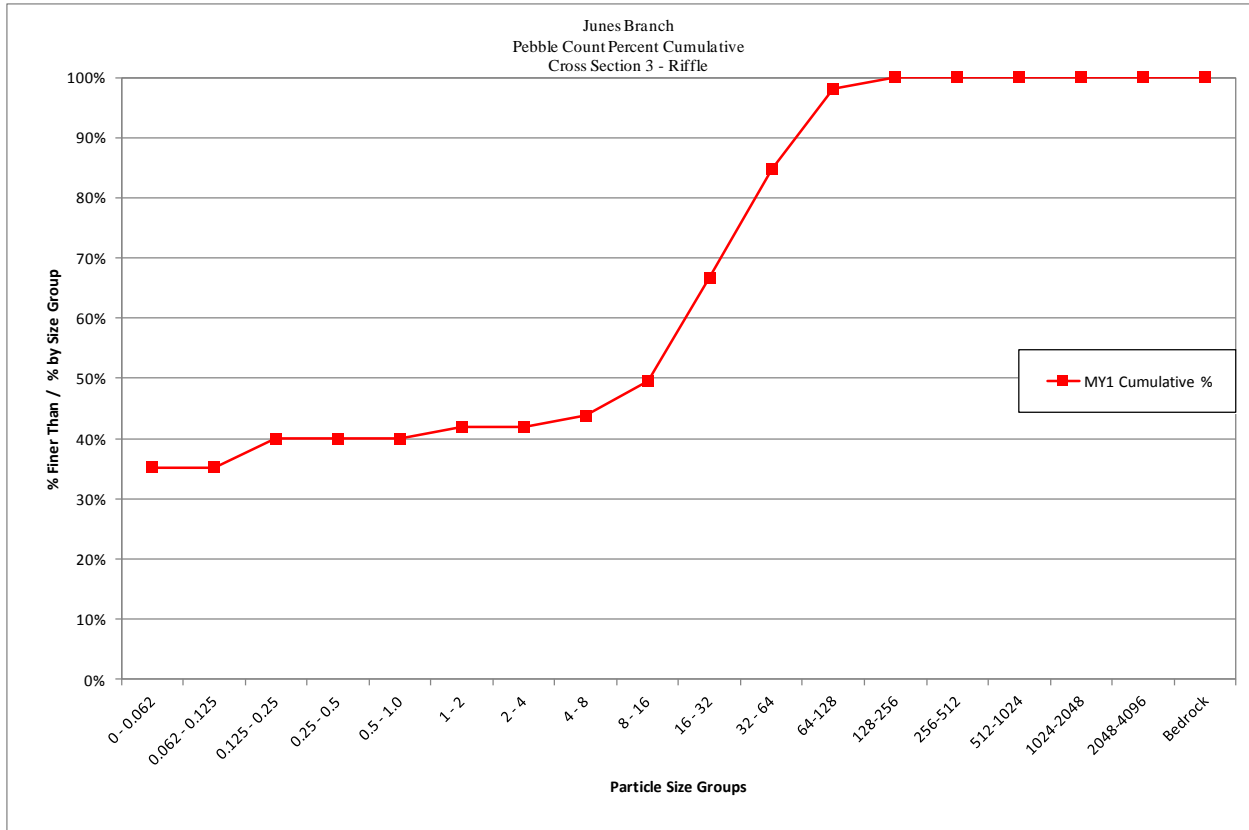
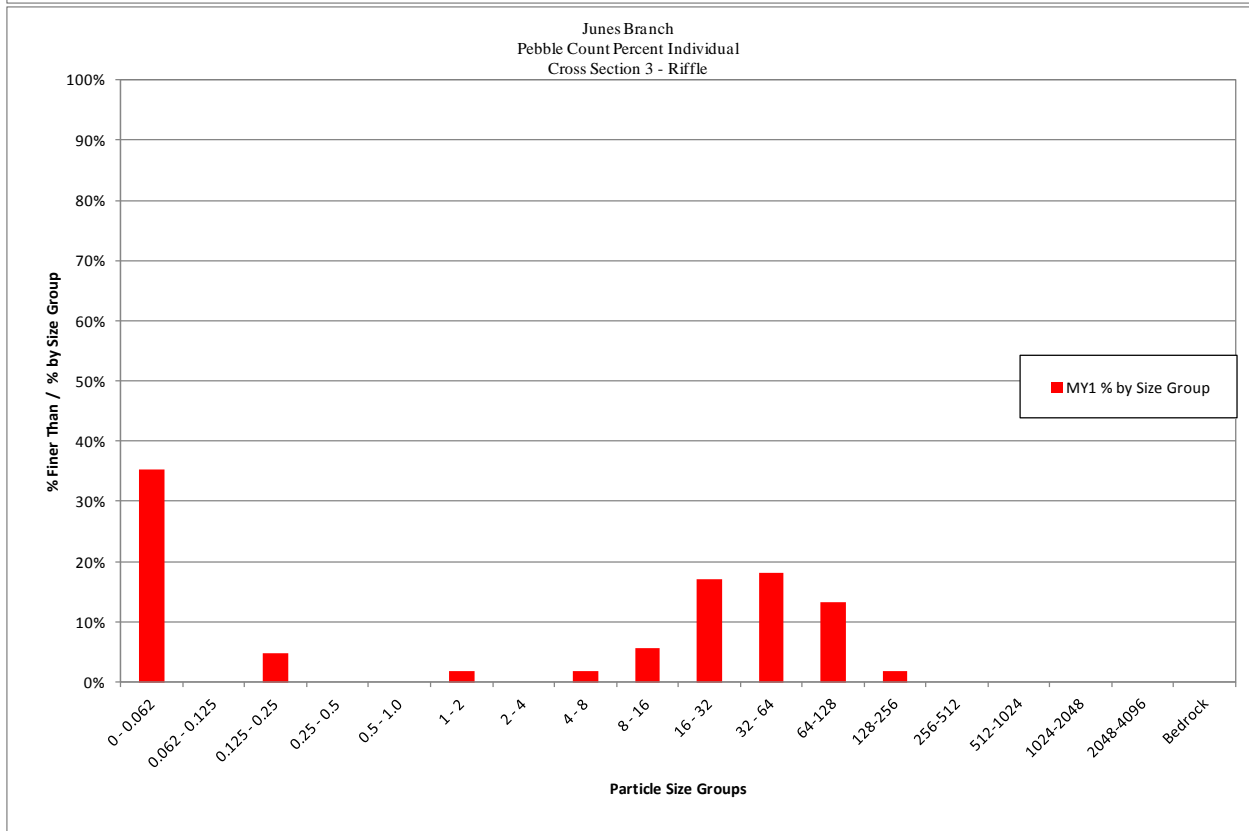
Junes Branch			
Cross Section 3 - Riffle			
Monitoring Year - 2015; MY1			
Bed Surface Material Particle Size Class (mm)	Number	% Individual	% Cumulative
0 - 0.062	37	35.2%	35%
0.062 - 0.125	0	0.0%	35%
0.125 - 0.25	5	4.8%	40%
0.25 - 0.5	0	0.0%	40%
0.5 - 1.0	0	0.0%	40%
1 - 2	2	1.9%	42%
2 - 4	0	0.0%	42%
4 - 8	2	1.9%	44%
8 - 16	6	5.7%	50%
16 - 32	18	17.1%	67%
32 - 64	19	18.1%	85%
64-128	14	13.3%	98%
128-256	2	1.9%	100%
256-512	0	0.0%	100%
512-1024	0	0.0%	100%
1024-2048	0	0.0%	100%
2048-4096	0	0.0%	100%
Bedrock	0	0.0%	100%
Total	105	100%	100%
		Summary Data	
		D50	16
		D84	62
		D95	87

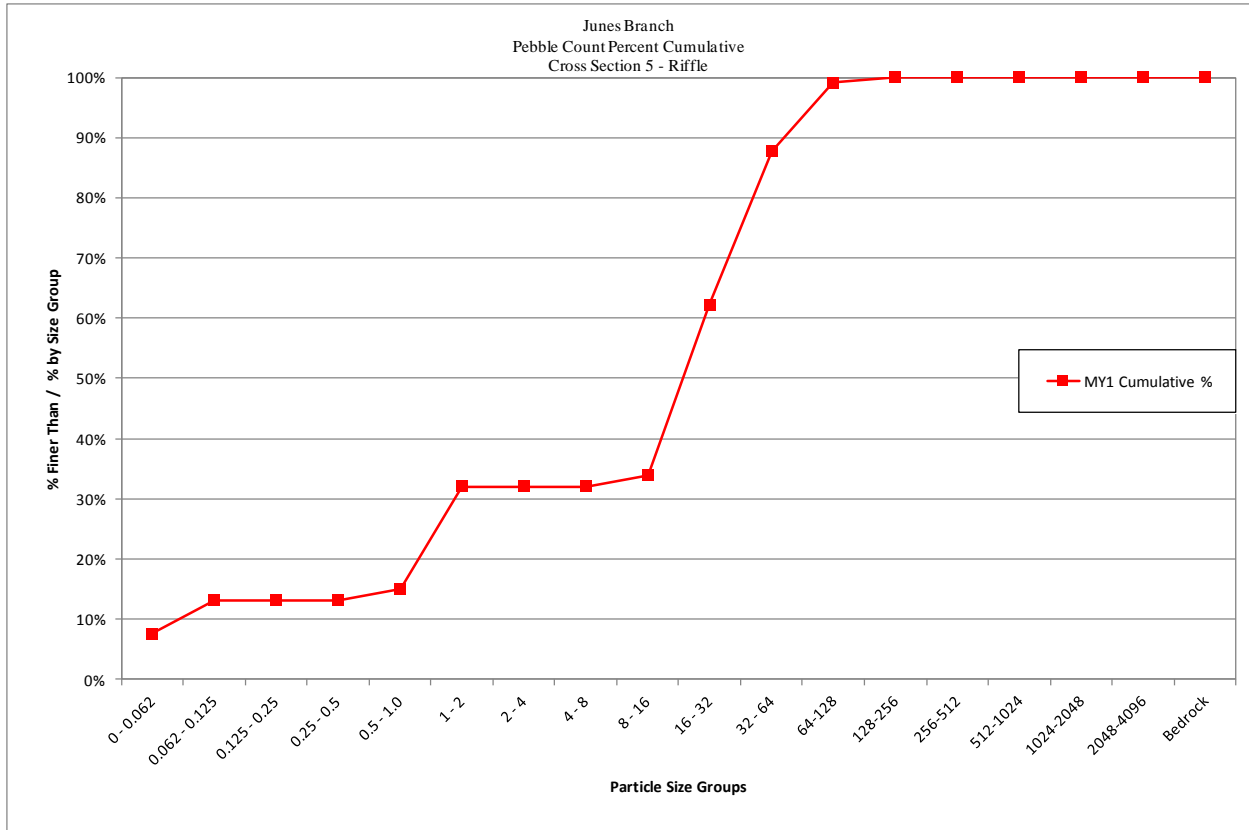
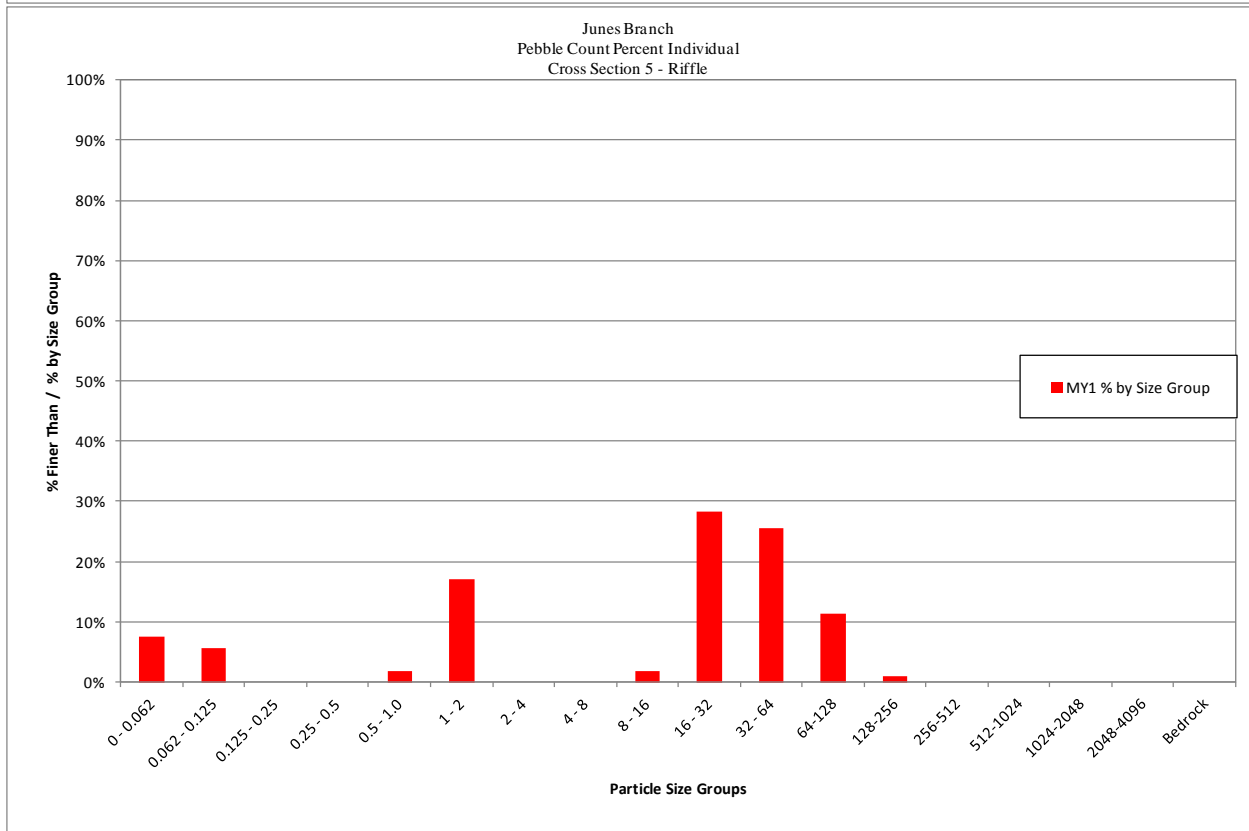
Junes Branch			
Cross Section 5 - Riffle			
Monitoring Year - 2015; MY1			
Bed Surface Material Particle Size Class (mm)	Number	% Individual	% Cumulative
0 - 0.062	8	7.5%	8%
0.062 - 0.125	6	5.7%	13%
0.125 - 0.25	0	0.0%	13%
0.25 - 0.5	0	0.0%	13%
0.5 - 1.0	2	1.9%	15%
1 - 2	18	17.0%	32%
2 - 4	0	0.0%	32%
4 - 8	0	0.0%	32%
8 - 16	2	1.9%	34%
16 - 32	30	28.3%	62%
32 - 64	27	25.5%	88%
64-128	12	11.3%	99%
128-256	1	0.9%	100%
256-512	0	0.0%	100%
512-1024	0	0.0%	100%
1024-2048	0	0.0%	100%
2048-4096	0	0.0%	100%
Bedrock	0	0.0%	100%
Total	106	100%	100%
		Summary Data	
		D50	25
		D84	56
		D95	95

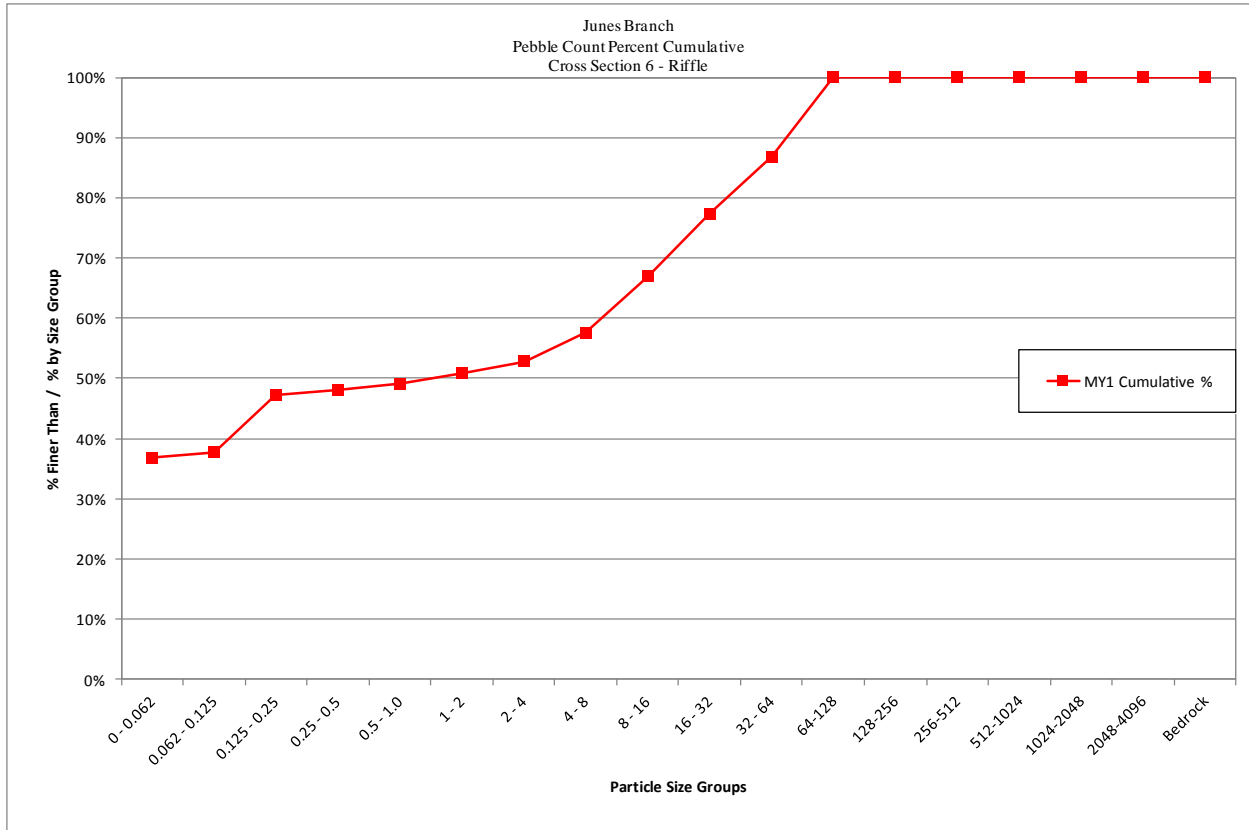
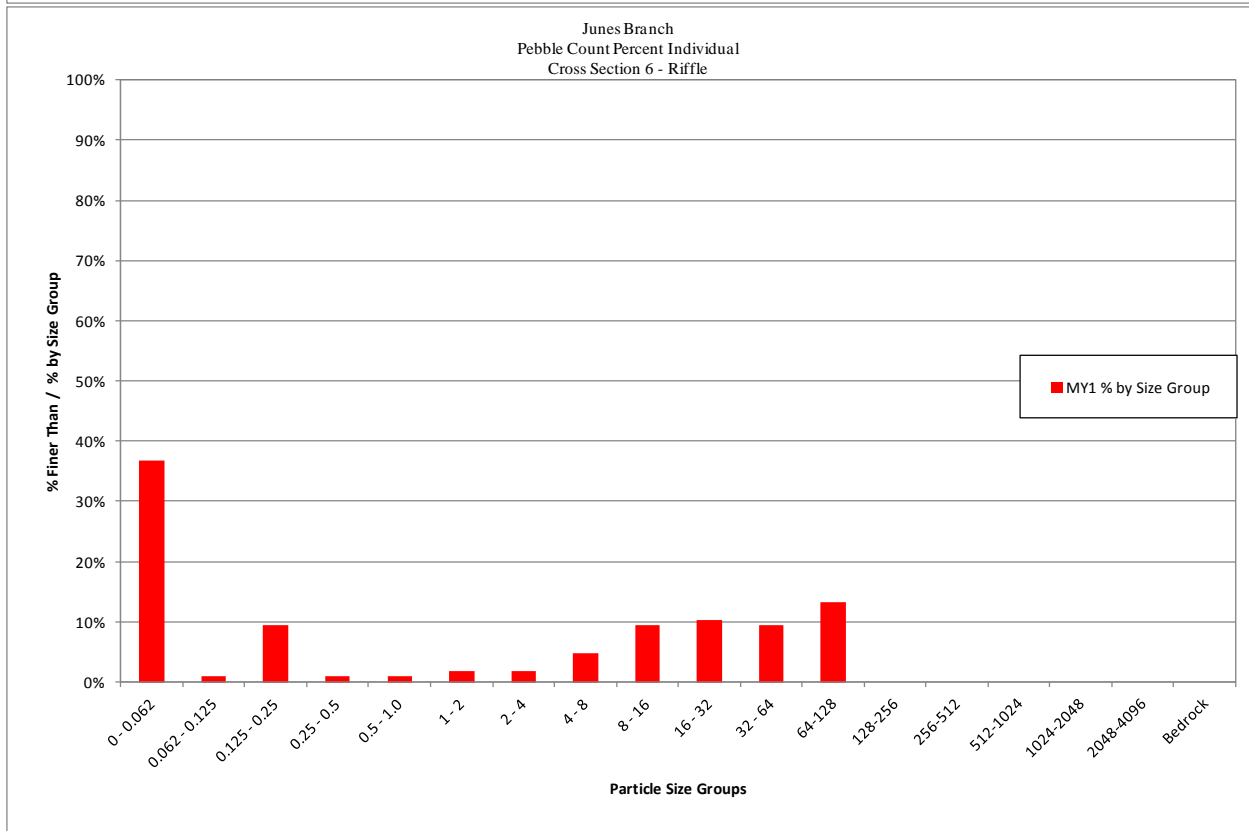
Junes Branch			
Cross Section 6 - Riffle			
Monitoring Year - 2015; MY1			
Bed Surface Material Particle Size Class (mm)	Number	% Individual	% Cumulative
0 - 0.062	39	36.8%	37%
0.062 - 0.125	1	0.9%	38%
0.125 - 0.25	10	9.4%	47%
0.25 - 0.5	1	0.9%	48%
0.5 - 1.0	1	0.9%	49%
1 - 2	2	1.9%	51%
2 - 4	2	1.9%	53%
4 - 8	5	4.7%	58%
8 - 16	10	9.4%	67%
16 - 32	11	10.4%	77%
32 - 64	10	9.4%	87%
64-128	14	13.2%	100%
128-256	0	0.0%	100%
256-512	0	0.0%	100%
512-1024	0	0.0%	100%
1024-2048	0	0.0%	100%
2048-4096	0	0.0%	100%
Bedrock	0	0.0%	100%
Total	106	100%	100%
		Summary Data	
		D50	1.4
		D84	52
		D95	86

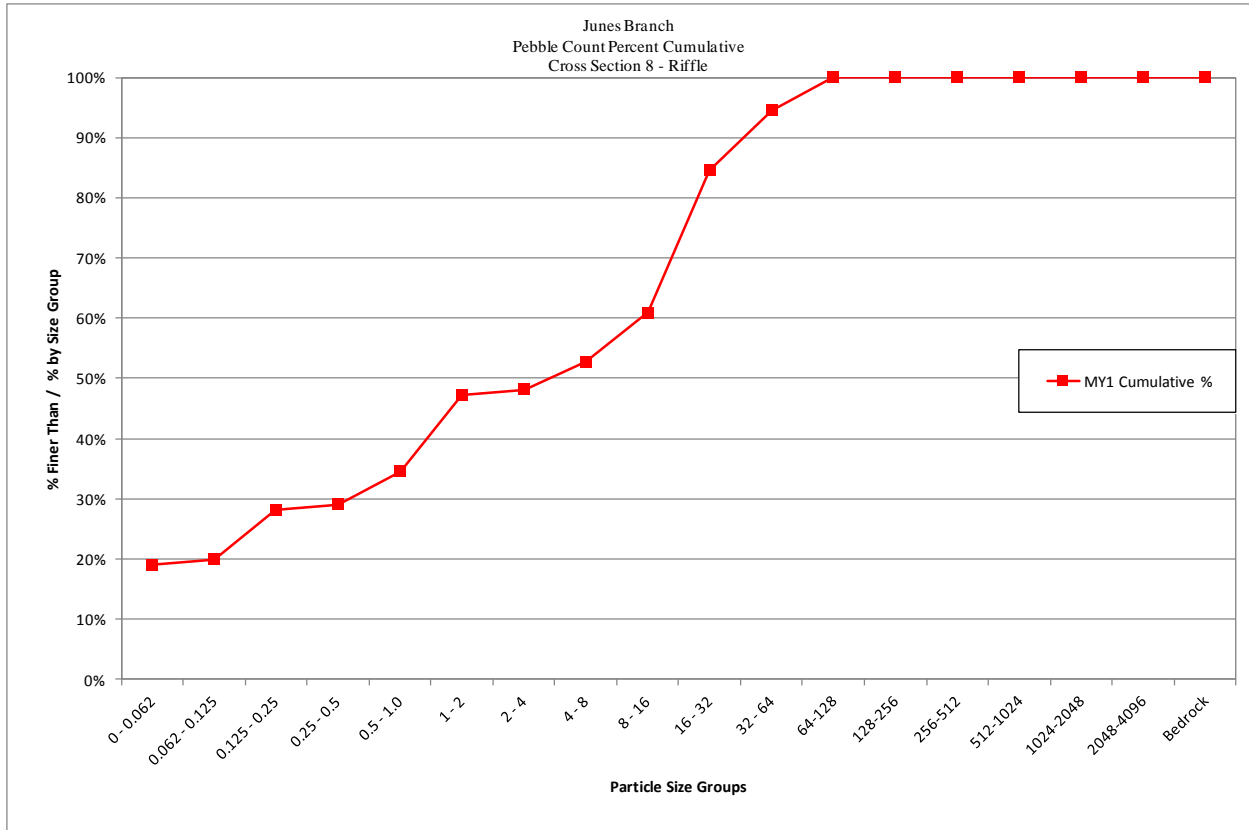
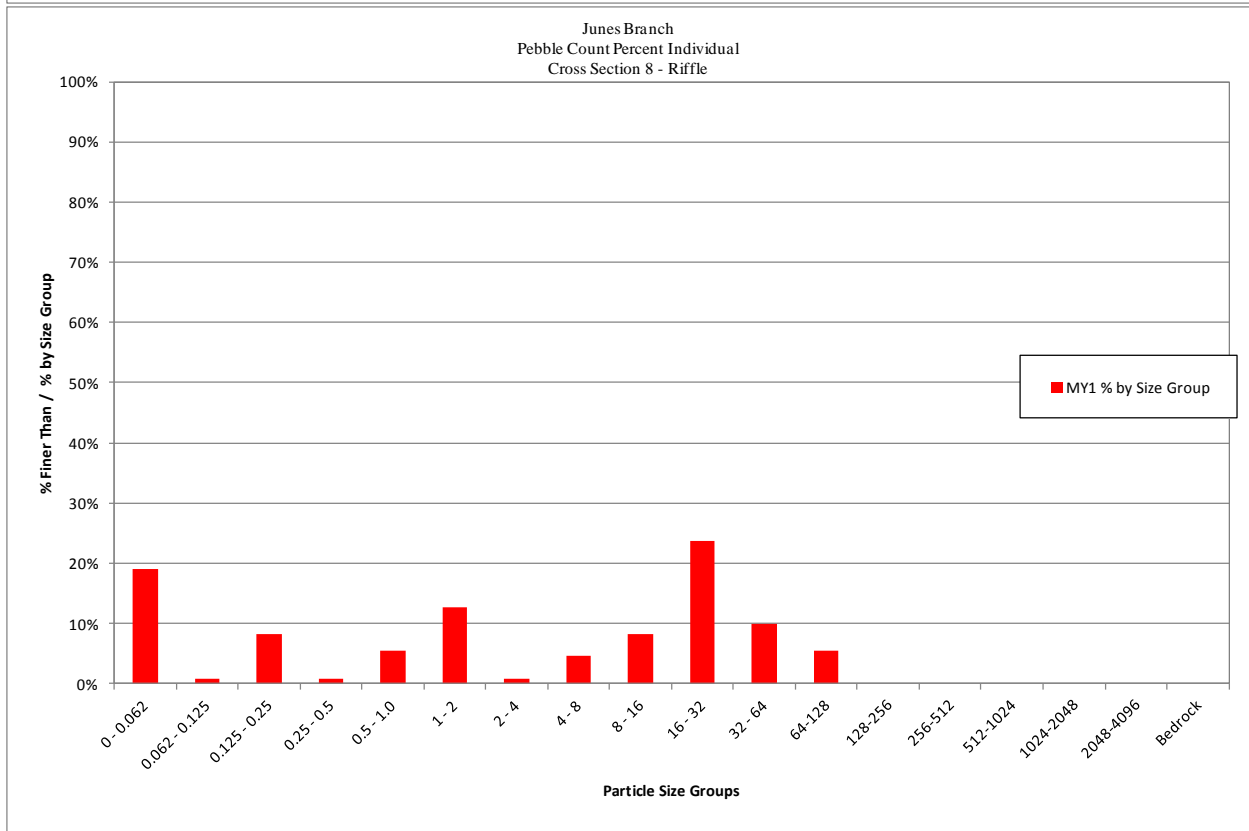
Junes Branch			
Cross Section 8 - Riffle			
Monitoring Year - 2015; MY1			
Bed Surface Material Particle Size Class (mm)	Number	% Individual	% Cumulative
0 - 0.062	21	19.1%	19%
0.062 - 0.125	1	0.9%	20%
0.125 - 0.25	9	8.2%	28%
0.25 - 0.5	1	0.9%	29%
0.5 - 1.0	6	5.5%	35%
1 - 2	14	12.7%	47%
2 - 4	1	0.9%	48%
4 - 8	5	4.5%	53%
8 - 16	9	8.2%	61%
16 - 32	26	23.6%	85%
32 - 64	11	10.0%	95%
64-128	6	5.5%	100%
128-256	0	0.0%	100%
256-512	0	0.0%	100%
512-1024	0	0.0%	100%
1024-2048	0	0.0%	100%
2048-4096	0	0.0%	100%
Bedrock	0	0.0%	100%
Total	110	100%	100%
		Summary Data	
		D50	4.7
		D84	32
		D95	66

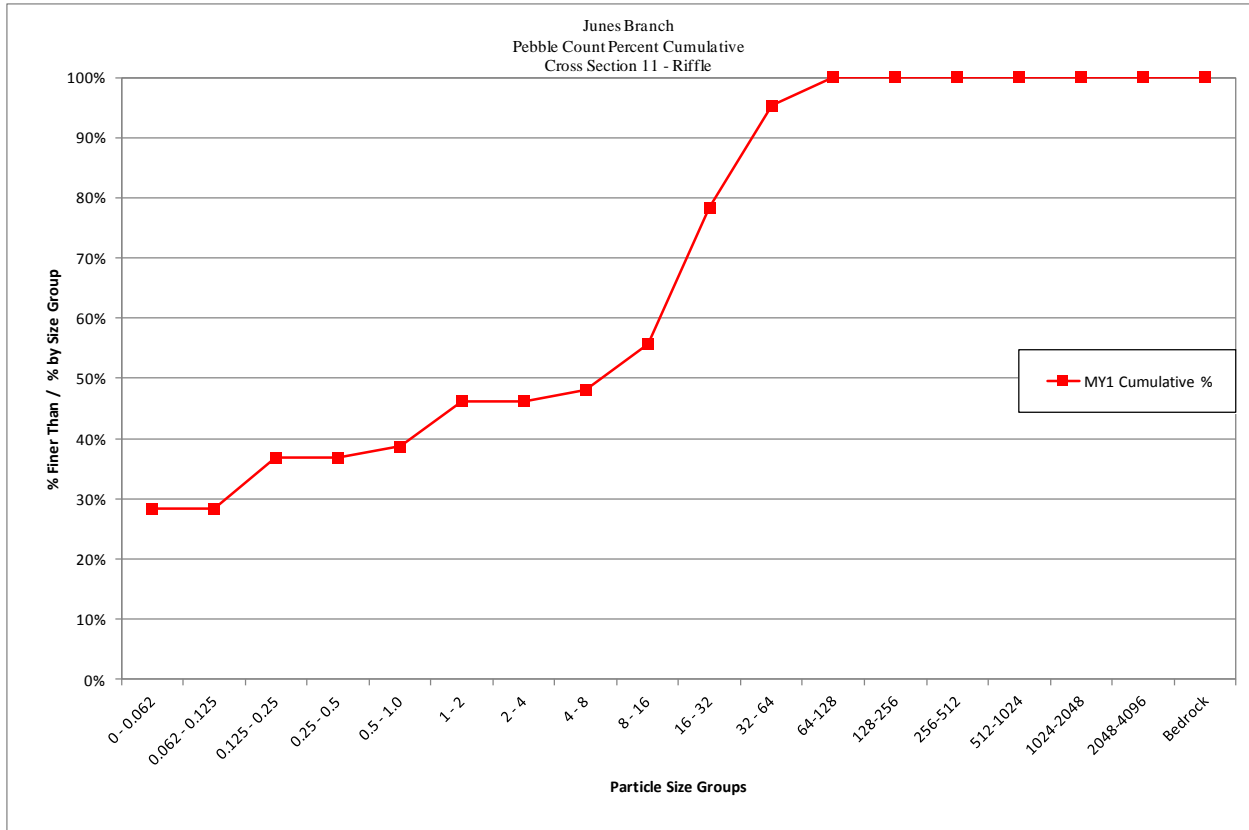
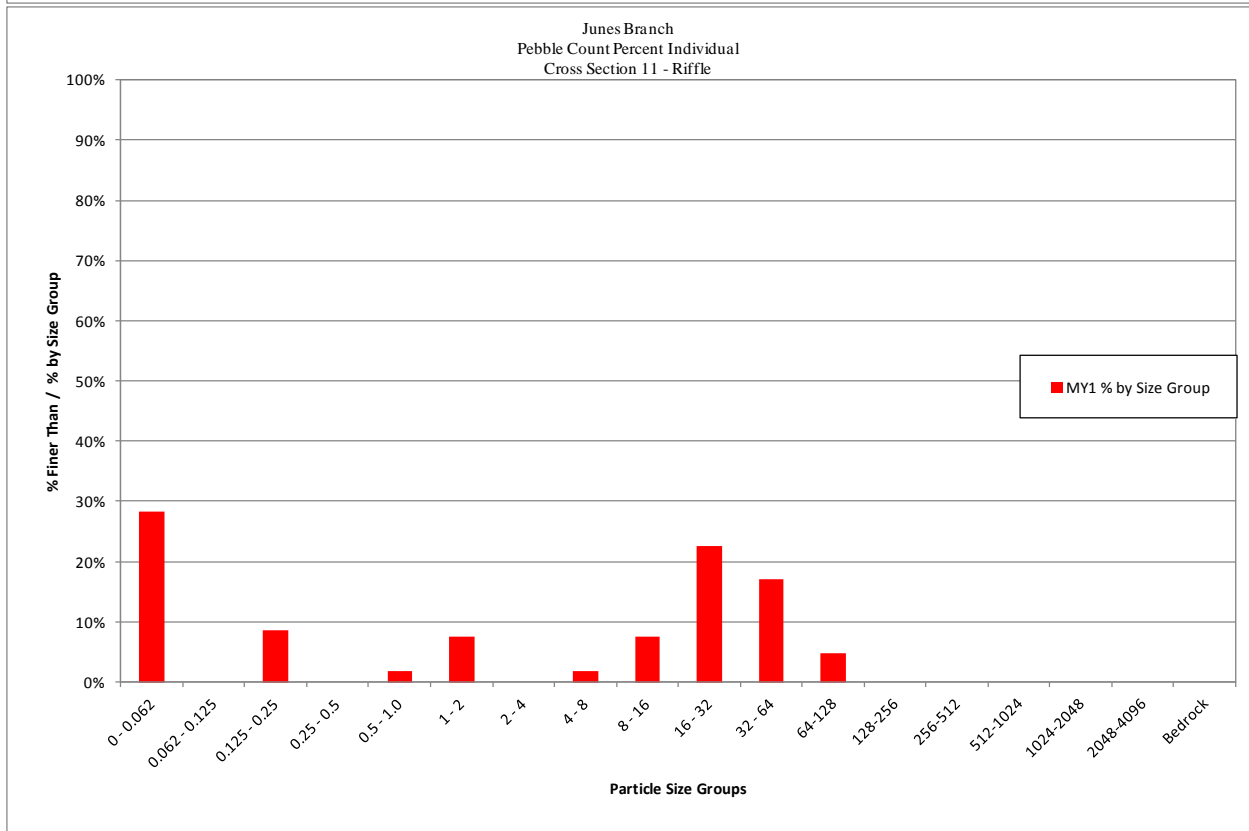
Junes Branch			
Cross Section 11 - Riffle			
Monitoring Year - 2015; MY1			
Bed Surface Material Particle Size Class (mm)	Number	% Individual	% Cumulative
0 - 0.062	30	28.3%	28%
0.062 - 0.125	0	0.0%	28%
0.125 - 0.25	9	8.5%	37%
0.25 - 0.5	0	0.0%	37%
0.5 - 1.0	2	1.9%	39%
1 - 2	8	7.5%	46%
2 - 4	0	0.0%	46%
4 - 8	2	1.9%	48%
8 - 16	8	7.5%	56%
16 - 32	24	22.6%	78%
32 - 64	18	17.0%	95%
64-128	5	4.7%	100%
128-256	0	0.0%	100%
256-512	0	0.0%	100%
512-1024	0	0.0%	100%
1024-2048	0	0.0%	100%
2048-4096	0	0.0%	100%
Bedrock	0	0.0%	100%
Total	106	100%	100%
		Summary Data	
		D50	12
		D84	39
		D95	63

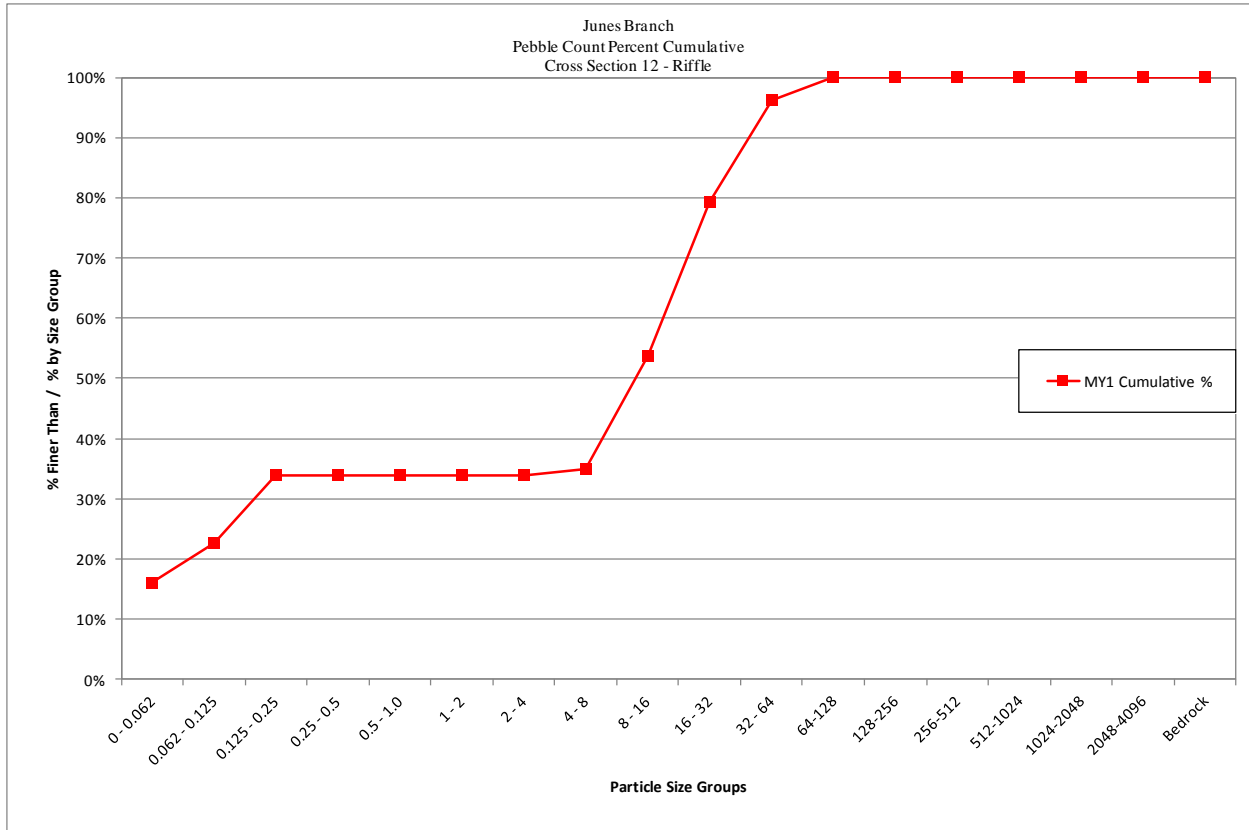
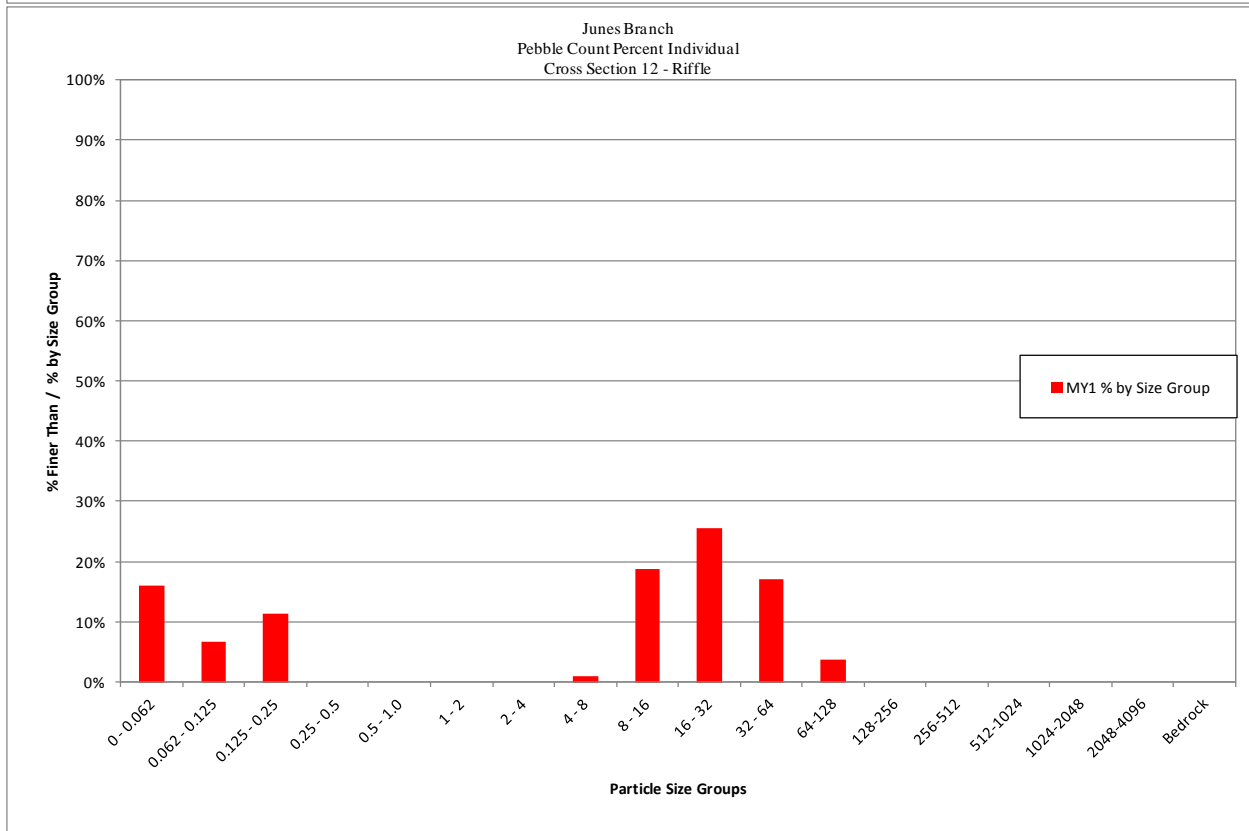
Junes Branch			
Cross Section 12 - Riffle			
Monitoring Year - 2015; MY1			
Bed Surface Material Particle Size Class (mm)	Number	% Individual	% Cumulative
0 - 0.062	17	16.0%	16%
0.062 - 0.125	7	6.6%	23%
0.125 - 0.25	12	11.3%	34%
0.25 - 0.5	0	0.0%	34%
0.5 - 1.0	0	0.0%	34%
1 - 2	0	0.0%	34%
2 - 4	0	0.0%	34%
4 - 8	1	0.9%	35%
8 - 16	20	18.9%	54%
16 - 32	27	25.5%	79%
32 - 64	18	17.0%	96%
64-128	4	3.8%	100%
128-256	0	0.0%	100%
256-512	0	0.0%	100%
512-1024	0	0.0%	100%
1024-2048	0	0.0%	100%
2048-4096	0	0.0%	100%
Bedrock	0	0.0%	100%
Total	106	100%	100%
		Summary Data	
		D50	15
		D84	37
		D95	58

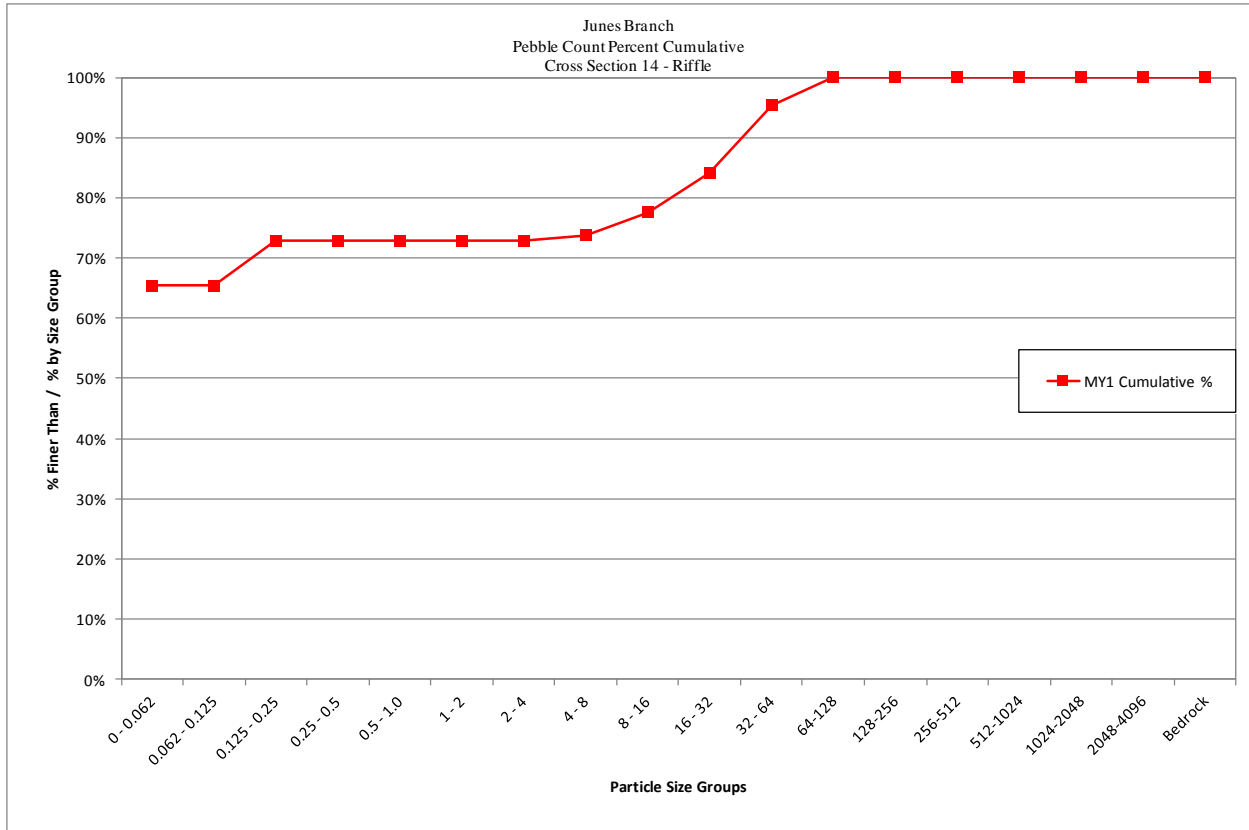
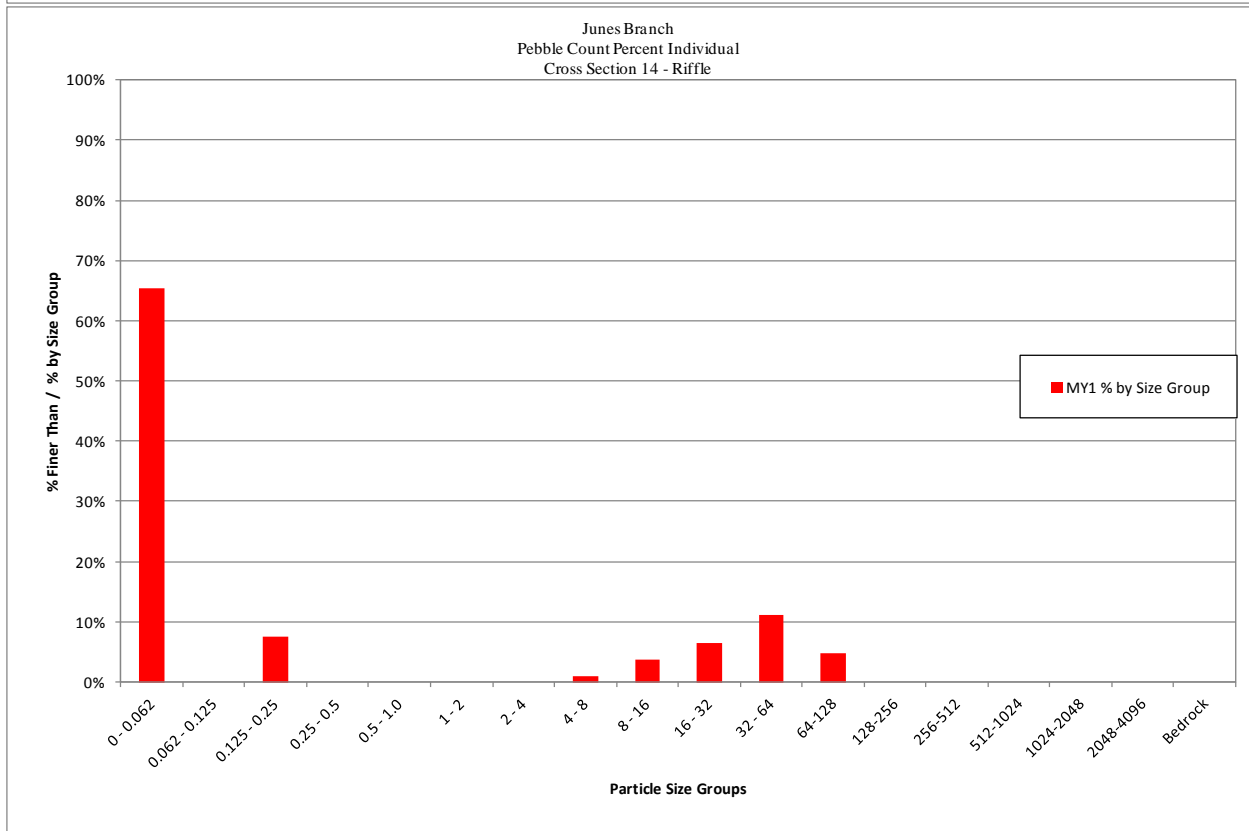
Junes Branch			
Cross Section 14 - Riffle			
Monitoring Year - 2015; MY1			
Bed Surface Material Particle Size Class (mm)	Number	% Individual	% Cumulative
0 - 0.062	70	65.4%	65%
0.062 - 0.125	0	0.0%	65%
0.125 - 0.25	8	7.5%	73%
0.25 - 0.5	0	0.0%	73%
0.5 - 1.0	0	0.0%	73%
1 - 2	0	0.0%	73%
2 - 4	0	0.0%	73%
4 - 8	1	0.9%	74%
8 - 16	4	3.7%	78%
16 - 32	7	6.5%	84%
32 - 64	12	11.2%	95%
64-128	5	4.7%	100%
128-256	0	0.0%	100%
256-512	0	0.0%	100%
512-1024	0	0.0%	100%
1024-2048	0	0.0%	100%
2048-4096	0	0.0%	100%
Bedrock	0	0.0%	100%
Total	107	100%	100%
		Summary Data	
		D50	0.062
		D84	32
		D95	62

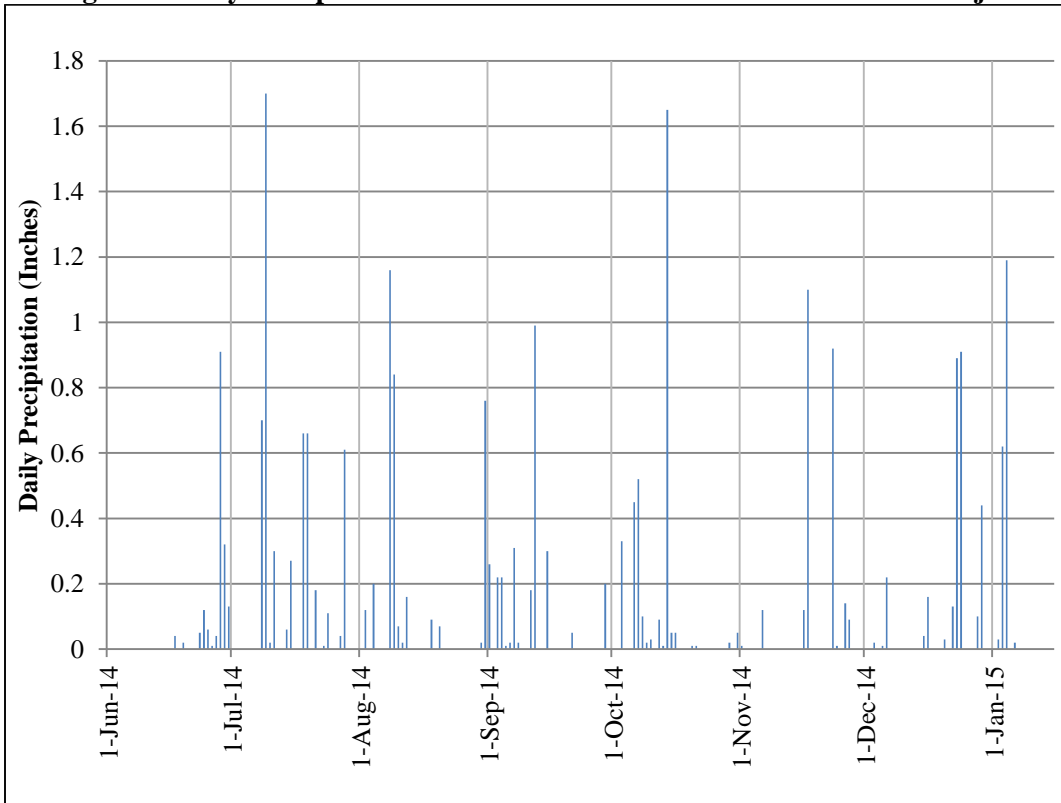
Figure 3. Daily Precipitation Totals for the Junes Branch Restoration Project

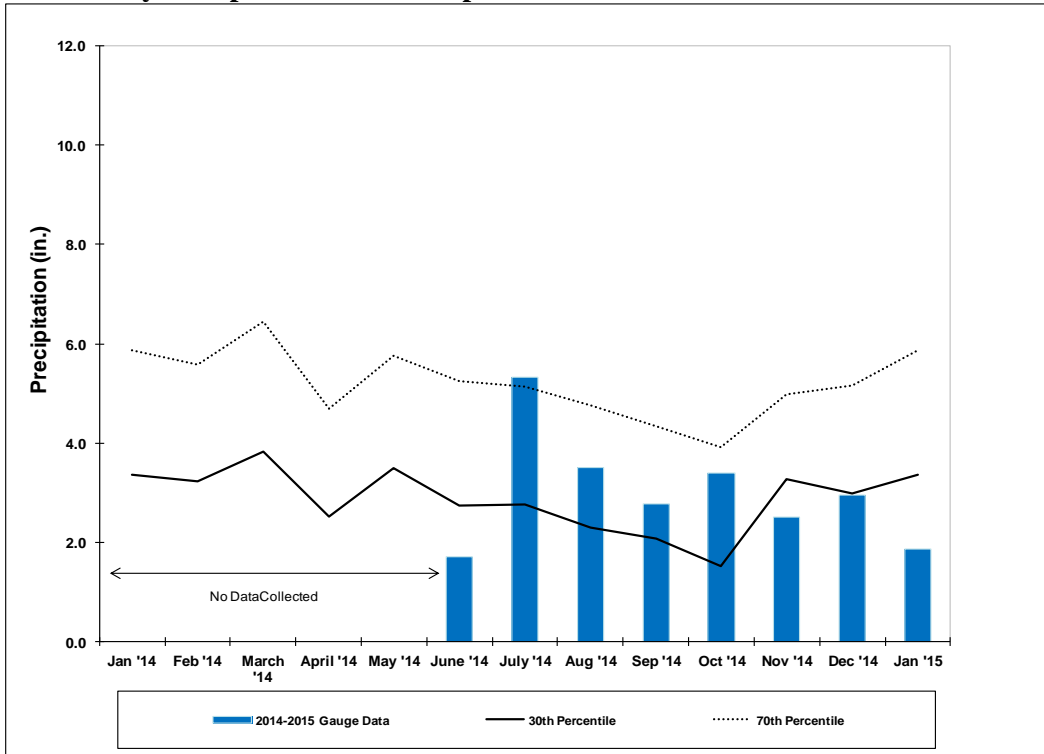
Figure 4. Monthly Precipitation Data Compared to 30th and 70th Percentiles for Jackson County
