Annual Monitoring Report

Monitoring Year 2 of 5

Project Name: Junes Branch Stream Restoration

Jackson County, NC

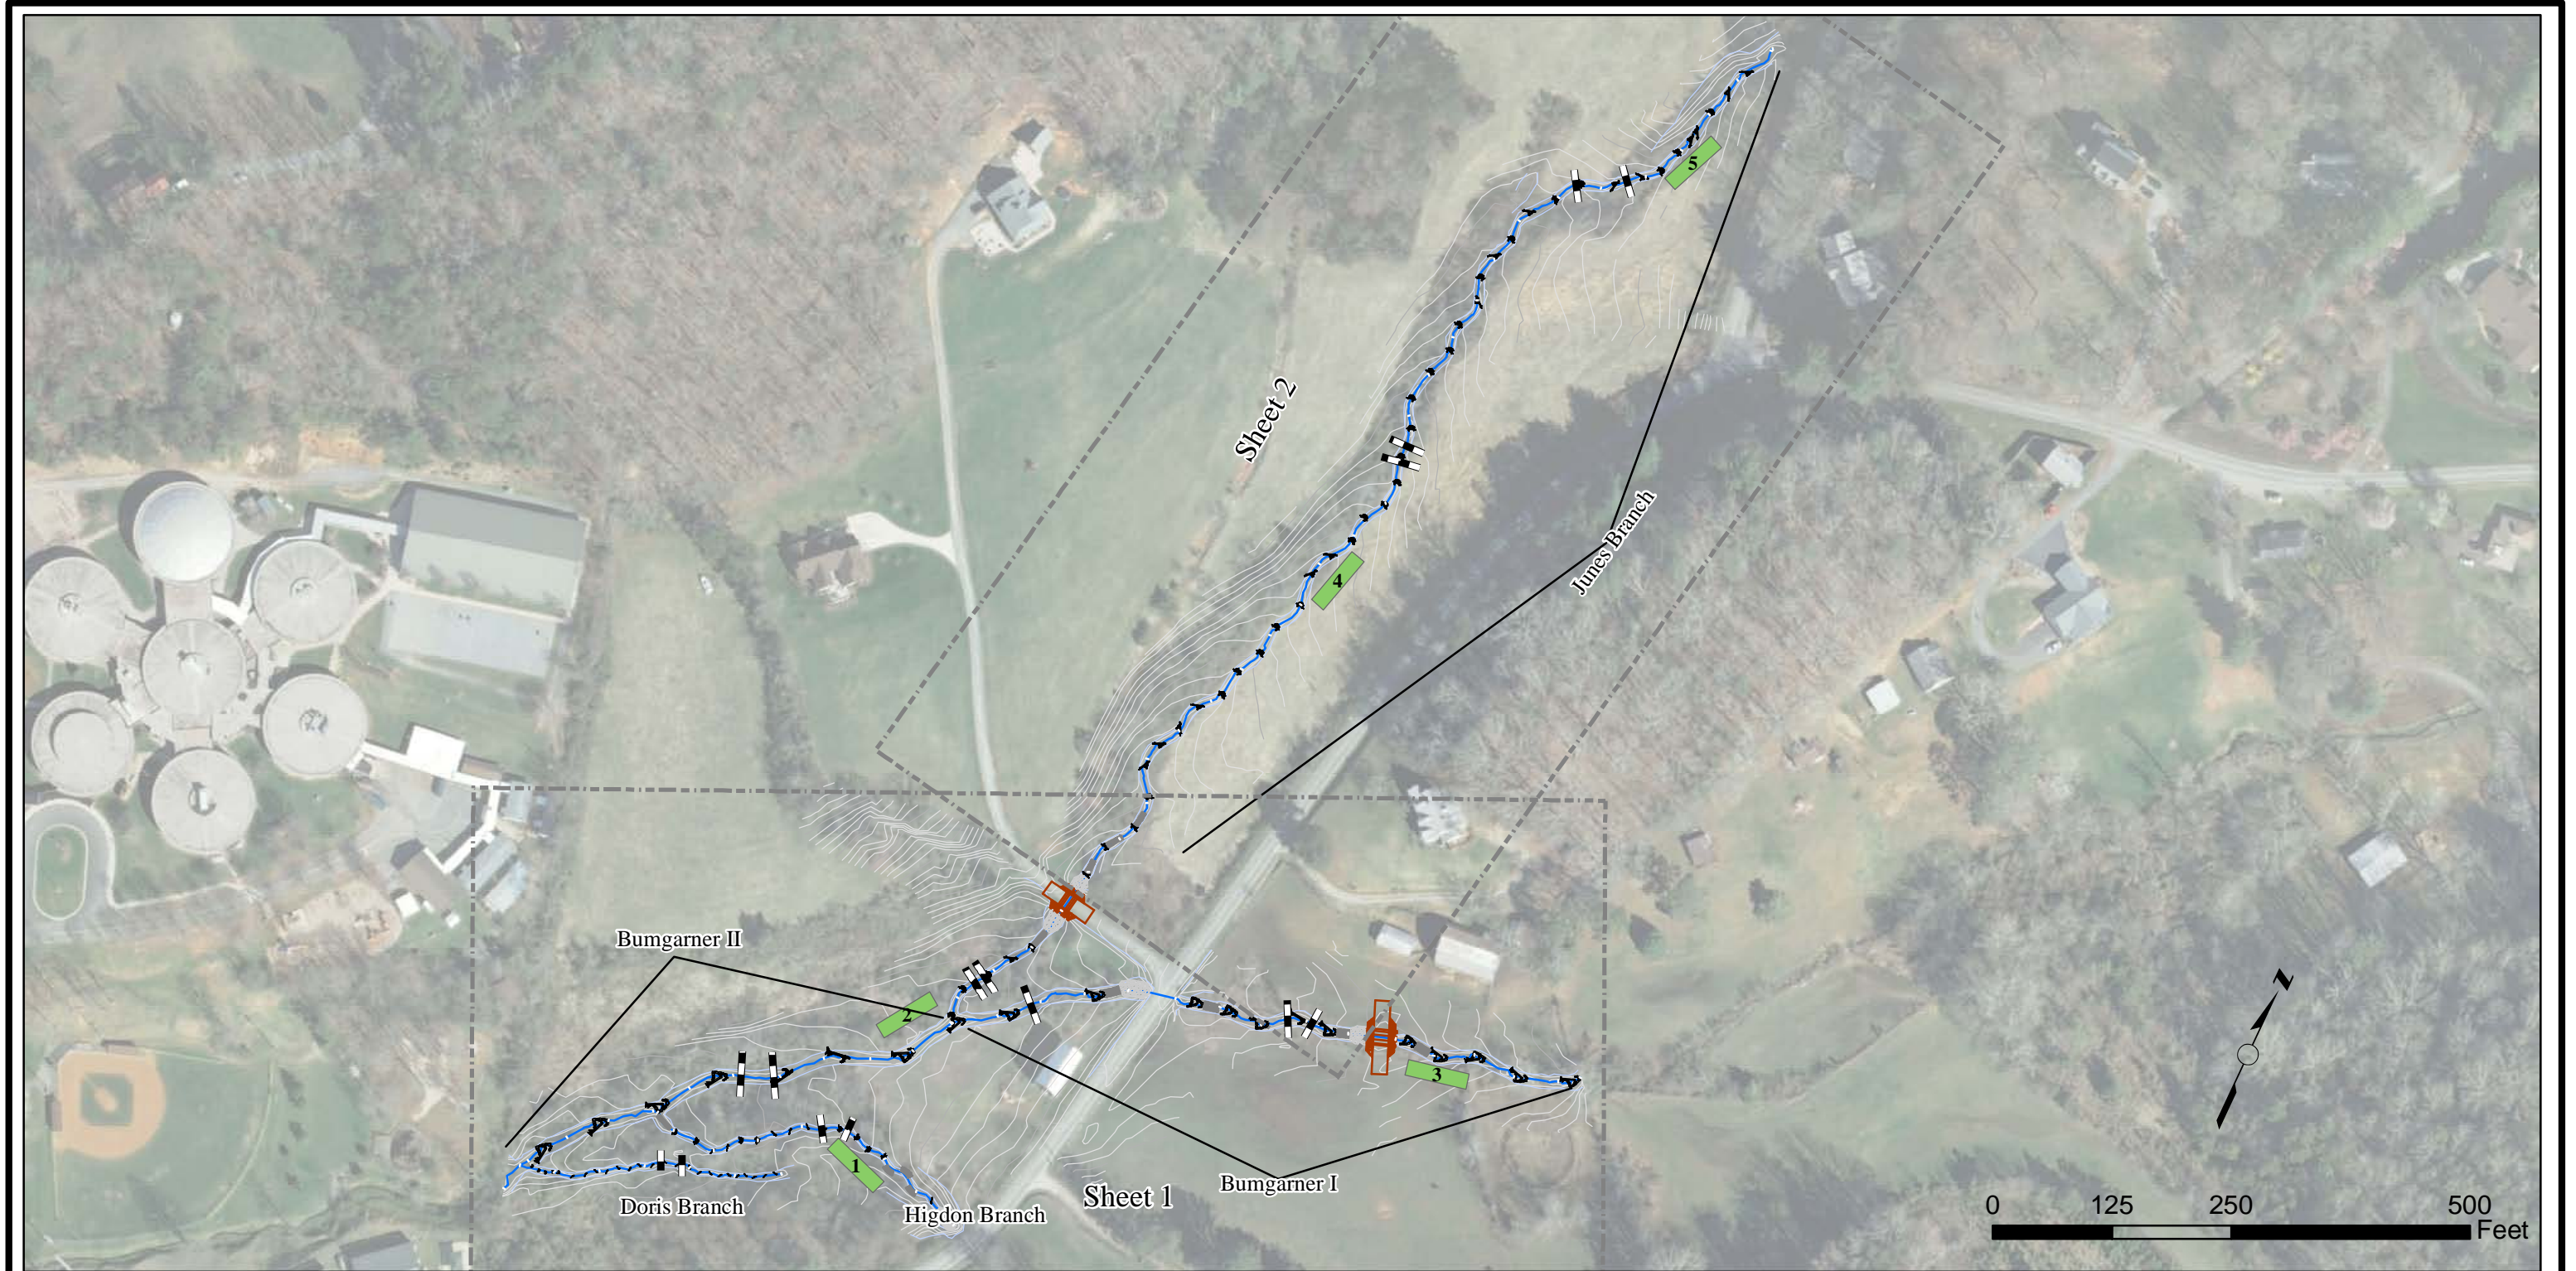
Figure 2. Integrated Current Condition Plan View Draft

Prepared for	Junes Branch Stream Restoration Project Monitoring Year 2 Sylva, Jackson County, NC NCDMS Contract No. 003979 NCDMS Project No.: 95027 November 2015 Overview

<table><tr> <td></td> <td>Cross-Section</td> <td></td> <td>Hook-Log Run</td> <td></td> <td>Log Vane with Hook</td> </tr></table>

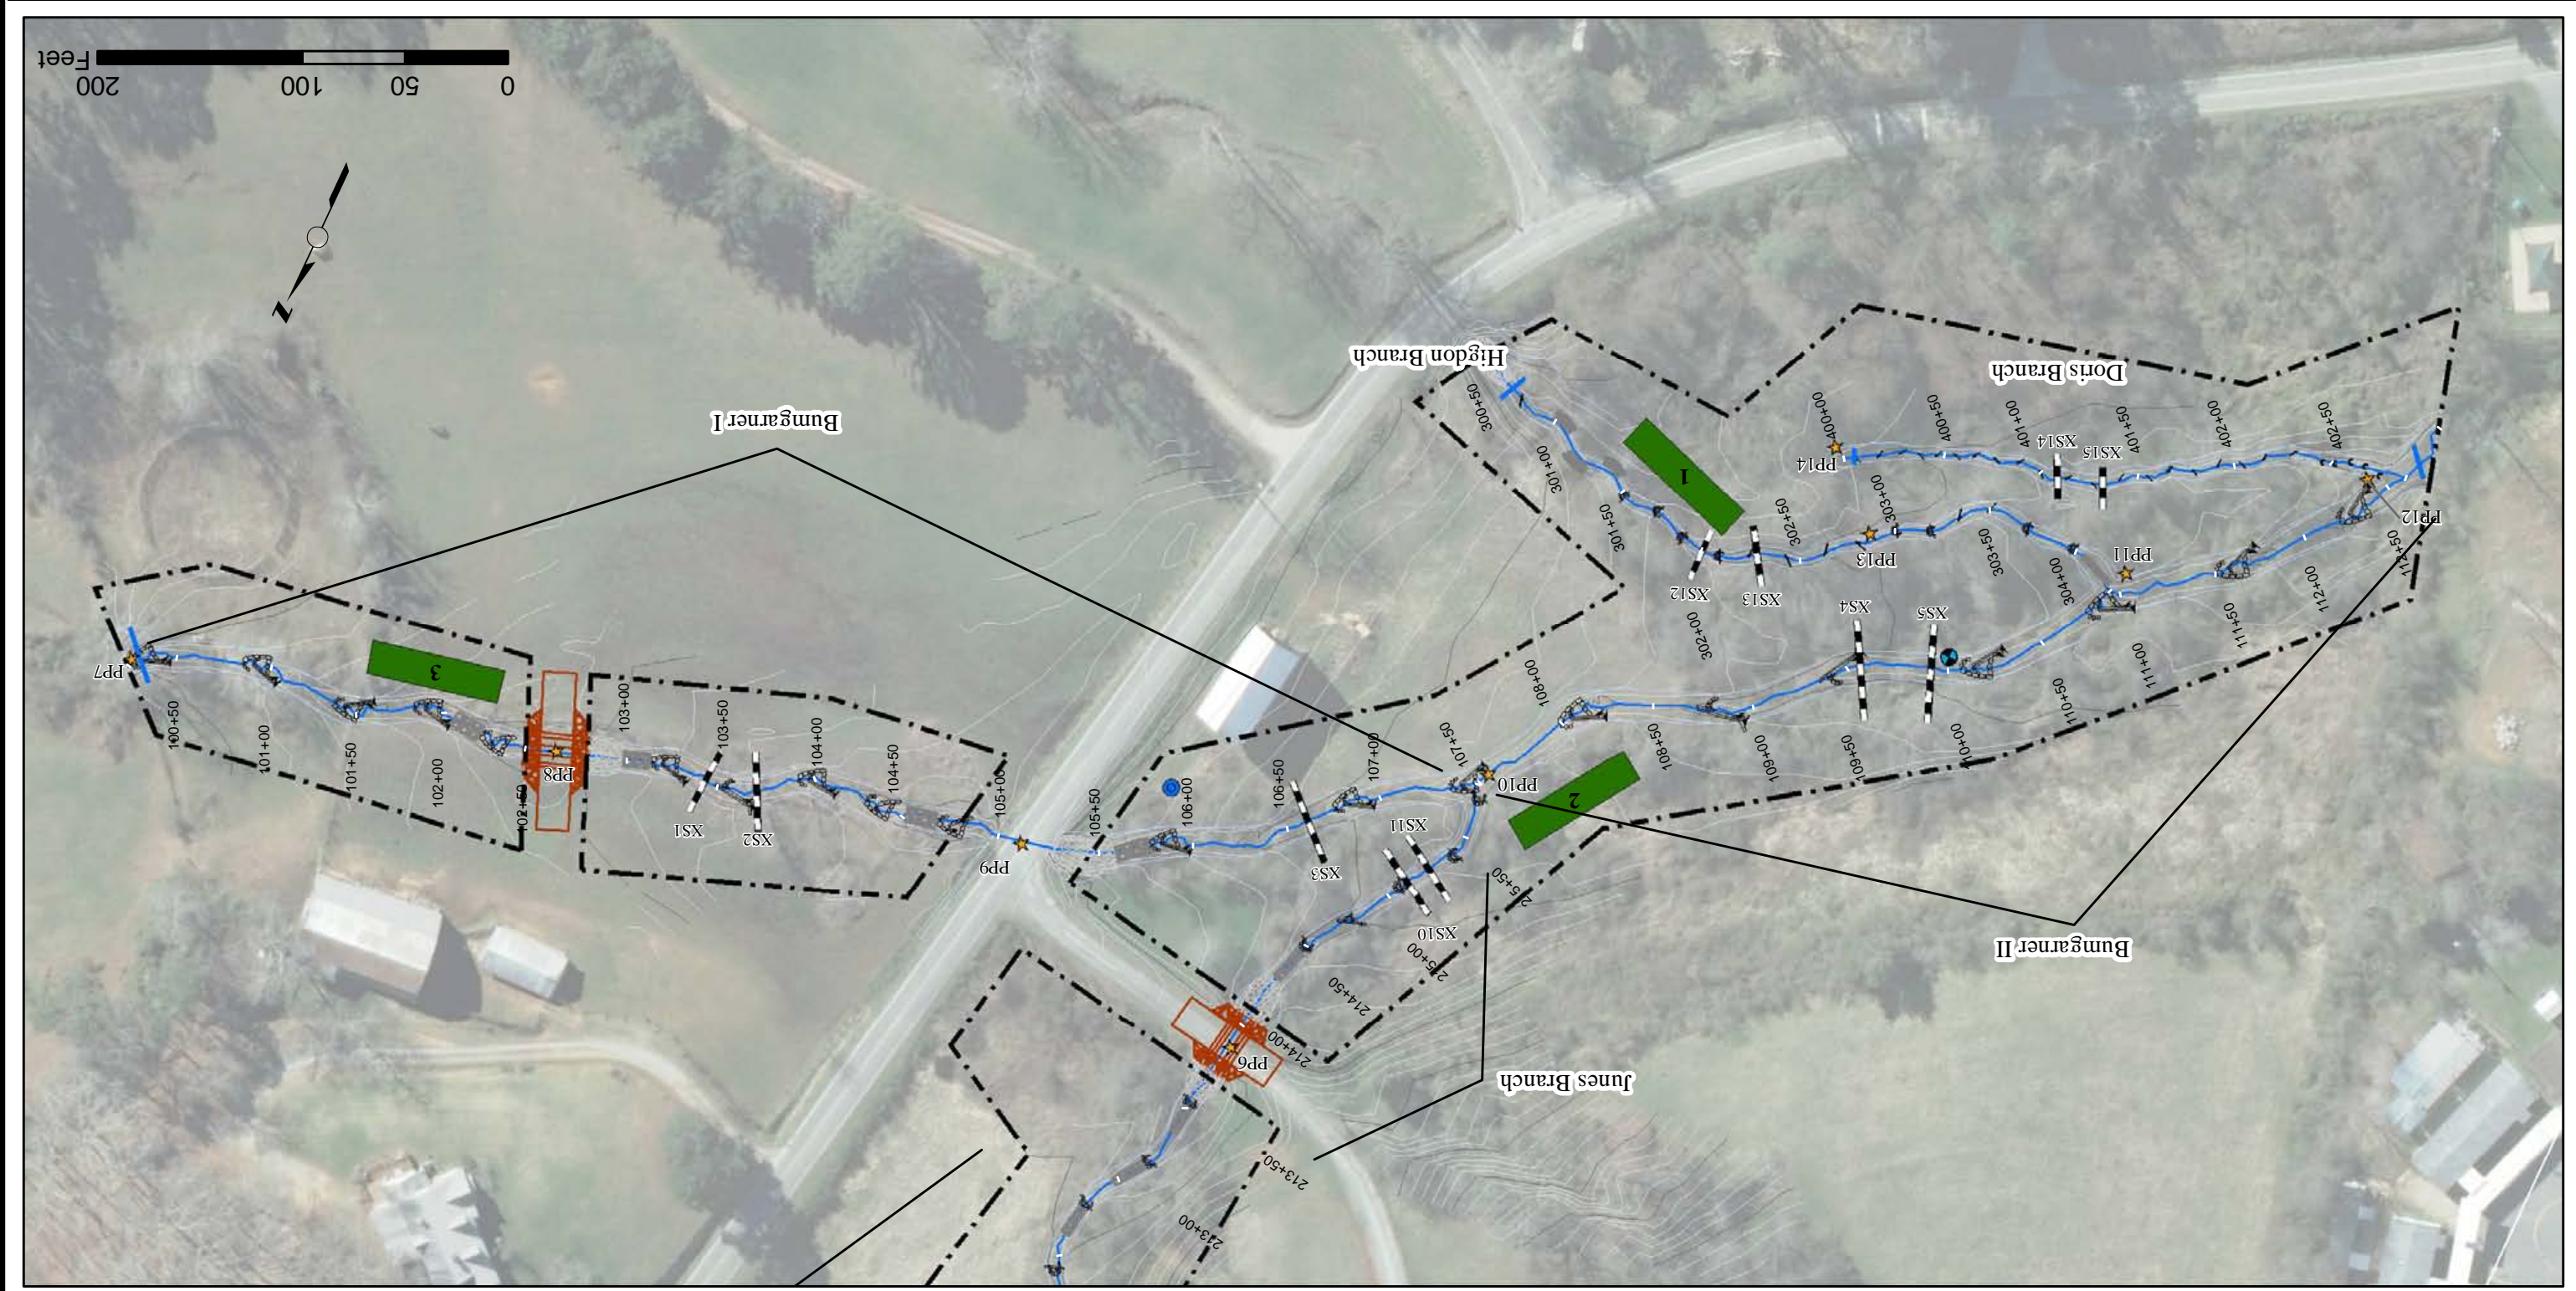
Figure 2. Integrated Current Condition Plan View

Rain Gauge
	Crest Gauge
	Photo Point
	Control Point
	Cross-Section
	Thalweg
	Top of Bank
	Contour-Major
	Contour-Minor

Easement
	Bare Area
	Encroachment
	Hook-Log Run
	Hook Run
	Boulder-Arch
	Boulder-Arch with Log
	Armored Rifle

Vegetation Plot Success
	Criteria Met
	Criteria Unmet
	Log Vane with Hook
	Log Sill
	Log Sill no Baffle
	Brush Toe

Generally, visual assessment of the project as a whole indicates that the streams are performing as desired and, with the exception of two small bare areas, vegetation is well established throughout the easement. Summary tables and photos taken at the permanent photo stations associated with the visual assessment are presented in Appendix B. Visual assessment of the stream was performed to document signs of instability, such as eroding banks, in-stream structural instability, or excessive sedimentation. No indication of instability was observed (Table 5 and Figure 2). Structures are intact and performing as designed. Herbaceous vegetation has become well established in both the wetland fringes along the stream as well as upland areas. Planted stems are becoming well established; however, two bare areas totaling 0.07 acre were noted along the Junes Branch reach (Table 6, Figure 2). The one small area of encroachment (mowing) noted at the private driveway crossing during MY1 has been corrected and vegetation is becoming re-established.

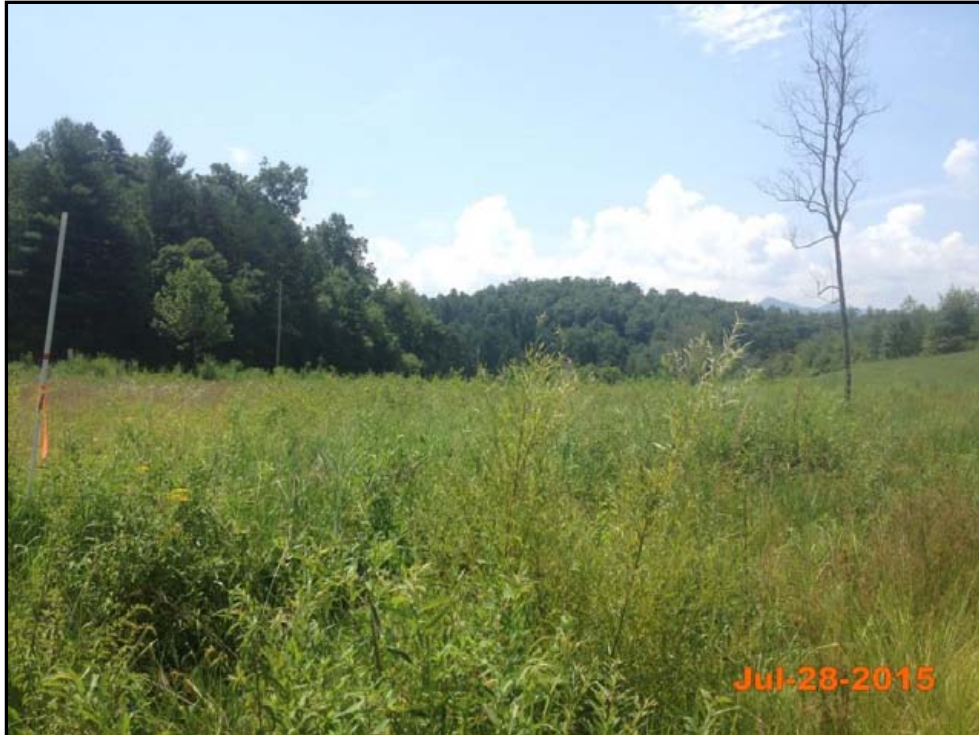
Junes Branch – Permanent Photo Station 1
Station 202+60 - Downstream

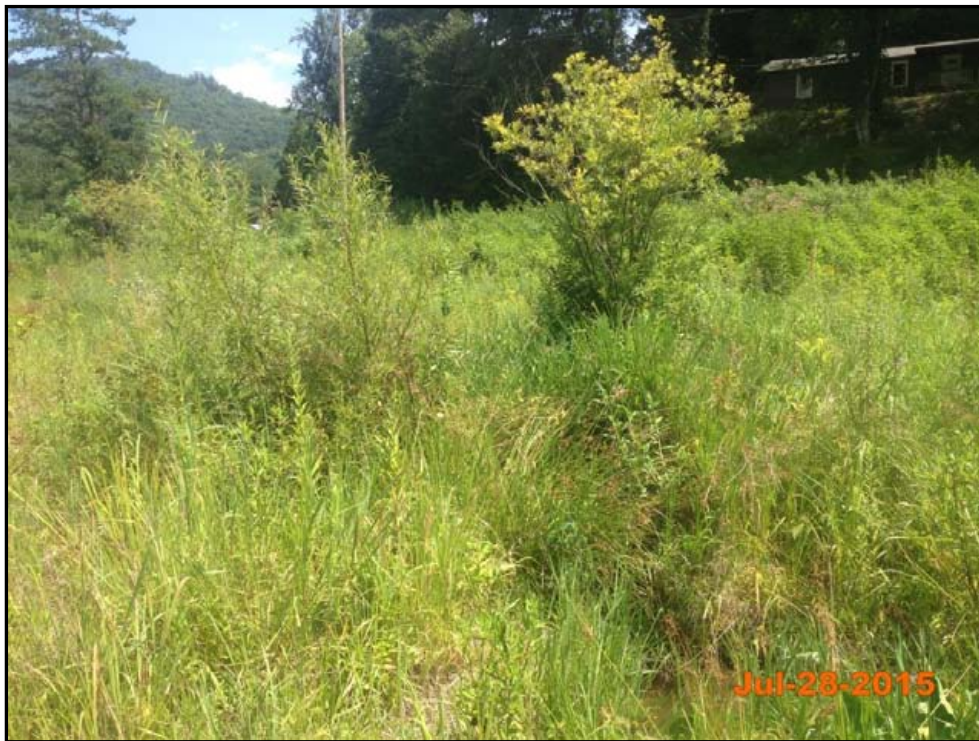
Junes Branch – Permanent Photo Station 1
Station 202+60 - Upstream

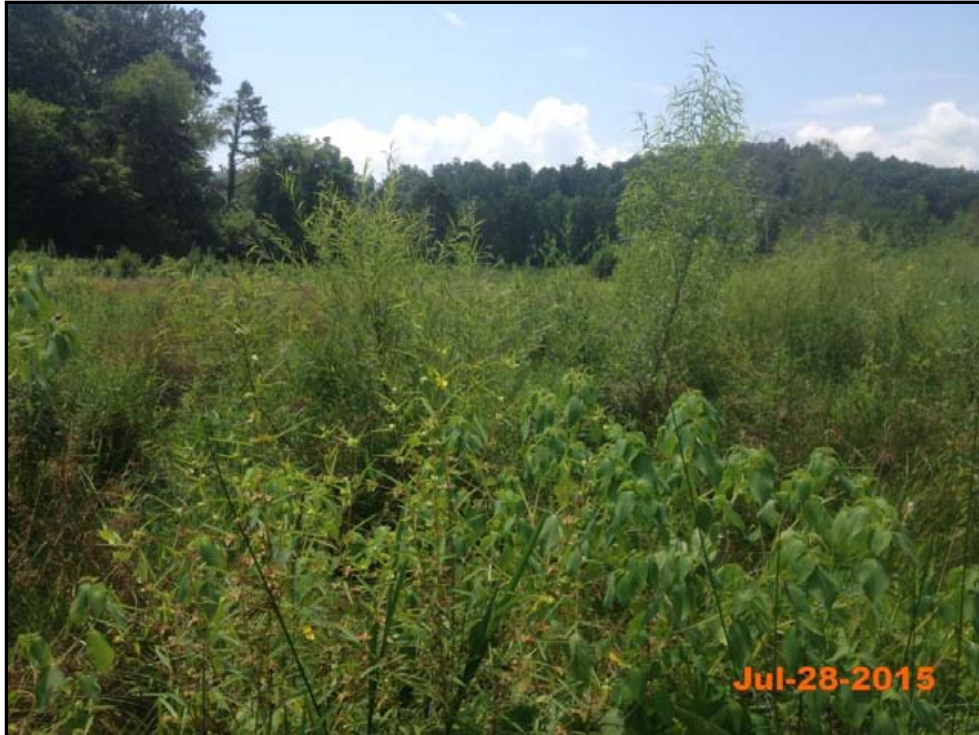
Junes Branch – Permanent Photo Station 2
Station 206+30 - Downstream

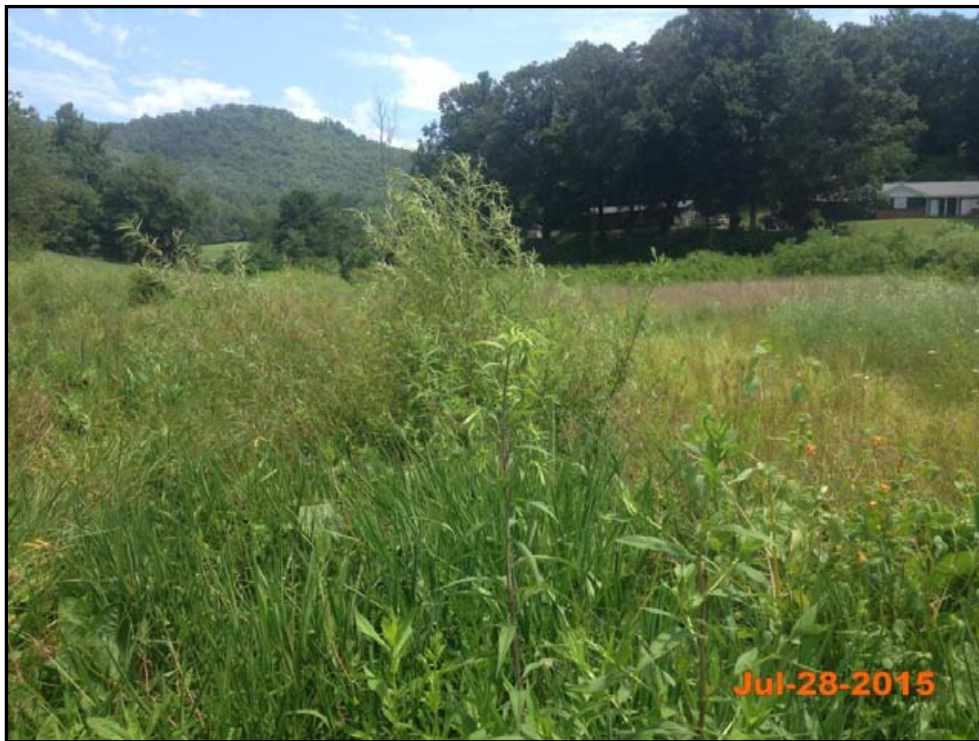
Junes Branch – Permanent Photo Station 2
Station 206+30 - Upstream

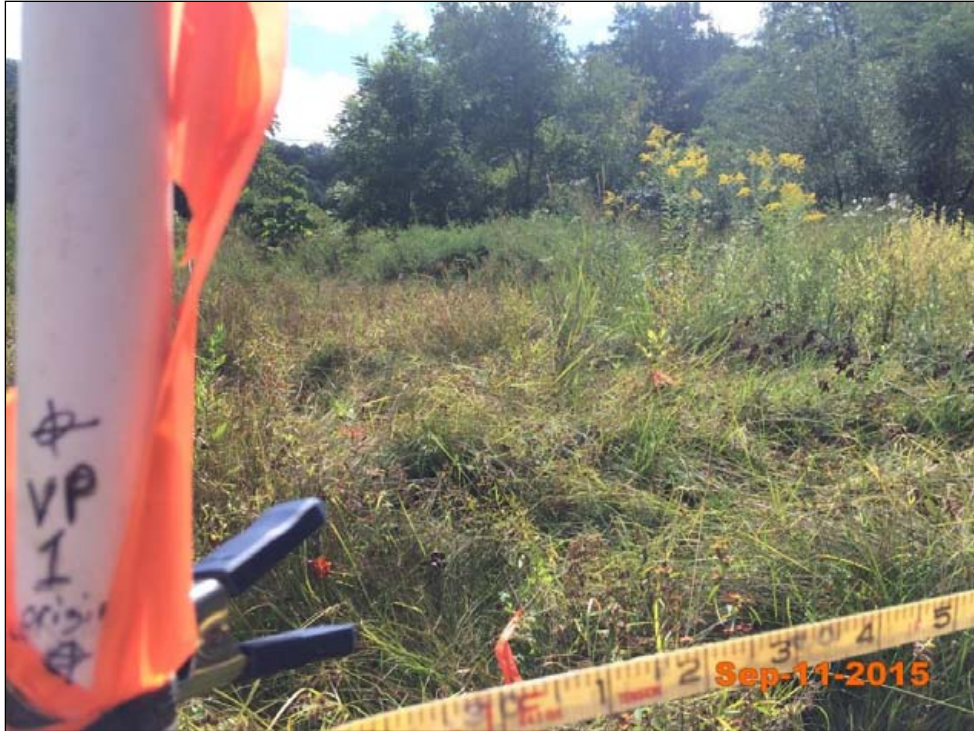
Junes Branch - Vegetation Monitoring Plot 1
September 11, 2015

Monitoring of permanent vegetation monitoring plots ($n = 5$) was completed during September 2015. Summary tables and photographs associated with MY2 monitoring can be found in Appendix C. Vegetation data for MY2 indicate that all vegetation monitoring plots are on track to meet the MY3 interim success criteria of 320 stems per acre. Stem densities ranged from 364 to 688 stems per acre with a mean of 526 stems per acre across all plots. A total of 12 species were documented within the monitoring plots. When volunteer stems are included, densities ranged between 728 and 2,064 stems per acre with a mean of 1,392 stems per acre across all plots.

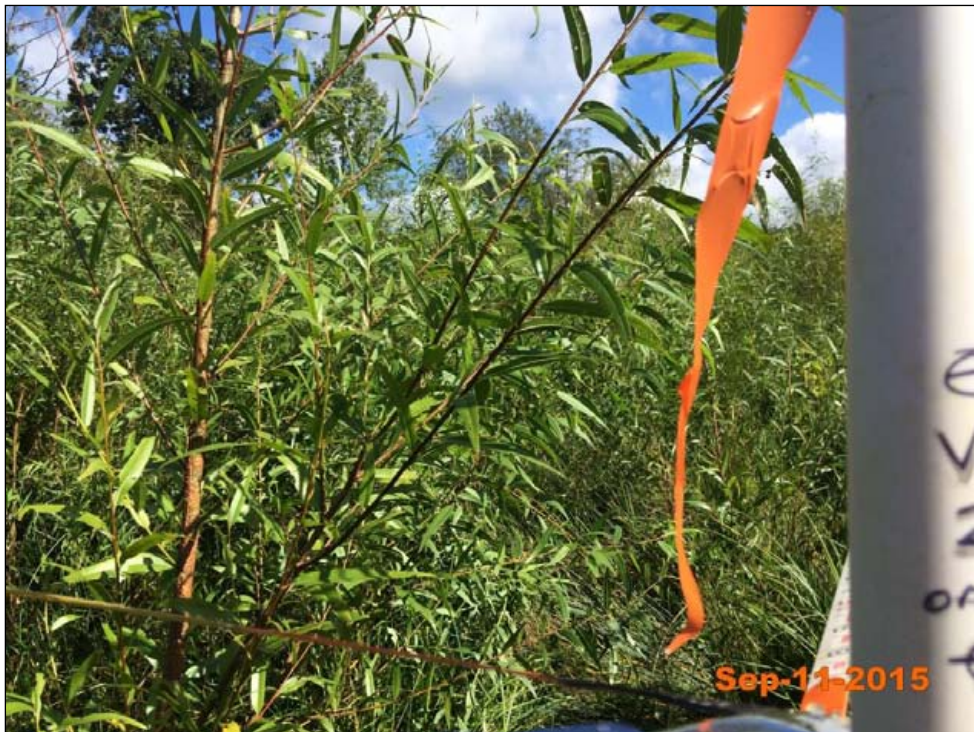
Junes Branch - Vegetation Monitoring Plot 2
September 11, 2015

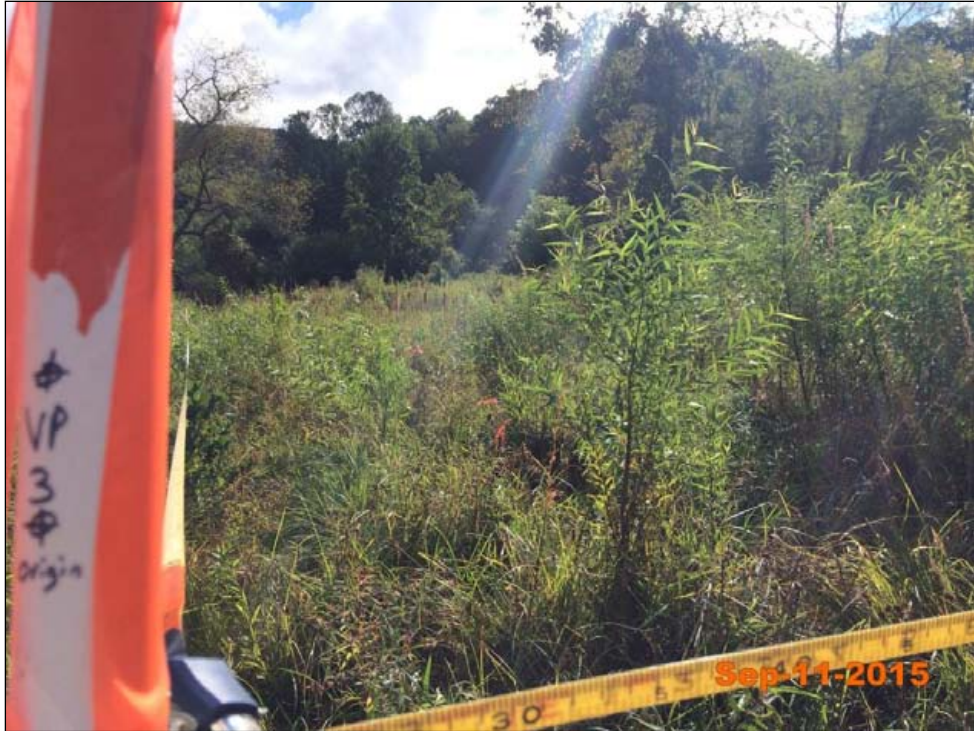
Junes Branch - Vegetation Monitoring Plot 3
September 11, 2015

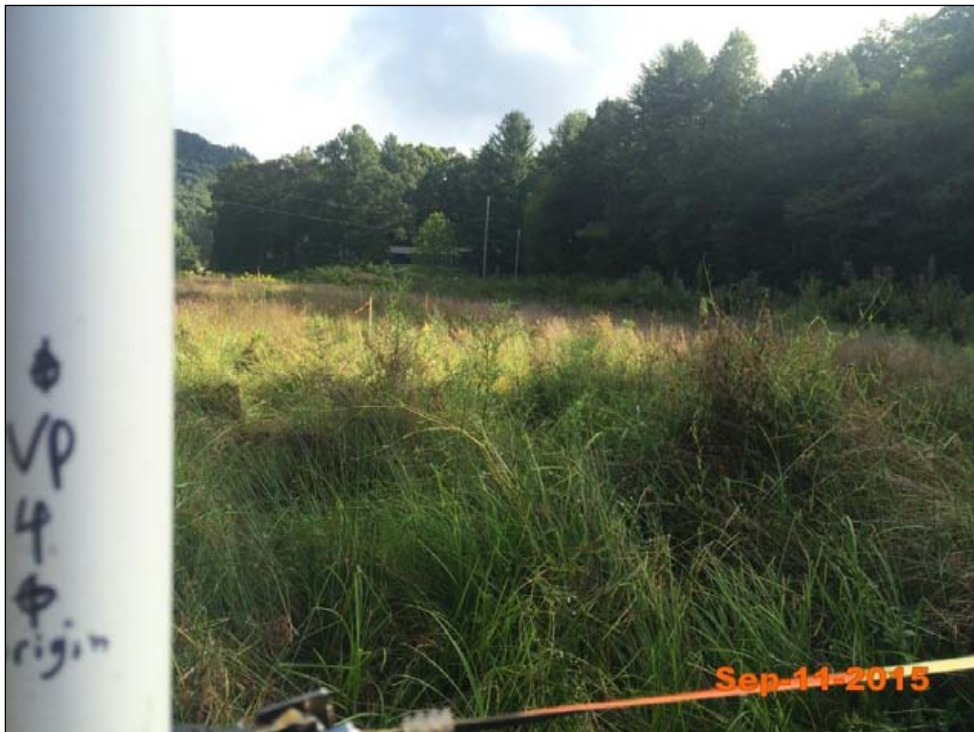
Junes Branch - Vegetation Monitoring Plot 4
September 11, 2015

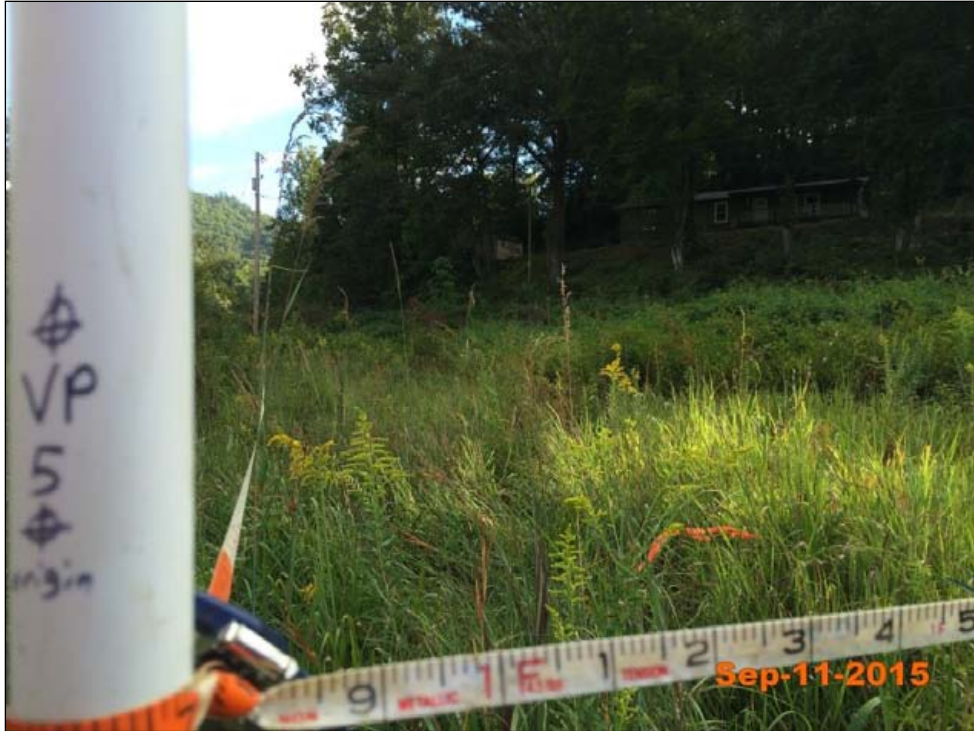
Junes Branch - Vegetation Monitoring Plot 5
September 11, 2015

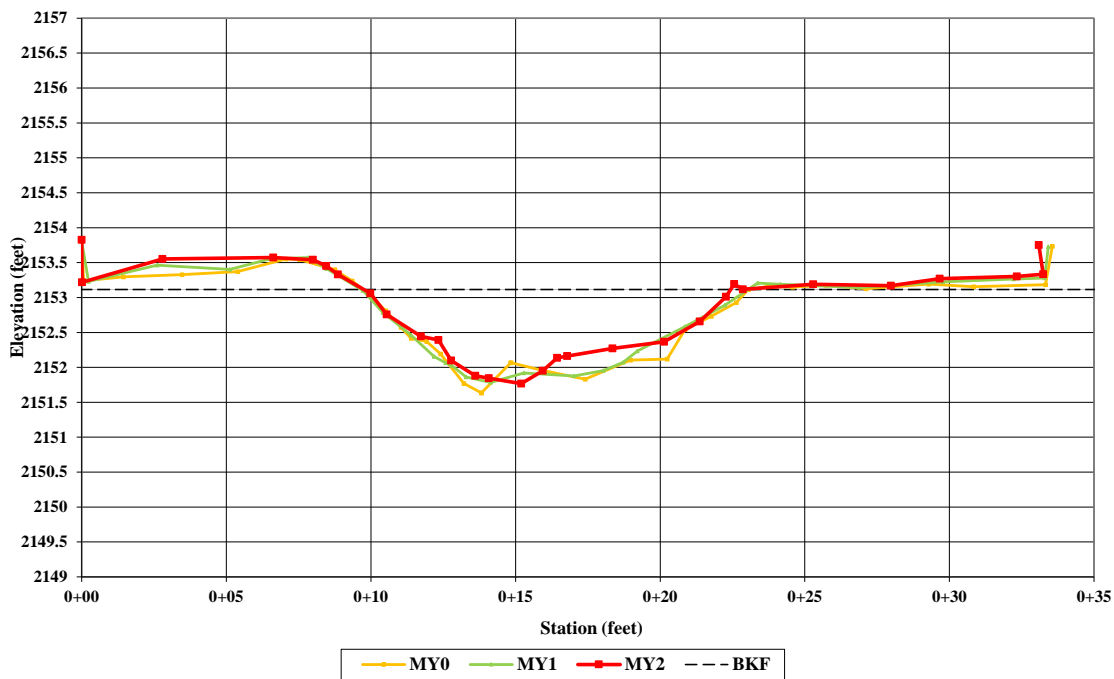
**Bumgarner I
Cross Section 1 - Riffle
Station 103+31**

Geomorphic measurements were taken during low flow conditions using a Nikon® NPR 332 Total Station. Three-dimensional coordinates associated with cross-section and profile data were collected in the field and geo-referenced (NAD83 State Plane feet FIPS 3200). Morphological data was limited to 15 cross-sections, and 3,050 feet of longitudinal profile. Survey data was imported into CAD, ArcGIS®, and Microsoft Excel® for data processing and analysis. Channel substrate was characterized using a Wolman Pebble Count outlined in the Harrelson et al (1994) and processed using Microsoft Excel.

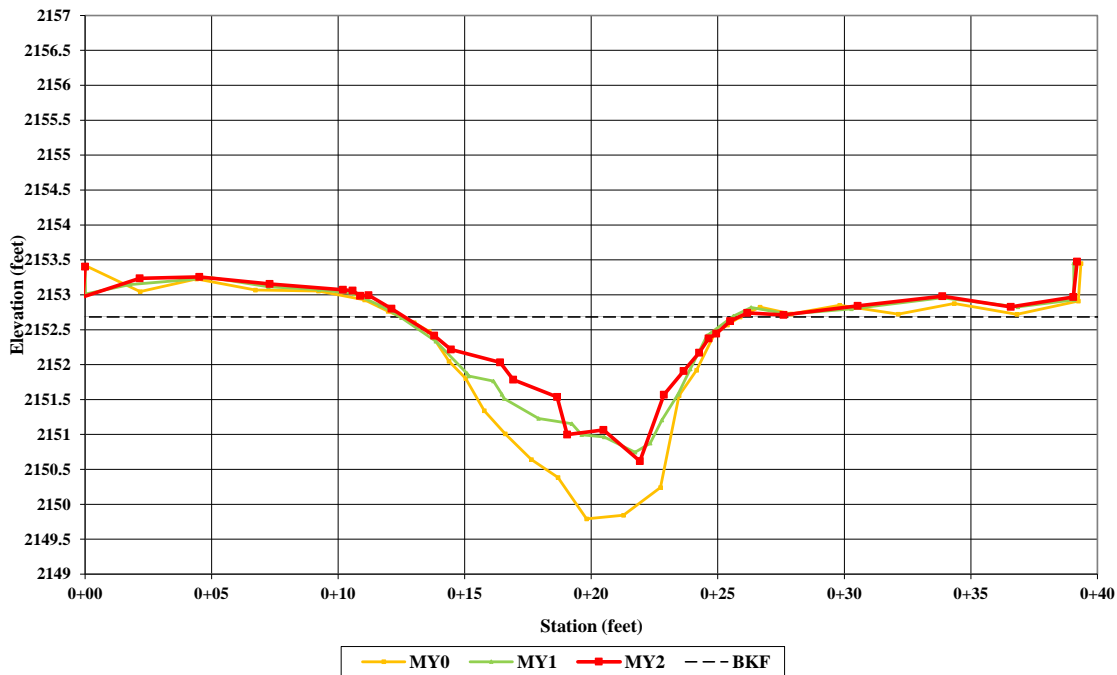
**Bumgarner I
Cross Section 2 - Pool
Station 103+56**

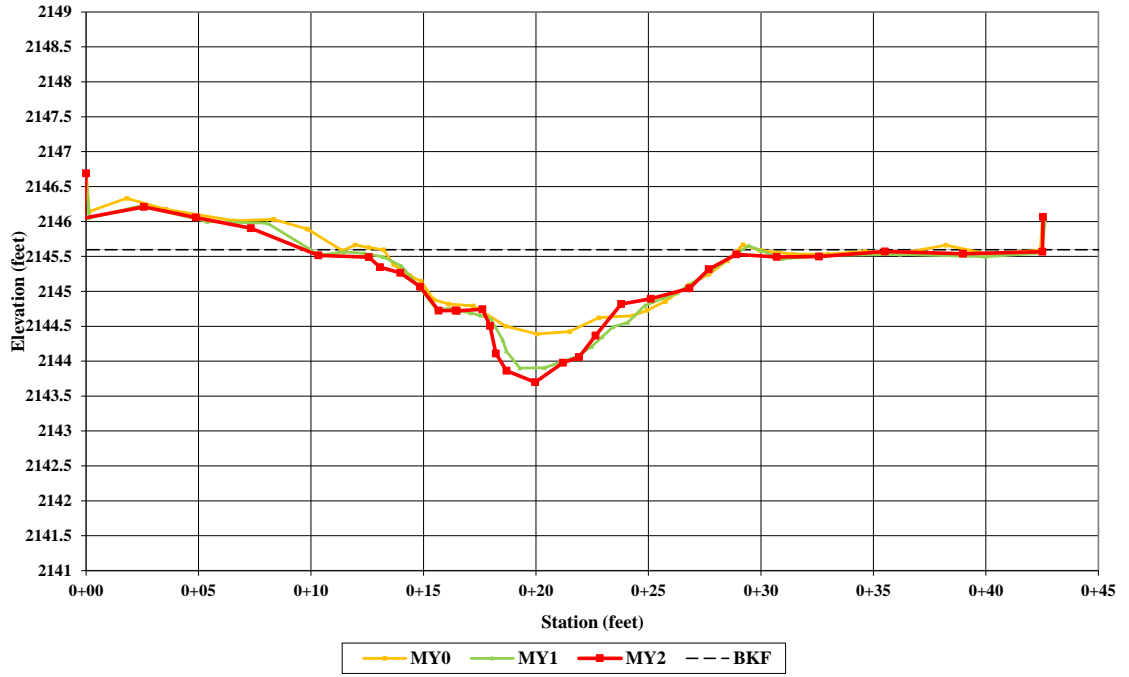
**Bumgarner I
Cross Section 3 - Riffle
Station 106+36**

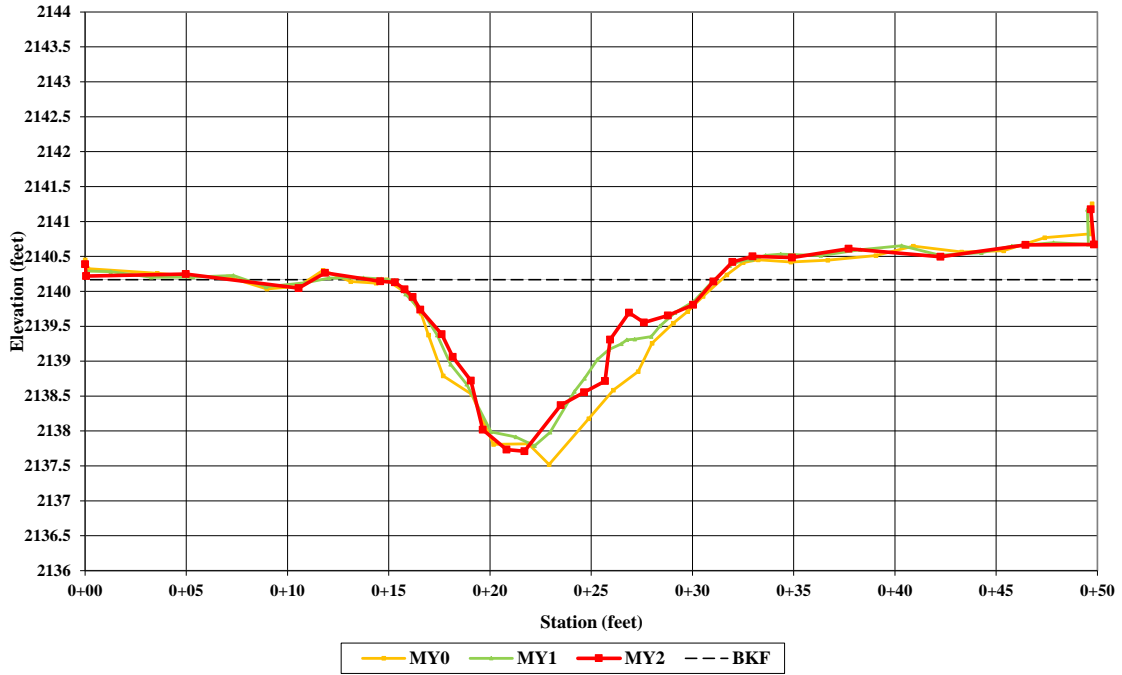
**Bumgarner II
Cross Section 4 - Pool
Station 109+24**

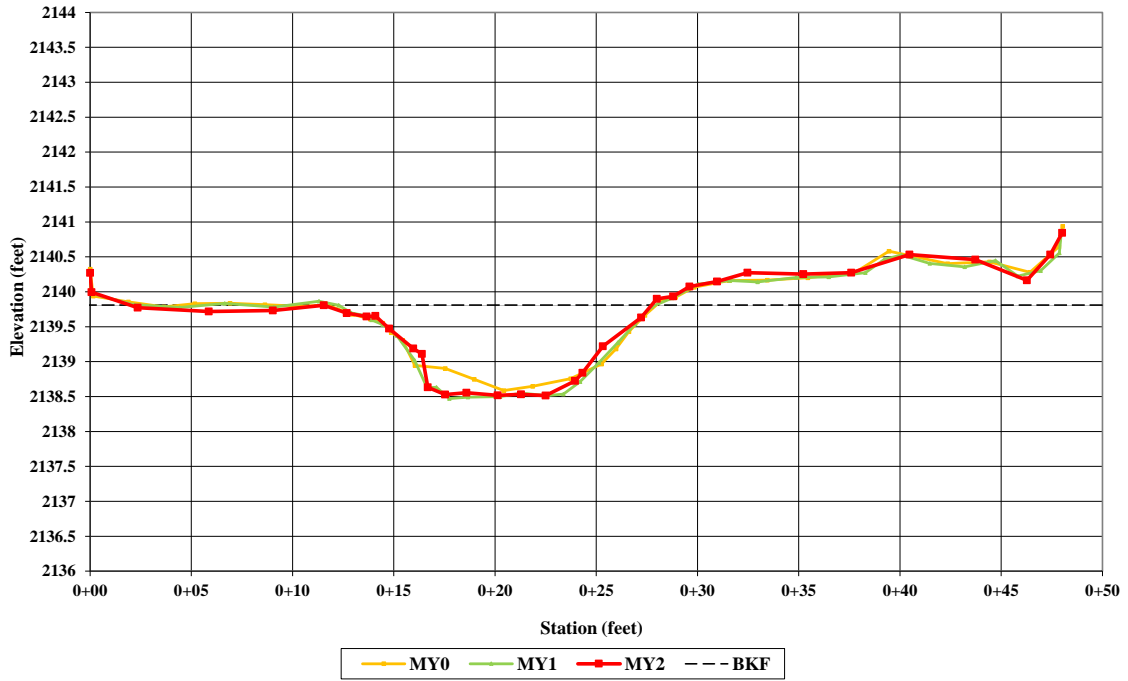
**Bumgarner II
Cross Section 5 - Riffle
Station 109+58**

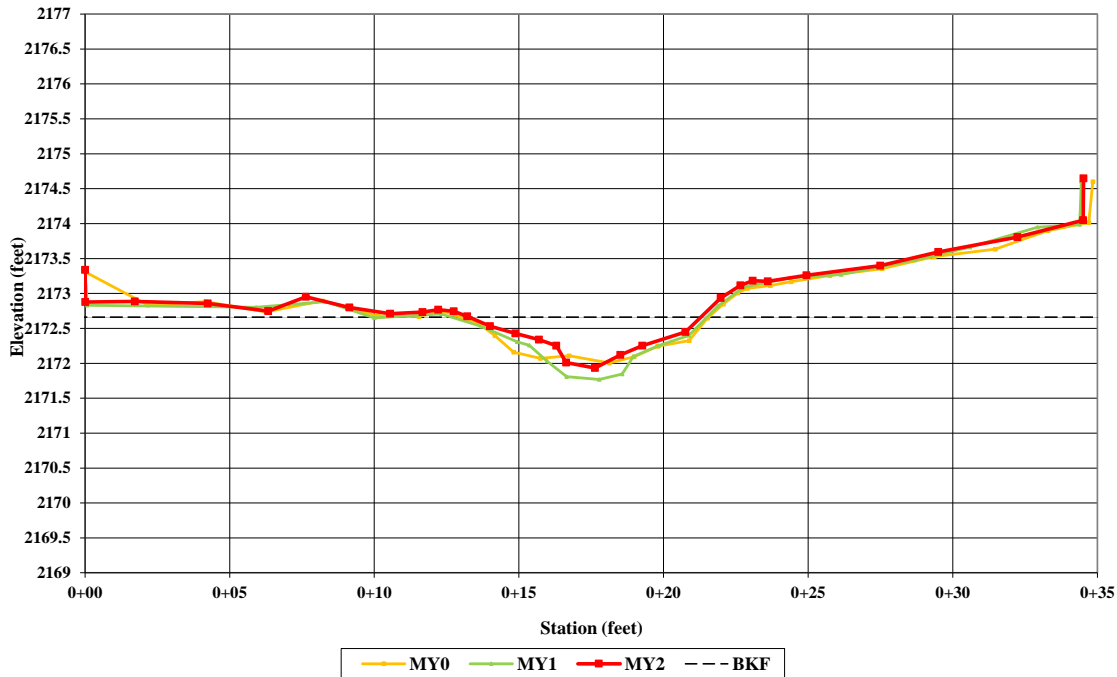
**Junes Branch
Cross Section 6 - Riffle
Station 202+94**

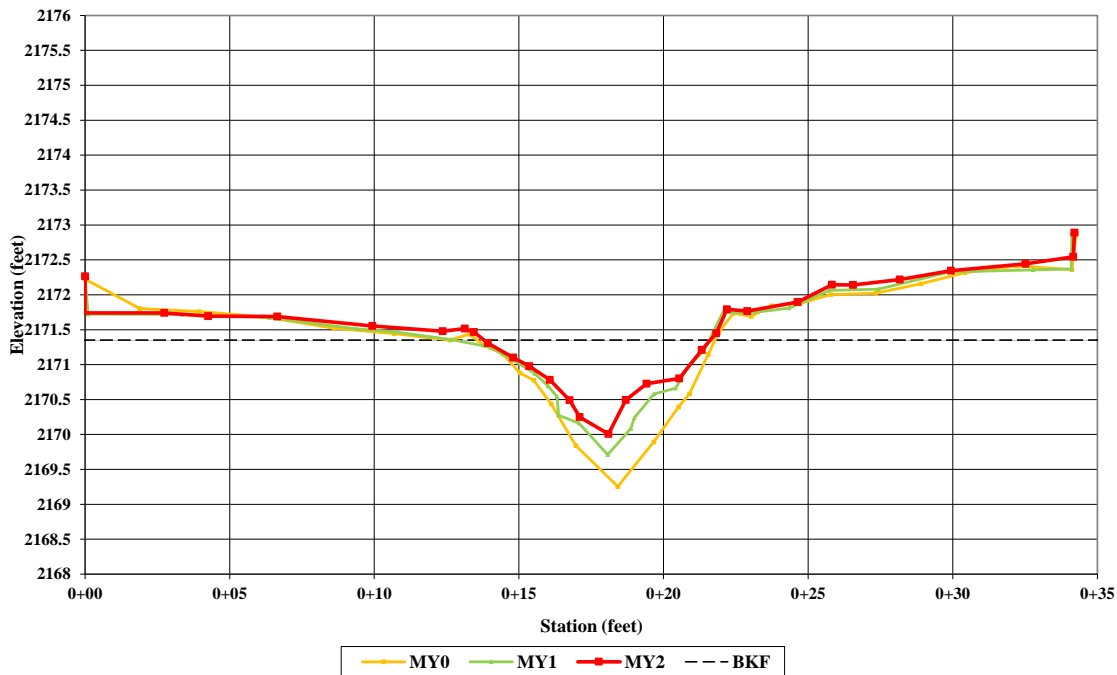
**Junes Branch
Cross Section 7 - Pool
Station 203+50**

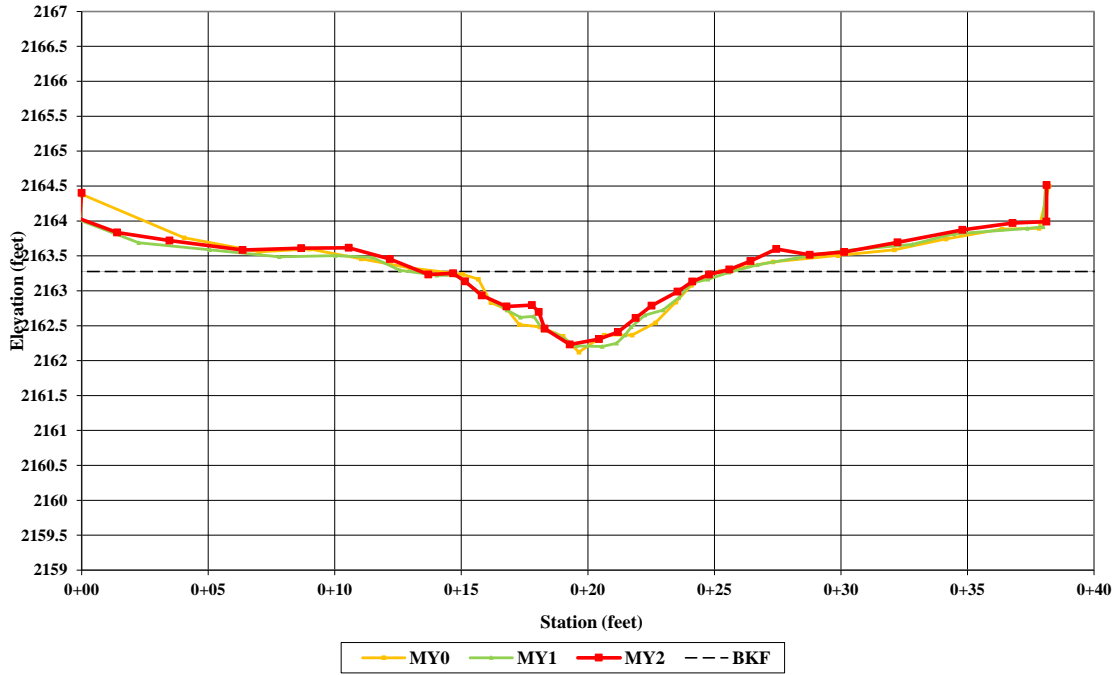
**Junes Branch
Cross Section 8 - Riffle
Station 20+99**

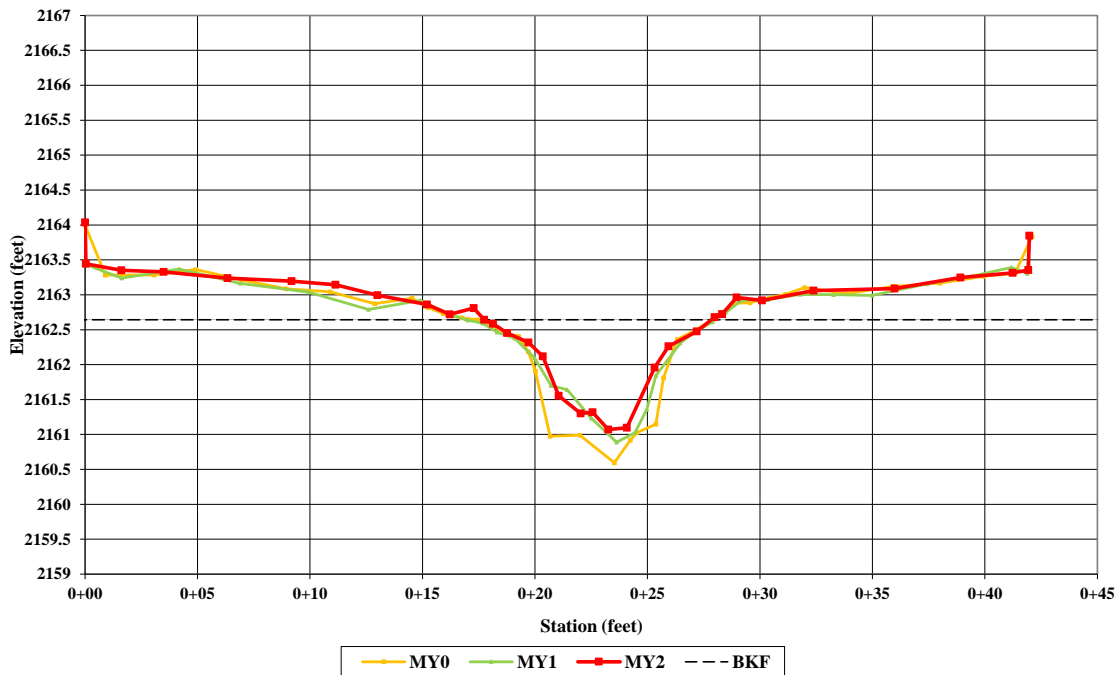
**Junes Branch
Cross Section 9 - Pool
Station 207+18**
