Annual Monitoring Report

Monitoring Year 2 of 5

Project Name: Junes Branch Stream Restoration

Jackson County, NC

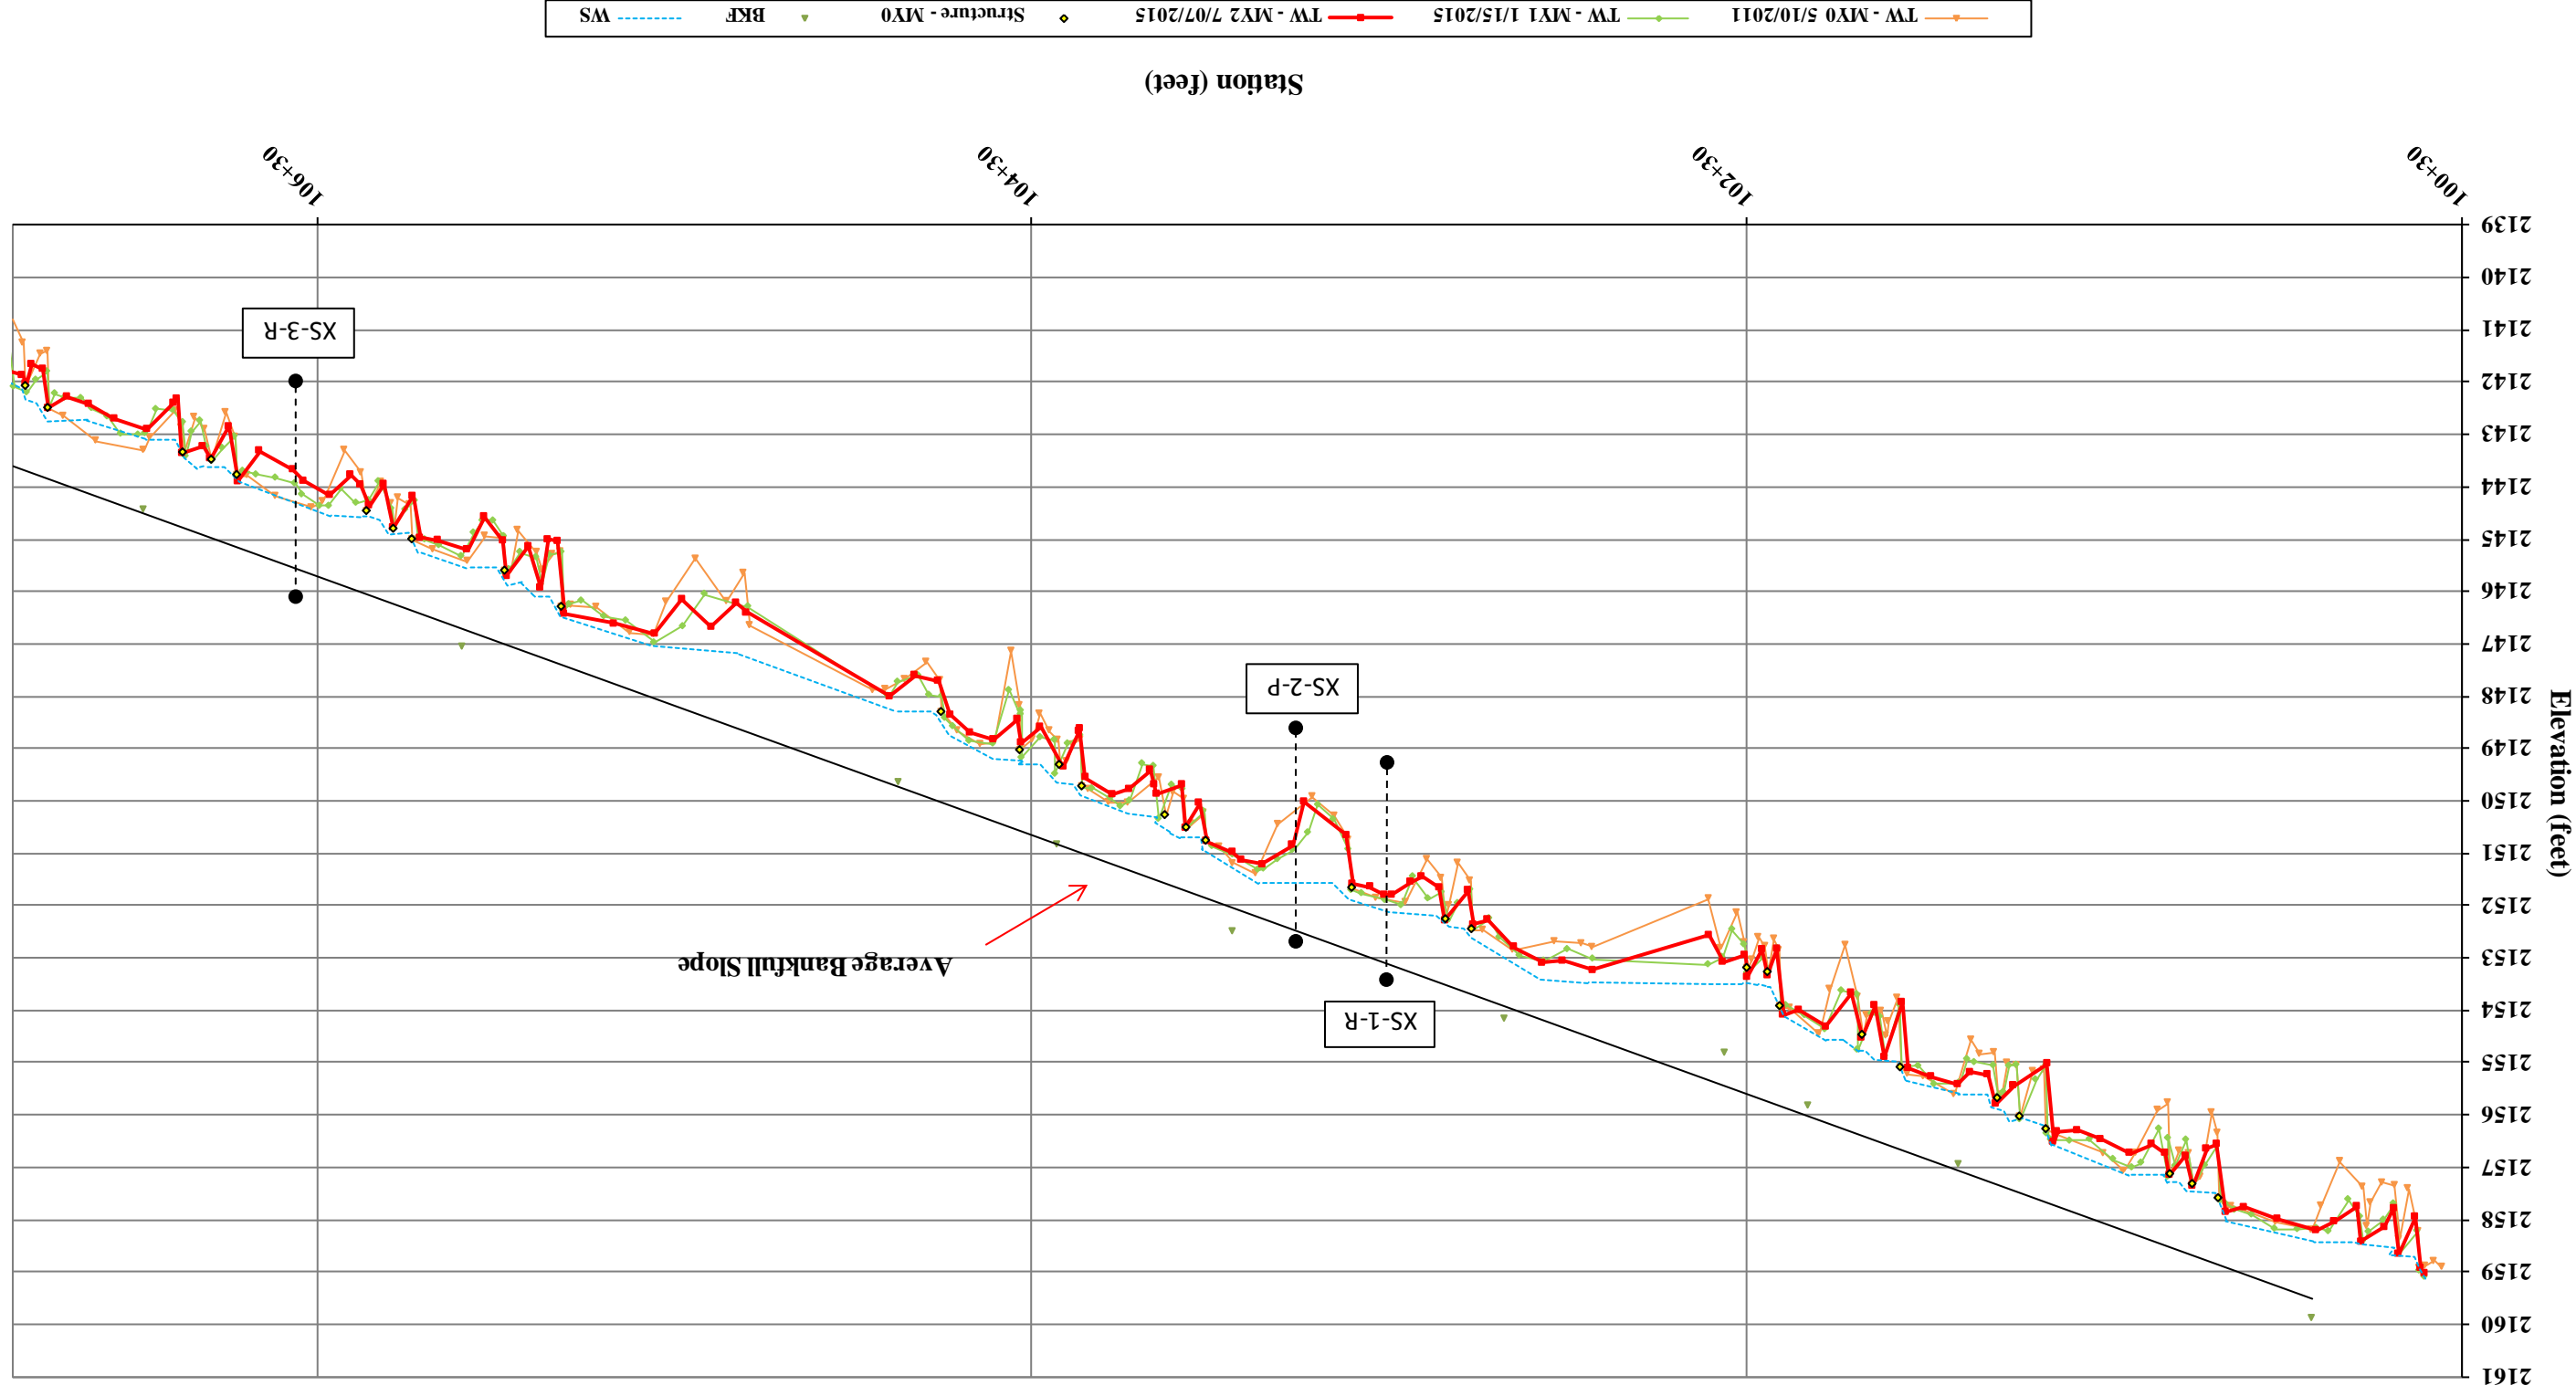
Bumgarner Branch I
 Longitudinal Profile
 Stationing 100+37 to 107+27

▲ TW - M/Y0 5/10/2011
 ■ TW - M/Y1 1/15/2015
 ● TW - M/Y2 7/07/2015
 ◆ Structure - M/Y0
 ▼ BKF
 - - - WS

Generally, longitudinal profile data (Appendix B, Table 11b) indicated relatively little change in riffle and pool dimensions between MY1 and MY2. All reaches showed a decrease in riffle length of between 0.2 feet and 1.6 feet, however these numbers are now falling closer to the baseline conditions. Each reach, with the exception of Doris Branch, also showed a decrease in average maximum pool depth between 0.1 feet and 0.2 feet.

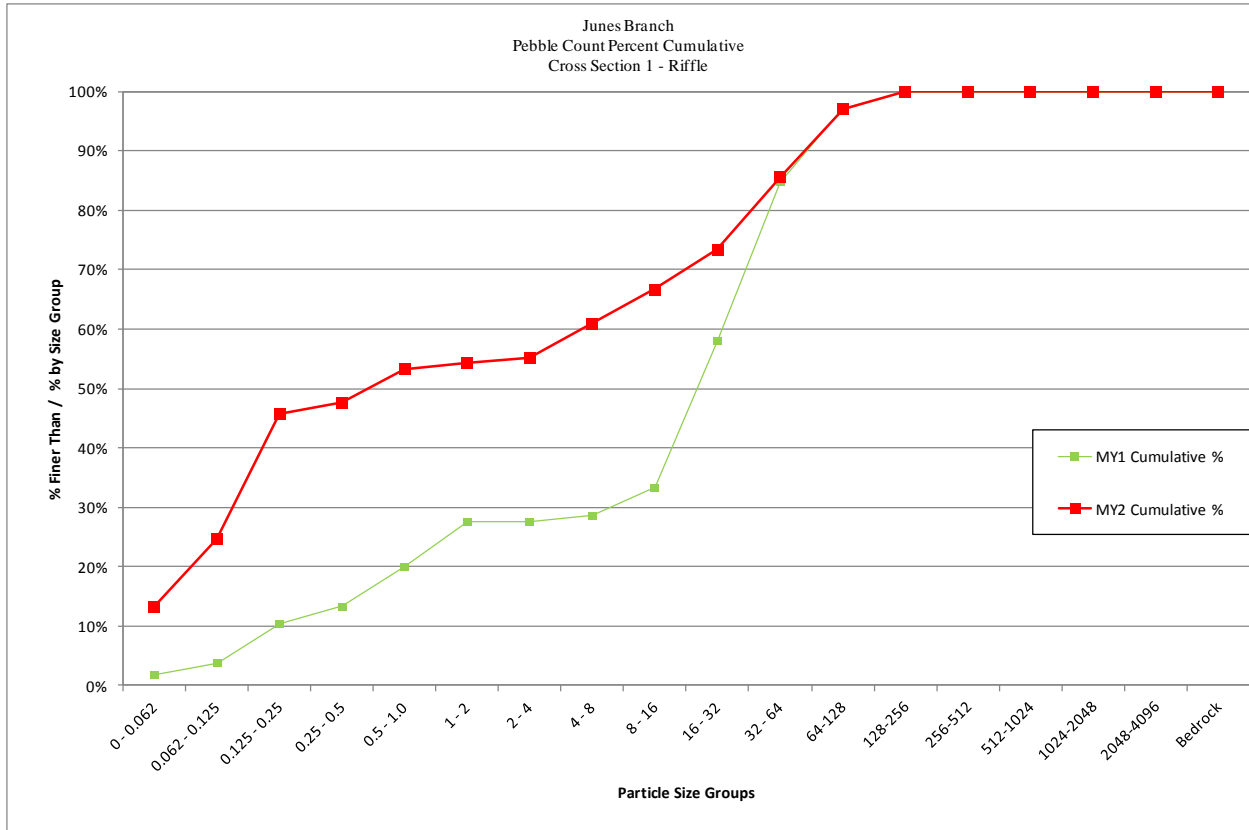
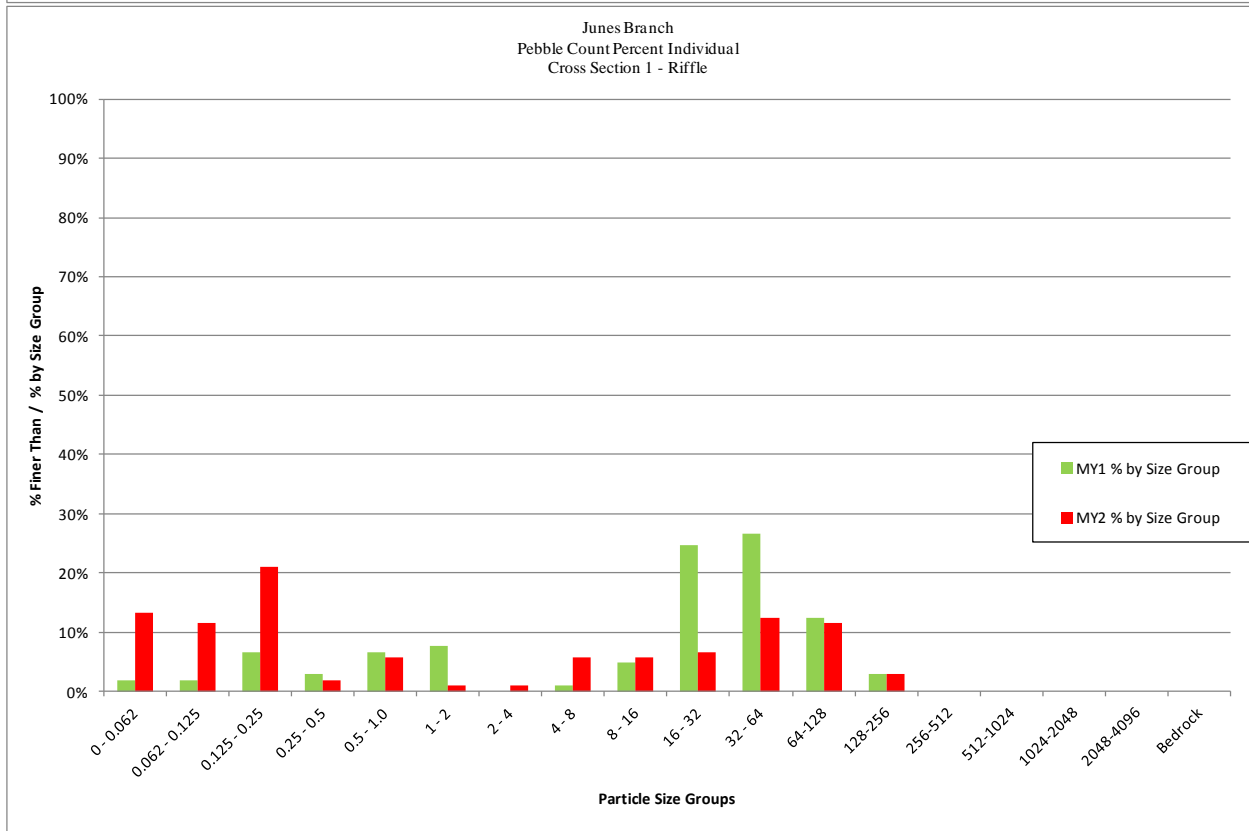
Junes Branch			
Cross Section 1 - Riffle			
Monitoring Year - 2015; MY2			
Bed Surface Material Particle Size Class (mm)	Number	% Individual	% Cumulative
0 - 0.062	14	13.3%	13%
0.062 - 0.125	12	11.4%	25%
0.125 - 0.25	22	21.0%	46%
0.25 - 0.5	2	1.9%	48%
0.5 - 1.0	6	5.7%	53%
1 - 2	1	1.0%	54%
2 - 4	1	1.0%	55%
4 - 8	6	5.7%	61%
8 - 16	6	5.7%	67%
16 - 32	7	6.7%	73%
32 - 64	13	12.4%	86%
64-128	12	11.4%	97%
128-256	3	2.9%	100%
256-512	0	0.0%	100%
512-1024	0	0.0%	100%
1024-2048	0	0.0%	100%
2048-4096	0	0.0%	100%
Bedrock	0	0.0%	100%
Total	105	100%	100%
Summary Data			
		D50	0.67
		D84	60
		D95	110

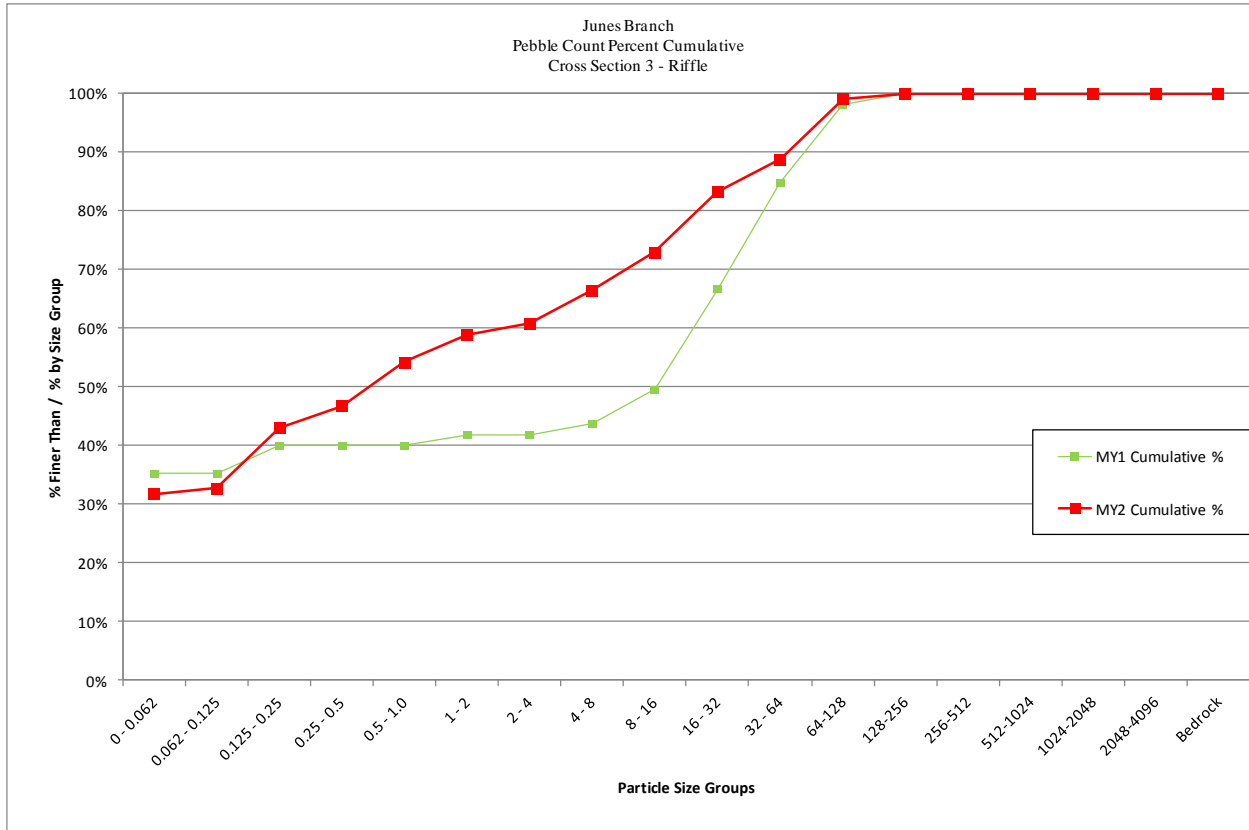
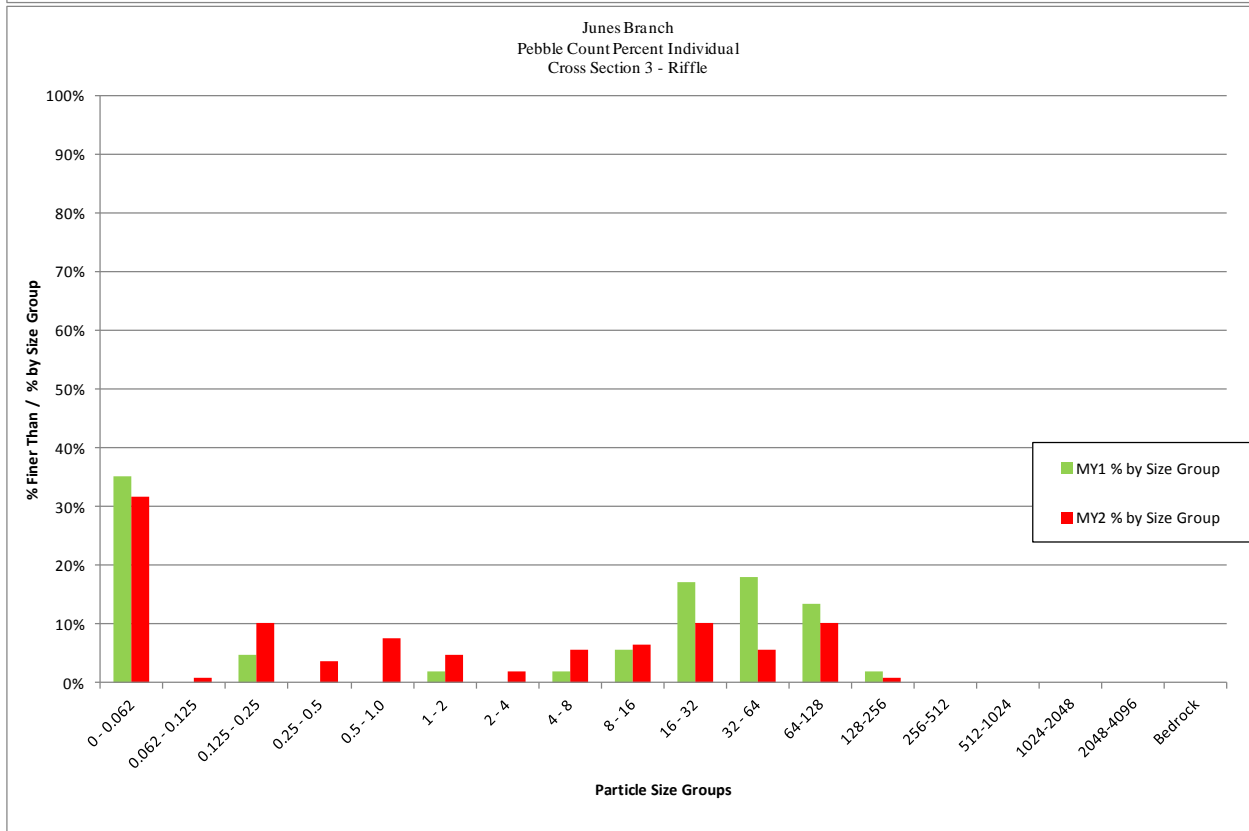
Junes Branch			
Cross Section 3 - Riffle			
Monitoring Year - 2015; MY2			
Bed Surface Material Particle Size Class (mm)	Number	% Individual	% Cumulative
0 - 0.062	34	31.8%	32%
0.062 - 0.125	1	0.9%	33%
0.125 - 0.25	11	10.3%	43%
0.25 - 0.5	4	3.7%	47%
0.5 - 1.0	8	7.5%	54%
1 - 2	5	4.7%	59%
2 - 4	2	1.9%	61%
4 - 8	6	5.6%	66%
8 - 16	7	6.5%	73%
16 - 32	11	10.3%	83%
32 - 64	6	5.6%	89%
64-128	11	10.3%	99%
128-256	1	0.9%	100%
256-512	0	0.0%	100%
512-1024	0	0.0%	100%
1024-2048	0	0.0%	100%
2048-4096	0	0.0%	100%
Bedrock	0	0.0%	100%
Total	107	100%	100%
		Summary Data	
		D50	0.68
		D84	43
		D95	99

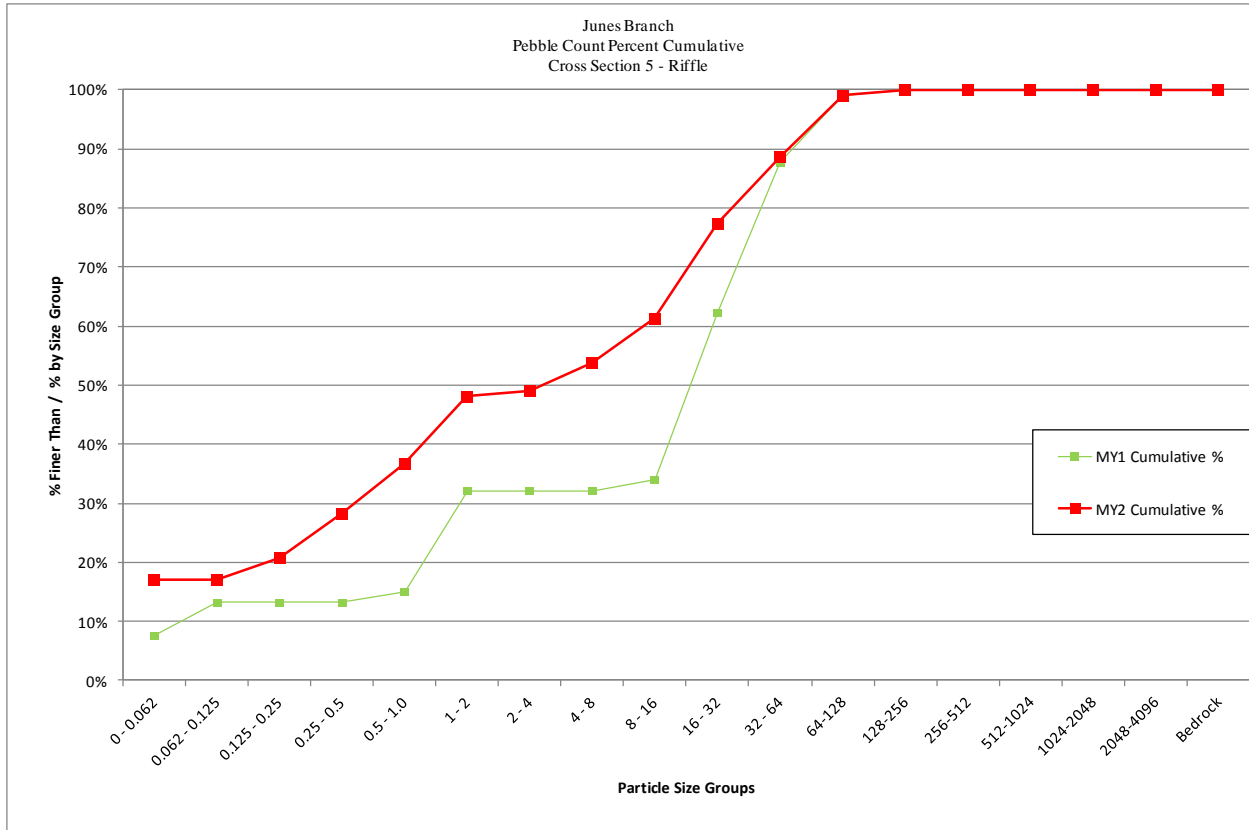
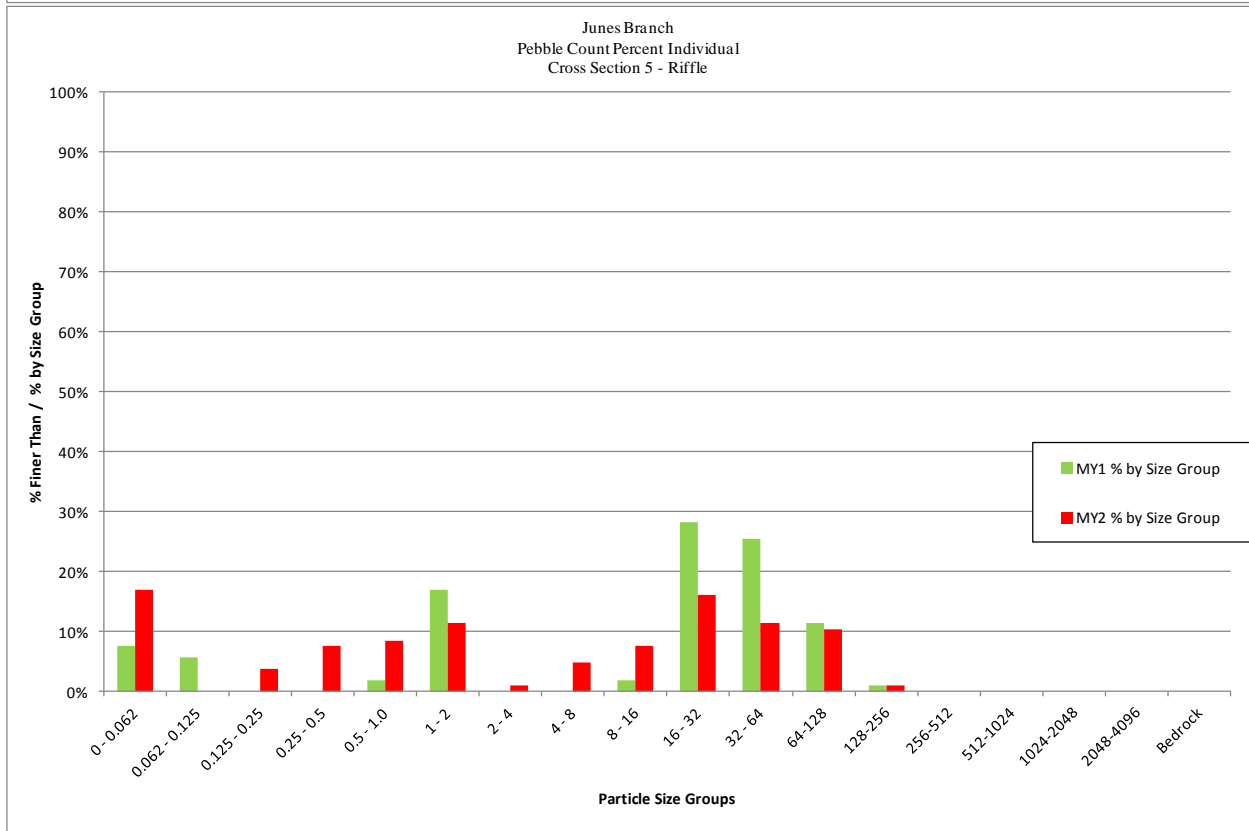
Junes Branch			
Cross Section 5 - Riffle			
Monitoring Year - 2015; MY2			
Bed Surface Material Particle Size Class (mm)	Number	% Individual	% Cumulative
0 - 0.062	18	17.0%	17%
0.062 - 0.125	0	0.0%	17%
0.125 - 0.25	4	3.8%	21%
0.25 - 0.5	8	7.5%	28%
0.5 - 1.0	9	8.5%	37%
1 - 2	12	11.3%	48%
2 - 4	1	0.9%	49%
4 - 8	5	4.7%	54%
8 - 16	8	7.5%	61%
16 - 32	17	16.0%	77%
32 - 64	12	11.3%	89%
64-128	11	10.4%	99%
128-256	1	0.9%	100%
256-512	0	0.0%	100%
512-1024	0	0.0%	100%
1024-2048	0	0.0%	100%
2048-4096	0	0.0%	100%
Bedrock	0	0.0%	100%
Total	106	100%	100%
		Summary Data	
		D50	4.9
		D84	50
		D95	100

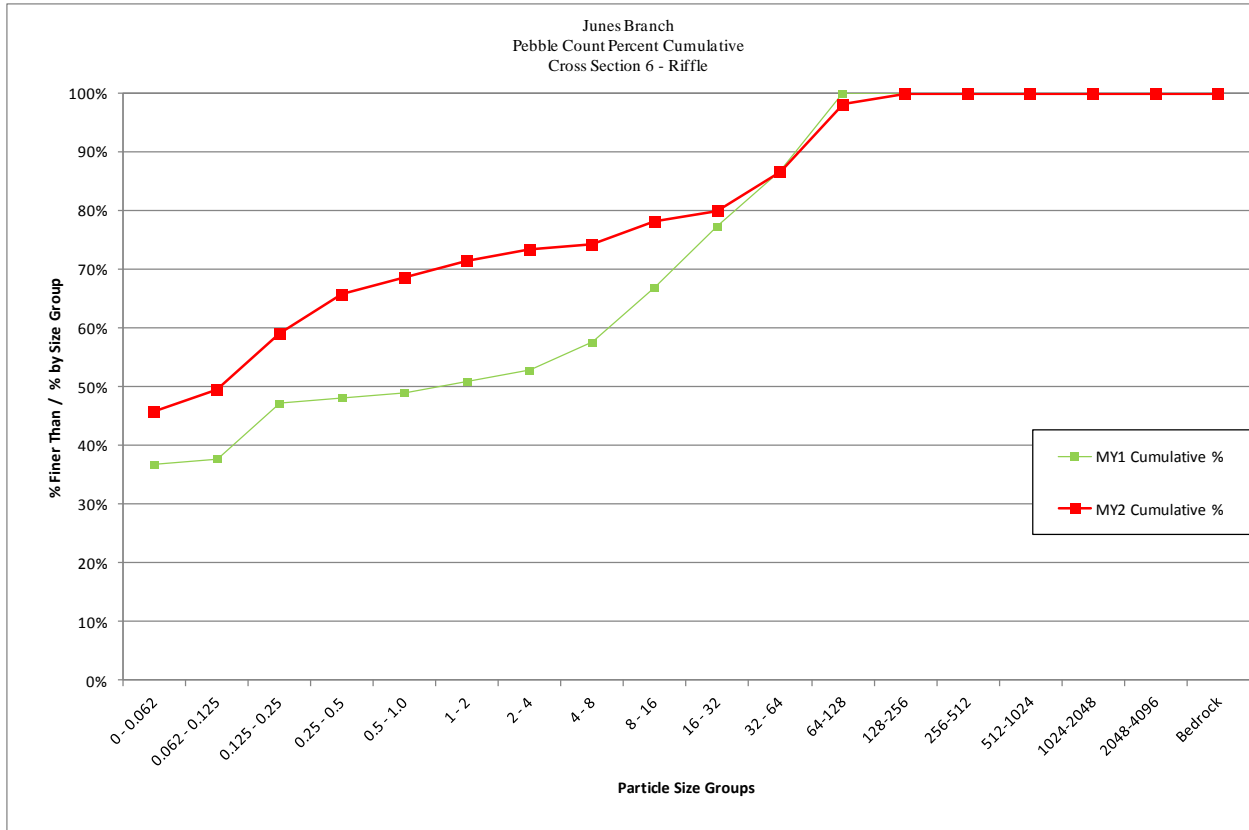
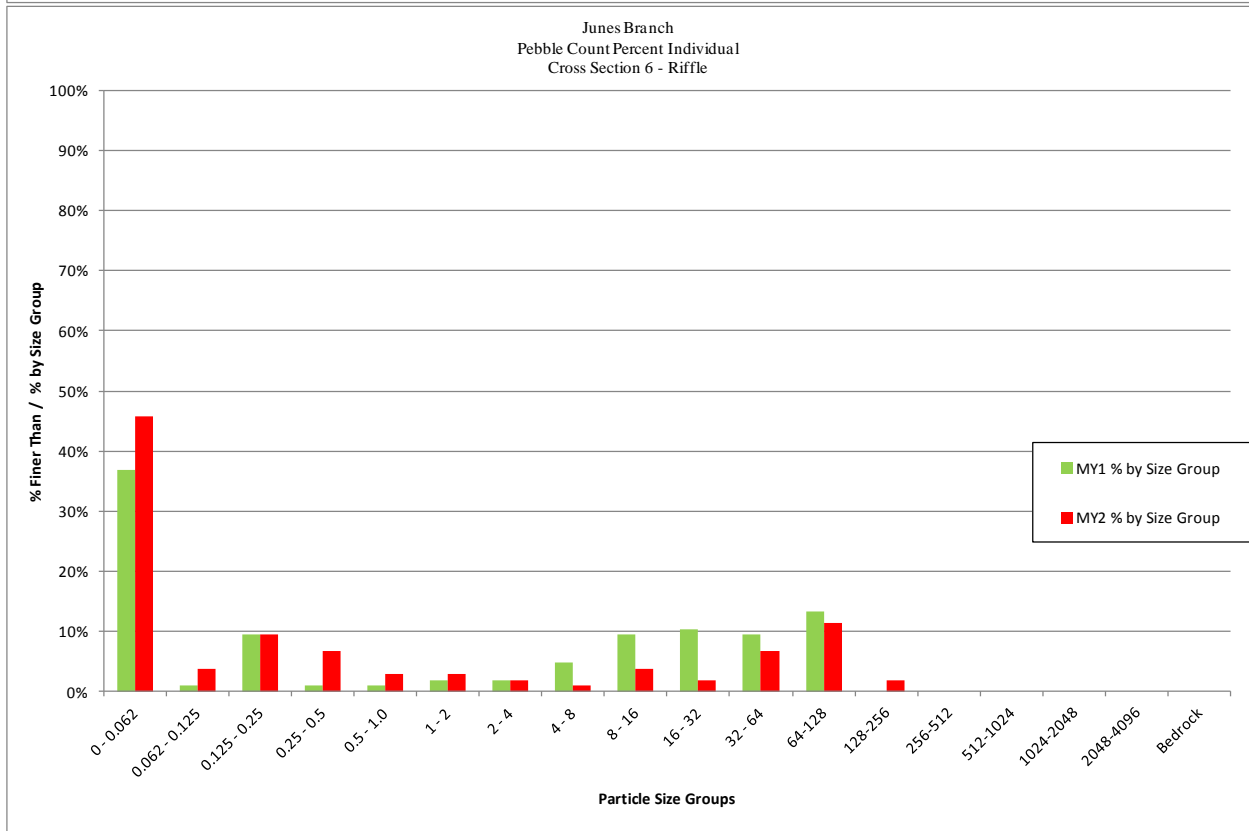
Junes Branch			
Cross Section 6 - Riffle			
Monitoring Year - 2015; MY2			
Bed Surface Material Particle Size Class (mm)	Number	% Individual	% Cumulative
0 - 0.062	48	45.7%	46%
0.062 - 0.125	4	3.8%	50%
0.125 - 0.25	10	9.5%	59%
0.25 - 0.5	7	6.7%	66%
0.5 - 1.0	3	2.9%	69%
1 - 2	3	2.9%	71%
2 - 4	2	1.9%	73%
4 - 8	1	1.0%	74%
8 - 16	4	3.8%	78%
16 - 32	2	1.9%	80%
32 - 64	7	6.7%	87%
64-128	12	11.4%	98%
128-256	2	1.9%	100%
256-512	0	0.0%	100%
512-1024	0	0.0%	100%
1024-2048	0	0.0%	100%
2048-4096	0	0.0%	100%
Bedrock	0	0.0%	100%
Total	105	100%	100%
Summary Data			
	D50	0.13	
	D84	53	
	D95	86

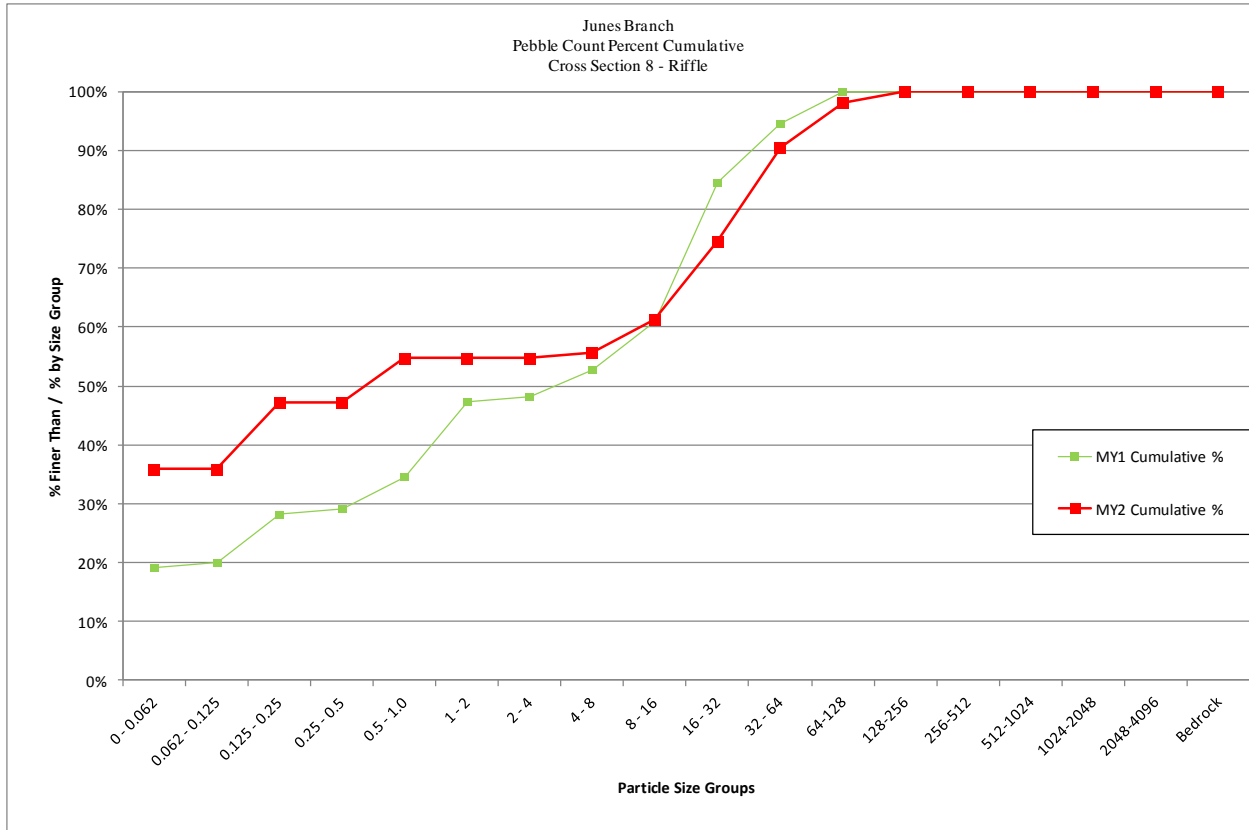
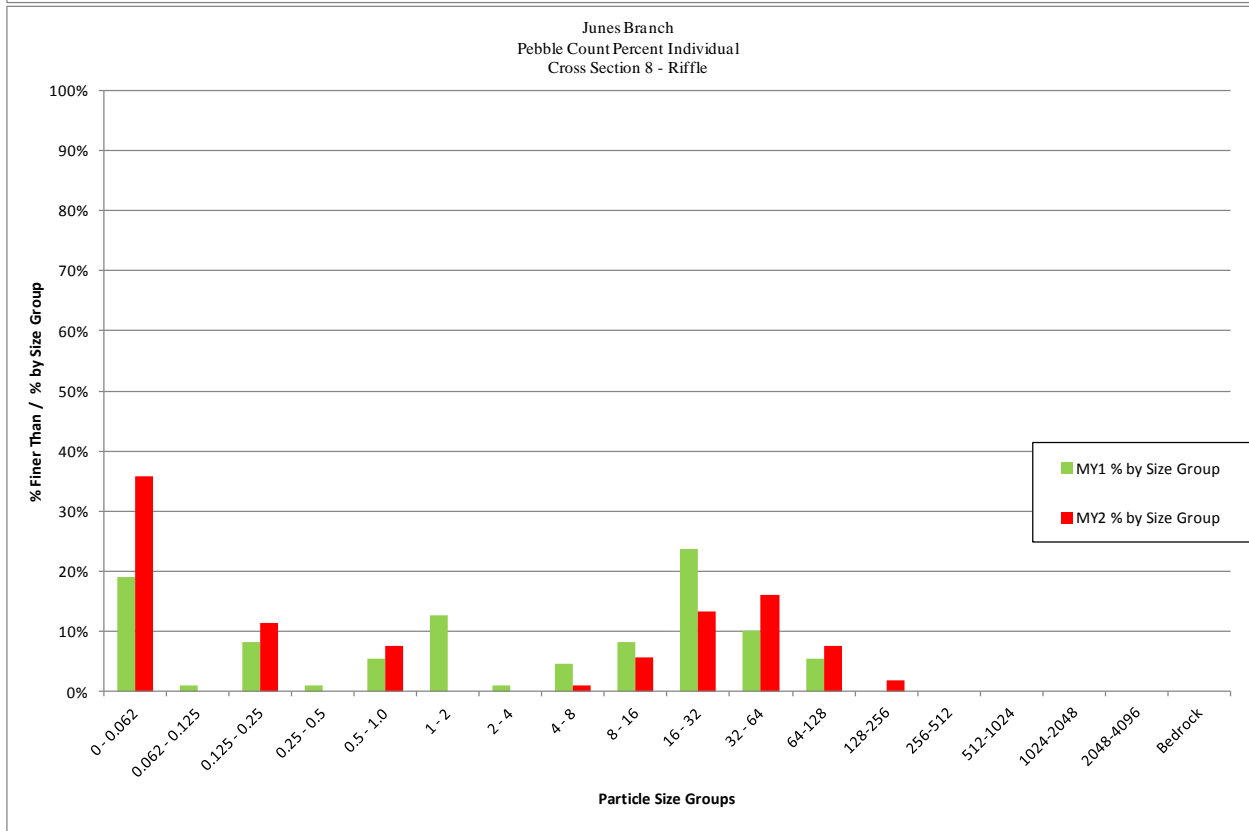
Junes Branch			
Cross Section 8 - Riffle			
Monitoring Year - 2015; MY2			
Bed Surface Material Particle Size Class (mm)	Number	% Individual	% Cumulative
0 - 0.062	38	35.8%	36%
0.062 - 0.125	0	0.0%	36%
0.125 - 0.25	12	11.3%	47%
0.25 - 0.5	0	0.0%	47%
0.5 - 1.0	8	7.5%	55%
1 - 2	0	0.0%	55%
2 - 4	0	0.0%	55%
4 - 8	1	0.9%	56%
8 - 16	6	5.7%	61%
16 - 32	14	13.2%	75%
32 - 64	17	16.0%	91%
64-128	8	7.5%	98%
128-256	2	1.9%	100%
256-512	0	0.0%	100%
512-1024	0	0.0%	100%
1024-2048	0	0.0%	100%
2048-4096	0	0.0%	100%
Bedrock	0	0.0%	100%
Total	106	100%	100%
Summary Data			
D50		0.65	
D84		50	
D95		84

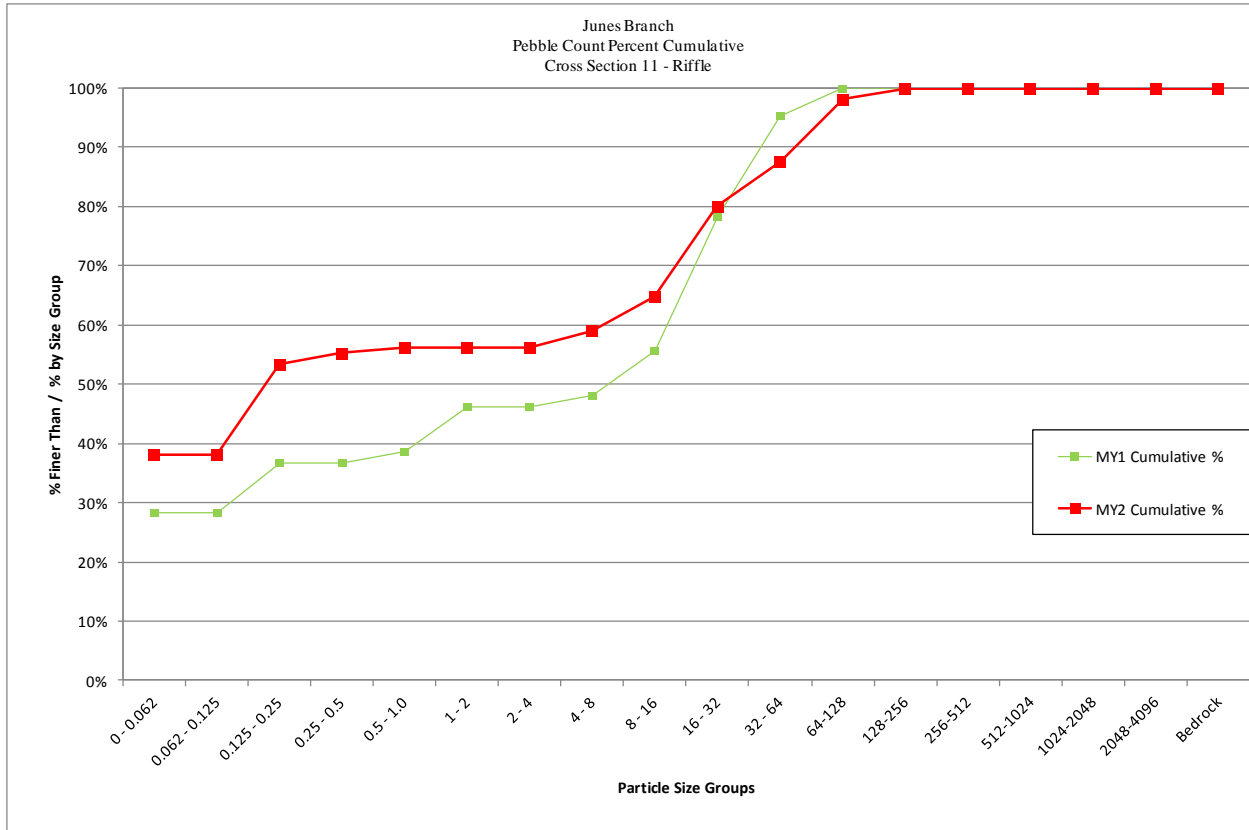
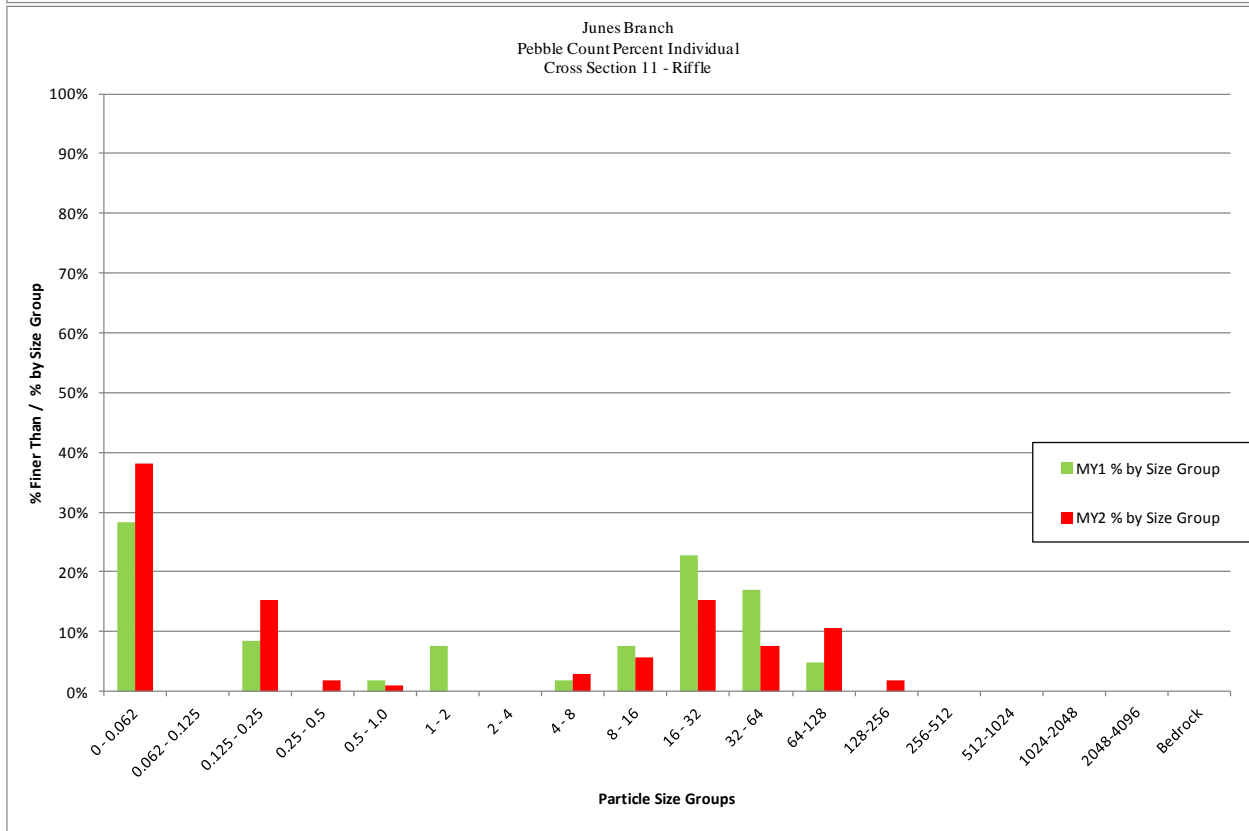
Junes Branch			
Cross Section 11 - Riffle			
Monitoring Year - 2015; MY2			
Bed Surface Material Particle Size Class (mm)	Number	% Individual	% Cumulative
0 - 0.062	40	38.1%	38%
0.062 - 0.125	0	0.0%	38%
0.125 - 0.25	16	15.2%	53%
0.25 - 0.5	2	1.9%	55%
0.5 - 1.0	1	1.0%	56%
1 - 2	0	0.0%	56%
2 - 4	0	0.0%	56%
4 - 8	3	2.9%	59%
8 - 16	6	5.7%	65%
16 - 32	16	15.2%	80%
32 - 64	8	7.6%	88%
64-128	11	10.5%	98%
128-256	2	1.9%	100%
256-512	0	0.0%	100%
512-1024	0	0.0%	100%
1024-2048	0	0.0%	100%
2048-4096	0	0.0%	100%
Bedrock	0	0.0%	100%
Total	105	100%	100%
		Summary Data	
		D50	0.21
		D84	49
		D95	86

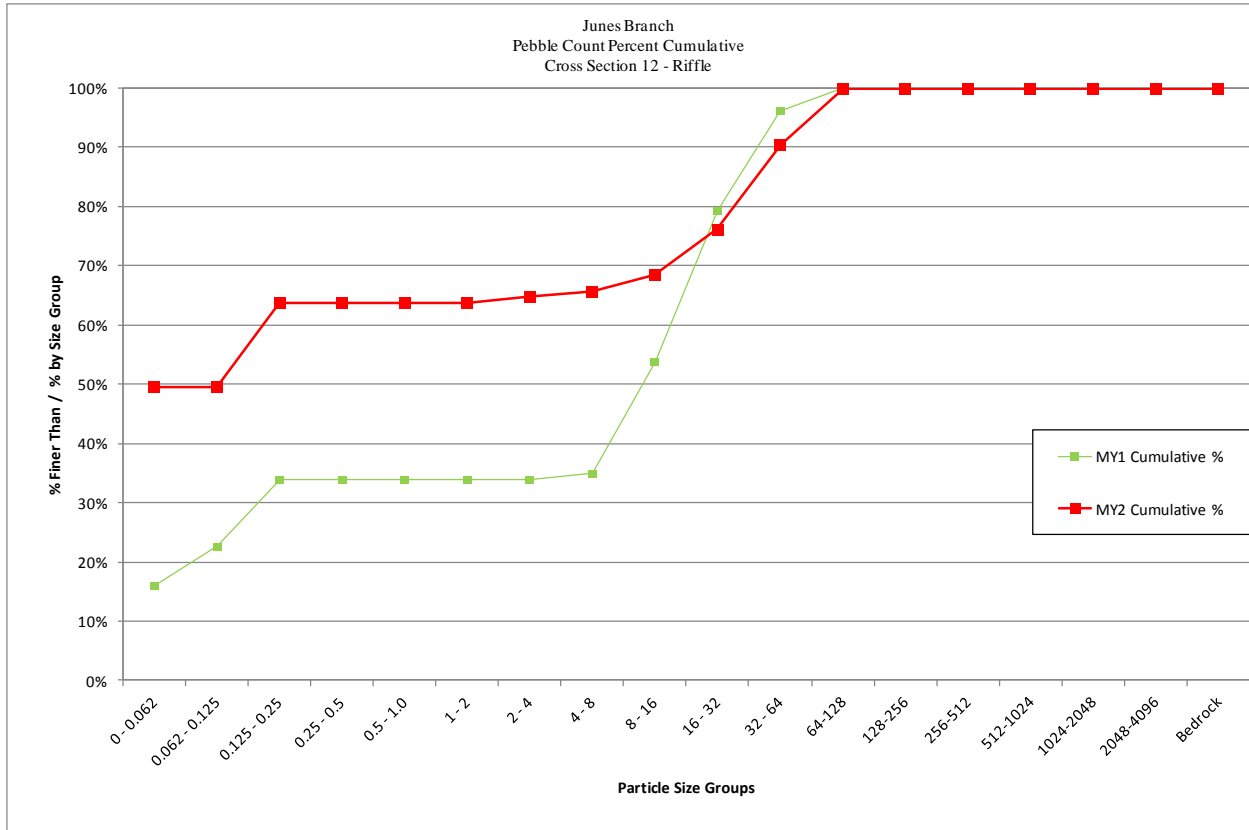
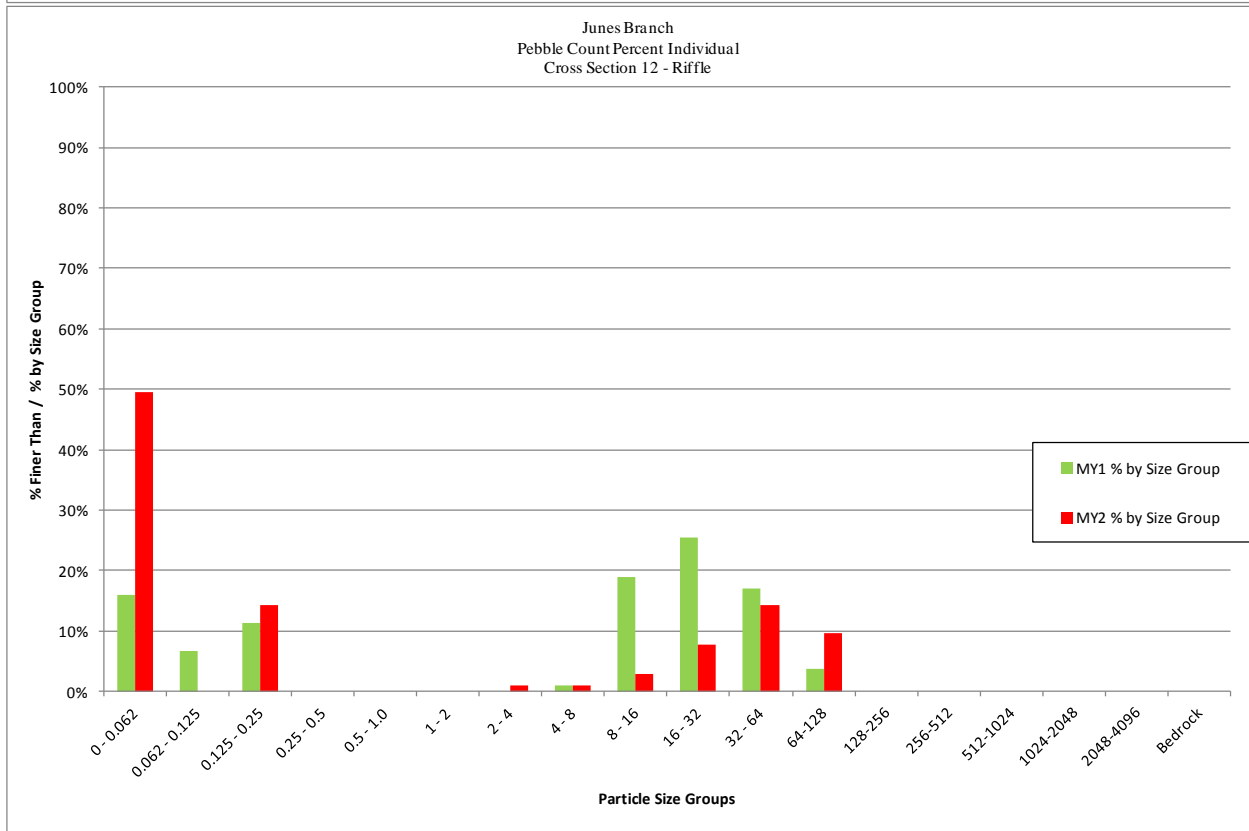
Junes Branch			
Cross Section 12 - Riffle			
Monitoring Year - 2015; MY2			
Bed Surface Material Particle Size Class (mm)	Number	% Individual	% Cumulative
0 - 0.062	52	49.5%	50%
0.062 - 0.125	0	0.0%	50%
0.125 - 0.25	15	14.3%	64%
0.25 - 0.5	0	0.0%	64%
0.5 - 1.0	0	0.0%	64%
1 - 2	0	0.0%	64%
2 - 4	1	1.0%	65%
4 - 8	1	1.0%	66%
8 - 16	3	2.9%	69%
16 - 32	8	7.6%	76%
32 - 64	15	14.3%	90%
64-128	10	9.5%	100%
128-256	0	0.0%	100%
256-512	0	0.0%	100%
512-1024	0	0.0%	100%
1024-2048	0	0.0%	100%
2048-4096	0	0.0%	100%
Bedrock	0	0.0%	100%
Total	105	100%	100%
		Summary Data	
		D50	0.13
		D84	45
		D95	77

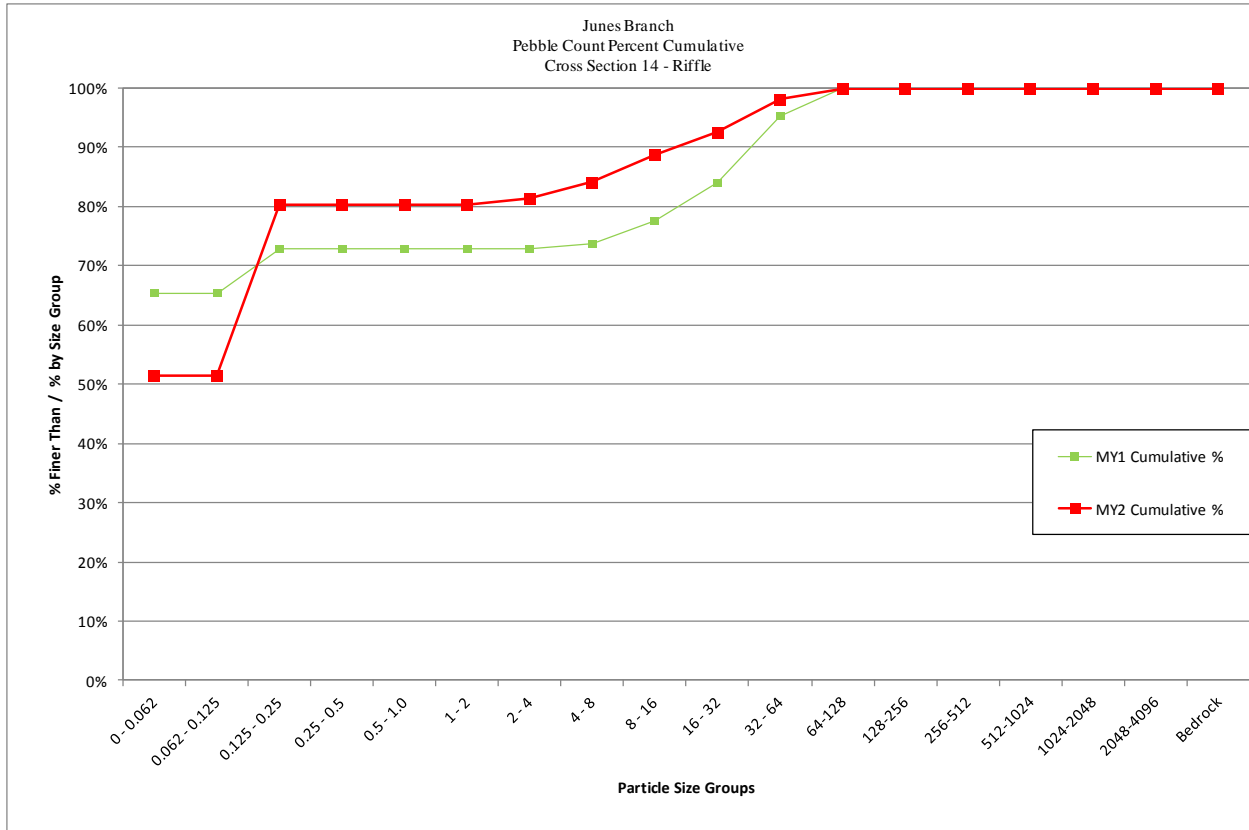
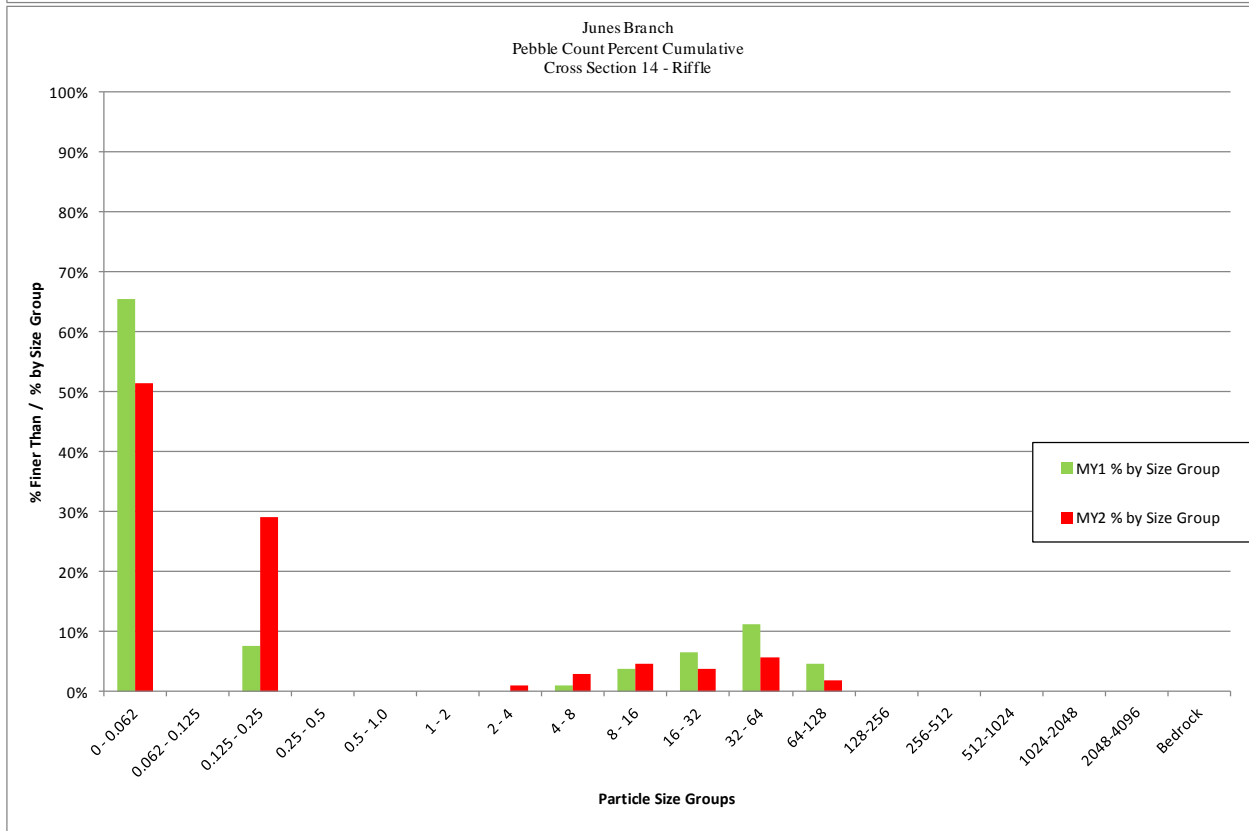
Junes Branch			
Cross Section 14 - Riffle			
Monitoring Year - 2015; MY2			
Bed Surface Material Particle Size Class (mm)	Number	% Individual	% Cumulative
0 - 0.062	55	51.4%	51%
0.062 - 0.125	0	0.0%	51%
0.125 - 0.25	31	29.0%	80%
0.25 - 0.5	0	0.0%	80%
0.5 - 1.0	0	0.0%	80%
1 - 2	0	0.0%	80%
2 - 4	1	0.9%	81%
4 - 8	3	2.8%	84%
8 - 16	5	4.7%	89%
16 - 32	4	3.7%	93%
32 - 64	6	5.6%	98%
64-128	2	1.9%	100%
128-256	0	0.0%	100%
256-512	0	0.0%	100%
512-1024	0	0.0%	100%
1024-2048	0	0.0%	100%
2048-4096	0	0.0%	100%
Bedrock	0	0.0%	100%
Total	107	100%	100%
		Summary Data	
		D50	0.062
		D84	7.7
		D95	51

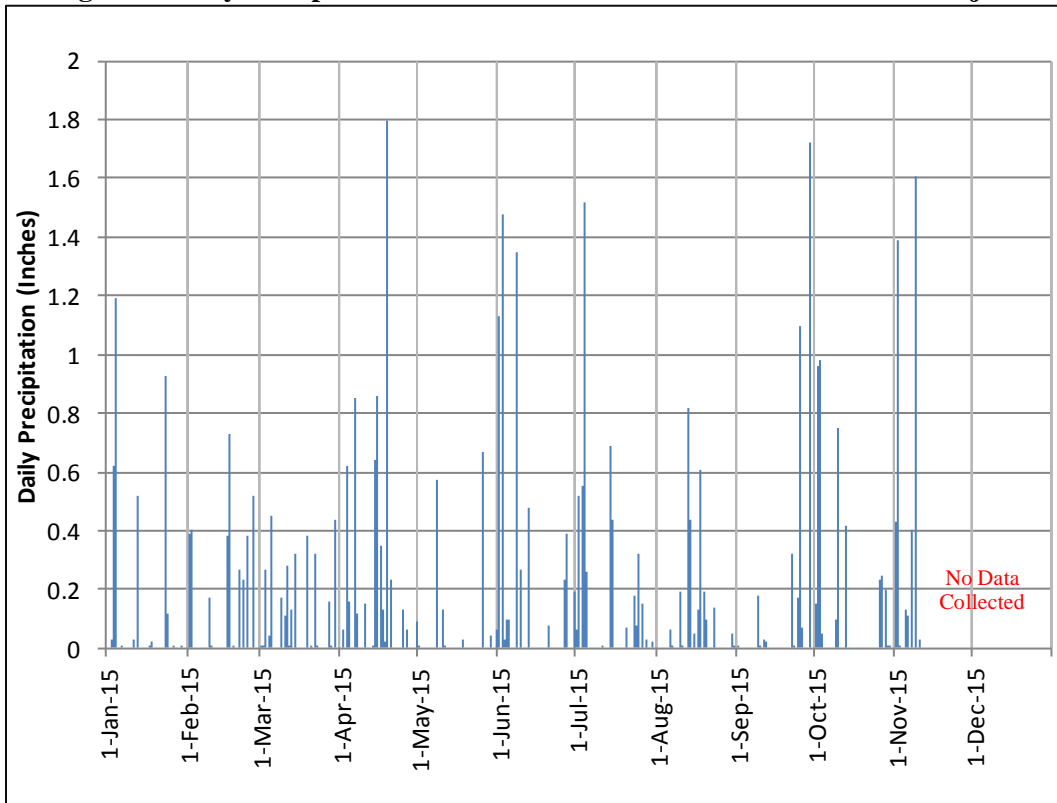
Figure 3. Daily Precipitation Totals for the Junes Branch Restoration Project
