Annual Monitoring Report

Monitoring Year 2 of 5

Project Name: Junes Branch Stream Restoration

Jackson County, NC

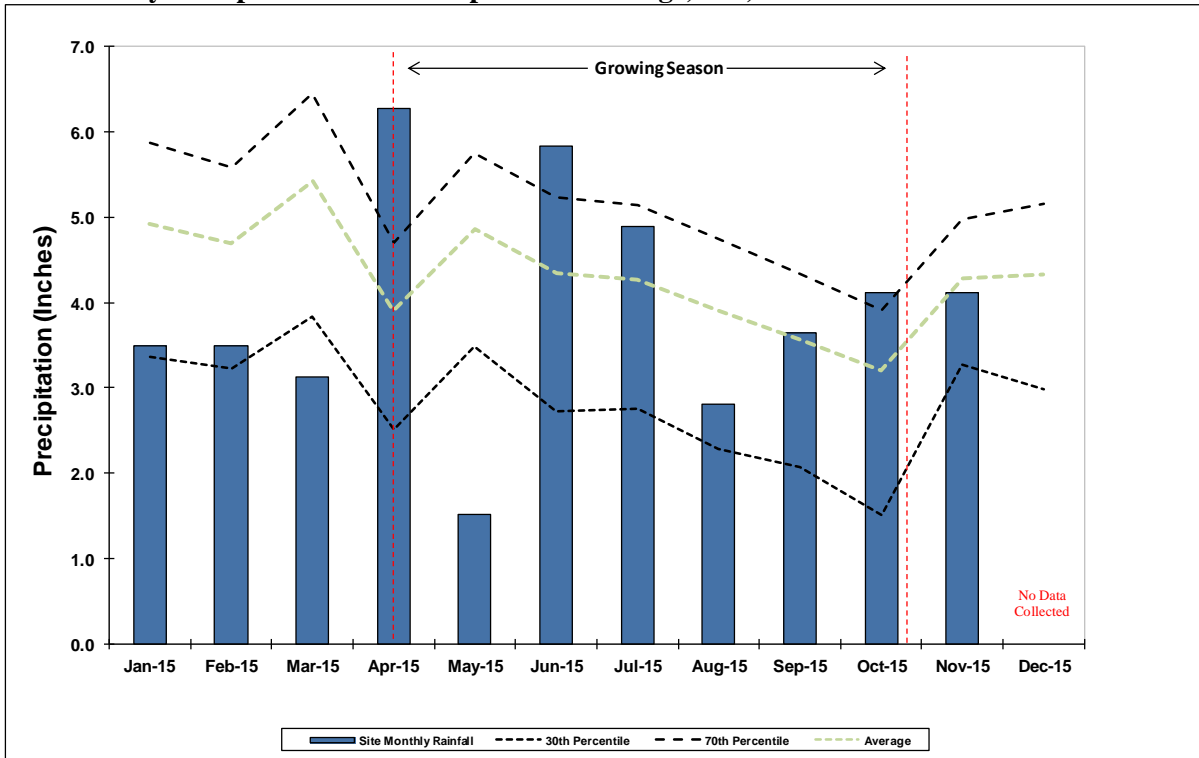
Figure 4. Monthly Precipitation Data Compared to Average, 30th, and 70th Percentiles for Jackson County
