As-Built Baseline Monitoring Report
FINAL VERSION
Lake Wendell Mitigation Project
Monitoring Year 0
Calendar Year of Data Collection: 2018

NCDEQ DMS Project Identification # 97081
NCDEQ DMS Contract # 6826
Neuse River Basin (Cataloging Unit 03020201)
USACE Action ID Number: SAW-2016-00876
NCDEQ DWR Project # 2016-0385
Johnston County, NC
Contracted Under RFP # 16-006477
Data Collection Period: March-June 2018, Submission Date: March 2019

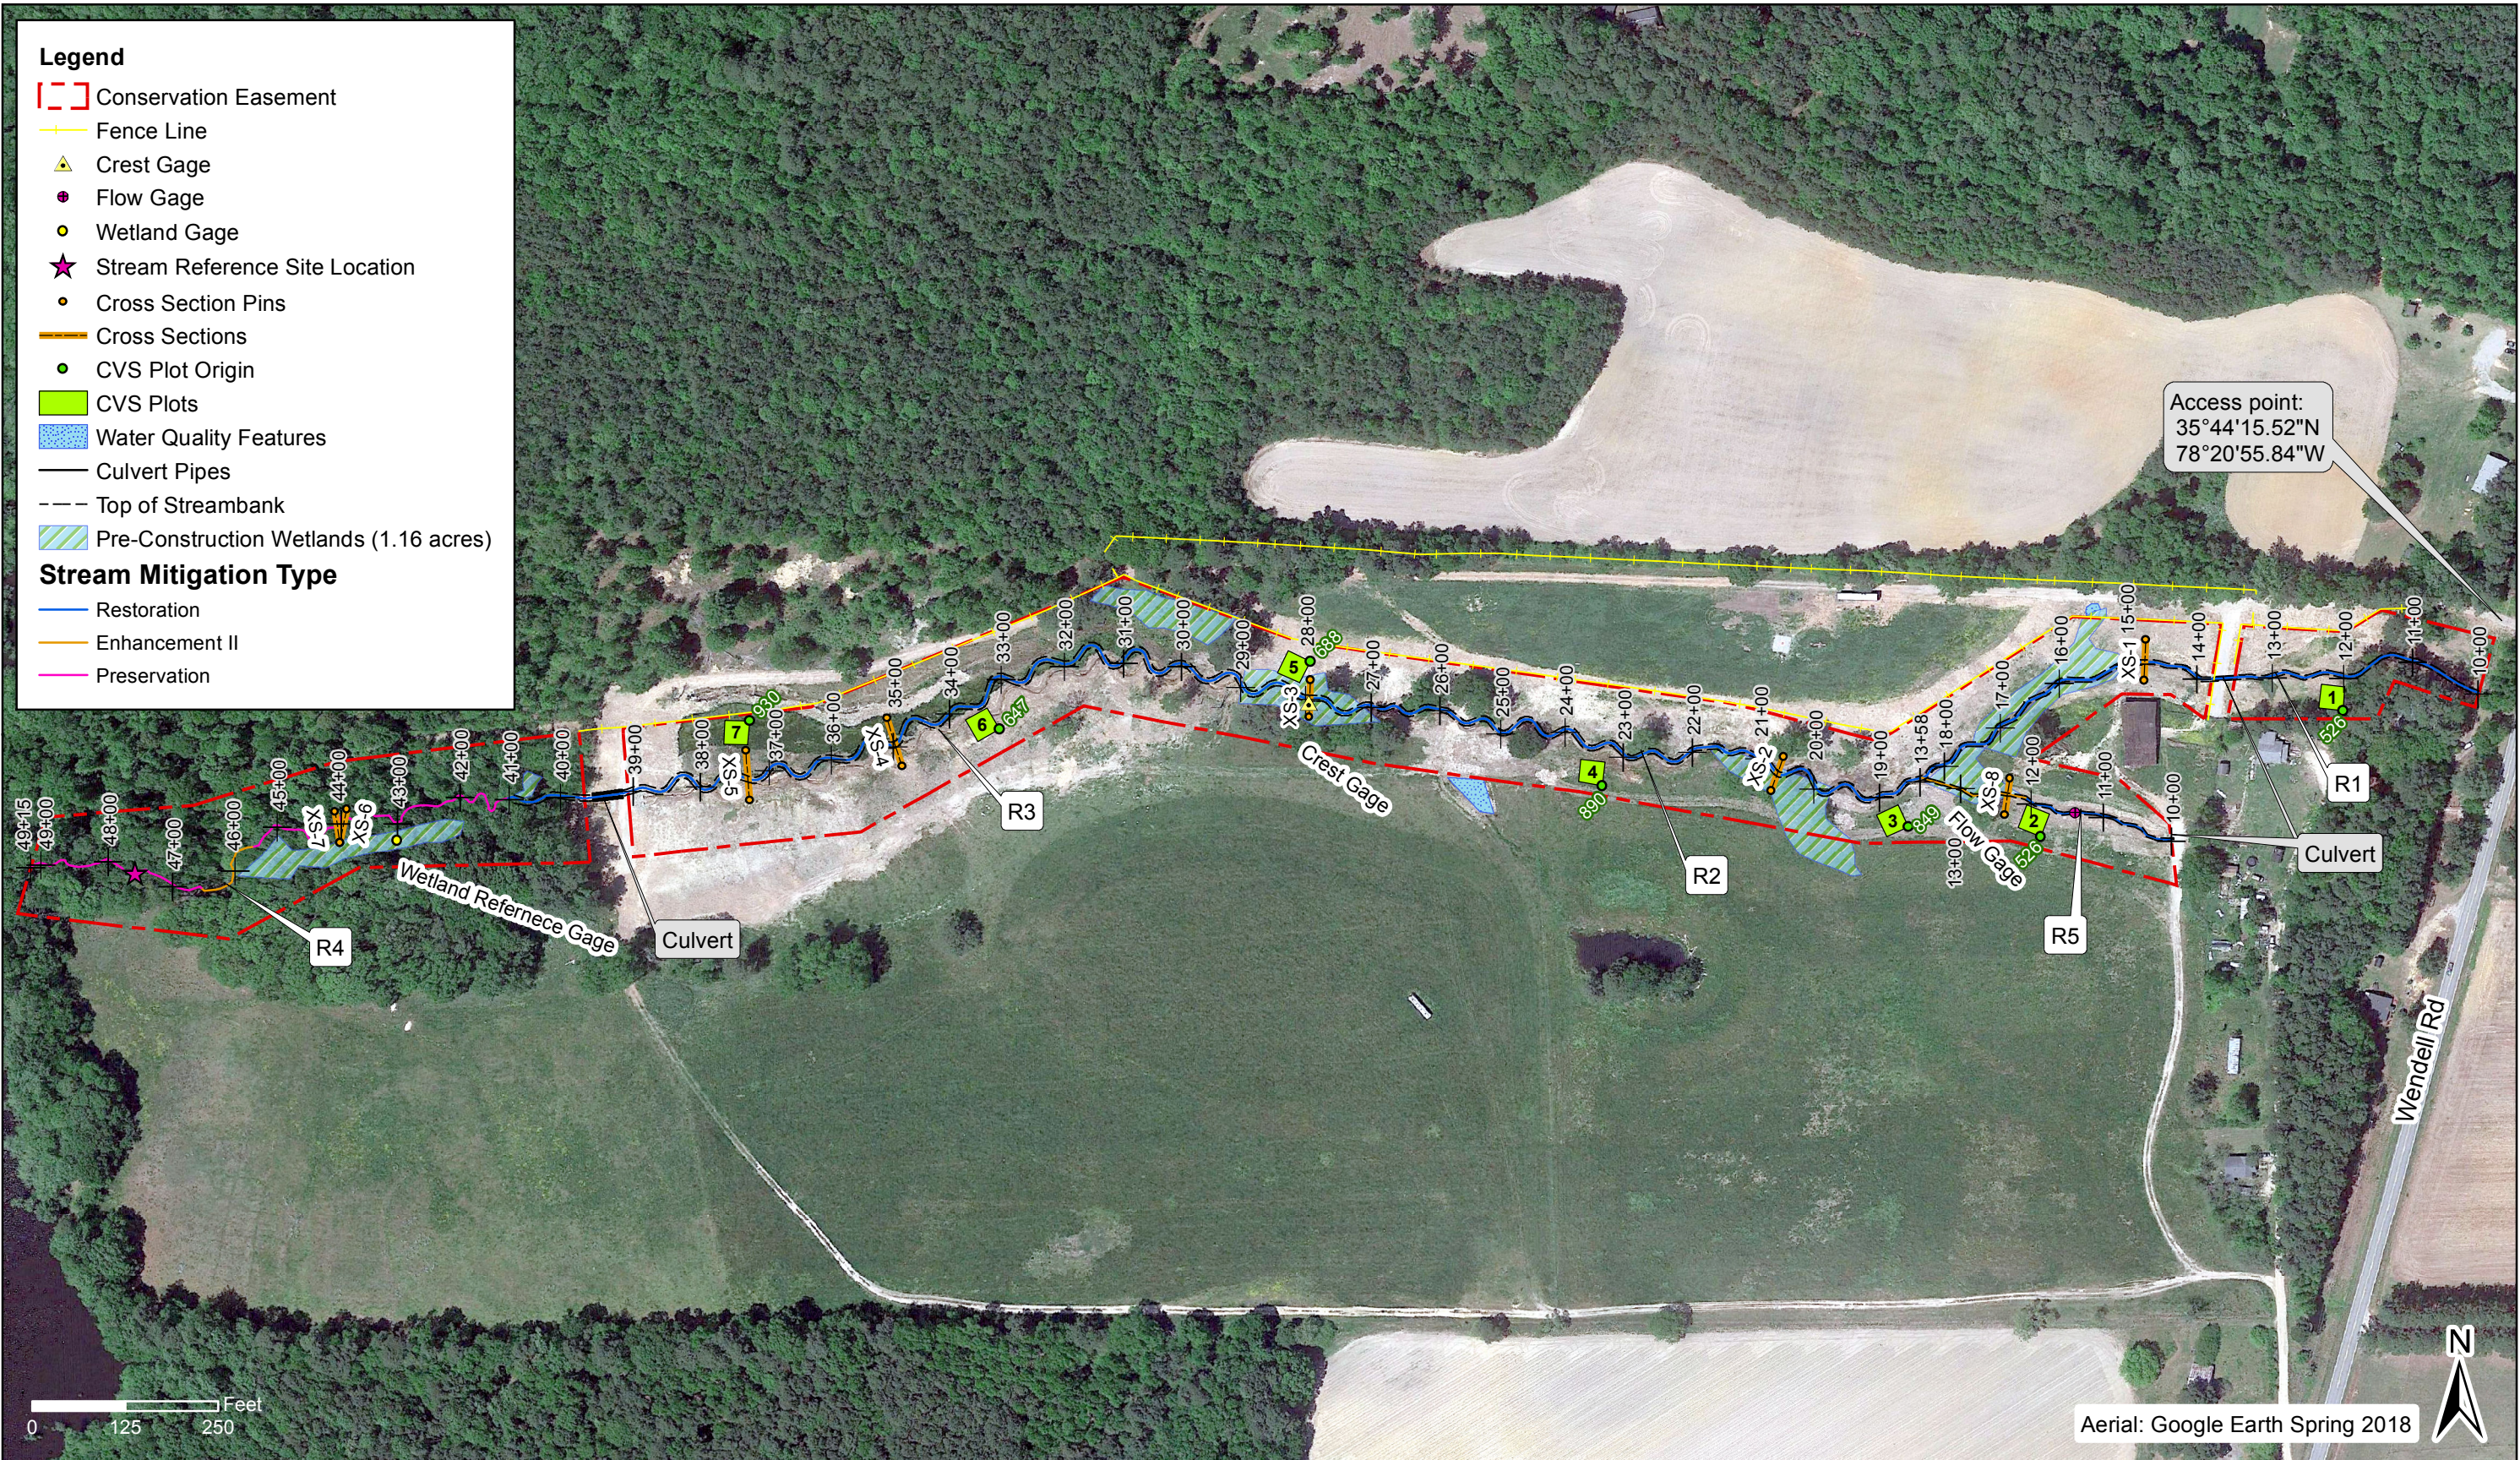
Table 5.
Project
Reach ID
Assessed Length

Visual Stream Morphology Stability Assessment
Lake Wendell Mitigation Project (NCDEQ DMS Project ID# 97081)
R1, R2, R3, R4, R5
4221

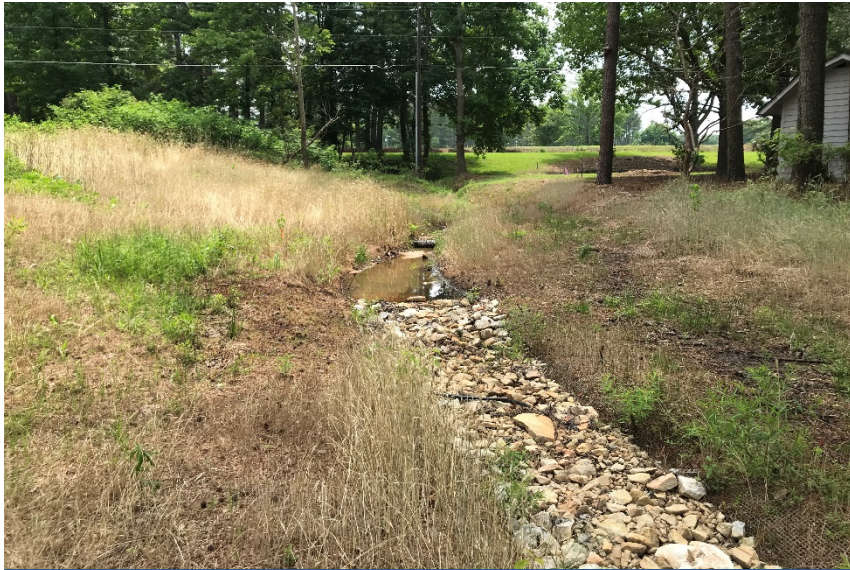
R1, facing upstream, Sta 11+50, June 11, 2018 (MY-00)

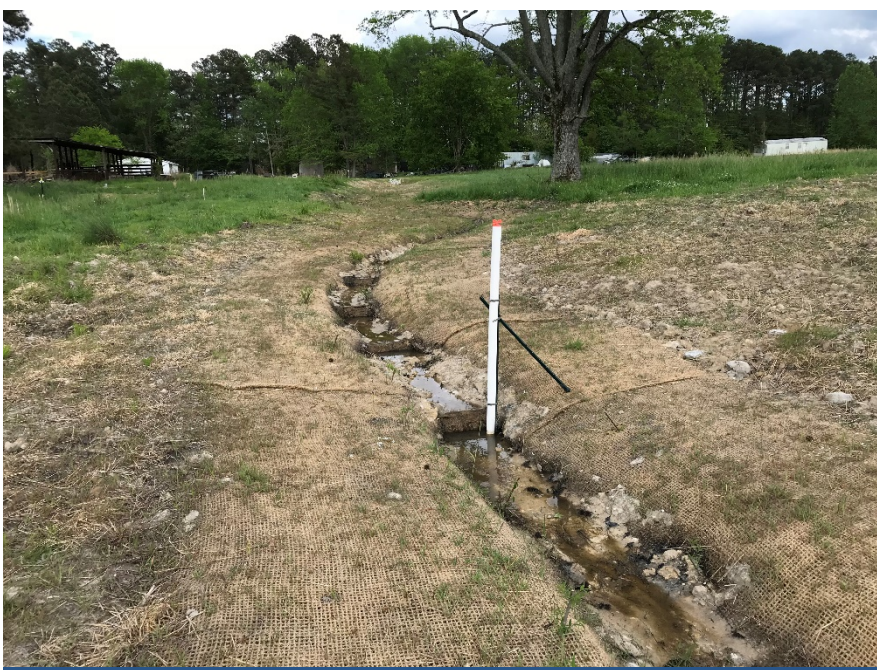
R5, facing upstream, old crest gage, Sta 13+50, Apr 27, 2018 (MY-00)

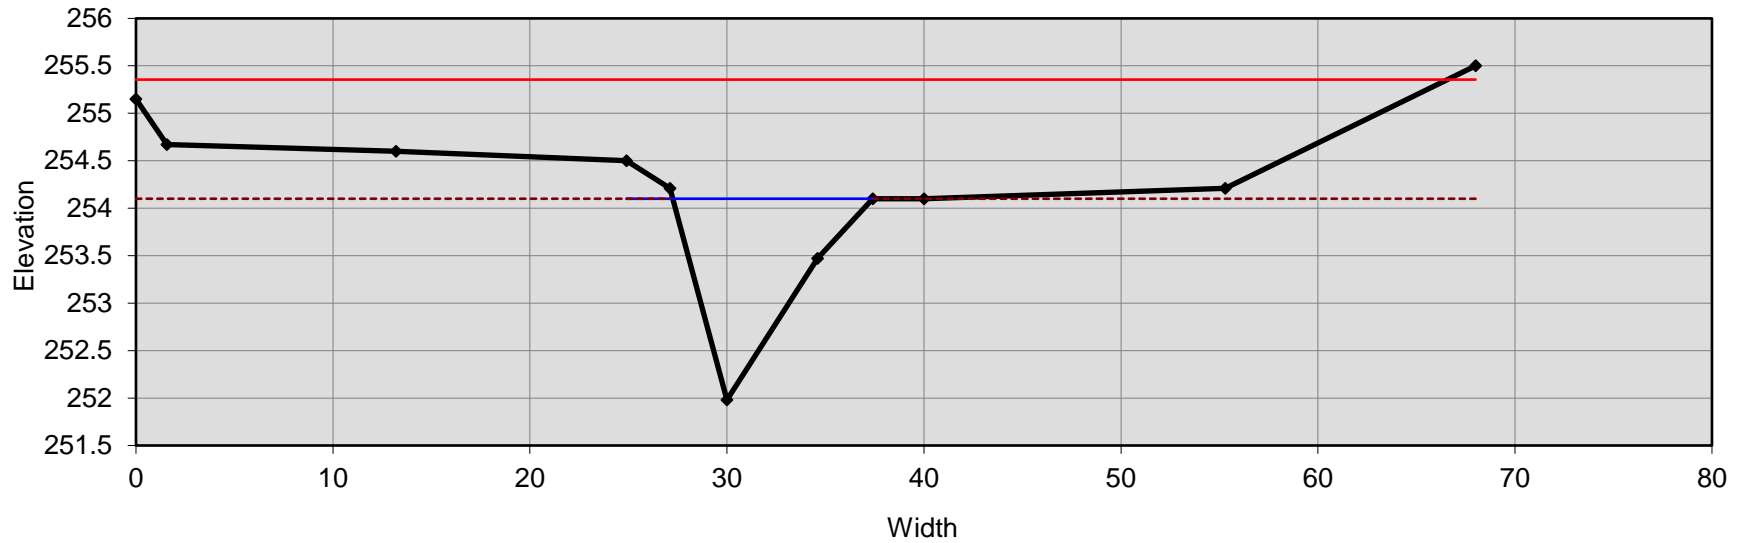
Cross Section X-4

Lake Wendell Mitigation Project - As-built (MY0), Pool

10.1	x-section area (ft.sq.)
10.2	width (ft)
1.0	mean depth (ft)
2.1	max depth (ft)
11.2	wetted parimeter (ft)
0.9	hyd radi (ft)
10.2	width-depth ratio

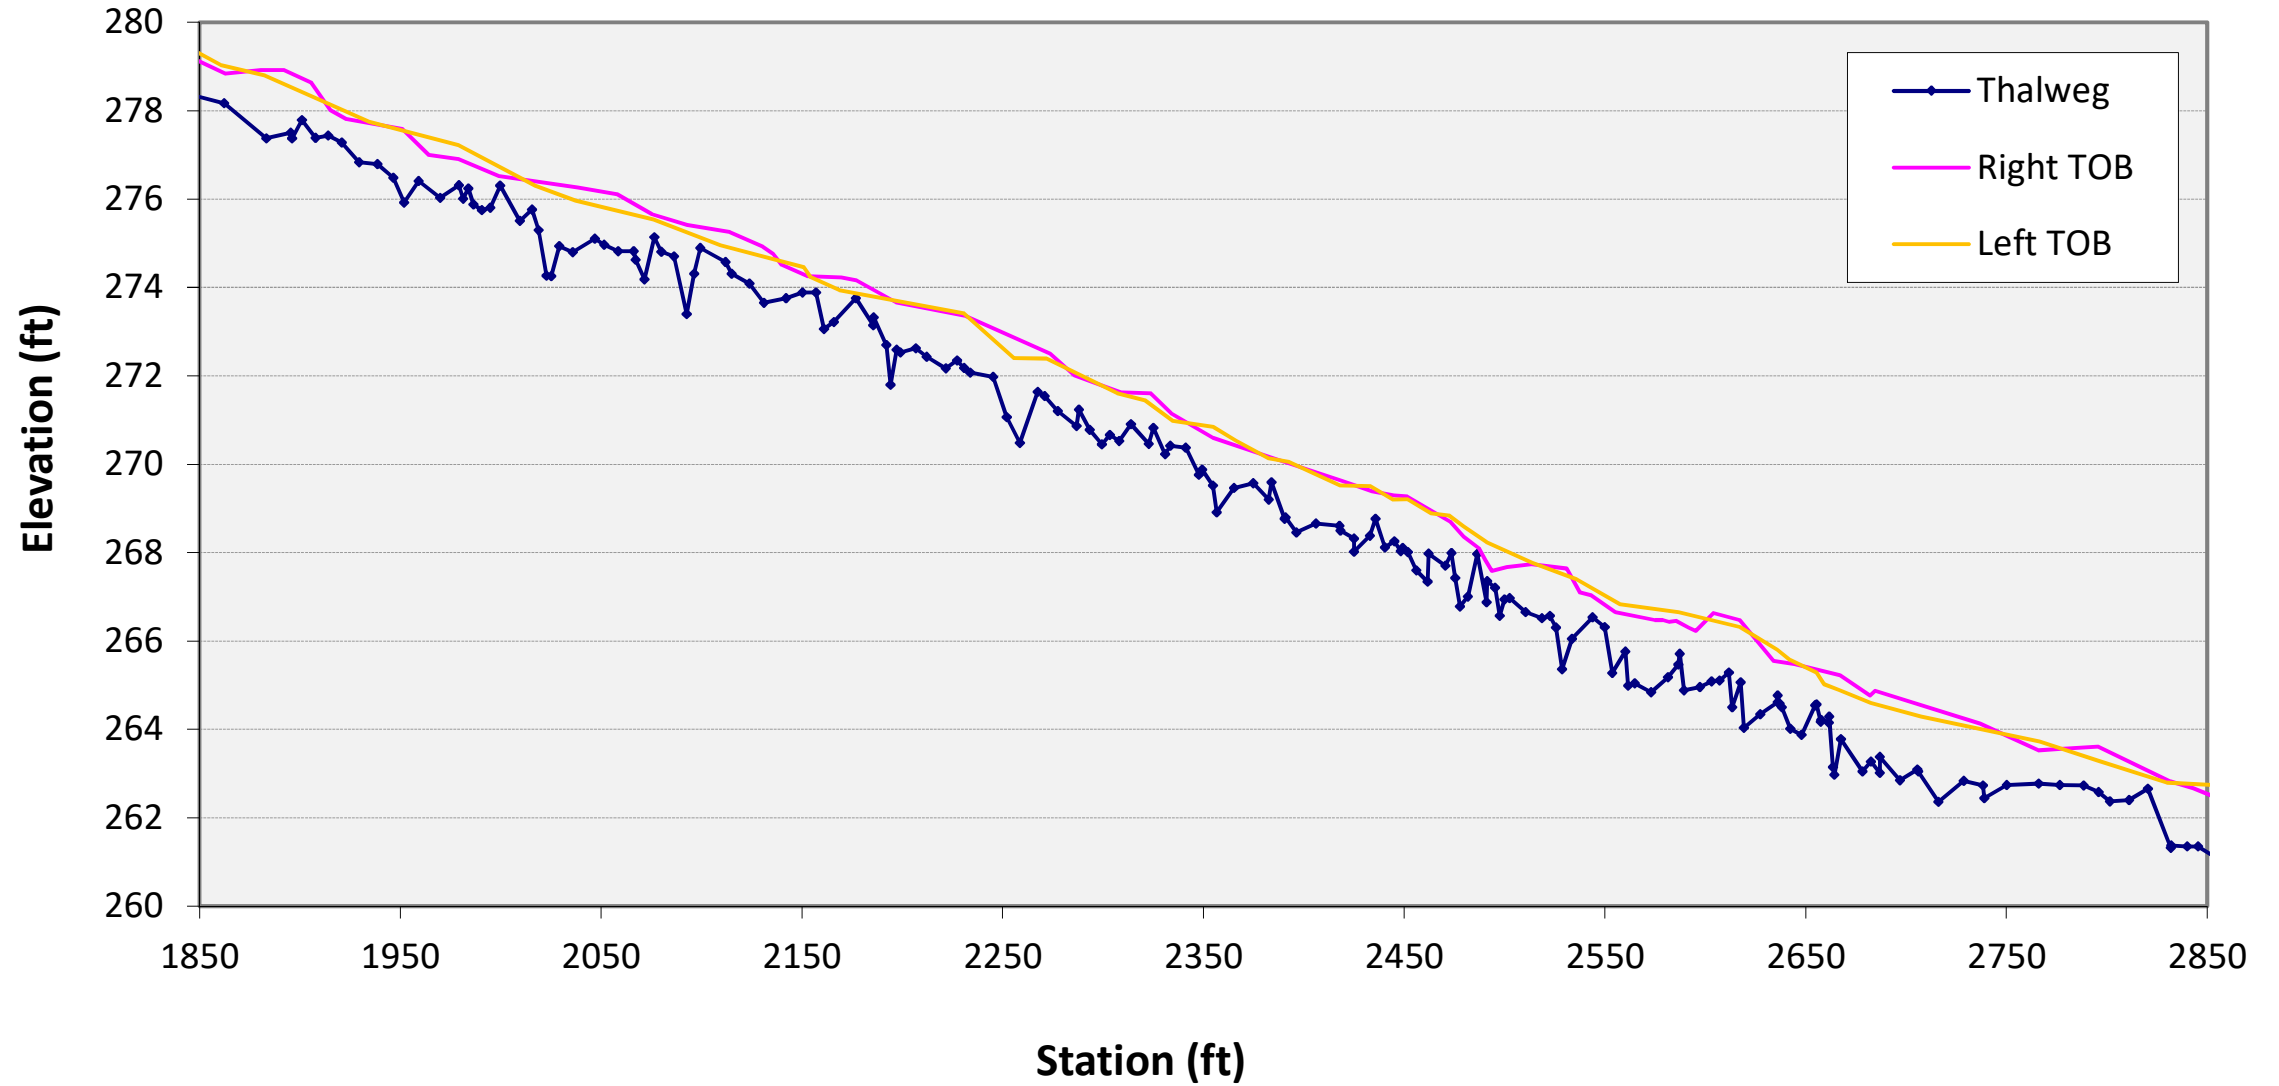
**Lake Wendell Mitigation Project
Longitudinal Profile - R2
As-Built (MY0 2018)**

Stream profiles, as a measure of vertical stability will be evaluated by looking at Bank Height Ratios (BHR). The BHR shall not exceed 1.2 along the restored project reaches. This standard only applies to the restored project reaches where BHRs were corrected through design and construction. In addition, observed bedforms should be consistent with those observed for channels of the design stream type(s). Vertical stability and floodplain access will both be evaluated by looking at Entrenchment Ratios (ER). The ER shall be no less than 2.2 (>1.5 for “B” stream types) along the restored project stream reaches. This standard only applies to restored reaches of the channel where ERs were corrected through design and construction.

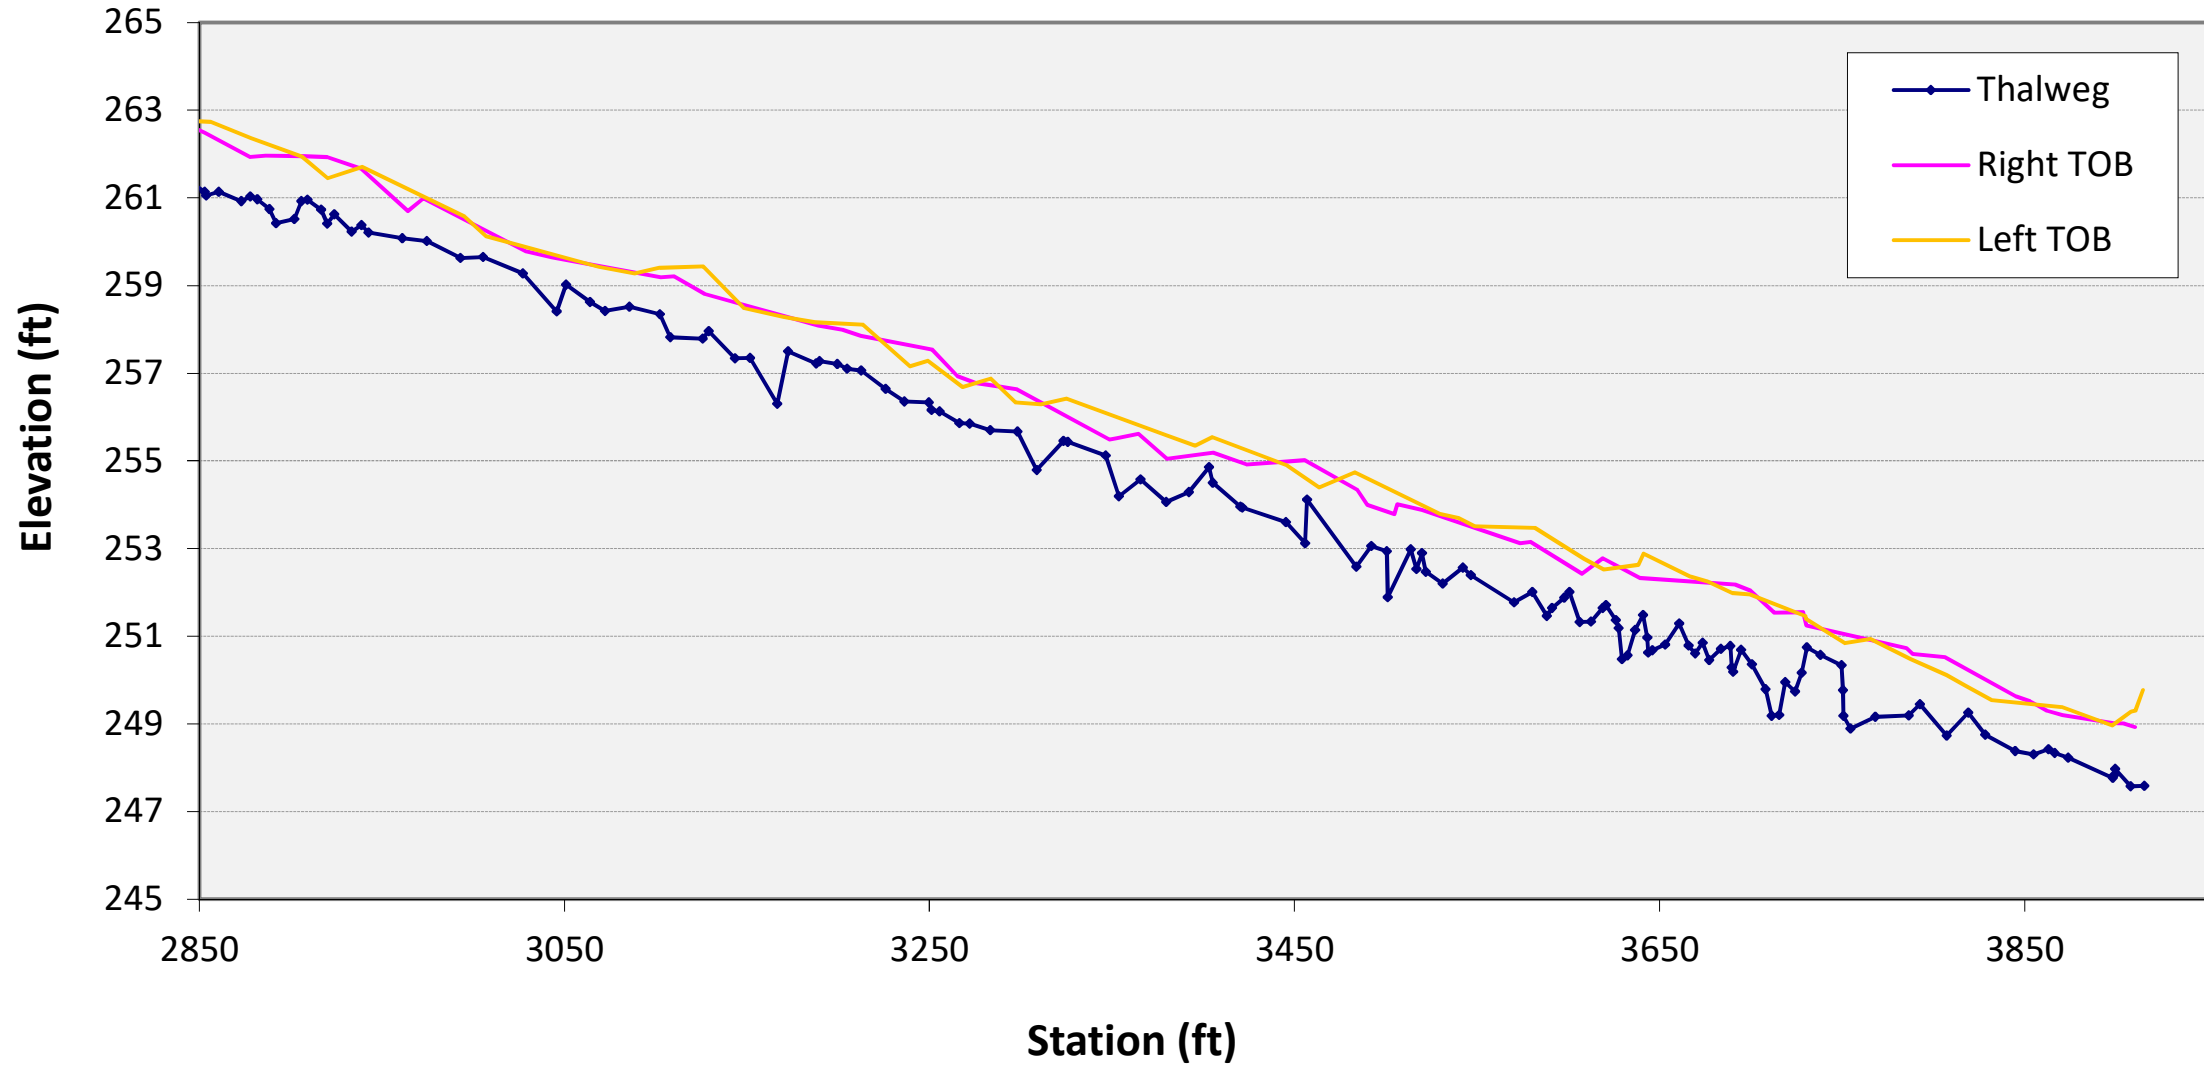
Lake Wendell Mitigation Project
Longitudinal Profile - R3
As-Built (MY0 2018)

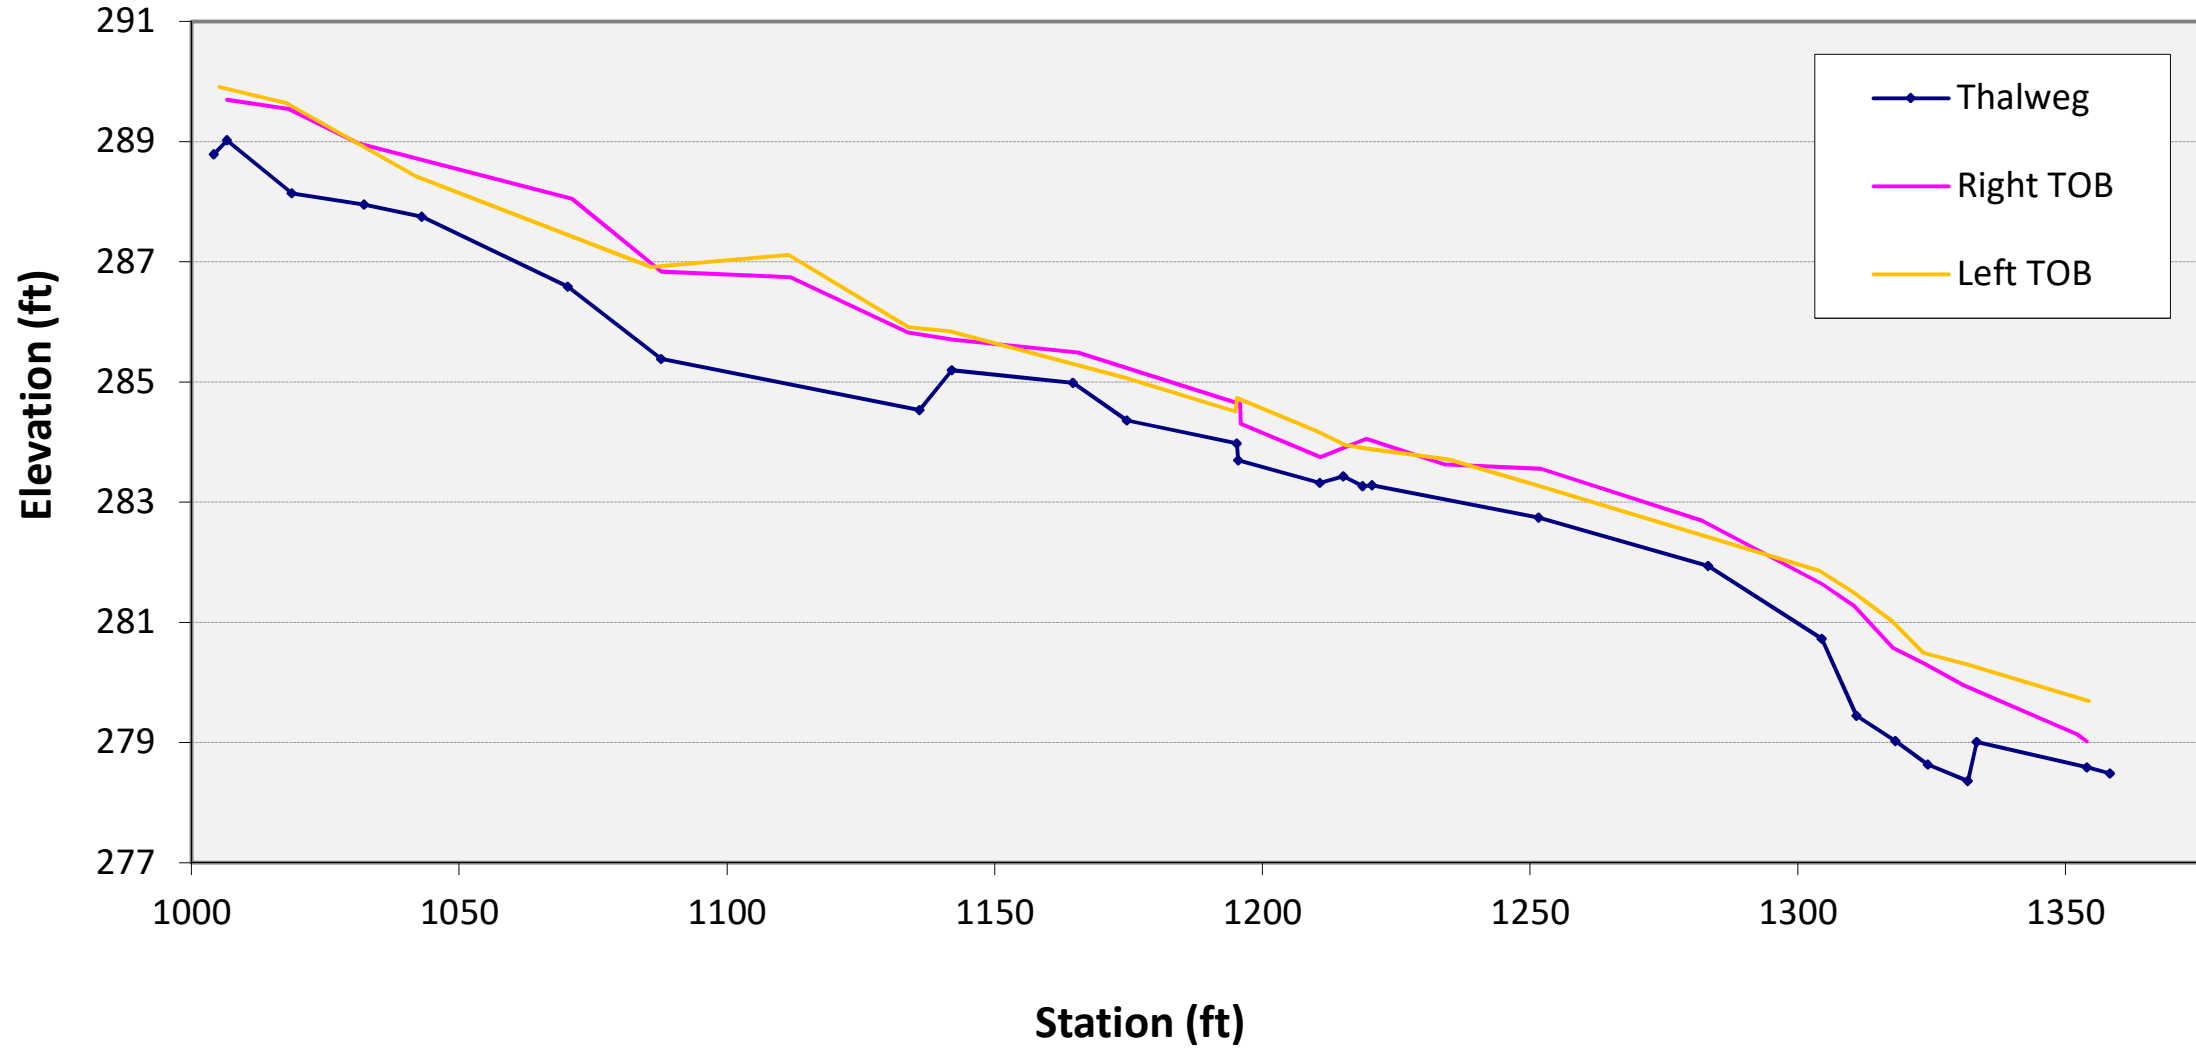
**Lake Wendell Mitigation Project
Longitudinal Profile - R5
As-Built (MY0 2018)**
