**As-Built Baseline Monitoring Report**

**LITTLE SEBASTIAN SITE**

NCDMS Project # 100027 (Contract # 7187) | RFP 16-006993 (Issued 9/16/2016)  
USACE Action ID: SAW-2017-01507 | DWR Project # 2017-1041

Surry County, North Carolina  
Yadkin River Basin  
HUC 03040101

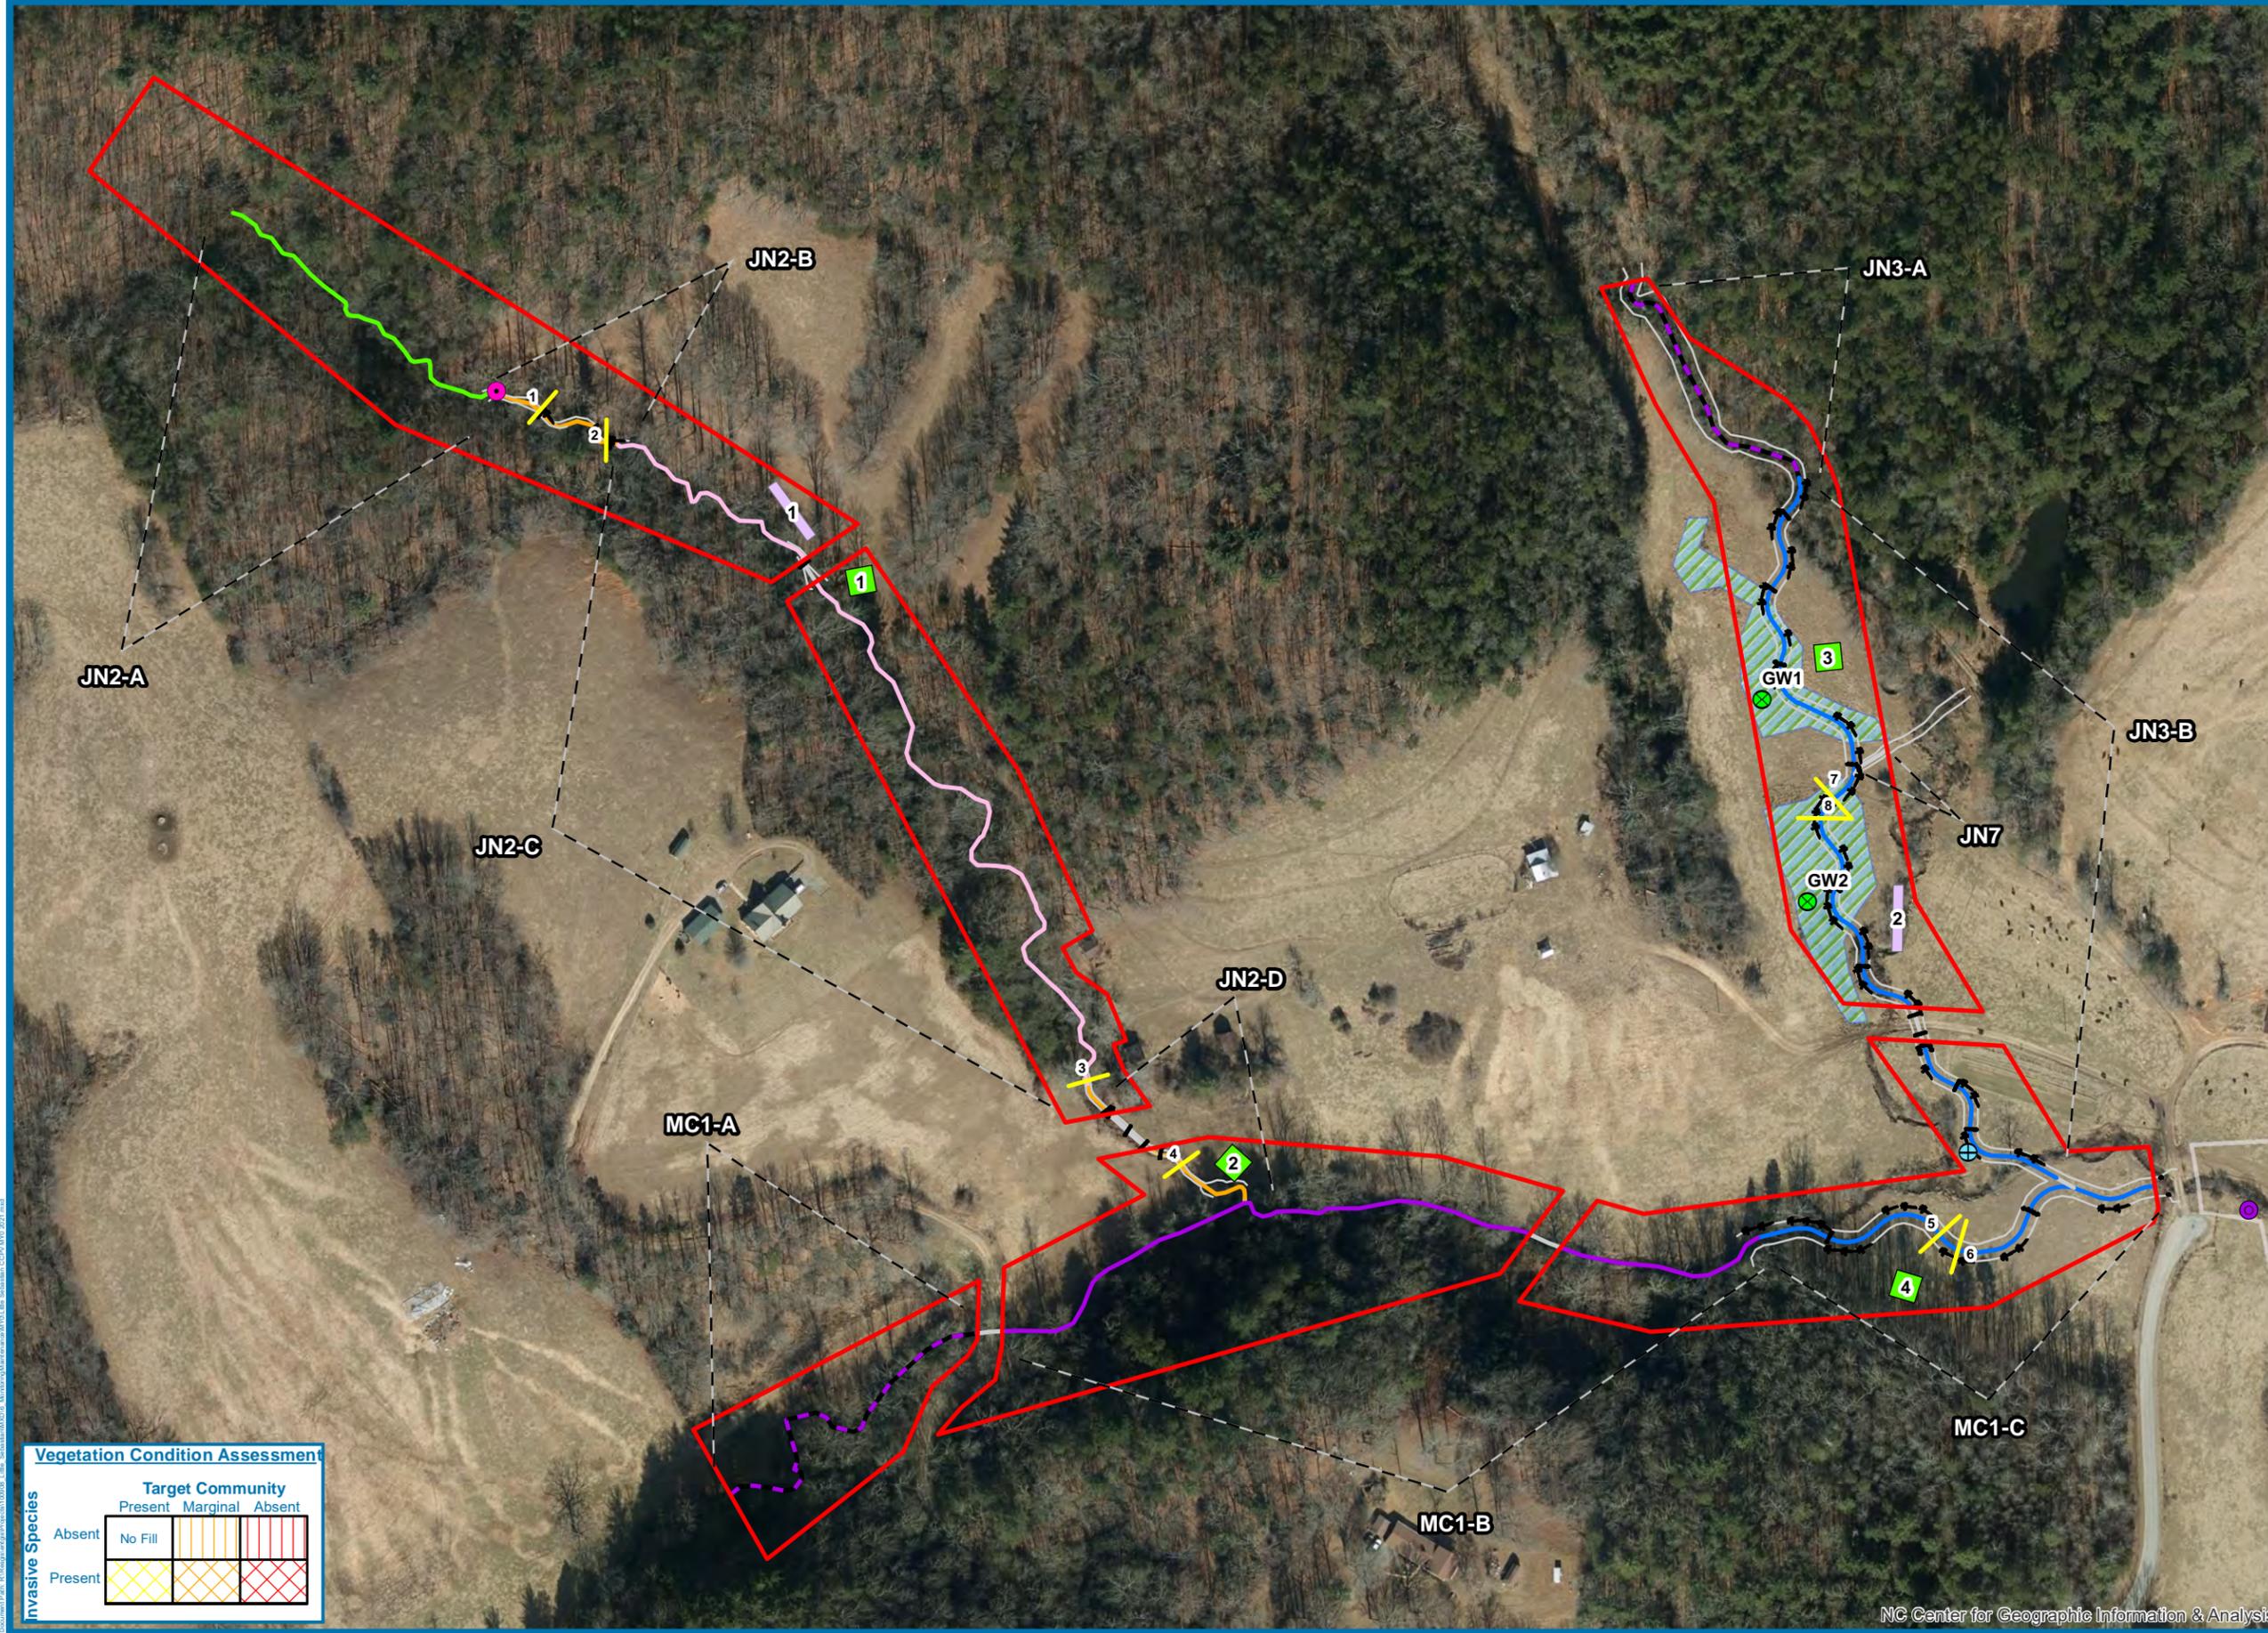
Current Conditions  
Plan View

- ▬ Conservation Easement
- Gideon Bank Site
- Fixed Veg Plot
- Random Veg Plot
- Existing Wetland
- Structure
- Top of Bank
- Cross Section
- Restoration
- Enhancement I
- Enhancement II
- Enhancement II (5:1)
- Enhancement II (7.5:1)
- Enhancement II (10:1)
- Preservation
- No Credit
- ⊗ Groundwater Well
- ⊕ Stage Recorder
- Flow Gauge
- Ambient

Two stage recorders and two flow gauges were installed on March 17, 2021 and will document bankfull events and flow days, respectively. Stream hydrology data will be included in the Monitoring Year 1 Report in this section and in the appendices. Gauge locations can be found on **Figure 2** and photos are in **Appendix B**. RES will add a flow gauge on JN7 this winter.

Two groundwater wells with automatic recording pressure transducers were installed in March 2021. The goal of the groundwater wells is to track the hydrology of the jurisdictional wetlands on site post-stream construction. There is no hydroperiod success criteria for these groundwater wells. Wetland hydrology data will be included in the Monitoring Year 1 Report in this section and in the appendices. Gauge locations can be found on **Figure 2** and photos are in **Appendix B**.

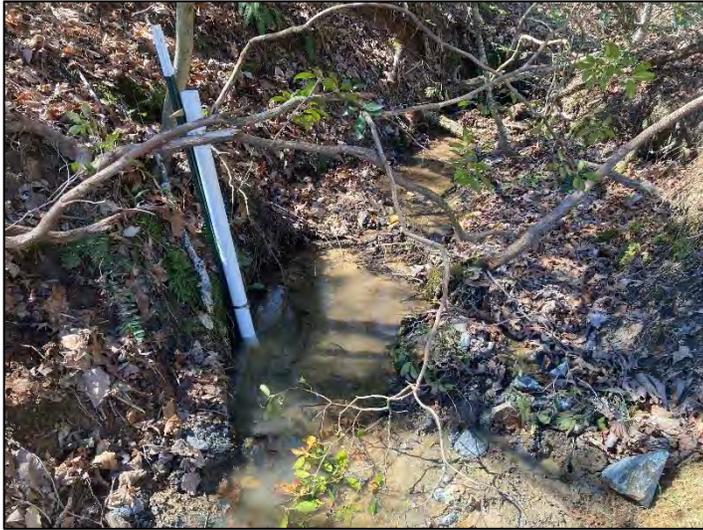
Flow Gauge JN2-A

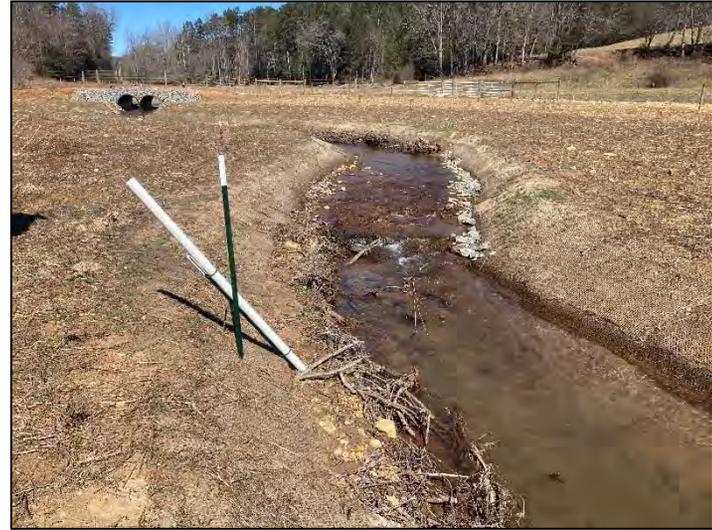
Stage Recorder JN3

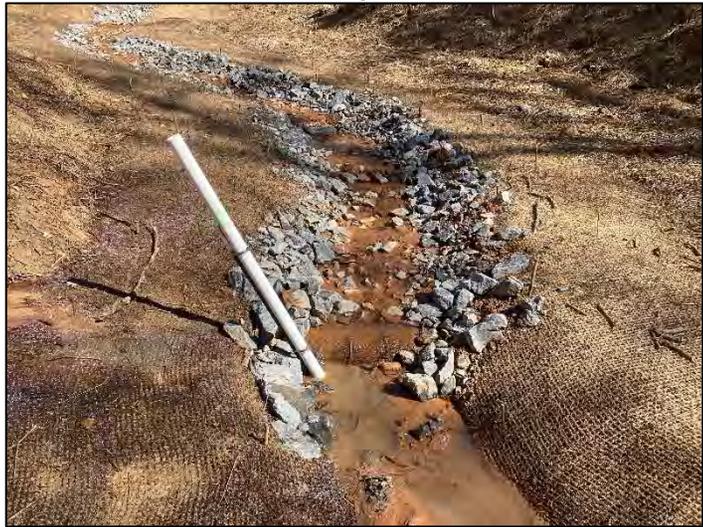
Flow Gauge BS1-A

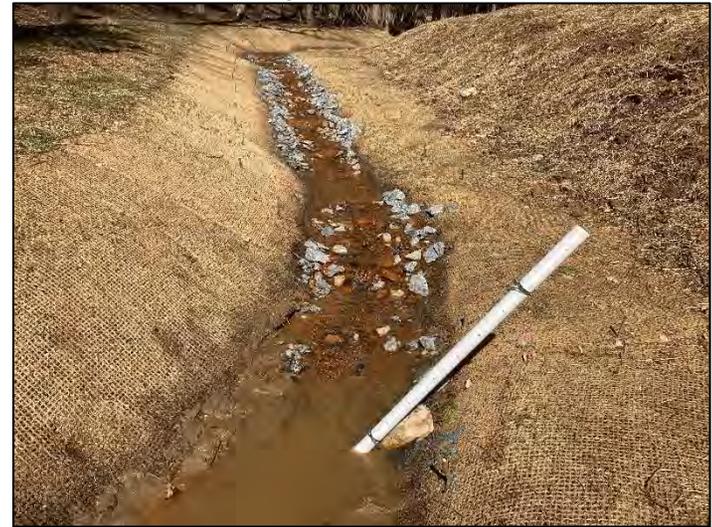
Stage Recorder BS1-E

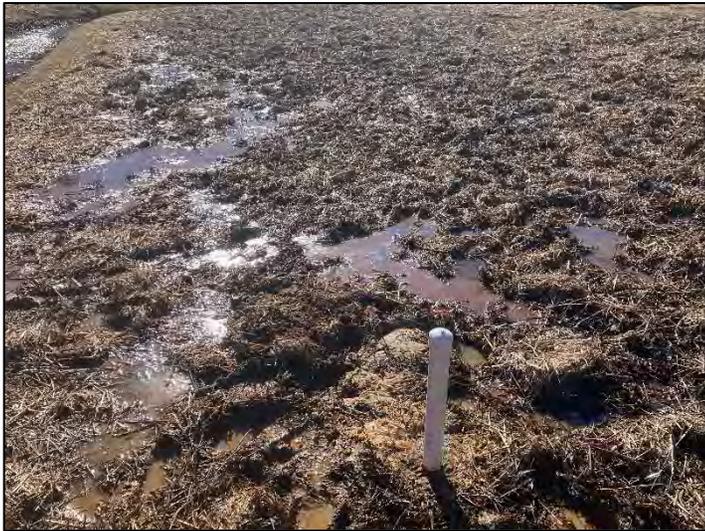
Groundwater Well 1

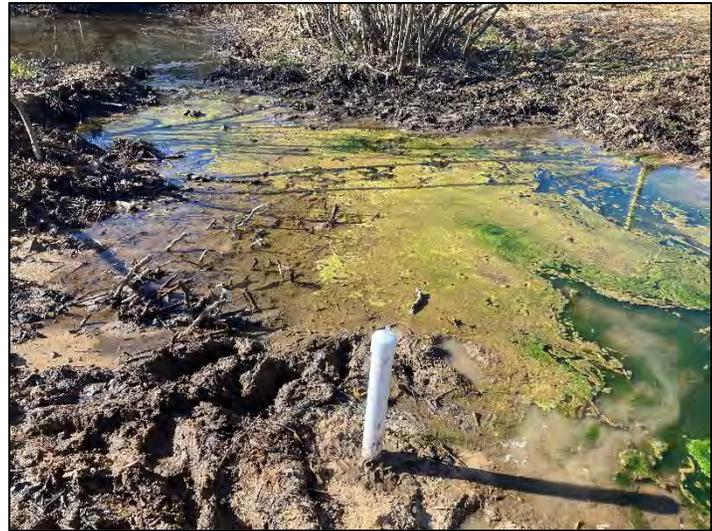
Groundwater Well 2

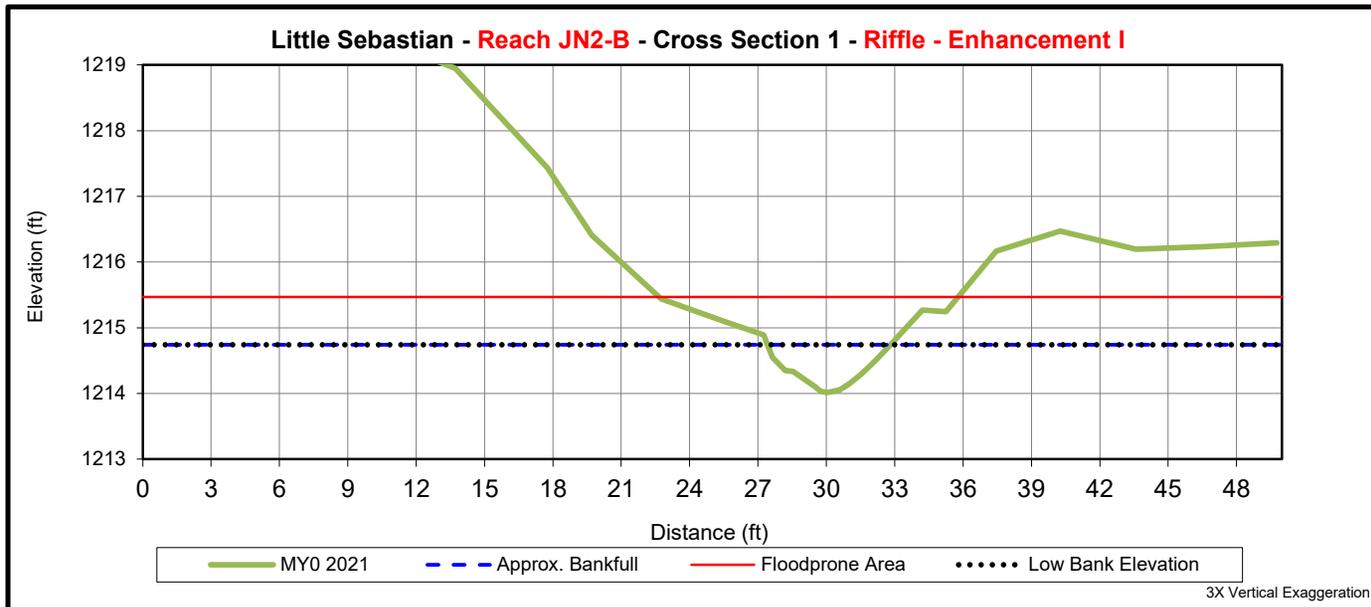
Cross Section 1 (Riffle)						
	Base	MY1	MY2	MY3	MY5	MY7	MY+
<b>Bankfull Elevation (ft) - Based on AB-XSA<sup>1</sup></b>	1214.7						
Bankfull Width (ft) <sup>1</sup>	5.4						
Floodprone Width (ft) <sup>1</sup>	13.1						
Bankfull Max Depth (ft) <sup>2</sup>	0.7						
Low Bank Elevation (ft)	1214.74						
Bankfull Cross Sectional Area (ft <sup>2</sup> ) <sup>2</sup>	2.4						
Bankfull Entrenchment Ratio <sup>1</sup>	2.4						
Bankfull Bank Height Ratio <sup>1</sup>	1.0

A total of 12 cross sections were installed on March 3, 2021, and geomorphology data collection for MY0 was conducted on March 16, 2021. Summary tables and cross section plots are in **Appendix D**. Overall the baseline cross sections and profile relatively match the proposed design. The as-built conditions show that shear stress and velocities have been reduced for the restoration reach. The reaches were designed as gravel/cobble bed channels and remain classified as gravel/cobble bed channels post-construction.

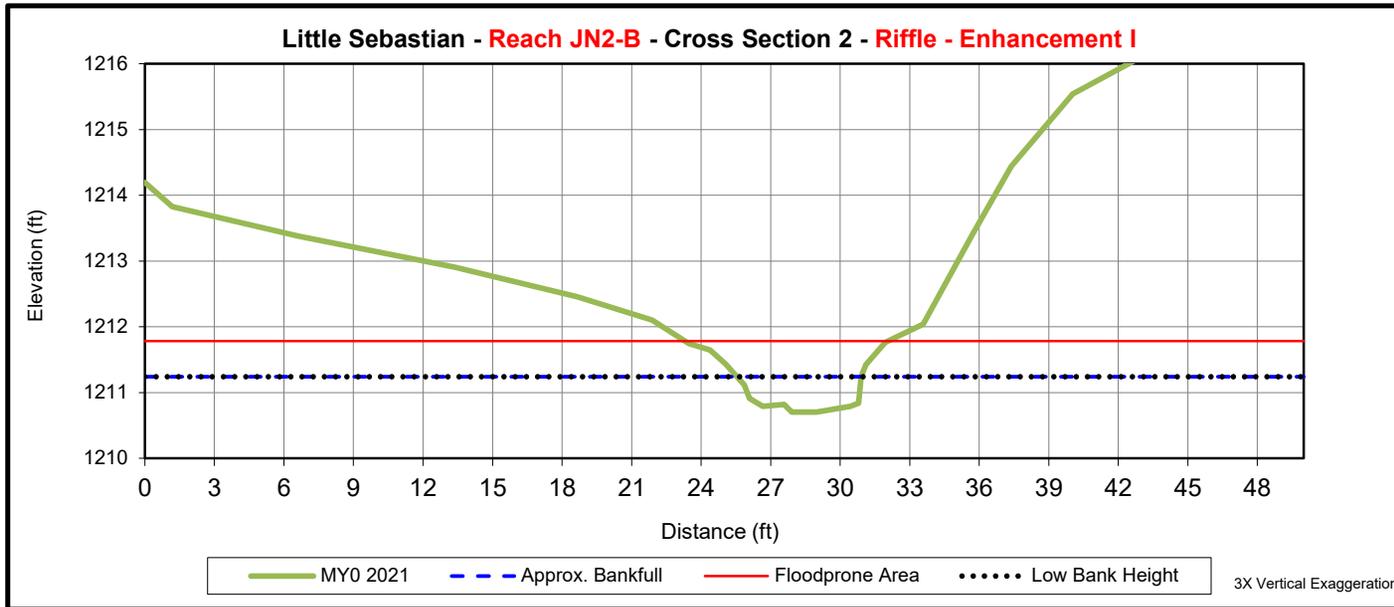
Cross Section 2 (Riffle)						
	Base	MY1	MY2	MY3	MY5	MY7	MY+
<b>Bankfull Elevation (ft) - Based on AB-XSA<sup>1</sup></b>	1211.2						
Bankfull Width (ft) <sup>1</sup>	5.4						
Floodprone Width (ft) <sup>1</sup>	8.7						
Bankfull Max Depth (ft) <sup>2</sup>	0.5						
Low Bank Elevation (ft)	1211.2						
Bankfull Cross Sectional Area (ft <sup>2</sup> ) <sup>2</sup>	2.3						
Bankfull Entrenchment Ratio <sup>1</sup>	1.6						
Bankfull Bank Height Ratio <sup>1</sup>	1.0

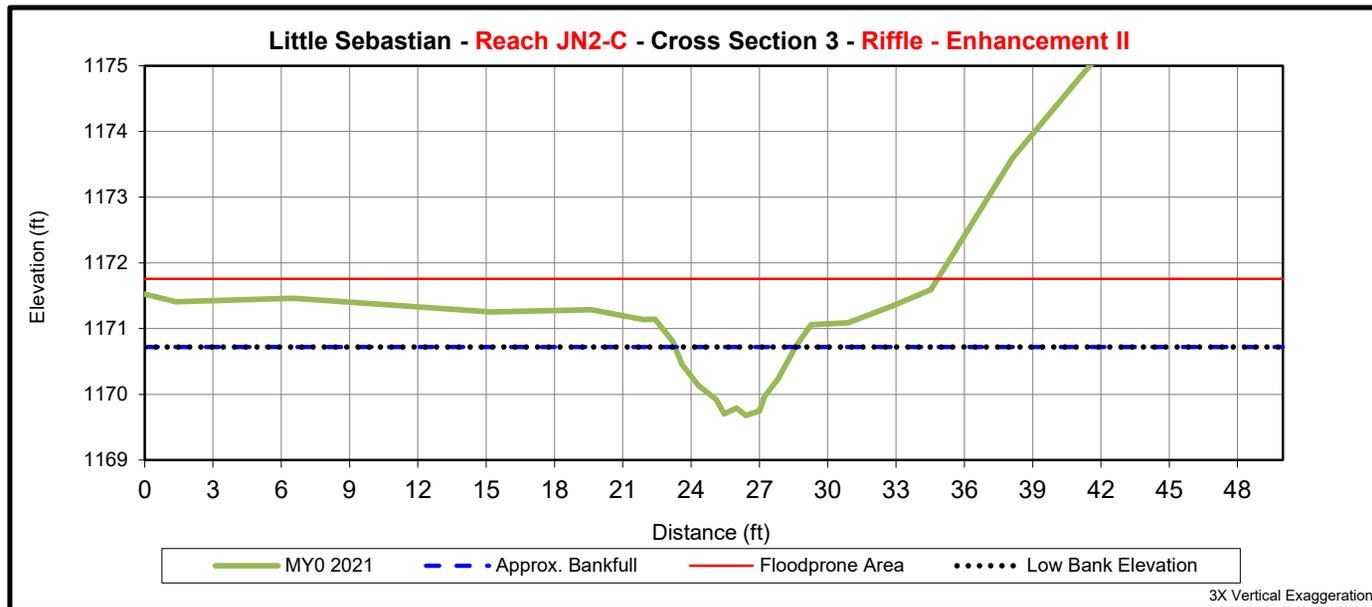
Cross Section 3 (Riffle)						
	Base	MY1	MY2	MY3	MY5	MY7	MY+
<b>Bankfull Elevation (ft) - Based on AB-XSA<sup>1</sup></b>	1170.7						
Bankfull Width (ft) <sup>1</sup>	5.3						
Floodprone Width (ft) <sup>1</sup>	>34.8						
Bankfull Max Depth (ft) <sup>2</sup>	1.0						
Low Bank Elevation (ft)	1170.7						
Bankfull Cross Sectional Area (ft <sup>2</sup> ) <sup>2</sup>	3.5						
Bankfull Entrenchment Ratio <sup>1</sup>	>6.6						
Bankfull Bank Height Ratio <sup>1</sup>	1.0

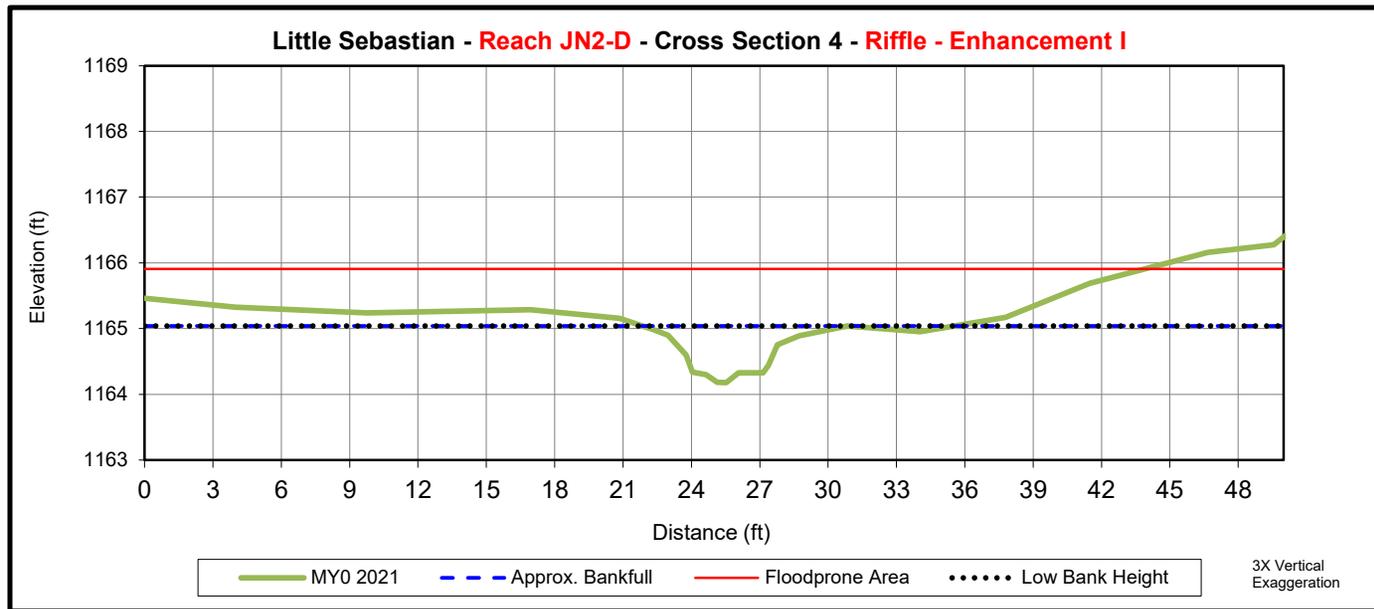
Cross Section 4 (Riffle)						
	Base	MY1	MY2	MY3	MY5	MY7	MY+
<b>Bankfull Elevation (ft) - Based on AB-XSA<sup>1</sup></b>	1165.0						
Bankfull Width (ft) <sup>1</sup>	9.0						
Floodprone Width (ft) <sup>1</sup>	>43.9						
Bankfull Max Depth (ft) <sup>2</sup>	0.9						
Low Bank Elevation (ft)	1165.0						
Bankfull Cross Sectional Area (ft <sup>2</sup> ) <sup>2</sup>	3.5						
Bankfull Entrenchment Ratio <sup>1</sup>	>4.9						
Bankfull Bank Height Ratio <sup>1</sup>	1.0

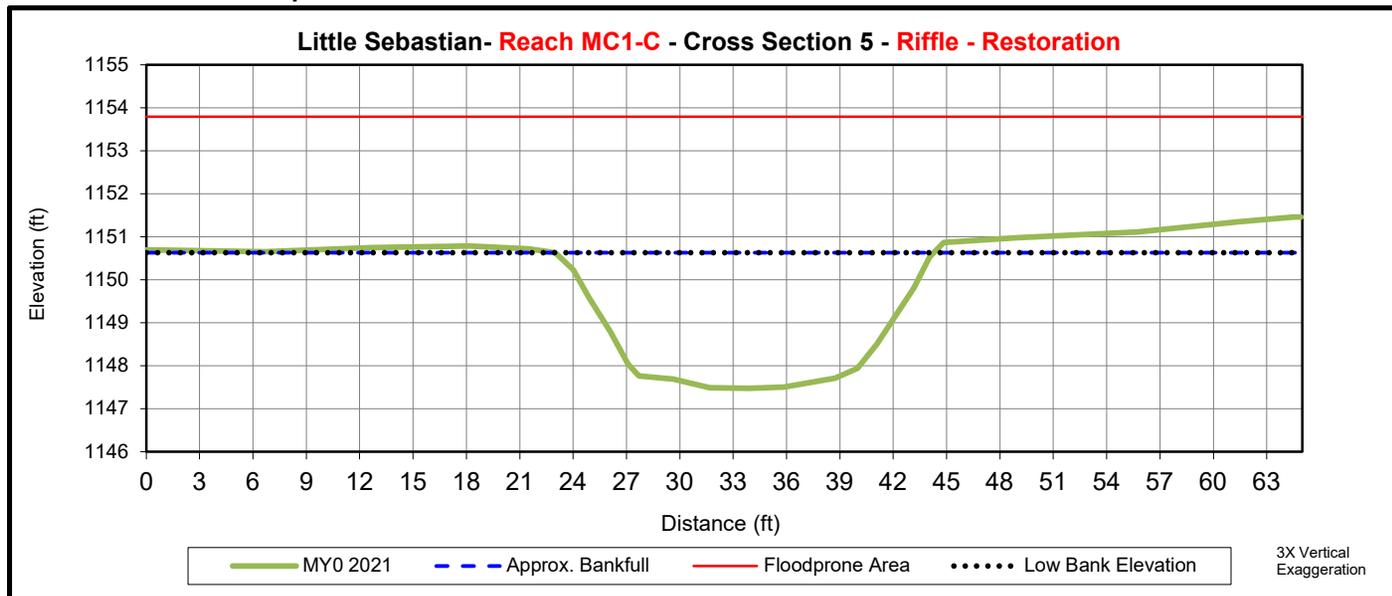
<b>Cross Section 5 (Riffle)</b>						
	Base	MY1	MY2	MY3	MY5	MY7	MY+
<b>Bankfull Elevation (ft) - Based on AB-XSA<sup>1</sup></b>	1150.6						
Bankfull Width (ft) <sup>1</sup>	21.3						
Floodprone Width (ft) <sup>1</sup>	>64.9						
Bankfull Max Depth (ft) <sup>2</sup>	3.2						
Low Bank Elevation (ft)	1150.6						
Bankfull Cross Sectional Area (ft <sup>2</sup> ) <sup>2</sup>	49.8						
Bankfull Entrenchment Ratio <sup>1</sup>	>3.0						
Bankfull Bank Height Ratio <sup>1</sup>	1.0

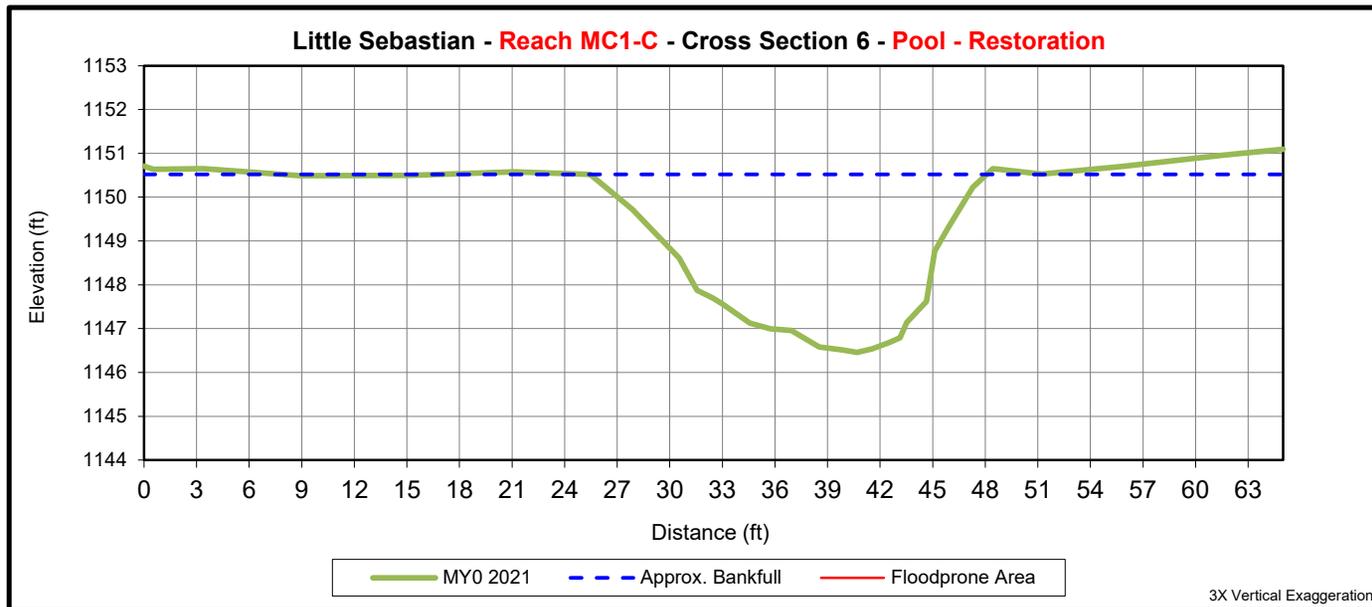
<b>Cross Section 6 (Pool)</b>						
	Base	MY1	MY2	MY3	MY5	MY7	MY+
<b>Bankfull Elevation (ft) - Based on AB-XSA<sup>1</sup></b>	1150.5						
Bankfull Width (ft) <sup>1</sup>	-						
Floodprone Width (ft) <sup>1</sup>	-						
Bankfull Max Depth (ft) <sup>2</sup>	4.1						
Low Bank Elevation (ft)	-						
Bankfull Cross Sectional Area (ft <sup>2</sup> ) <sup>2</sup>	56.7						
Bankfull Entrenchment Ratio <sup>1</sup>	-						
Bankfull Bank Height Ratio <sup>1</sup>	-

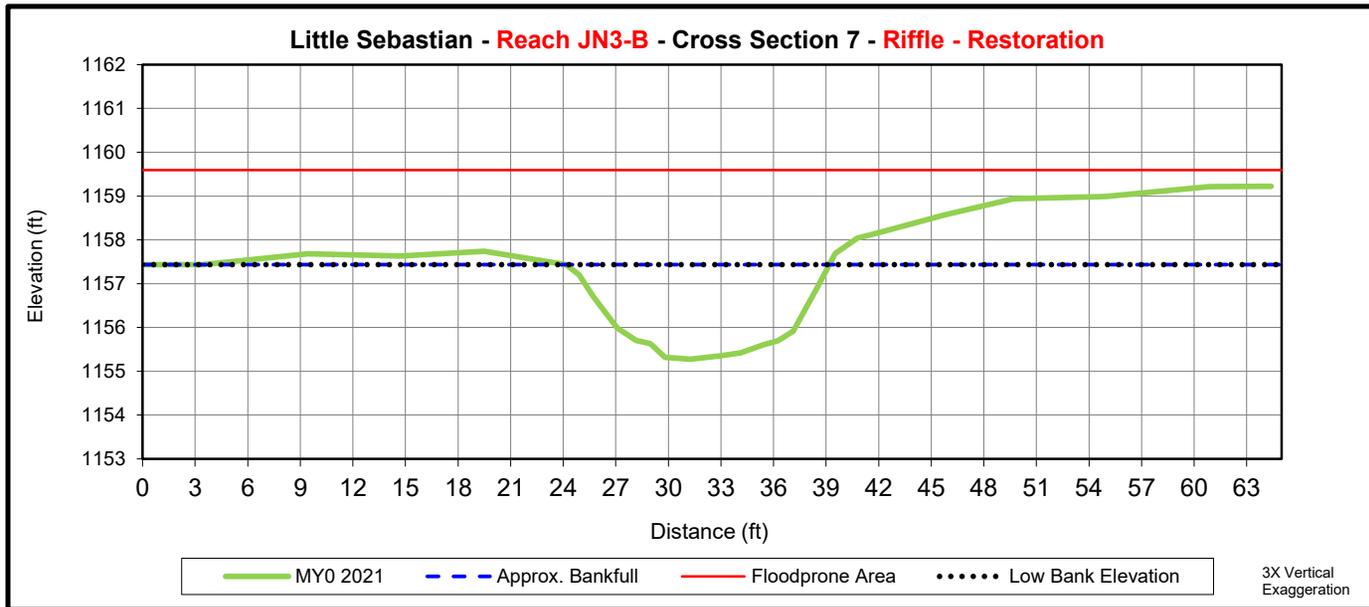
<b>Cross Section 7 (Riffle)</b>						
	Base	MY1	MY2	MY3	MY5	MY7	MY+
<b>Bankfull Elevation (ft) - Based on AB-XSA<sup>1</sup></b>	1157.4						
Bankfull Width (ft) <sup>1</sup>	15.0						
Floodprone Width (ft) <sup>1</sup>	>64.4						
Bankfull Max Depth (ft) <sup>2</sup>	2.2						
Low Bank Elevation (ft)	1157.4						
Bankfull Cross Sectional Area (ft <sup>2</sup> ) <sup>2</sup>	22.8						
Bankfull Entrenchment Ratio <sup>1</sup>	>4.3						
Bankfull Bank Height Ratio <sup>1</sup>	1.0

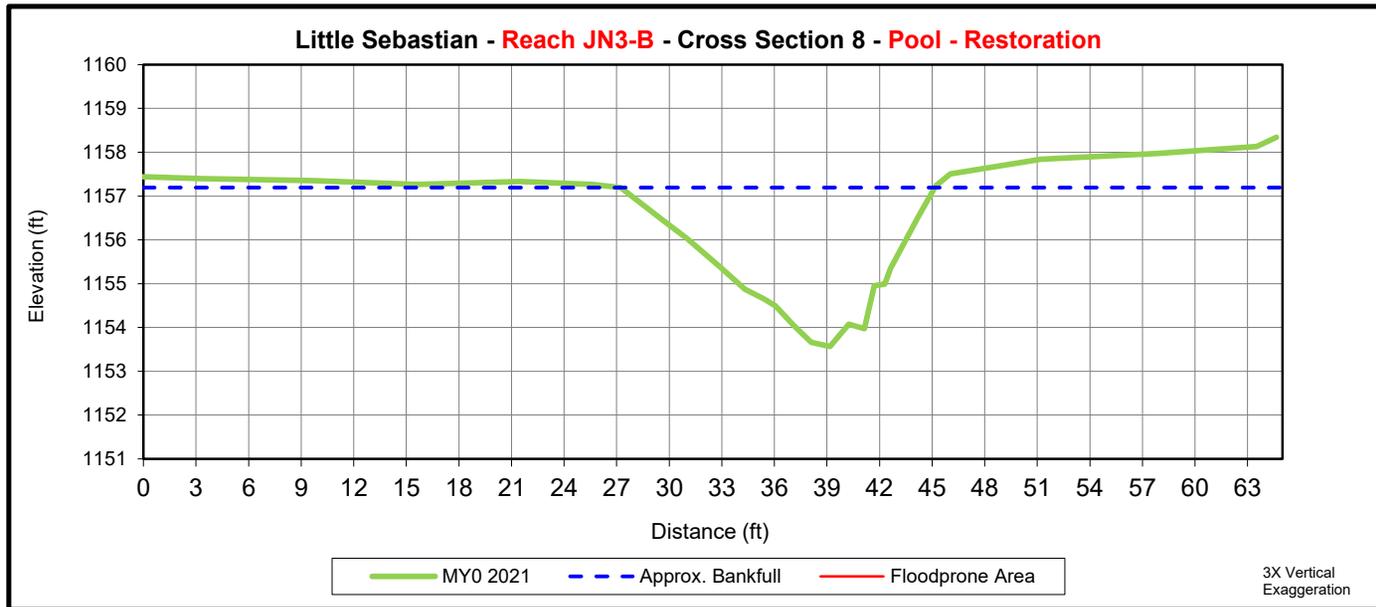
<b>Cross Section 8 (Pool)</b>						
	Base	MY1	MY2	MY3	MY5	MY7	MY+
<b>Bankfull Elevation (ft) - Based on AB-XSA<sup>1</sup></b>	1157.2						
Bankfull Width (ft) <sup>1</sup>	-						
Floodprone Width (ft) <sup>1</sup>	-						
Bankfull Max Depth (ft) <sup>2</sup>	3.6						
Low Bank Elevation (ft)	-						
Bankfull Cross Sectional Area (ft <sup>2</sup> ) <sup>2</sup>	34.8						
Bankfull Entrenchment Ratio <sup>1</sup>	-						
Bankfull Bank Height Ratio <sup>1</sup>	-

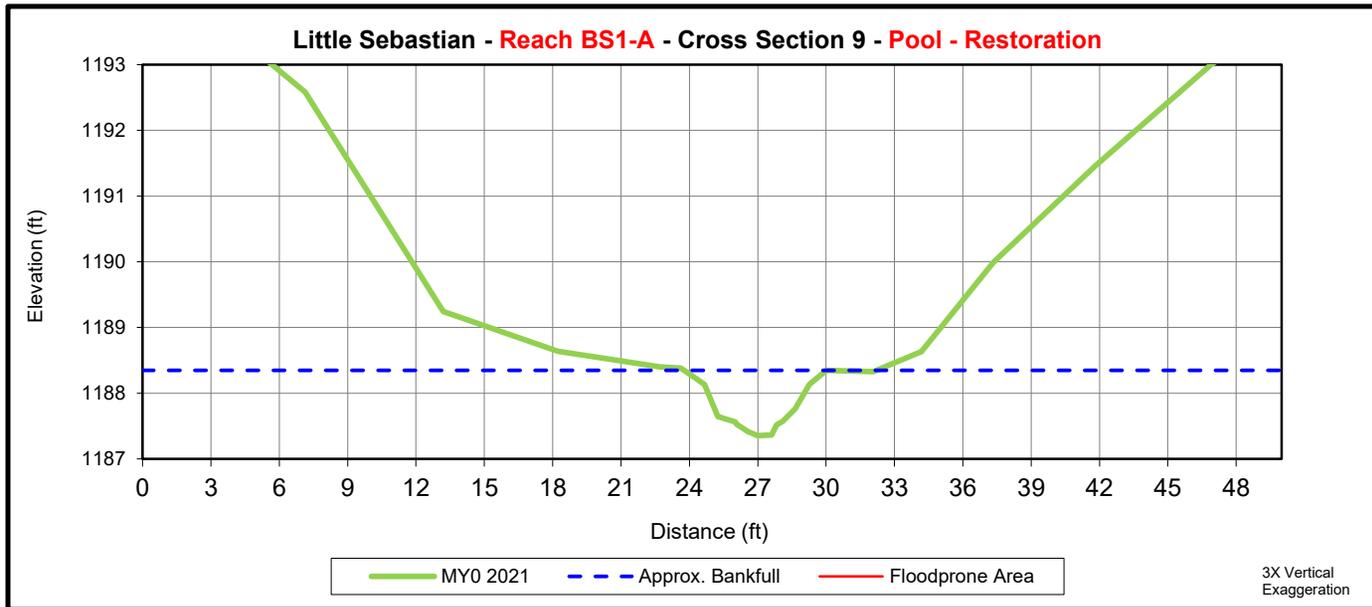
<b>Cross Section 9 (Pool)</b>						
	Base	MY1	MY2	MY3	MY5	MY7	MY+
<b>Bankfull Elevation (ft) - Based on AB-XSA<sup>1</sup></b>	1188.3						
Bankfull Width (ft) <sup>1</sup>	-						
Floodprone Width (ft) <sup>1</sup>	-						
Bankfull Max Depth (ft) <sup>2</sup>	1.0						
Low Bank Elevation (ft)	-						
Bankfull Cross Sectional Area (ft <sup>2</sup> ) <sup>2</sup>	3.6						
Bankfull Entrenchment Ratio <sup>1</sup>	-						
Bankfull Bank Height Ratio <sup>1</sup>	-

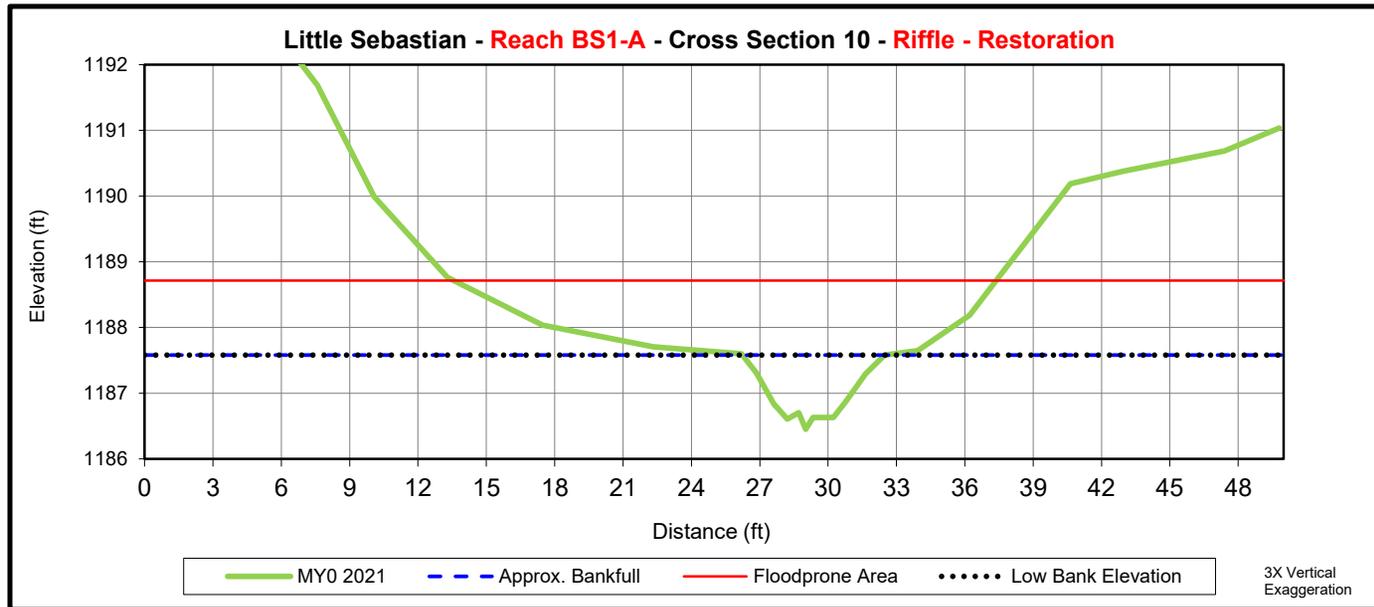
Cross Section 10 (Riffle)						
	Base	MY1	MY2	MY3	MY5	MY7	MY+
<b>Bankfull Elevation (ft) - Based on AB-XSA<sup>1</sup></b>	1187.6						
Bankfull Width (ft) <sup>1</sup>	6.3						
Floodprone Width (ft) <sup>1</sup>	23.8						
Bankfull Max Depth (ft) <sup>2</sup>	1.1						
Low Bank Elevation (ft)	1187.6						
Bankfull Cross Sectional Area (ft <sup>2</sup> ) <sup>2</sup>	4.0						
Bankfull Entrenchment Ratio <sup>1</sup>	3.8						
Bankfull Bank Height Ratio <sup>1</sup>	1.0

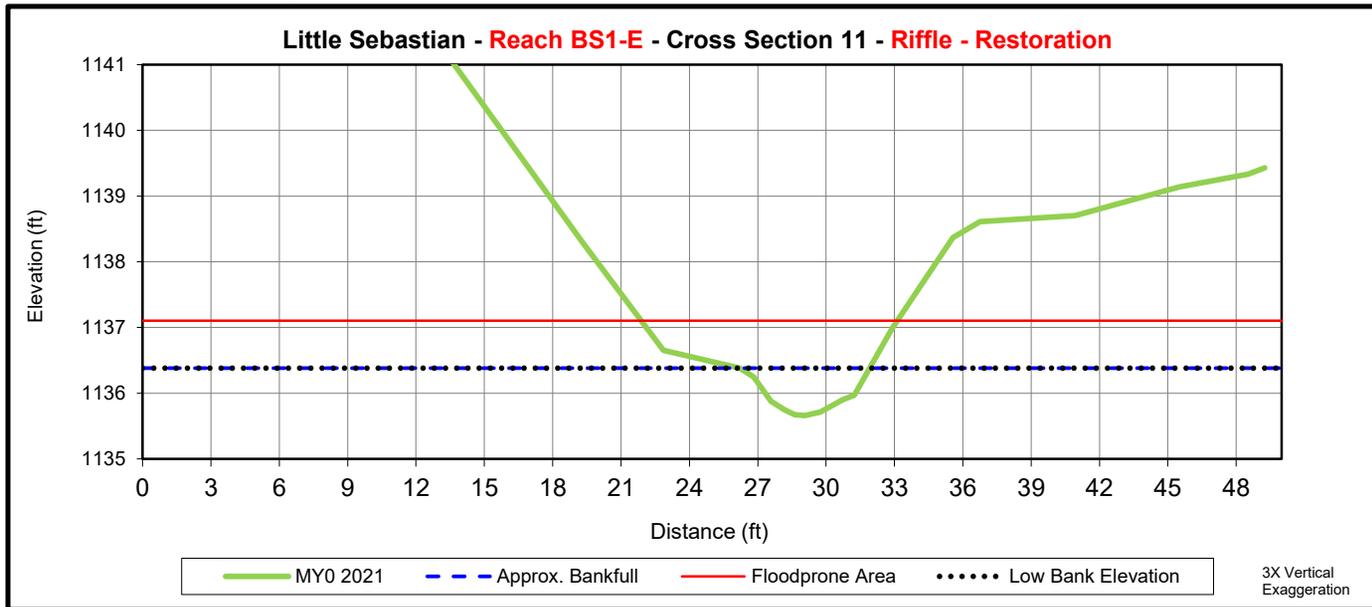
Cross Section 11 (Riffle)						
	Base	MY1	MY2	MY3	MY5	MY7	MY+
<b>Bankfull Elevation (ft) - Based on AB-XSA<sup>1</sup></b>	1136.4						
Bankfull Width (ft) <sup>1</sup>	5.7						
Floodprone Width (ft) <sup>1</sup>	11.3						
Bankfull Max Depth (ft) <sup>2</sup>	0.7						
Low Bank Elevation (ft)	1136.4						
Bankfull Cross Sectional Area (ft <sup>2</sup> ) <sup>2</sup>	2.6						
Bankfull Entrenchment Ratio <sup>1</sup>	2.0						
Bankfull Bank Height Ratio <sup>1</sup>	1.0

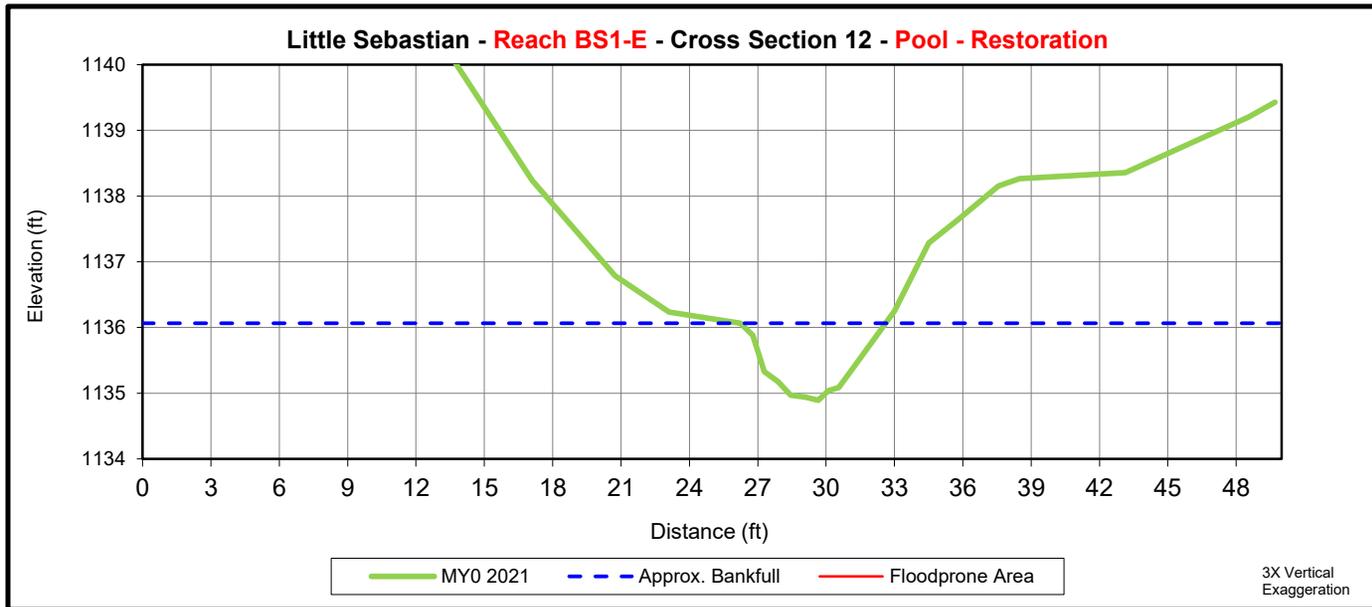
Cross Section 12 (Pool)						
	Base	MY1	MY2	MY3	MY5	MY7	MY+
<b>Bankfull Elevation (ft) - Based on AB-XSA<sup>1</sup></b>	1136.1						
Bankfull Width (ft) <sup>1</sup>	-						
Floodprone Width (ft) <sup>1</sup>	-						
Bankfull Max Depth (ft) <sup>2</sup>	1.2						
Low Bank Elevation (ft)	-						
Bankfull Cross Sectional Area (ft <sup>2</sup> ) <sup>2</sup>	4.6						
Bankfull Entrenchment Ratio <sup>1</sup>	-						
Bankfull Bank Height Ratio <sup>1</sup>	-

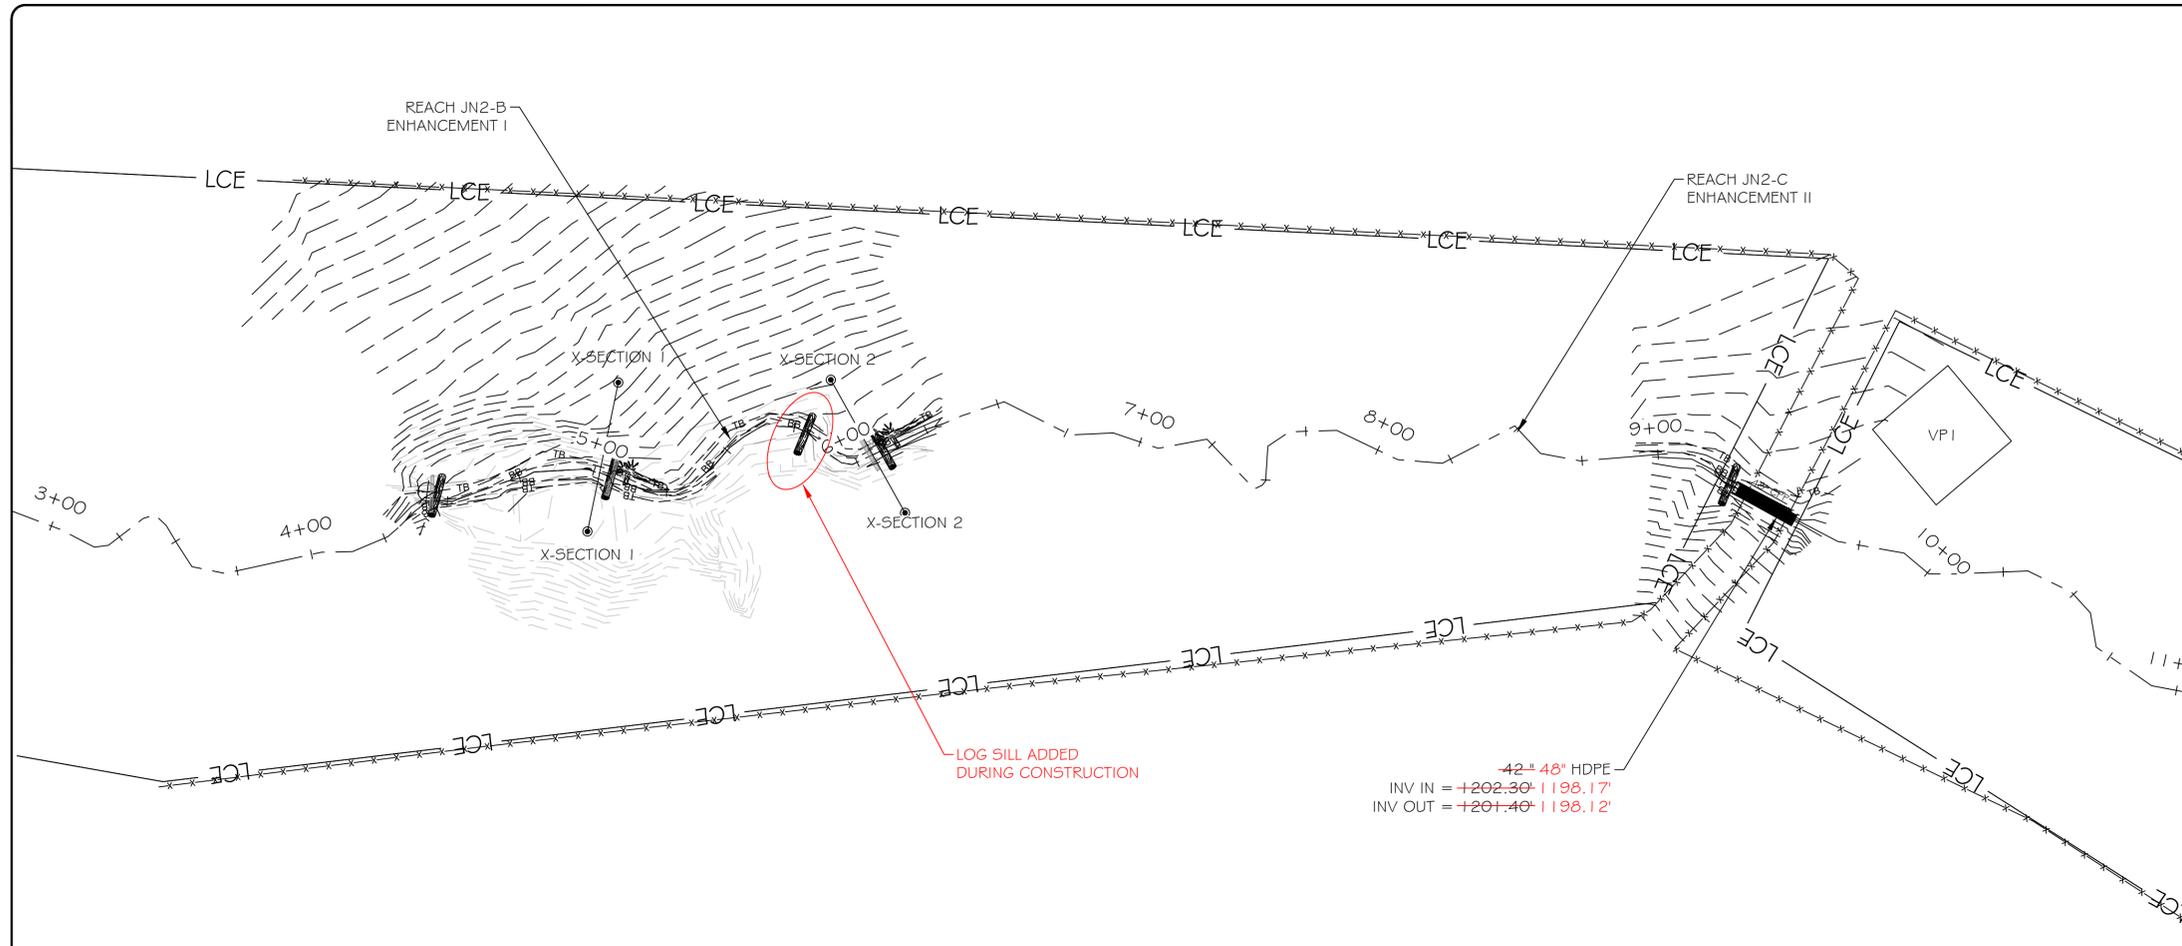
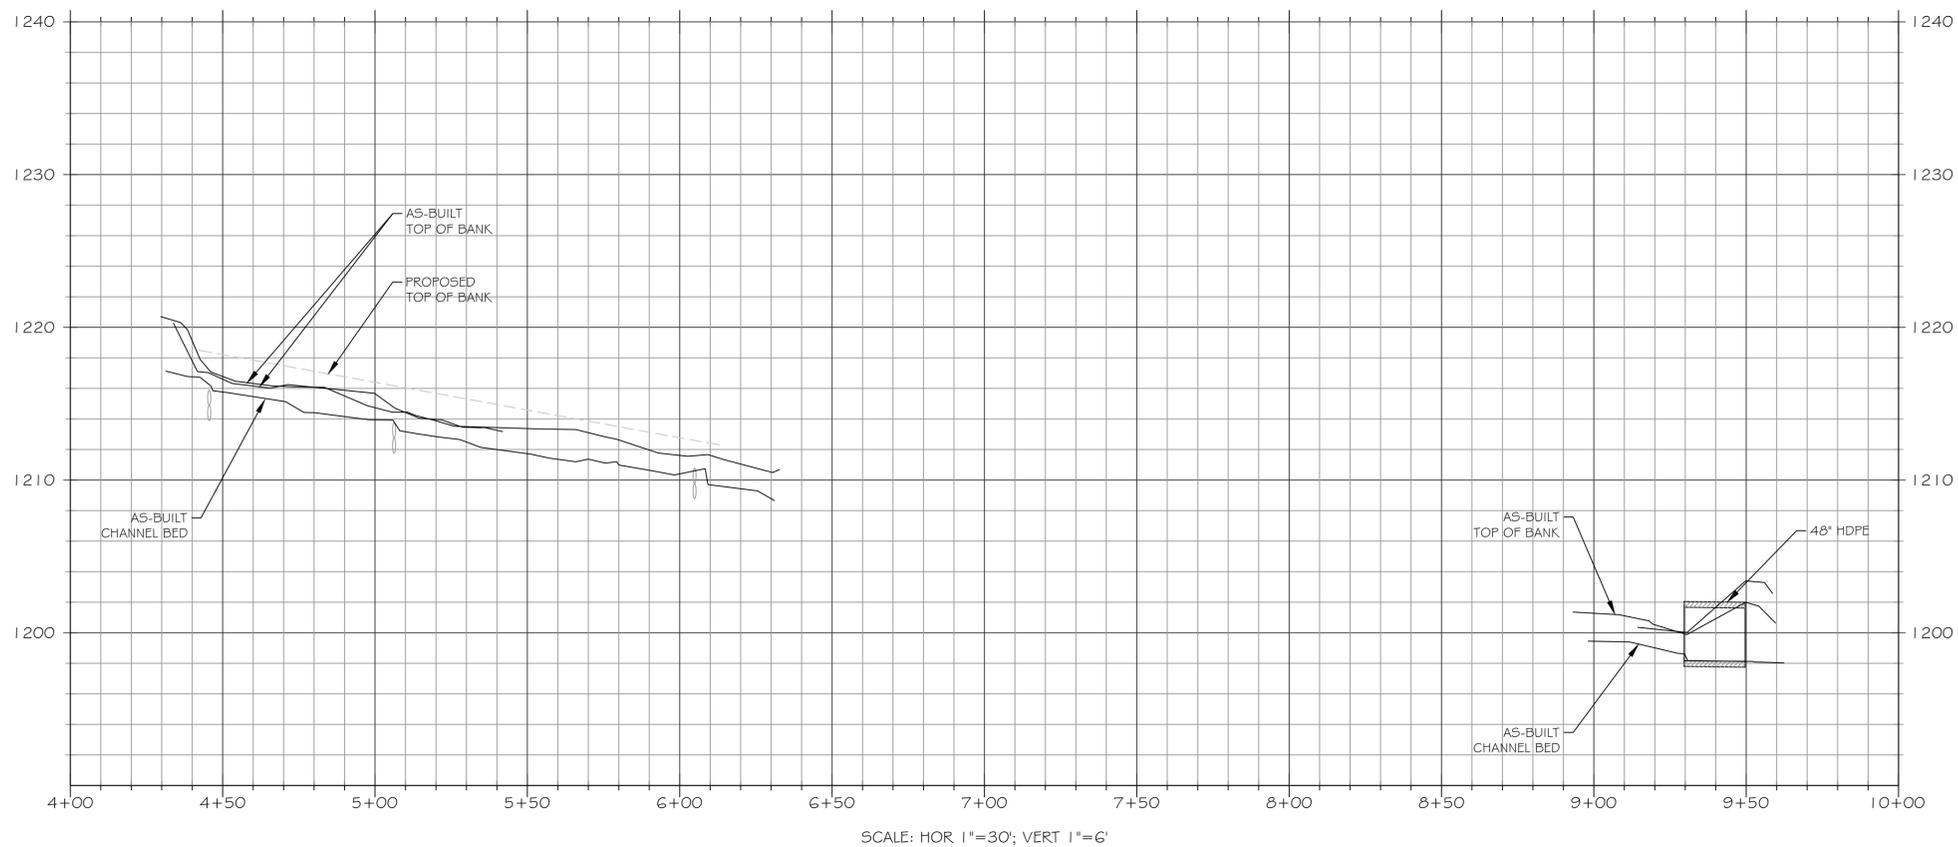
SHEET NUMBER:  
**S1**

-42" 48" HDPE  
 INV IN = +202.30' 1198.17'  
 INV OUT = +201.40' 1198.12'
