**As-Built Baseline Monitoring Report**

**LITTLE SEBASTIAN SITE**

NCDMS Project # 100027 (Contract # 7187) | RFP 16-006993 (Issued 9/16/2016)  
USACE Action ID: SAW-2017-01507 | DWR Project # 2017-1041

Surry County, North Carolina  
Yadkin River Basin  
HUC 03040101

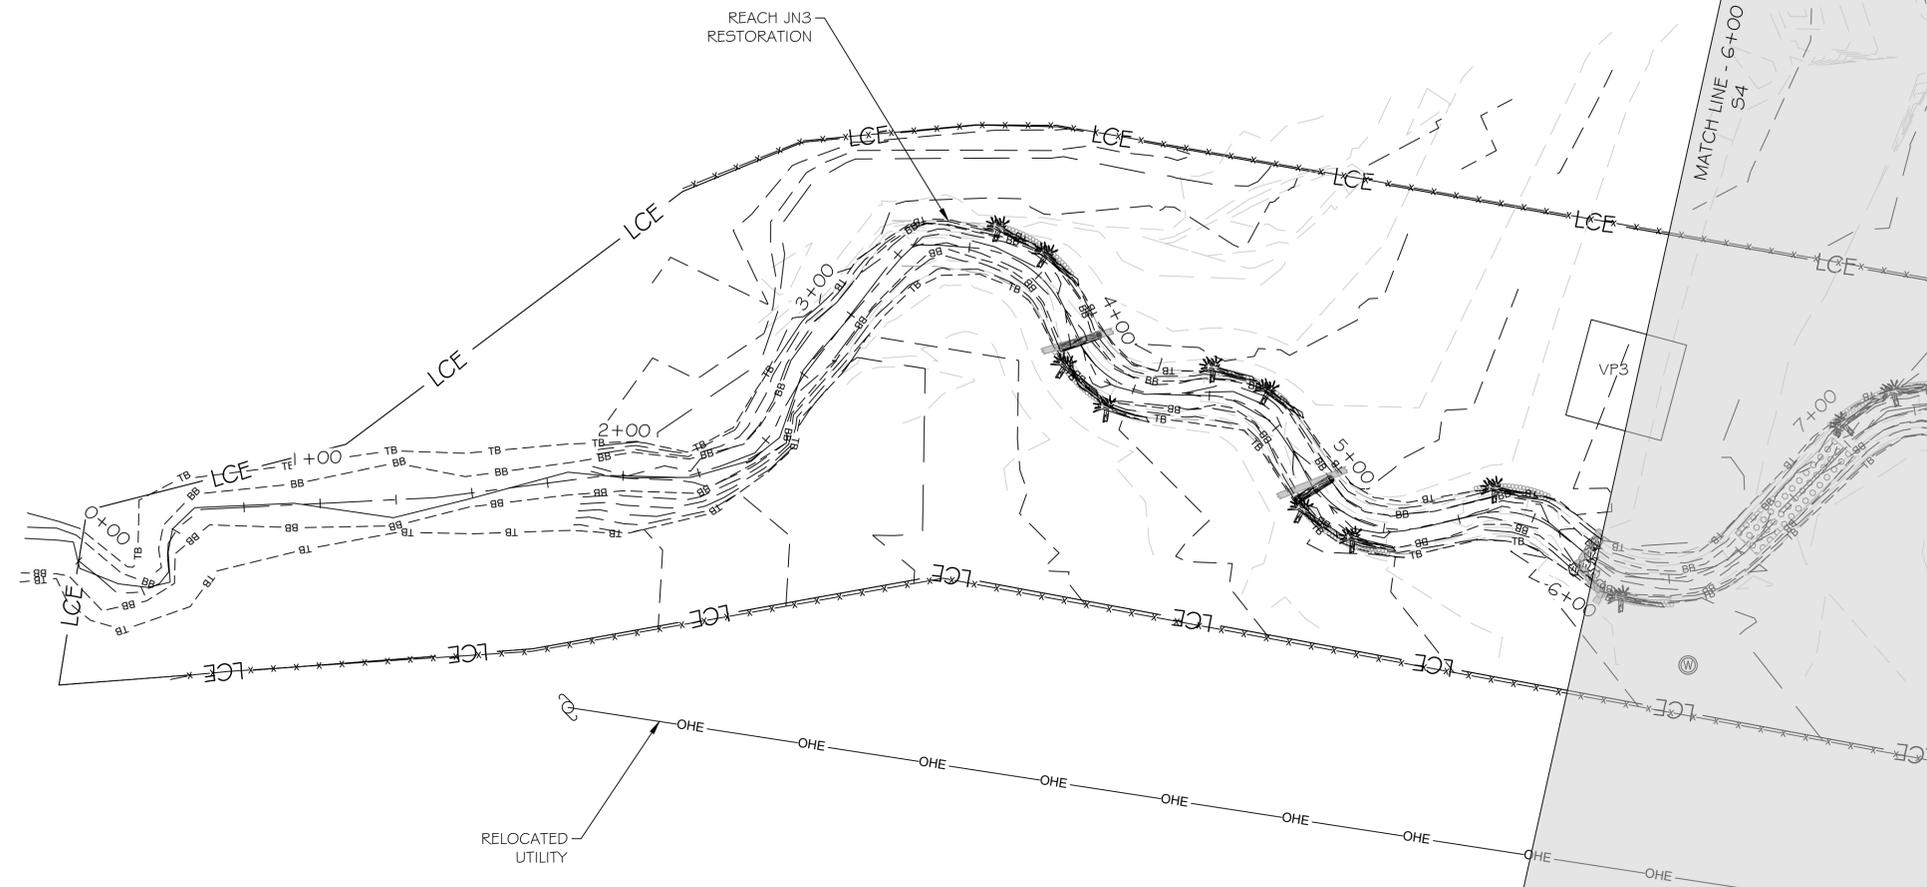
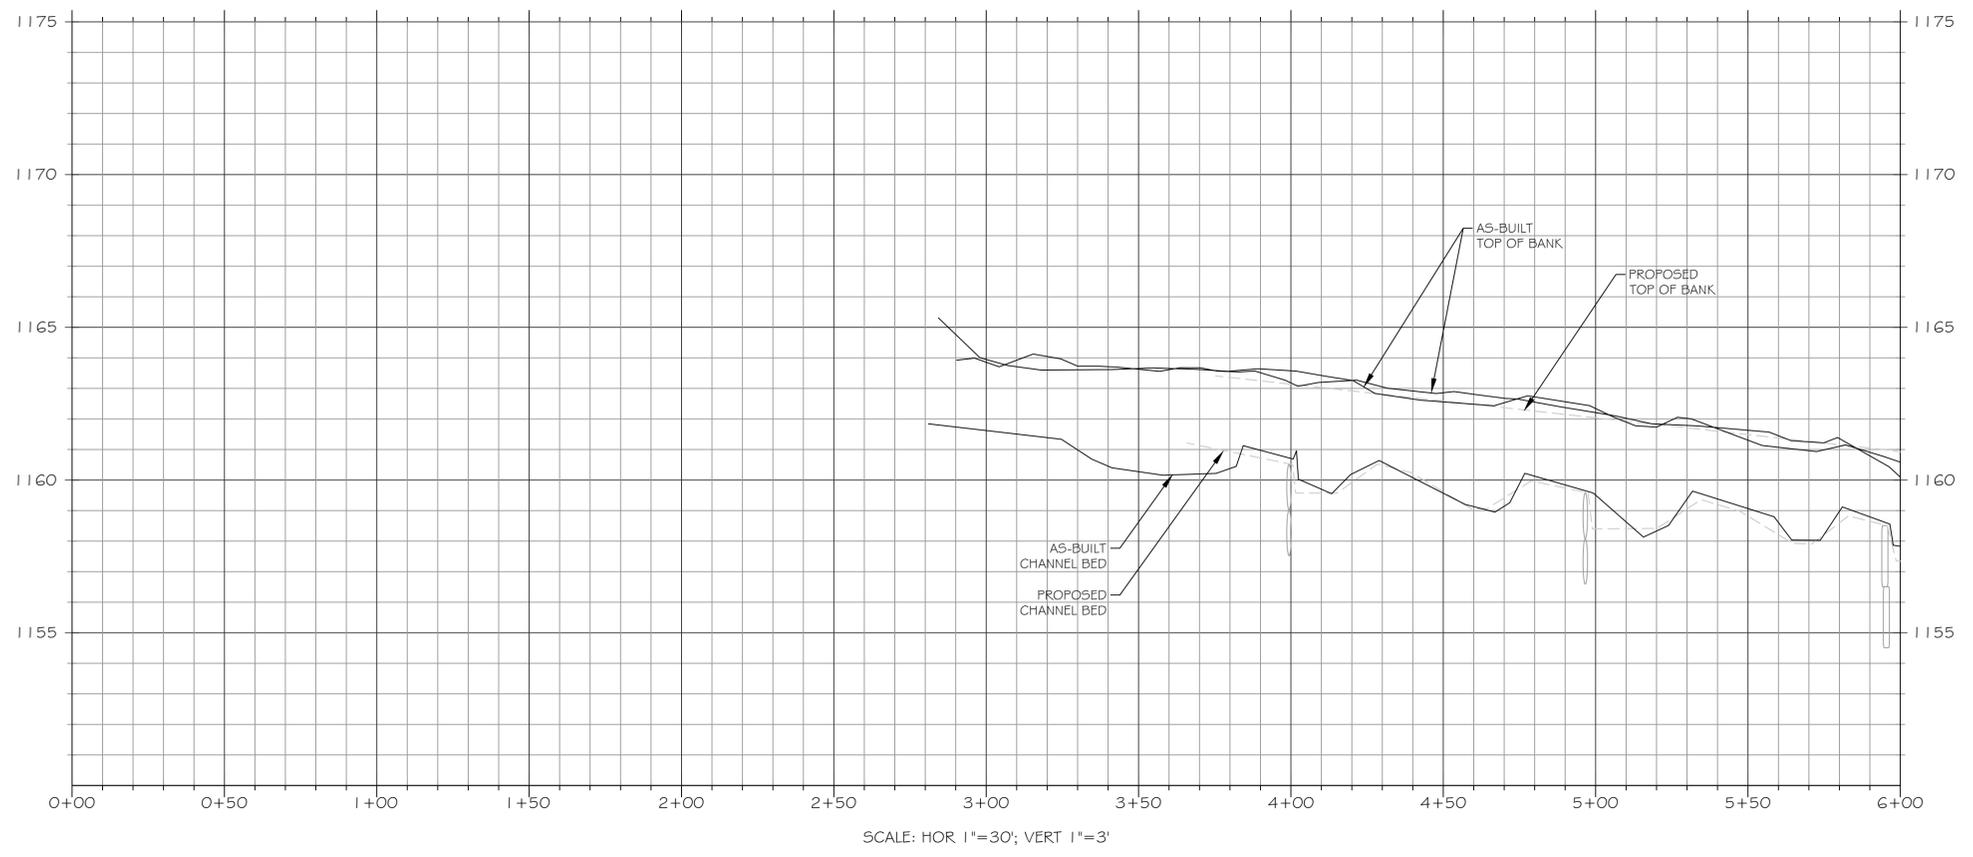
SHEET NUMBER:  
S3

NOTE: ALL SIGNIFICANT CHANGES FROM THE DESIGN ARE SHOWN IN RED

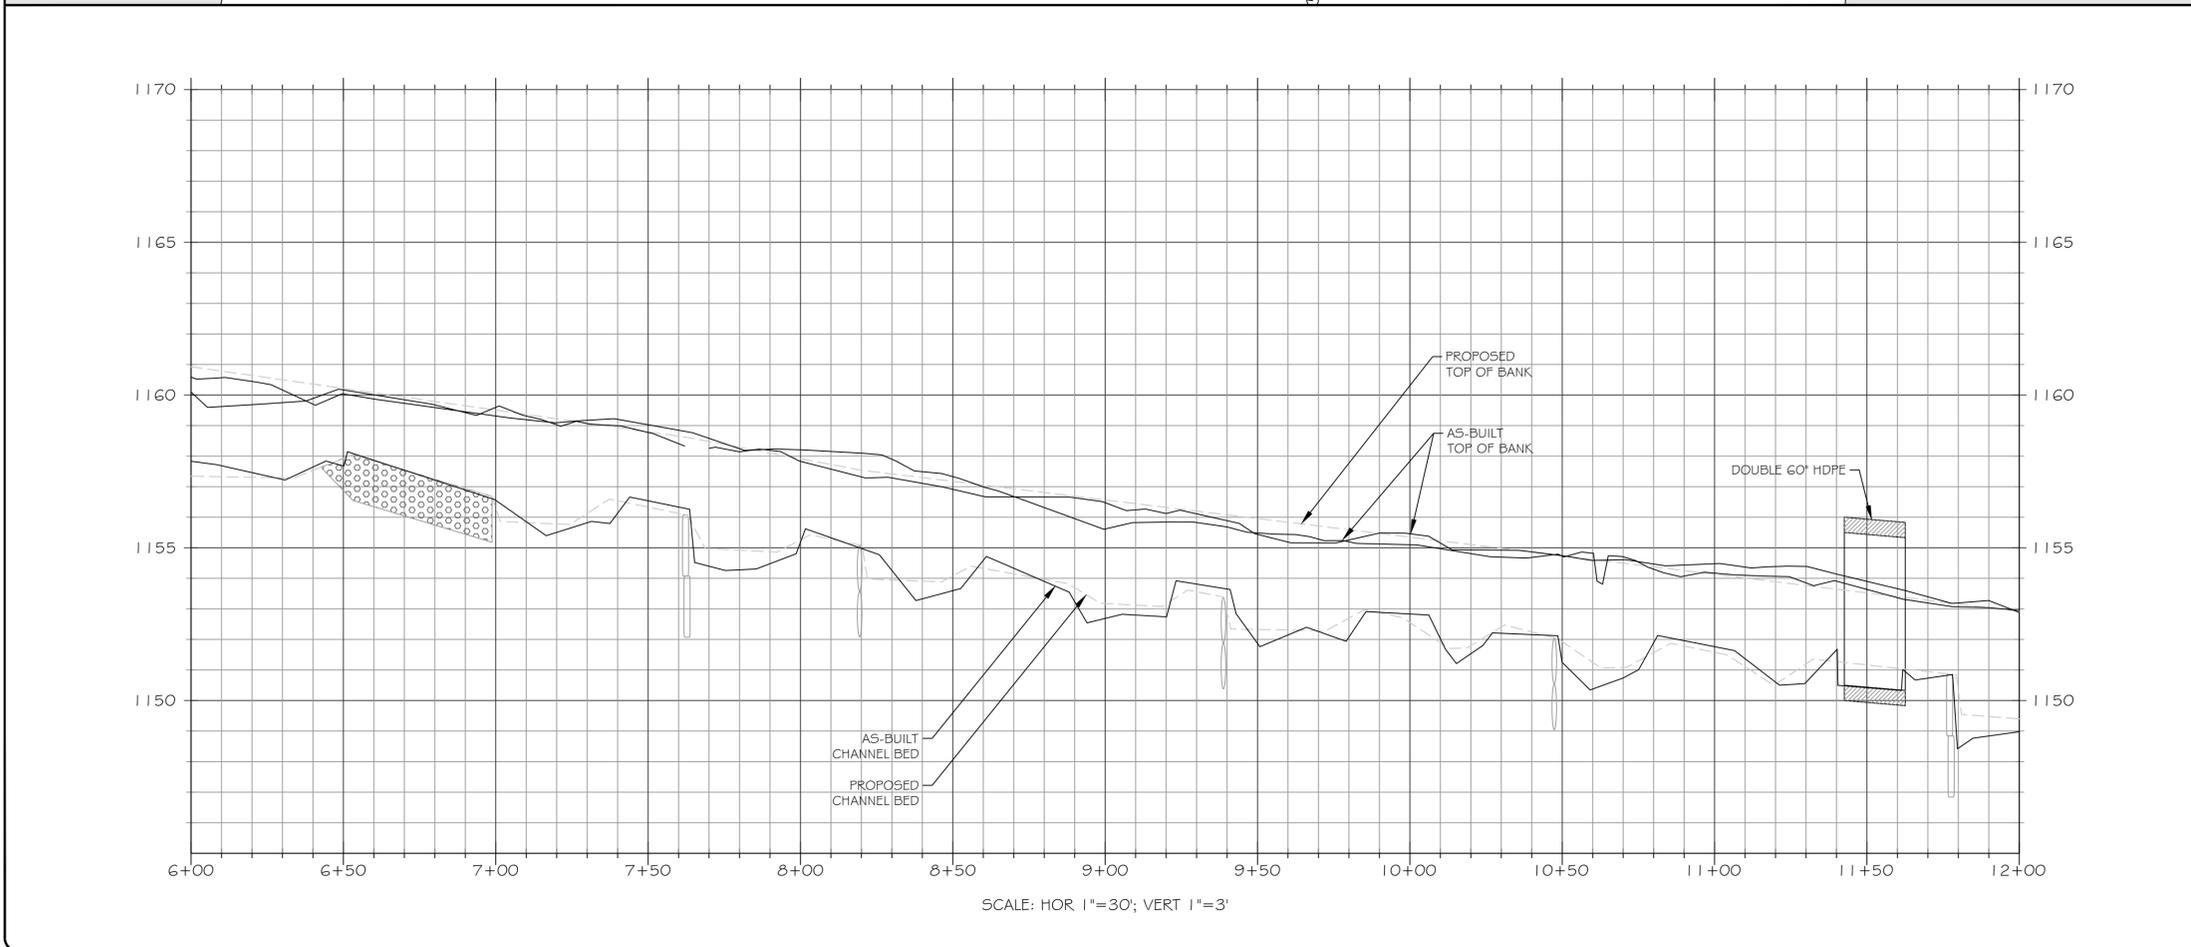
NOTE: ALL SIGNIFICANT CHANGES FROM THE DESIGN ARE SHOWN IN RED

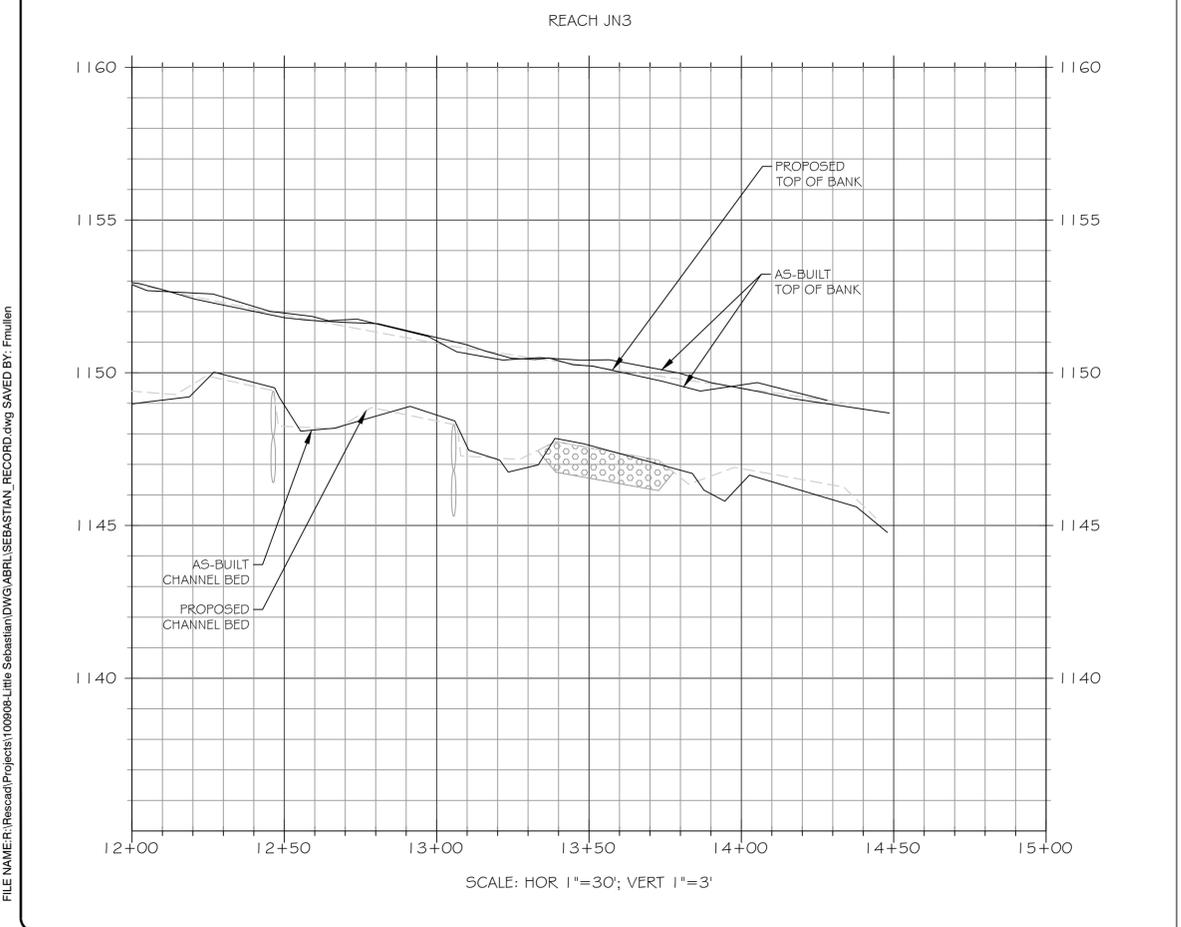
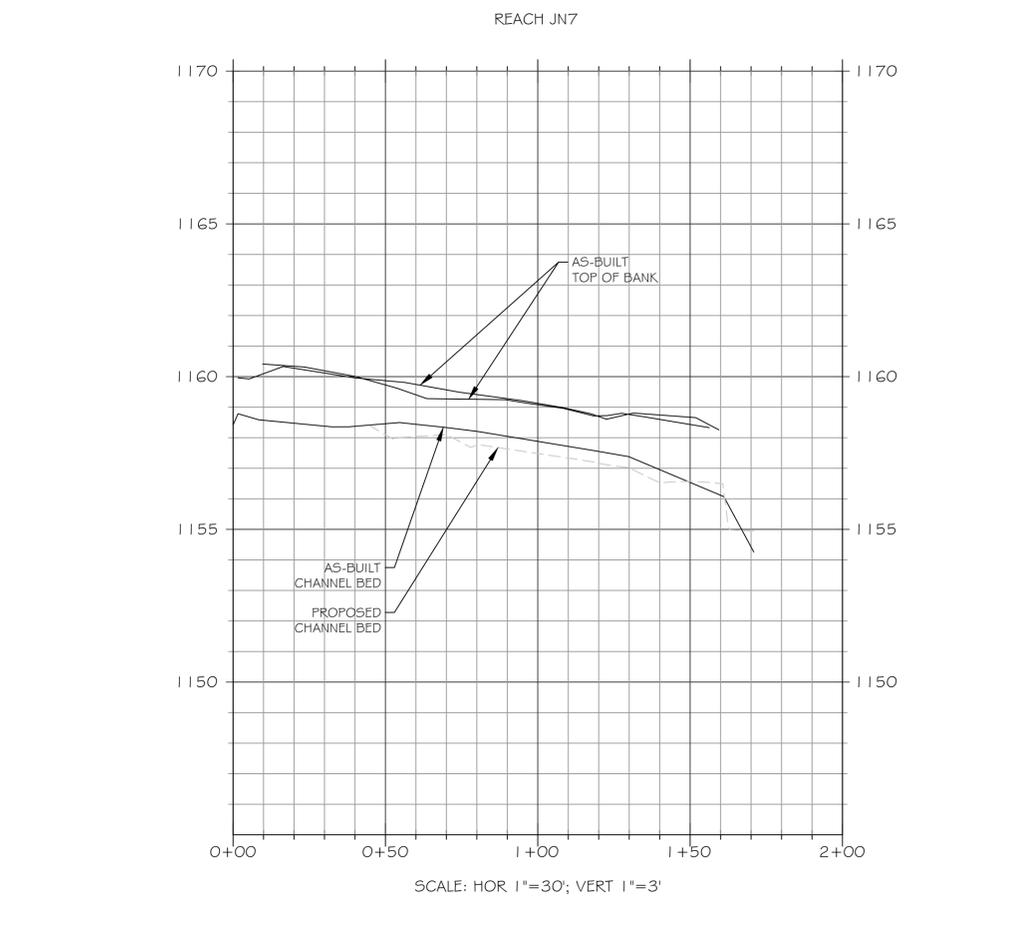
NOTE: ALL SIGNIFICANT CHANGES FROM THE DESIGN ARE SHOWN IN RED
