LITTLE TROUBLESOME CREEK MITIGATION SITE

*Rockingham County, NC
DENR Contract 003267
EEP Project Number 94640*

Baseline Monitoring Document and As-Built Baseline Report FINAL

LITTLE TROUBLESOME CREEK MITIGATION SITE
Baseline Monitoring Document and As-Built Baseline Report

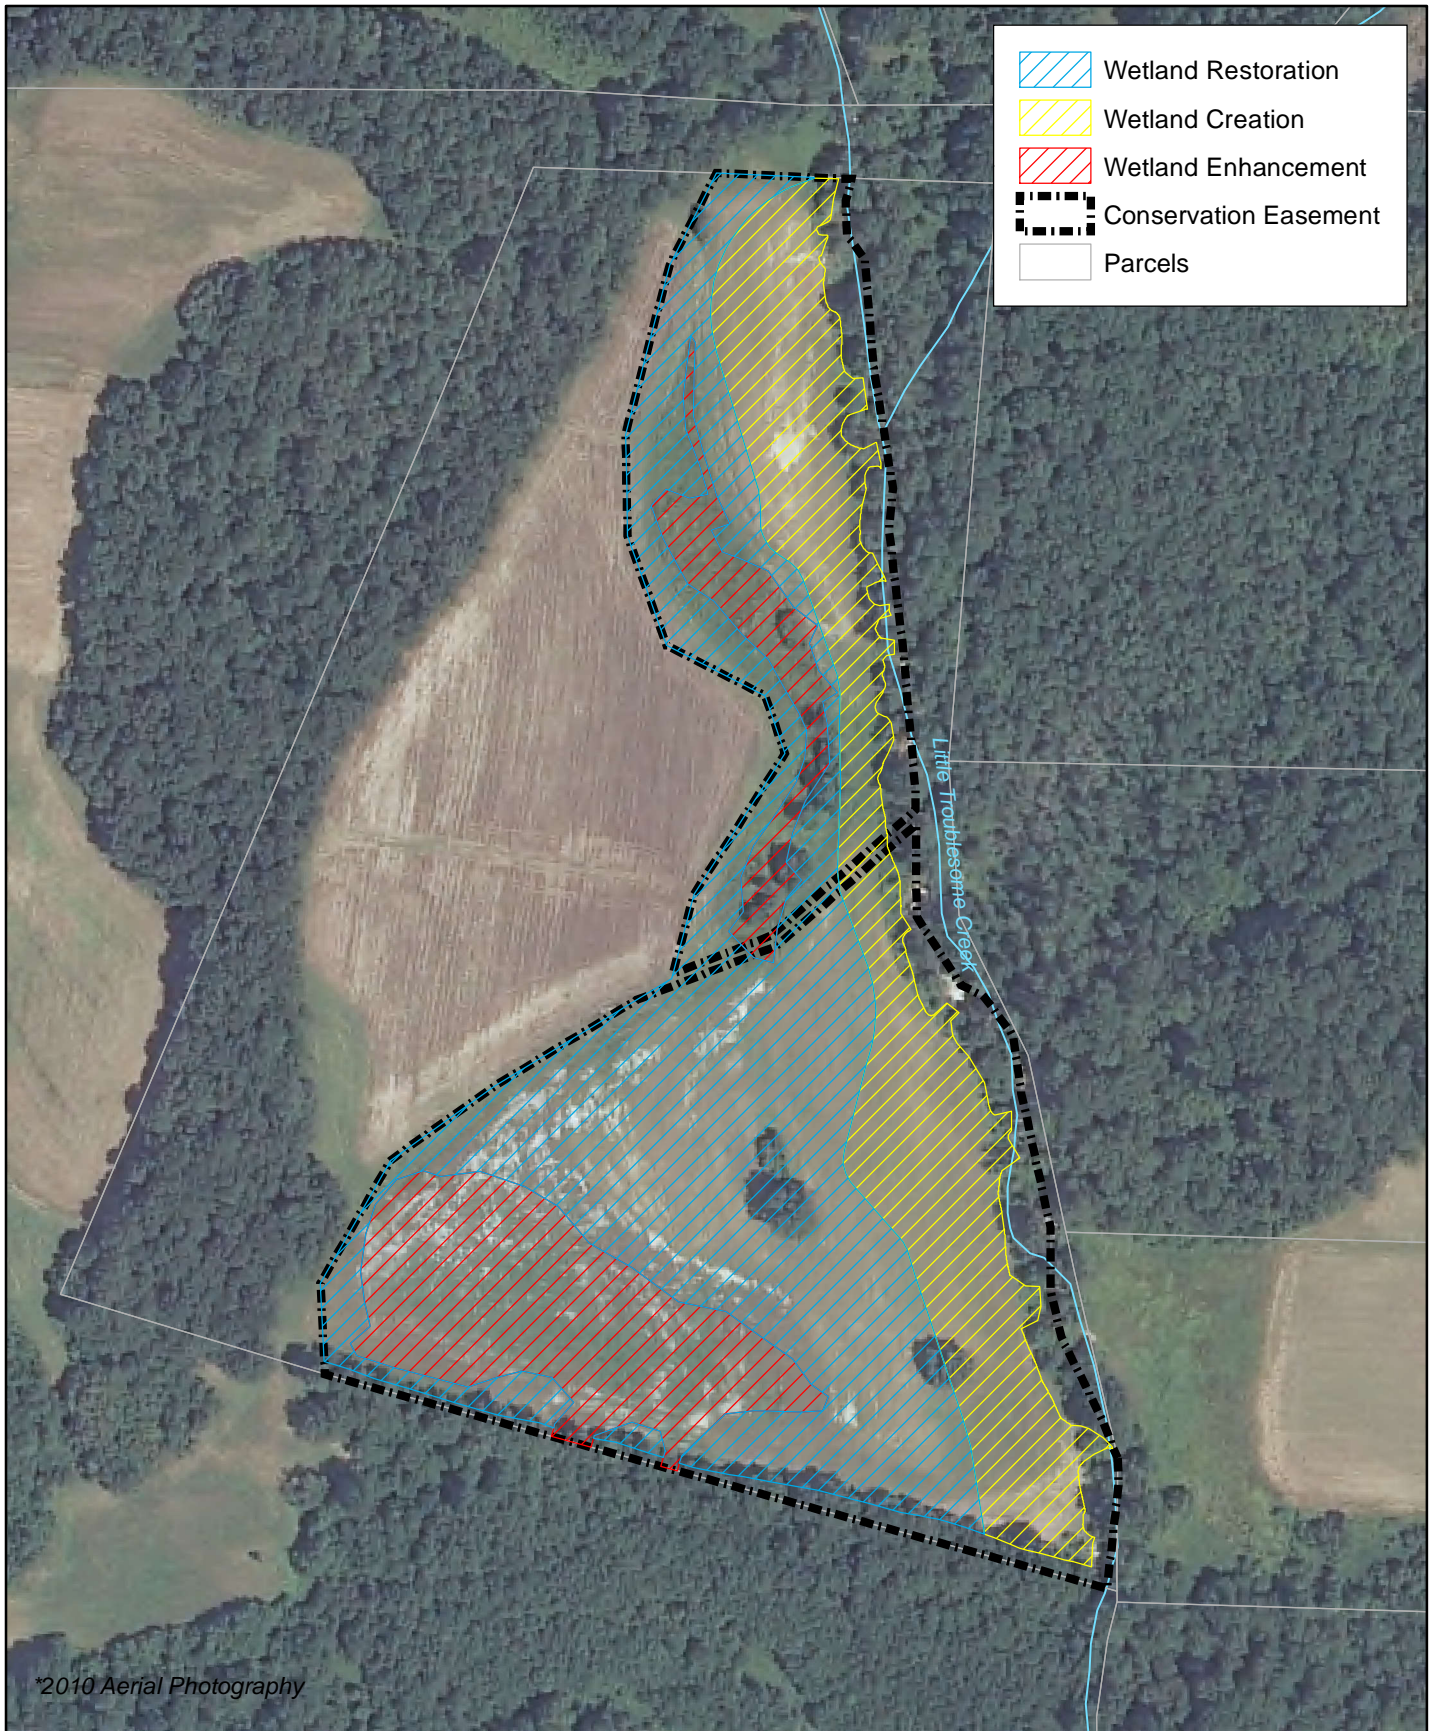
Figure 2b. Project Component/Asset Map
 Little Troublesome Creek Mitigation Site
 Wetland Site
 NCEEP Project Number 94640
 Monitoring Year 0

Please refer to Figure 2 for the project component/asset map for the monitoring and restoration feature exhibits on Little Troublesome Creek and its tributaries and Table 1 for the project component and mitigation credit information for the Stream and Wetland Sites.

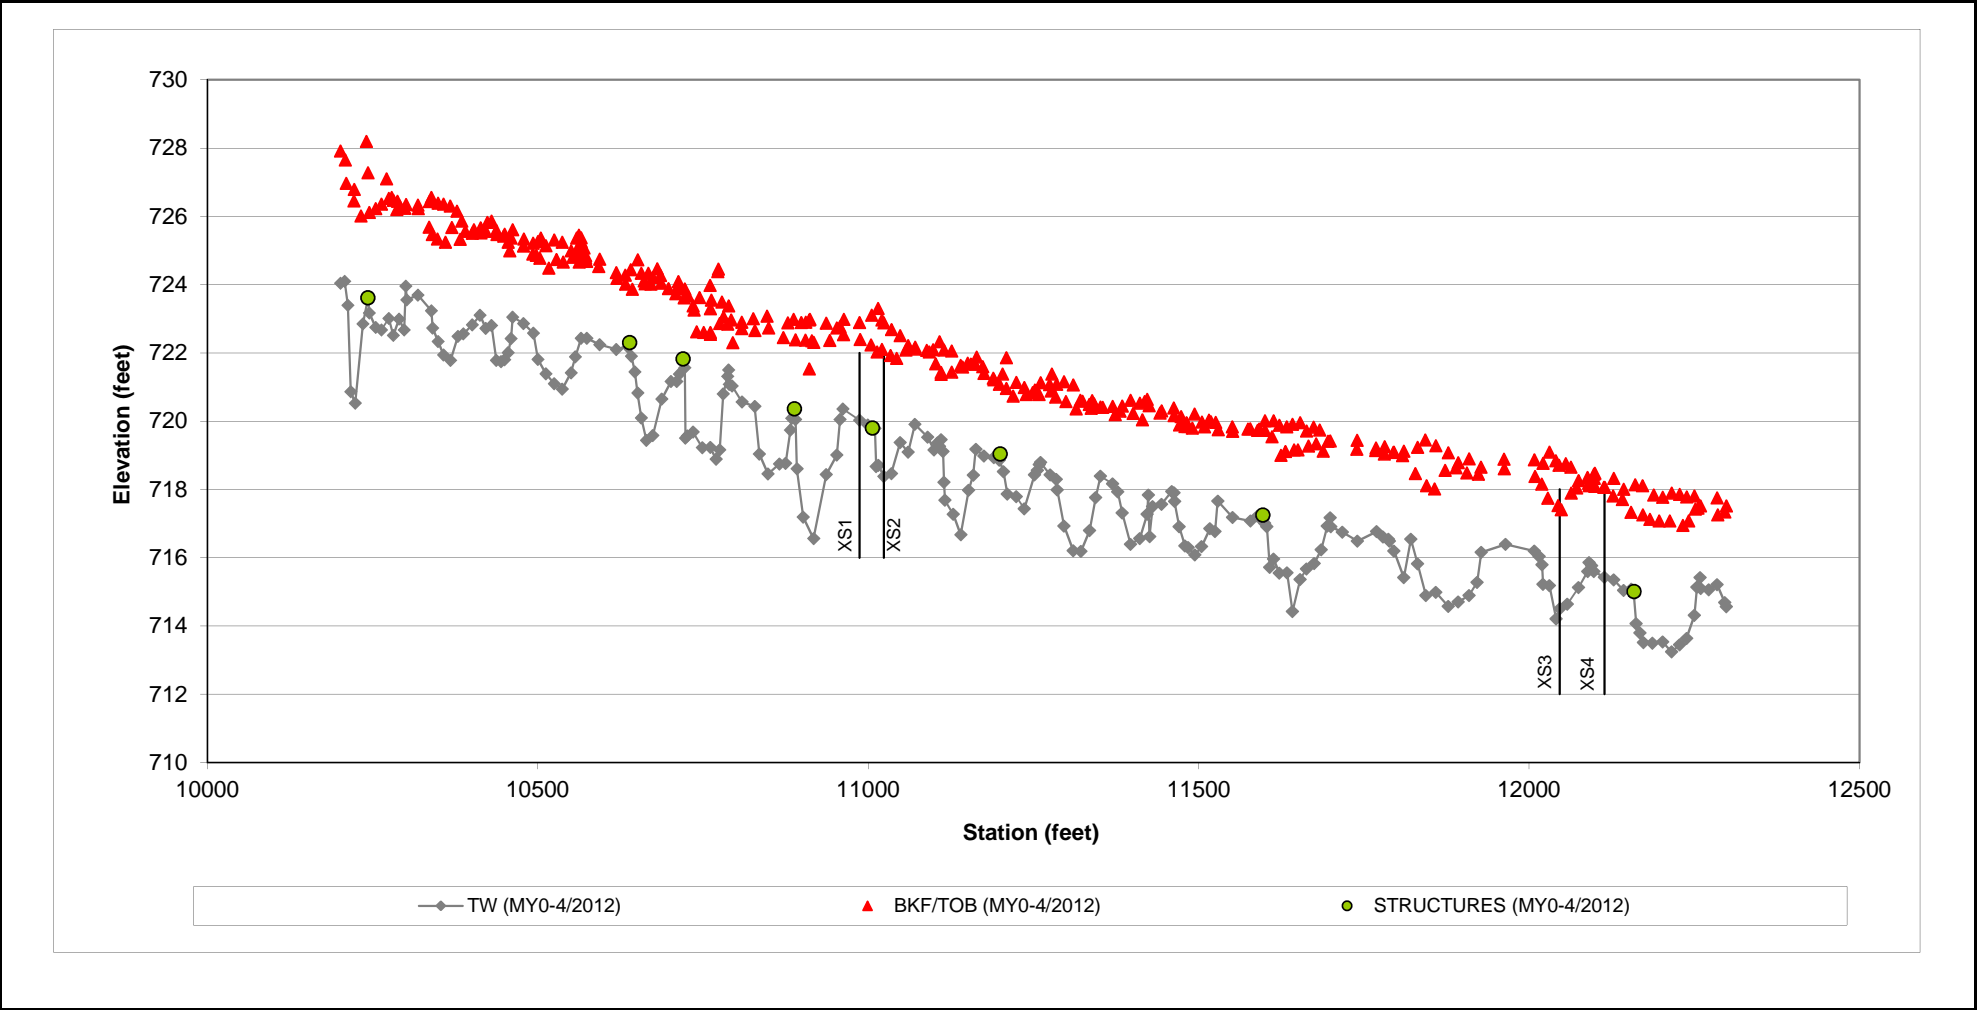
Appendix 2. Morphological Summary Data and Plots
Figure 3a. Longitudinal Profile Plots
Little Troublesome Creek Mitigation Site (NCEEP Project No. 94640)
Irvin Creek Reach 1
Monitoring Year 0

The baseline (MY-0) profile numbers are closely matched to the design parameters. The plotted longitudinal profile and related summary data can be found in Appendix 2.

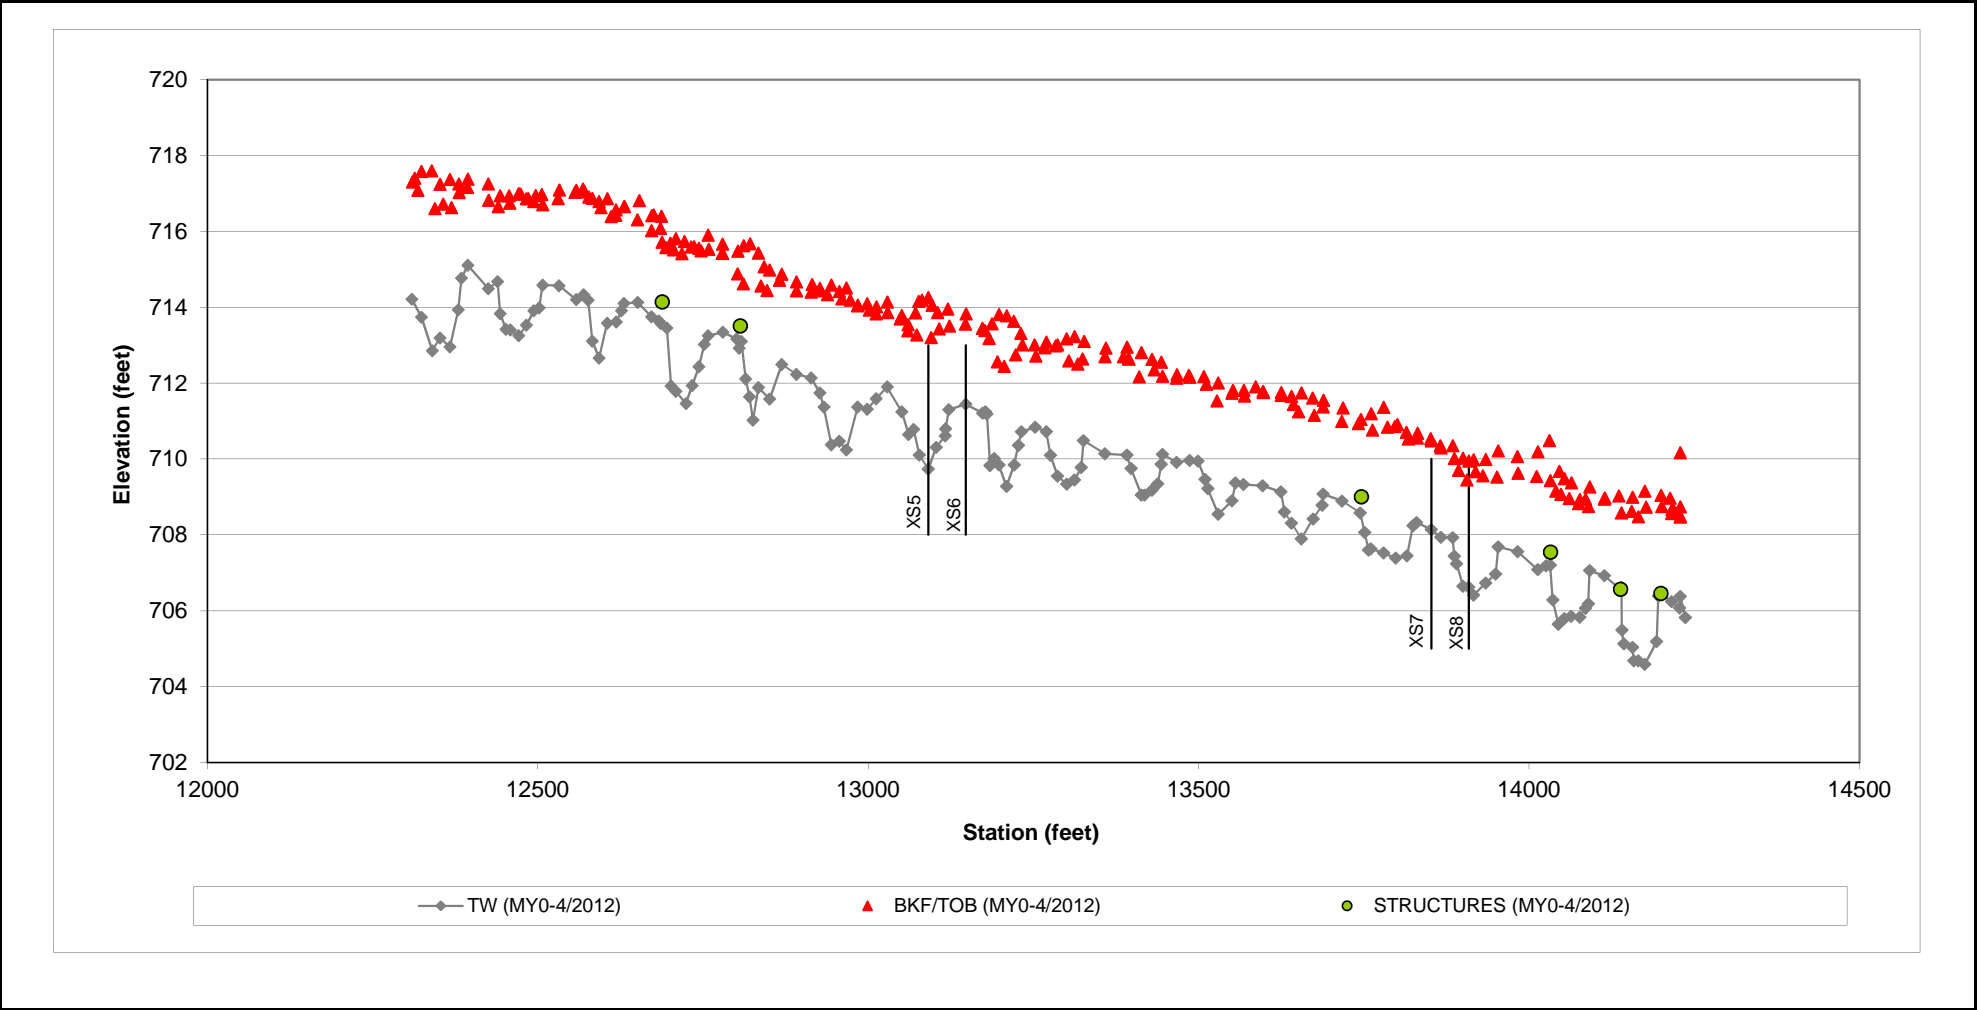
Appendix 2. Morphological Summary Data and Plots
Figure 3b. Longitudinal Profile Plots
Little Troublesome Creek Mitigation Site (NCEEP Project No. 94640)
Irvin Creek Reach 2
Monitoring Year 0

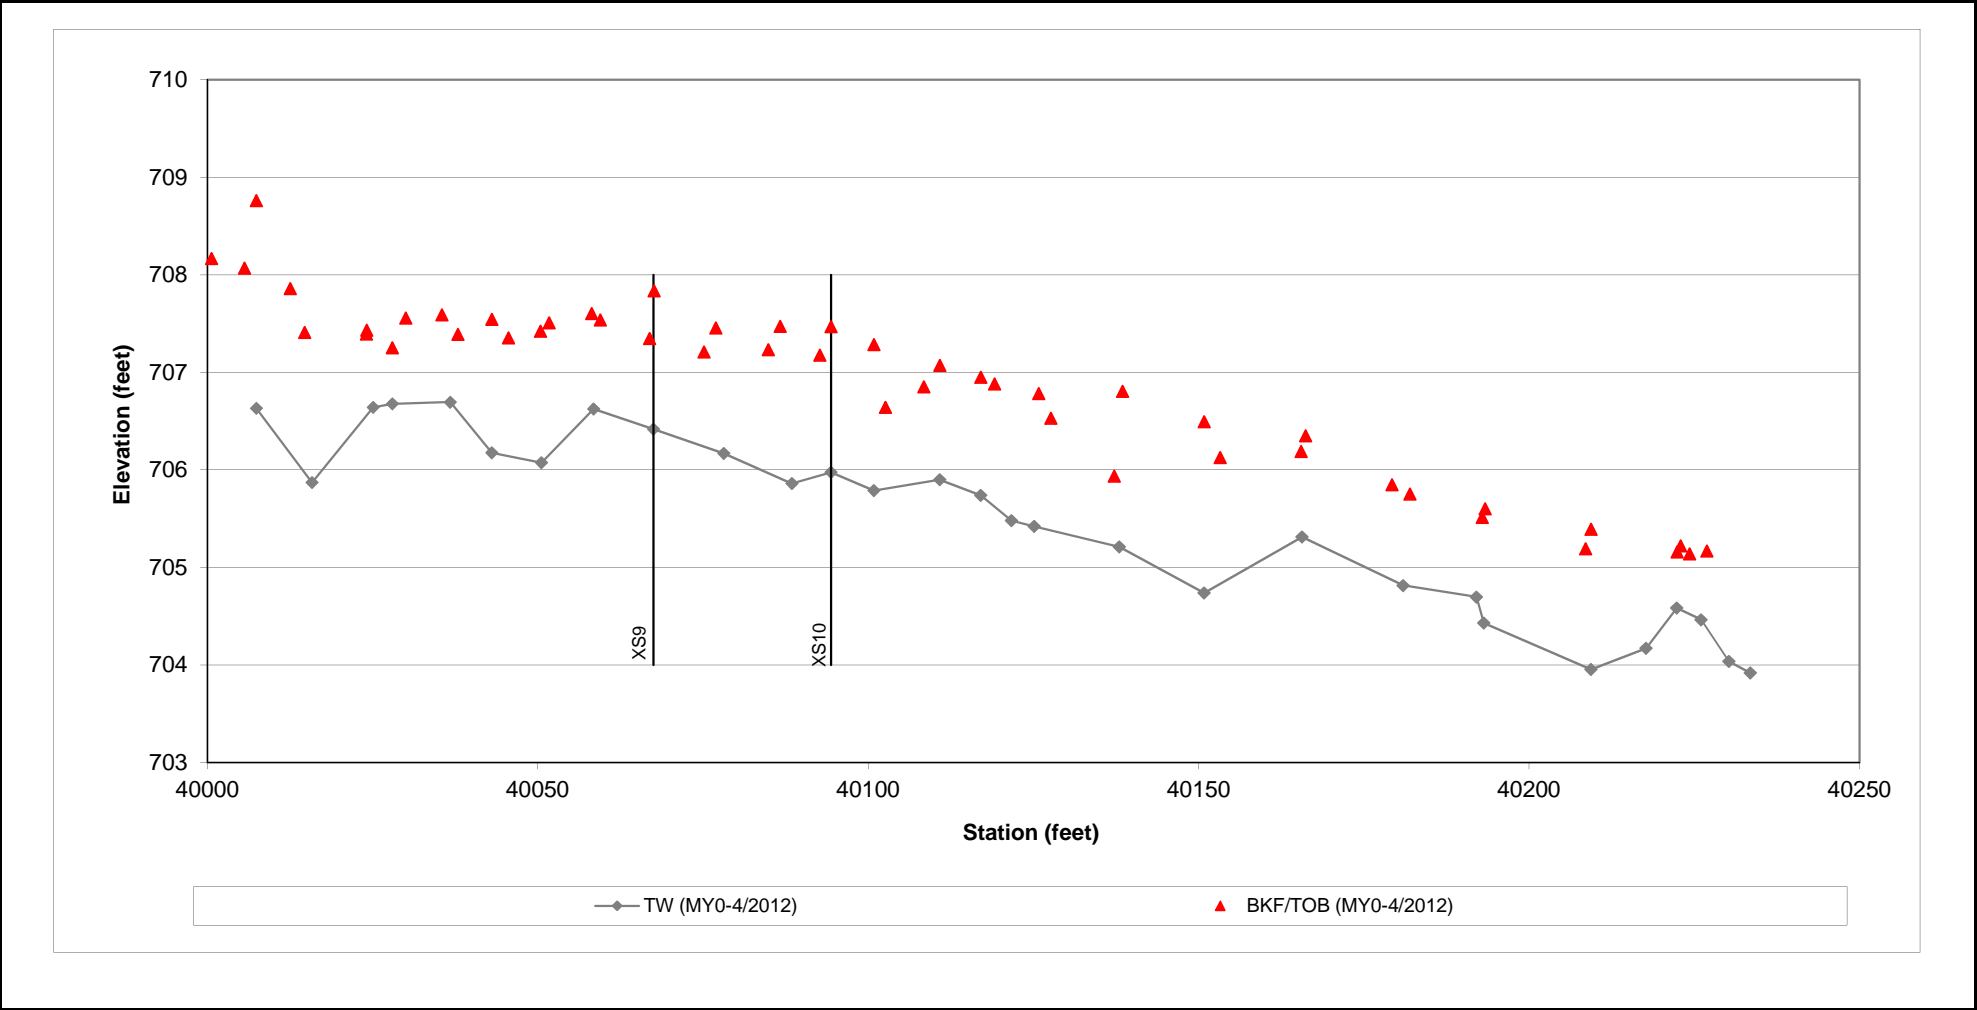
Appendix 2. Morphological Summary Data and Plots
Figure 3c. Longitudinal Profile Plots
Little Troublesome Creek Mitigation Site (NCEEP Project No. 94640)
UT1
Monitoring Year 0

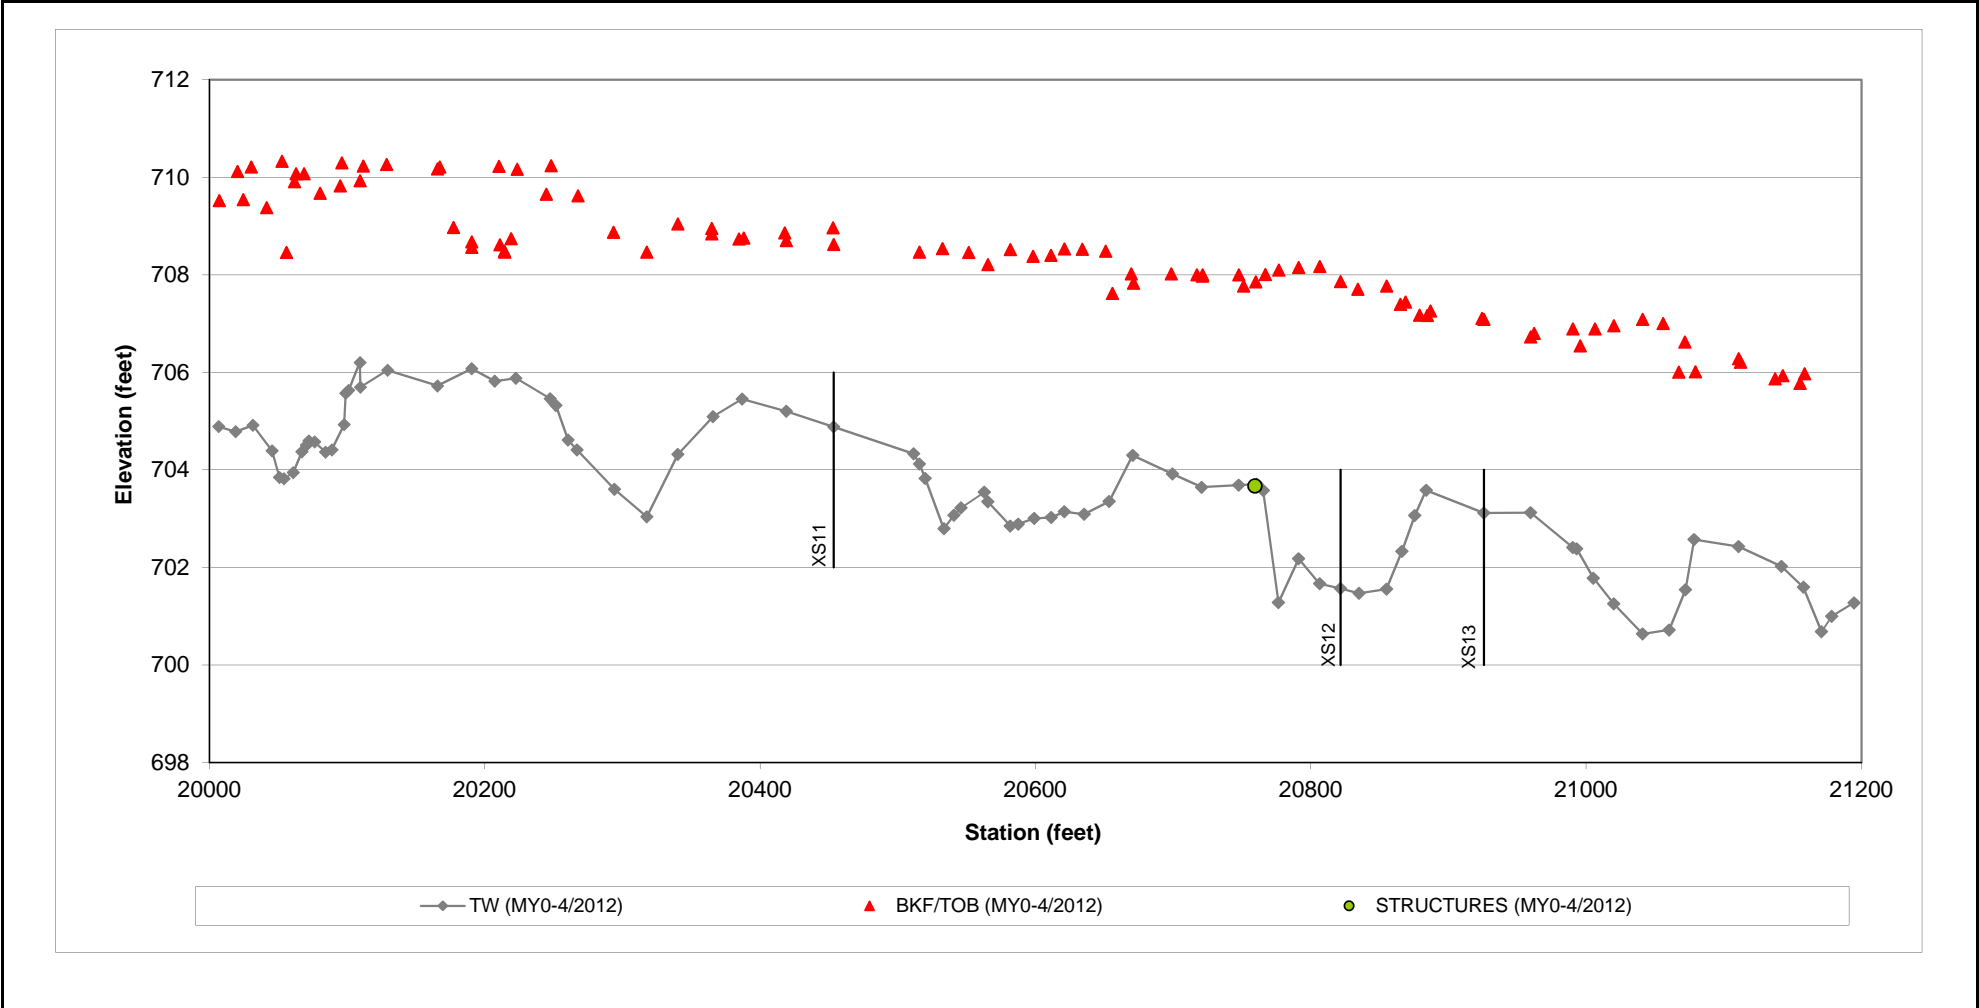
Appendix 2. Morphological Summary Data and Plots
Figure 3d. Longitudinal Profile Plots
Little Troublesome Creek Mitigation Site (NCEEP Project No. 94640)
Little Troublesome Creek
Monitoring Year 0

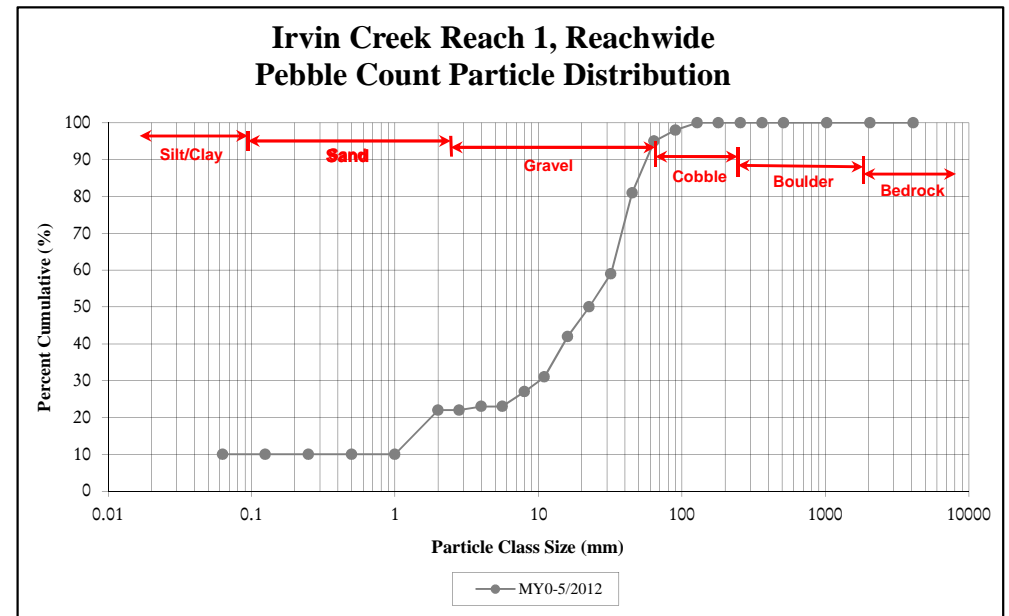
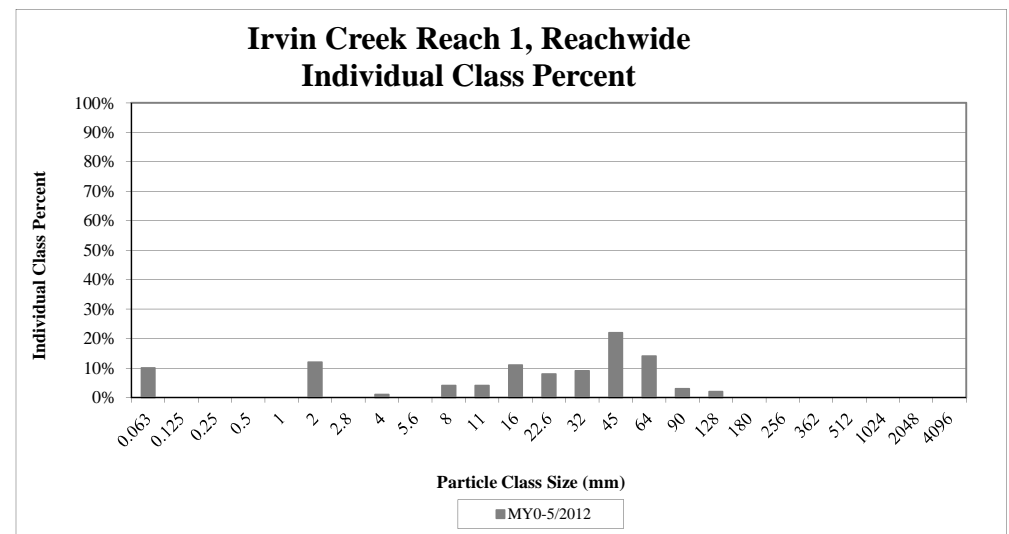
Appendix 2. Morphological Summary Data and Plots
Figure 5a. Reachwide and Cross-Section Pebble Count Plots
Little Troublesome Creek Mitigation Site (NCEP Project No. 94640)
Irvin Creek Reach 1, Reachwide
Monitoring Year 0

Reachwide Channel materials (mm)	
D ₁₆ =	Silt/Clay
D ₃₅ =	Silt/Clay
D ₅₀ =	22.6
D ₈₄ =	48.5
D ₉₅ =	64.0
D ₁₀₀ =	128.0

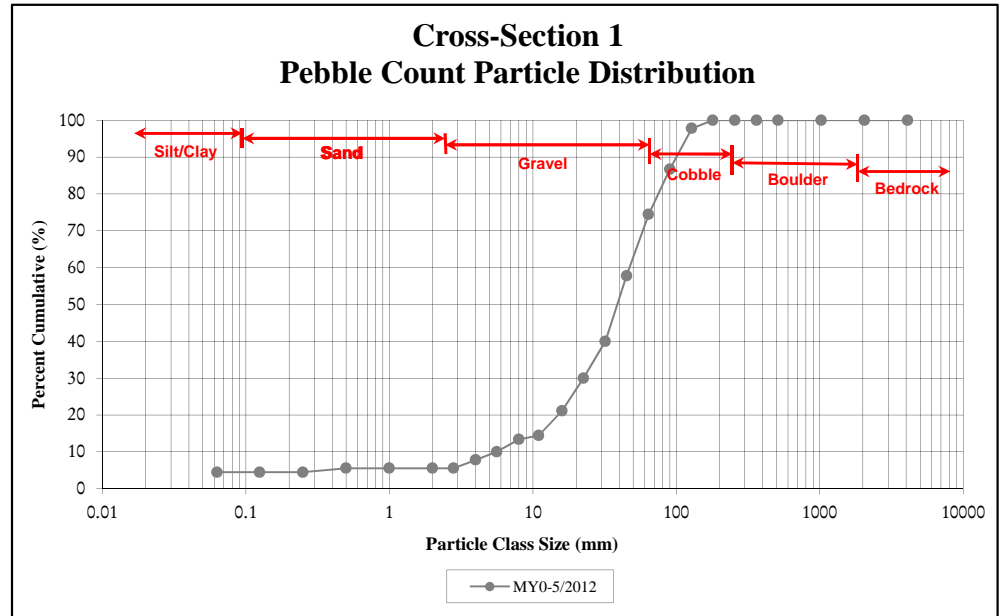
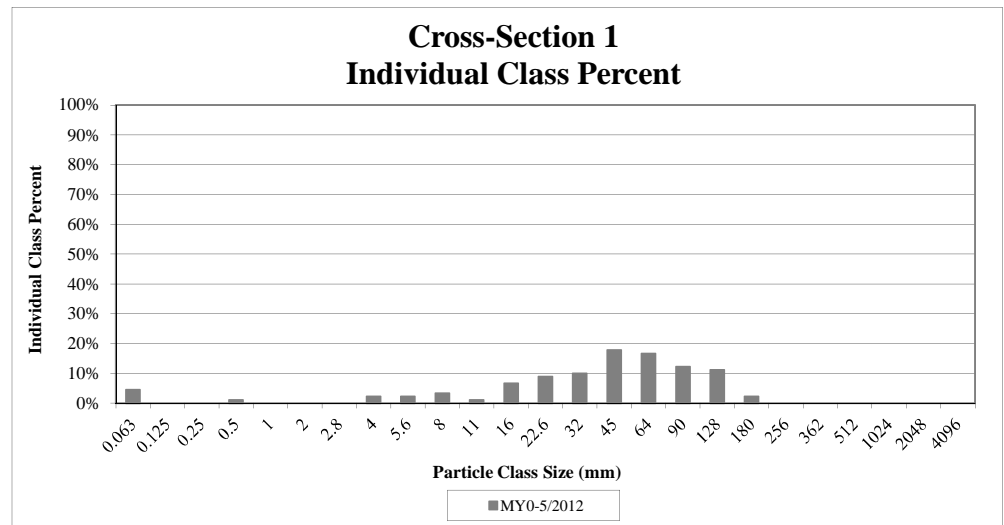
Appendix 2. Morphological Summary Data and Plots
Figure 5b. Reachwide and Cross-Section Substrate Plots
Little Troublesome Creek Mitigation Site (NCEEP Project No. 94640)
Irvin Creek Reach 1, Cross-Section 1 (Riffle)
Monitoring Year 0

Cross-Section 1 Channel materials (mm)	
D ₁₆ =	12.0
D ₃₅ =	26.9
D ₅₀ =	38.8
D ₈₄ =	83.5
D ₉₅ =	117.2
D ₁₀₀ =	180.0

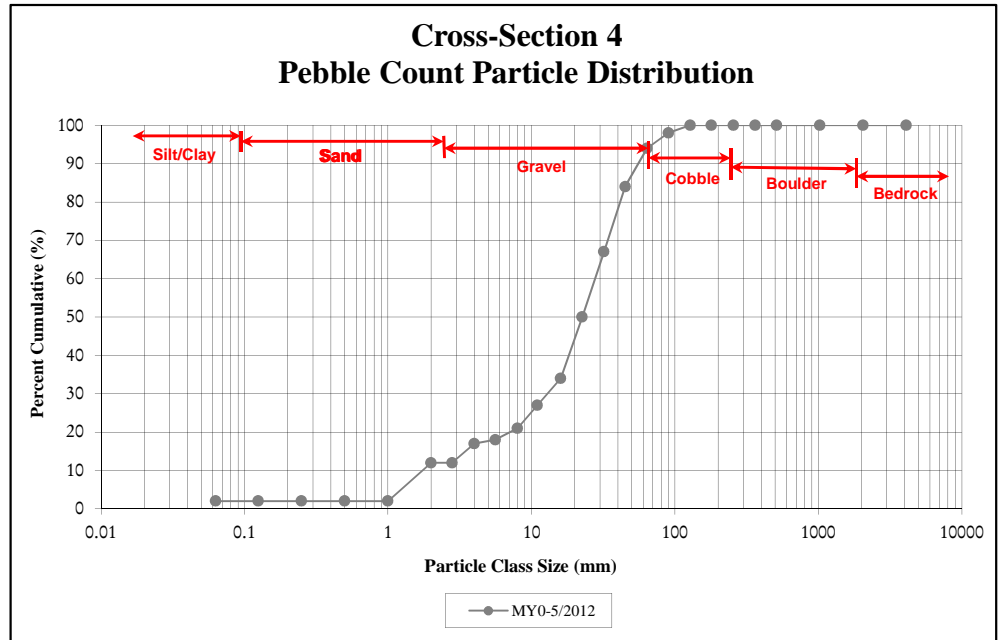
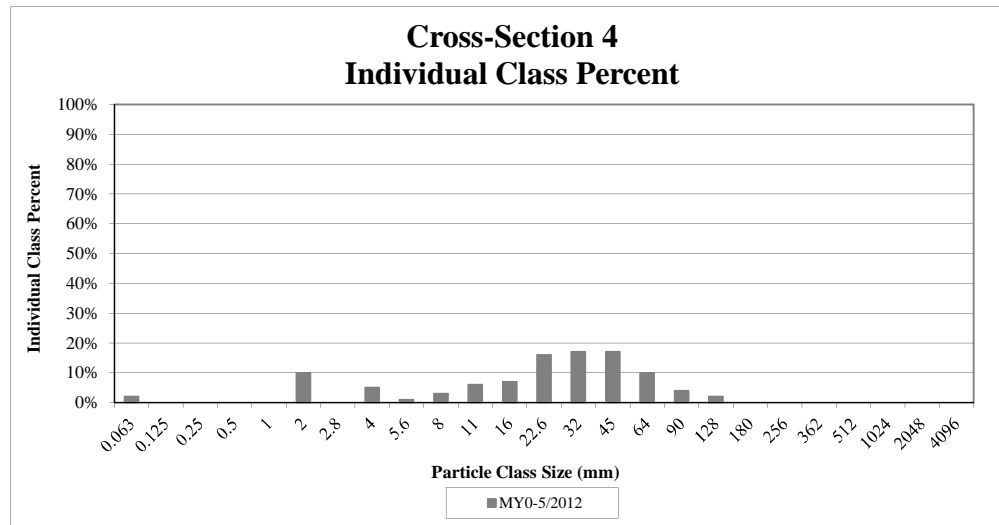
Appendix 2. Morphological Summary Data and Plots
Figure 5c. Reachwide and Cross-Section Substrate Plots
Little Troublesome Creek Mitigation Site (NCEP Project No. 94640)
Irvin Creek Reach 1, Cross-Section 4 (Riffle)
Monitoring Year 0

Cross-Section 4 Channel materials (mm)	
D ₁₆ =	3.7
D ₃₅ =	16.3
D ₅₀ =	22.6
D ₈₄ =	45.0
D ₉₅ =	69.7
D ₁₀₀ =	128.0

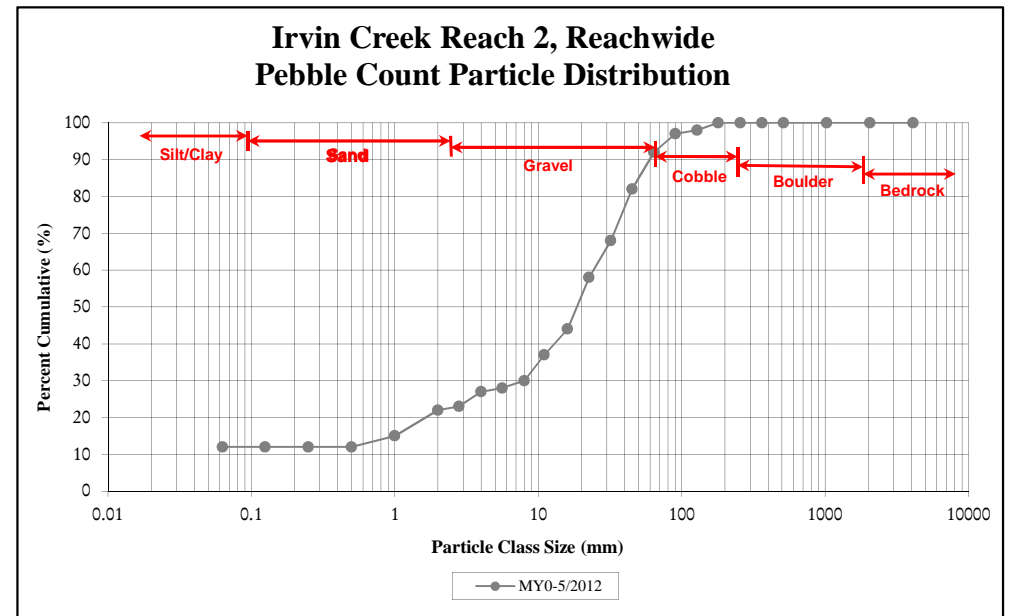
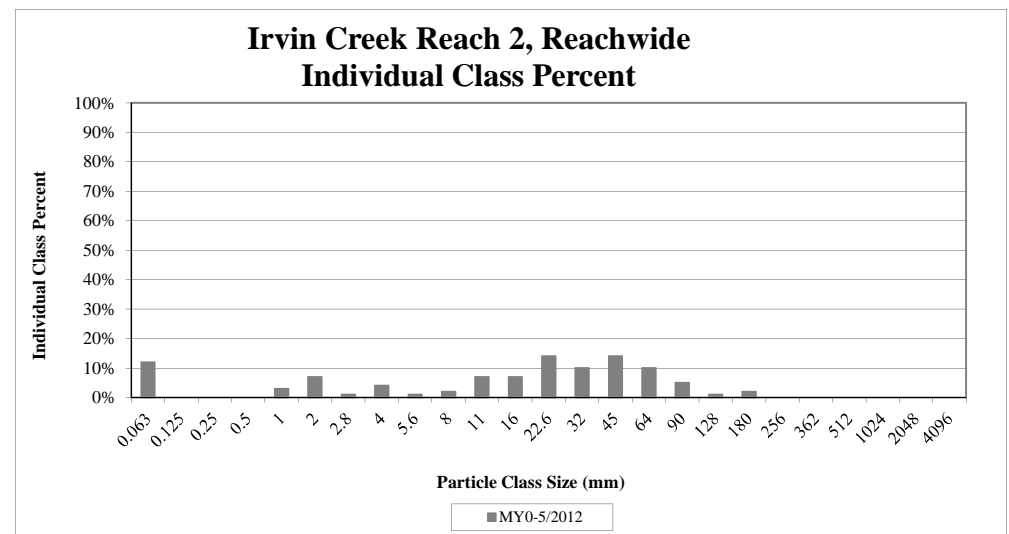
Appendix 2. Morphological Summary Data and Plots
Figure 5d. Reachwide and Cross-Section Pebble Count Plots
Little Troublesome Creek Mitigation Site (NCEEP Project No. 94640)
Irvin Creek Reach 2, Reachwide
Monitoring Year 0

Reachwide Channel materials (mm)	
D ₁₆ =	Silt/Clay
D ₃₅ =	Silt/Clay
D ₅₀ =	18.6
D ₈₄ =	48.3
D ₉₅ =	78.5
D ₁₀₀ =	180.0

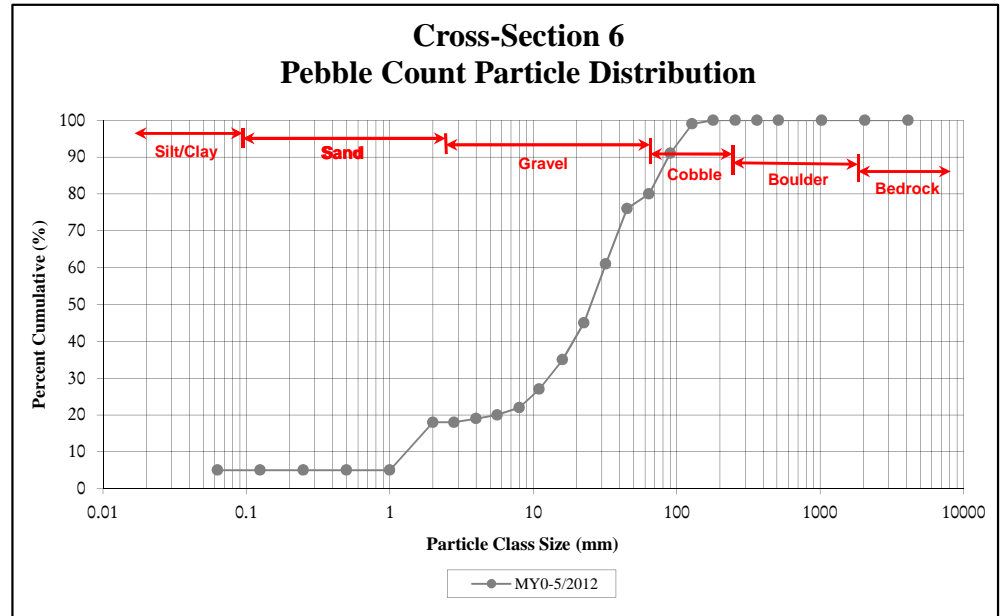
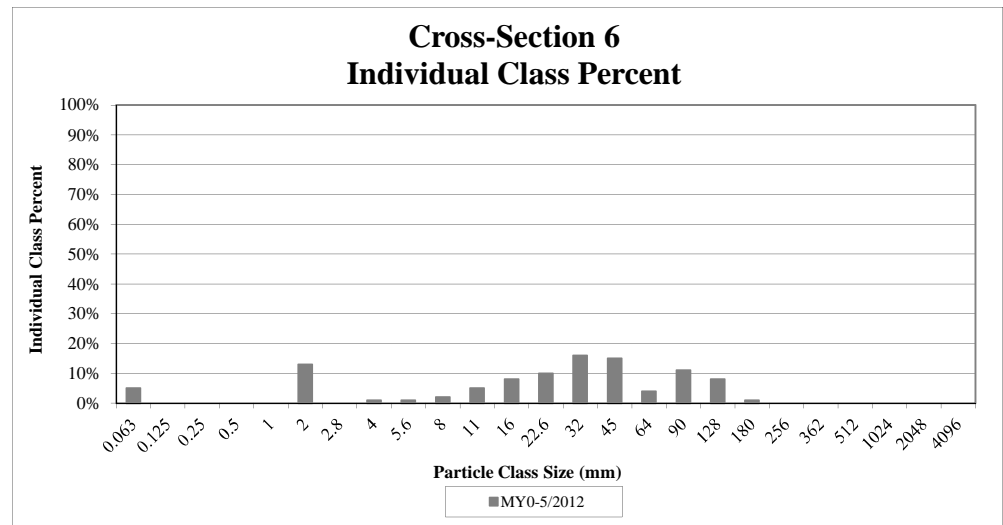
Appendix 2. Morphological Summary Data and Plots
Figure 5e. Reachwide and Cross-Section Substrate Plots
Little Troublesome Creek Mitigation Site (NCEEP Project No. 94640)
Irvin Creek Reach 2, Cross-Section 6 (Riffle)
Monitoring Year 0

Cross-Section 6 Channel materials (mm)	
D ₁₆ =	1.8
D ₃₅ =	16.0
D ₅₀ =	25.2
D ₈₄ =	58.1
D ₉₅ =	90.0
D ₁₀₀ =	128.0

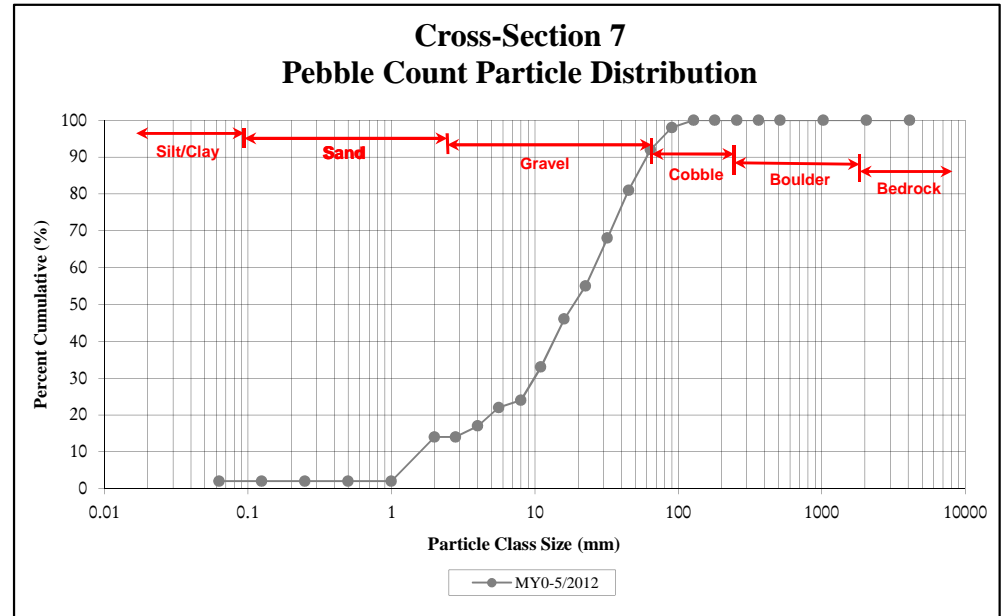
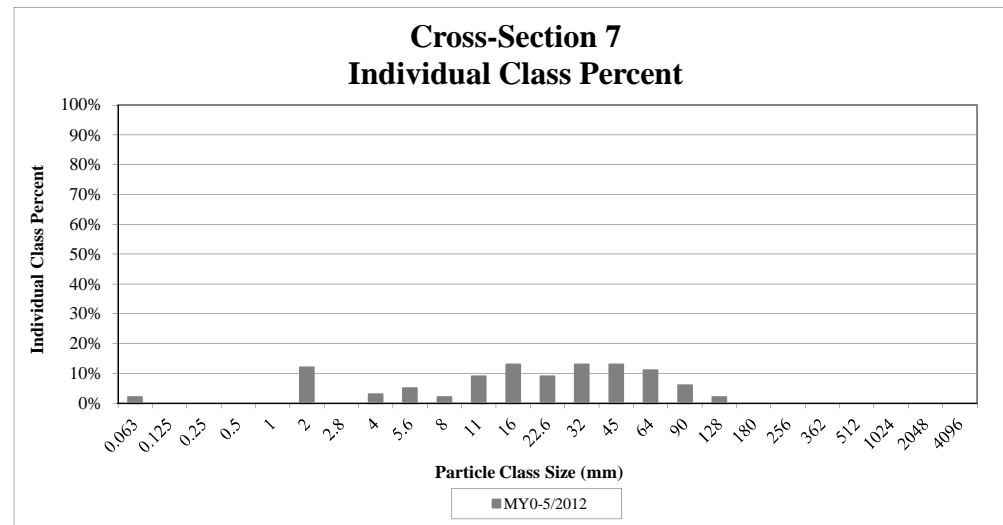
Appendix 2. Morphological Summary Data and Plots
Figure 5f. Reachwide and Cross-Section Substrate Plots
Little Troublesome Creek Mitigation Site (NCEEP Project No. 94640)
Irvin Creek Reach 2, Cross-Section 7 (Riffle)
Monitoring Year 0

Cross-Section 7 Channel materials (mm)	
D ₁₆ =	3.6
D ₃₅ =	11.7
D ₅₀ =	18.7
D ₈₄ =	49.5
D ₉₅ =	75.9
D ₁₀₀ =	128.0

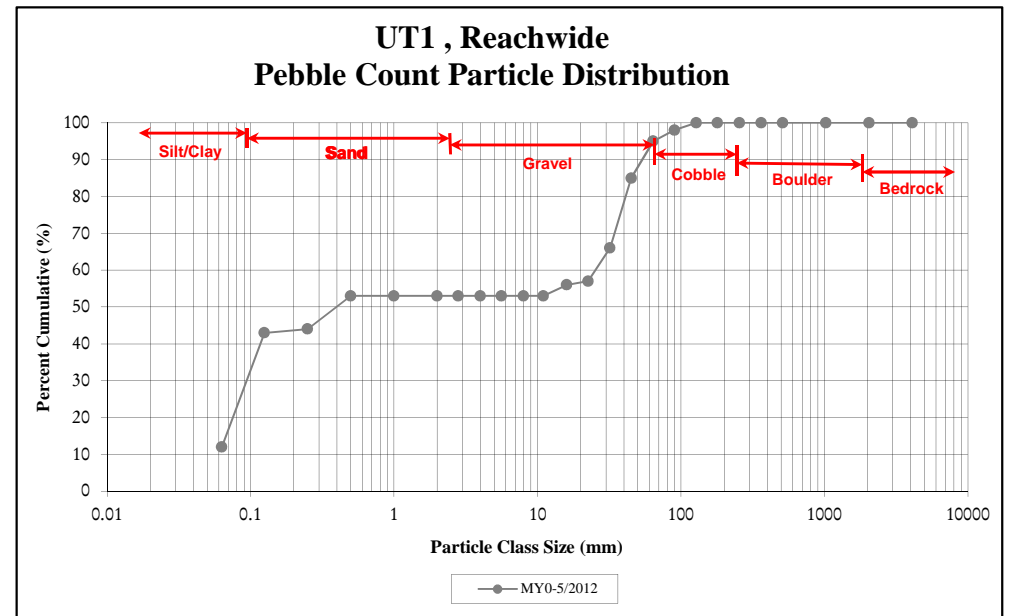
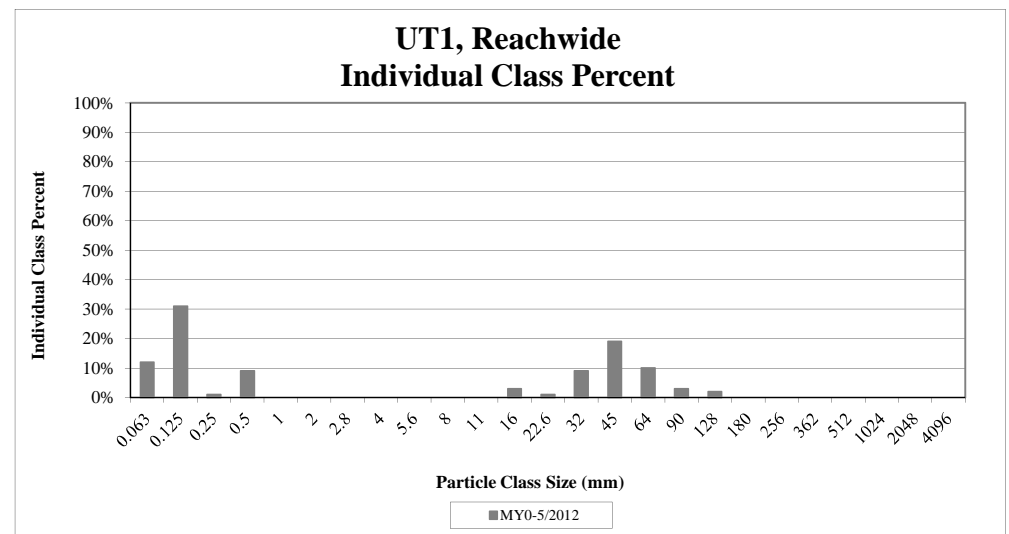
Appendix 2. Morphological Summary Data and Plots
Figure 5g. Reachwide and Cross-Section Pebble Count Plots
Little Troublesome Creek Mitigation Site (NCEEP Project No. 94640)
UT1, Reachwide
Monitoring Year 0 of 5

Reachwide Channel materials (mm)	
D ₁₆ =	Silt/Clay
D ₃₅ =	Silt/Clay
D ₅₀ =	0.4
D ₈₄ =	44.2
D ₉₅ =	64.0
D ₁₀₀ =	128.0

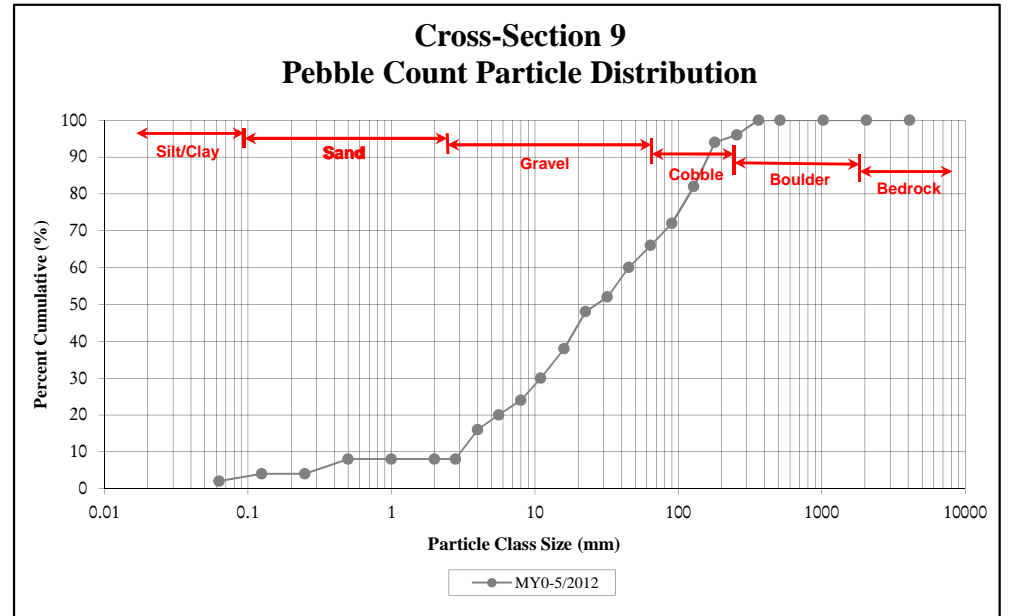
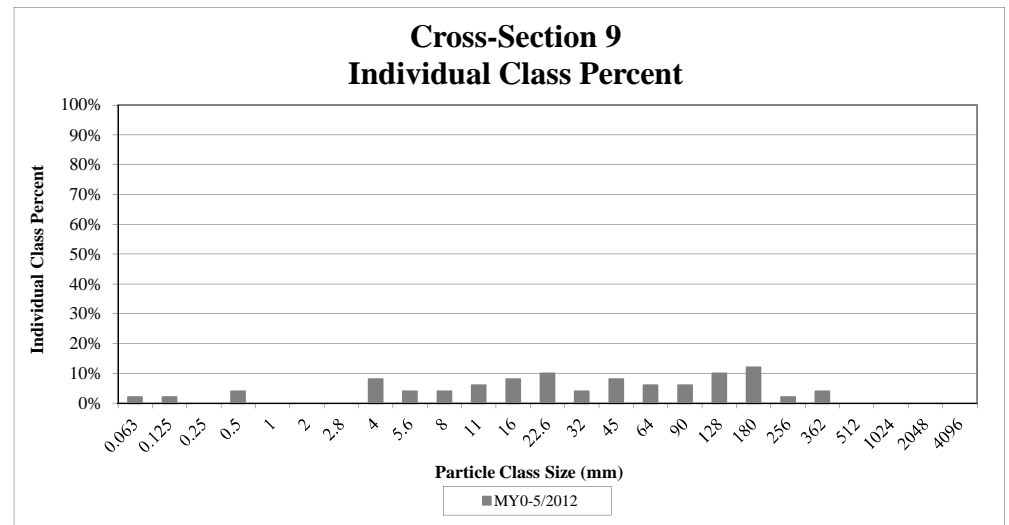
Appendix 2. Morphological Summary Data and Plots
Figure 5h. Reachwide and Cross-Section Substrate Plots
Little Troublesome Creek Mitigation Site (NCEEP Project No. 94640)
UT1, Cross-Section 9 (Riffle)
Monitoring Year 0 of 5

Cross-Section 9 Channel materials (mm)	
D ₁₆ =	8.0
D ₃₅ =	21.3
D ₅₀ =	27.3
D ₈₄ =	49.1
D ₉₅ =	75.9
D ₁₀₀ =	128.0

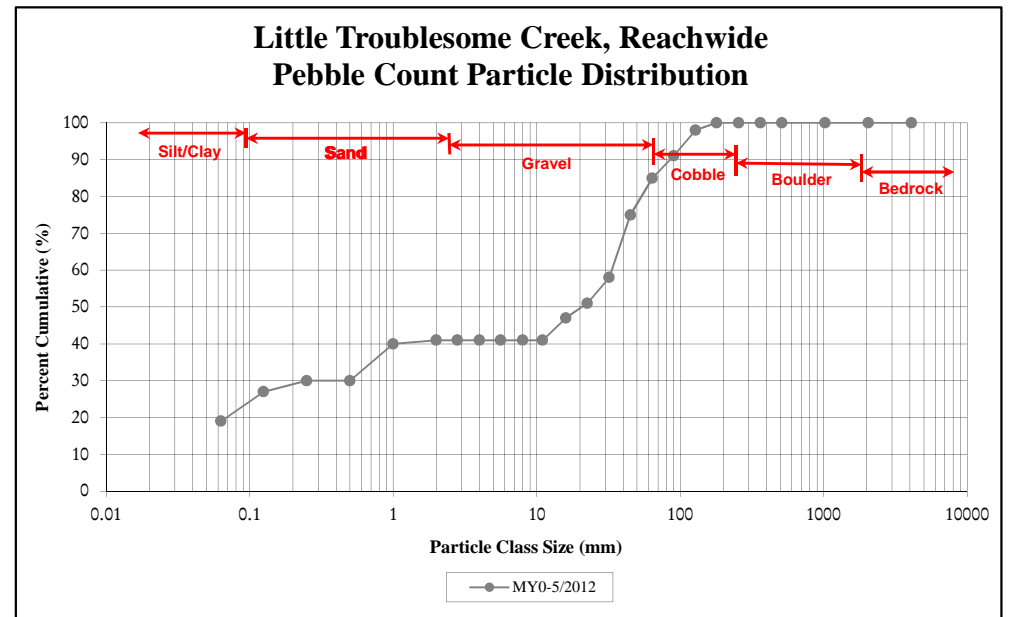
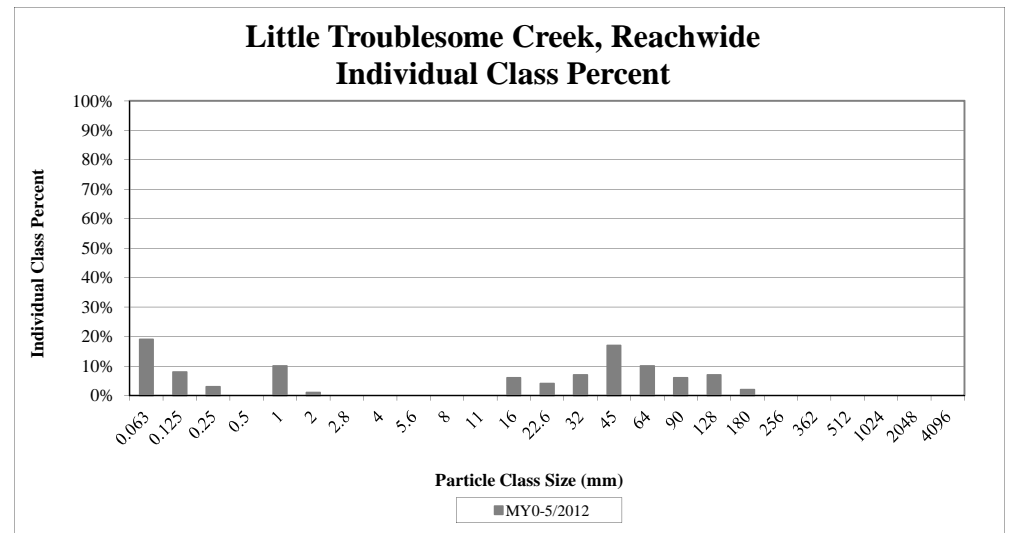
Appendix 2. Morphological Summary Data and Plots
Figure 5i. Reachwide and Cross-Section Pebble Count Plots
Little Troublesome Creek Mitigation Site (NCEEP Project No. 94640)
Little Troublesome Creek, Reachwide
Monitoring Year 0

Reachwide Channel materials (mm)	
D ₁₆ =	Silt/Clay
D ₃₅ =	Silt/Clay
D ₅₀ =	20.7
D ₈₄ =	61.8
D ₉₅ =	110.1
D ₁₀₀ =	180.0
