LITTLE TROUBLESOME CREEK MITIGATION SITE

*Rockingham County, NC
DENR Contract 003267
EEP Project Number 94640*

Baseline Monitoring Document and As-Built Baseline Report FINAL

LITTLE TROUBLESOME CREEK MITIGATION SITE
Baseline Monitoring Document and As-Built Baseline Report

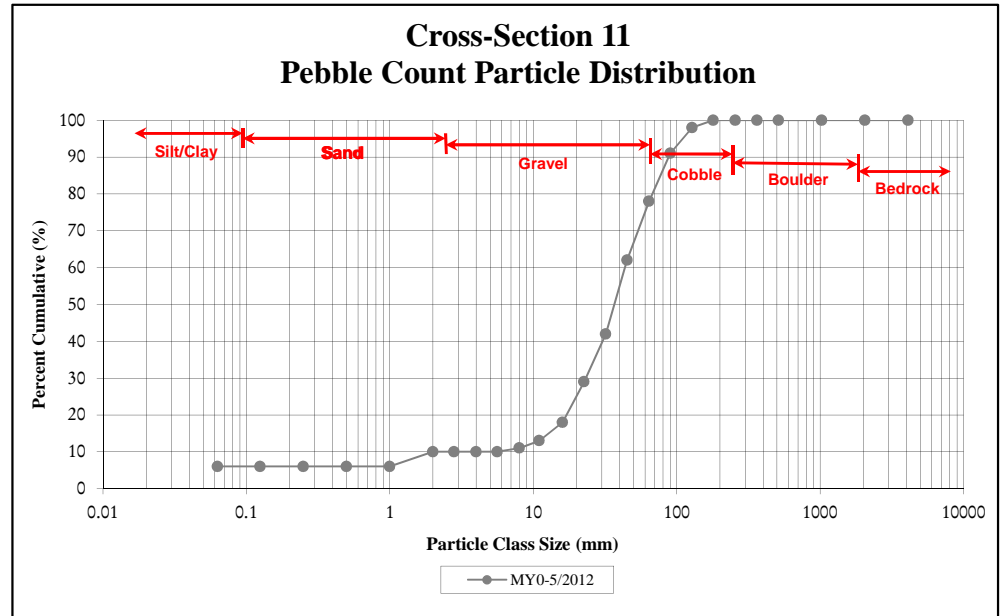
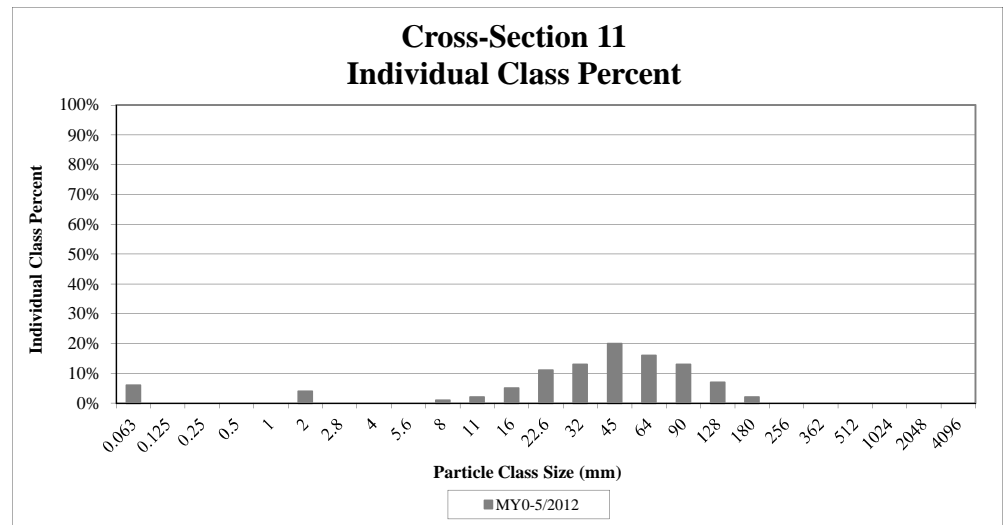
Appendix 2. Morphological Summary Data and Plots
Figure 5j. Reachwide and Cross-Section Substrate Plots
Little Troublesome Creek Mitigation Site (NCEP Project No. 94640)
Little Troublesome Creek , Cross-Section 11 (Riffle)
Monitoring Year 0

Cross-Section 11 Channel materials (mm)	
D ₁₆ =	13.8
D ₃₅ =	26.5
D ₅₀ =	36.7
D ₈₄ =	74.9
D ₉₅ =	110.1
D ₁₀₀ =	180.0

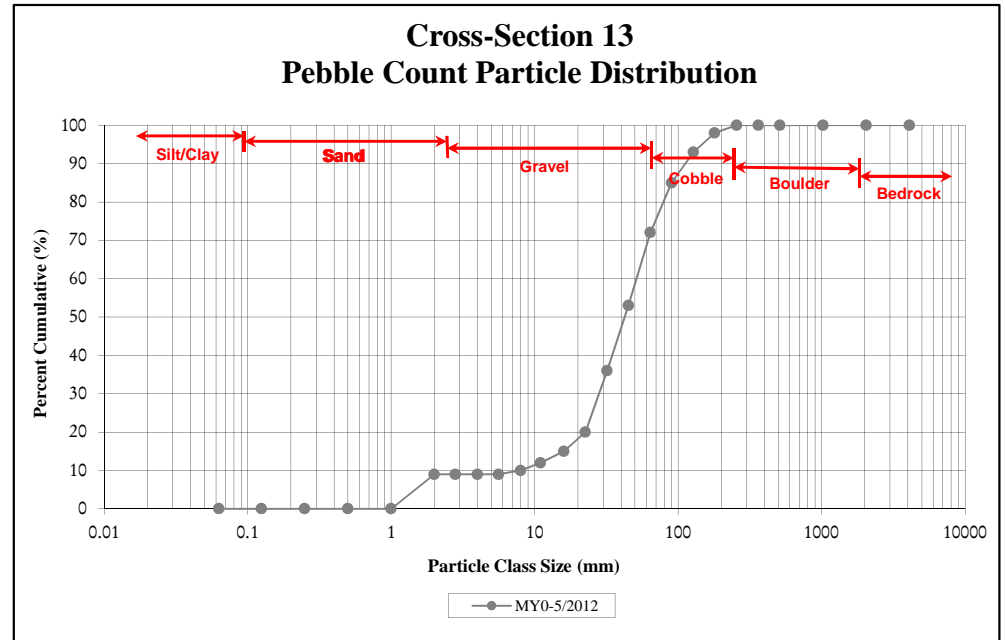
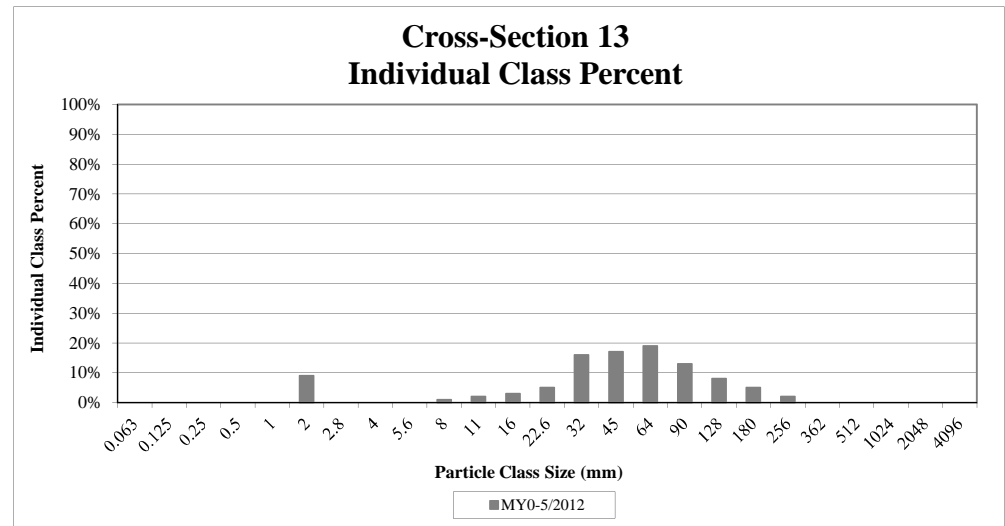
Appendix 2. Morphological Summary Data and Plots
Figure 5k. Reachwide and Cross-Section Substrate Plots
Little Troublesome Creek Mitigation Site (NCEP Project No. 94640)
Little Troublesome Creek , Cross-Section 13 (Riffle)
Monitoring Year 0

Cross-Section 13 Channel materials (mm)	
D ₁₆ =	17.1
D ₃₅ =	31.3
D ₅₀ =	42.4
D ₈₄ =	87.7
D ₉₅ =	146.7
D ₁₀₀ =	256.0

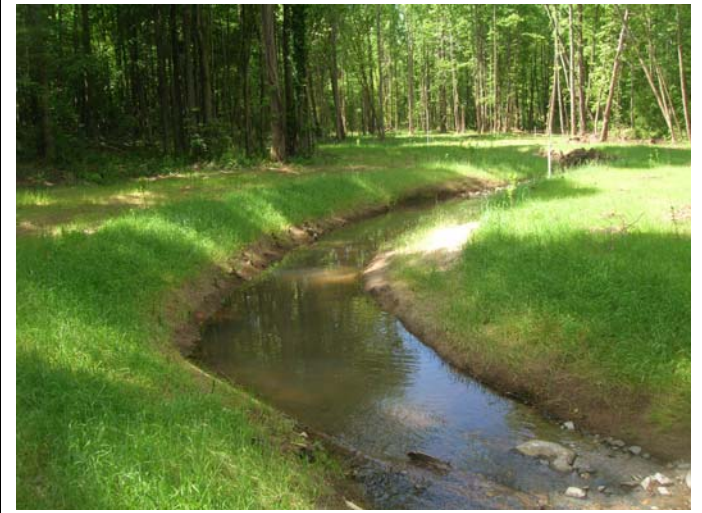
Photo Point 5 – looking downstream (05/17/2012)

A total of 25 permanent photographs locations were surveyed by Turner Land Surveying and photographed by WEI. These photographs can be found in Appendix 2.

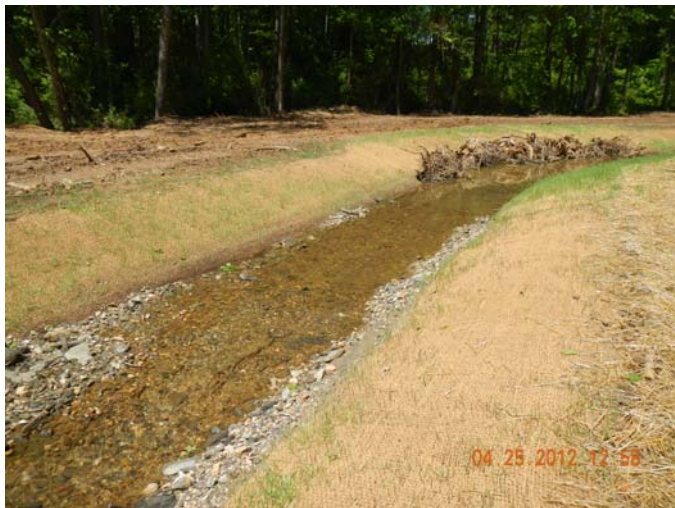
Photo Point 6 – looking upstream (04/25/2012)

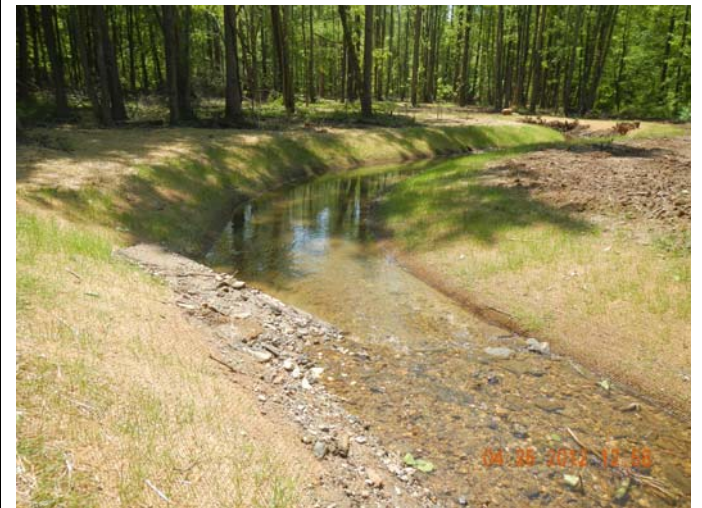
Photo Point 6 – looking downstream (04/25/2012)

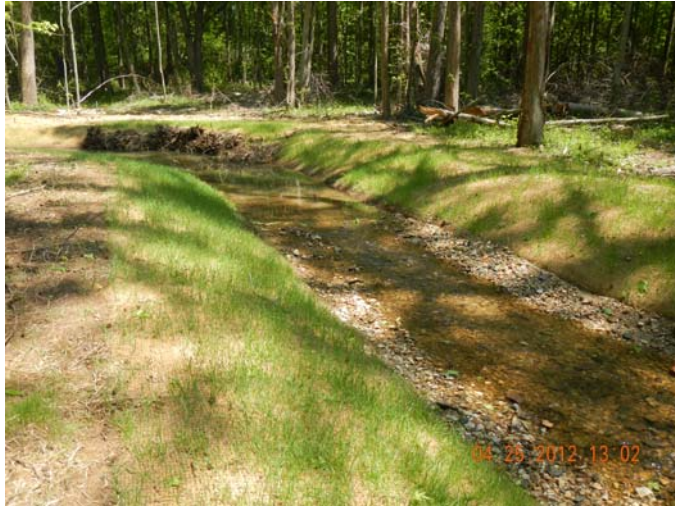
Photo Point 7 – looking upstream (04/25/2012)

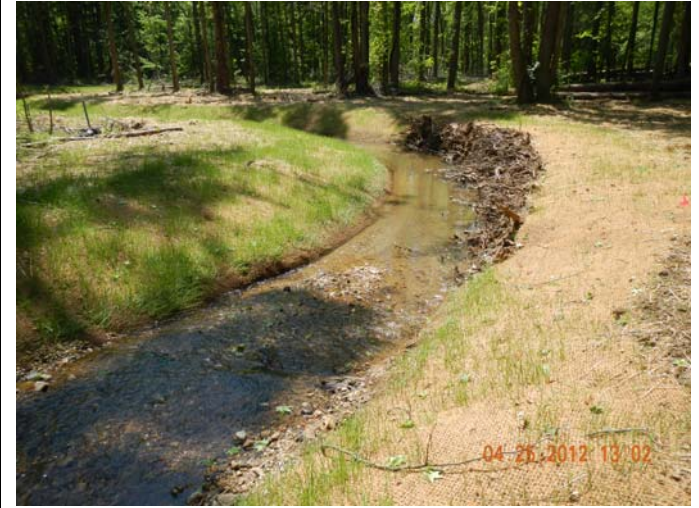
Photo Point 7 – looking downstream (04/25/2012)

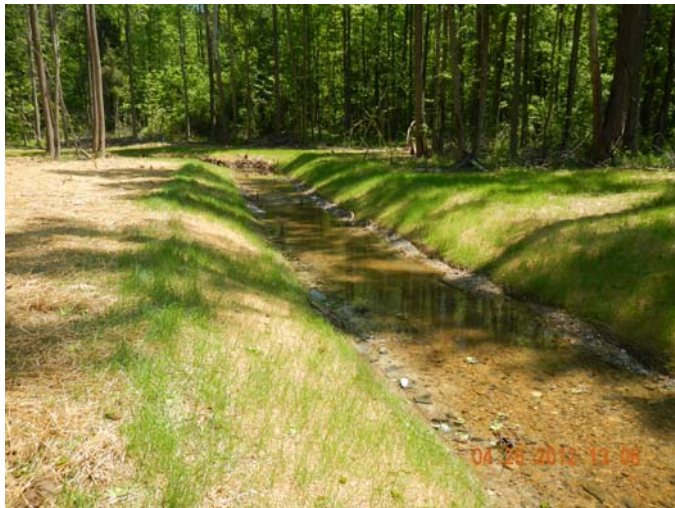
Photo Point 8 – looking upstream (04/25/2012)

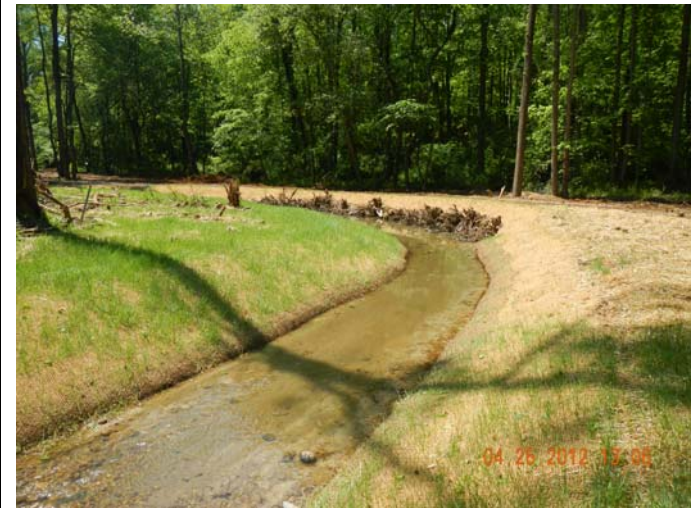
Photo Point 8 – looking downstream (04/25/2012)

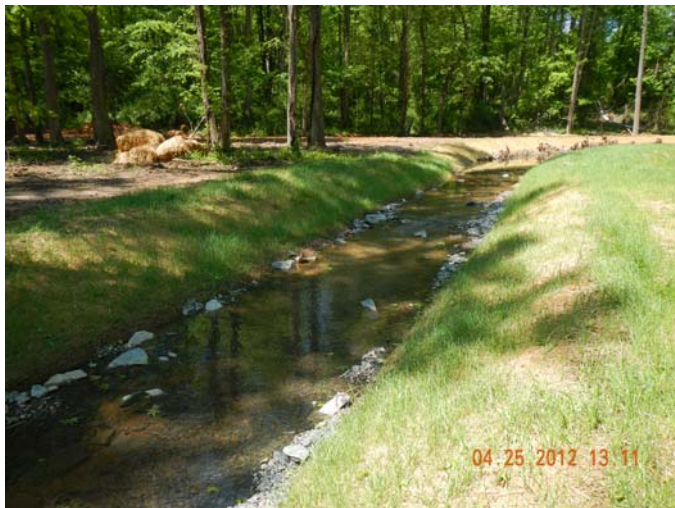
Photo Point 9 – looking upstream (04/25/2012)

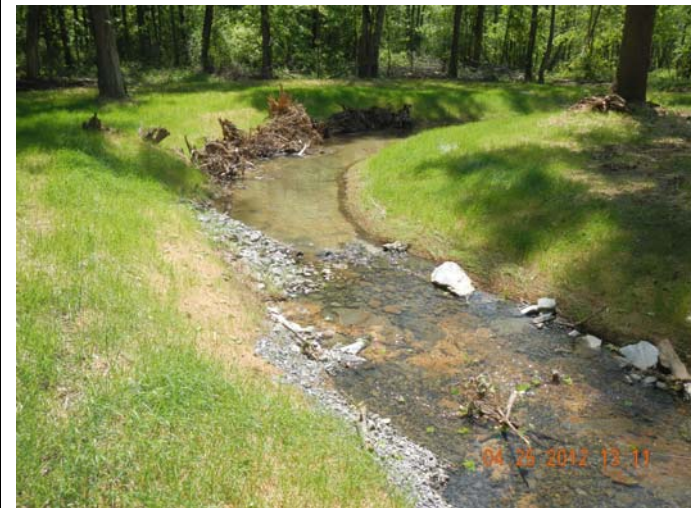
Photo Point 9 – looking downstream (04/25/2012)

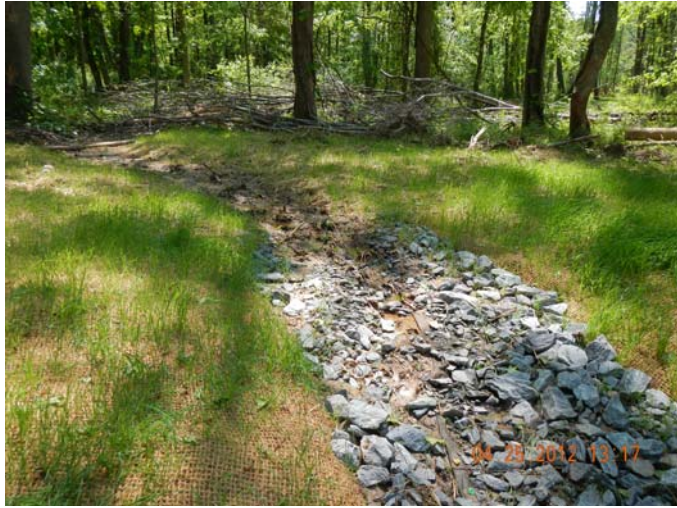
Photo Point 10 – looking upstream (04/25/2012)

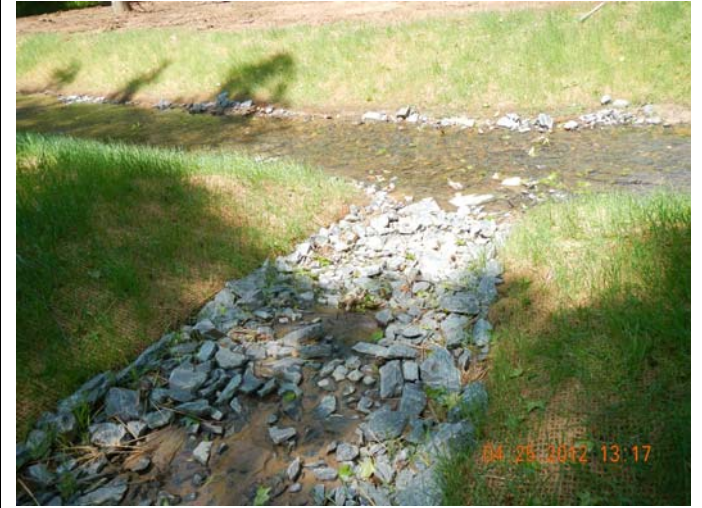
Photo Point 10 – looking downstream (04/25/2012)

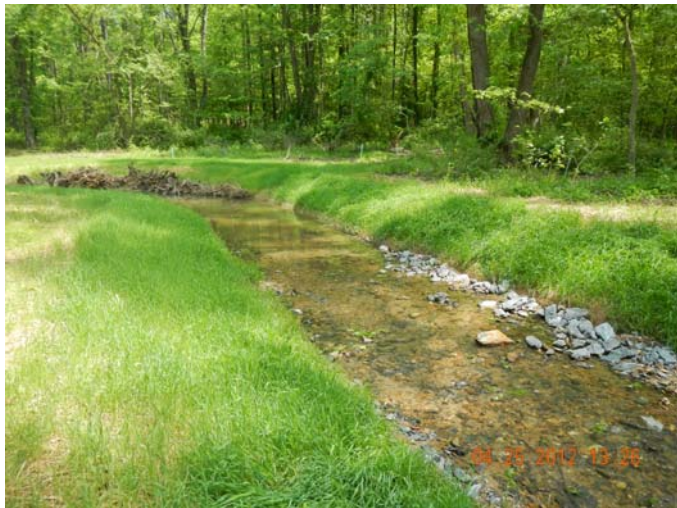
Photo Point 11 – looking upstream (04/25/2012)

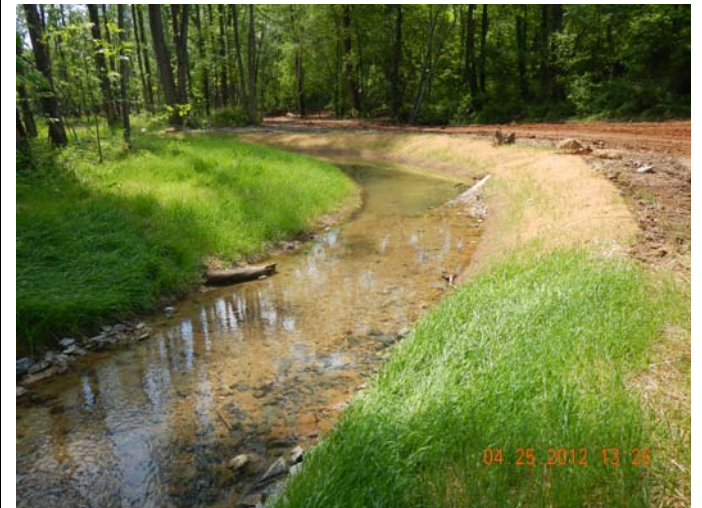
Photo Point 11 – looking downstream (04/25/2012)

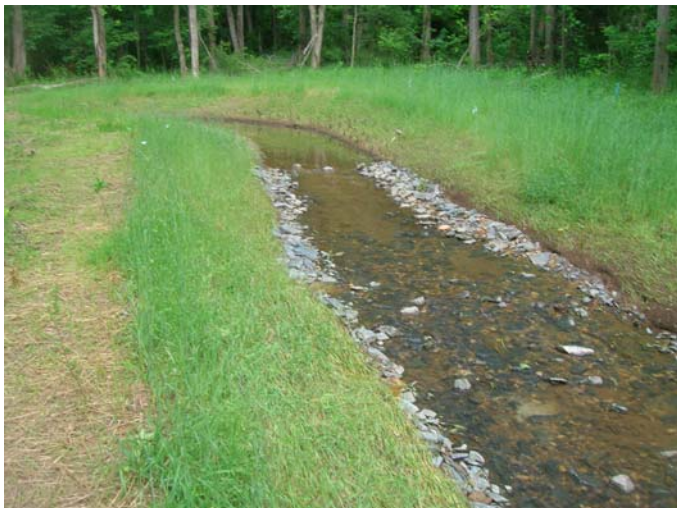
Photo Point 12 – looking upstream (05/17/2012)

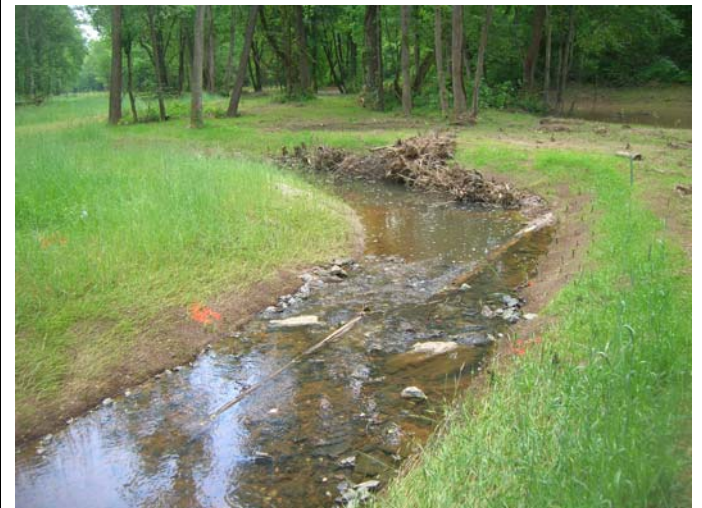
Photo Point 12 – looking downstream (05/17/2012)

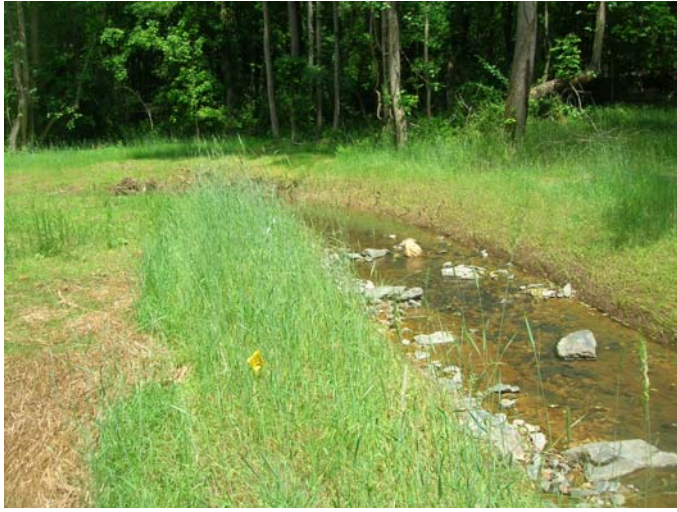
Photo Point 13 – looking upstream (05/17/2012)

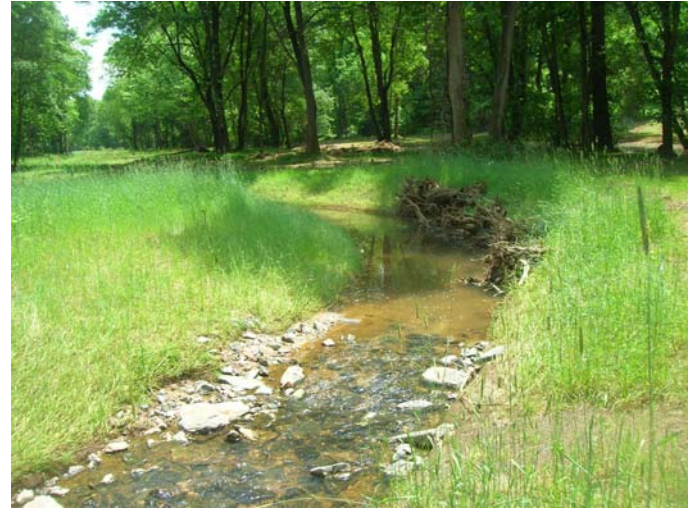
Photo Point 13 – looking downstream (05/17/2012)

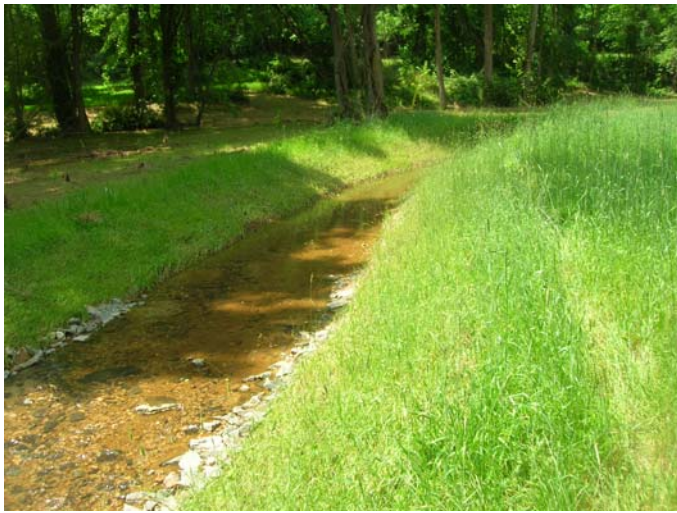
Photo Point 14 – looking upstream (05/17/2012)

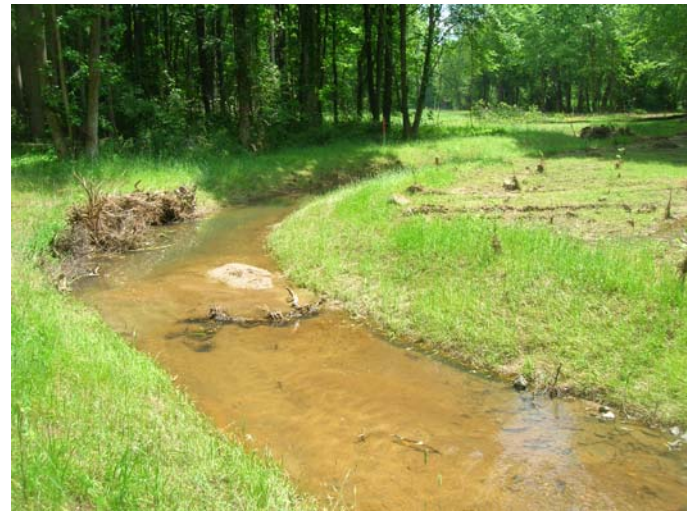
Photo Point 14 – looking downstream (05/17/2012)

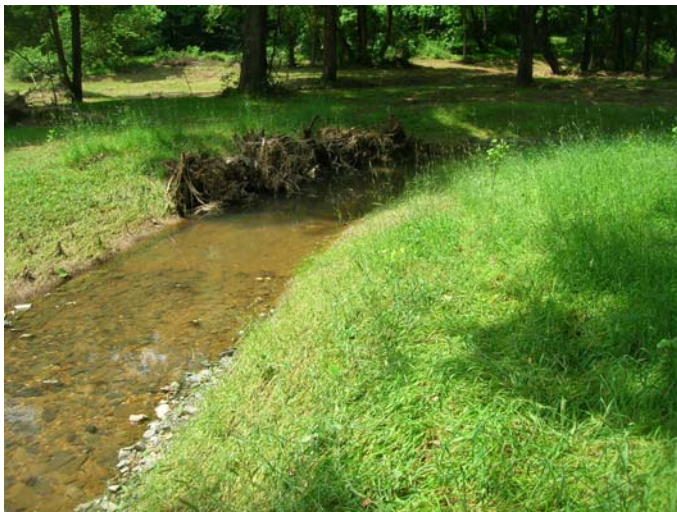
Photo Point 15 – looking upstream (05/17/2012)

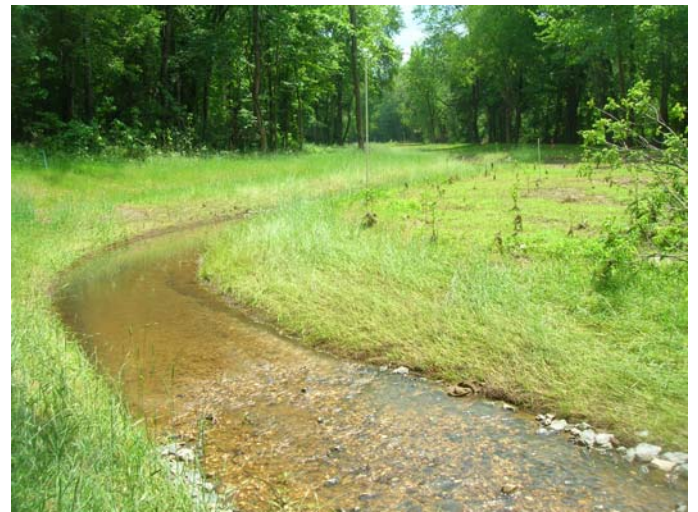
Photo Point 15 – looking downstream (05/17/2012)

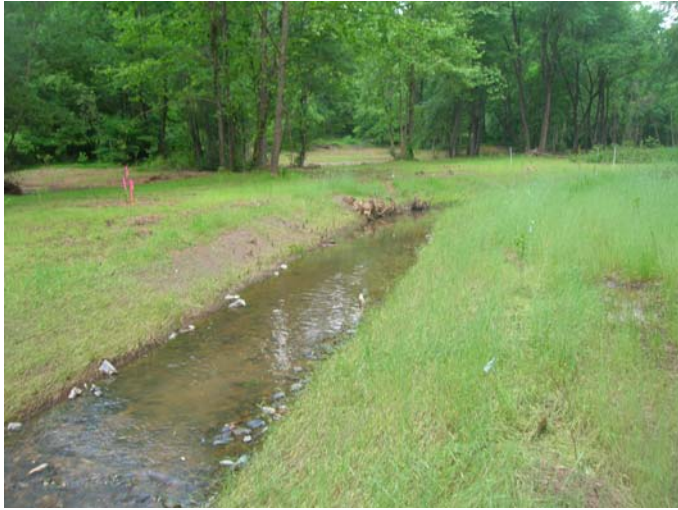
Photo Point 16 – looking upstream (05/17/2012)

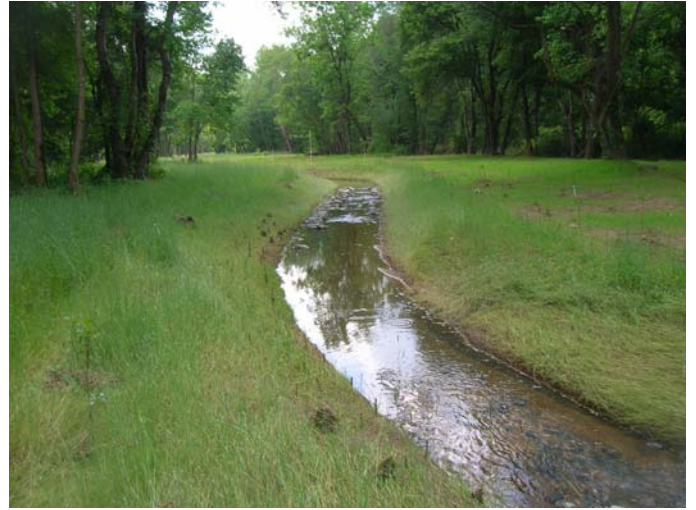
Photo Point 16 – looking downstream (05/17/2012)

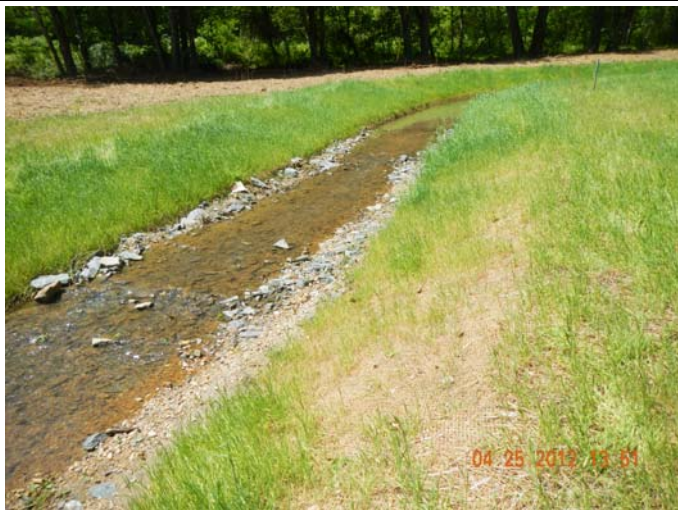
Photo Point 17 – looking upstream (04/25/2012)

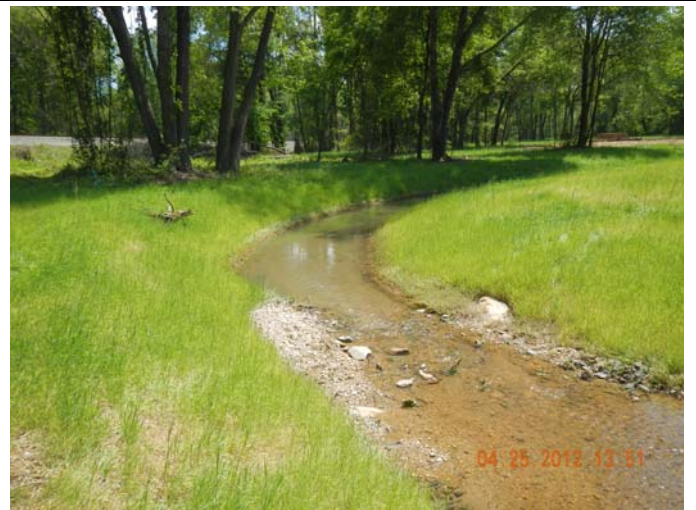
Photo Point 17 – looking downstream (04/25/2012)

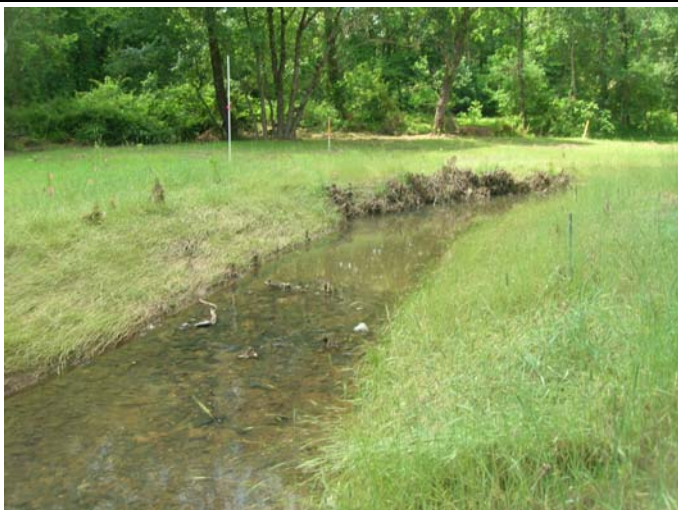
Photo Point 18 – looking upstream (05/17/2012)

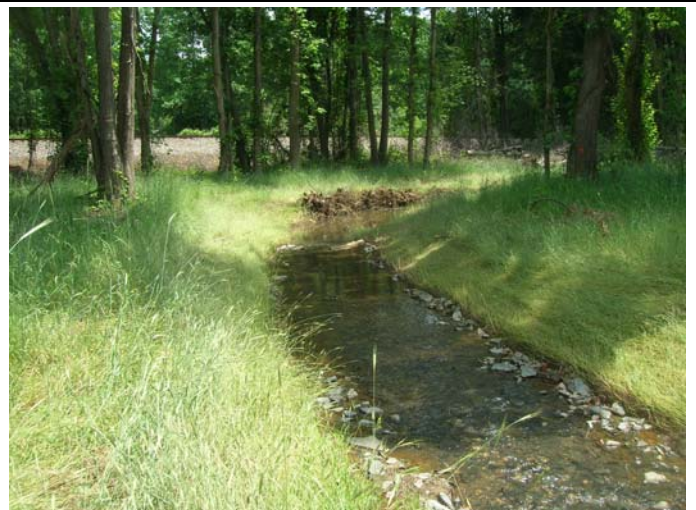
Photo Point 18 – looking downstream (05/17/2012)

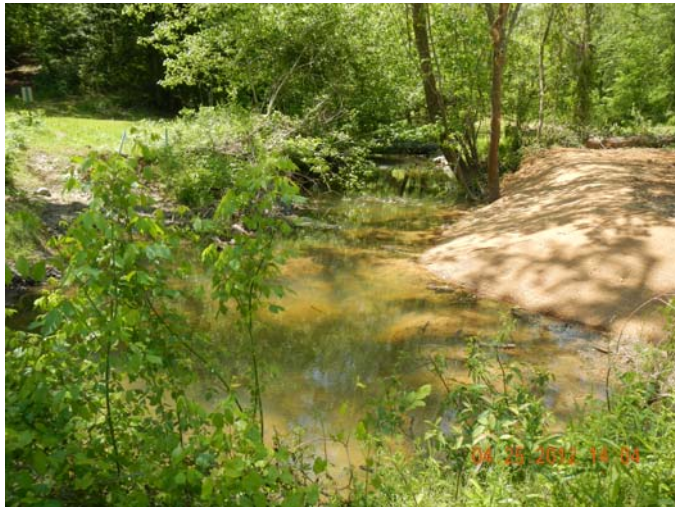
Photo Point 19 – looking upstream (04/25/2012)

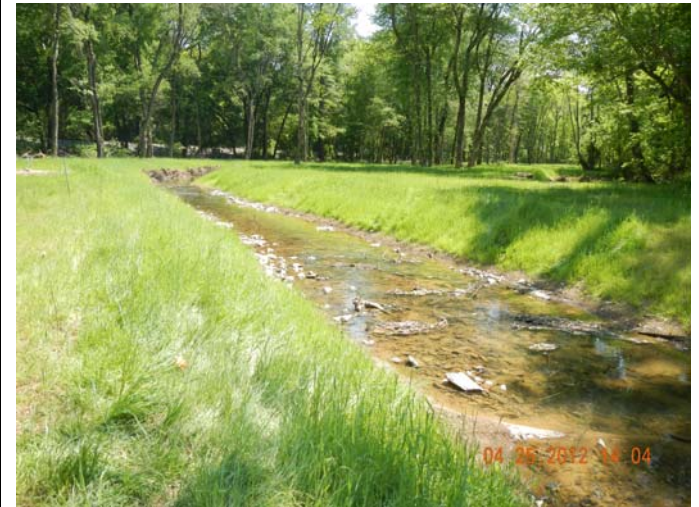
Photo Point 19 – looking upstream (04/25/2012)

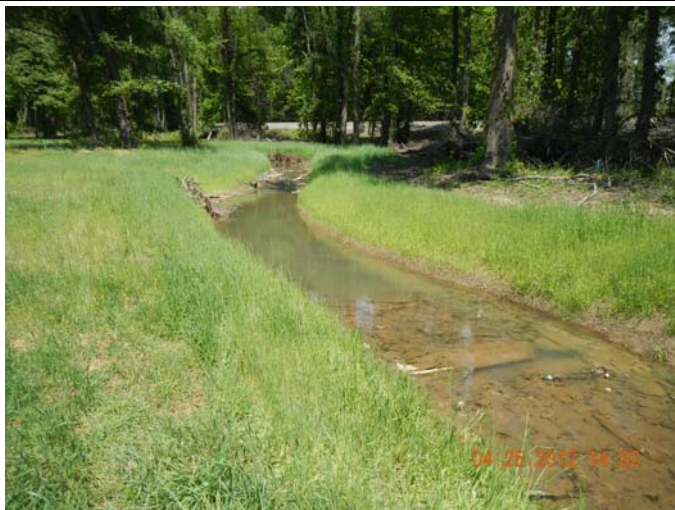
Photo Point 20 – looking upstream - Irvin (04/25/2012)

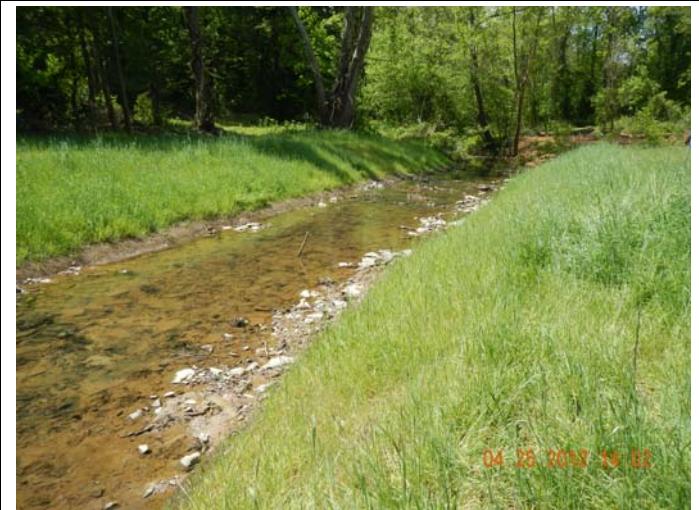
Photo Point 20 – looking upstream – LTC (04/25/2012)

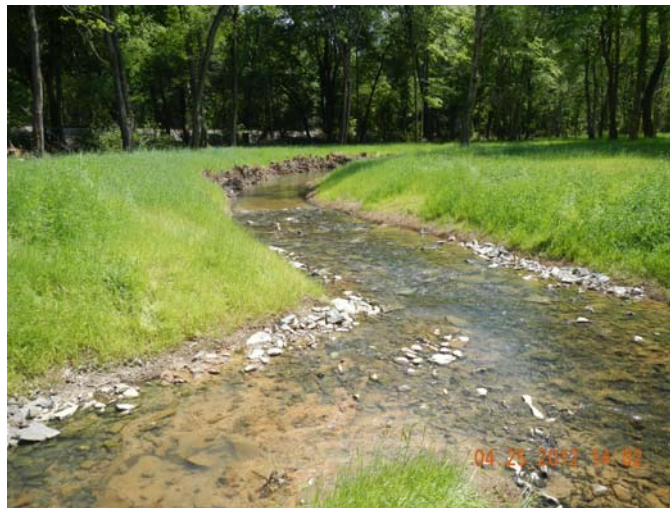
Photo Point 20 – looking downstream - LTC (04/25/2012)

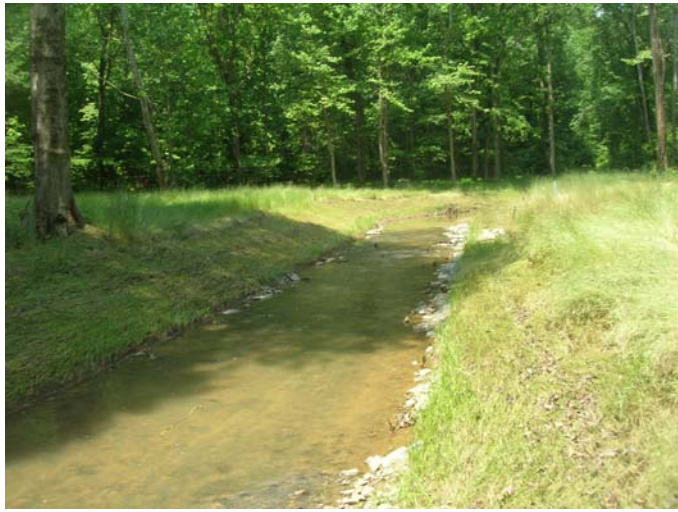
Photo Point 21 – looking upstream (05/17/2012)

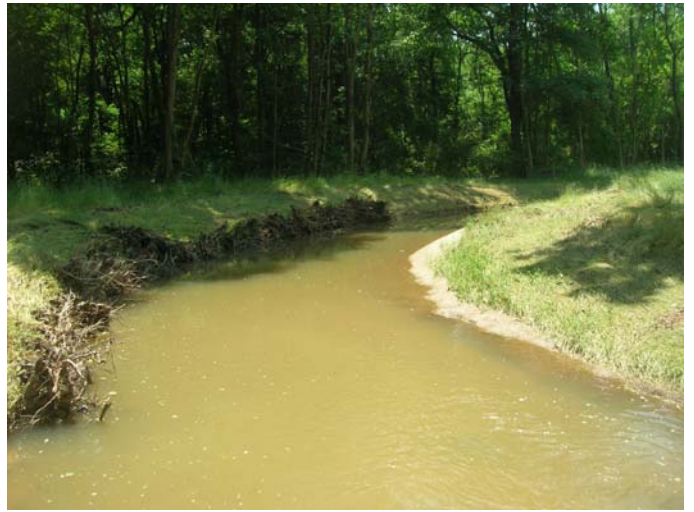
Photo Point 21 – looking downstream (05/17/2012)

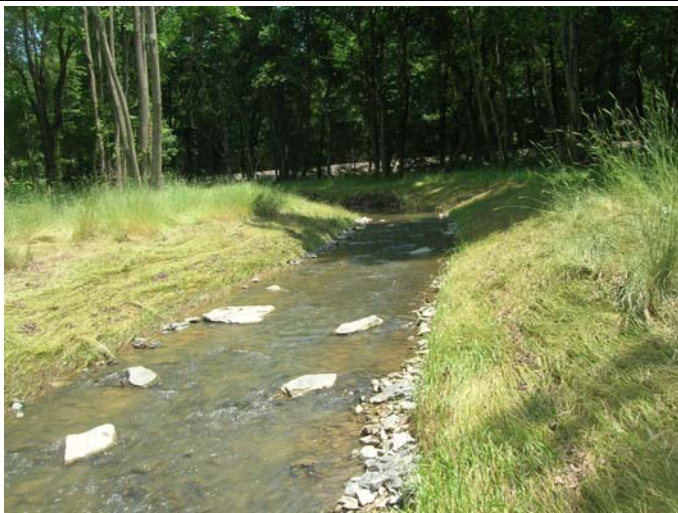
Photo Point 22 – looking upstream (05/17/2012)

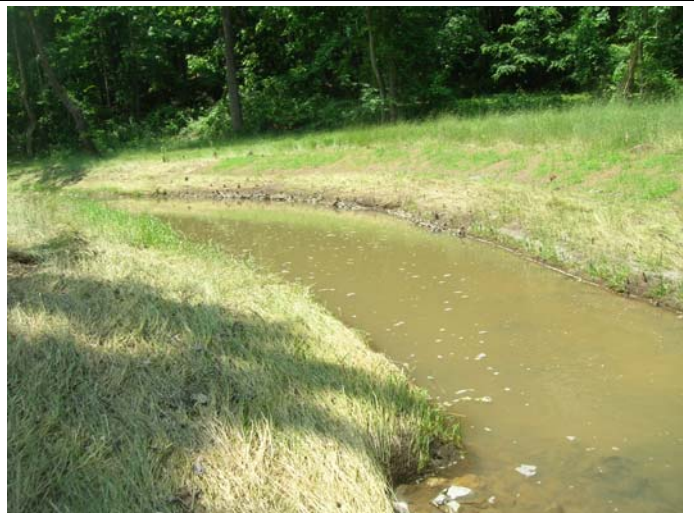
Photo Point 22 – looking downstream (05/17/2012)

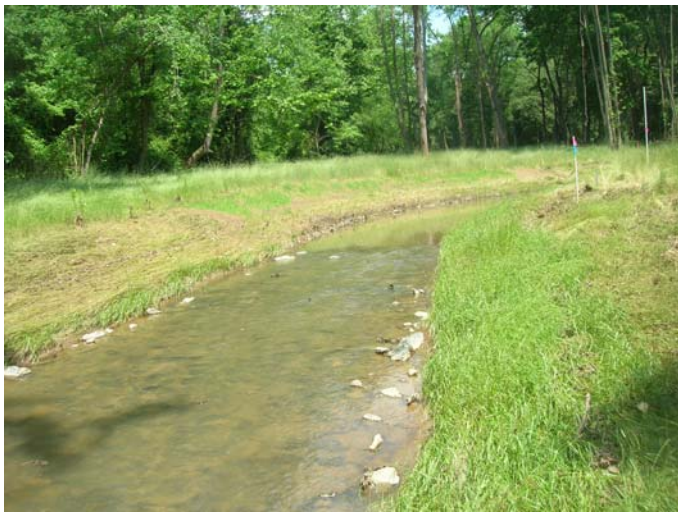
Photo Point 23 – looking upstream (05/17/2012)

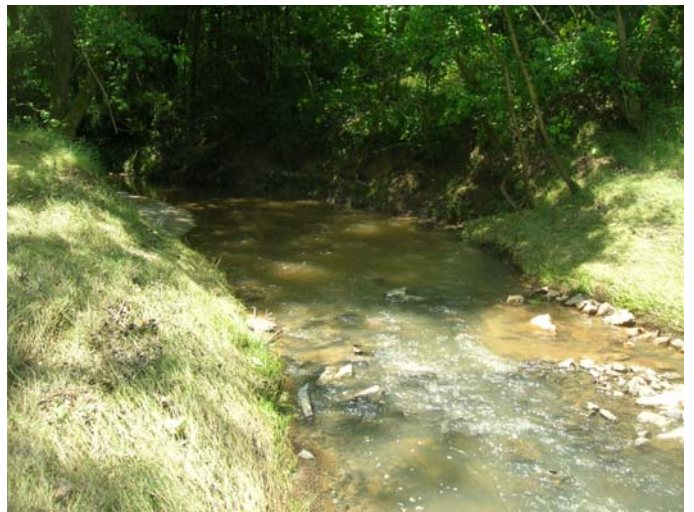
Photo Point 23 – looking downstream (05/17/2012)

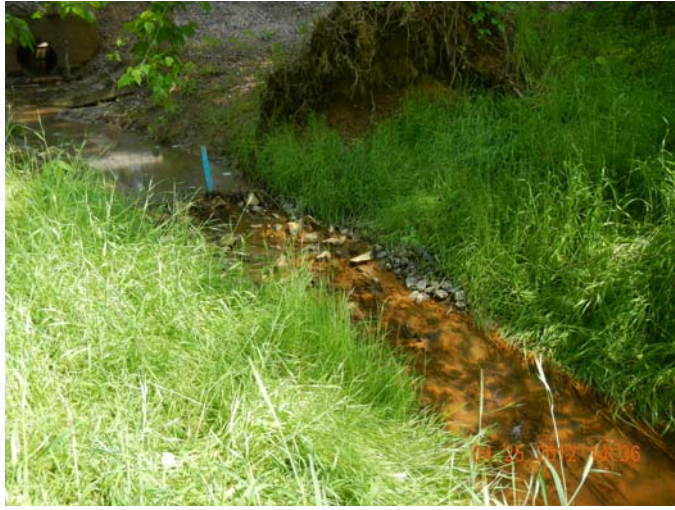
Photo Point 24 – looking upstream (04/25/2012)

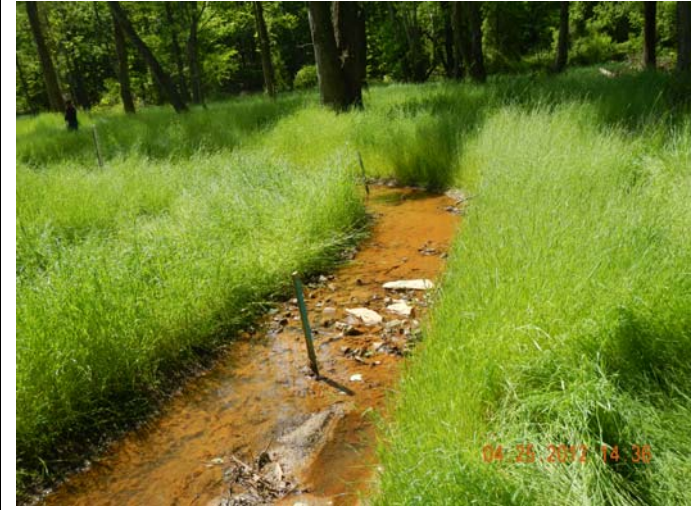
Photo Point 24 – looking downstream (04/25/2012)

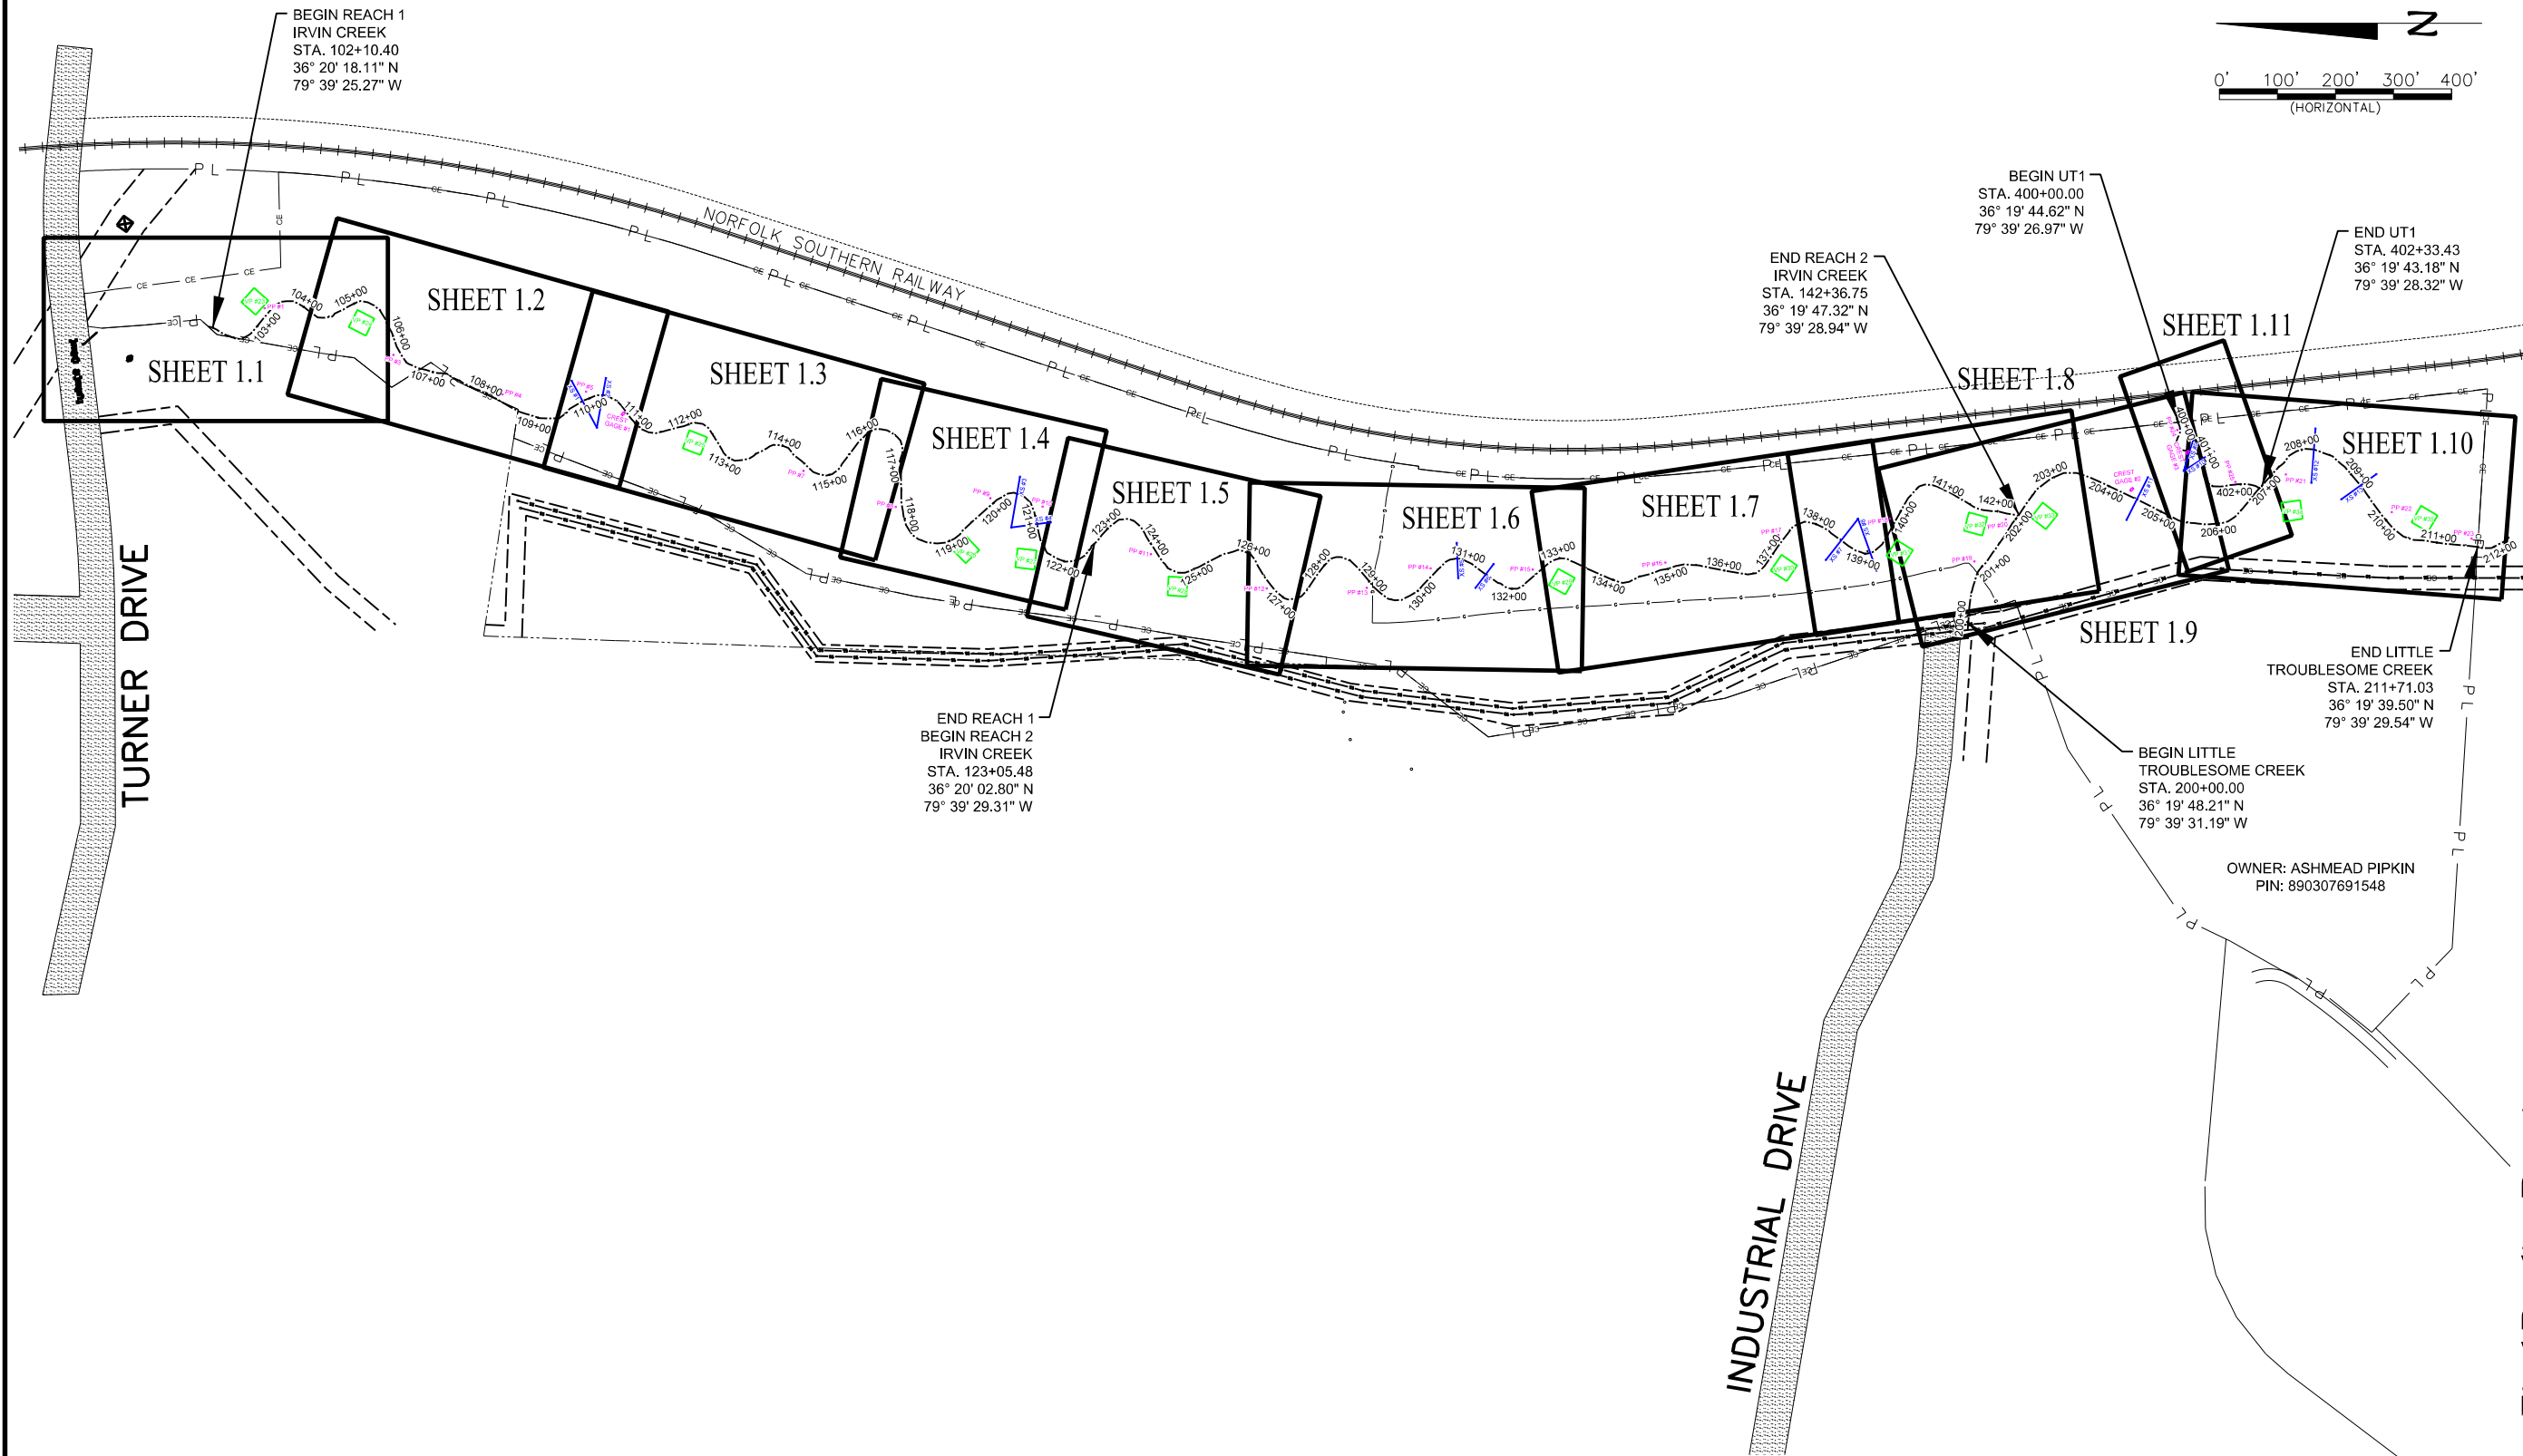
Little Troublesome Creek Mitigation Site
Rockingham County, NC
Stream Baseline Overview

Final Baseline Drawing

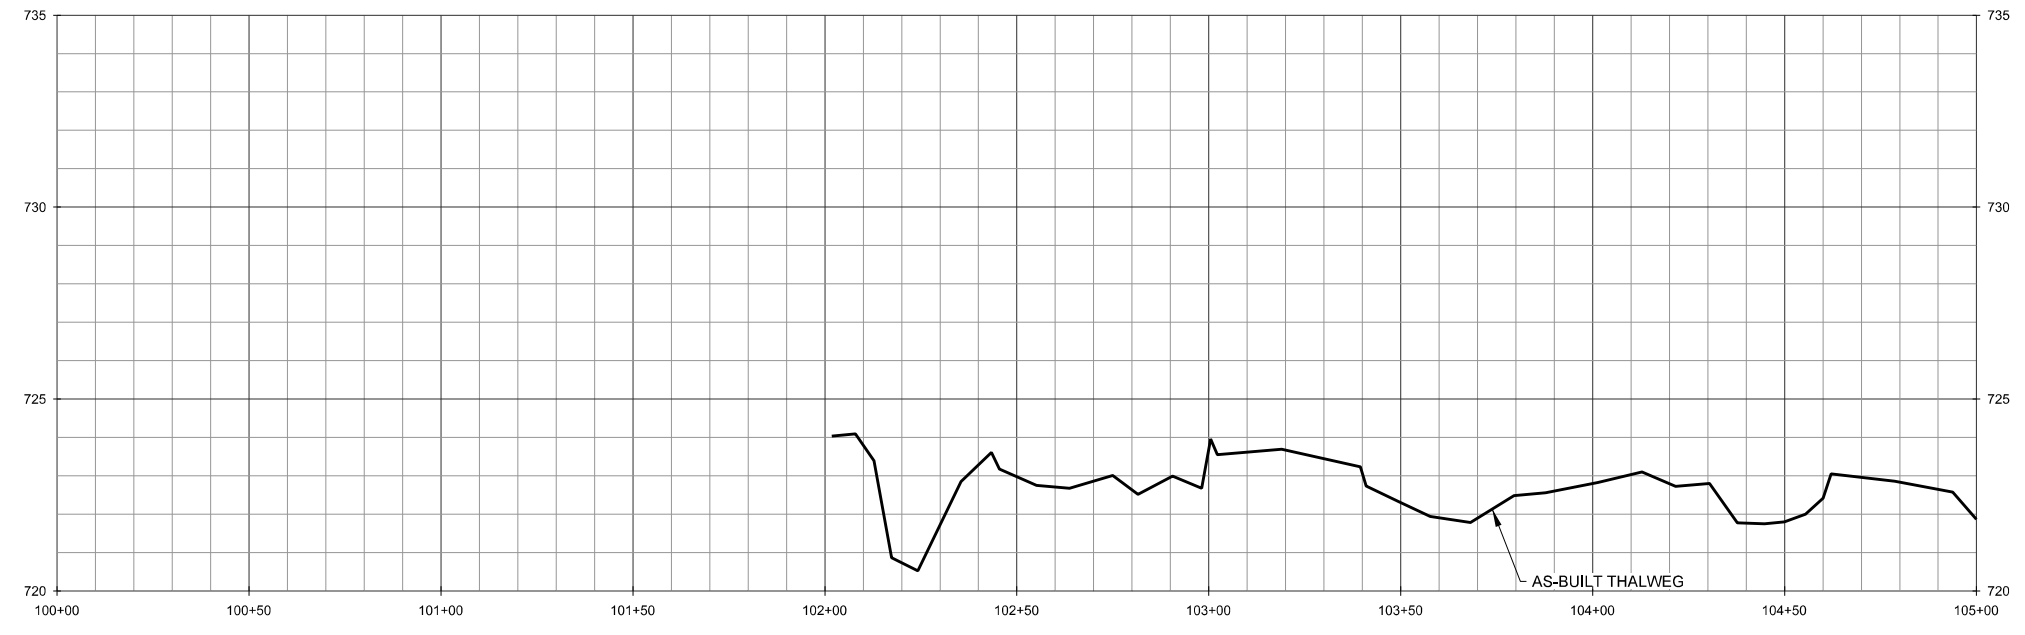
1.0

Little Troublesome Creek Mitigation Site
Rockingham County, NC
Stream Baseline Plans
Irvin Creek Reach 1 Plan and Profile
