LITTLE TROUBLESOME CREEK MITIGATION SITE

*Rockingham County, NC
DENR Contract 003267
EEP Project Number 94640*

Baseline Monitoring Document and As-Built Baseline Report FINAL

LITTLE TROUBLESOME CREEK MITIGATION SITE
Baseline Monitoring Document and As-Built Baseline Report

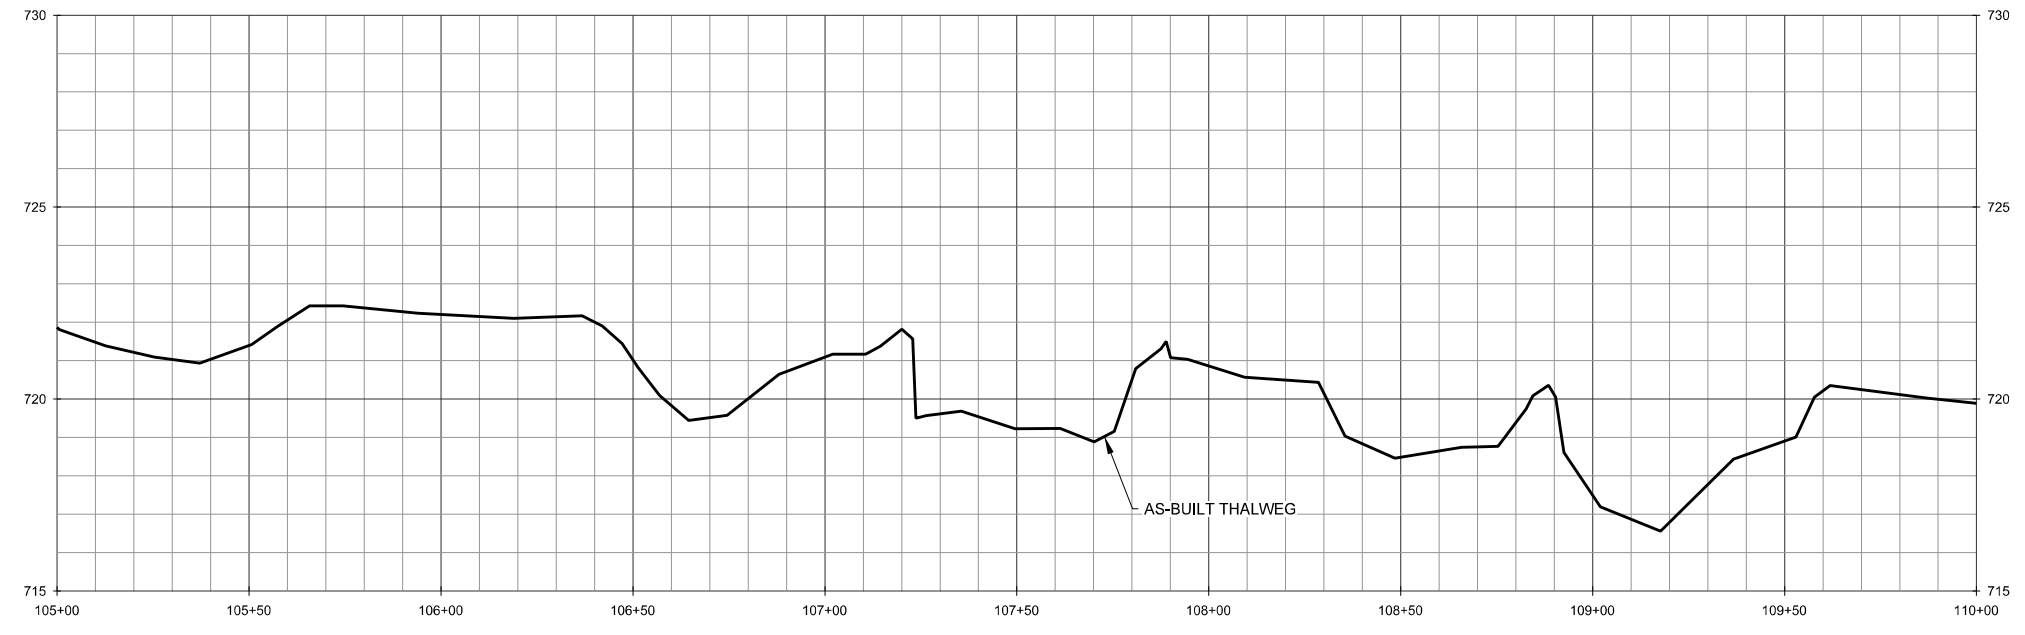
Little Troublesome Creek Mitigation Site
Rockingham County, NC
Stream Baseline Plans
Irvin Creek Reach 1 Plan and Profile

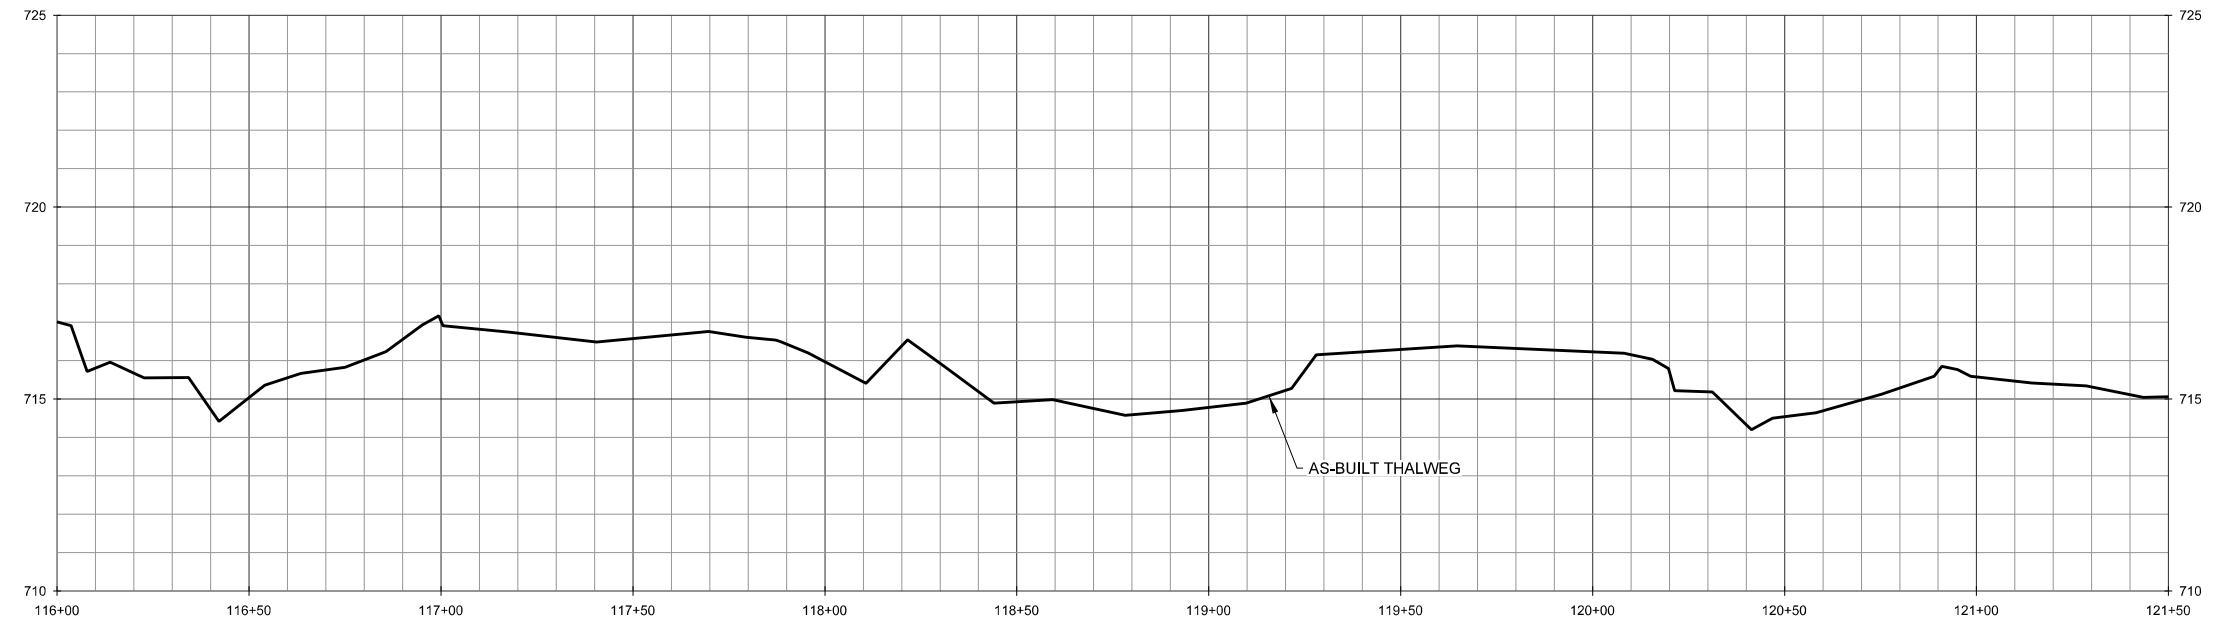
Little Troublesome Creek Mitigation Site
Rockingham County, NC
Stream Baseline Plans
Irvin Creek Reach 1 Plan and Profile

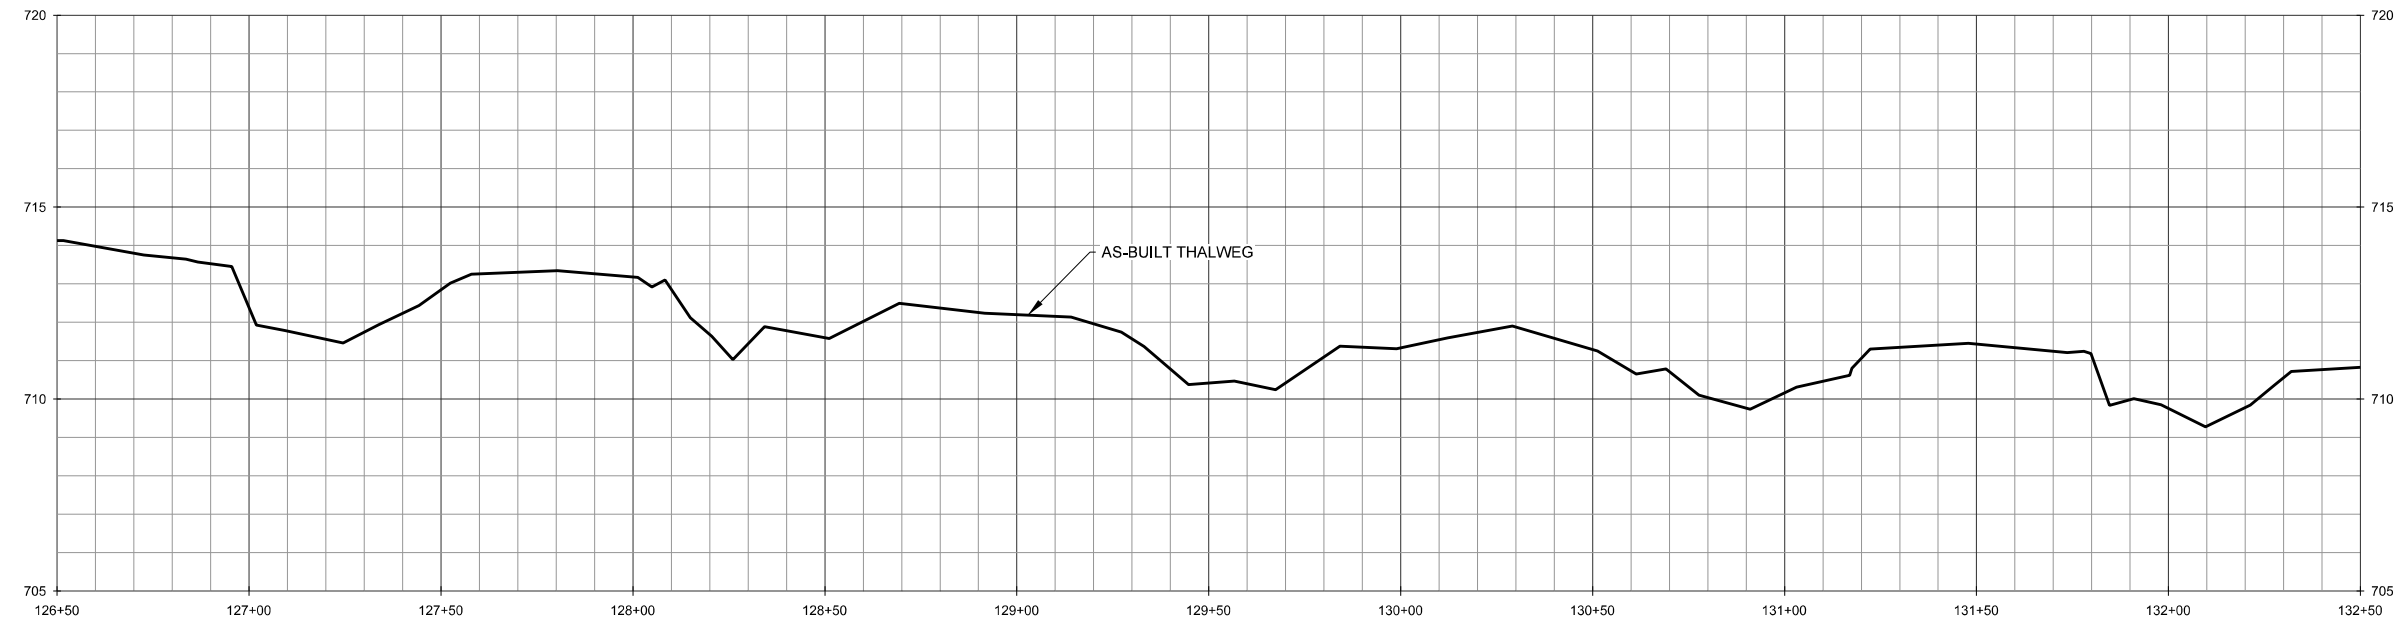
Little Troublesome Creek Mitigation Site
Rockingham County, NC
Stream Baseline Plans
Irvin Creek Reach 2 Plan and Profile

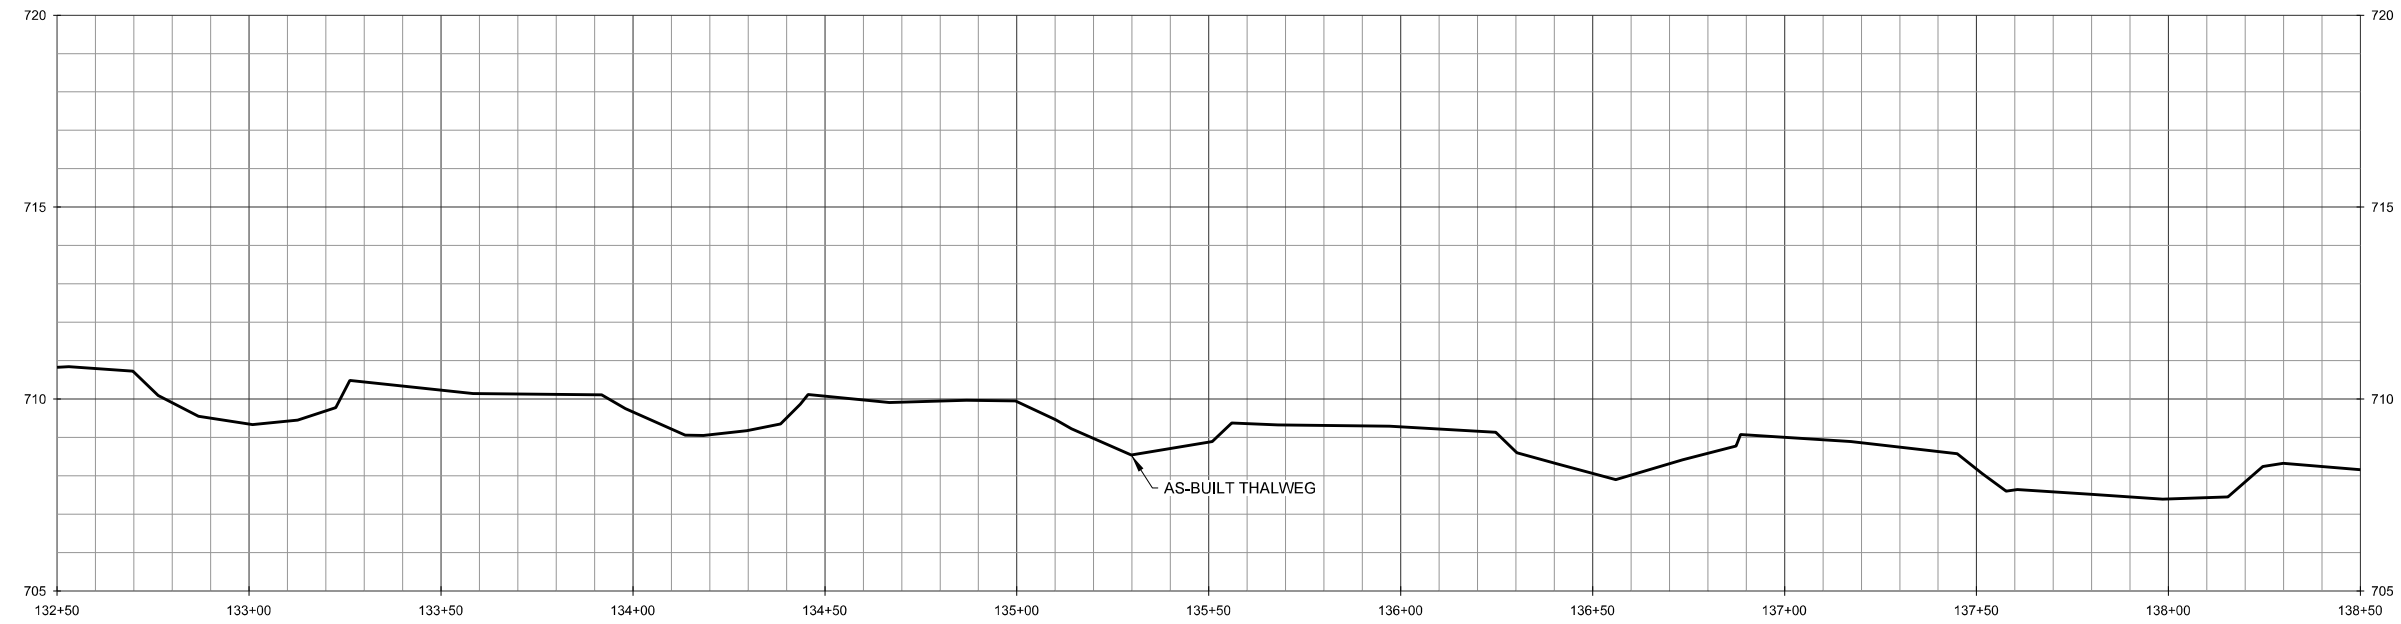
Little Troublesome Creek Mitigation Site
Rockingham County, NC
 Stream Baseline Plans
 Irvin Creek Reach 2 Plan and Profile

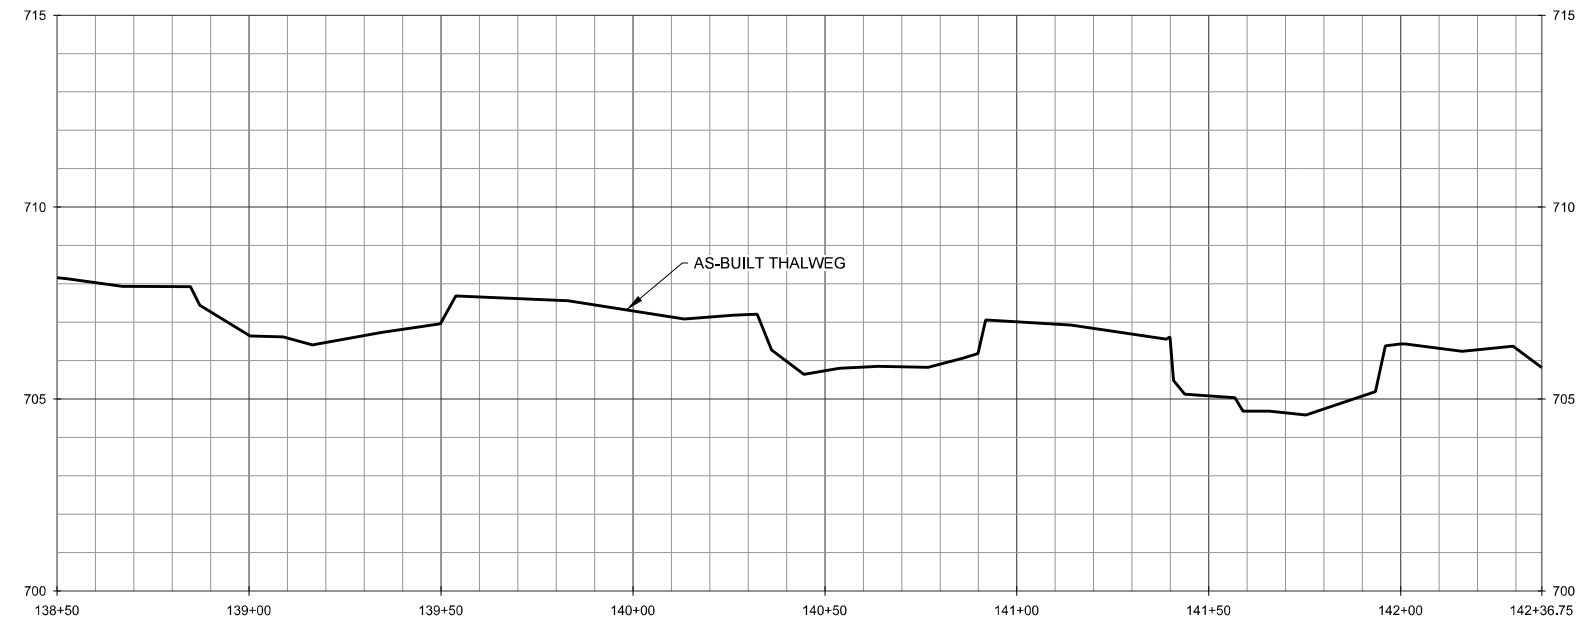
Little Troublesome Creek Mitigation Site
Rockingham County, NC
Stream Baseline Plans
Irvin Creek Reach 2 Plan and Profile

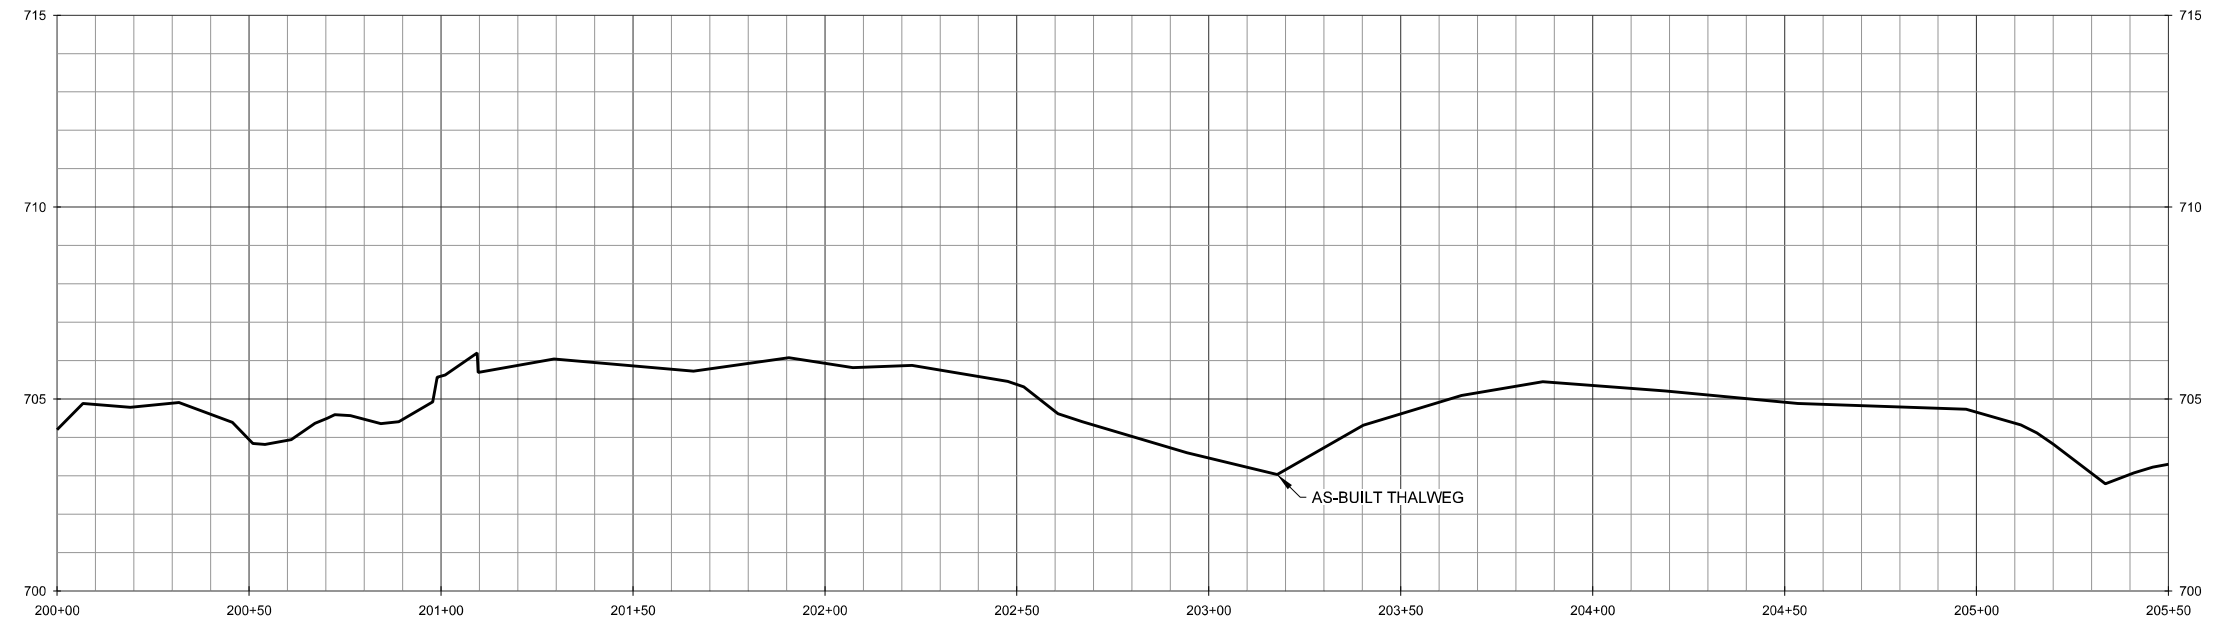
Little Troublesome Creek Mitigation Site
Rockingham County, NC
Stream Baseline Plans
Little Troublesome Creek Plan and Profile
