# LITTLE TROUBLESOME CREEK MITIGATION SITE

*Rockingham County, NC*

*NCEEP Project Number 94640*

## Monitoring Year 1 Annual Report

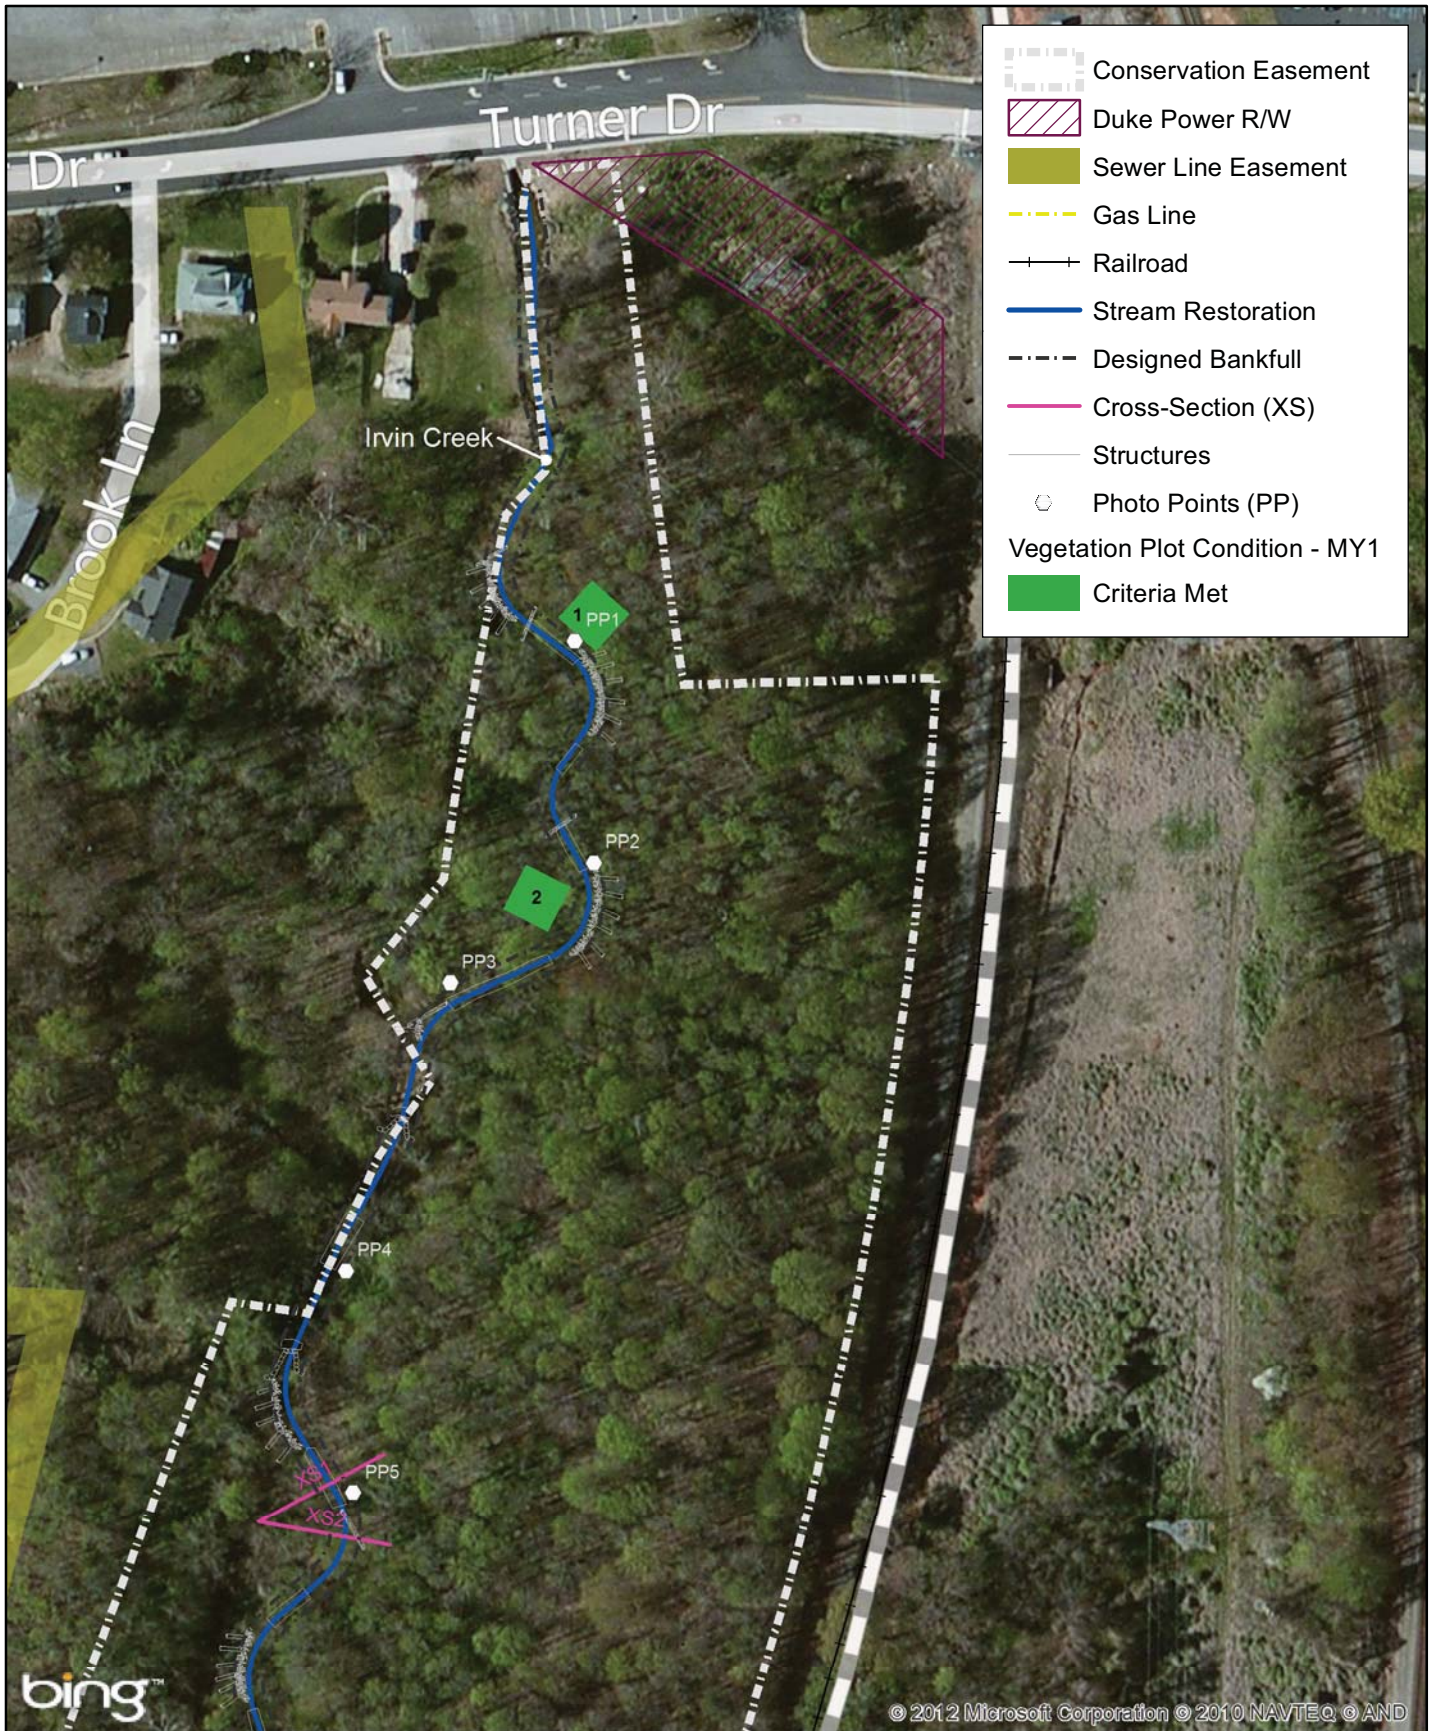
Figure 3.1 Integrated Current Condition  
 Plan View (Sheet 1 of 4)  
 Little Troublesome Creek Mitigation Site  
 Stream Site  
 NCEP Project Number 94640  
 Monitoring Year 1

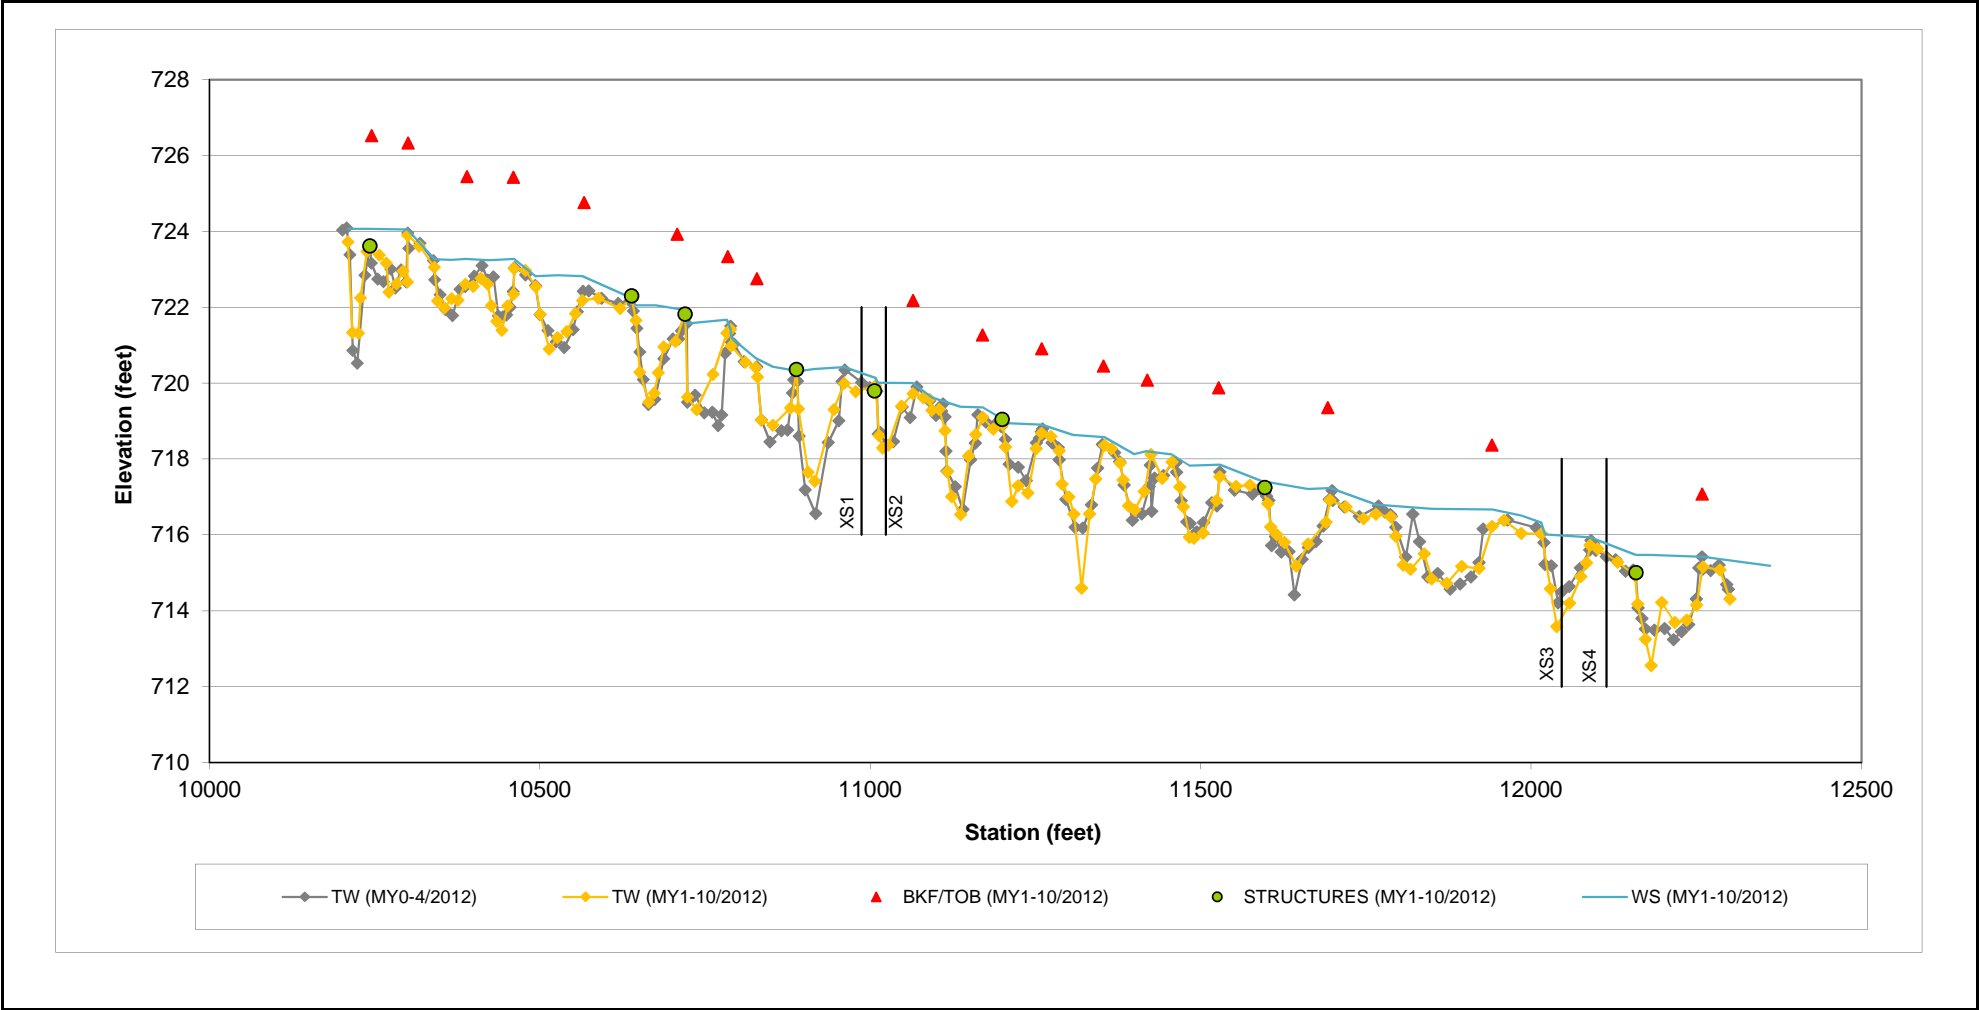
Appendix 4. Morphological Summary Data and Plots  
Figure 4a. Longitudinal Profile Plots  
Little Troublesome Creek Mitigation Site (NCEEP Project No. 94640)  
Irvin Creek Reach 1  
Monitoring Year 1

Morphological surveys for the MY-1 were conducted in October 2012. All streams within the Site met the success criteria for MY-1. Please refer to Appendix 2 for the visual assessment table, current condition plan view (CCPV), and photographs and Appendix 4 for morphological data and plots.

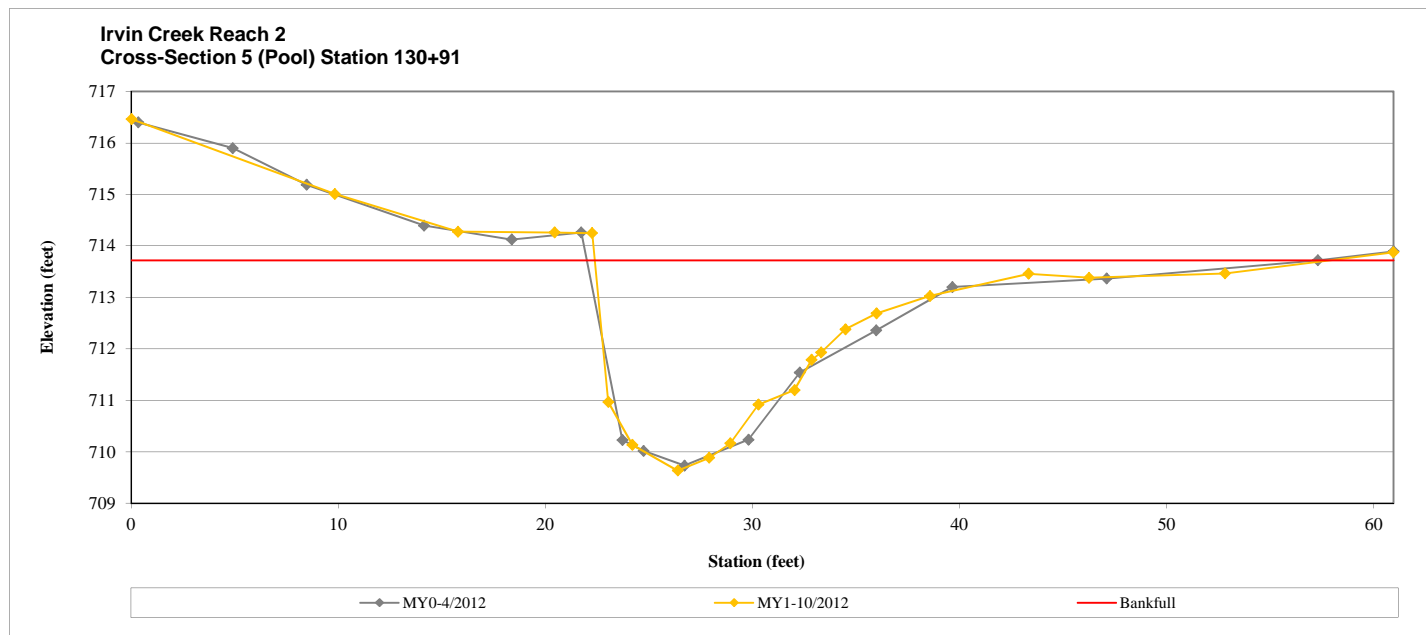
**Figure 5e. Cross-Section Plots**

<b>River Basin</b>	Cape Fear
<b>Watershed HUC</b>	3030002
<b>XS ID</b>	5
<b>Drainage Area</b>	0.9 sq.mi
<b>Date</b>	10/18/2012
<b>Field Crew</b>	Wildlands Engineering

<b>Summary Data</b>	
<b>Bankfull Elevation (ft)</b>	713.7
<b>Bankfull Cross-Sectional Area (ft2)</b>	46.0
<b>Bankfull Width (ft)</b>	35.6
<b>Flood Prone Area Elevation (ft)</b>	N/A
<b>Flood Prone Width (ft)</b>	N/A
<b>Max Depth at Bankfull (ft)</b>	4.1
<b>Mean Depth at Bankfull (ft)</b>	1.3
<b>W/D Ratio</b>	27.5
<b>Entrenchment Ratio</b>	N/A
<b>Bank Height Ratio</b>	1.0
<b>Stream Type</b>	N/A

Station	Elevation	Station	Elevation
0.03	716.46		
9.83	715.01		
15.78	714.28		
20.45	714.26		
22.26	714.25		
23.04	710.97		
24.20	710.14		
26.40	709.64		
27.92	709.88		
28.93	710.17		
30.29	710.92		
32.04	711.20		
32.86	711.79		
33.33	711.93		
34.49	712.38		
35.99	712.69		
38.57	713.03		
43.34	713.46		
46.26	713.38		
52.82	713.46		
60.95	713.87

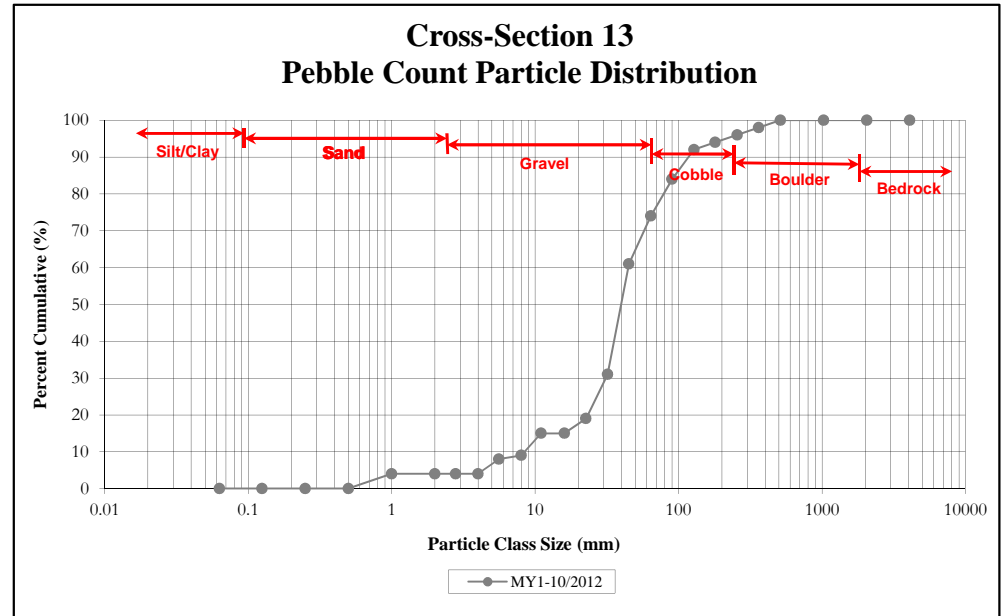
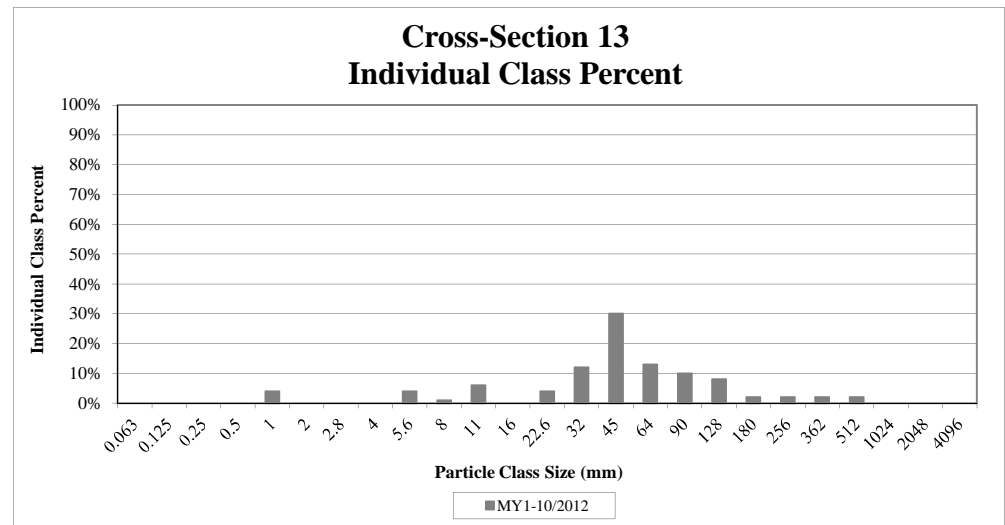
**Appendix 4. Morphological Summary Data and Plots**  
**Figure 6k. Reachwide and Cross-Section Substrate Plots**  
**Little Troublesome Creek Mitigation Site (NCEEP Project No. 94640)**  
**Little Troublesome Creek , Cross-Section 13 (Riffle)**  
**Monitoring Year 1**

Cross-Section 13 Channel materials (mm)	
D <sub>16</sub> =	17.4
D <sub>35</sub> =	33.5
D <sub>50</sub> =	39.7
D <sub>84</sub> =	90.0
D <sub>95</sub> =	214.7
D <sub>100</sub> =	512.0
