LITTLE TROUBLESOME CREEK MITIGATION SITE  
*Rockingham County, NC*  
*NCDENR Contract 003267*  
*NCEEP Project Number 94640*

**Monitoring Year 2 Annual Report**  
**FINAL**

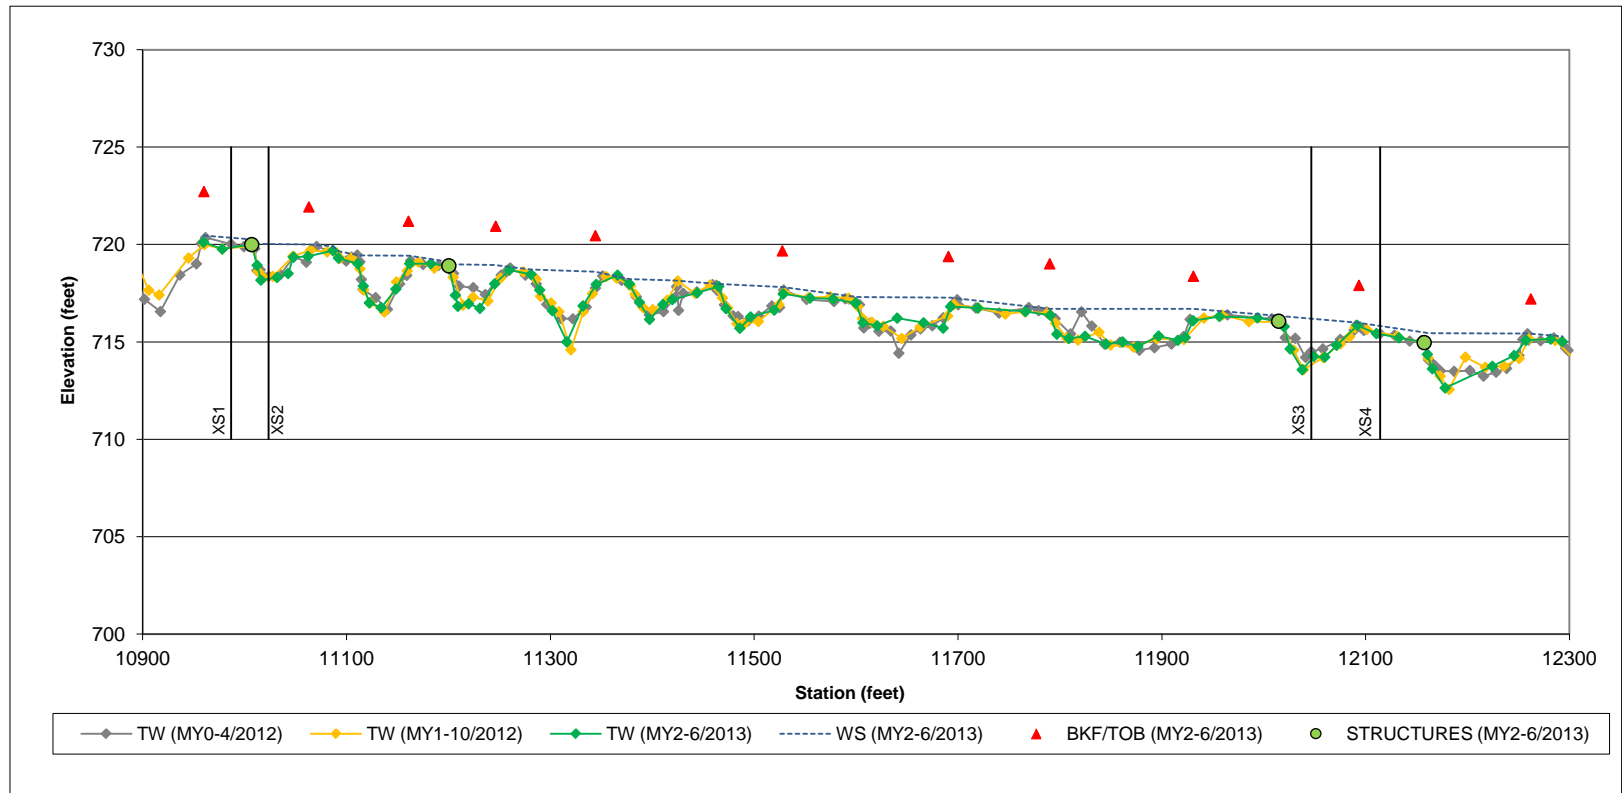
Longitudinal Profile Plots  
Little Troublesome Creek Mitigation Site (NCEEP Project No. 94640)  
Irvin Creek Reach 1  
Monitoring Year 2

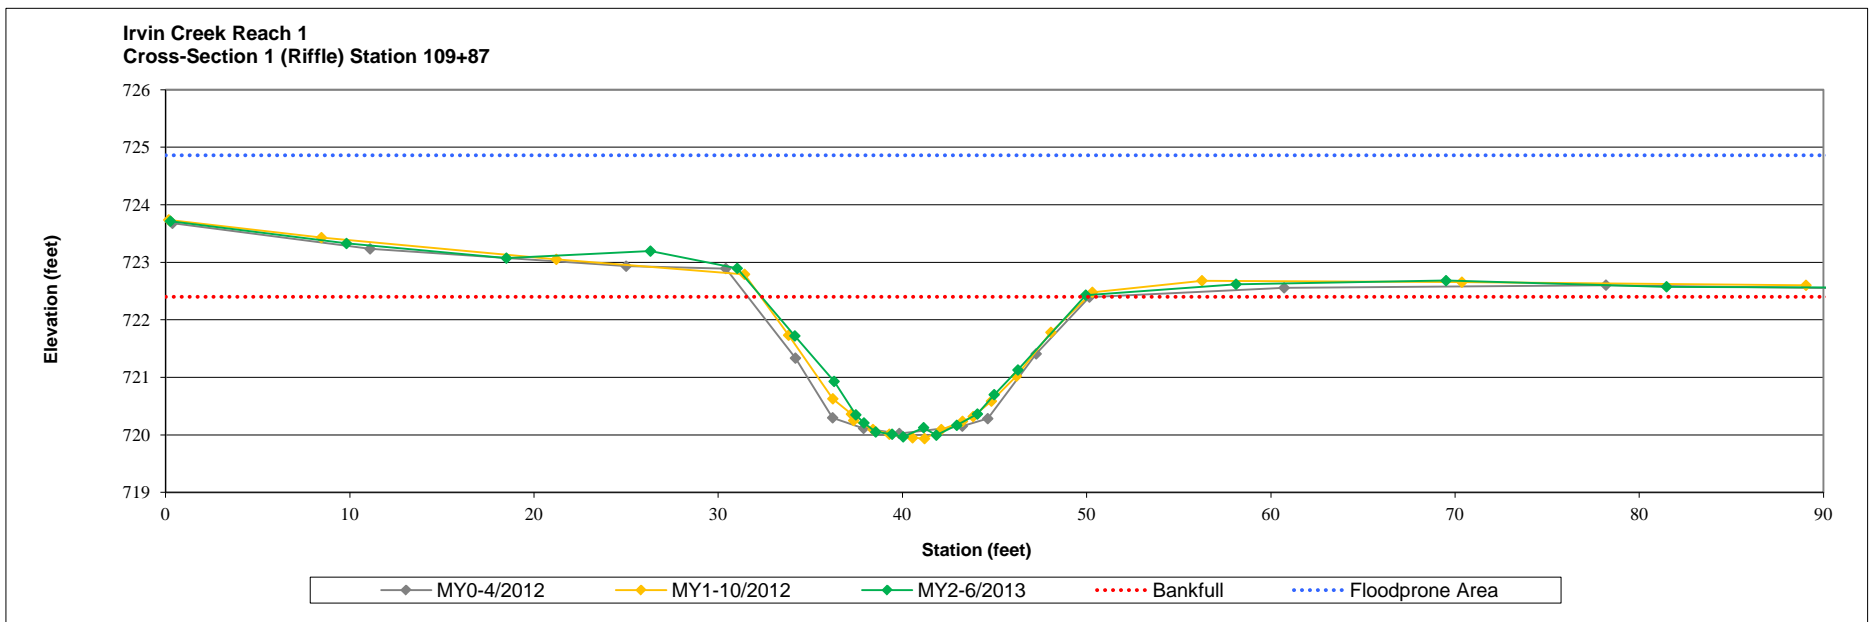
Cross-Section Plots  
 Little Troublesome Creek Mitigation Site (NCEEP Project No. 94640)  
 Irvin Creek Reach 1, Cross-Section 1 (Riffle)  
 Monitoring Year 2

River Basin	Cape Fear
Watershed HUC	3030002
XS ID	1
Drainage Area	0.8 sq.mi
Date	6/27/2013
Field Crew	Wildlands Engineering

Summary Data	
Bankfull Elevation (ft)	722.4
Bankfull Cross-Sectional Area (ft <sup>2</sup> )	26.0
Bankfull Width (ft)	17.5
Flood Prone Area Elevation (ft)	724.83
Flood Prone Width (ft)	200+
Max Depth at Bankfull (ft)	2.4
Mean Depth at Bankfull (ft)	1.5
W/D Ratio	11.79
Entrenchment Ratio	2.2+
Bank Height Ratio	1.0
Stream Type	E

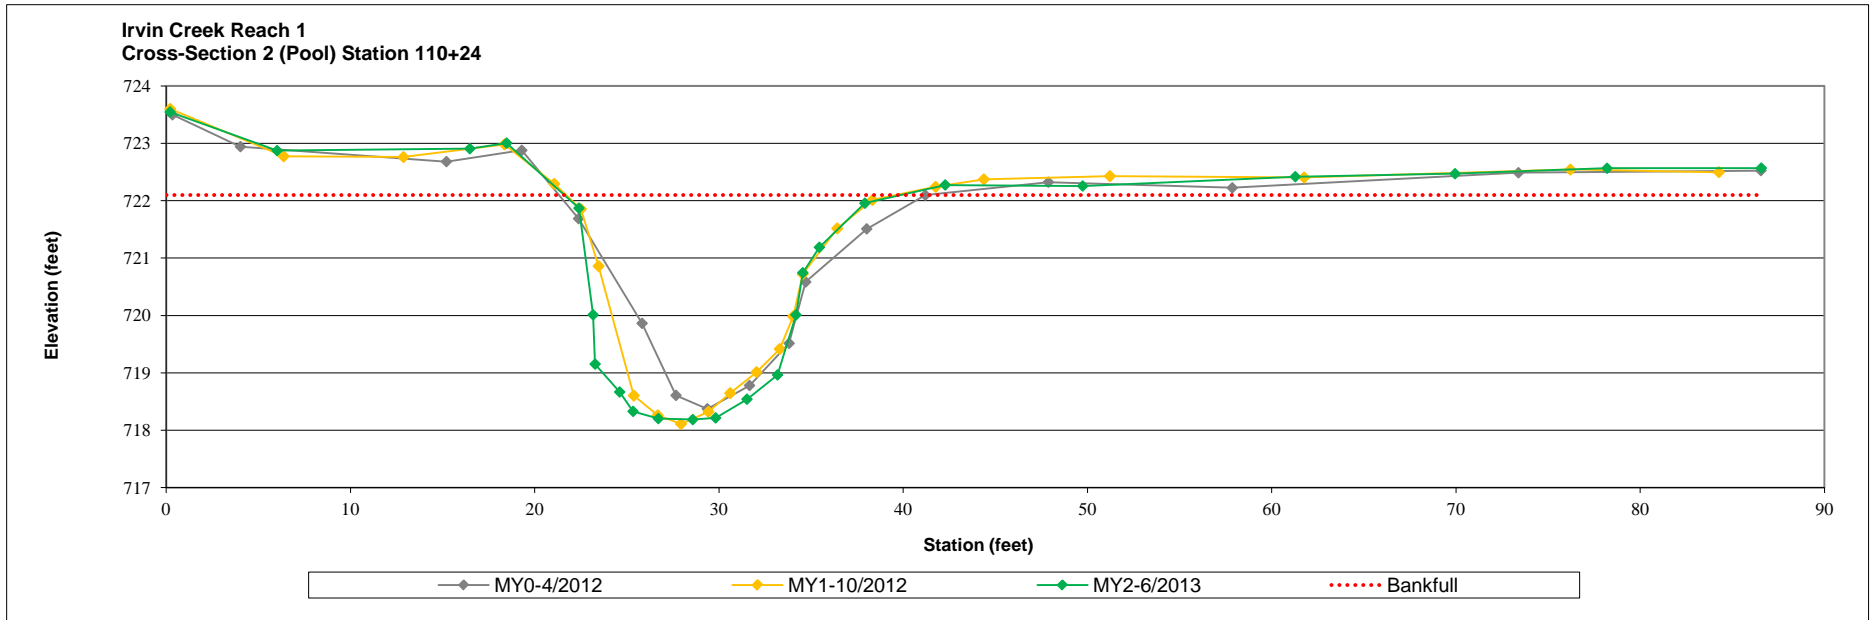
Cross-Section Plots  
 Little Troublesome Creek Mitigation Site (NCEEP Project No. 94640)  
 Irvin Creek Reach 1, Cross-Section 2 (Pool)  
 Monitoring Year 2

River Basin	Cape Fear
Watershed HUC	3030002
XS ID	2
Drainage Area	0.8 sq.mi
Date	6/27/2013
Field Crew	Wildlands Engineering

Summary Data	
Bankfull Elevation (ft)	722.1
Bankfull Cross-Sectional Area (ft <sup>2</sup> )	43.13
Bankfull Width (ft)	18.29
Flood Prone Area Elevation (ft)	N/A
Flood Prone Width (ft)	N/A
Max Depth at Bankfull (ft)	3.91
Mean Depth at Bankfull (ft)	2.36
W/D Ratio	7.76
Entrenchment Ratio	N/A
Bank Height Ratio	1.0
Stream Type	N/A

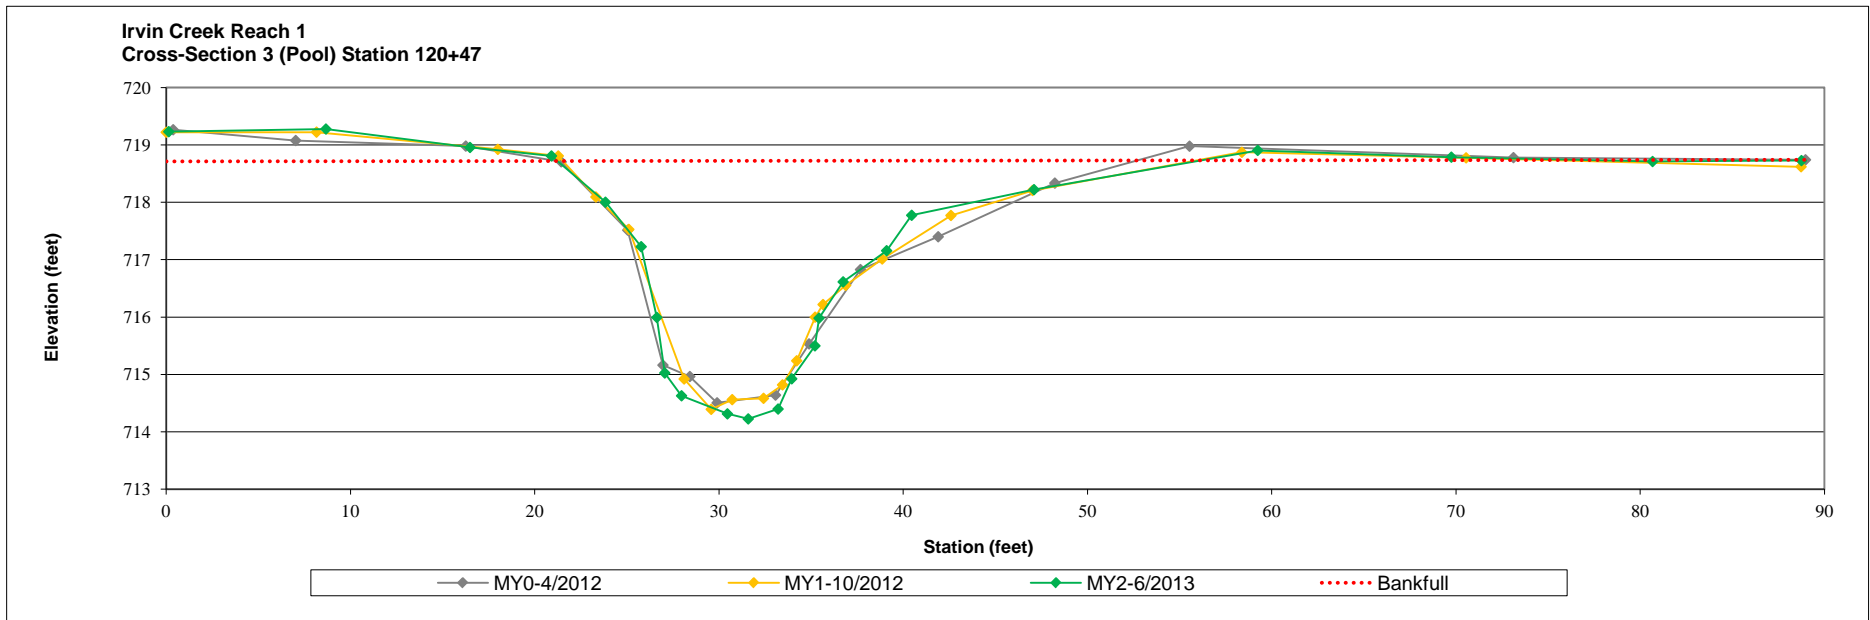
River Basin	Cape Fear
Watershed HUC	3030002
XS ID	3
Drainage Area	0.8 sq.mi
Date	6/27/2013
Field Crew	Wildlands Engineering

Summary Data	
Bankfull Elevation (ft)	718.7
Bankfull Cross-Sectional Area (ft <sup>2</sup> )	56.5
Bankfull Width (ft)	34.5
Flood Prone Area Elevation (ft)	N/A
Flood Prone Width (ft)	N/A
Max Depth at Bankfull (ft)	4.5
Mean Depth at Bankfull (ft)	1.6
W/D Ratio	21.1
Entrenchment Ratio	N/A
Bank Height Ratio	1.0
Stream Type	N/A

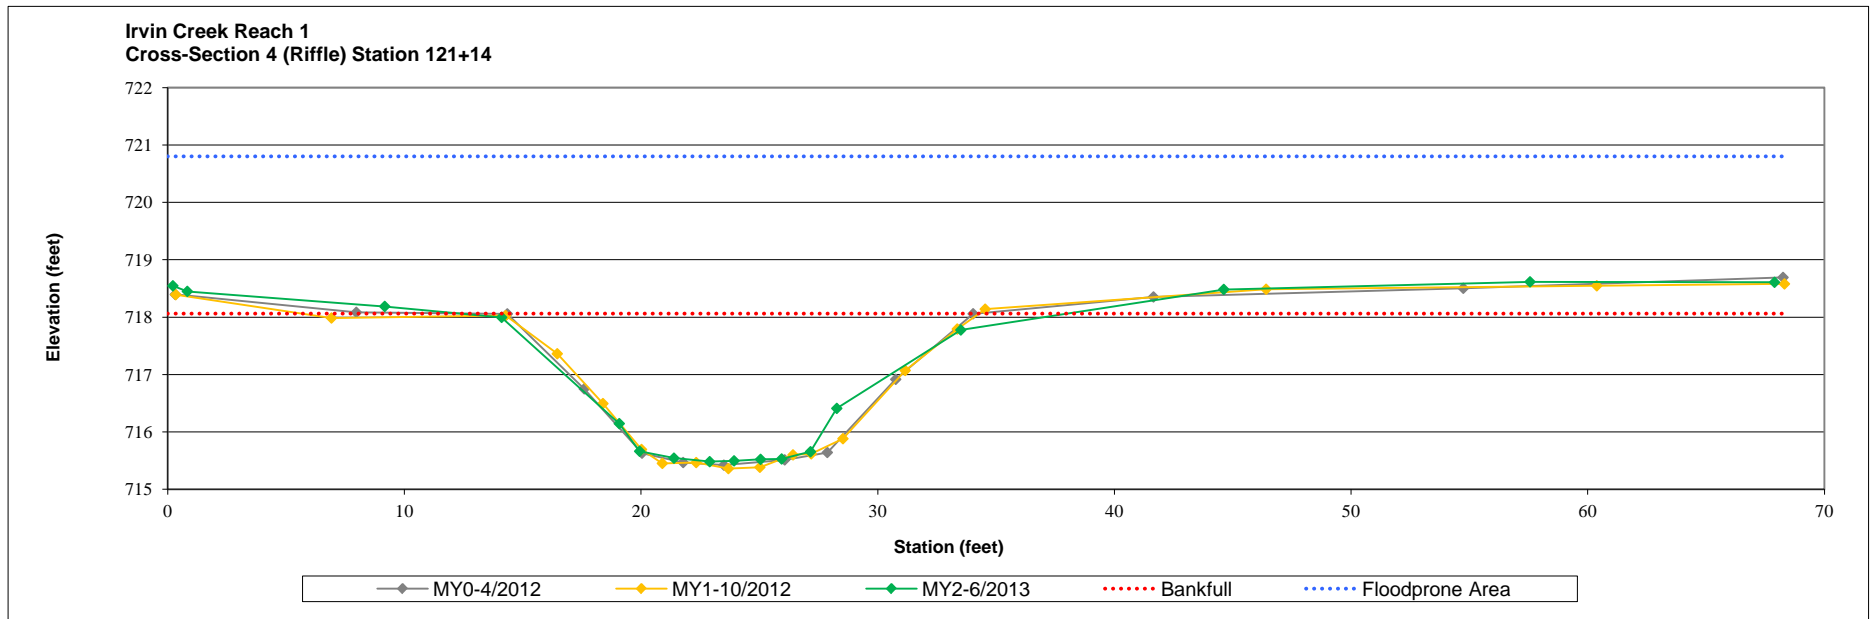
<b>River Basin</b>	Cape Fear
<b>Watershed HUC</b>	3030002
<b>XS ID</b>	4
<b>Drainage Area</b>	0.8 sq.mi
<b>Date</b>	6/27/2013
<b>Field Crew</b>	Wildlands Engineering

Summary Data	
<b>Bankfull Elevation (ft)</b>	718.1
<b>Bankfull Cross-Sectional Area (ft<sup>2</sup>)</b>	33.0
<b>Bankfull Width (ft)</b>	25.5
<b>Flood Prone Area Elevation (ft)</b>	720.6
<b>Flood Prone Width (ft)</b>	200+
<b>Max Depth at Bankfull (ft)</b>	2.6
<b>Mean Depth at Bankfull (ft)</b>	1.3
<b>W/D Ratio</b>	19.8
<b>Entrenchment Ratio</b>	2.2+
<b>Bank Height Ratio</b>	1.0
<b>Stream Type</b>	C

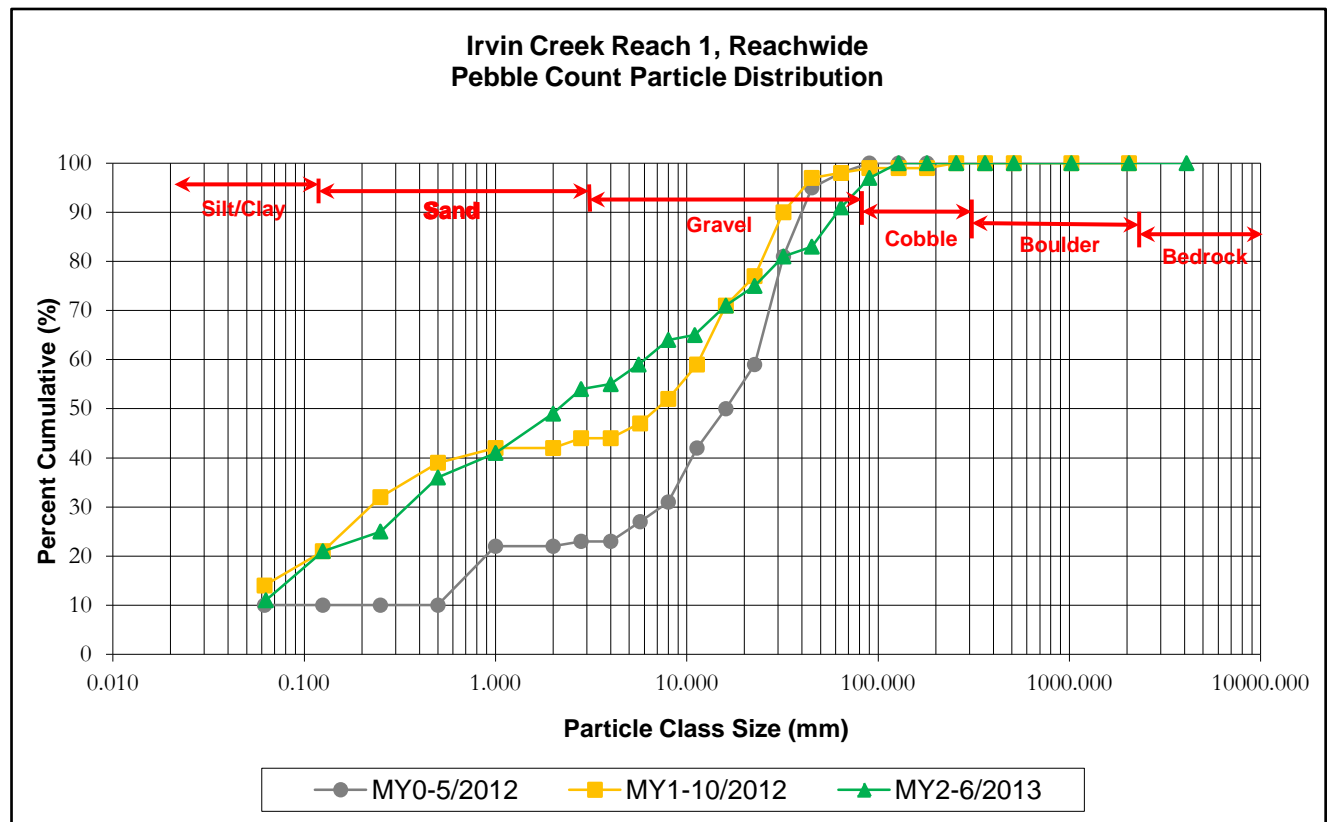
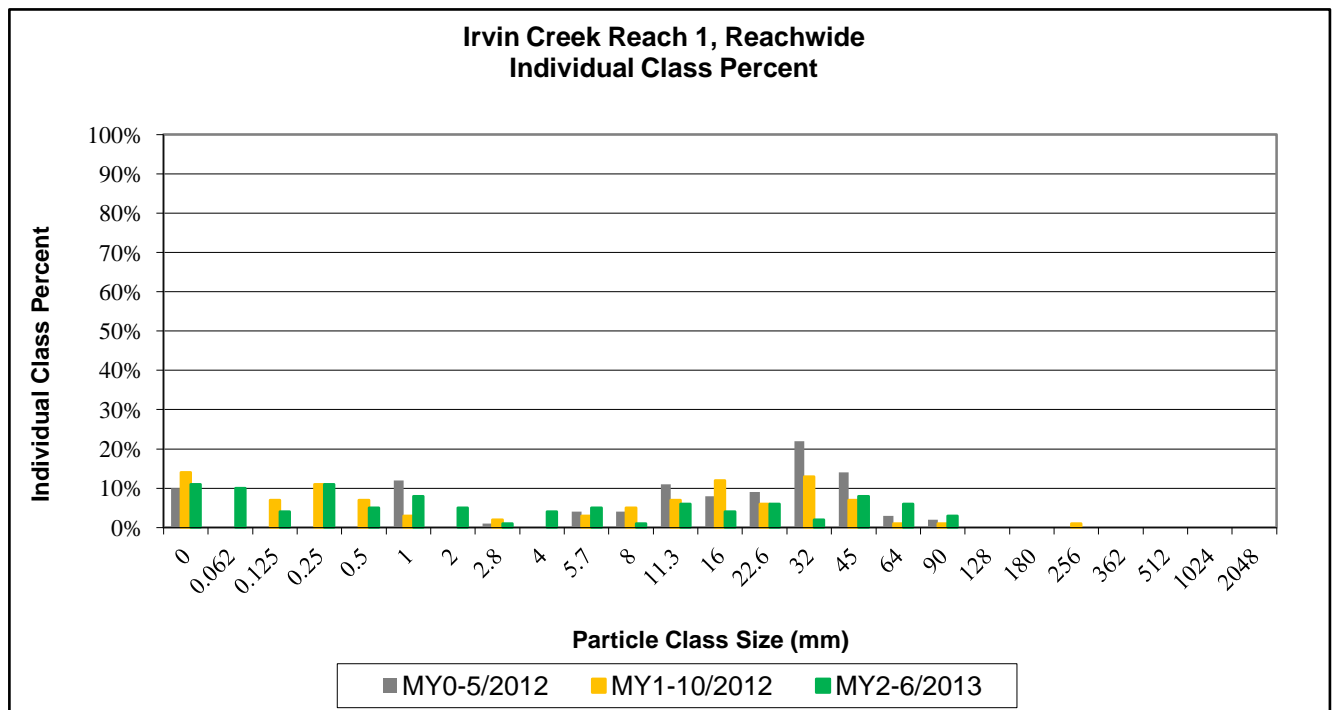
Reachwide and Cross-Section Substrate Plots  
 Little Troublesome Creek Mitigation Site (NCEP Project No. 94640)  
 Irvin Creek Reach 1, Reachwide  
 Monitoring Year 2

Particle Class		Diameter (mm)		Particle Count			Irvin Creek Reach 1 Summary	
		min	max	Riffle	Pool	Total	Class Percentage	Percent Cumulative
SILT/CLAY		0.000	0.062	2	9	11	11	11
SAND	Very fine	0.062	0.125	4	6	10	10	21
	Fine	0.125	0.250	3	1	4	4	25
	Medium	0.250	0.500	2	9	11	11	36
	Coarse	0.5	1.0		5	5	5	41
	Very Coarse	1.0	2.0	1	7	8	8	49
GRAVEL	Very Fine	2.0	2.8		5	5	5	54
	Very Fine	2.8	4.0	1		1	1	55
	Fine	4.0	5.7		4	4	4	59
	Fine	5.7	8.0	2	3	5	5	64
	Medium	8.0	11.3	1		1	1	65
	Medium	11.3	16.0	5	1	6	6	71
	Coarse	16.0	22.6	4		4	4	75
	Coarse	22.6	32	6		6	6	81
	Very Coarse	32	45	2		2	2	83
	Very Coarse	45	64	8		8	8	91
COBBLE	Small	64	90	6		6	6	97
	Small	90	128	3		3	3	100
	Large	128	180					100
	Large	180	256					100
BOULDER	Small	256	362					100
	Small	362	512					100
	Medium	512	1024					100
BEDROCK	Large/Very Large	1024	2048					100
	Bedrock	2048	>2048					100
<b>Total</b>				<b>50</b>	<b>50</b>	<b>100</b>	<b>100</b>	<b>100</b>

Reachwide Channel materials (mm)	
D <sub>16</sub> =	0.1
D <sub>35</sub> =	0.5
D <sub>50</sub> =	2.1
D <sub>84</sub> =	47.0
D <sub>95</sub> =	80.3
D <sub>100</sub> =	128.0

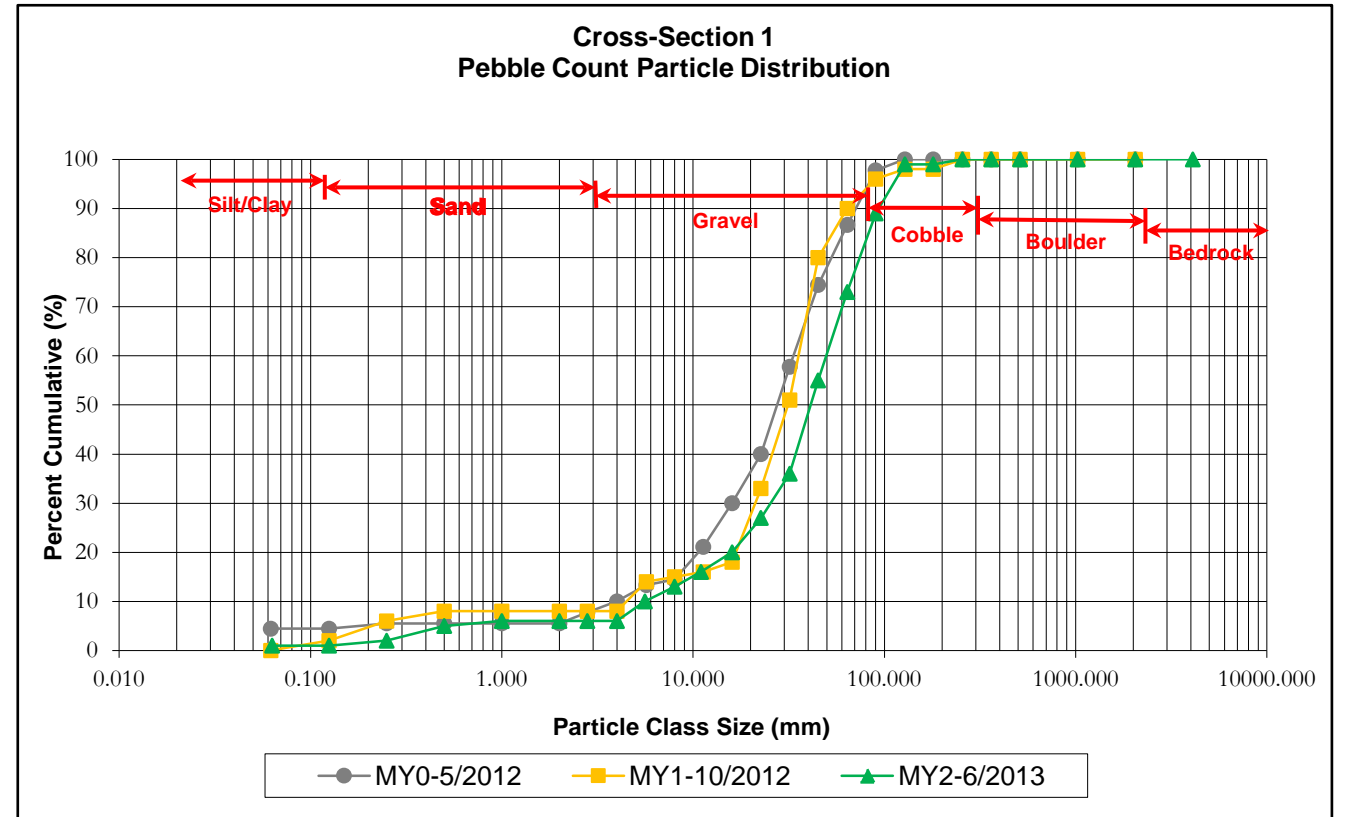
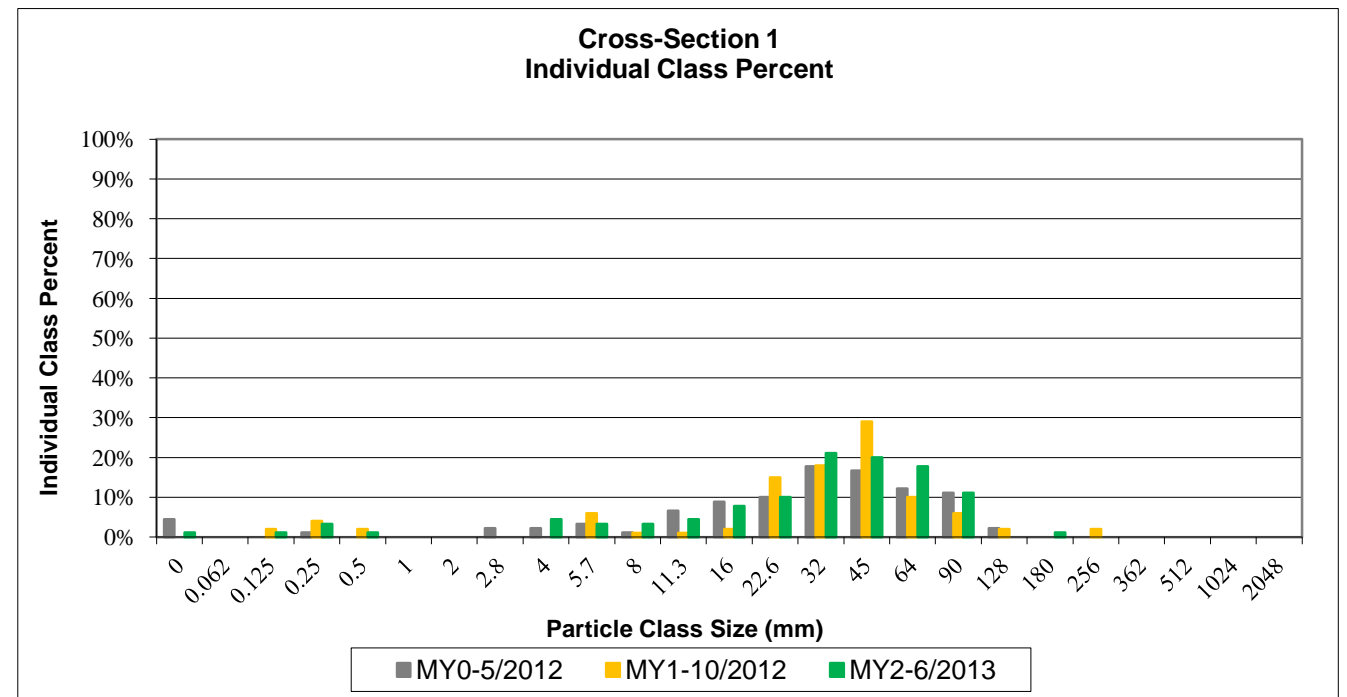
Reachwide and Cross-Section Substrate Plots  
 Little Troublesome Creek Mitigation Site (NCEEP Project No. 94640)  
 Irvin Creek Reach 1, Cross-Section 1 (Riffle)  
 Monitoring Year 2

Particle Class		Diameter (mm)		Particle Count	Cross-Section 1 Summary	
		min	max		Class Percentage	Percent Cumulative
SILT/CLAY		0.000	0.062	1	1	1
SAND	Very fine	0.062	0.125			1
	Fine	0.125	0.250	1	1	2
	Medium	0.250	0.500	3	3	5
	Coarse	0.5	1.0	1	1	6
	Very Coarse	1.0	2.0			6
FINE GRAVEL	Very Fine	2.0	2.8			6
	Very Fine	2.8	4.0			6
	Fine	4.0	5.7	4	4	10
	Fine	5.7	8.0	3	3	13
	Medium	8.0	11.3	3	3	16
	Medium	11.3	16.0	4	4	20
	Coarse	16.0	22.6	7	7	27
	Coarse	22.6	32	9	9	36
	Very Coarse	32	45	19	19	55
	Very Coarse	45	64	18	18	73
COBBLE	Small	64	90	16	16	89
	Small	90	128	10	10	99
	Large	128	180			99
	Large	180	256	1	1	100
Boulder	Small	256	362			100
	Small	362	512			100
	Medium	512	1024			100
	Large/Very Large	1024	2048			100
BEDROCK	Bedrock	2048	>2048			100
<b>Total</b>				<b>100</b>	<b>100</b>	<b>100</b>

Cross-Section 1 Channel materials (mm)	
D <sub>16</sub> =	11.0
D <sub>35</sub> =	30.8
D <sub>50</sub> =	41.1
D <sub>84</sub> =	80.9
D <sub>95</sub> =	111.2
D <sub>100</sub> =	256.0

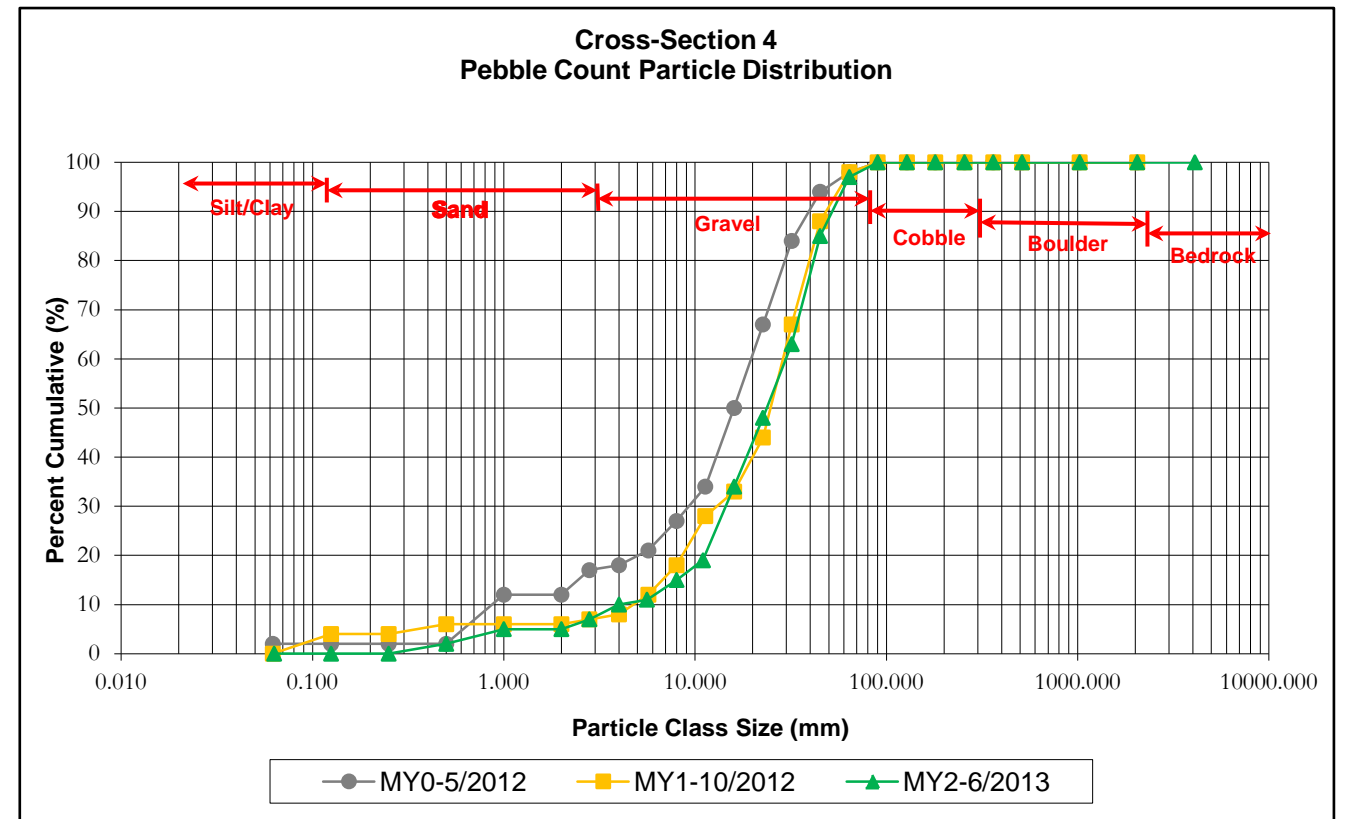
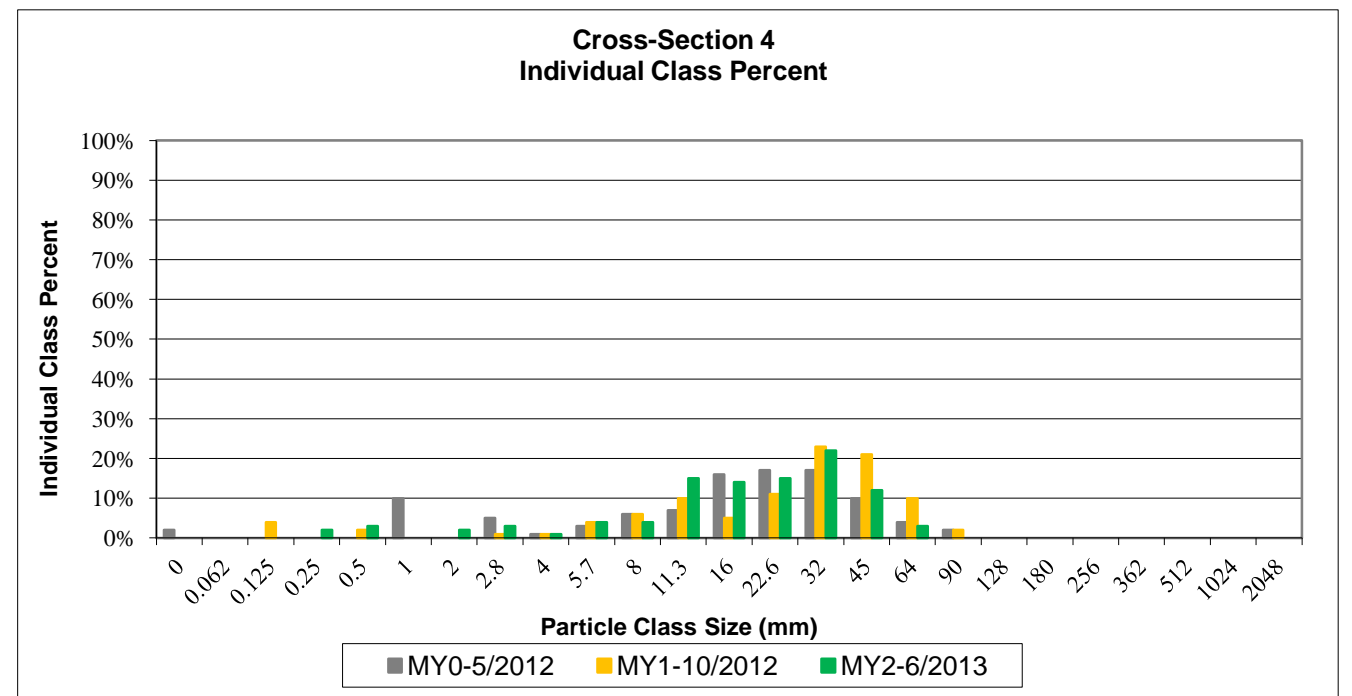
Reachwide and Cross-Section Substrate Plots  
 Little Troublesome Creek Mitigation Site (NCEP Project No. 94640)  
 Irvin Creek Reach 1, Cross-Section 4 (Riffle)  
 Monitoring Year 2

Particle Class		Diameter (mm)		Particle Count	Cross-Section 4 Summary	
		min	max		Class Percentage	Percent Cumulative
SILT/CLAY		0.000	0.062			0
SAND	Very fine	0.062	0.125			0
	Fine	0.125	0.250			0
	Medium	0.250	0.500	2	2	2
	Coarse	0.5	1.0	3	3	5
	Very Coarse	1.0	2.0			5
GRAVEL	Very Fine	2.0	2.8	2	2	7
	Very Fine	2.8	4.0	3	3	10
	Fine	4.0	5.7	1	1	11
	Fine	5.7	8.0	4	4	15
	Medium	8.0	11.3	4	4	19
	Medium	11.3	16.0	15	15	34
	Coarse	16.0	22.6	14	14	48
	Coarse	22.6	32	15	15	63
	Very Coarse	32	45	22	22	85
	Very Coarse	45	64	12	12	97
BOULDER	Small	64	90	3	3	100
	Small	90	128			100
	Large	128	180			100
	Large	180	256			100
BEDROCK	Small	256	362			100
	Small	362	512			100
	Medium	512	1024			100
	Large/Very Large	1024	2048			100
BEDROCK		2048	>2048			100
<b>Total</b>				<b>100</b>	<b>100</b>	<b>100</b>

Cross-Section 4 Channel materials (mm)	
D <sub>16</sub> =	8.7
D <sub>35</sub> =	16.4
D <sub>50</sub> =	23.7
D <sub>84</sub> =	44.3
D <sub>95</sub> =	60.4
D <sub>100</sub> =	90.0

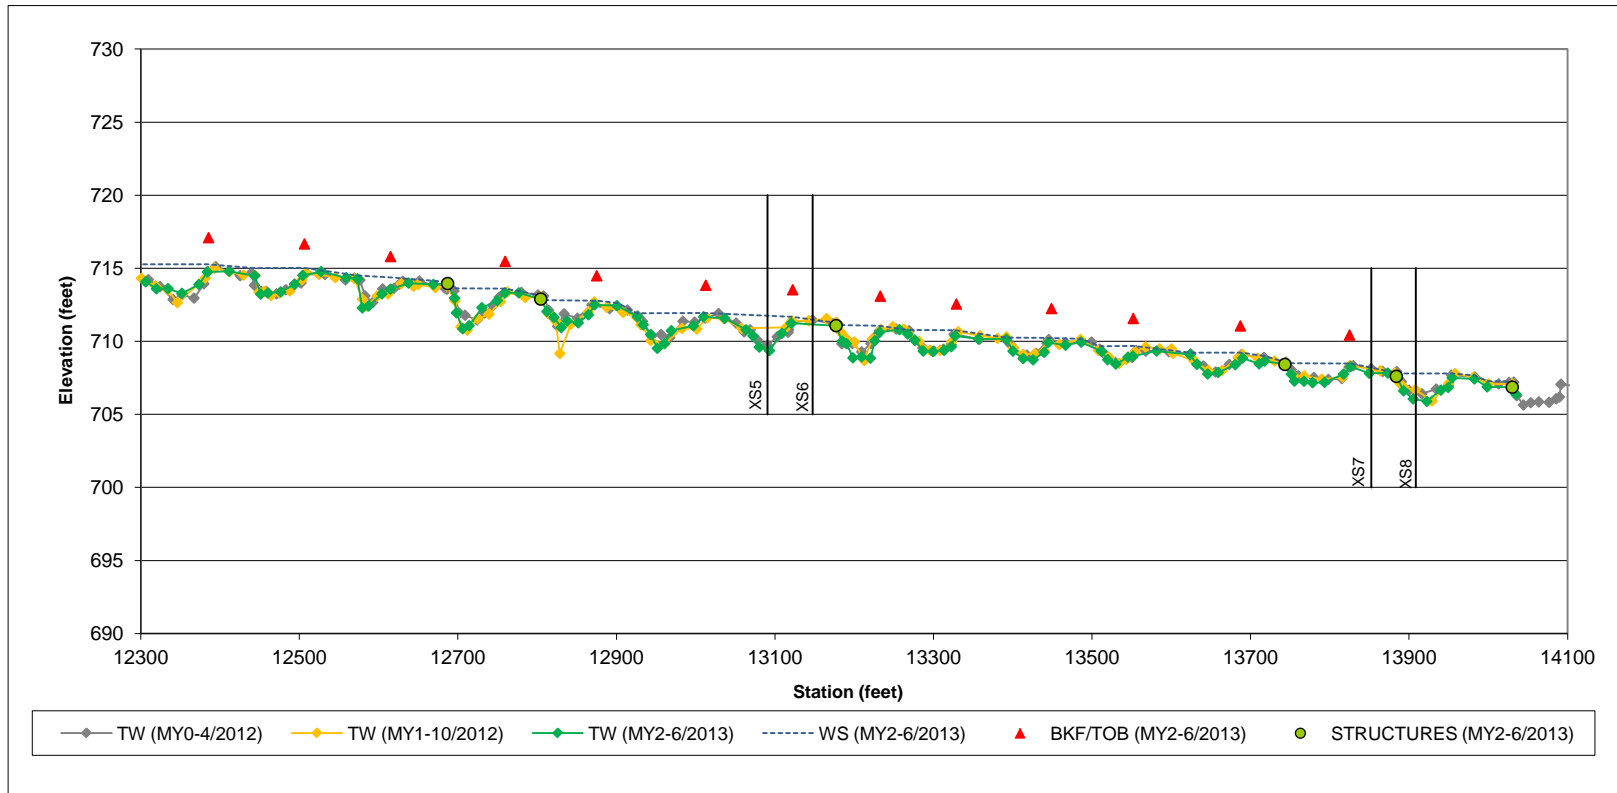
Longitudinal Profile Plots  
Little Troublesome Creek Mitigation Site (NCEEP Project No. 94640)  
Irvin Creek Reach 2  
Monitoring Year 2

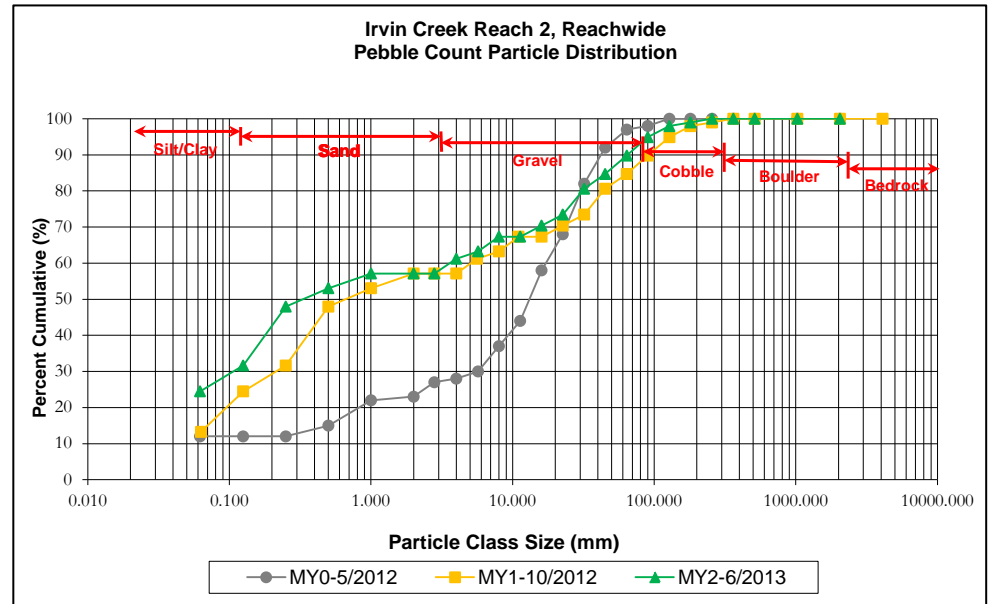
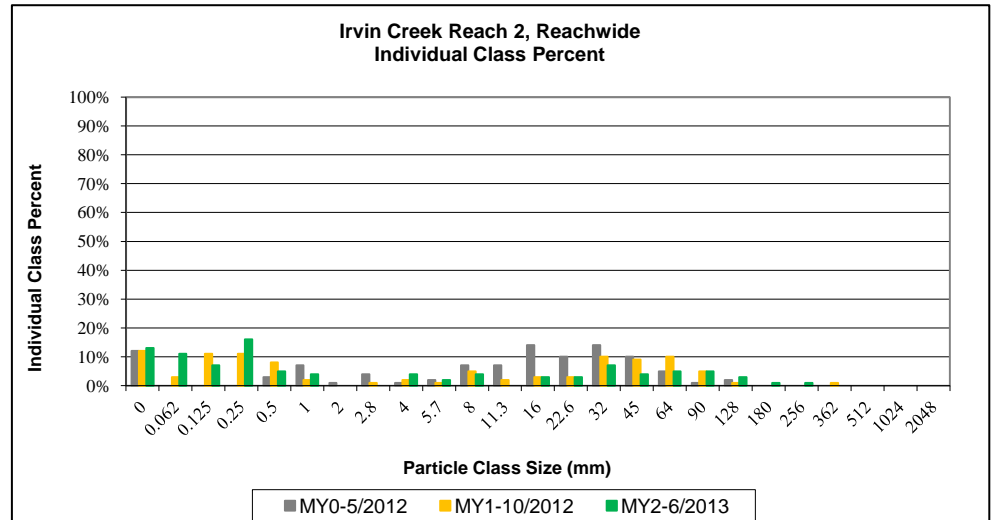
Reachwide and Cross-Section Substrate Plots  
 Little Troublesome Creek Mitigation Site (NCEEP Project No. 94640)  
 Irvin Creek Reach 2, Reachwide  
 Monitoring Year 2

Reachwide Channel materials (mm)	
D <sub>16</sub> =	0.1
D <sub>35</sub> =	0.3
D <sub>50</sub> =	0.7
D <sub>84</sub> =	60.3
D <sub>95</sub> =	129.5
D <sub>100</sub> =	362.0

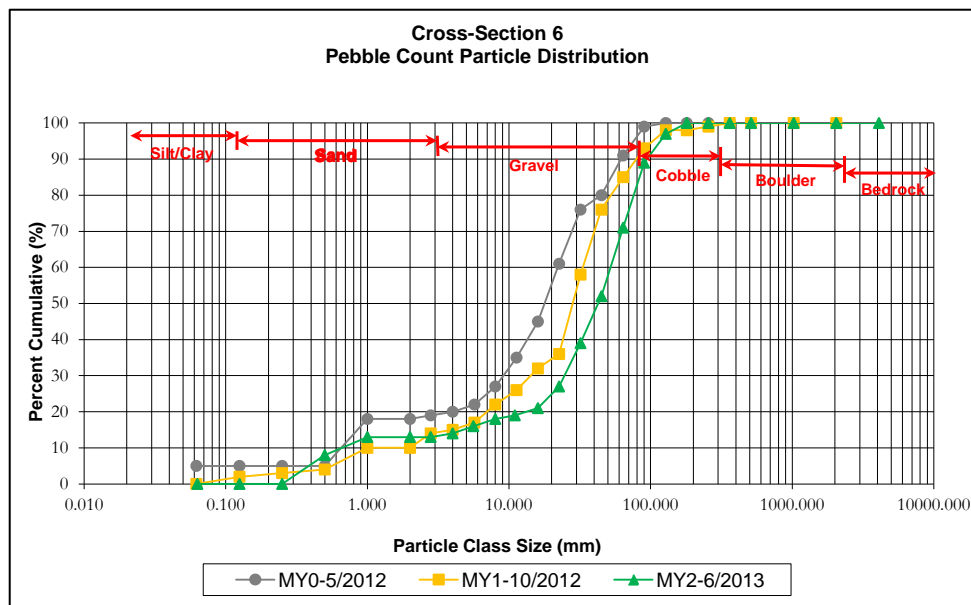
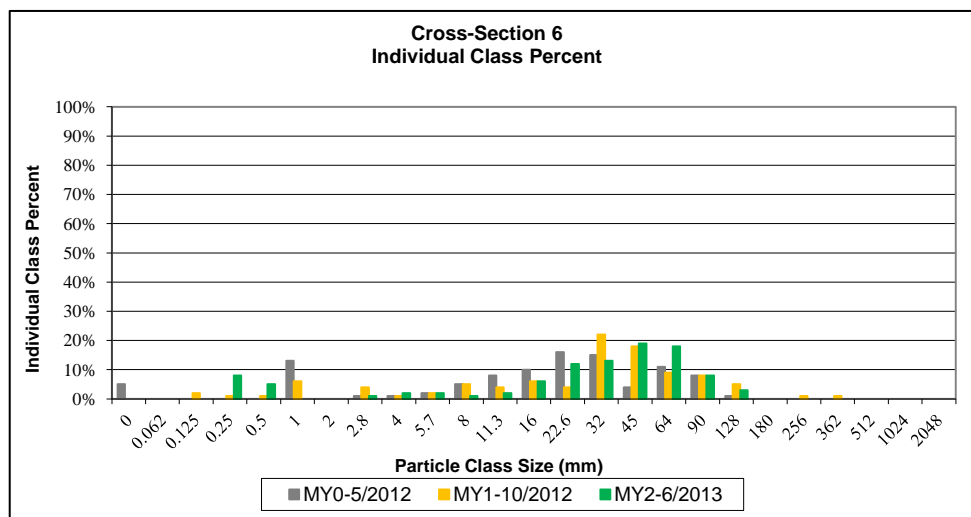
Reachwide and Cross-Section Substrate Plots  
 Little Troublesome Creek Mitigation Site (NCEEP Project No. 94640)  
 Irvin Creek Reach 2, Cross-Section 6 (Riffle)  
 Monitoring Year 2

Cross-Section 6 Channel materials (mm)	
D <sub>16</sub> =	5.6
D <sub>35</sub> =	28.5
D <sub>50</sub> =	42.7
D <sub>84</sub> =	81.9
D <sub>95</sub> =	117.2
D <sub>100</sub> =	180.0

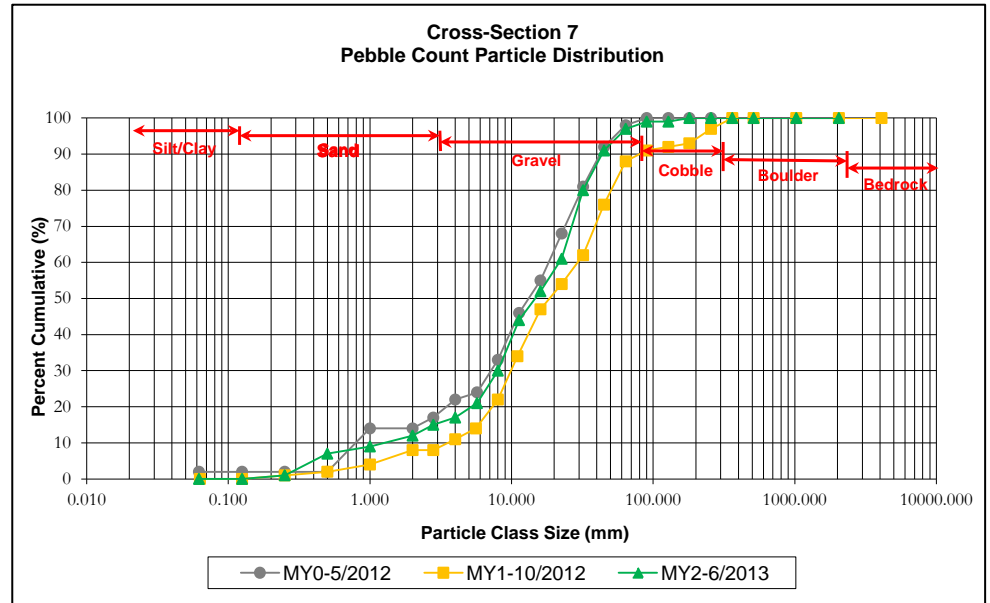
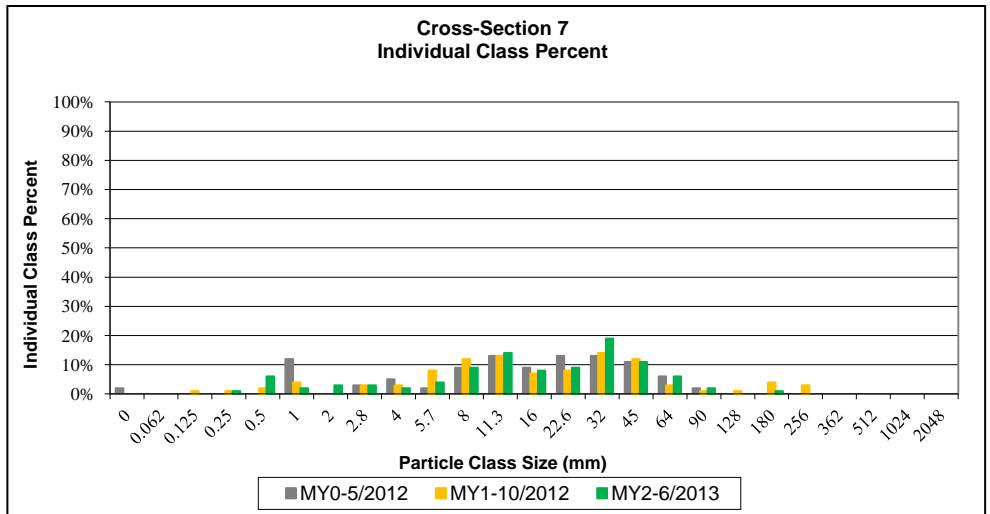
Reachwide and Cross-Section Substrate Plots  
 Little Troublesome Creek Mitigation Site (NCEP Project No. 94640)  
 Irvin Creek Reach 2, Cross-Section 7 (Riffle)  
 Monitoring Year 2

Cross-Section 7 Channel materials (mm)	
D <sub>16</sub> =	4.7
D <sub>35</sub> =	12.6
D <sub>50</sub> =	20.7
D <sub>84</sub> =	51.1
D <sub>95</sub> =	80.3
D <sub>100</sub> =	256.0

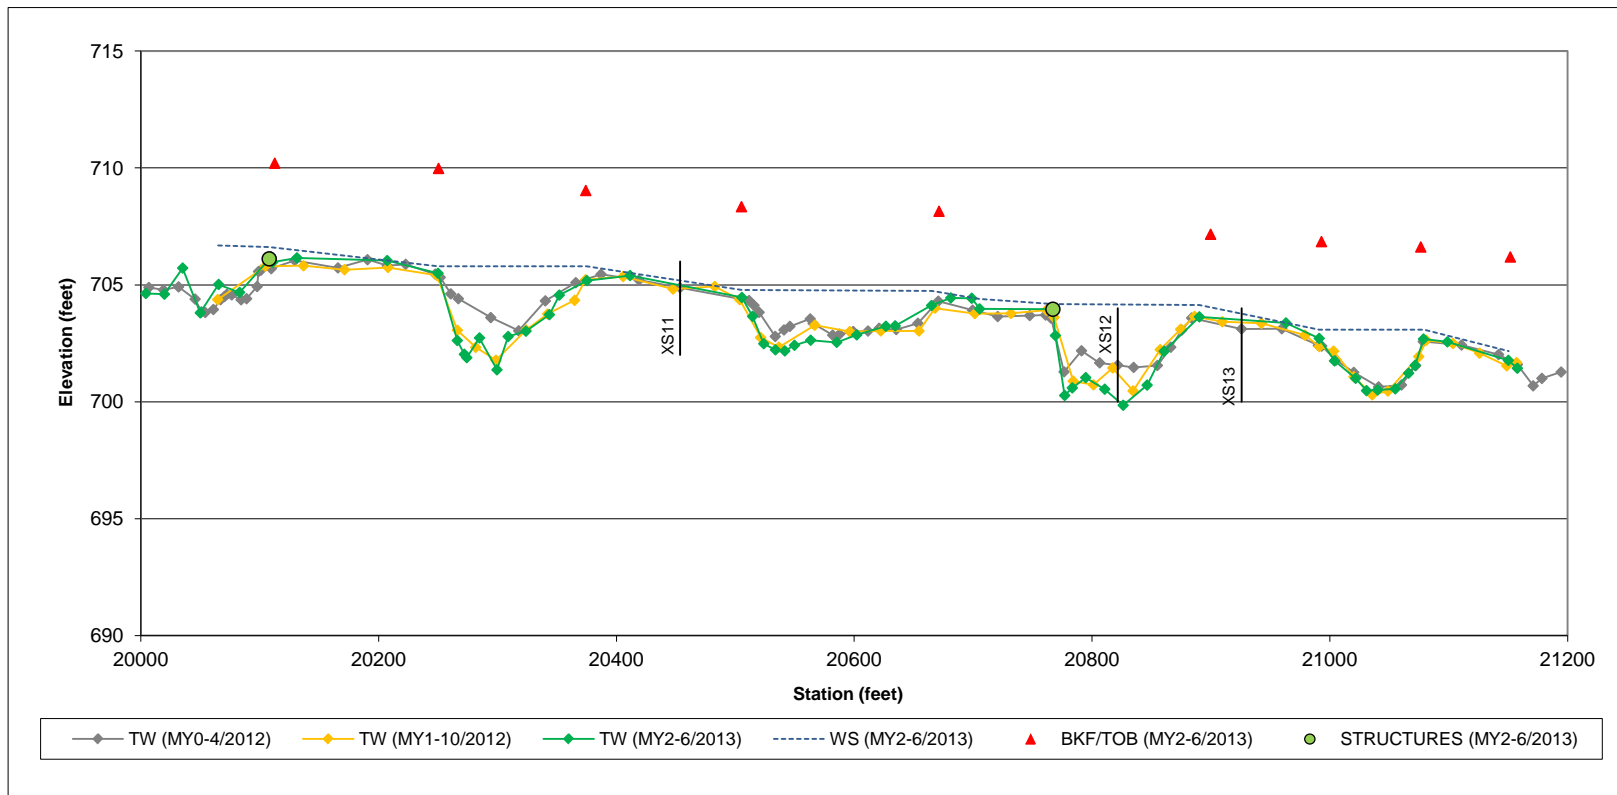
Longitudinal Profile Plots  
 Little Troublesome Creek Mitigation Site (NCEEP Project No. 94640)  
 Little Troublesome Creek  
 Monitoring Year 2

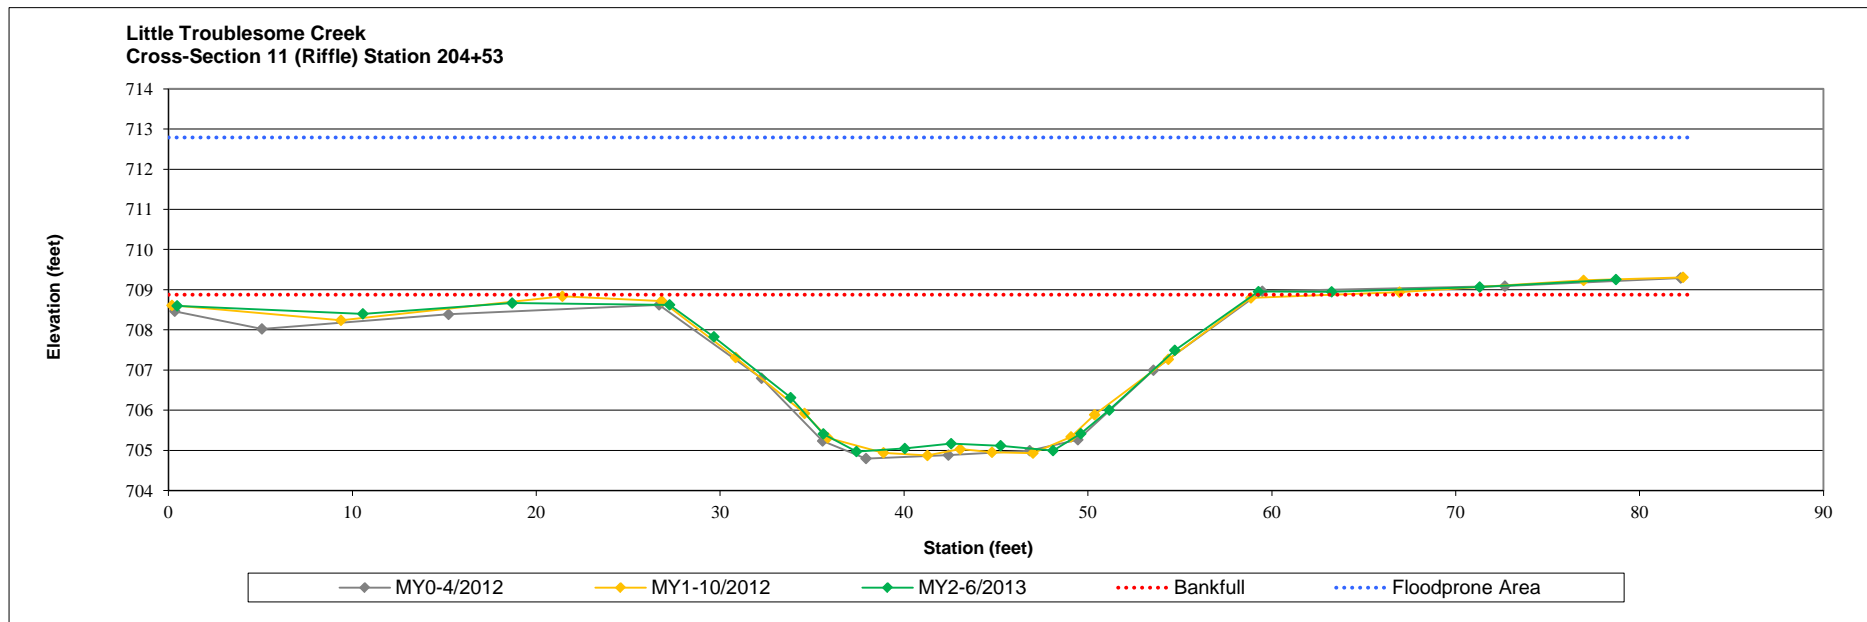
Cross-Section Plots

Little Troublesome Creek, Cross-Section 11 (Riffle)

Summary Data	
Bankfull Elevation (ft)	708.9
Bankfull Cross-Sectional Area (ft <sup>2</sup> )	82.8
Bankfull Width (ft)	31.9
Flood Prone Area Elevation (ft)	712.8
Flood Prone Width (ft)	200+
Max Depth at Bankfull (ft)	3.9
Mean Depth at Bankfull (ft)	2.6
W/D Ratio	12.3
Entrenchment Ratio	2.2+
Bank Height Ratio	1.0
Stream Type	C

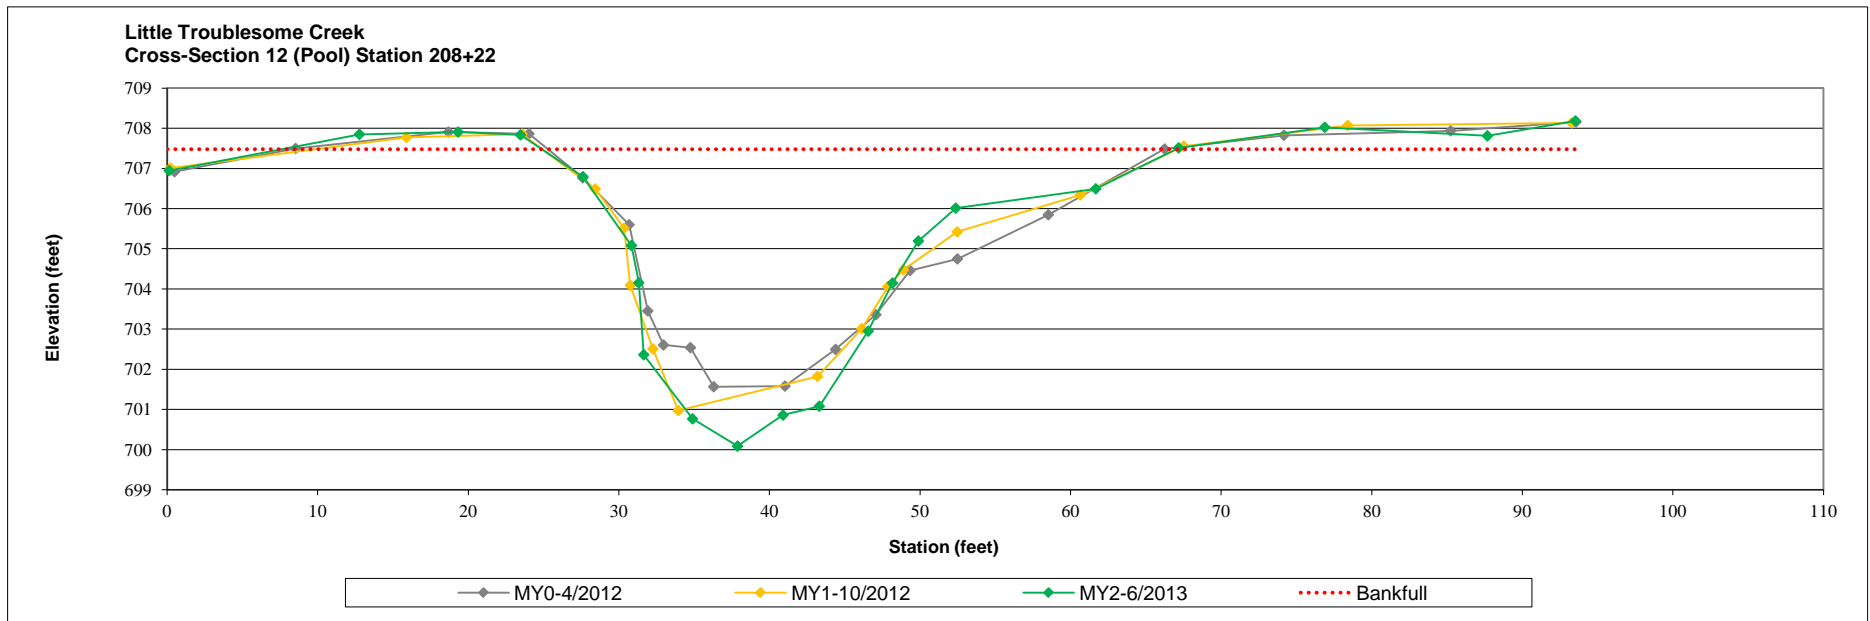
Cross-Section Plots  
 Little Troublesome Creek Mitigation Site (NCEEP Project No. 94640)  
 Little Troublesome Creek, Cross-Section 12 (Pool)  
 Monitoring Year 2

Summary Data	
Bankfull Elevation (ft)	707.5
Bankfull Cross-Sectional Area (ft <sup>2</sup> )	133.4
Bankfull Width (ft)	42.1
Flood Prone Area Elevation (ft)	N/A
Flood Prone Width (ft)	N/A
Max Depth at Bankfull (ft)	7.4
Mean Depth at Bankfull (ft)	3.2
W/D Ratio	13.3
Entrenchment Ratio	N/A
Bank Height Ratio	1.0
Stream Type	N/A
