LITTLE TROUBLESOME CREEK MITIGATION SITE  
*Rockingham County, NC*  
*NCDENR Contract 003267*  
*NCEEP Project Number 94640*

**Monitoring Year 2 Annual Report**  
**FINAL**

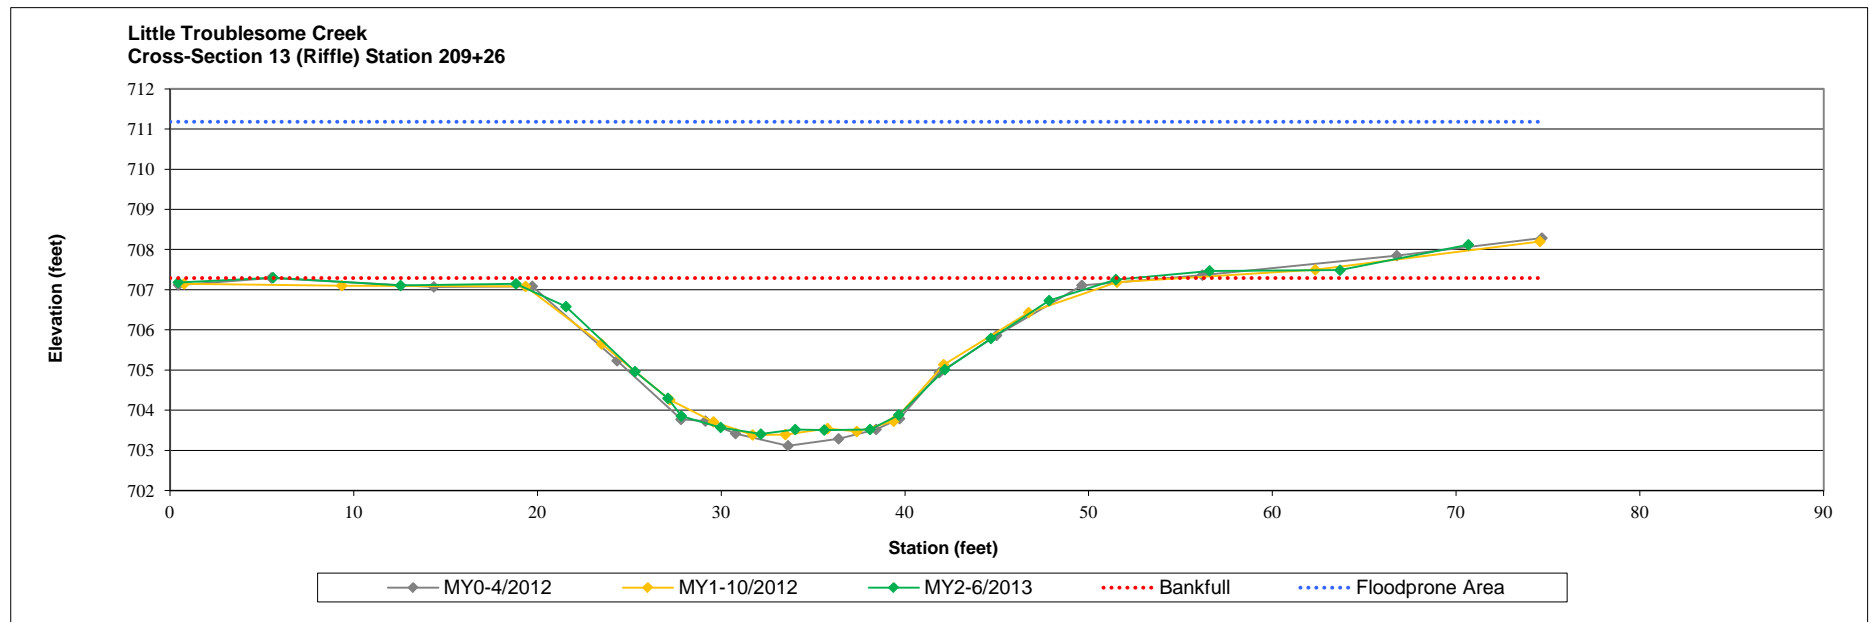
Little Troublesome Creek, Cross-Section 13 (Riffle)

Summary Data	
Bankfull Elevation (ft)	707.3
Bankfull Cross-Sectional Area (ft <sup>2</sup> )	74.4
Bankfull Width (ft)	33.7
Flood Prone Area Elevation (ft)	711.2
Flood Prone Width (ft)	200+
Max Depth at Bankfull (ft)	3.9
Mean Depth at Bankfull (ft)	2.2
W/D Ratio	15.3
Entrenchment Ratio	2.2+
Bank Height Ratio	1.0
Stream Type	C

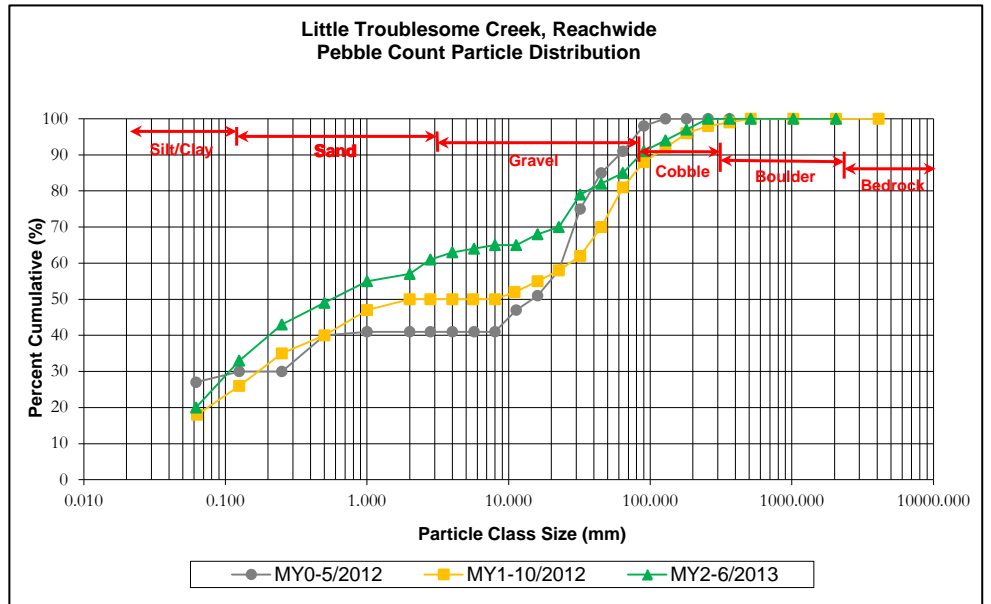
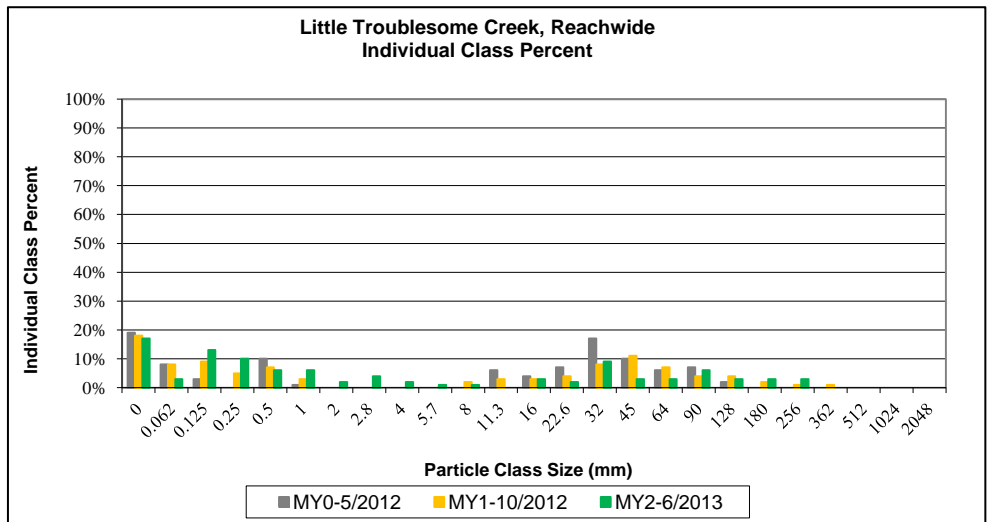
Reachwide and Cross-Section Substrate Plots  
 Little Troublesome Creek Mitigation Site (NCEEP Project No. 94640)  
 Little Troublesome Creek, Reachwide  
 Monitoring Year 2

Reachwide Channel materials (mm)	
D <sub>16</sub> =	Silt/Clay
D <sub>35</sub> =	3.4
D <sub>50</sub> =	32.0
D <sub>84</sub> =	116.3
D <sub>95</sub> =	265.0
D <sub>100</sub> =	362.0

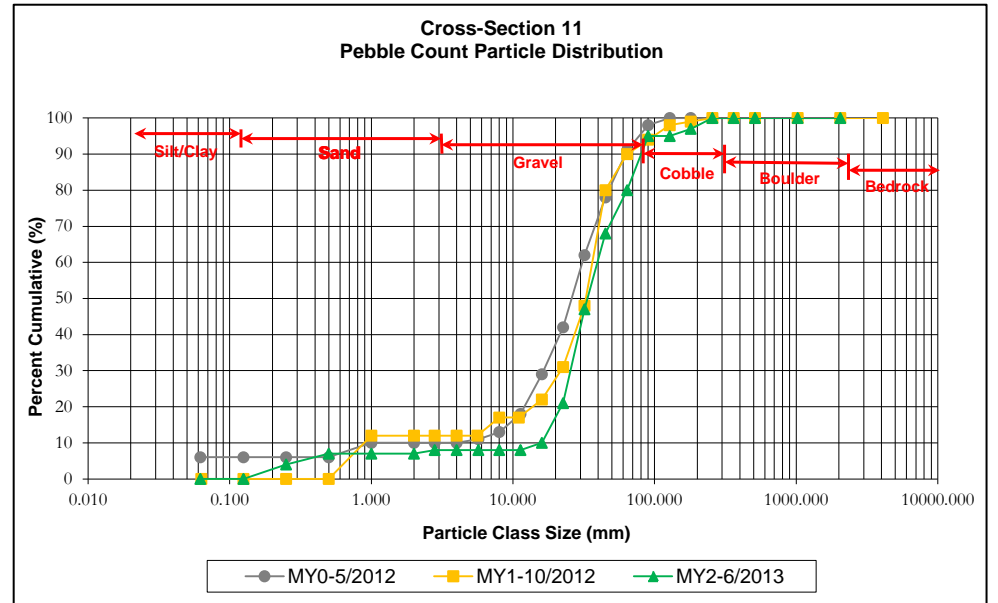
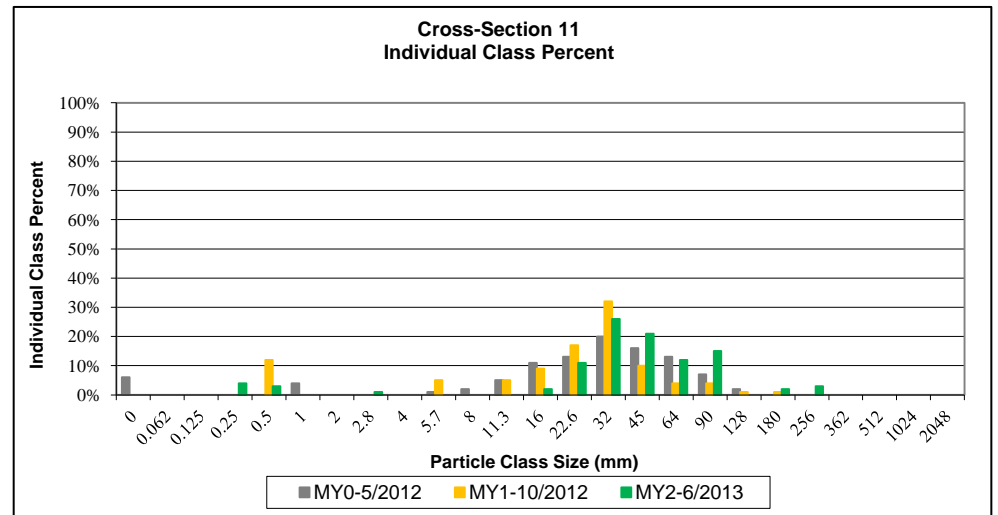
Reachwide and Cross-Section Substrate Plots  
 Little Troublesome Creek Mitigation Site (NCEEP Project No. 94640)  
 Little Troublesome Creek , Cross-Section 11 (Riffle)  
 Monitoring Year 2

Cross-Section 11 Channel materials (mm)	
D <sub>16</sub> =	27.3
D <sub>35</sub> =	38.4
D <sub>50</sub> =	47.3
D <sub>84</sub> =	98.9
D <sub>95</sub> =	180.0
D <sub>100</sub> =	362.0

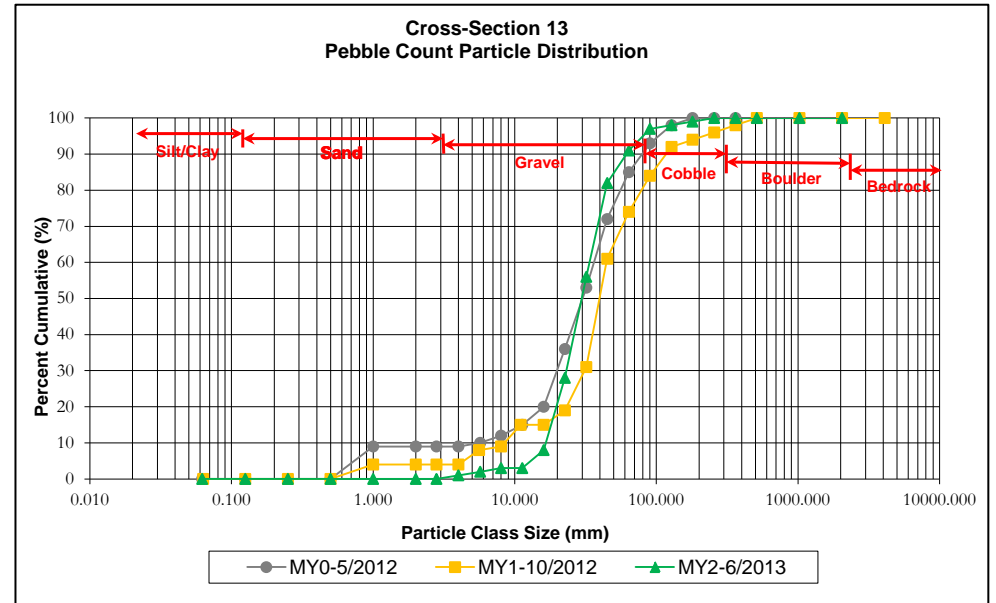
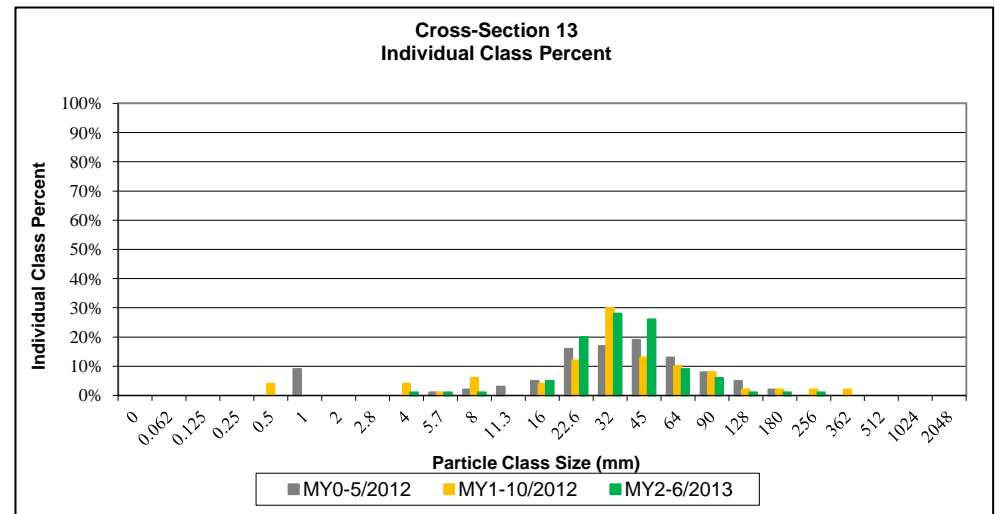
Reachwide and Cross-Section Substrate Plots  
 Little Troublesome Creek Mitigation Site (NCEEP Project No. 94640)  
 Little Troublesome Creek , Cross-Section 13 (Riffle)  
 Monitoring Year 2

Cross-Section 13 Channel materials (mm)	
D <sub>16</sub> =	26.0
D <sub>35</sub> =	34.8
D <sub>50</sub> =	41.8
D <sub>84</sub> =	69.0
D <sub>95</sub> =	113.8
D <sub>100</sub> =	362.0

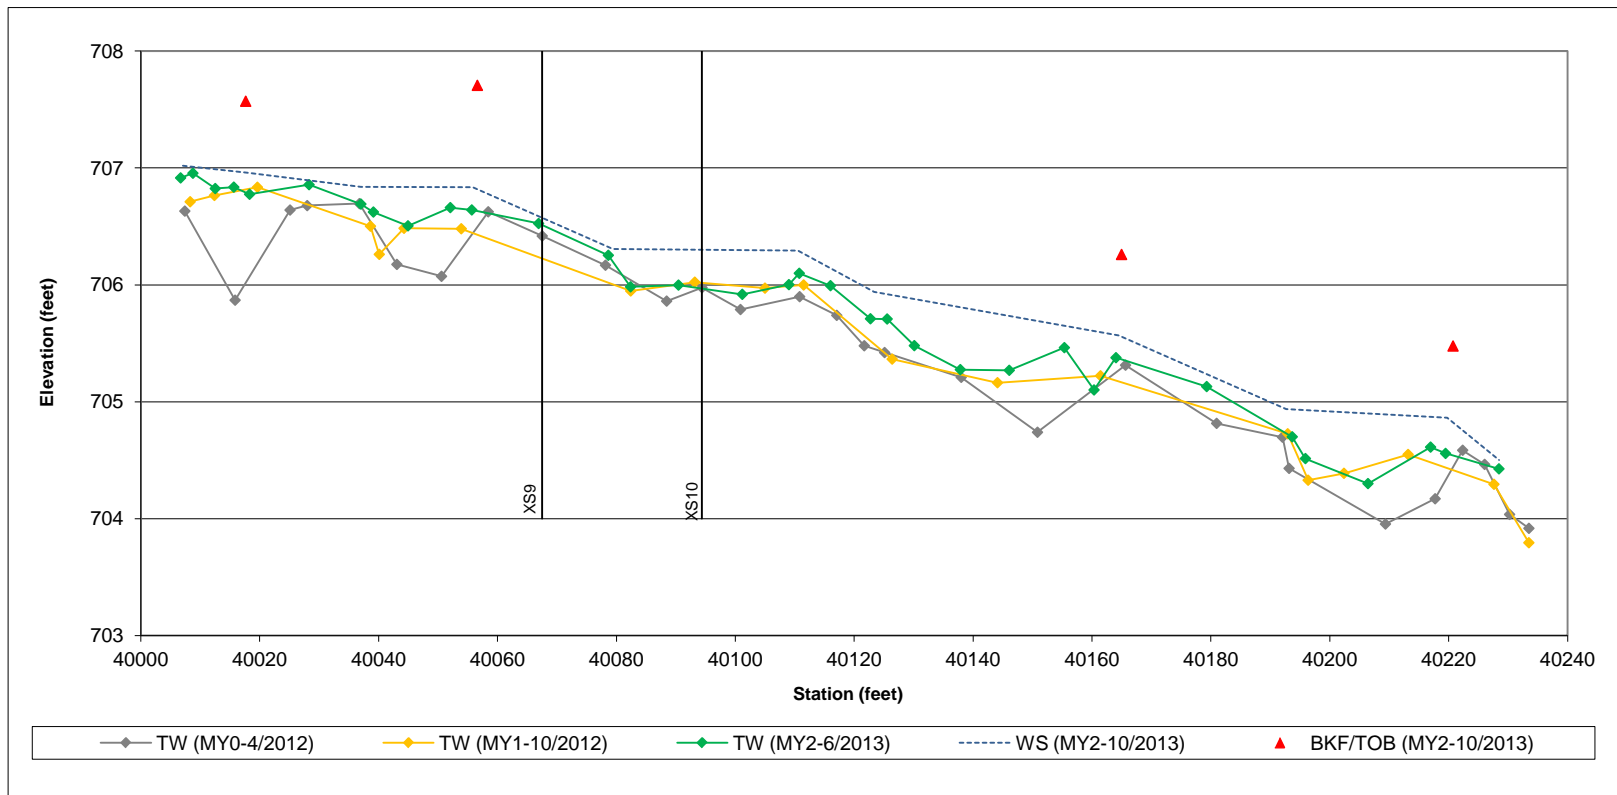
Longitudinal Profile Plots  
 Little Troublesome Creek Mitigation Site (NCEEP Project No. 94640)  
 UT1  
 Monitoring Year 2

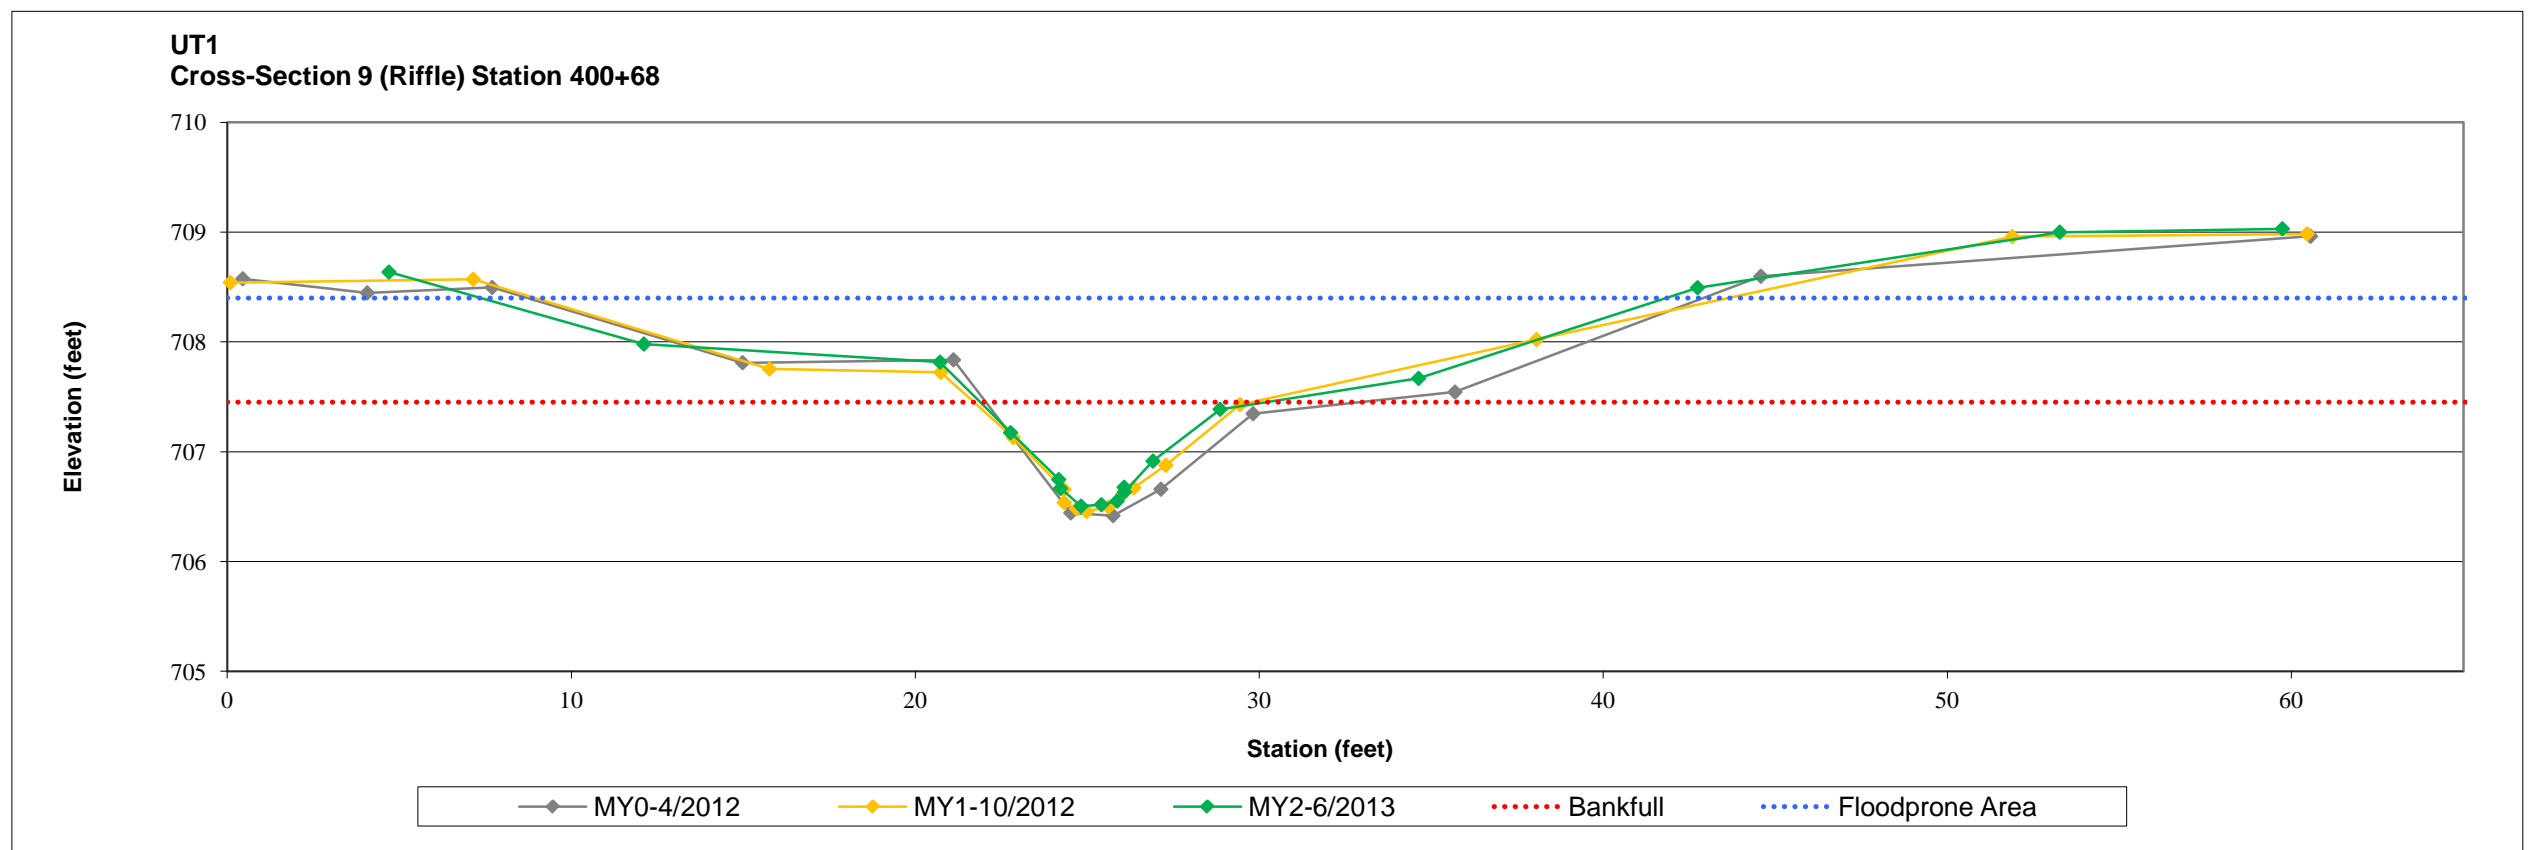
UT1, Cross-Section 9 (Riffle)

Summary Data	
Bankfull Elevation (ft)	707.5
Bankfull Cross-Sectional Area (ft <sup>2</sup> )	3.7
Bankfull Width (ft)	8.3
Flood Prone Area Elevation (ft)	708.4
Flood Prone Width (ft)	34.3
Max Depth at Bankfull (ft)	1.0
Mean Depth at Bankfull (ft)	0.5
W/D Ratio	18.5
Entrenchment Ratio	2.2+
Bank Height Ratio	1.0
Stream Type	C

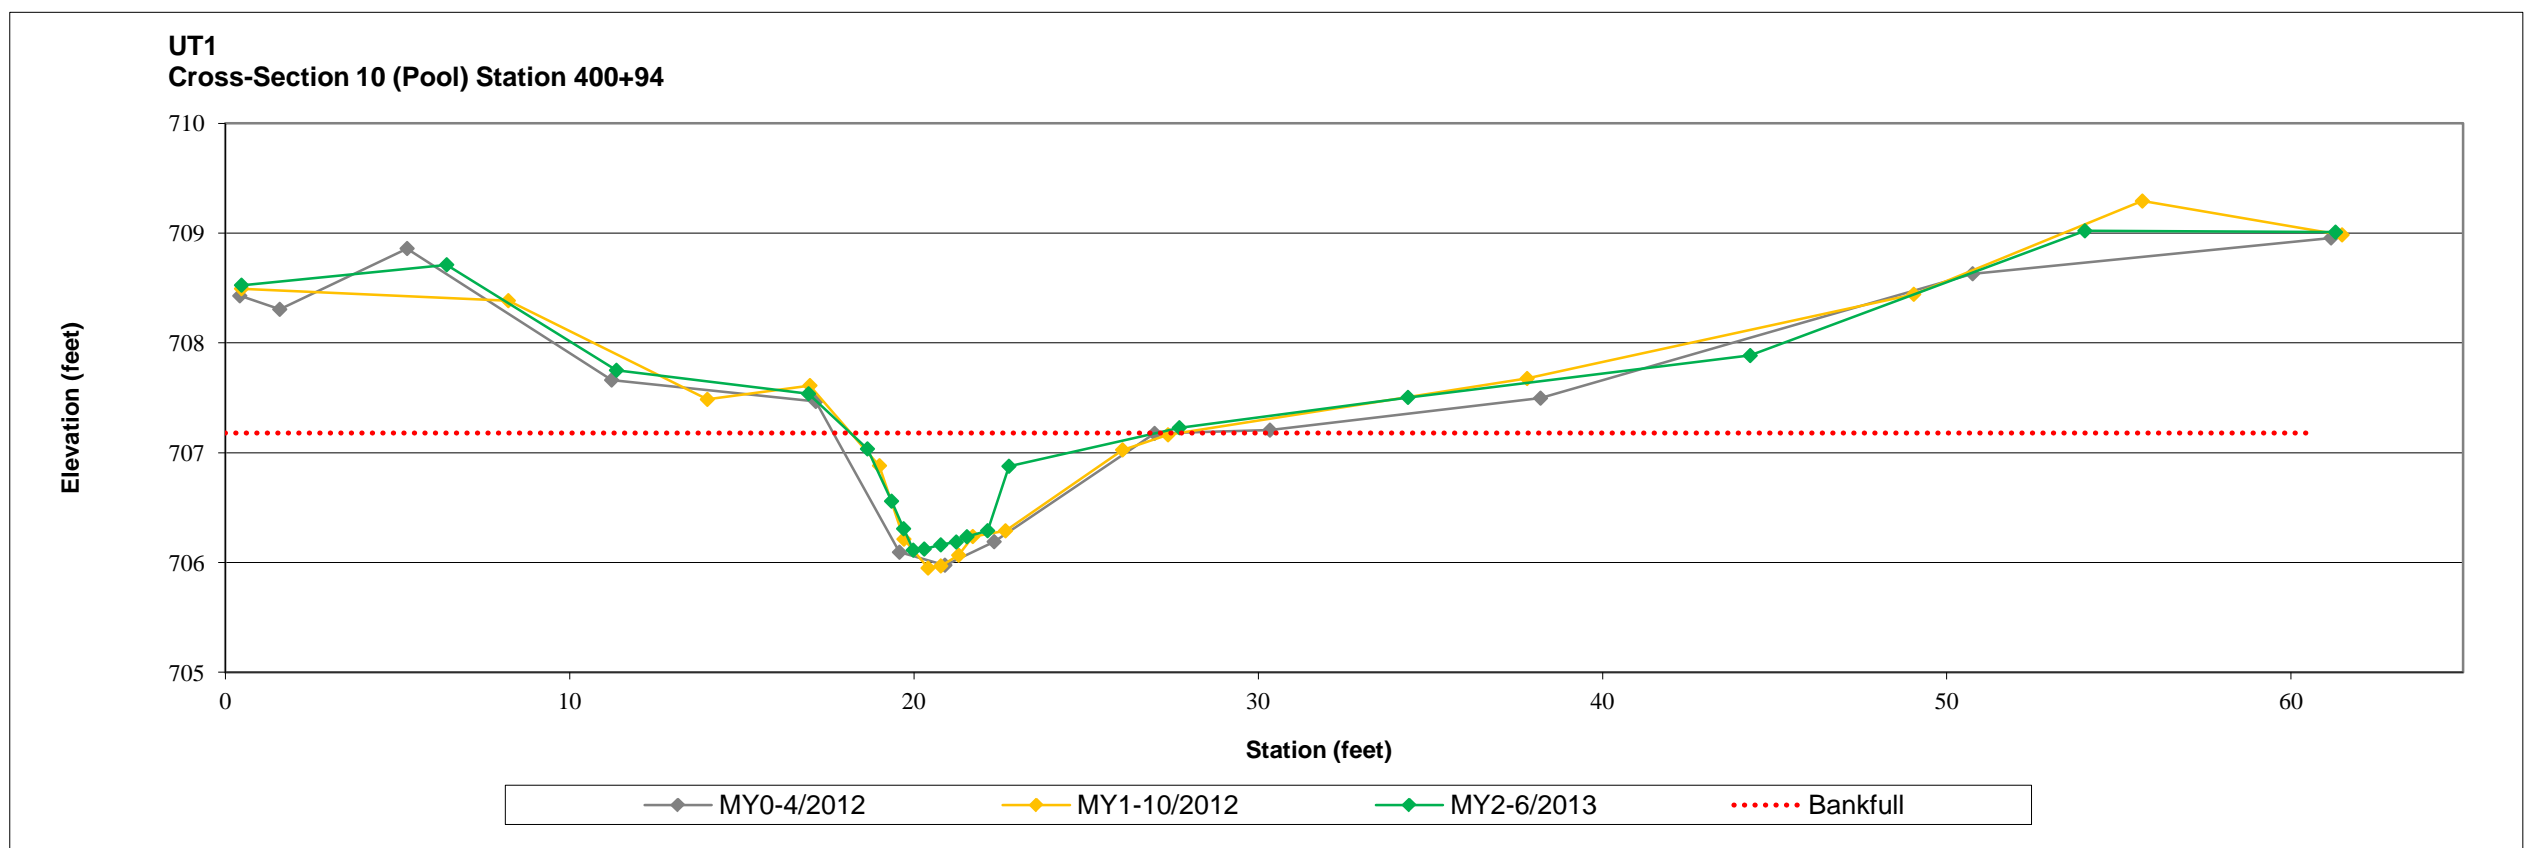
UT1, Cross-Section 10 (Pool)

Summary Data	
Bankfull Elevation (ft)	707.2
Bankfull Cross-Sectional Area (ft <sup>2</sup> )	4.0
Bankfull Width (ft)	8.9
Flood Prone Area Elevation (ft)	N/A
Flood Prone Width (ft)	N/A
Max Depth at Bankfull (ft)	1.1
Mean Depth at Bankfull (ft)	0.5
W/D Ratio	19.7
Entrenchment Ratio	N/A
Bank Height Ratio	1.0
Stream Type	N/A

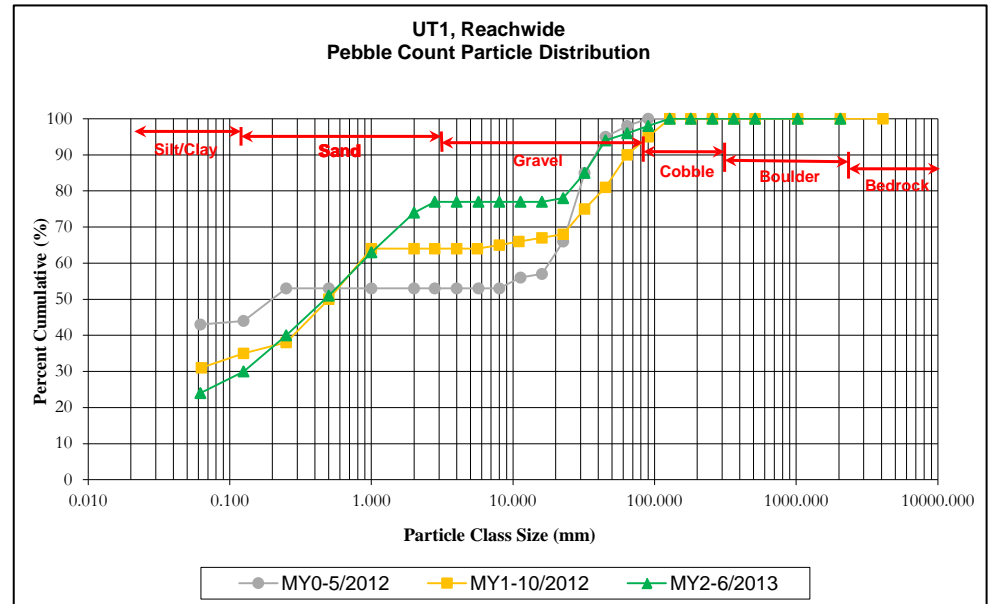
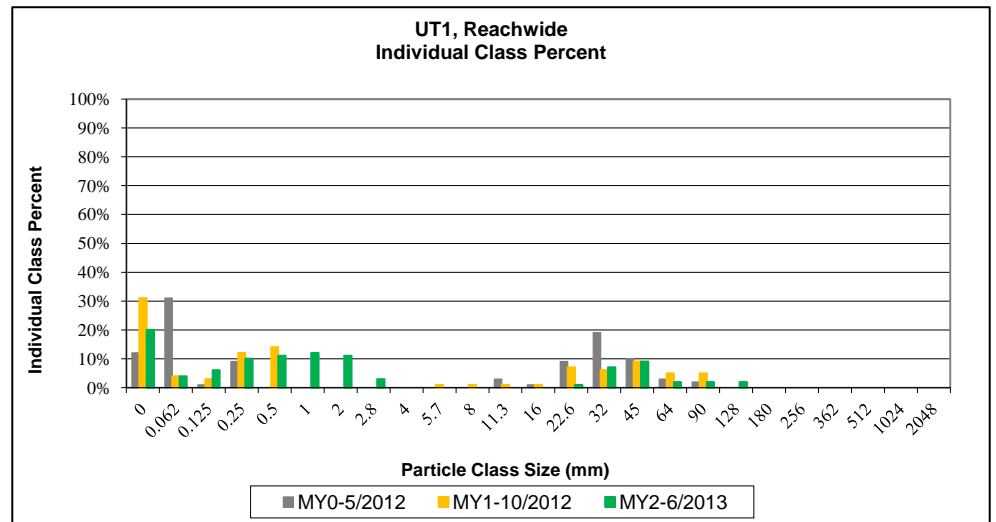
Reachwide Channel materials (mm)	
D <sub>16</sub> =	Silt/ Clay
D <sub>35</sub> =	0.4
D <sub>50</sub> =	0.9
D <sub>84</sub> =	42.9
D <sub>95</sub> =	75.9
D <sub>100</sub> =	180.0

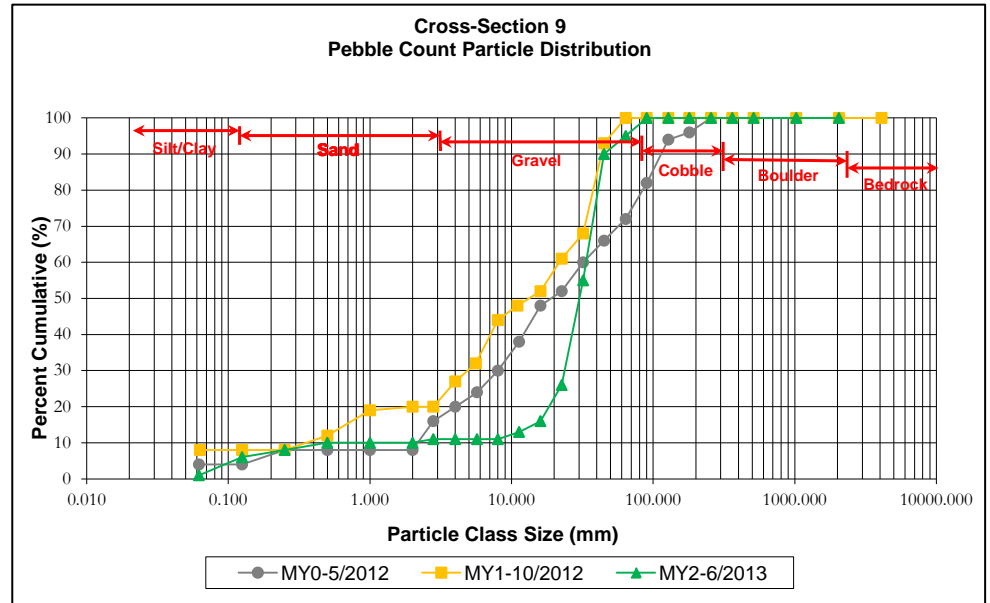
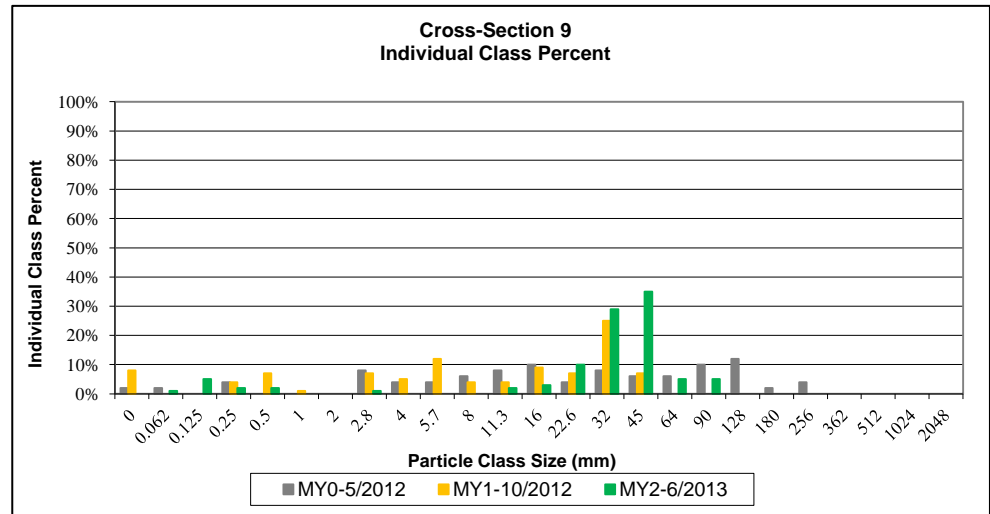
Reachwide and Cross-Section Substrate Plots  
 Little Troublesome Creek Mitigation Site (NCEP Project No. 94640)  
 UT1, Cross-Section 9 (Riffle)  
 Monitoring Year 2

Particle Class		Diameter (mm)		Particle Count	Cross-Section 9 Summary	
		min	max		Class Percentage	Percent Cumulative
SILT/CLAY		0.000	0.062			0
SAND	Very fine	0.062	0.125	1	1	1
	Fine	0.125	0.250	5	5	6
	Medium	0.250	0.500	2	2	8
	Coarse	0.5	1.0	2	2	10
	Very Coarse	1.0	2.0			10
GRAVEL	Very Fine	2.0	2.8			10
	Very Fine	2.8	4.0	1	1	11
	Fine	4.0	5.7			11
	Fine	5.7	8.0			11
	Medium	8.0	11.3			11
	Medium	11.3	16.0	2	2	13
	Coarse	16.0	22.6	3	3	16
	Coarse	22.6	32	10	10	26
	Very Coarse	32	45	29	29	55
	Very Coarse	45	64	35	35	90
COBBLES	Small	64	90	5	5	95
	Small	90	128	5	5	100
	Large	128	180			100
	Large	180	256			100
BOULDER	Small	256	362			100
	Small	362	512			100
	Medium	512	1024			100
	Large/Very Large	1024	2048			100
BEDROCK	Bedrock	2048	>2048			100
<b>Total</b>				<b>100</b>	<b>100</b>	<b>100</b>

Cross-Section 9 Channel materials (mm)	
D <sub>16</sub> =	22.6
D <sub>35</sub> =	35.6
D <sub>50</sub> =	42.4
D <sub>84</sub> =	60.2
D <sub>95</sub> =	90.0
D <sub>100</sub> =	128.0

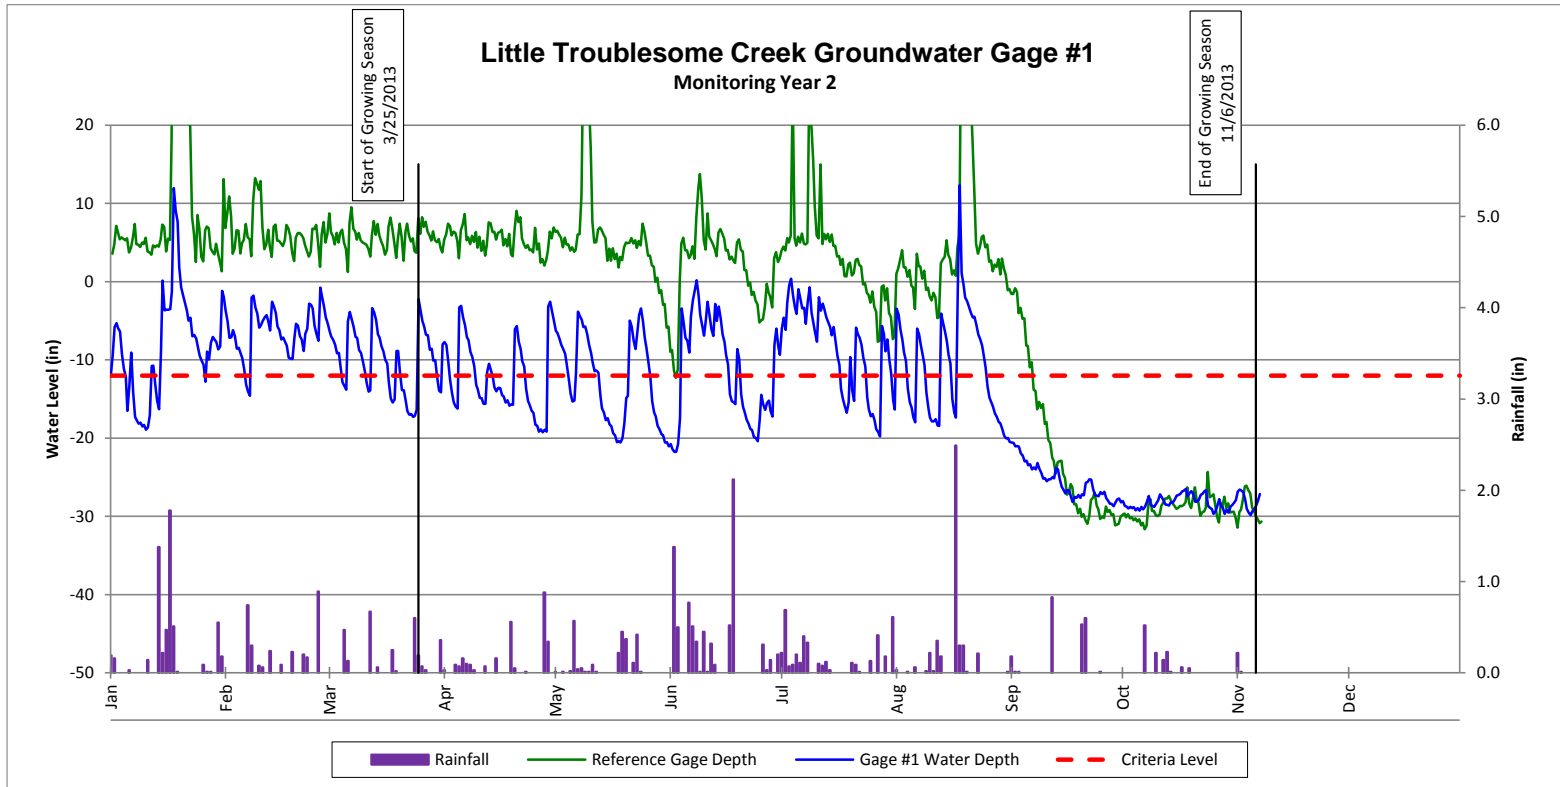
**Groundwater Gage Plots**  
**Little Troublesome Creek Wetland (EEP Project No. 94640)**  
**Wetland RW1**  
**Monitoring Year 2**

Summary of Groundwater Gage Results for Years 1 through 7							
Gage	Success Criteria Achieved/Max Consecutive Days During Growing Season (Percentage)						
	Year 1 (2012)	Year 2 (2013)	Year 3 (2014)	Year 4 (2015)	Year 5 (2016)	Year 6 (2017)	Year 7 (2018)
1	No/5.5 Days (2.4%)	Yes/18.0 Days (8.0%)					
2	Yes/26/5 Days (11.7%)	Yes/61.5 Days (27.2%)					
3	Yes/87.5 Days (38.7%)	Yes/195.5 Days (86.5%)					
4	Yes/65.5 Days (29%)	Yes/165.5 Days (73.2%)					
5	Yes/60.5 Days (26.8%)	Yes/24.0 Days (10.6%)					
6	No/6.0 Days (2.7%)	Yes/17.5 Days (7.7%)					
7	Yes/83.0 Days (36.7%)	Yes/70.0 Days (31.0%)					
8	No/11.5 Days (5.1%)	Yes/31.5 Days (13.9%)

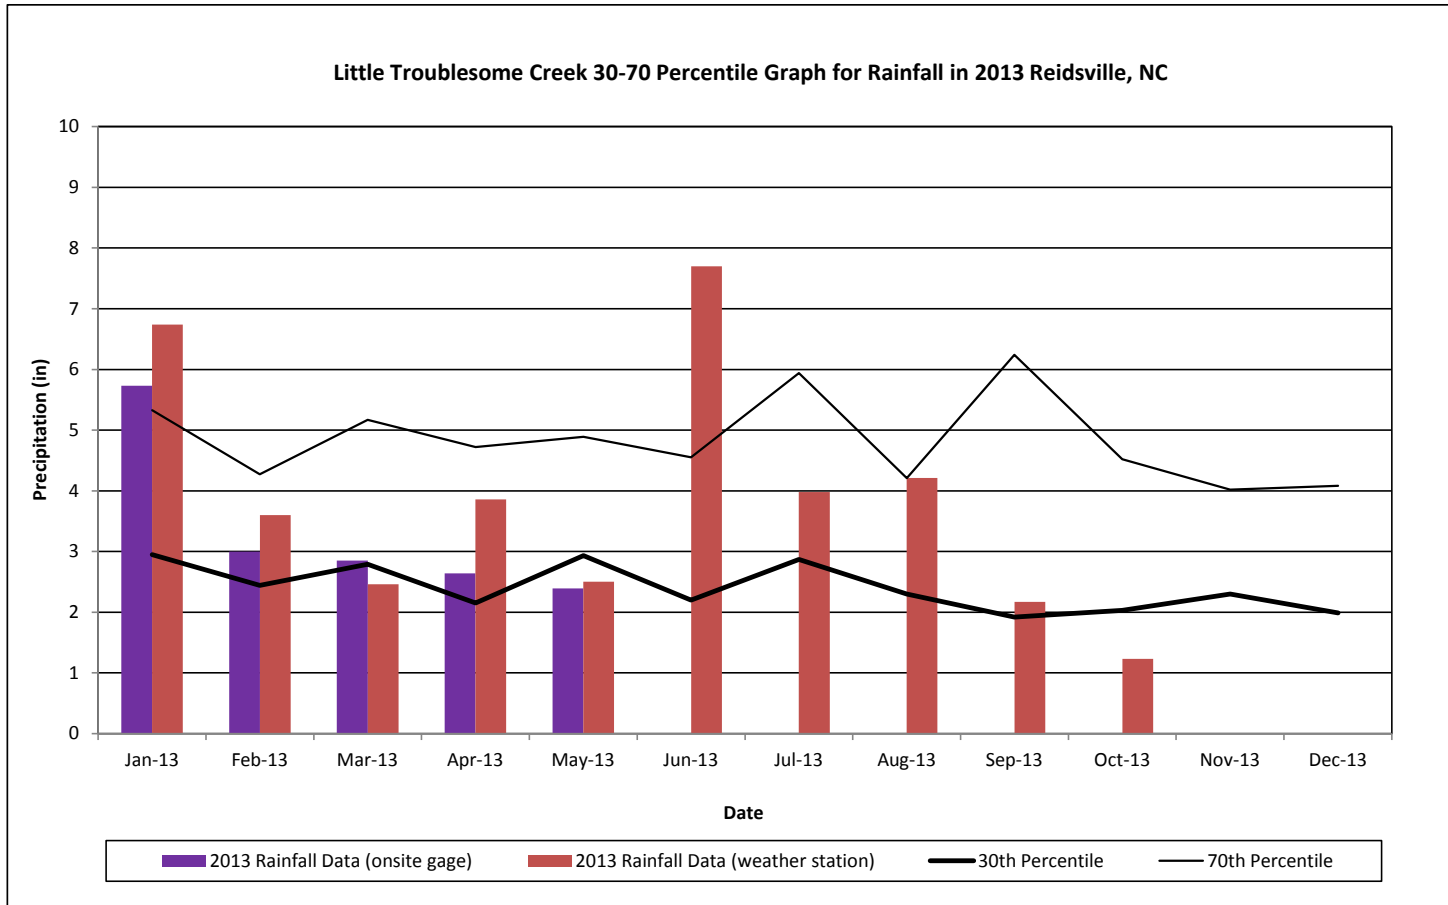
Monthly Rainfall Data  
 Little Troublesome Creek Mitigation Site (NCEP Project No. 94640)  
 Monitoring Year 2

<sup>1</sup> 2013 monthly rainfall collected by onsite rainfall gage, and the ECONet weather station "REID" at Upper Piedmont Research Station, Reidsville, NC (NCSCO, 2013)

<sup>2</sup> 30th and 70th percentile rainfall data collected from weather station NC7202, in Reidsville, NC (USDA, 2002).
