MONITORING YEAR 3 ANNUAL REPORT Final

LITTLE TROUBLESOME CREEK MITIGATION SITE
Rockingham County, NC
DENR Contract 003267
NCEEP Project Number 94640

Data Collection Period: May 2014-November 2014
Draft Submission Date: December 1, 2014
Final Submission Date: December 19, 2014

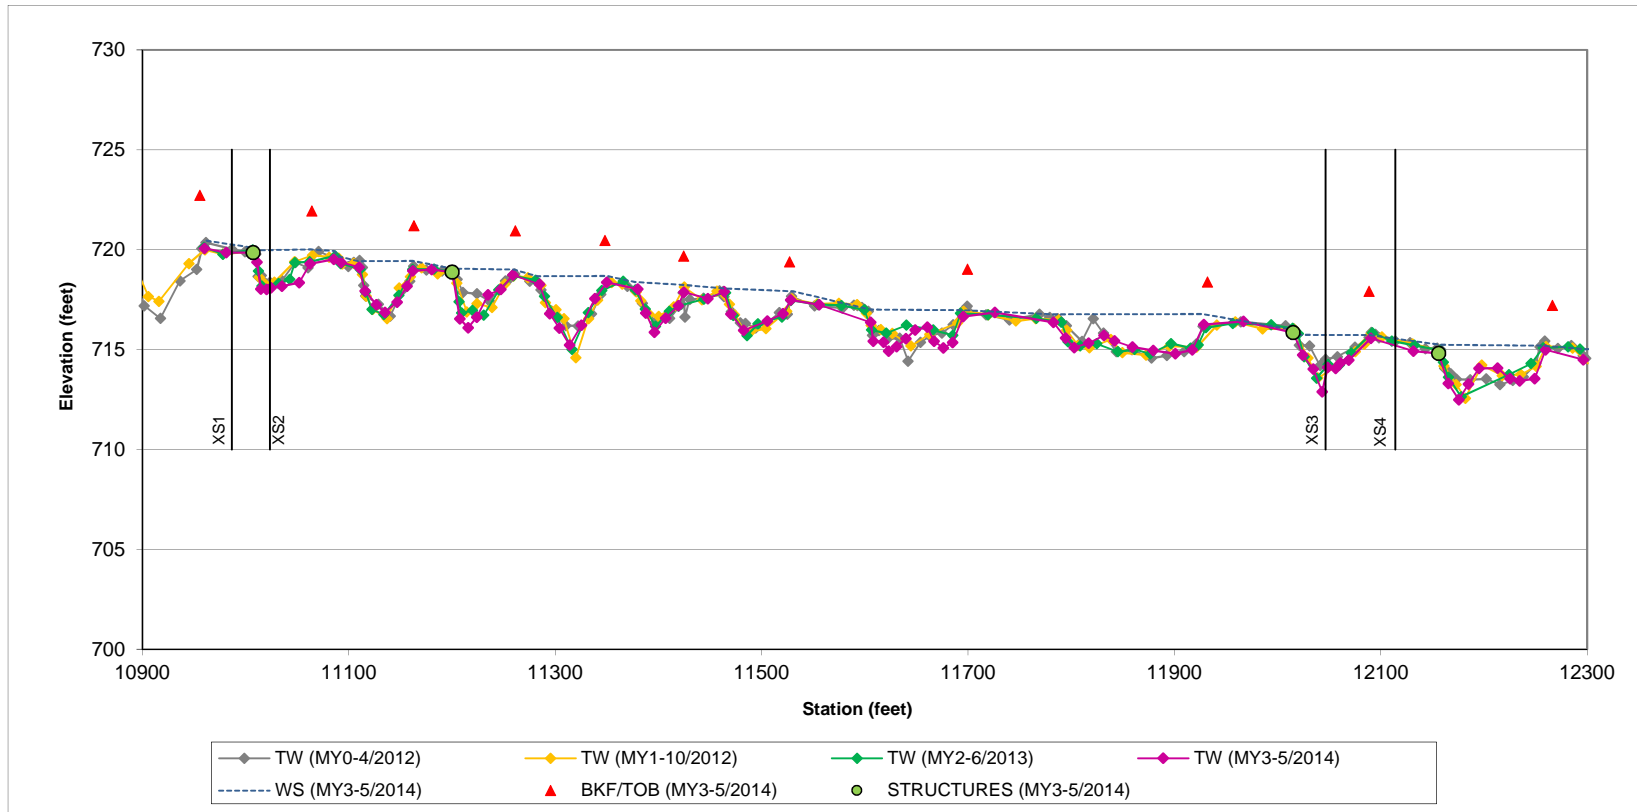
Longitudinal Profile Plots
Little Troublesome Creek Mitigation Site (NCEEP Project No. 94640)
Irvin Creek Reach 1
Monitoring Year 3

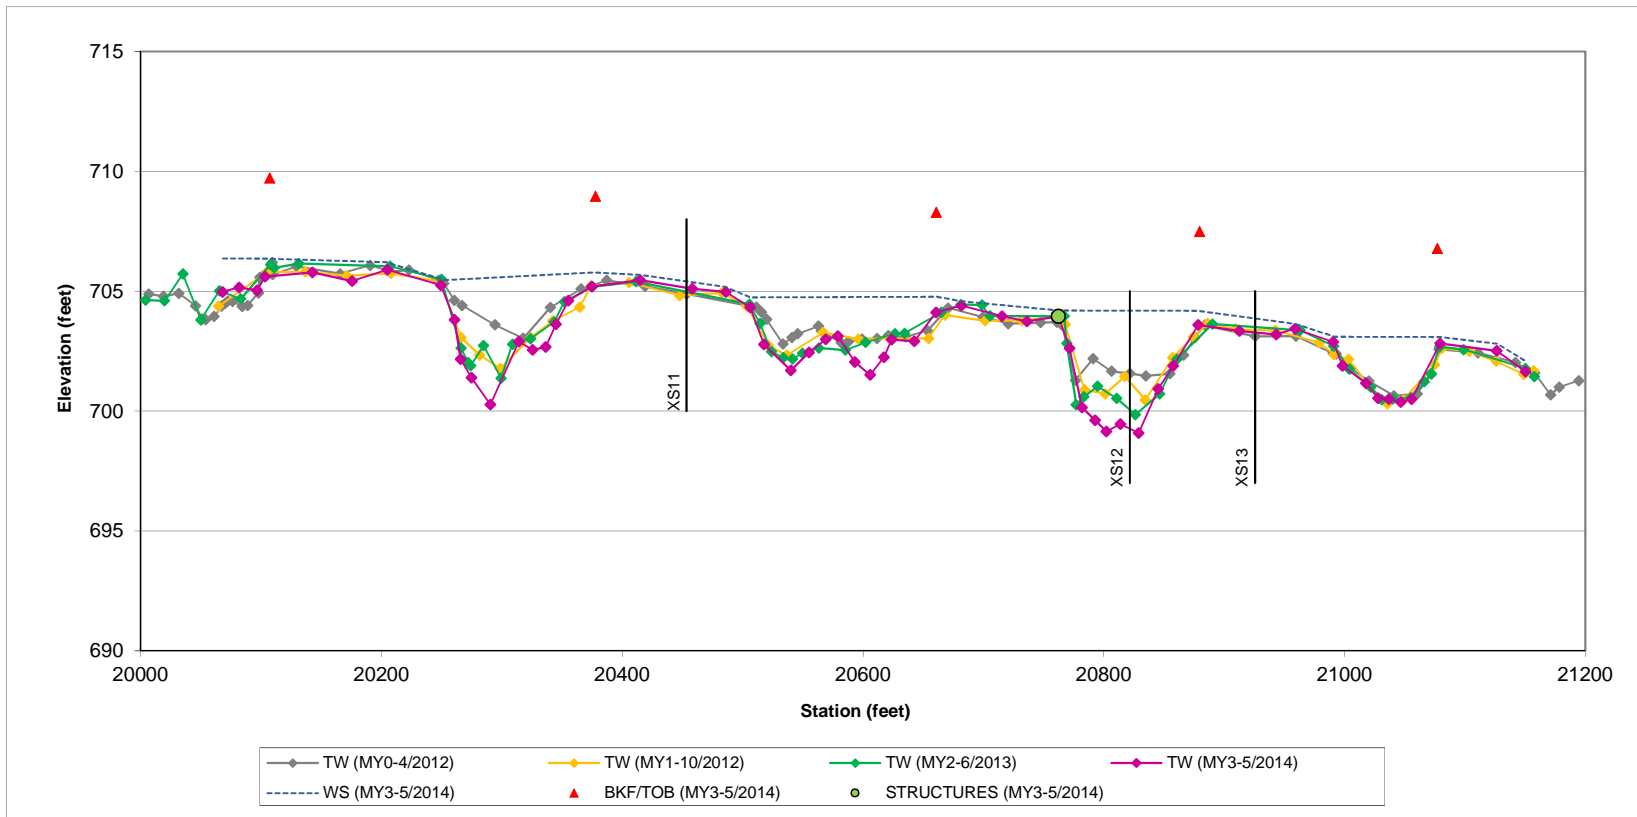
Longitudinal Profile Plots
Little Troublesome Creek Mitigation Site (NCEEP Project No. 94640)
Little Troublesome Creek
Monitoring Year 3

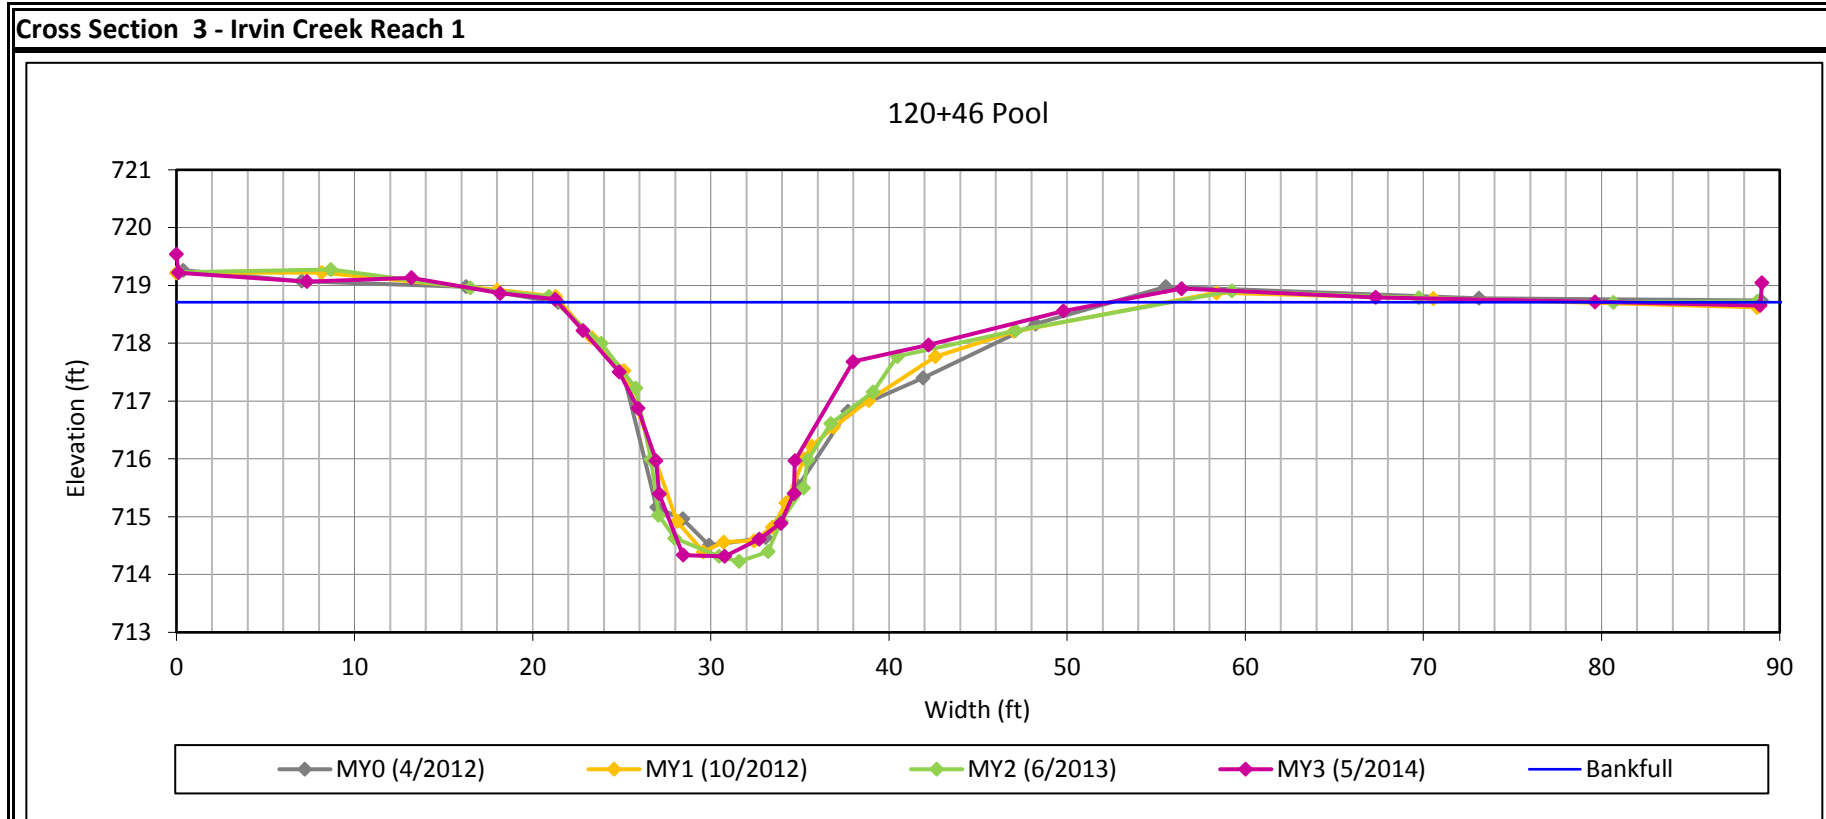
Cross-Section Plots
 Little Troublesome Creek Mitigation Site (NCEEP Project No. 94640)
 Monitoring Year 3

Bankfull Dimensions

51.4	x-section area (ft.sq.)
39.1	width (ft)
1.3	mean depth (ft)
4.4	max depth (ft)
41.9	wetted parimeter (ft)
1.2	hyd radi (ft)
29.8	width-depth ratio

Survey Date: 5/2014
 Field Crew: Wildlands Engineering

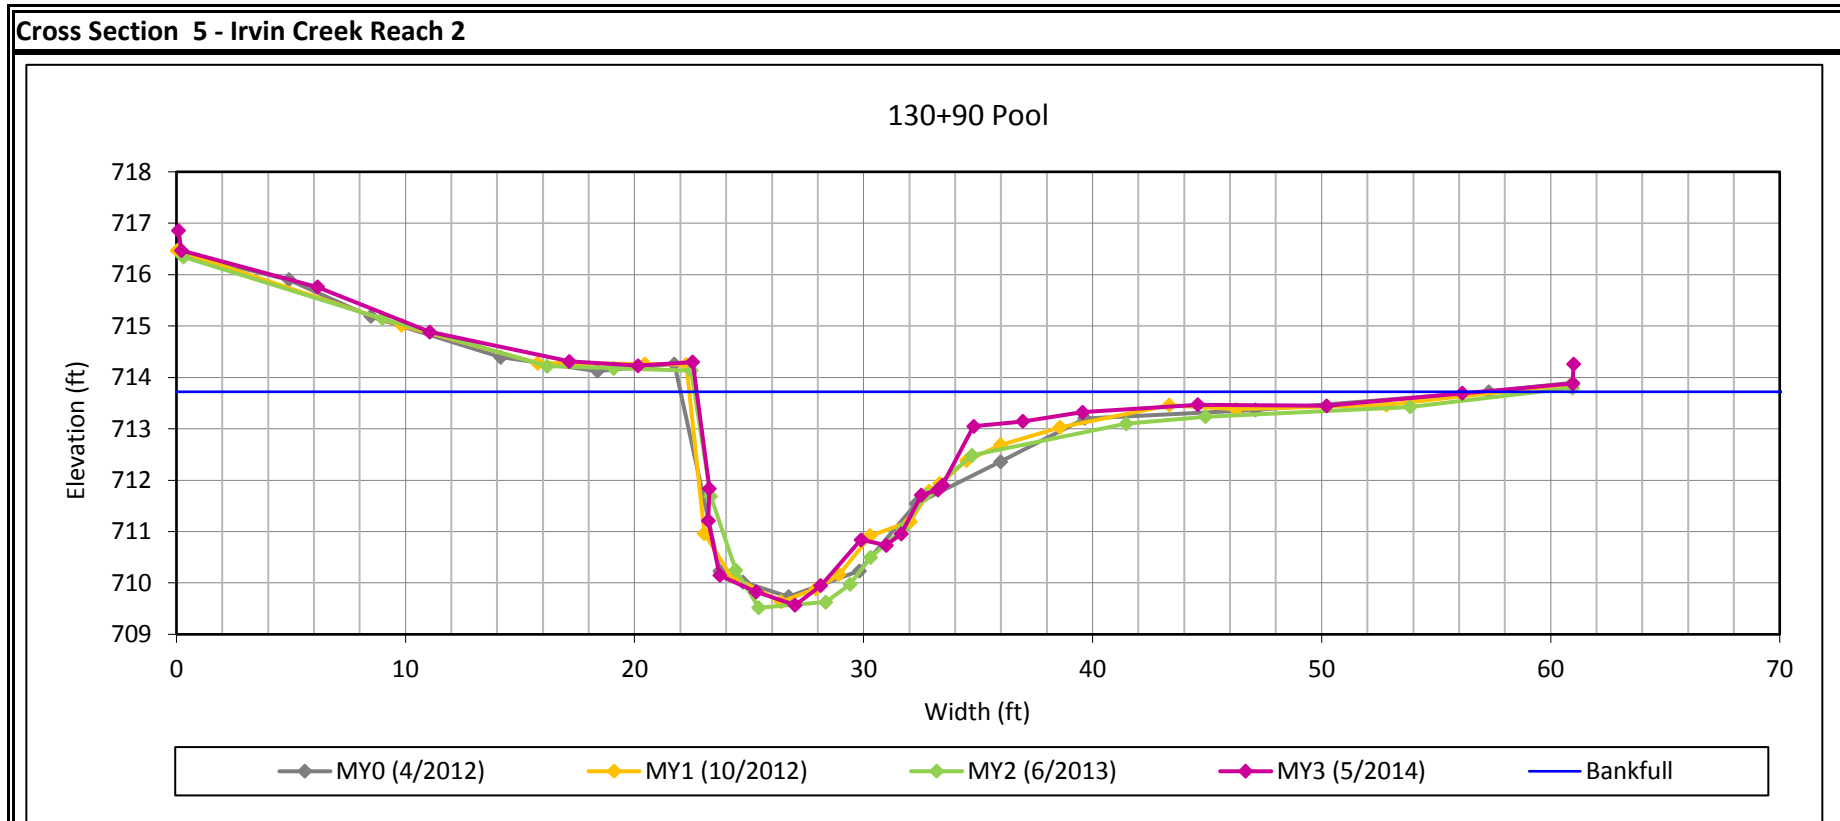
Cross-Section Plots
 Little Troublesome Creek Mitigation Site (NCEEP Project No. 94640)
 Monitoring Year 3

Bankfull Dimensions

42.3	x-section area (ft.sq.)
34.2	width (ft)
1.2	mean depth (ft)
4.1	max depth (ft)
38.1	wetted parimeter (ft)
1.1	hyd radi (ft)
27.6	width-depth ratio

Survey Date: 5/2014
 Field Crew: Wildlands Engineering

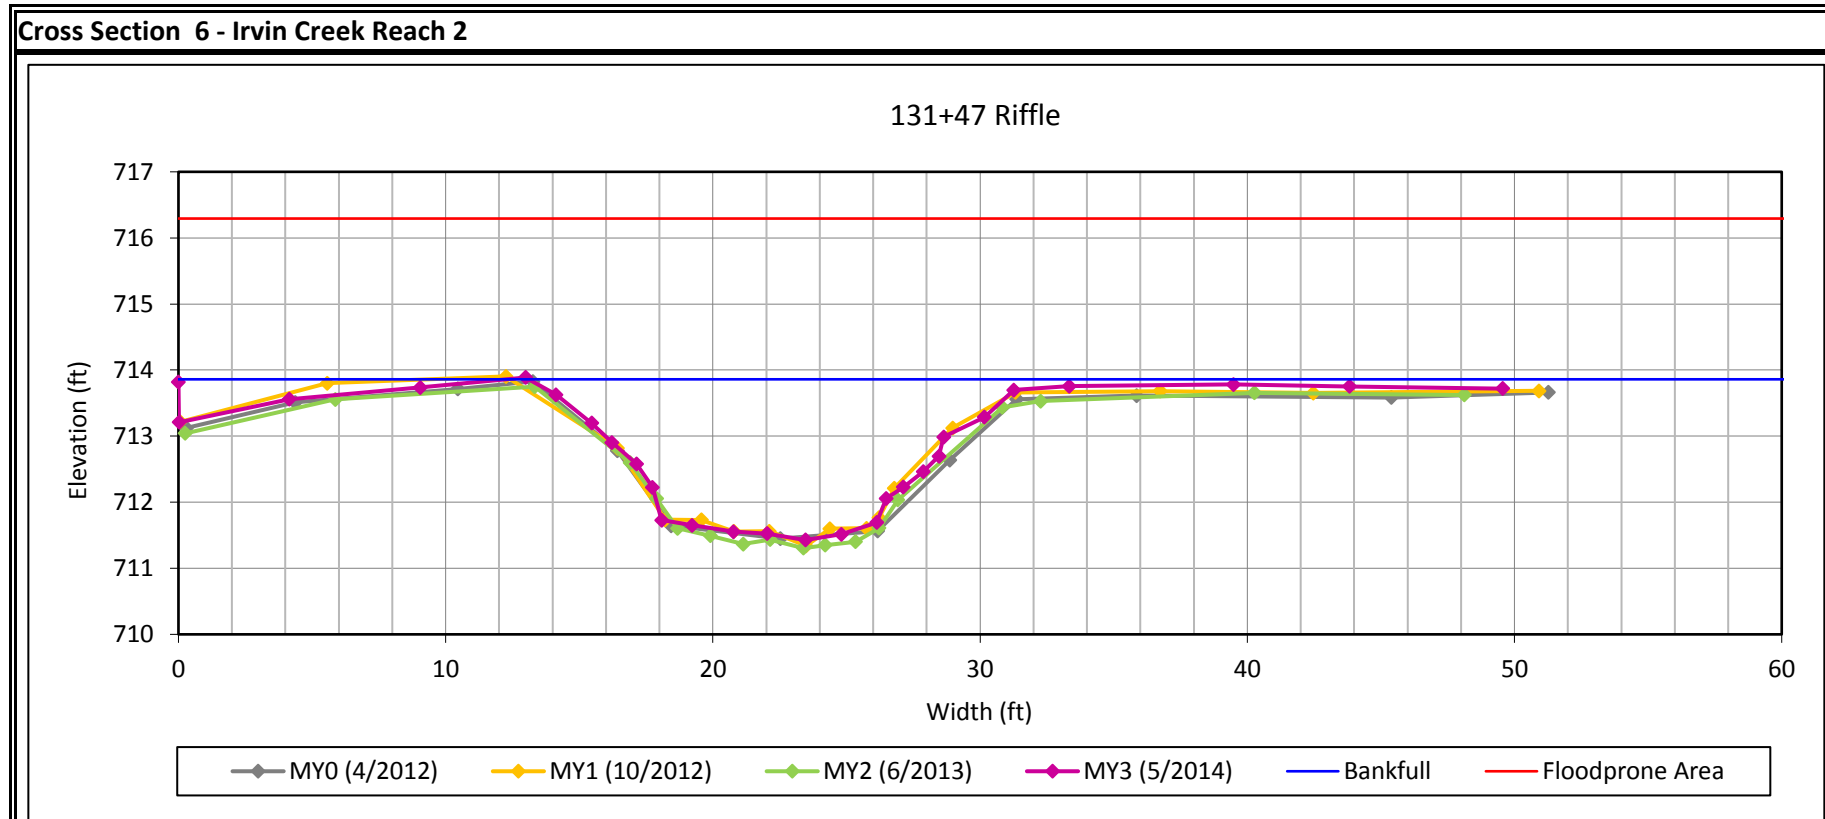
Cross-Section Plots
 Little Troublesome Creek Mitigation Site (NCEEP Project No. 94640)
 Monitoring Year 3

Bankfull Dimensions

27.8	x-section area (ft.sq.)
18.2	width (ft)
1.5	mean depth (ft)
2.4	max depth (ft)
19.3	wetted parimeter (ft)
1.4	hyd radi (ft)
11.9	width-depth ratio
---	W flood prone area (ft)
---	entrenchment ratio
---	low bank height ratio

Survey Date: 5/2014
 Field Crew: Wildlands Engineering

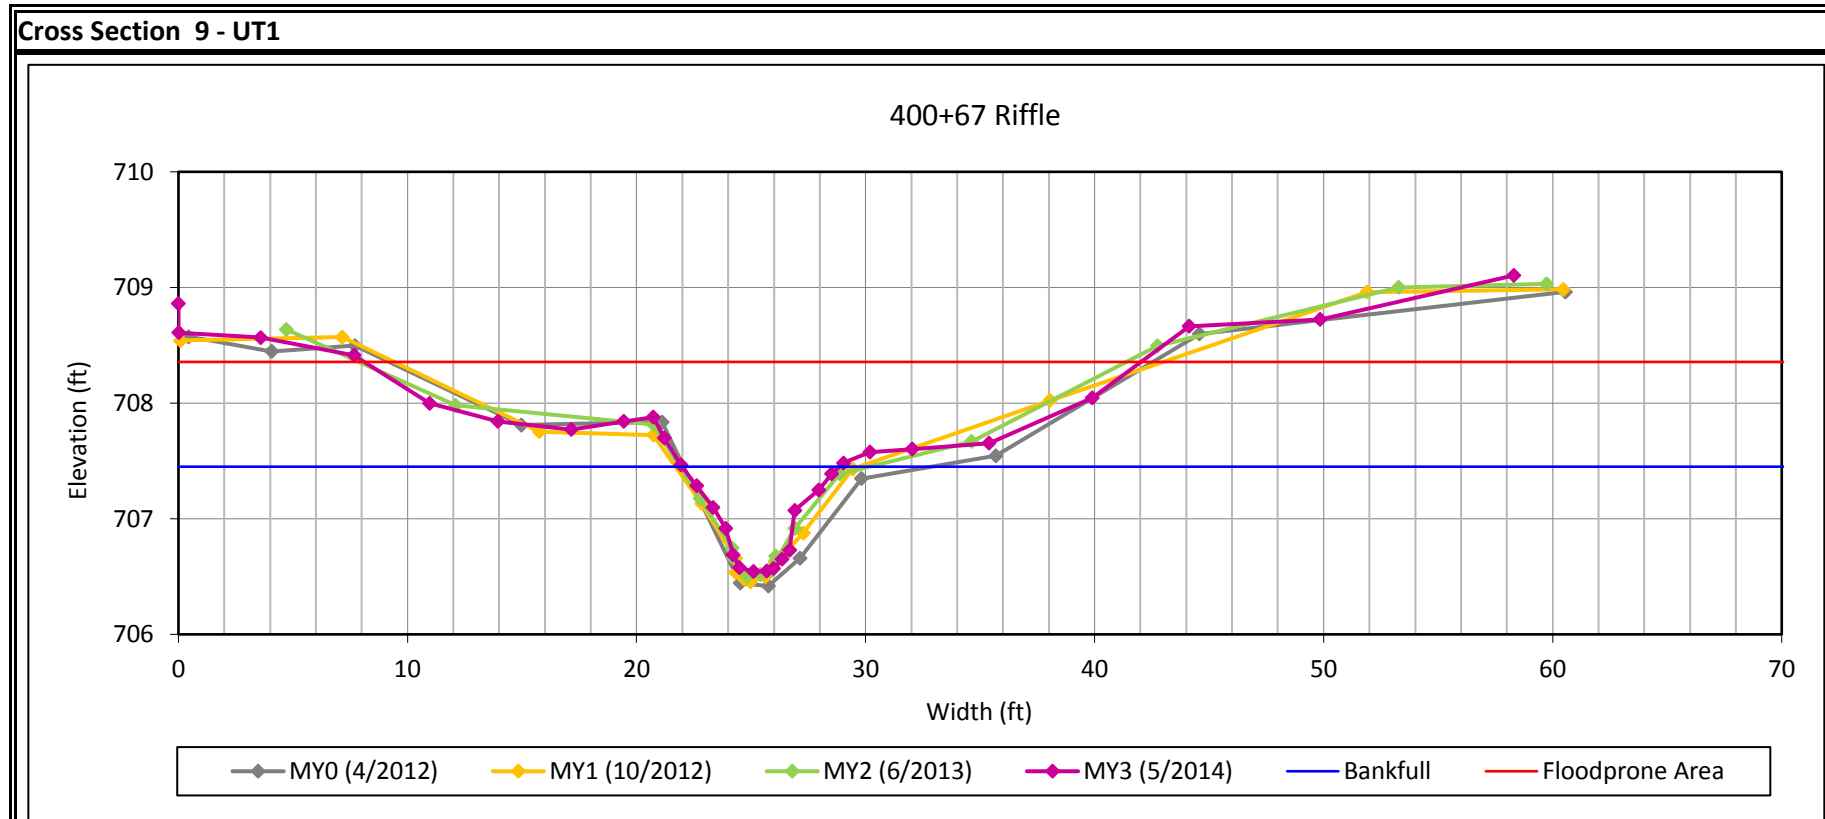
Cross-Section Plots
 Little Troublesome Creek Mitigation Site (NCEEP Project No. 94640)
 Monitoring Year 3

Bankfull Dimensions

3.3	x-section area (ft.sq.)
6.9	width (ft)
0.5	mean depth (ft)
0.9	max depth (ft)
7.3	wetted parimeter (ft)
0.5	hyd radi (ft)
14.2	width-depth ratio
33.9	W flood prone area (ft)
4.9	entrenchment ratio
---	low bank height ratio

Survey Date: 5/2014
 Field Crew: Wildlands Engineering

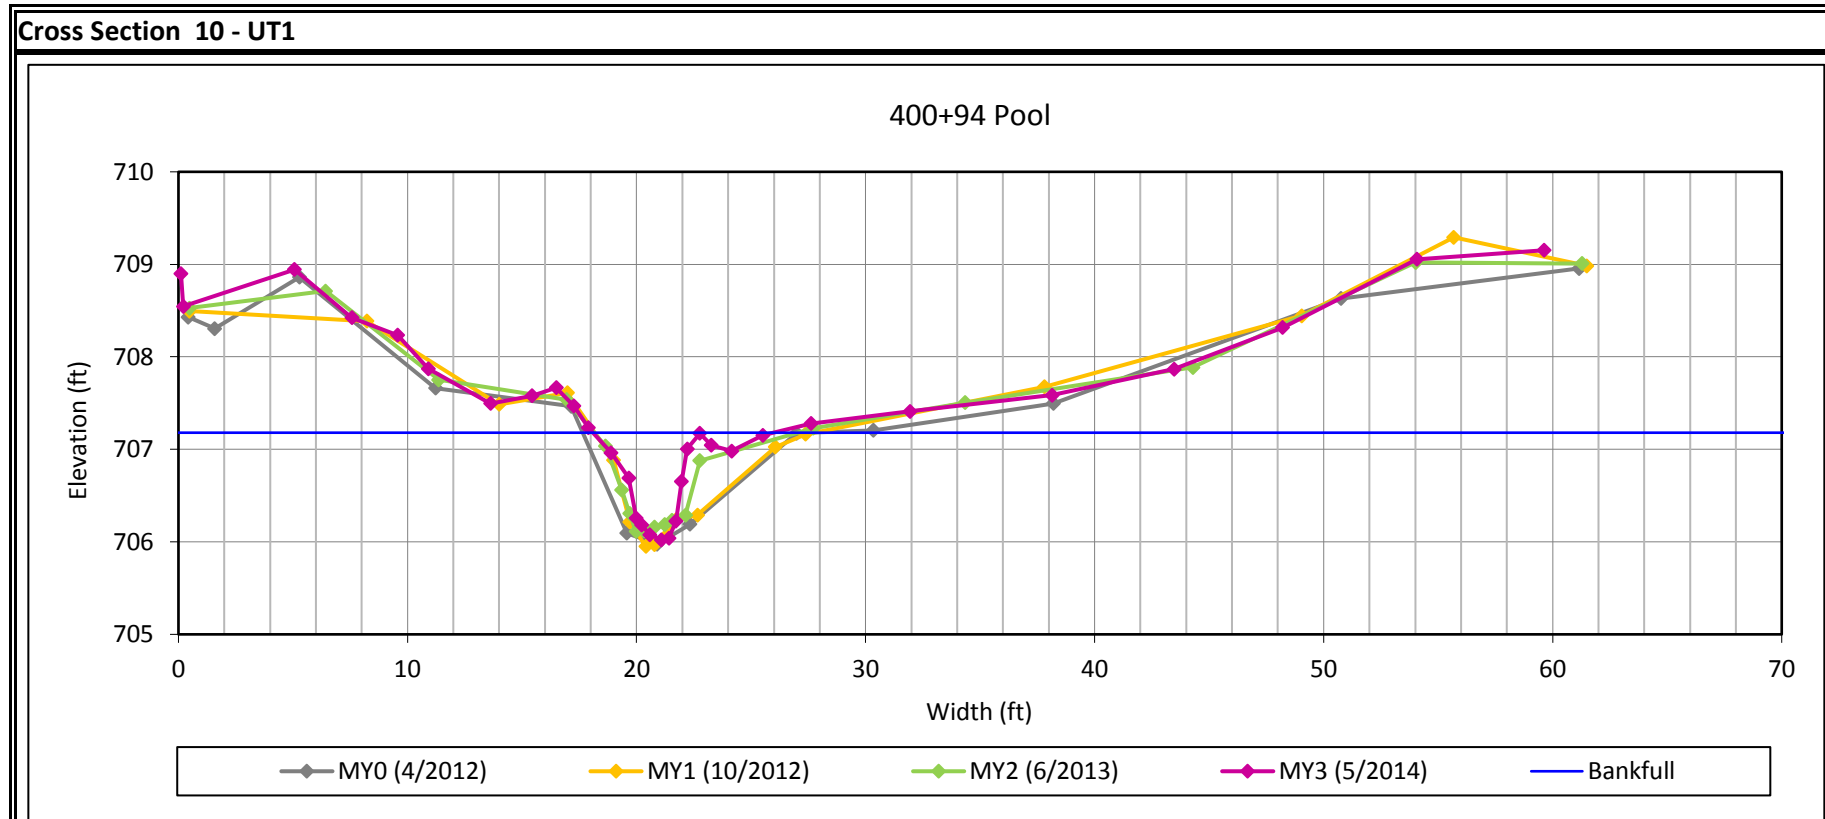
Cross-Section Plots
 Little Troublesome Creek Mitigation Site (NCEEP Project No. 94640)
 Monitoring Year 3

Bankfull Dimensions

3.1	x-section area (ft.sq.)
7.9	width (ft)
0.4	mean depth (ft)
1.2	max depth (ft)
8.7	wetted parimeter (ft)
0.4	hyd radi (ft)
19.9	width-depth ratio

Survey Date: 5/2014
 Field Crew: Wildlands Engineering

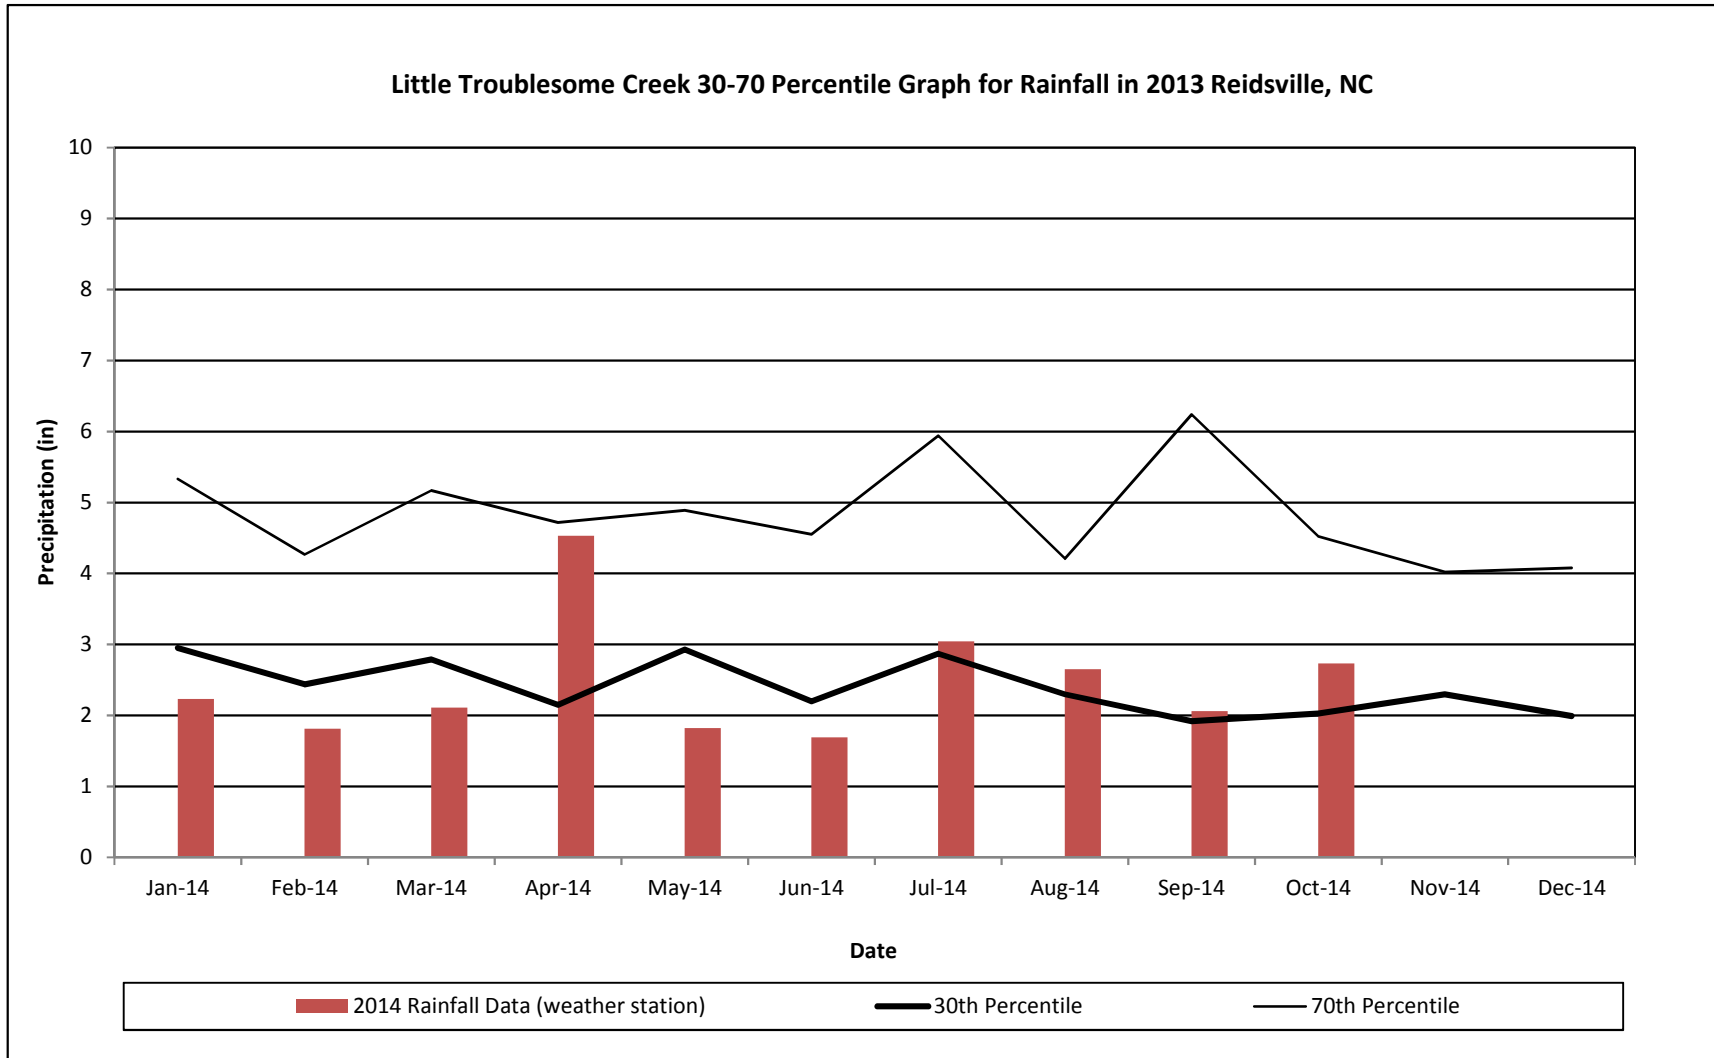
Monthly Rainfall Data
Little Troublesome Creek Mitigation Site (NCEEP Project No. 94640)
Monitoring Year 3

¹ 2014 monthly rainfall collected by Weather Underground Station KNCBROWN2 (Reidsville, NC).

² 30th and 70th percentile rainfall data collected from weather station NC7202, in Reidsville, NC (USDA, 2002).
